**2020 ANNUAL REPORT ON
THE CONDITION OF THE MUNICIPAL BEACHES FOR
THE BOROUGH OF STONE HARBOR, CAPE MAY COUNTY, NEW JERSEY**

**PREPARED FOR: THE BOROUGH OF STONE HARBOR
9508 SECOND AVENUE
STONE HARBOR, NJ 08247**

**PREPARED BY: THE STOCKTON UNIVERSITY COASTAL RESEARCH CENTER
30 WILSON AVENUE
PORT REPUBLIC, NEW JERSEY 08241**

January 15, 2021

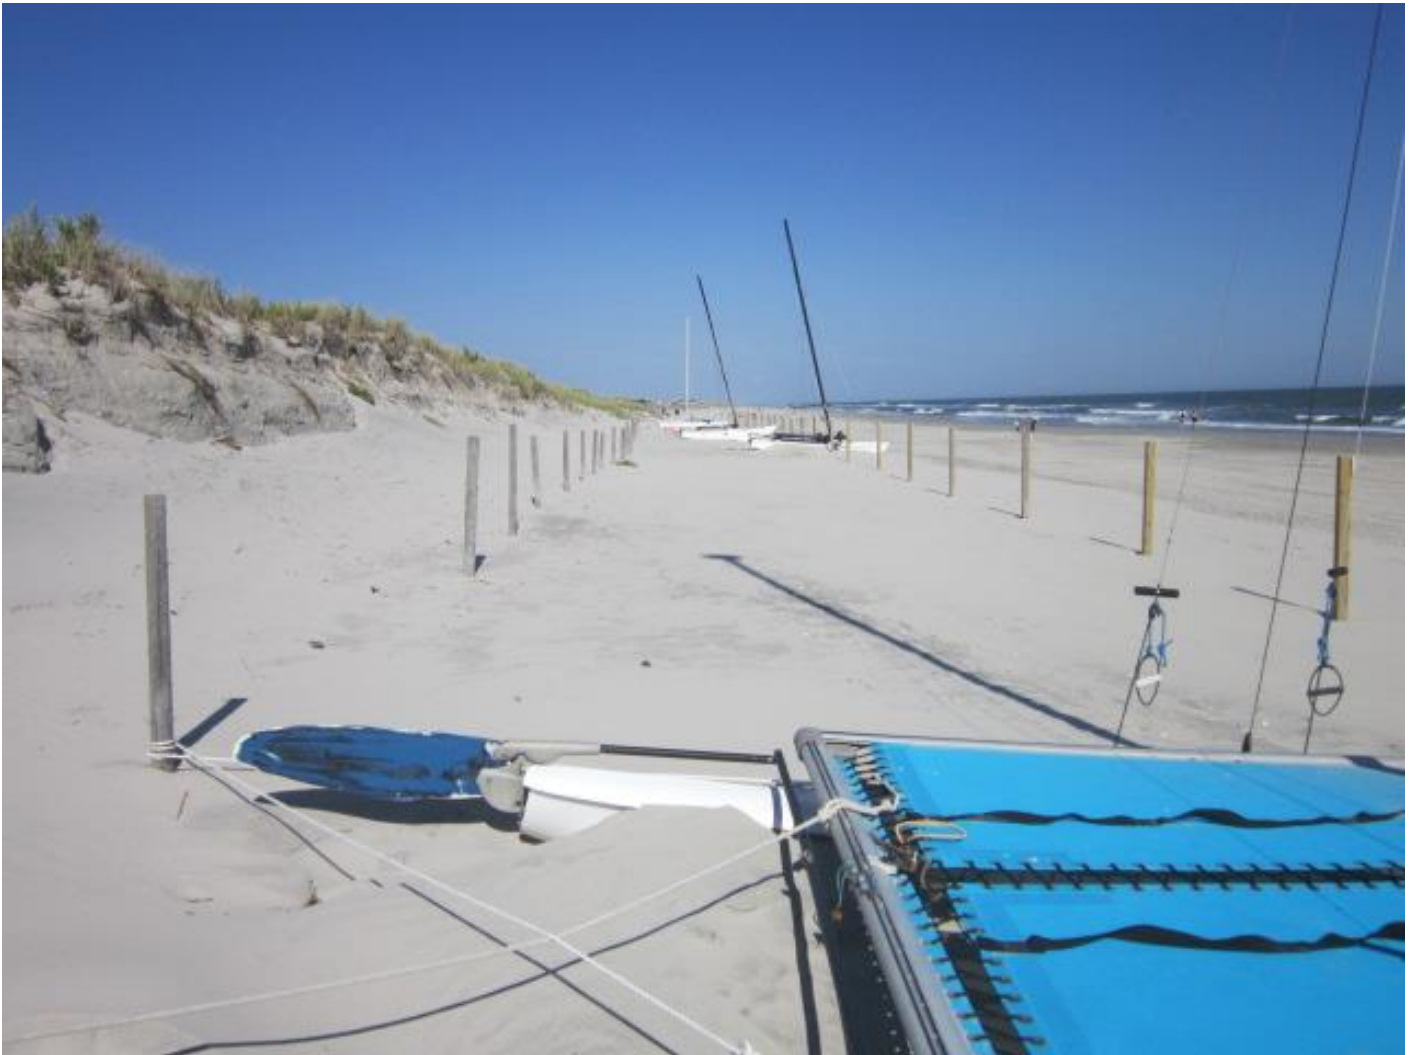
This view to the north along the 123rd Street survey line as of October 4, 2020 a year after the view presented on the cover for the 2019 report. This view shows the best outcome for natural accumulation during a summer of mild wave action and wind transport. The scarp cut last fall is still present, but the wind has deposited a slope of dry sand about half way up the eroded bluff. The beach berm has added a narrow strip between the normal high tide line and the dune toe completing the typical summer beach “profile”. However, the most moderate of northeast storms will renew the erosion of the primary dune scarp going into the winter months.

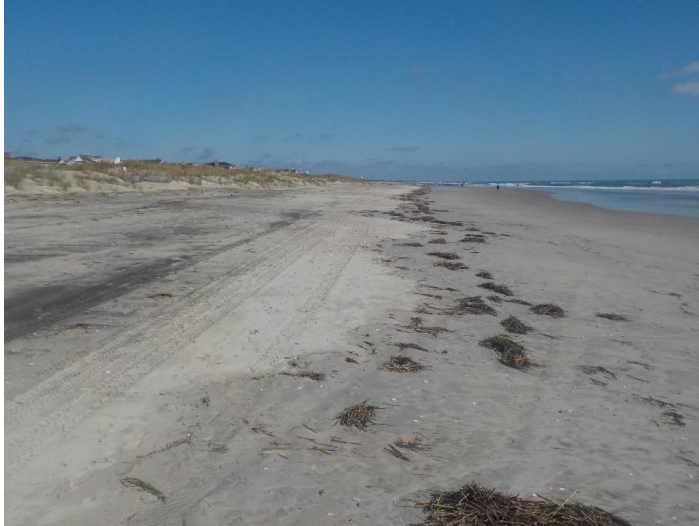
Site SH-82 – 82nd Street (Photos 1a-1c)

Photo 1a – Photo taken October 14, 2019, the debris on the berm was left by early northeast waves.

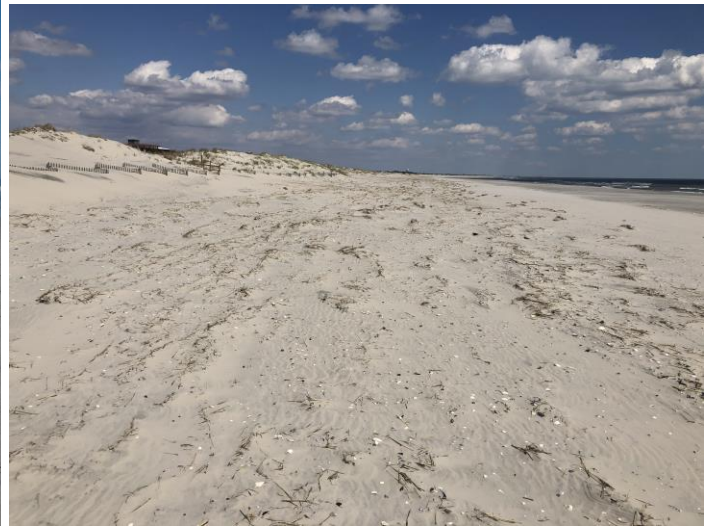
Photo 1b - Photo taken April 16, 2020 showing a wide, dry beach and sand accumulation at the dune fencing.

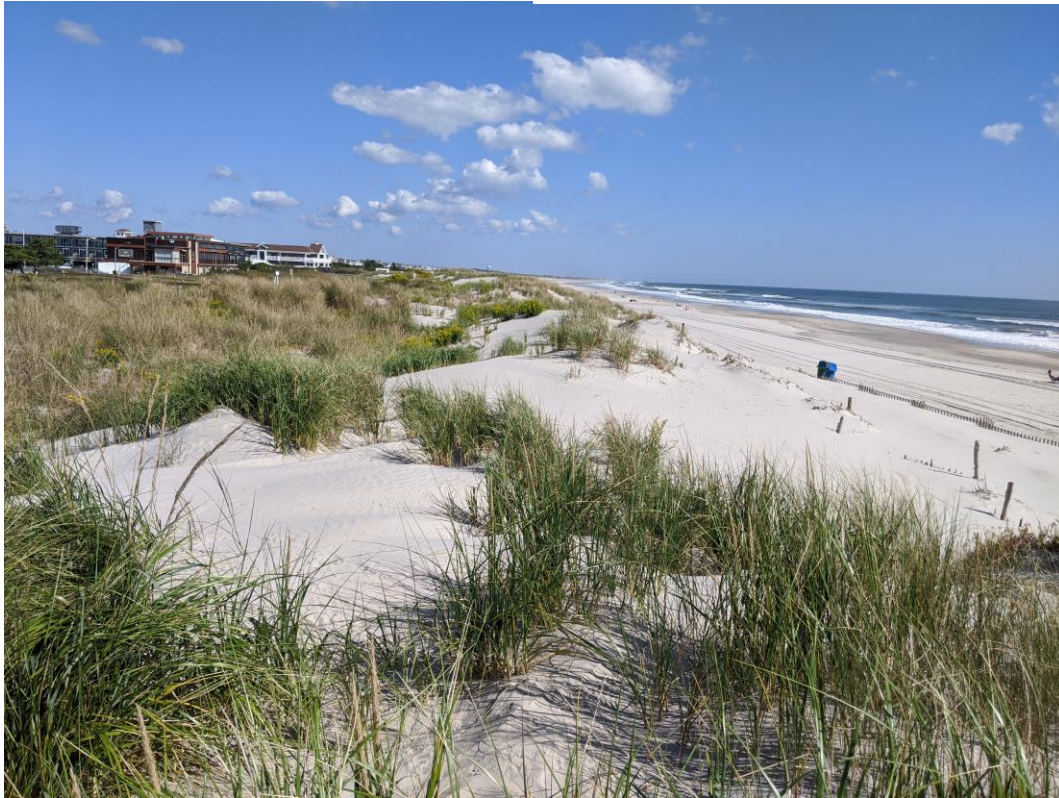
Photo 1c – Photo taken on October 6, 2020, looking north along the dune crest where sand has been transported into the dunes and the sand fence is essentially buried by what could become a new foredune line.

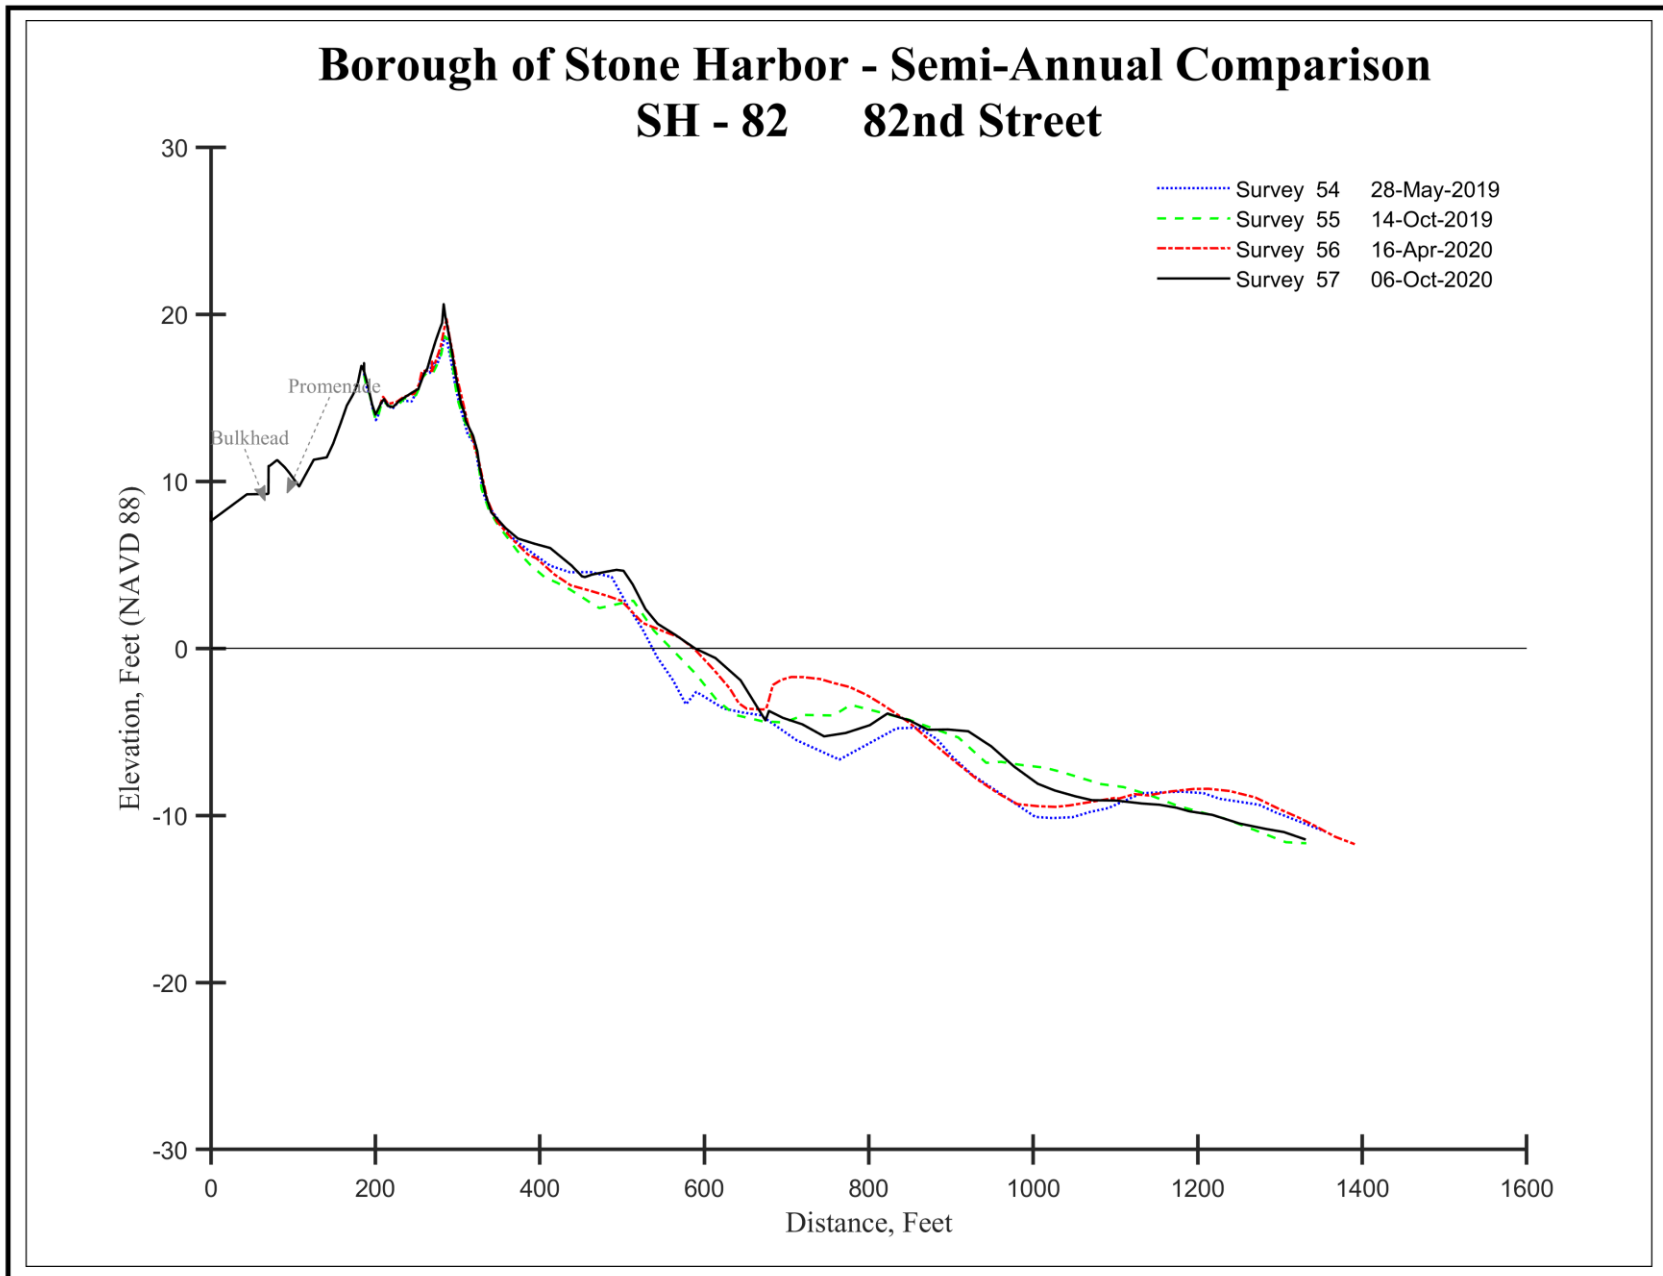
The dune remained stable, though with a steep seaward dune slope to the toe. A sizable beach berm developed during the summer of 2020 as seen in the early October 2020 survey. Offshore, the bar shown in the April 2020 survey appears to have provided the sand supply generating the berm and higher beach elevation seen in October 2020.

Figure 1d. The most interesting transition occurred between the presence of a nearby offshore bar as of April 2020 that moved onto the beach generating the higher berm and sand supply feeding into the dunes. This material addition was likely sourced from along the Avalon and Stone Harbor beaches to the north of the site.

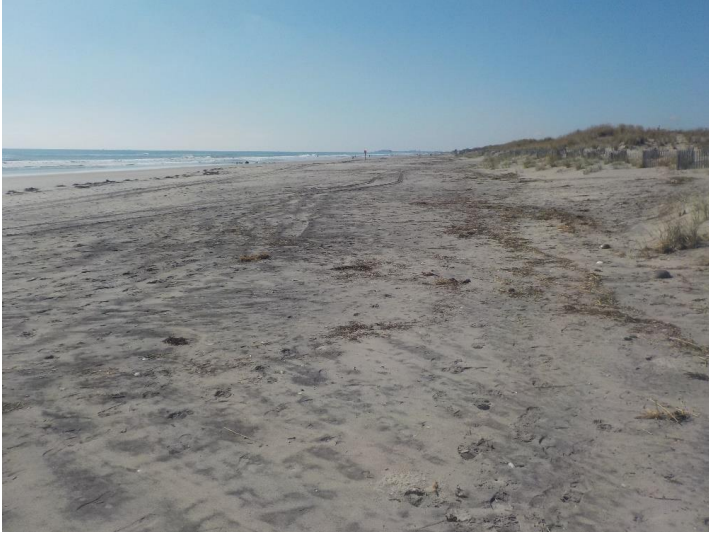
Site SH-90 – 90th Street (Photographs 2a-2c)

Photo 2a – Photo taken October 14, 2019 shows dune growth, while wave action almost reaches the dune toe.

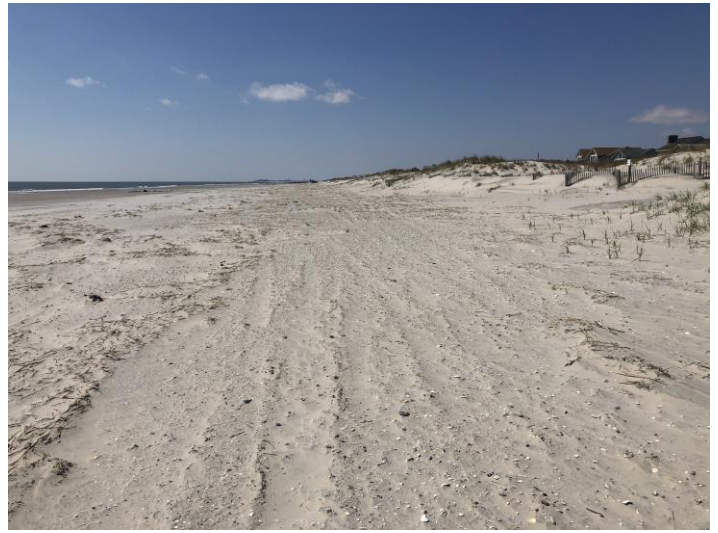
Photo 2b - Photo taken April 16, 2020 showing a slight improvement in dry beach width as summer began.

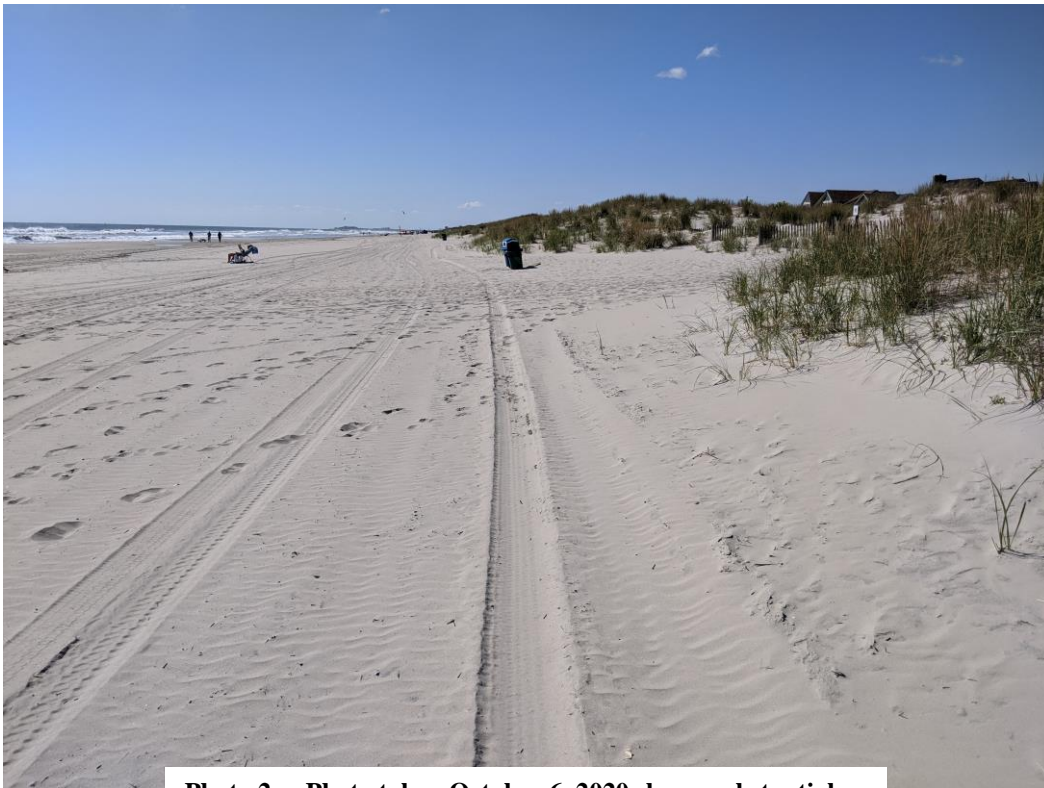
Photo 2c - Photo taken October 6, 2020 shows substantial dune growth and the wider expanse of dry sand beach following the summer accumulation.

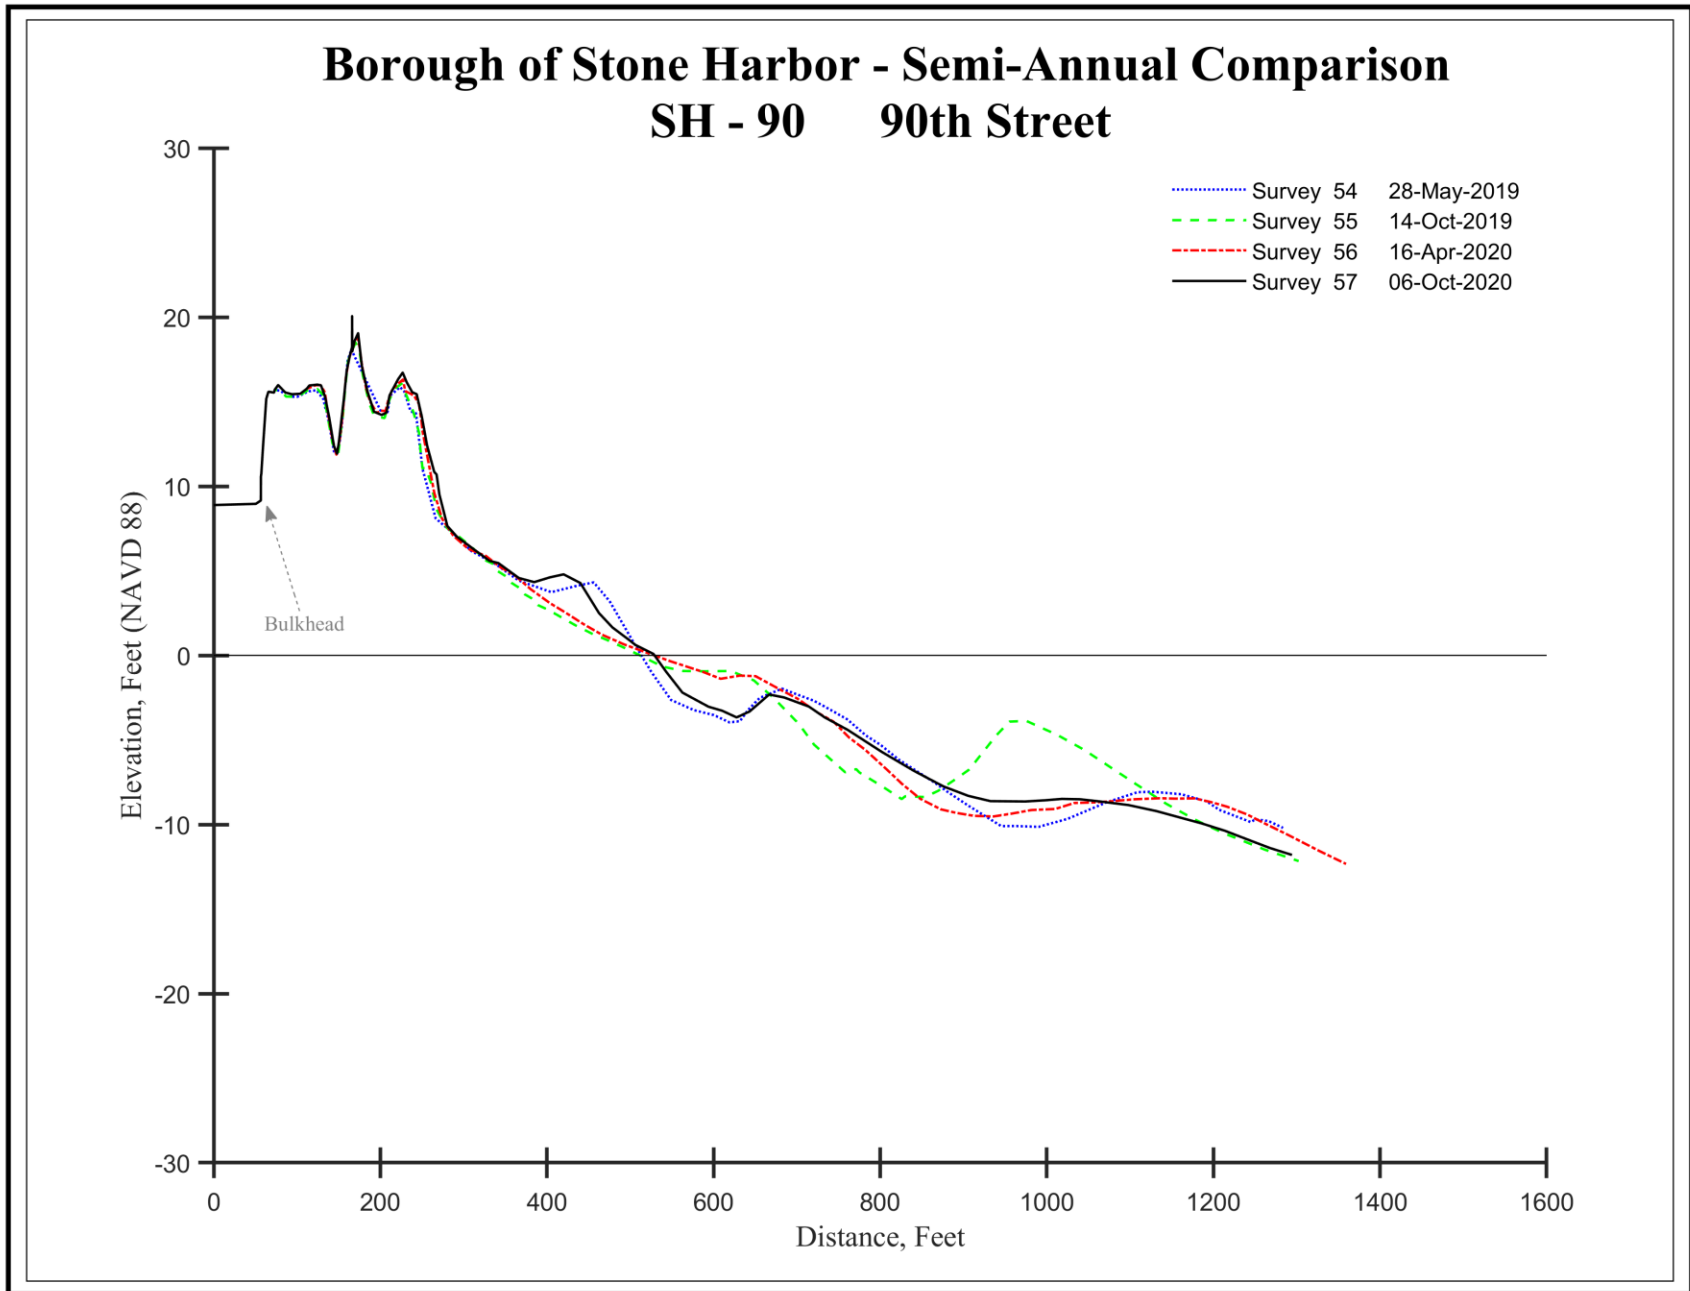
Sand appeared incrementally across the seaward dune slope and deposited as a berm on the beach by October 2020. Offshore sand transport to the beach was the probable method for accumulation.

Figure 2d. Sand was added to the dune's seaward slope and a substantial berm was generated by October 2020 derived from offshore bar migration toward the shoreline. As of the Oct. 2020 survey another ridge of sand was migrating toward the beachface.

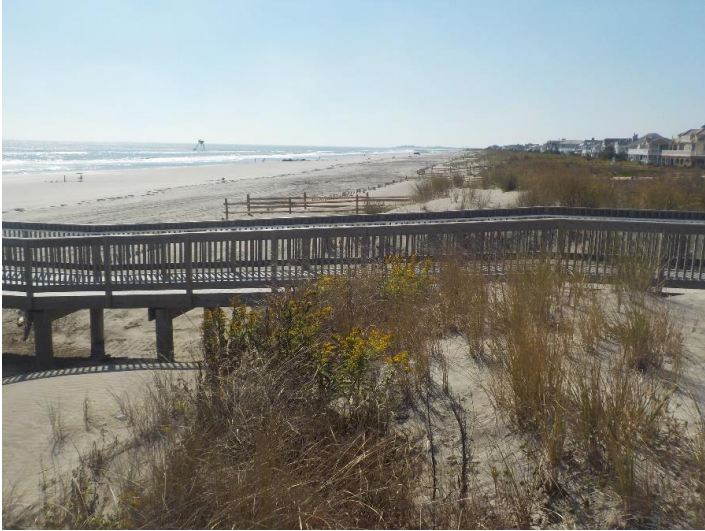
Site SH-95 – 95th Street (Photoplates 3a-3c)

Photo 3a - Photo taken October 14, 2019 shows a height over the access walkway that includes the dune and the beach to the south.

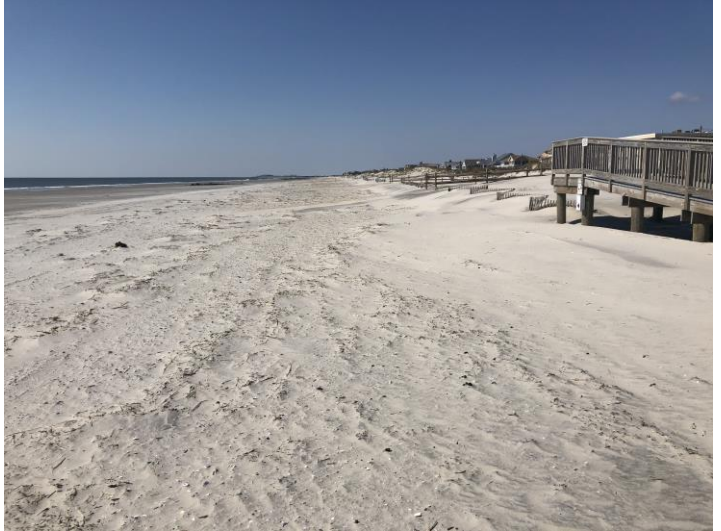
Photo 3b – The April 16, 2020 photo presents a wider dry beach with sand added to the nearly buried sand fencing at the toe of the seaward dune slope.

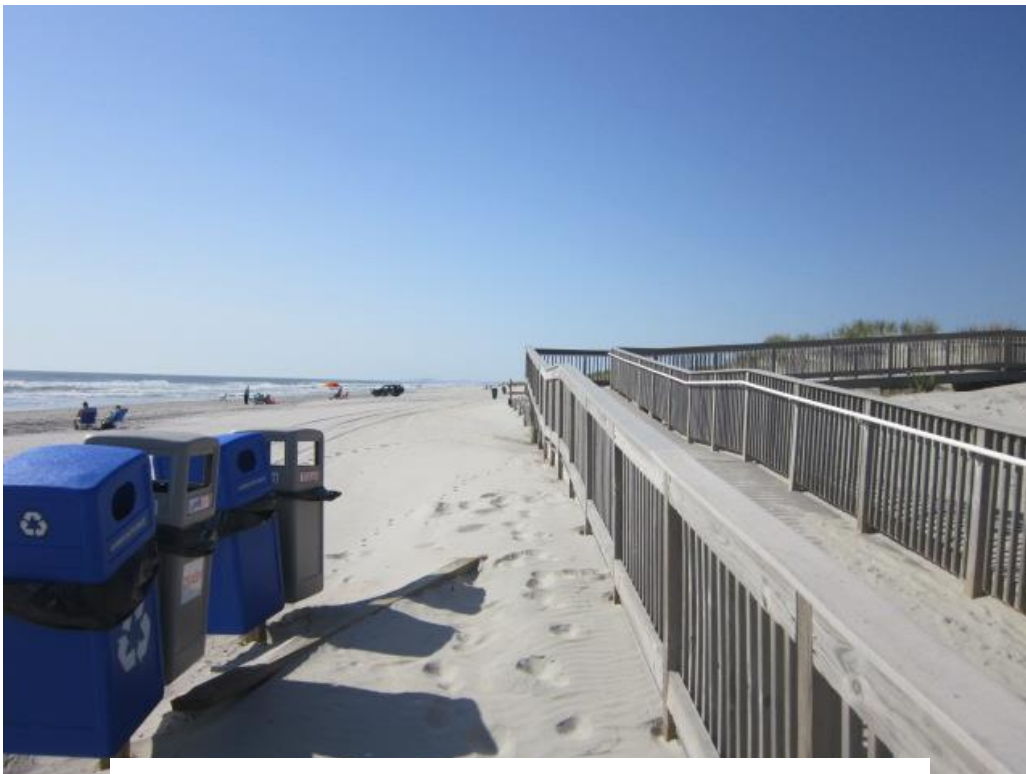
Photo 3c – The photo taken October 6, 2020 along the access pathway. The beach continued to accumulate sand at the dune toe.

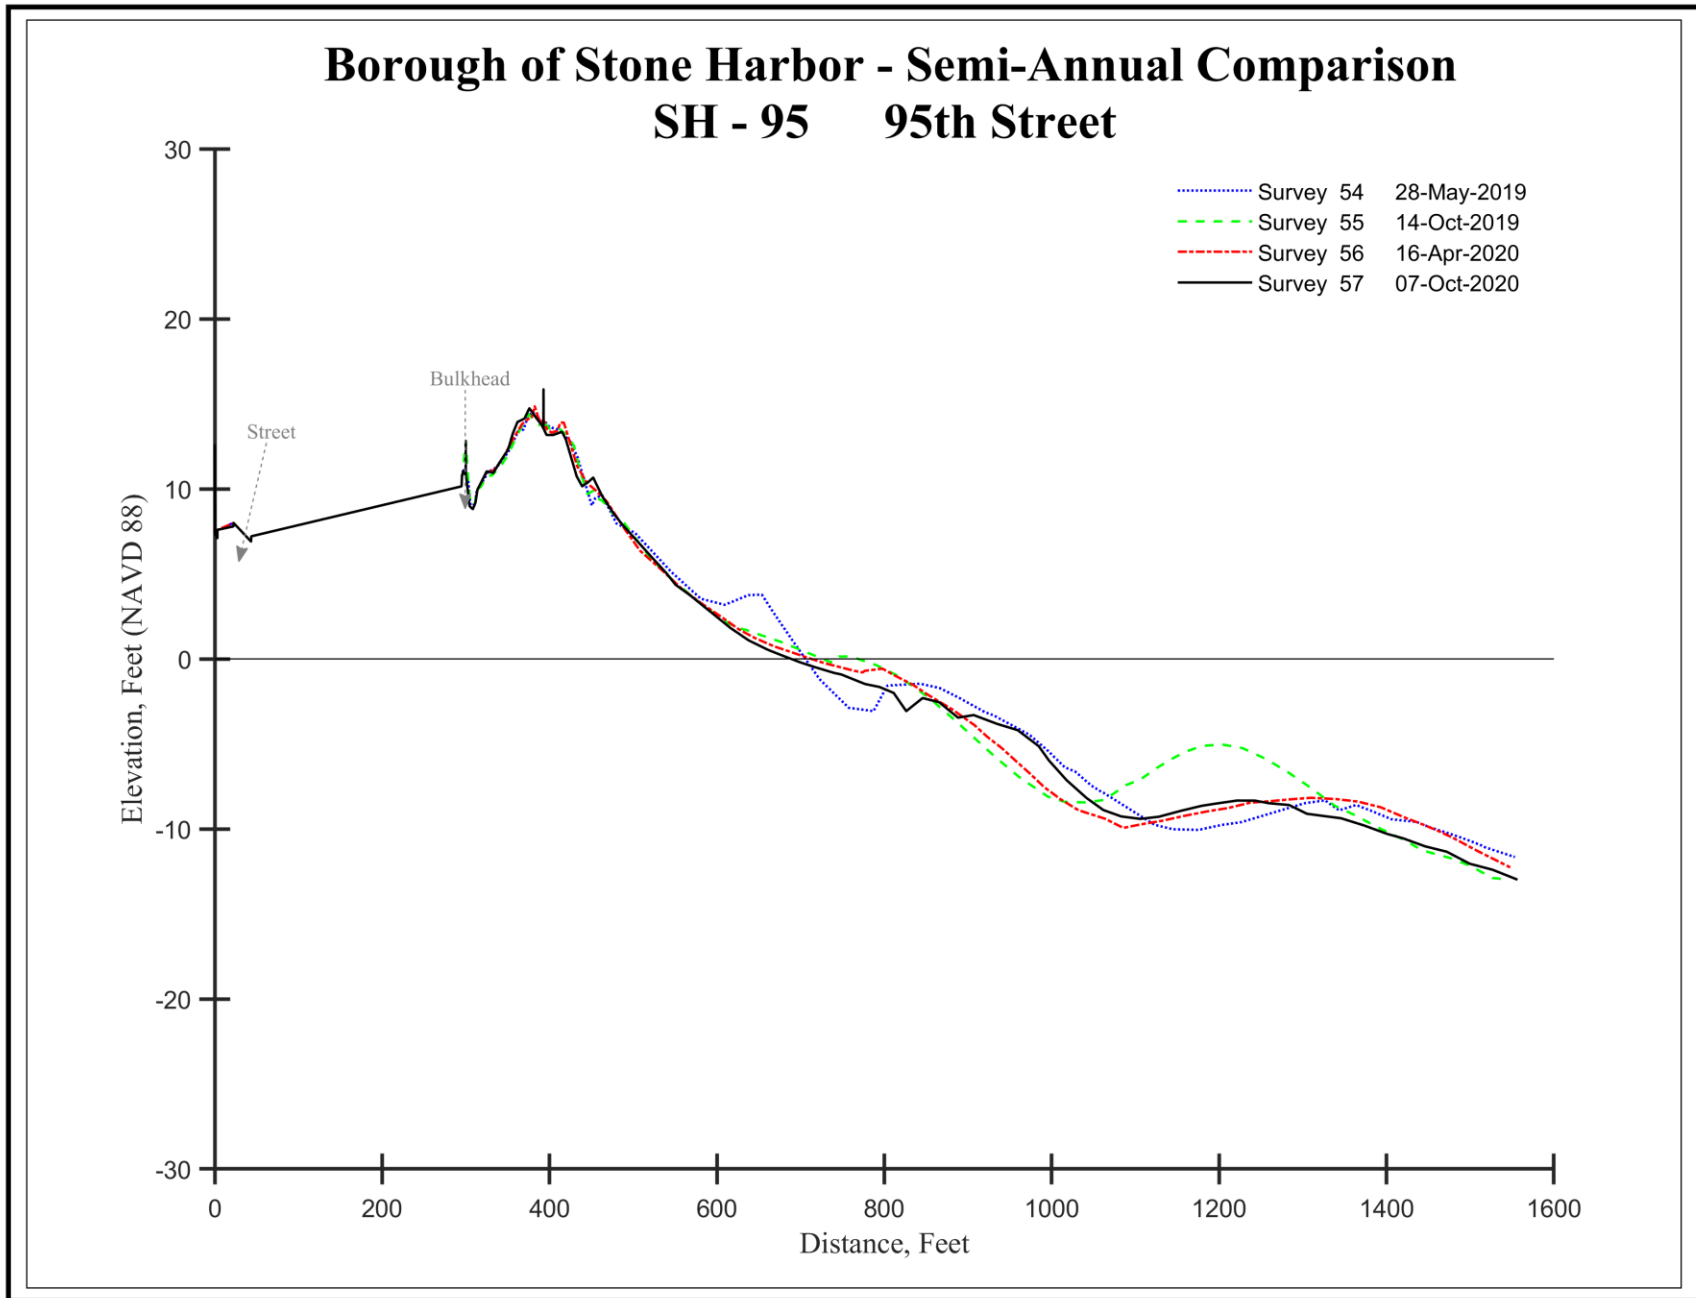
Sand moved beyond the dune crest this year adding to the bulk, but not on the seaward slope. The beach remained at the initial position and configuration seen as of May 2019, but without the enhanced berm crest. Offshore sand was redistributed leading to a small loss across the profile.

Figure 3d. Sand was added to the landward dune slope by Oct. 2020 and the small foredune at the fencing line increased in size. The beach remained at the same configuration as May 2019, but without an enhanced berm crest. Offshore the large bar, seen in October 2019 had moved landward as a series of ridges.

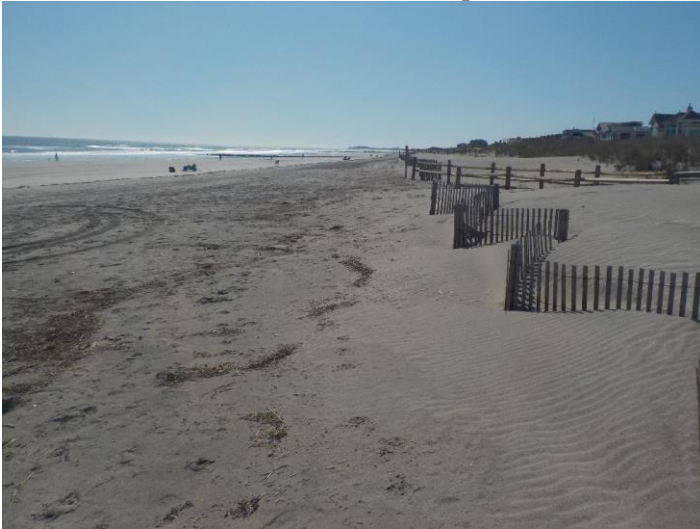
Site SH-103 – 103rd Street (Photoplates 4a-4c)

Photoplate 4a - Photo taken October 14, 2019 showing sand continuing to fill the 4-foot high snow fencing creating a new foredune. The beach width was sufficient to provide the supply.

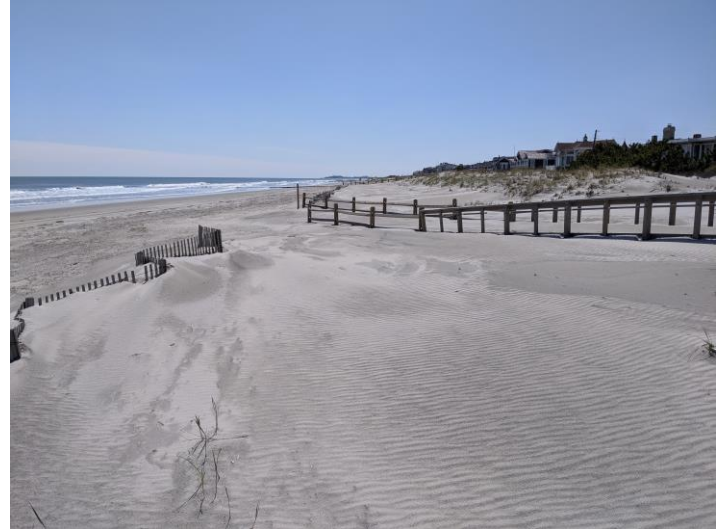
Photoplate 4b - Photo taken April 15, 2020 shows sand filling in the lower section of the access pathway burying the fencing.

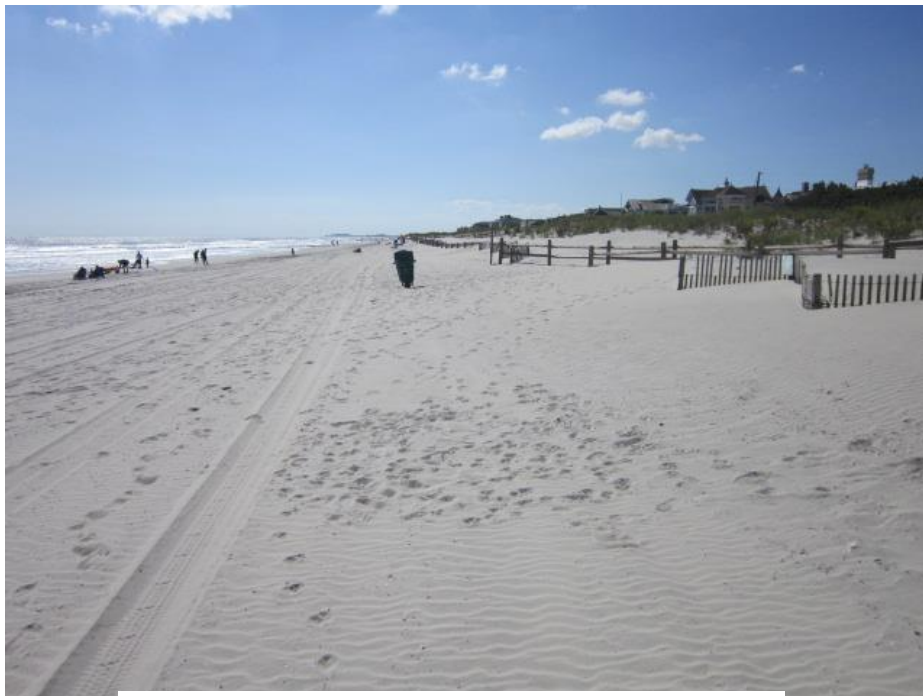
Photoplate 4c – Photo taken October 6, 2020 on the beach just seaward of the dune’s seaward slope that included the new foredune development.

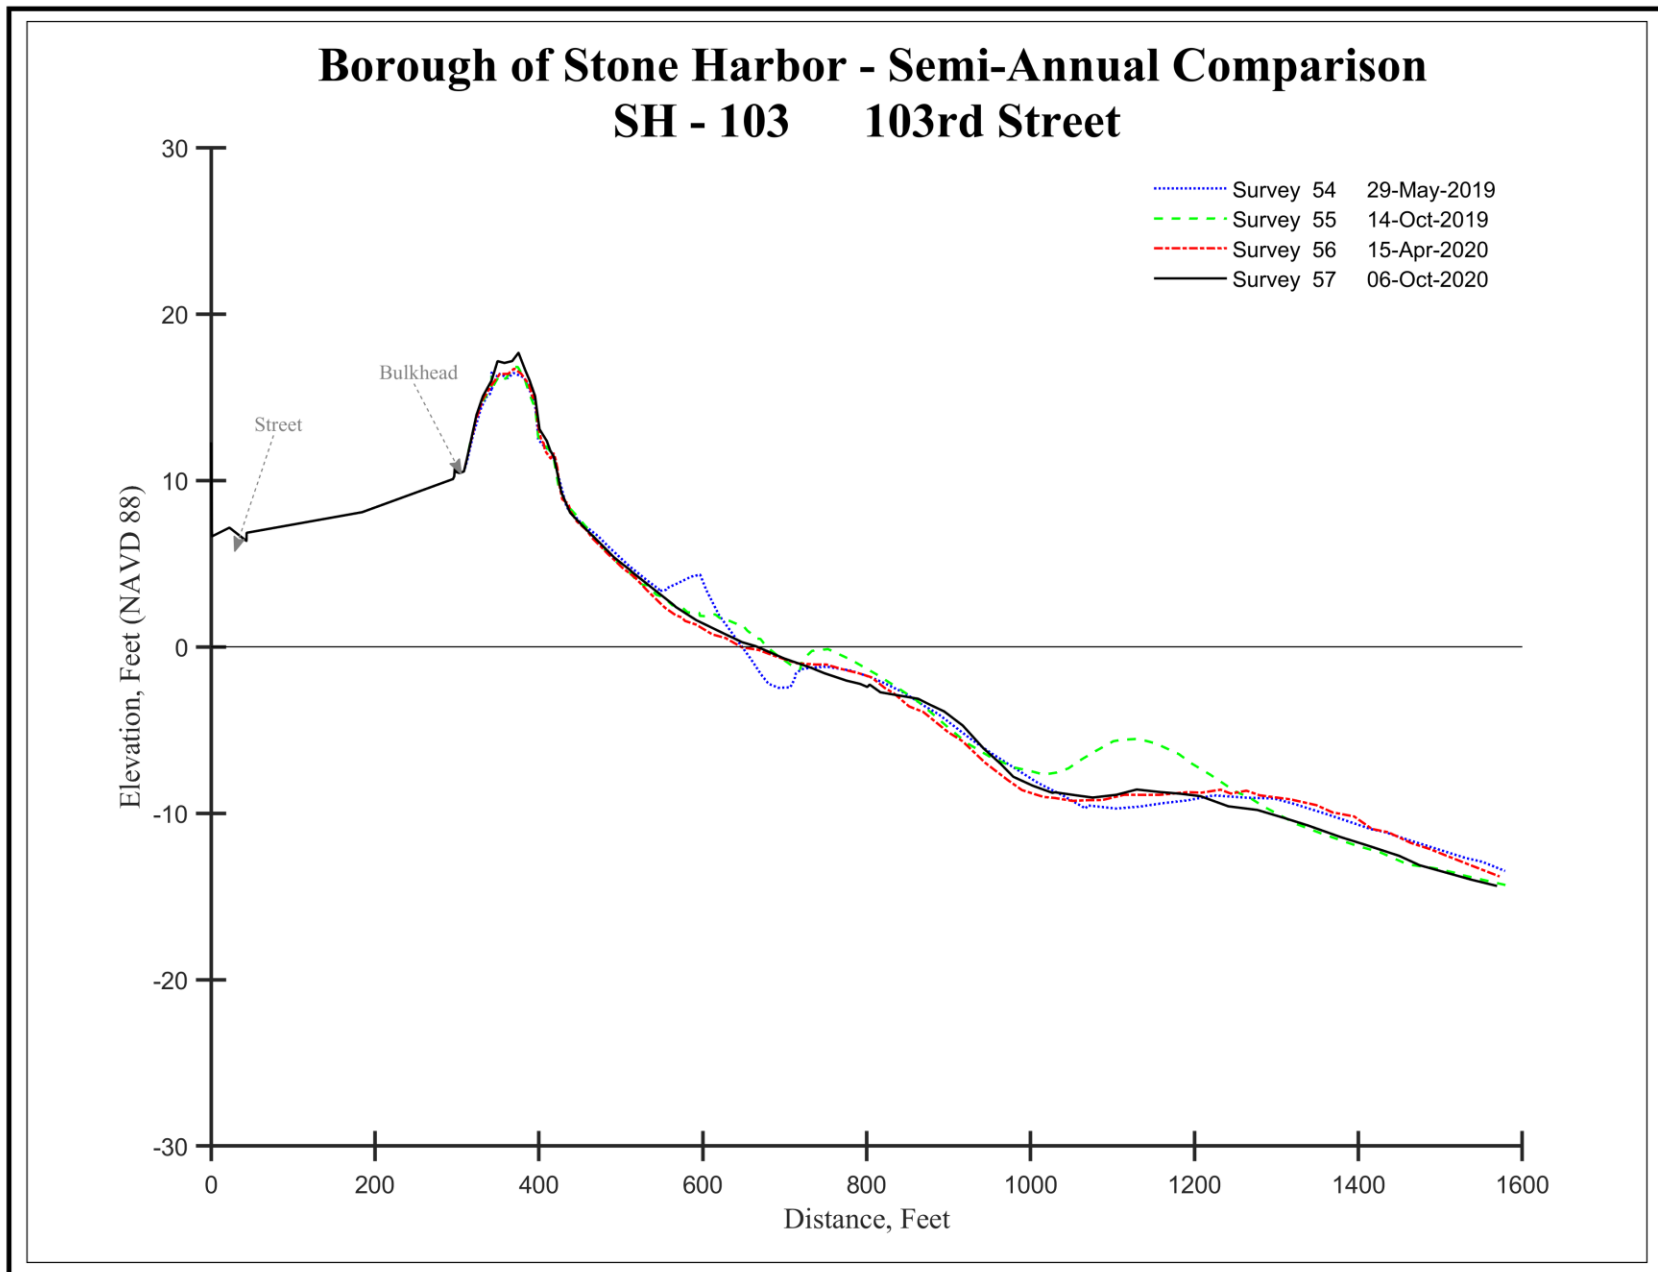
Behaving in similar fashion to SH-95, the beach configuration changed little except for no summer berm like that present in May 2019 present on the profile by October 2020. Some of the October 2019 offshore bar sand appears to have migrated onto the beachface slope by October 2020.

Figure 4d. The cross sections at 103rd Street show a similar pattern to that seen at 95th Street where the May 2019 berm was not reproduced by late summer 2020. Sand did migrate onto the beach in minor quantities adding to the dunes, but not to the beach itself.

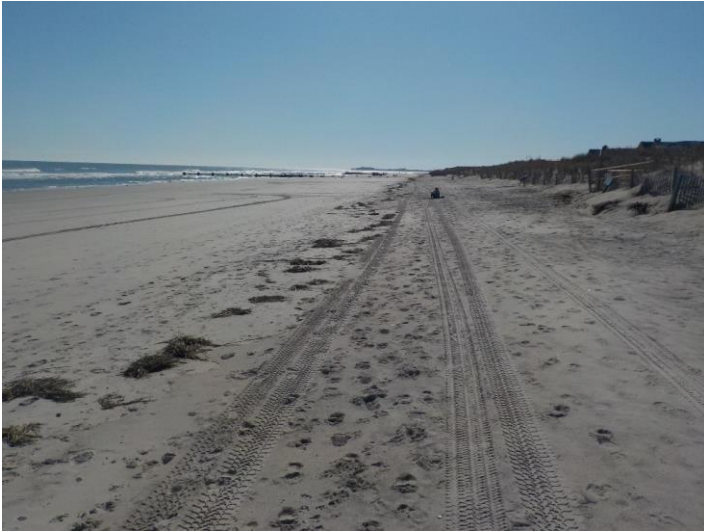
Photoplate 5a – The October 14, 2019 photo shows the proximity of the high tide to the dunes on a narrow beach.

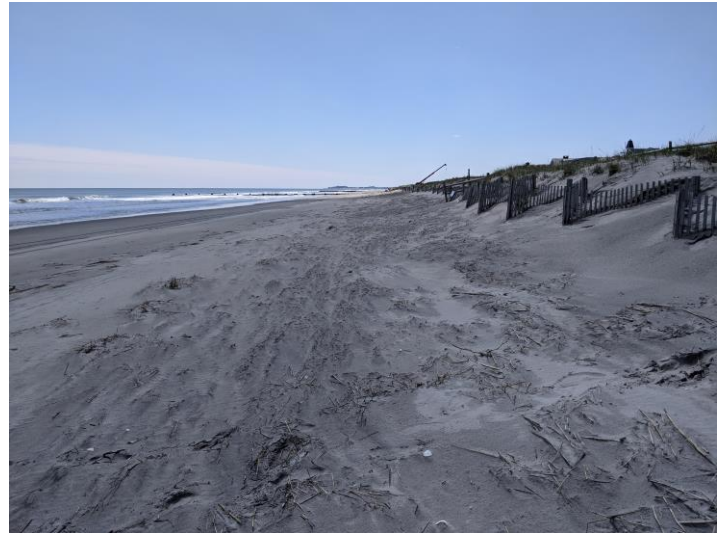
Photoplate 5b – The photo taken April 15, 2020 shows minor additions of sand near the dune toe, but a similar width beach to the water line.

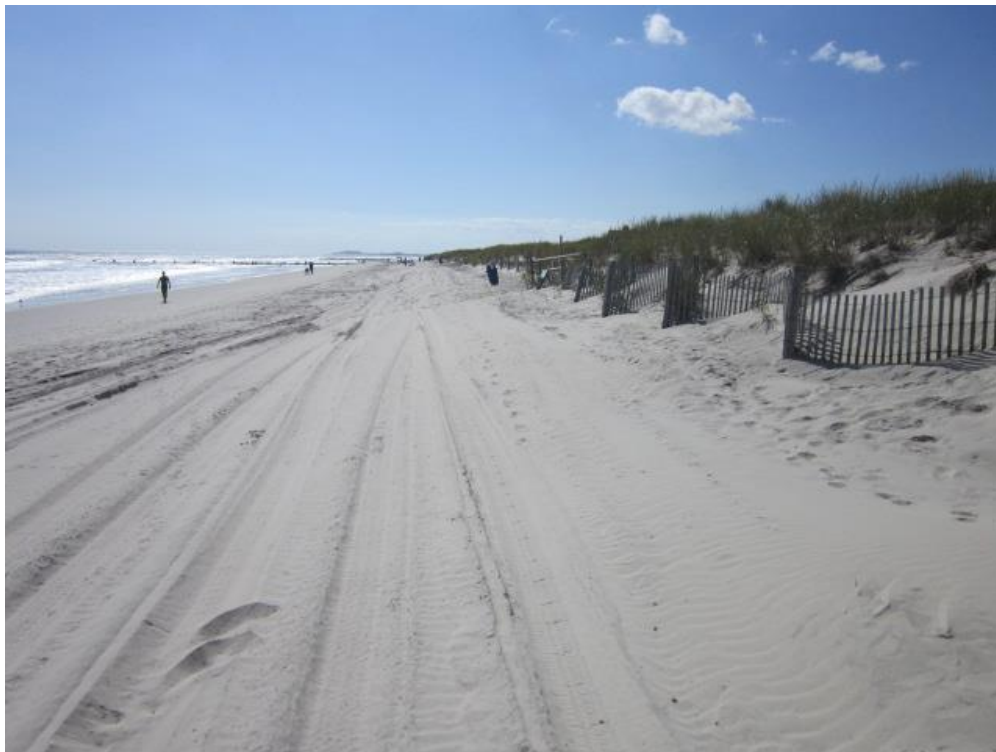
Photoplate 5c – Photo taken October 6, 2020 shows improvement in beach width as sand was added to the upper part of the dry beach.

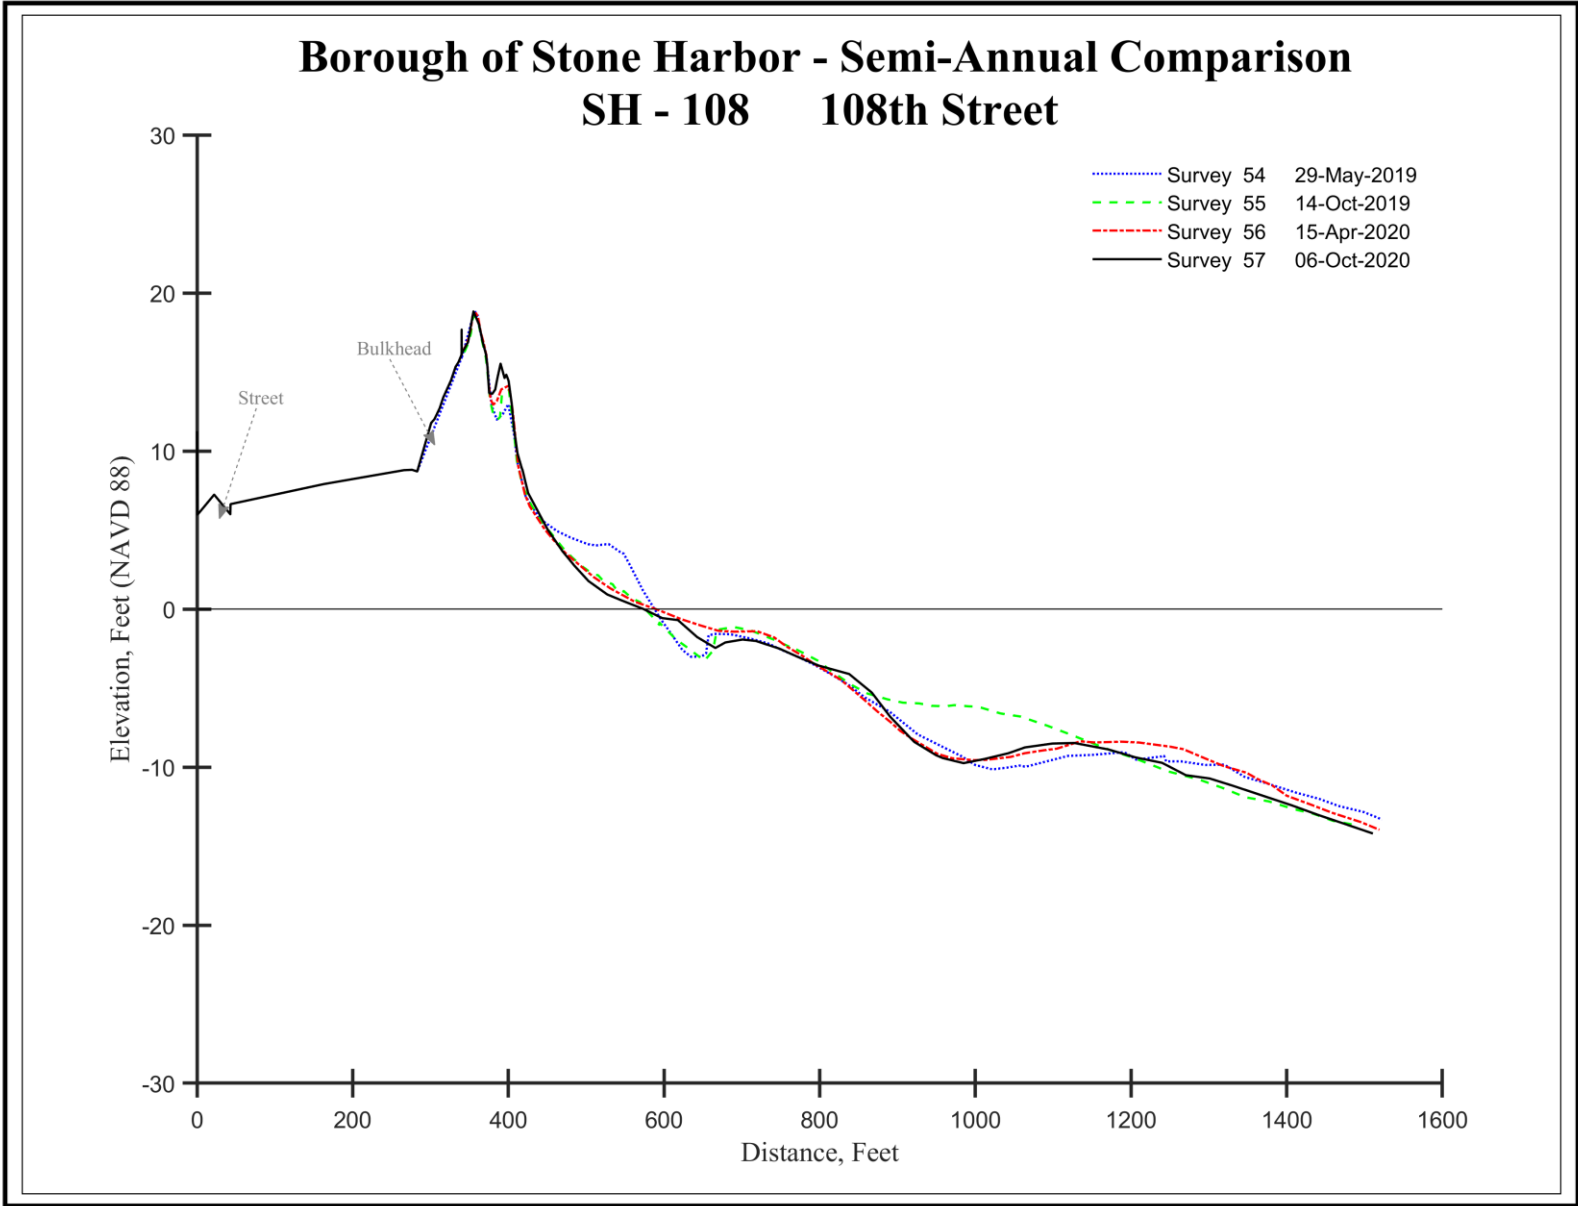
Considerable sand volume was added to the dunes while the beach remained at the May 2019 configuration minus the berm crest seen in the May cross section. The offshore region provided the sand supply to the beach from the October 2019 bar arrangement seen.

Figure 5d. Dune growth was substantial at the foredune location as all four surveys documented additional height and width to the feature. The generous berm present in May 2019 was not replicated subsequently, but the offshore bar ridge in October 2019 appears to have moved onto the beach as small ridges of sand.

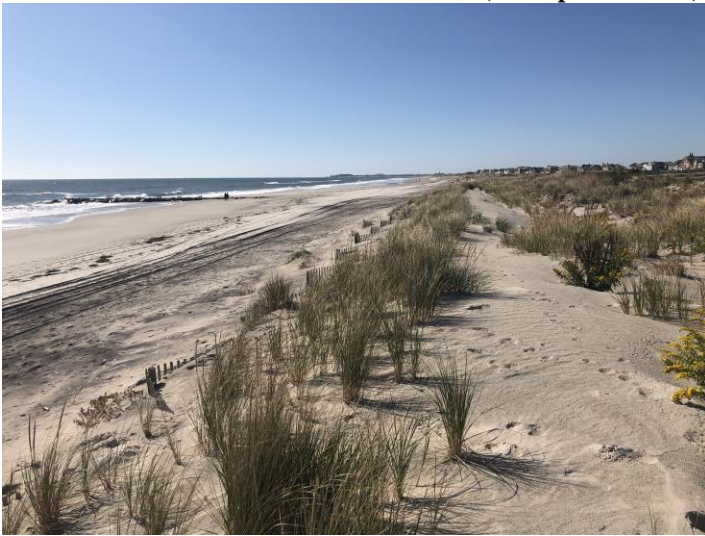
Photoplate 6a – The October 15, 2019 overlooking the accreting foredune encroaching onto the planted project dune slope. The fencing is buried with new sand from the beach that is colonized quite densely.

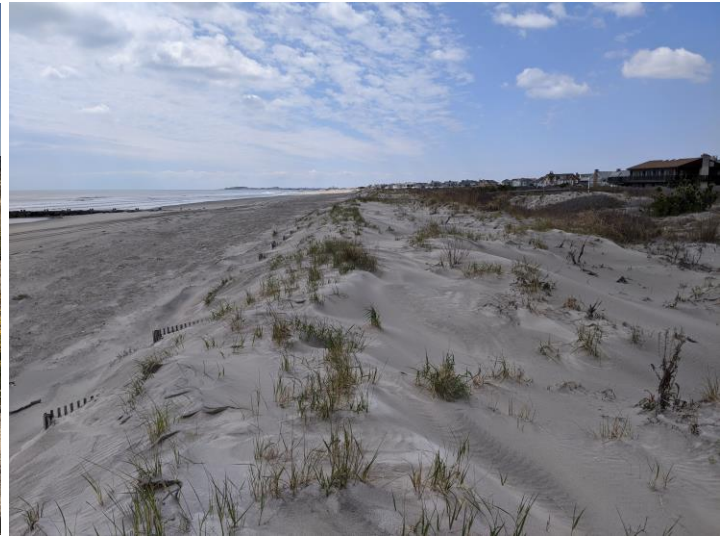
Photoplate 6b - Photo taken April 15, 2020 and shows large amounts of wind deposition around the existing plants.

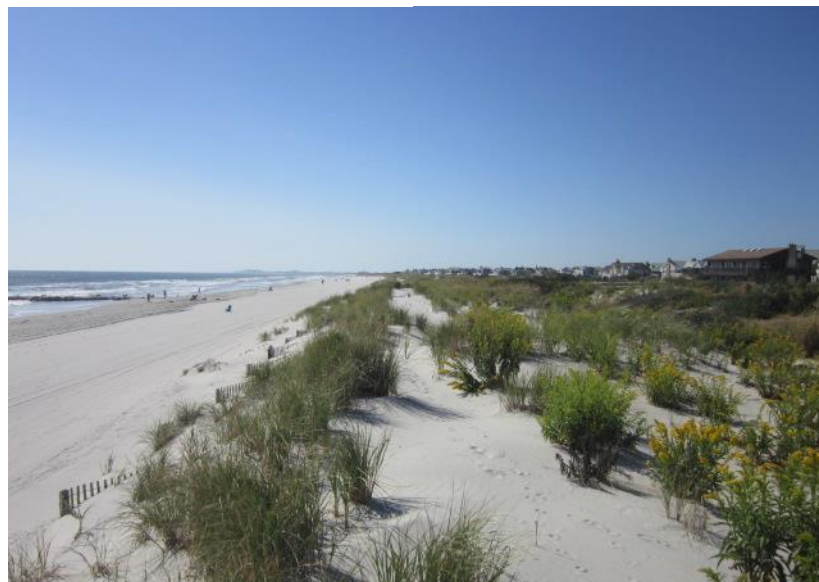
Photoplate 6c – Photo taken October 7, 2020 where the seasonal plant growth has taken hold on the new sediment supplied by the wind.
