**2020 ANNUAL REPORT ON
THE CONDITION OF THE MUNICIPAL BEACHES FOR
THE BOROUGH OF STONE HARBOR, CAPE MAY COUNTY, NEW JERSEY**

**PREPARED FOR: THE BOROUGH OF STONE HARBOR
9508 SECOND AVENUE
STONE HARBOR, NJ 08247**

**PREPARED BY: THE STOCKTON UNIVERSITY COASTAL RESEARCH CENTER
30 WILSON AVENUE
PORT REPUBLIC, NEW JERSEY 08241**

January 15, 2021

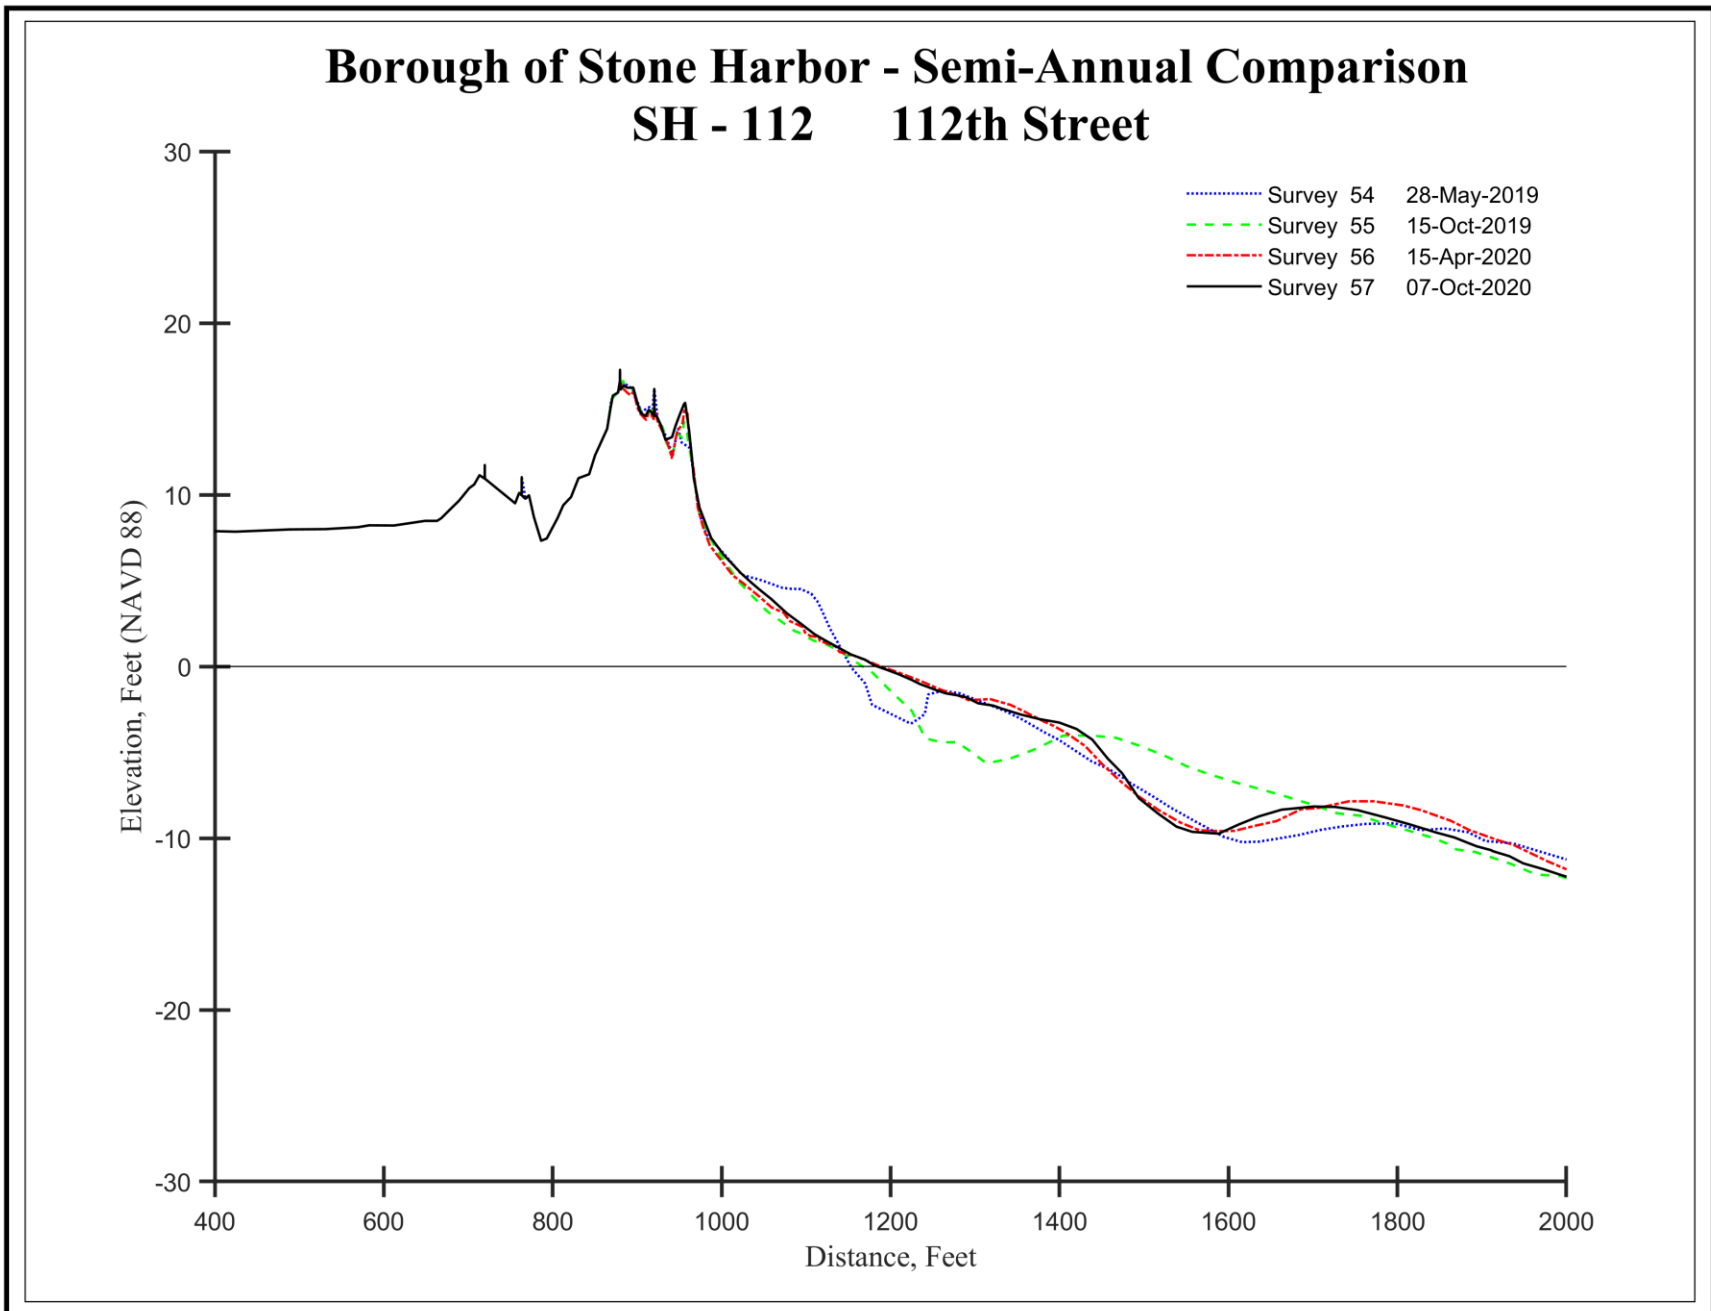
A berm crest on the beach together with a close-to-the-beach sand ridge offshore appears to have provided a stable beach profile between the dunes and the water's edge. The offshore region shifted by October 2019 to a more distant, low elevation bar system.

Figure 6d. The profiles at 112th Street continued the pattern where the beach slope and position maintained the same configuration following the addition of a berm from offshore sand supplies in May 2019. Continued cross-shore migration continued after October 2019 as the entire system stabilized with few changes in 2020.

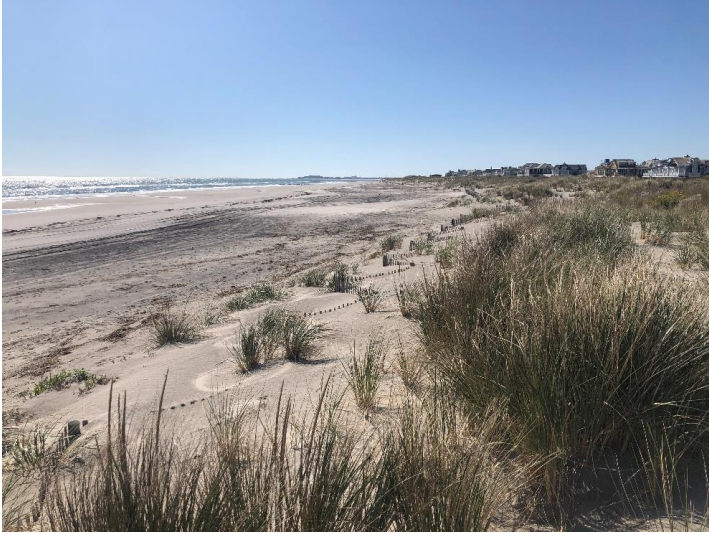
Photoplate 7a - Photo taken October 15, 2019 finds the fencing placed in 2017 buried and luxuriant dune grass growing across the feature created since the fence was built.

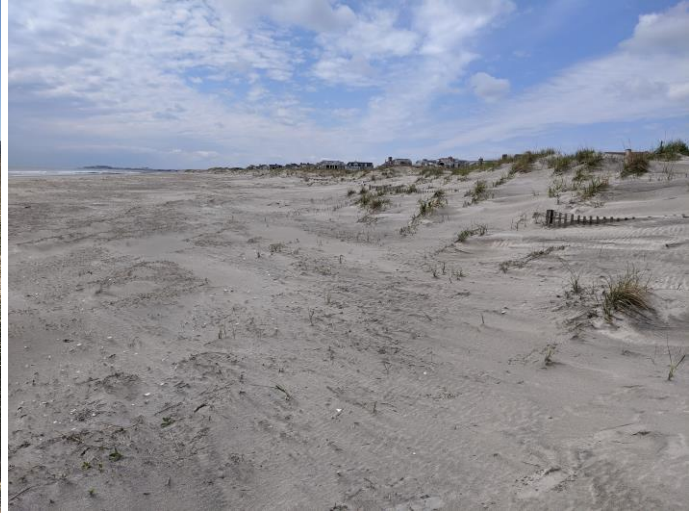
Photoplate 7b – Photo taken April 15, 2020 showing continued sand deposition around fencing locations and a wide beach seaward .

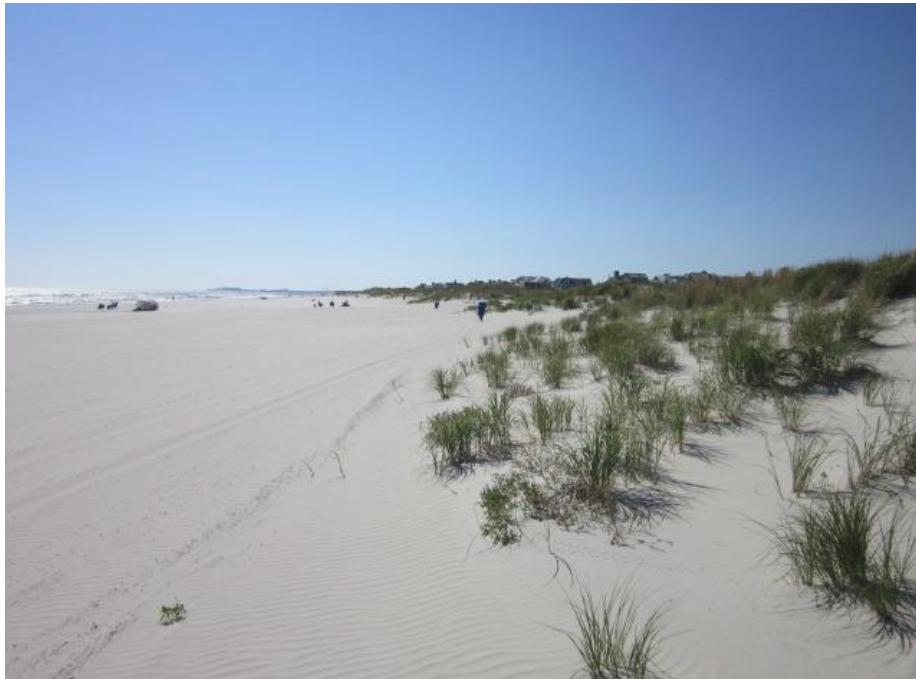
Photoplate 7c – Photo taken October 7, 2020 provides a view of the wide dry beach and sand deposited among the dune plants at 116th Street.

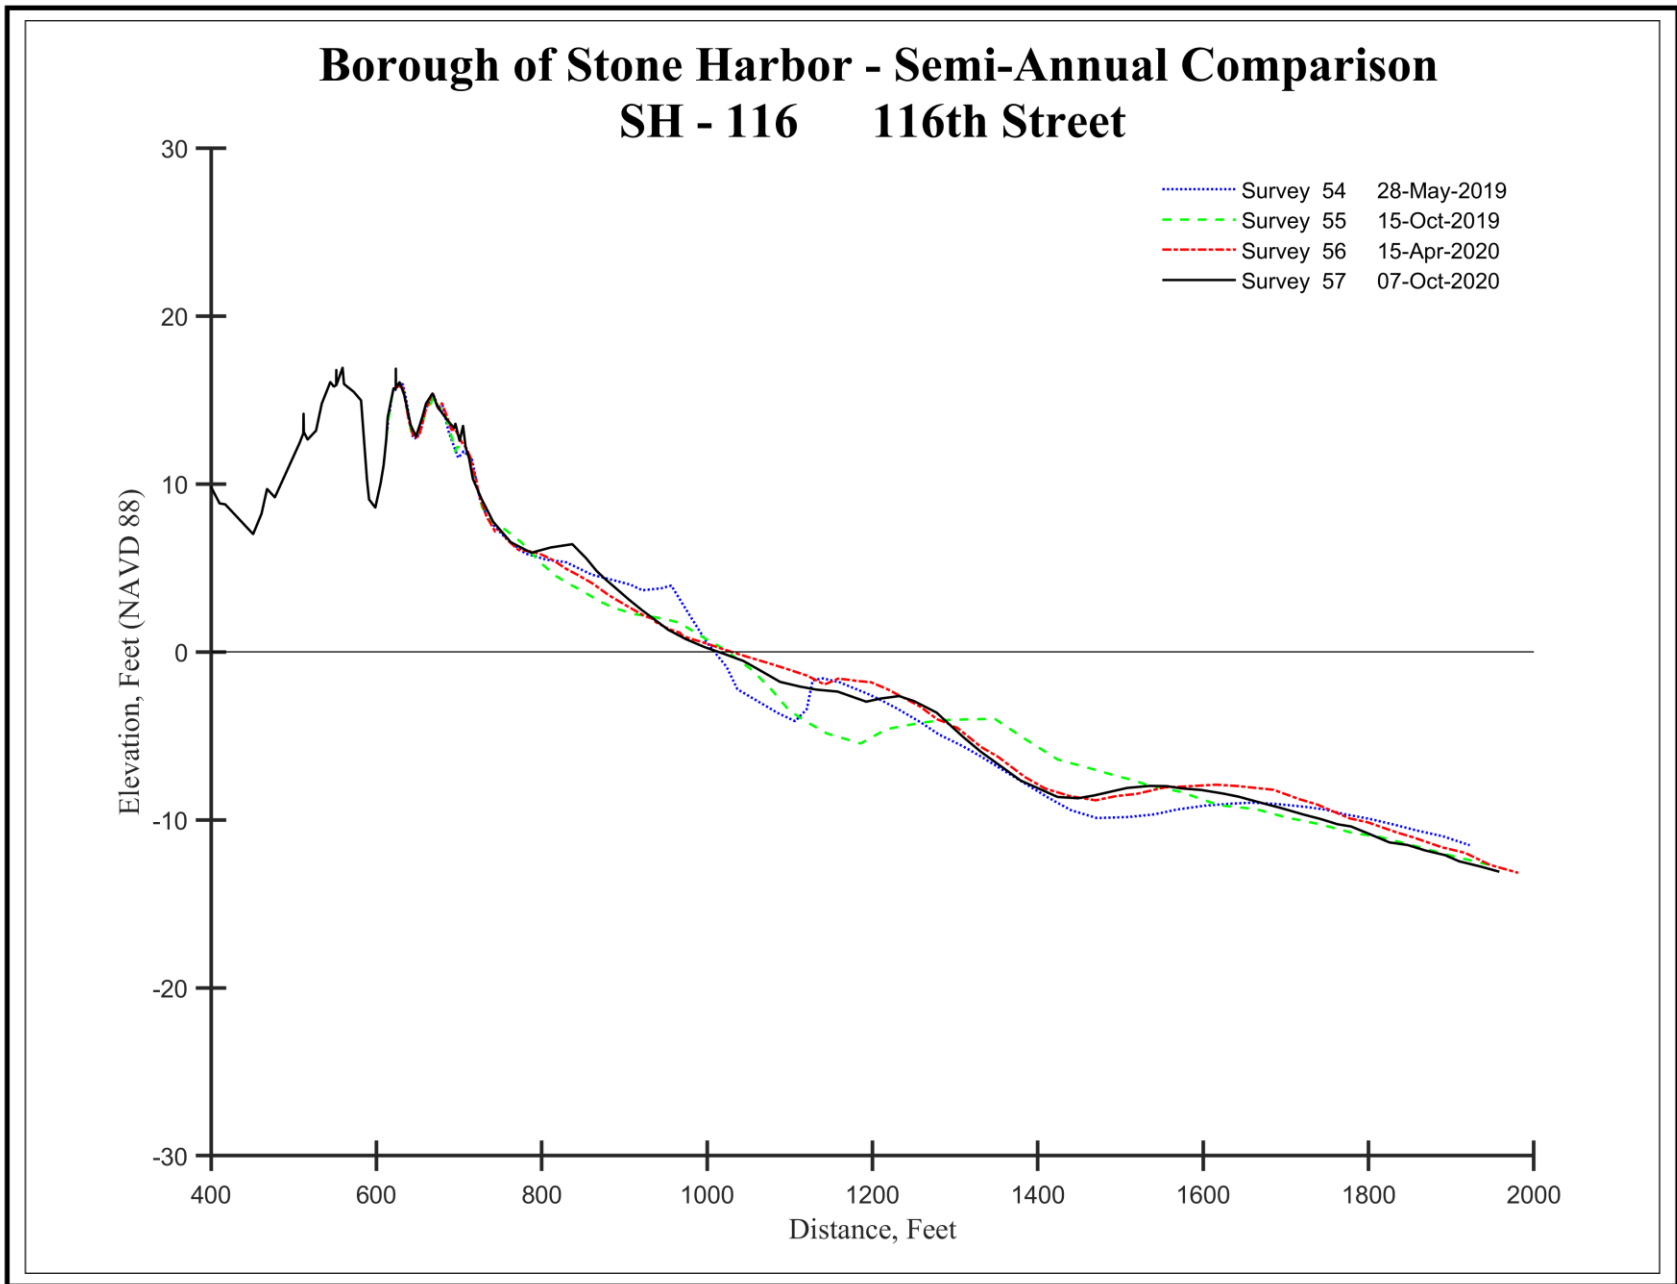
The site was unique in the generation of a late summer 2020 berm crest to pair with that found on the May 2019 survey. The dunes accumulated sand similar to other sites while the offshore region stabilized around small offshore bars as considerable distance from the water's edge.

Figure 7d. The 116th Street location includes a double dune system that continues to capture wind transported material mostly on the seaward slopes. This site developed a prominent berm crest ridge in 2020 duplicating the one present in May 2019, but further landward. Offshore bar material provided the supply of sand.

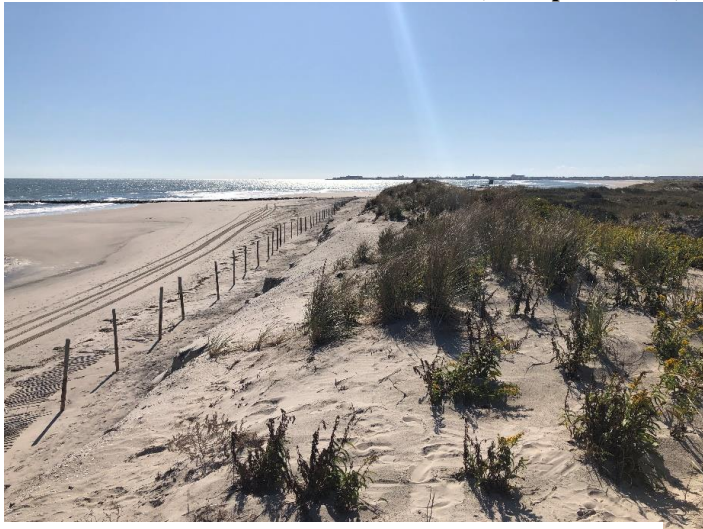
Photoplate 8a - Photo October 15, 2019 following another episode of dune toe erosion generating a 4-foot scarp in the toe. The sand supply is not sufficient to maintain even a minor storm proof dune.

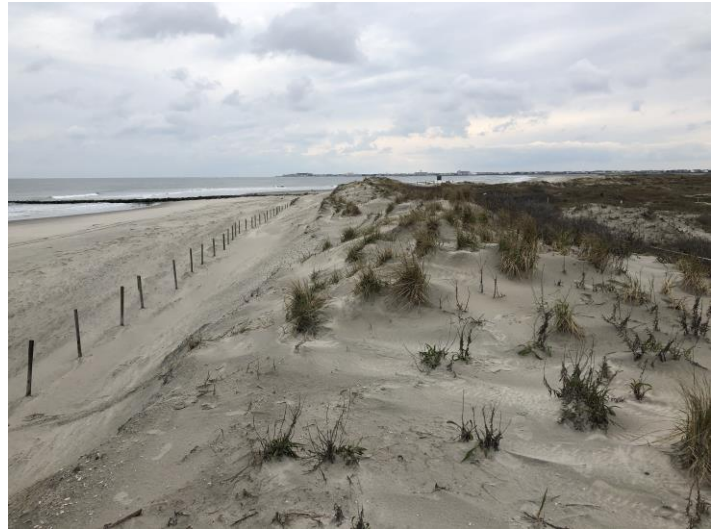
Photoplate 8b – Photo taken April 15, 2020 following a long interval of quite waves and wind transport placing sand at the scarp. Crest slumping also added sand to the slope.

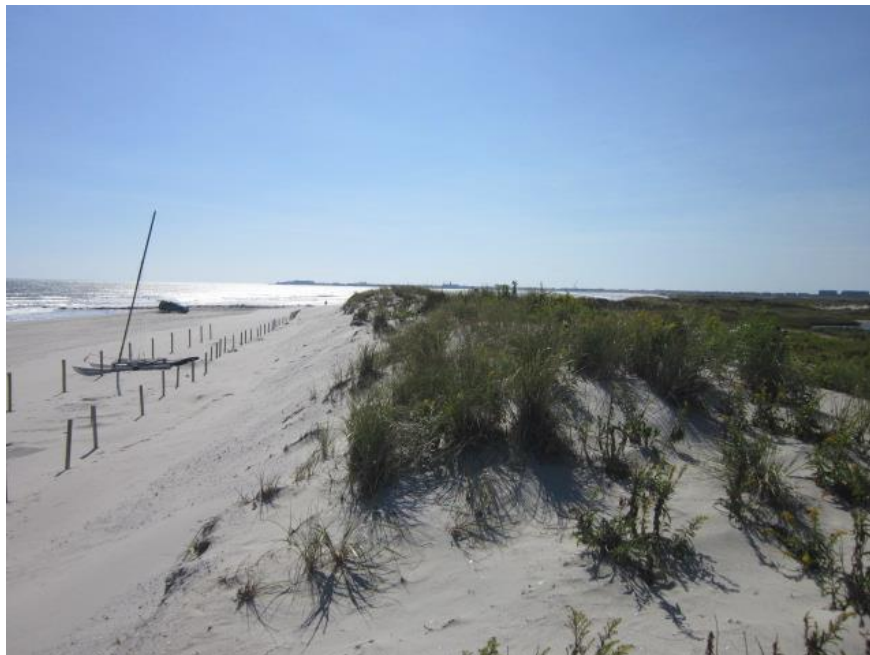
Photoplate 8c – The photo taken October 7, 2020 illustrates the maximum impact natural wind deposition can have in restoration of dune erosion damage. The beach is wider at the close of the 2020 summer season.

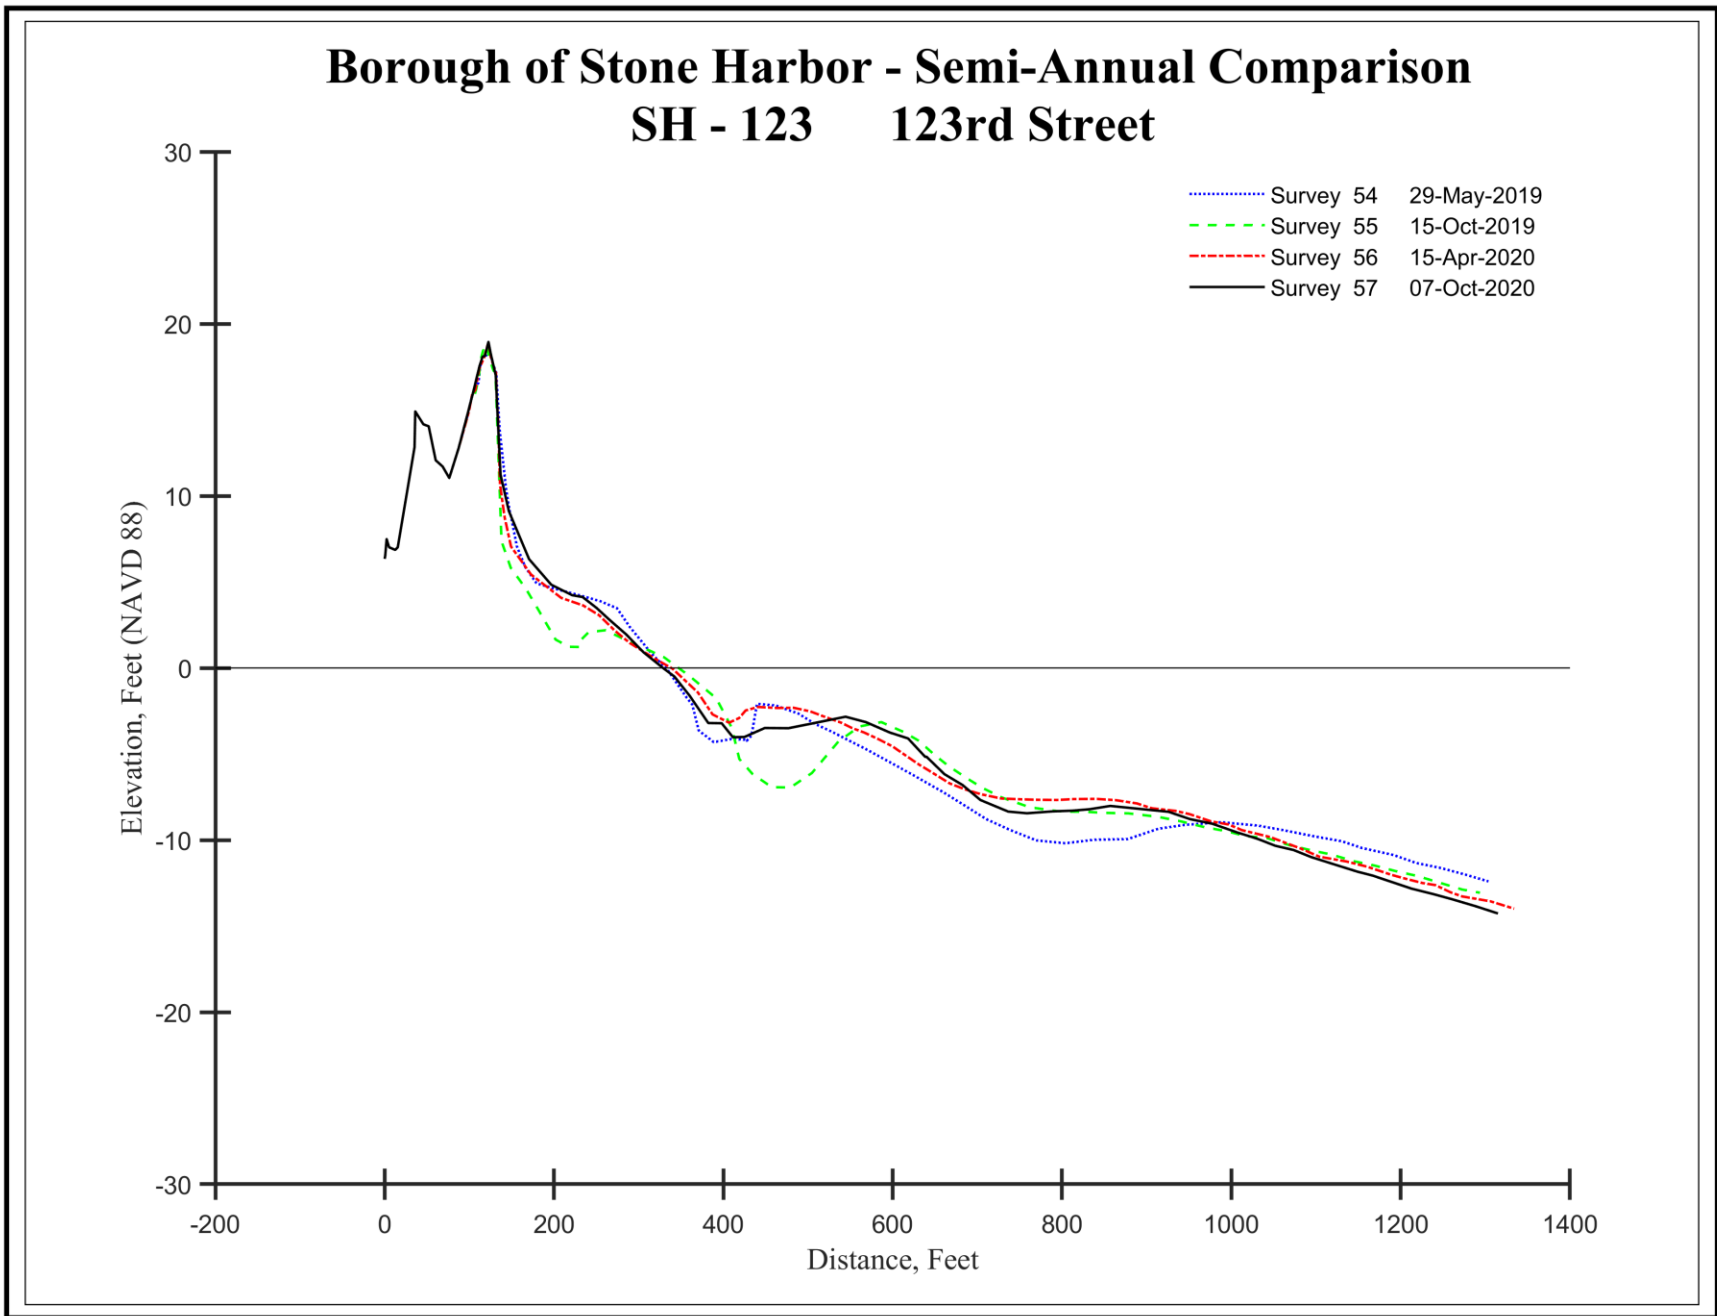
The abrupt scarp cut into the dunes last fall was partially covered by a slope of dry sand that was wind transported to conceal about two-thirds of the eroded face of the dunes. Accumulation of sand on the beach above high tide also widened the profile. Offshore bar migration provided the necessary sand supply during both summer seasons.

Figure 8d. 123rd Street site was eroded at the dune toe slope in May 2019 when sand commenced migrating onto the beach from offshore sources moderating the scarp and adding a dry sand slope toward the dune crest by October 2020. The bar sequence offshore was more variable than other sites, but still was adding sand to the beach.

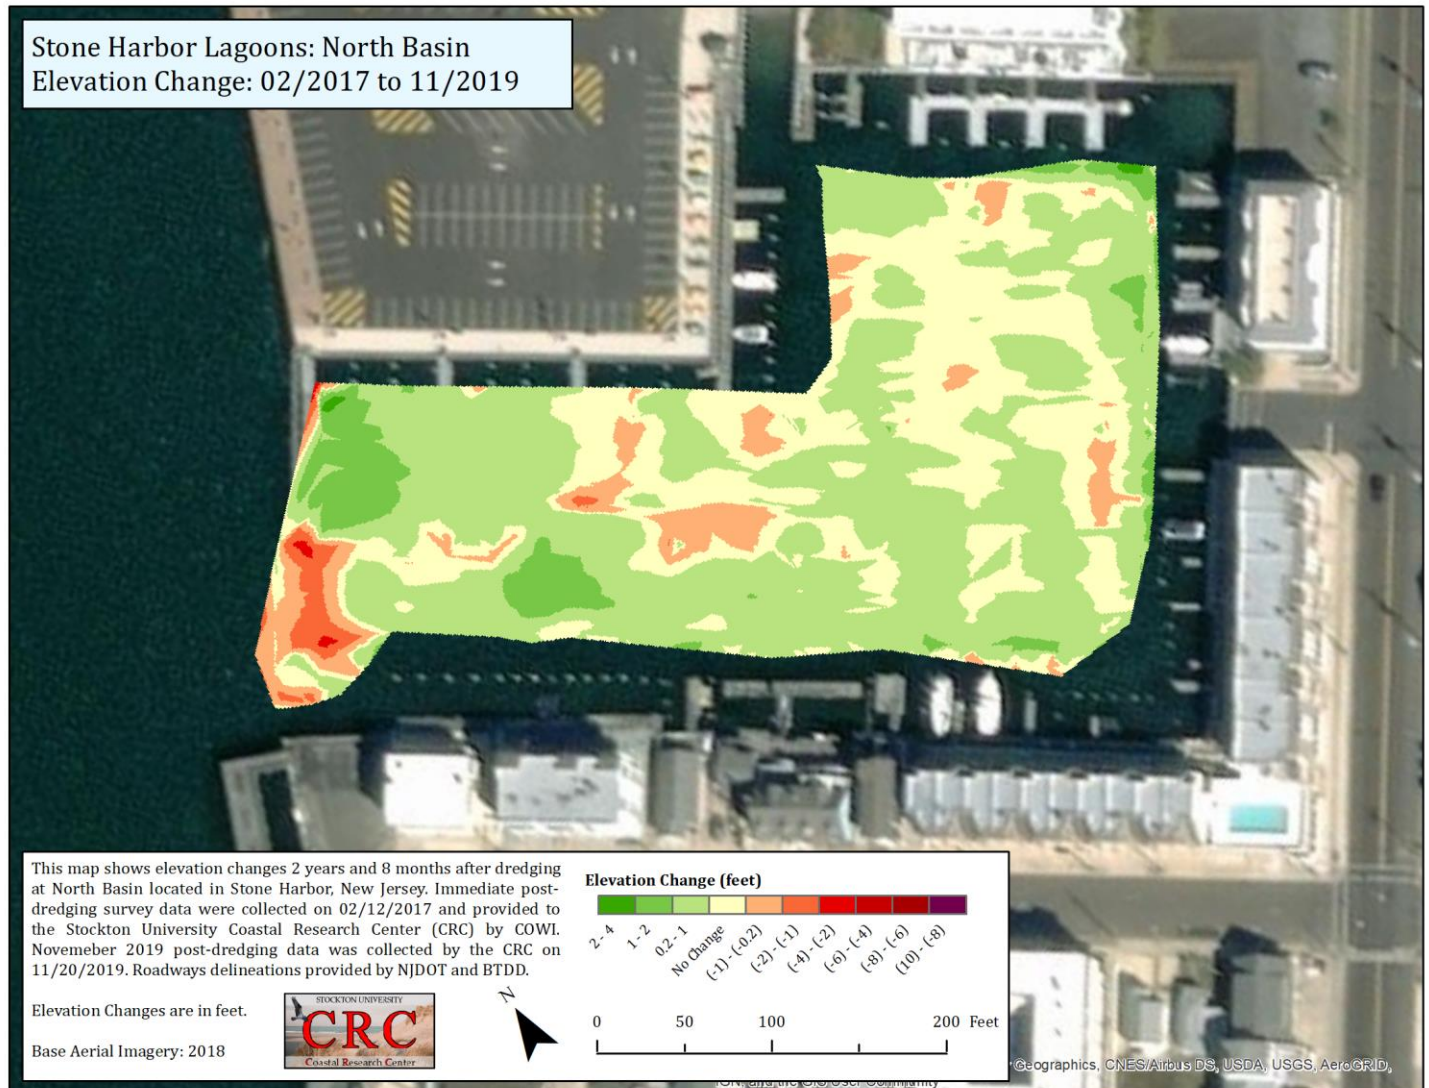
Figure 9a. This basin remains at or slightly shallower than it was immediately after dredging was complete. The entrance area is between 0.2 and 2.0 feet deeper in a narrow zone right at the point where tidal water enters the lagoon. The inner basin remains with about half the area as dredged and half about 0.2 to 1.0 feet shallower. There were a number of spots where the depths were 0.2 to 1.0 feet deeper than immediately after dredging.

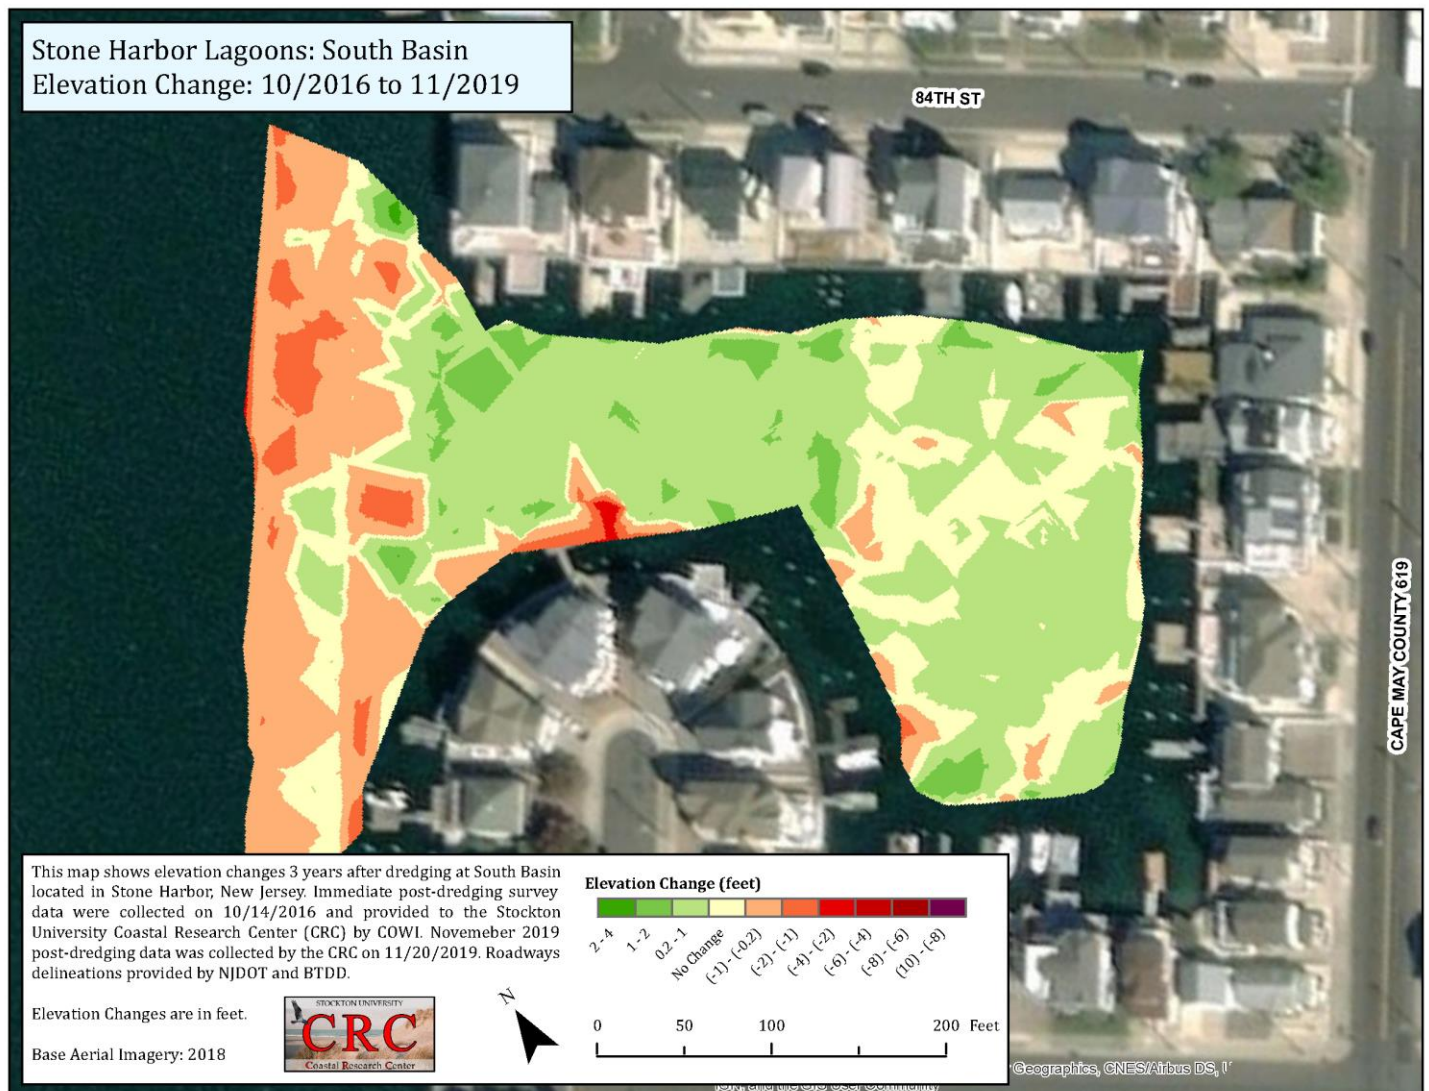
South Basin lagoon has behaved in similar fashion with deposition concentrated in the main entry channel adding as much as 2.0 feet of sediment in spots while the inner basin accumulated 0.2 to 1.0 feet of sediment across much of the area. South Basin did see greater entry point depths as a result of main Thorofare migration toward the bayshore in Stone Harbor. This is a relatively new pattern because prior to dredging, the entry points were the most impacted by accumulated sediments.

Figure 9b. South Basin has performed in similar fashion to the post-dredging changes seen in the North Basin. Between 0.2 and 1.0 feet of sedimentation since dredging has appeared over three years across the main channel and to a lesser degree, within the inner basin, while entry point erosion has created deeper water where the Great Thorofare main channel joins the navigation channel into South Basin.

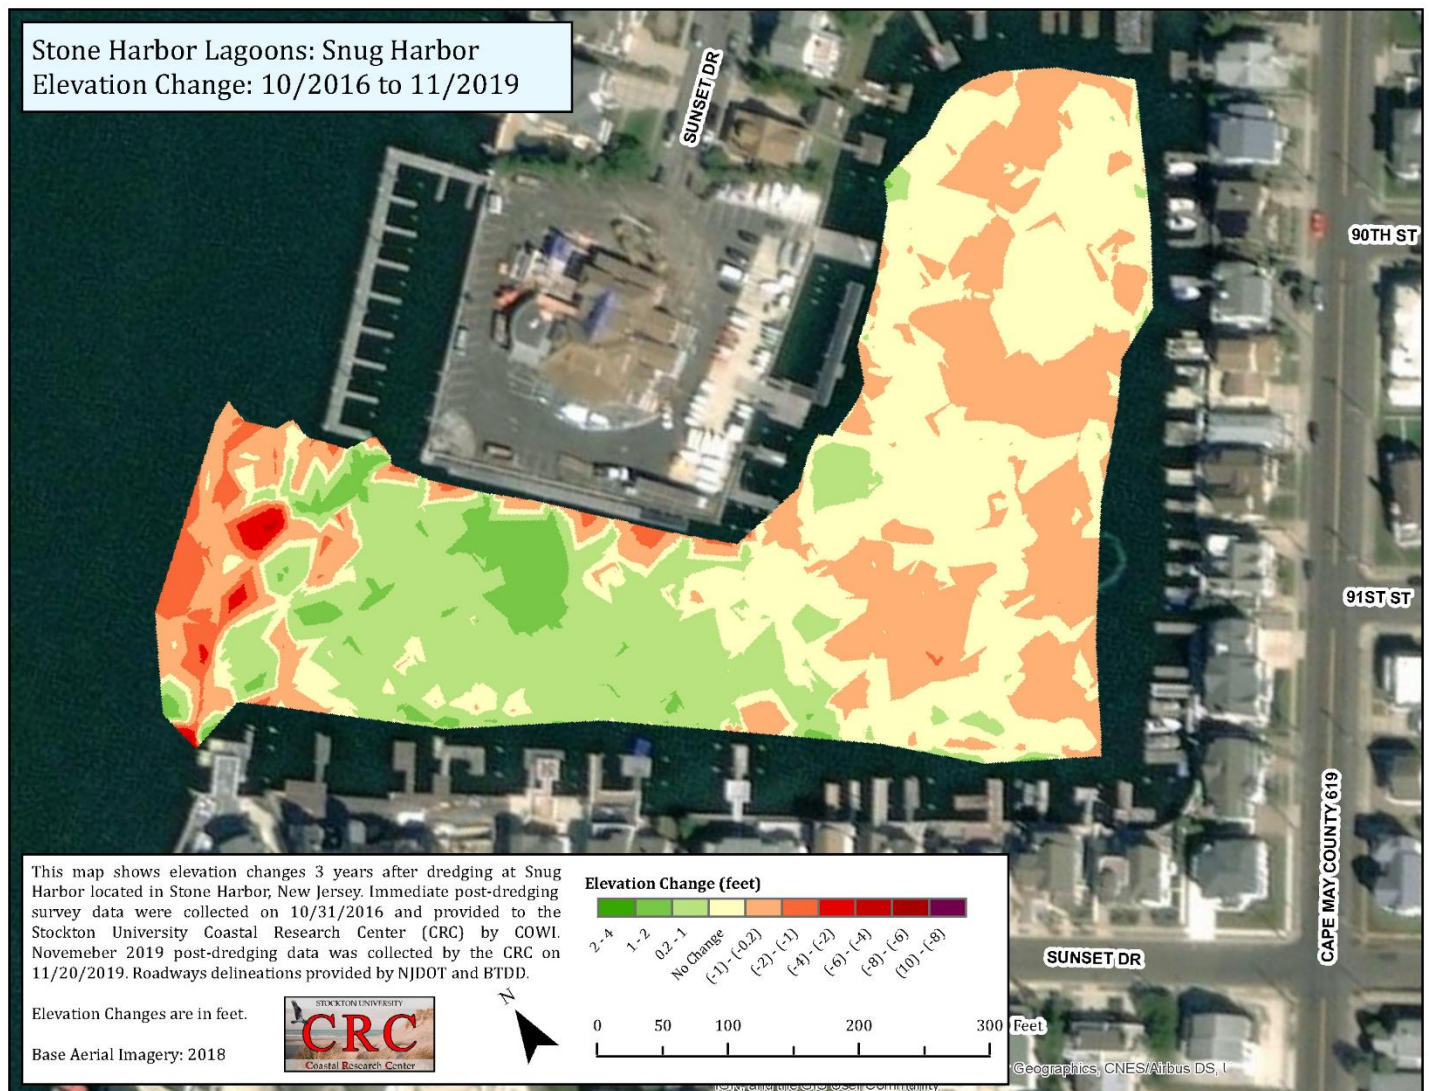
Snug Harbor shows a contrast between the inner basin where some minor deepening has occurred. The yellow color represents + or - 0.2 feet of change while the lightest green color represents between 0.2 and 1.0 feet of sediment accumulation. The entrance channel area has become between 0.2 to 1.0 feet shallower since October 2016 with a zone between 1 to 2 feet of deposition adjacent to the yacht club. At the entrance point from Great Thorofare there are multiple bands of deeper areas ranging up to 3.0 feet deeper in small patches. The eastern channel margin of Great Thorofare has been migrating closer to Stone Harbor bayside development for a couple of years, evidenced by the erosion seen right at the entry point into the lagoon basins.

Figure 10. Snug Harbor shows between zero and 1.0 feet of deepening in the inner basin, while showing 0.2 to 2.0 feet of shallower areas within the entrance channel. A complex set of bands across the entrance show areas of deeper depths with patches of shallower areas. These range from -3.0 to zero to 1.0 foot shallower. The survey covered a zone into the main channel at the yacht club.

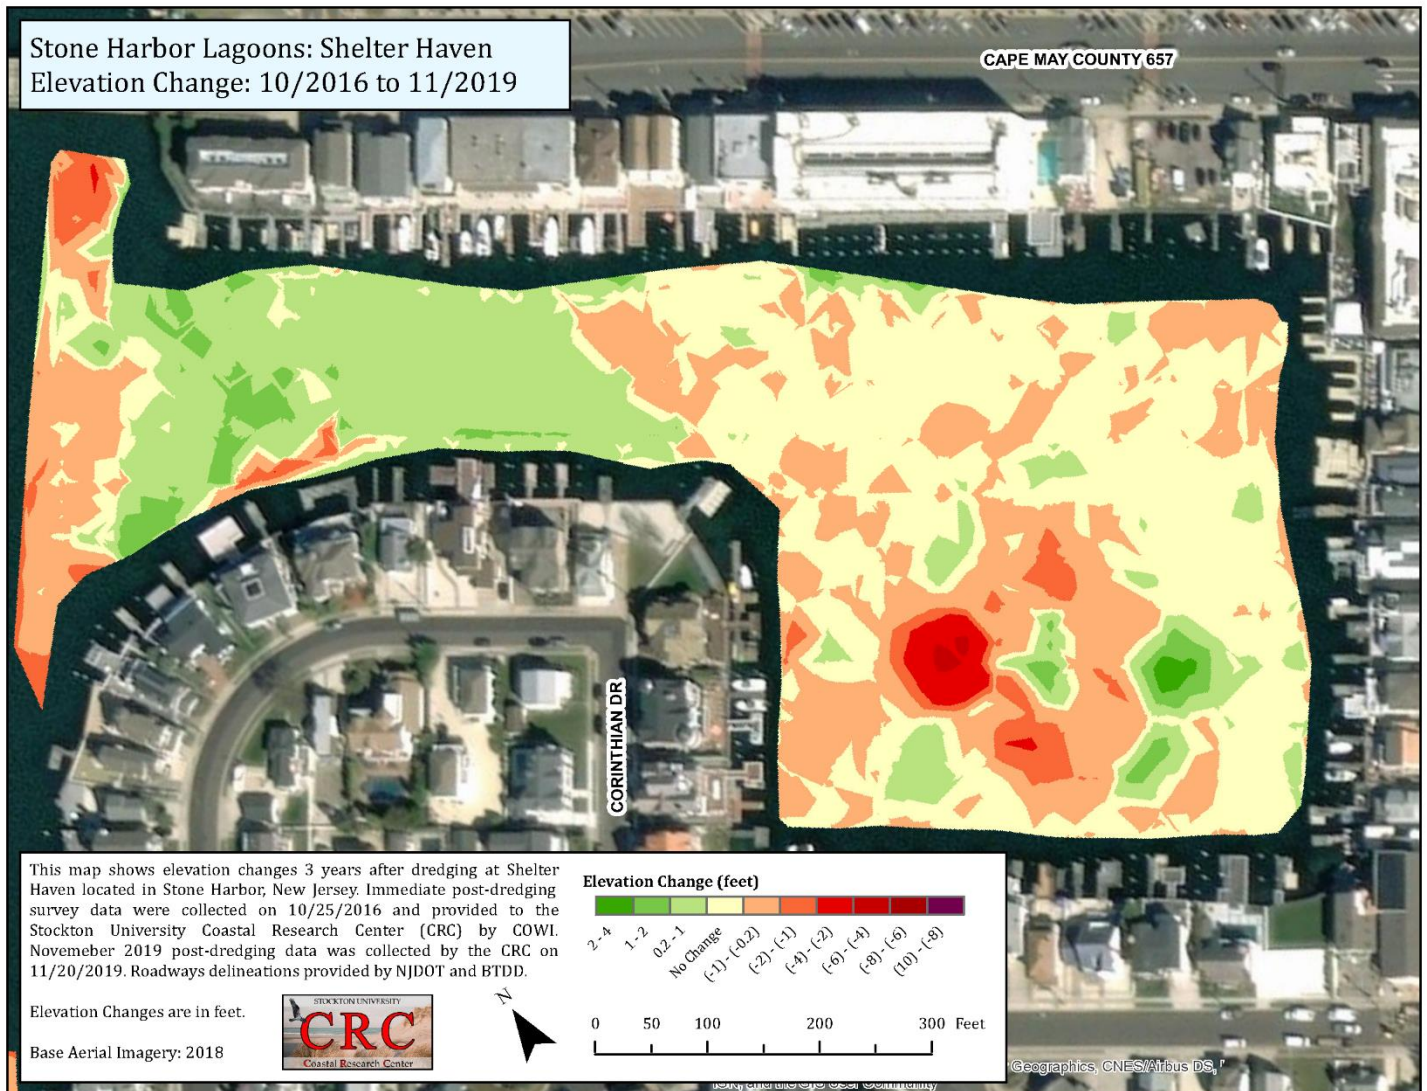
Shelter Haven compares in pattern to the two northern sites where the inner basin shows no change to a minor amount of sediment accumulation between 0.2 and 1.0 feet. The inner basin has a circular depression reaching 22 feet of depth in the southwest corner where depths have increased by between 2 and 4 feet. There were a few areas of deeper water as well. This excavation likely dates to the initial regional development when the lagoon basin was originally created. The entrance channel showed regional deposition by 0.2 to 1.0 feet with a few areas of no change, and erosion along the south channel margin. The entry point from Great Thorofare shows between 0.2 and 1.0 feet of sediment removal.

Figure 11. Shelter Haven is located just south of 96th Street and is similar in the pattern to the north where the inner basin is unchanged or marginally deeper, the entrance channel is up to a foot shallower and the entry point from Great Thorofare has seen sediment erosion at the point where the eastern Great Thorofare channel margin is met.

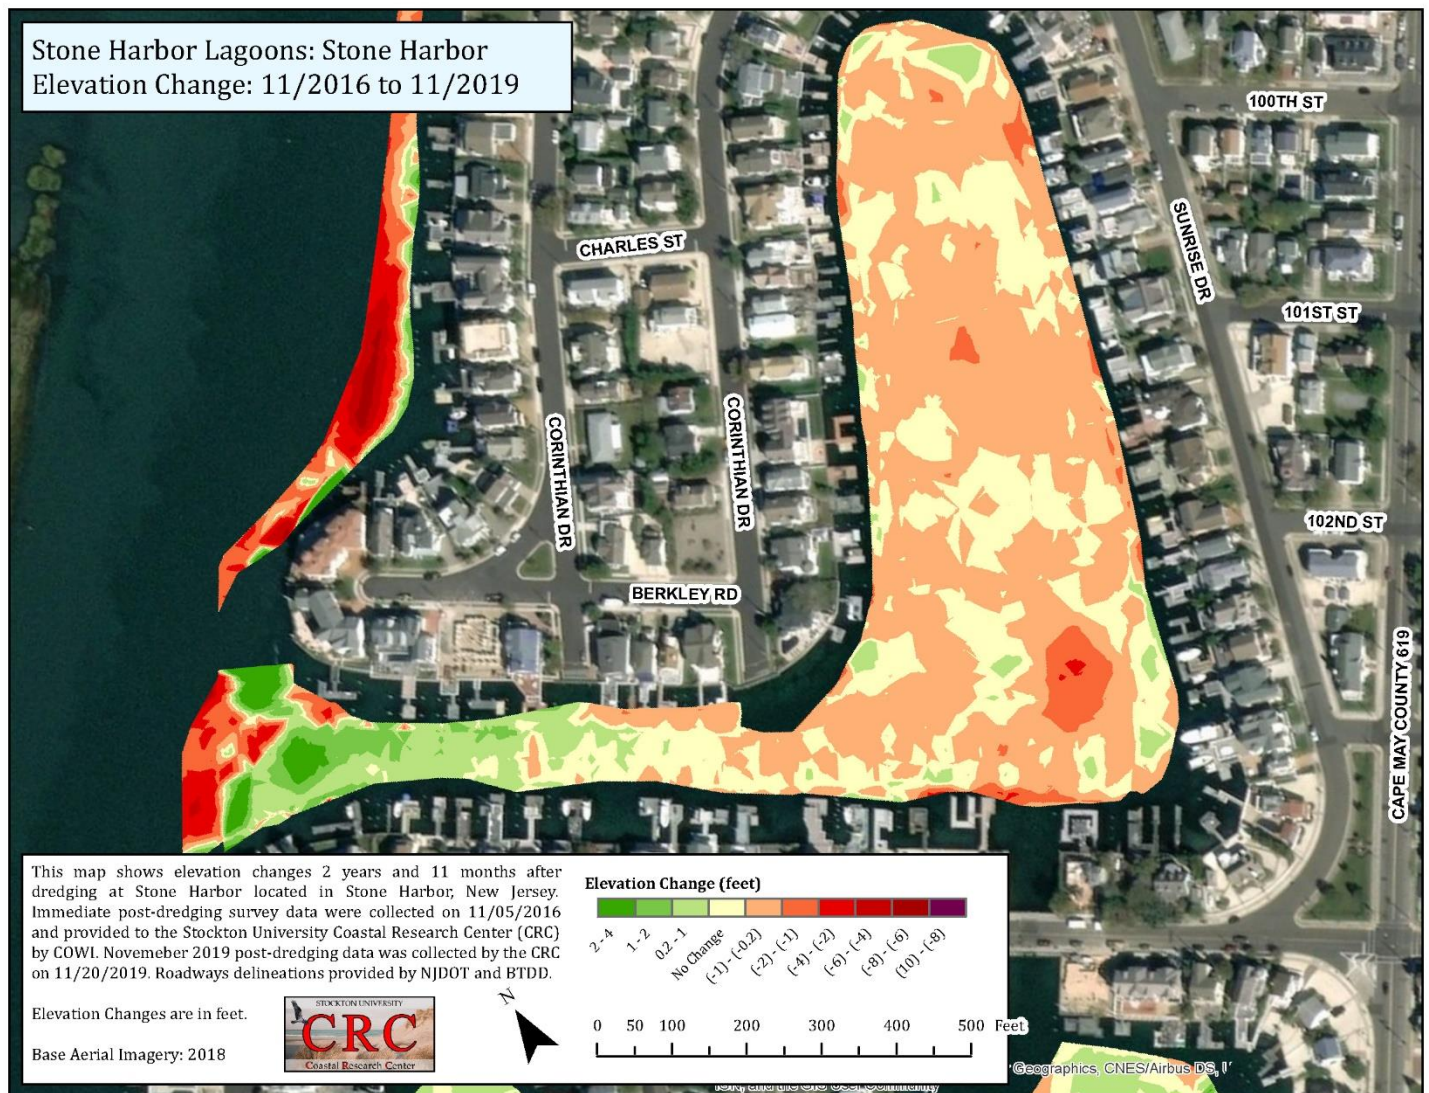
In addition, the survey conducted along the Great Thorofare east channel margin north of the entry to Stone Harbor Lagoon emphasizes the migration of the main channel toward the developed shoreline. Greater depths approaching -10 feet appear opposite the cove by Berkley Rd. and Corinthian Drive.

Figure 12. Stone Harbor Lagoon displays a consistent pattern associated with the northern basins where the inner basin has remained as dredged or become marginally deeper (-0.2 to -1.0 feet) while the entrance channel has become shallower since November 2016. Sediment erosion has impacted the entry point with up to 4 feet of lost material at the southern margin bulkhead. This erosion extends north of the entrance as well, reaching 10-foot greater water depths.

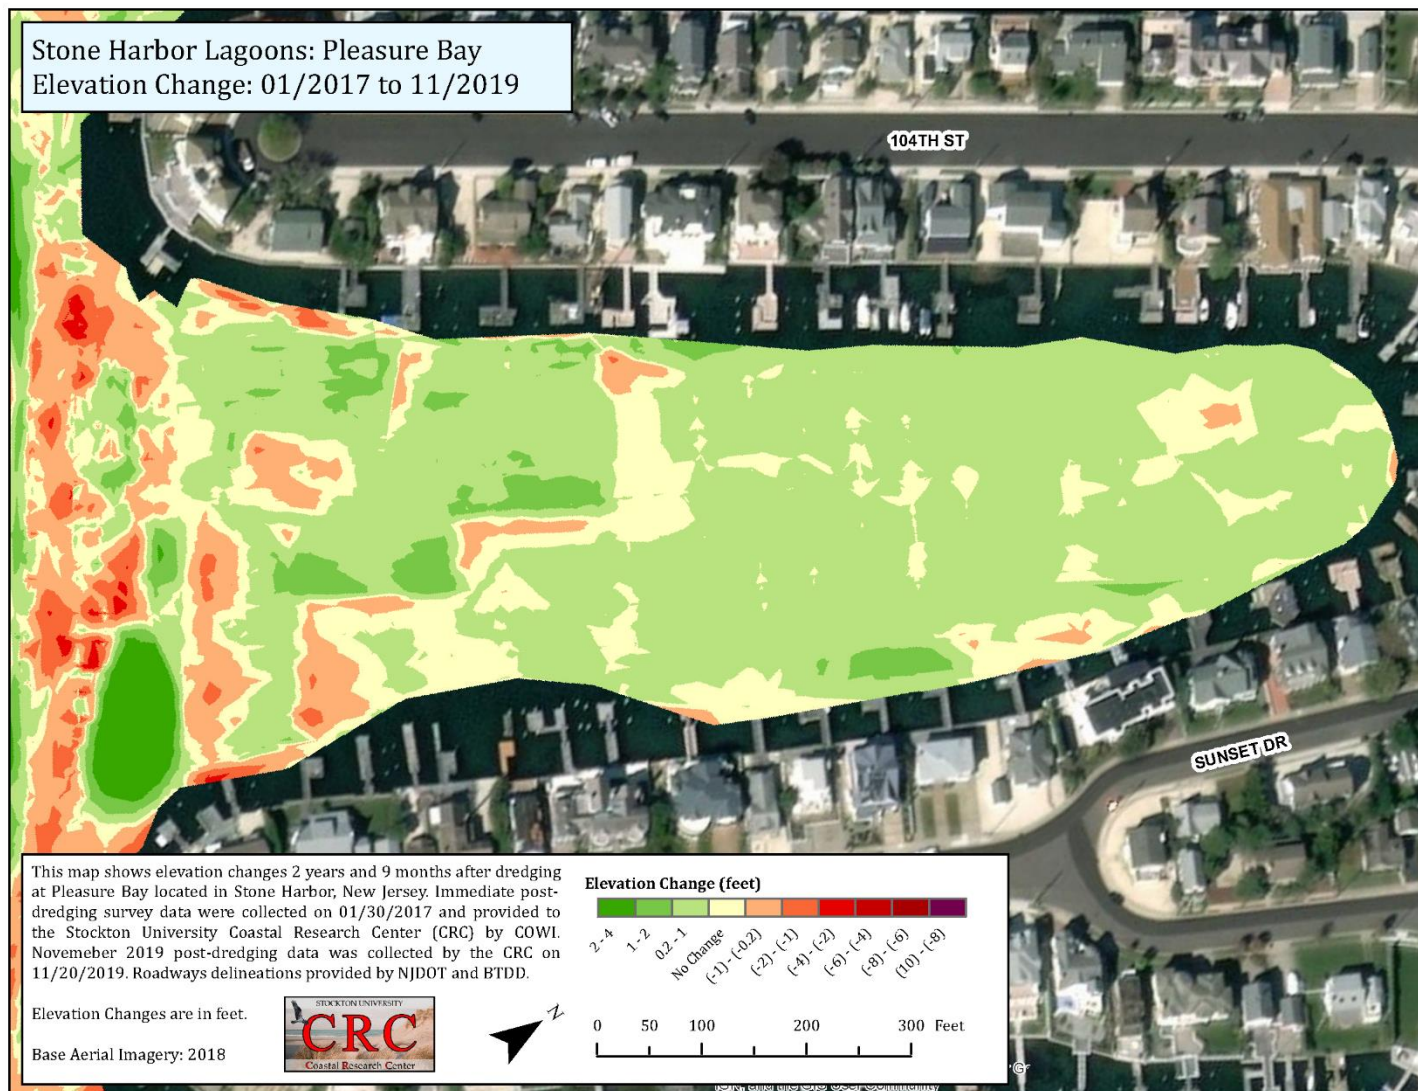
Pleasure Bay is the western one of a pair of identical shaped lagoons lying between 104th and 109th Streets essentially side by side with Corinthian Drive in between. These lagoons are examined as a pair because there is a difference in performance that is striking. Pleasure Bay has generally become slightly shallower since January 2017 following dredging while there have been smaller sediment volume changes in Carnival Bay. The entire basin in Pleasure Bay shows minor depth reductions between 0.2 and 1.0 feet, while Carnival Bay has shallower areas to the south end and little change showing in the northern two thirds. Some entry channel scour occurred between Pleasure and Carnival Bays, but the south margin was excavated into a wide, very shallow sand flat that is unmarked navigationally and results in vessel grounding at all but the highest tides when the edge is crossed onto the remaining flat.

Figure 13a. Pleasure Bay is the westernmost lagoon of this pair, located south of 104th Street. This basin has become between zero and 1.0 feet shallower since March 2017. There is a scour located at the entry to Pleasure Bay that continues east to the entrance of Carnival Bay. The entry areas show spotty sediment accumulation at the entry point.

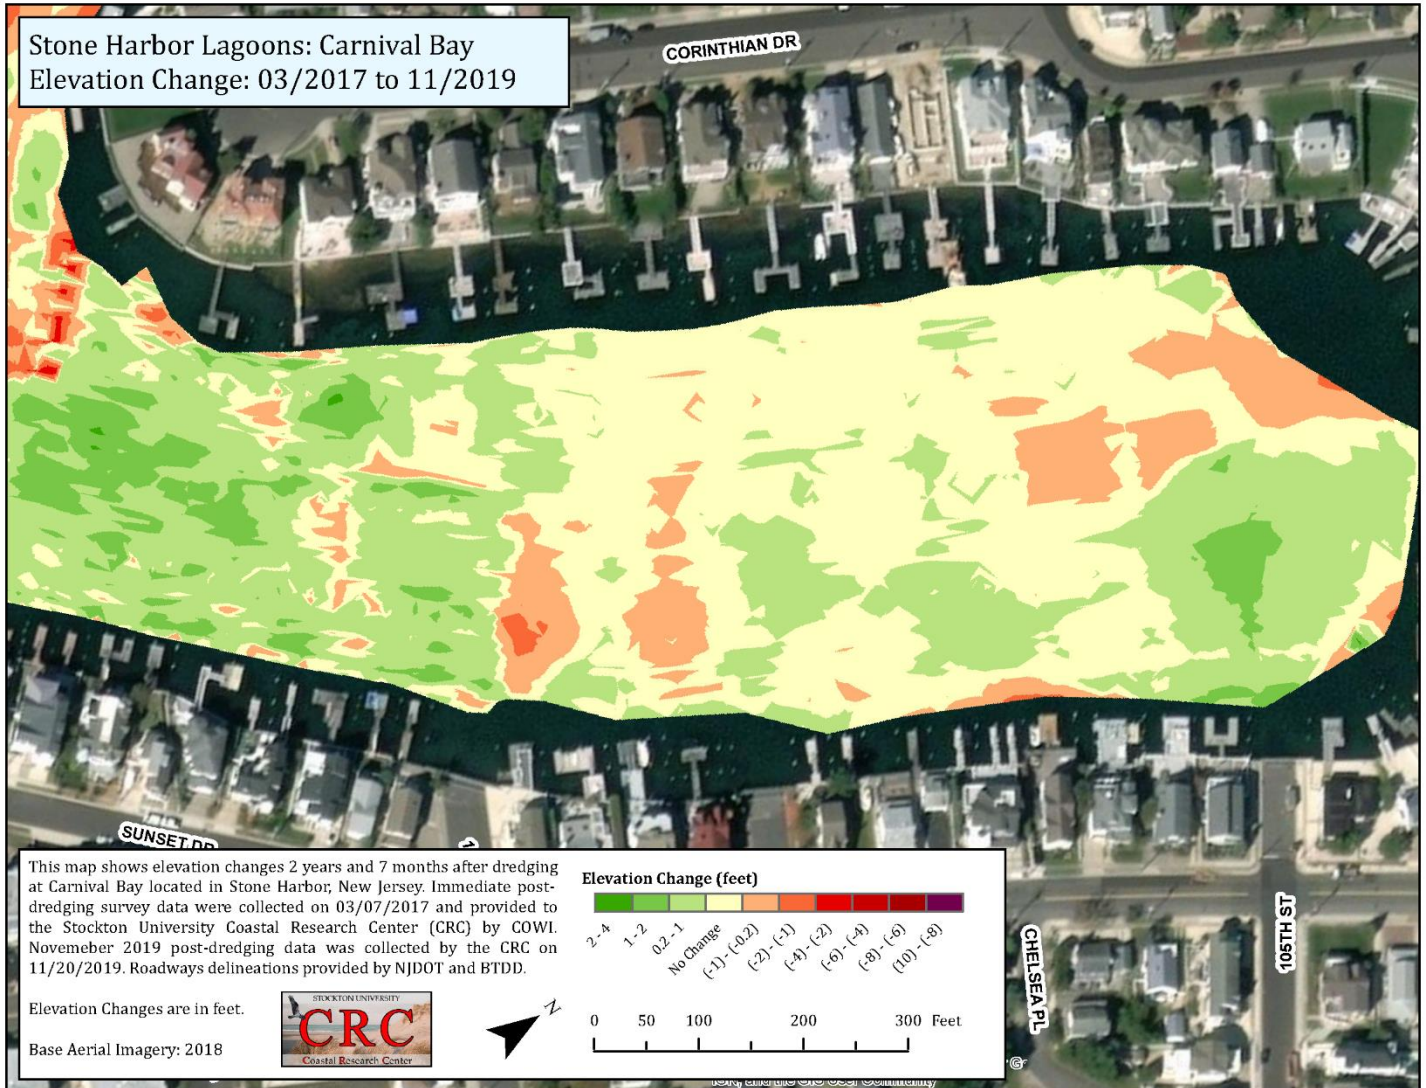
Figure 13b. Carnival Bay is east of Pleasure Bay and conforms to the same general configuration, but east of Corinthian Drive. The southern third is shallower while the remainder of the basin shows either no change or a pattern of zones of accretion and deepening. This area is at a maximum distance from the sediment source carried by incoming tidal flow, so receives smaller quantities of suspended sediment.
