**2020 ANNUAL REPORT ON
THE CONDITION OF THE MUNICIPAL BEACHES FOR
THE BOROUGH OF STONE HARBOR, CAPE MAY COUNTY, NEW JERSEY**

**PREPARED FOR: THE BOROUGH OF STONE HARBOR
9508 SECOND AVENUE
STONE HARBOR, NJ 08247**

**PREPARED BY: THE STOCKTON UNIVERSITY COASTAL RESEARCH CENTER
30 WILSON AVENUE
PORT REPUBLIC, NEW JERSEY 08241**

January 15, 2021

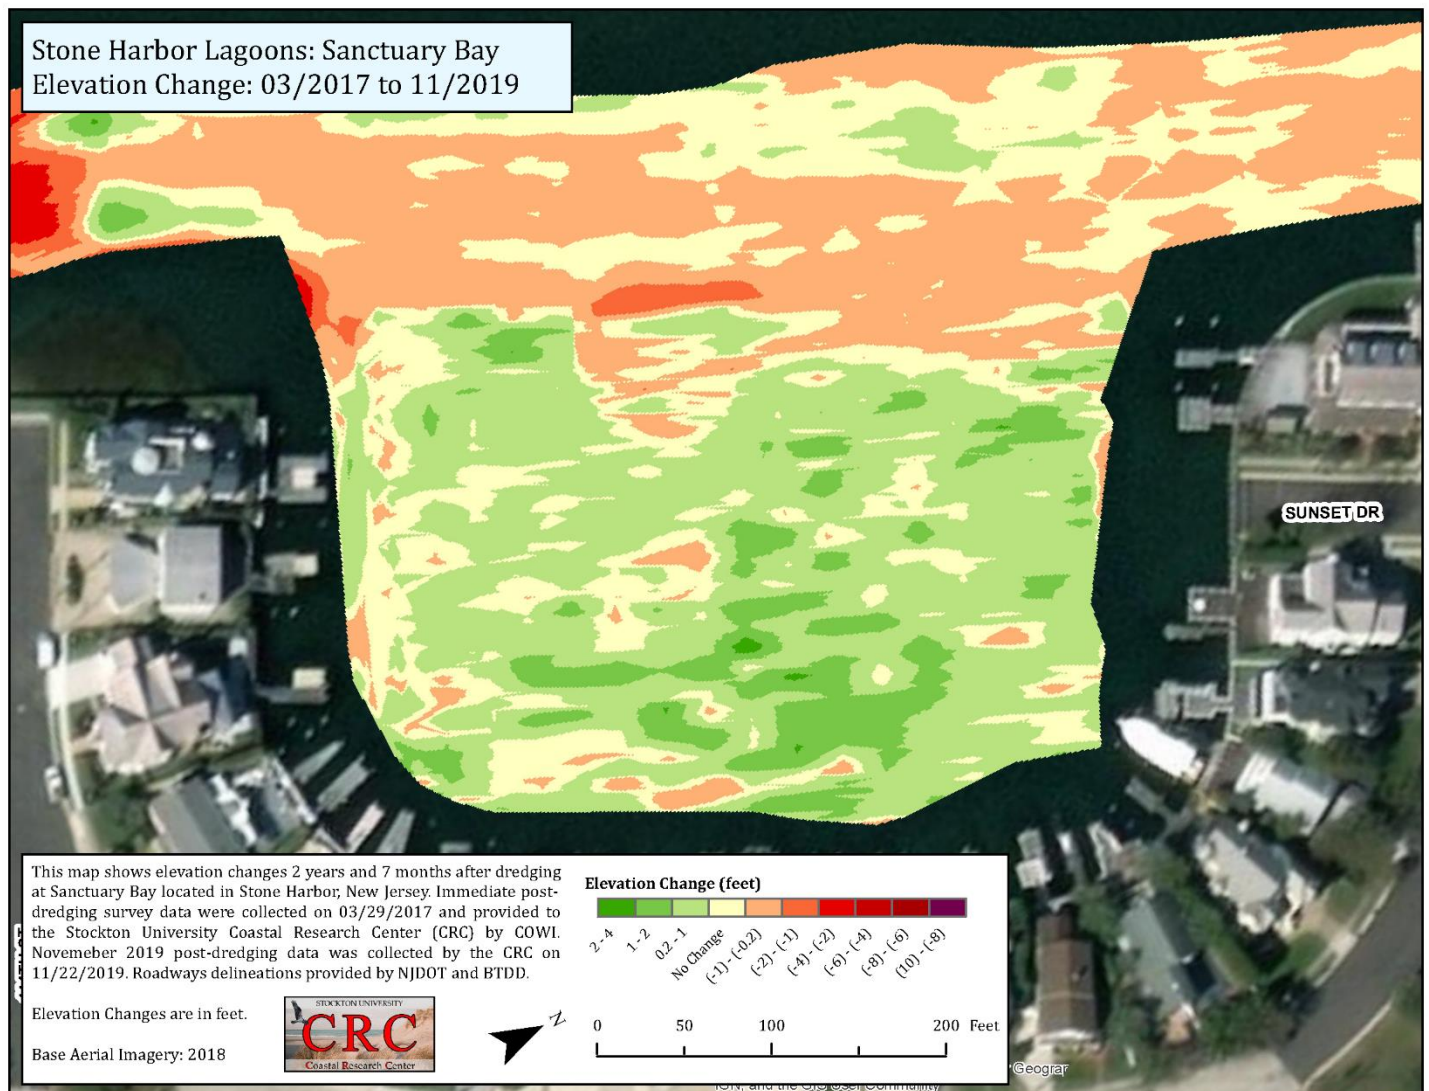
Sanctuary Bay is a cove along the bayshore where depth changes appear generally shallower by 0.2 to 2.0 feet in the excavated cove, but deeper along the axis of the tidal channel leading from Carnival Bay to the exit point back to Great Thorofare at the bridge to North Wildwood.

Figure 14. Sanctuary Bay lies east of the channel running south from the entrance to Carnival Bay and that exits at the bridge to North Wildwood. The excavated basin appears shallower by 0.2 to 2.0 feet in some spots, while the channel area is deeper by the same measure (0.2 to 2.0 feet). Substantial areas of no change still exist.

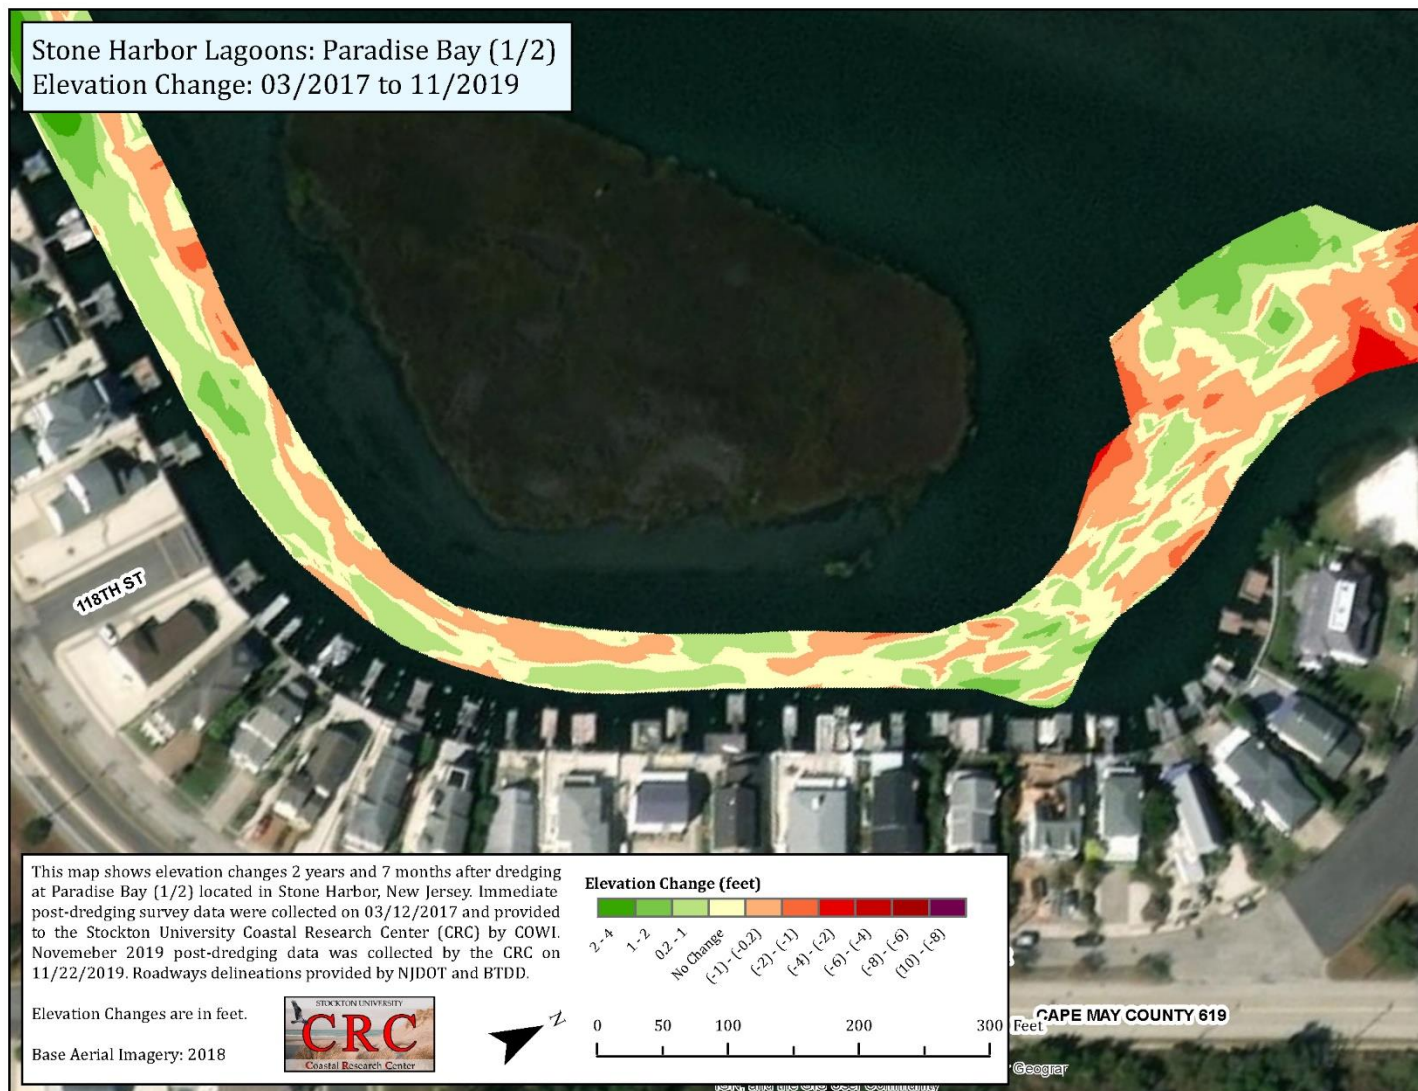
The southernmost area is a developed channel margin along the original salt marsh edge more than it is a “lagoon”. This area shows a relatively linear pattern of shoals and deeper spots that mirror tidal distribution of sediment.

Figure 15a. The northern end of Paradise Bay is a dug channel between development and a marsh bay island to the west. There is spotty pattern of accumulation, no change and erosion since March 2017 when dredging was completed. The pathway south between marsh islands west of this channel is shallower to the point of avoidance by larger vessels particularly at low tide.

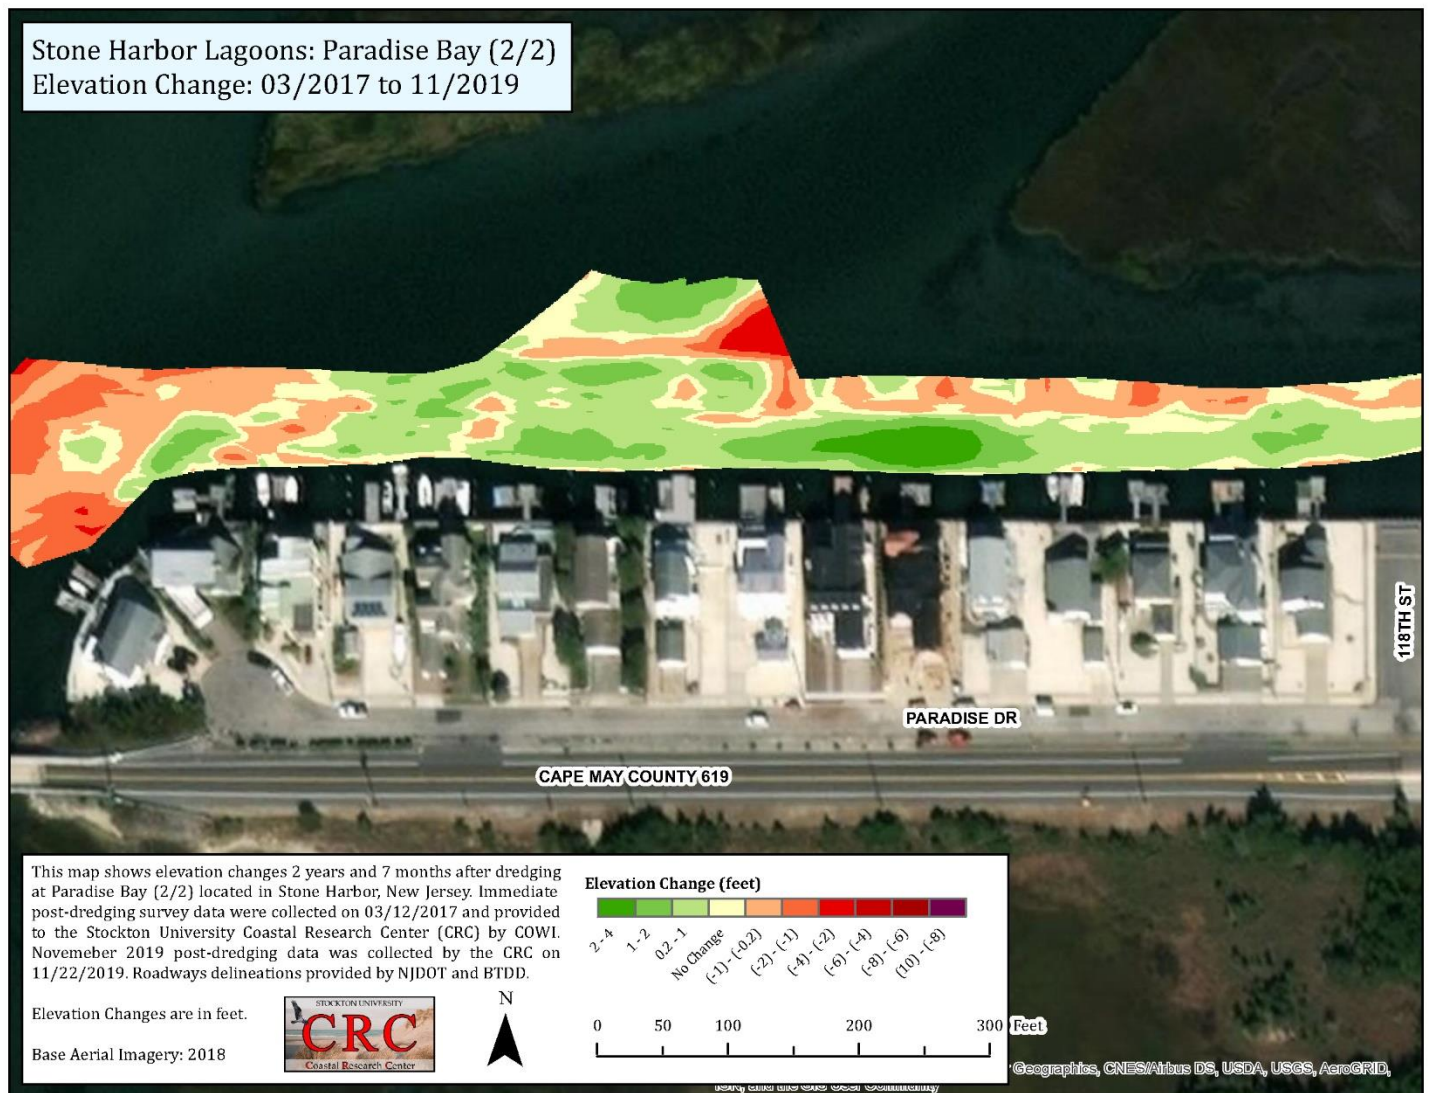
Figure 15b. The southern end of the Paradise Bay channel has accumulated sediment since dredging except for the entry back into Great Thorofare. The branch leading north between the marsh islands was surveyed but was barely navigable except within a few feet from the bay island to the right side going north in the cut. The western shoreline was exposed as a mud flat when the 2019 review was conducted.

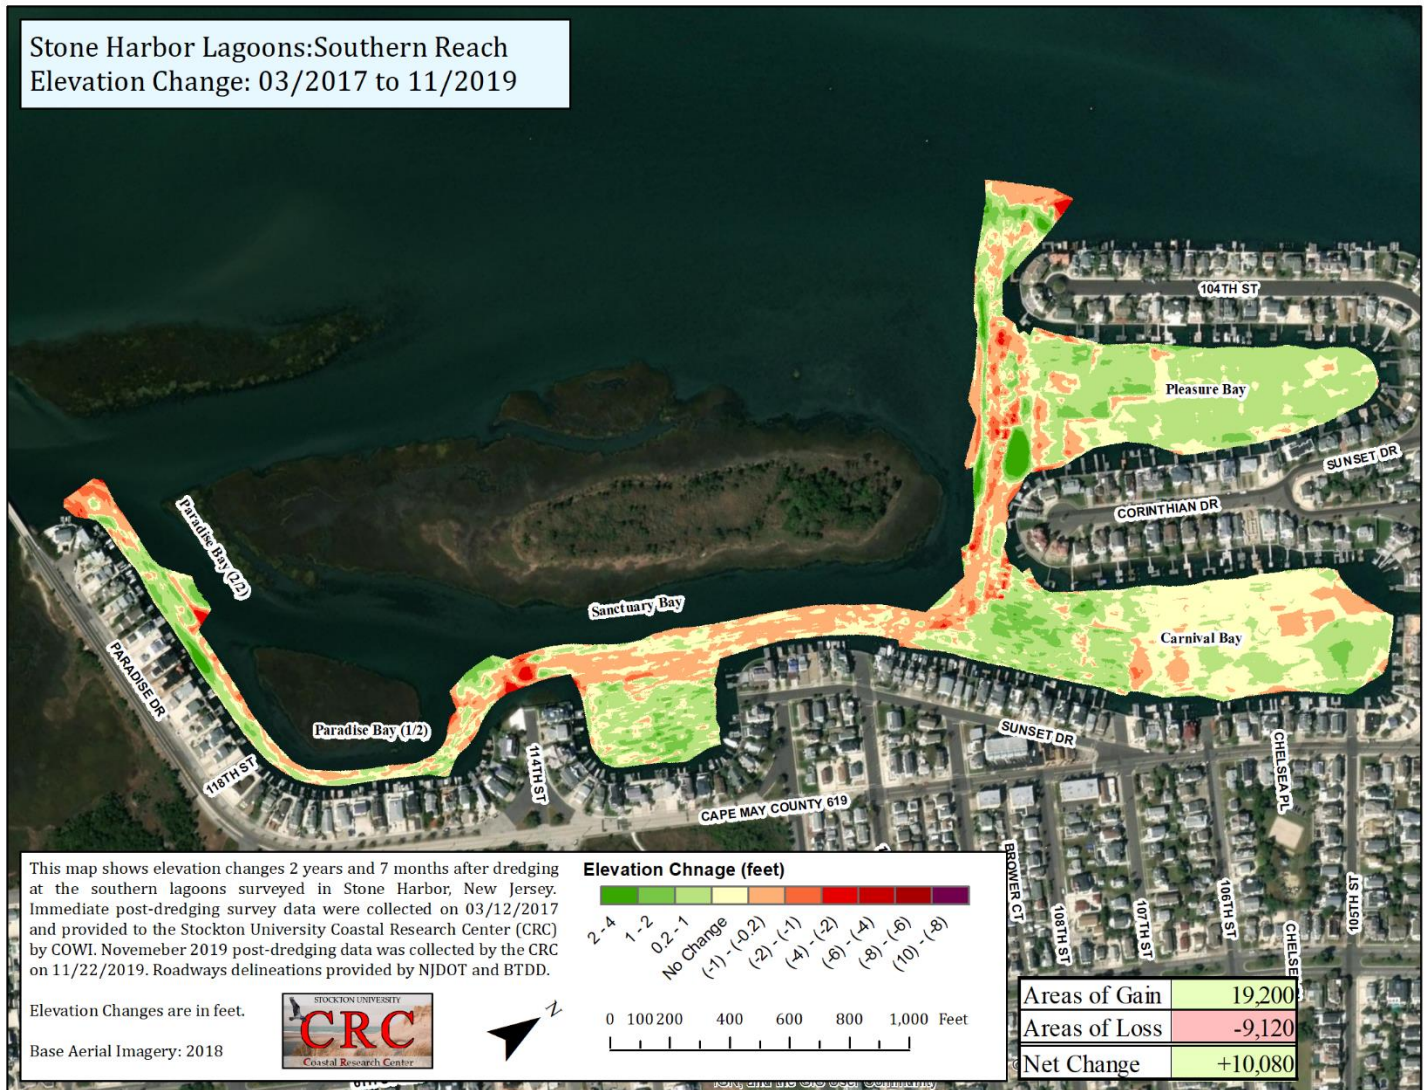
In order to show the complex of channels and basins associated with Sanctuary Bay which includes both Pleasure and Carinival Bays, plus Paridise Bay channels, the regional map is produced as Figure 16. The entire area gained about 10,000 cubic yards of new sediment since dredging was completed, over 8,700 cubic yards of which was deposited in Pleasure and Carinival Bays. The Paridise Bay channels are the most difficult to navigate for larger vessels due to compact width limits and perioding shoals already appearing. The direct route north toward Carnival Bay is marginally navigable at present at low tide. The western margin along the marsh island was exposed as a wide mud flat in Decemeber 2019, so was not surveyed. The navigation channel exists within a few feet of the sod bank on the eastern marsh island.

Figure 16. This map ties together five separate locations above into a composite for Sanctuary Bay and its associated lagoon basins. The entire region gained just over 10,000 cubic yards of sediment since dredging was completed. This was dominated by sediment deposition in Pleasure and Carnival Bays. The access route among the four developed lagoons appears to be getting deeper since dredging with minor exceptions along Paradise Bay channel.
