**ANNUAL REVIEW FOR 2017
OF THE CAPE MAY POINT, NJ MUNICIPAL BEACHES**

PREPARED FOR: THE BOROUGH OF CAPE MAY POINT
215 LIGHTHOUSE AVENUE
CAPE MAY POINT, NJ 08212

PREPARED BY: STOCKTON UNIVERSITY COASTAL RESEARCH CENTER
30 WILSON AVENUE
PORT REPUBLIC, NJ 08241

June 1, 2017

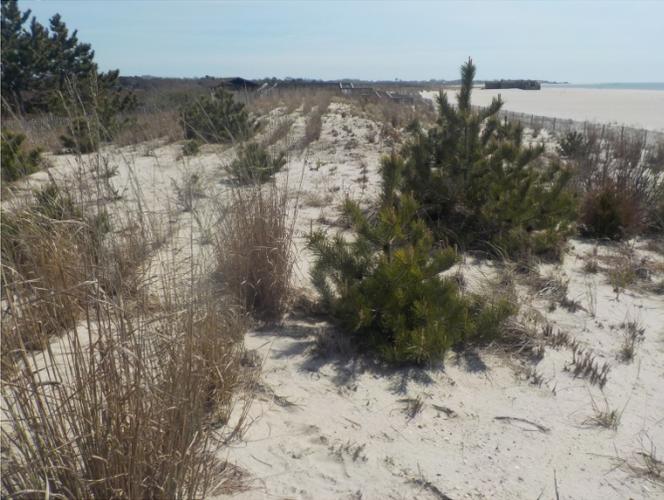
Lighthouse Avenue

The photo taken in April 2016 shows the dune and beach remained remarkably stable. There were few visible changes to the beach or dune system other than continued plant growth.

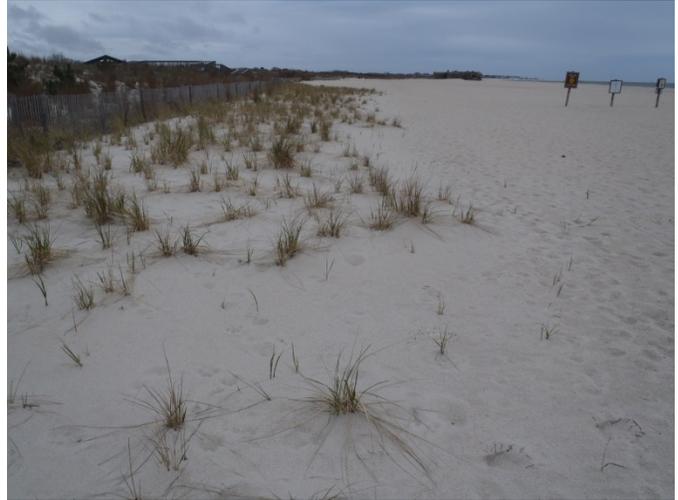
The photo taken in April 24, 2017 shows the dune toe and wider beach looking toward the Nature Conservancy. This has been a substantially wider beach as a result of the USACE work.

The recent USACE activity has added 78,184 cubic yards of new material to this site and Lehigh Avenue beach immediately to the southwest. The cross section shows that the beach grew wider in each of the past two years at this site.

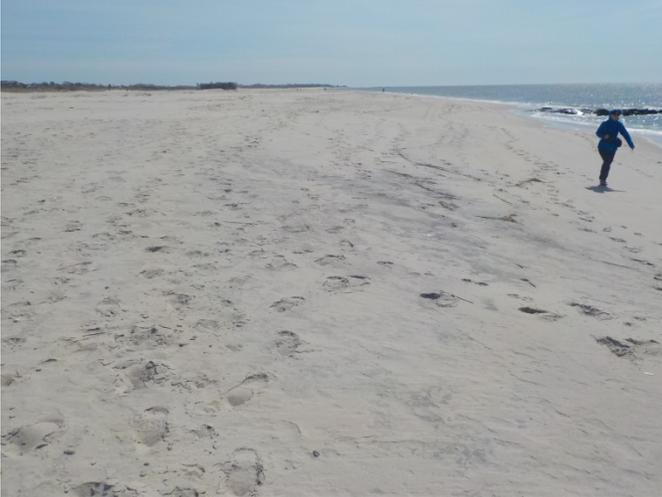
Lehigh Avenue

Taken on April 21, 2016, photo shows a stable to slightly accretive beach. The berm is noticeably wider and higher. Sand has accumulated along the beach berm and beachface slope, advancing the shoreline position.

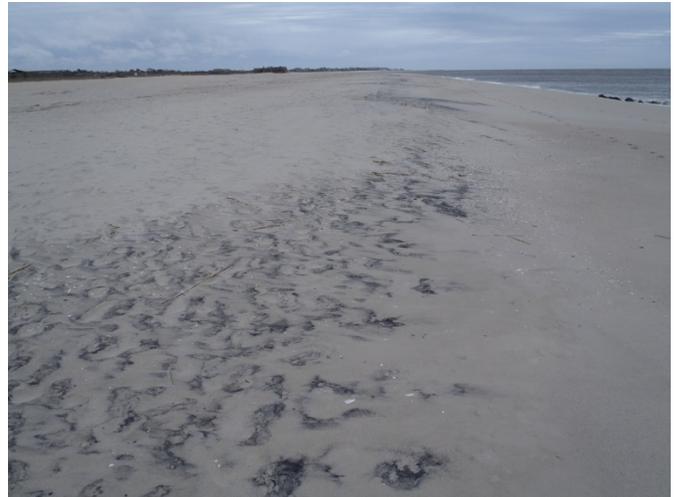
Taken on April 26, 2017, the photo shows a stable to slightly accretive beach. The berm is wider and slightly higher a year later, sand has accumulated along the beach berm and beachface slope, advancing the shoreline position post-project.

The shoreline advance has brought the zero elevation position 70 feet seaward compared to last year. This material will migrate slowly west along the shoreline benefitting the adjacent beach cells over time.

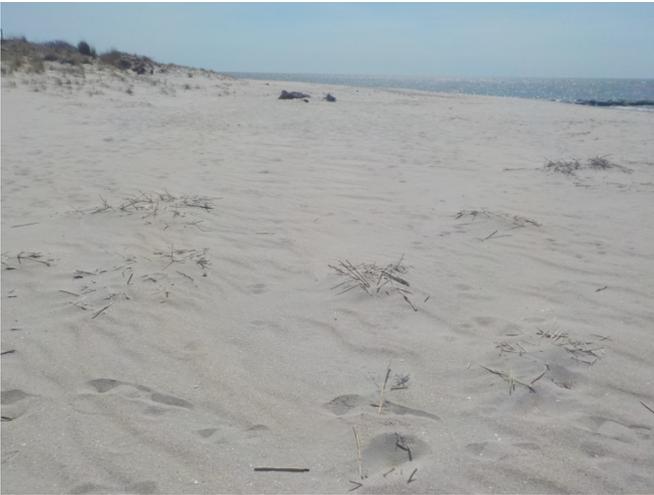
Lehigh to Whilldin Avenues

The photo above was taken on April 21, 2016. Seaward dune slope has accumulated sand and the beach is considerably wider in 2017.

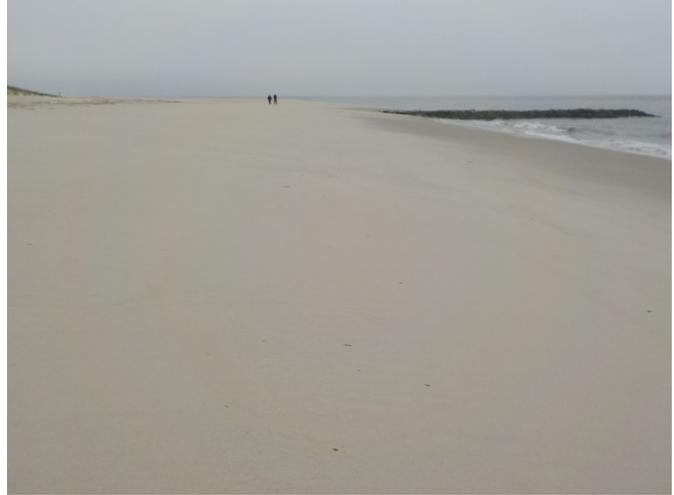
This view from the berm shot April 24, 2017 is out on the new, wider beach showing two distant figures near the groin.

The recent cycle of USACE sand placement also did not directly put sand into this cell. However, the natural transfer of material has created a 24-foot shoreline advance and an net gain of 22.16 yds³/ft. in sand volume.

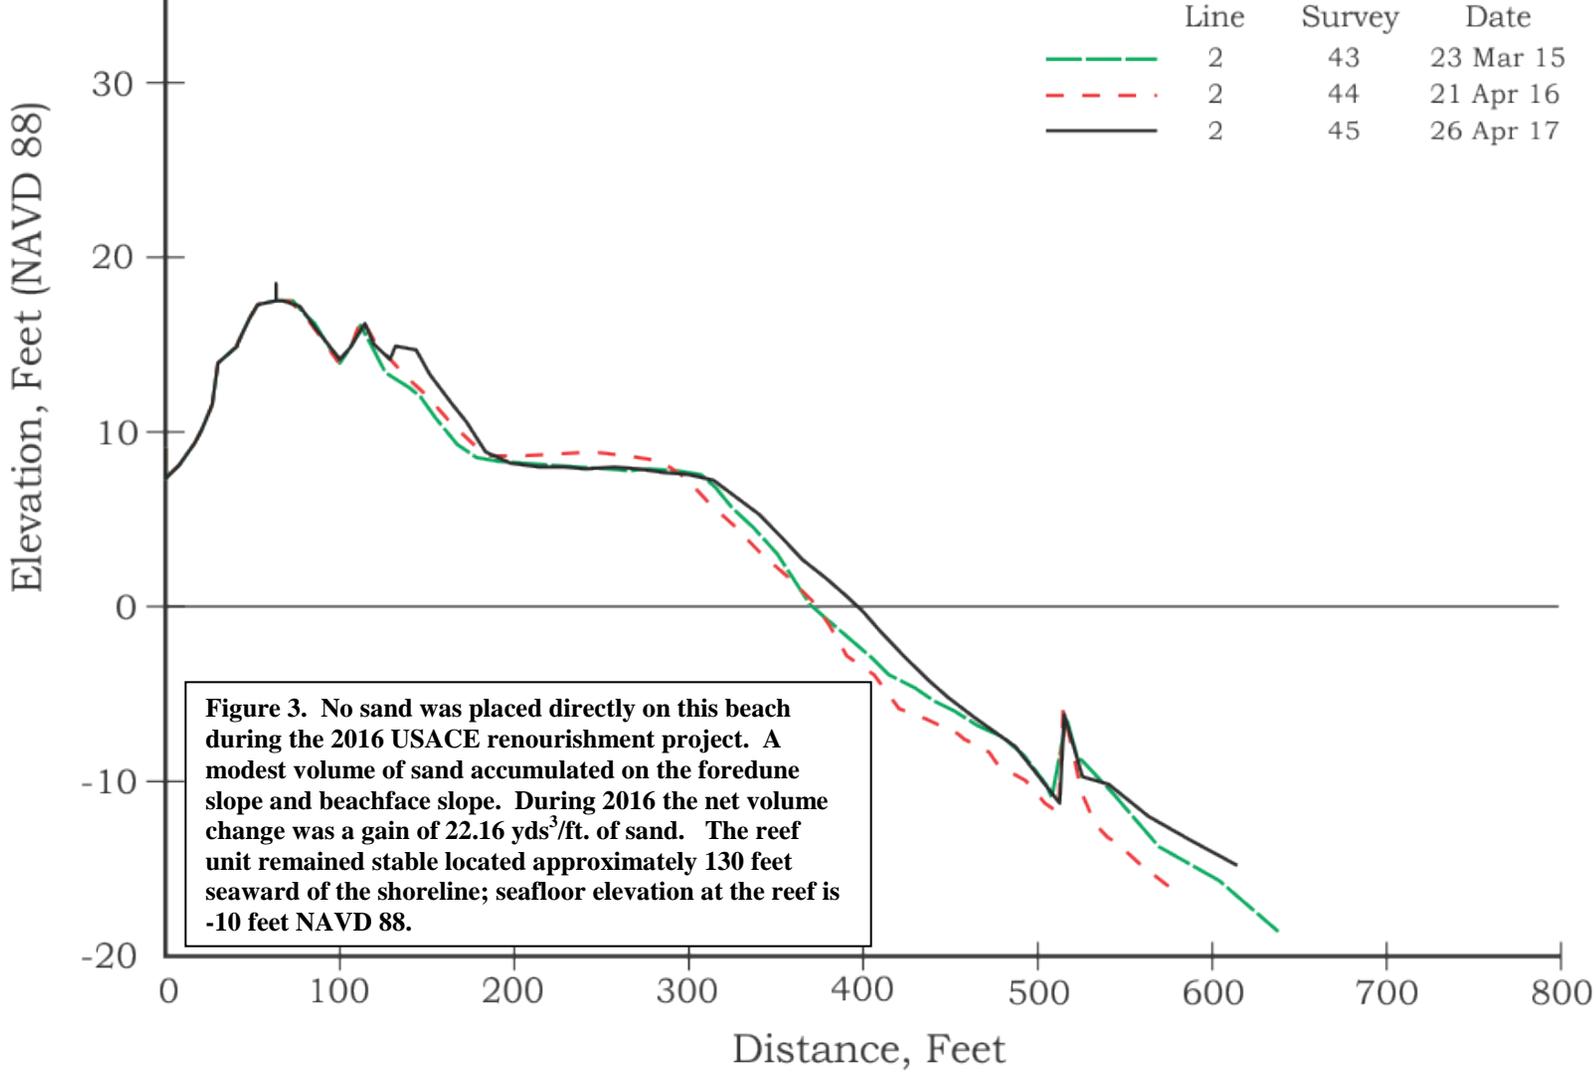
CMP - Line 2 - Willdin Avenue

The “Beachsaver” unit crest remains about six feet above the nearshore seabed slope. Landward of the units, a trough also remains at shallower depths than last year, but in a similar range. The top elevation has remained constant for many years, so the structure appears stable.

As of April 2017, the reef crest was 110 feet seaward of the zero elevation shoreline position (about mid-tide position) with the concrete units residing in -11 to -12 feet of water below the NAVD88 zero elevation. The reef crest protrudes up to elevation -6 feet NAVD88. In this position the units are unlikely to be encountered by swimmers this season within the middle of the groin cell. Caution and restrictions should be in placed closer to the groins where the shoreline sand extends outward toward the concrete reef along each groin.

2. Cell 2 at Whilldin Avenues, the shoreline position (zero datum) is approximately 110 feet distance from the breakwater structure. Depth of the scour trough landward of the units has decreased to -10 feet NAVD88. The swimming area remains limited, especially closer to the groins but should be manageable in the mid- beach cell this year. The CRC again recommends installing a line of floats indicating the maximum distance for swimming that should be about 30 feet from the breakwater reef. This is due to wave surge turbulence during larger wave size events.

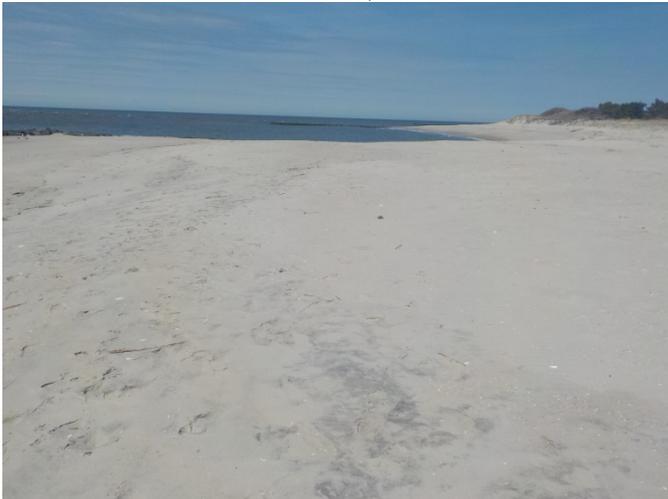
Whilldin to Coral Avenues;

The April 21, 2016 photo shows the beach offset along the Coral Avenue groin continues to widen. By far this offset is the most pronounced in Cape May Point.

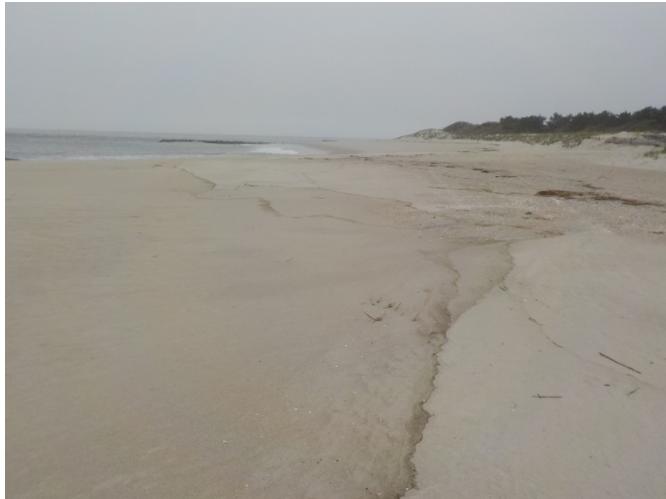
By April 26, 2017, the offset in beach width has decreased as more sand was added to the western half. The dune increased, while the beach remained constant at the cross section location.

CMP-3 is bounded by rock groins at Whilldin Avenue and Coral Avenue. This beach cell was the other original 1993 “Beachsaver” unit installation in Cape May Point. Sand added to the system during the initial USACE project had resulted in the near burial of the entire beach unit structure. No additional sand was placed here during the 2nd maintenance cycle (2012-2013). No new sand was added here during the recent USACE project either. Sand accumulated on the dunes, and minimally on the beach.

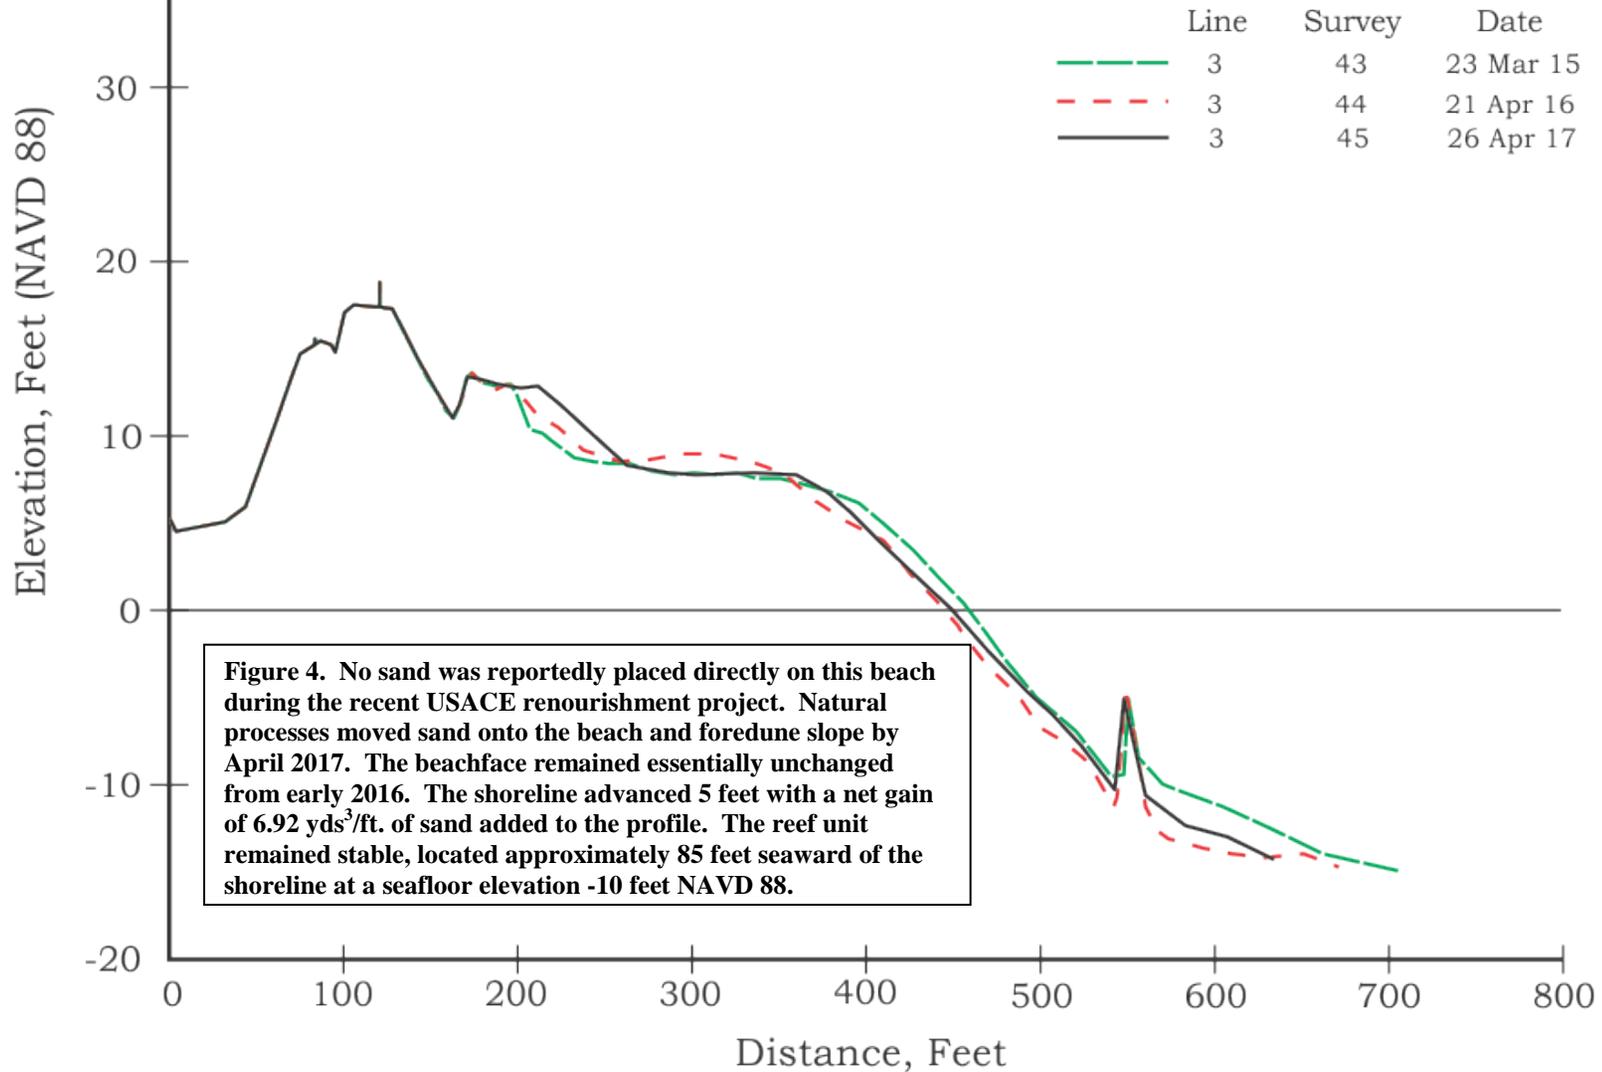
CMP - Line 3 - Coral Avenue

The minimal change to the beach width keeps the “Beachsaver” units within relative close proximity to the shoreline, approximately 85 feet. The concrete crest protrudes to elevation -5.0 feet (NAVD88 zero datum) while the base is at -11 to -12 feet NAVD88. This location has been restricted for several years as the beach width brings the zero elevation position within 100 feet of the reef structure. There is a deep trough at the landward side of the reef structure and the swimming space has decreased marginally. Again this year the recommendation is to allow swimmers to wade nearshore in shallow water less than 3-4 feet deep regardless of the tide level. Water access could be allowed here in mid-beach but water access near the groins where the units are closer to shore should be prohibited. Another hazard is the wave surge turbulence as larger waves pass over the submerged reef units. Someone of limited swimming ability might panic if buffeted about by this repetitive water turbulence within 40 feet of the reef units. This is only a concern when larger waves are reaching the shoreline.

3. Cell 3 at Coral Avenue, the shoreline position remained constant; the breakwater units in April 2017 were approximately 100 feet from the shoreline position (zero datum). The beachface slope remains fairly steep with continued existence of a scour trough landward of the units (-10 feet NAVD88). In the current beach configuration this location would only allow approximately half the distance between the reef and the mid-tide beach's water edge as safe for water activity. It is the CRC recommendation that entry into the water be limited to no more than 3- to 4-foot depths (defined by a line of floats) until such time that excavation removes sufficient sand from this

region to draw the shoreline landward and increase the distance between the shoreline and the concrete units.

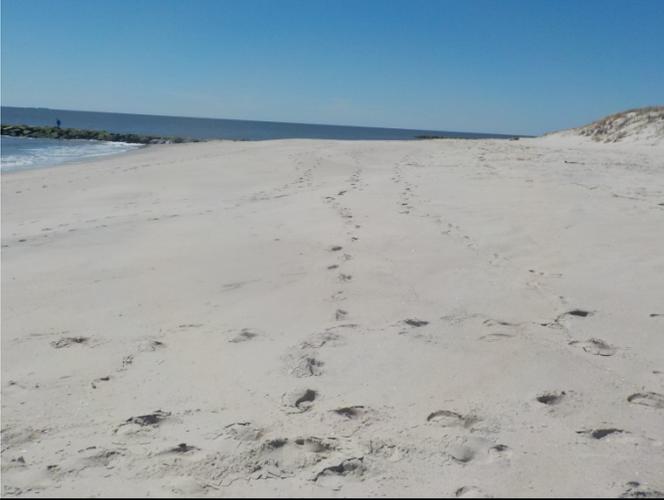
Coral Avenue to Lake Drive

Photo above was taken on April 20, 2016 looking west at Lake Drive. There was a modest shift in sand from the beachface slope to the upper beach.

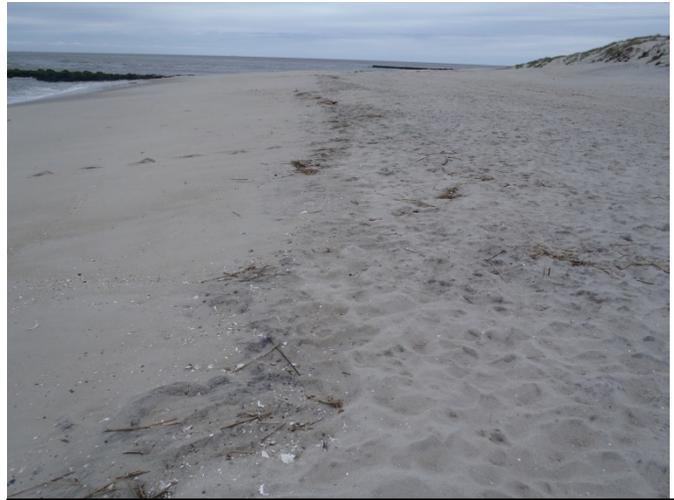
A similar view on April 24, 2017 shows a higher beach elevation with a well-defined wave limit on the sand.

The dune has remained relatively stable to slightly accretive through the recent monitoring time interval. The new sand shows as a wider berm accompanied by a 45-foot shoreline advance seaward. This added width will be welcome this summer since this is one of the most popular beach sites in the Borough.

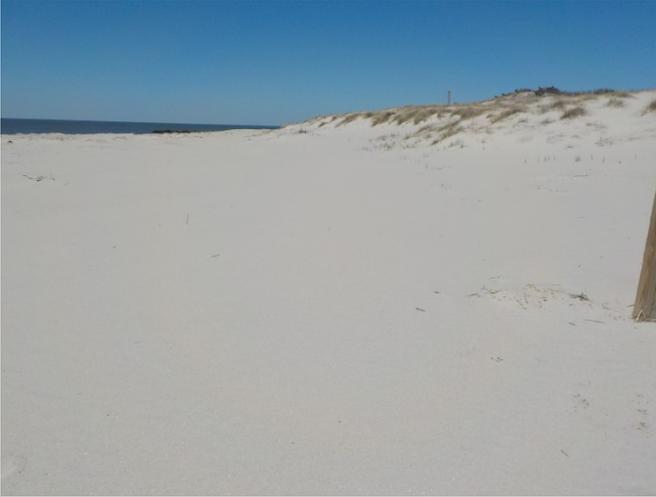
Surf to Cape Avenues

The Photo above, taken on April 20, 2016 shows sand accumulation on the seaward dune slope and upper beach berm that partially buried early colonizing plants but enhanced storm resiliency.

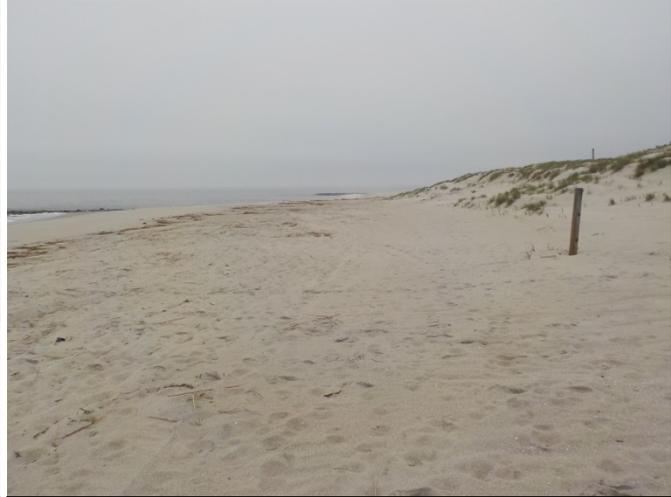
The view above was taken April 24, 2017 and includes the same pole on the beach as shown to the left. Dune enhancement occurred along with more sand at the dune toe.

No sand was placed west of Lake Drive during the 2012-2013 USACE renourishment project or during the recent 2016 effort, but natural processes have moved sand from east to west along the Borough's shoreline over time. The wider beaches have provided a source of sand for the wind to move sand onto the seaward slope and crest of the dune. This process added 7.87 yds³/ft. in sand volume combined with an 8-foot shoreline advance seaward.

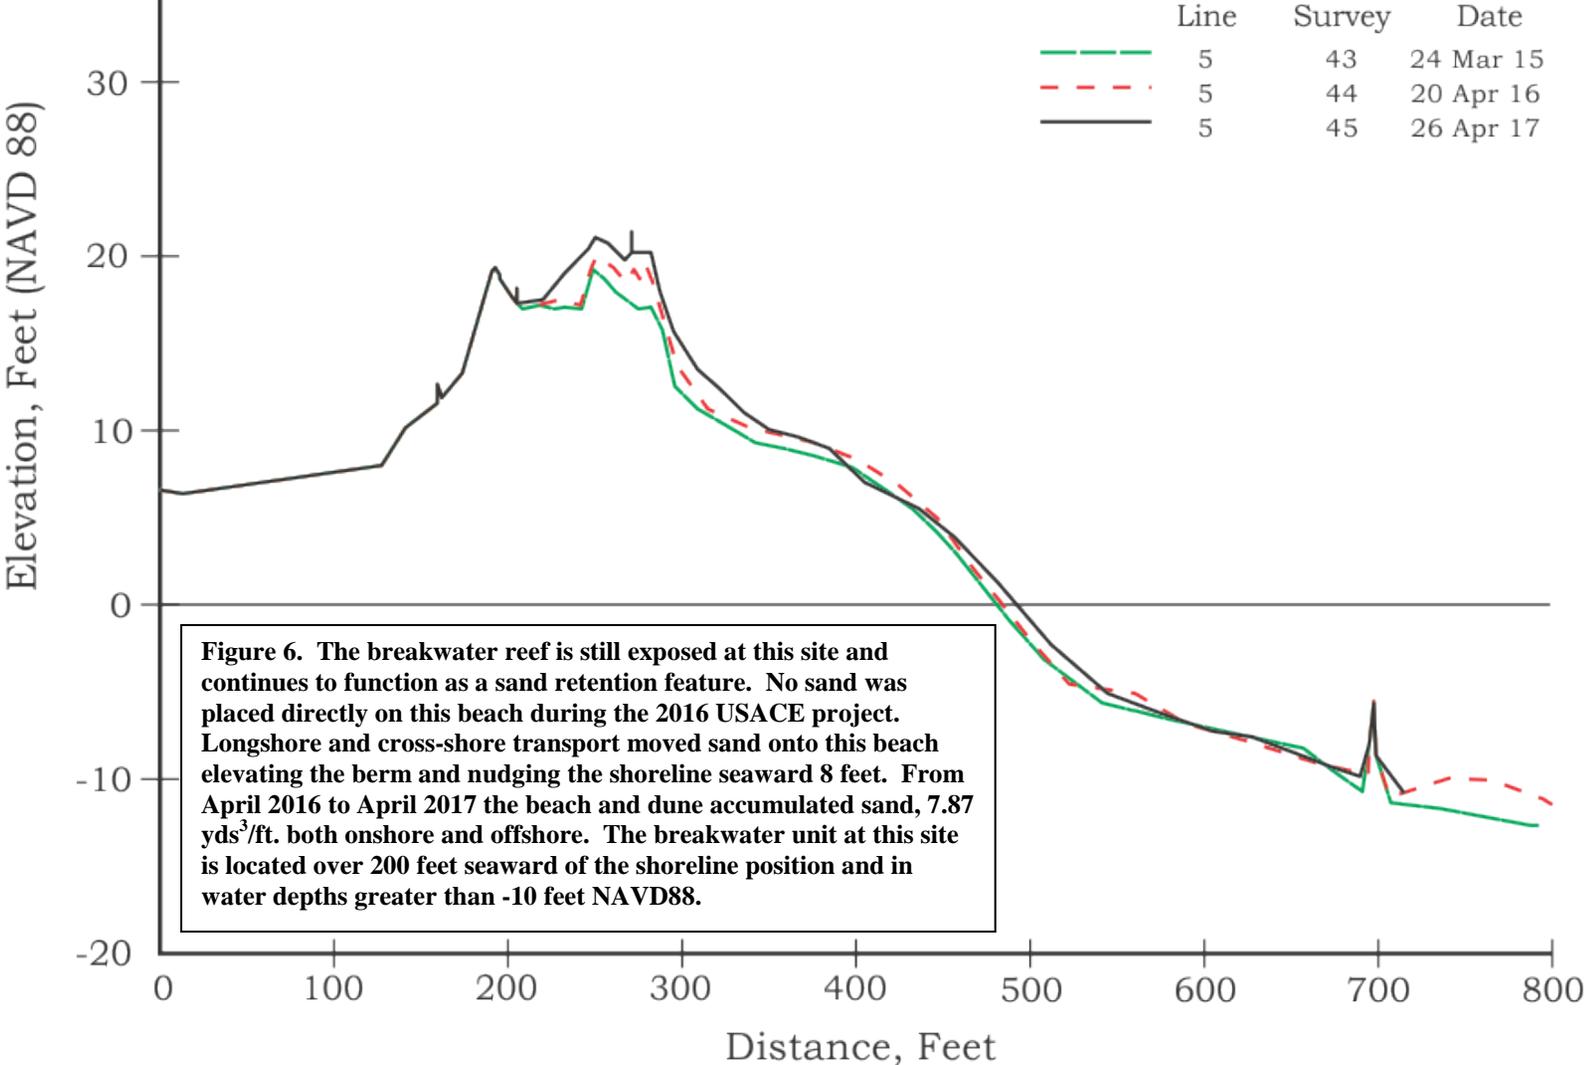
CMP - Line 5 - Cape Avenue

CMP-5 (Cell 5) contains the nearshore breakwater unit installed in 2002 during the USACE CMP-227 experimental project. The breakwater units are still present, located just under 200-feet seaward of the zero elevation shoreline position. These units are furthest from the shoreline and lowest in elevation in the cell's mid-section where swimming is allowed. That prevents individuals from encountering the units. In this cell the units pose little threat to recreational swimming but swimming along the rock groins should be restricted where the units are closer to shore due to sand accumulation at the rocks.

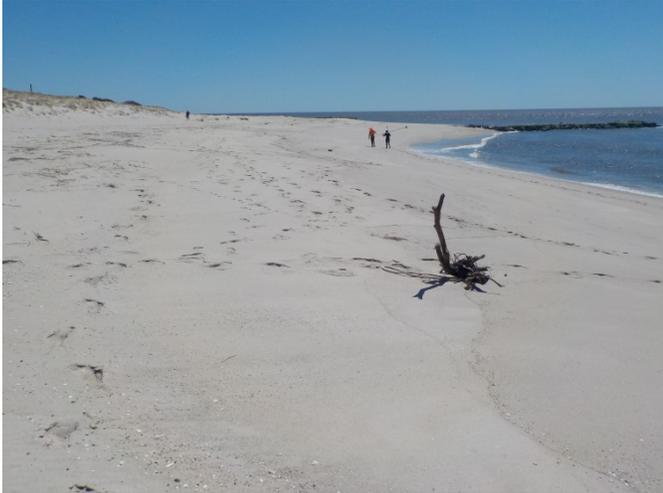
Cape to Pearl Avenues

This photo taken on April 20, 2016 shows accumulation of sand along the seaward dune slope and upper beach. Beach cusp formation in the beachface on the downdrift side of the groin resulted in modest shoreline retreat.

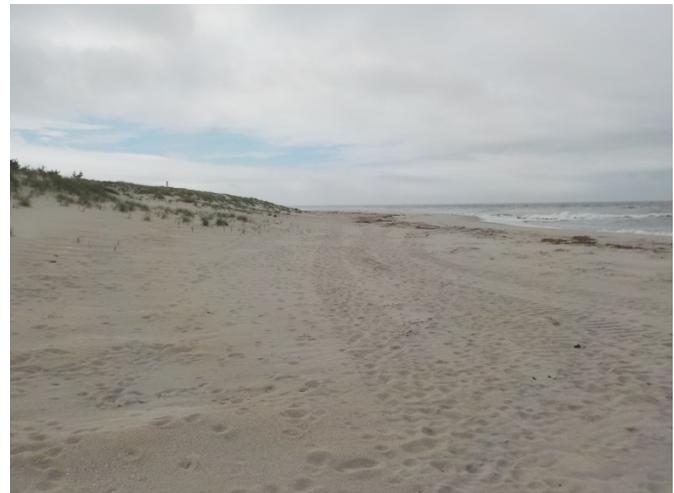
This view was taken April 26, 2017 at the toe of the dunes looking east. The beach is a little wider, but the majority of the added sand has accumulated on the dunes and at the dune toe.

No sand was placed this far west during the USACE nourishment project, so beach building has been a result of natural processes. By April 2017, sand had accumulated on the dry recreational beach berm and seaward dune slope and crest through aeolian processes and wave run-up. The beach width remains at its 2016 position with a similar offshore slope. The sand volume decreased by 3.69 yds³/ft. while the shoreline change was just 0.05 feet since last year.

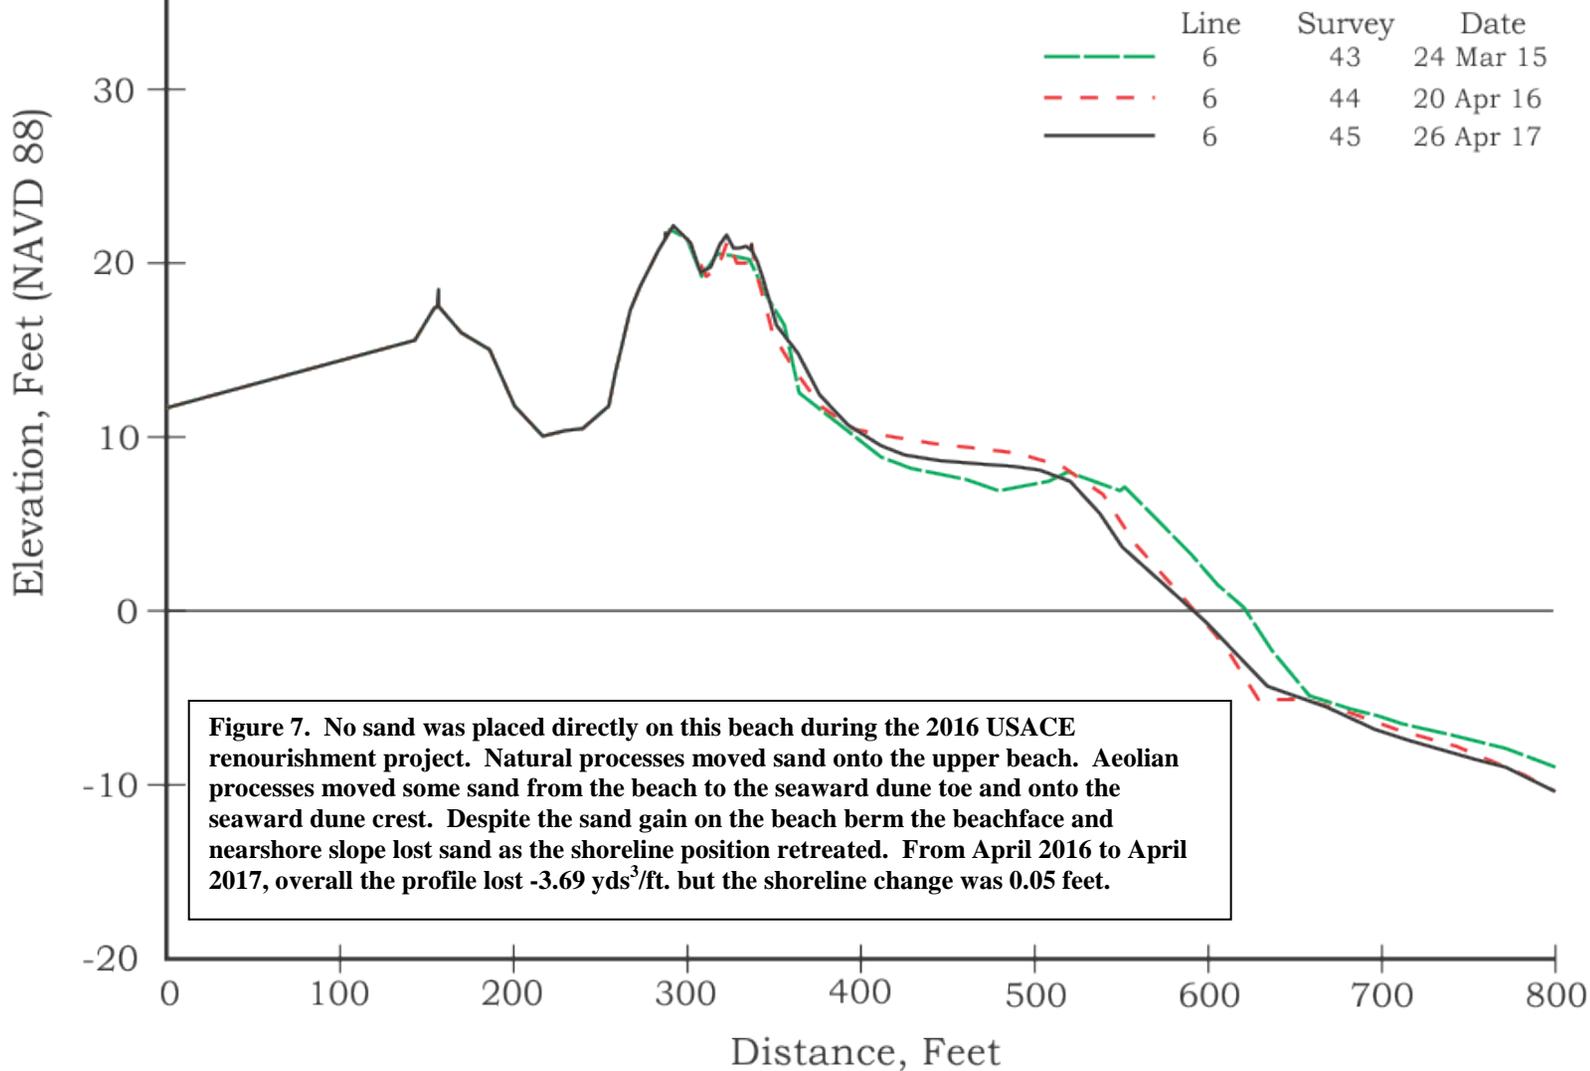
CMP - Line 6 - Pearl Avenue

CMP-6 (Cell 6) is bounded by the rock groins at Cape Avenue and Pearl Avenue. The nearshore bay floor contains the “Double Tee” structures that were installed as part of the USACE CMP-227 experimental project. These units were quickly buried and have remained buried by sand in the past eight annual surveys. Consequently, they have limited ability to influence additional sand retention.

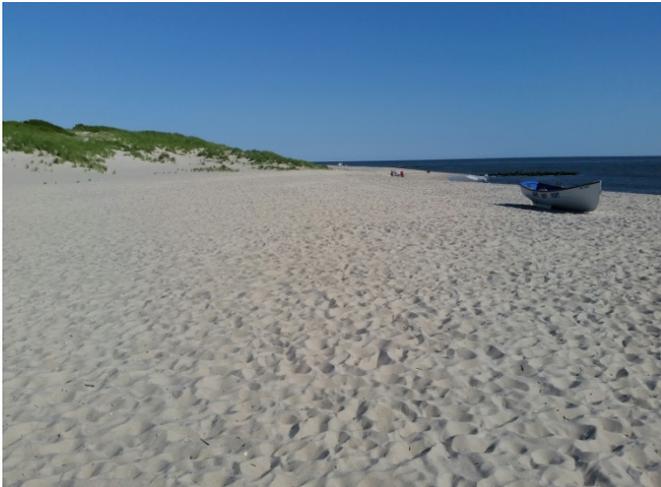
Pearl to Stites Avenues

The photo above was taken on June 1, 2016 from a mid-beach perspective. Dune grass has colonized the seaward slope to the toe. The wider beach berm provides sufficient storm protection for continued dune growth.

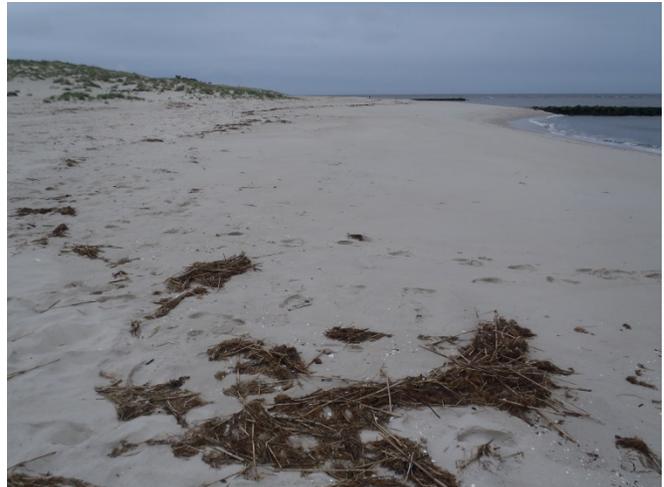
By April 24, 2017, the berm was a bit wider, the dune grew above 30.0 feet NAVD 88 in elevation and sand accumulated at the seaward dune slope.

In 2017, the annual net volume gain was 11.65 yds³/ft. of sand with 20 feet of seaward shoreline position advance. The elevation of the recreational beach berm remained constant compared to last year and sand accumulated offshore. Aeolian transport moved sand to the seaward dune slope and up to the crest. Stites Avenue is the first Cape May Point dune to grow higher than 30 feet in elevation. The wind transport effect has been evident on the Stites Avenue beach access pathway where sand deposition has repeatedly buried the pathway and seating area at the dune crest.

Two solutions were suggested last year; 1) place 40-50 feet of snow fencing more or less parallel with the cut at the crest, but 30 feet toward the west from the cut; or 2) abundantly plant the 30 feet of dune crest toward the west with beach roses or dune grass between the existing dense vegetation and partly down the upper seaward dune slope. Either solution will reduce the deposition of sand in the Stites Avenue dune walk over. Each winter add another row of fencing at the toe of material trapped by the initial fence row or add more plants at the sand toe.

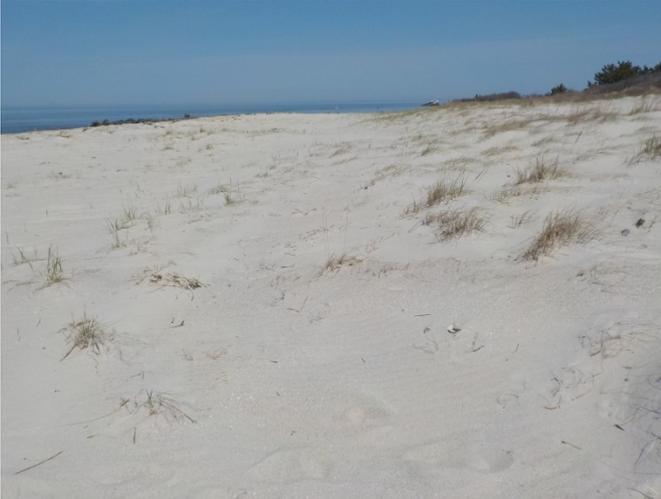
Stites to Alexander Avenues

This photo taken on April 19, 2016 shows continued dune growth and seaward expansion of the beach berm and shoreline position.

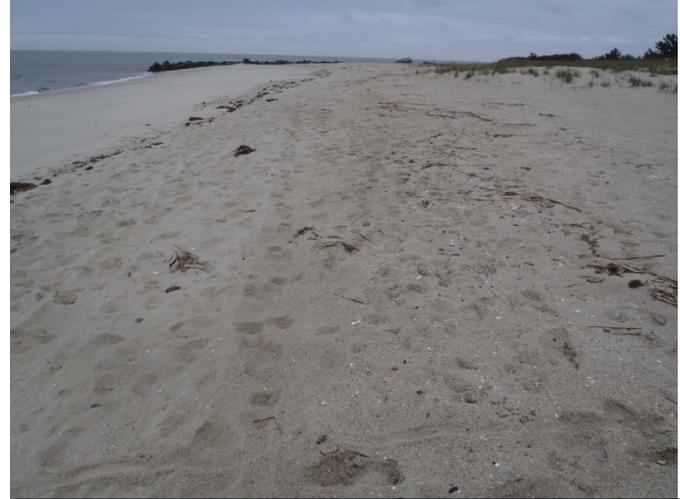
Sand left the Alexander Avenue beach as littoral processes moved it further west into the bay from the final groin or onto the Sunset Beach to the west.

Following completion of the initial USACE project sand began to accumulate in increasing amounts, 2015 was the first year in which this accretive trend stopped. In 2016, the accretive trend continued with a large wedge of sand accumulating from the seaward dune crest seaward to the profile limits. The dune advanced seaward 20 feet as a result of sand accumulation on the seaward slope. However, by April 2017, the shoreline retreat was 39 feet as 22.33 yds³/ft. in sand volume left the cell.

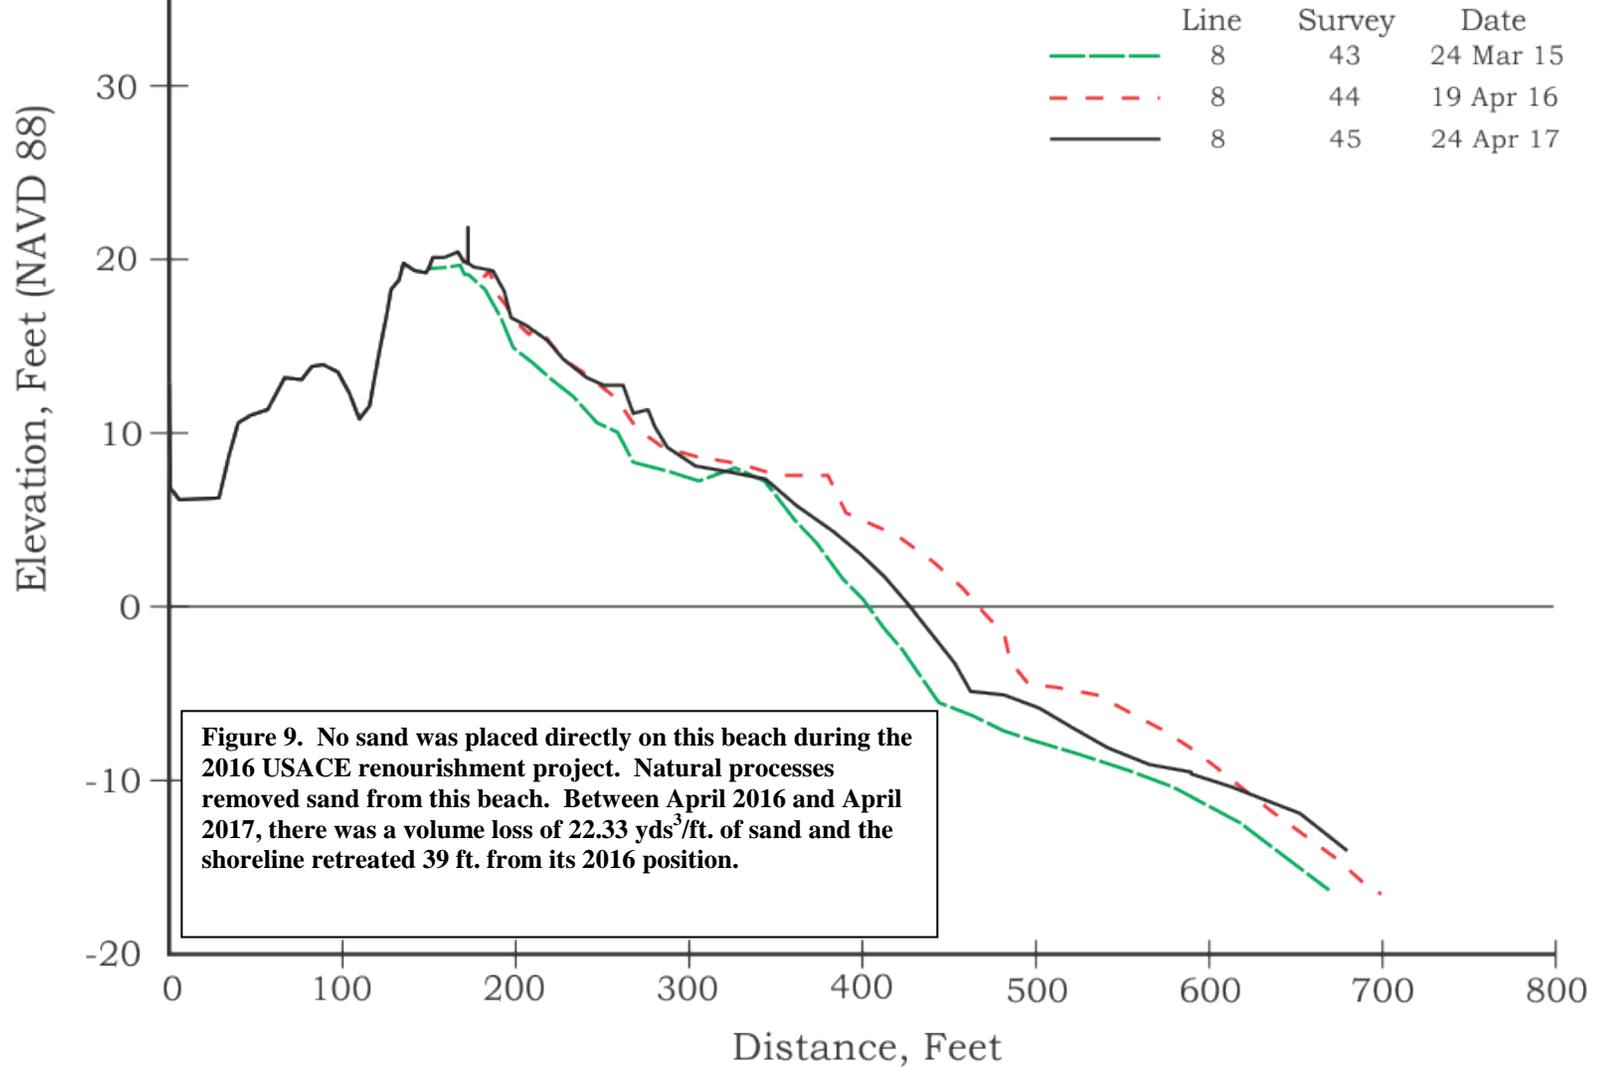
CMP - Line 8 - Alexander Avenue

The dry beach provides ample area to support summer recreational activity onshore while the nearshore slope is steeper in this cell with water depths of -10 feet NAVD88 within 100 feet of the shoreline. The steeper slope and drop off near the end of the groins along with strong tidal currents in this region should probably limit swimming activity by most to the shallow nearshore region. Swimming has not been permitted at Alexander Avenue for many years with the final groin a long-time favorite for fishing activities.
