**ANNUAL REVIEW FOR 2019  
OF THE CAPE MAY POINT, NJ MUNICIPAL BEACHES**

PREPARED FOR: THE BOROUGH OF CAPE MAY POINT  
215 LIGHTHOUSE AVENUE  
CAPE MAY POINT, NJ 08212

PREPARED BY: STOCKTON UNIVERSITY COASTAL RESEARCH CENTER  
30 WILSON AVENUE  
PORT REPUBLIC, NJ 08241

May 30, 2019

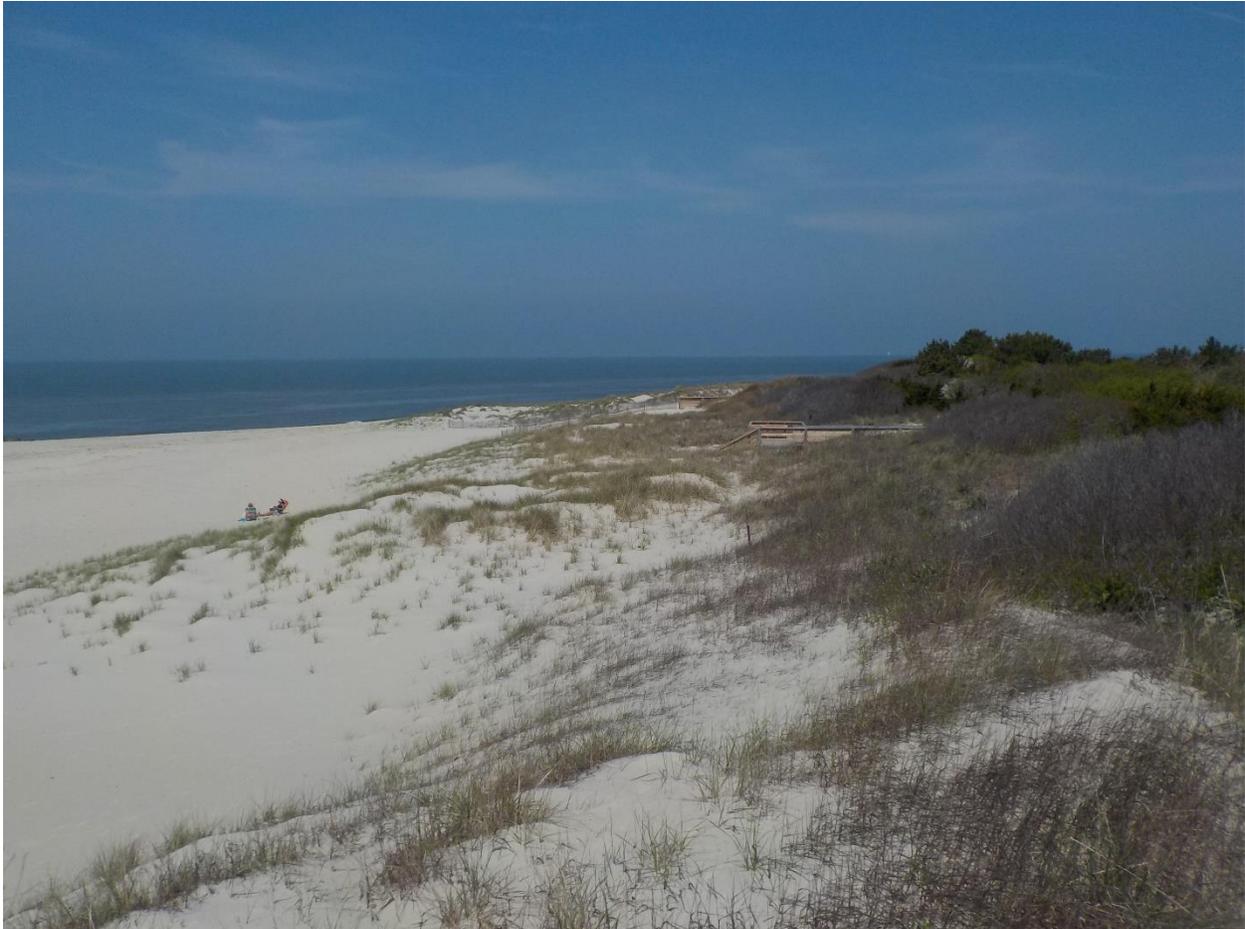
*The photo above taken on May 2, 2019 from the instrument set-up location on the dune crest near Brainard Avenue looking west shows an entire vegetated foredune slope created by west wind transport of sand. The sand supply was significantly enhanced by tide currents moving it around the point where the northwest winds could move it into the dunes. The scale is provided by two early pioneers this beach bathing season.*

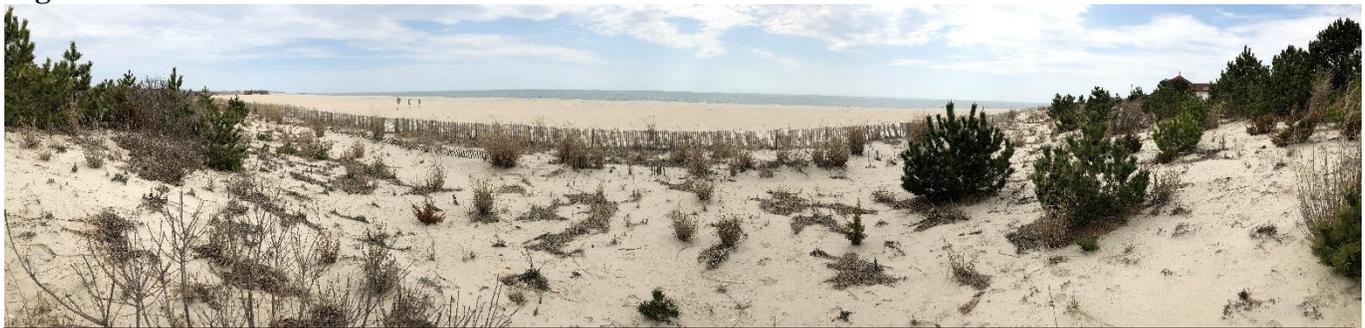
**Lighthouse Avenue**

*Figure 1. This panoramic view from April 12, 2018 was taken from the dunes to provide an extended view of the entire beach cell. This expanse remains a substantially wider beach as a result of the USACE work.*

CMP-0 is the northeastern-most cell that borders the State Park and is bounded to the southwest by a rock groin. This location has benefited tremendously from the USACE Lower Cape May Meadows – Cape May Point restoration project, where initial construction was completed June 2007. The project added over 250 feet of recreational beach berm and established a stable dune system 100 feet wide at the toe with a crest elevation of 18 feet NAVD88. Prior to the initial project the beach was narrow; a small dune armored with tensor mats on the seaward slope protecting the exposed dune system from severe erosion. There is no public access from Lighthouse Avenue to the beach.

In 2016, USACE activity added 78,184 cubic yards of new material to this site and the Lehigh Avenue beach immediately to the southwest. The cross sections show that the beach grew wider following the 2016 survey and remained stable since adding additional sand volumes in 2018 and 2019, totaling 43,232 cubic yards.

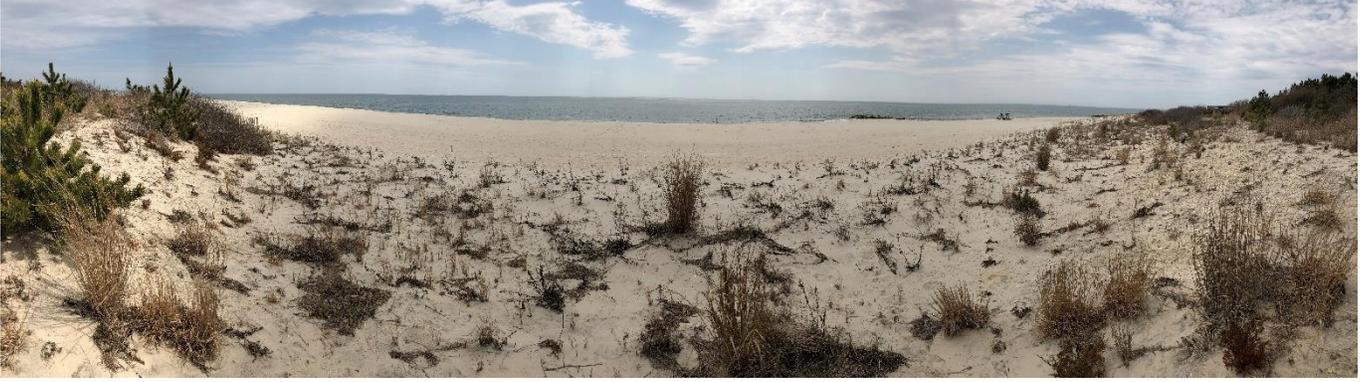
## Lehigh Avenue

*Figure 2. Taken on April 12, 2018, the photo shows the dunes and a stable to slightly accretive beach. Dune vegetation is sparse directly seaward of the reference location, but improves to the sides. This remains the best view of this site.*

CMP-1 stretches from the Lighthouse Avenue groin to Lehigh Avenue. Prior to the initial USACE project no dry beach was present between the rock groins. Shore protection was provided by a rock seawall that armored the seaward dune slope. Beyond the groins the seafloor steeply dropped into the adjacent tidal channel. The initial USACE project re-established a dry recreational berm and covered the seawall with sand to restore the dune.

This site also received sand during the USACE authorized second maintenance project conducted between November 2012 and January 2013. The project restored the design beach width and elevation. The beach width increased by 60 feet with 56.39yds<sup>3</sup>/ft. of sand added to each foot of shoreline seaward from the dune toe. Following the project the beach elevation was 10 feet NAVD 88 and extended about 170 feet seaward of the seaward dune toe. The most recent project counted both Lighthouse and Lehigh sites as one placement volume at 78,174 cubic yards. The visual impact is like that seen at Lighthouse Avenue with both sites seeing similar shoreline advances. Sand continued to move into this groin cell in both 2018 and 2019. The addition was modest, but 8.9 and 15.7 yds<sup>3</sup>/ft. in each of the two years means that material is still arriving faster than it leaves.

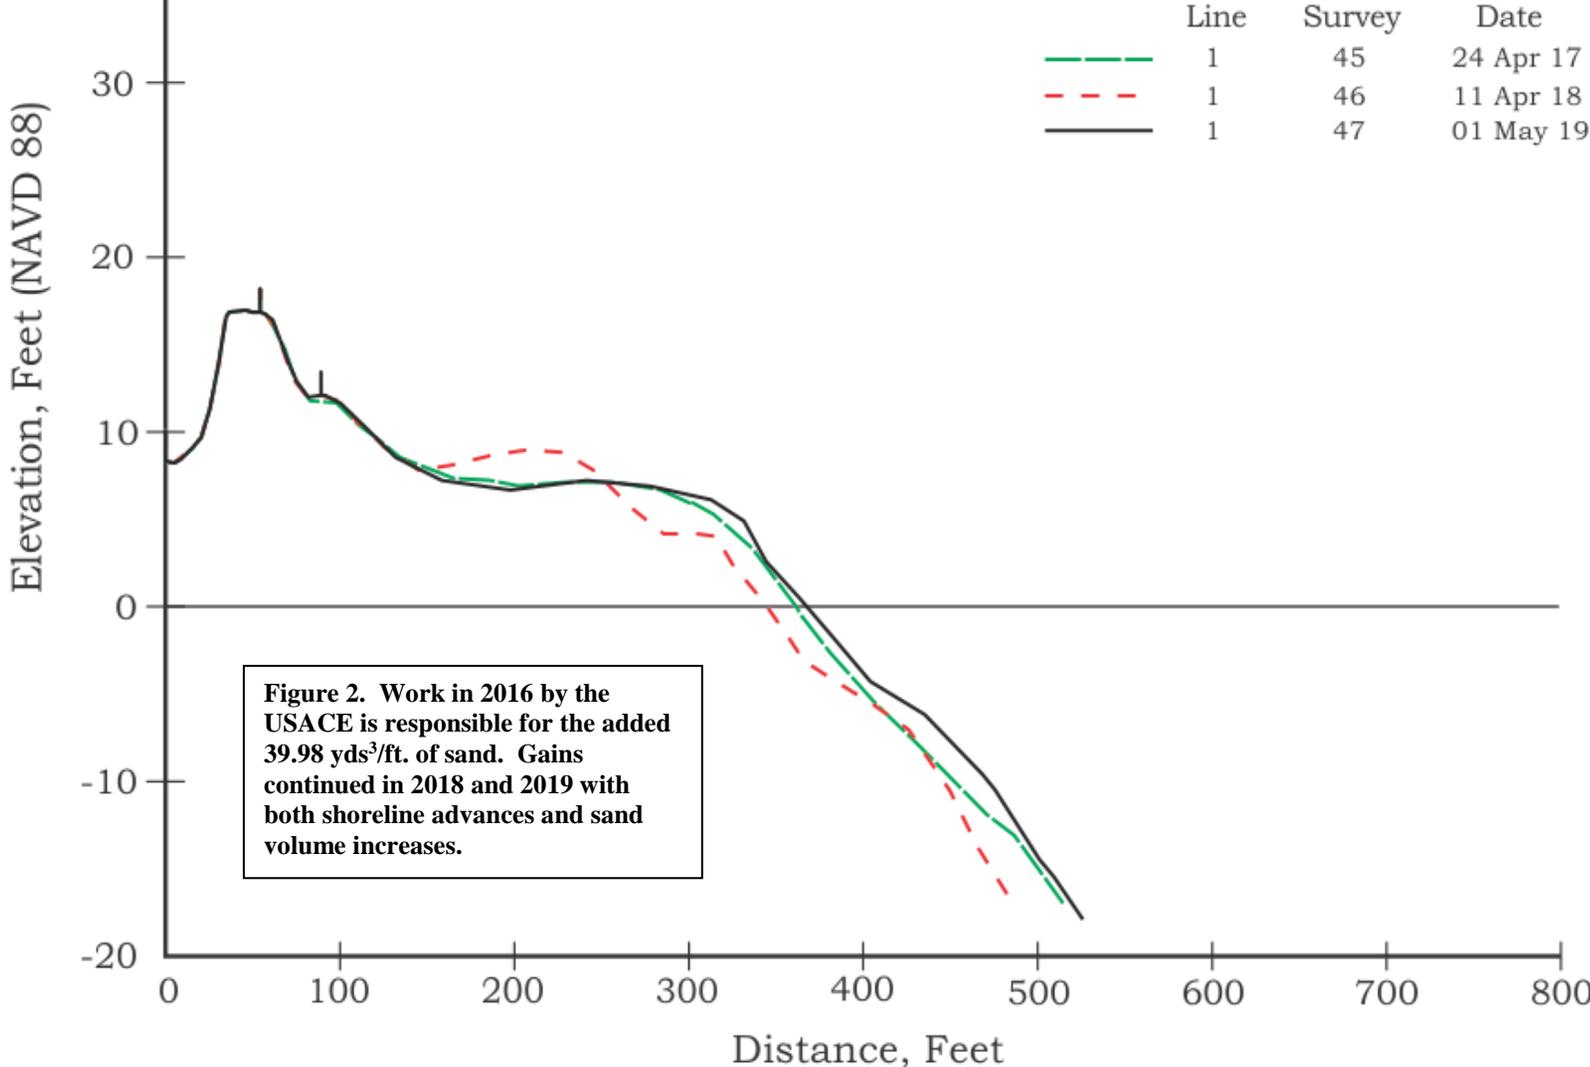
## CMP - Line 1 - Lehigh Avenue

**Figure 2. Work in 2016 by the USACE is responsible for the added 39.98 yds<sup>3</sup>/ft. of sand. Gains continued in 2018 and 2019 with both shoreline advances and sand volume increases.**

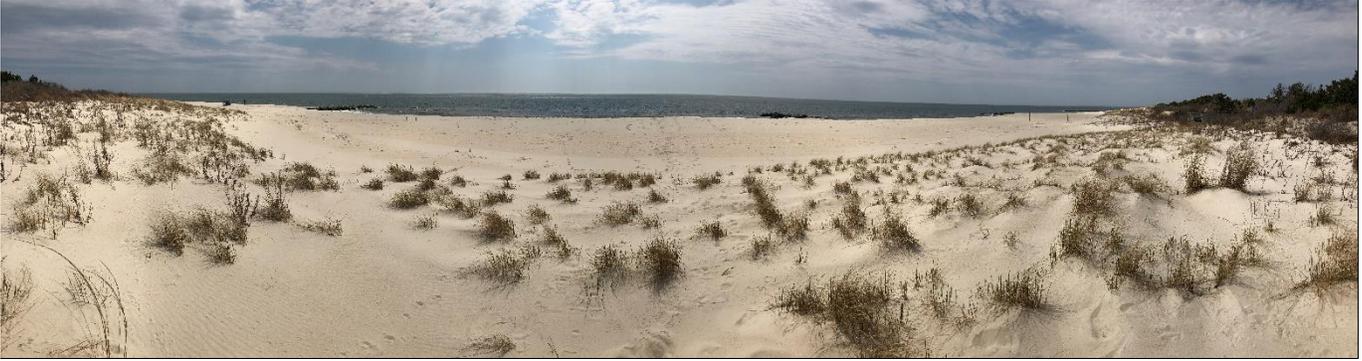
## Lehigh to Whilden Avenues

*Figure 3. This view from the beach entrance shot April 12, 2018 shows the beach from groin to groin along with the dunes. This view remains unchanged in 2019.*

The CMP-2 beach is the southeastern-most of the groin cells with an early installation of the “Beachsaver” units from 1993, which still are functioning and show on the profile cross-section at the 520-foot distance from the reference point and remain stable. Sand added to the system during the initial USACE project has resulted in the near burial of a rock seawall that served as property protection prior to the project. No additional sand was placed here during the 2013 2<sup>nd</sup> maintenance cycle.

The recent cycle of USACE sand placement also did not directly put sand into this cell. However, the natural transfer of material created a 16-foot shoreline advance and an net gain of 27.64 yds<sup>3</sup>/ft. in sand volume. This gain occurred in the first year following the 2016 project with minor changes since.

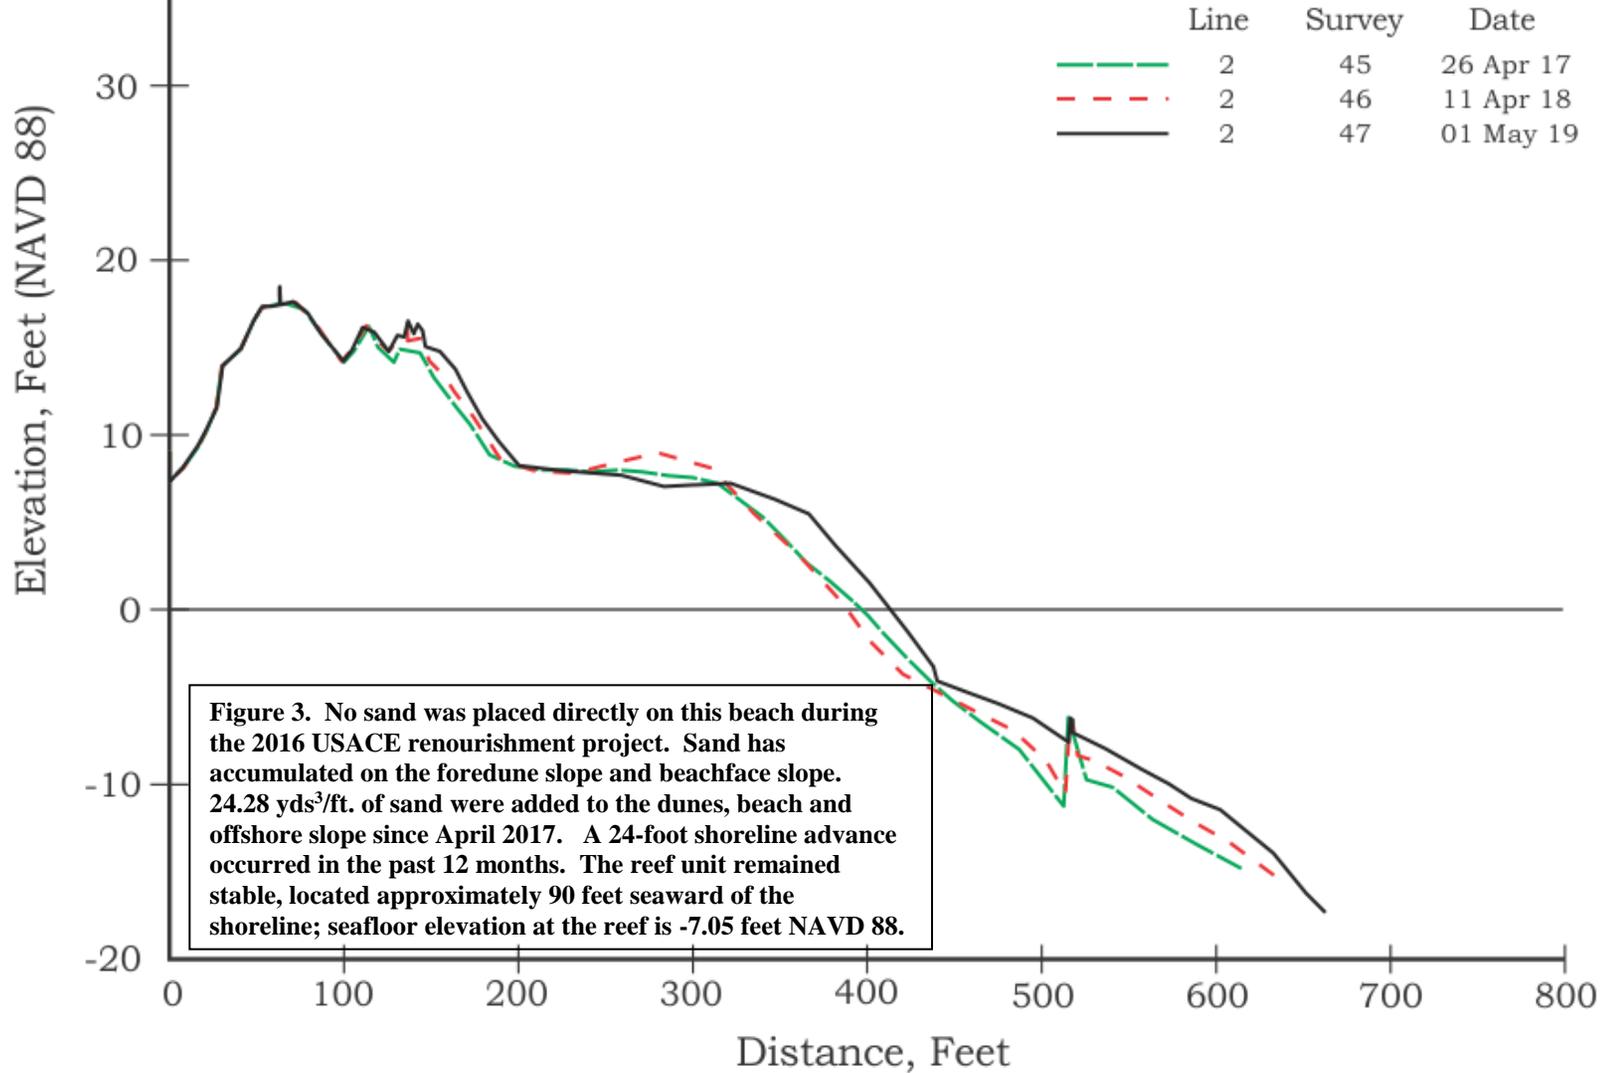
## CMP - Line 2 - Wilden Avenue

The “Beachsaver” unit crest has been incrementally buried by sand reducing its exposure above the seabed from 6 to barely 2.0 feet above the nearshore seabed slope. Landward of the units, a very minor trough remains with even shallow sand slopes further seaward as material has been added offshore. There is a 90-foot area between the zero elevation position on the beach and the barriers. The top elevation has remained constant for many years, so the structure appears stable. At low tide the distance would be less than 90 feet and at high tide a bit more. The depth at the base of the beachsaver is 7.05 feet NAVD 1988.

The reef crest protrudes up to elevation -6 feet NAVD88. In this position the units are unlikely to be encountered by swimmers this season within the middle of the groin cell. Caution and restrictions should be in place closer to the groins where the shoreline sand extends outward toward the concrete reef along each groin. The lower profile exposed in the water column means less wave surge over the reef and a lower risk of swimmer injury from the surging waves. However, the concrete barriers are still exposed on the seabed and have become more of a tripping hazard and risk of cut feet on the marine growth on the structure than previous potential for wave rush or back wash of swimmers into the structures.

2. Cell 2 at Whilden Avenues, the shoreline position (zero datum) is approximately 90 feet distance from the breakwater structure. Depth of the scour trough landward of the units has decreased to -7.05 feet NAVD88 with less than 2 feet of the reef structure now exposed above the sea floor around the units. The swimming area remains limited, especially closer to the groins but should be manageable mid-beach this year. The greatest risk is unwitting contact with the barnacle encrusted reef crest generating cuts and abrasions. Wave surge should be far less than when 6-7 feet of height existed between the reef crest and the landward seafloor. The CRC again recommends installing a line of floats indicating the maximum distance for swimming that should be about 20 feet from the breakwater reef.

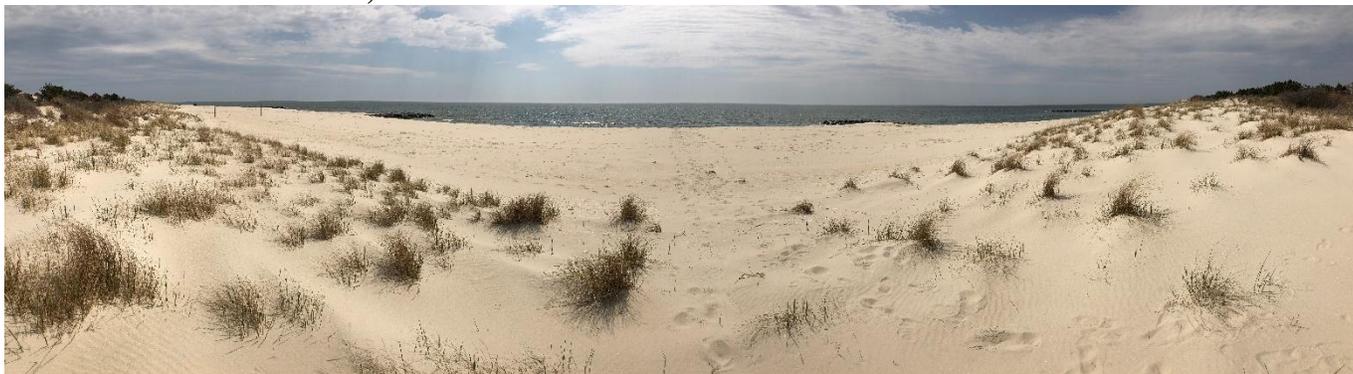
## Whilden to Coral Avenues;

*Figure 4. This view from the profile reference position on April 12, 2018 shows the dune vegetation and the beach extent seaward of this location. As of May 1, 2019, this view remains the same with incremental grass growth seen.*

CMP-3 is bounded by rock groins at Whilden Avenue and Coral Avenue. This beach cell was the other original 1993 “Beachsaver” unit installation in Cape May Point. Sand added to the system during the initial USACE project had resulted in the near burial of the entire beach unit structure. No additional sand was placed here during the 2<sup>nd</sup> maintenance cycle (2012-2013). No new sand was added here during the 2016 USACE project either. Sand accumulated on the dunes, and minimally on the beach. The largest sand volume gain occurred at and beyond the beachsaver reef offshore creating a much flatter slope offshore.

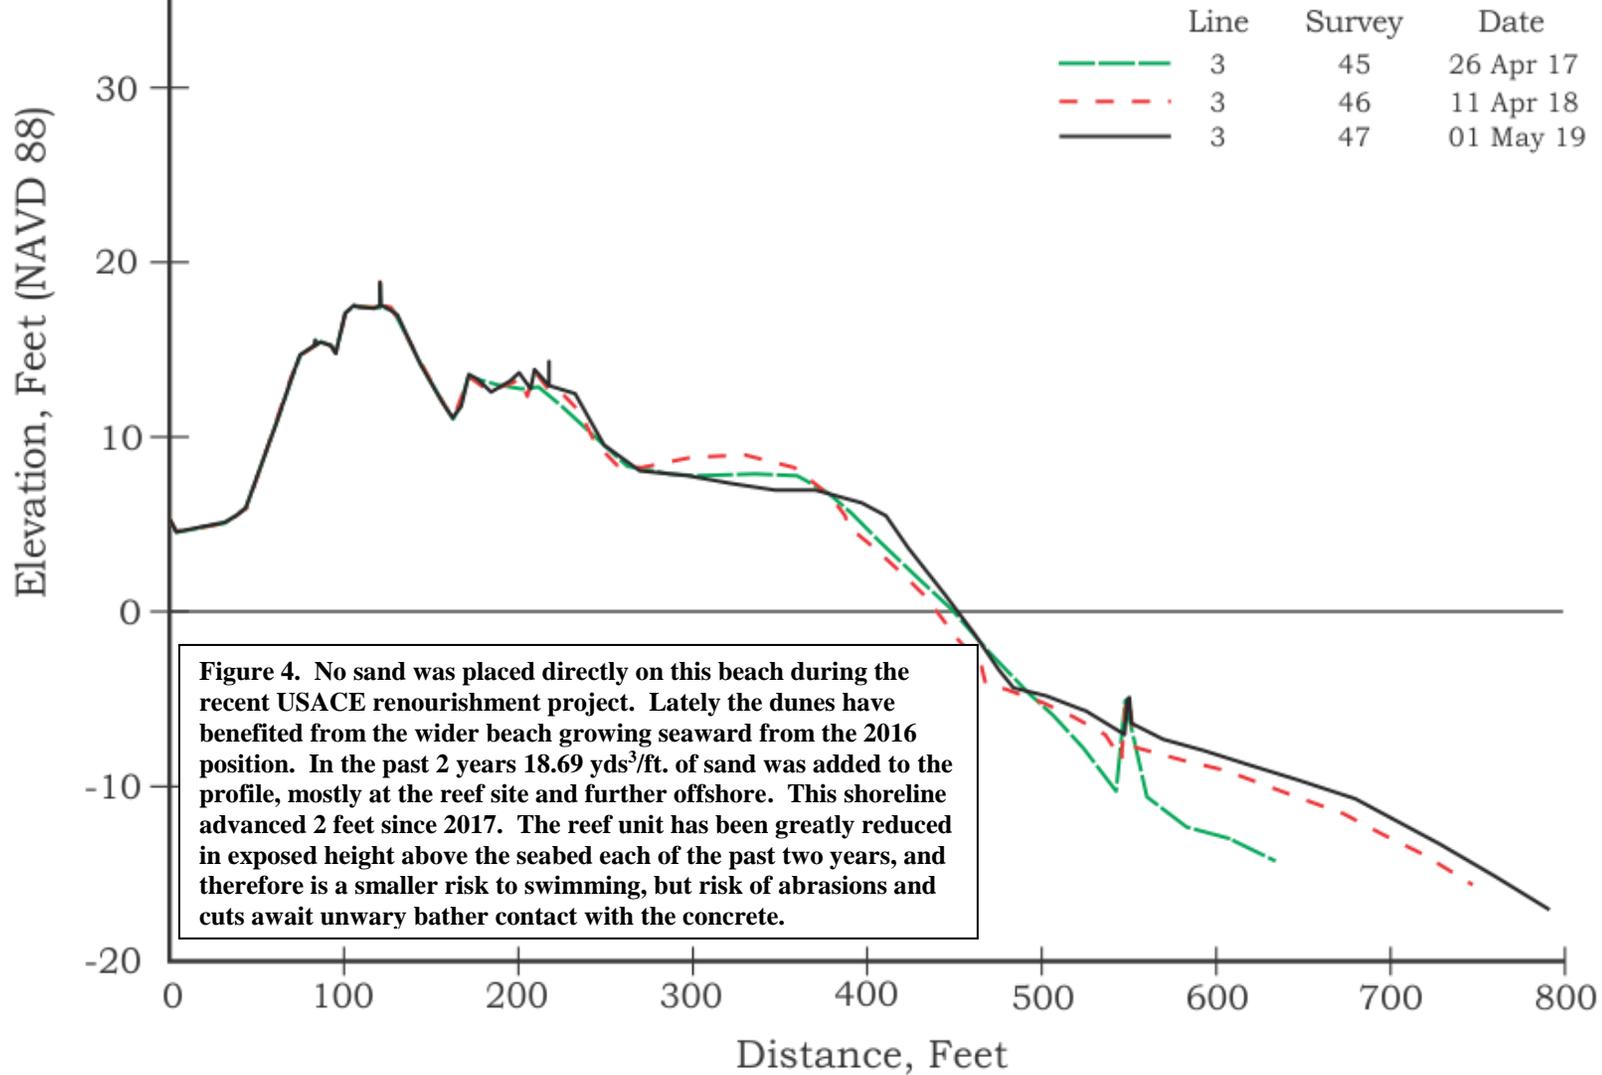
## CMP - Line 3 - Coral Avenue

This site has seen near burial of the “beachsaver” reefs where the elevation relief on the concrete structures has been reduced from 5.0 feet showing above the seabed in 2016 to 2.25 to 2.5 feet showing May 1, 2019. Large volumes of sand have been added further seaward of the structures. Last year’s berm has been flattened out, with material added to widen it to the beachface. Since 2017, 18.69 yds<sup>3</sup>/ft. in new sand has been added. The reef structures are presently located less than 100 feet seaward of the zero elevation position.

3. Cell 3 at Coral Avenue, the shoreline position remained relatively constant; the breakwater units in May 2019 were approximately 100 feet from the shoreline position (zero datum). The space between the water's edge and the reefs filled in dramatically as did the offshore region beyond the reef structure. Wave turbulence over the structures should be minimal this season because about 2 feet of reef structure is exposed above the seafloor. The reduction in exposed reef structure above the sand surface reduces the wave turbulence over the reef and makes for safer swimming.

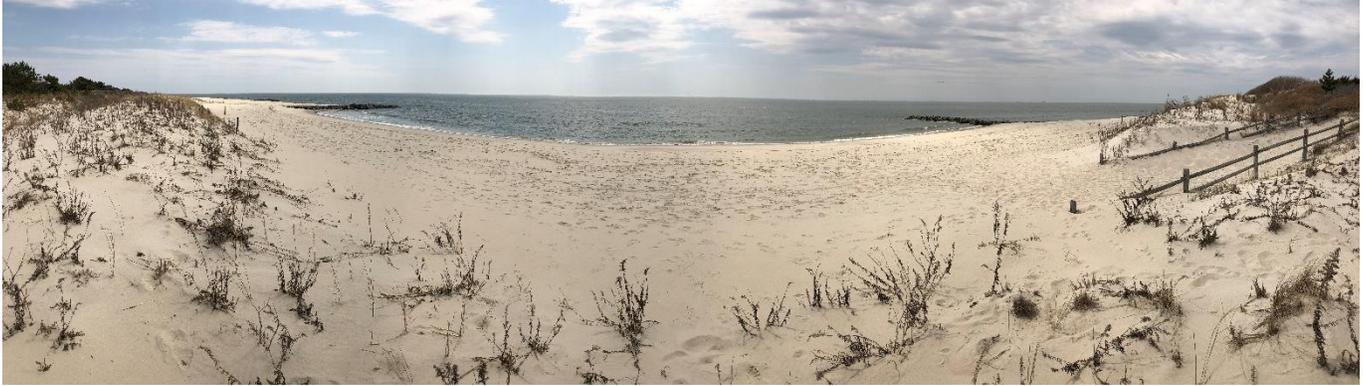
## Coral Avenue to Lake Drive

*Figure 5. This April 12, 2018 view shows the entire cell between the two groins along with the beach entrance path and the foredune vegetation. Grass growth has enhanced the dune's lower slope at this site.*

The Lake Drive (CMP-4) beach cell is bounded by the rock groins at Coral Avenue and south of Lake Drive (closer to Surf Avenue). This cell does not contain any nearshore “Beachsaver” structures but it has received sand both during the initial project and in the 2<sup>nd</sup> maintenance cycle nourishment project. Over the 2012/2013 winter, the USACE reported sand placement of 37,000 cubic yards in the Lake Drive beach cell (Dwight Pakan, USACE). This site also received modest sand placement in 2016 (42,300 cubic yards, Dwight Pakam, personal communication).

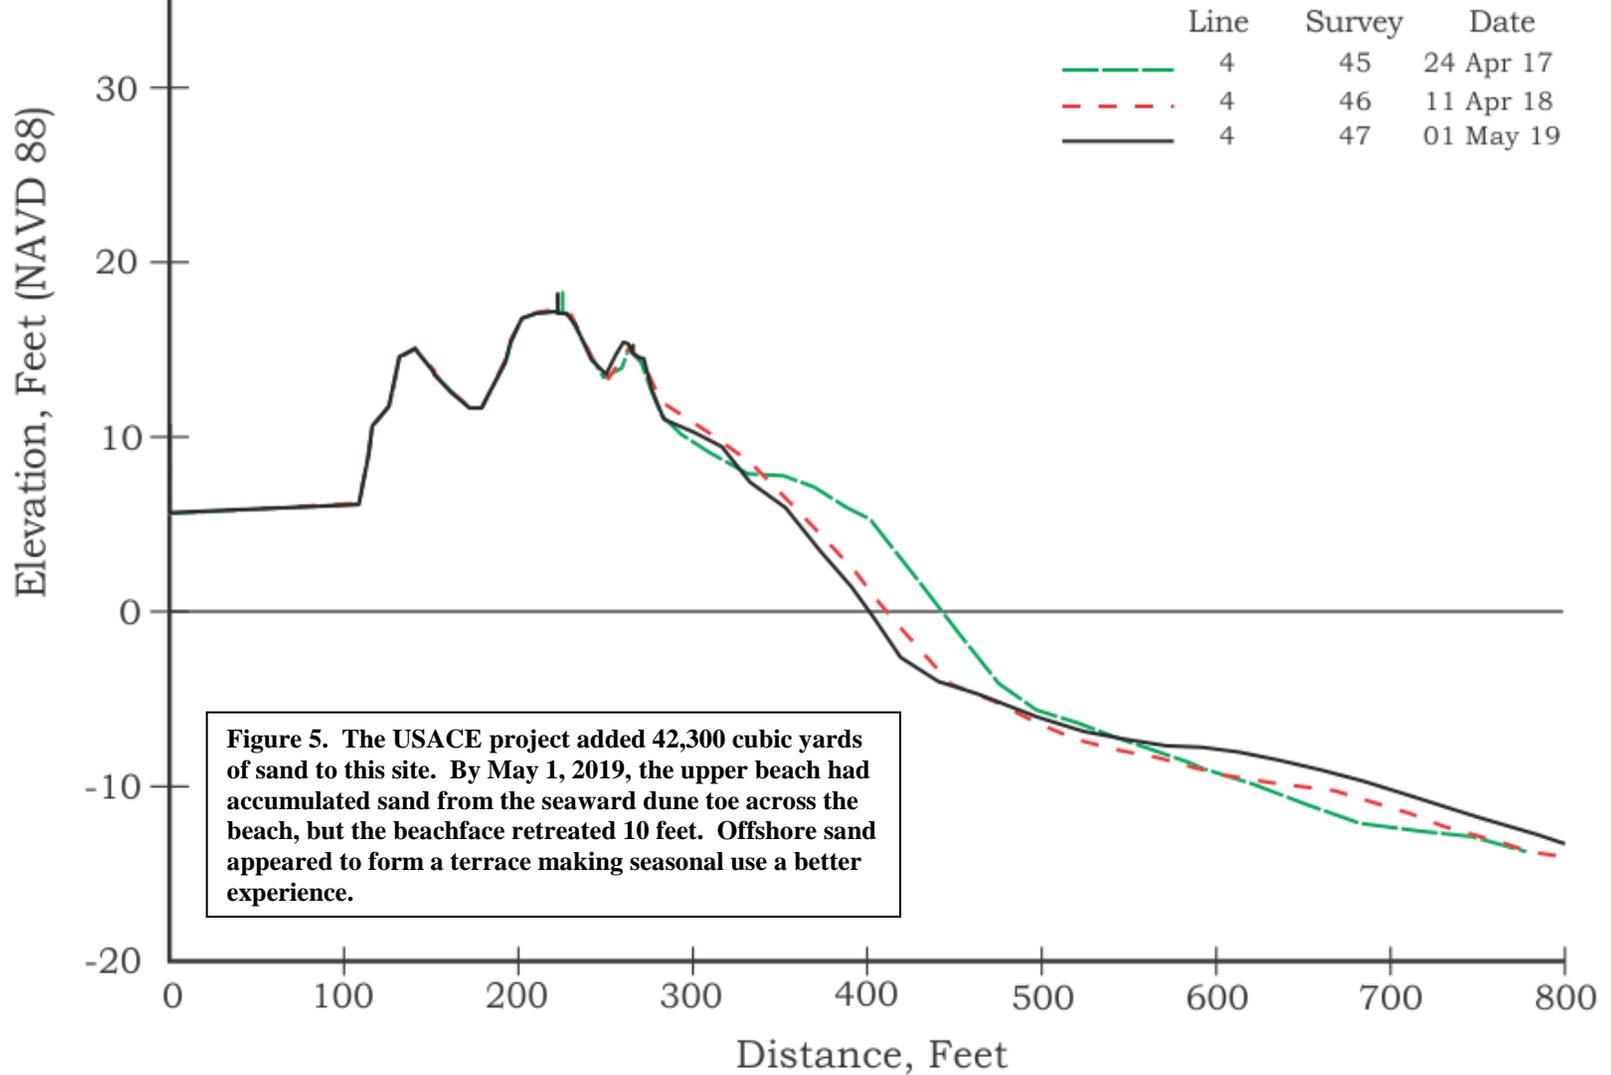
## CMP - Line 4 - Lake Avenue

The 2016 beach berm has retreated largely between 2016 and 2017 (total of 42 feet with 10 of those feet in the past 12 months). Sand lost from the beachface has appeared in part further offshore creating a more gentle offshore slope for bathing. Sand volume decreased slightly by 5.17 yds<sup>3</sup>/ft. between 2018 and 2019, which reduced the 2017 to 2018 gain of 6.83 yds<sup>3</sup>/ft. to minimal values for the total change since the last USACE project work.

4. Cell 4 (Lake Ave.) has no structures offshore and a relatively flatter nearshore slope. This site remains overall a good option for a swimming beach in Cape May Point this season and the

recreational berm is about the same this year. The relatively shallow slope platform in the water between groins make wading and swimmer relatively safer for beach patrons.

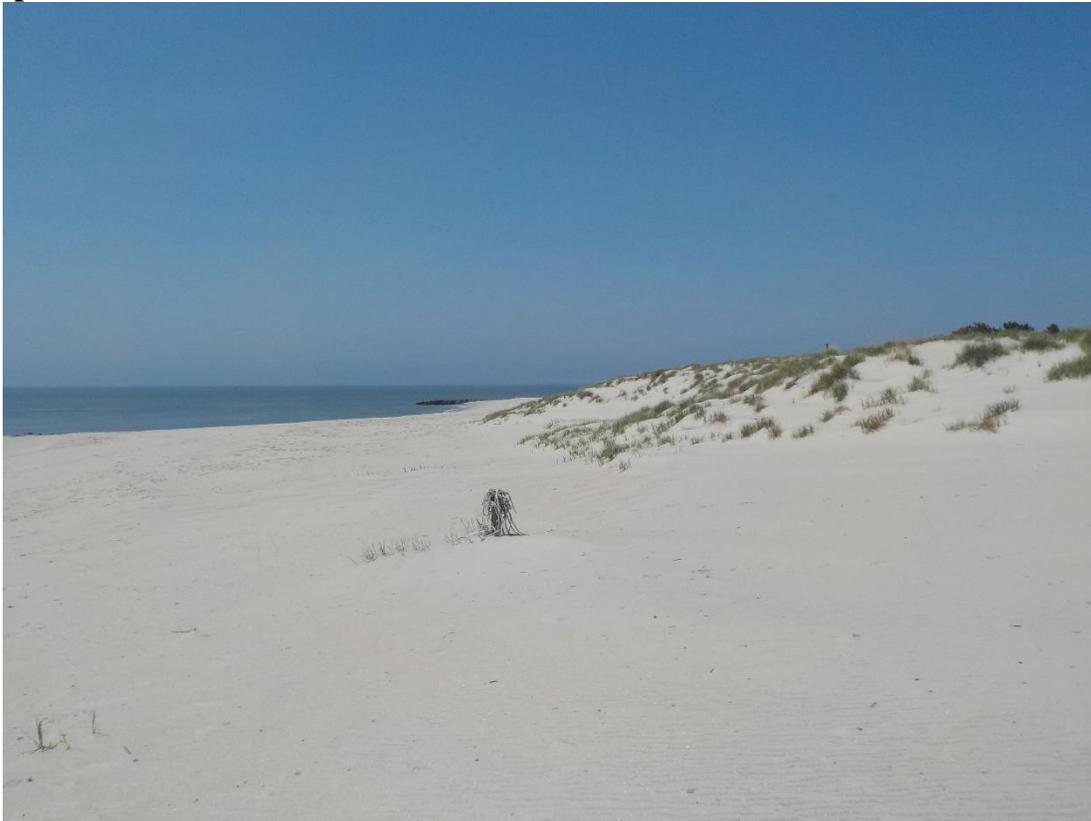
## Surf to Cape Avenues

*Figure 6. The southwest view above was taken May 2, 2019 and includes the dune vegetation, the beach extent and the western cell-defining groin.*

CMP-5 contains the nearshore “beachsaver” units installed in 2002 during the USACE CMP-227 experimental project. The breakwater units are still present, located just over 240-feet seaward of the zero elevation shoreline position. These units are furthest from the shoreline and lowest in elevation in the cell’s mid-section where swimming is allowed. That prevents individuals from encountering the units. In this cell the units pose little threat to recreational swimming but swimming along the rock groins should be restricted where the units are closer to shore due to sand accumulation at the rocks.

Sand did accumulate on the landward side of the beachsaver array making wave surge over them much lower in intensity, but offshore the very steep decline has been replaced by much shallower seafloor due to sand accumulation.

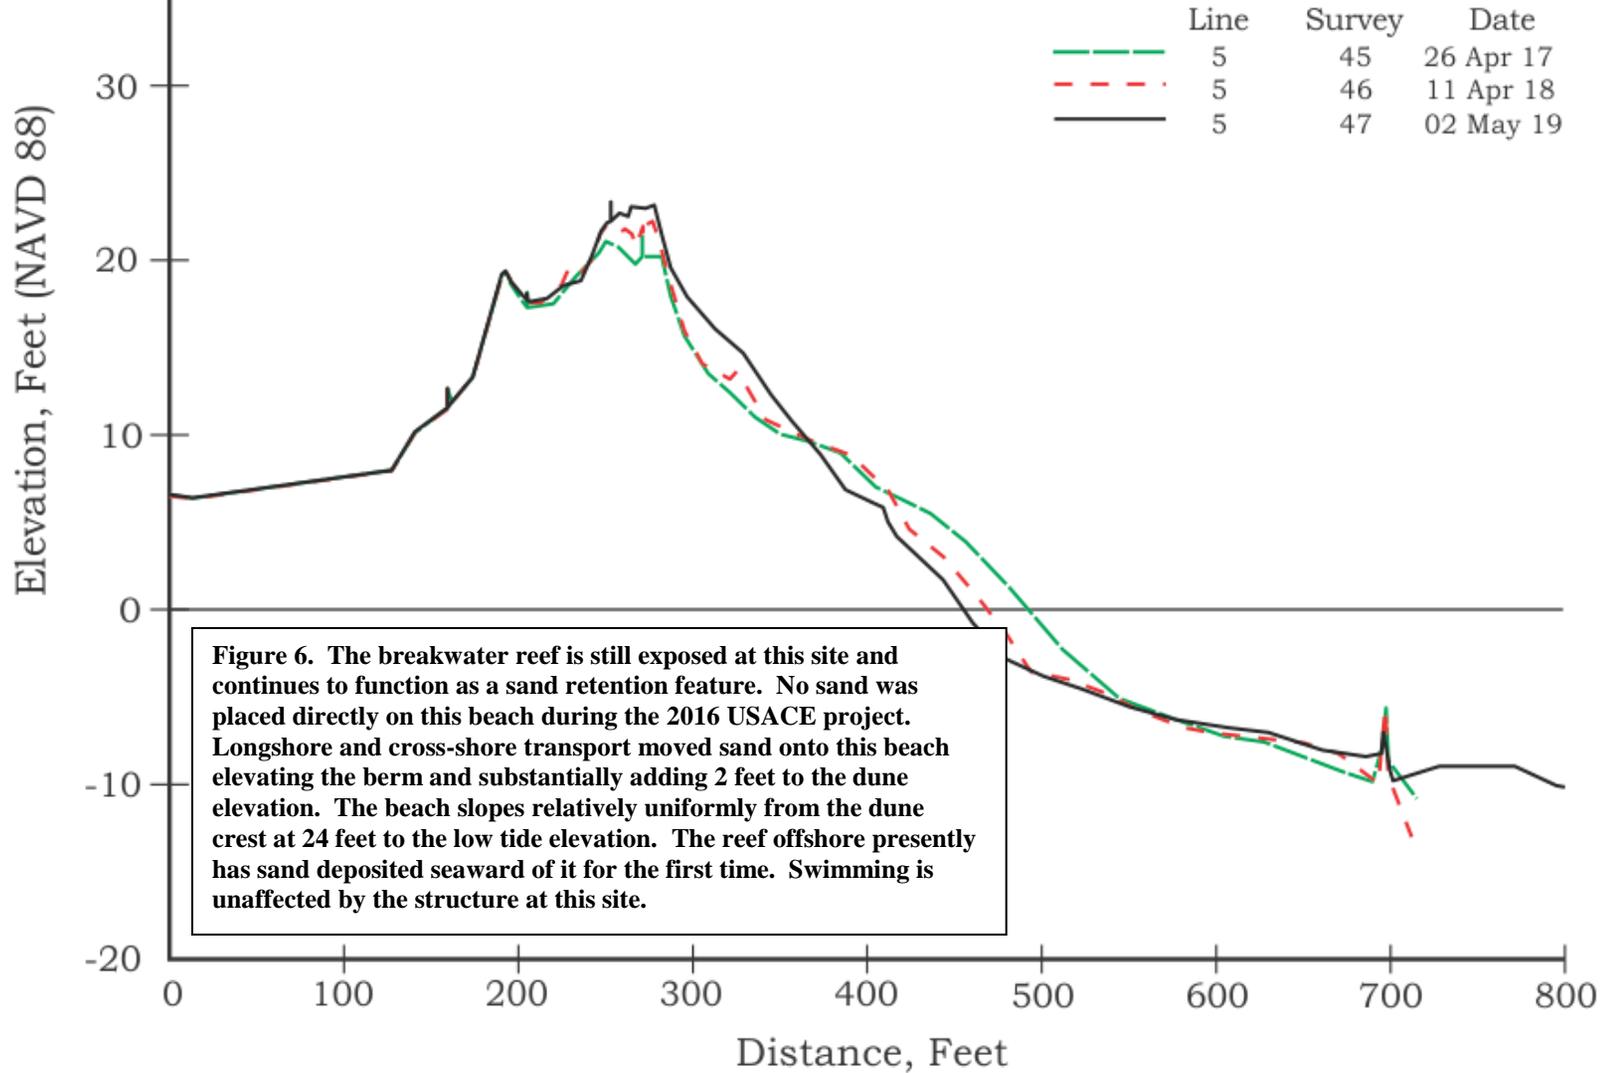
## CMP - Line 5 - Cape Avenue

No sand was placed west of Lake Drive during the 2012-2013 USACE renourishment project or during the recent 2016 effort, but natural processes have moved sand from east to west along the Borough’s shoreline over time. The wider beaches have provided a source of sand for the wind to move sand onto the seaward slope and crest of the dune. This process added 1.74 yds<sup>3</sup>/ft. in sand volume combined with a 14-foot shoreline retreat landward. The majority of the shoreline retreat occurred in 2017 as 23 feet of landward shoreline movement cancelled most of the 2016 to 2017 advance.

5. Cells 5 (Cape Ave.) and 6 (Pearl Ave.) contain the newer submerged breakwater units but they pose minimal risk for swimming in 2019. Both reef structures lie in greater than -8 feet of water approximately 200 hundred feet from the shoreline at low tide. The landward trough filled in at Cell 5 as well, generating a fairly flat area between the reef and the shoreline. The “Double Tee” structure in Cell 6 is buried with additional sand. Swimming near the groins should always be avoided since the units are slightly closer to the beach adjacent to the rocks.

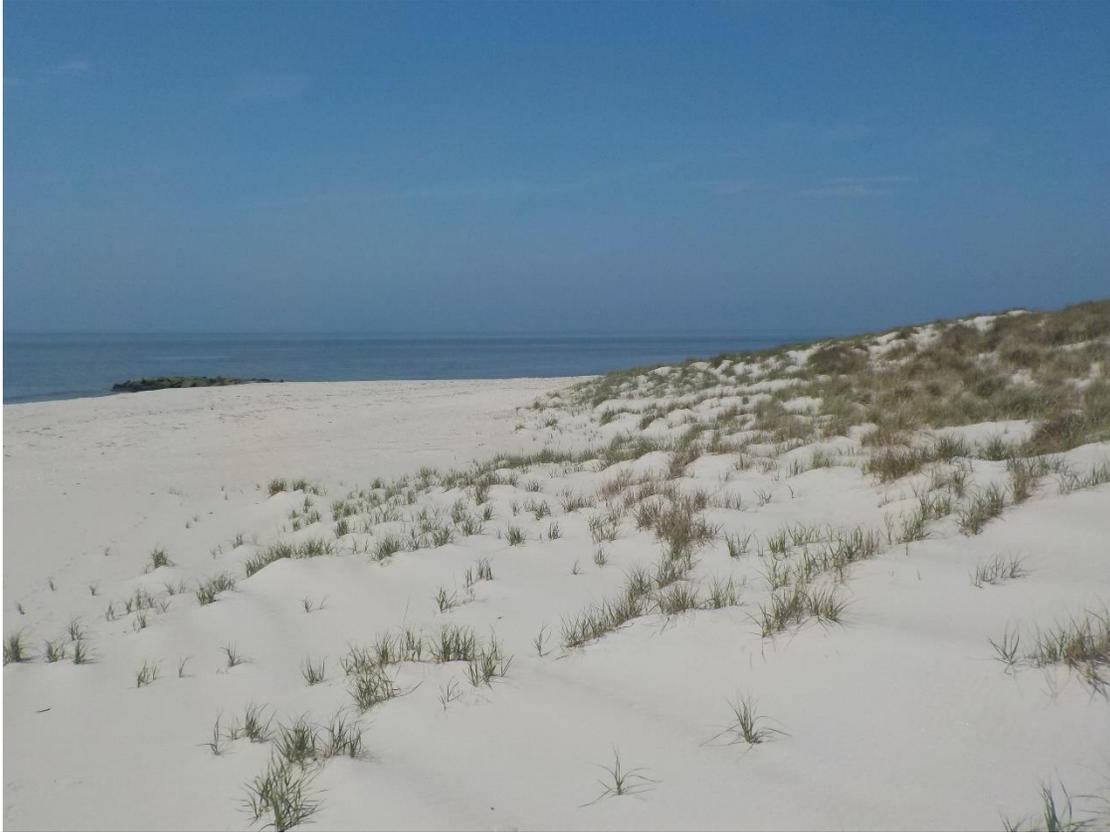
## Cape to Pearl Avenues

*Figure 7. This view was taken May 2, 2019 near the dune crest looking southwest across the beach. The beach access pathway from Pearl Avenue traverses the trees before climbing up the landward dune slope. This past winter sand continued to accumulate, though not at the pace seen last year.*

CMP-6 is bounded by the rock groins at Cape Avenue and Pearl Avenue. The nearshore bay floor contains the “Double Tee” structures that were installed as part of the USACE CMP-227 experimental project. These units were quickly buried and have remained buried by sand in the past ten annual surveys. Consequently, they have limited ability to influence additional sand retention.

Sand shed from the initial up drift federal project beaches moves into this site seasonally by predominant longshore drift. The barrier units are located on the seafloor 11 feet below the 0.0 ft. NAVD88 datum and buried by 4 feet of sand nearly 100 feet offshore. The units however might be accessible adjacent to the rock groins, and any recreational activity in the water close to the rock groins is already prohibited.

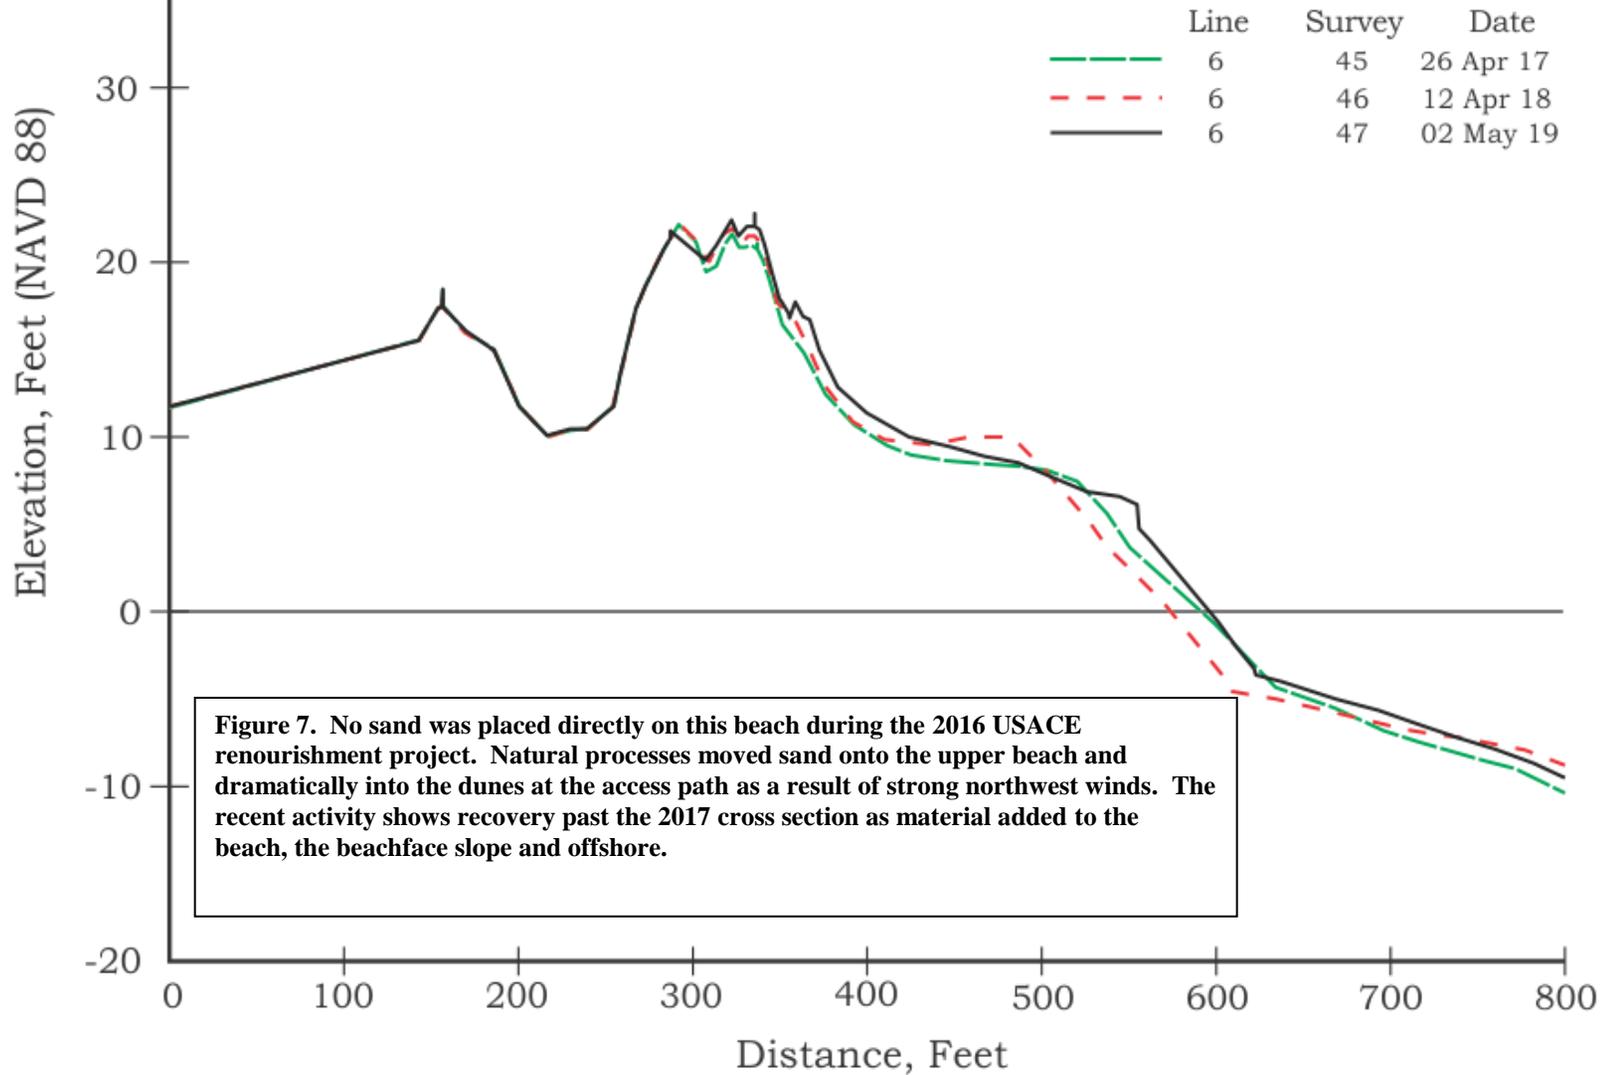
## CMP - Line 6 - Pearl Avenue

No sand was placed this far west during the USACE nourishment project, so beach building has been a result of natural processes. The entire cross section has seen sand added since 2017 from the dunes to offshore. The beachface has advanced 22 feet, mostly during 2018 adding 13.6 yds<sup>3</sup>/ft. in sand volume.

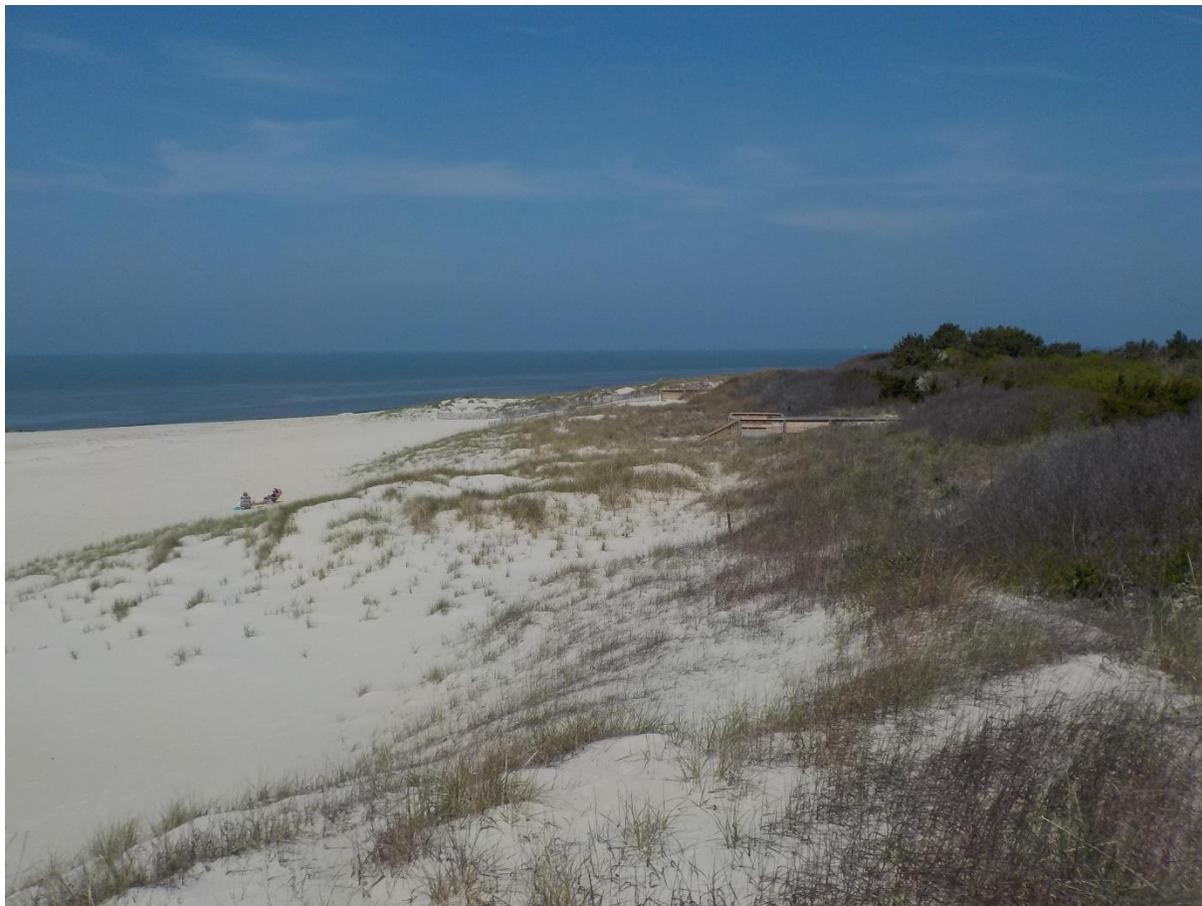
## Pearl to Stites Avenues

***Figure 8. The May 2, 2019 view at CMP-7 shows the scale of the dunes defending this cell's beach. The entire vegetated foredune zone behind the two early birds on the beach has been deposited since 2007 as natural wind deposition.***

Profile CMP-7, located southeast of Brainard Avenue, is bounded by the rock groins near Pearl Avenue and Stites Avenue. The cell has not received any sand directly from the past USACE beach restoration or maintenance projects. Natural processes dominated by longshore drift continue to transfer sand from east to west along the Borough's shoreline. With no submerged offshore structures present at this location the wide dry beach should provide beach patrons with abundant recreational area and good nearshore swimming conditions for the summer season.
