**ANNUAL REVIEW FOR 2019  
OF THE CAPE MAY POINT, NJ MUNICIPAL BEACHES**

PREPARED FOR: THE BOROUGH OF CAPE MAY POINT  
215 LIGHTHOUSE AVENUE  
CAPE MAY POINT, NJ 08212

PREPARED BY: STOCKTON UNIVERSITY COASTAL RESEARCH CENTER  
30 WILSON AVENUE  
PORT REPUBLIC, NJ 08241

May 30, 2019

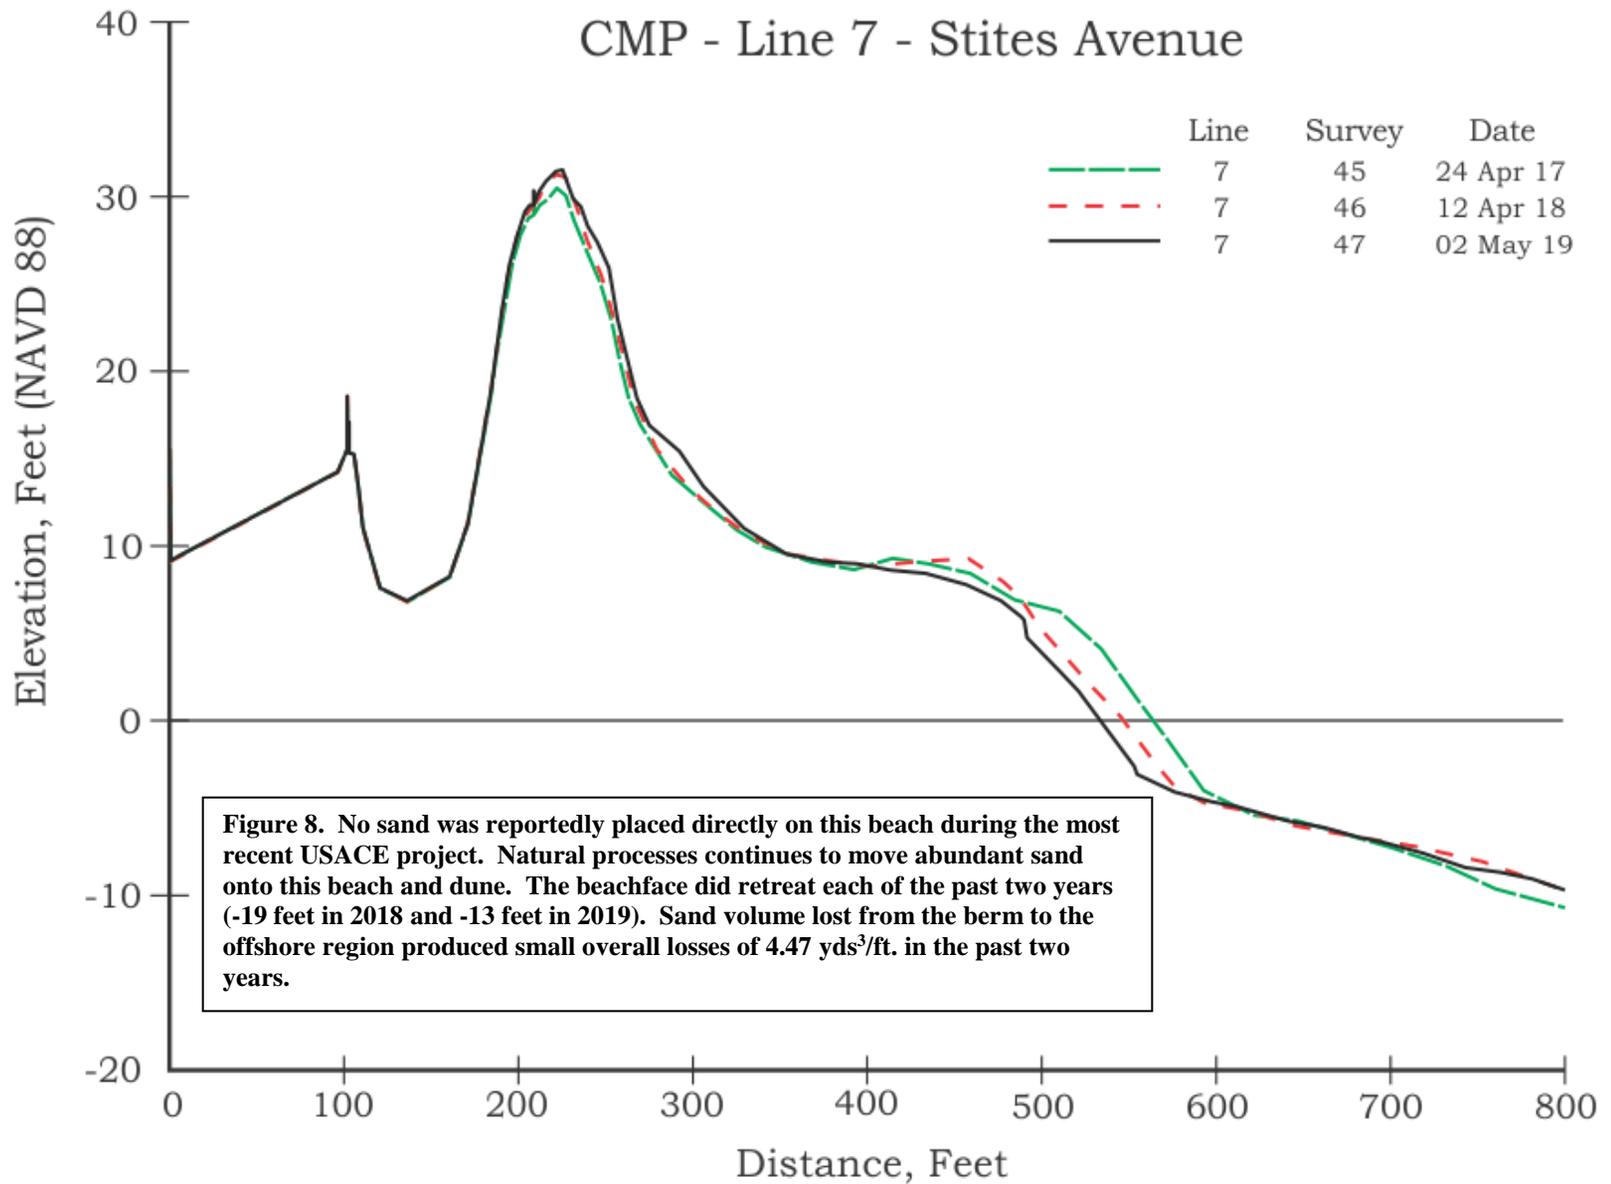
## CMP - Line 7 - Stites Avenue

Dune crest elevations in excess of 30 feet NAVD 1988 provide excellent storm protection, especially since the beach faces southwest where major events do not directly impact the shoreline. The 2017 to 2019 shoreline change was an advance of 5 feet combined with a gain of 14.4 yds<sup>3</sup>/ft. In the past 12 months the shoreline advanced 22 feet with 13.6 yds<sup>3</sup>/ft. in sand addition. This means that the 2018 - 2019 season was very beneficial of the past 24 months.

6. Cell 7 at Stites Avenue benefited from a stable berm area enhancing the recreational value of the beach, this paired with the shallow offshore platform will offer a relatively safe option for swimming. The beach is narrower in 2019, but only by 13 feet.

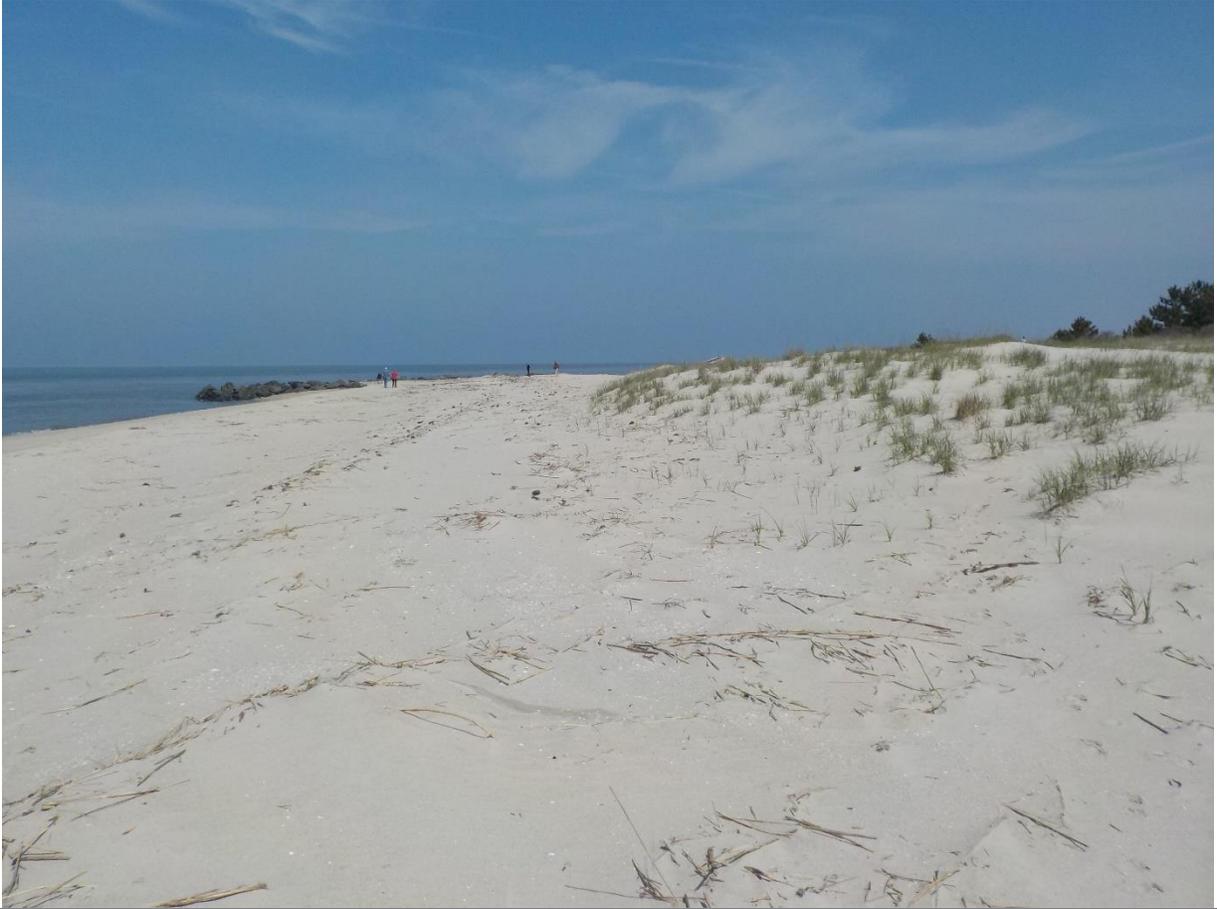
## Stites to Alexander Avenues

*Figure 9. This westernmost cell is defined by The Township of Lower to the west of the Alexander Avenue groin with the CMP-8 cell to the left of the groin on the beach. The figures in the distance are nearly at the Alexander Ave. groin.*

The Alexander Avenue location, CMP-8 is the western most beach cell in the Borough. Sand placement was never included for this location during the USACE projects. Natural processes have moved sand from the project beaches to this location. The beach extends seaward nearly to the tip of the western groin. Sediment loss from this cell moves onto the western Delaware Bay shoreline and shoals locally known as the “Cape May Rips”. The offset landward in the beach west of the Alexander Avenue groin means that most of the sand is transported to the nearby bay floor and does not appear on the Sunset Beach shoreline. The dominance of the tidal currents over the minimal wave transport landward for sand allows the currents to distribute sand on the shallow bay floor in the vicinity, instead of large quantities making it to the Sunset Beach shoreline.

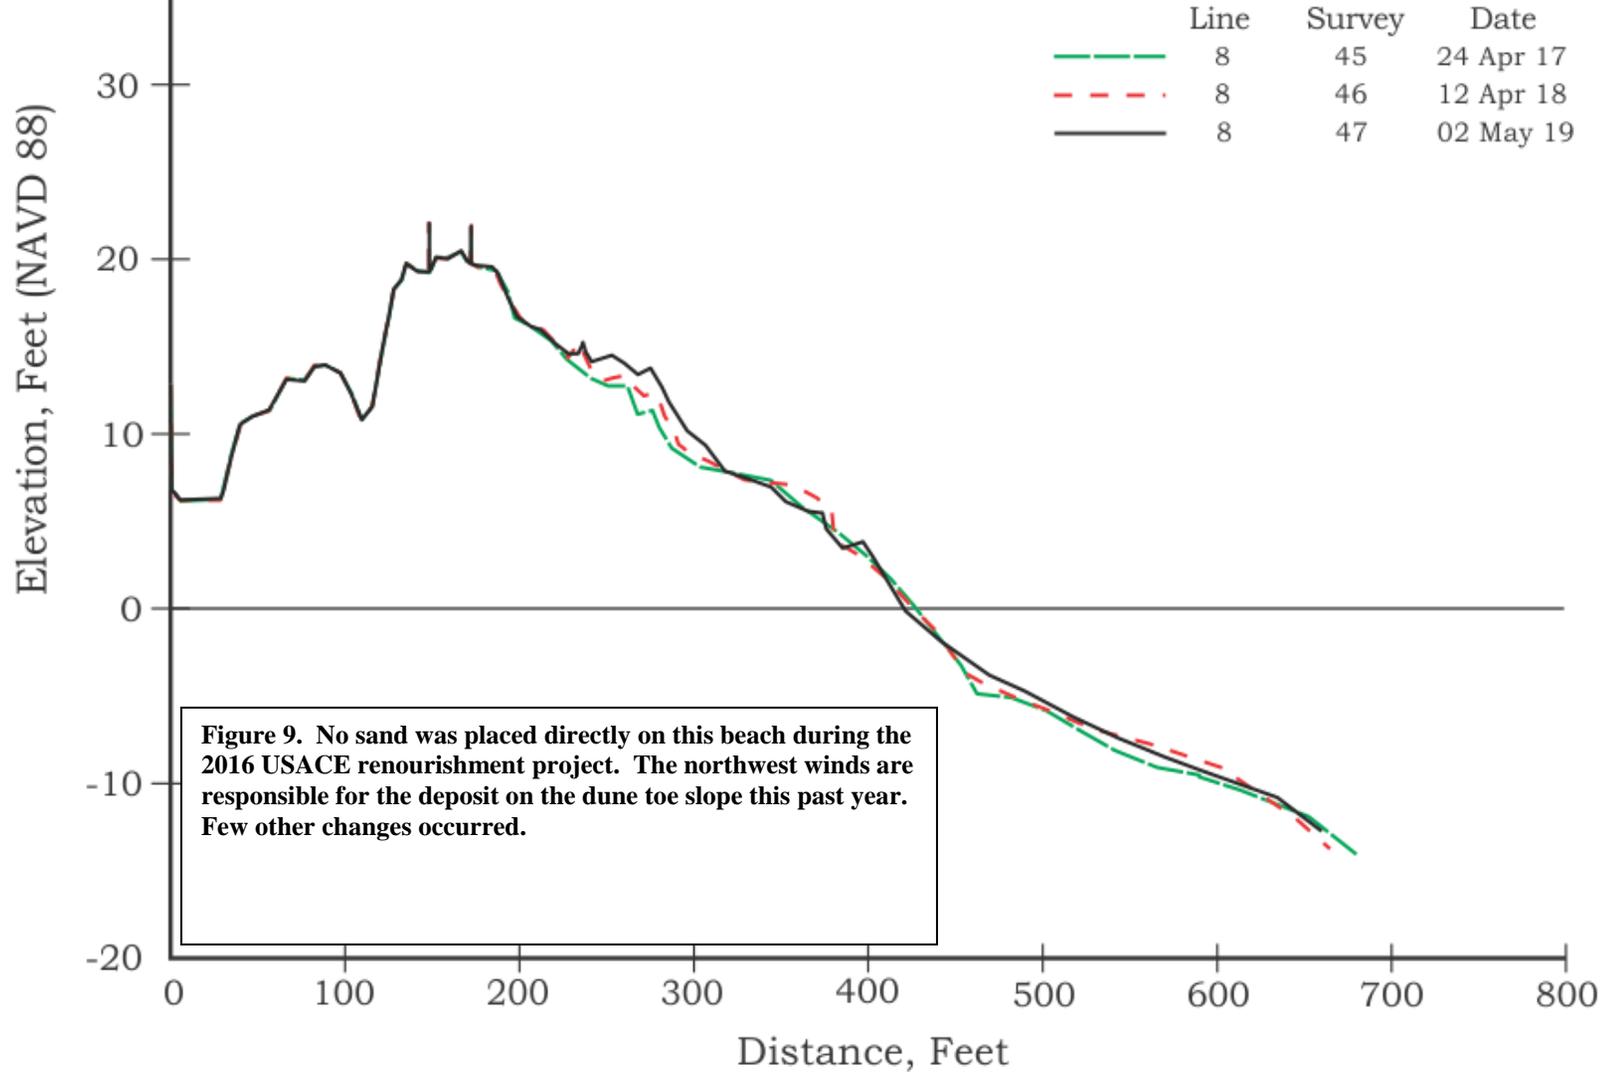
## CMP - Line 8 - Alexander Avenue

Following completion of the initial USACE project sand began to accumulate in increasing amounts, 2015 was the first year in which this accretive trend stopped. In 2016, sand accumulation resumed with a large wedge of sand appearing from the seaward dune crest seaward to the profile limits. The dune advanced seaward 20 feet as a result of sand accumulation on the seaward slope. However, by April 2017, the shoreline retreat was 39 feet as 22.33 yds<sup>3</sup>/ft. in sand volume left the cell. By April 2018, the conditions stabilized as sand added to the seaward dune slope, but changed very little elsewhere along the profile line. The 2018 annual change was a gain of 5.90 yds<sup>3</sup>/ft. as the shoreline retreated one foot. During 2018 summer and into 2019, the dune toe accumulated a large volume of wind transported sand as

northwest winds continued to influence this beach. All else remained stable to marginally accretional. The site added 2.5 yds<sup>3</sup>/ft. this past year as the shoreline retreated 6 feet. The wind deposit at the dune toe was 3.03 yds<sup>3</sup>/ft. just in the area shown in the cross section plot below.

7. Cell 8 at Alexander Avenue has remained at last year’s width, but the available recreational area has been substantially improved at this beach since 2005, especially in the seaward dune slope region. The sand lost from Alexander Avenue does not accumulate on the Sunset Beach segment, but adds to the sediment layers on the nearshore Delaware Bay floor instead.
