**2016 ANNUAL REPORT ON
THE CONDITION OF THE MUNICIPAL BEACHES FOR
THE BOROUGH OF STONE HARBOR, CAPE MAY COUNTY, NEW JERSEY**

**PREPARED FOR: THE BOROUGH OF STONE HARBOR
9508 SECOND AVENUE
STONE HARBOR, NJ 08247**

**PREPARED BY: THE STOCKTON UNIVERSITY COASTAL RESEARCH CENTER
30 WILSON AVENUE
PORT REPUBLIC, NEW JERSEY 08241**

December 15, 2016

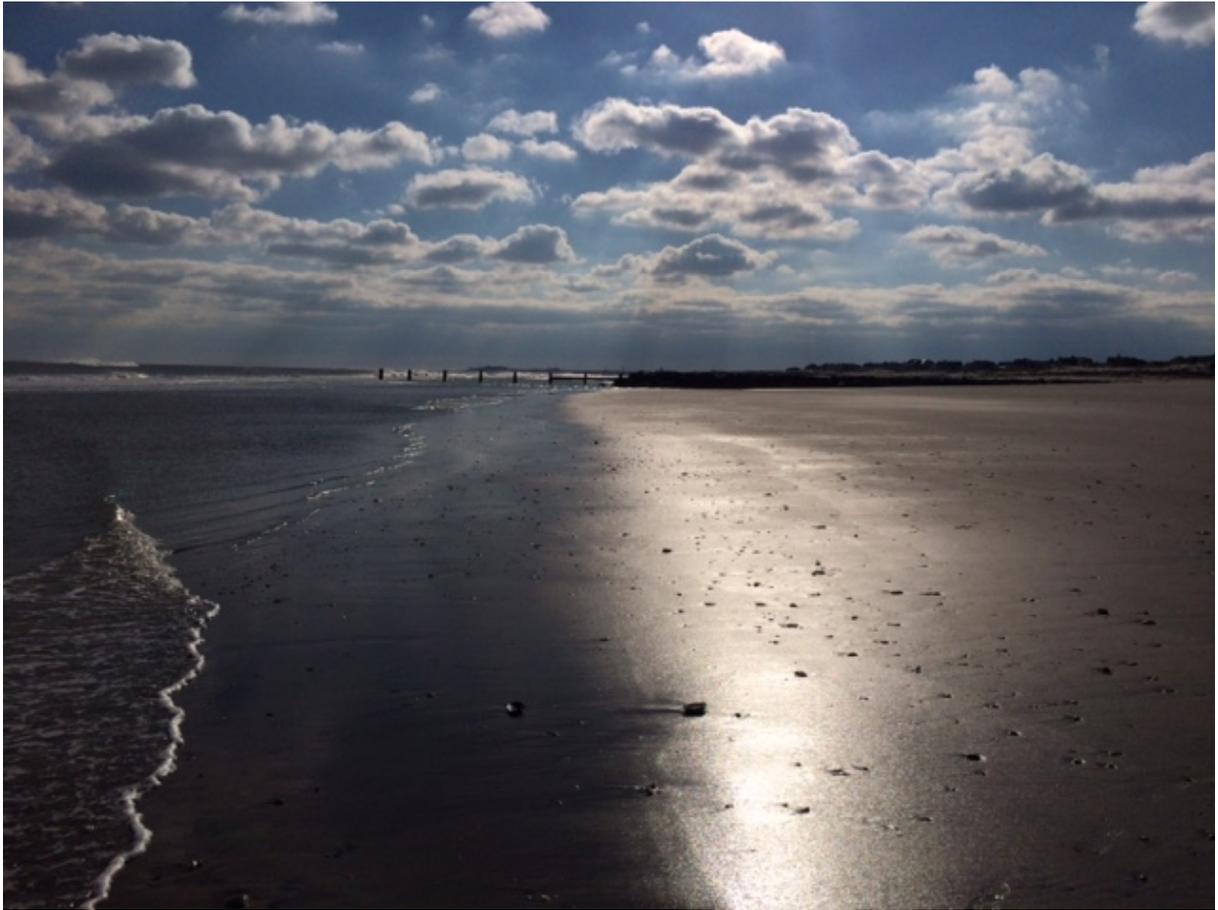
View of the beach at the low tide line looking south following two Northeast storms in January and early February 2016. The photo shows the condition of the municipal shoreline two days following northeast storm Nacio on February 9, 2016. Erosion was particularly severe in Cape May County during these events with tidal flooding exceeding that from Hurricane Sandy.

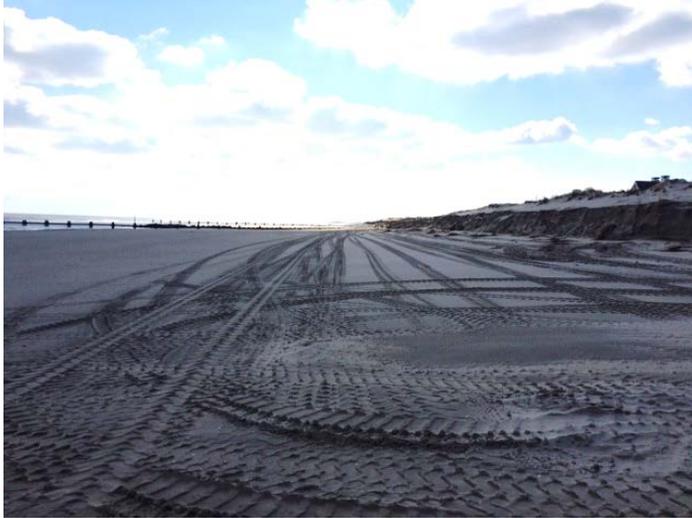
Photoplate 1a - Photo taken February 11, 2016 following both Jonas and Nacio. View to south along the dune toe from 82nd Street. The dune fence installed after the USACE project to capture aeolian sand was destroyed.

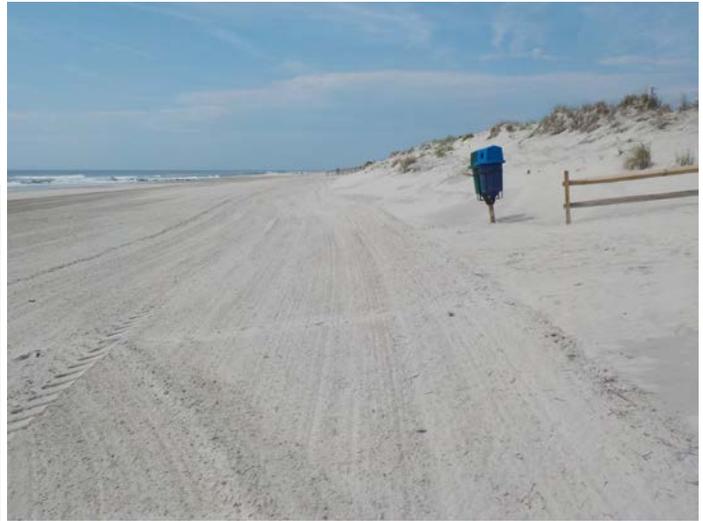
Photoplate 1b - Photo taken May 23, 2016 showing that the dune sand slumped seaward, re-generating the seaward slope, without new fencing. The beach was still relatively flat.

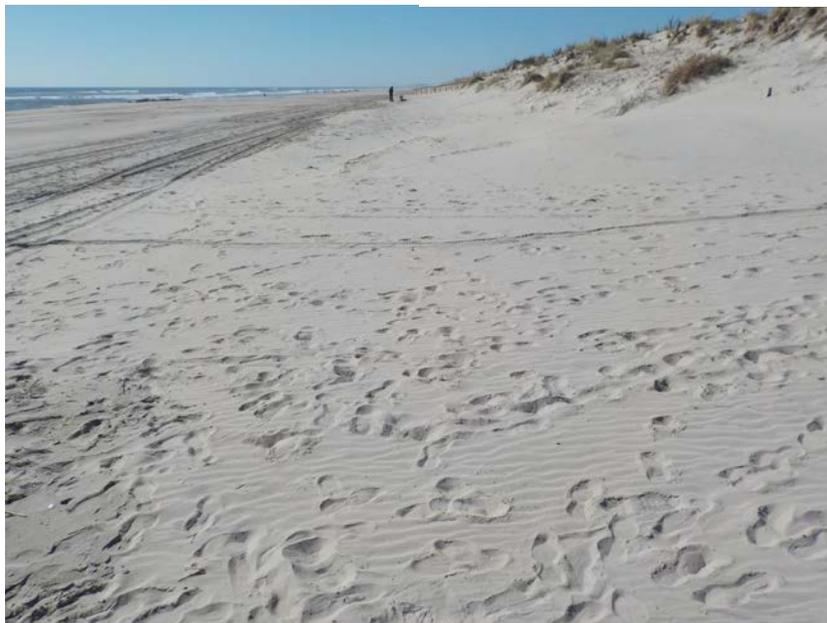
Photoplate 1c – Taken October 14, 2016 showing that the -0.57 yds³/ft. sand volume seen above the zero datum was, in fact, quite real. The beach remained flat with little new material at the dune.

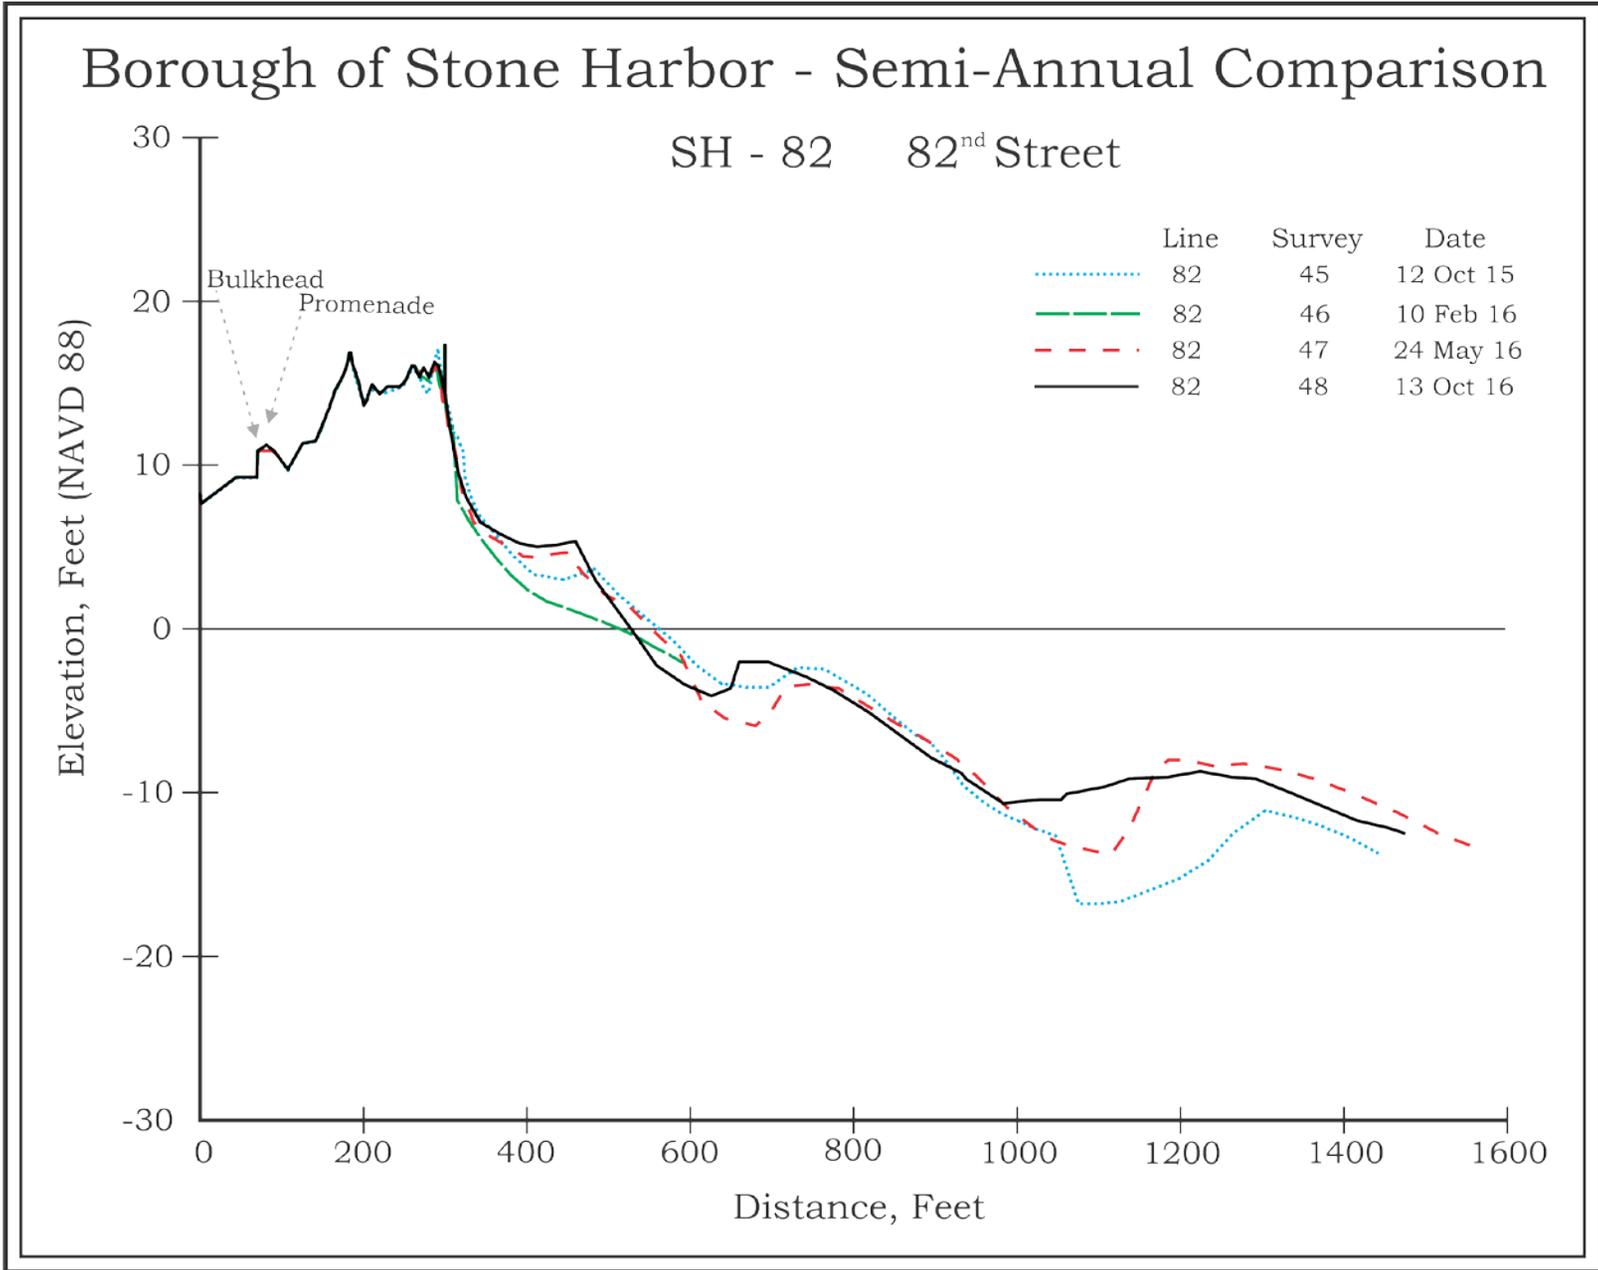
Figure 1a. These cross sections bracket northeast storm Jonas (survey #46) and show the dramatic difference among surveys far offshore where major troughs develop and then fill with sand. The beach reflects the severe flattening seen in Jonas with post-storm berm development producing an above datum recovery. The 55 yds³/ft. gain seen offshore is due to the filling of the trough with a bar feature present one year following the October 2015 survey.

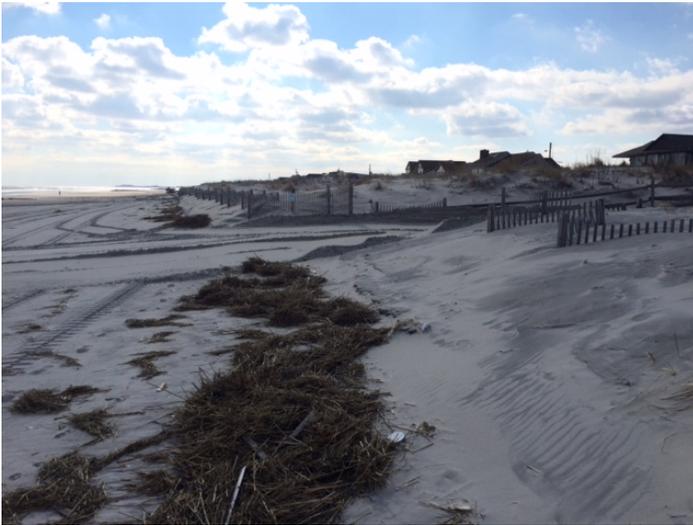
Photoplate 2a - Photo taken February 11, 2016 following Jonas and a second event two weeks later. The wrack line reached the beach entrance at the dune toe making a small scarp in places. The dune fence was still unaffected at this location

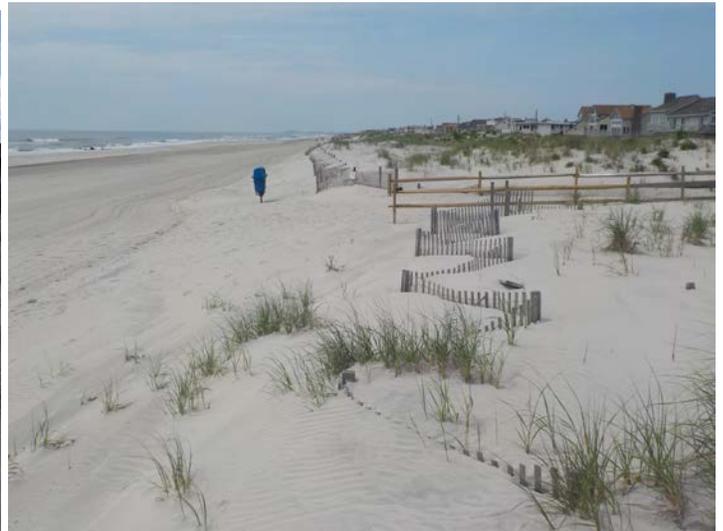
Photoplate 2b - Photo taken May 16, 2016 following the spring. No additional storm activity affected the site, the debris had been cleaned up and a minor addition of sand was made to the dune toe.

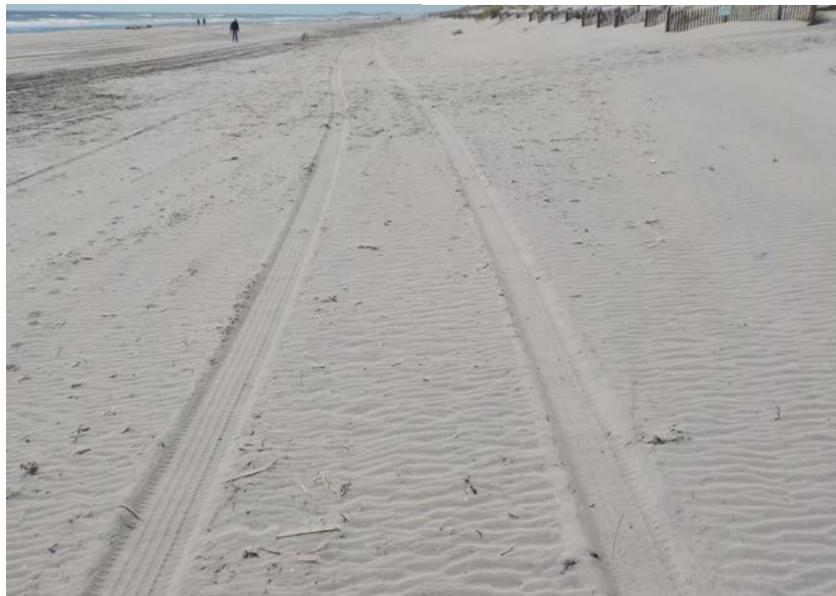
Photoplate 2c – By October 13, 2016 the beach was narrower than a year earlier, but with a berm developed with a gentle slope up to the dunes.

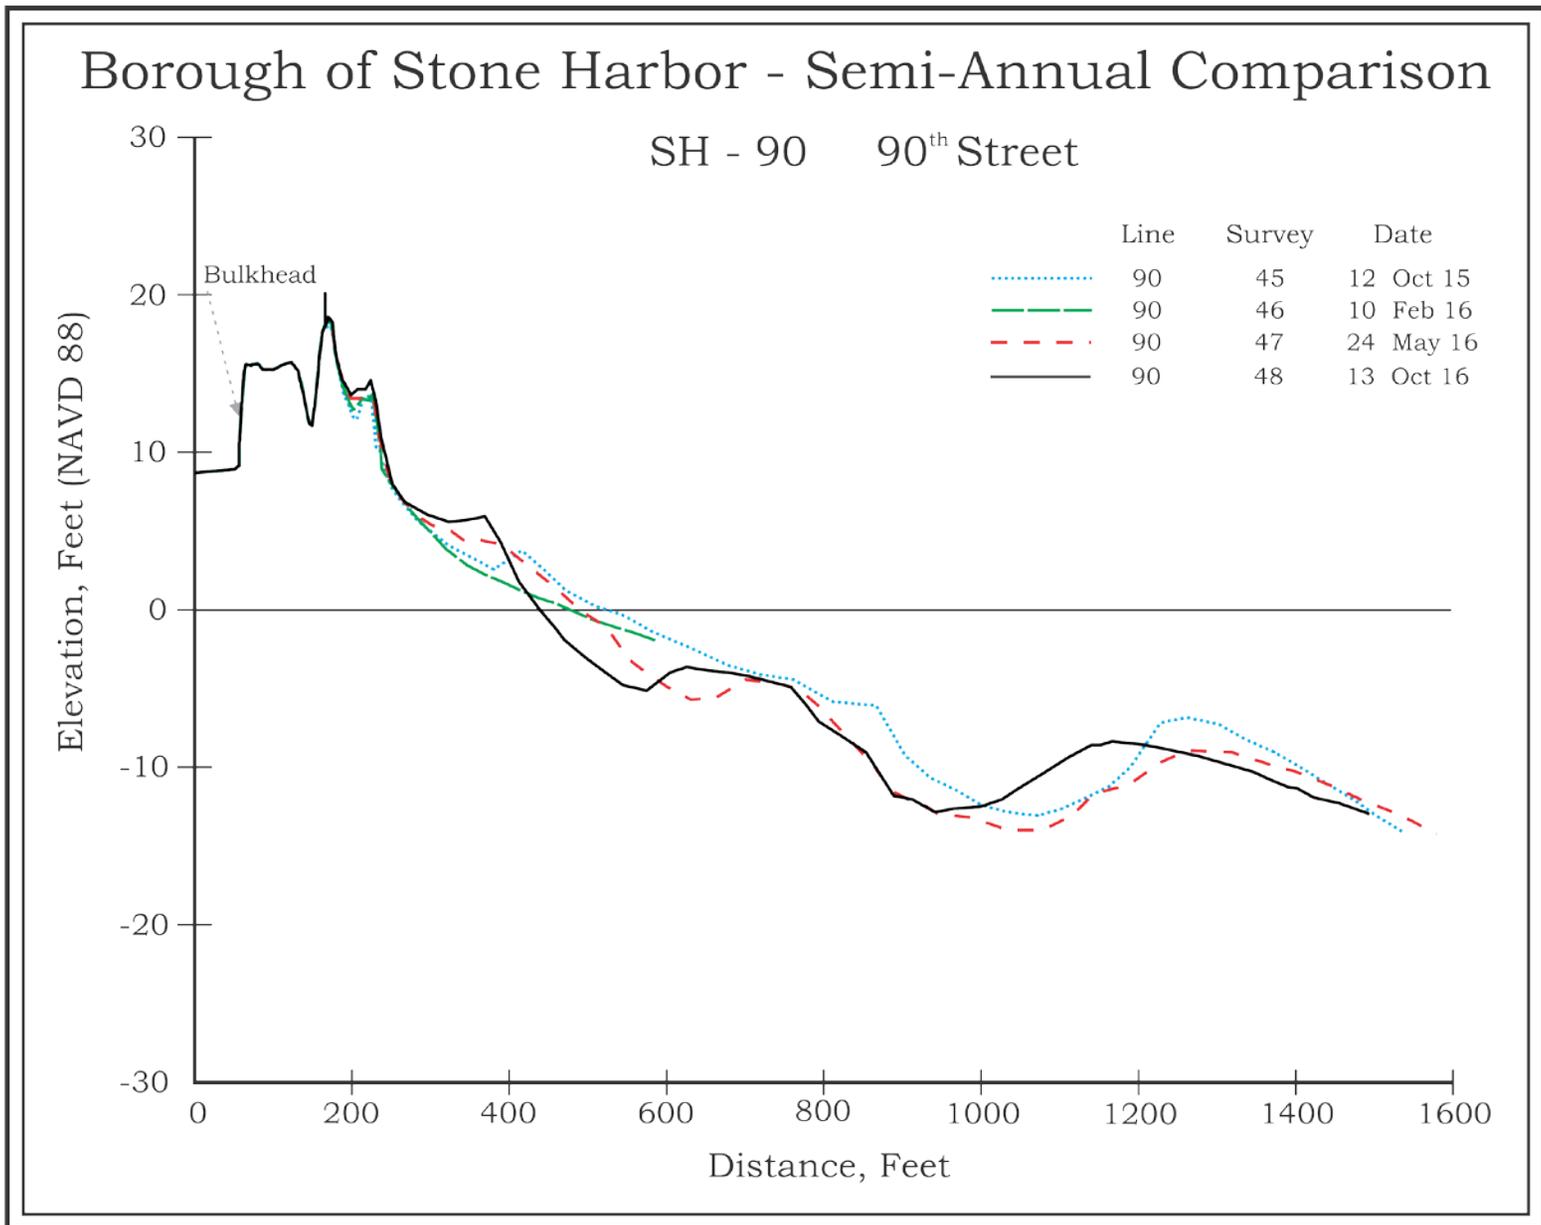
Figure 2a. There was a loss in elevation between the offshore bar and the beach berm over the year. Elevations just offshore decreased and the beach became 83 feet narrower as the beachface steepened. Perhaps the late September 2016 storm event that lasted three days cut into the nearshore material because the event was relatively mild, but long in duration.

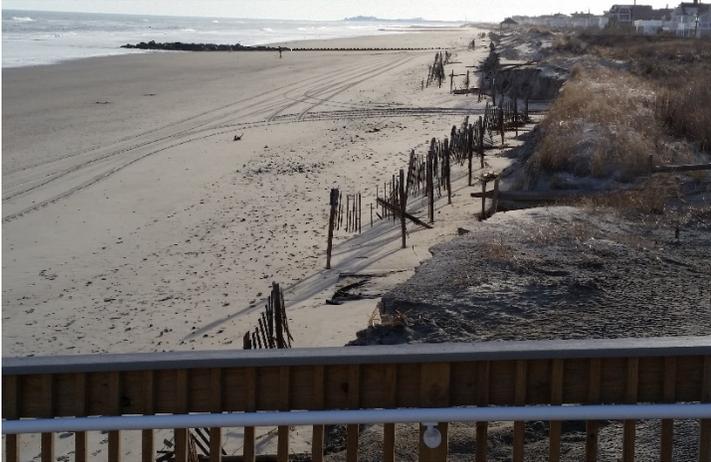
Photoplate 3a - Photo taken January 25, 2016 following Jonas. The access ramp was undercut and exposed. The last segment of the railing was gone, otherwise the structure was fine. The dune fencing was destroyed in both directions with 25 feet of seaward slope erosion beyond the fencing position.

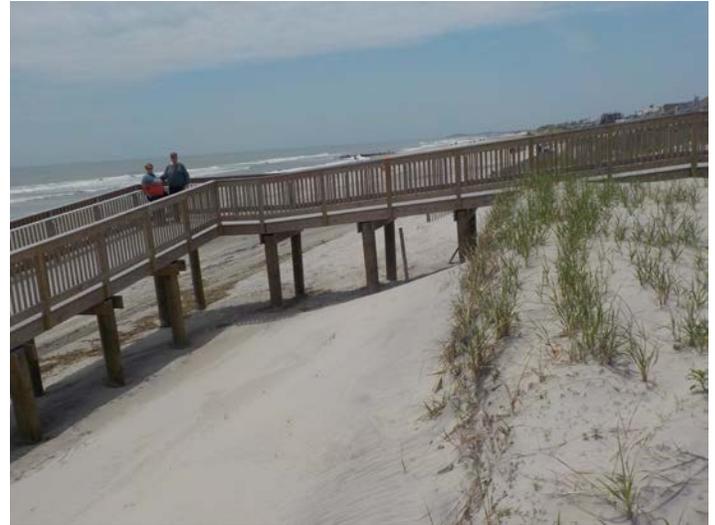
Photoplate 3b – By May 24, 2016 the dune scarp had blended into the seaward slope again, but the loss under the access ramp is still clear from the edge of the grass outward.

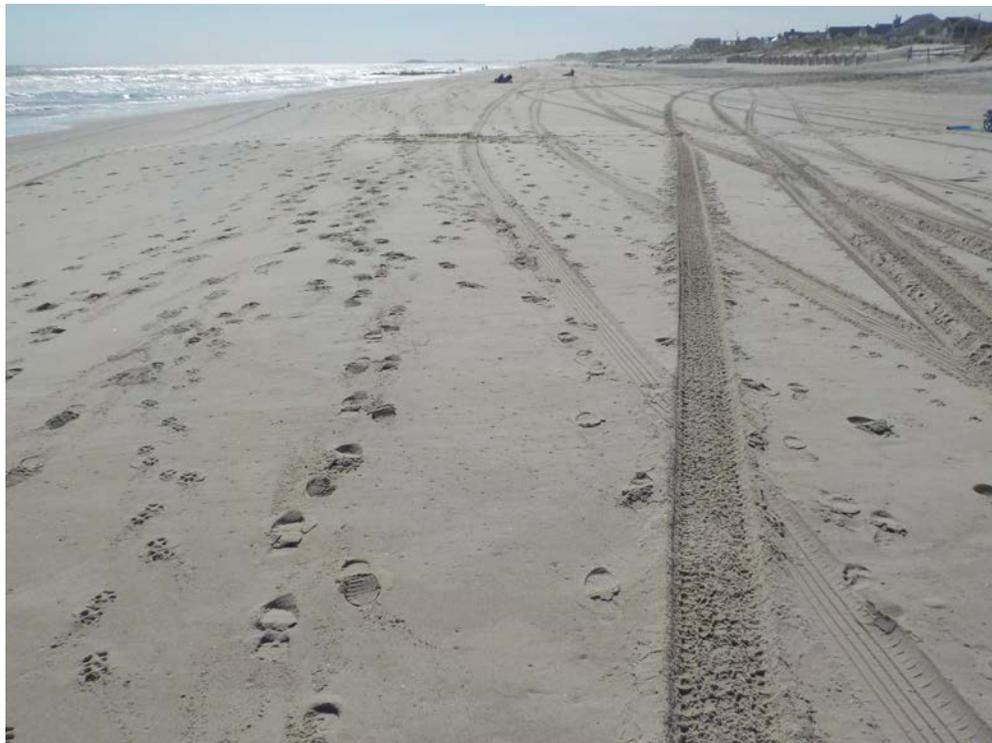
Photoplate 3c – October 13, 2016 found a berm developed on the beach, but the dune loss is still evident in the distance. The beach is approximately the same width it was a year ago but there is a pronounced trough just offshore.

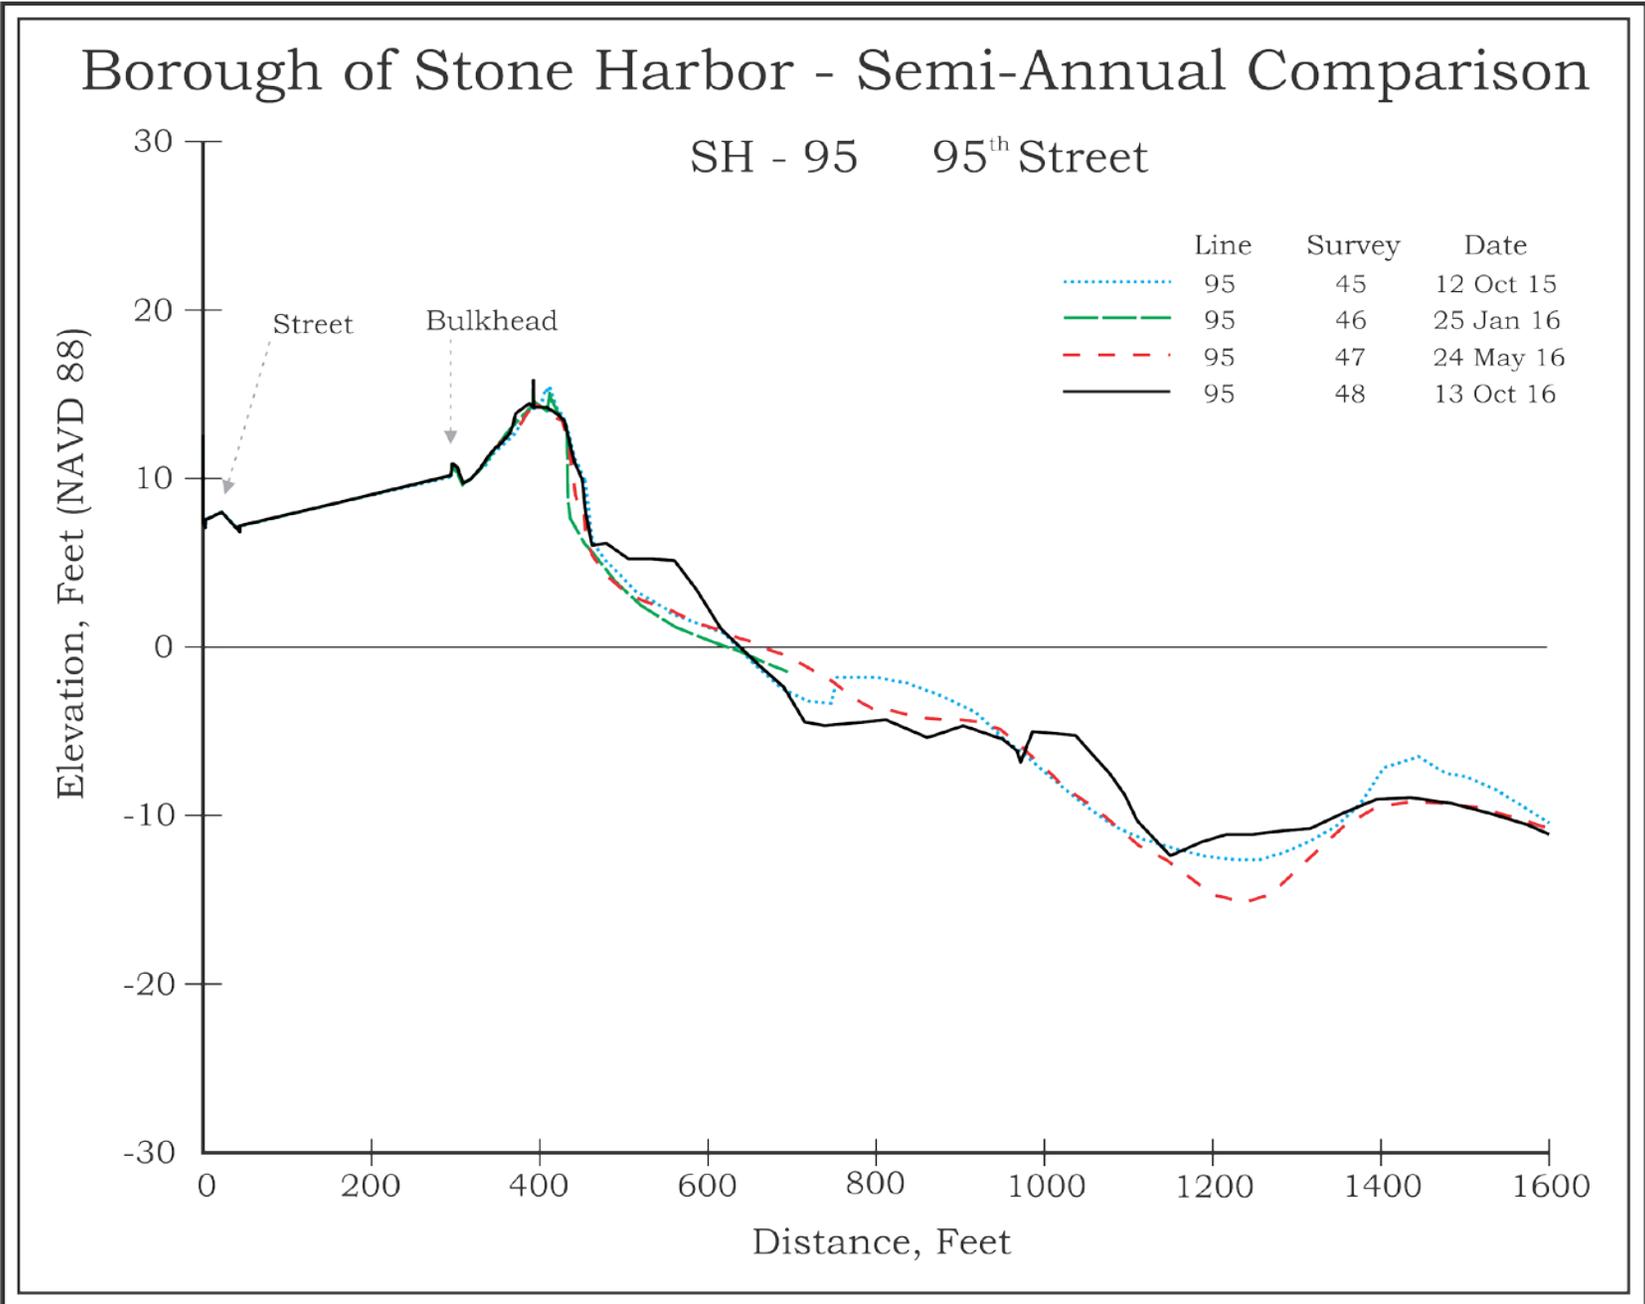
Figure 3a. At 95th Street the Jonas storm impact shows as dune erosion between surveys 45 and 46. Sand blew back into the void restoring the seaward slope almost completely as the berm developed at the shoreline with bar material advancing landward to a small degree.

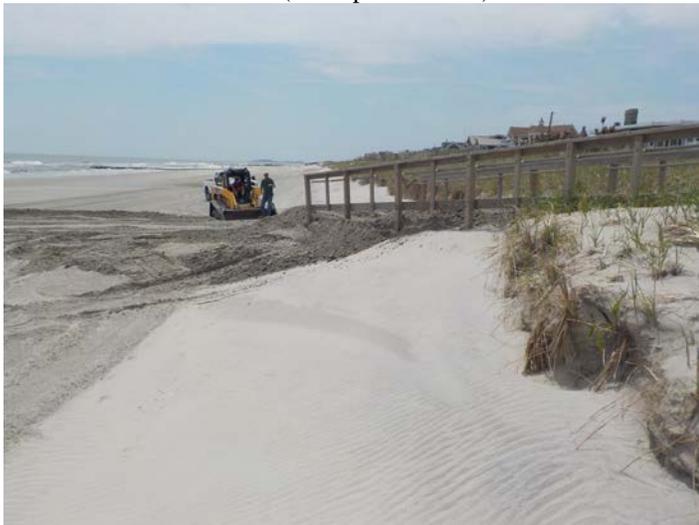
Photoplate 4a - Photo taken May 24, 2016 showing grading work taking place around the access pathway. There was erosion at the dune toe during Jonas that slowly recovered as sand was blown toward the dune from the beach.

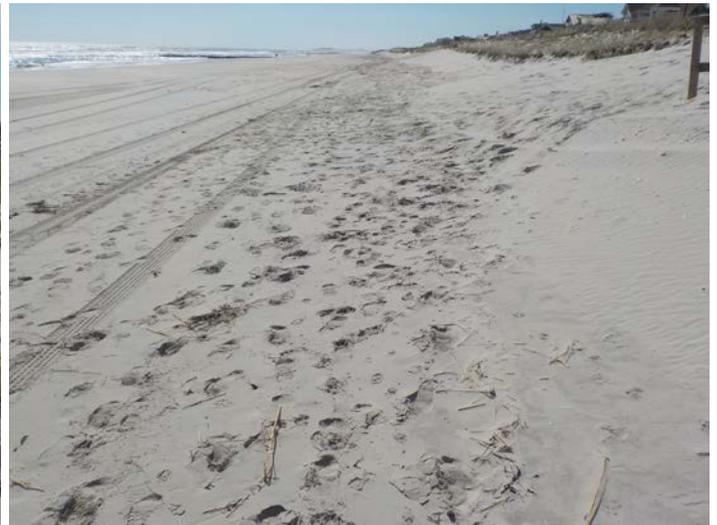
Photoplate 4b - Photo taken October 13, 2016 looking along the seaward dune toe location. The berm regrew and some sand was added to the dune toe making up for Jonas's erosion.

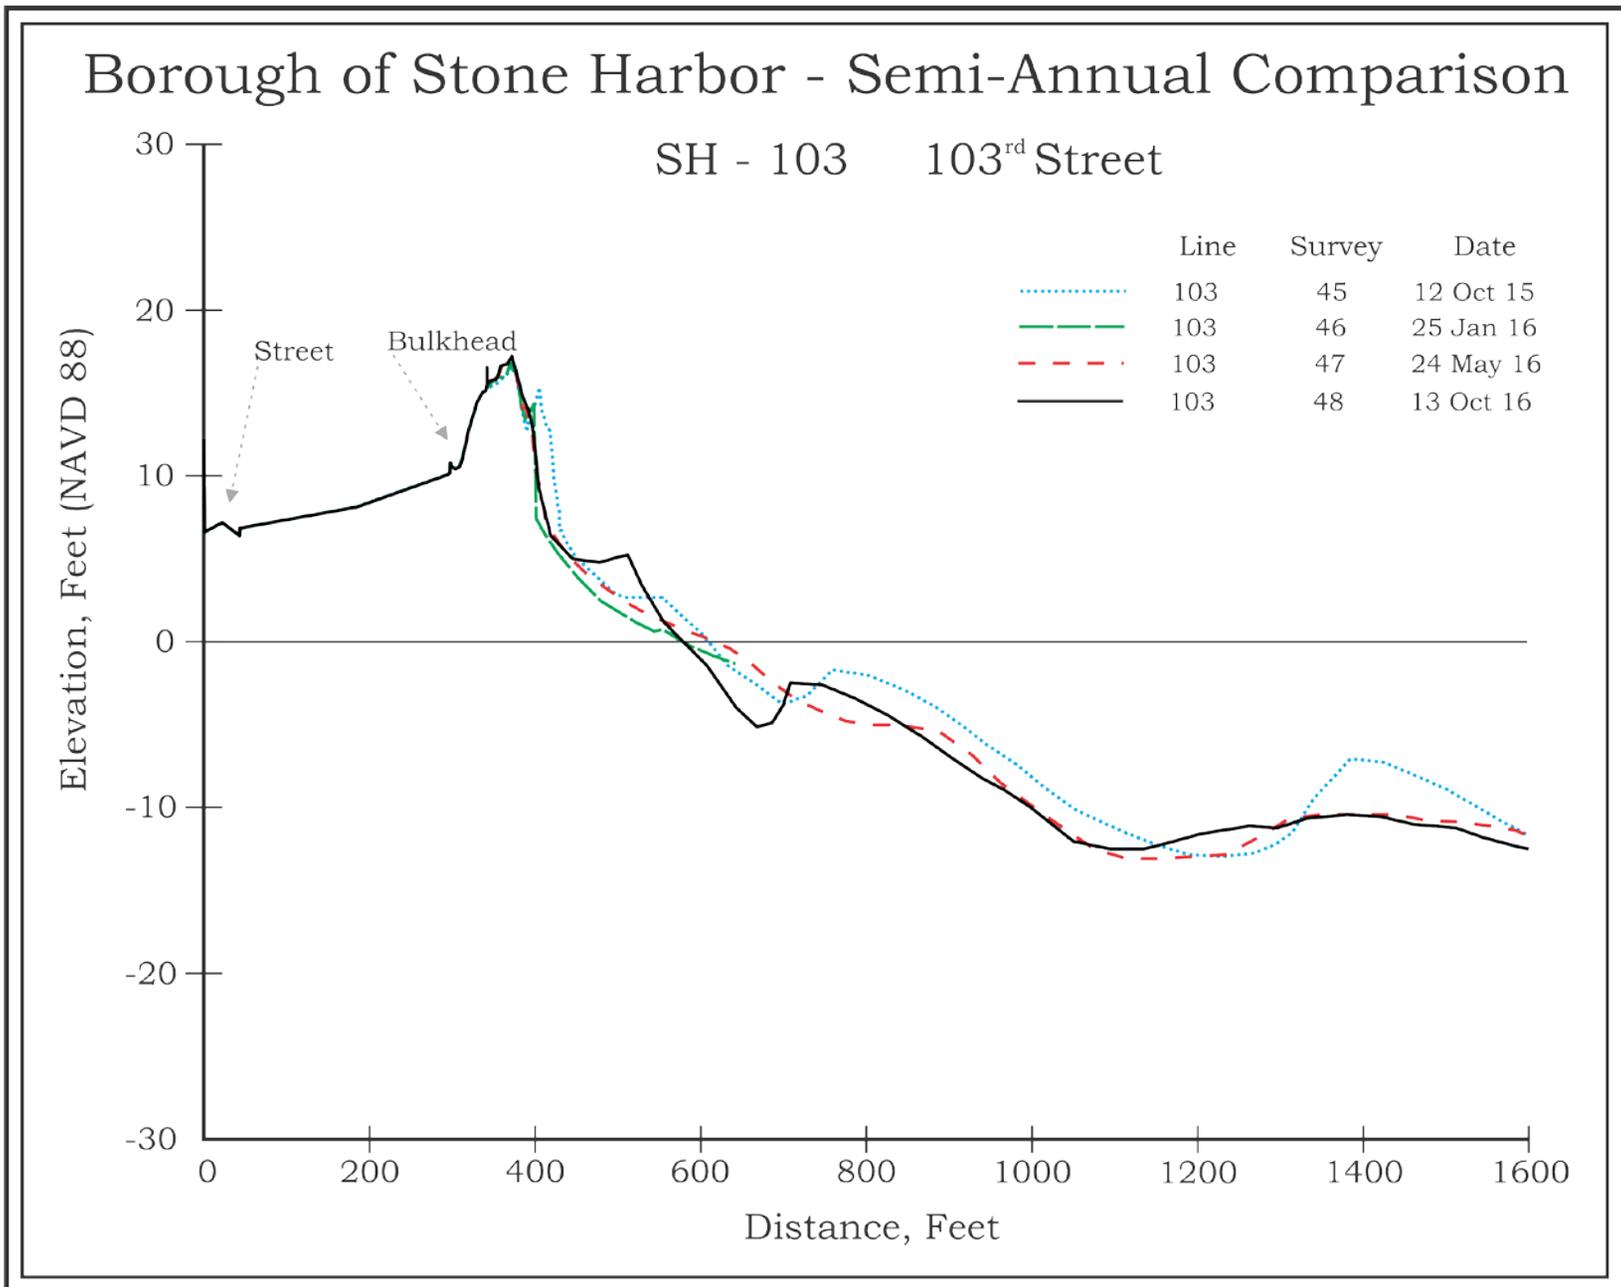
Figure 4a. Dune toe losses were not recovered after the late January NE storm Jonas. Offshore, loss mounted as the bar moved landward and diminished in size. The berm was small and the zero elevation position retreated 30 feet.

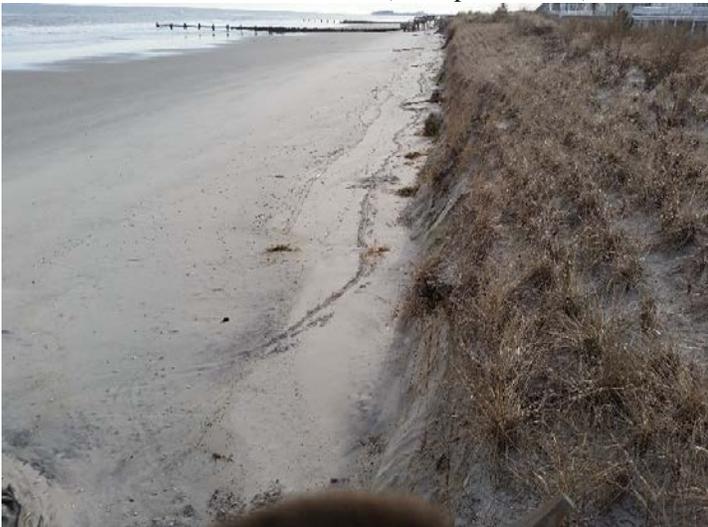
Photoplate 5a - Photo taken January 25, 2016 showing the dune scarp at 108th Street looking south along the cut. The beach was wet to the toe of the scarp from the last high tide. Two weeks later additional erosion took place. All the dune fencing was destroyed with the storm taking all the recent deposition as well.

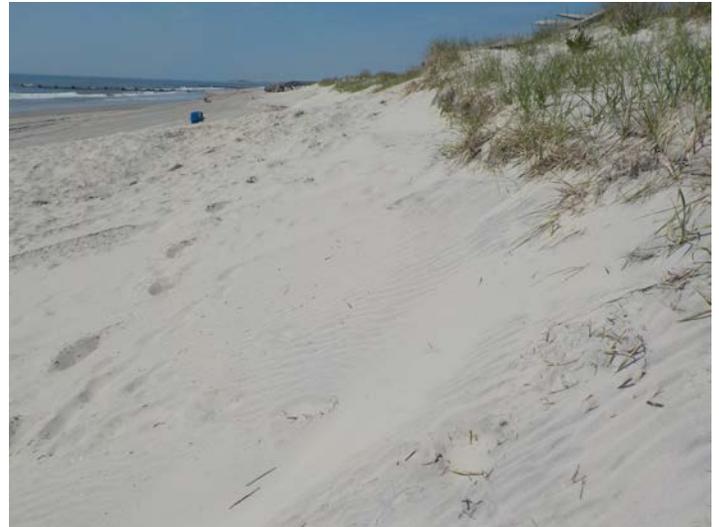
Photoplate 5b – Photo taken May 24, 2016 following sand slumping and wind deposition up to the scarp cut by Jonas. The beach remained narrow and storm surge waves can easily reach the dune toe at the present time.

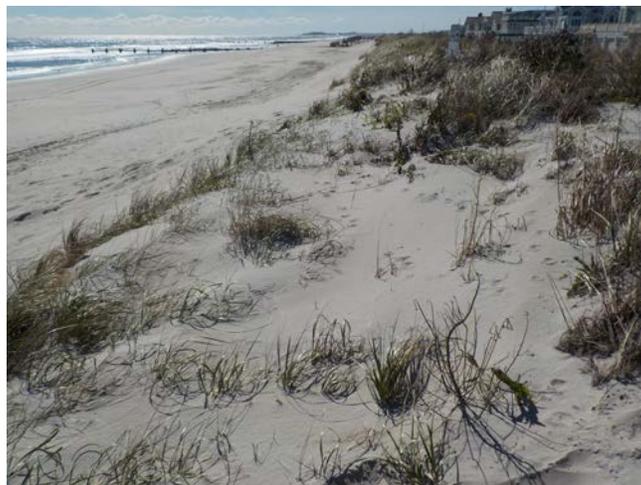
Photoplate 5c – By October 13, 2016 the dune and beach had recovered some berm elevation with sand transported to the dune toe. The loss in dune width was still evident in the plots.

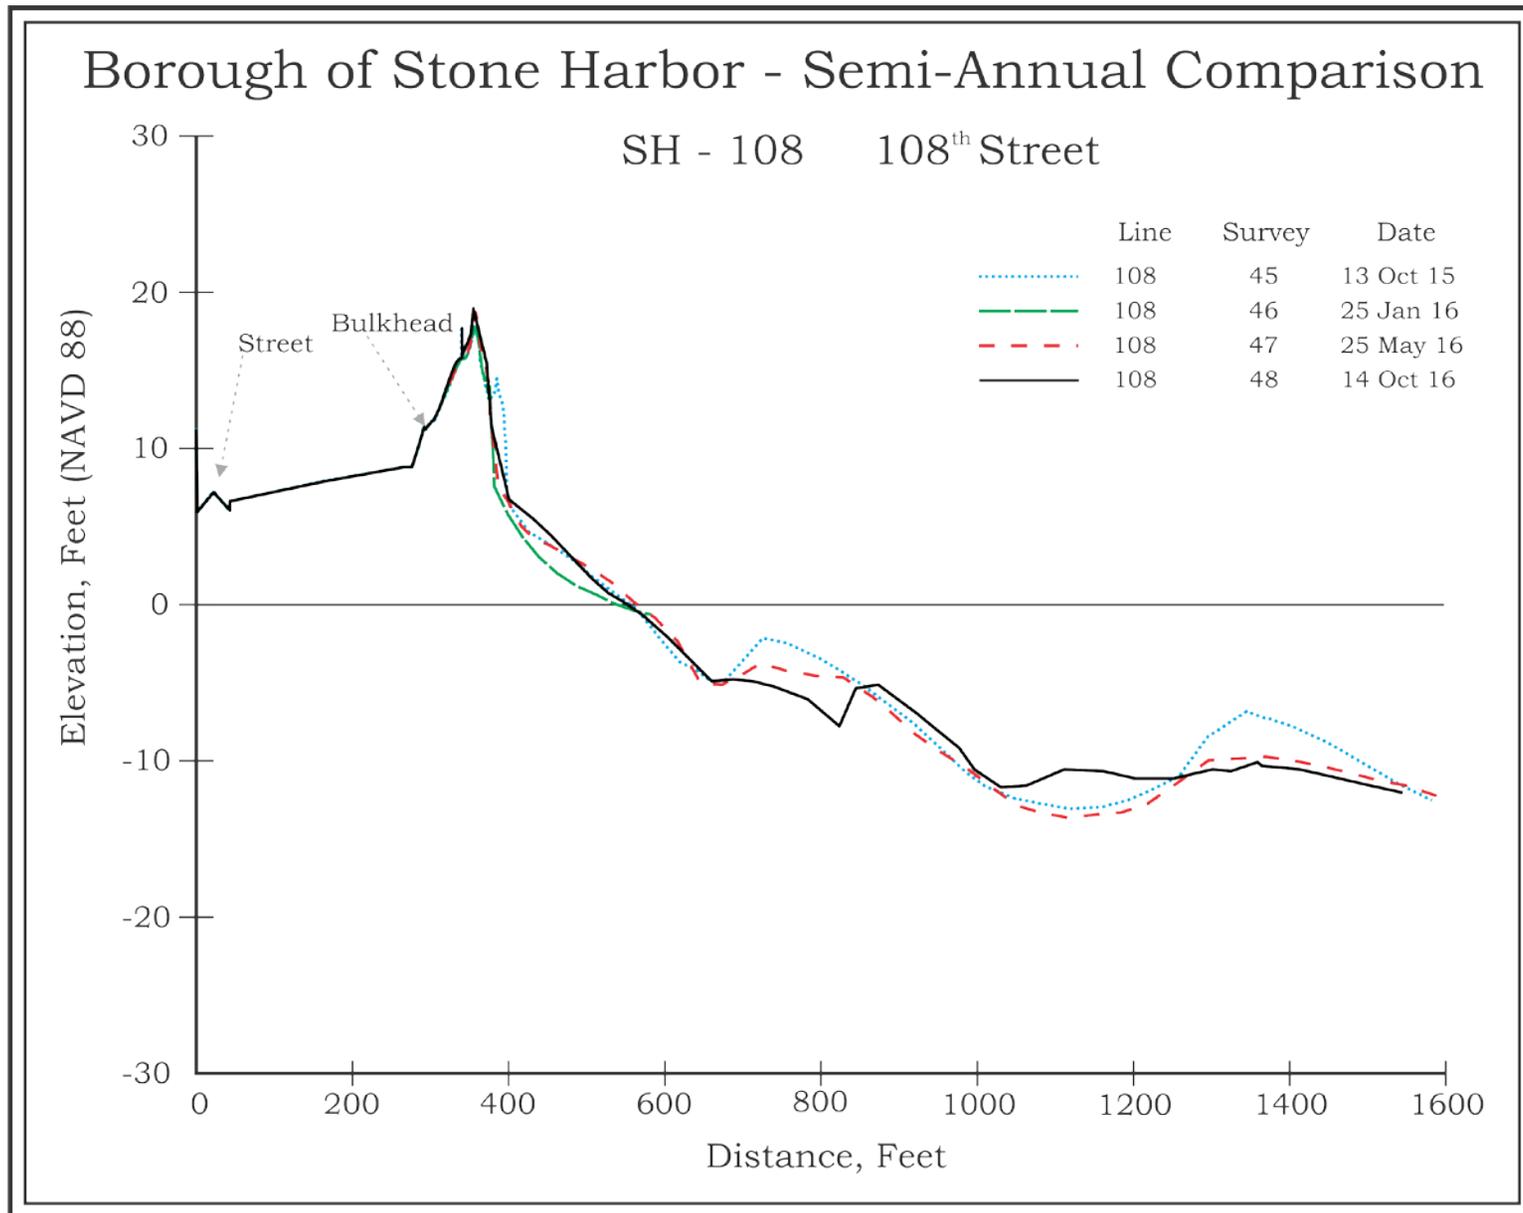
Figure 5a. The dune loss shows between survey #45 and the post-Jonas survey (#46). Recovery over the year developed a berm and some sand deposited at the toe of the scarp from the storm. Offshore the bar elevations decreased making the net change negative for this site.

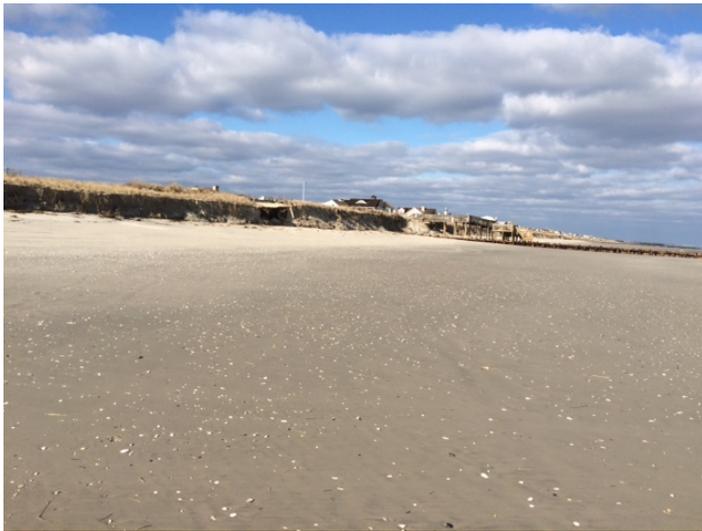
Photoplate 6a - Photo taken February 11, 2016 following Jonas and a second storm February 7, 2016. Note the 3 to 4-foot scarp cut into the seaward dune toe slope and the flat beach showing high tide wave activity nearly to the scarp days later. The newly accumulated foredune was removed back into the established grasses.

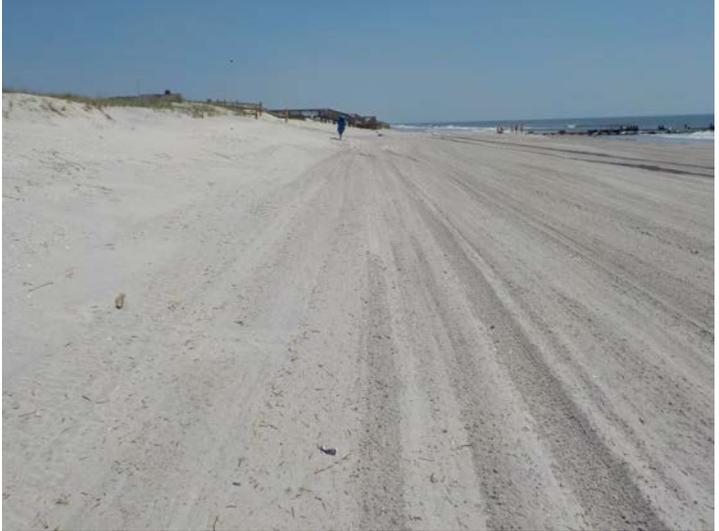
Photoplate 6b - Photo taken May 24, 2016 with a berm redeveloped and the sand slope from the dune grass muted from the vertical cut after Jonas into a more typical slope angle. Sand was deposited at the dune toe and upper berm over the summer.

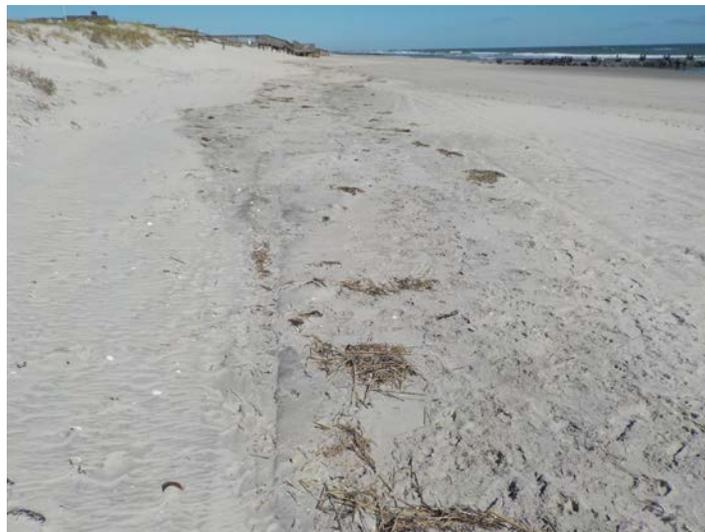
Photoplate 6c – By October 13, 2016 the beach width was approximately the same as it was earlier, but as the picture shows, the wave run-up reached almost to the dune toe meaning that future storm action would produce additional erosion.

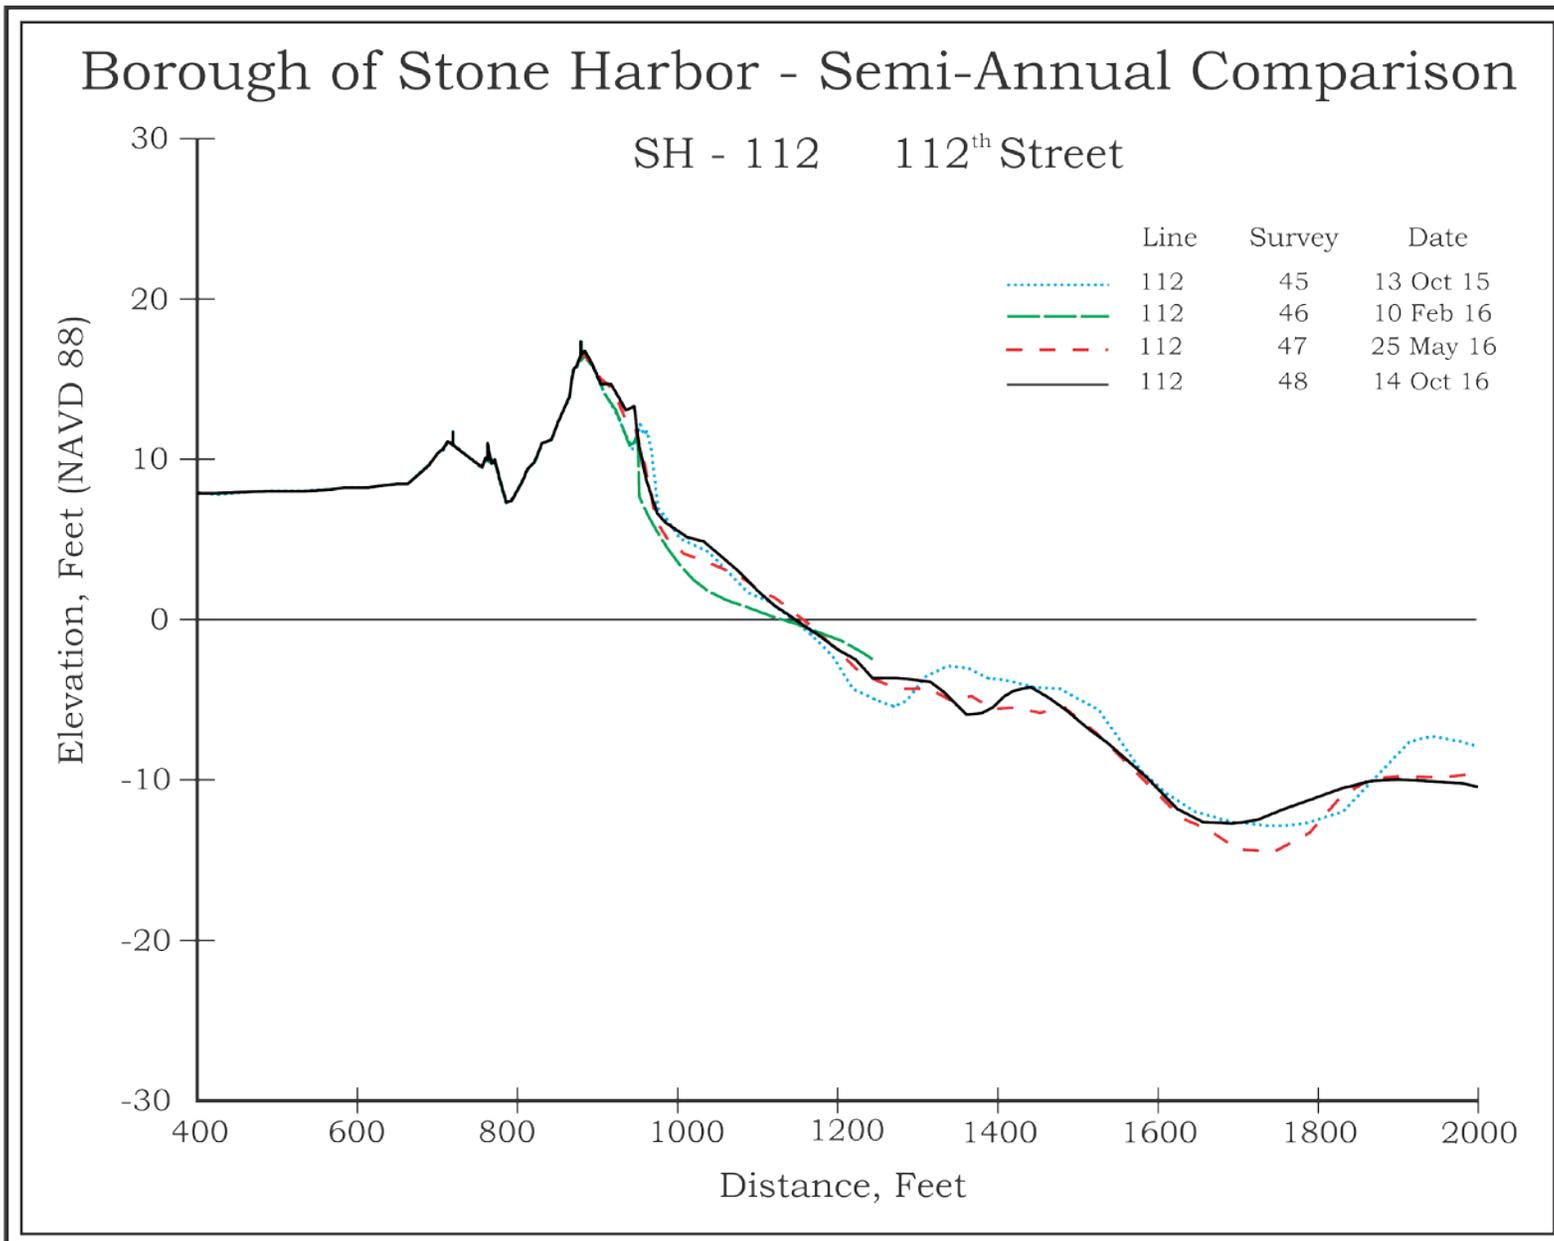
Figure 6a. The storm erosion is apparent looking at the cut in the dunes on February 10, 2016. Sand did accumulate at the scarp and a berm developed over the summer. The shoreline position did not change much and offshore some bar elevation reduction did occur, but on a more minimal scale at this site.

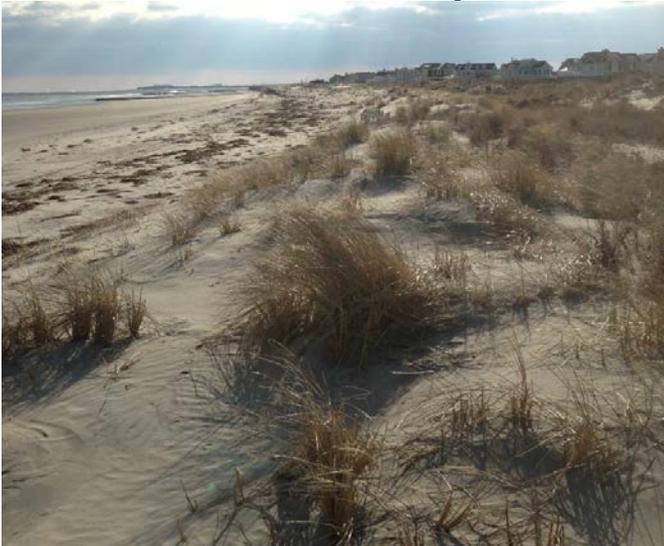
Photoplate 7a - Photo taken February 1, 2016 following Jonas and a second, smaller northeast storm two weeks later. Note the wrack line at the toe of the dunes making the beach wet to the toe following the storms. The dune damage was relatively minor at this site.

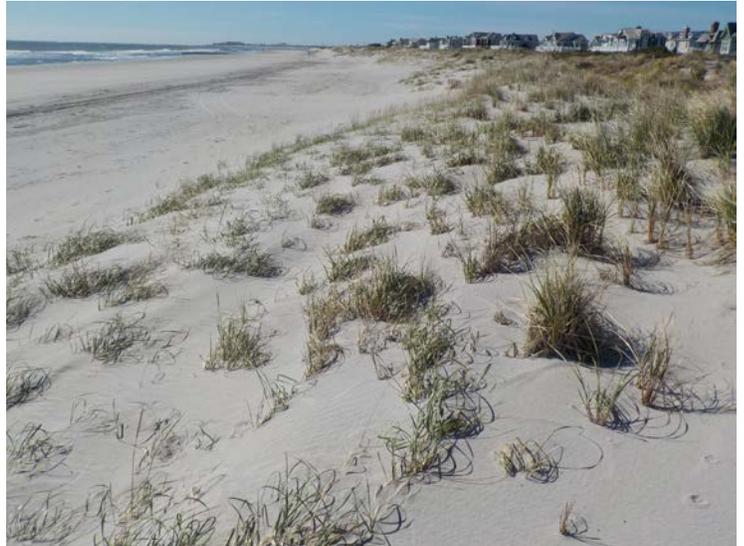
Photoplate 7b - Photo taken October 14, 2016 with the same perspective as that on the left. Sand has accumulated among the clumps of dune grass and the dry beach has accumulated a bar at the water's edge.
