**2016 ANNUAL REPORT ON
THE CONDITION OF THE MUNICIPAL BEACHES FOR
THE BOROUGH OF STONE HARBOR, CAPE MAY COUNTY, NEW JERSEY**

**PREPARED FOR: THE BOROUGH OF STONE HARBOR
9508 SECOND AVENUE
STONE HARBOR, NJ 08247**

**PREPARED BY: THE STOCKTON UNIVERSITY COASTAL RESEARCH CENTER
30 WILSON AVENUE
PORT REPUBLIC, NEW JERSEY 08241**

December 15, 2016

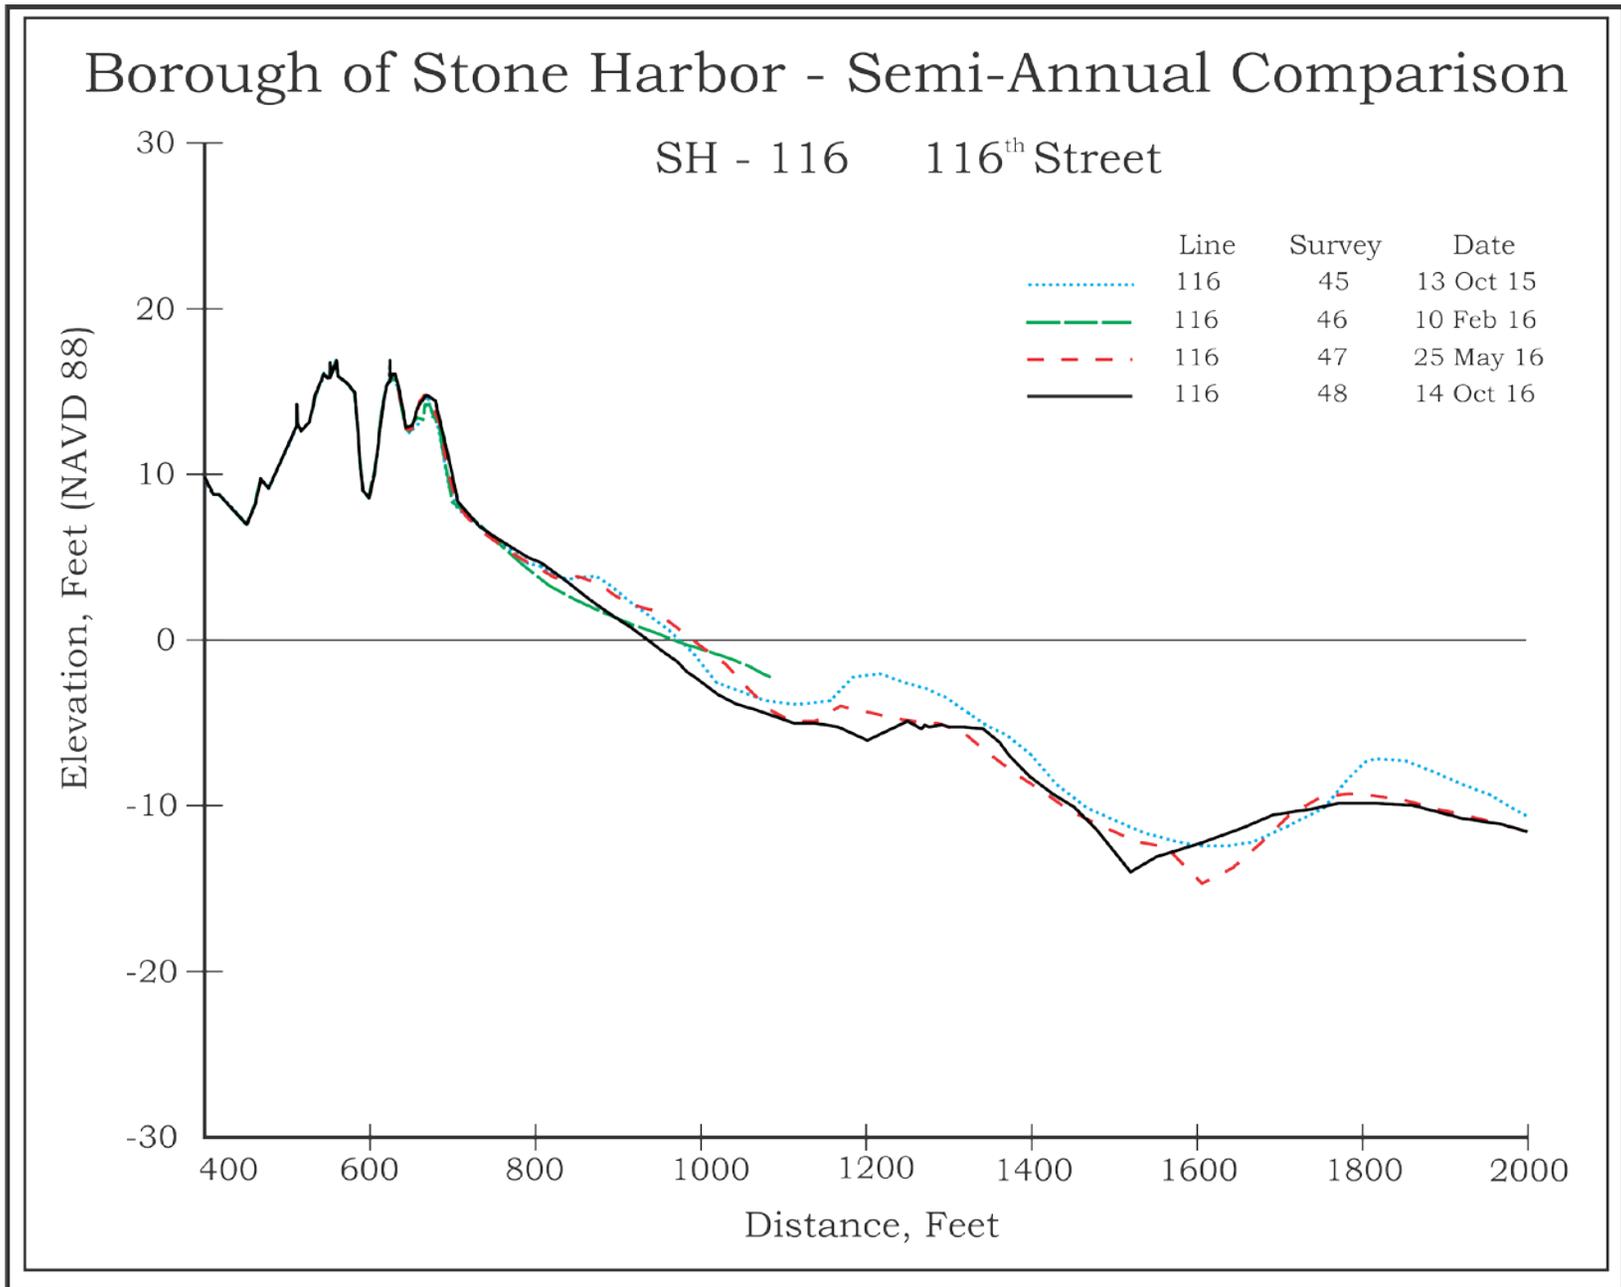
Figure 7a. 116th Street has an excellent double dune system with a wider beach naturally that adds stability. The Jonas event did not impact the dune in any way with debris piled up at the toe of the dune. Sand added to the seaward slope this year and a minor berm developed. Offshore the elevation loss accounted for the decline in sand volume recorded (-51.16 yds³/ft. with just 2.94 yds³/ft. of that loss coming from the dune/beach above zero elevation.

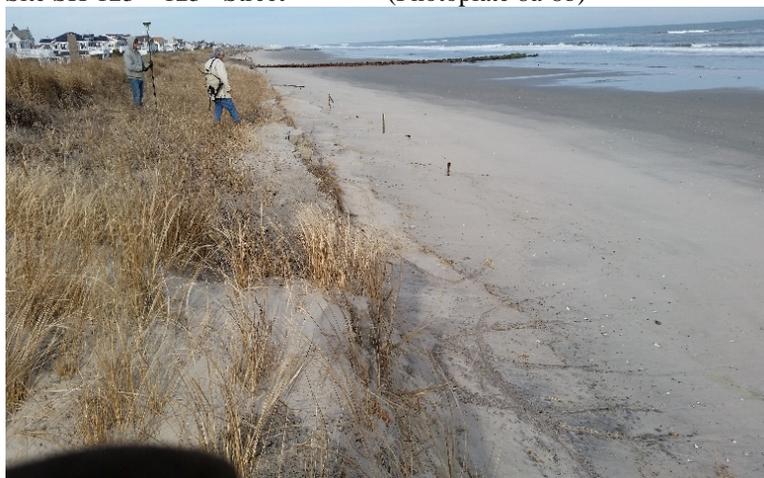
Photoplate 8a - Photo taken January 25, 2016 following Jonas. The scarp was 8 to 10 feet high and the seaward dune toe was cut back to within 20 feet of the bench up to the crest. The beach was flat and wet to the toe on the last high tide.

- The worst dune loss occurred in the cell defined by 123rd Street cross section. Here the dune was eroded back to essentially the crest elevation with a 10-foot scarp along the segment.

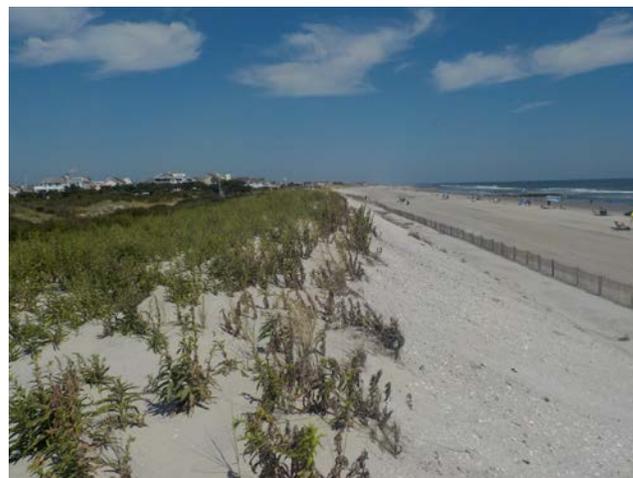
Photoplate 8b – Photo taken September 14, 2016 a few days after Hurricane Hermine passed the coast. The scarp has muted due to sand sloughing off the crest and wind deposition at the toe. A new sand fence was added and has started sand capture. There is a bar on the beach as a result of summer accumulation of sand.

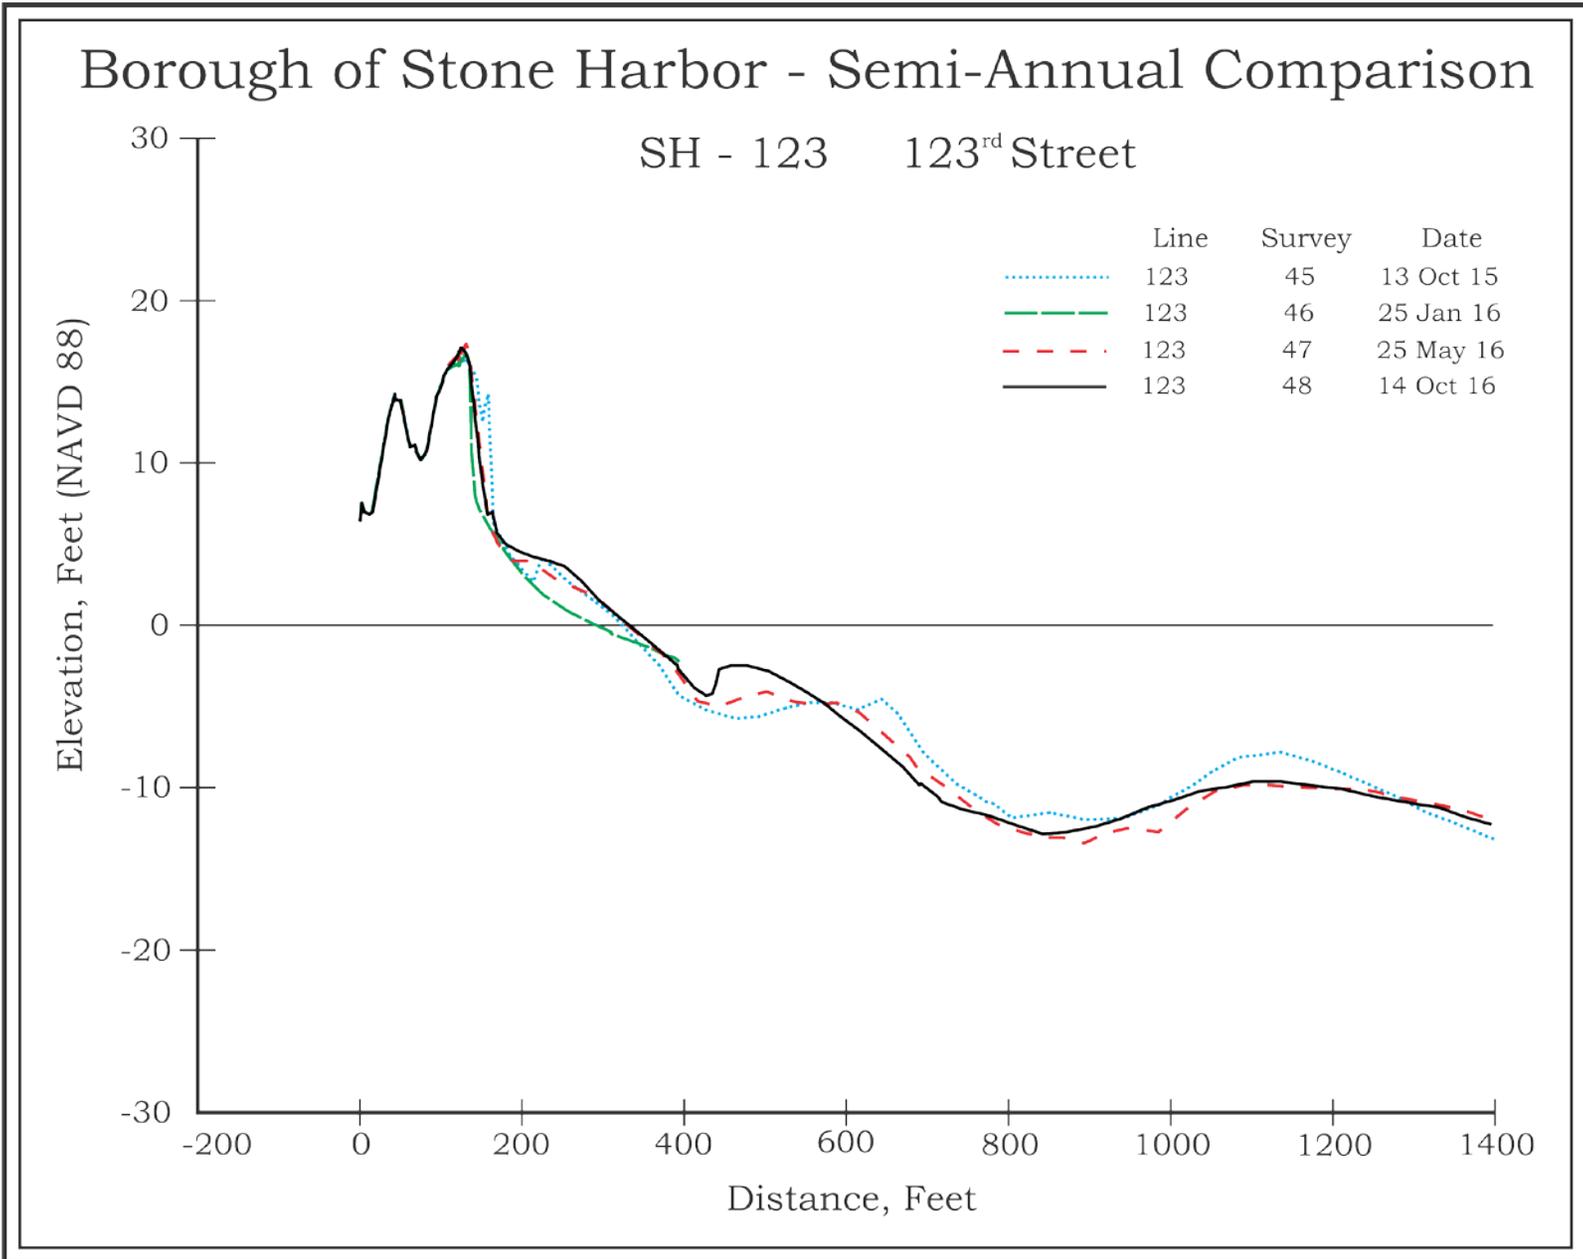
Figure 8a. 123rd Street suffered dune erosion during Jonas taking the vertical scarp to 10-foot heights into the established dune grass. The flat, post-storm beach was wet at high tide to the scarp afterwards. Since the slumping of sand from the dune combined with wind deposition along the toe has generated a gentle slope and a deposit of berm sand on the beach. A bar was migrating onto the low tide zone by October 14, 2016. Losses further offshore yielded a net loss for the year of 12.68 yds³/ft.
