New Jersey Beach Profile Network

Ocean County

Manasquan Inlet
to Little Egg Inlet

Hurricane Sandy's Impact on the Ocean County Shoreline:

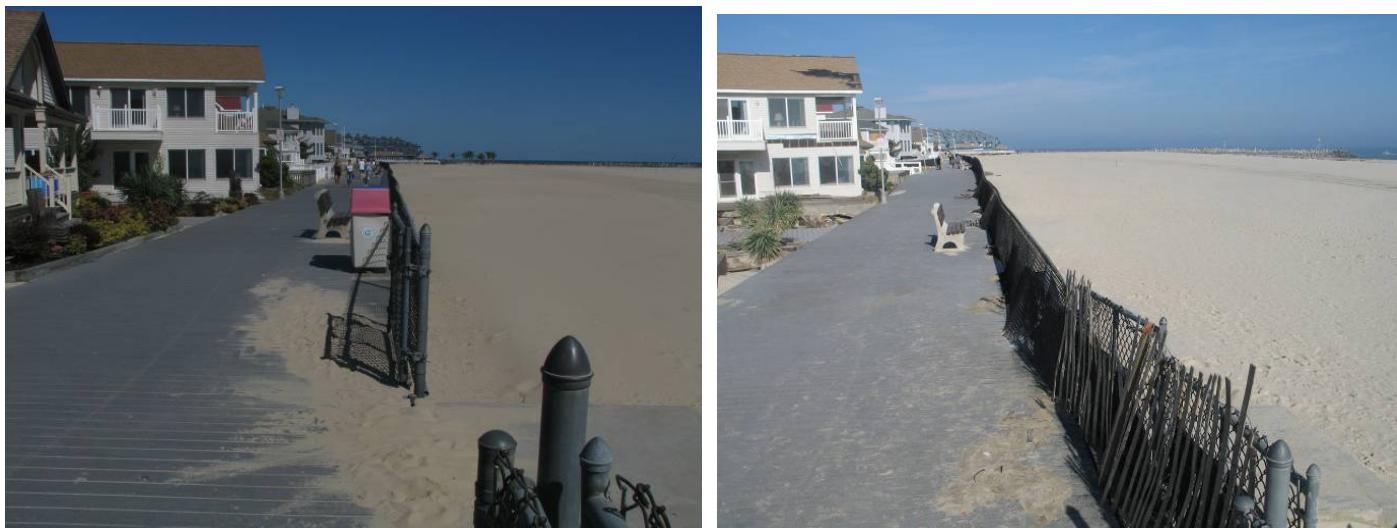
NJBPN 156 – Water Street, Point Pleasant

The photograph on the left was taken on September 21, 2012. The one on the right shows no noticeable change to the backbeach elevation following the storm (taken November 12, 2012). This urban beach did not have a dune system but was spared from more severe damages by the over 600-foot protective berm.

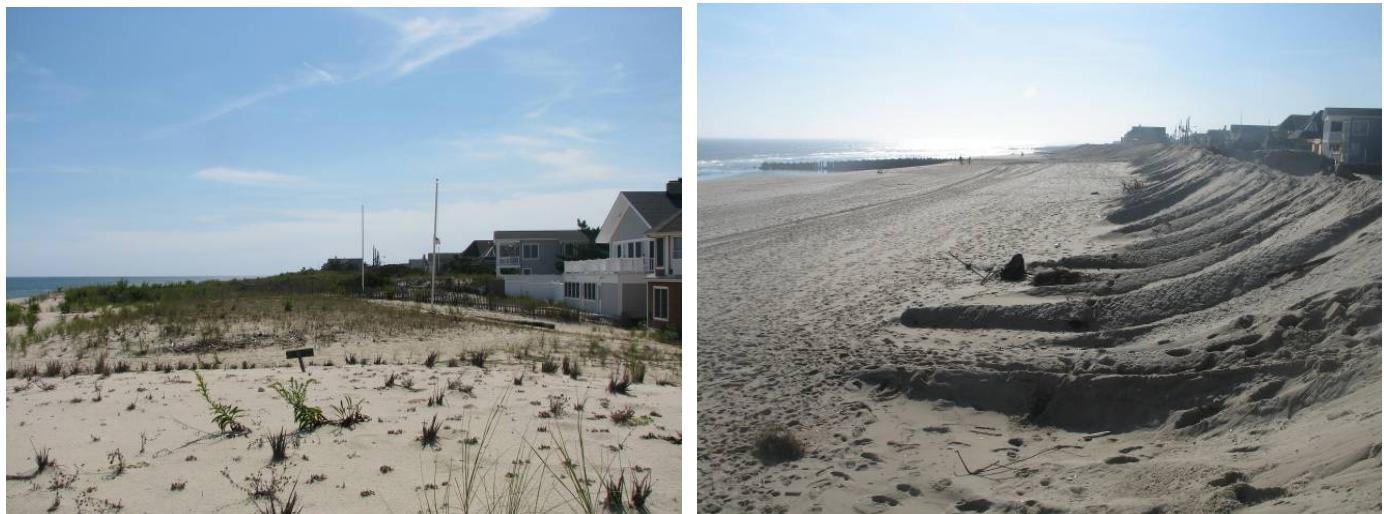
NJBPN 155 – Maryland Avenue, Point Pleasant

The photograph on the left shows the dune that has occurred at this site for 25 years (taken on September 17, 2012) and on the right, the damages and local restoration efforts of the former dune (taken on November 12, 2012). Lower elevation shore-perpendicular access ways may have channeled wave activity landward. The plot depicts the changes caused by the storm and the losses of the berm and poorly vegetated dune system where 45.7 yds^3/ft . of sand were removed during the storm. By the time of the post-storm survey, the municipality had begun relocating sand from the berm to the former dune location.

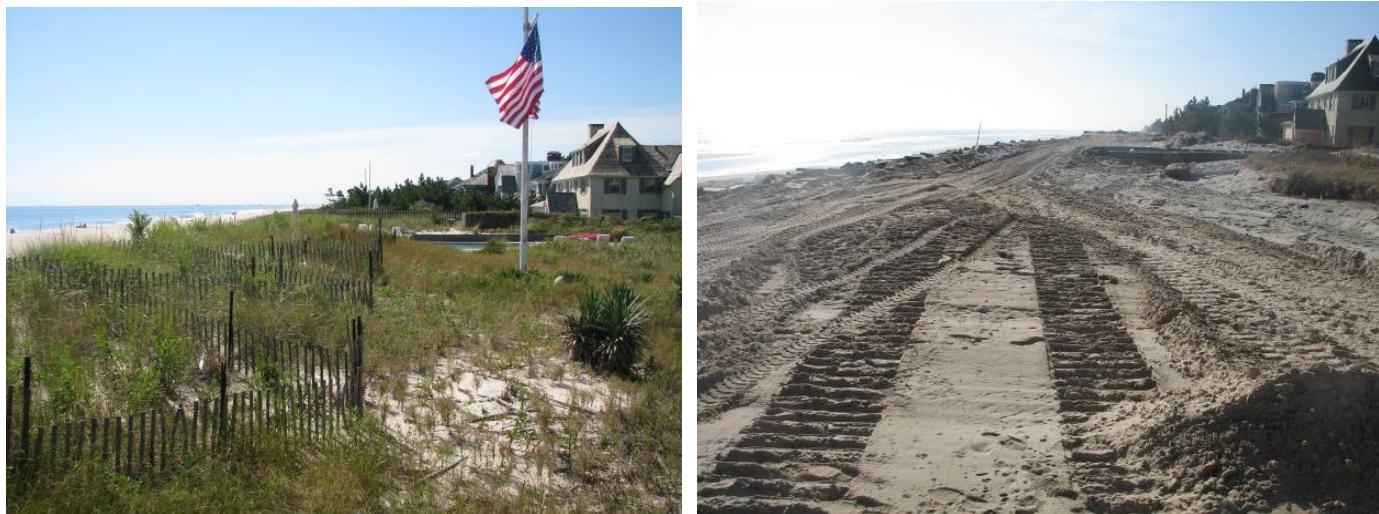
NJBPN 154 – Johnson Avenue, Bay Head

The photograph on the left (September 17, 2012) shows the low dunes before Sandy and on the right, post-storm conditions (November 12, 2012). The plot depicts the changes and the losses of the berm and moderate dune where $36.8 \text{ yds}^3/\text{ft}$. of sand were removed during the storm (calculated from extending the November 2012 survey to the datum at a 1:20 slope). The dune seaward of the homes was obliterated during the storm and exposed a base rubble-mound revetment layer. The beach was lowered, and sand was overwashed between the oceanfront homes and carried landward to the backbarrier.

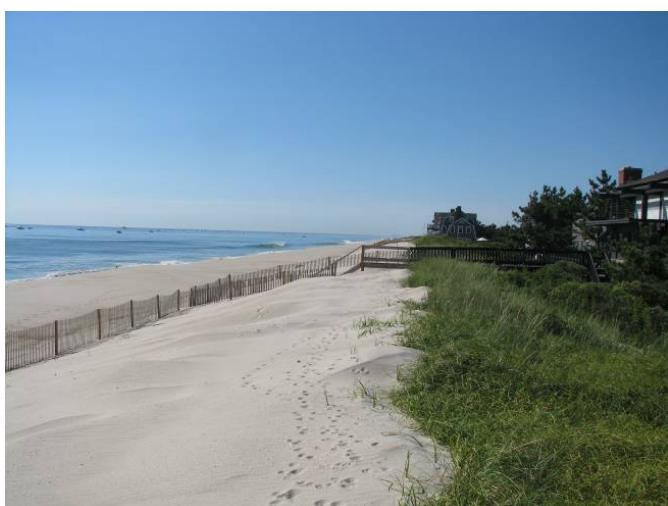
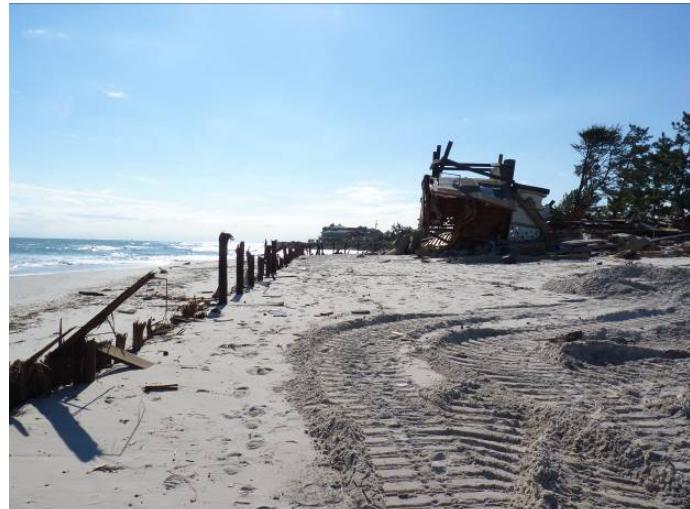
NJBPN 153 – 1117 Ocean Avenue, Mantoloking

Pre-storm conditions of the modified dune are shown in the September 17, 2012 (left). This view shows the results of the restoration effort following Hurricane Irene (August 2011). The November 5, 2012 (right) was taken at the same location. This profile location is within 300 feet from the temporary breach that opened during Sandy. The home at 1117 Ocean Avenue was completely removed from its location and the residence in the photograph was also destroyed.

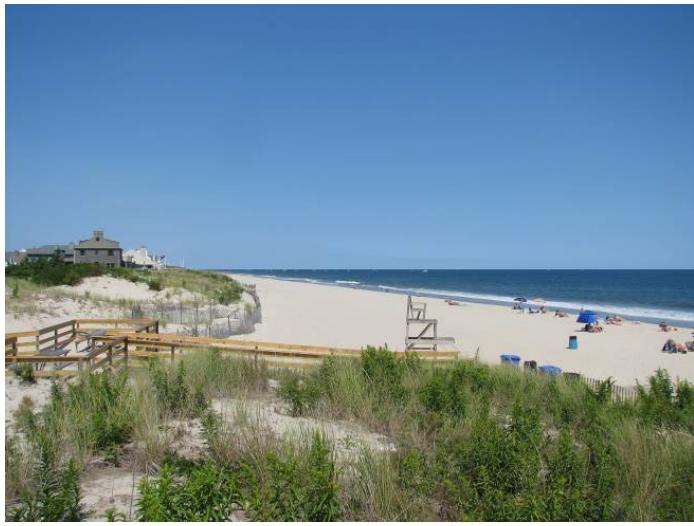
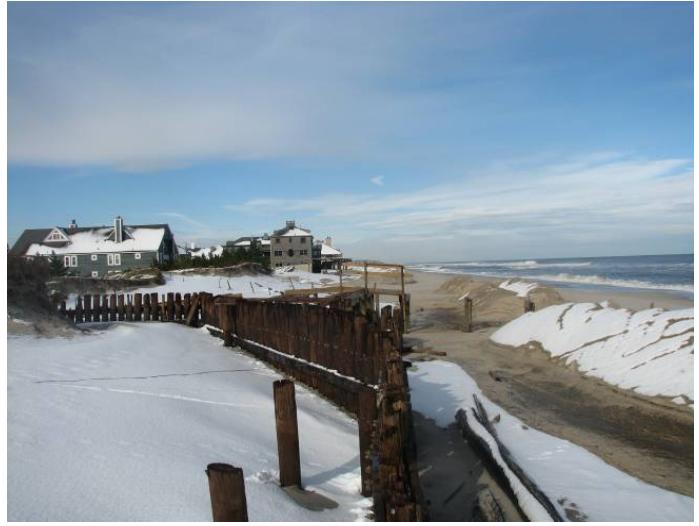
NJBPN 152 – Public Beach #3, Brick Township

The photograph on the left shows the public access way, dune, and moderate berm on September 14, 2012. The post-storm photo on the right (November 8, 2012) shows municipal efforts in protecting what was left of the former dunes.

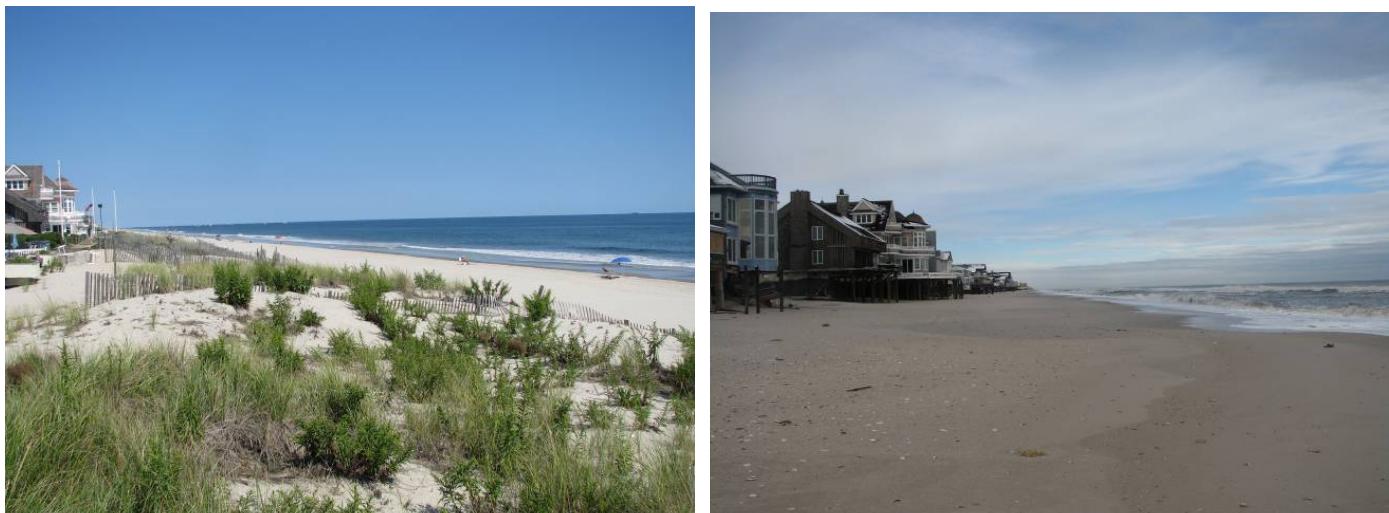
NJBPN 151 – 1st Avenue, Normandy Beach

The photograph on the left (September 14, 2012) shows the limited dune system and minimal berm prior to Sandy. On the right (November 8, 2012), the photo shows damages to structures and exposure of once-buried bulkheads following the storm. Significant overwash occurred at this site and many oceanfront and landward homes were damaged.

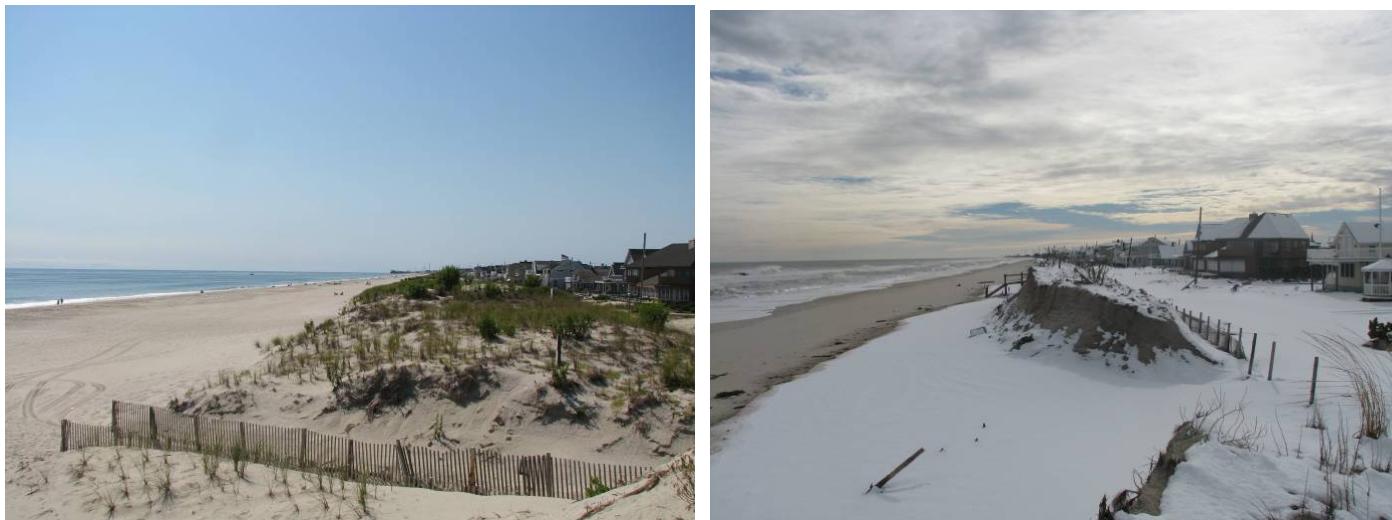
NJBPN 150 – White Avenue, Lavallette

through the dune system created low areas allowing the intense waves riding on the evening storm surge to easily erode those areas and create a number of serious breaches. While some remnants of dunes remained following the storm in the northern portion of the municipality (proximal to site #150), beach-dune widths and elevations in areas to the south were not adequate and wide-scale overwash and breaching occurred. This caused severe damage to infrastructure and property. Following Hurricane Sandy, Site #150 had sand volume loss of 51.7 yds³/ft.

The photograph on the left (September 14, 2012) shows the dune that was created over time through municipal efforts. On the right (November 8, 2012), the photo shows the losses of the berm and dune where 51.1 yds³/ft. of sand were removed during the storm. This location experienced beach and dune erosion; however, overwash only occurred where the dune was lower and breached.

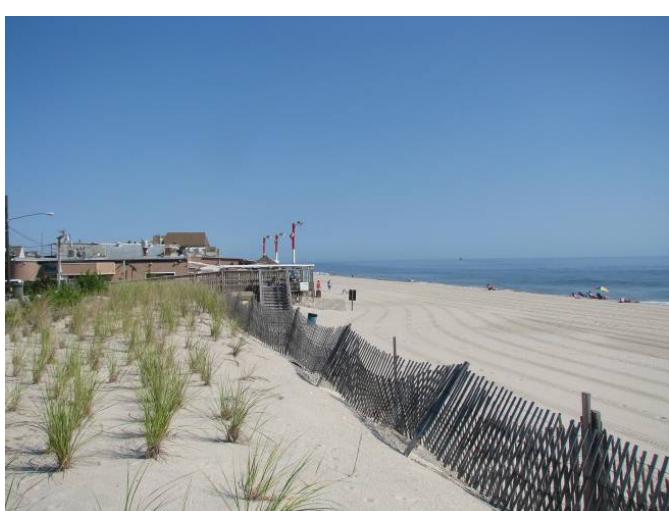
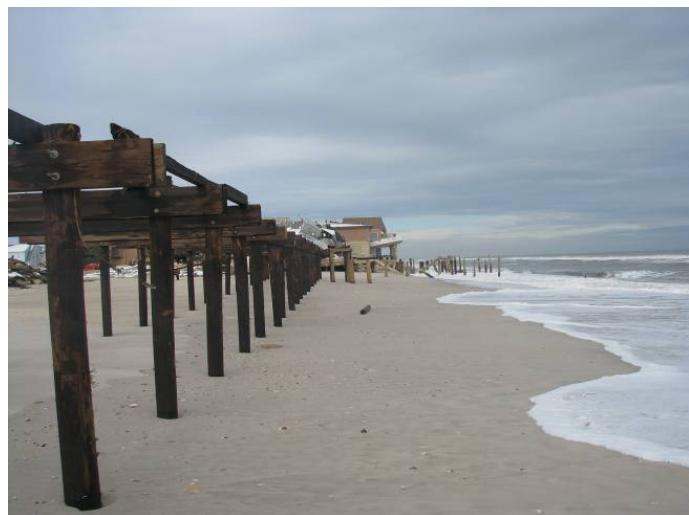
NJBPN 149 – 8th Avenue, Ortley Beach

The photograph on the left (September 14, 2012) shows a modest berm and the municipal dune present prior to the storm. On the right (November 8, 2012), 68.7 yds³/ft of berm and dune were removed during the storm. Over 10 feet of dune height was pushed landward in overwash deposits. The boardwalk was located landward of the dunes (left) Ocean Avenue was destroyed as well as several homes. The photo on the right shows a classic flat beach created by the large waves.

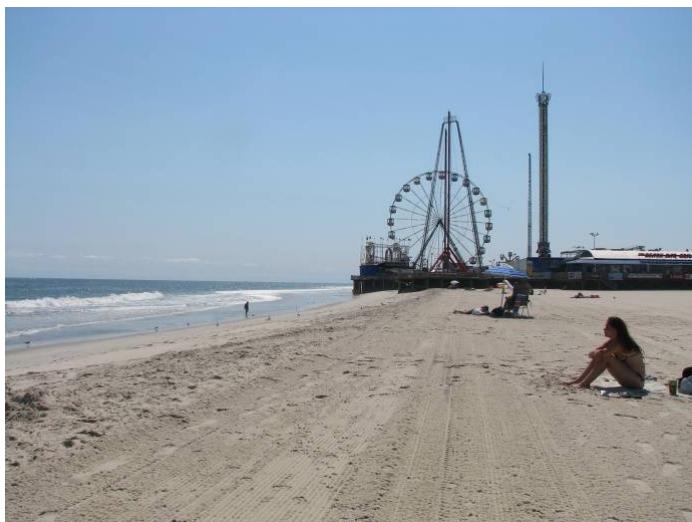
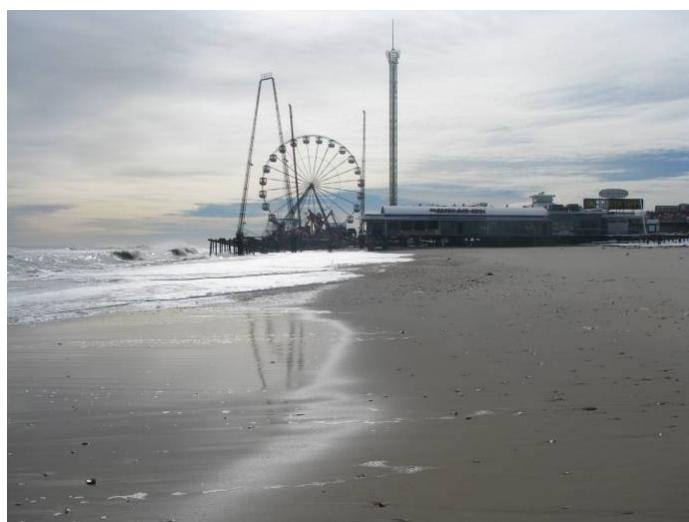
NJBPN 248 – Franklin Avenue, Seaside Heights

The September 13, 2012 photo on the left shows the bathing beach prior to Hurricane Sandy. The photo on the right shows the November 8, 2012 post-storm beach. This urban beach did not have a dune system and the photo on the right shows the obvious damages to the pier and amusements.

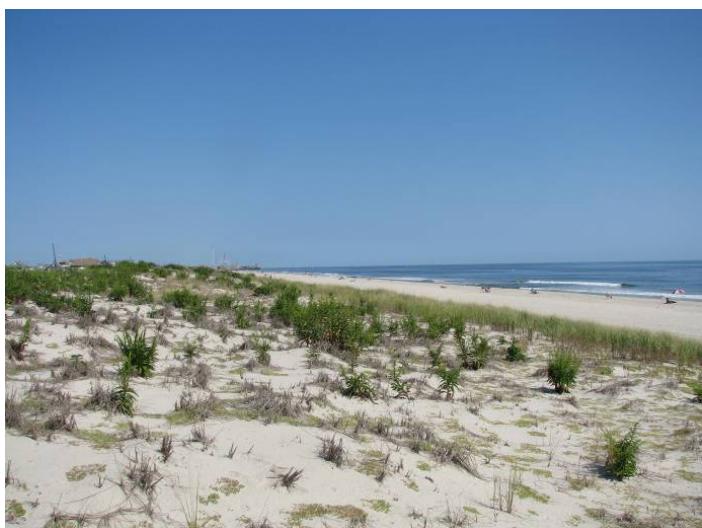
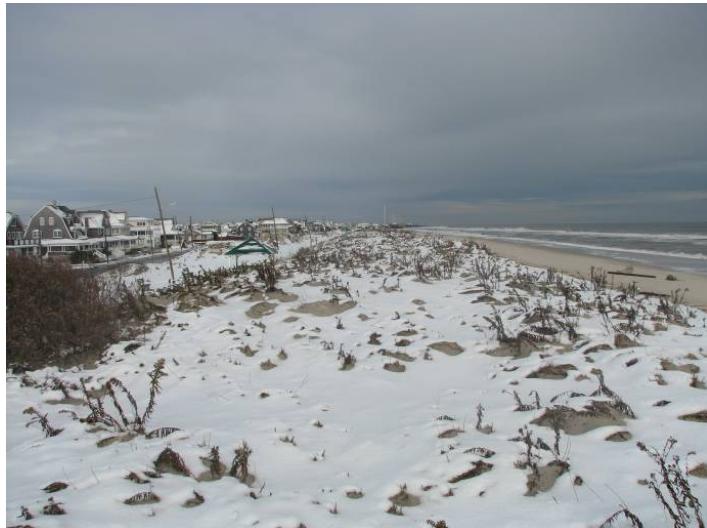
NJBPN 148 – 4th Avenue, Seaside Park

The pre- and post-storm analysis for site #148 at 4th Avenue showed that a portion of the foredune was removed during the storm; however, the remainder of the dune provided protection to the landward structures. No overwash occurred at the profile location. The dune's approximate 25-foot elevation (NAVD88) and 150-foot width (at the base) combined with a 150-foot wide beach provided adequate protection from tidal surge and wave action. As has been noted in other areas along the northern Ocean County barrier-spit, areas where beach accessways were carved through the dune system created low areas that were more easily eroded, resulting in wave overwash and sand being transported landward of the beach-dune system into the streets and private properties. While homes sustained flood damage in this segment from Barnegat Bay, loss of infrastructure and homes was minimized due to the larger beach-dune system hindering the waves that were crossing over land.

The left photograph was taken on September 13, 2012 and shows the extensive dune prior to Hurricane Sandy. On the right (taken November 8, 2012), a northeast storm had dumped snow on the shoreline nearly a week after Sandy's landfall. Although there was loss of dune from the storm, no overwash occurred at this location.

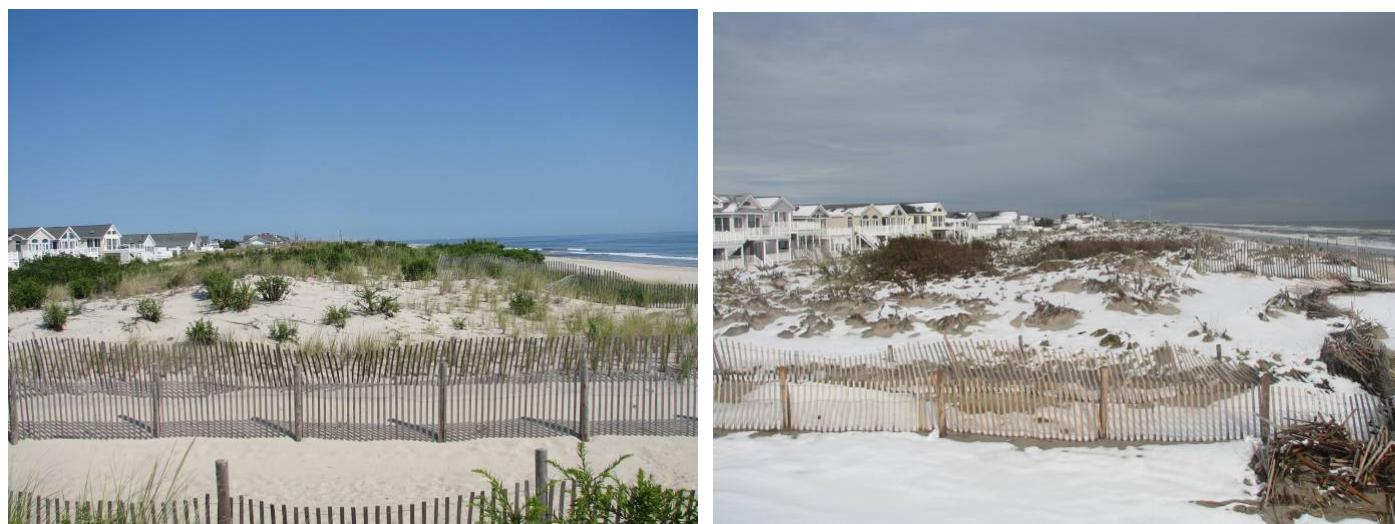
NJBPN 347 – 6th Lane, Midway Beach

Site 347 in Midway Beach showed significant sand losses to the beach and dune but a portion of the dune remained to protect the landward homes and infrastructure. While overwash covered some of the streets and properties with sand, much of the overwash was limited to the areas proximal to street ends. These beach accessways were carved through the dune system, creating low areas that were more easily eroded, resulting in wave overwash. While homes sustained flood damage in this segment, loss of infrastructure and homes was minimized due to the larger beach-dune system.

The left photograph was taken on September 13, 2012 and on the right (taken November 8, 2012), a northeast storm had dumped snow on the shoreline nearly a week after Sandy's landfall. The figure below depicts the changes caused by the storm and the losses of the berm and dune where 48.7 yds³/ft. of sand were removed during the storm. Though there were measured losses of the berm and dune, enough dune remained to protect the landward homes and infrastructure.

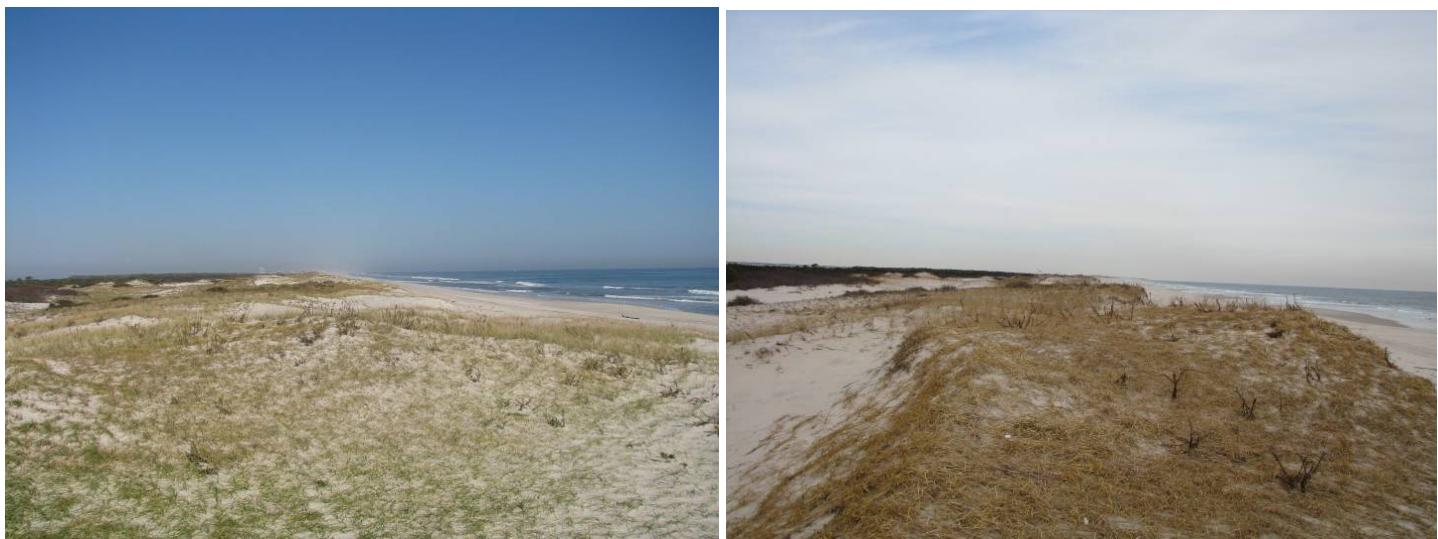
NJBPN 247 – North End, Island Beach State Park

The left photograph was taken on November 8, 2011 and shows a wide natural dune system. The right photo (taken December 12, 2012) shows the condition of the dune system nearly six weeks after Sandy's landfall.

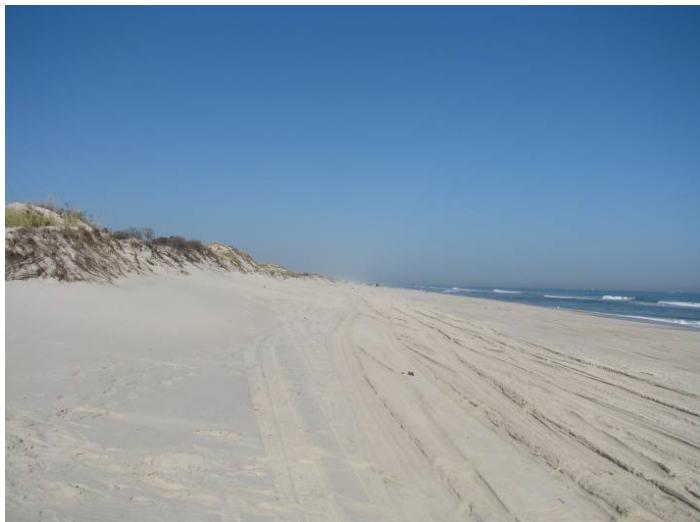
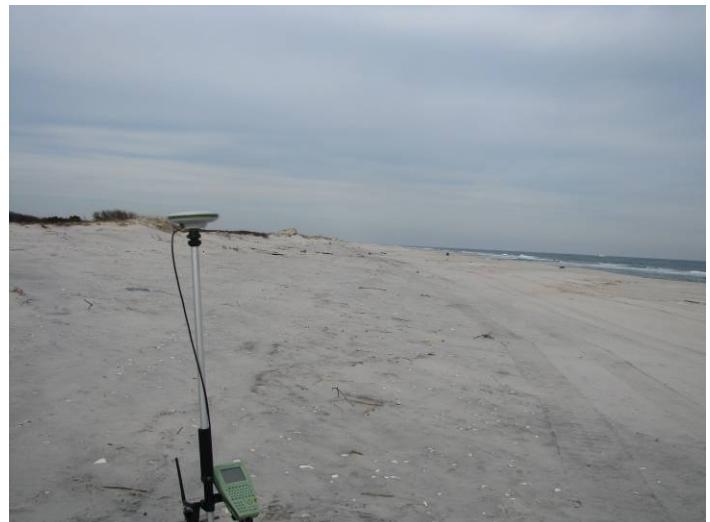
NJBPN 246 – Parking Lot A7, Island Beach State Park

The left photograph was taken on November 8, 2011 and shows a wide natural dune system. Six weeks after Sandy, (right photo taken December 12, 2012) the dune and berm had eroded and sand was moved into a nearshore bar.

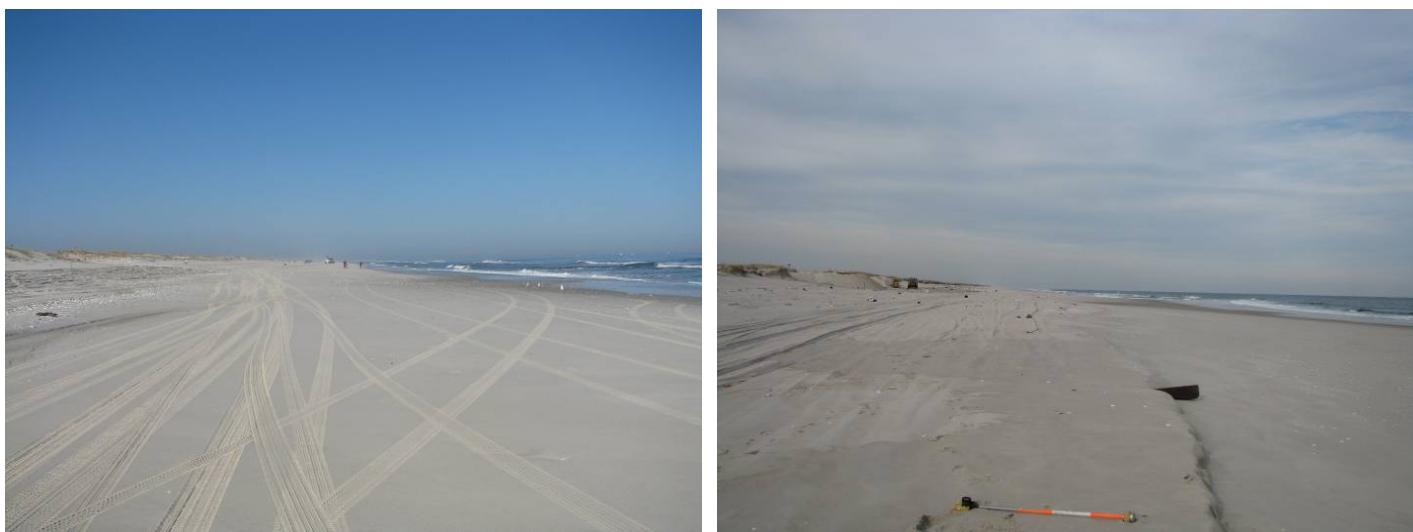
NJBPN 146 – Parking Lot A7, Island Beach State Park

This site within the state protected area is less than a mile from the north Barnegat Inlet jetty. The left photograph was taken on November 8, 2011 and shows the wide beach and natural dunes. The photo on the right, six weeks after Sandy (December 12, 2012) shows the conditions of the dune and berm.

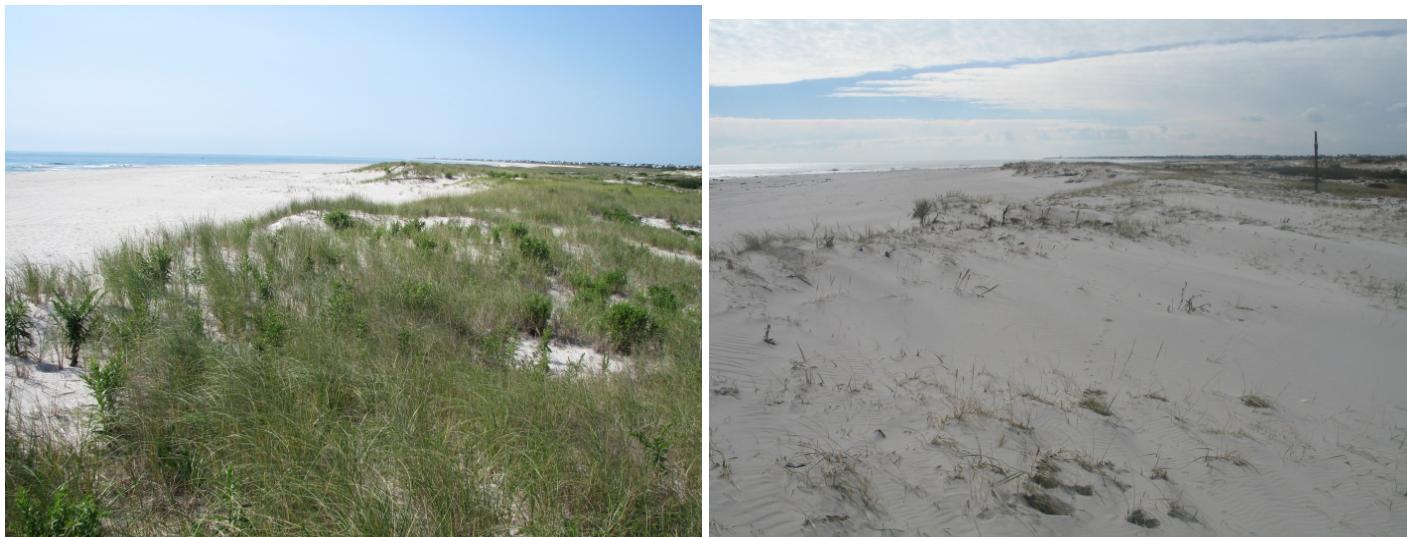
NJBPN 245 – 10th Street, Barnegat Light

This site is located approximately 1500 feet south of the Barnegat Inlet south jetty and was established to monitor the changes at the inlet. The left photo (taken on September 12, 2012) shows the dune and beach conditions before Sandy and the dense vegetation along the landward dune slope. The photo on the right (taken on November 2, 2012) shows the impact of Sandy where sand was overwashed and blown landward across the dune burying but not killing the vegetation.

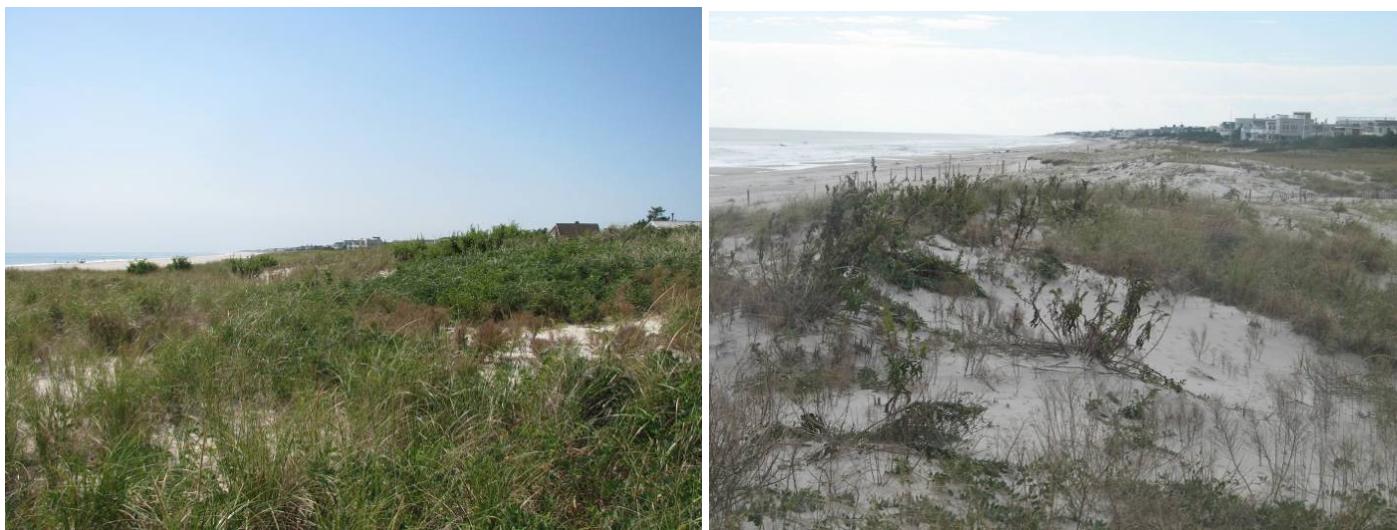
The photo on the left was taken on September 12, 2012 and shows the dune and beach conditions and dense vegetation before Sandy. In the photo on the right taken on November 2, 2012 from a similar location looking south post-Sandy the impact of the storm is evident from the sand overwashed and blown landward across the dune burying the dense vegetation seen in the September picture and by the narrower beach width.

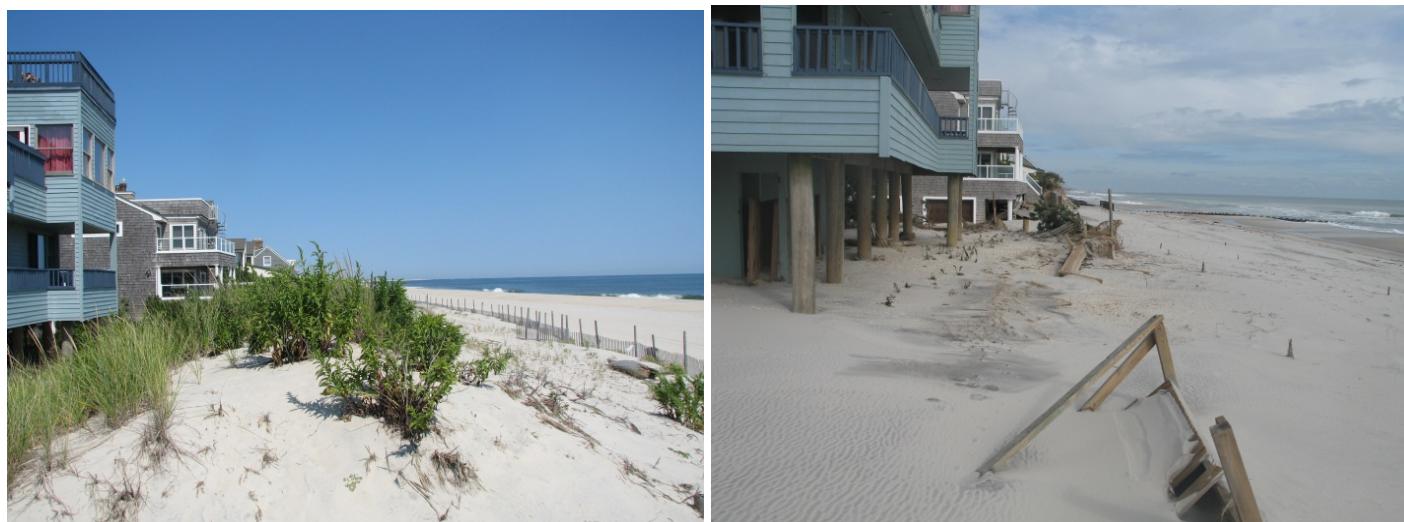
The La Baia Street profile site did have dunes that survived, but at this location the public access pathway was at least 6 feet lower than the adjacent dune crests. The waves found the gap, cut it at least two house lots wider and water and sand flowed landward to the boulevard. This scenario was repeated many places where the simple expedient of having public works place sand and grade a dune cross over to the adjacent elevations could have prevented this particular overwash. Dune failure was likely related to individual access pathways to the beach from individual homes excavated below the average dune elevation. Along this segment of LBI, the dune width was higher than average.

Above are two photos taken at La Baia Street before and after Hurricane Sandy. The photo on the left (taken September 12, 2012) shows the dune and beach conditions prior to the storm. In the photo on the right (taken November 2, 2012) the impact of the storm is evident. The former dune was removed and the shoreline moved 110.1 feet landward. Sand was overwashed between the oceanfront homes and carried landward to the road.

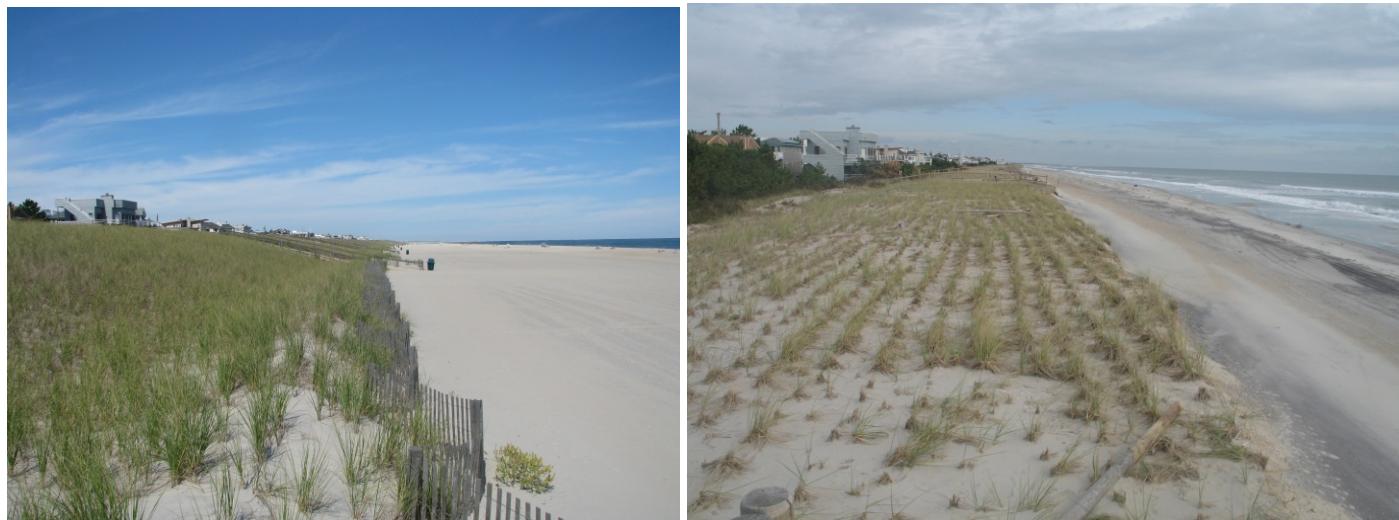
NJBPN 143 – 73rd Street, Harvey Cedars

The photo on the left was taken on September 11, 2012 while the photo on the right was taken on November 2, 2012 from a similar location looking north. This site had received sand as part of the 2010 USACE beach nourishment project for Long Beach Island. The project provided ample dune and beach width enhancement and storm protection for the oceanfront properties. The post-Sandy photo shows the impact of the storm with a significant dune scarp at the seaward crest and a narrow, lower-elevation beach remaining. However there was no evidence that sand overwashed the dune at this location.

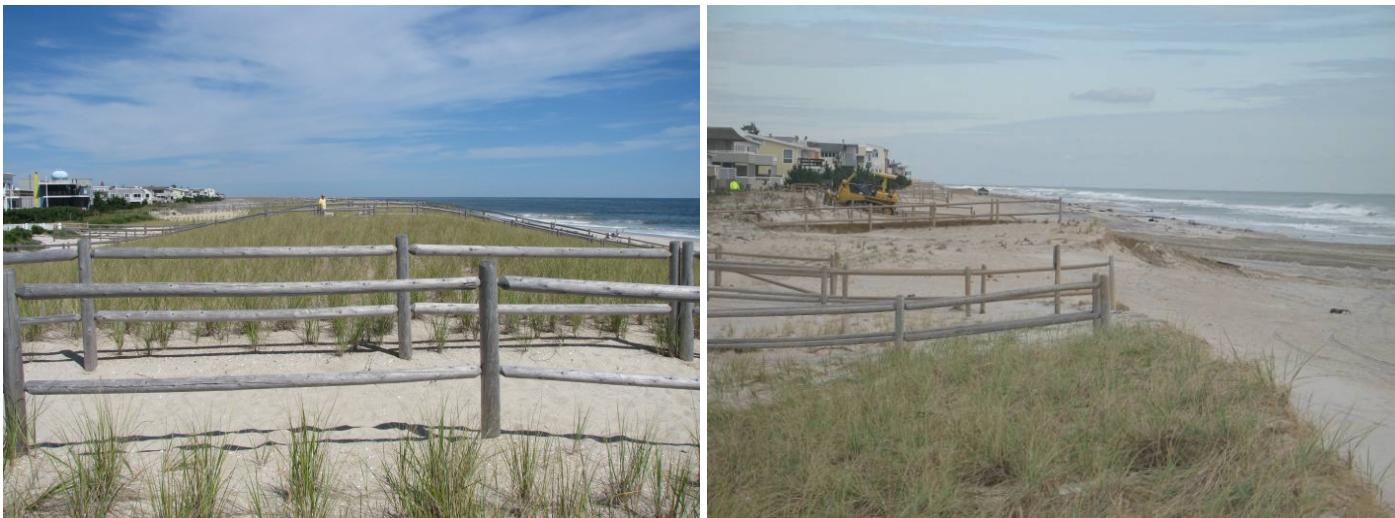
NJBPN 142 – Tranquility Drive, Harvey Cedars

The Tranquility Drive site was included in the 2010 USACE beach nourishment project. The photo on the left was taken on September 11, 2012 and shows the dune and beach conditions of the USACE engineered beach before Sandy. On the right, the photo (taken on November 2, 2012 - post-Sandy) shows the impact of the storm by the significant loss of dune seaward of the homes and the lower and narrower beach. Despite the significant loss of dune, overwash did not occur and the oceanfront properties were protected from wave damages.

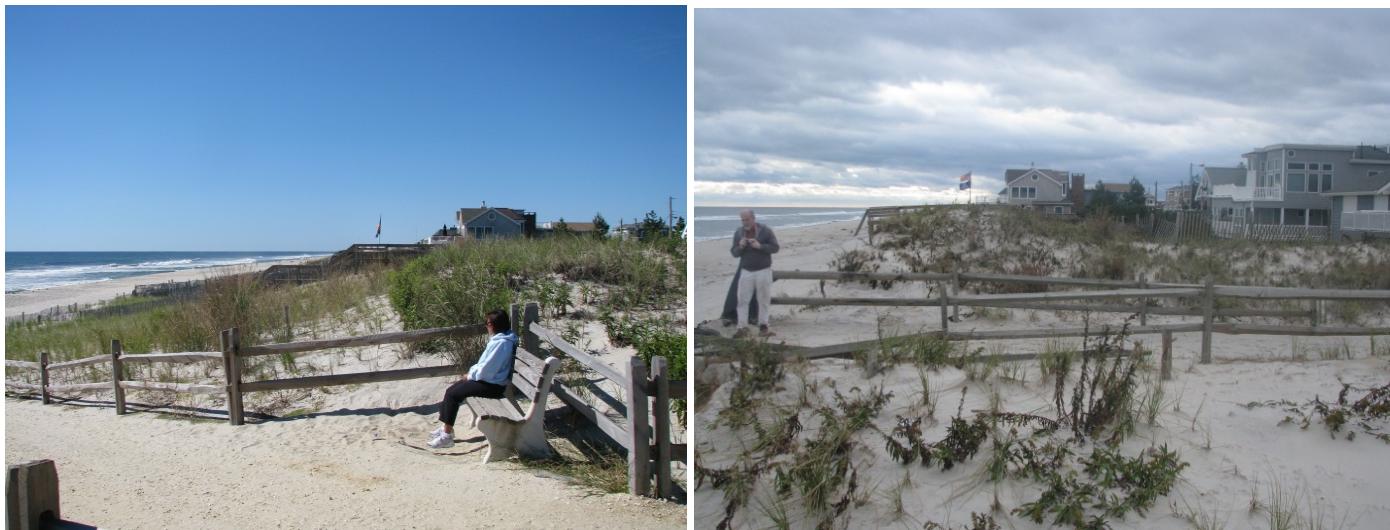
The photographs above were taken on September 11th, 2012 (left) and November 1st, 2012 (right). Both images show the view of 20th Street (site 241) looking south. This location in Surf City received a beach replenishment in 2007, which increased the sand volume and width of the dune and berm. The dune and berm both experienced substantial erosion; however no overwash occurred at this location.

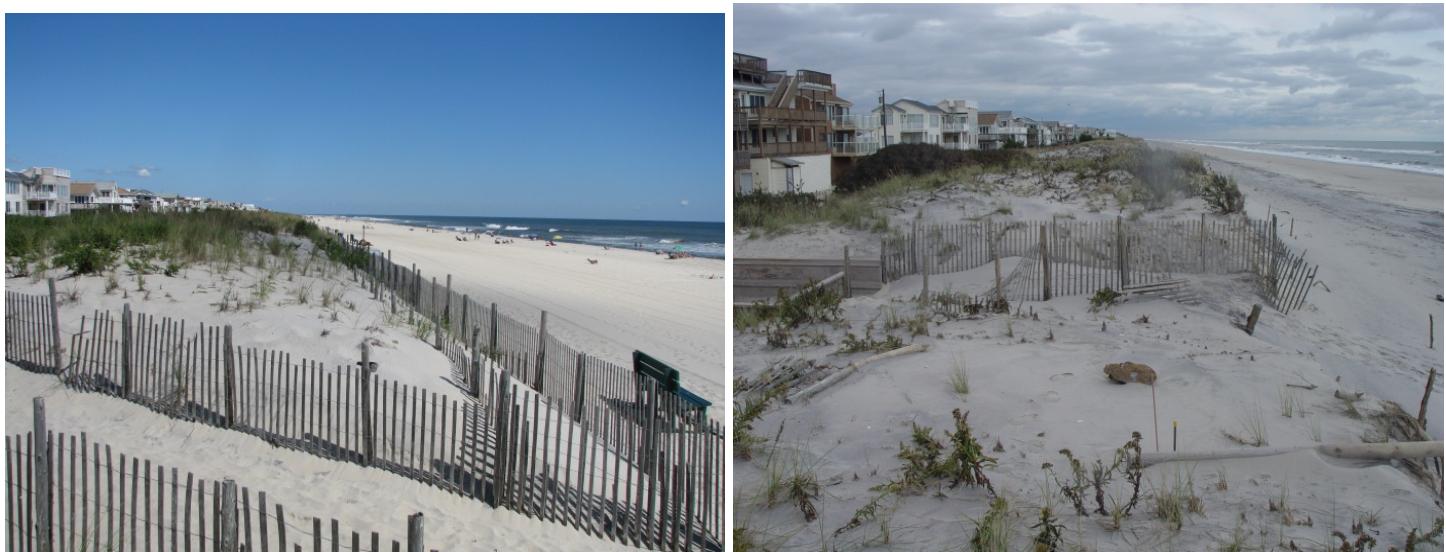
NJBPN 141 – 8th Street, Ship Bottom

The photographs above were taken on September 10th, 2012 (left) and November 1st, 2012 (right). Both images show the view of 8th street (site 141) looking north. This location in Ship Bottom experienced erosion of the beach and dune from Sandy, however the dune was not breached and no overwash occurred at this location.

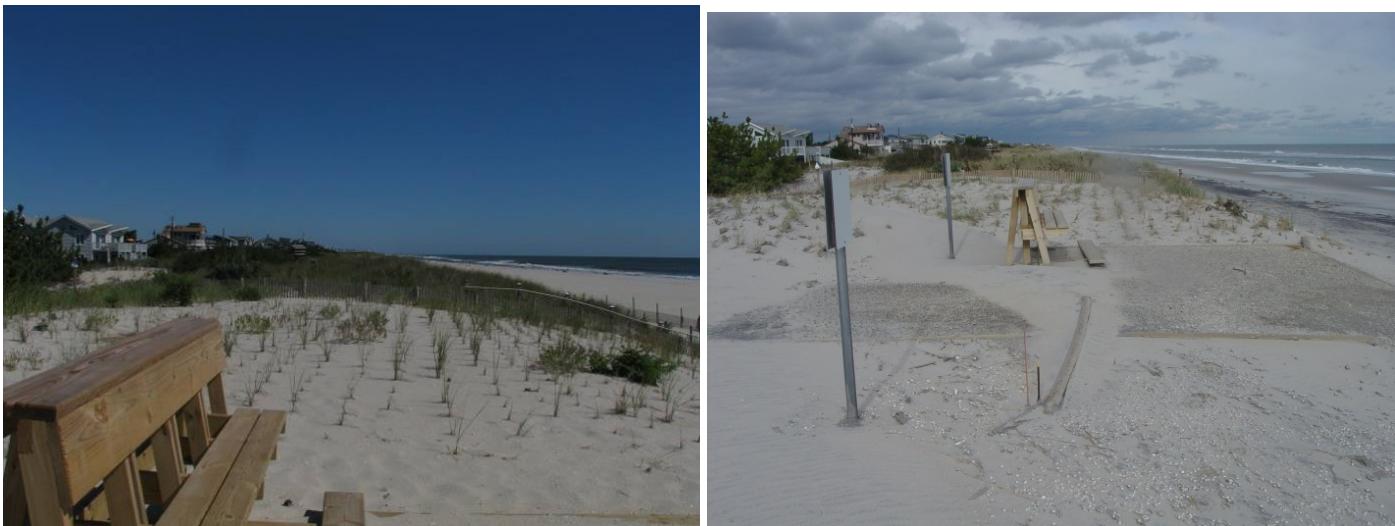
NJBPN 140 – 32nd Street, Long Beach Township

The photographs above were taken on September 10th, 2012 (left) and November 1st, 2012 (right). Both images show the view of 32nd street (site 140) looking north. This location in the Brant Beach section of Long Beach Township received beach replenishment in spring 2012, which increased the sand volume and width of the dune and berm. The foredune slope experienced minor erosion during Sandy, while the berm was severely eroded. No overwash occurred at this location. The park bench remained in its original position.

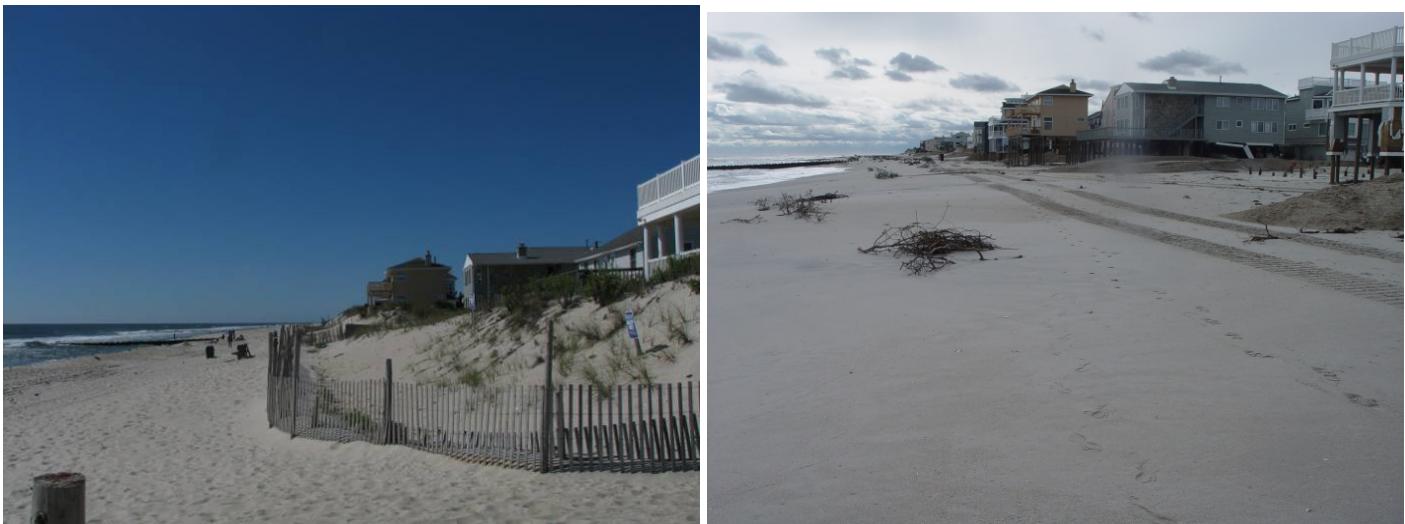
NJBPN 139 – 81st Street, Long Beach Township

The story was different at Beach Haven Crest where the dune failed at 81st Street. The pre-Sandy photograph depicts a narrow dune with a 16-foot crest elevation. This proved insufficient to stop the wave assault and extensive damage resulted. Both beach width and dune mass are essential, working as a team to protect from wave damage because both are essentially piles of sand which do erode at fairly rapid rates. If a dune were to erode at a 10 feet per hour rate, then it would need to be 100 feet thick to withstand a 10-hour duration of a steady intense storm activity. This approximates Sandy's level of violence over two high tide intervals on Monday October 29th.

The photographs above were taken on September 10th, 2012 (left) and November 1st, 2012 (right). Both images show the view of 81st street (site 139) looking south. It is evident in the photographs that the existing dune was completely eroded away and overwash occurred, with waves pushing water and sand under the oceanfront homes and into the streets landward of them. The dune elevation was about 16 feet.

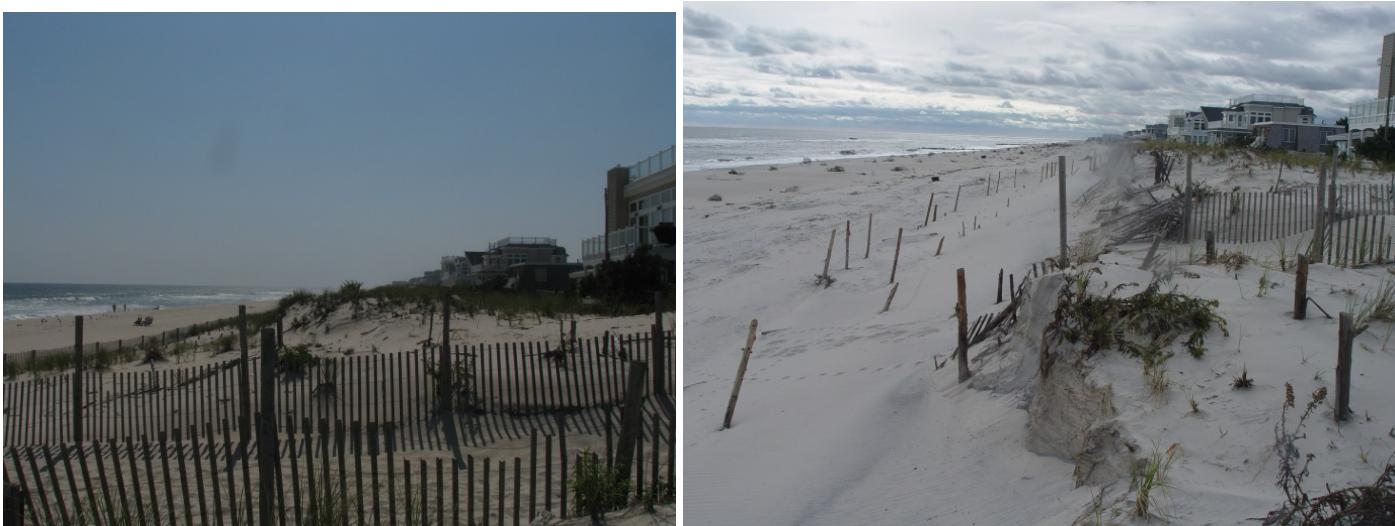
NJBPN 138 – Old Whaling Road (124th Street), Long Beach Township

The site at Old Whaling Road was different in Spray Beach due to a wider, higher dune. About a third of the dune was eroded taking the entire seaward slope, but the height prevented overwash and the properties landward were spared.

The photographs above were taken on September 7th, 2012 (left) and November 1st, 2012 (right). Both images show the view of Old Whaling Road (site 138) looking south. The existing dune experienced erosion, however it was not completely removed and no overwash occurred at this location. Surprisingly, two blocks to the north a dune of comparable size and shape was eroded away and overwash occurred.

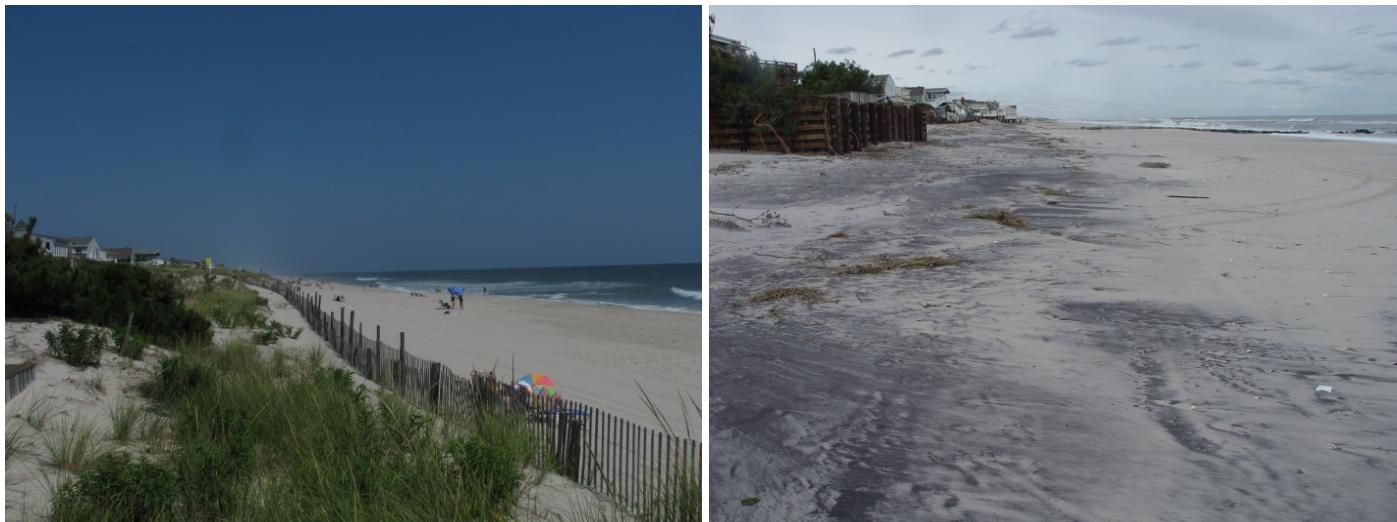
NJBPN 137 – Taylor Avenue, Beach Haven

The photographs above were taken on September 7th, 2012 (left) and November 1st, 2012 (right). Both images show the view of Taylor Avenue looking north. It is evident in the photographs that the existing dune was completely eroded away and overwash occurred, with waves pushing water and sand under the oceanfront homes and into the streets landward of them. The crib timber structure in the above right photograph was instrumental in saving the home from significant damage. The cribbing was back-filled with rocks and masonry debris and provided an effective barrier to direct wave impacts. The landward returns on the structure were critical in saving the property.
