New Jersey Beach Profile Network

Ocean County

Manasquan Inlet
to Little Egg Inlet

Hurricane Sandy's Impact on the Ocean County Shoreline:

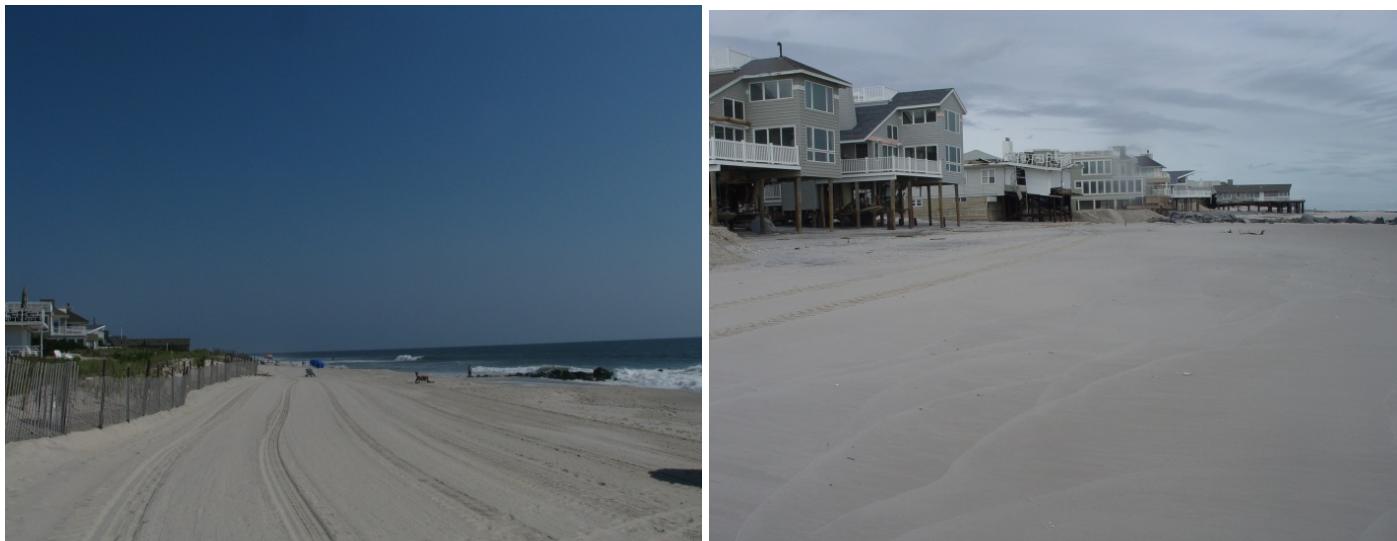
NJBPN 136 – Dolphin Avenue, Beach Haven

The photographs above were taken on September 6th, 2012 (left) and November 1st, 2012 (right). Both images show the view of Dolphin Avenue (site 136) looking north. It is evident in the photographs that the existing dune was completely eroded away and overwash occurred, with waves pushing water and sand under the oceanfront homes and into the streets landward of them. Damage was clear and very common.

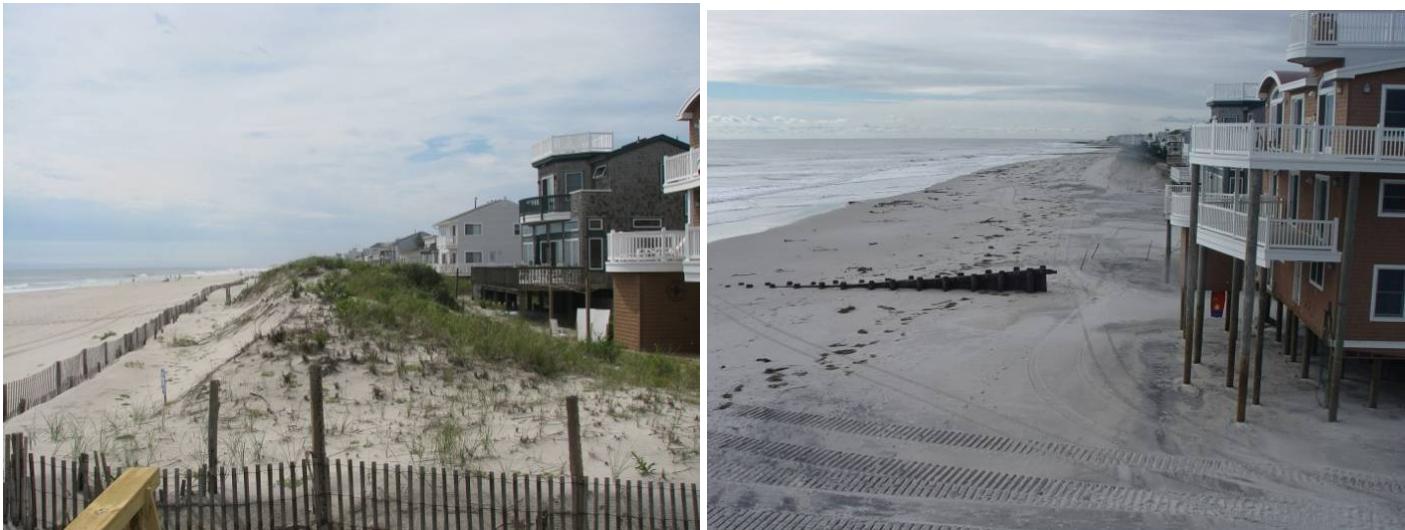
NJBPN 135 – Webster Avenue, Long Beach Township

The site #135 at Webster Avenue was typical of the wholesale damage done as the dune system was essentially erased and washed across the island into Barnegat Bay in many cases. Sand thicknesses of 3 to 4 feet were observed on Long Beach Island Boulevard and down the side streets to the bay. Low elevation homes were destroyed and even some larger structures showed serious impacts. The practice of oceanfront owners closing in the ground level area under the first habitable floor level with a concrete floor, insulated walls, and installing the furnace, hot water heater, the air conditioner compressor, and storing a myriad of possessions in an area designated as open space to allow waves to pass under the building with minimal impact, vastly increased the damage to individual properties as the wave of debris piled up against landward structures and penetrated into other ground level spaces. Individuals found that their space under the house now contained an intertwined complex of debris densely filling the entire area under the house. Clearly the dunes were too thin, too low and the beach too narrow to block Sandy in any meaningful way.

The photographs above were taken on September 6th, 2012 (left) and November 1st, 2012 (right). Both images show the view of Webster Avenue in Beach Haven (site 135) looking south. It is evident in the photographs that the existing dune was completely eroded away and overwash occurred, with waves pushing water and sand under the oceanfront homes and into the streets landward of them exposing the timber section of an old groin that was not exposed prior to the storm.

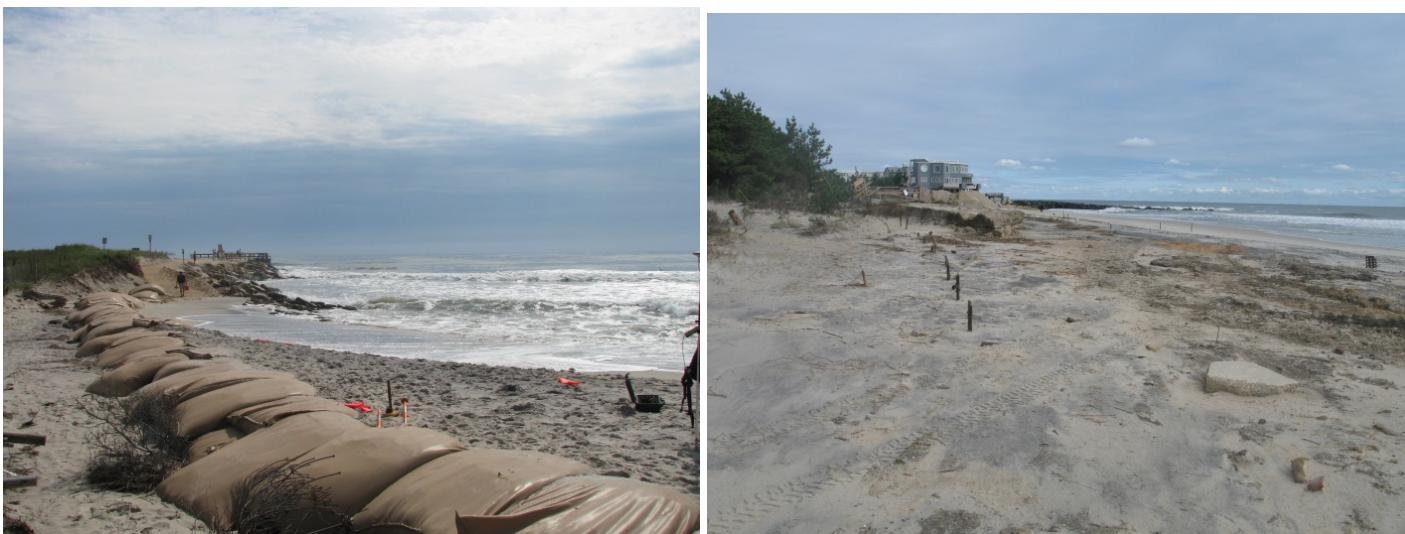
NJBPN 234 – Forsythe National Wildlife Refuge, Holgate Entrance, Long Beach Township

The photographs above were taken on September 6th, 2012 (left) and November 1st, 2012 (right). Both images show the view looking north at the beach-buggy entrance to the Forsythe Refuge (site 234). Wide-scale overwash occurred that extended to Barnegat Bay at this location due to the effect of Hurricane Sandy. All traces of a dune system in the natural area were flattened and moved landward as an overwash deposit.
