**2020 FINAL REPORT - TO THE CITY OF NORTH WILDWOOD
ON THE
CONDITION OF THE CITY BEACHES**

**PREPARED FOR: THE CITY OF NORTH WILDWOOD
901 ATLANTIC AVENUE
NORTH WILDWOOD, NJ 08260**

**PREPARED BY: THE STOCKTON UNIVERSITY COASTAL RESEARCH CENTER
30 WILSON AVENUE
PORT REPUBLIC, NJ 08241
MARCH 19, 2021**

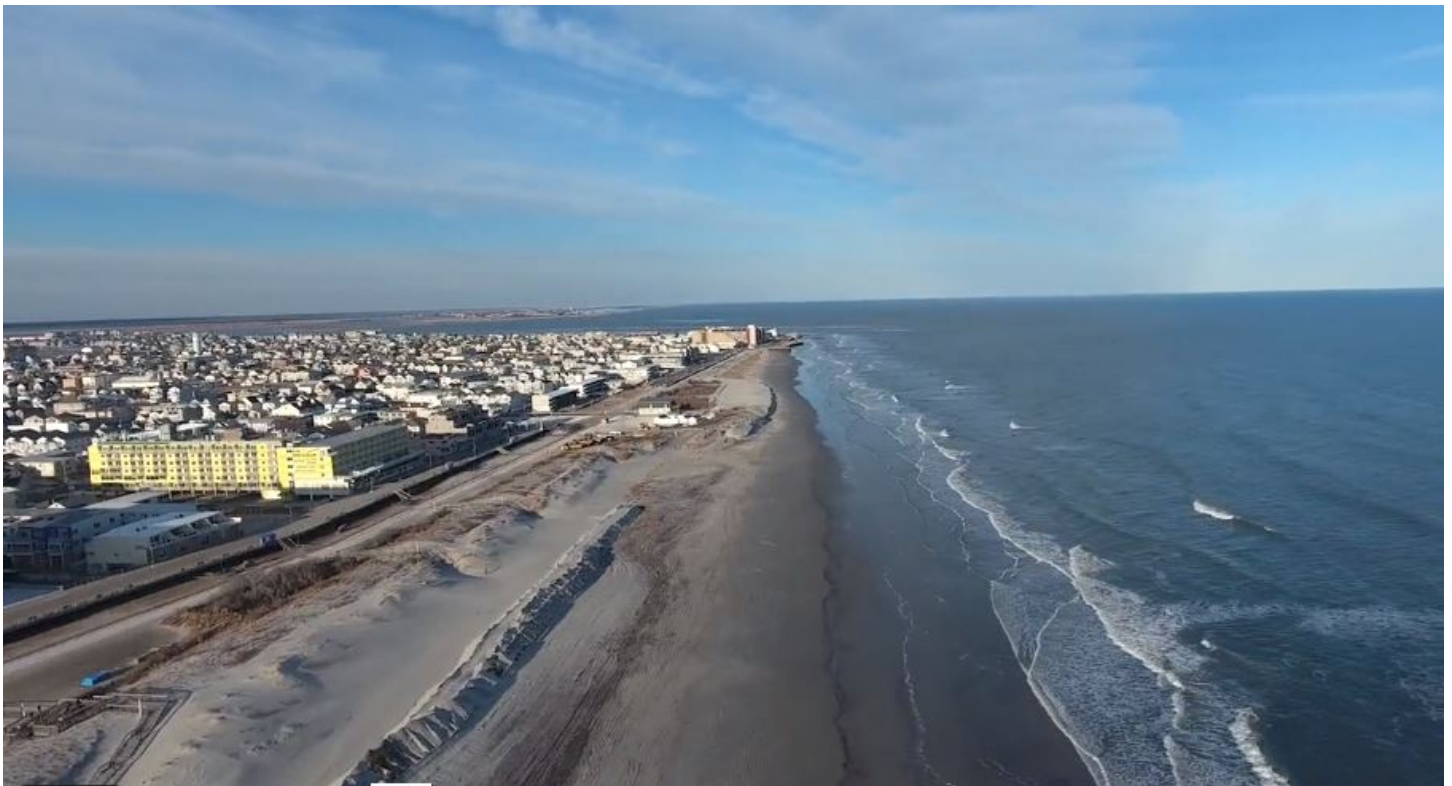
Figure 1. This Feb. 6, 2021 view looking north from a point just north of the first timber pier shows the extent of the damage. The beach is wet to the dune ridges and at the bulkhead/revetment north of 7th Avenue.

The northern two thirds of the North Wildwood beach have been reduced to 20% or less of the 2009 NJ/local beach restoration. A ridge of pushed up sand helps defend the remaining dunes south of the life guard station at 15th Avenue. The plateau of back-pass sand lies with a scarp at the water line for several blocks north of the life guard stand.

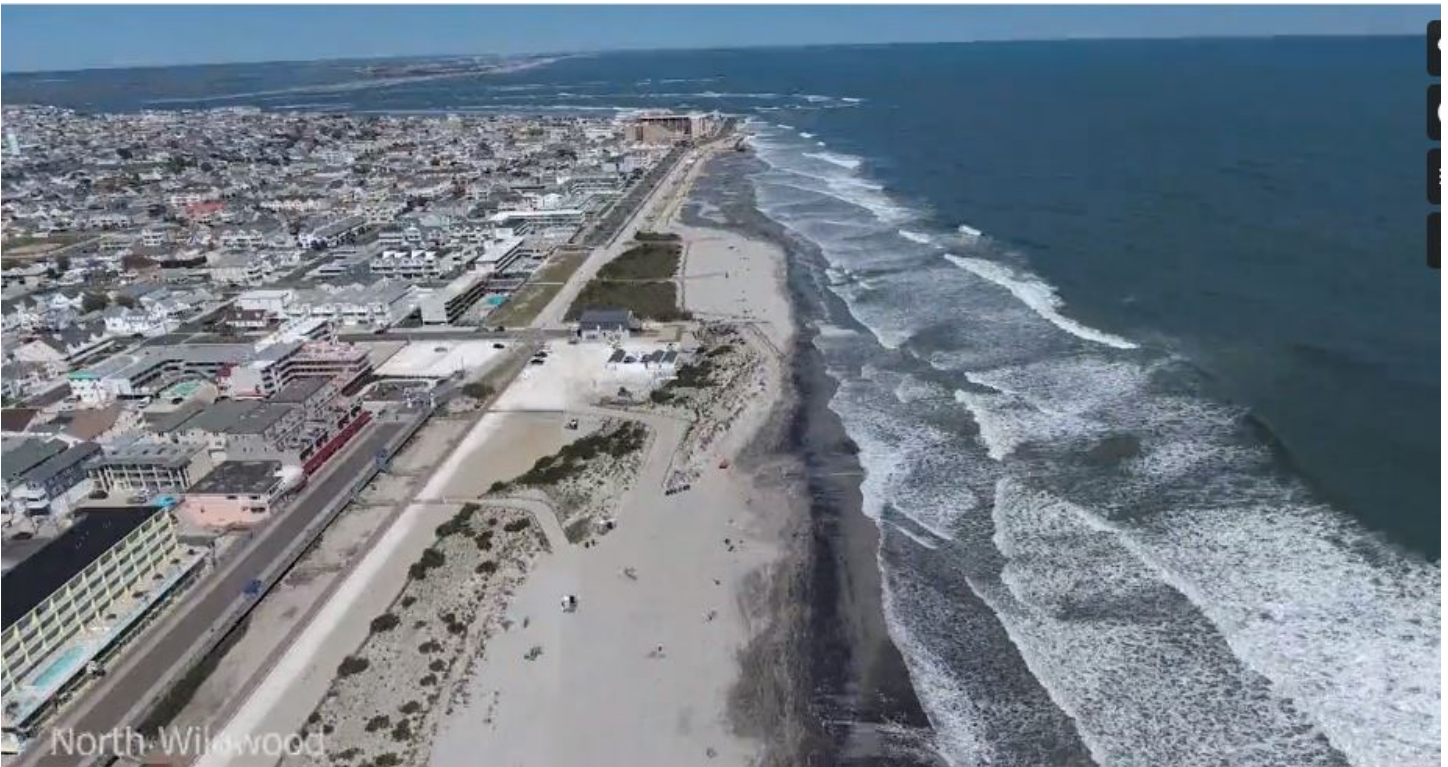
Figure 2. A Sept. 22, 2020 view to the north from almost the same perspective as Figure 1. The beach was inundated at this point in time as well, but there was more sand present along the 15th Avenue life guard station and the dunes to the south of the station were not yet affected by storm damage.

The September view over the same segment of the beachfront shows the extent of beach present earlier, but still only a fraction of the 2009 project extent.

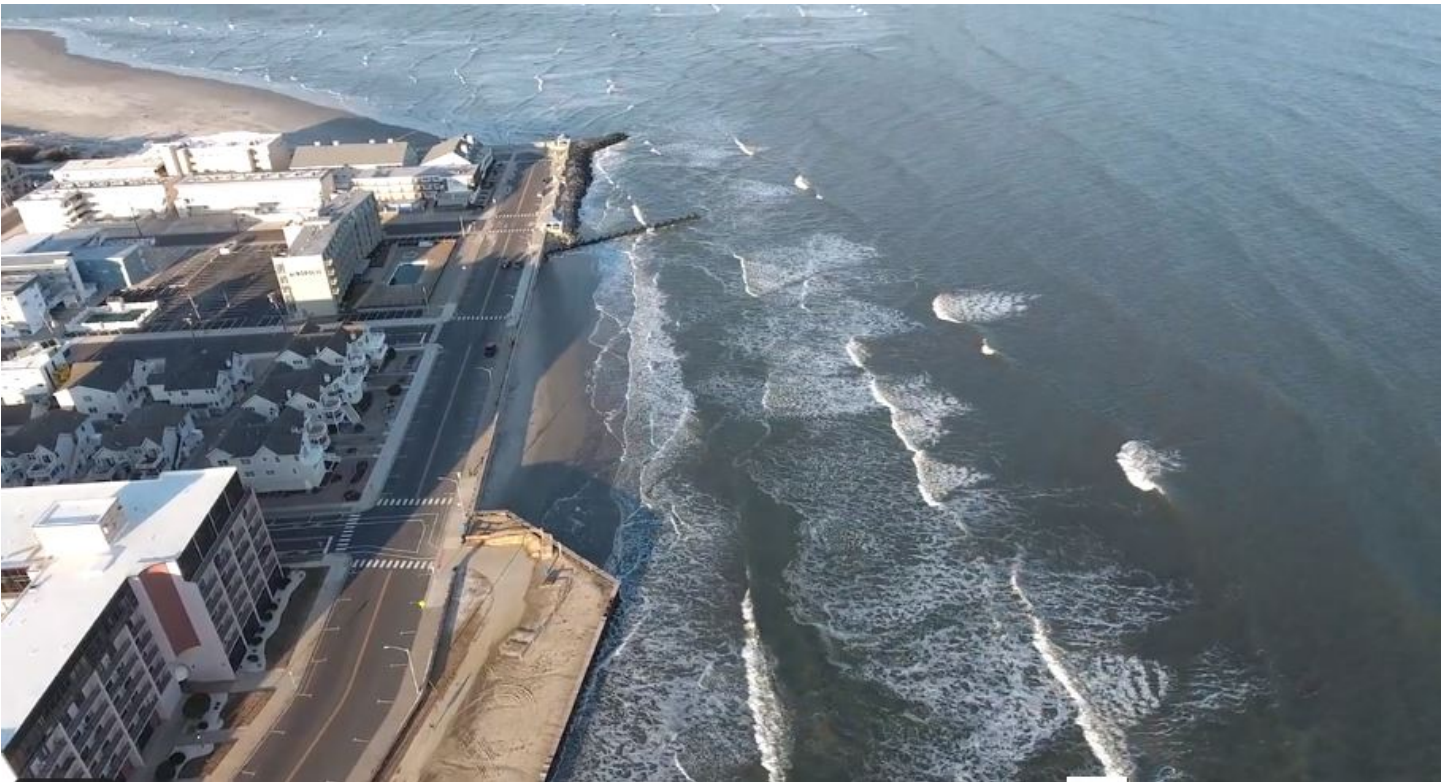
Figure 3. Feb. 6, 2021 view of the north end of North Wildwood oceanfront from between 5th and 6th Avenues.

After the northeaster, the waves at mid-tide easily reach the final protection features on the oceanfront. There is no remaining “shore protection” from the beach and dune system.

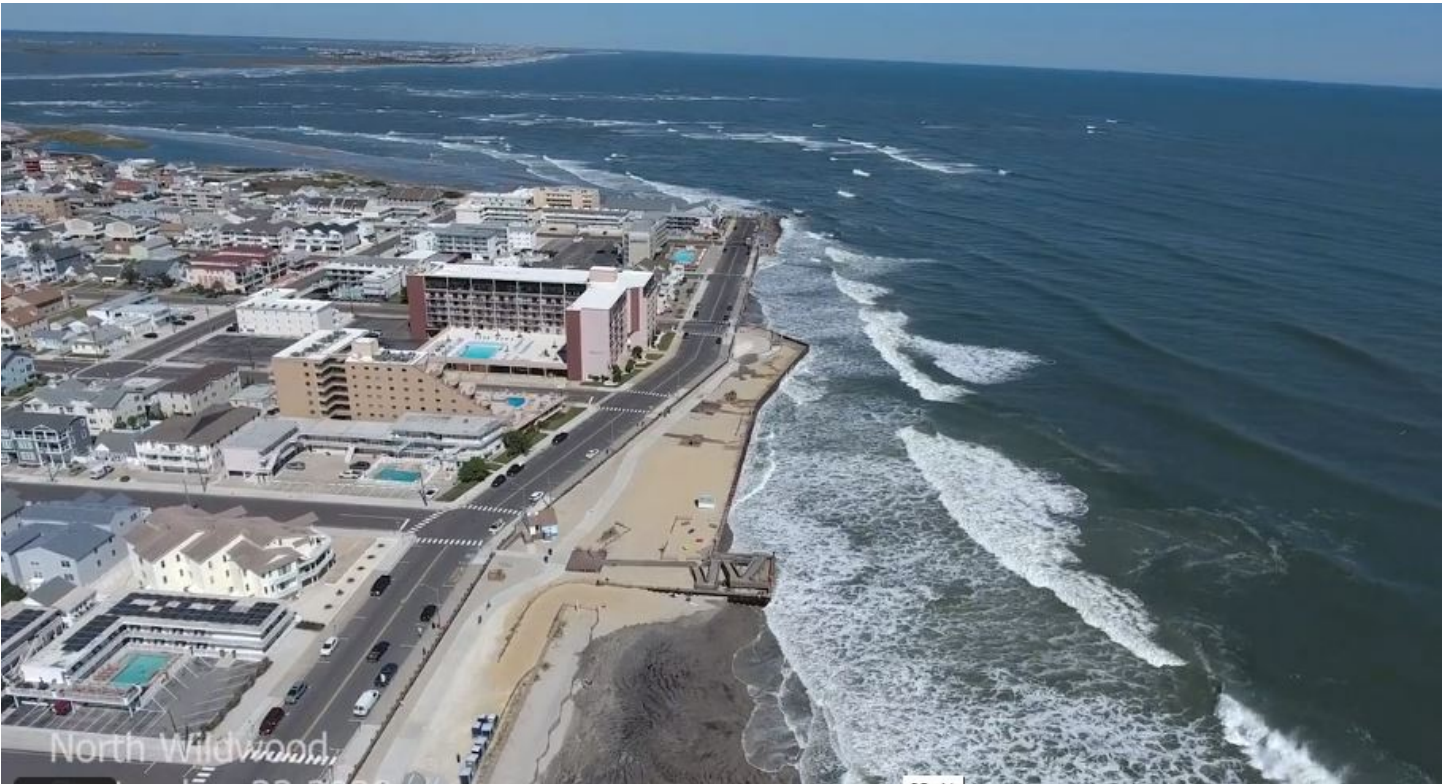
Figure 4. This Sept 22, 2020 view of the north end beach shows waves at the revetment and at the steel wall on a clear day with sizable surf coming in from the east, northeast.

As far back as late September, there was no shore protection offered by the oceanfront beach and at this point the waves were reflecting off the steel wall with sufficient force to transport sand south away from this beach segment far faster than any amount of material could be trucked into place or move onto the beach naturally.

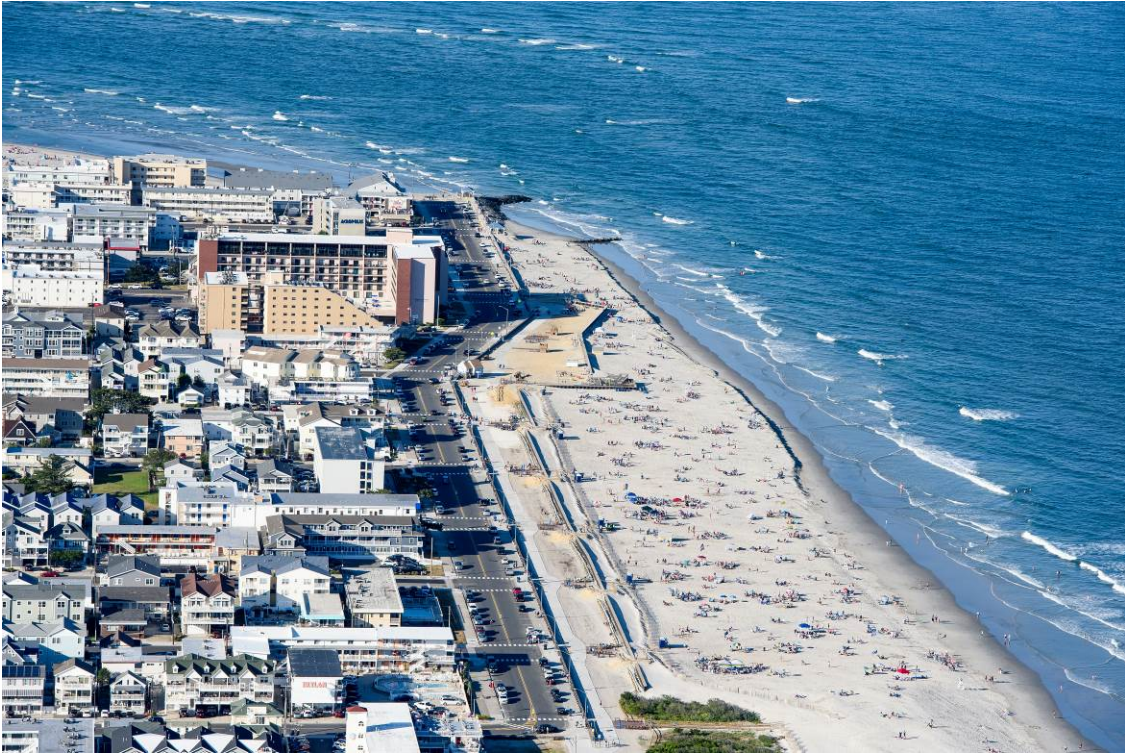
Figure 5. This view of the North Wildwood oceanfront beach extends from 13th Avenue north to the 2nd Ave. jetty. and shows the steel wall extended to 12th Avenue and the sand added to the oceanfront shoreline derived from the City of Wildwood beaches. Photograph date is June 13, 2020 (photos by Ted Kingston). The scarp at the berm extends between 3rd Avenue and 8th Avenue on the beach.

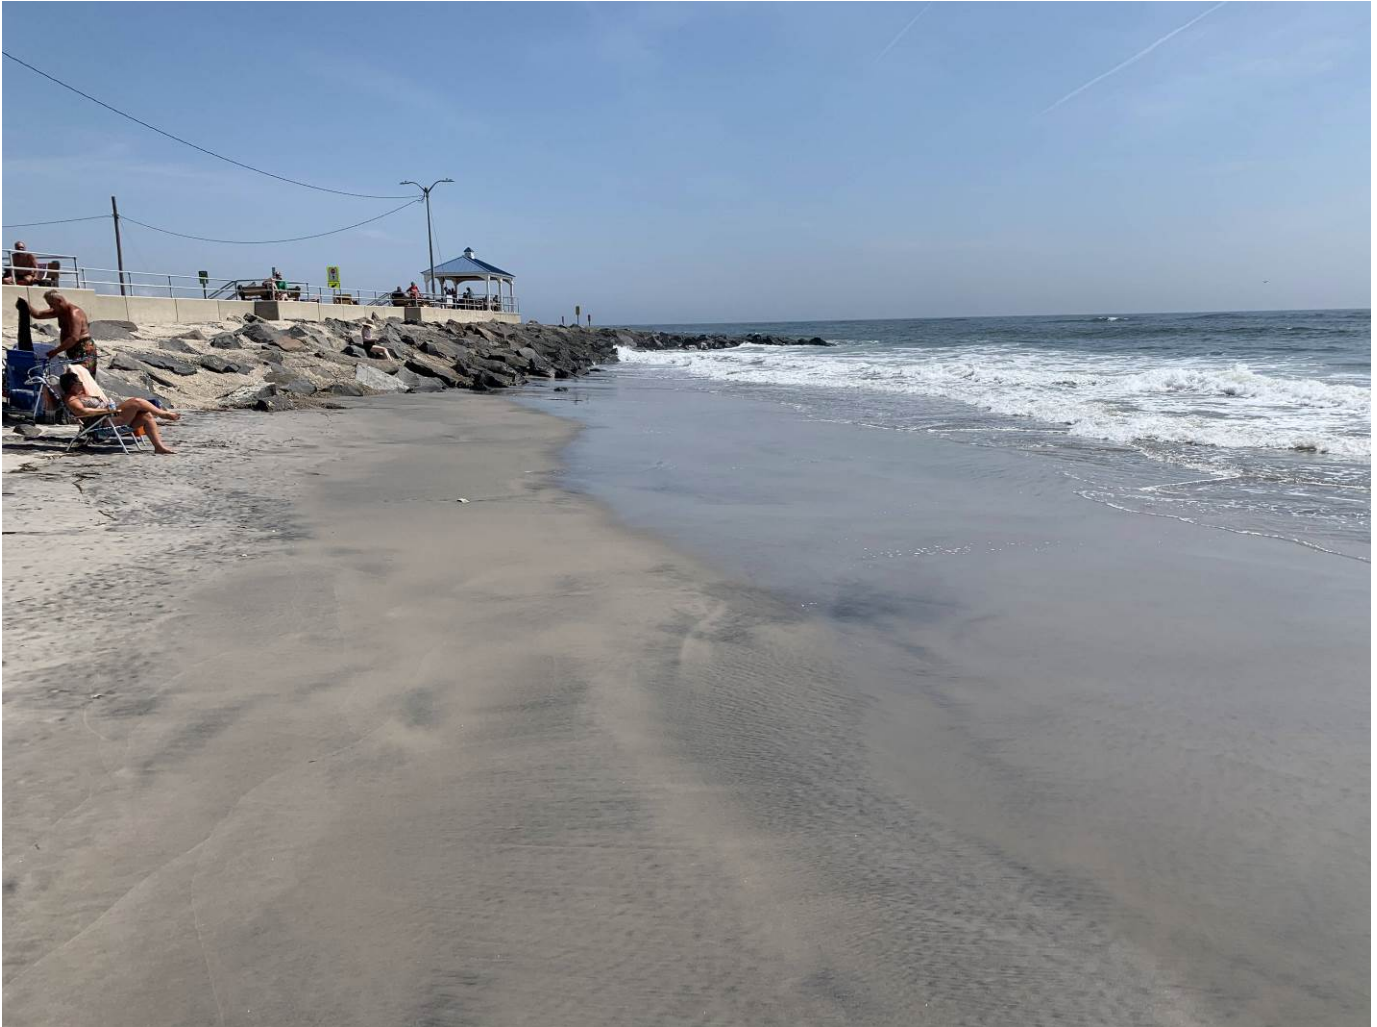
Figure 6. View to the north taken July 8, 2020 showing the inlet gazebo and inlet jetty beach. The photograph covers the northernmost 200 feet of beachfront following sand placement. In Jan. 2021 no wet sand was exposed even at low tide.

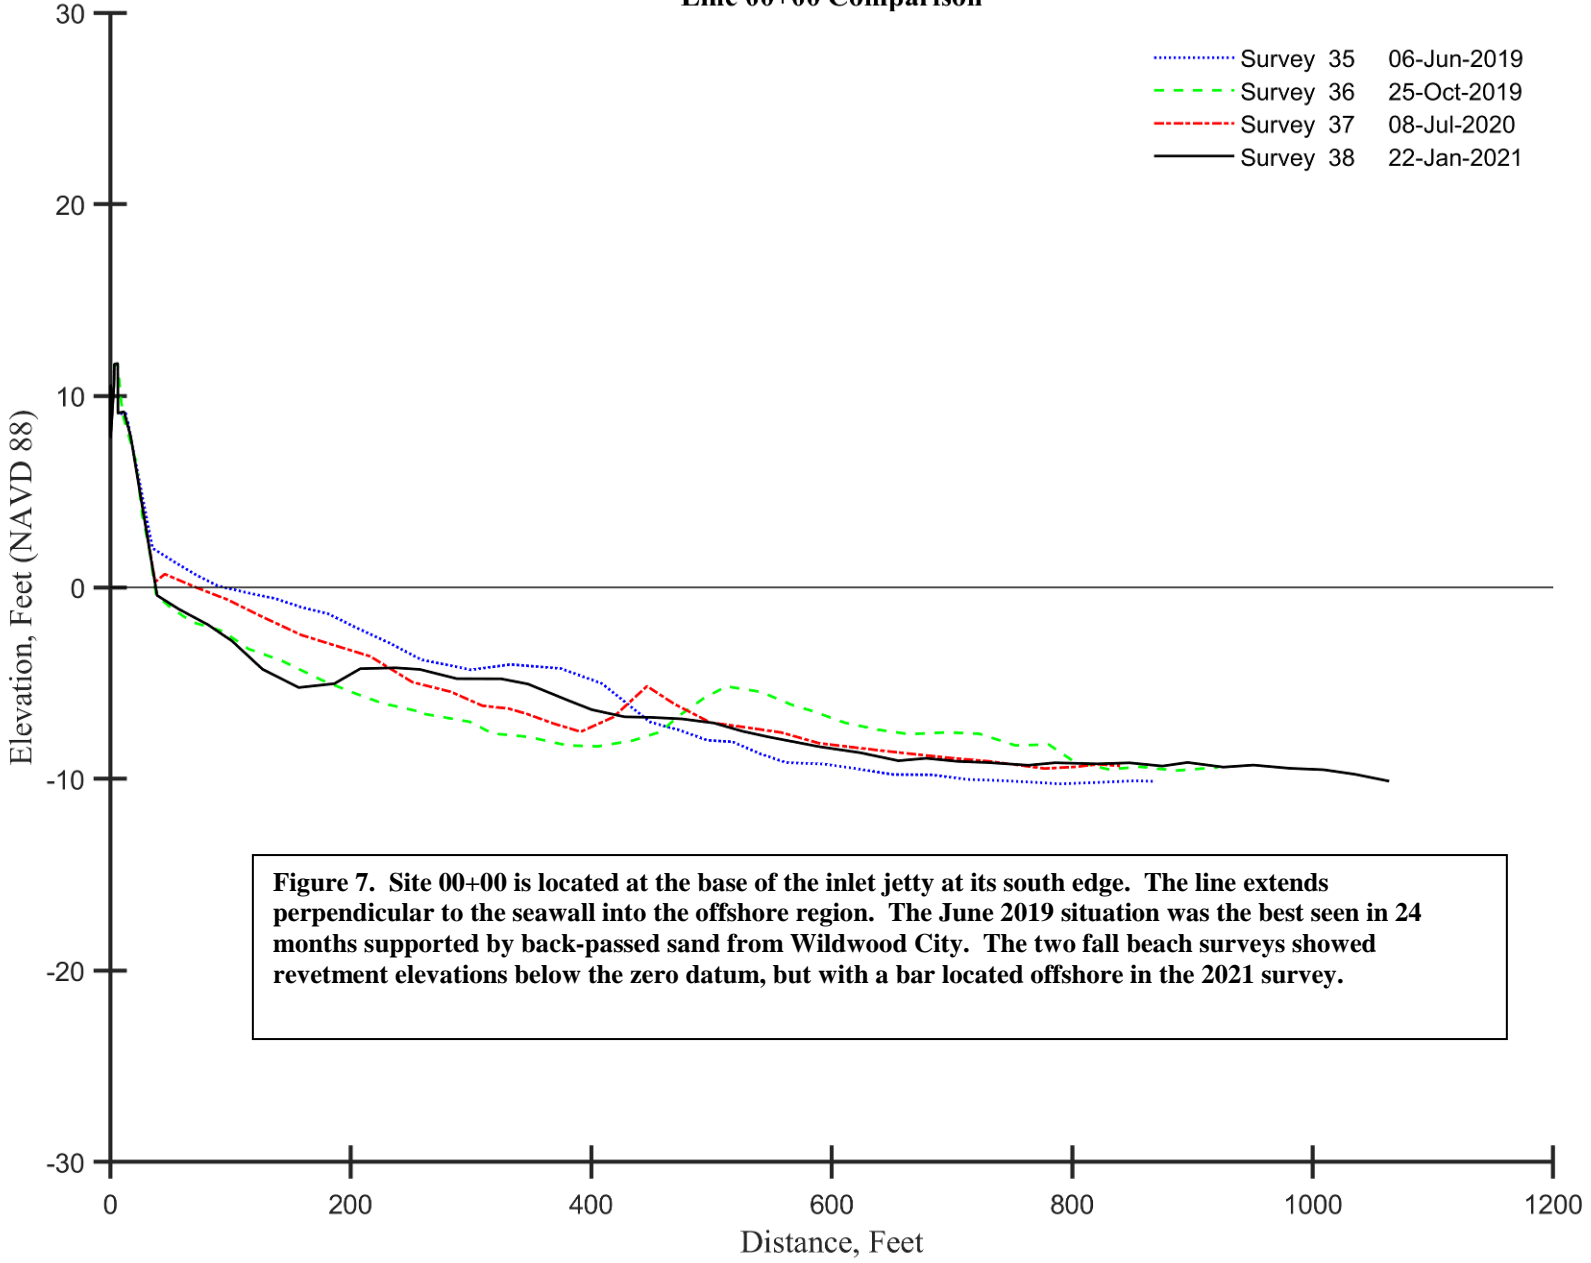
**North Wildwood - Semi-Annual Comparison
Line 00+00 Comparison**

The northernmost oceanfront survey line is dominated by sand retention by the jetty with the offshore region exposed to the full impact of northeast storm waves. Sand passes by this location with ease during high wave energy episodes. Flood tides carry material into the inlet shoreline while ebb flows move sand offshore in the expansive ebb tidal shoal system extending over two thousand feet seaward of the jetty.

Each spring/summer survey found a narrow dry sand beach at the revetment and bulkhead as a result of sand backpassing efforts moving material in from Wildwood City beaches. This sand eroded away by the fall survey each of the two years. The last survey in Jan. 2021 shows a severely eroded beach zone but a bar located offshore with some sand volume within its extent.

Figure 7. Site 00+00 is located at the base of the inlet jetty at its south edge. The line extends perpendicular to the seawall into the offshore region. The June 2019 situation was the best seen in 24 months supported by back-passed sand from Wildwood City. The two fall beach surveys showed revetment elevations below the zero datum, but with a bar located offshore in the 2021 survey.

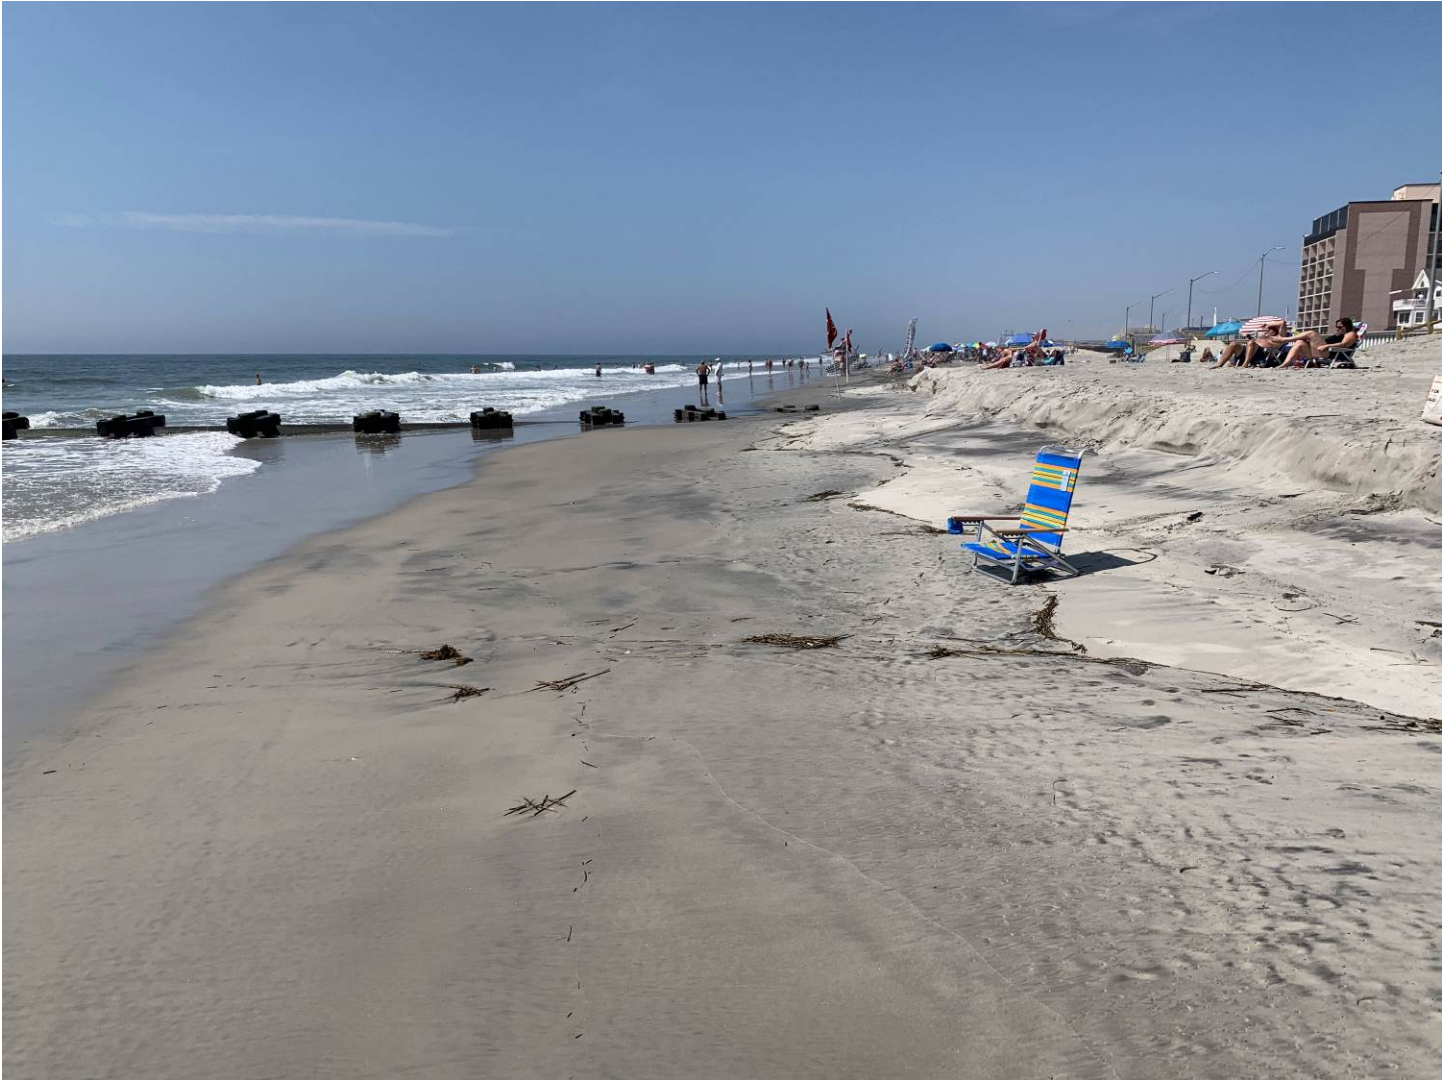
Station 02+00 crosses the 3rd Avenue storm water pipeline into the ocean south of it. The backpassing operation provided sand for the summer 2020 season, but fall losses removed enough material to have water at the revetment even at low tide by Jan. 2021.

Figure 8. View to the south across site 02+00 and toward the stormwater pipeline showing the scarp cut into the back-passed sand volume on the beach as of July 8, 2020. There is sand offshore, but not in sufficient elevation or quantity to assist in providing any measure of adequate shore protection.

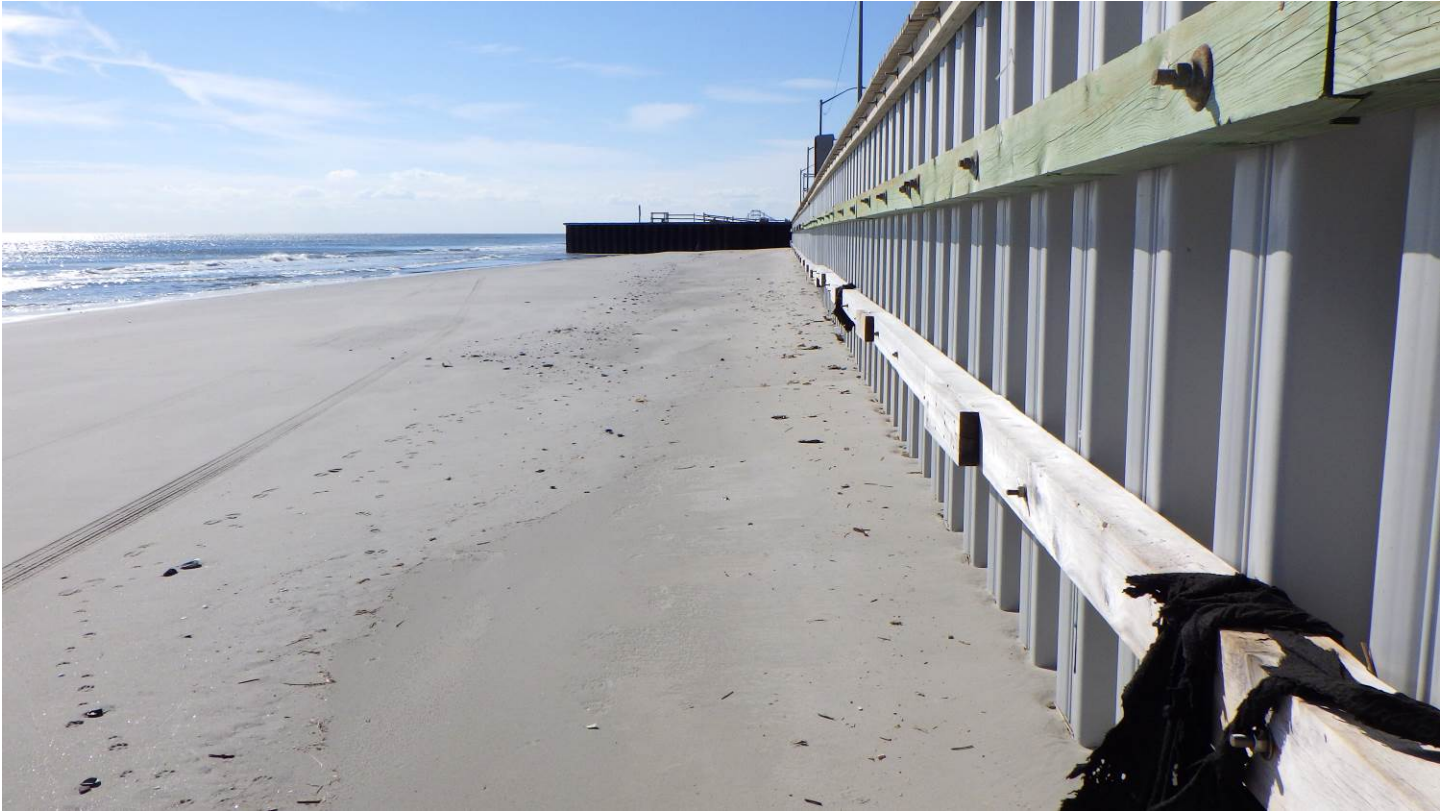
Figure 10. View to the south taken from directly in front of the new bulkhead that starts just south of the 3rd Avenue gazebo on Jan. 22, 2021. The beach was wet to the bulkhead and only about 60 feet wide to the water at low tide. Waves reach the hard structures at any elevation of mid tide and higher. During the past summer there was a dry beach composed of Wildwood City sand transported north into the area.

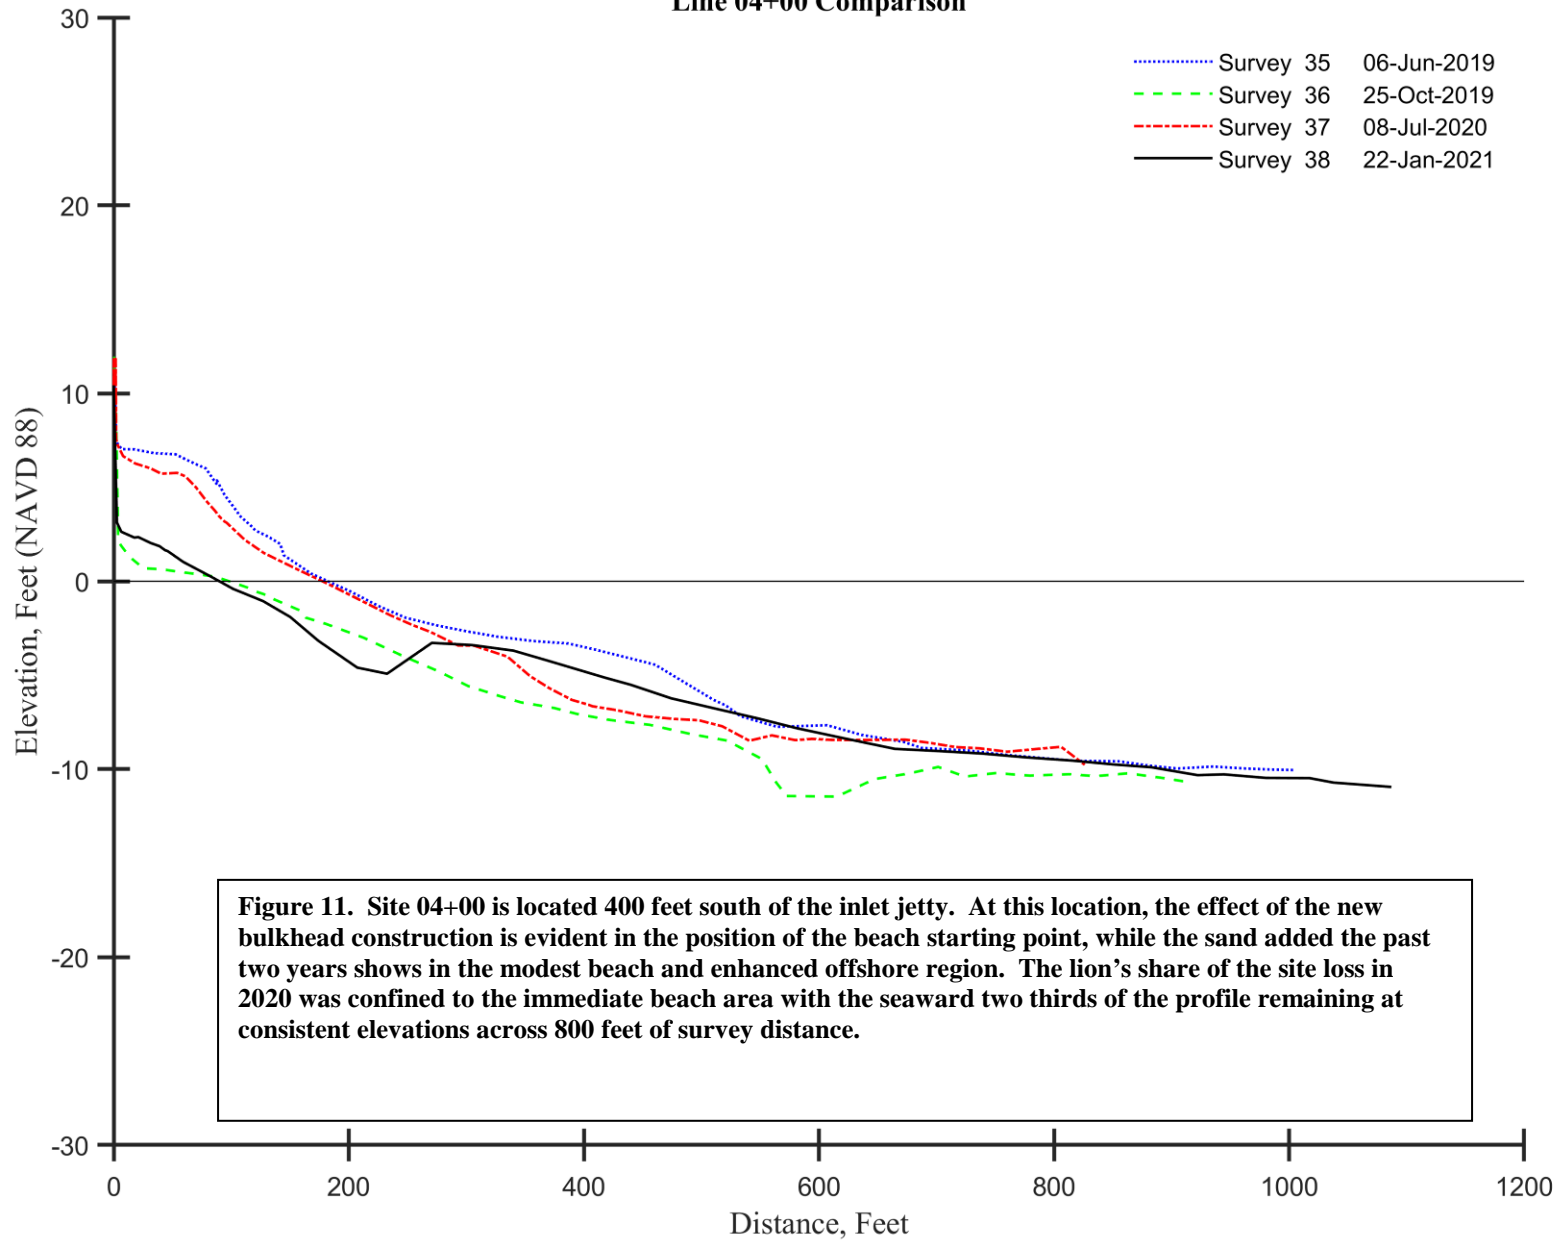
**North Wildwood - Semi-Annual Comparison
Line 04+00 Comparison**

The site is in the northern portion of the island adjacent to Hereford Inlet 400 feet south of the 2nd Avenue jetty. This area has typically been an erosional shoreline due to its proximity to the inlet and the direct impact from northeast storms. The sand graded onto this location following both the 2019 and 2020 back pass operations from Wildwood is evident in the dry beach width and the elevation against the bulkhead in the two summer cross sections. The loss of sand by the fall into winter was duplicated each of the two years with more sand present as an offshore bar in 2020 than present in 2019.

Figure 11. Site 04+00 is located 400 feet south of the inlet jetty. At this location, the effect of the new bulkhead construction is evident in the position of the beach starting point, while the sand added the past two years shows in the modest beach and enhanced offshore region. The lion's share of the site loss in 2020 was confined to the immediate beach area with the seaward two thirds of the profile remaining at consistent elevations across 800 feet of survey distance.

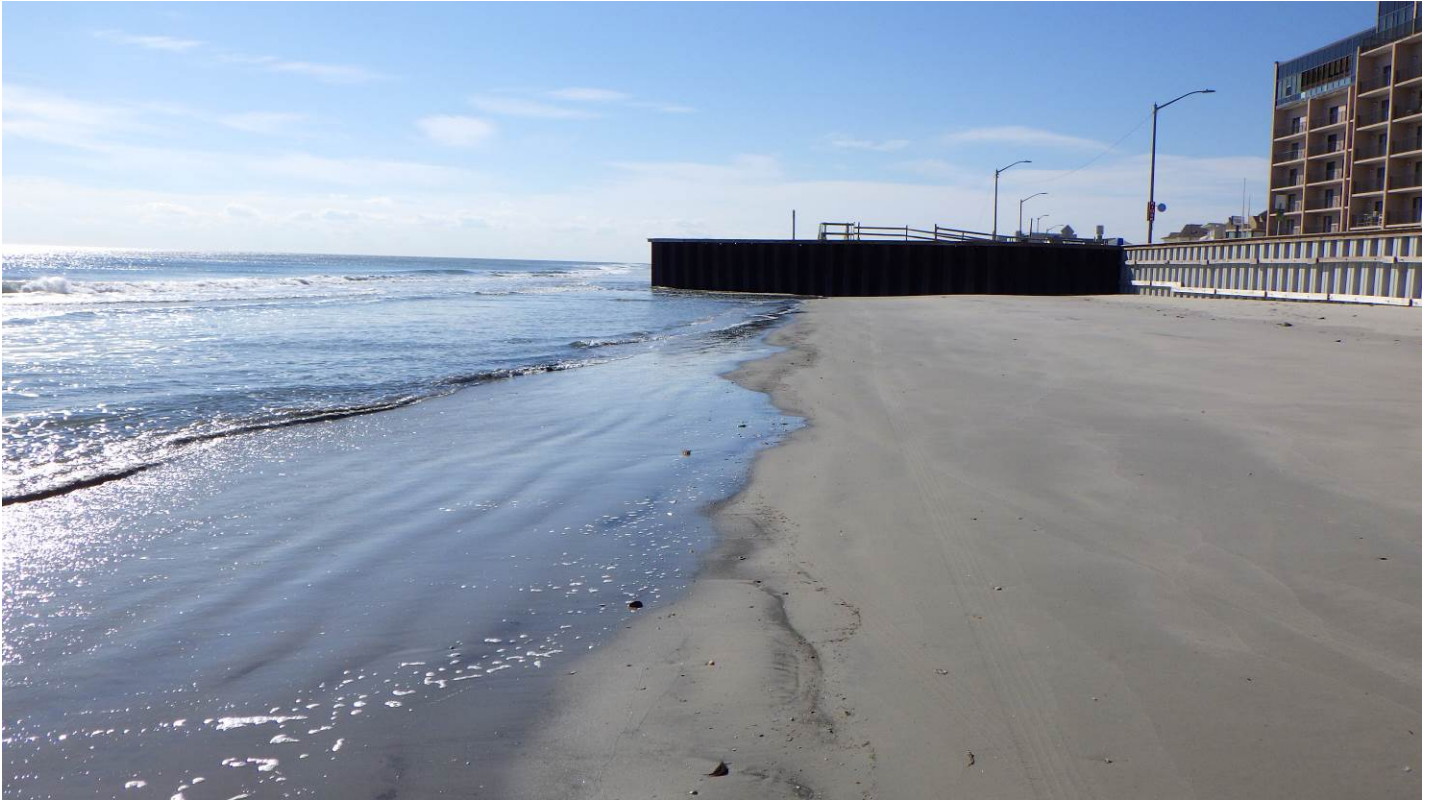
This location is at the end of 4th Avenue where the new bulkhead was completed in early 2018. Erosion acted to expose the new structure to wave run-up during the winter of 2019. By July 2020, the beach restoration had provided a bathing opportunity once again. This view below looks south across survey line 06+00.

Figure 12. Site 06+00 is on the beach slightly north of where the new steel bulkhead extends seaward into the surf zone. The beach is a bit wider than at the 04+00 site, but high tide still reaches the bulkhead each time. The wave conditions on Jan 22, 2021 were extremely mild and the water was still at the bulkhead during the previous high water.

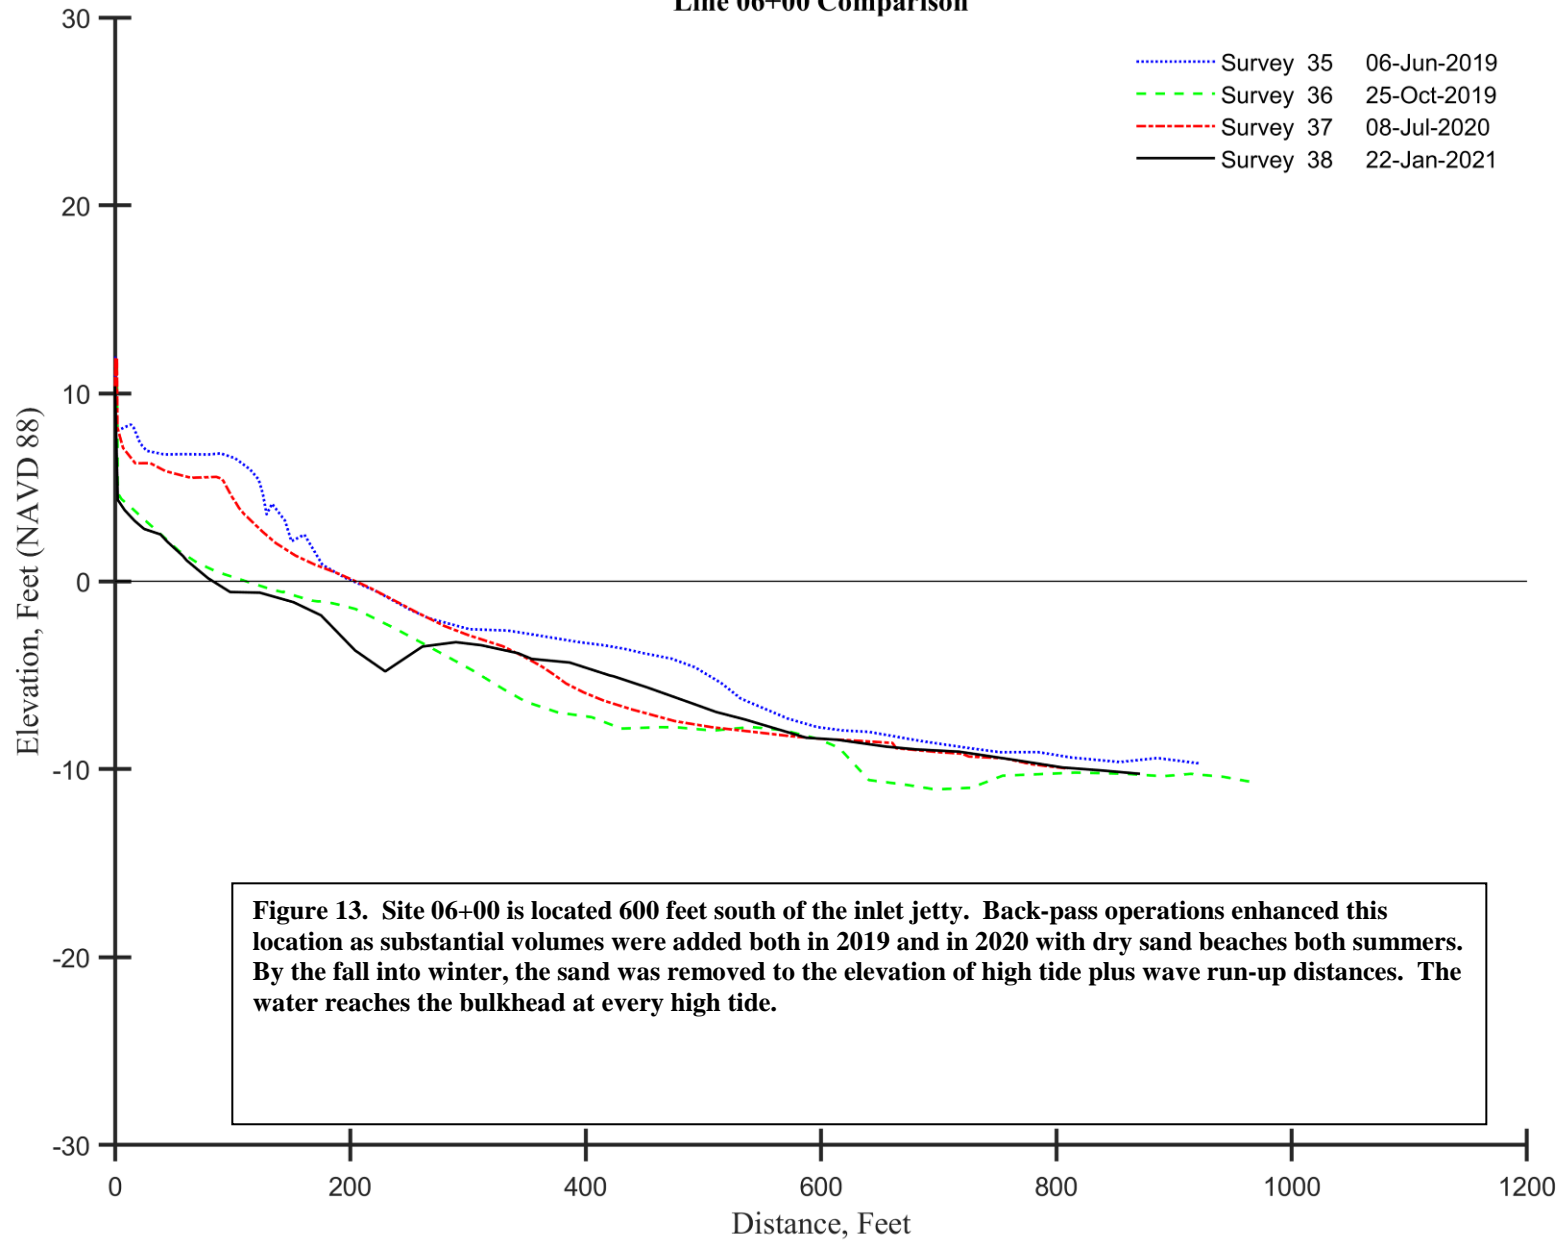
North Wildwood - Semi-Annual Comparison Line 06+00 Comparison

Figure 13. Site 06+00 is located 600 feet south of the inlet jetty. Back-pass operations enhanced this location as substantial volumes were added both in 2019 and in 2020 with dry sand beaches both summers. By the fall into winter, the sand was removed to the elevation of high tide plus wave run-up distances. The water reaches the bulkhead at every high tide.

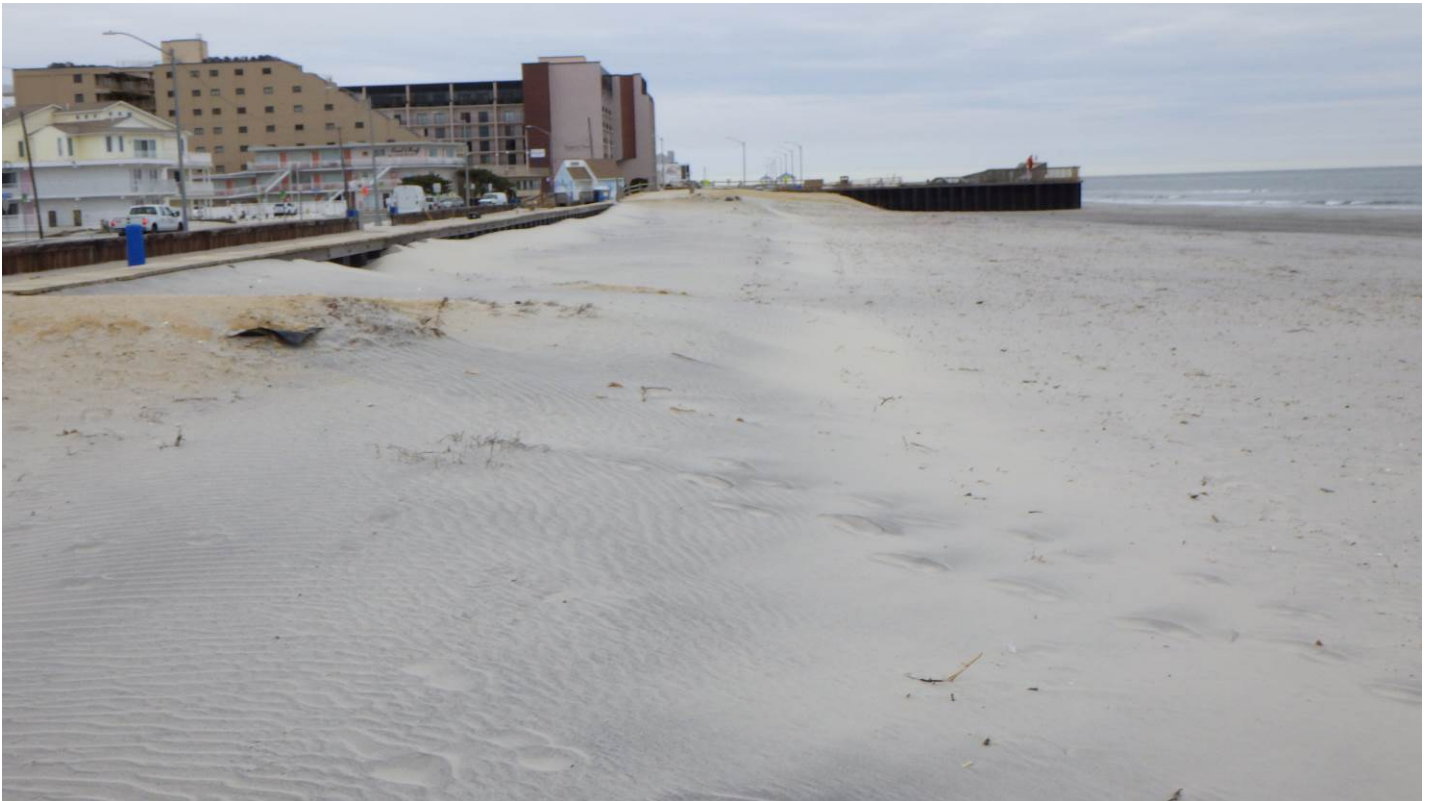
This site is located 2,000 feet south of the inlet jetty and was reasonably stable up until this past year. Dune erosion took the entire feature during installation of the steel sheet pile bulkhead. The material seaward of the bulkhead was transported from the 2020 Wildwood source stockpile. While normal high tide does not reach the sand ridge, any northeast event could easily overtop the bulkhead and pour inland.

Figure 14. View to the north taken from the beach at 10th Ave. on January 21, 2021 following loss of the dune constructed in 2009. The new steel bulkhead is partially buried in sand, but there is little added protection from the beach/dune system remaining.

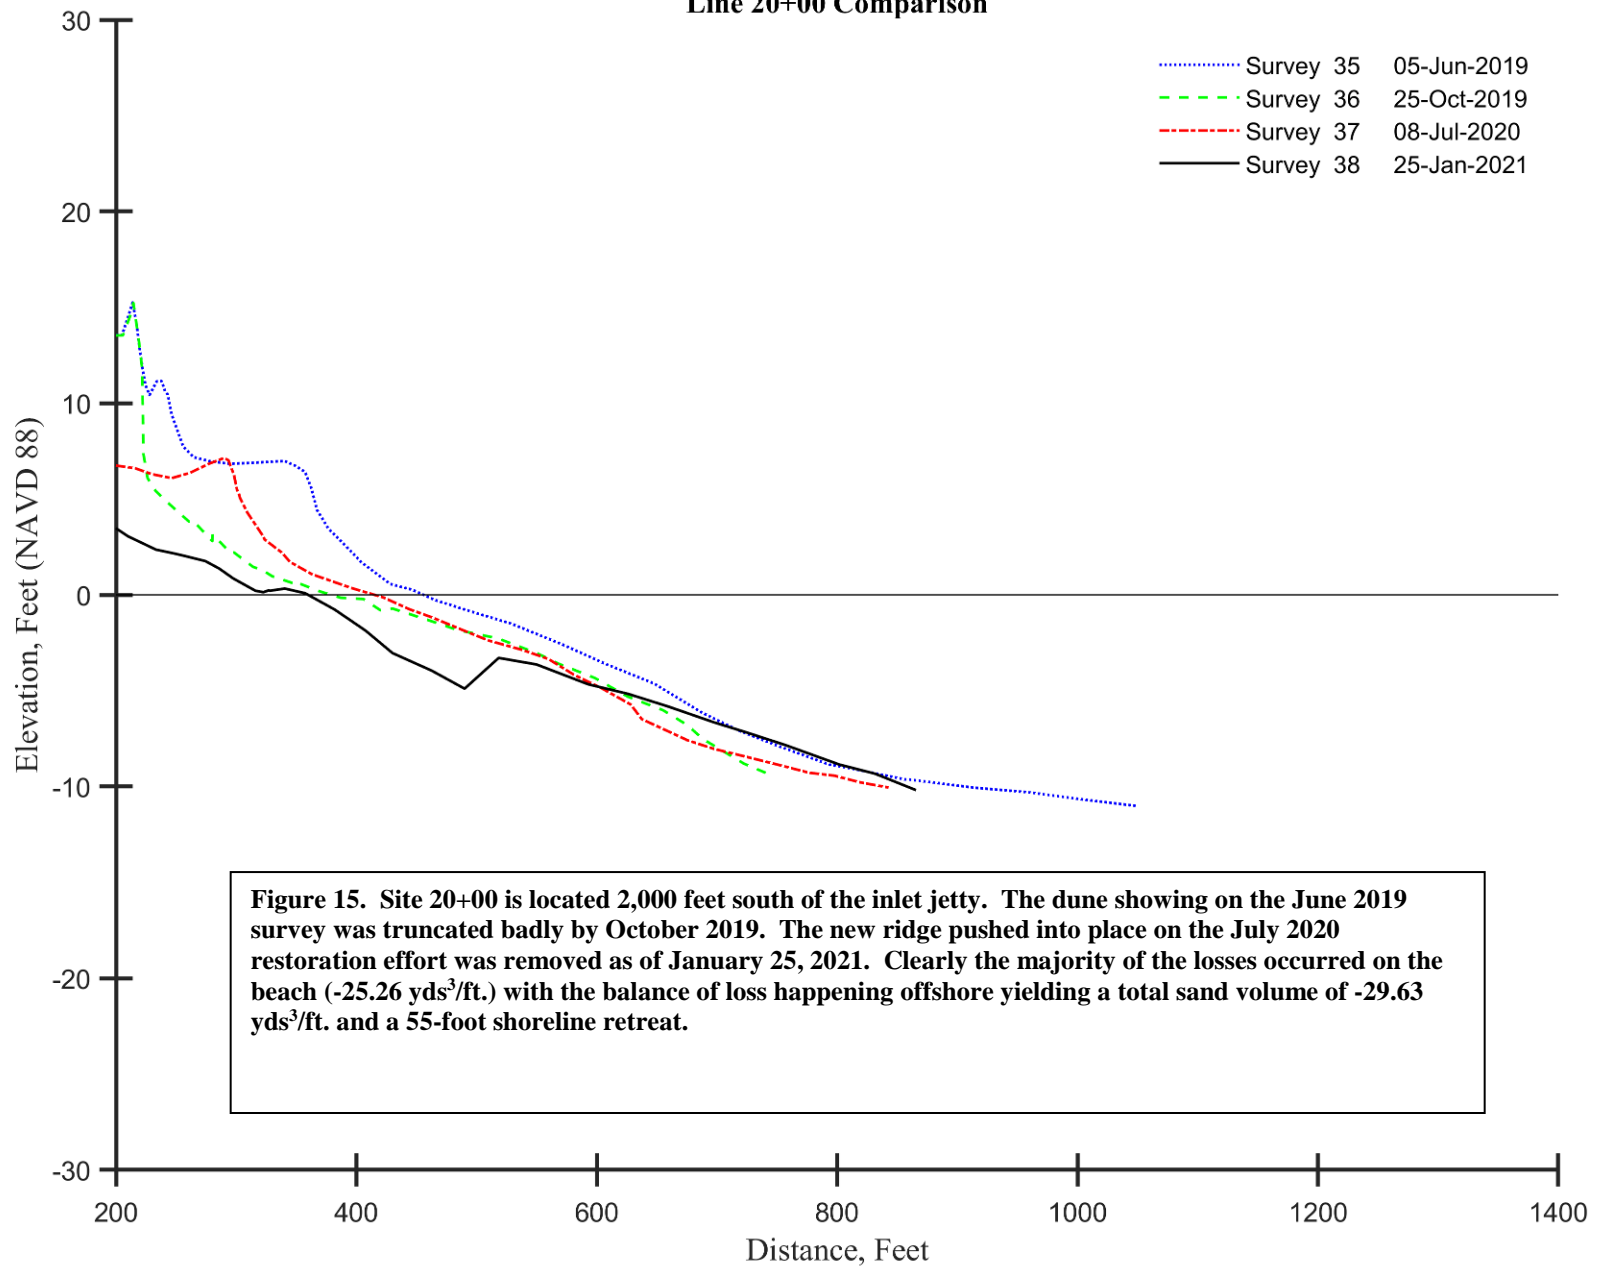
**North Wildwood - Semi-Annual Comparison
Line 20+00 Comparison**

Figure 15. Site 20+00 is located 2,000 feet south of the inlet jetty. The dune showing on the June 2019 survey was truncated badly by October 2019. The new ridge pushed into place on the July 2020 restoration effort was removed as of January 25, 2021. Clearly the majority of the losses occurred on the beach (-25.26 yds³/ft.) with the balance of loss happening offshore yielding a total sand volume of -29.63 yds³/ft. and a 55-foot shoreline retreat.
