**2020 FINAL REPORT - TO THE CITY OF NORTH WILDWOOD
ON THE
CONDITION OF THE CITY BEACHES**

**PREPARED FOR: THE CITY OF NORTH WILDWOOD
901 ATLANTIC AVENUE
NORTH WILDWOOD, NJ 08260**

**PREPARED BY: THE STOCKTON UNIVERSITY COASTAL RESEARCH CENTER
30 WILSON AVENUE
PORT REPUBLIC, NJ 08241
MARCH 19, 2021**

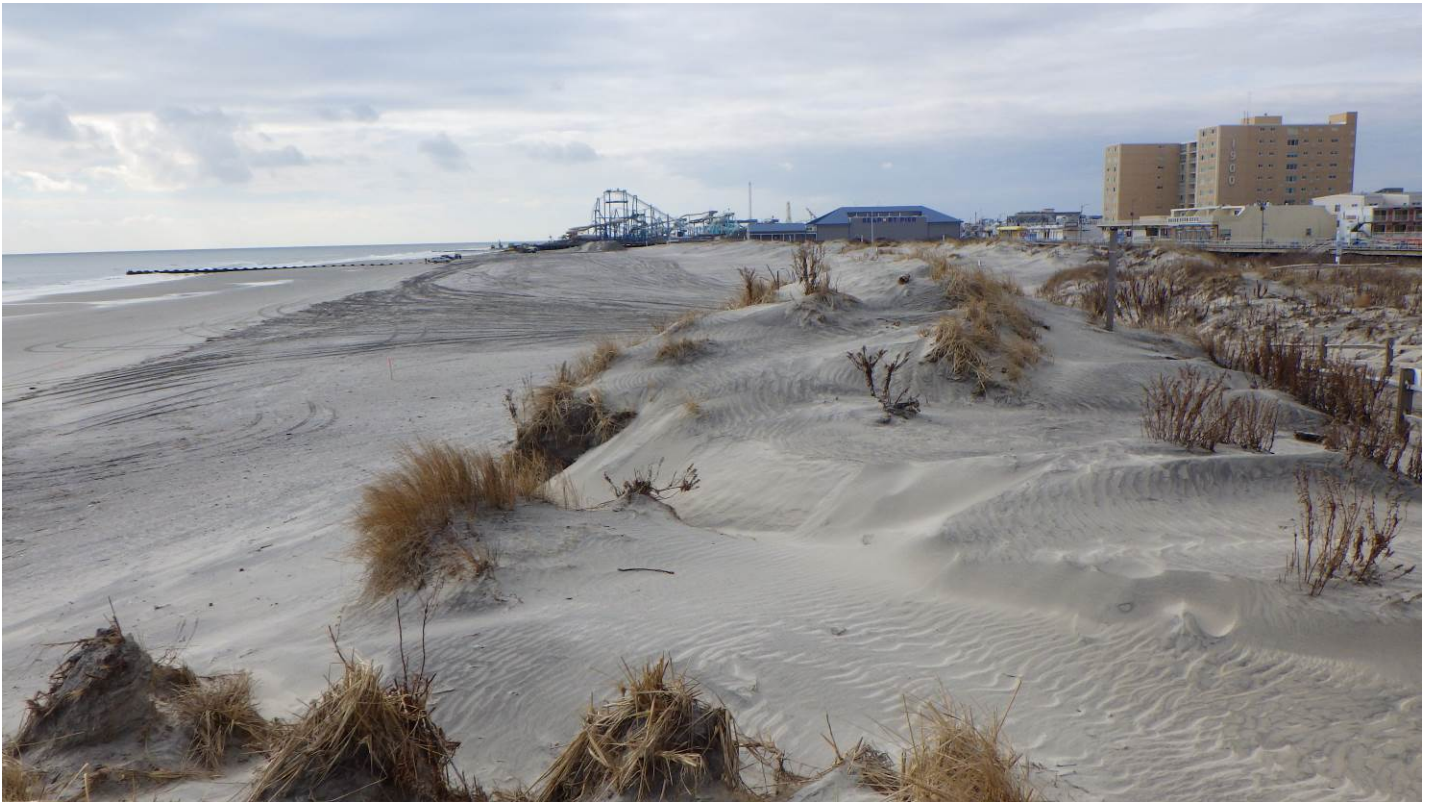
Positioned 4,000 feet south of the 2nd Avenue jetty, this site is located two blocks south of the lifeguard station in the mid-section of the City's oceanfront beaches. Following initial construction in 2009 this region has remained relatively stable. The dry sand expanse has diminished over the past decade, leaving the visitor area dependent on wave run-up conditions. The bar offshore was in the process of adding material to the beachface in modest amounts. Backpassed sand was not directly placed here, but a quantity did migrate onto the beach during the summer.

Figure 16. View to the south along the seaward dune slope and upper beach on January 27, 2021. The 2020 sand stockpile shows in the middle ground with the tracks on it. The dunes and beach lost 6.99 yds³/ft. with sand deposited offshore as a bar.

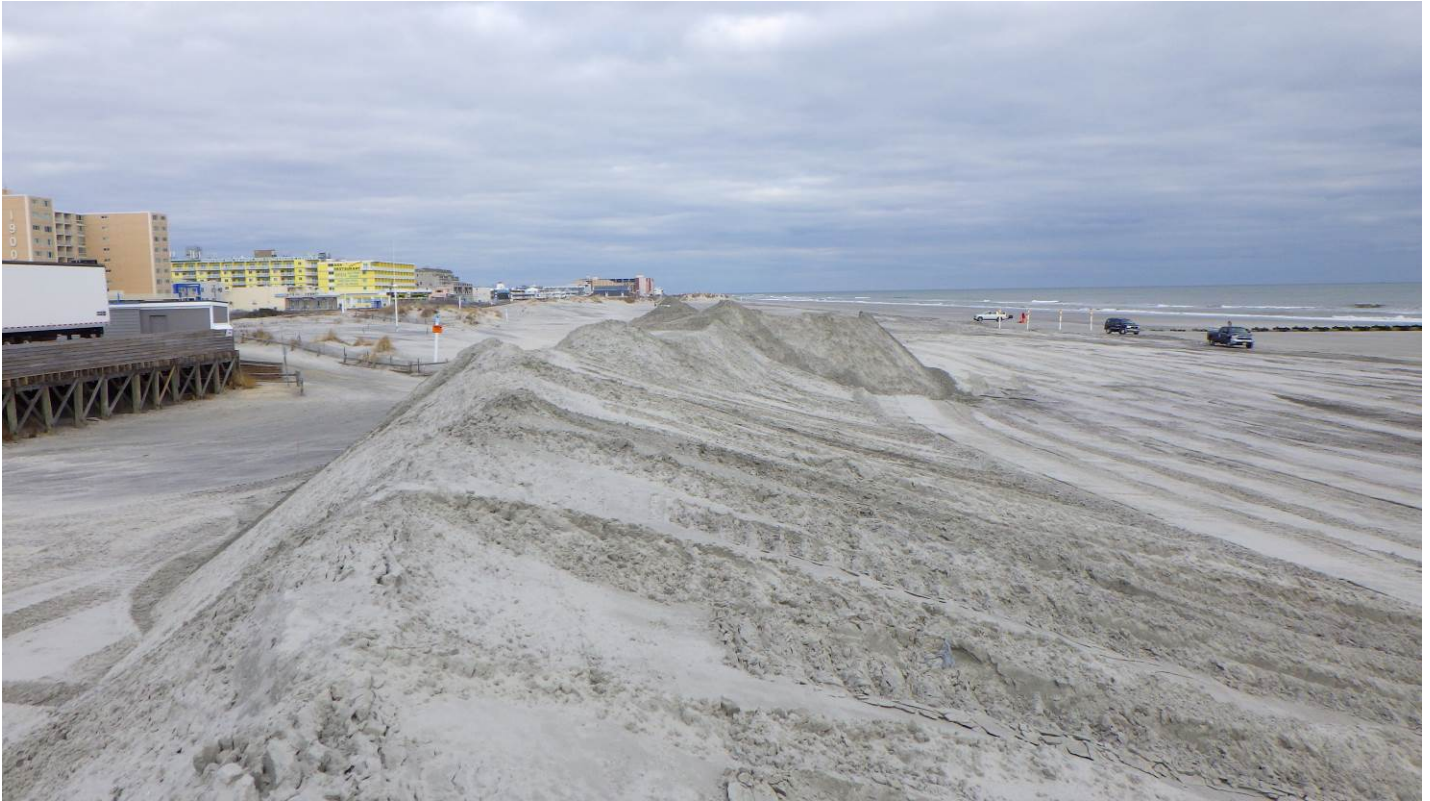
This view was taken at 56th Avenue looking north toward the survey site 400 feet to the north. The 2009 dune was still present at the site, but a large volume of stored sand extended south from what had been the end of the original 2009 dune system where it curved seaward to pass in front of the timber pier to the left in the photograph. Hurricane Sandy removed the dune from in front of the piers and the barrier was shifted landward between them. This material was truck-hauled north from Wildwood City in the spring of 2020 for redistribution.

Figure 18. View to the north taken from line 56+00 looking toward the dunes present at line 52+00 across the piles of Wildwood City sand stored for redistribution along the beaches.

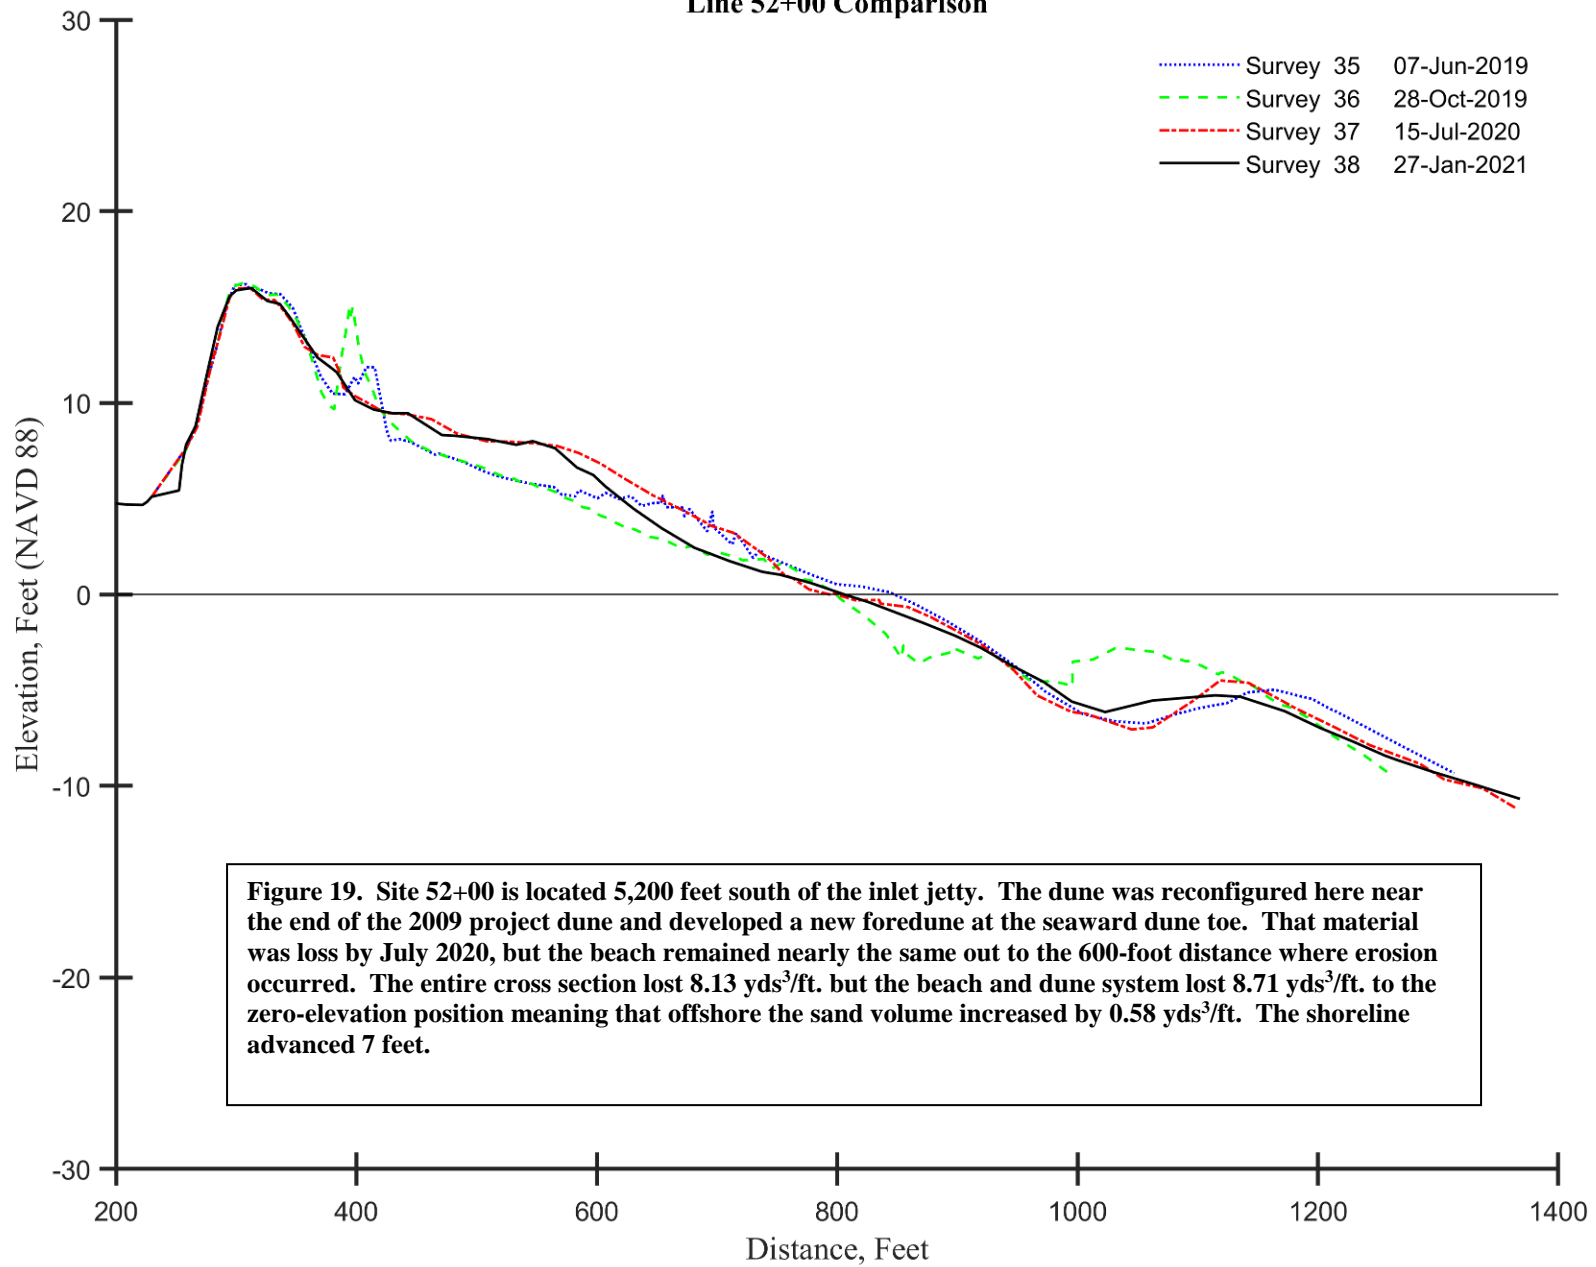
North Wildwood - Semi-Annual Comparison
Line 52+00 Comparison

Figure 19. Site 52+00 is located 5,200 feet south of the inlet jetty. The dune was reconfigured here near the end of the 2009 project dune and developed a new foredune at the seaward dune toe. That material was loss by July 2020, but the beach remained nearly the same out to the 600-foot distance where erosion occurred. The entire cross section lost 8.13 yds³/ft. but the beach and dune system lost 8.71 yds³/ft. to the zero-elevation position meaning that offshore the sand volume increased by 0.58 yds³/ft. The shoreline advanced 7 feet.

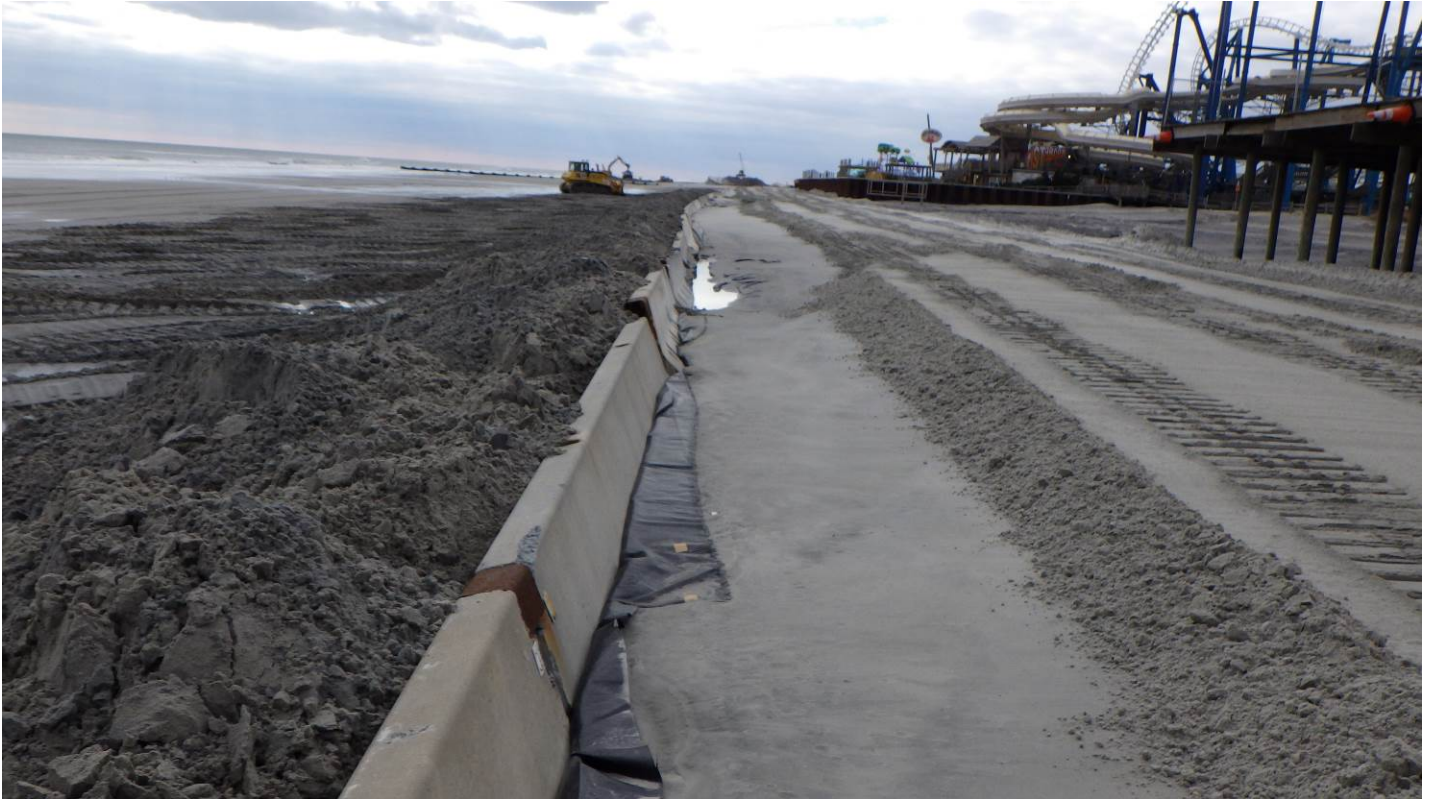
This site is located in the southern section of the City's oceanfront where the engineered dune system was originally constructed seaward of the piers. An effort was made in 2013 to restore the dune, but events in 2014 forced re-positioning the dune system landward between the piers and including a large vegetated island dune that had existed between Morey's Surfside Pier and the adjacent timber pier.

As of January 27, 2021, a temporary haul road had been built seaward of the piers so trucks could move sand north from Wildwood at high tide. This feature was broken up by the February 2021 storm, but work had ceased on hauling sand.

Figure 20. The January 27, 2021 view to the south looks across the front of the timber pier with the sand haul road in place to ease the trip past the pier at high tide. Morey's Surfside Pier can be seen in the distance further south with a wide, flat beach exposed at low tide.

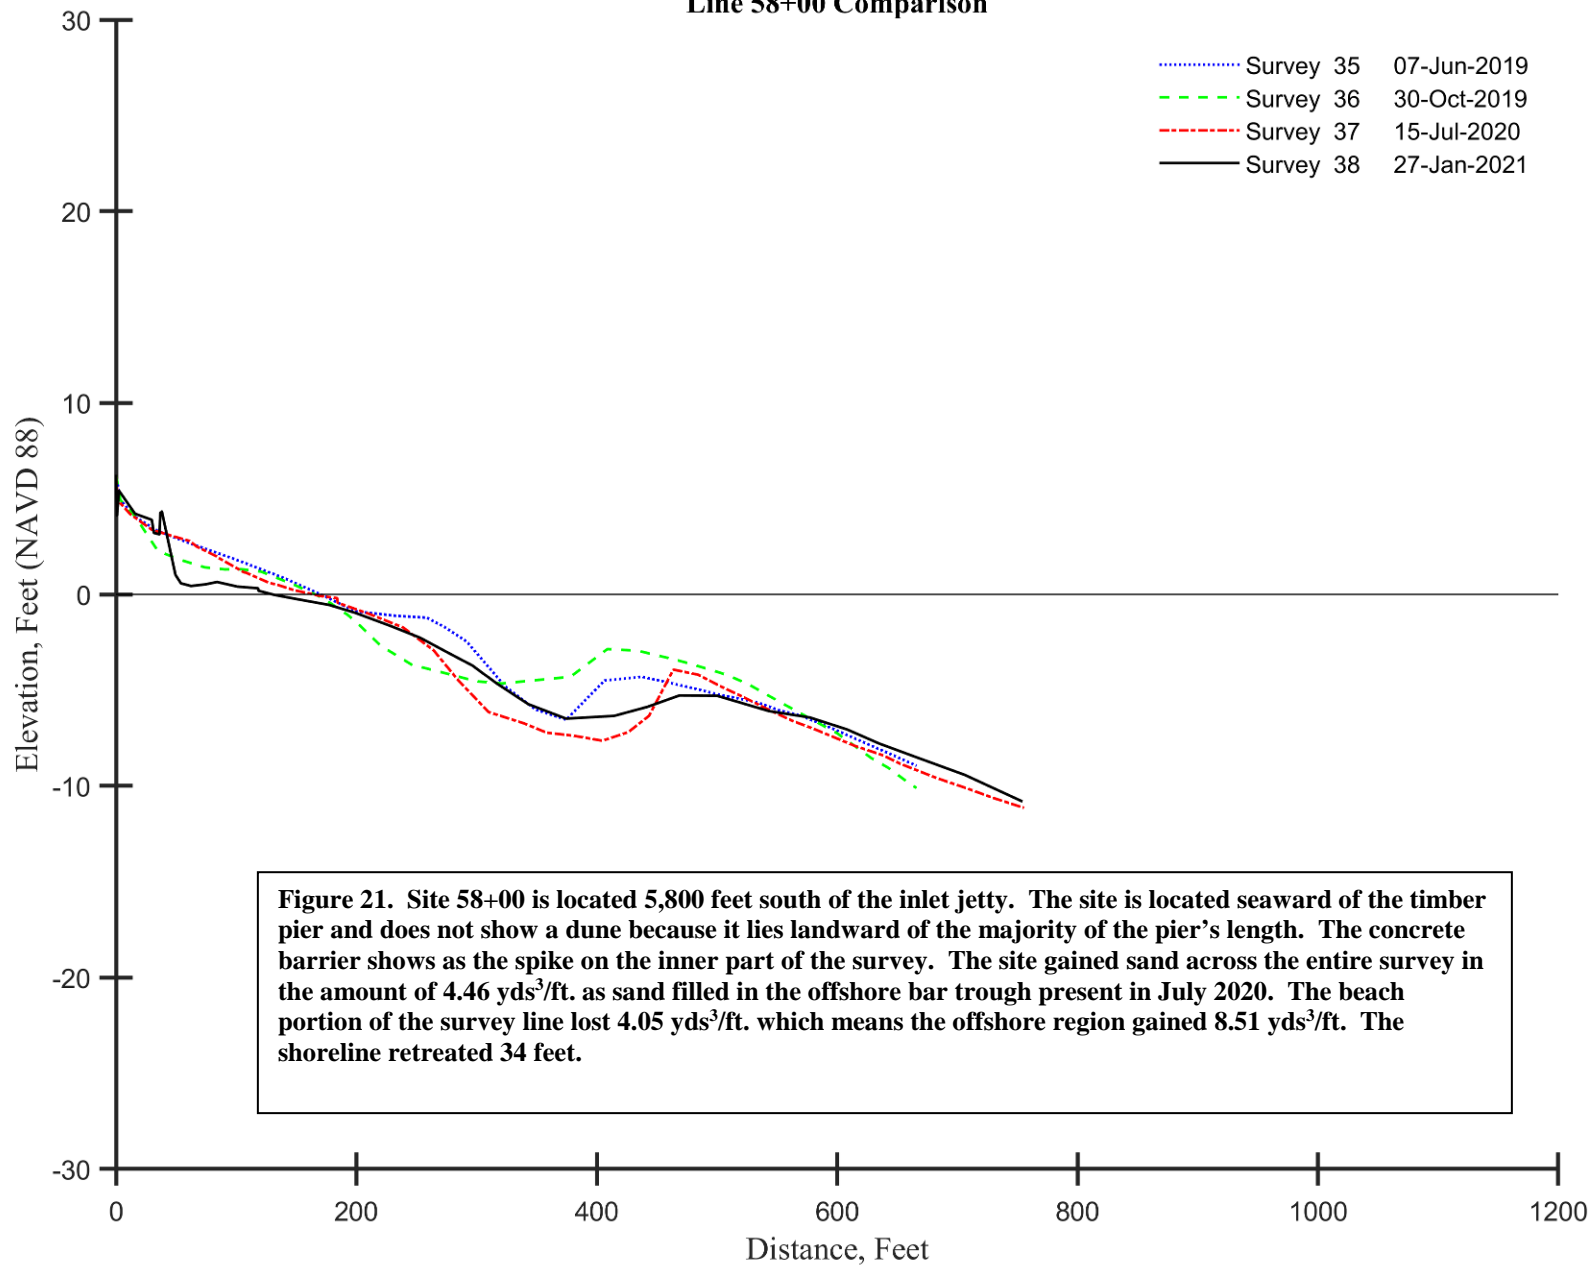
**North Wildwood - Semi-Annual Comparison
Line 58+00 Comparison**

Figure 21. Site 58+00 is located 5,800 feet south of the inlet jetty. The site is located seaward of the timber pier and does not show a dune because it lies landward of the majority of the pier's length. The concrete barrier shows as the spike on the inner part of the survey. The site gained sand across the entire survey in the amount of 4.46 yds³/ft. as sand filled in the offshore bar trough present in July 2020. The beach portion of the survey line lost 4.05 yds³/ft. which means the offshore region gained 8.51 yds³/ft. The shoreline retreated 34 feet.

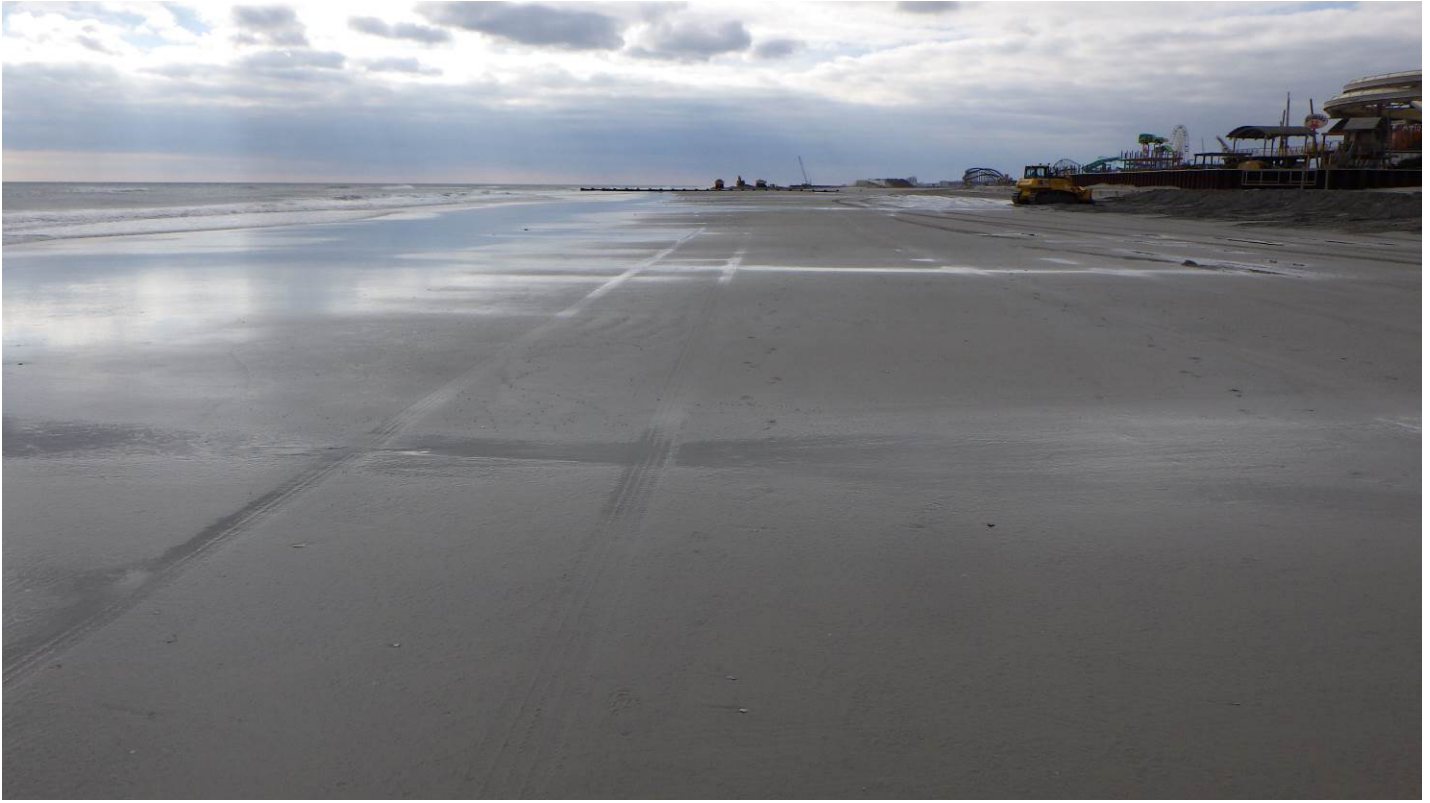
In an effort to better define the beach zone where piers dominate in North Wildwood, this site was included to show the changes to enhance dune protection since Hurricane Sandy. The main feature is an old dune island likely developed around beach raking debris left in a variety of places when the North Wildwood beach was much wider. The piers originally had the 2009 dune built seaward of the pier ends on the outer beach, but storm erosion starting November 2009 and climaxing with Hurricane Sandy in October 2012 saw complete loss of the dune seaward of the three piers. The existing situation was completed in 2014 and has established quite well. However shoreline retreat has forced the high tide line under the two timber piers producing the need for the haul road. This beach in Jan. 2021 was extremely flat following two storms in December 2020.

Figure 22. Site 60+00 lies between Morey’s Surfside Pier and the next timber pier to the north. The bulldozer is maintaining the haul road entrance past the two timber piers.

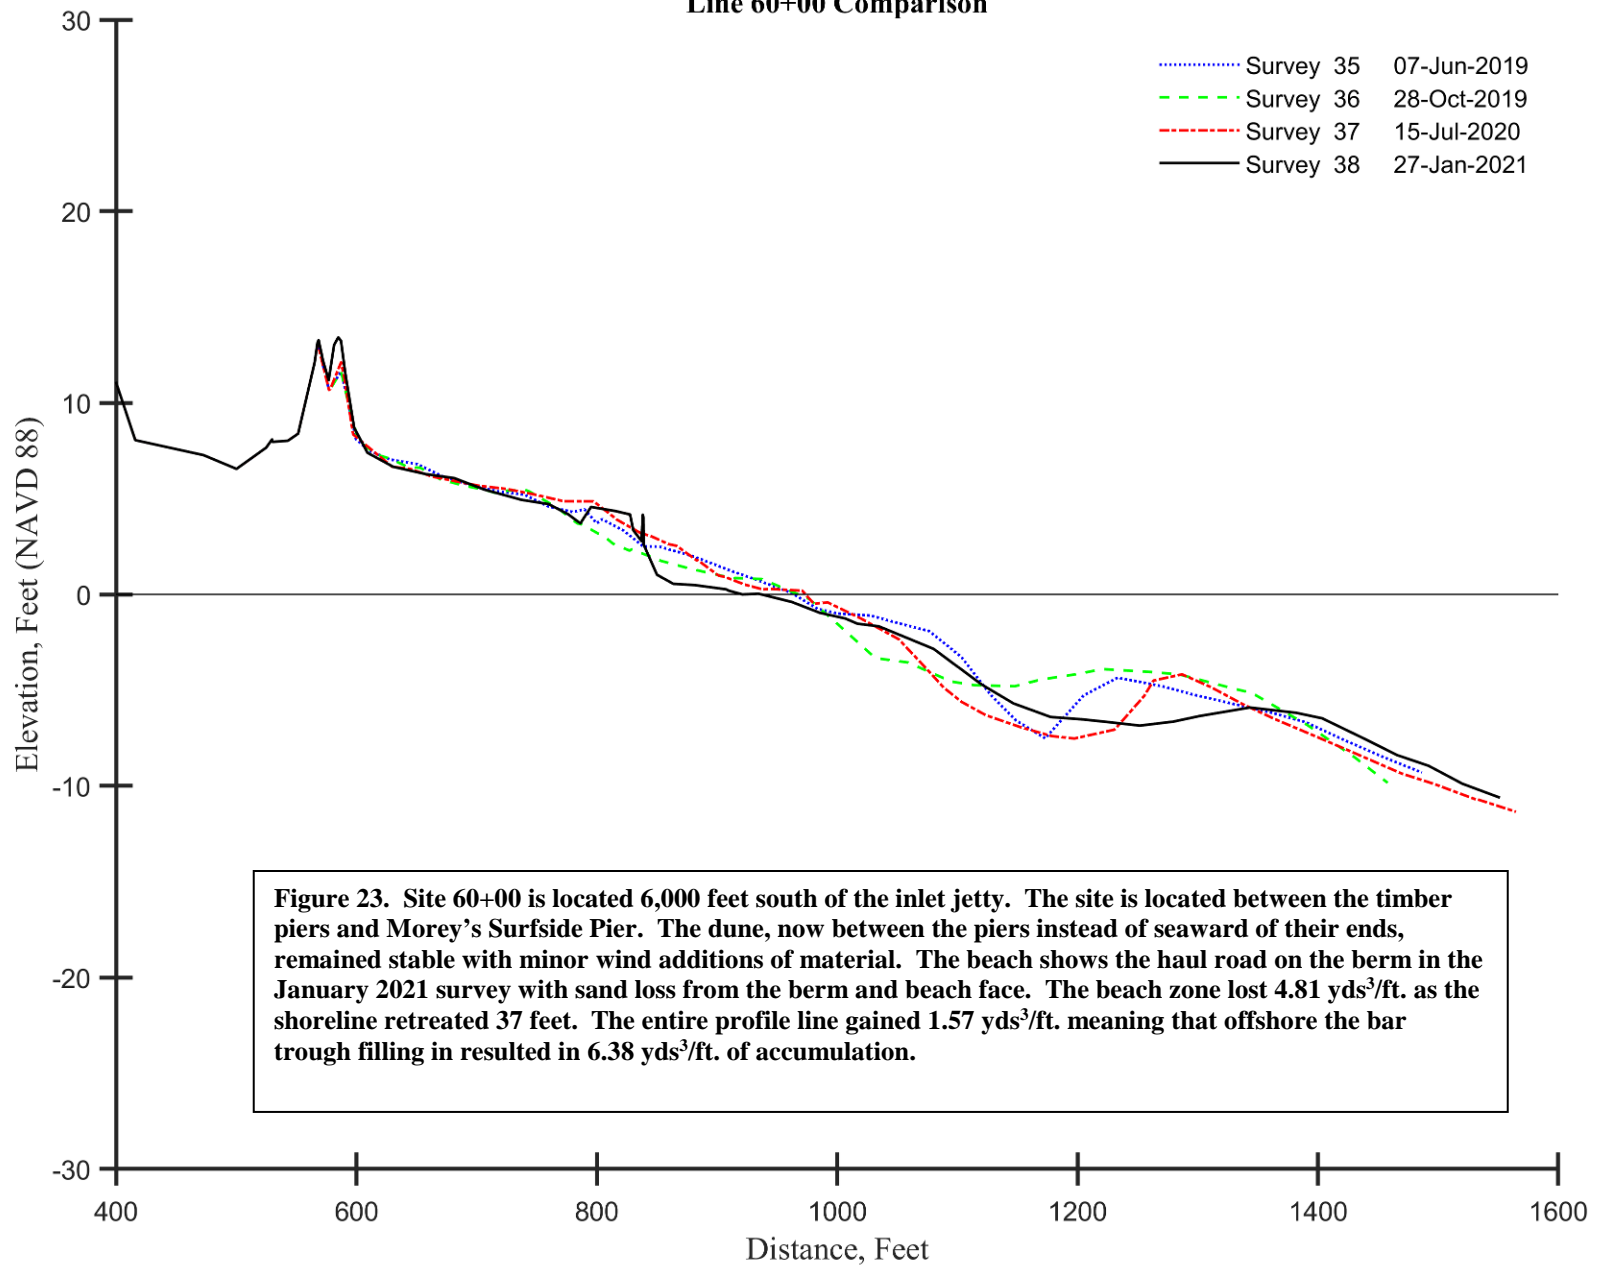
**North Wildwood - Semi-Annual Comparison
Line 60+00 Comparison**

Figure 23. Site 60+00 is located 6,000 feet south of the inlet jetty. The site is located between the timber piers and Morey's Surfside Pier. The dune, now between the piers instead of seaward of their ends, remained stable with minor wind additions of material. The beach shows the haul road on the berm in the January 2021 survey with sand loss from the berm and beach face. The beach zone lost 4.81 yds³/ft. as the shoreline retreated 37 feet. The entire profile line gained 1.57 yds³/ft. meaning that offshore the bar trough filling in resulted in 6.38 yds³/ft. of accumulation.

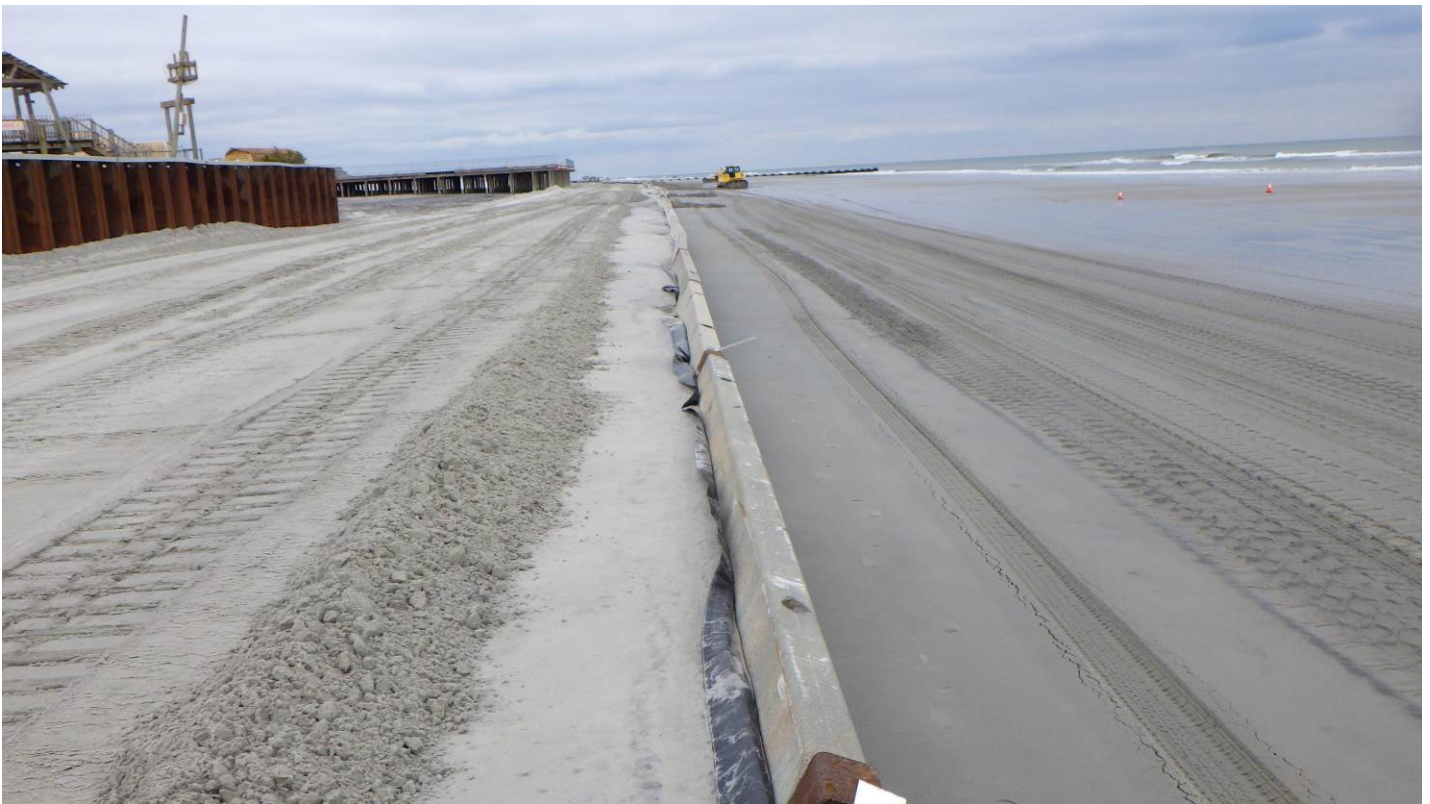
This is the southern-most cross section of the selected profiles within the larger database and just 400 feet from the southern limit of surveys. Located seaward of the Surfside Pier and Ocean Oasis Water Park and Beach Club this site represents conditions at the south end engineered beach and its taper near the Wildwood and North Wildwood border. Initially the engineered beach design template placed the dune feature 30 feet seaward of the pier's steel bulkhead. A series of storm events that followed construction in 2009 resulted in multiple episodes of erosion followed by restoration efforts to maintain this section of dune. By the spring 2014 survey (April 25th), the beach and dune had eroded to a point where the City was forced to reposition this feature landward of the easternmost point of the piers. No dune was replaced south of Surfside Pier because the City of Wildwood declined to allow the original design to be re-established. Morey's Pier company erected the steel sheet pile bulkhead following the initial series of northeast storms prior to Hurricane Irene in 2011 and it has been the starting point since. The sand haul road extends past this pier as well so at high tide the haul trucks could pass through.

Figure 24. View to the north taken on January 27, 2021 looking along the concrete “Jersey barriers” employed to retain the sand for the road. Seaward the beach is extremely flat, but quite wide. Waves easily reach the bulkhead making a dry berm unlikely until the shoreline advances seaward about 100 feet further seaward.

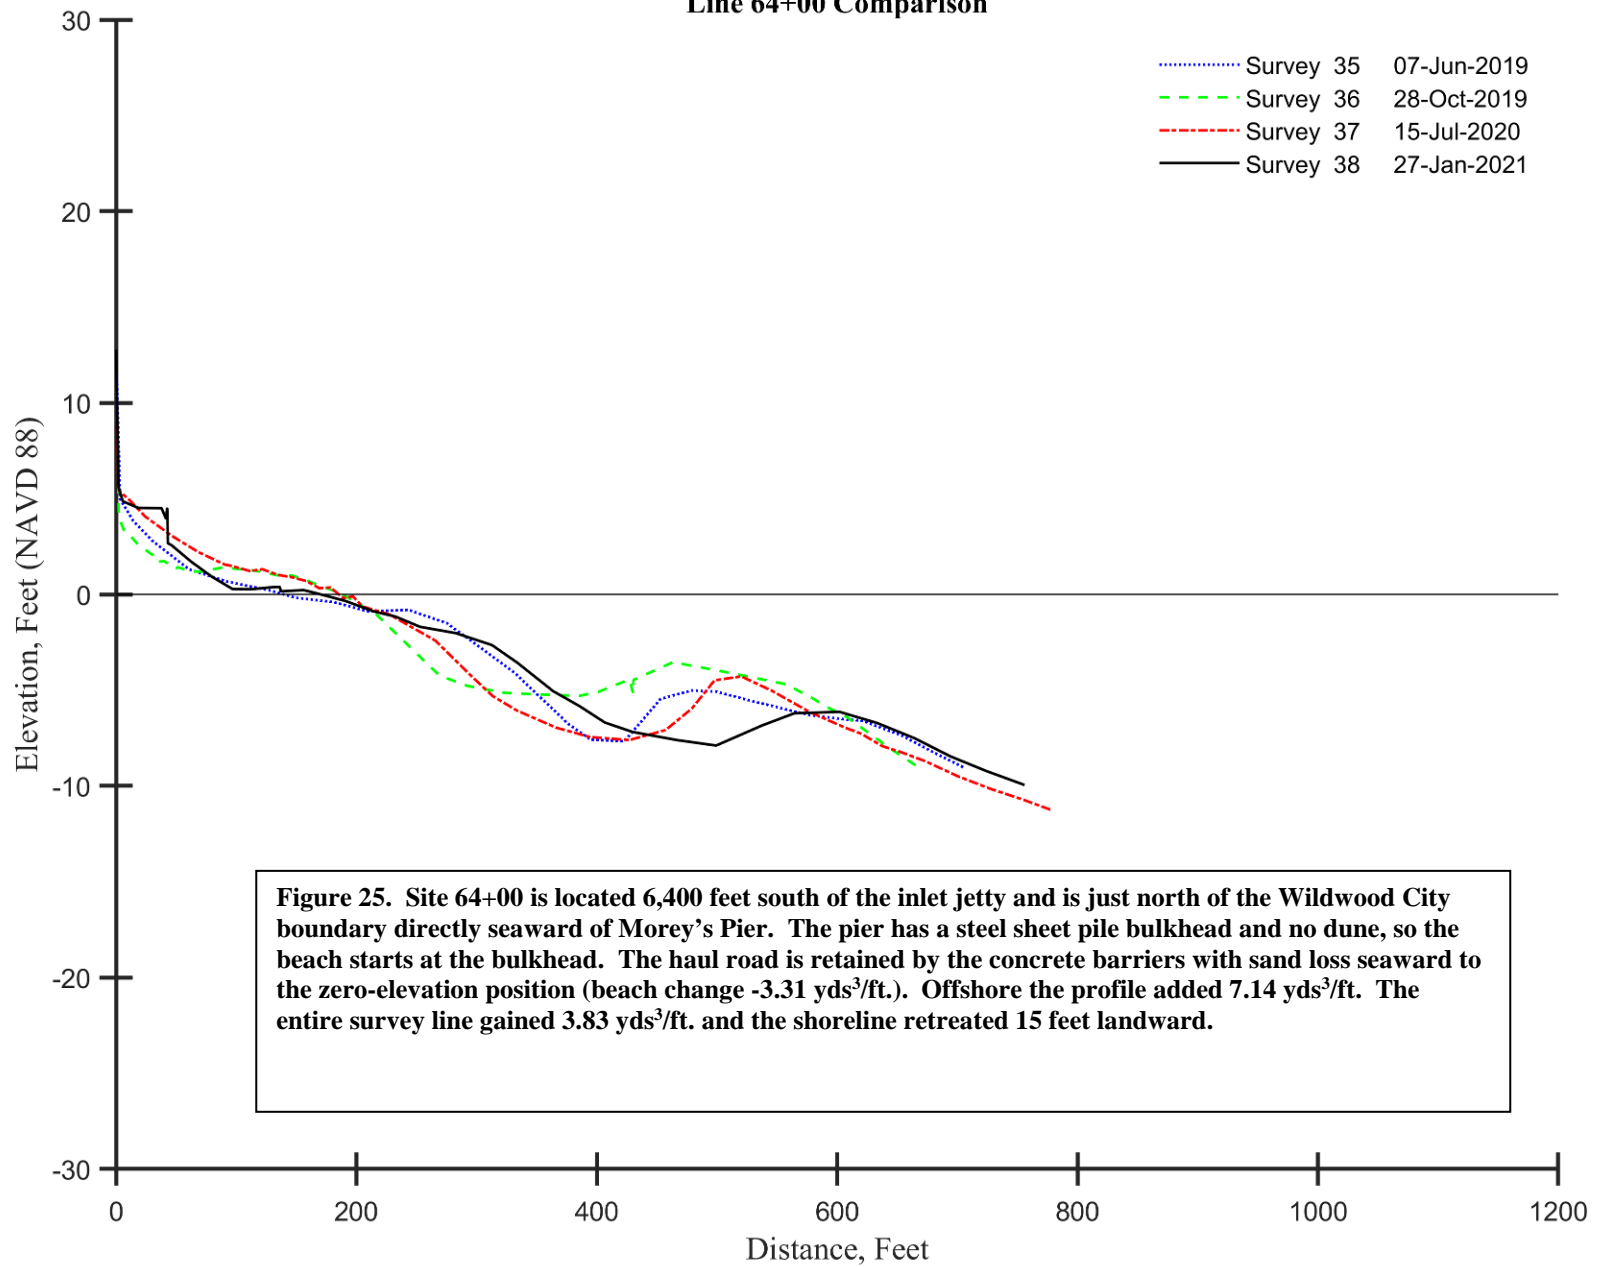
**North Wildwood - Semi-Annual Comparison
Line 64+00 Comparison**

Figure 25. Site 64+00 is located 6,400 feet south of the inlet jetty and is just north of the Wildwood City boundary directly seaward of Morey’s Pier. The pier has a steel sheet pile bulkhead and no dune, so the beach starts at the bulkhead. The haul road is retained by the concrete barriers with sand loss seaward to the zero-elevation position (beach change -3.31 yds³/ft.). Offshore the profile added 7.14 yds³/ft. The entire survey line gained 3.83 yds³/ft. and the shoreline retreated 15 feet landward.

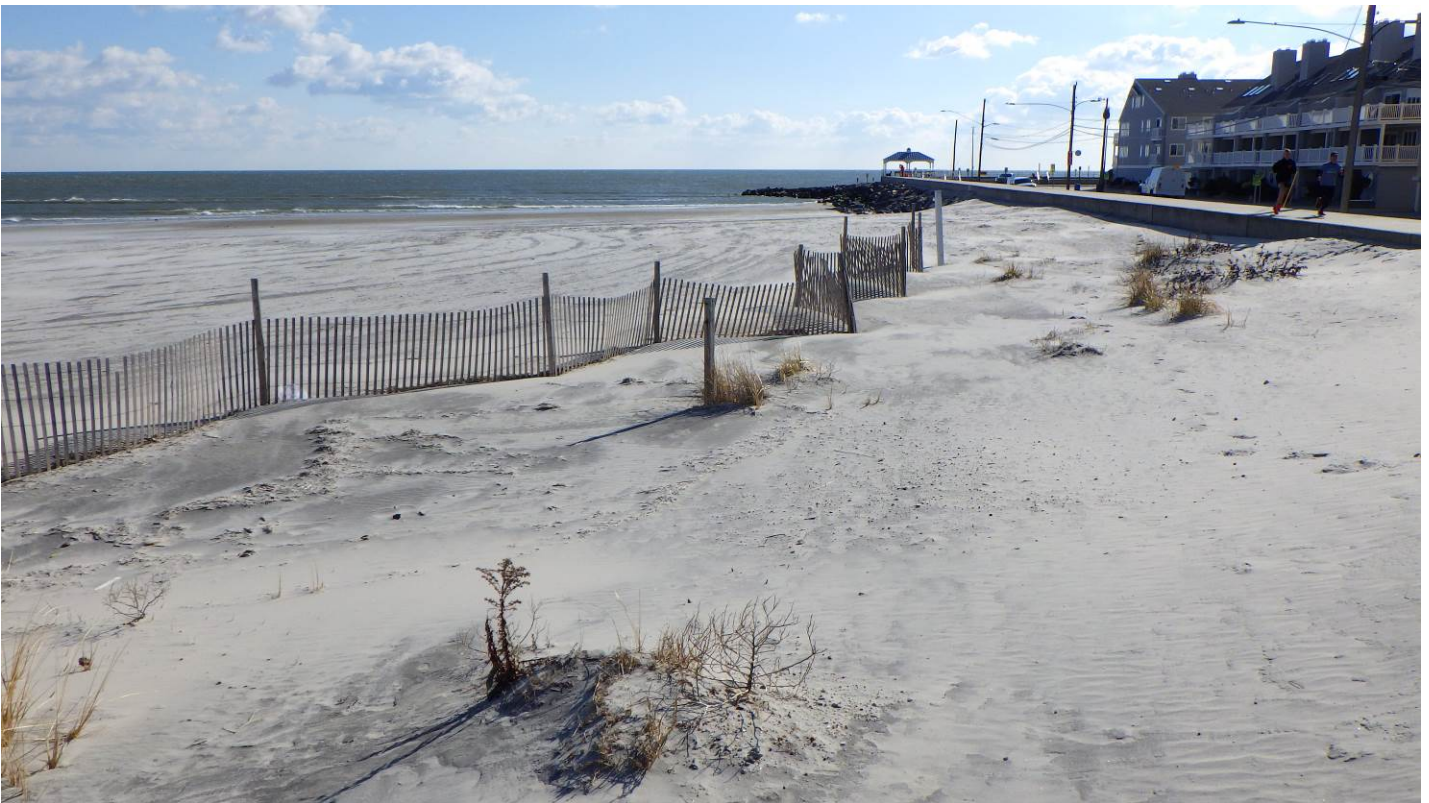
This is the northwestern most cross section on beaches open to public bathing. Further up the inlet the beach is closed for endangered species bird nesting every summer starting March 15th until August 30th. Sand was deposited here in quantity starting in about 2000 creating a large spit growing along the inlet revetment toward the end of New Jersey Avenue in North Wildwood. Surveys were initiated here during the 2009 NJ State/North Wildwood beach restoration project. In the past several years the southeastern portion of this beach has been erosional as inlet currents alter sand deposition and the oceanfront beach retreated to the point where material was unable to move past the jetty into the inlet shore.

Figure 26. This view on January 22, 2021 shows a view to the southeast along the toe of the dunes. The bathing beach is substantial in width with a taper to zero width at the 2nd Ave. and Kennedy Blvd. gazebo. The site stability is tied to loss from the oceanfront sand deposited each year derived from Wildwood City beaches. Flood tides act in concert with wave activity to move sand past the jetty into Hereford Inlet and it deposits along the inlet shoreline as an extended sand spit oriented into the inlet, along the City shoreline. Material initially deposits in the nearby offshore allowing ocean waves to move it landward adding to the beach eventually.

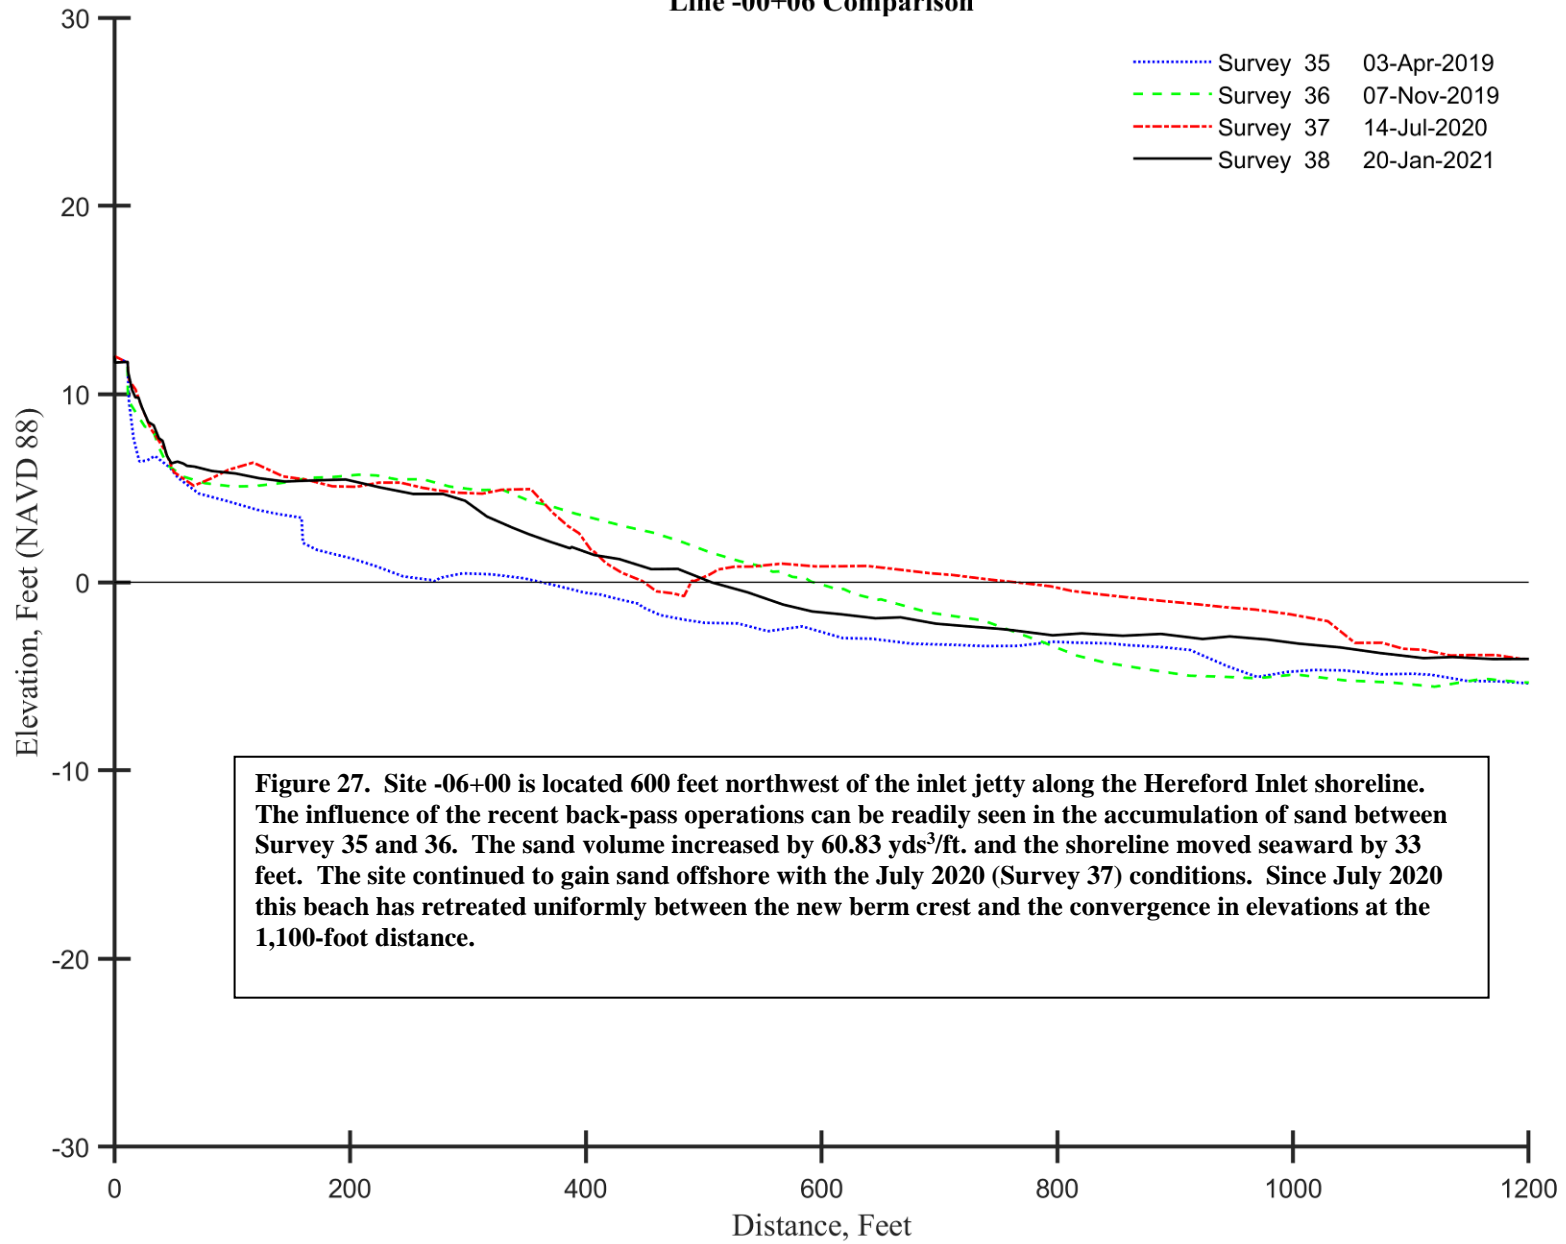
North Wildwood - Semi-Annual Comparison
Line -00+06 Comparison

Figure 27. Site -06+00 is located 600 feet northwest of the inlet jetty along the Hereford Inlet shoreline. The influence of the recent back-pass operations can be readily seen in the accumulation of sand between Survey 35 and 36. The sand volume increased by 60.83 yds³/ft. and the shoreline moved seaward by 33 feet. The site continued to gain sand offshore with the July 2020 (Survey 37) conditions. Since July 2020 this beach has retreated uniformly between the new berm crest and the convergence in elevations at the 1,100-foot distance.
