THE RICHARD STOCKTON COLLEGE OF NEW JERSEY

**An Assessment of Cape May County Beaches
at the
New Jersey Beach Profile Network (NJBPN) Sites
After Hurricane Sandy
Related to
(DR-NJ 4086)**

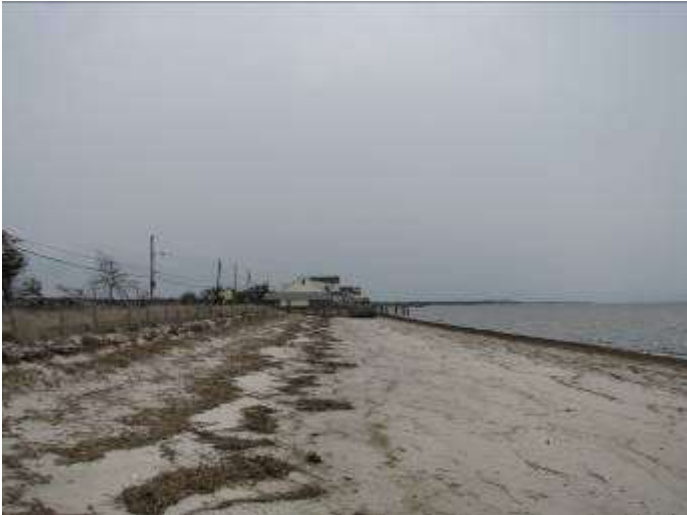
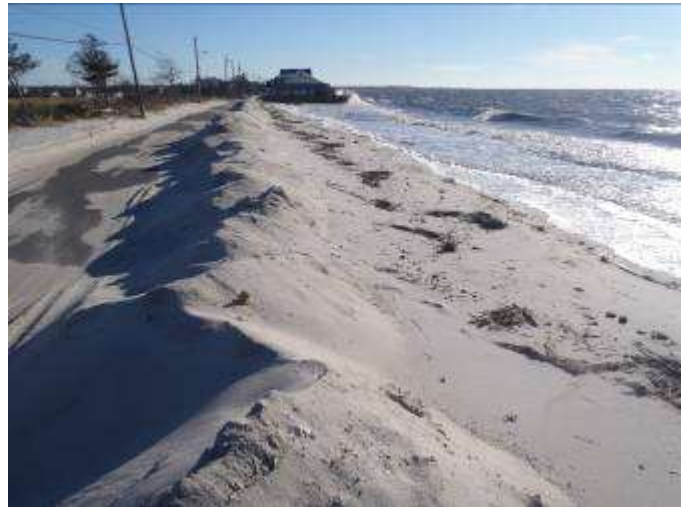
Reeds Beach, Cape May County, Site #100;

The left photograph was taken March 5, 2012 looking south. The dune was vegetated and the beach was higher in elevation compared to the post-Sandy picture on the right taken November 9, 2012. The sand in the center of the right photo has been transferred from the roadway back to the beach as a series of piles.

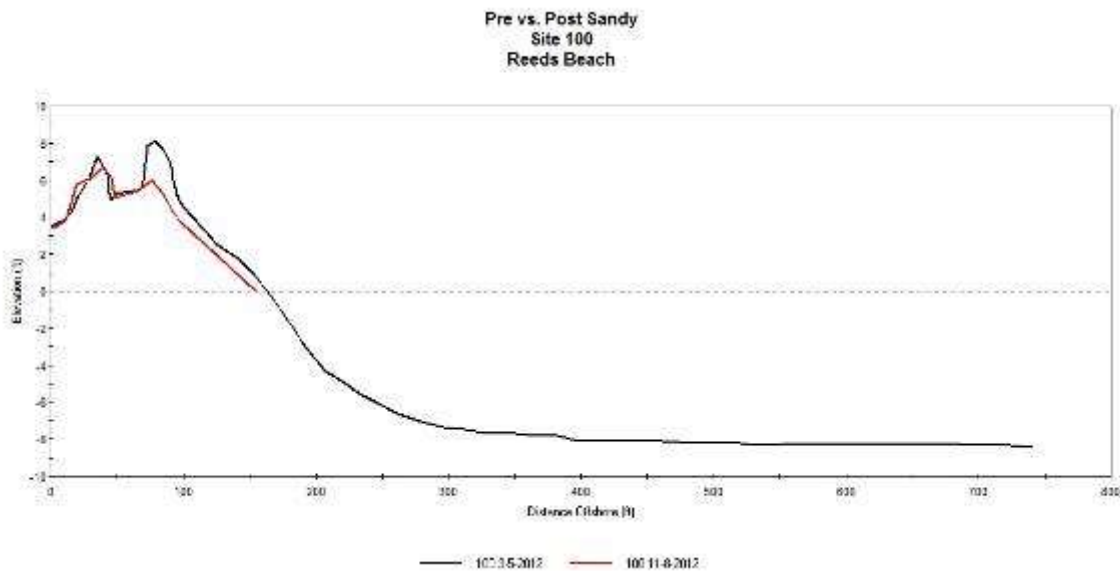
Figure 2. Reeds Beach, Cape May County is located on the western shoreline facing into Delaware Bay. This beach was nourished using dredge material from Bidwell Creek to the north in 2010. The “dune” between the road and the bay was removed and the sand pushed across the road into the salt marsh. The shoreline retreated 8 feet as well. The lost material will not return to the beach except for the material excavated from the roadway.

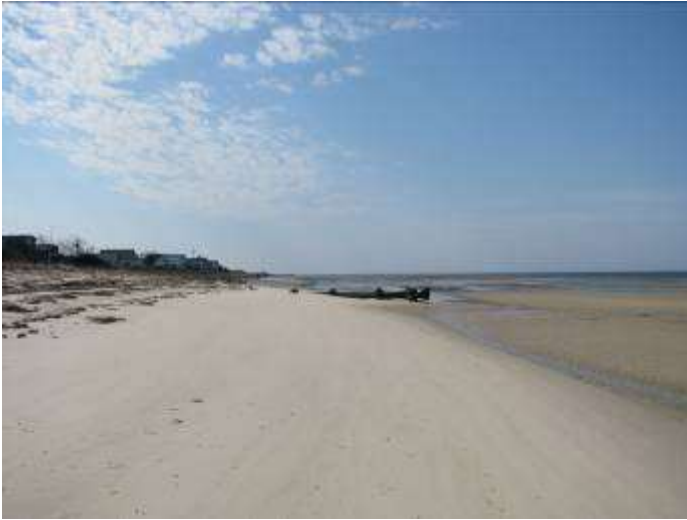
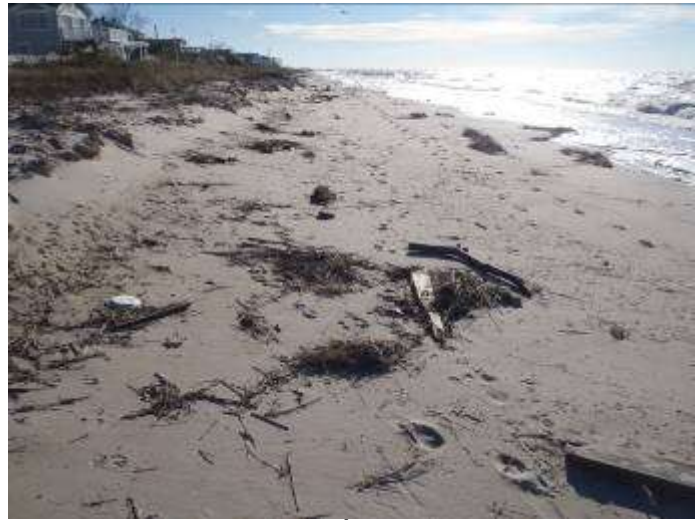
Pacific Avenue, Villas, Cape May County, Site #201;

The left view was taken March 7, 2012 looking south along the beachfront. By November 9th the storm impact was found to have eroded the beach into the toe of the dune reducing the beach elevation and creating a minor scarp. The height of the uplands bluff prevented local wave or tidal flooding.

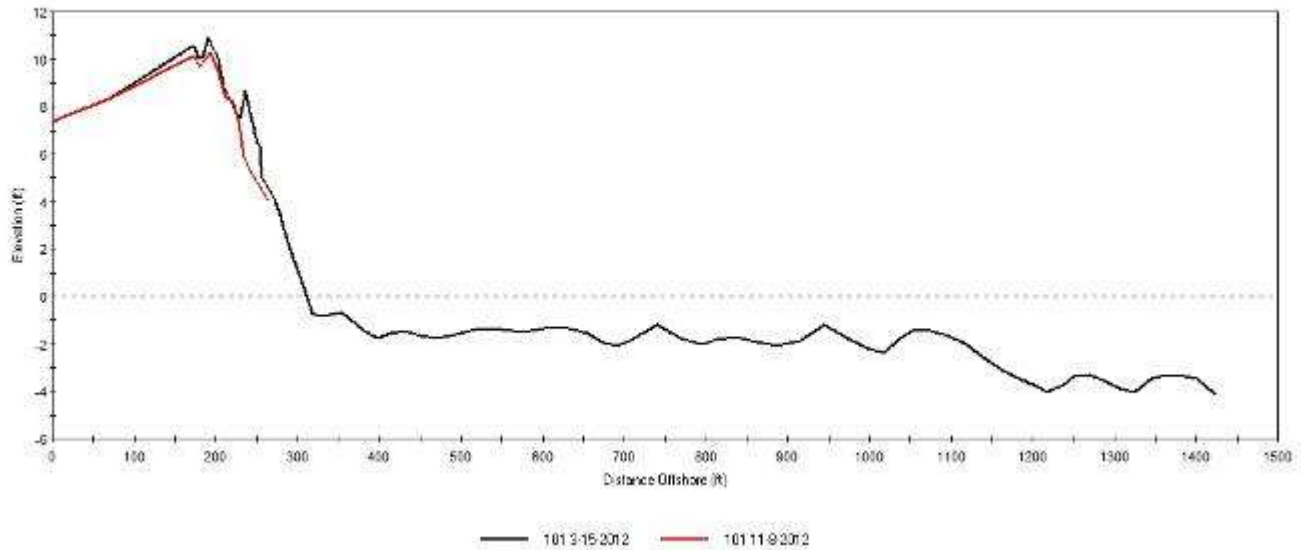
Pre vs. Post Sandy
Site 201
Pacific Ave., Villas

Figure 3. The wide shelf terrace likely saw sediment shifted around, but little erosion vertically appeared to have drastically changed the situation. The small foredune was removed and waves lowered the beach elevation, likely moving sand onto the nearshore terrace segment.

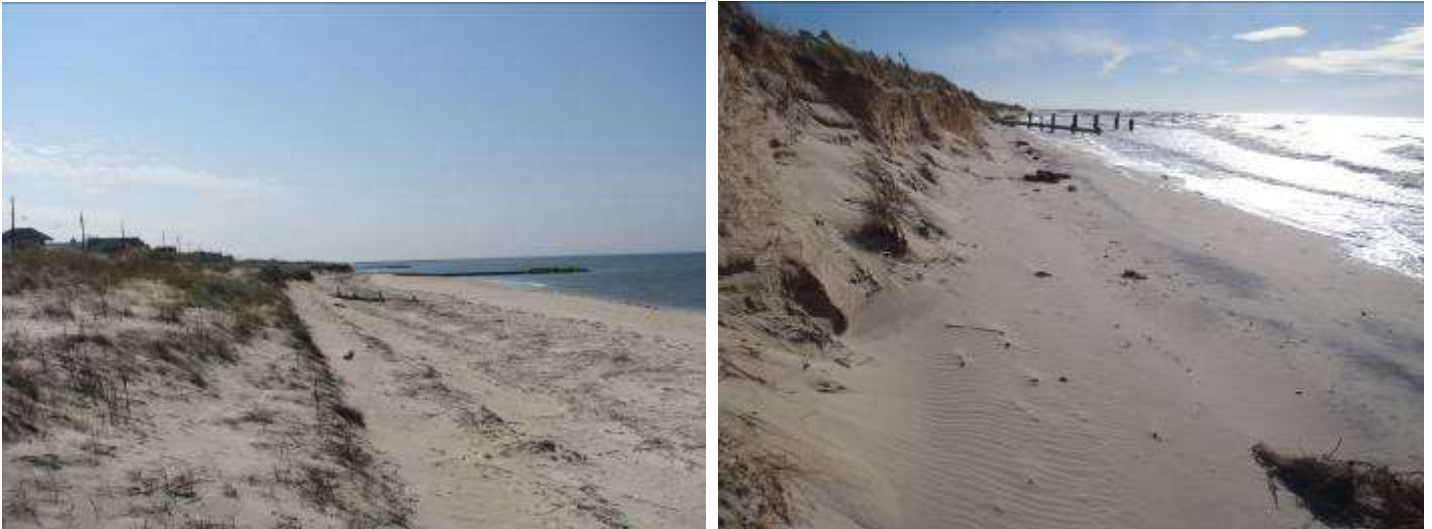
Whittier Avenue, North Cape May, Cape May County, Site #102;

At Whittier Avenue the drainage line shows the extent of beach erosion between March 15, 2012 and after Sandy on November 9th. Sand was moved offshore onto the terrace, but the dune withstood the majority of the Delaware Bay wave assault on this shoreline.

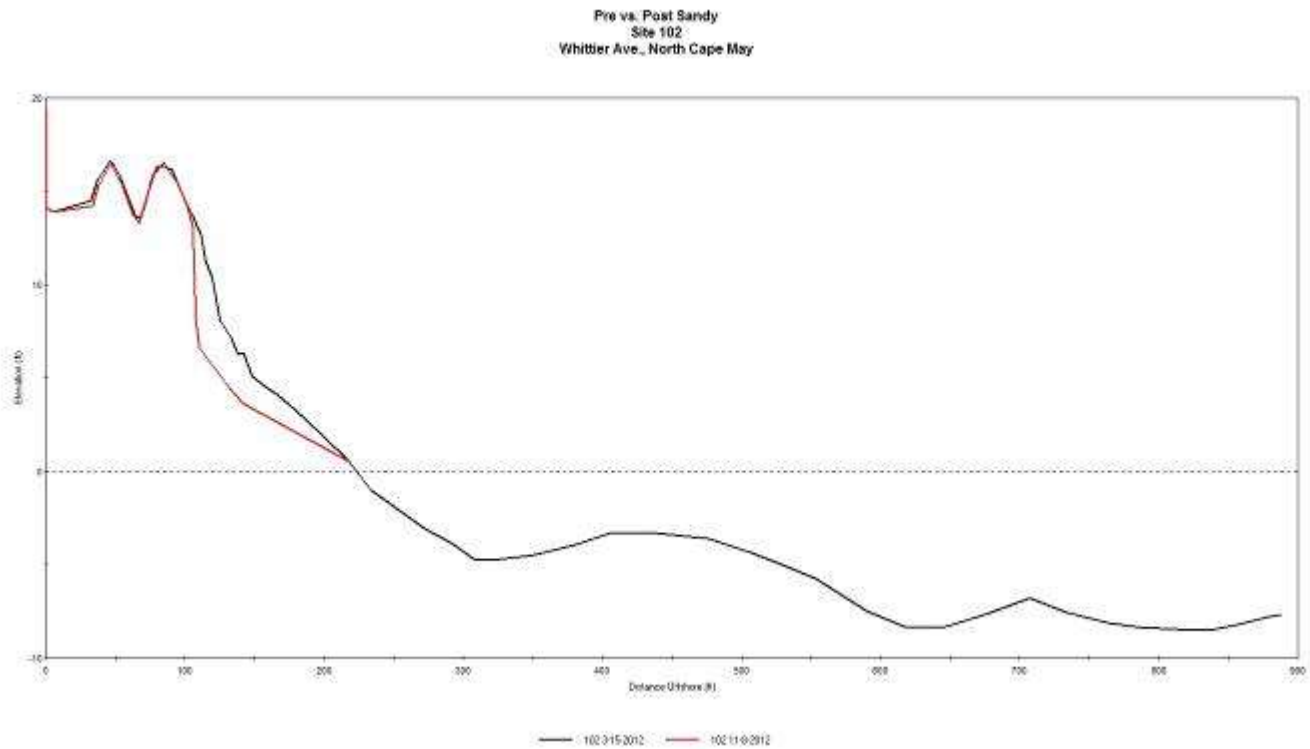
Figure 4. The cross section shows the erosion into the seaward toe of the dune with the post-storm beach slope meeting the pre-storm line at a much lower slope angle. Sand was transported offshore at the expense of the existing beach and dune.

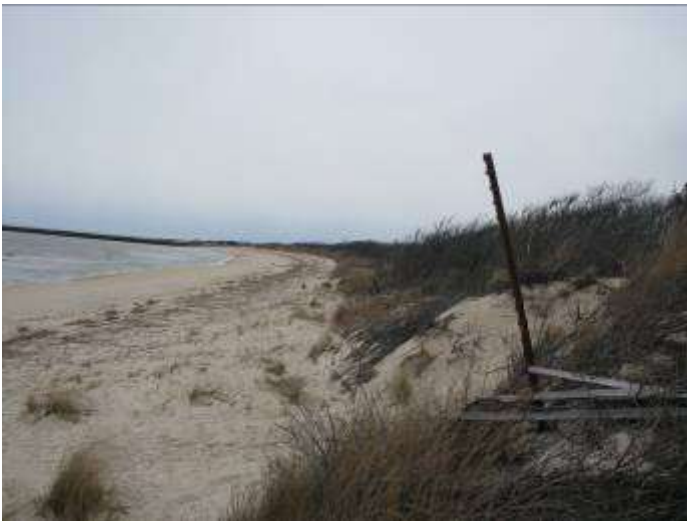
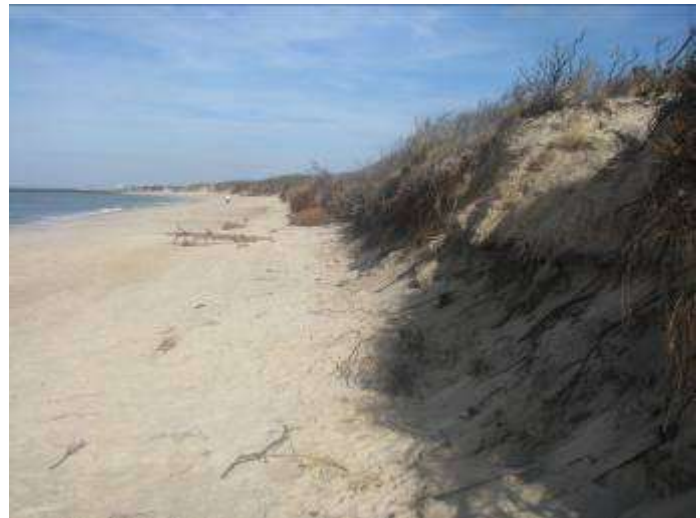
Higbee Beach State Park, Cape May County, Site #103;

The left picture was taken March 5, 2012 while the post-storm picture on the right was taken November 20, 2012. The shoreline at the State Park, south of the Cape May Canal suffered bluff erosion into the mantle of wind-deposited sand that mantles the scarp. The incipient grasses were stripped away between the high tide line and the base of the bluff during Sandy. The beach was lower but wider with some sand moved into the bay.

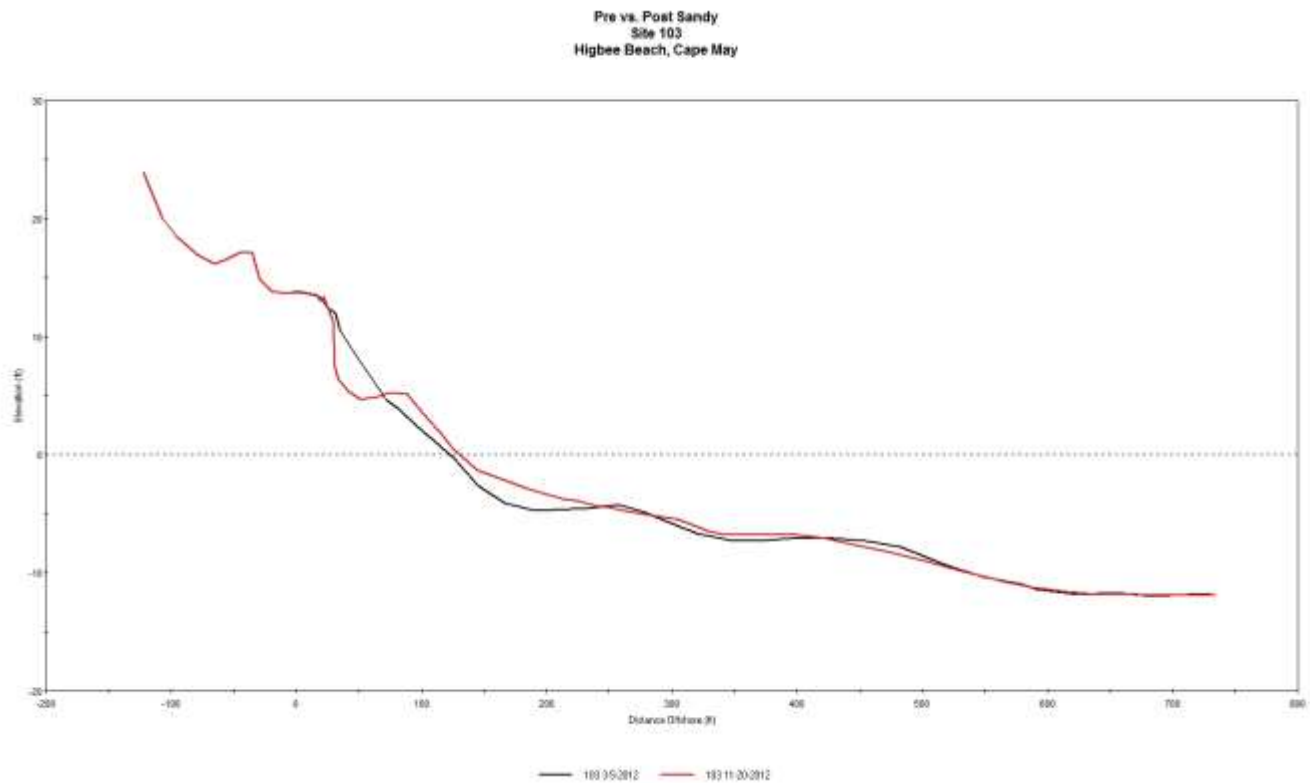
Figure 5. The bluff was cut into a more vertical slope to the beach with sand deposited offshore. Note that little change occurred further into the bay below the 5.0-foot depth. While the waves were large by Delaware Bay standards, they were of short period and therefore unable to impact the bay floor below the 5-foot depths. Surge elevations made the depths greater by 4-5 feet as well, so when the waves were active the bay floor beyond the 250-foot distance was between 10 and 12 feet of water depth.

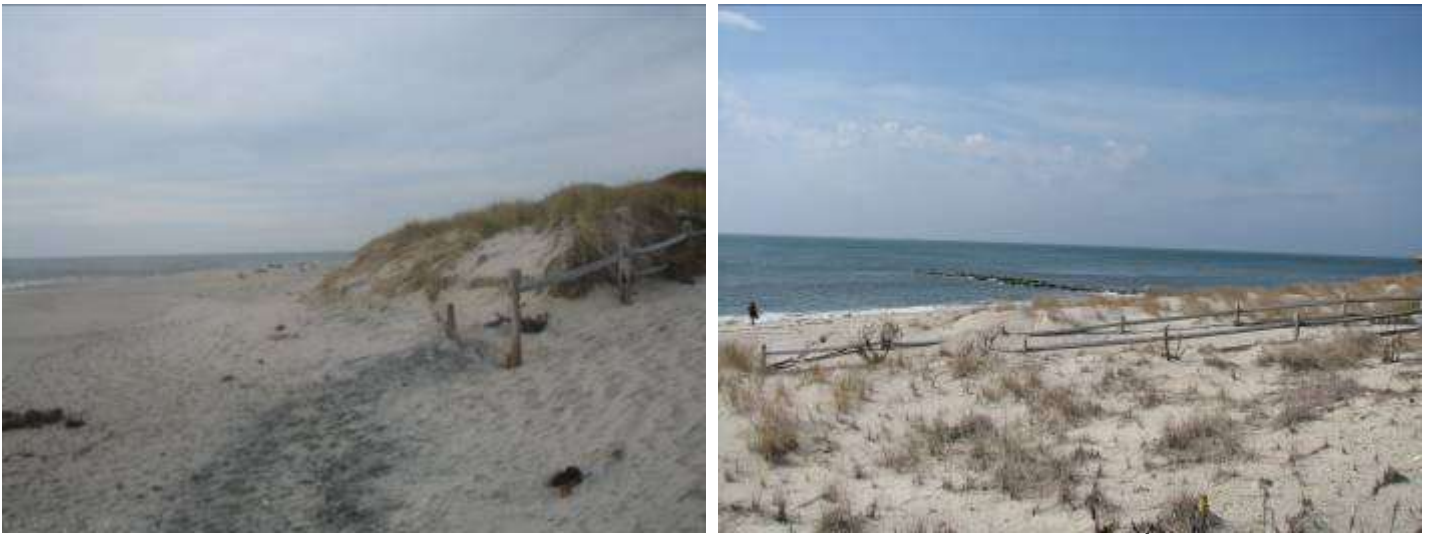
Lake Drive Cape May Point, Cape May County, Site #104;

The left picture was taken March 15, 2012 while the post-storm photograph was taken November 20th looking across the dunes to the bay. The beach was reduced in width somewhat, but no erosion occurred in the dunes. This location was essentially untouched by the storm.

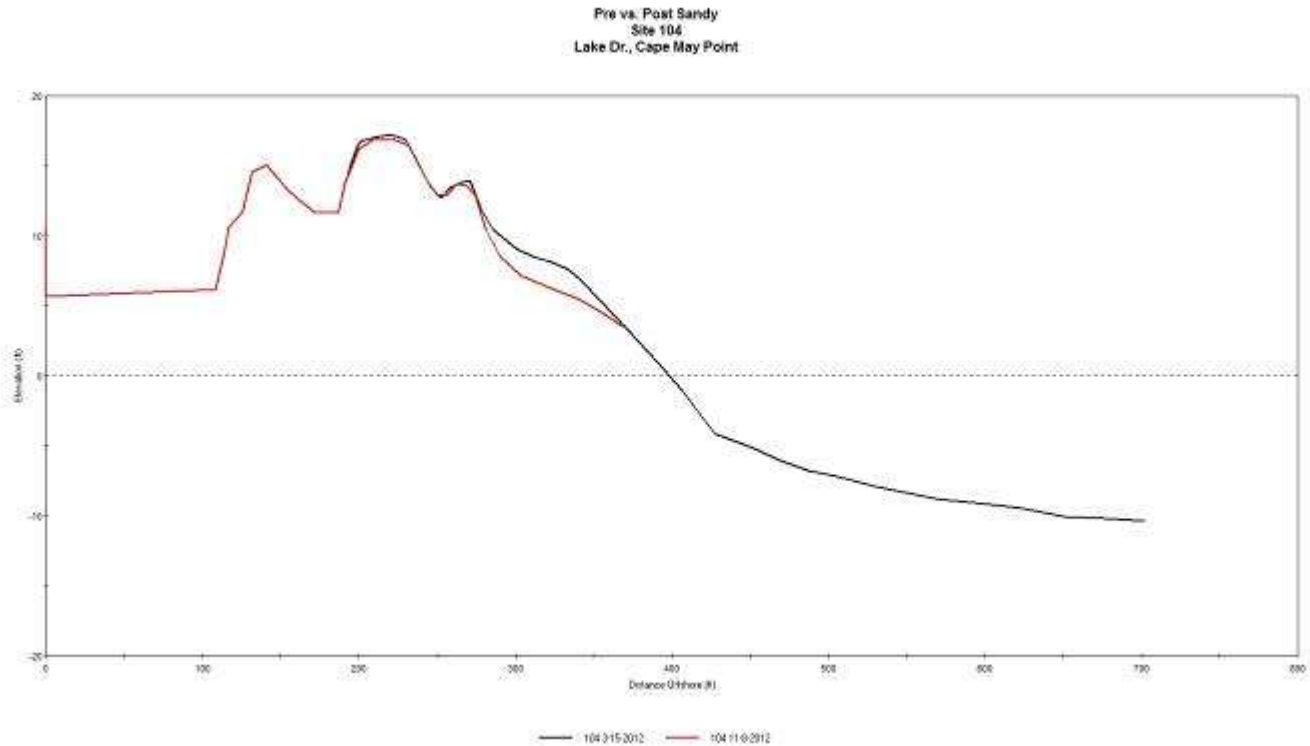
Figure 6. The Lake Drive location faced in a direction where very little direct storm impact was seen. The northeast winds early in the Sandy storm had no impact, while the southwest waves from Delaware Bay reached to the toe of the dunes and acted solely on the upper beach surface to lower its elevation somewhat.

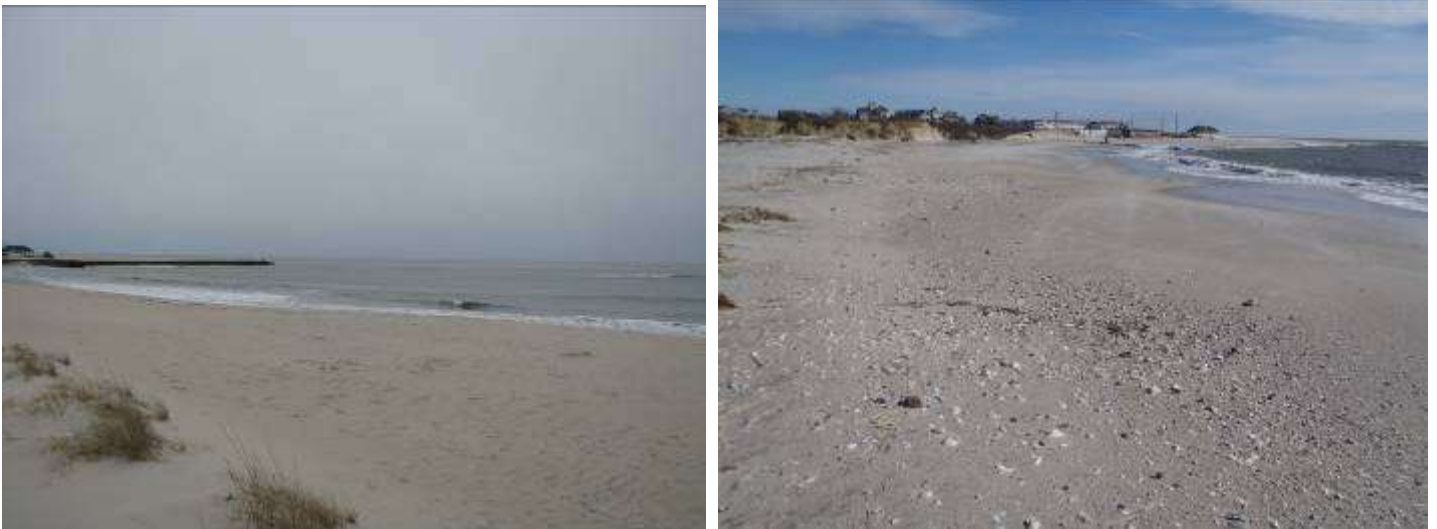
Nature Conservancy, Cape May County, Site #105;

The left picture was taken March 5, 2012 looking toward the terminal groin in Cape May City. The left shot was done November 9th showing the dune erosion and overwash into the newer dune development that has occurred over the past 22 years since the initial beach restoration took place in Cape May City in 1990.

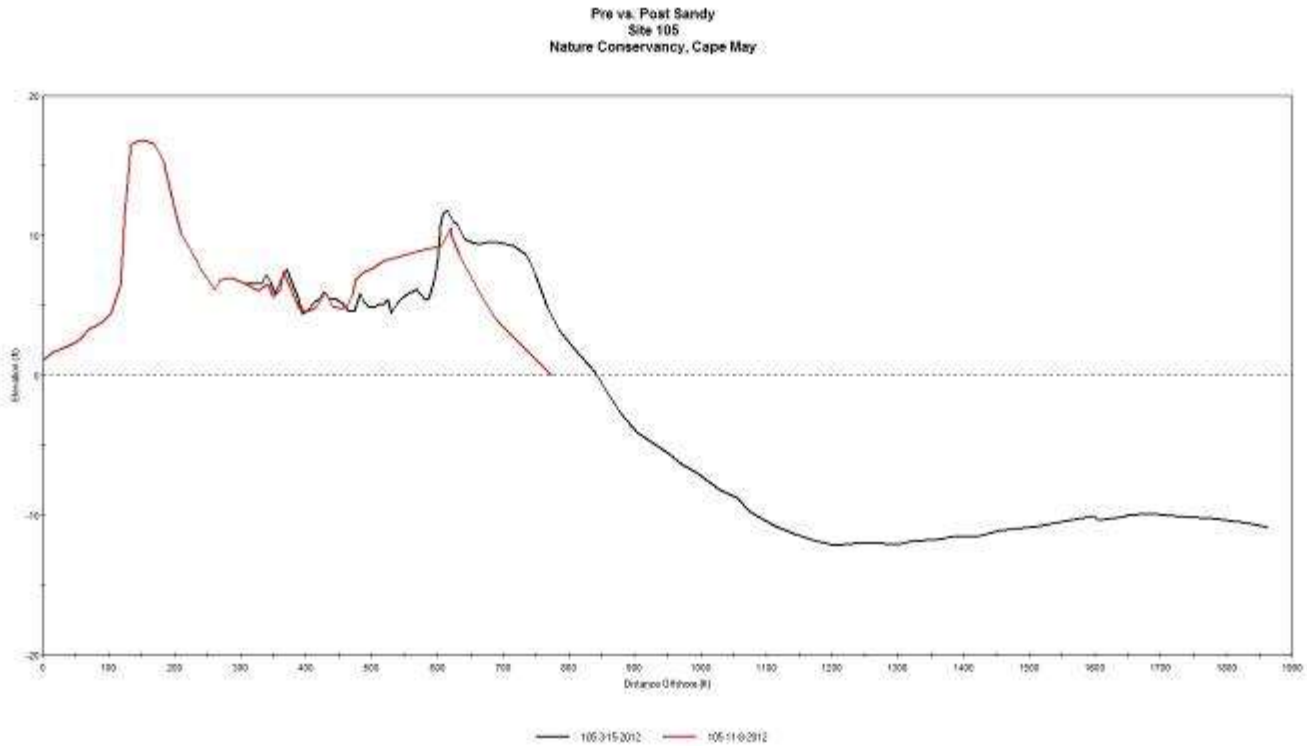
Figure 7. The very south section of Cape May City was exposed to storm damage because almost no dune or hard structure protection existed immediately south of the Third Avenue rock groin. A few buildings, several owners of which had opposed the building of an extension of the dune system found in the Nature Conservancy lands suffered wave surge flooding as a result. The storm surge did invade the naturally extended dunes depositing substantial quantities of the beach and seaward dune material.

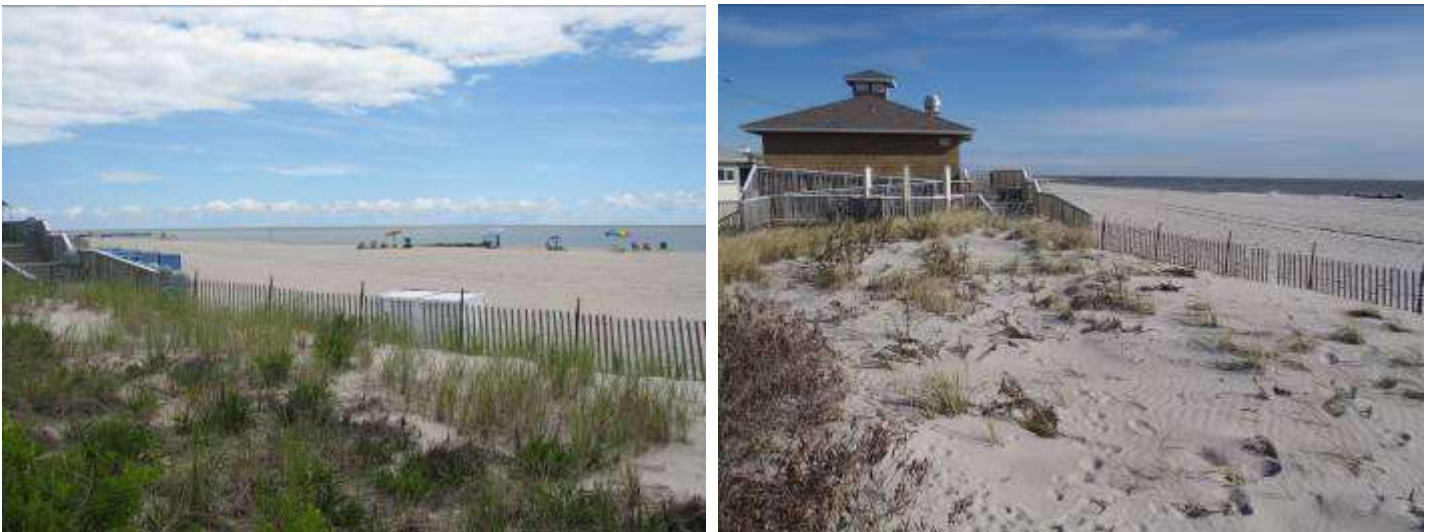
Broadway Avenue, Cape May City, Cape May County, Site #206;

The June 5, 2012 picture shows the popular bathing beach at the beginning of the last summer season. The right side shows the post-storm view on November 9th. The elevation increase shown below can be seen in the smaller slice of ocean in the right-hand view as compared to the left side. The seaward stair railings in both pictures have the same relative relationship to the horizon indicating that the view from the camera is almost the same elevation in both pictures.

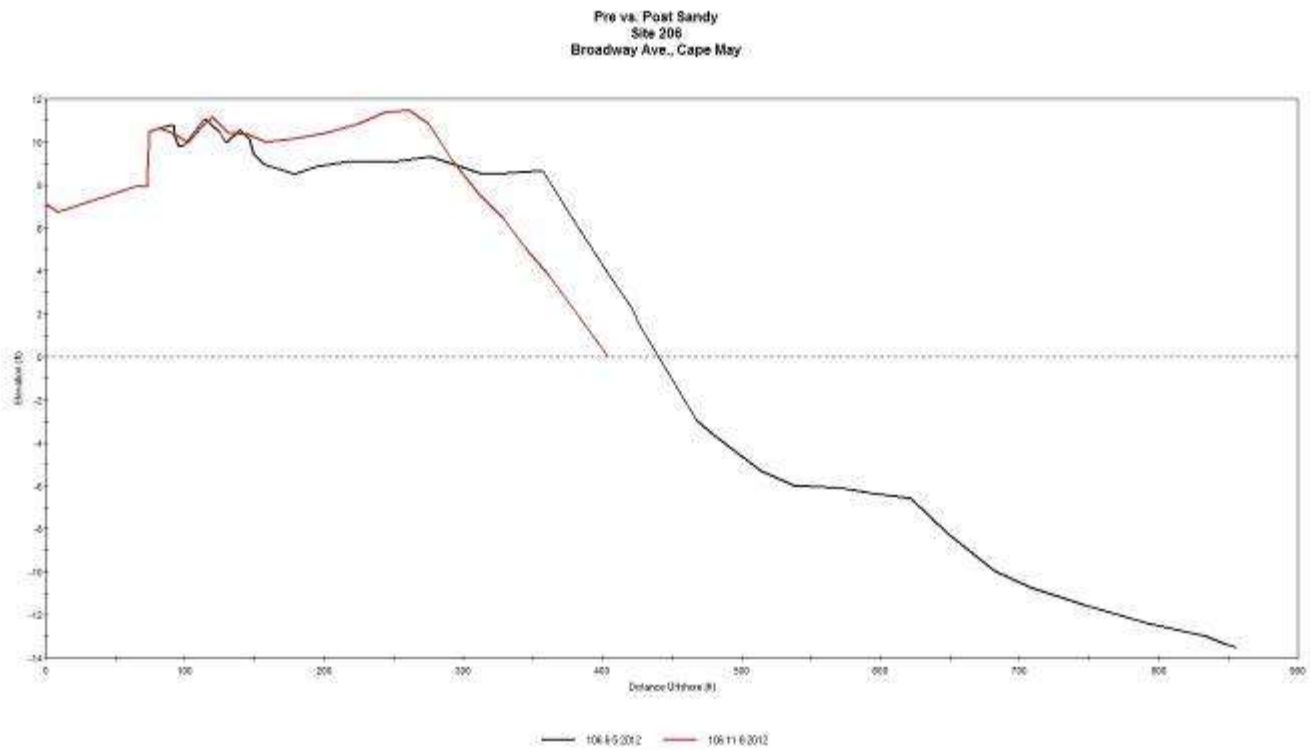
Figure 8. Located at the southwestern end of the Cape May City beach, this site saw substantial beach width loss, but the sand removed was pushed landward onto the remaining dry beach raising its elevation by up to 5 feet. Very little sand was transported into Ocean Avenue by the storm.

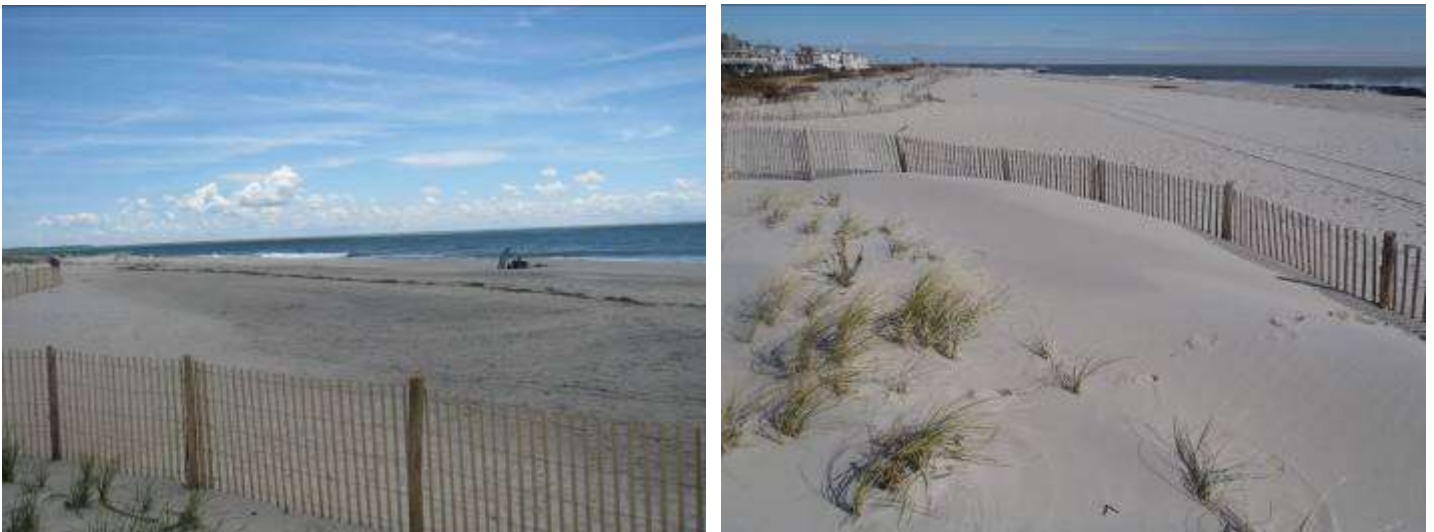
Baltimore Avenue, Cape May City, Cape May County, Site #107;

The left picture was taken in June 5, 2012 showing the beach toward the northeast. The post-storm shot on the right was taken November 9th in the same orientation. The sand can be seen deposited around the fencing leaving only two rows of wire above the sand while in June there were 5 rows of wire showing. Here the beach was also widened toward the zero elevation position.

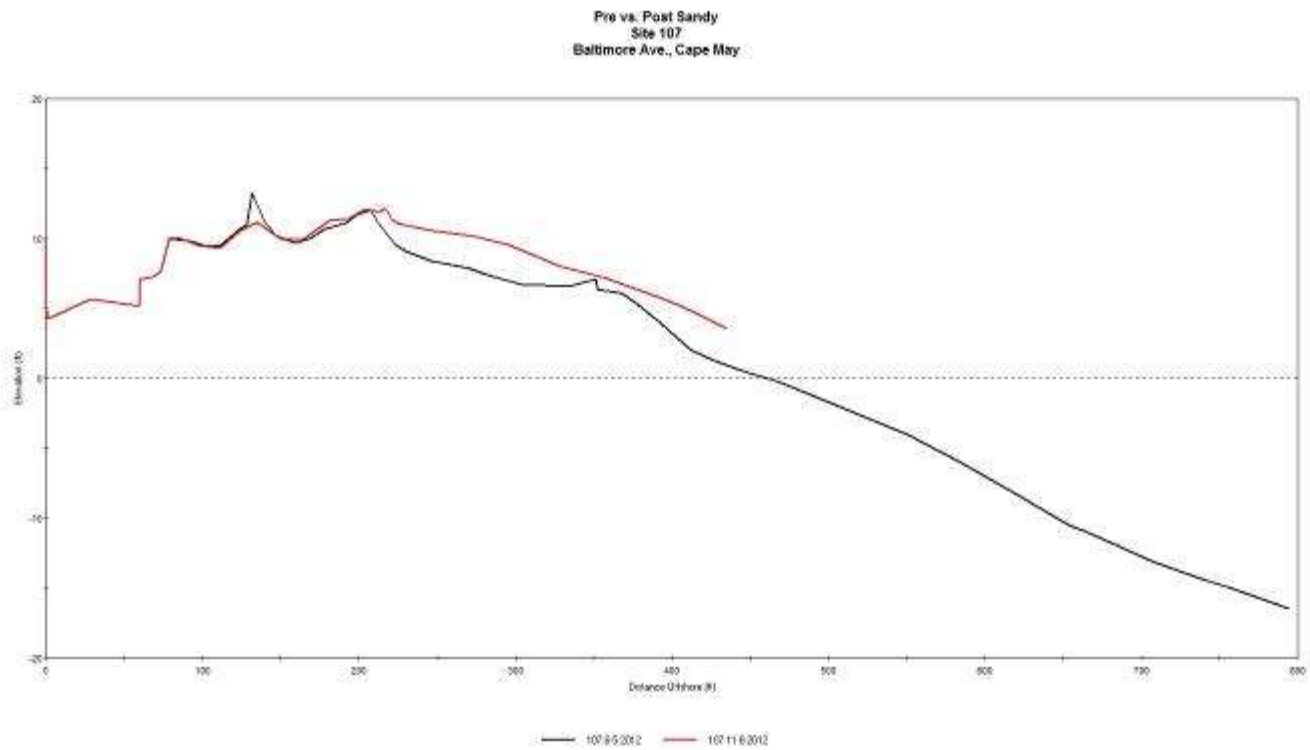
Figure 9. At Baltimore Avenue the beach was made wider and sand was pushed up onto the berm raising its elevation by 2-3 feet all the way landward to the fore dune slope. This beach segment had unusual responses to Hurricane Sandy.

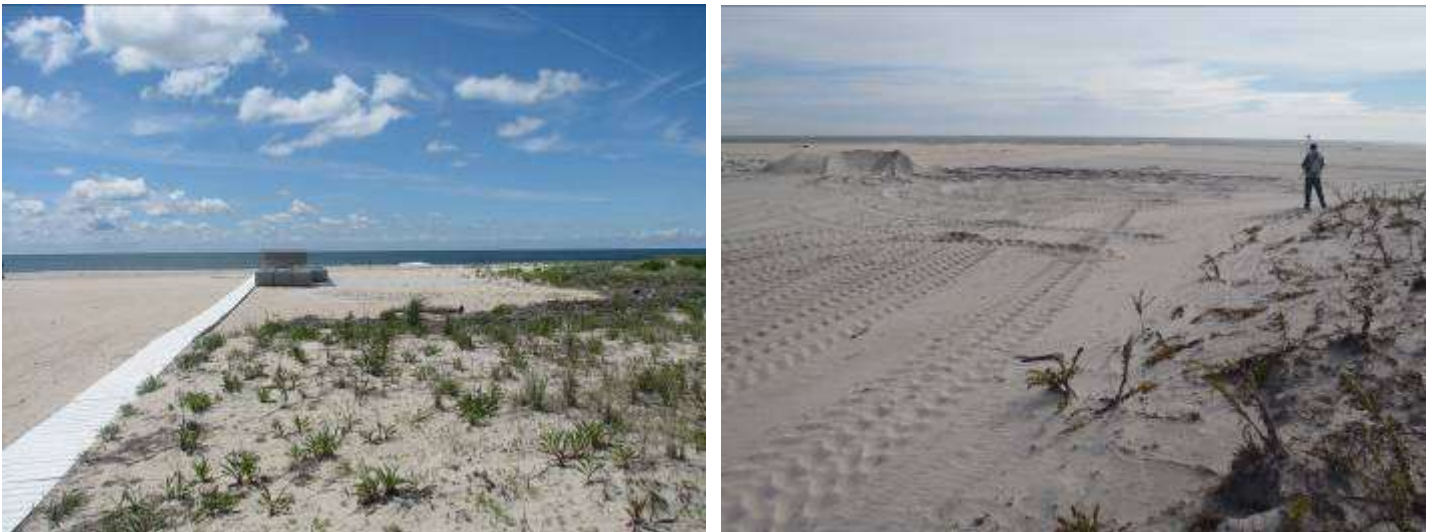
Cape May Beach Club, Cape May City, Cape May County, Site #108;

On June 5, 2012, the beach was wide with the removable boardwalk ready for the summer. The post-storm picture on the right was taken November 9th at approximately the same spot looking southeast to the ocean. Assuming that the photographers are all about the same height and were standing when they took the shots, the berm elevation covers far more of the view of the ocean in November than it did in June. The cross section below shows why.

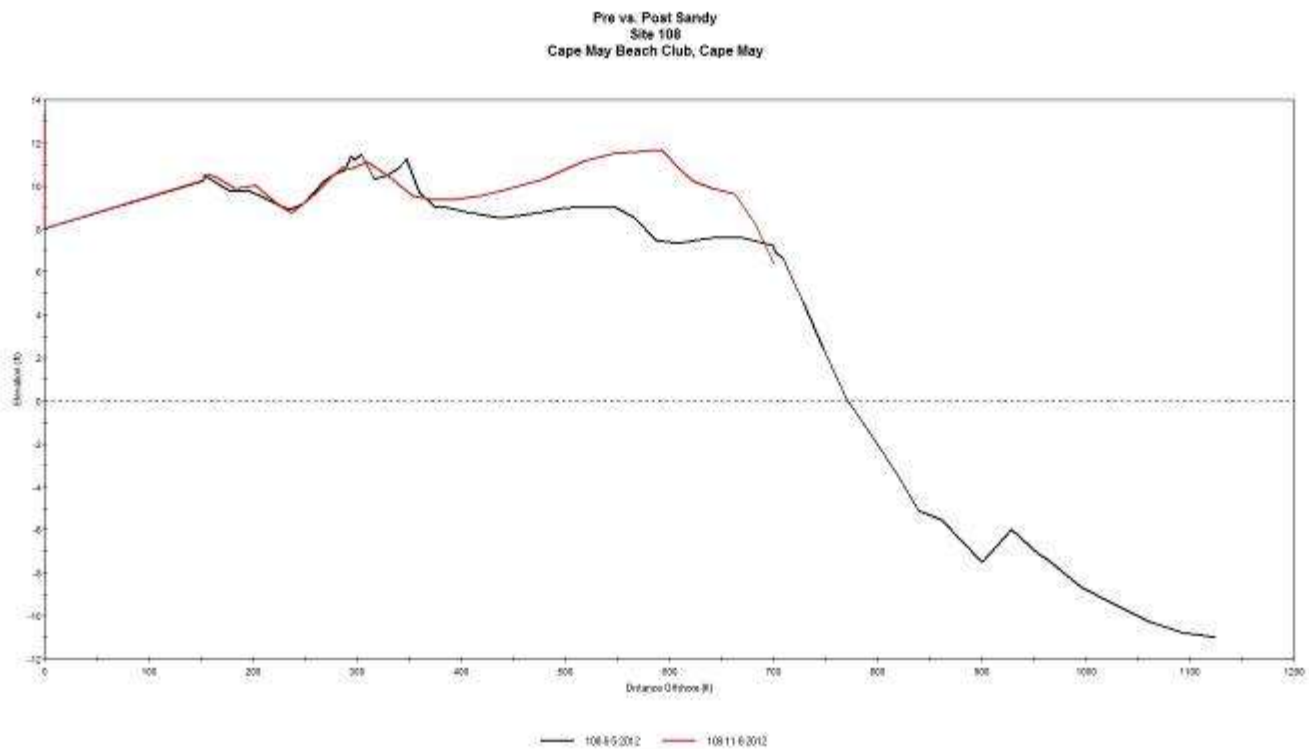
Figure 10. The northeastern most site in Cape May City is occupied by the Cape May Beach Club. Here the beach remained essentially the same width, but with up to 3 vertical feet of sand deposited on the dry sand between the berm crest and the small dunes landward. The deposit covers 300 feet horizontally and amounts to 22.63 yds³/ft. of sand from up drift or offshore deposited above high tide by the storm. The CRC staff captured NJ surf cam views of ocean waves on October 28th and 29th prior to the loss of electric power and the Cape May City camera recorded absolutely picture-perfect 8-10 foot breaking waves ideal for surfing. These waves came to the Cape May City shoreline suited for building up sand beaches, not eroding them. The data for sites #105, 206, 107 and 108 bear this out since all exhibit deposition on the upper dry beach accompanied by some erosion of the beachface.

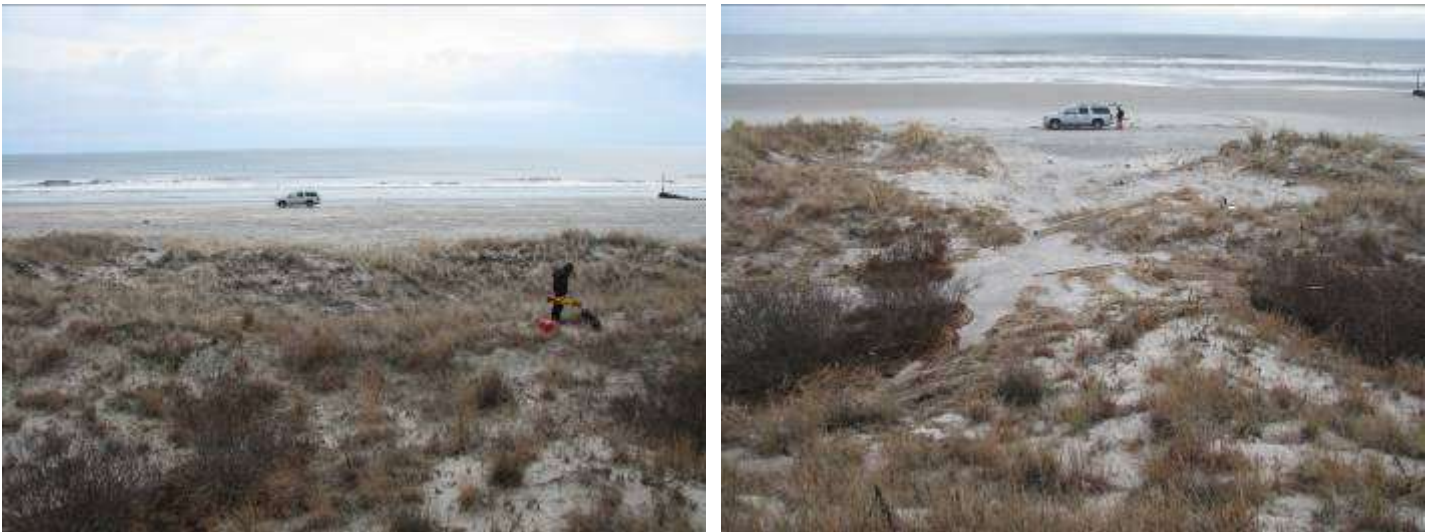
US Coast Guard Base, Lower Township, Cape May County, Site #208;

The left picture was taken March 9, 2012 looking toward the sea. The natural areas were surveyed last and done with normal procedures, so the length of the surveys are equal and extend well off shore. The outfall line shows in both photographs (December 11th for the right side) and shows that little change in beach elevation occurred. The berm was eroded somewhat and transported toward the dunes. Water reached into the new foredune area directly landward of the vehicle and washed up into the second ridgeline. The new, white sand in the center of the right photo is not present on the left side.

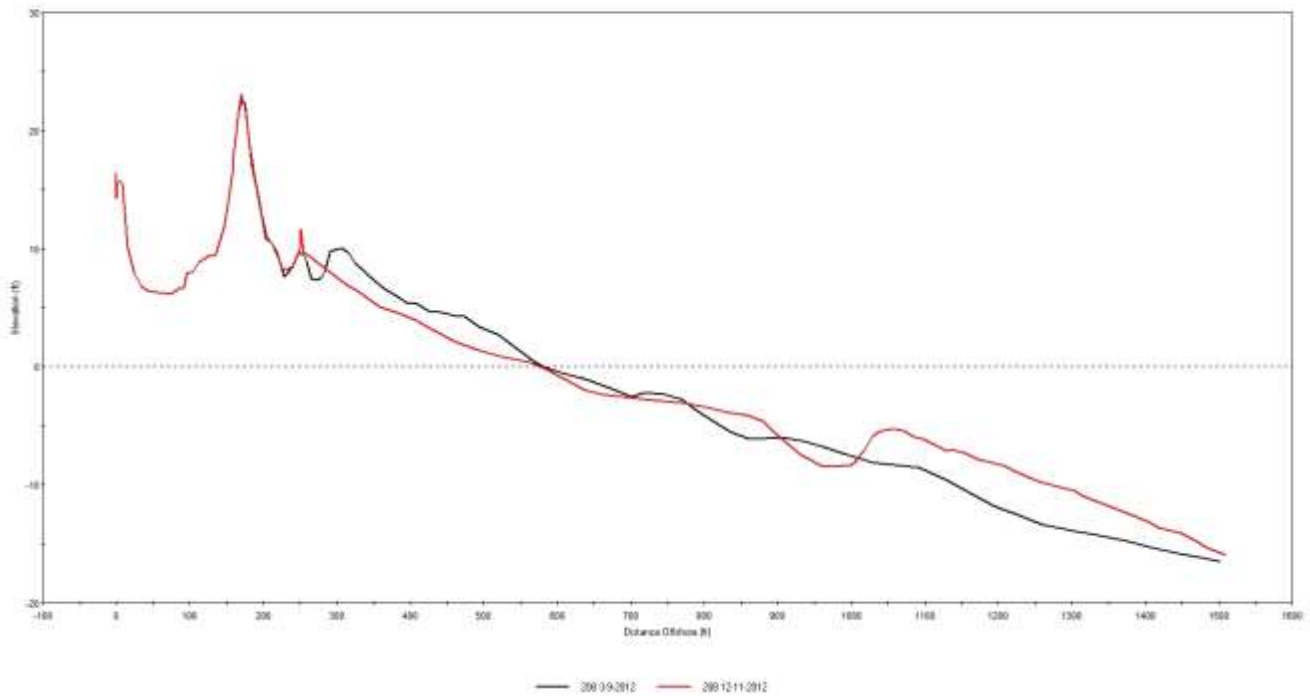
Pre vs. Post Sandy
Site 208
Cape NWR, Lower Township

Figure 11. The small foredune was eroded away along with the upper berm on the beach. Bar material was becoming organized offshore by December 11, 2012 when this site was surveyed following Sandy.

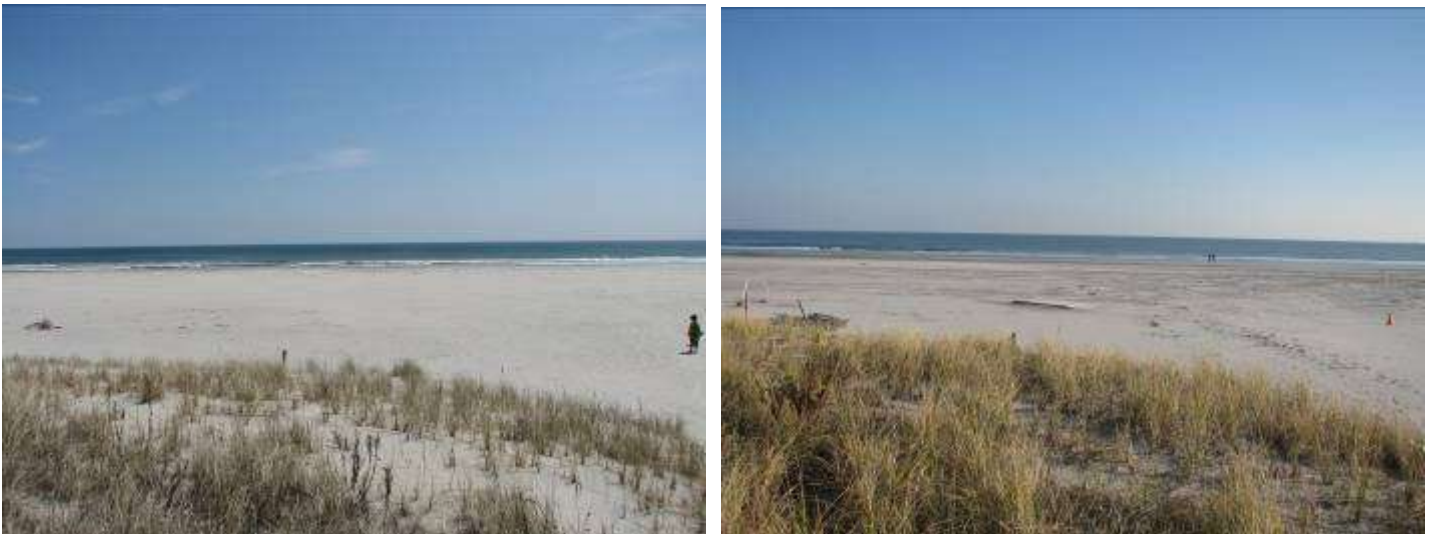
Raleigh Avenue, Lower Township, Cape May County, Site #109;

The early spring photograph of the beach taken April 4, 2012 is shown on the left. The right-hand view was taken November 29th a month after the storm. Here sand was forced landward to the toe of the dunes where a deposit filled in a slightly lower part of the beach than the berm. The sand on the berm was likely the source of the deposit since the storm surge flooded the entire dry beach.

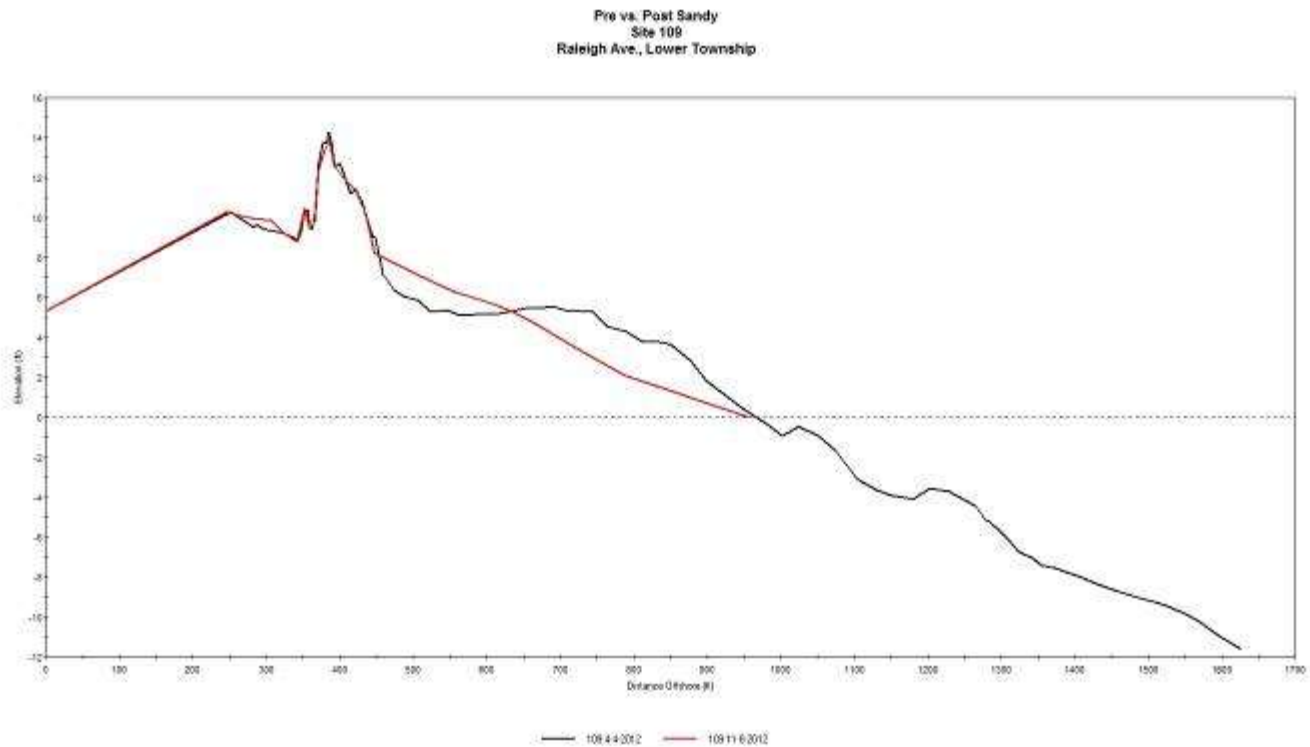
Figure 12. The storm's beach flattening power is evident here as the berm was planed off and sand pushed landward into the seaward dune slope. The losses slightly exceeded the gains above the zero elevation datum. One would expect that sand was also deposited offshore rearranging the offshore bars.

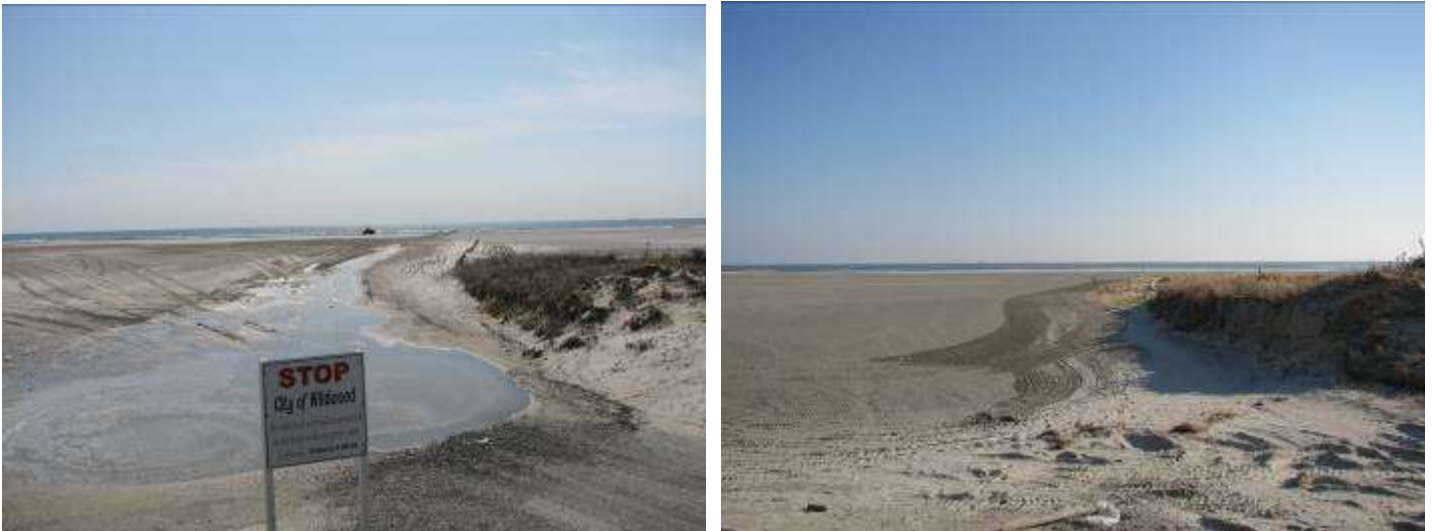
Cresse Avenue, Wildwood, Cape May County, Site #110;

On April 4, 2012 the view across the beach in Wildwood was taken from the tiny dune in front of the boardwalk. The November 29th view on the right was taken from the same location, but minus the sign. The beach gained sand at the berm 600 feet seaward of the boardwalk. The sand deposit probably was derived from the erosion of the spring survey's berm.

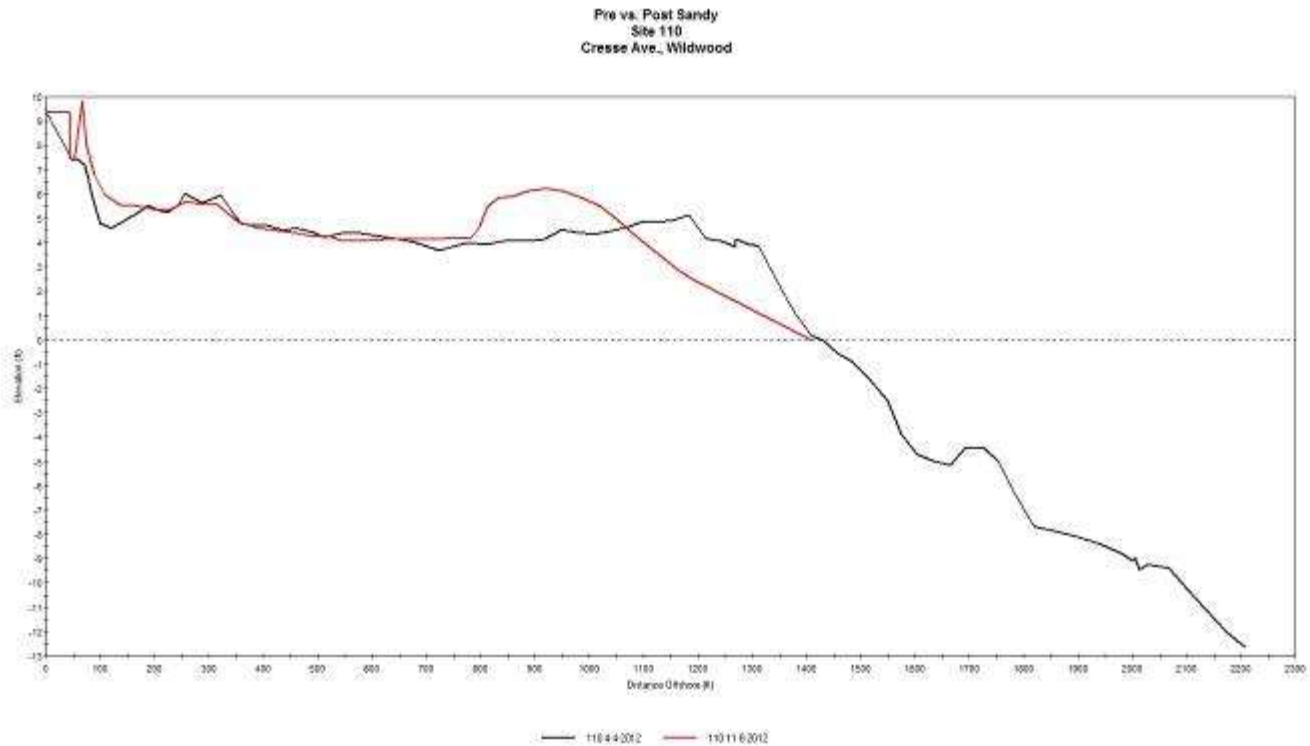
Figure 13. The beach in Wildwood responded differently by having the berm and upper beachface moved landward by 250 feet and deposited as a “super berm” well above sea level. One unanticipated consequence of this style of deposition is that future seawater over-topping of this deposit could cause serious flooding by trapping rain plus seawater between the berm and the City. The City has been plagued with repetitive “berm-top ponds” in the past and this looks like a potential issue.
