THE RICHARD STOCKTON COLLEGE OF NEW JERSEY

**An Assessment of Cape May County Beaches
at the
New Jersey Beach Profile Network (NJBPN) Sites
After Hurricane Sandy
Related to
(DR-NJ 4086)**

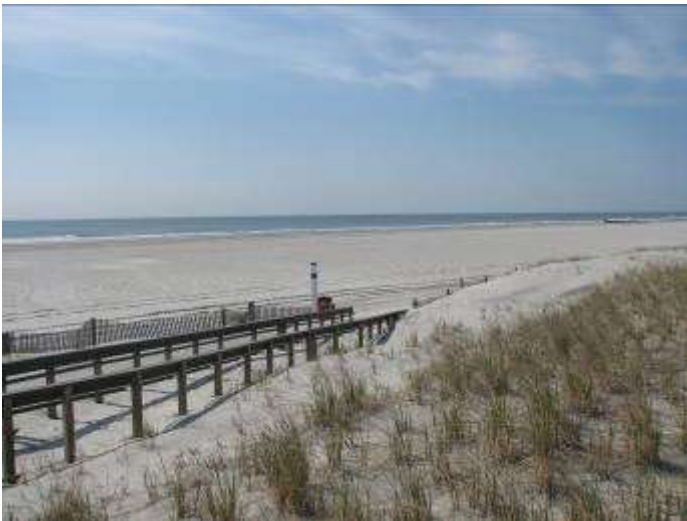
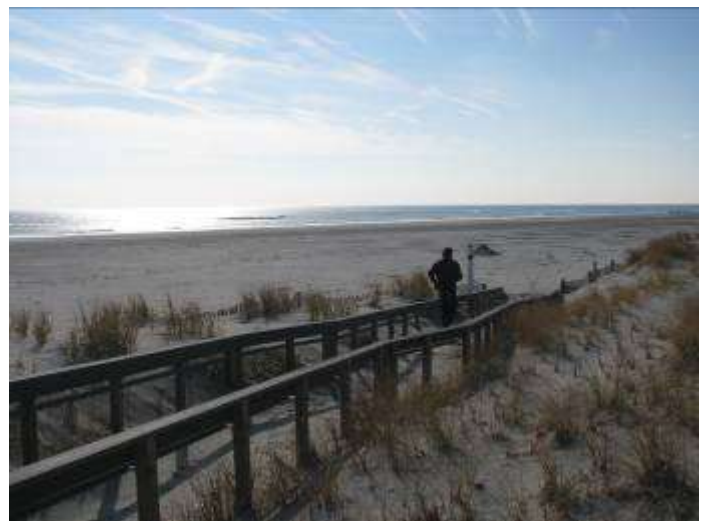
15th Avenue, North Wildwood, Cape May County, Site #111;

The view to the southeast from 15th Avenue dune crossover was taken April 4, 2012. The picture following Sandy was taken on November 29th and is on the right. Summer dune grass growth shows in spite of the storm. The waves did flow across the entire dry beach (seen on TV, channel 10 Monday morning) and ramped up a deposit onto the seaward dune toe. No dune breach occurred near this location. Further south at the piers, the dune was erased because it was built to pass seaward of the pier ends and was far more exposed to wave action. Erosion at the very northeast corner of the City also removed the dune south to 4th Avenue and over-topped the bulkhead revetment there.

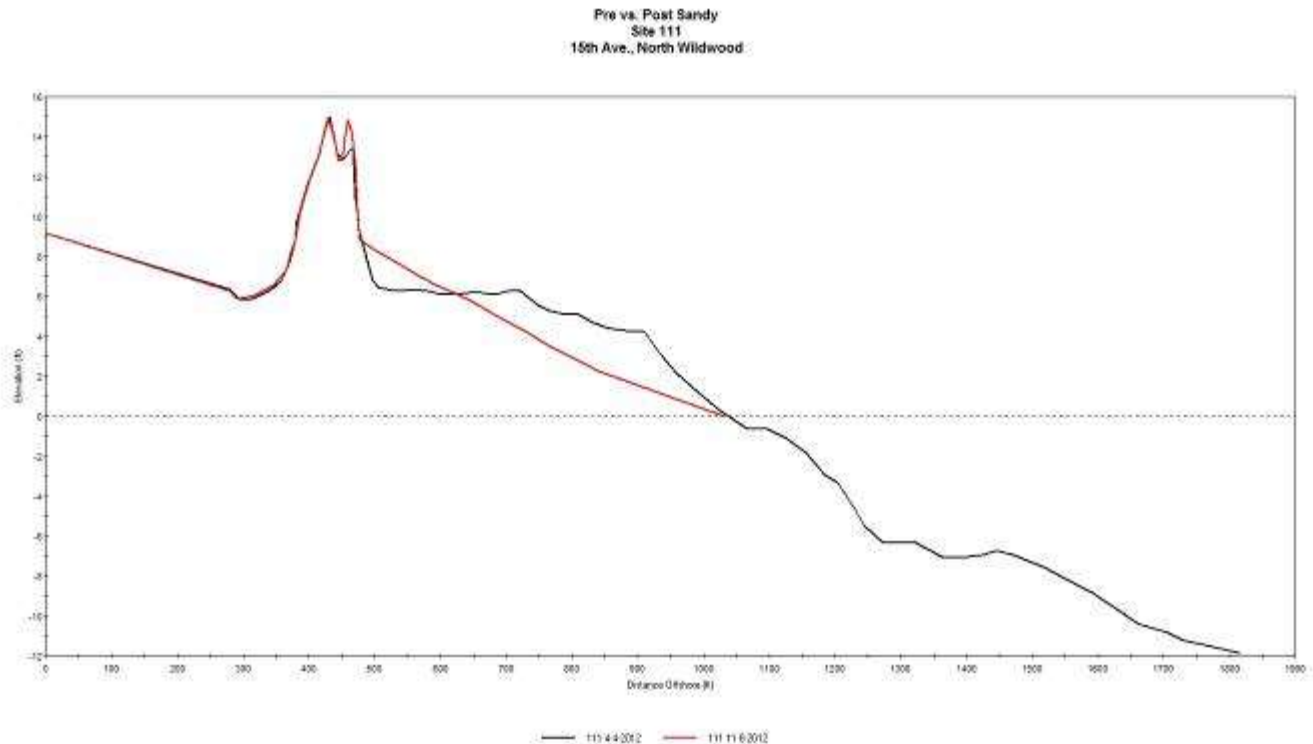
Figure 14. This North Wildwood site was included in the 2009 beach nourishment project conducted by the State and local funding. Damaged by three northeast storms between November 2009 and December 2010, a FEMA-coordinated repair was completed in late 2011 into 2012. During the spring of 2012 the municipality completed a 93,000 cubic yard sand backpass from the Borough of Wildwood Crest, placing the sand along the dune toe from 3rd Avenue south to 7th Avenue. The dry beach here was dramatically flattened by Sandy with sand pushed up to elevation 9.0 at the seaward dune toe, derived from the seaward berm and beachface. Sand further offshore may move landward to restore some of the lost material over time.

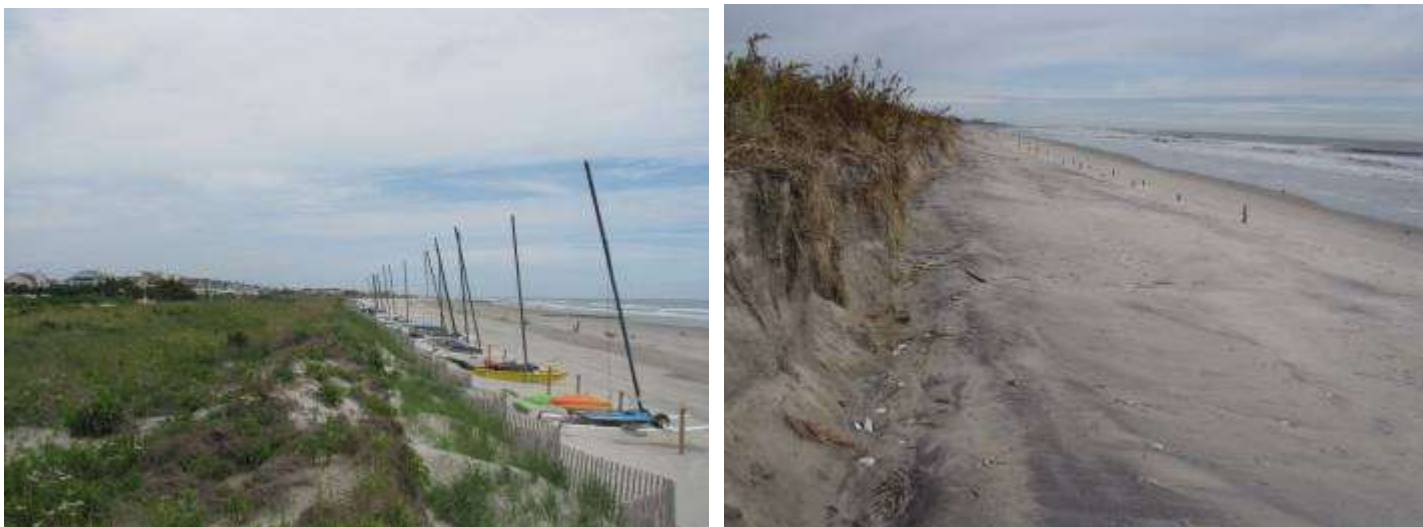
121st Street, Stone Harbor, Cape May County, Site #212;

The southern cross section in Stone Harbor was re-established just north of the terminal rock groin along the Borough oceanfront following the loss of South Point in 1990. The left picture shows the conditions in June 2012 where sand had deposited seaward of an older scarp cut into the dunes, building out to the sand fencing. Sandy eliminated all the newly-deposited material moving the beach landward uniformly by 50 feet. The catamarane pilings show a closer proximity to the surf after Sandy than prior to the storm (Nov. 8, 2012). The erosional cut in the dunes returned to approximately the location of the cut made in November 2009.

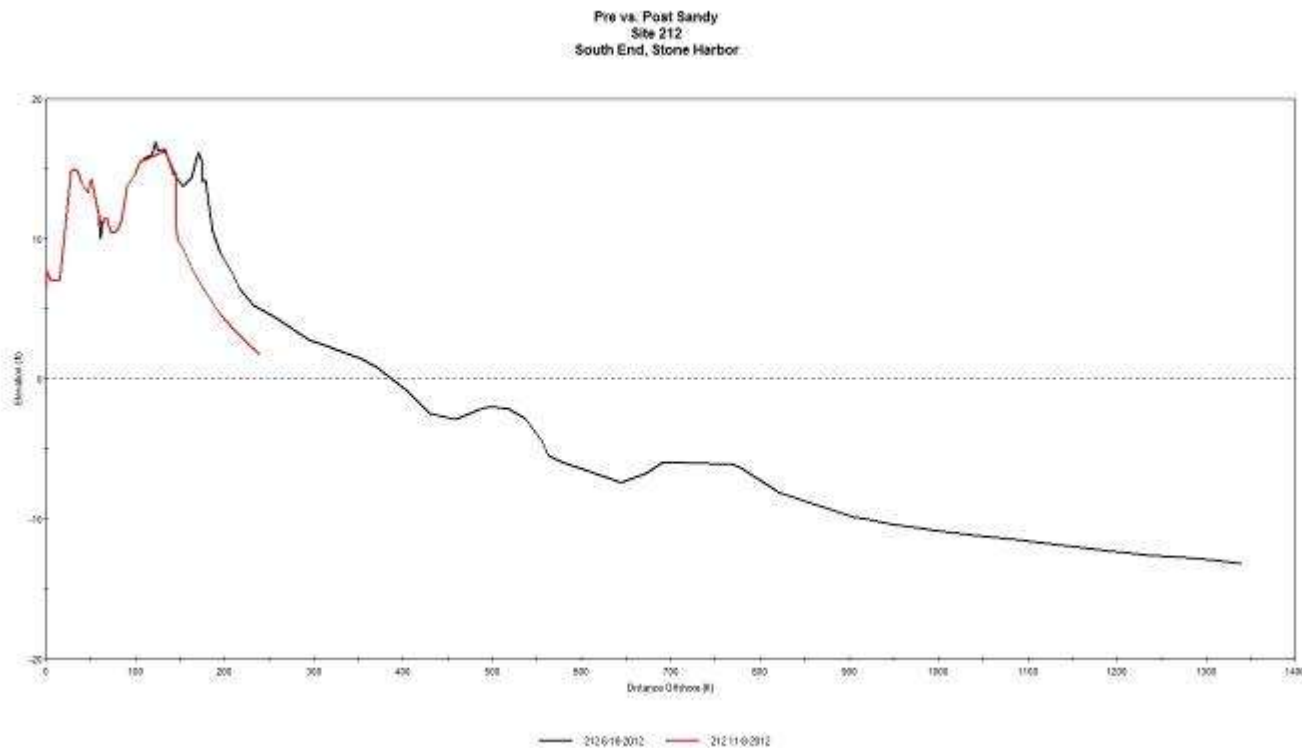
Figure 15. Sandy cut into both the dune and beachface pushing the shoreline position landward by 50+ feet. Sand was moved to the dune crest, likely by the wind, because other pictures show no grass damage above the scarp. The sand volume to produce dune recovery will likely need to come from mechanical transfer unless it is decided to allow nature to once again bring beach sand to the dune fencing when it is re-established.

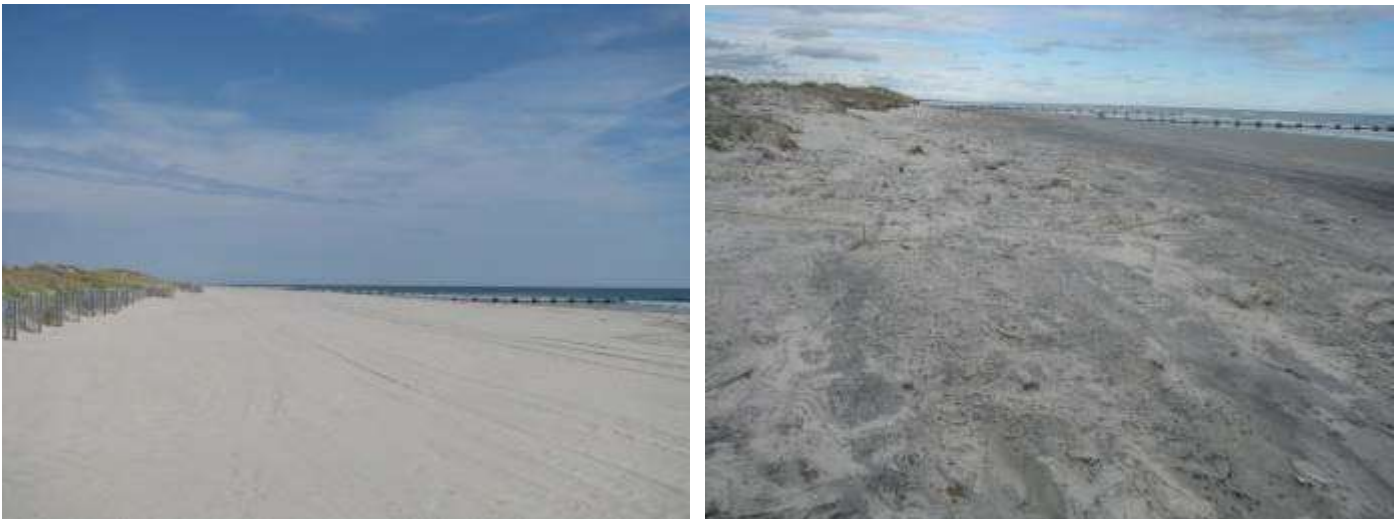
90th Street, Stone Harbor, Cape May County, Site #113;

The left photograph was taken October 24, 2012 just prior to Sandy. The right picture was taken October 31, 2012 and shows the effects of lowering the berm elevation and some minor dune toe erosion. This site did not suffer significant erosion damage and no overwash beyond the dune toe area.

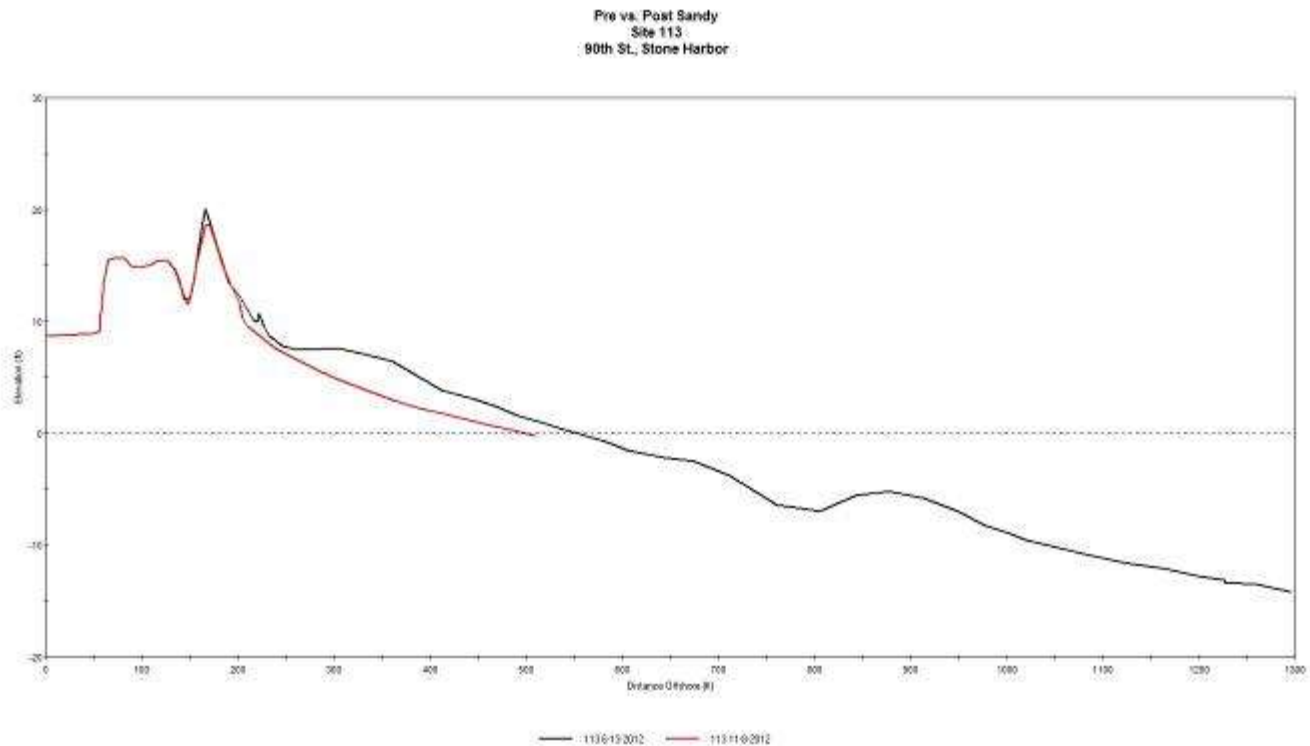
Figure 16. The two cross sections show modest berm loss as sand was likely transferred offshore and to the south by the strong littoral current flow. The dune toe damage should recover naturally.

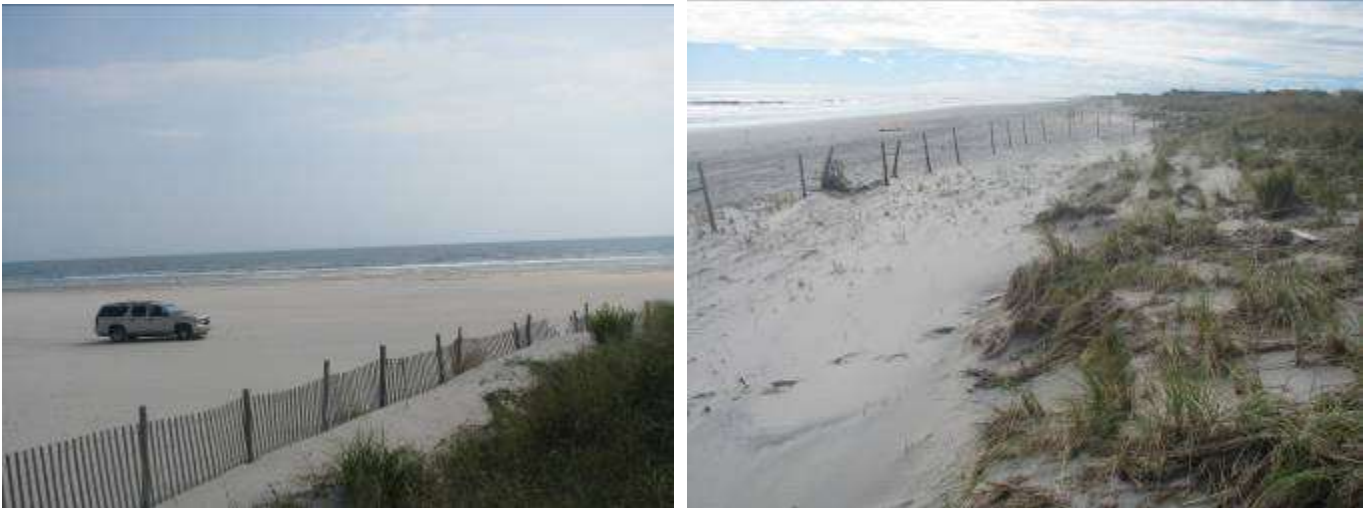
70th Street, Avalon, Cape May County, Site #114;

The left picture was taken September 28, 2012 during the late summer survey, and the nearly identical view was obtained October 31st just after Sandy. Note that there are two pairs of closely spaced fence posts that have a small angle between them in their vertical positions. The two pairs of posts are present in both photographs and show the loss in seaward dune toe grass and sand. The berm along the ocean's edge was also reduced in elevation.

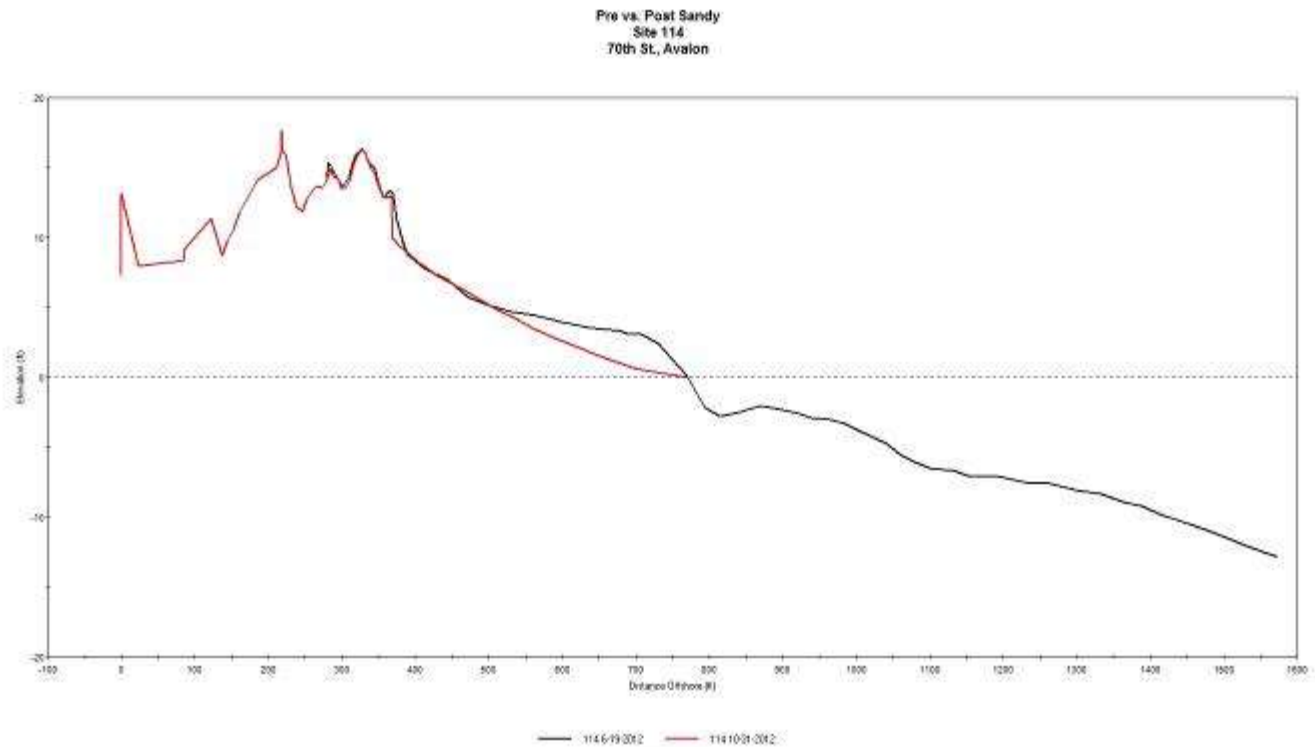
Figure 17. The loss in berm sand was nearly universal north of Wildwood, NJ as the more easterly orientation of the shoreline brought the waves more directly to bear on the coast. The minor loss in dune sand shows at the seaward toe. Storm surge washed among the foredunes, flooding the lower swales between ridges. This water was still draining across the beach when the surveys were done.

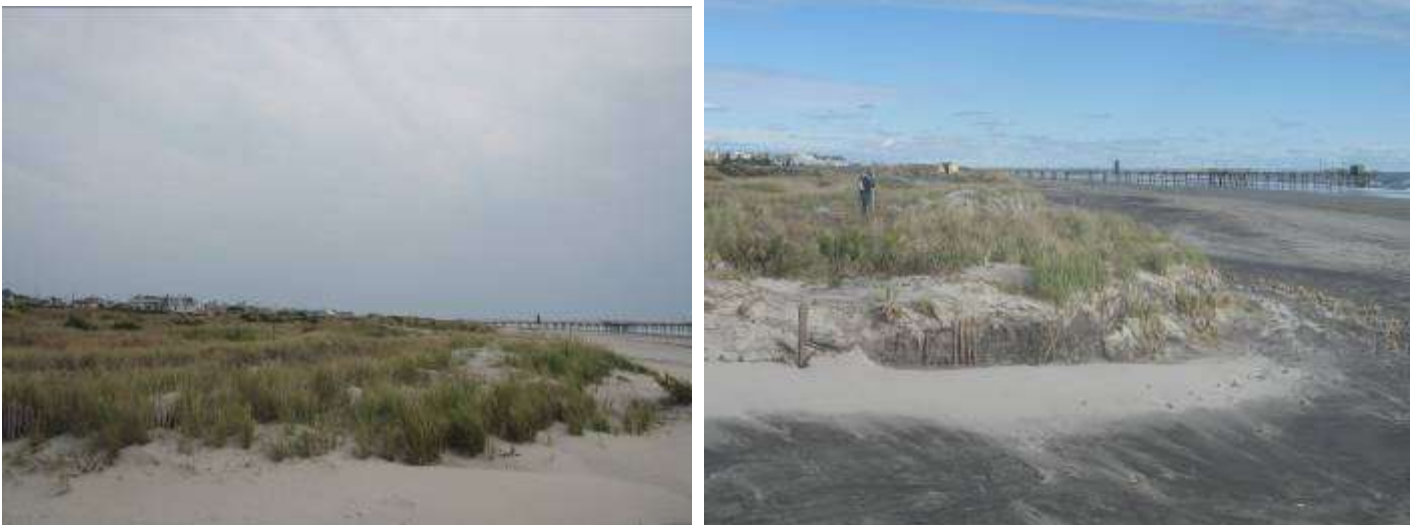
35th Street, Avalon, Cape May County, Site #115;

Between September 27th and October 31st, the beach at 35th Street suffered foredune flooding and minor erosion of the seaward toe. Sand was stripped from the berm and washed into the lower elevation dune field. The loss to individual plants can be determined by careful examination of the two photographs.

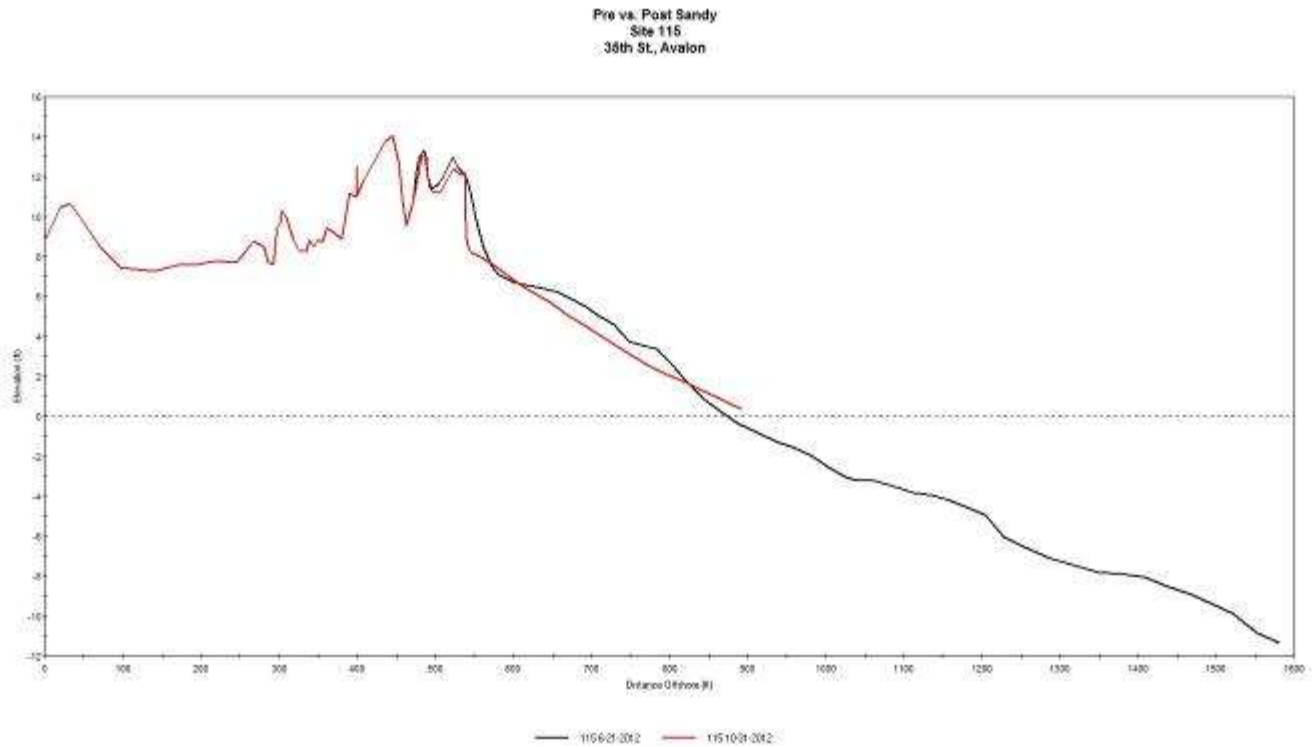
Figure 18. Erosion to the seaward dune toe was minor in nature and of no real significance to shore protection. The wide expanse of dunes allowed the storm waves to flood between or over the lower ridge of dunes at the rear of the beach and simply dissipate their energy over a 500-foot wide expanse of vegetation. The sand loss at the berm was likely transported seaward as the shorter post-Sandy cross section shows at the seaward end.

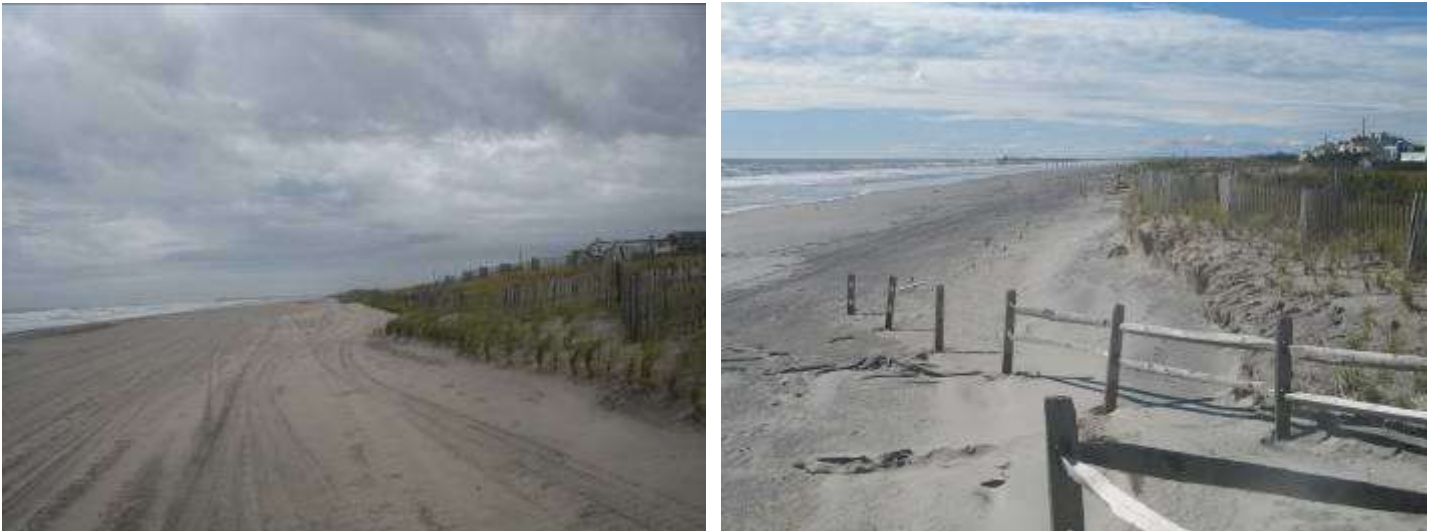
23rd Street, Avalon, Cape May County, Site #116;

The left picture was taken September 25, 2012 and shows the beach late in the summer with a generous post-sand fill berm present and a healthy season's growth in new dune plants. By October 31st, the beach was much lower in elevation as sand was carried offshore and the dune's seaward slope was cut and sand washed into the grasses. The entrance pathway was truncated at most Avalon street-end entrances.

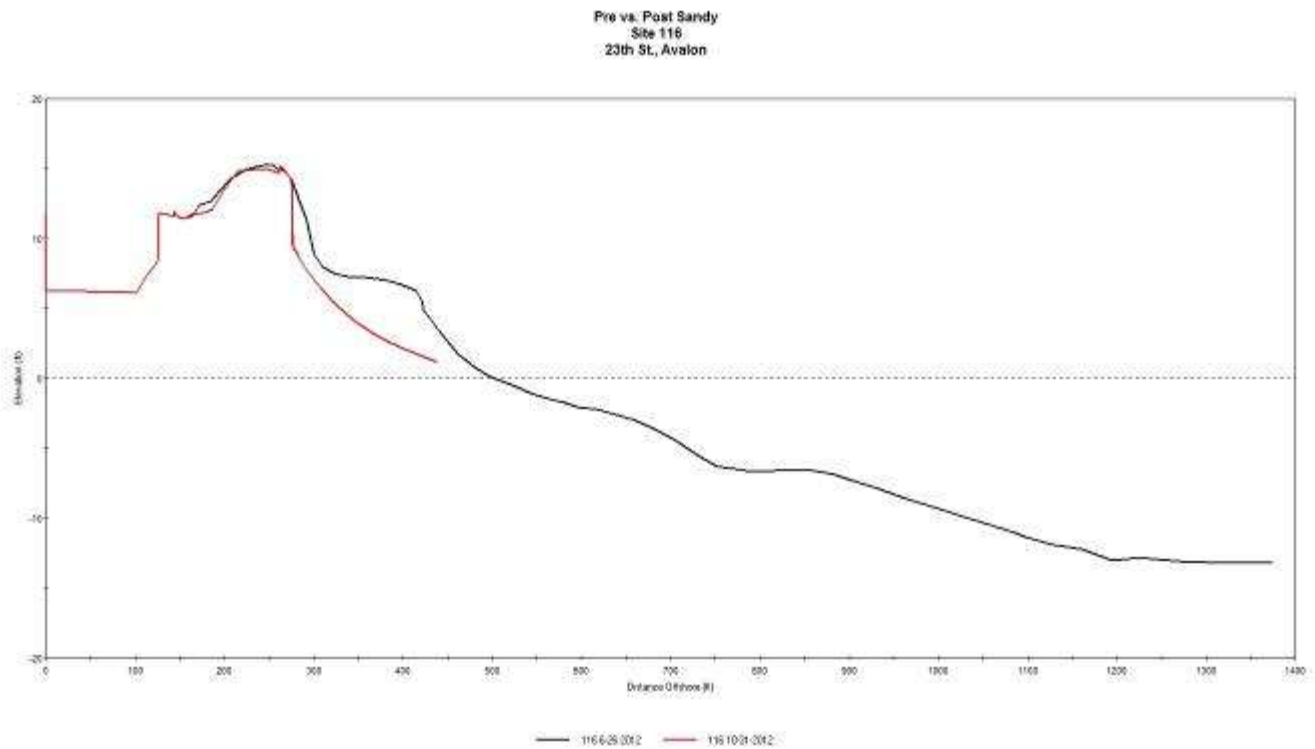
Figure 19. The degree of beach and dune erosion increased toward the north end of the island, with the worst losses seen between this site and the 9th Street position. The loss to the berm makes the dunes susceptible to future storm erosion.

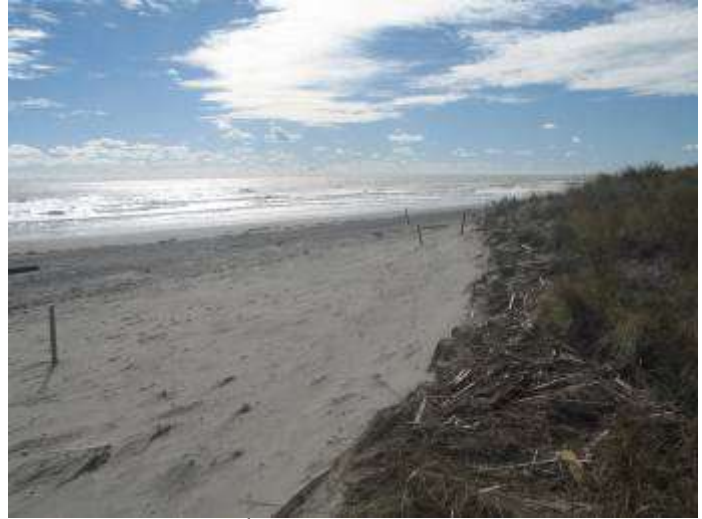
9th Street, Avalon, Cape May County, Site #216;

The September 25th photograph shows the wide berm and seasonal plant growth at the 9th Street site. Following Sandy the fence was taken out as was the wide berm with erosion cutting into the seaward dune toe slope. The litter deposited on the dune slope shows the elevation to which the waves ran up the dunes (14.0 feet NAVD88 in Avalon).

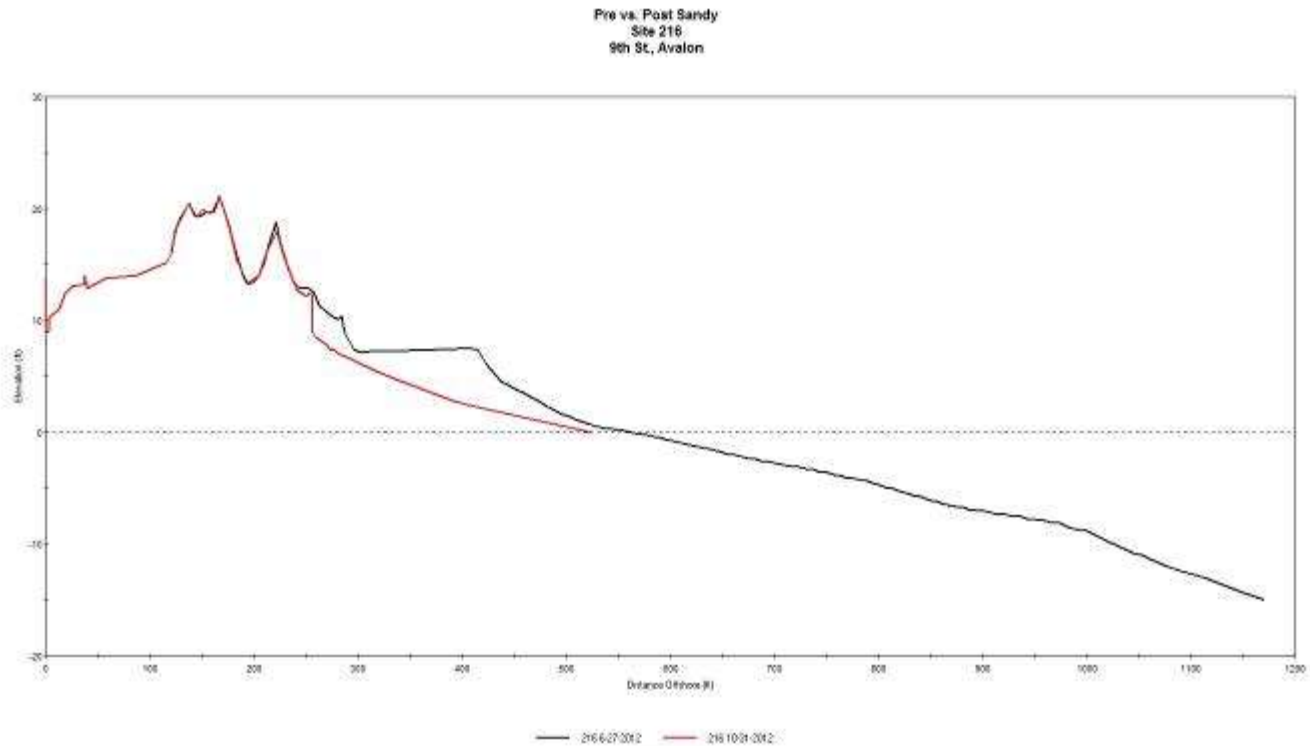
Figure 20, The erosion was significant between 23rd Street and 9th Street removing the wide berm deposited during the recent beach maintenance completed in 2011. The lost sand was carried offshore and to the south.

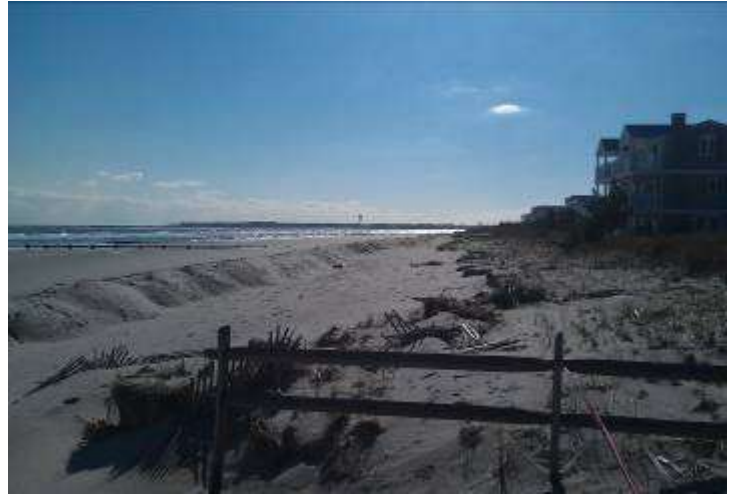
80th Street, Sea Isle City, Cape May County, Site #117;

On October 22, 2012 the beach possessed a recently deposited foredune developed at fencing installed in the past year. The beach was wider and higher than the scene following the storm. On the right, the post-Sandy clean-up was responsible for the deposition of sand, washed inland, having been hauled back to the beach to form a linear ridge to help with future storm protection.

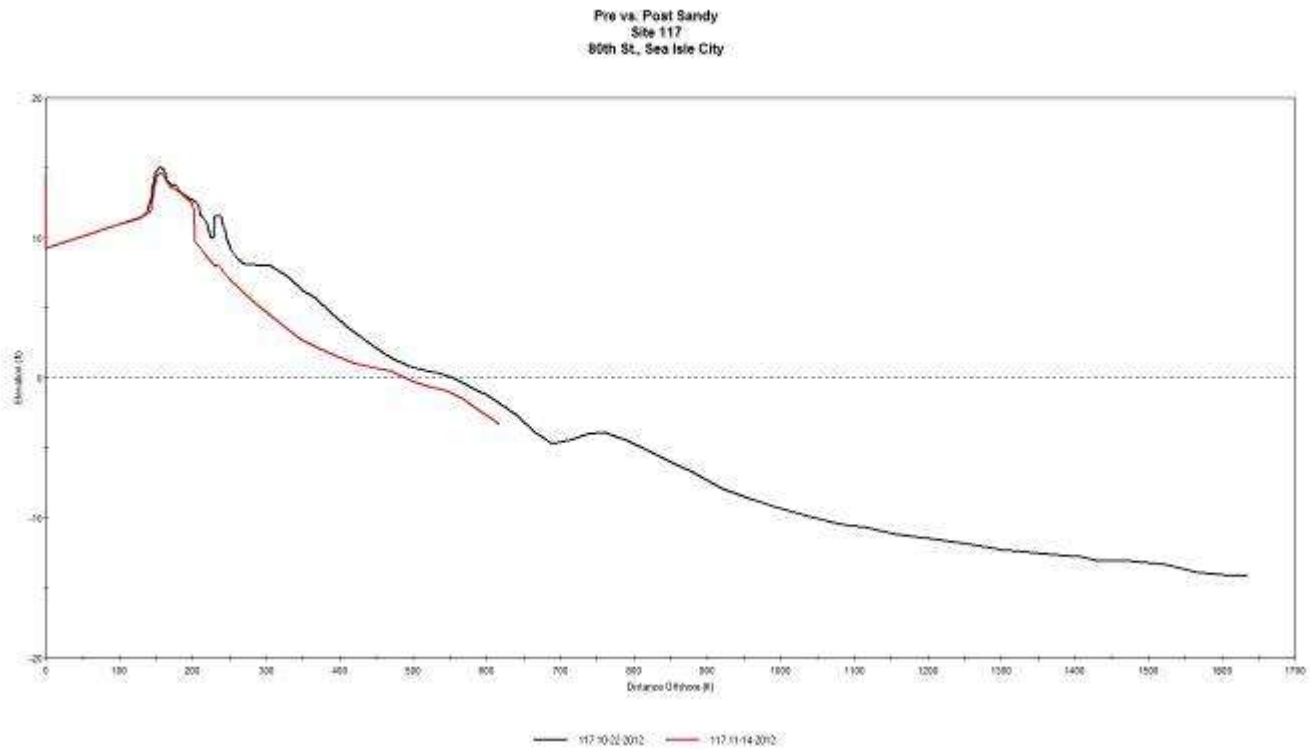
Figure 21. The dune was impacted by retreat and the total loss of the newer fore dune built around recent fencing. The berm was reduced in elevation and the shoreline retreated about 45 feet.

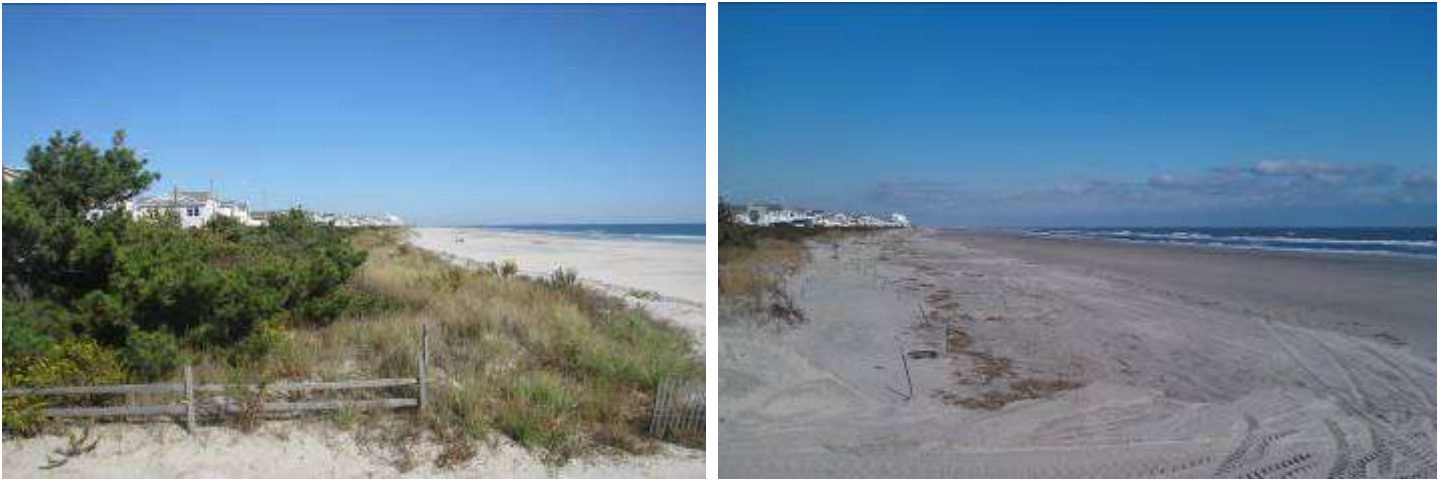
57th Street, Sea Isle City, Cape May County, Site #118;

The left picture was taken October 22, 2012 and shows the dune system landward of a wide, dry beach. Following Sandy on November 14, 2012, the beach was much lower in elevation and the dune was carved away nearly to the crest. The scarp had slumped two weeks later, but the impact can clearly be seen below.

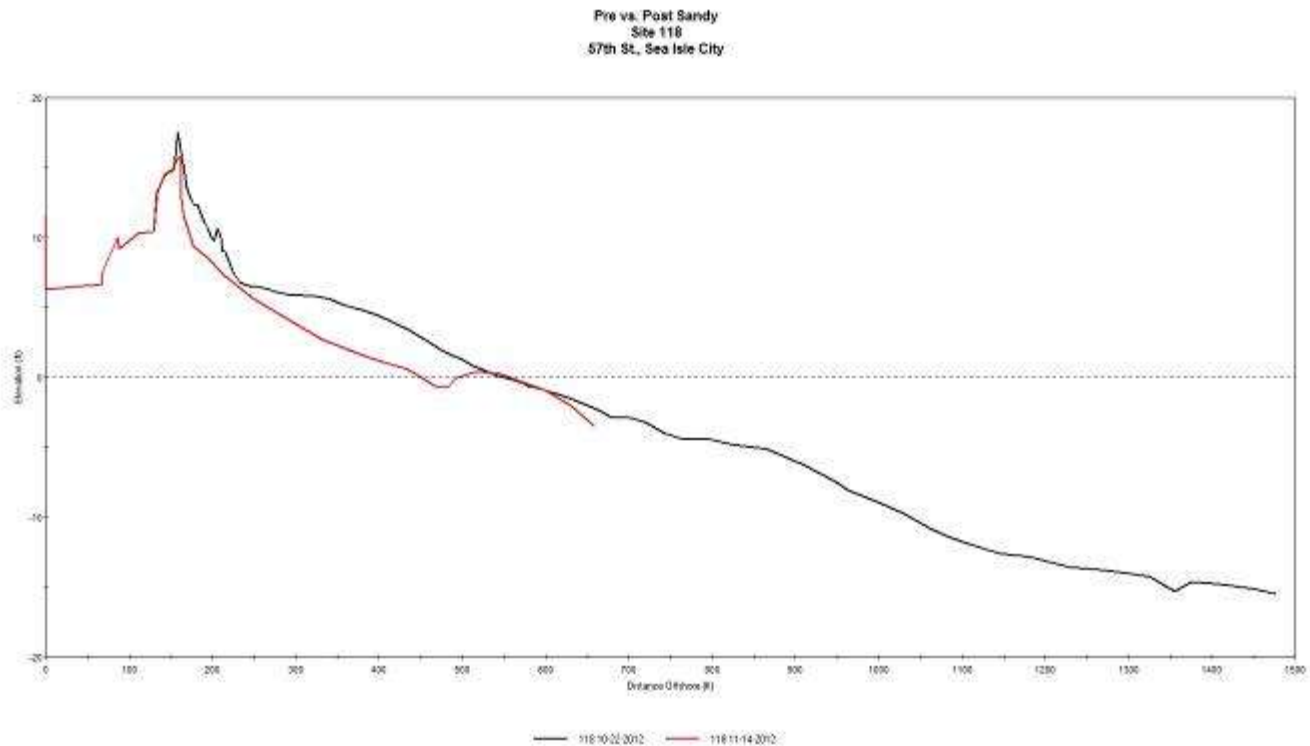
Figure 22. The loss to the dune was greater at 57th Street as the berm was scoured over three feet vertically in spots. The sand was likely transported seaward beyond the limits of the short post-Sandy surveys.

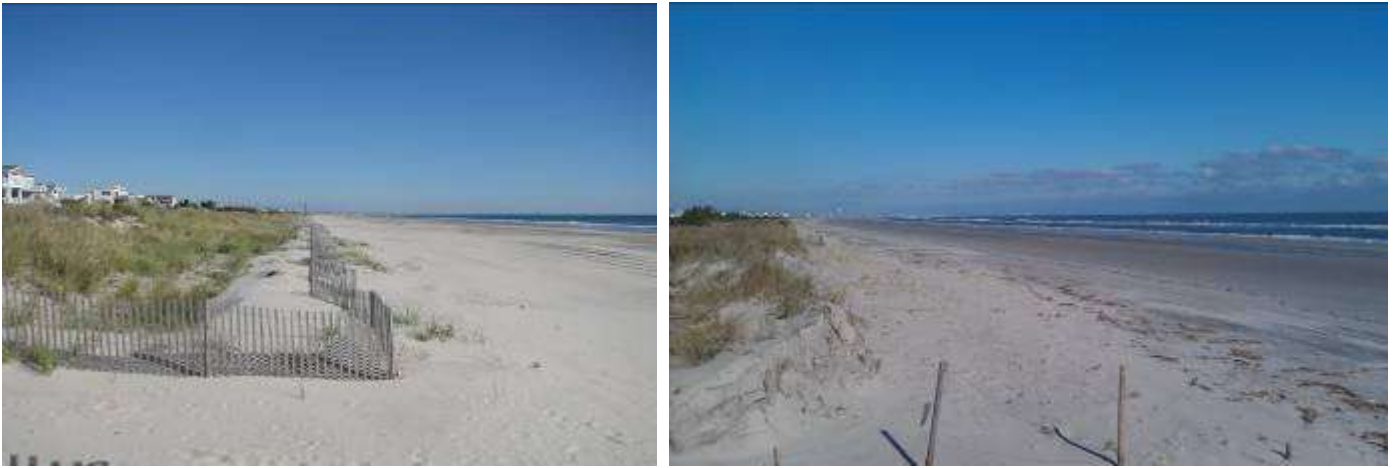
25th Street, Sea Isle City, Cape May County, Site #119;

On October 22, 2012, the beach was relatively wide and dry with a decent new deposit of sand along the recent fencing installed at the seaward toe of the dune system. After Sandy on November 14, 2012 the beach was lower in elevation, all the fencing was missing and sand was pushed back into the dunes, up the seaward slope.

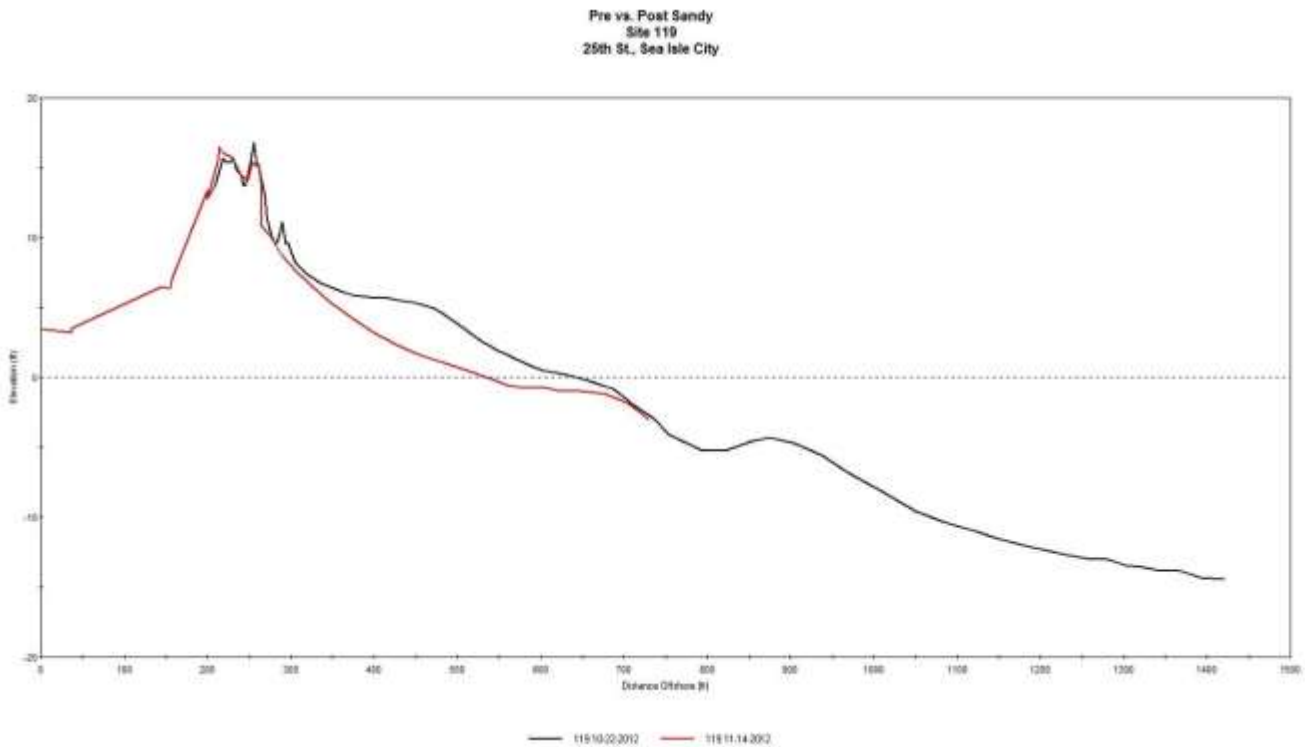
Figure 23. The sand volume loss was concentrated on the berm with the majority of the sand moved further seaward than the post-Sandy profile, or moved south along the shoreline. The dunes withstood the waves allowing overwash only at low elevation pedestrian access pathways.

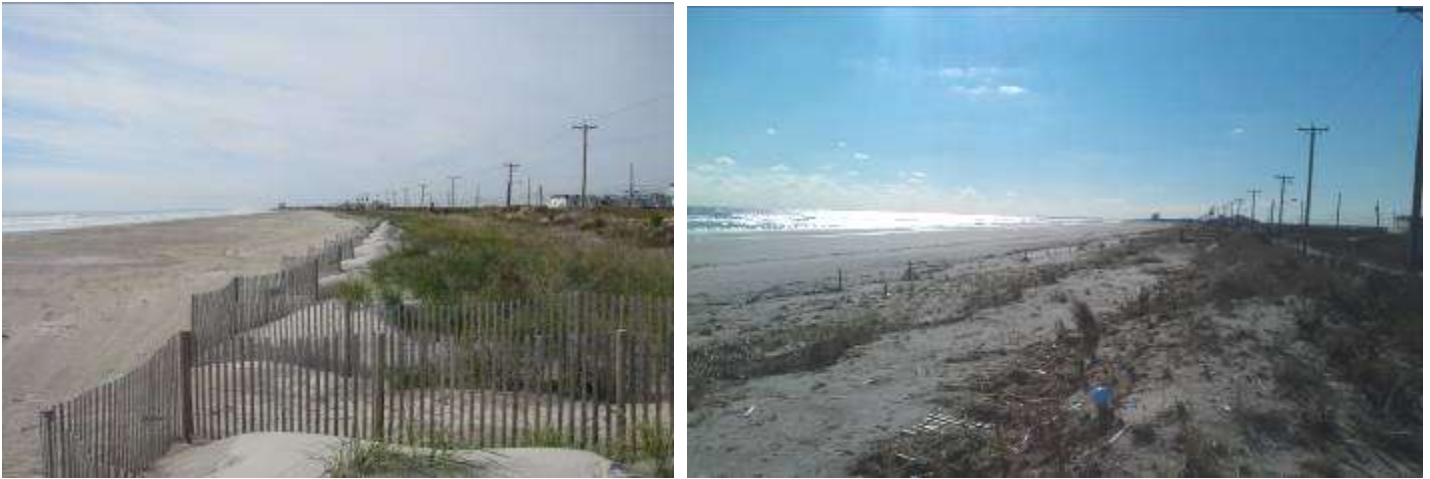
1st Street, Sea Isle City, Cape May County, Site #120;

This location is on the boundary between Sea Isle City and Strathmere along the main (and only) road parallel to the ocean. The sand transported into the dune by October 17, 2012 was washed across by Sandy as seen on the left picture on November 14, 2012. Some minor breaching occurred along Commonwealth Avenue, but the dune remained relatively in tact.

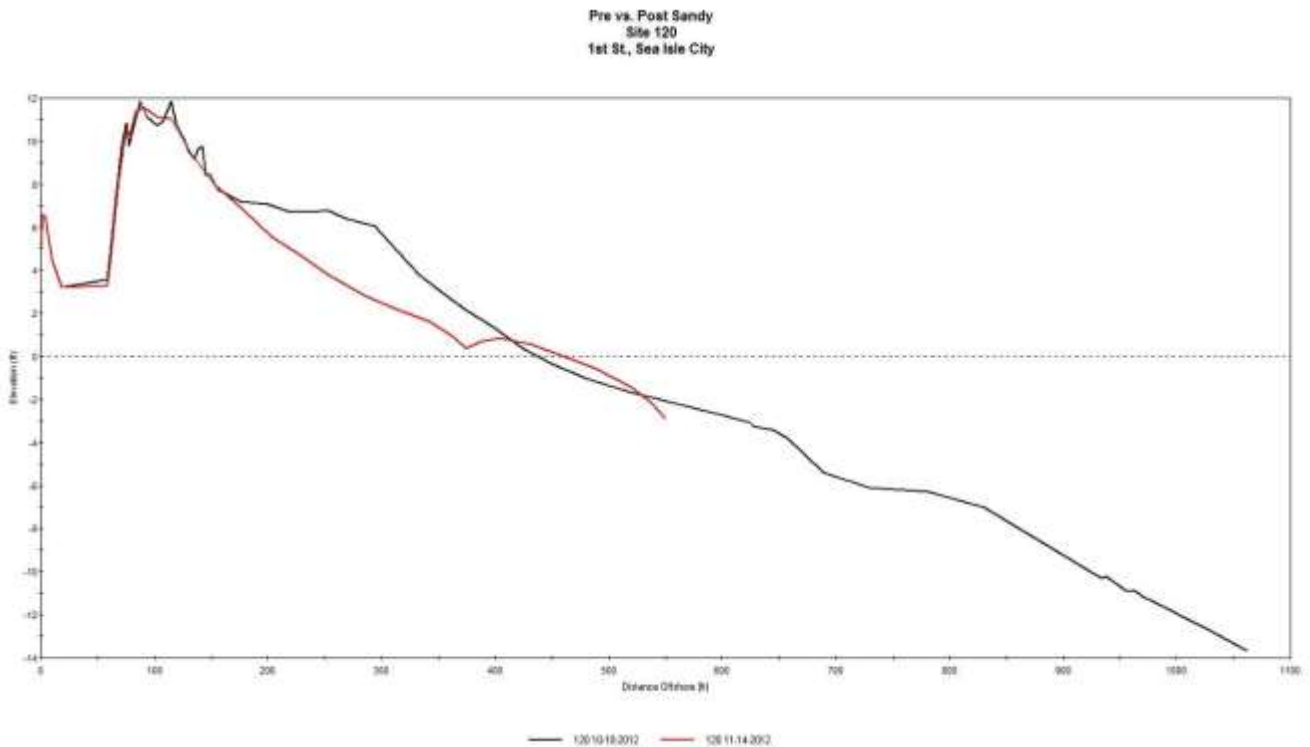
Figure 24. The beach was scoured, removing the berm and a large amount of sand that was transported offshore and carried south along the coast. The dunes were just high enough to withstand the wave onslaught without failure.

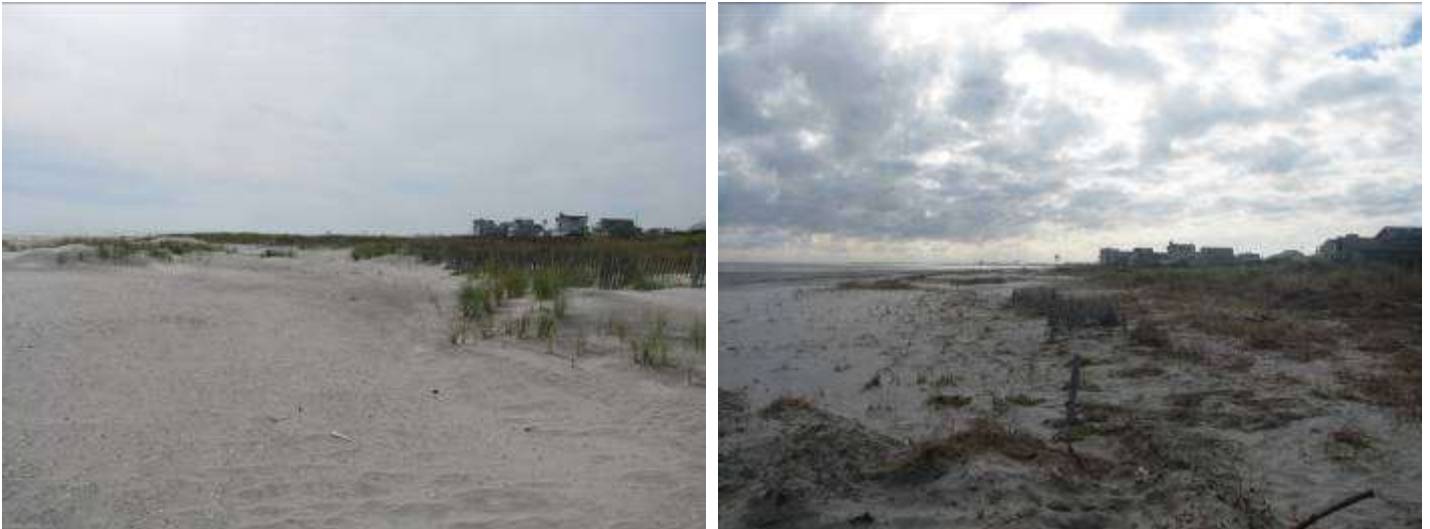
Williams Road, Strathmere, Cape May County, Site #121;

The left picture was taken October 17, 2012 looking across the wide dune zone area seaward of the primary feature. On November 5, 2012 the same view following Sandy shows that the area was flooded by waves that knocked down the highest primary dune, but did not flood the immediate landward area. The beach was flattened by the storm surge. The dune removed was only three feet higher than the post-storm feature however.

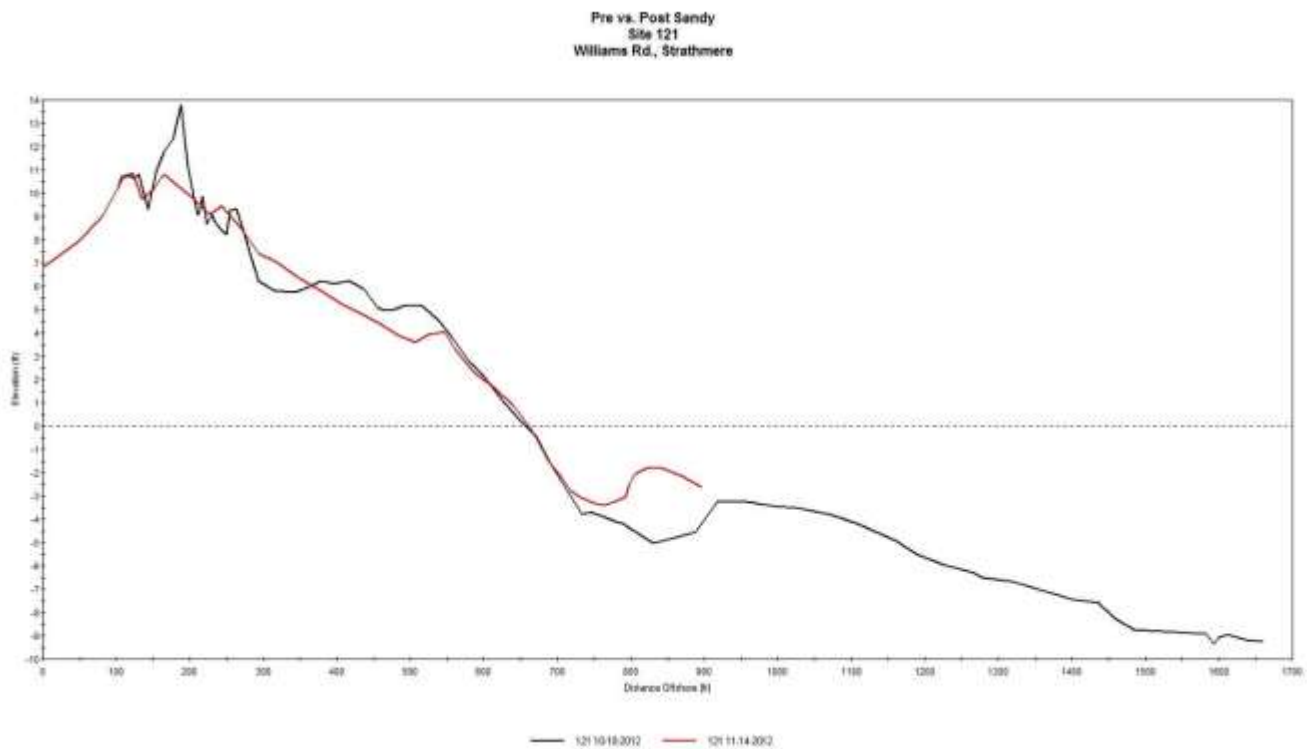
Figure 25. The cross sections do show the transport of sand offshore as well as the extensive flattening of the beach surface all the way into the dunes. The graph is extremely vertically exaggerated and the dune removed was only 3 feet higher than the surroundings.
