THE RICHARD STOCKTON COLLEGE OF NEW JERSEY

**An Assessment of Cape May County Beaches
at the
New Jersey Beach Profile Network (NJBPN) Sites
After Hurricane Sandy
Related to
(DR-NJ 4086)**

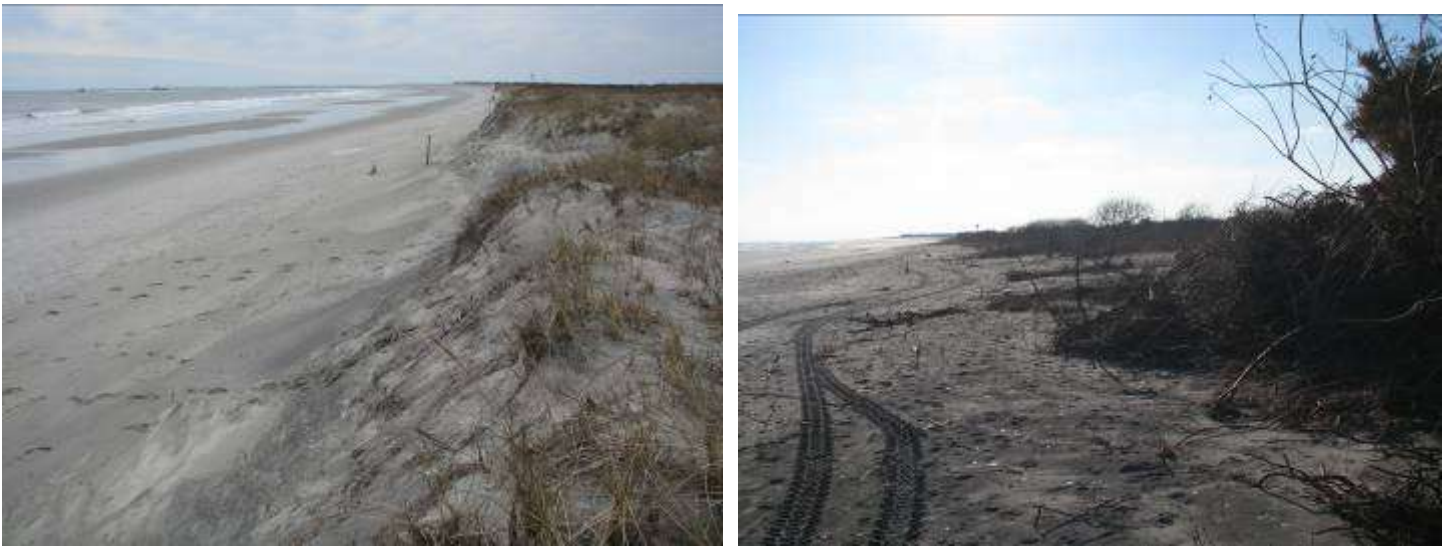
59th Street, Ocean City, Cape May County, Site #222;

The left picture, taken March 9, 2012, shows an erosional scarp in the spring of 2012. This condition did not change during the summer and the waves during Sandy carved deeply into the remaining dunes. The erosion reflected up the beach into the southernmost development in Ocean City as well. The left picture was taken November 28, 2012 and shows large scale wash over and inundation of the lower sections of the dune system. The scarp was pushed landward a minimum of 155 feet with loss in elevation to the remaining dunes because the erosion passed the crest of the main dune ridge.

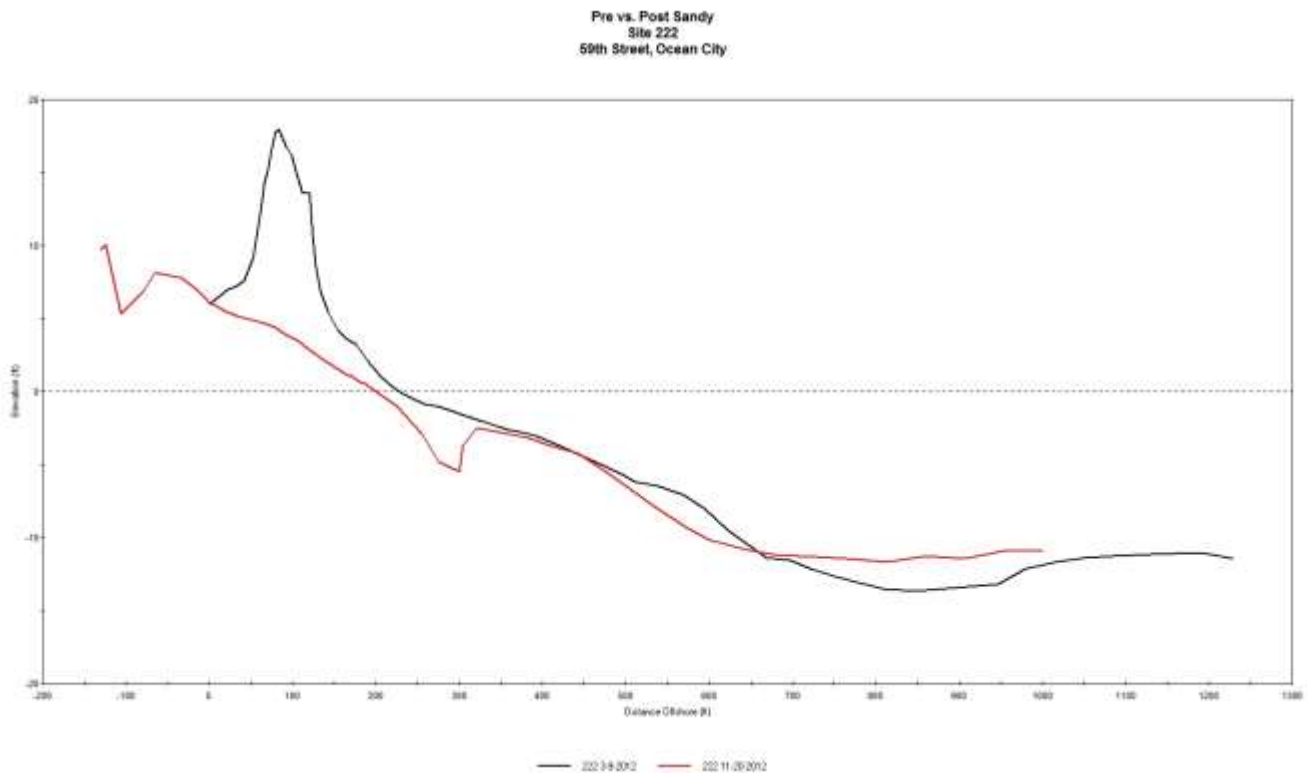
Figure 26. The primary dune was lost entirely as over 150 feet of landward migration occurred. Sand was deposited offshore, well outside the normal cycle of cross-shore movement possibilities in the future. Bar material was migrating back to the beach by November 20, 2012, almost a month after the storm.

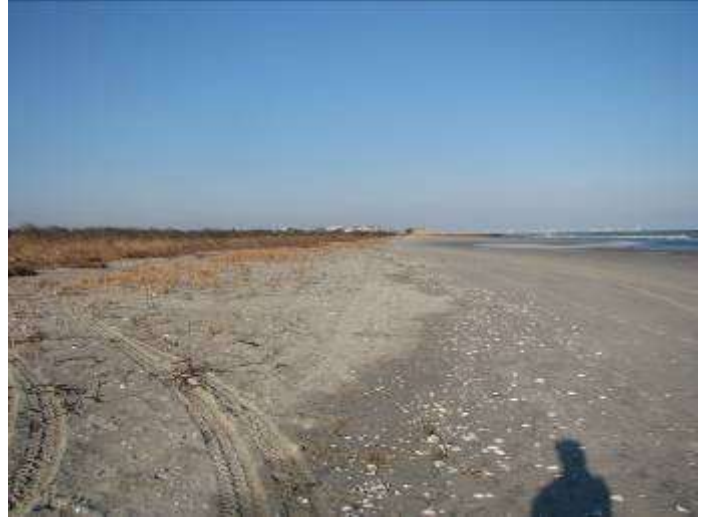
Corson's Inlet State Park, Ocean City, Cape May County, Site #221;

Positioned about a half-mile south of the development in Ocean City, the site has been one where the dune was repeatedly under erosion attack since the spring of 2012. Sandy hit this site pretty hard as a result of a narrow, low elevation beach. The November 28, 2012 picture on the right shows that the higher elevation dune was removed and the water pushed inland over lower elevation vegetation. There is an older, vegetated dune line over a hundred feet further landward that finally stopped the storm surge.

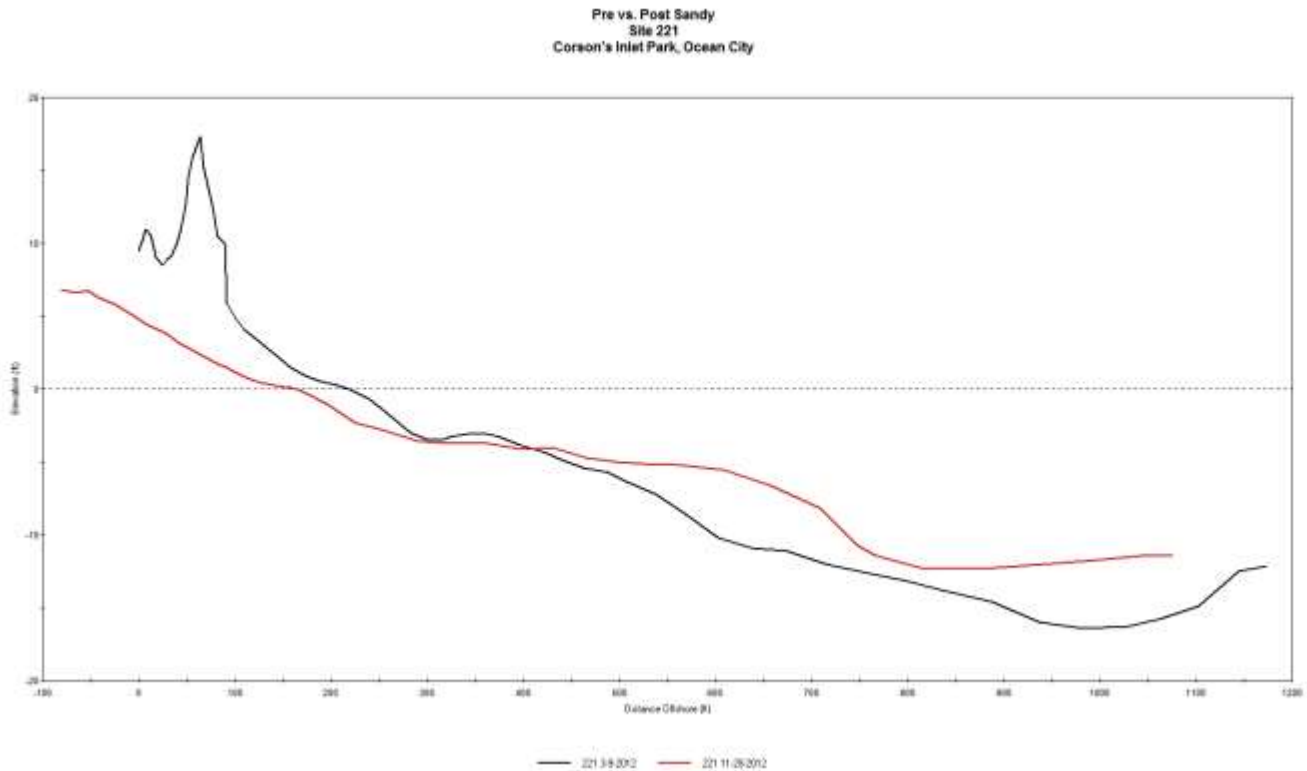
Figure 27. The landward retreat at the mid-point along the Park's Peck's Beach shoreline was about 160 feet with no significant dune remaining to block further retreat. Huge volumes of sand were deposited offshore due to littoral transport added to the volume carved from the local site's beach and dune. The zone of erosion came to 37.1 yds³/ft. while the gain offshore doubled that loss (63.2 yds³/ft.). This sand will most likely accumulate on the ebb-tidal delta shoals surrounding Corson's Inlet.

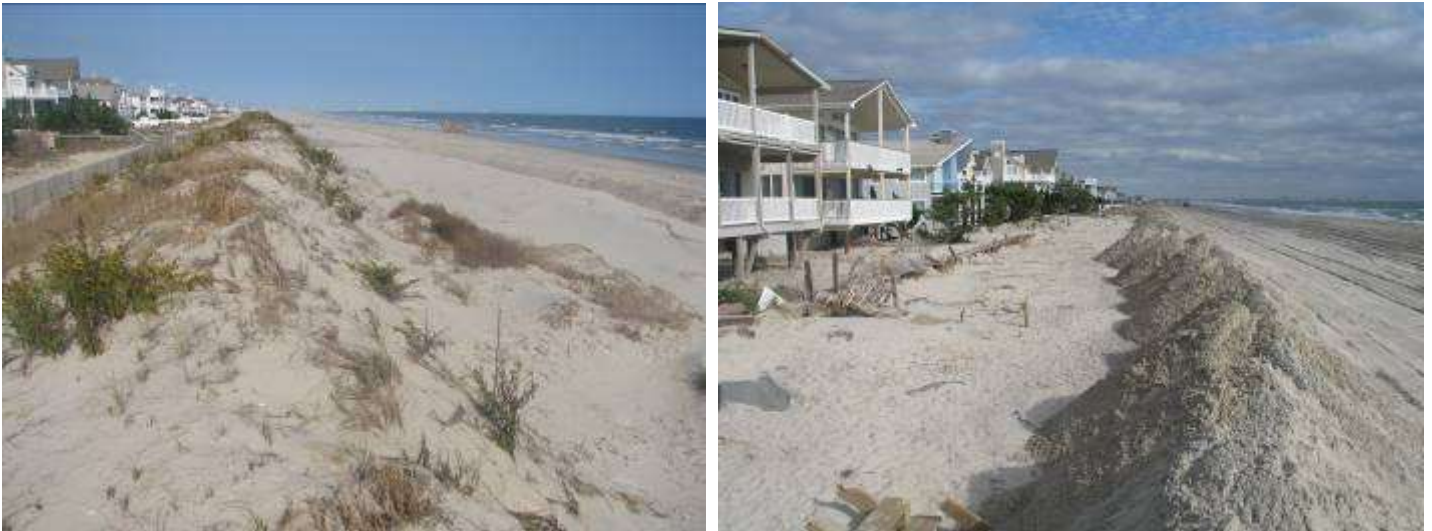
56th Street, Ocean City, Cape May County, Site #122;

The left photograph was taken October 26, as Sandy was approaching NJ. Machines were deployed pushing up a ridge of sand seaward of the existing dunes at this site. Sandy overwhelmed the shore protection, jumped the old bulkhead and washed well inland producing damage and flooding. The right picture was taken November 6th and shows recent bulldozing efforts to provide a small measure of protection for homes with nothing between them and the sea.

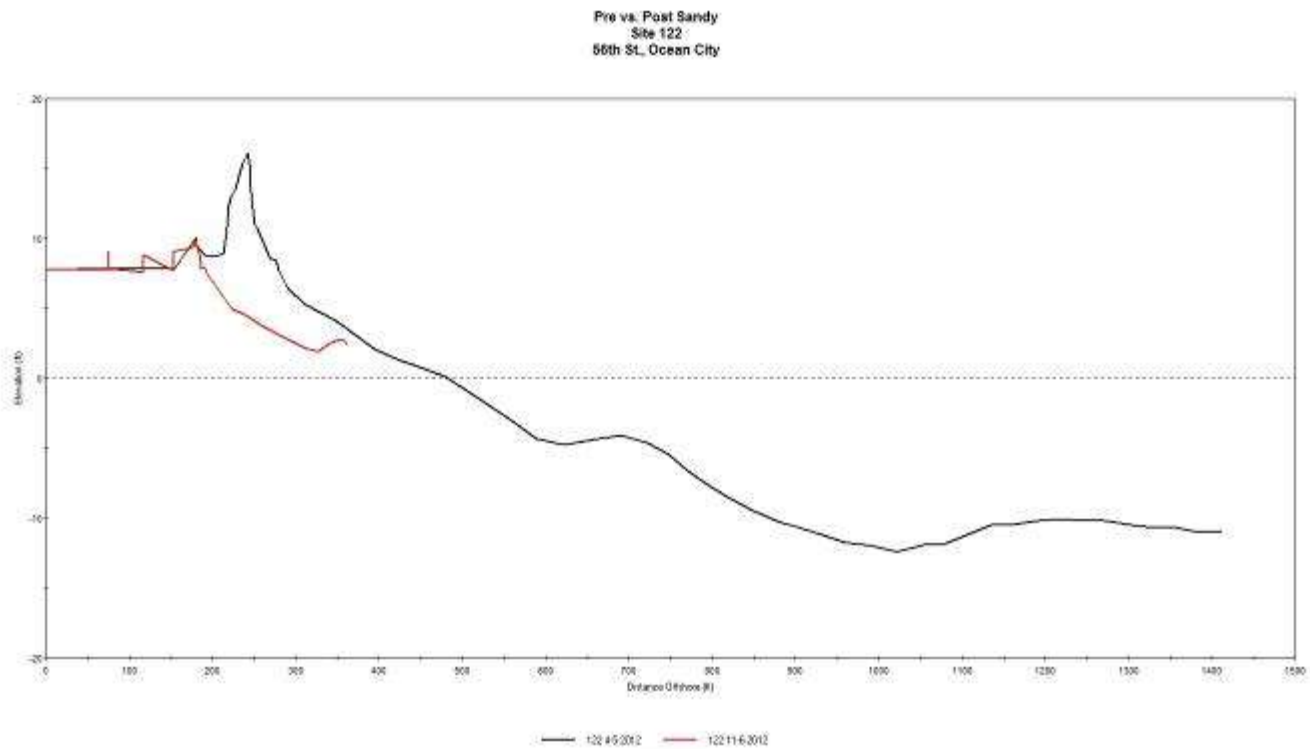
Figure 28. The southern 10 blocks of Ocean City had seen the 1995 beachfill deteriorate to the point where the dune was not protected by much beach width and the dune was not much over 50 feet in base width as well. The shoreline was pushed back toward the homes and the erosion was substantial.

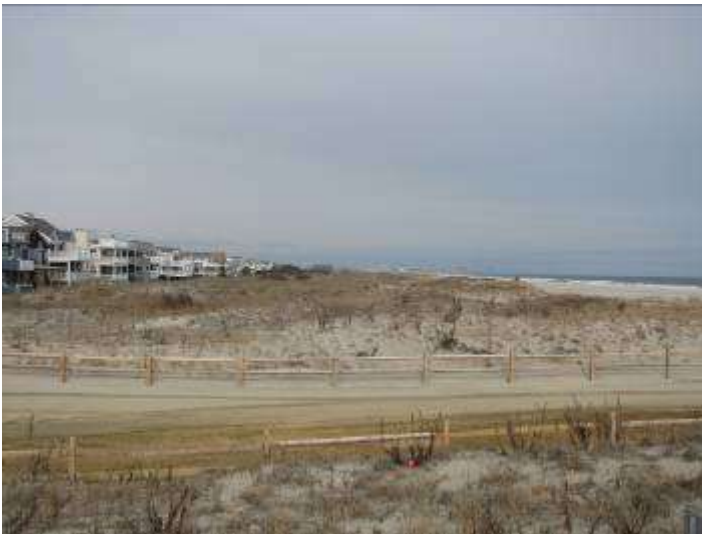
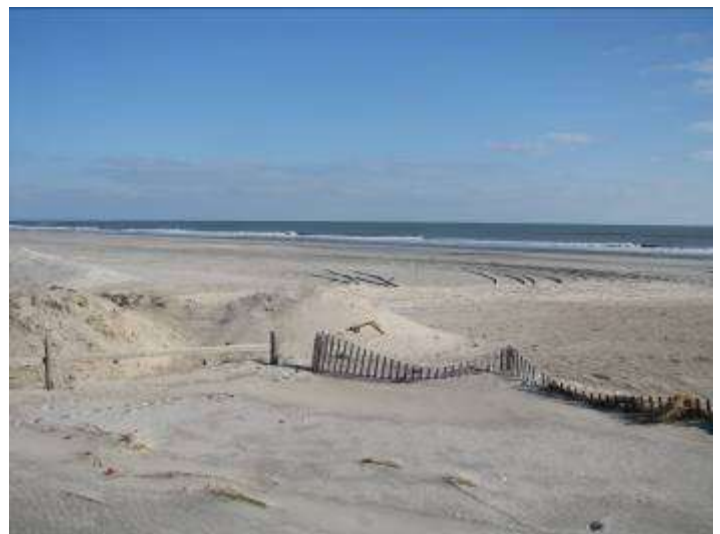
34th Street, Ocean City, Cape May County, Site #223;

The 34th Street site has always possessed a low threshold dune that really is little more than a mound with a wide access path for both vehicles and pedestrians. The March 2, 2012 view shows the relatively wide dunes north of the site, but the storm barreled through the pathway into 34th Street landward. The piles of sand on the right picture were transported back to the beach as of November 28th. The beach berm was cut back, but since this site was surveyed a month following the storm a new berm was in the process of reconstruction.

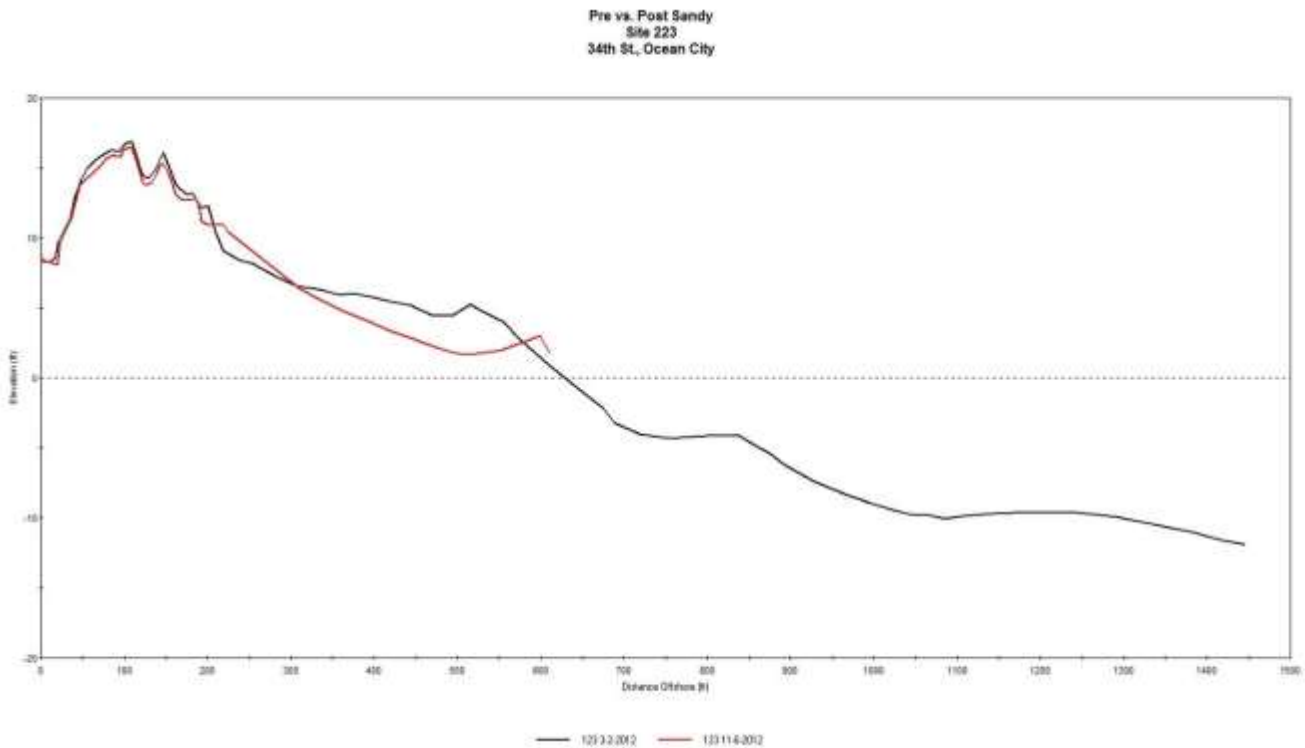
Figure 29. The sand was pushed up to the toe of the dune where the dune was developed to its regional elevation, but in the 34th Street pathway, the wide gap allowed water to flow into the city with considerable volume of sand transported. The month-after survey also shows the speed of sand recovery from offshore with a berm crest and beachface built on the erosional surface following the storm.

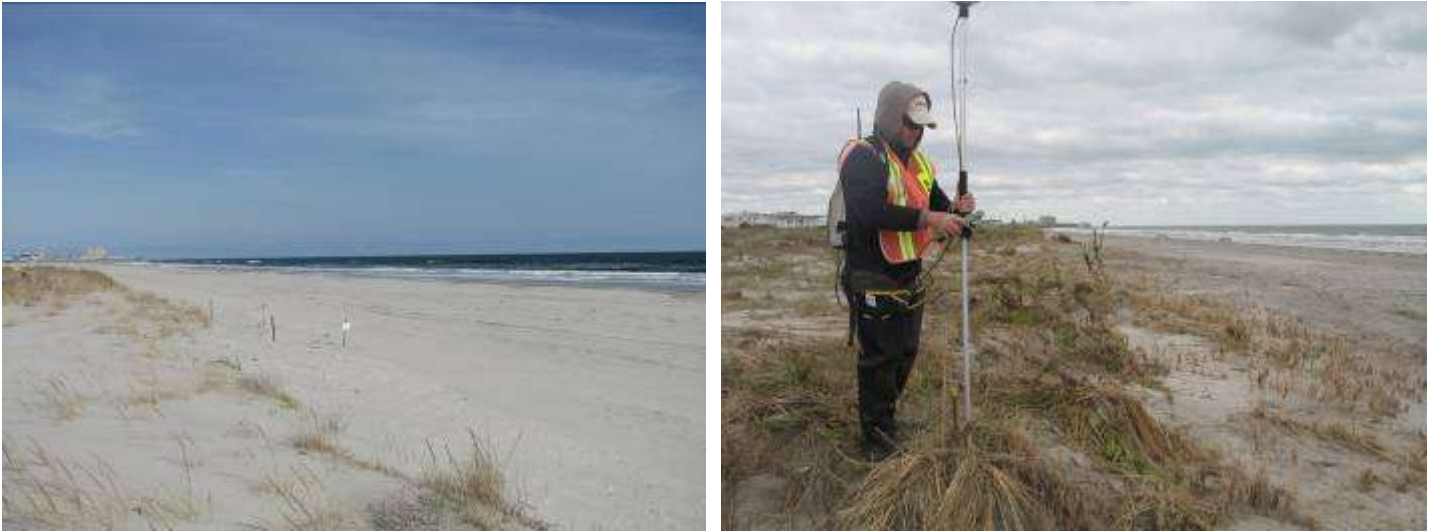
20th Street, Ocean City, Cape May County, Site #124;

The 20th Street site is at the maximum retention of beach restoration sand anywhere along the oceanfront. This site has seen the shoreline move seaward by 600 feet since the 1980's with 460 feet of dunes. The photograph on the right was taken March 2, 2012 showing the beach and gentle gradient into the seaward-most dune ridge. Following Sandy on November 6, 2012 the zone of about 150 feet in width had been inundated by the storm surge with sand pushed landward into the first major swale. The berm was lowered as would be expected without much shoreline retreat.

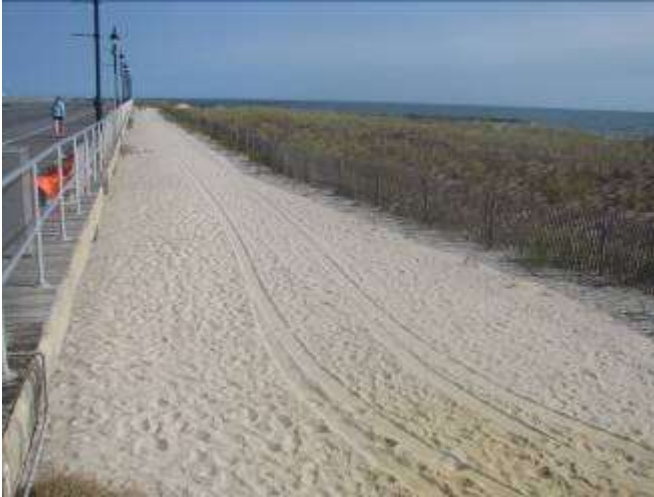
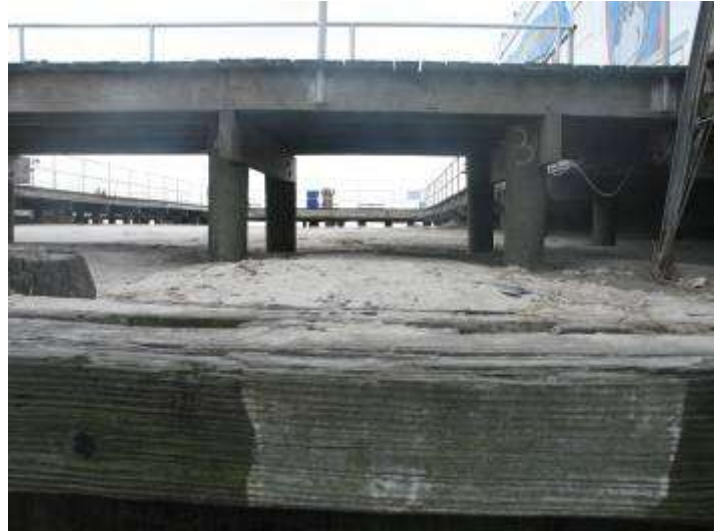
6th Street, Ocean City, Cape May County, Site #125;

The left photograph was taken October 26, 2012 just prior to the storm. The dune was in tact, but the beach was extremely narrow so the initial storm action was able to attack the dune. The right photograph was taken November 6, 2012 from the back shot position standing on the street end paving that had been excavated of sand, looking seaward to the boardwalk about 120 feet seaward. The sand had been deposited to the top of the timber by the storm surge. The wedge of sand was swept landward of the boardwalk.

Between October 26 and November 6, 2012 Hurricane Sandy removed 125 feet of dune vegetation at elevation 12.0 NAVD 88 or higher. The beach was not wide and occupied just 50 feet between the seaward dune toe and the zero elevation position. The home in both pictures was impacted with water inside due to wave surges, but could be repaired. The large pine trees actually helped save the home.

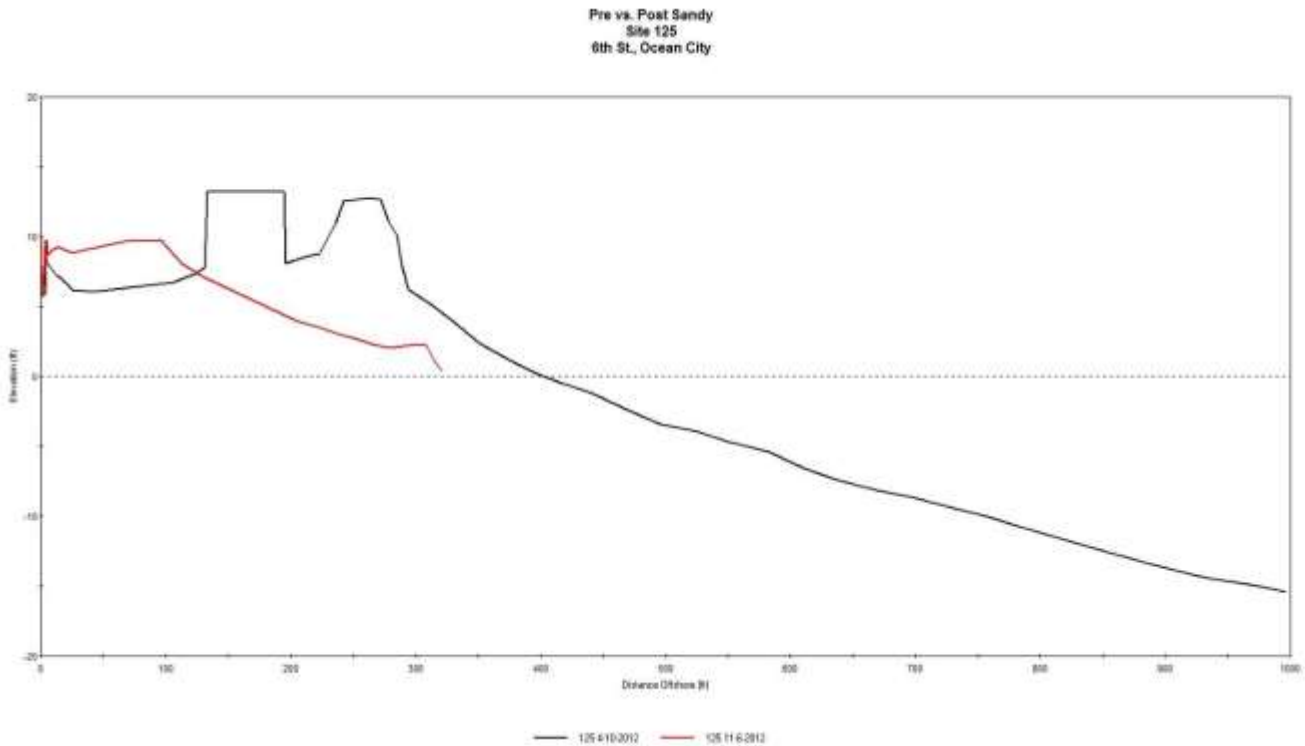
Figure 31. The cross section shows the setup leading to dune failure. The beach slope seaward begins immediately seaward of the dune toe and reaches zero elevation in about 100 feet. The retreat amounts to 200 feet placing 10-foot elevation sand landward of the boardwalk with a beachface slope under the structure after Sandy.
