New Jersey Beach Profile Network

Ocean County

**Manasquan Inlet
to Little Egg Inlet**

**NJBPN Profile #'s
156 - 234**

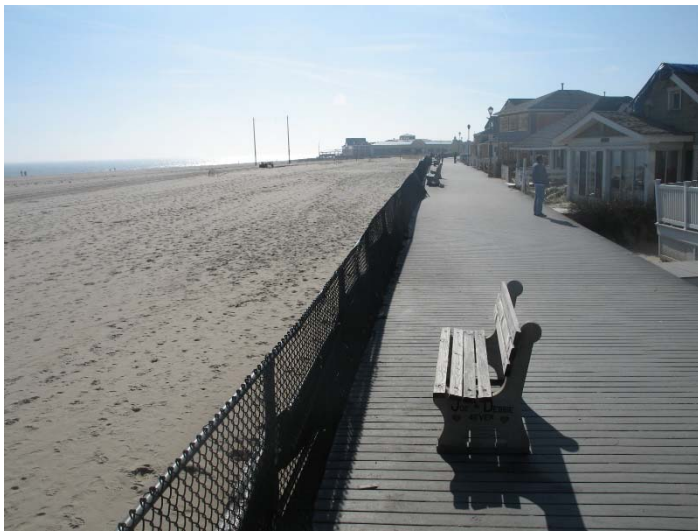
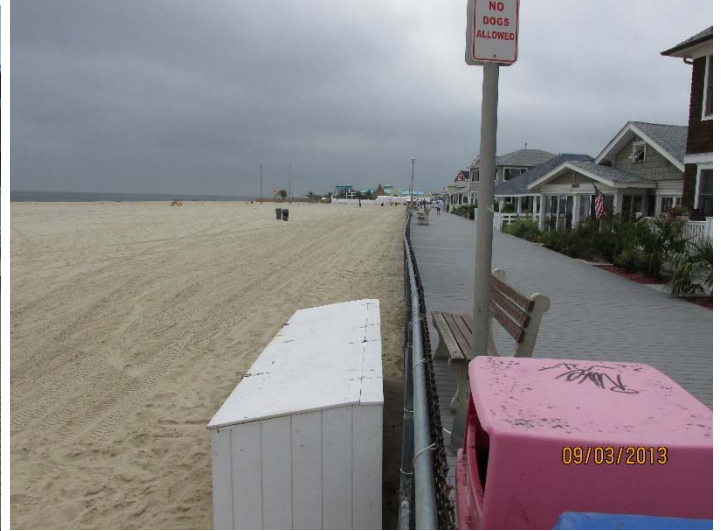
NJBPN 156 – Water Street, Point Pleasant

The photograph on the left was taken November 12, 2012. During Hurricane Sandy, this urban beach did not have a dune system and overwashed sediments spilled landward, but was spared from more severe damages by the over 600-foot protective berm. The photo on the right (taken September 3, 2013) shows the backshore nearly a year after the storm as a result of local efforts in maintaining the shoreline. This beach is included in the proposed Federal shore protection project (Manasquan Inlet to Barnegat Inlet).

Significant beach recovery took place, but no dune yet at Water Street. The restoration is relatively complete south of the boardwalk to the dunes. All recovery is due to natural migration of Sandy-generated deposits back toward the beach.

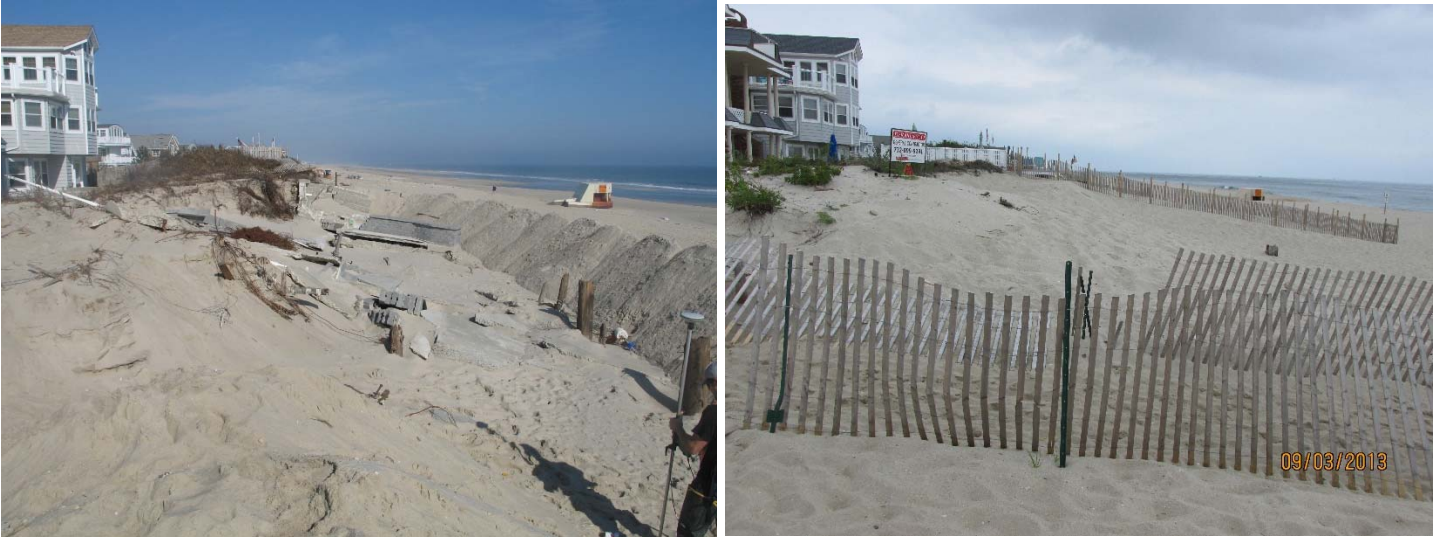
NJBP 155 – Maryland Avenue, Point Pleasant

The photograph on the left shows the damages from H. Sandy and local restoration efforts to restore the former dune (taken on November 12, 2012). Here at Maryland Ave, the lower elevation, shore-perpendicular access ways channeled wave activity landward. By the time of the post-storm survey, the municipality had begun relocating sand from the berm to the former dune location. The photo on the right (taken September 3, 2013) shows a debris-free beach with some wind-deposited sand at the dune toe.

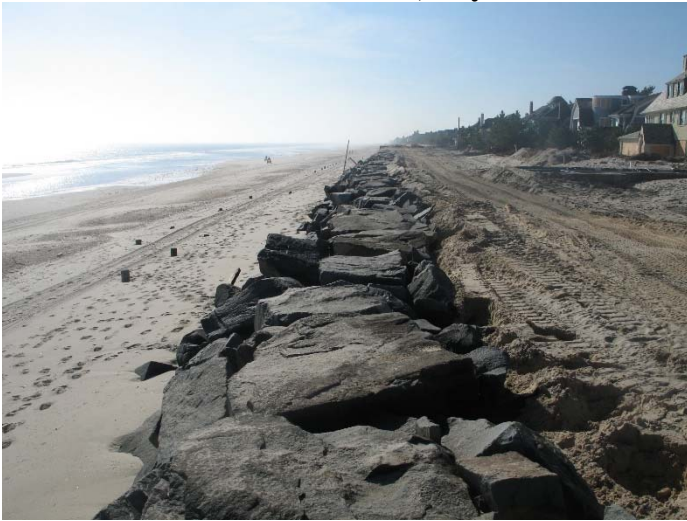
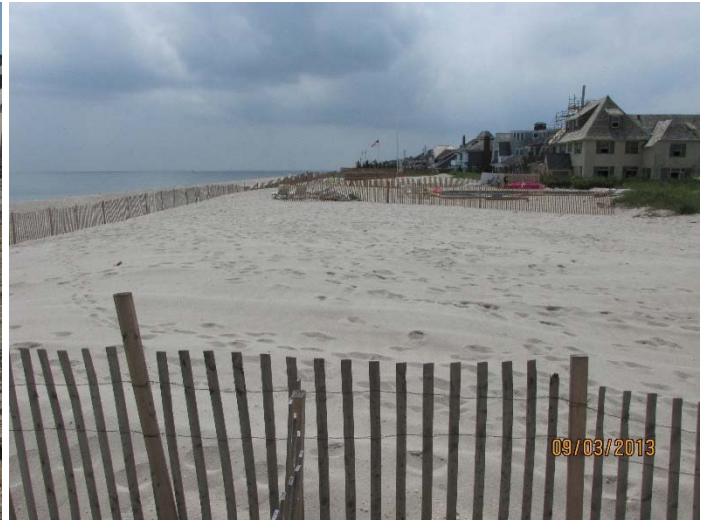
NJBPN 154 – Johnson Avenue, Bay Head

The community of Bay Head experienced wide-scale overwash during H. Sandy stripping away the low dunes and exposing the 5,500-foot rock revetment that was constructed after the 1962 northeast storm (left photo taken November 12, 2012). On the right, (September 3, 2013) sand recovered from the overwash deposits inland was returned to the beach to cover the rocks once again.

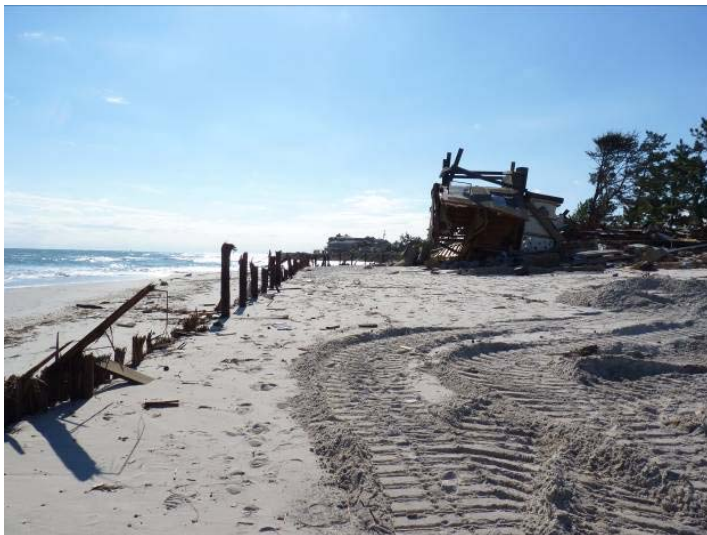
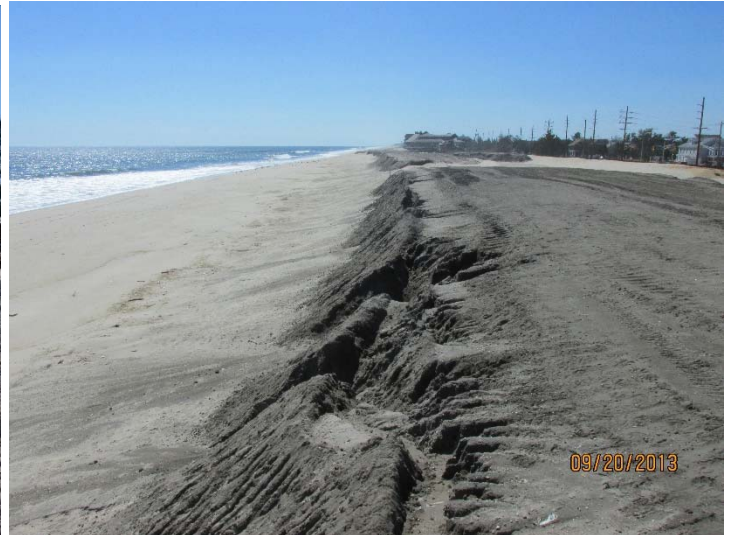
The November 5, 2012 (left) was taken within 300 feet from the temporary breach that opened during Sandy. The home at 1117 Ocean Avenue was completely removed from its location and the residence in the photograph was also destroyed. The photo on the right (September 20, 2013) shows the ridge of recovered sand from inland and dredged from Barnegat Bay.

A massive effort closed the three breaches within 6 days and the year was spent demolishing the homes found too badly damaged to restore. Route 35 work continued for months along with all types of utility work to restore the lost infrastructure. A continuation of the rock revetment completed in Bay Head is planned to start

shortly that will install a sheet steel bulkhead along the entire Mantoloking oceanfront south into Brick Township promoted as a final line of defense for the NJ State highway 35. The dune will be restored covering this structure. All the sand hauled back to the beach was utilized to construct a dune. The sand brought in to close the breaches did add new material to the shoreline, but far less than is necessary.

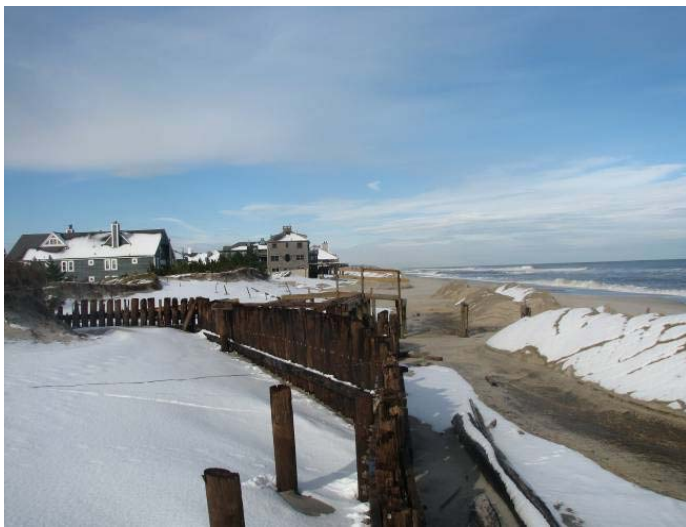
NJBPN 152 – Public Beach #3, Brick Township

The post-H. Sandy photo on the left (November 8, 2012) shows municipal efforts in protecting what was left of the former dunes. On the right (taken September 5, 2013) shows a restored dune cross section combined with a berm deposited over the summer of 2013.

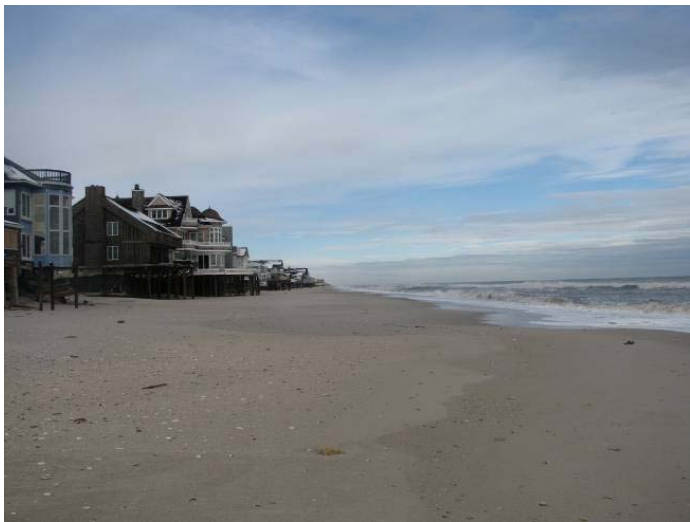
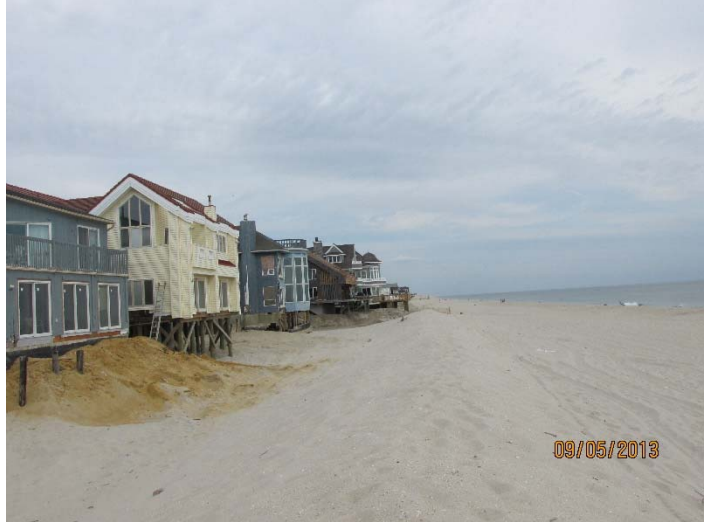
NJBPN 151 – 1st Avenue, Normandy Beach

The photo on the left (November 8, 2012), shows damages to structures and exposure of once-buried bulkheads following H. Sandy. Significant overwash occurred at this site and many oceanfront and landward homes were damaged. On the right (September 5, 2013), and nearly a year later, oceanfront homeowners were still in the clean-up process. The municipality pushed sand into a small continuous berm just seaward of the structures. The appearance of a wide berm reflects the calm conditions during the spring/summer months that allow the beach to naturally replenish.

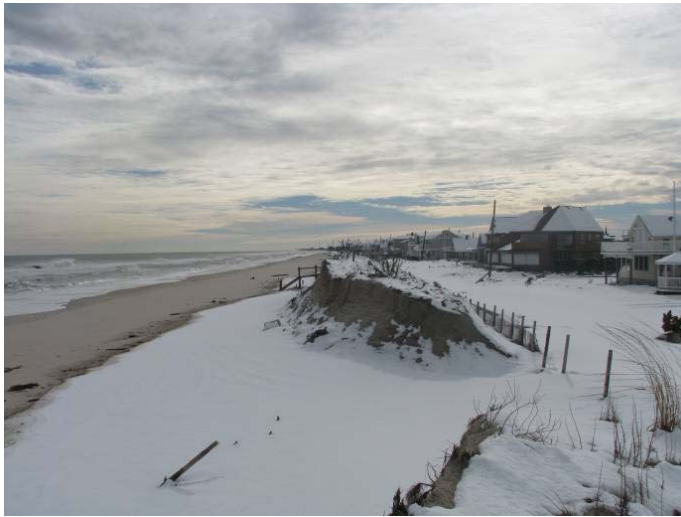
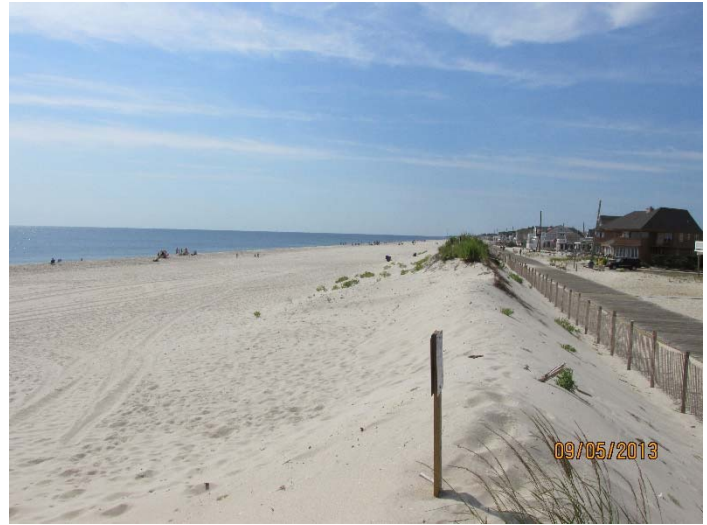
NJBPN 150 – White Avenue, Lavallette

The photograph on the left (November 8, 2012) shows the losses of the berm and dune removed during H. Sandy (51.1 yds³/ft). Some dunes remained intact preventing overwash which was mainly channeled through lower elevation dunes and access ways. On the right (September 5, 2013), sand was pushed up against the boardwalk in an effort to maintain a continuous dune line.

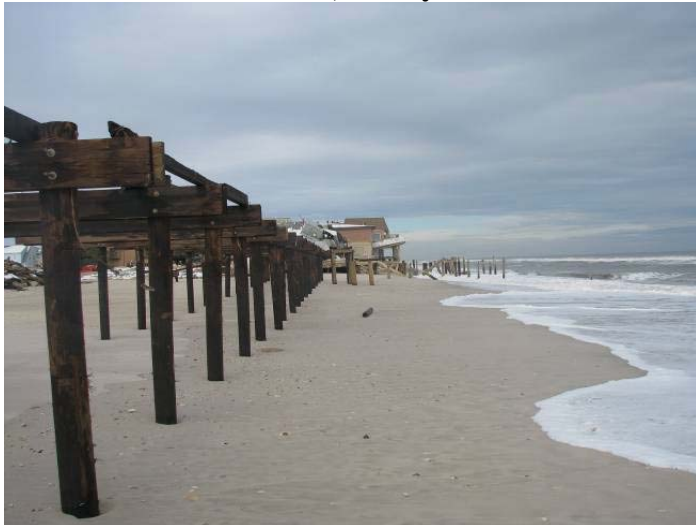
NJBPN 149 – 8th Avenue, Ortley Beach

The photograph on the left (November 8, 2012) shows the beach following the removal of 68.7 yds³/ft. of berm and dune during Sandy. Over 10 feet of dune height was pushed landward in overwash deposits. On the right, (taken November 7, 2013) the restored boardwalk was moved landward of its original position (about 25 feet) with a new dune composed of recovered sand.

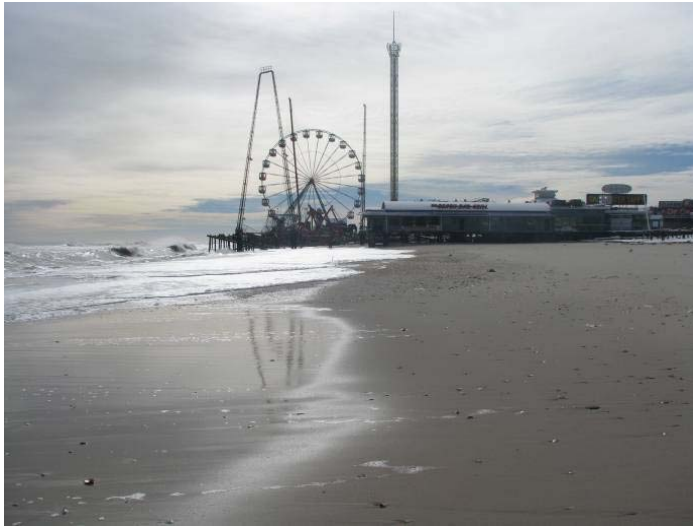
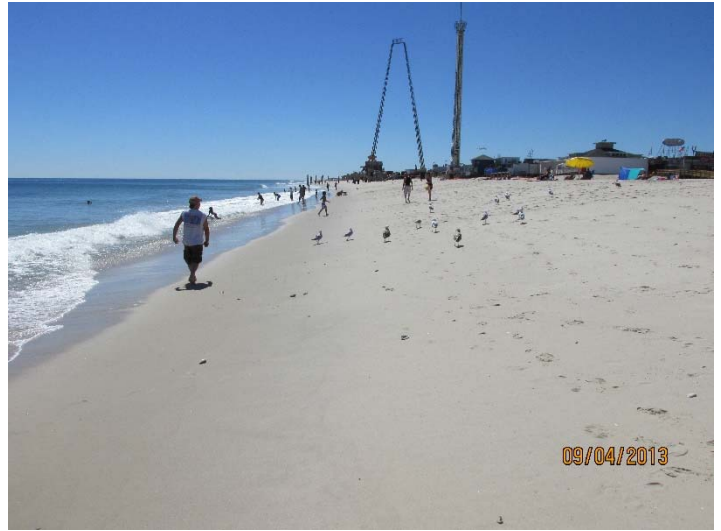
NJBPN 248 – Franklin Avenue, Seaside Heights

The November 8, 2012 post- H. Sandy beach (left photo) did not have a dune system prior to the storm resulting in damages to the pier and amusements. The photo on the right (taken September 4, 2013) shows the general location of the shoreline after nearly a year following the storm.

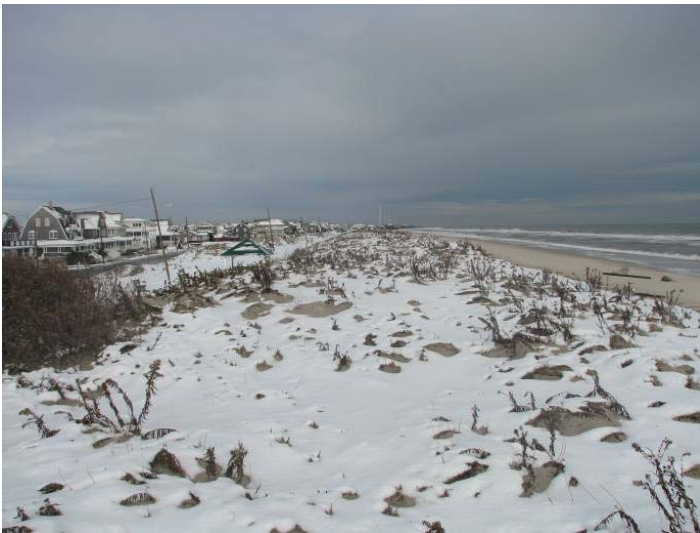
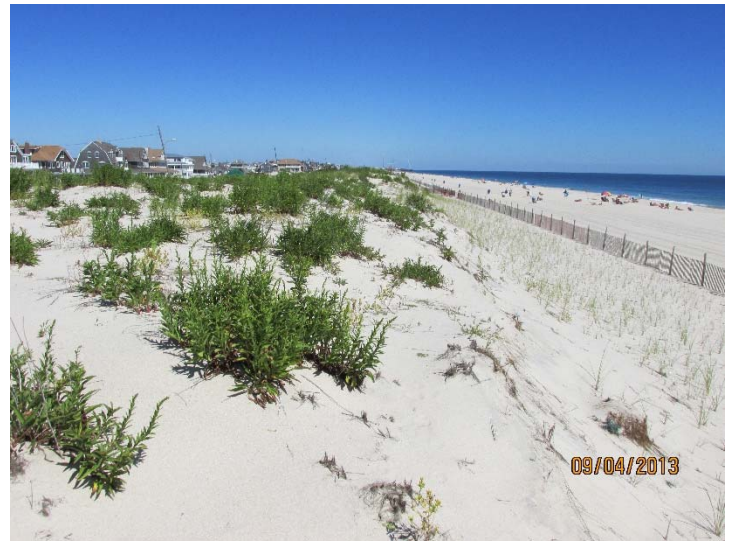
NJBPN 148 – 4th Avenue, Seaside Park

The left photograph was taken on November 8, 2012 after a northeast storm had dumped snow on the shoreline nearly a week after H. Sandy's landfall. There was some loss of the dune, but no overwash occurred at this location from the hurricane. The photo on the right (taken September 4, 2013) shows the results of local efforts to restore the eroded dune and trap sand at a new dune fence system.

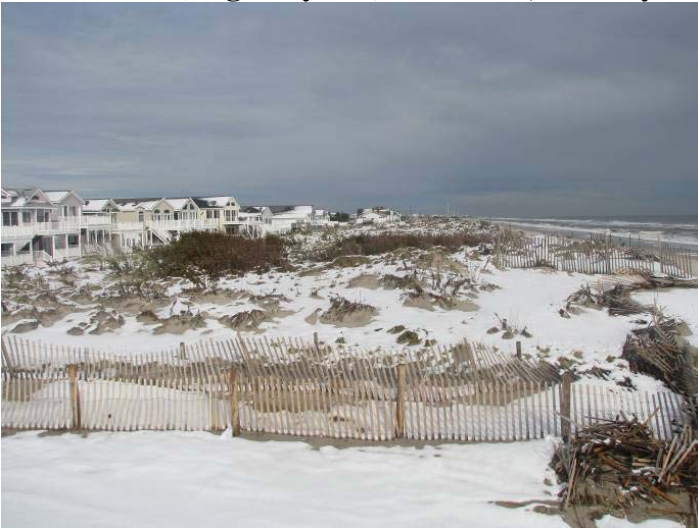
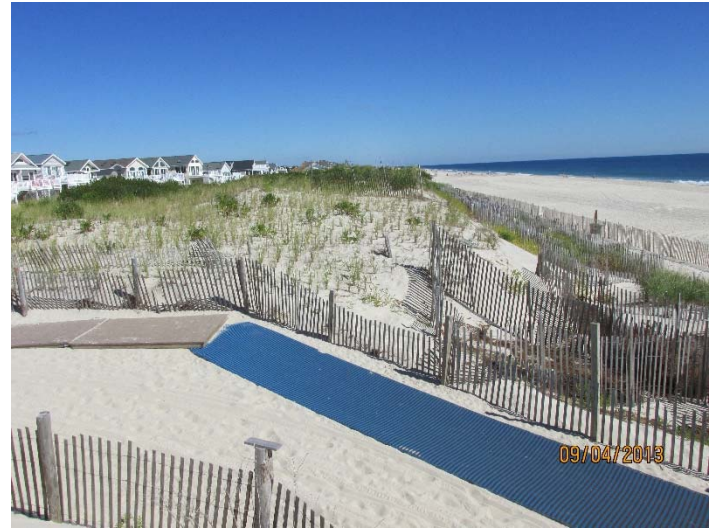
NJBPN 347 (originally 147) – 6th Lane, Midway Beach

The left photograph was taken on November 8, 2012 following a northeast storm that had dumped snow on the shoreline nearly a week after Sandy's landfall. On the right (photo taken on September 4, 2013), sand fencing and dune grass plants were added to trap additional sand to allow natural dune growth. This site was a dramatic testimony to the effect local efforts in shore protection could have in preventing major storm damages.

The private dune here was wide and high enough to be an island of low damage in an otherwise devastated region.

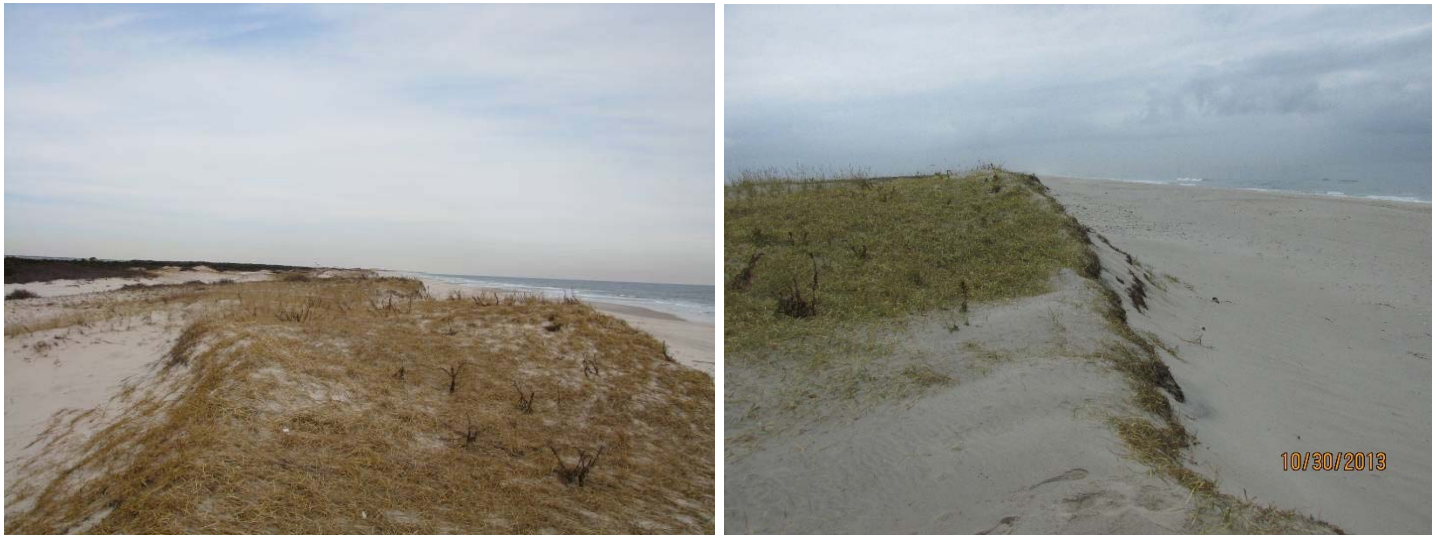
The left photograph was taken on December 12, 2012 and shows the beach and remaining dune. The right photo (taken October 30, 2013) shows the cut scarp in the dune system a year after Sandy that is demonstrated in the profile plots below.

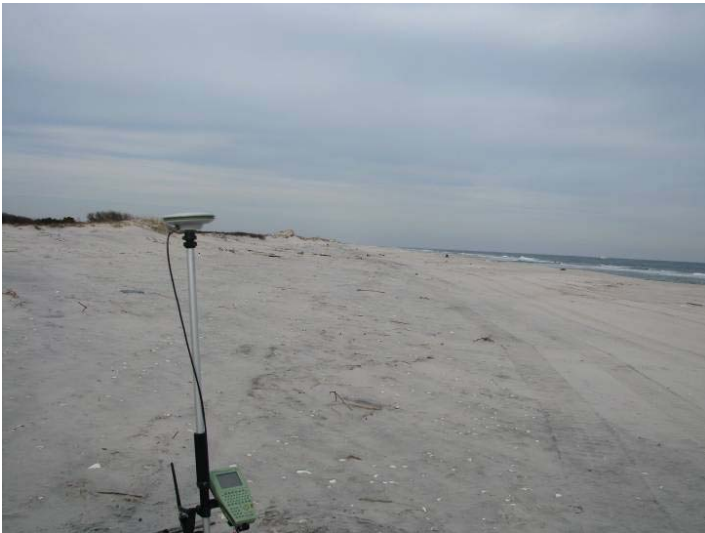
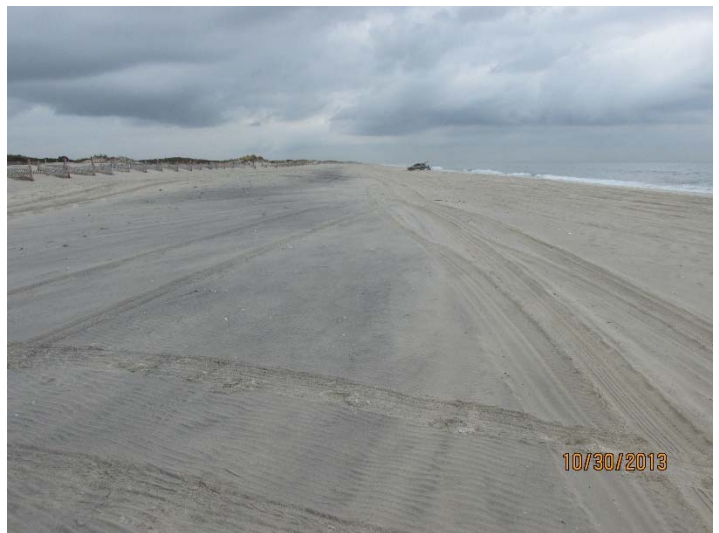
NJBPN 246 – Parking Lot A7, Island Beach State Park

The left photograph was taken on December 12, 2012 and shows the post-Sandy beach. By October 30, 2013 sand had returned from offshore bringing a wider beach, but little progress in rebuilding the pre-Sandy dune.

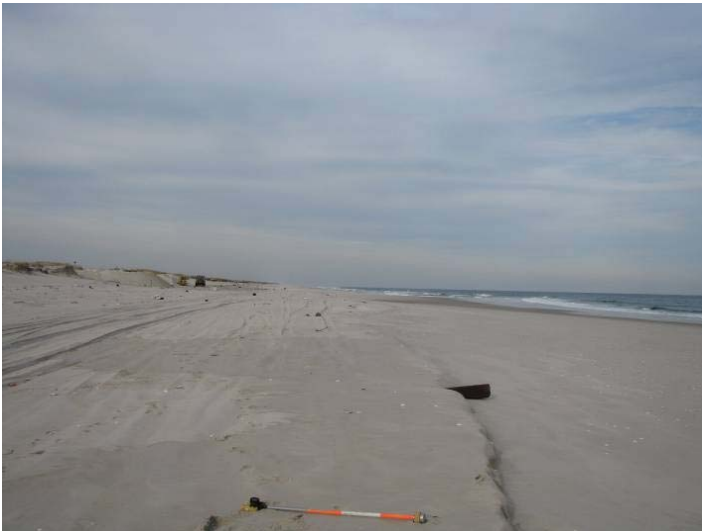
This site within the state protected area is less than a mile from the north Barnegat Inlet jetty. The left photograph was taken on December 12, 2012 and shows the narrower beach. The photo on the right, a years after Sandy (October 30, 2013) shows a wider beach and berm, but little growth in the dunes. This dune was cut less than the northern two sites, but natural recovery will be slow.

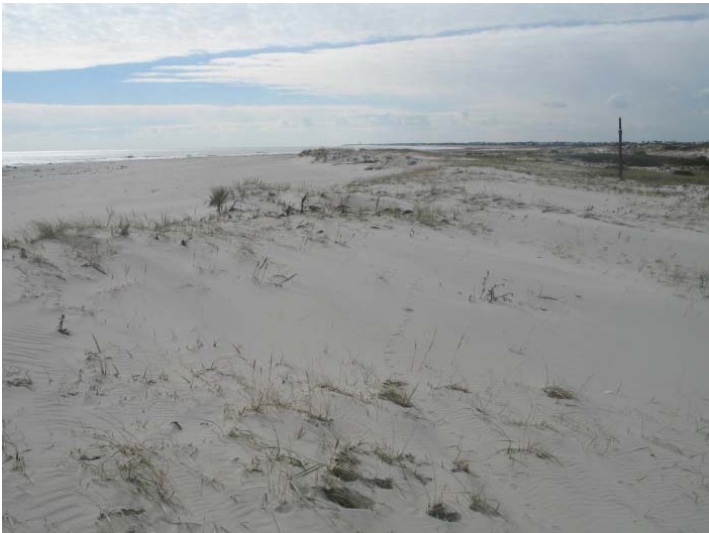
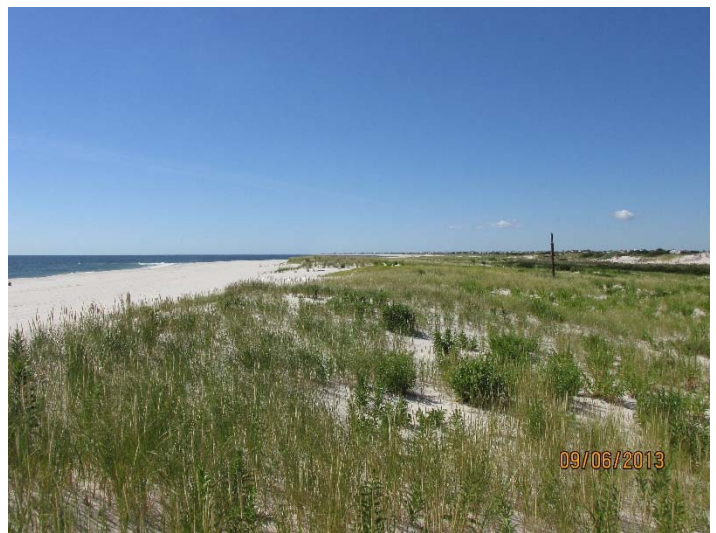
NJBPN 245 – 10th Street, Barnegat Light

This site is located approximately 1500 feet south of the Barnegat Inlet south jetty and was established to monitor the changes at the inlet. The left photo (taken on November 2, 2012) shows the immediate post-Sandy conditions with sand blown over the grass and minor dune toe erosion. The photo on the right (taken on September 6, 2013) shows that the vegetation recovered well and sand smoothed out the seaward slope. The vertical “pole” in both pictures is the mast of a fishing vessel that sank offshore in the 1980’s (profile caption below).

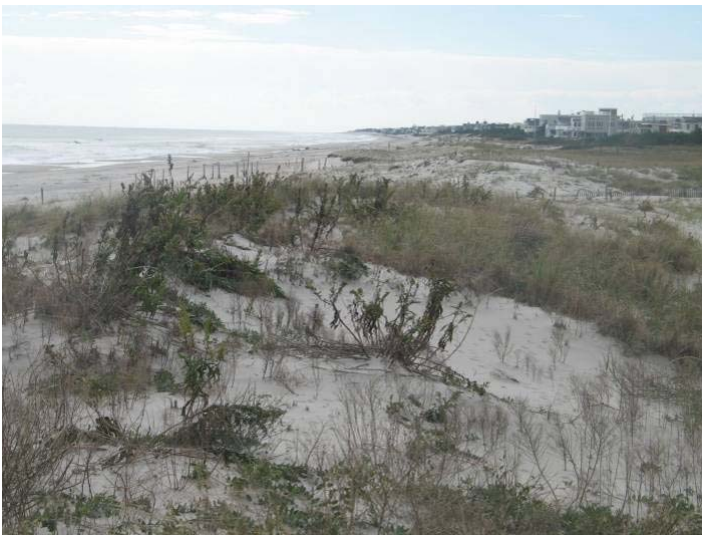
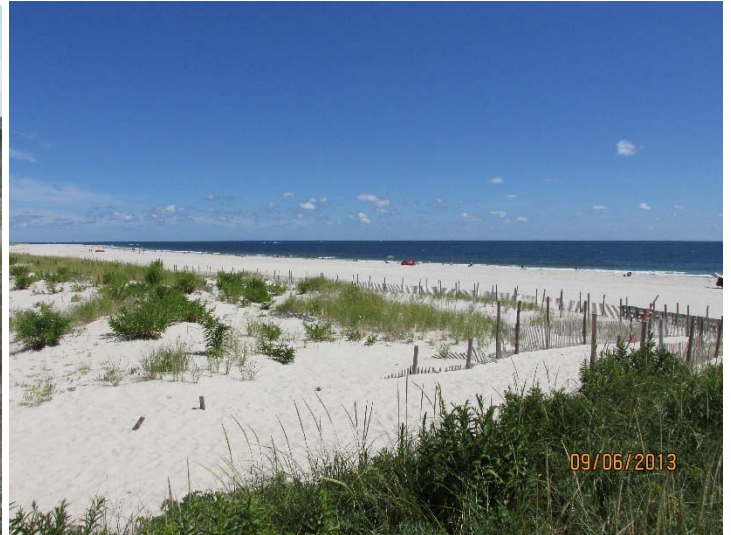
NJBPN 145 – 26th Street, Barnegat Light

The photo on the left was taken on November 2, 2012 and shows the post-Sandy beach/dune condition where minor toe erosion and wind transport inland among the vegetation had occurred. By September 6, 2013 the vegetation was spreading, sand was accumulating along the fencing and the berm had redeveloped naturally to 65% of that present pre-Sandy.

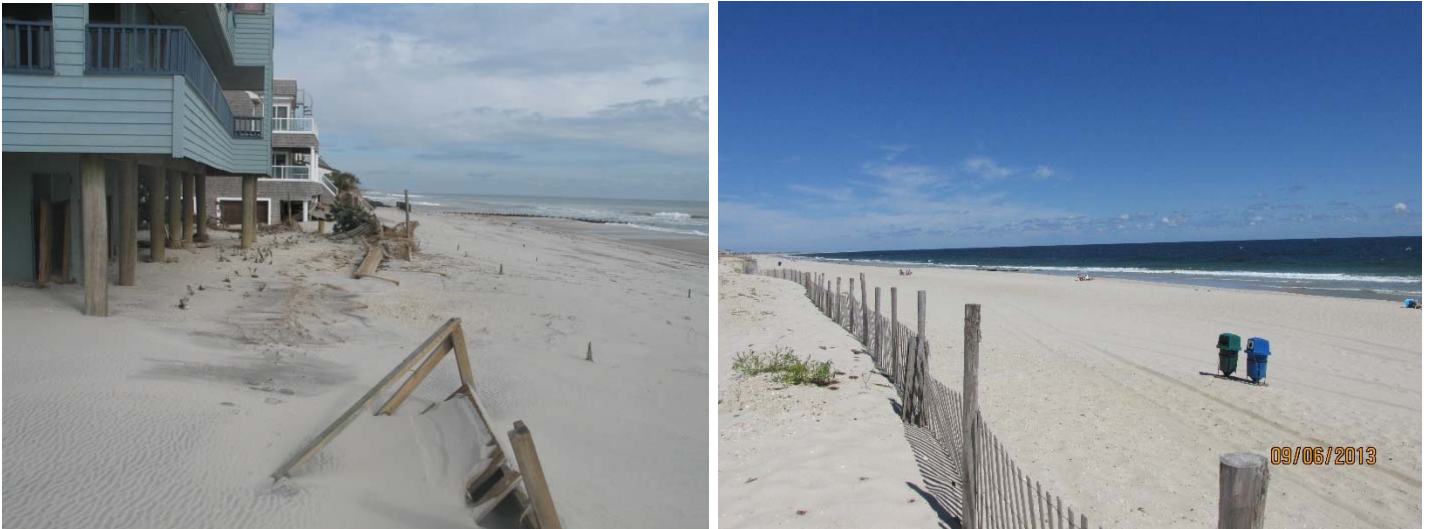
Above are two photos taken at La Baia Street immediately after Hurricane Sandy (Nov. 2, 2012) and almost a year later (Sept. 6, 2013). The overwash cut-through at the pedestrian access pathway was restored and the sand recovered to make a small dune along the properties. The fencing was added to enhance sand trapping from the wider berm.

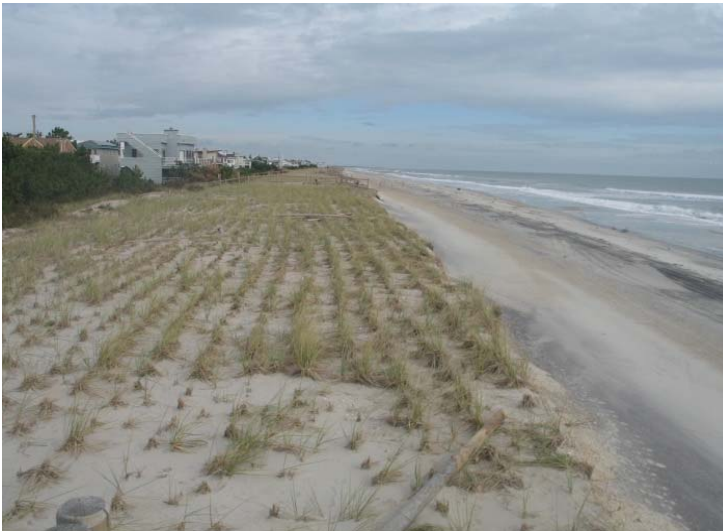
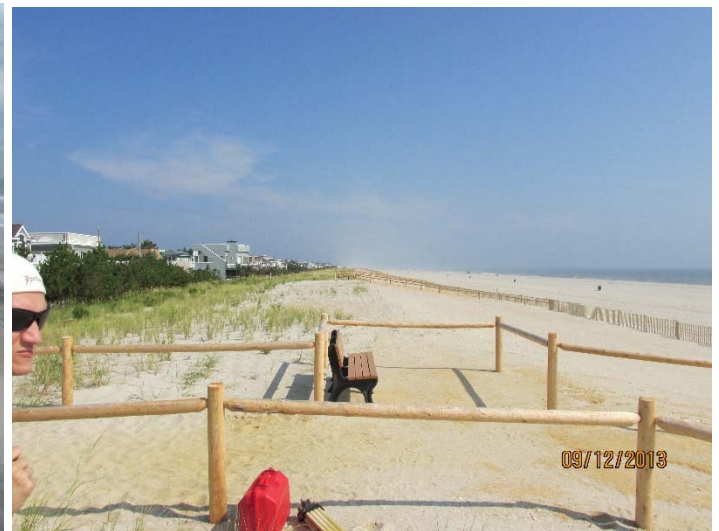
The photo on the left was taken on November 2, 2012 while the photo on the right was taken on September 12, 2013 from a similar location looking north. This site had received sand as part of the 2010 USACE beach nourishment project for Long Beach Island. By the fall of 2013 sand had been pumped back onto this part of the ACOE project restoring the berm and grading out the last of the cut in the dunes, the majority of which had been done by April 2013.

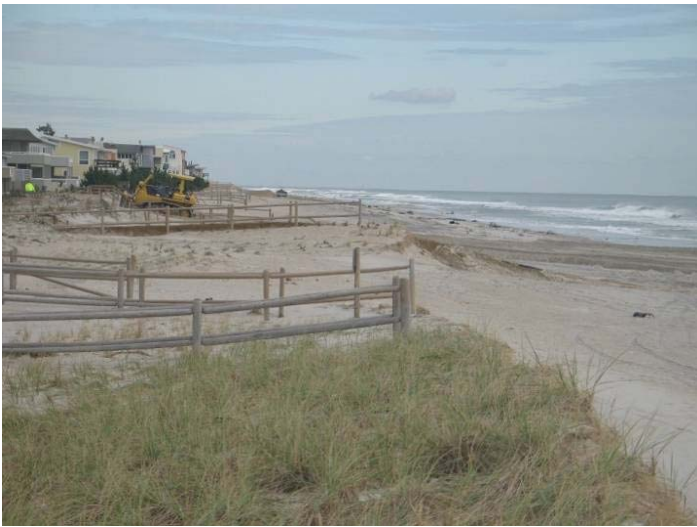
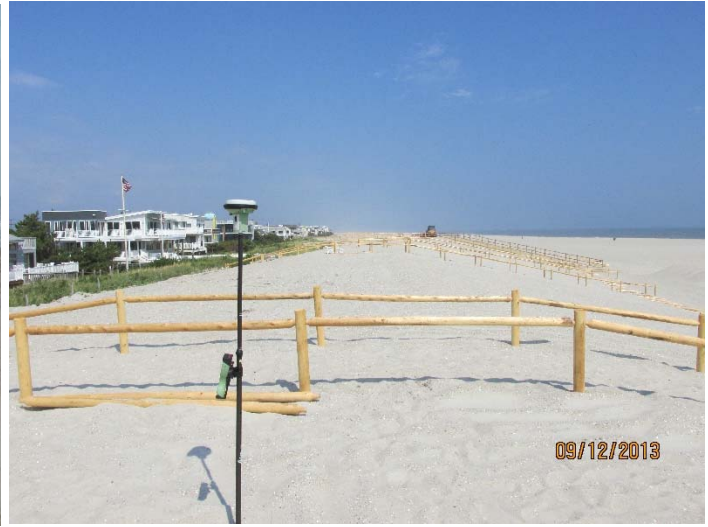
The Tranquility Drive site was included in the 2010 USACE beach nourishment project. The photo on the left was taken on November 2, 2012 and shows the dune and beach conditions immediately after Sandy. On the right, the photo (taken on September 12, 2013 – a year post-Sandy) shows the results of ACOE efforts in restoring the dune and berm to design template specifications. New grass and completion of the fencing was on-going.

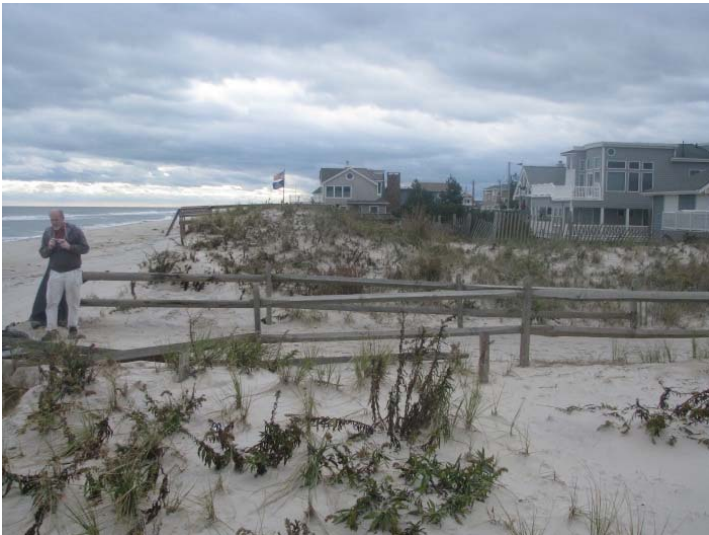
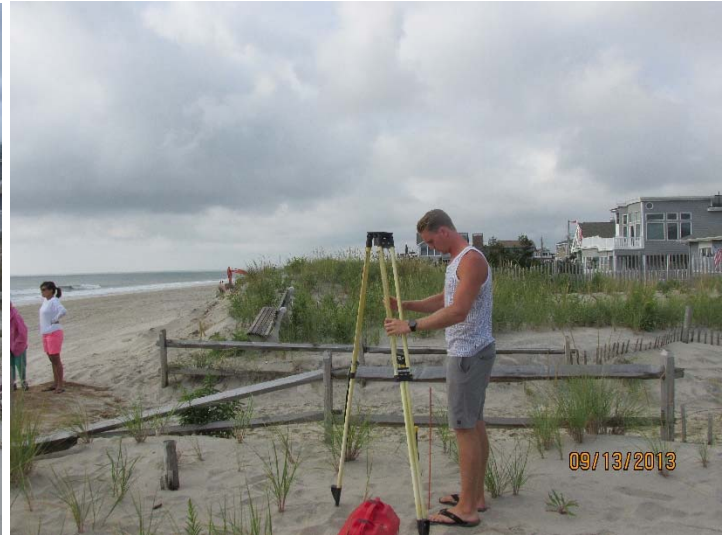
The photographs above were taken on November 1st, 2012 (left) and September 13, 2013 (right). Both images show the view of 20th Street (site 241) looking south. This location in Surf City received a beach replenishment in 2007 and was in the process of being restored to design specifications in Sept. 2013. The process was incomplete a year later as can be seen in the position of the split rail fencing being identical in both photographs. The sand, however, was back on the beach with some recovery to the foredune slope.

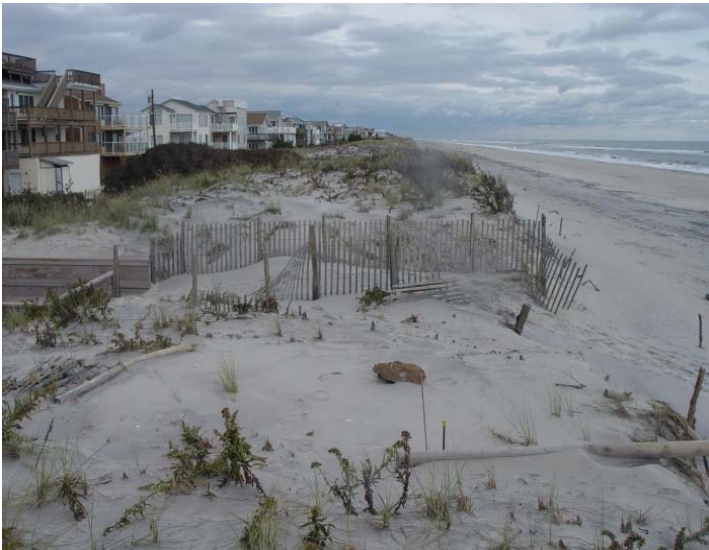
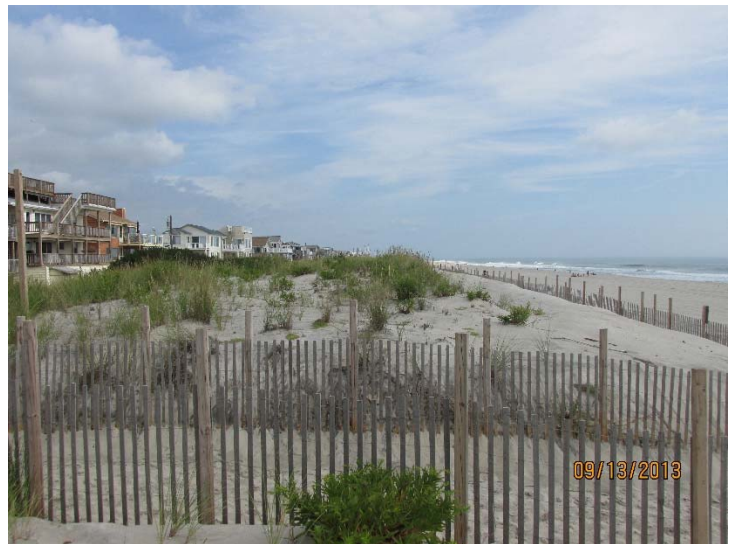
NJBPN 141 – 8th Street, Ship Bottom

The photographs above were taken on November 1, 2012 (left) and September 13, 2013 (right). Both images show the view of 8th street (site 141) looking north. The beach recovered substantially by the fall of 2013, new fencing was installed, but the dune volume remains as Sandy left it.

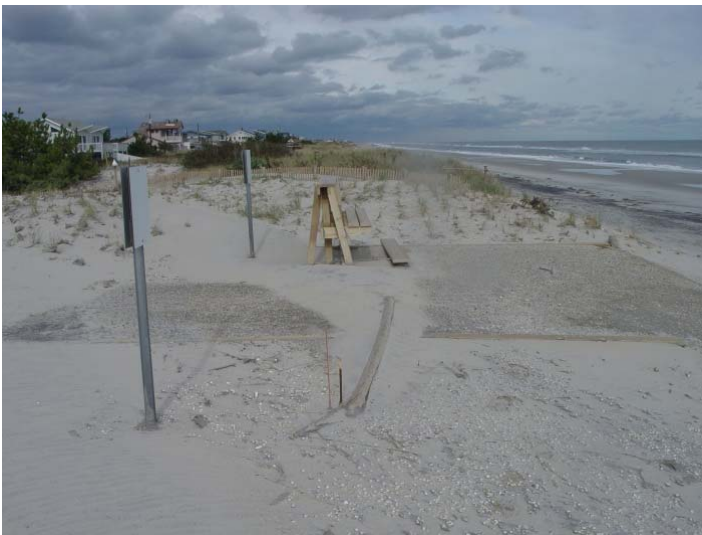
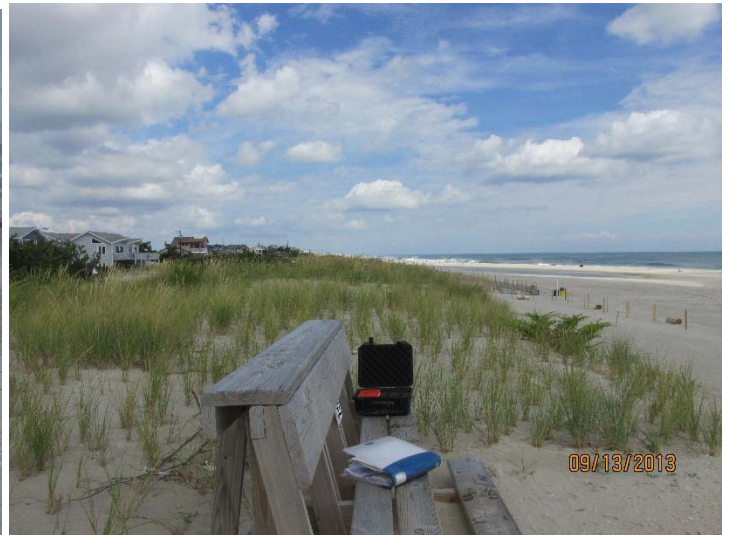
NJBPN 140 – 32nd Street, Long Beach Township

The photographs above were taken on November 1, 2012 (left) and September 13, 2013 (right). Both images show the view of 32nd street (site 140) looking north. This location in the Brant Beach section of Long Beach Township received beach replenishment in spring 2012 just in time. The damage immediately after the storm is evident to the left with the restoration showing on the right. The berm recovered and the post-Sandy volume added was quite large.

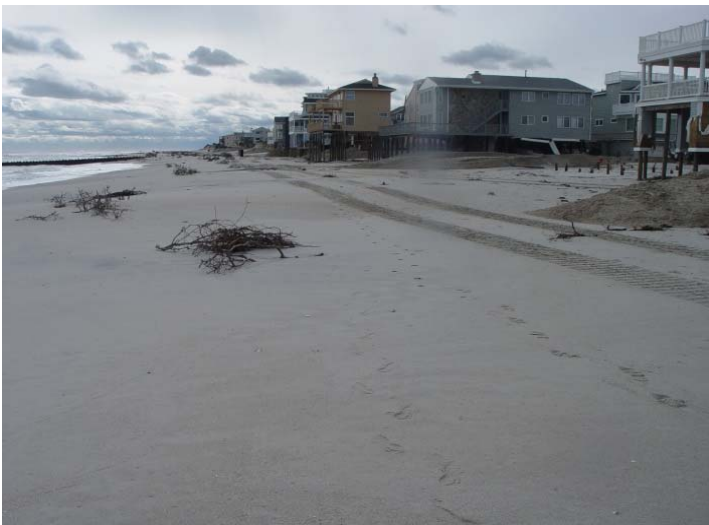
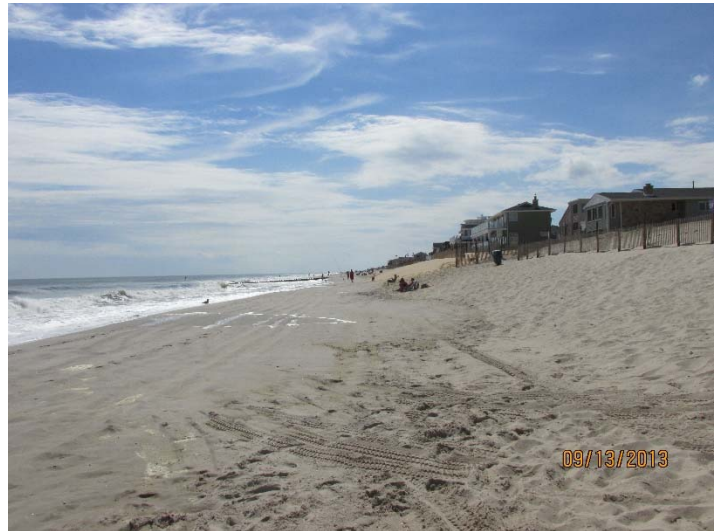
NJBPN 139 – 81st Street, Long Beach Township

The photographs above were taken on November 1, 2012 (left) and September 13, 2013 (right). Both images show the view of 81st street (site 139) looking south. Damage was extensive and the dune restoration was derived from recovered sand hauled back to the beach from inland. Sand also returned naturally from offshore where Sandy deposited a large volume.

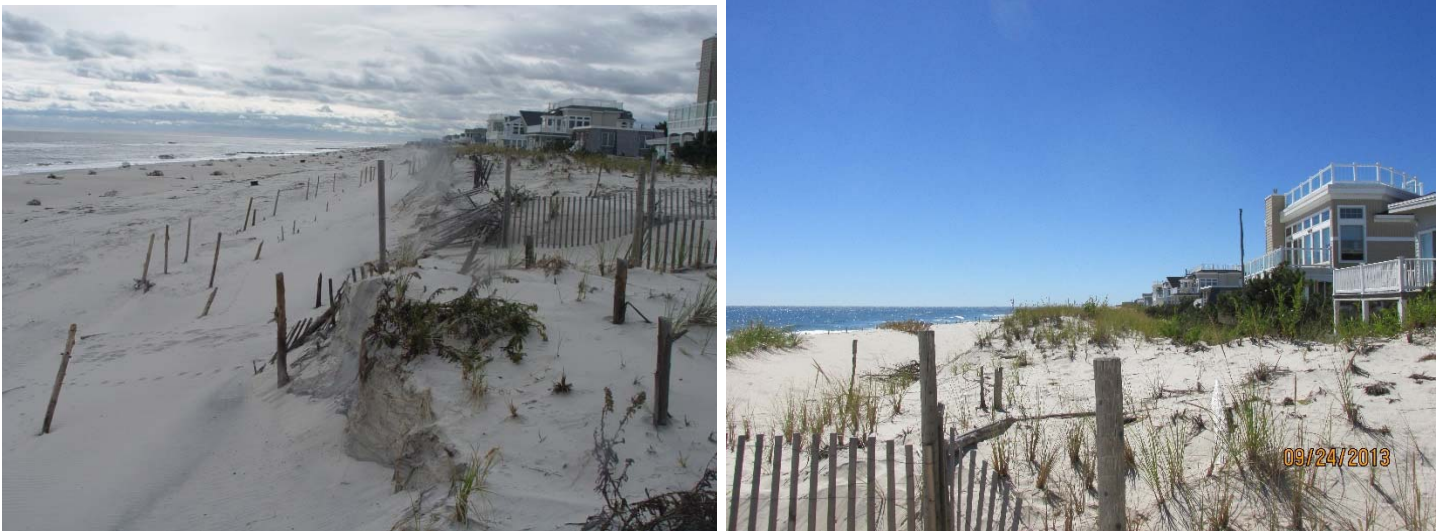
NJBPN 138 – Old Whaling Road (124th Street), Long Beach Township

The photographs above were taken on November 1, 2012 (left) and September 24, 2013 (right). Both images show the view of Old Whaling Road (site 138) looking south. Sand was brought back to the dune's seaward slope to restore storm damage. The beach has not widened naturally as much as other non-federal project locations.

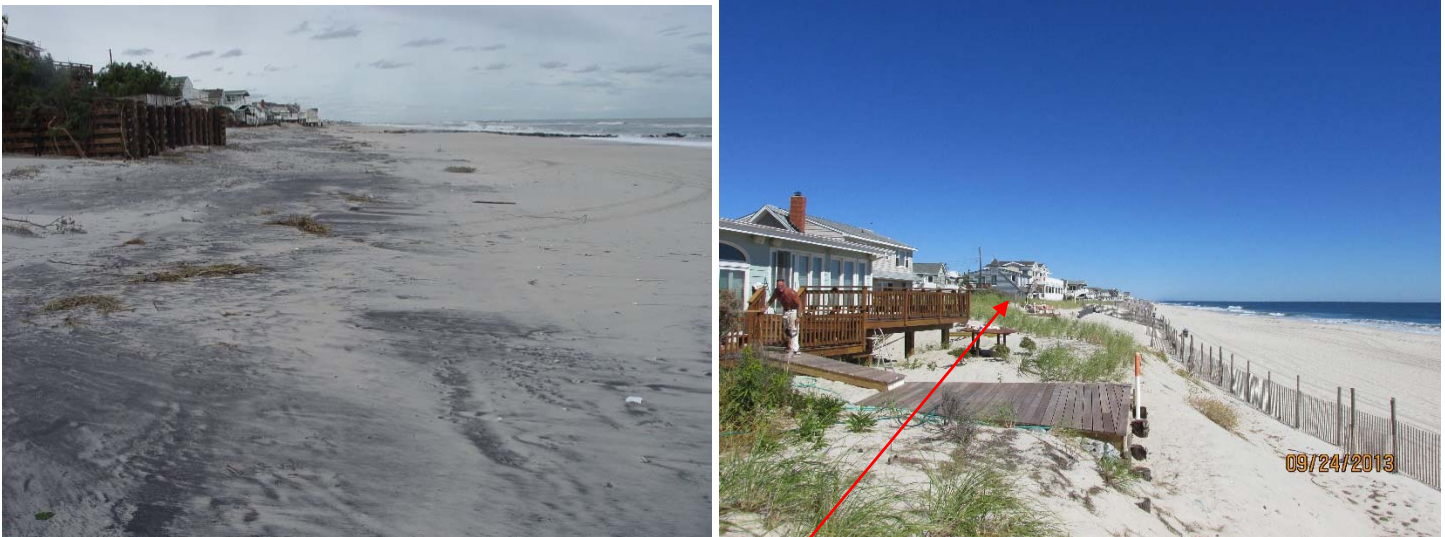
NJBPN 137 – Taylor Avenue, Beach Haven

The photographs above were taken on November 1, 2012 (left) and September 24, 2013 (right). Both images show the view of Taylor Avenue looking north. The immediate result of Sandy was the total loss of the dune with major overwash inland. A year later the dune had been substantially reconstructed from recovered sand hauled back to the beach. The private timber shore protection served well and is still visible in the distance.

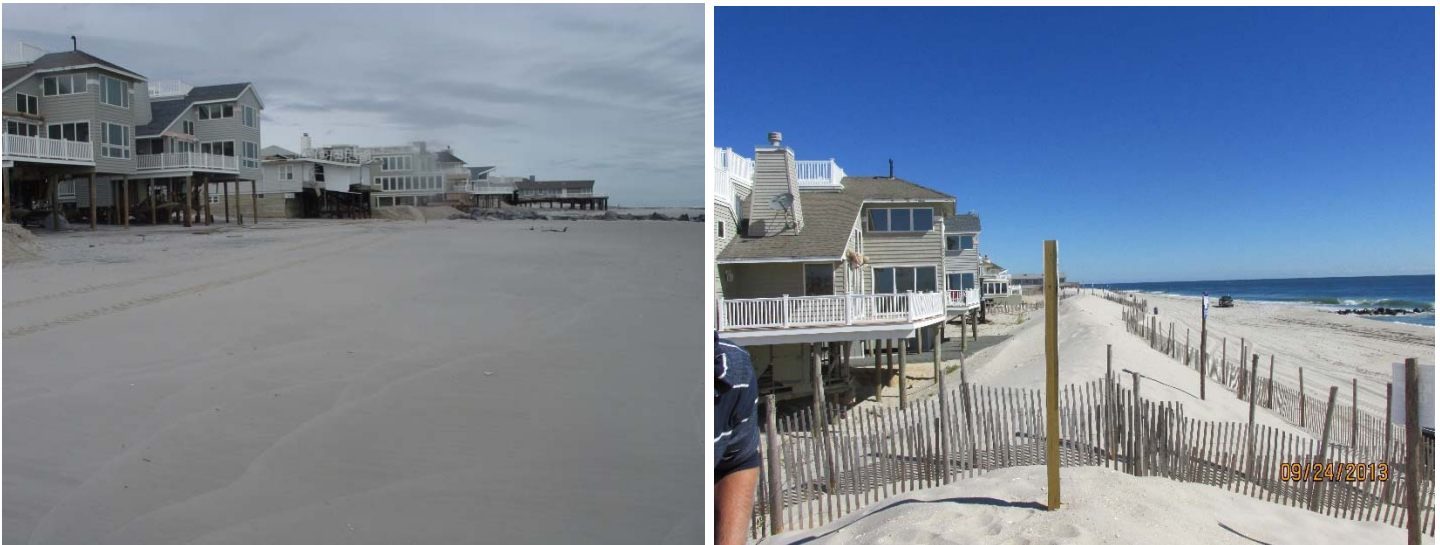
NJBPN 136 – Dolphin Avenue, Beach Haven

The photographs above were taken on November 1, 2012 (left) and September 24, 2013 (right). Both images show the view of Dolphin Avenue (site 136) looking north. The lost dune was replaced by a smaller feature using sand hauled back to the beach from inland deposits. There is a wider beach as a result of a year’s natural accretion.

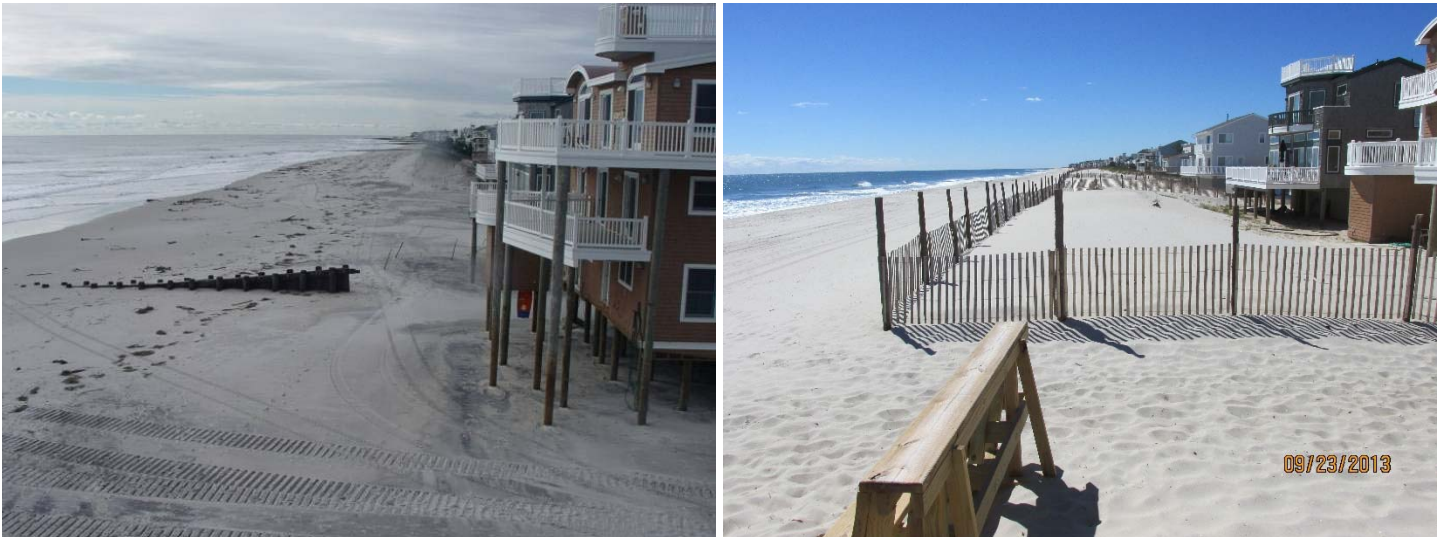
The photographs above were taken on November 1, 2012 (left) and September 23, 2013 (right). Both images show the view of Webster Avenue in Beach Haven (site 135) looking south. The dune was replaced nearly as it had been with sand hauled back to the beach from overwash deposition inland. Sand also migrated back to the shoreline adding width to the berm.
