New Jersey Beach Profile Network

Ocean County

**Manasquan Inlet
to Little Egg Inlet**

**NJBPN Profile #'s
156 - 234**

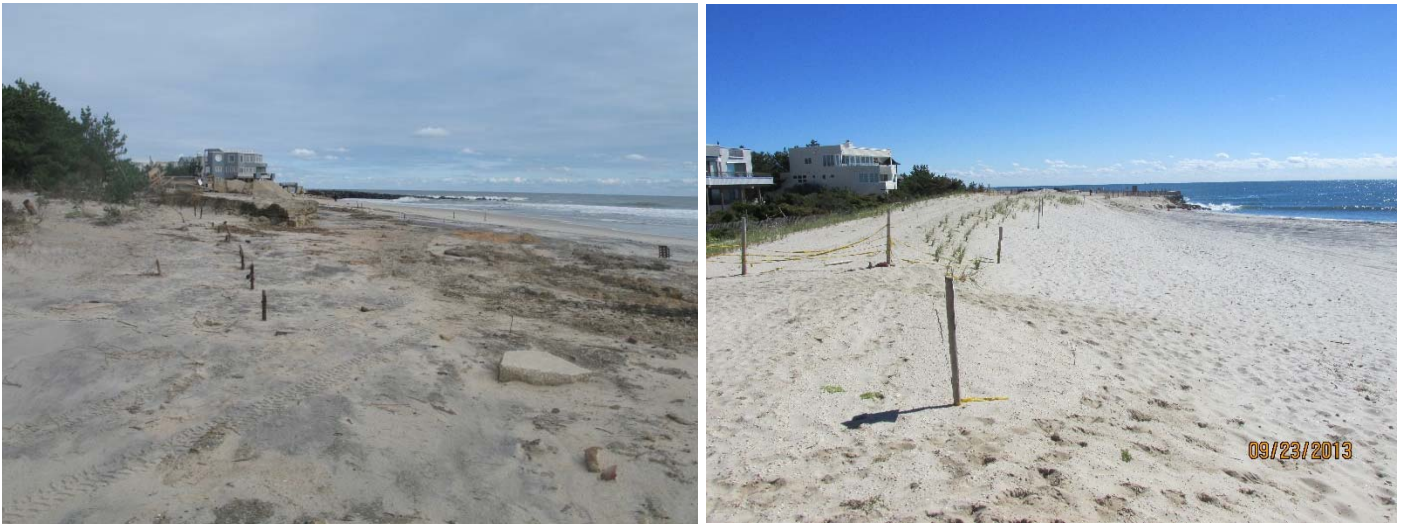
The photographs above were taken on November 1, 2012 (left) and September 23, 2013 (right). Both images show the view looking north at the beach-buggy entrance to the Forsythe Refuge (site 234). Sand was pushed south to create a “dune” following complete overwash by the storm surge flattening all elevation features on the refuge property. Sand did deposit quite rapidly just south of the terminal groin on Holgate, but did not remain in place by fall 2013.

Total overwash occurred all along the refuge zone spread clean sand across the vegetation and into Barnegat Bay. Recovery will be slow while the shorebirds have a wide open habitat for some time. No tidal inlet breach occurred, so Long Beach Island retains its pre-Sandy dimensions.
