**FINAL REPORT FOR 2018
ON THE CONDITION OF THE MUNICIPAL OCEANFRONT BEACHES
THE BOROUGH OF AVALON, CAPE MAY COUNTY, NEW JERSEY**

**PREPARED FOR: THE BOROUGH OF AVALON
3100 DUNE DRIVE
AVALON, NJ 08202**

**PREPARED BY: THE STOCKTON UNIVERSITY COASTAL RESEARCH CENTER
30 WILSON AVENUE
PORT REPUBLIC, NEW JERSEY 08241**

**ANNUAL REPORT FOR 2018 - TO THE BOROUGH OF AVALON
ON THE
CONDITION OF THE MUNICIPAL BEACHES**

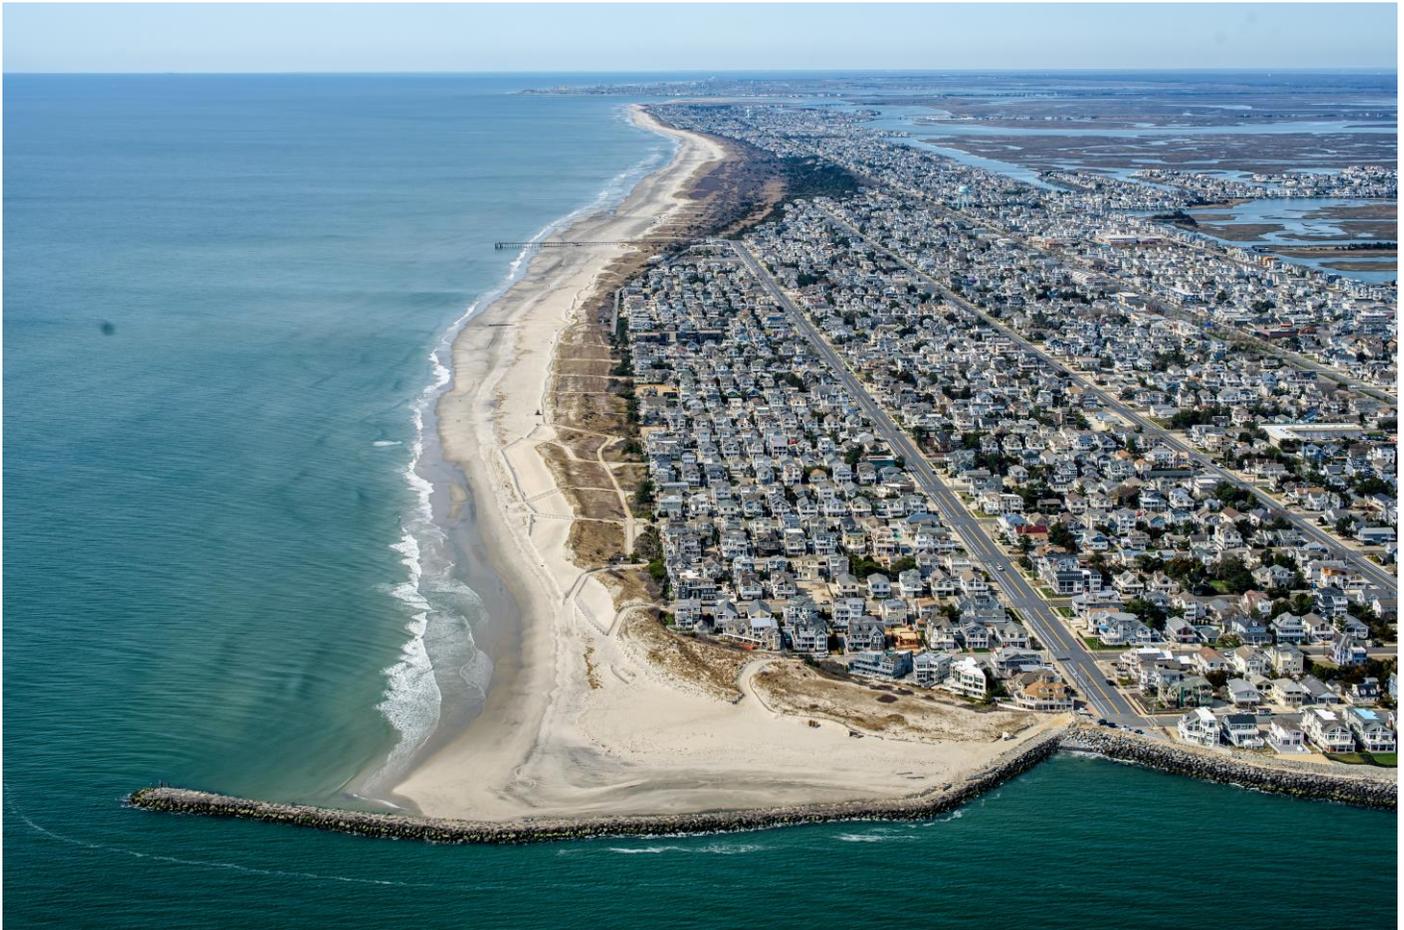
View of the Avalon oceanfront April 21, 2018, a year following the US Army Corps of Engineers maintenance beach nourishment sediment that was put between 9th and 26th Streets restoring the project to the initial design specifications. This expanse shows the relationship among all the development and the beach/dune areas representing protection for that development from severe storms. PHOTO by Ted Kingston.

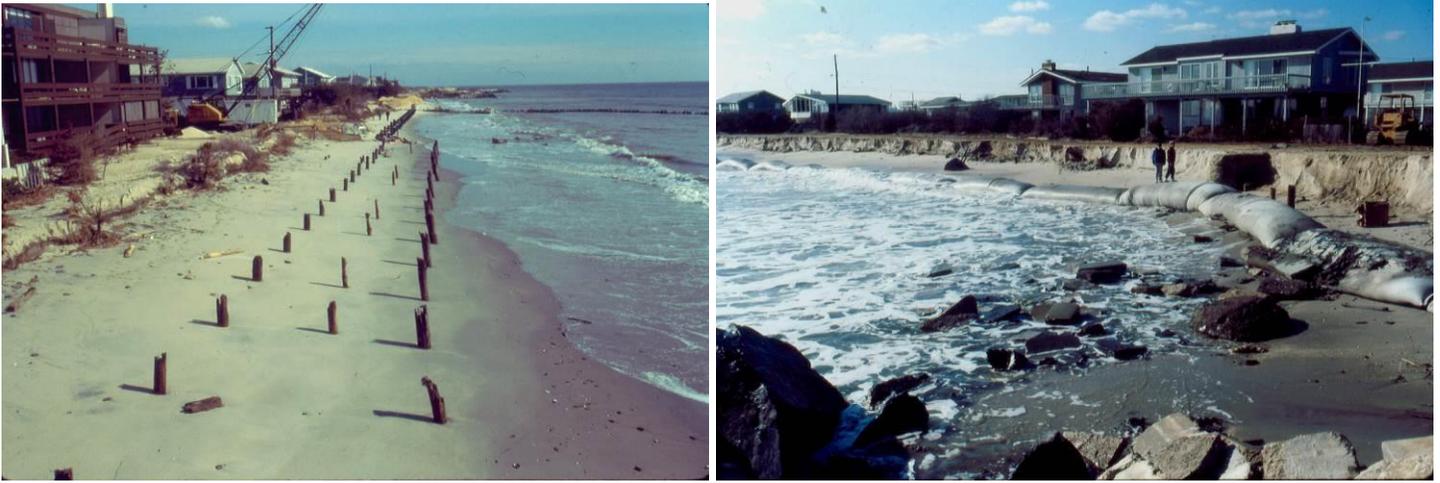
Figure 1. On the left is an October 1986 view north from 20th Street showing the exposed support pilings for the boardwalk that once extended further north of its present ending street. There were no more dunes and homes were within easy reach of larger waves even at a normal high tide. To provide some economic insight as to the value of shore protection; one house in this section sold in early 1987 on the beach for \$82,000. The new owner held it until after the 1987 beachfill, then sold it in October for \$365,000 without doing a single improvement.

On the right is a February 1987 view from the end of the seaside bulkhead that ended at 17th Street with erosion approaching the oceanfront home on the south side of 17th Street. The white bags were placed earlier that winter, filled with concrete to protect the buried sewage service line running just seaward of the private property lines (formerly over 500 feet from the water's edge in 1981). By April 1987 the posts supporting the second floor deck were at the edge of the sand scarp with the resident's doghouse sitting at the very edge of the scarp leaving a 4-foot jump down if the dog wished to use the house. The 1987 2.35 million cubic yard initial beachfill came in time to save this property from total loss, and by 1997 it had been torn down and replaced by a much more expensive structure.

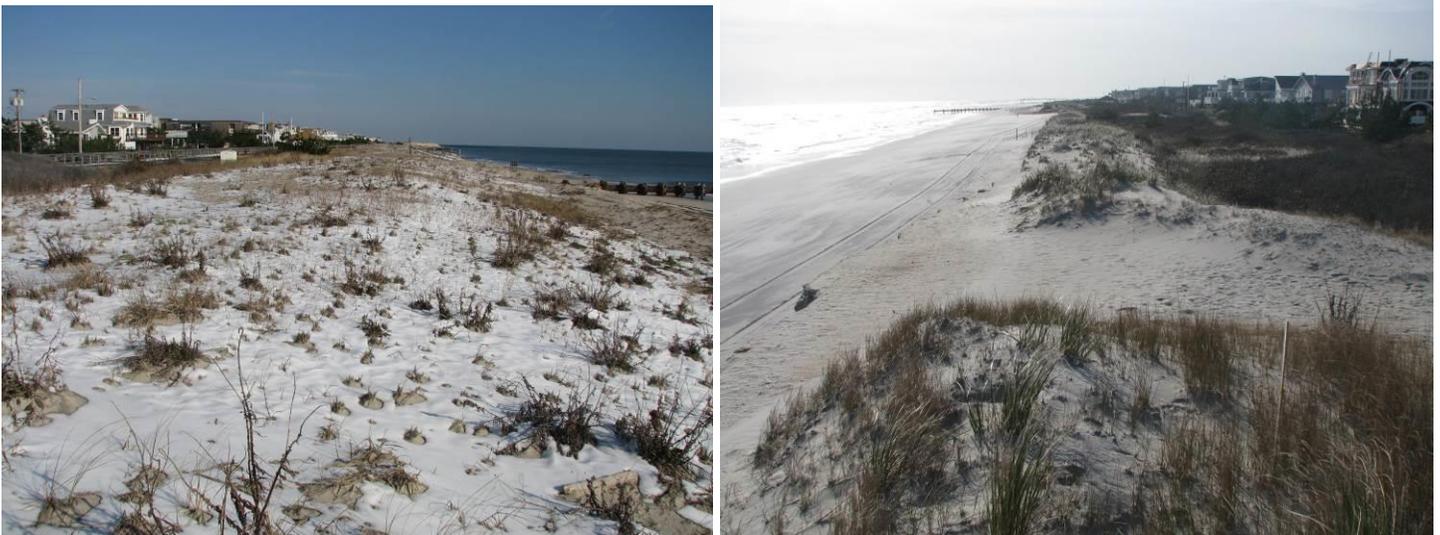
Figure 2. This pair of photographs are from late 2009 following the worst erosion seen since 1987. Multiple storms produced beach retreat, dune erosion which triggered the purchase of quarry sand by the Borough to bolster the dunes in the right side

picture taken from the sand covering the rock seawall at 17th Street. On the left is a view north from 23rd Street including the boardwalk to the extreme left 22 years after waves washed under the structure at mid-tide every day.

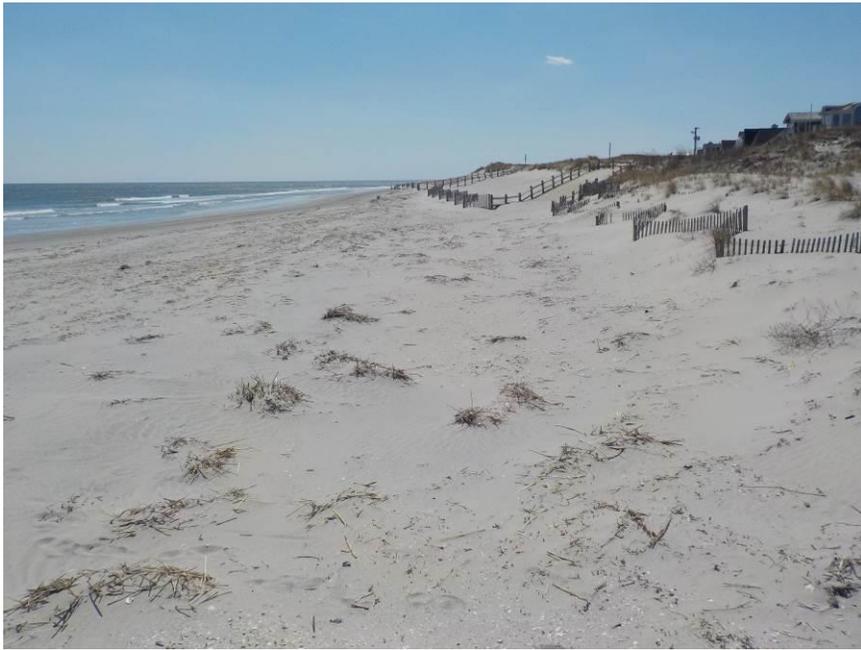
1a. April 5, 2018

View 1a shows the beach and seaward dune slope after the majority of the sequence of weekly northeast storms. Little dune damage occurred, but the beach was flattened to the toe of the dunes.

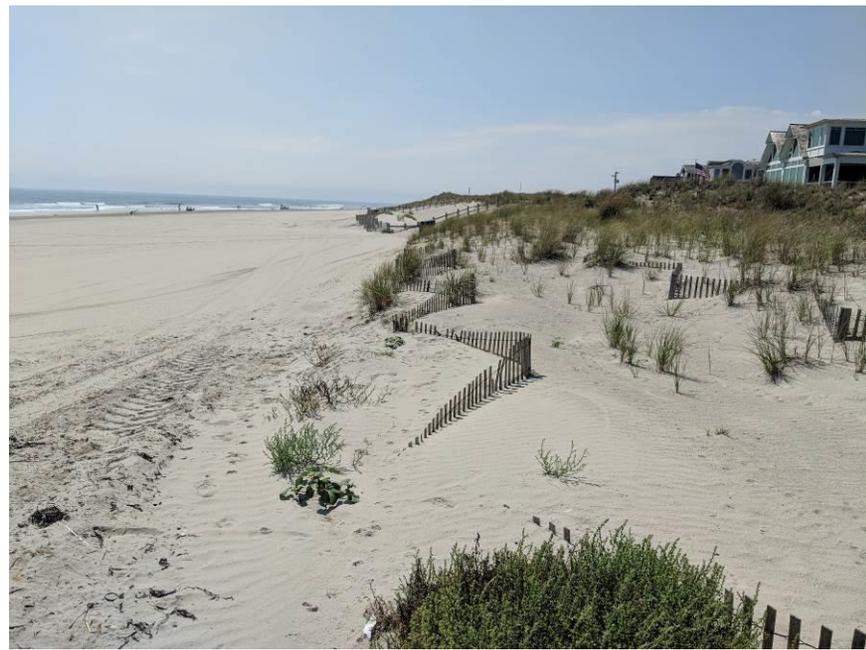
1b. September 10, 2018

View 1b was taken in September following berm development showing sand restored to the beach and added to the seaward dune slope.

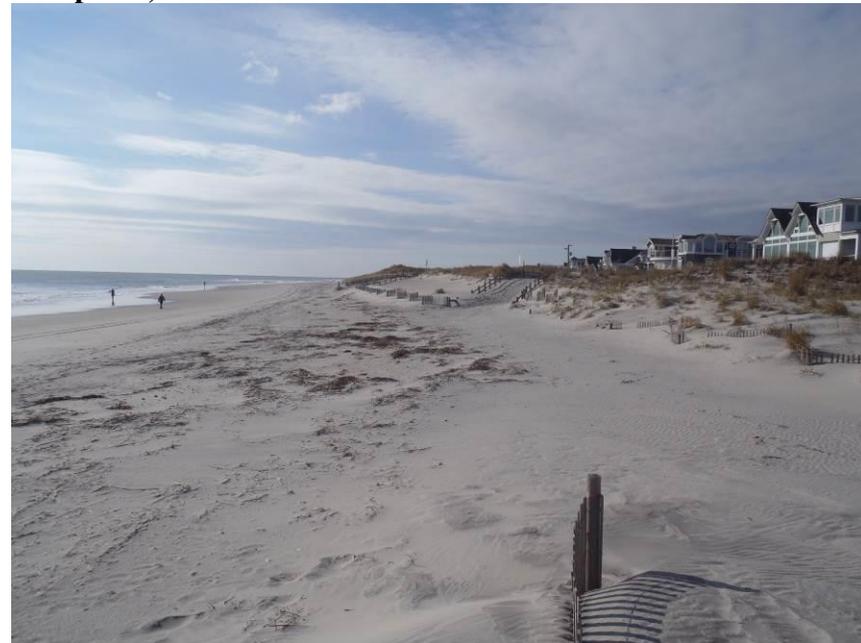
1c. December 6, 2018

View 1c This view from early December shows the storm debris washed up to the seaward dune toe once again with the beach flattened by wave activity.

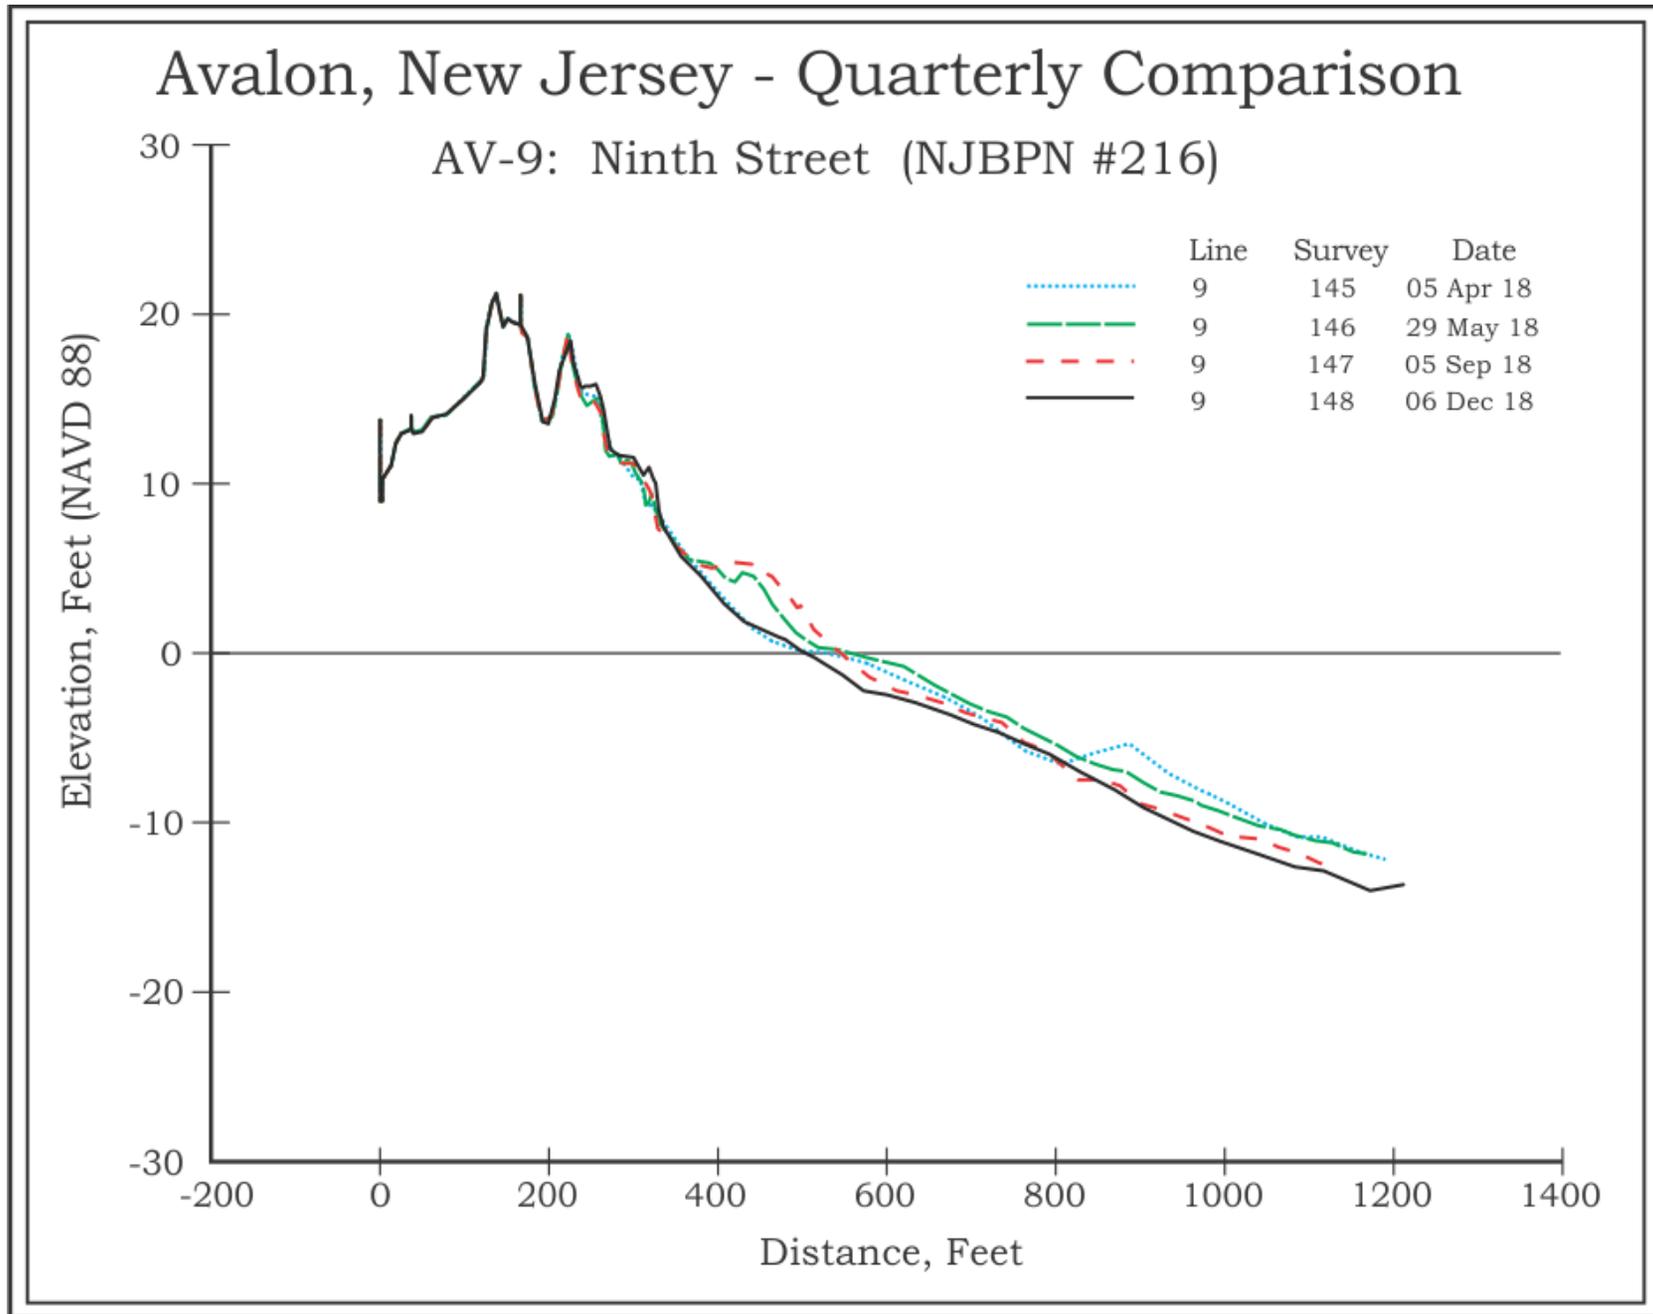
Figure 3. At 9th Street conditions ended in December 2018 approximately where they were as of April 2018. The summer accumulation built a significant beach berm and deposited sand offshore close to the beach, which eroded away between September and December 2018. Sand was minimally added to the dunes by the wind.

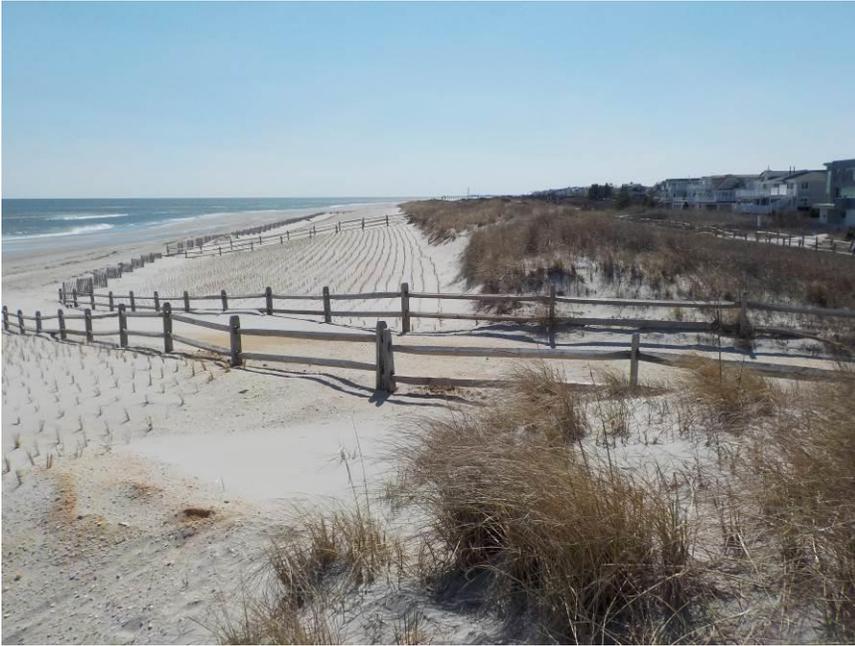
2a. April 6, 2018

View 2a shows 12th Street following the series of northeast storms that reduced the beach width, but did not impact the new seaward dune slope that had been newly planted with grass.

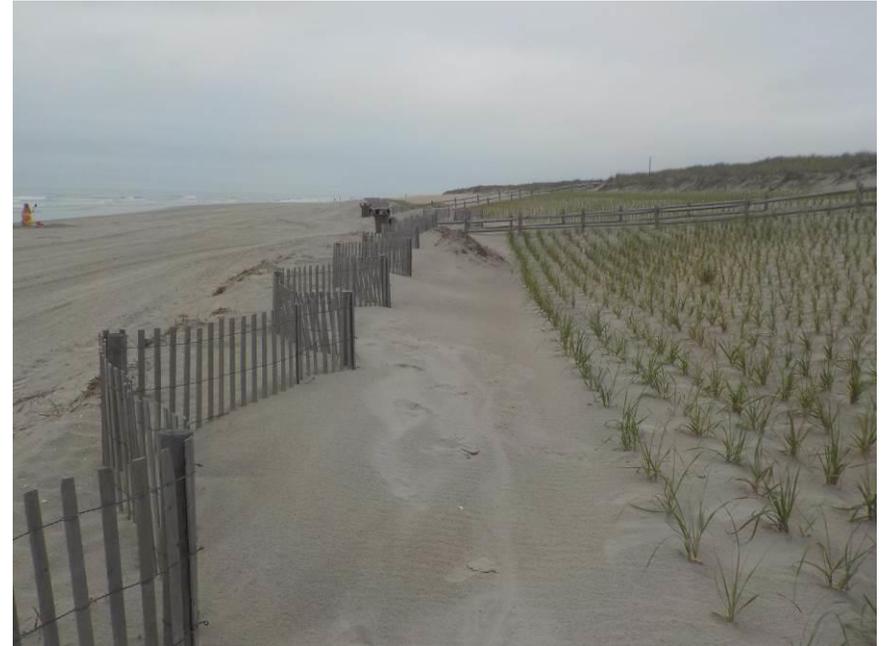
2b. May 29, 2018

View 2b was taken just after Memorial Day with a small foredune developed at the fencing seaward of the new dune grass plants.

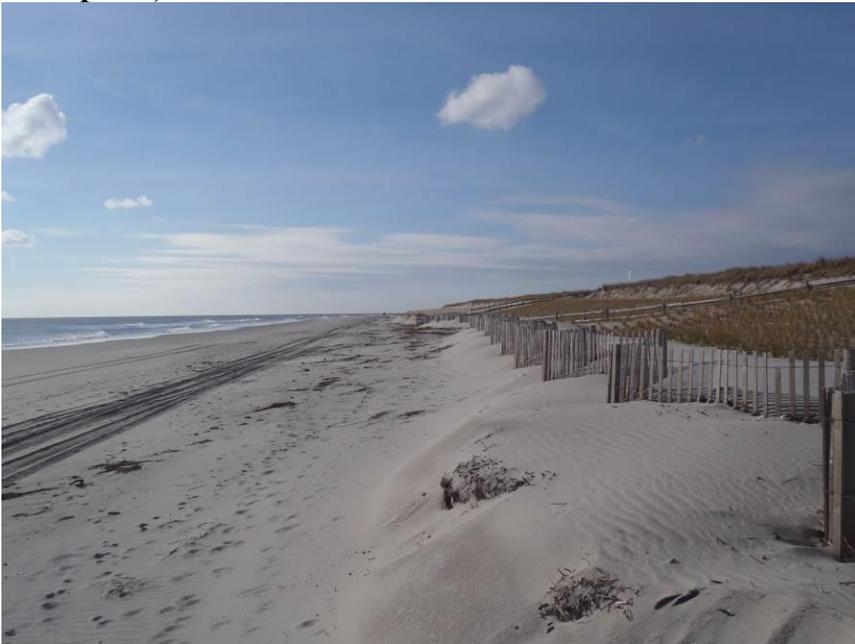
2c. December 6, 2018

View 2c was taken after the summer season where minor storm activity had reached the toe of the new fore dune developed at the fence line. The season produced almost 2 feet of deposition from wind transport since the project was complete in March/April 2017.

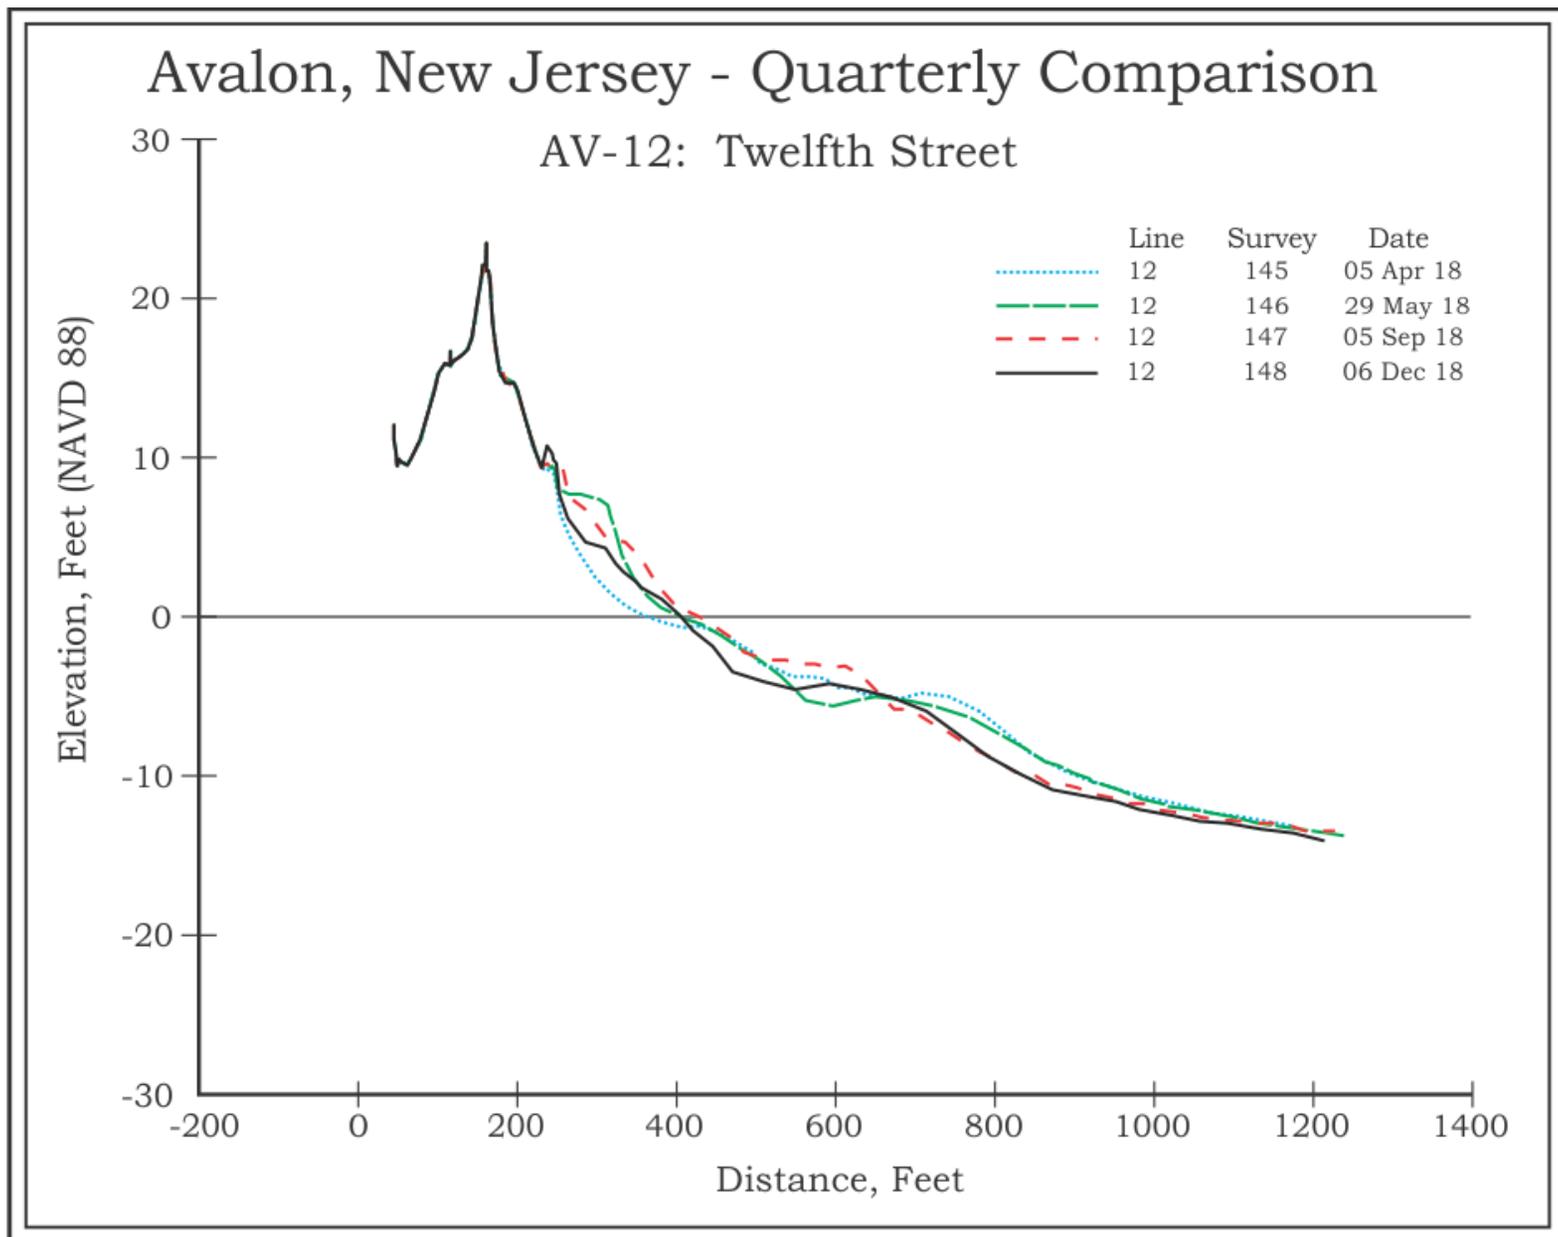
Figure 4. April 2018 survey revealed the smallest beach volume of sand. The spring and summer conditions added sand to the beach as material offshore moved landward. Sand was added to the dune toe as the early winter events cut into the berm built up over the summer. This year was not the most erosional ever seen at 12th Street, with conditions relatively consistent, but still in the loss column.

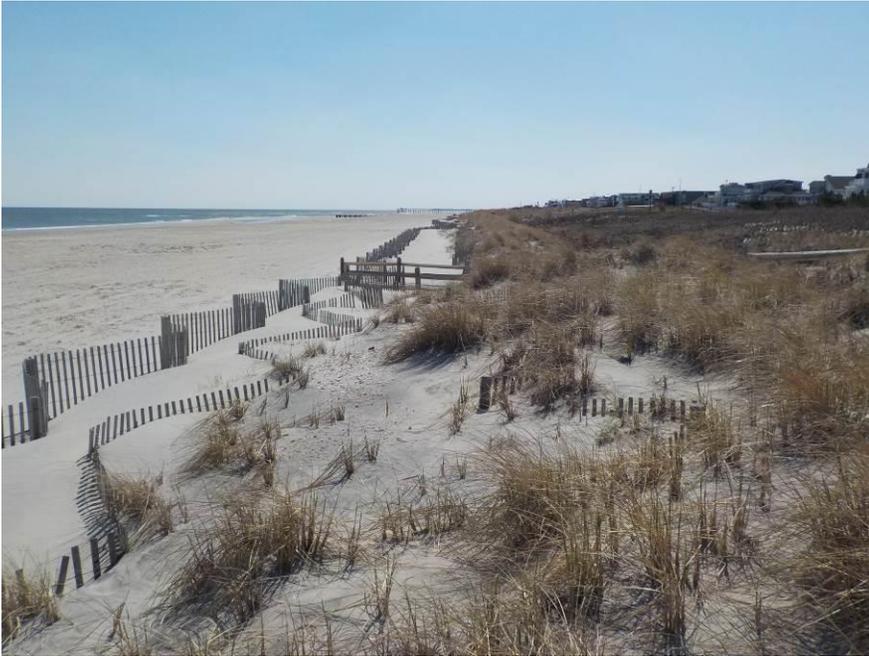
3a. April 5, 2018

View 3a Following a series of northeast events, the beach remained wide with sand accumulating along the two rows of fencing.

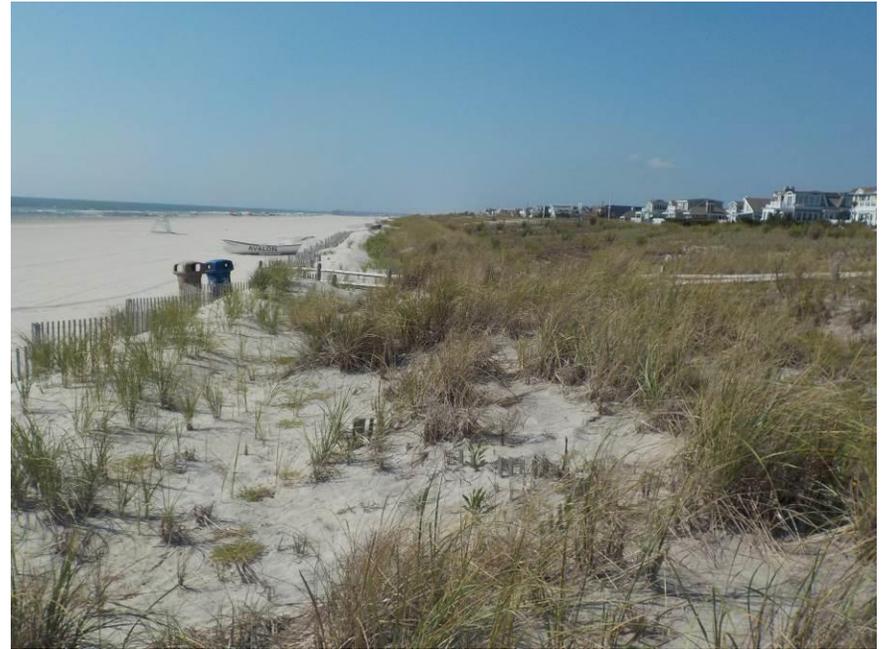
3b. September 6, 2018

View 3b By September, the grass had advanced into the ridge between the fences. The beach remained in decent condition as the new dune ridge continued to grow.

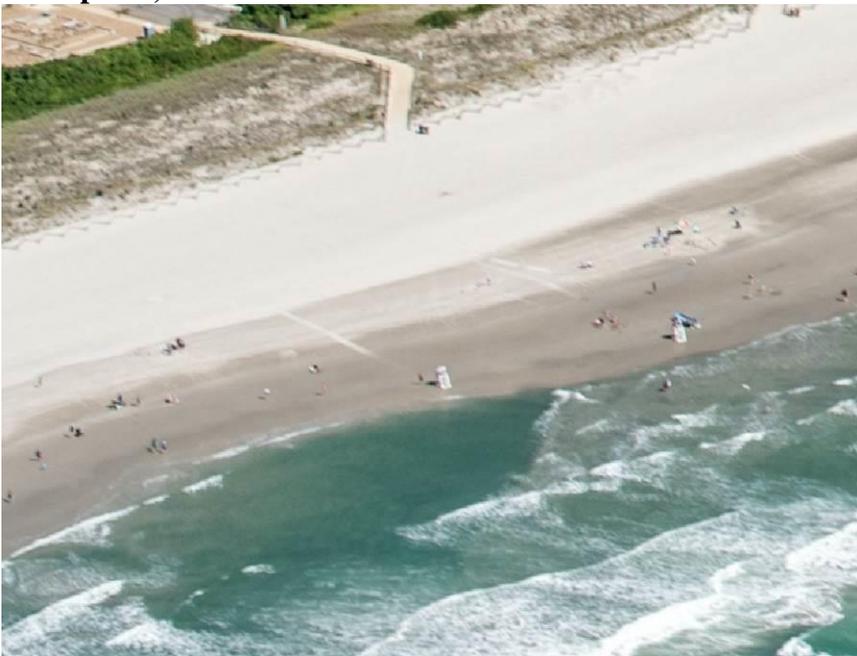
3c. Summer 2018

View 3c The aerial view is from the summer of 2018 showing the dune pathway to the beach. The beach width is approximately equal to that of the dune with a broad intertidal beach as well. Bars had formed in the surf zone by the mid-summer.

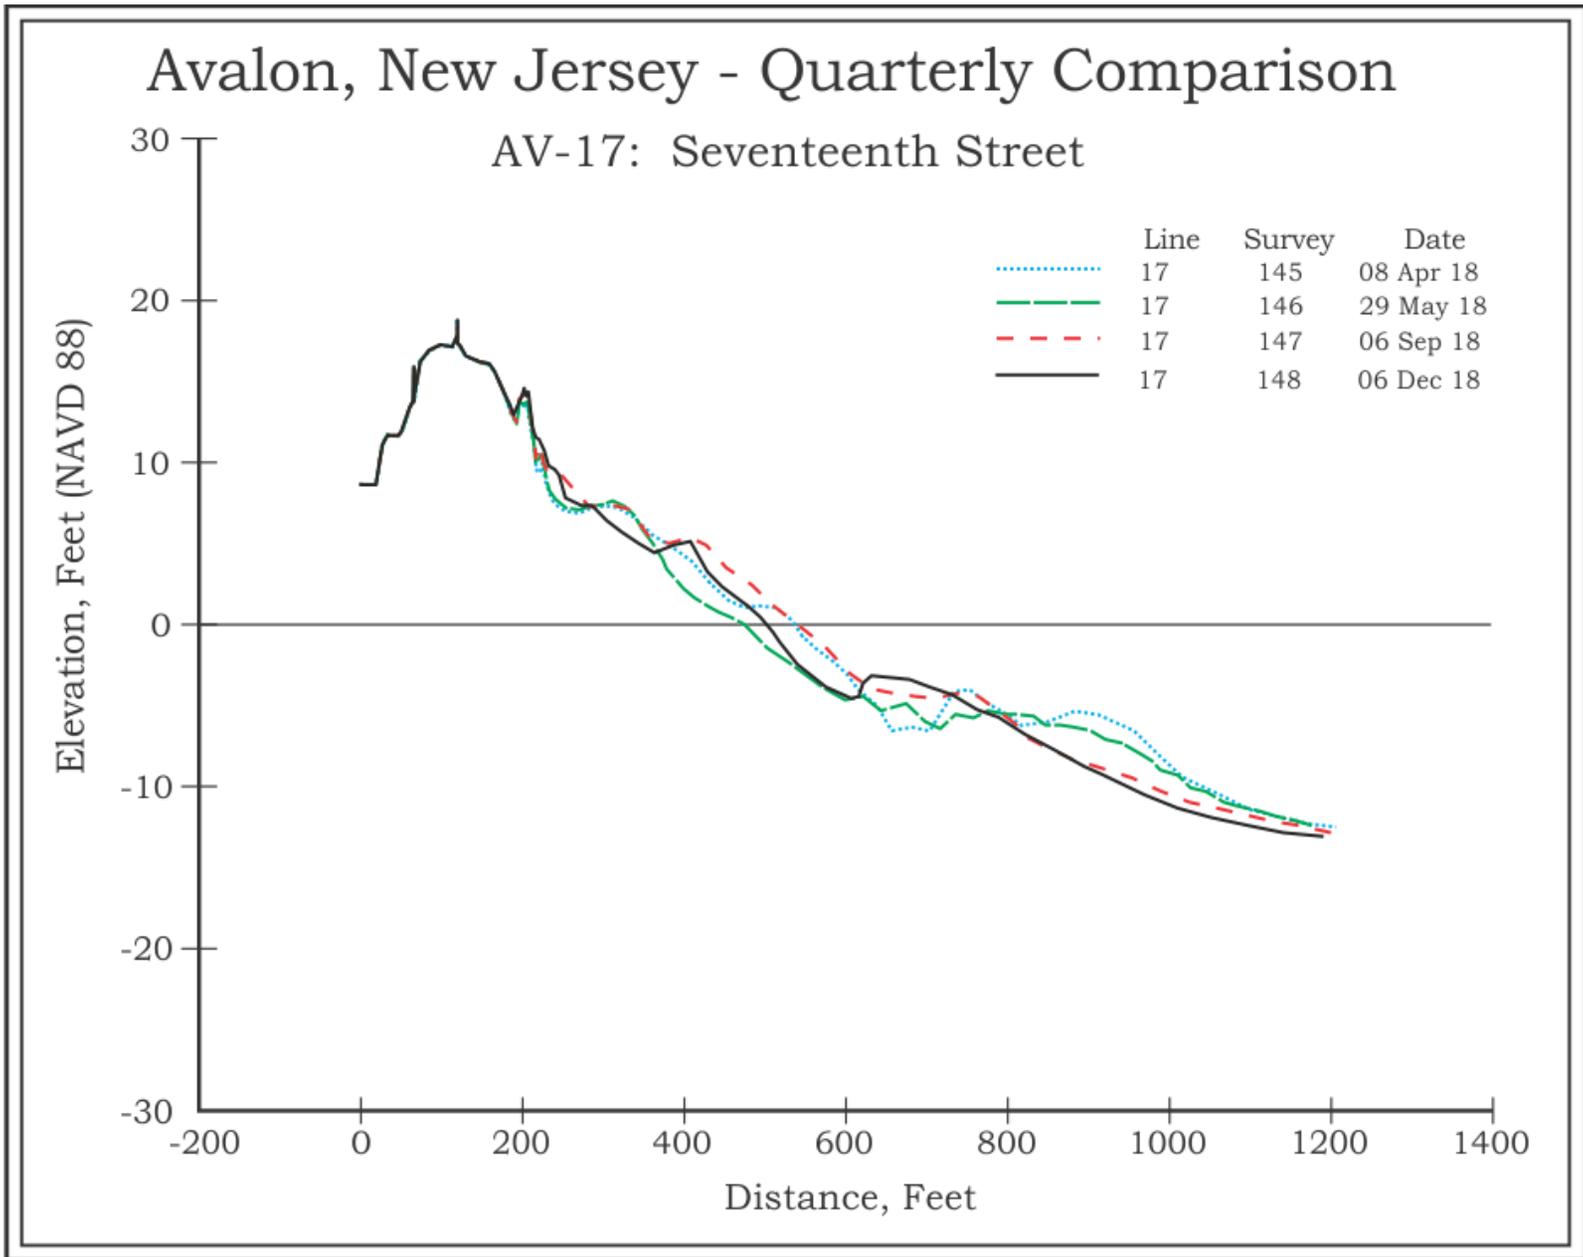
Figure 5. The April 2018 beach was negatively impacted by the weekly northeast storms by May 29th. The loss was on the beachface and nearby offshore. Sand returned abundantly to this area of the cross section by September 2018 provided by sand moved onto the beach from offshore. By December 2018 the beach had been reduced somewhat, but an offshore bar was poised to add to the beach from the nearby offshore region. The seaward dune toe gained material over the summer months.

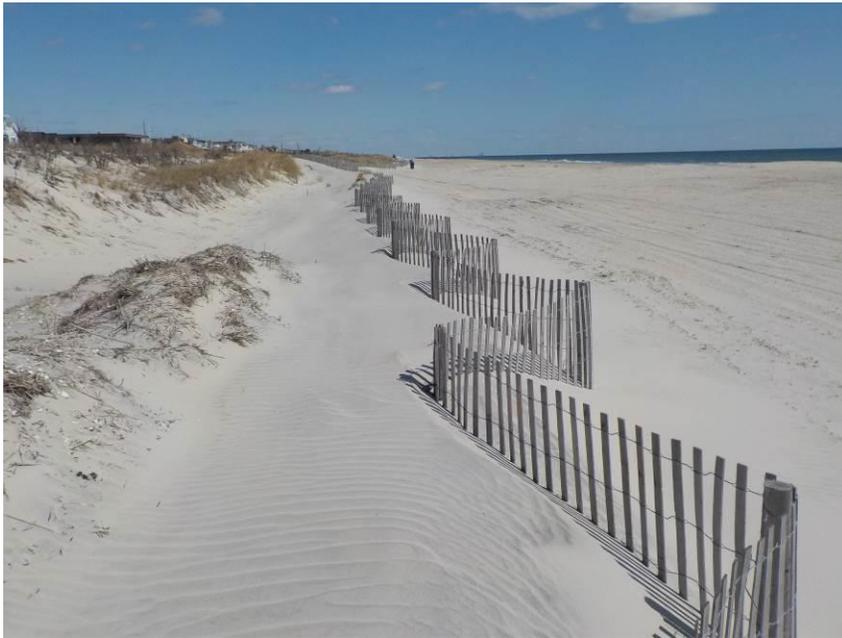
4a. April 5, 2018

View 4a The April view shows the fencing installed after the 2017 federal project was complete. Sand has gathered at the fence in the initial year. The beach remained wide with the 21st Street stormwater pipeline still buried.

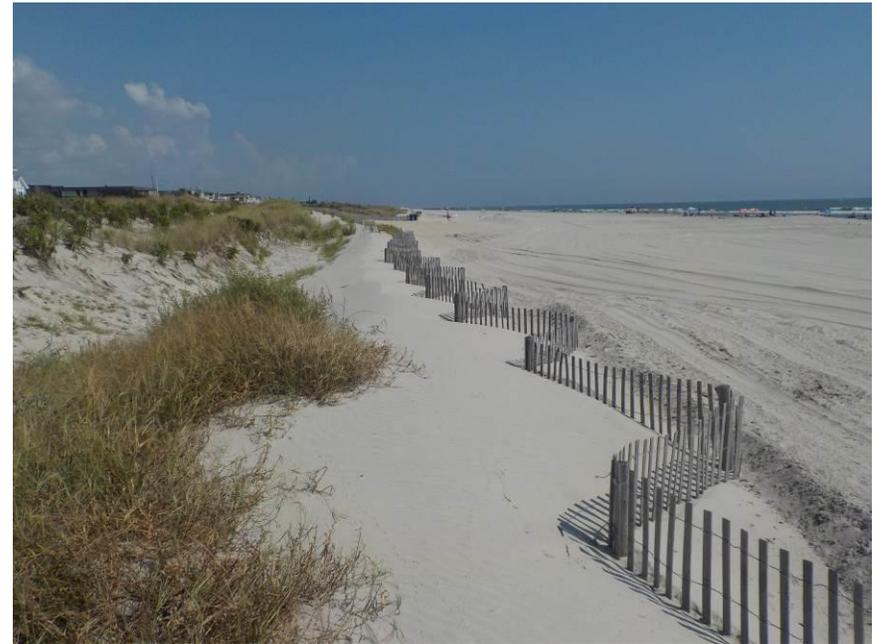
4b. September 6, 2018

View 4b By September the fence was two-thirds buried and plants were starting to colonize the new dune toe. The stormwater pipeline was still buried.

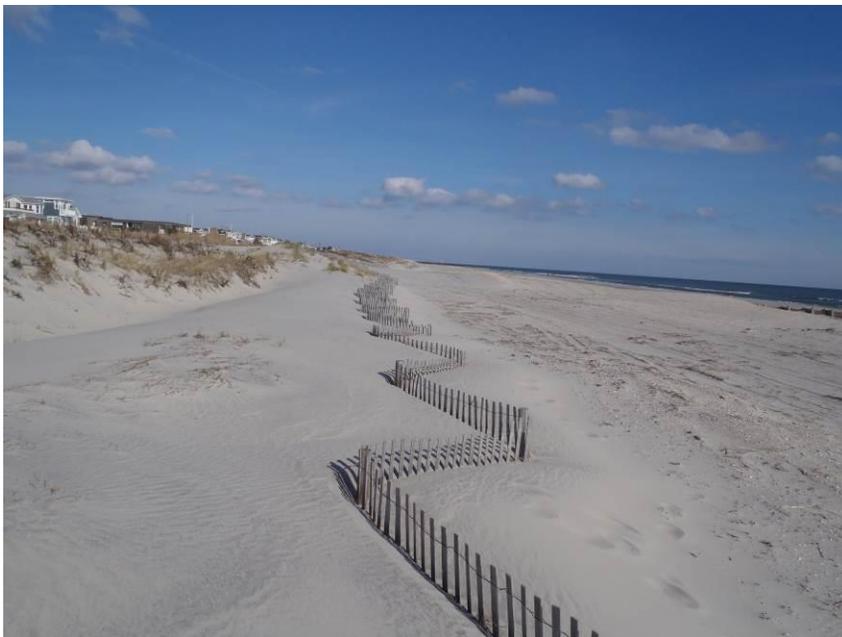
4c. December 6, 2018

View 4c In December, only the top foot of the 4-foot fence was visible. The stormwater pipeline can be seen on the lower beachface to the extreme right side of the view.

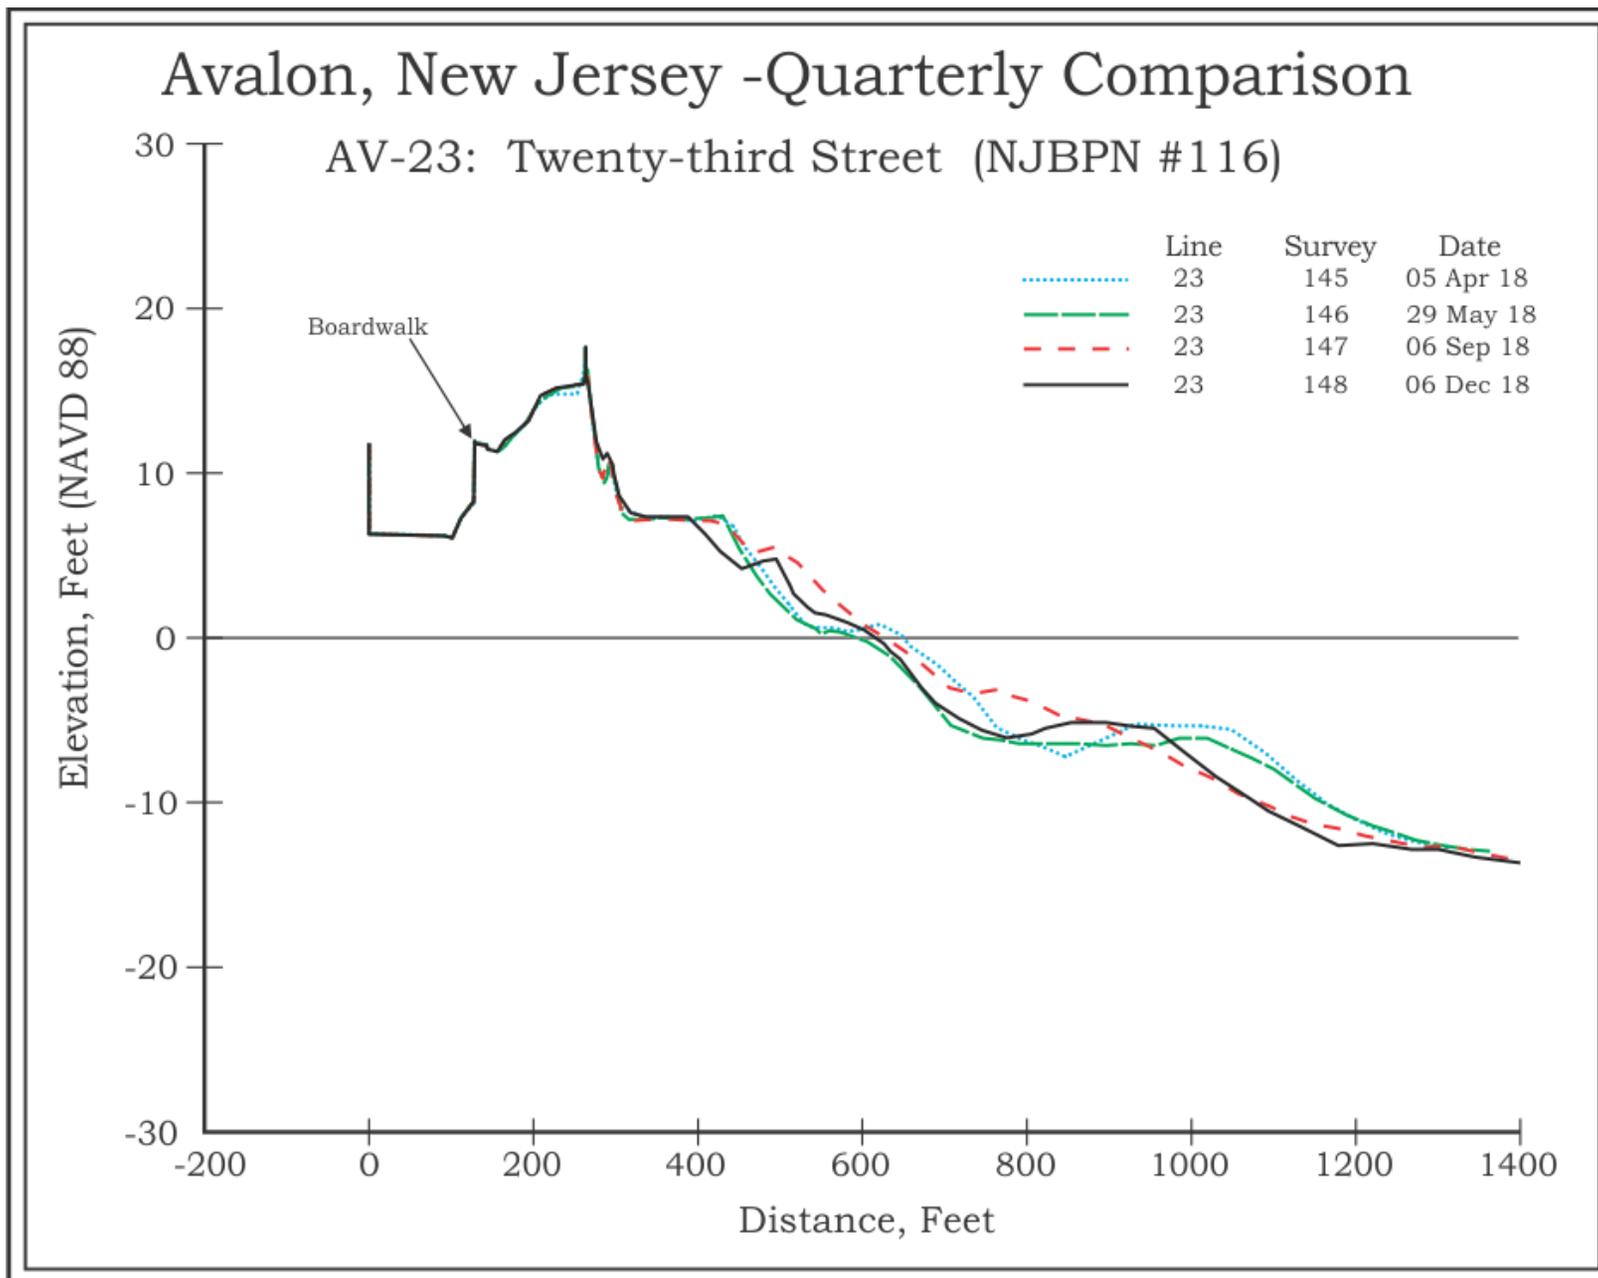
Figure 6. The April survey shows that the spring losses occurred offshore near sea level at 23rd St. However, the summer months brought offshore sand back to the beach building a significant berm. The fall losses were confined to the lower beachface and nearby offshore areas with the annual shoreline retreat just 33 feet.

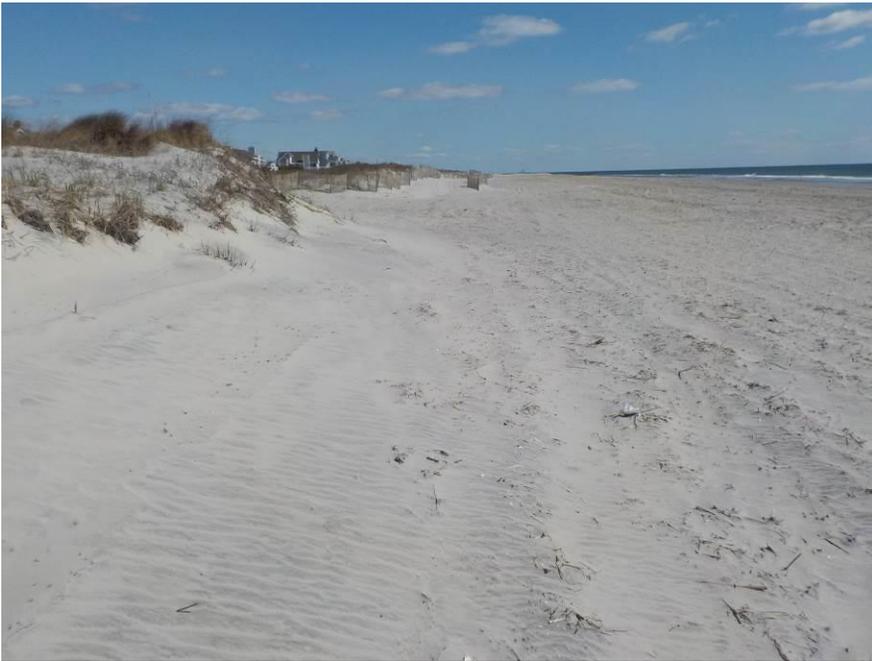
5a. April 5, 2018

View 5a shows the beach following multiple northeast storms. The dune toe received a row of fencing in the spring.

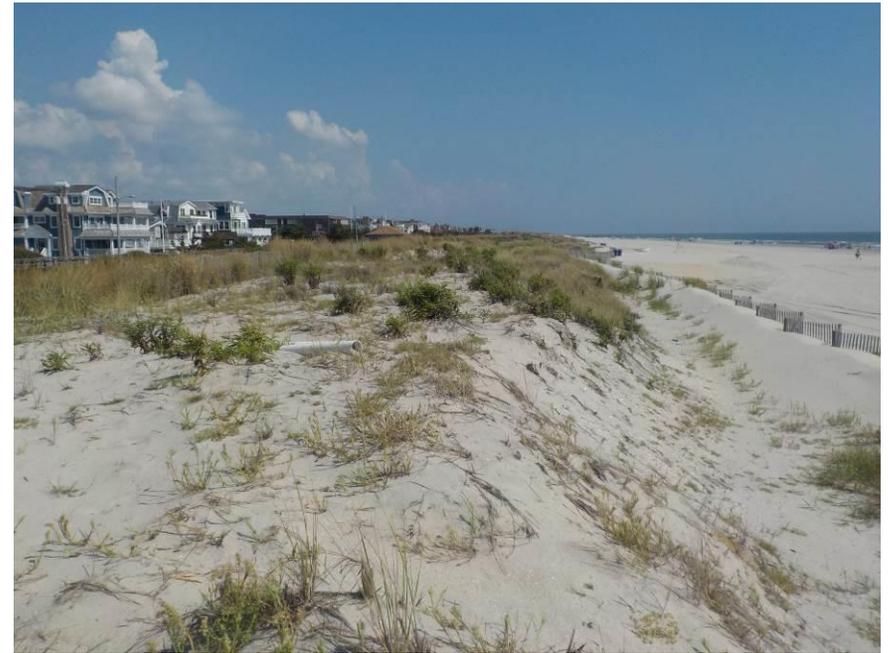
5b. September 6, 2018

View 5b shows the 28th Street beach following the summer season where the wind transported sand to the new fence building a small foredune.

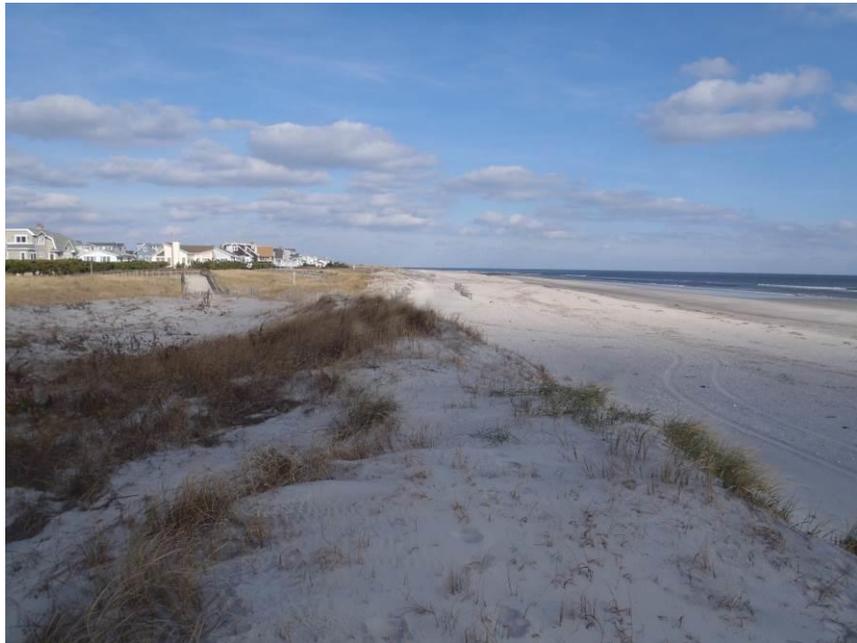
5c. December 4, 2017

View 5c is a view December 6, 2018. The sand fencing has been buried as the seaward dune slope accumulated wind transported material. The summer berm has been leveled out so that the wet/dry line on the beach is closer to the dunes.

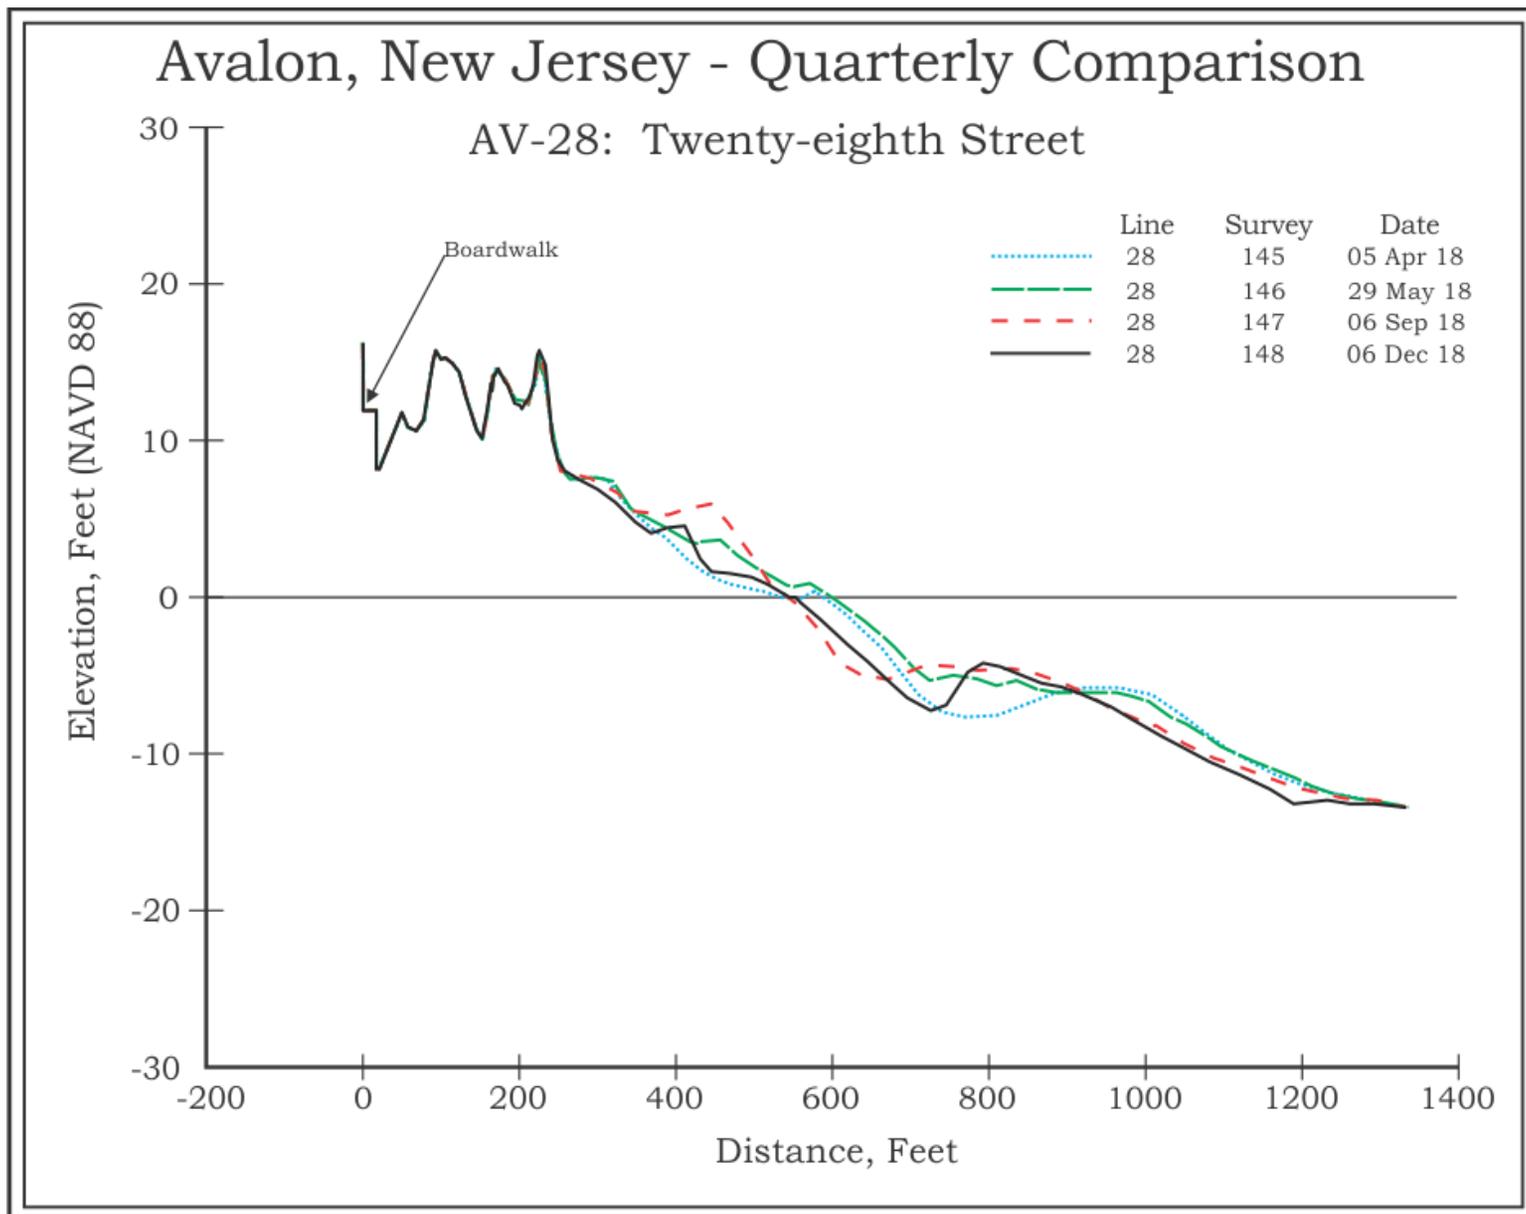
Figure 7. The 28th Street site was just south of the USACE sand template for 2017. Sand did move to the area from the deposit with the April survey showing some loss. The spring and summer seasons saw the beach develop into a sizable berm by Sept 6th. This berm was reduced by December 2018, but a bar was building offshore at the 670-foot distance from the reference.
