**FINAL REPORT FOR 2018
ON THE CONDITION OF THE MUNICIPAL OCEANFRONT BEACHES
THE BOROUGH OF AVALON, CAPE MAY COUNTY, NEW JERSEY**

**PREPARED FOR: THE BOROUGH OF AVALON
3100 DUNE DRIVE
AVALON, NJ 08202**

**PREPARED BY: THE STOCKTON UNIVERSITY COASTAL RESEARCH CENTER
30 WILSON AVENUE
PORT REPUBLIC, NEW JERSEY 08241**

**ANNUAL REPORT FOR 2018 - TO THE BOROUGH OF AVALON
ON THE
CONDITION OF THE MUNICIPAL BEACHES**

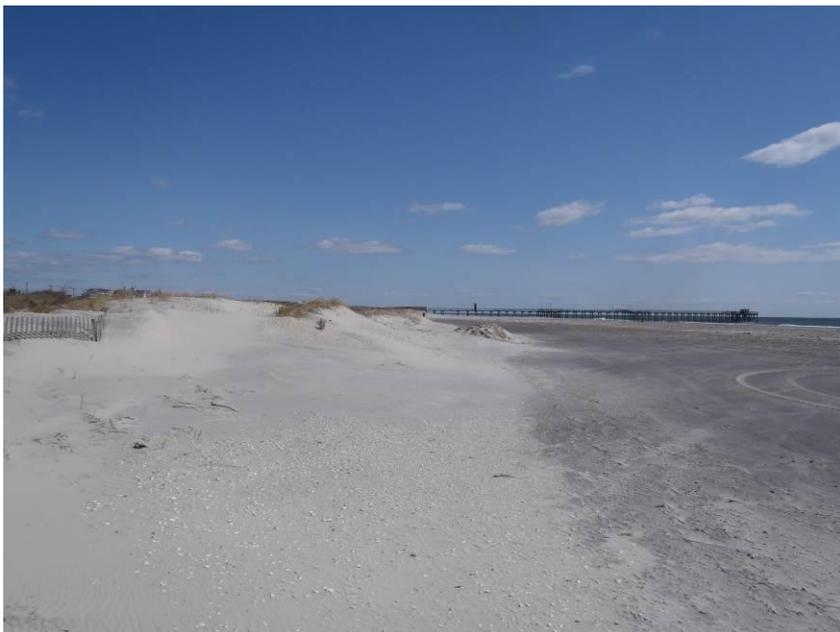
6a. April 5, 2018

View 6a As of April 2018, the storms had reached the dune toe, but did not cause damage. The beach was flatter and narrower.

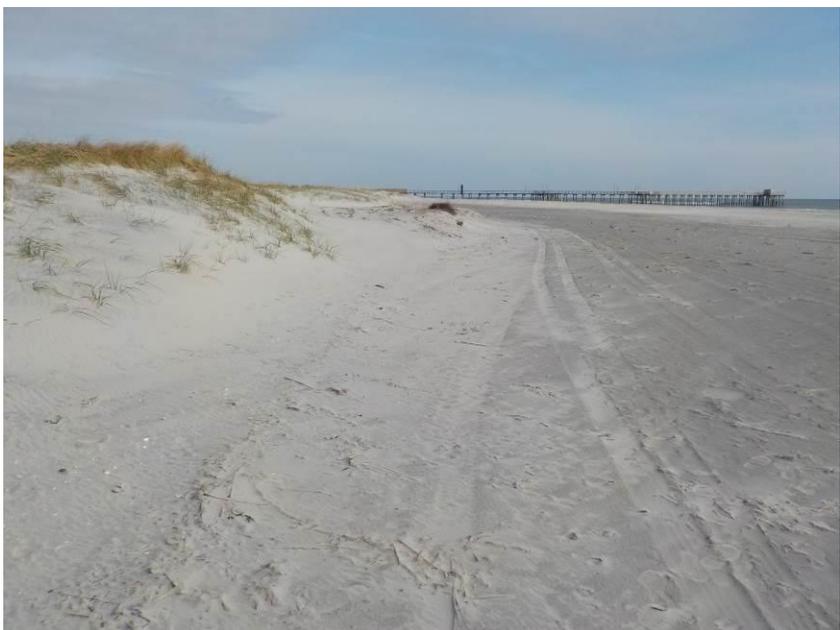
6c. December 6, 2018

View 6c The seaward dune slope did accumulate a little sand during the fall season. The wide beach allows material to be continuously added to the dune stockpile any time a sea breeze exceeds 10 MPH.

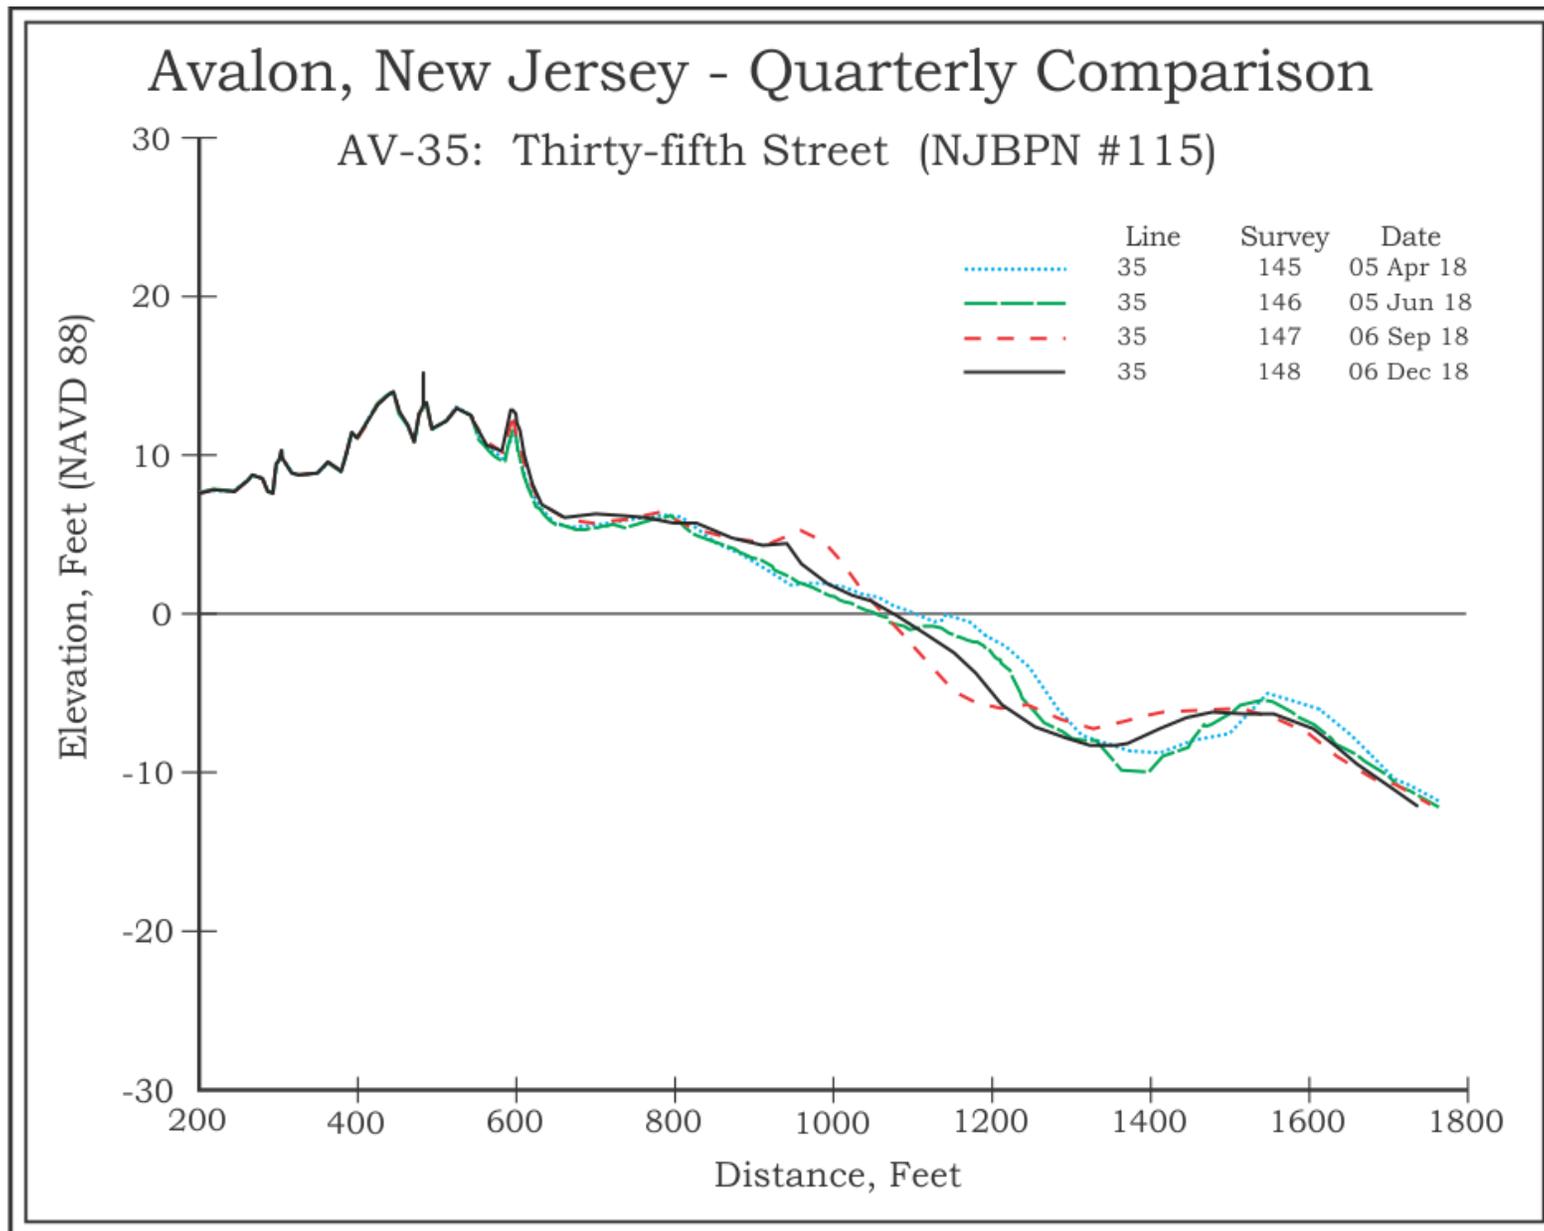
Figure 8. 35th Street location usually contains a substantial offshore bar which is the source of the material adding to the beach and dunes. The December 2018 beach is enhanced relative to the cross section present in April 2018. Offshore the slope into the bar trough is closer to the shoreline than it was in April generating the majority of the sand volume loss. The bar itself remained in position.

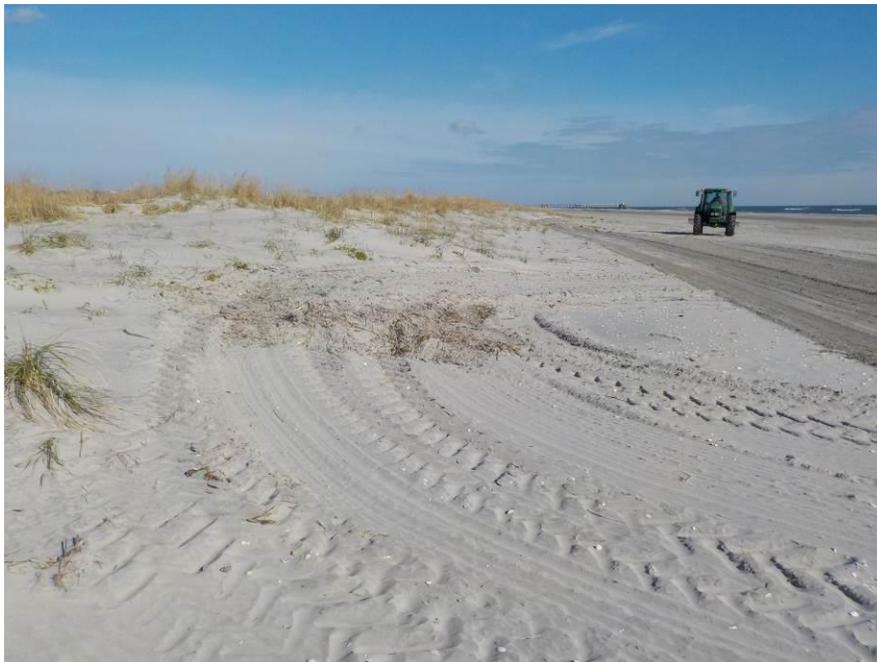
7c. December 6, 2018

View 7c shows the seaward dune toe slope with grass plants migrating down the slope. The Borough was in process of debris raking at the time. This plant waste is placed on the slope where any migratory seeds might germinate next season.

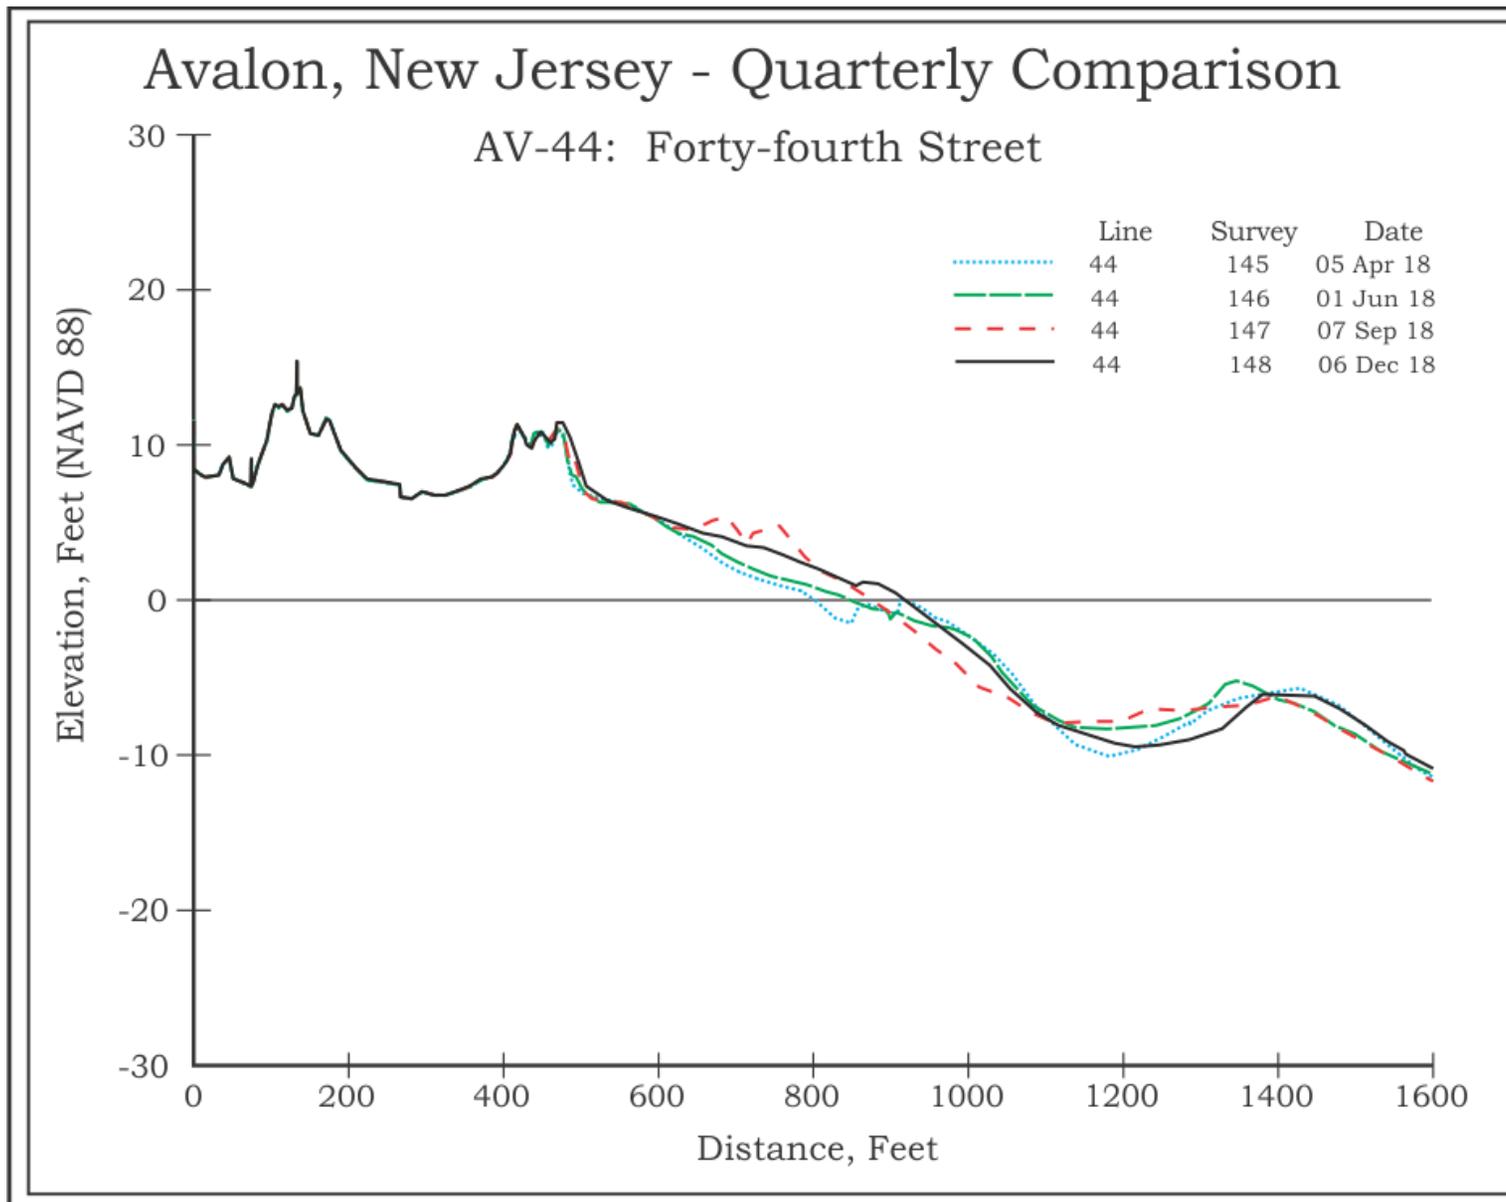
Figure 9. Dune growth was substantial at the seaward dune slope. The zero elevation shoreline position advanced steadily seaward over the year moving 130 feet altogether. The late summer profile shows two berm ridges developed on the beach which were leveled out by December without producing net beach slope elevation loss.

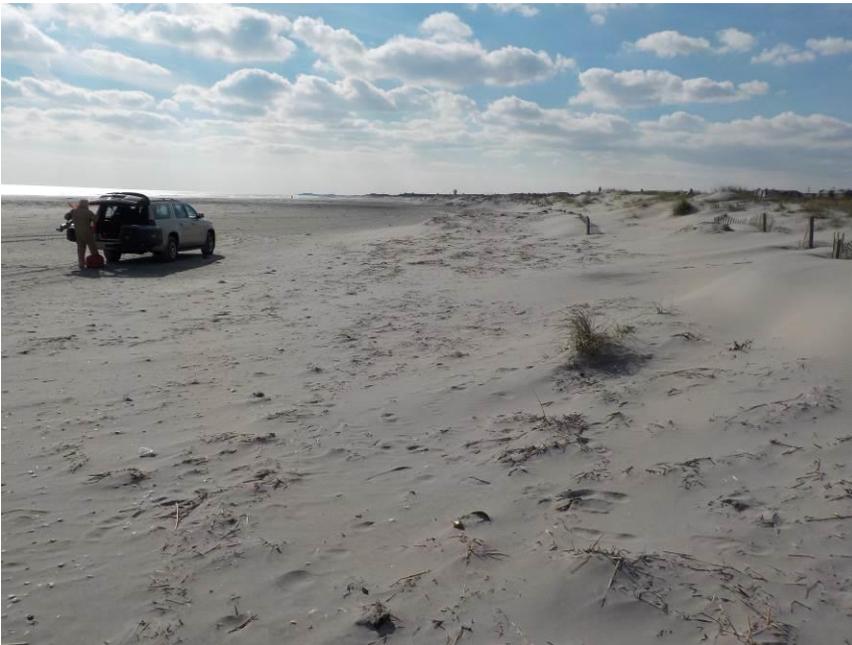
8c. December 6, 2018

View 8c The December view shows that the wind can essentially bury a four-foot fence in a season if the beach is sufficiently wide. This ensures that the dune continues to grow upward and seaward with time.

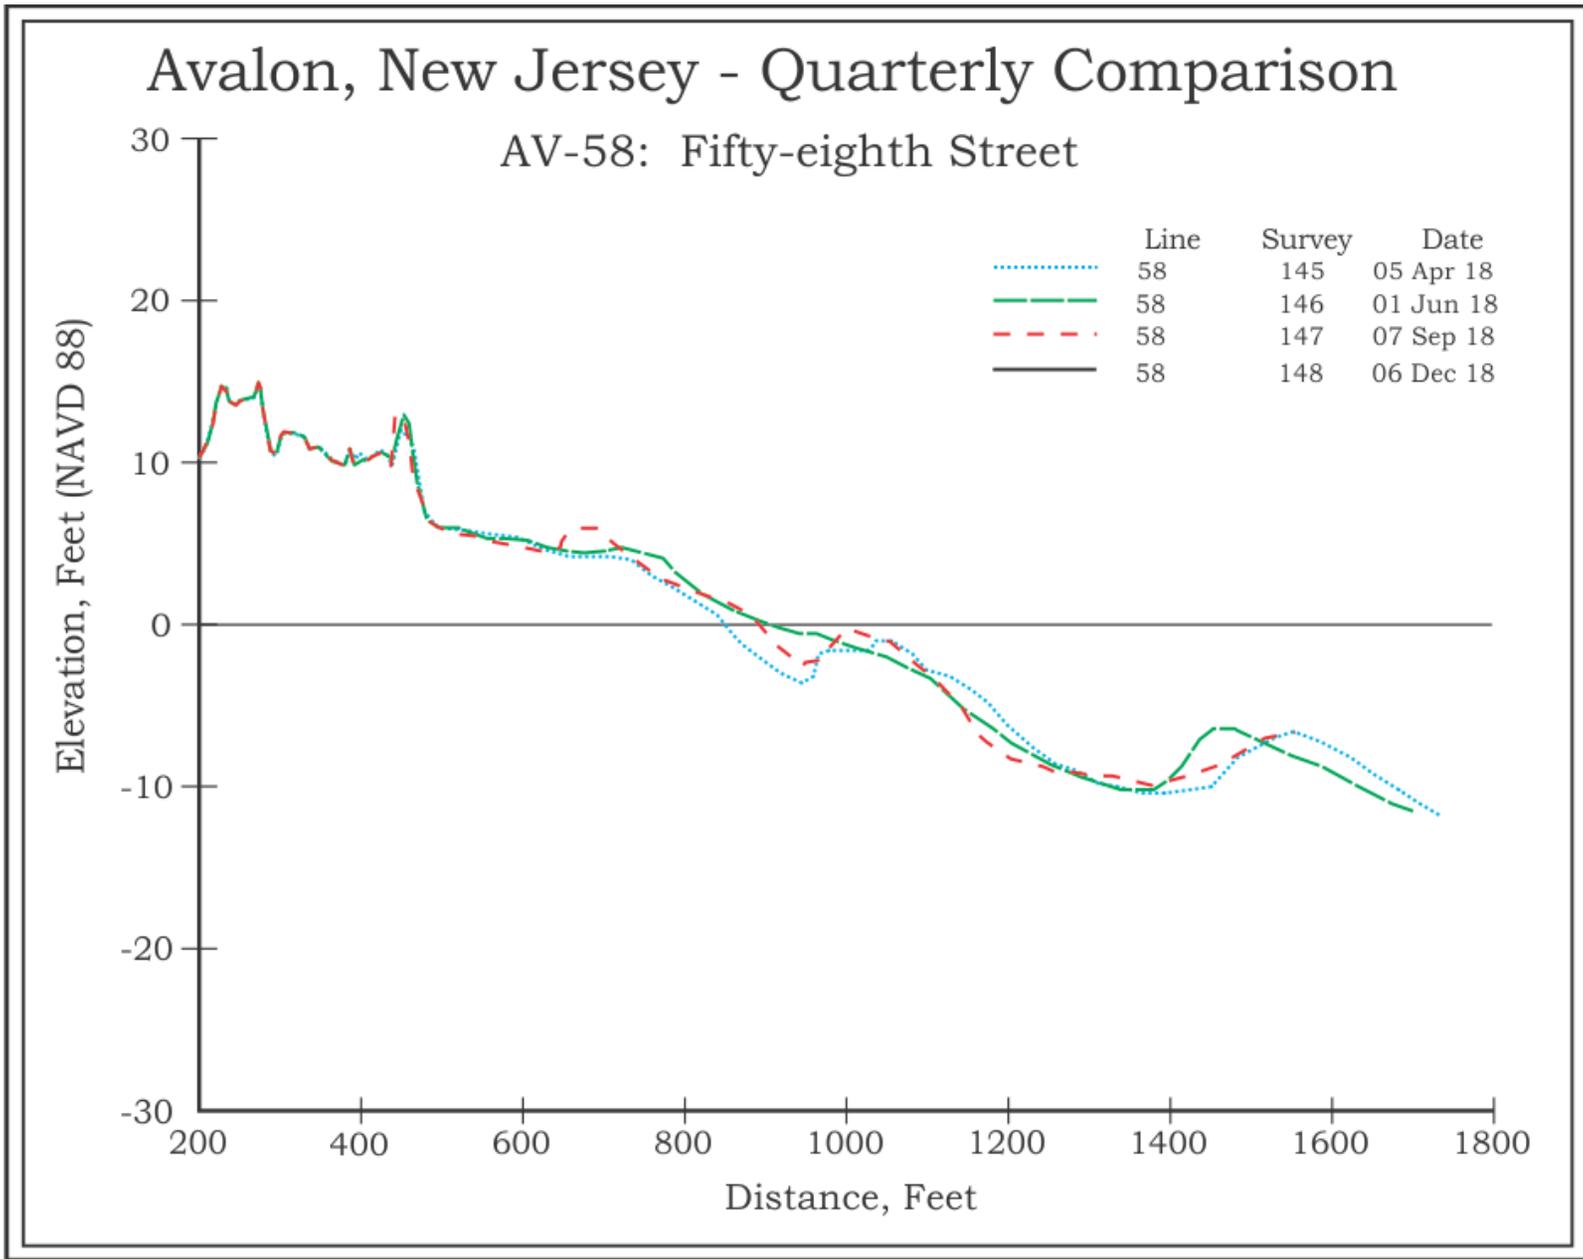
Figure 10. Sand was added to the seaward dune ridge in significant quantities. The beach's shoreline position advanced 72 feet seaward during the year as well. The bar system offshore shifted central position, but did not migrate toward the shoreline. Smaller bars did materialize and move landward in December 2017 and September 2018.

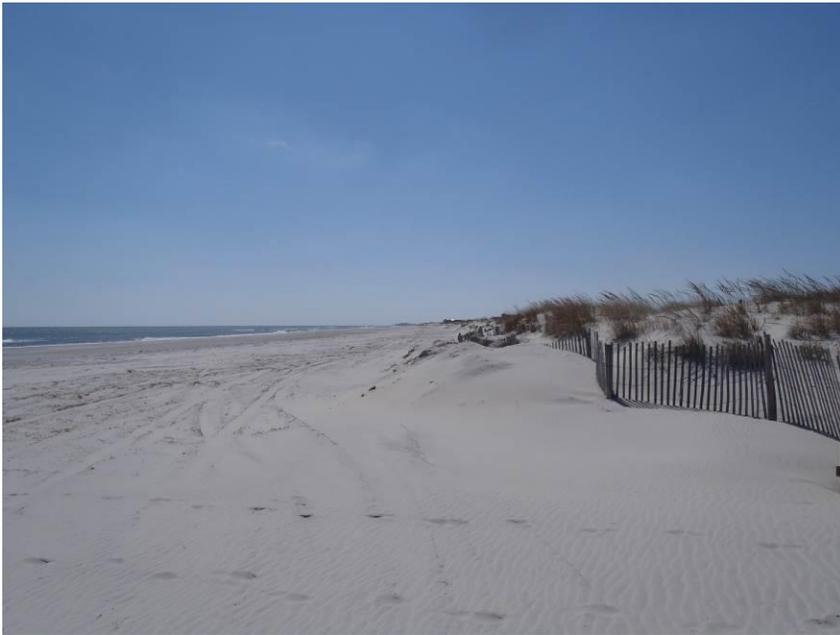
9a. April 5, 2018

View 9a shows the dune toe and beach conditions following the majority of the spring 2018 northeast storms. No dune damage occurred.

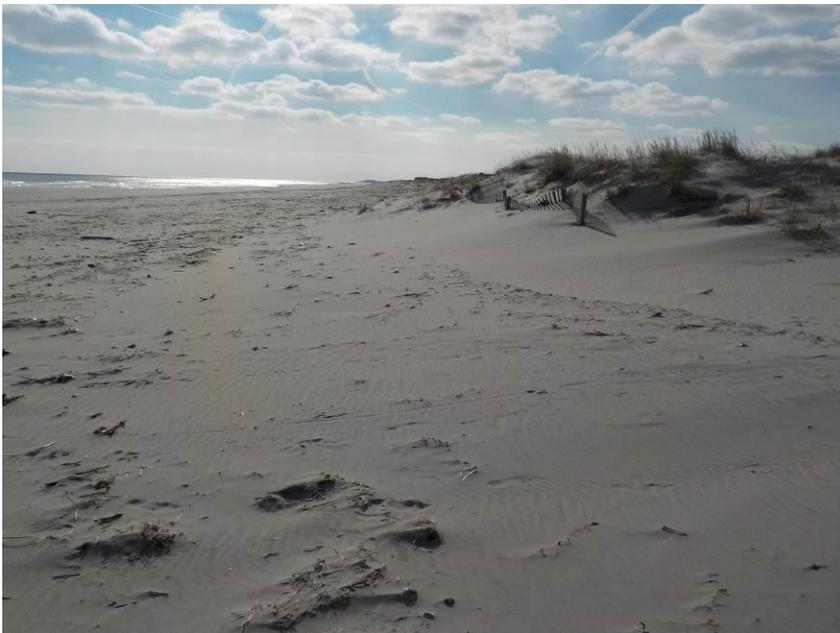
9c. December 6, 2018

View 9c The beach at the access pathway is open at the dune toe with wind deposition filling in the gap to some extent. This access point has developed a significant dune system since the site was established back in 1992.

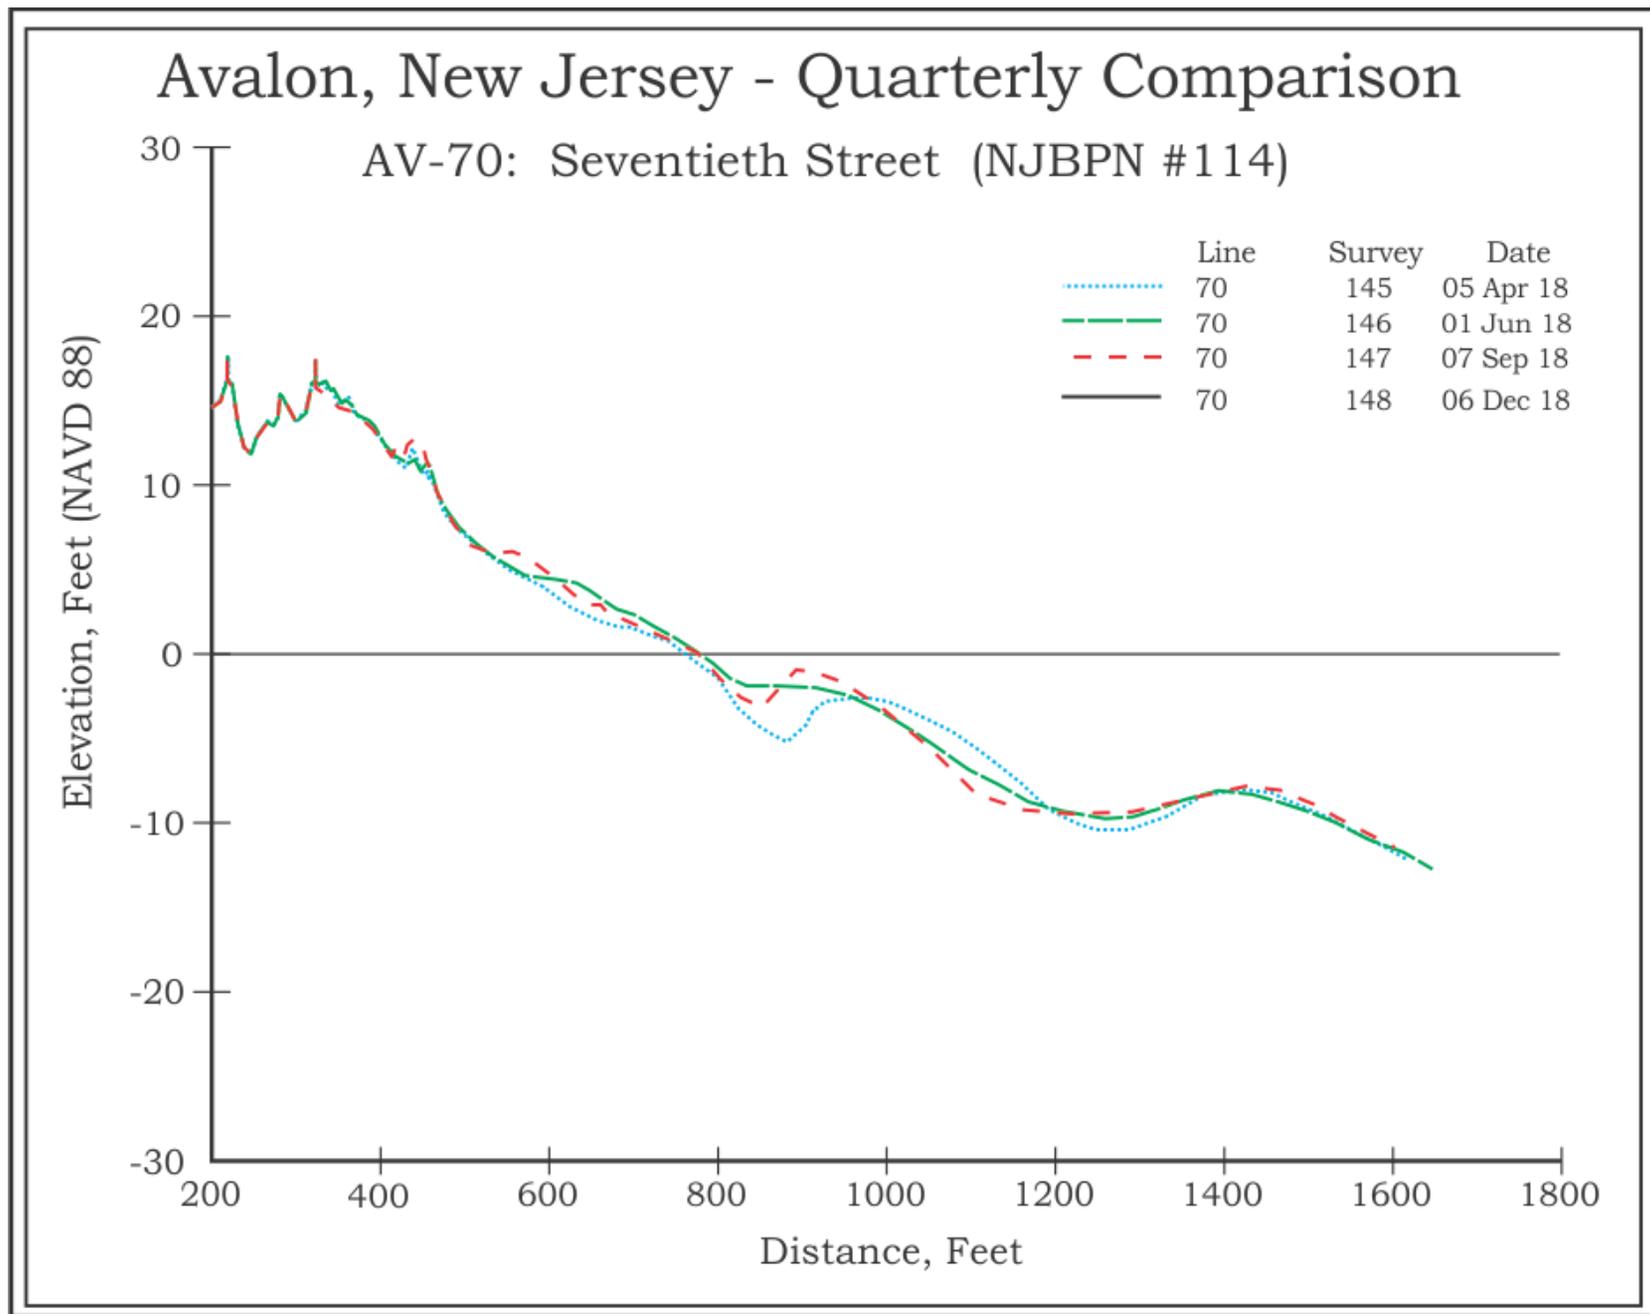
Figure 11. This site gained sand in the dunes at the seaward dune ridgeline. The beach had its largest berm ridge in December 2018 in spite of a summer of sand accretion. The offshore region remained active, particularly close to the zero elevation location. The distant bar changed little.

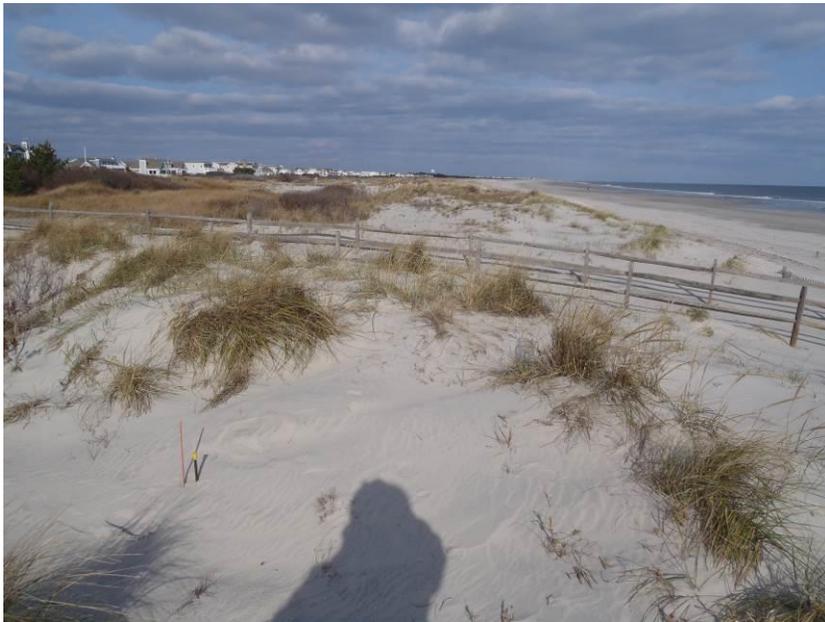
10c. December 6, 2018

View 10c is a December view of the dunes, beach and oceanfront expanse of the protection these extensive features provide Avalon residents.

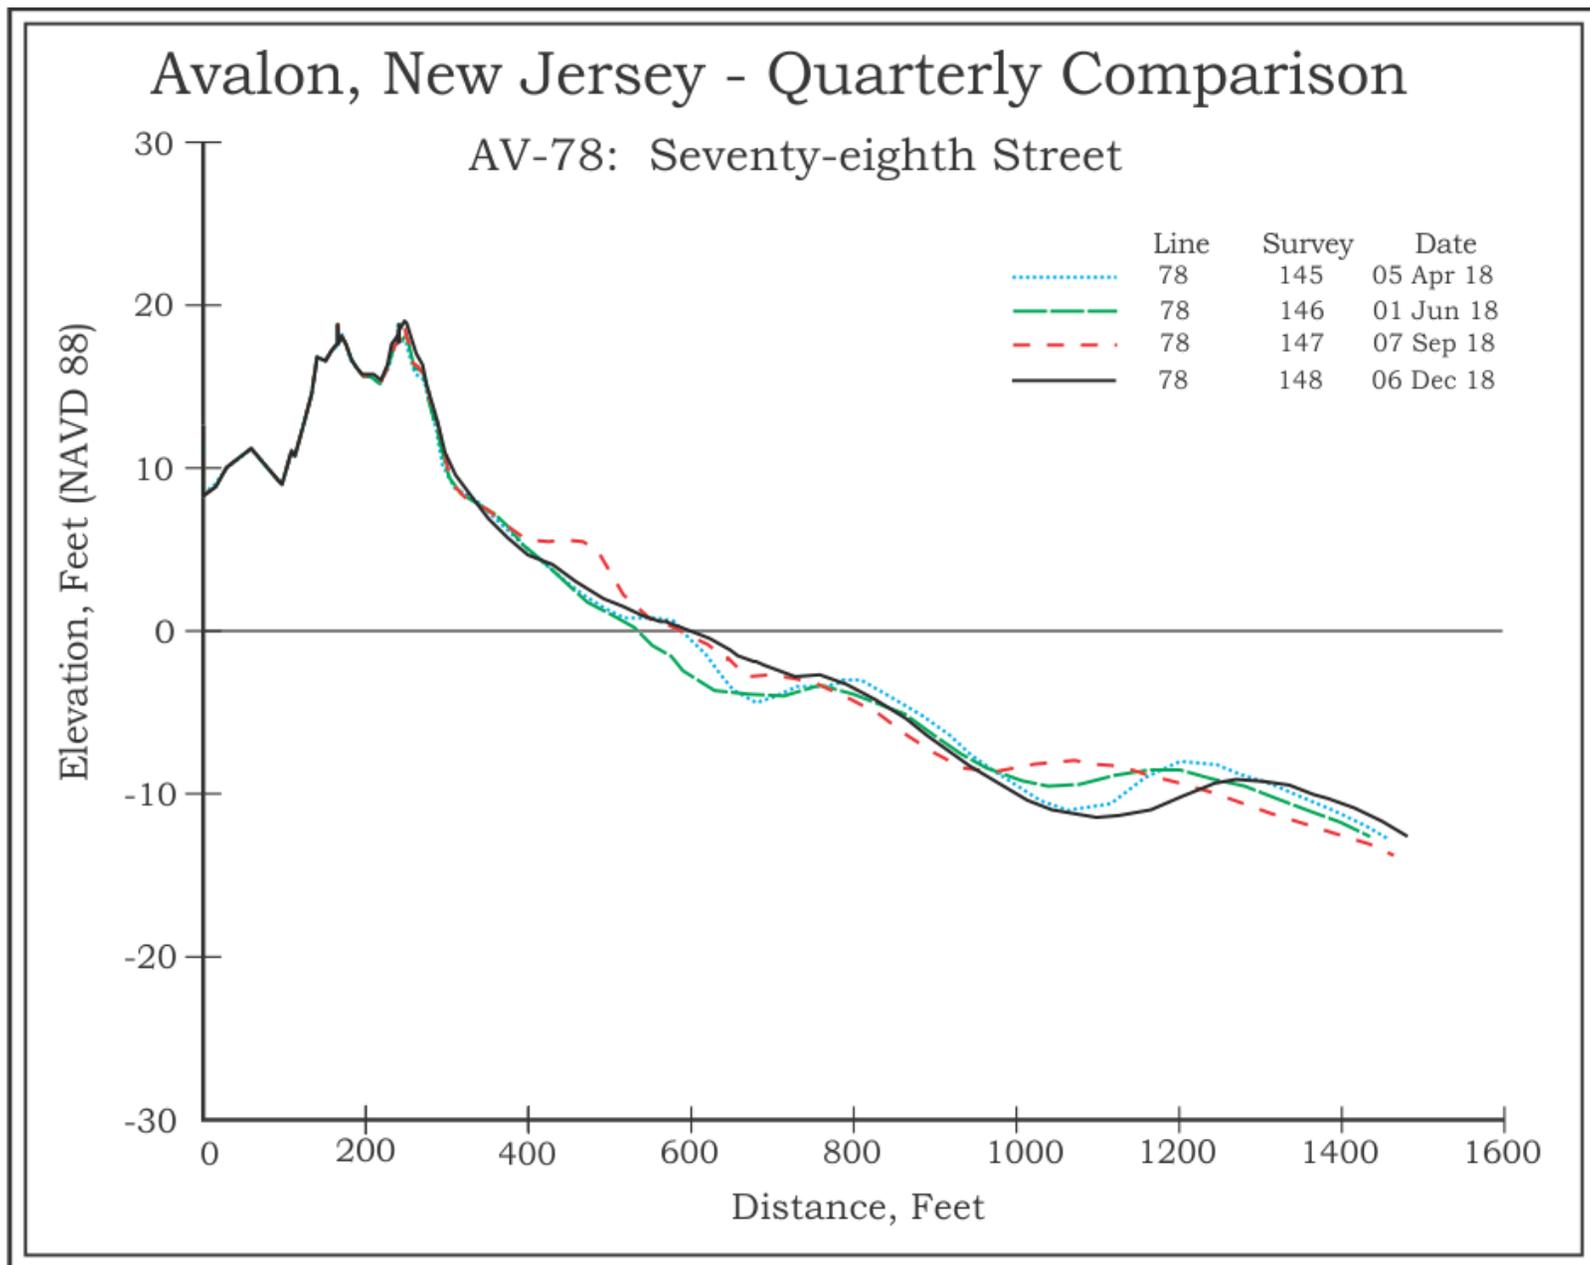
Figure 12. Sand did add to the dune, but as a thin sheet extending to the main seaward dune crest. The beach saw a summer berm that was flattened out by December. Sand moved landward from bars located close to the shoreline, but the offshore bar system changed position marginally.

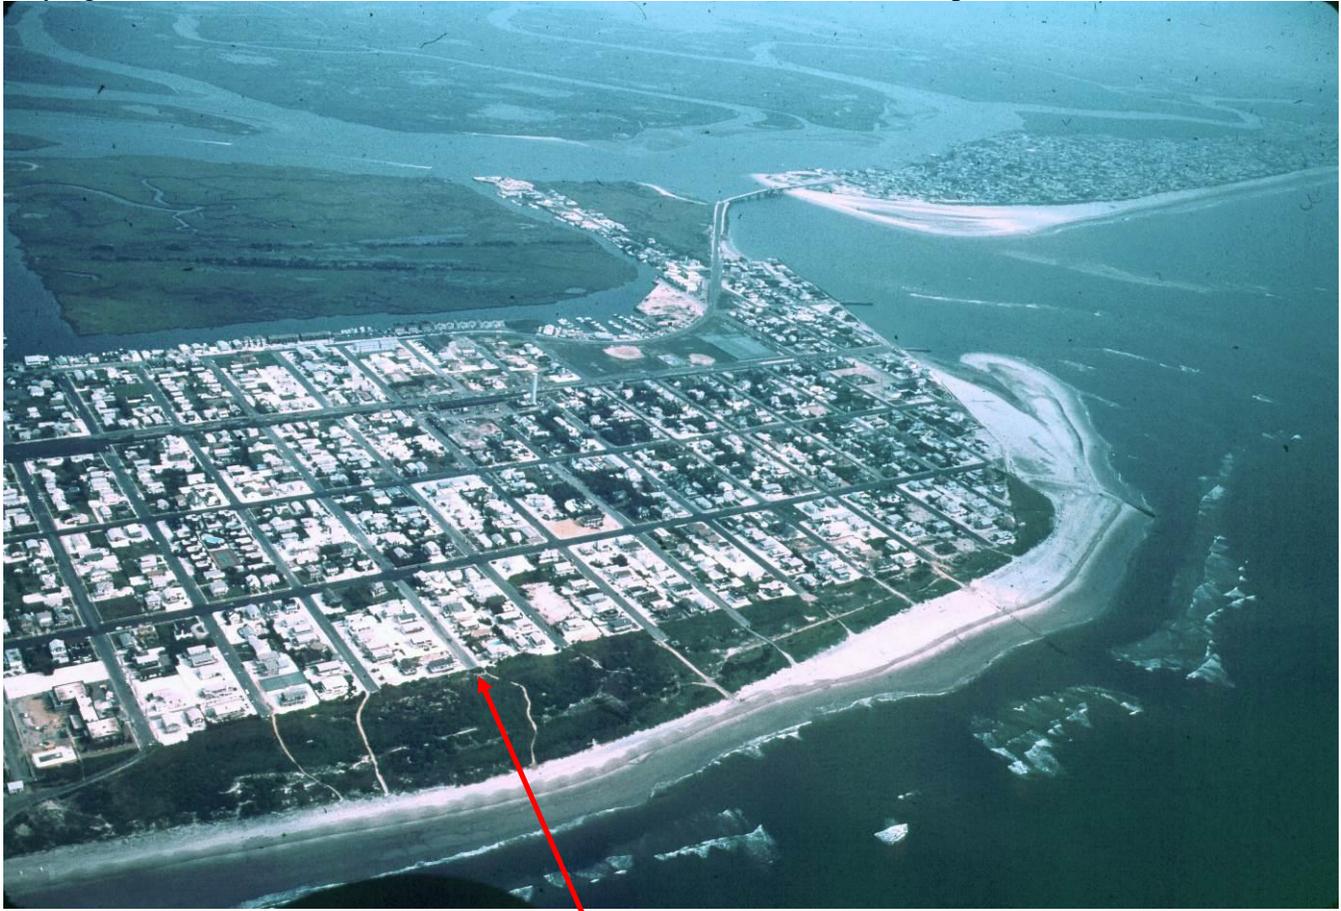
Figure 3. June 1981 aerial photograph of the northern Avalon beachfront and Townsend's Inlet 3 years after the initial sand dredging in the inlet to supply material to Sea Isle City. The main tidal channel shifted to follow the dredge cut along the Sea Isle City shoreline. This significant change in the ebb-tidal flow along the Avalon shoreline allowed the flood tide to assume dominance. This produced the new sand spit seen attached to the 8th Street jetty extending almost to Dune Drive along the inlet shoreline. There were still substantial offshore bars present between the jetty and 18th Street. However, erosion of the dry beach to the dune vegetation was becoming a problem that summer. The 17th Street access pathway wandered for 465 feet through the dunes to the beach (red arrow), where the beach was now narrowing to cut into the dune toe. In 3 more years all the sand was gone into the inlet leaving the homes directly exposed south of 17th Street. The 1987 municipal/state beach restoration was the first of 9 leading to the current USACE project in 2002. The inlet geometry is critical to long term stability in Avalon. In the past 25 years there have never been offshore bars seaward of the beach between the jetty and 18th Street where waves broke on these shoals.

Figure 3 above is an aerial photograph taken in 1981 that shows shoaling conditions and configurations changed by inlet dredging contributing to major changes to the Avalon shoreline. The introduction of sand

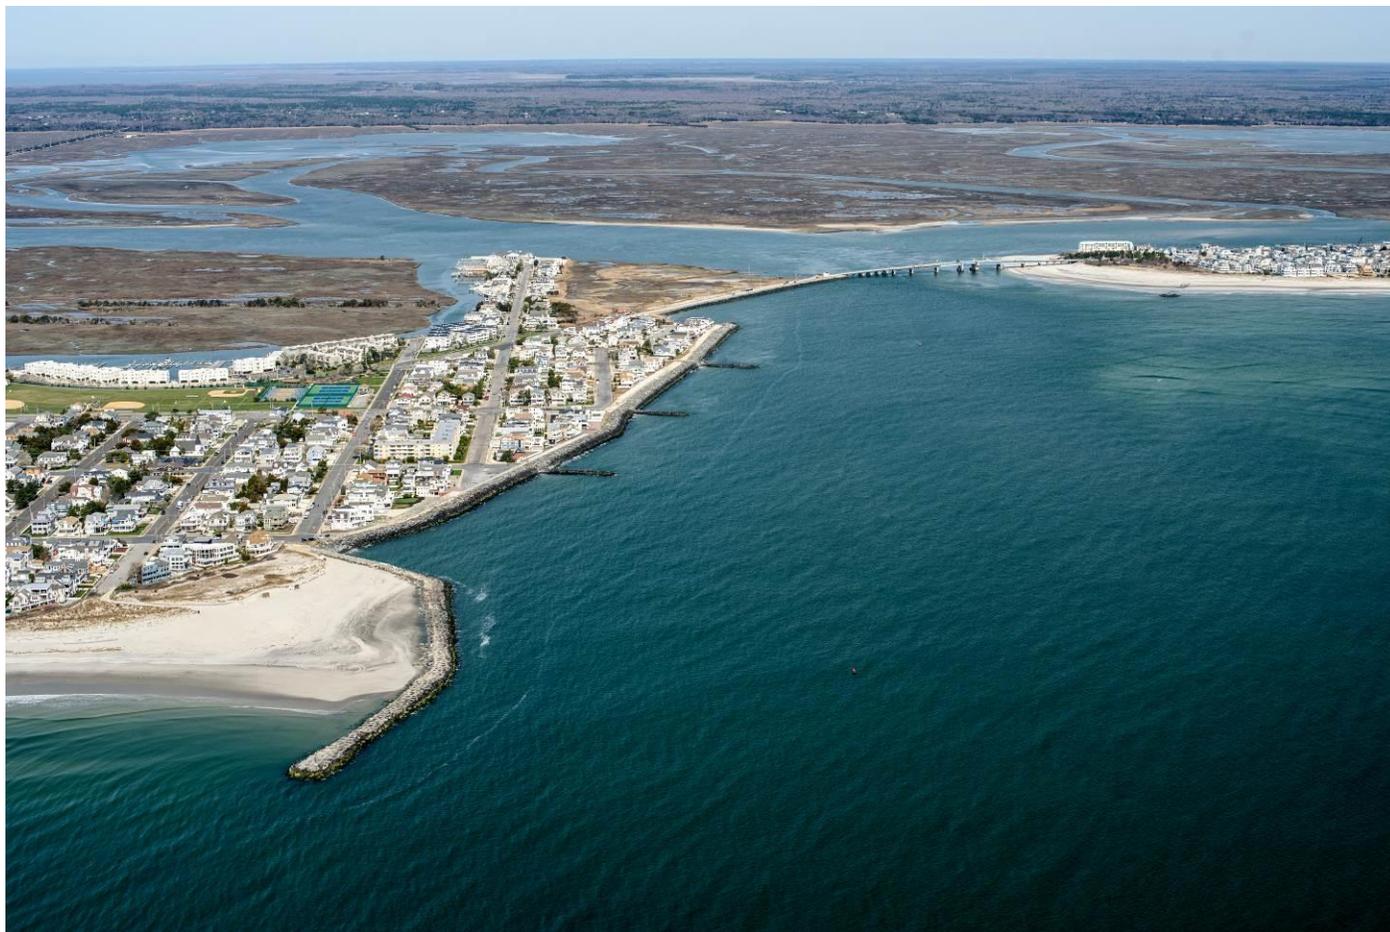
Figure 14. View into Townsend's Inlet April 21, 2018 on a very calm day showing some of the Sea Isle City shoals near the beach, but little if any evidence of shoals on the Avalon side. The sand spit along the Avalon inlet shoreline is long gone with tiny pocket beaches at the points where the three finger groins intersect the seawall.

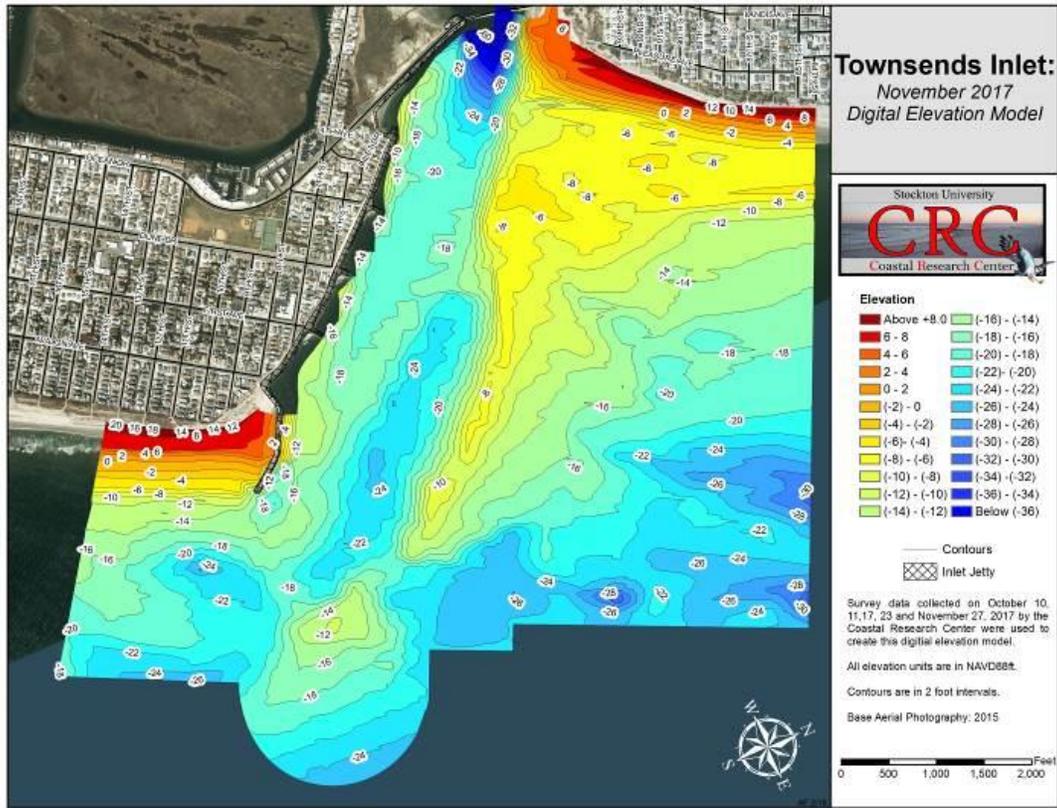
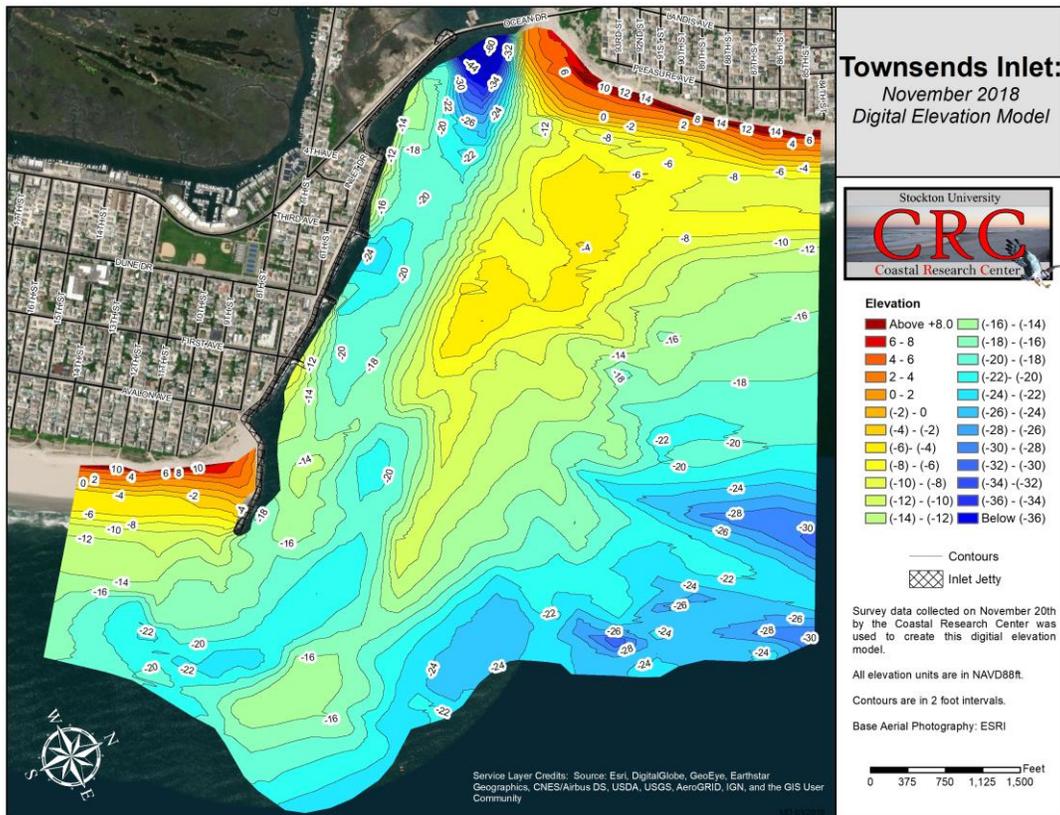
Figure 15. The Digital Elevation Map on the top shows elevation conditions in November 2017, following the extensive dredging by the USACE for beach nourishment material. The red and orange colors represent the beach and dunes while blues are the lowest elevations, contour intervals are shown at two foot intervals. The excavation within the authorized borrow zone shows as a linear blue area with a maximum depth over 24 feet. The DEM on the bottom was done November 2018 where the same zone shows extensive deposition expanding the shoals attached to the Sea Isle beach and a depth reduction of most of the blue zone to much less than 20 feet.

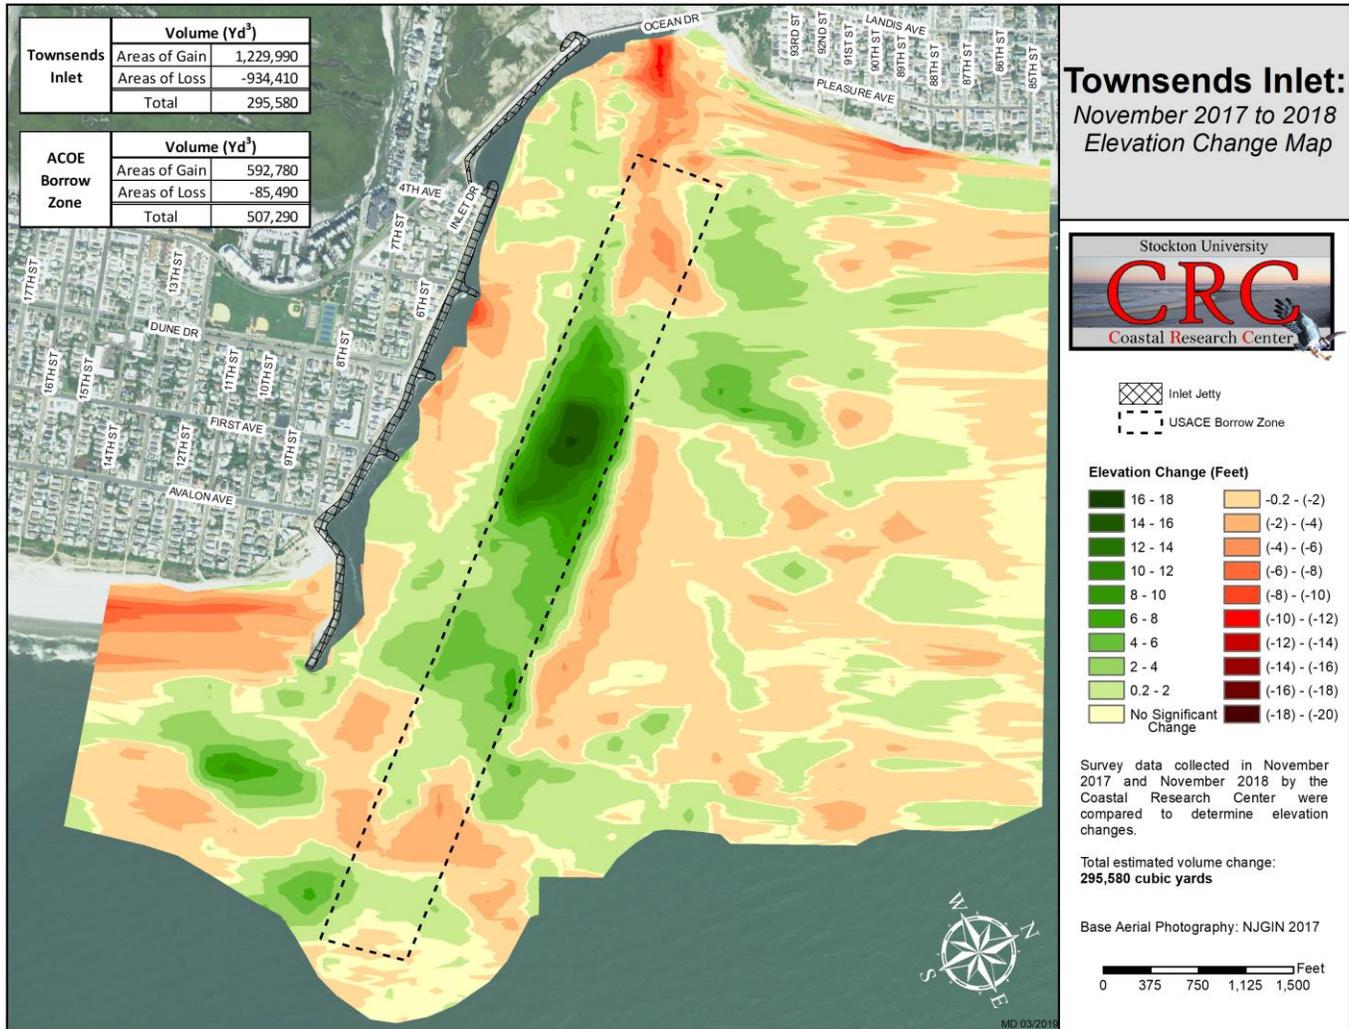
Figure 16. The map above is an elevation change map between surveys conducting November 2017 and November 2018. Green colored regions are areas of elevation gains while orange and red are regions where the elevation decreased. Yellow shaded areas are regions of no significant elevation change. The black dashed rectangle demarks the approved borrow zone used for each cycle of the federal nourishment maintenance efforts on Avalon's north end. The central area of the borrow zone gained 18 feet vertically in new sand filling in the excavation made a year earlier. A minor zone of accumulation has appeared just east of the inlet jetty in Avalon (8 feet vertically in the center). The beach area did lose sand as was shown in the 9th Street cross sections (Figure 3).

Figure 16 above is an elevation change map between the November 2017 and the November 2018 survey of the inlet. The map clearly shows extensive regions of sand accumulation on the shoal and areas of loss from both island beaches adjacent to the inlet. Other areas of gain or loss are measured in 0.2 to 2.0-foot increments over wide areas. An assumption for the loss observed along the northeast margin of the borrow zone is thought to come from sluffing of the cut bank into the excavation as it was filling in.
