**FINAL REPORT FOR 2015
ON THE CONDITION OF THE MUNICIPAL BEACHES
IN
THE CITY OF BRIGANTINE BEACH, ATLANTIC COUNTY, NEW JERSEY**

**PREPARED BY: THE STOCKTON UNIVERSITY COASTAL RESEARCH CENTER
30 WILSON AVENUE
PORT REPUBLIC, NEW JERSEY 08241**

May, 2016

Annual Report for 2015 to the City of Brigantine Beach on the Condition of Municipal Ocean Beaches

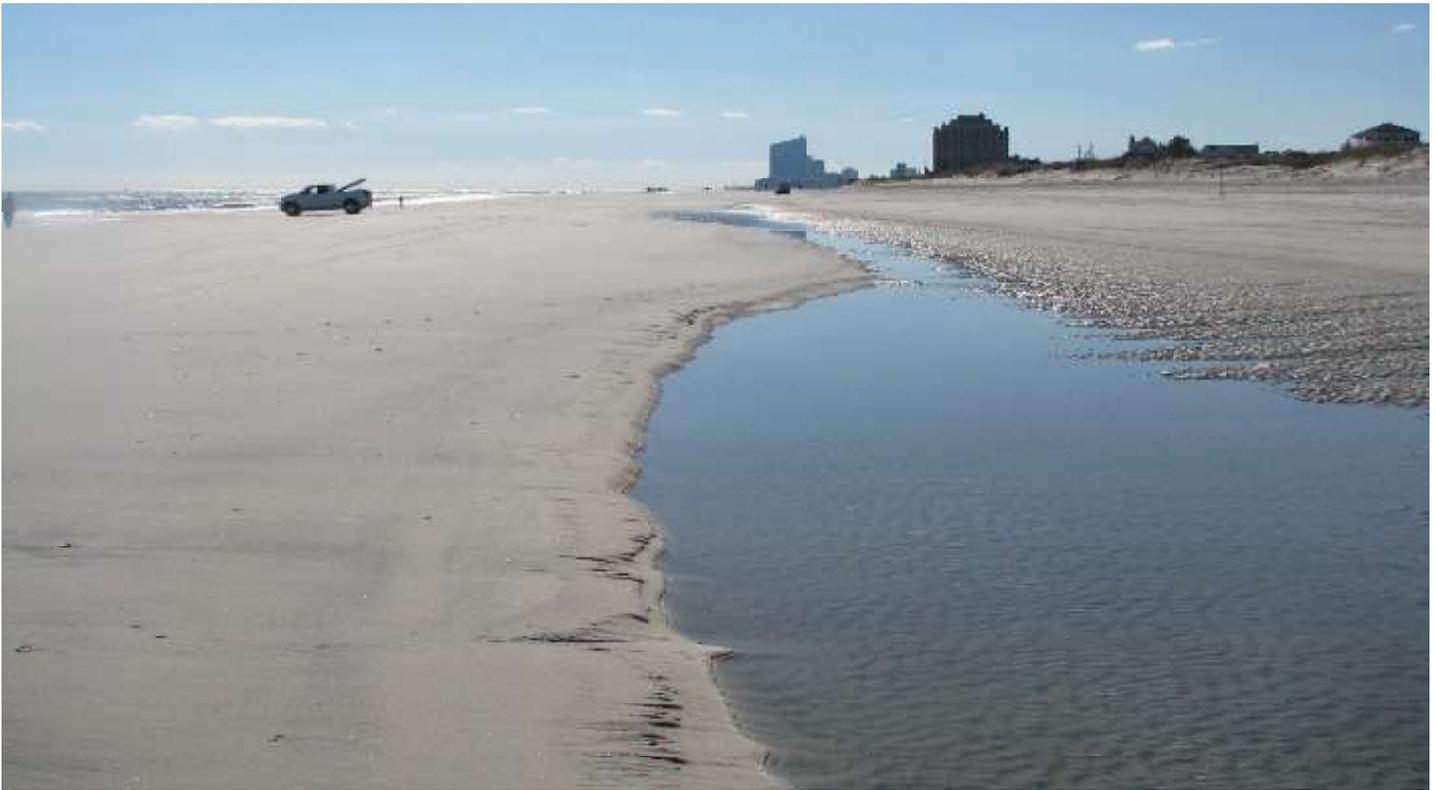
View to the south from 5th Street showing Atlantic City in the distance. This photo represents conditions along Brigantine's southern shoreline following an early October 2015 northeast storm event. Beach width decreased and the beach berm was flattened from the storm waves but the dune toe remained intact at this location and through the southern section. This photo taken about 11 days following the storm event shows a ridge of sand already moving back onshore. Natural recovery was already underway with favorable weather conditions that persisted through the remainder of 2015. (Photo taken October 15, 2015)

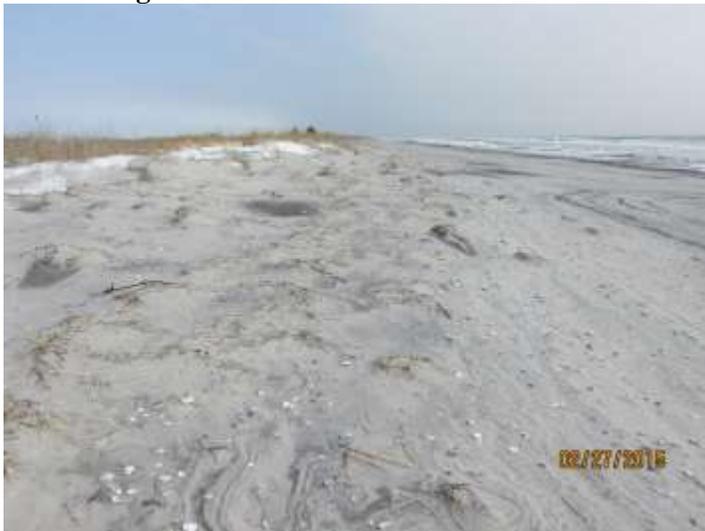
Figure 1a taken on February 27, 2015 looking north shows the dune and beach conditions had continued to naturally recover approximately 30-months following Hurricane Sandy. The post sandy dune scarp is no longer prominent.

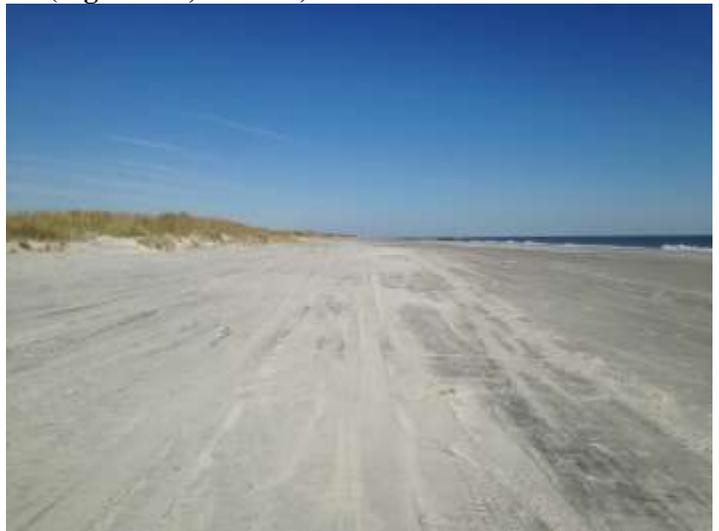
Figure 1b taken on October 16, 2015 from the same perspective shows a slightly wider beach but the beach elevation was flattened by storm waves from the October 2015 nor'easter. The existing beach width protected the dune toe from storm waves and further erosion.

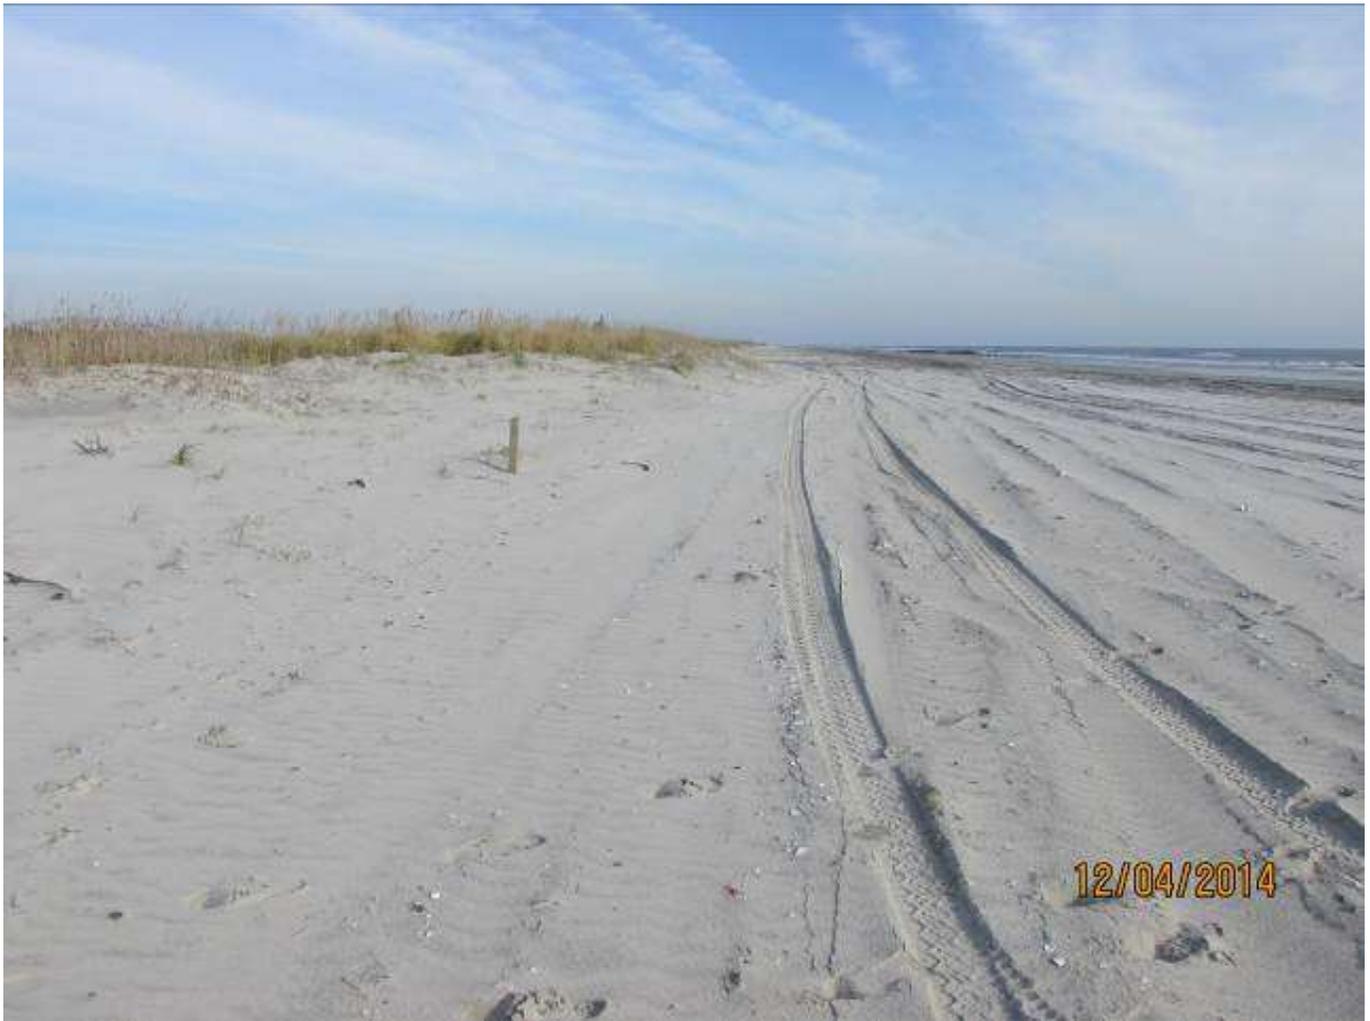
Figure 1c was taken on December 4, 2014 from the same location it was included to depict the relatively stable to slightly accretive conditions at this beach during 2015.

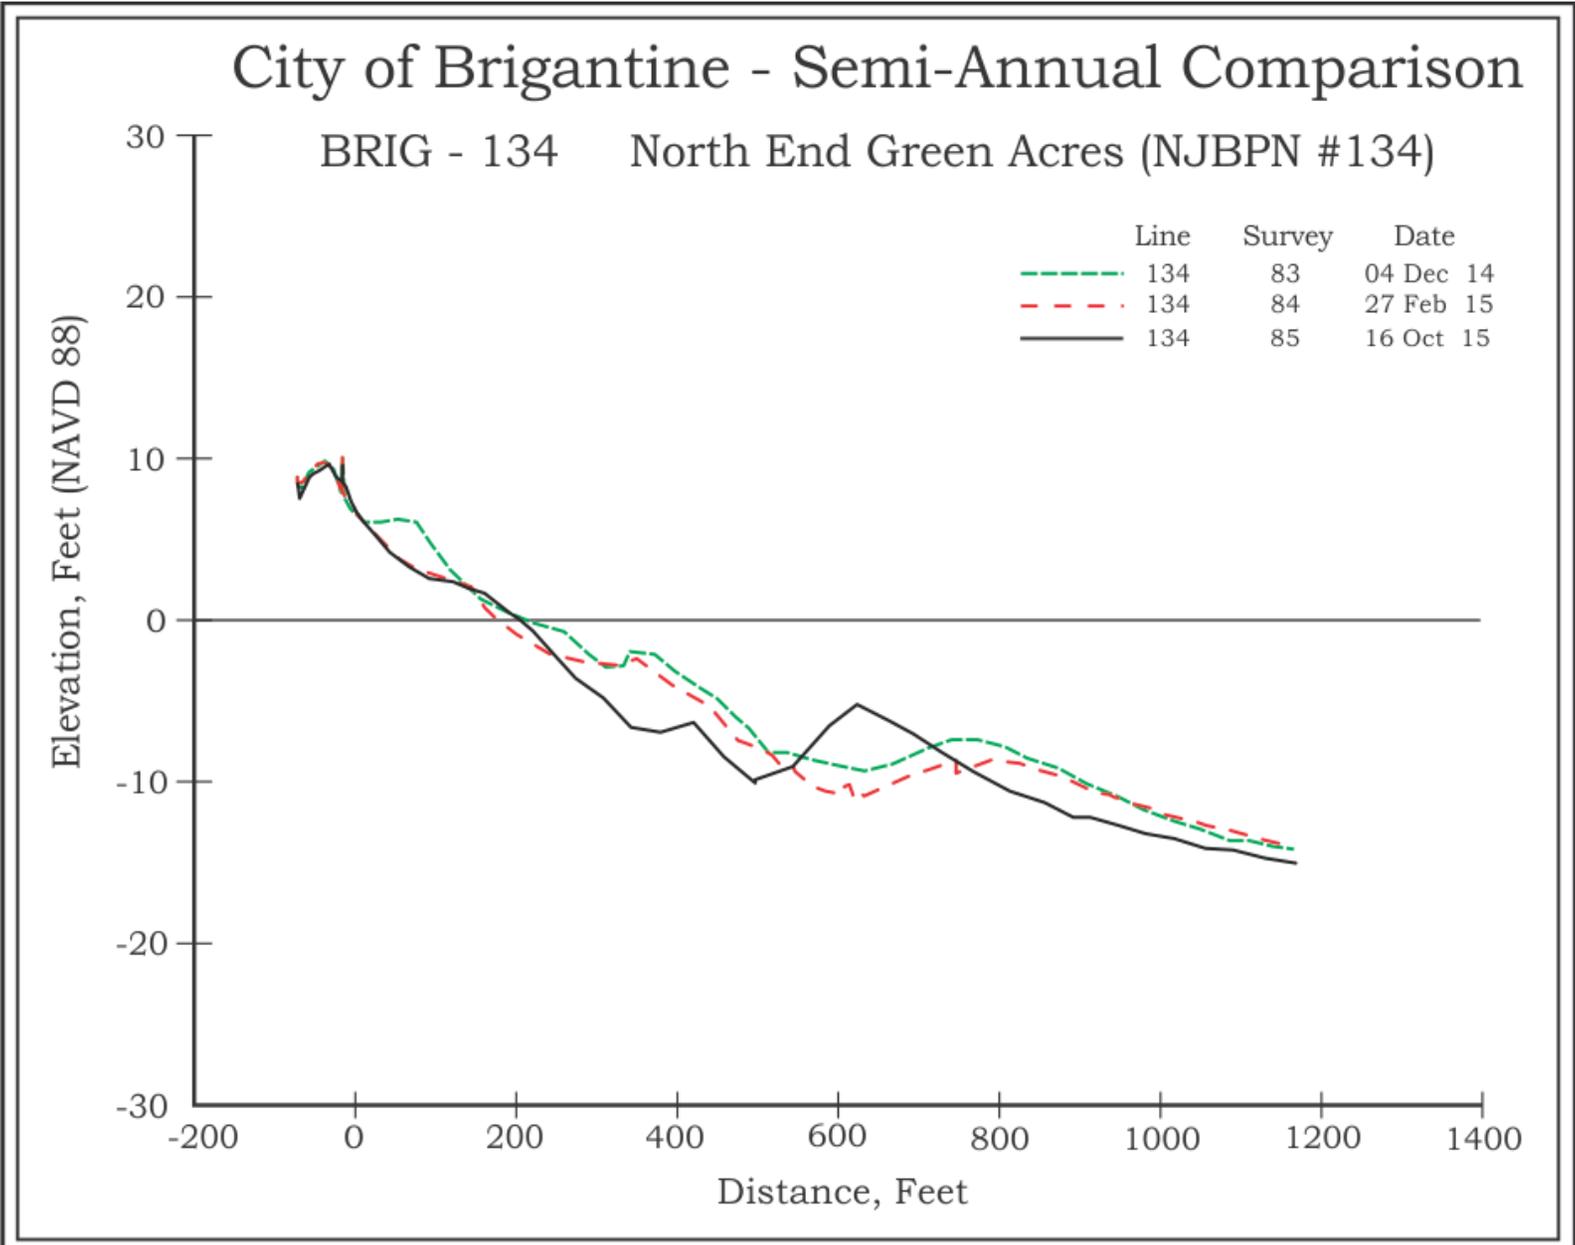
Figure 10 - The three cross sections above show the semi and annual changes in beach conditions at the Green Acres site. The beach berm eroded over the winter of 2015 along with modest scouring of the nearshore seafloor. Over the summer and fall the beach remained relatively stable while the nearshore suffered significant scouring. The offshore bar position moved landward approximately 200 feet with a loss of sand from offshore to the profile extent. A net annual loss of -52.27 yds³/ft. of sand occurred this year.

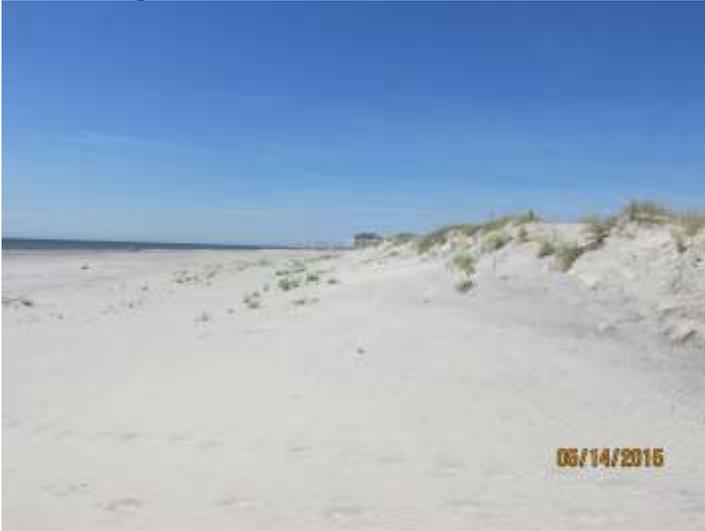
Figure 2a was taken May 14, 2015 and the view is to the south. Aeolian transport has moved sand to the dune toe where the wind-blown sand has accumulated. Early colonizing plants have begun to spread across the seaward slope onto the wide beach.

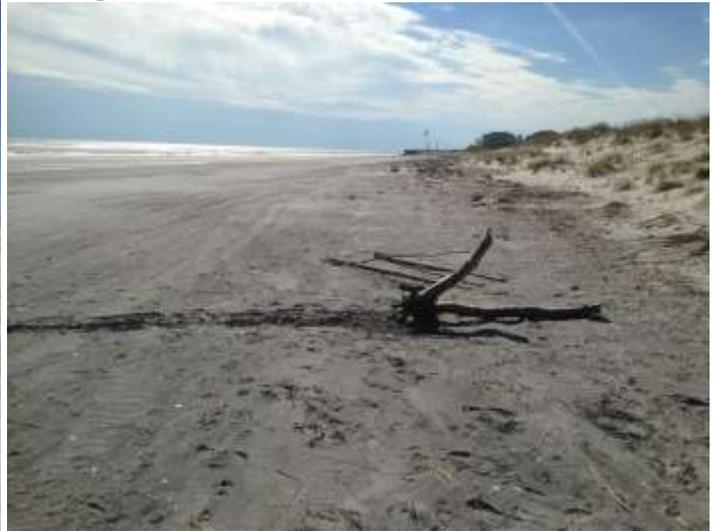
Figure 2b taken October 16, 2015 shows storm waves from the early October nor'easter reached the seaward dune toe. The beach was flattened but the dune remained intact.

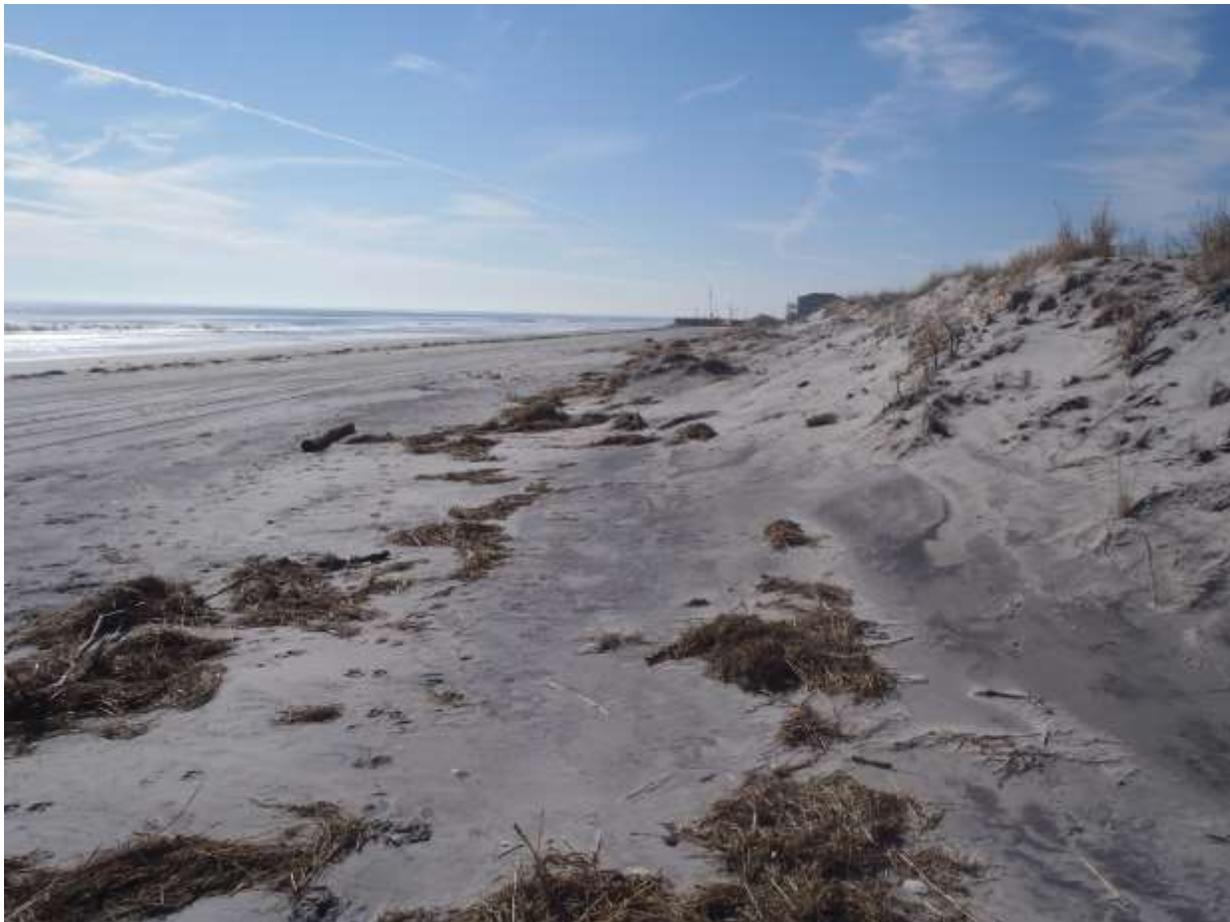
Figure 2c the photo above was taken January 28, 2016 following winter storm Jonas. Storm wave runup reached the seaward dune slope, reduced the beach width and further flattened the beach slope and berm elevations. In its current condition, depleted of sand, this beach no longer feeds sufficient sand to the downdrift promenade beaches to prevent exposure of the rock revetment.

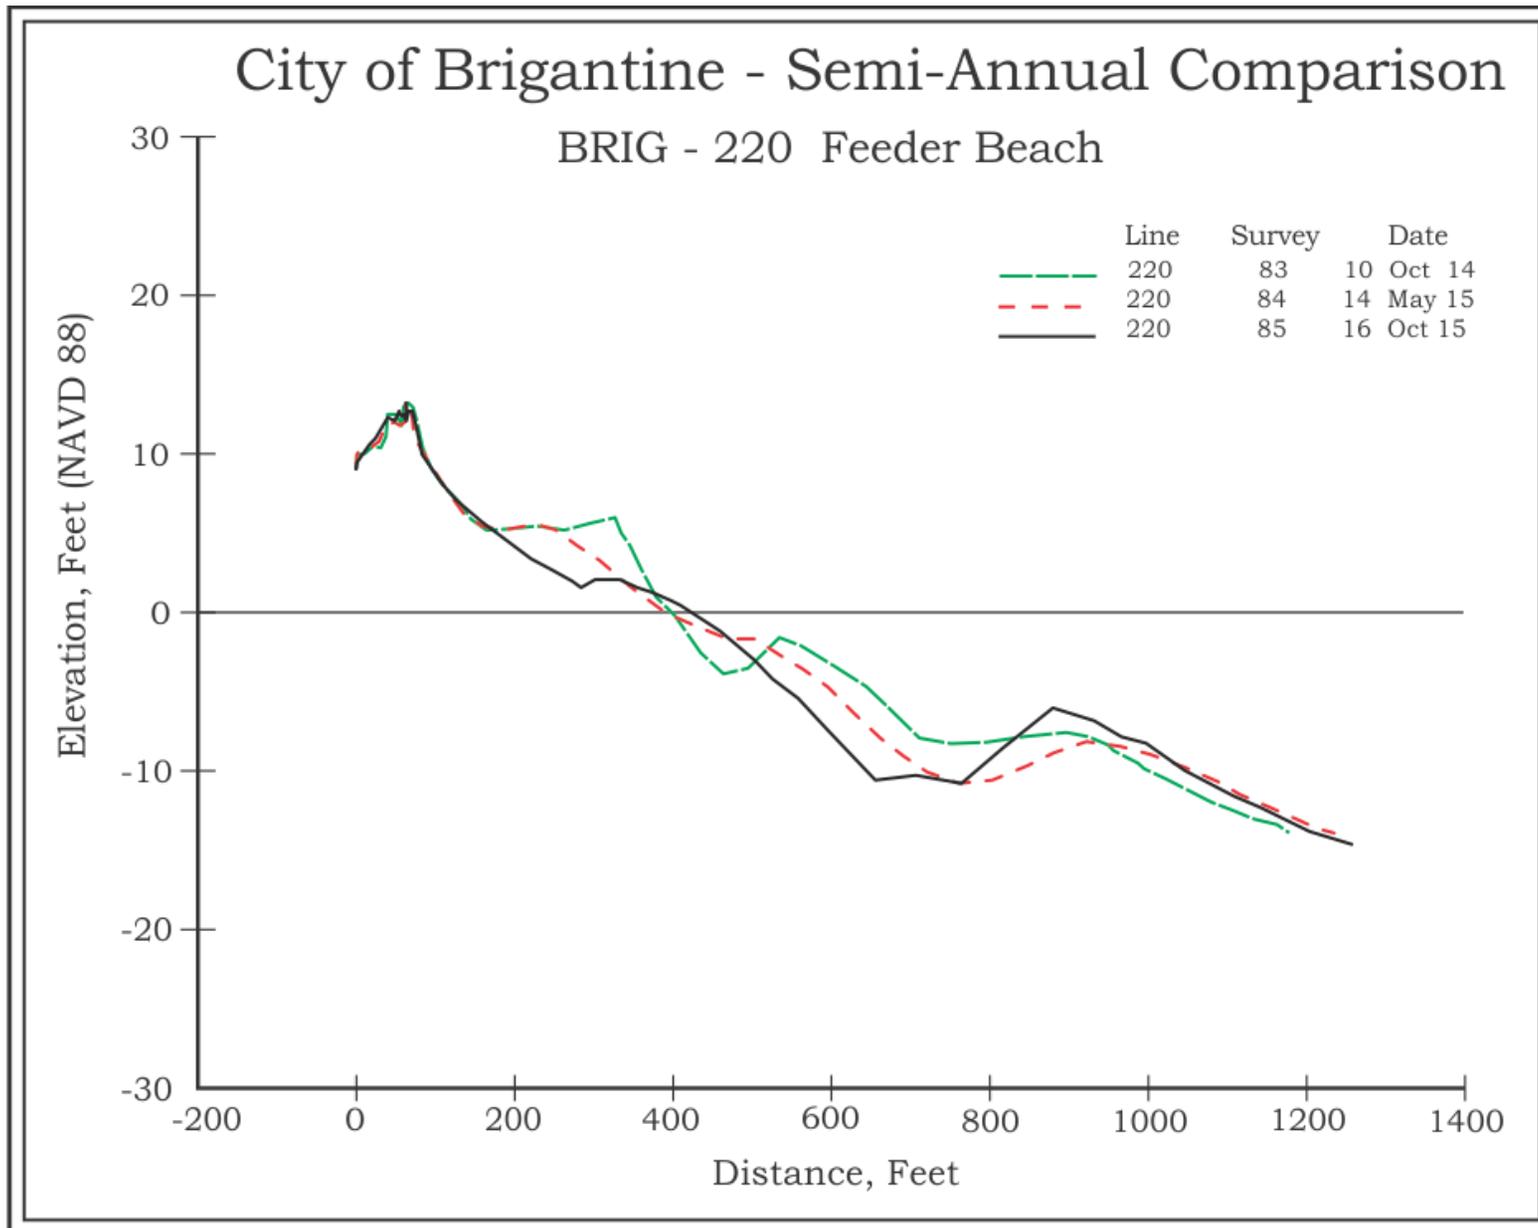
Figure 12 – The dune remained relatively stable to slightly accretive while the beach berm eroded through the year. Offshore bar development continued through 2015 while nearshore sand was lost forming a deep trough between the shoreline and offshore bar. The shoreline position change was a modest 25-foot seaward advance but with a net loss of -32.83 yds³/ft. of sand through 2015.

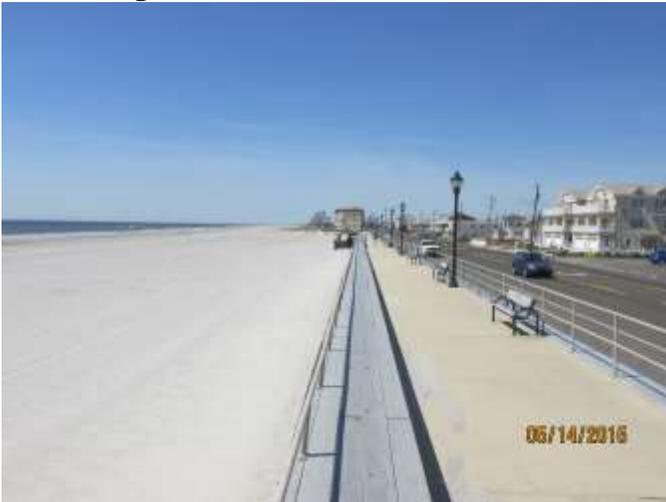
Figure 3a taken on May 14, 2015 the restored beach template remained relatively stable since completion of the 2013 USACE project. The mild 2014-2015 winter season were absent of severe storms allowing the wide beach berm to persist through to spring of 2015.

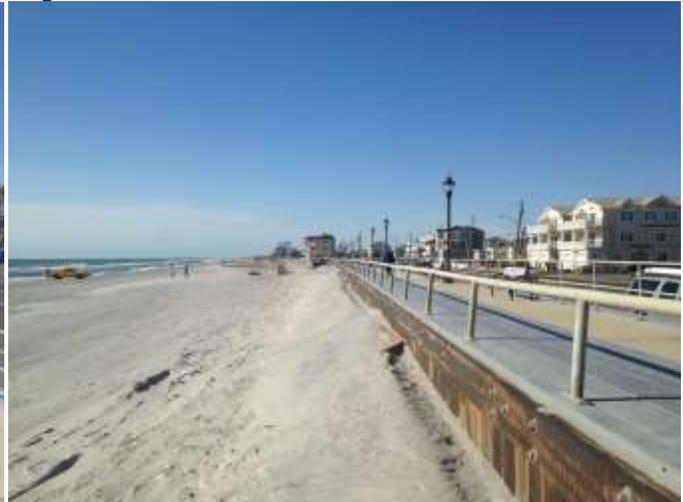
Figure 3b photo above was taken October 16, 2015 from a similar location. The wide beach berm still present in spring 2015 has been flattened by storm wave runup that nearly reached the revetment two weeks prior during the early October nor'easter.

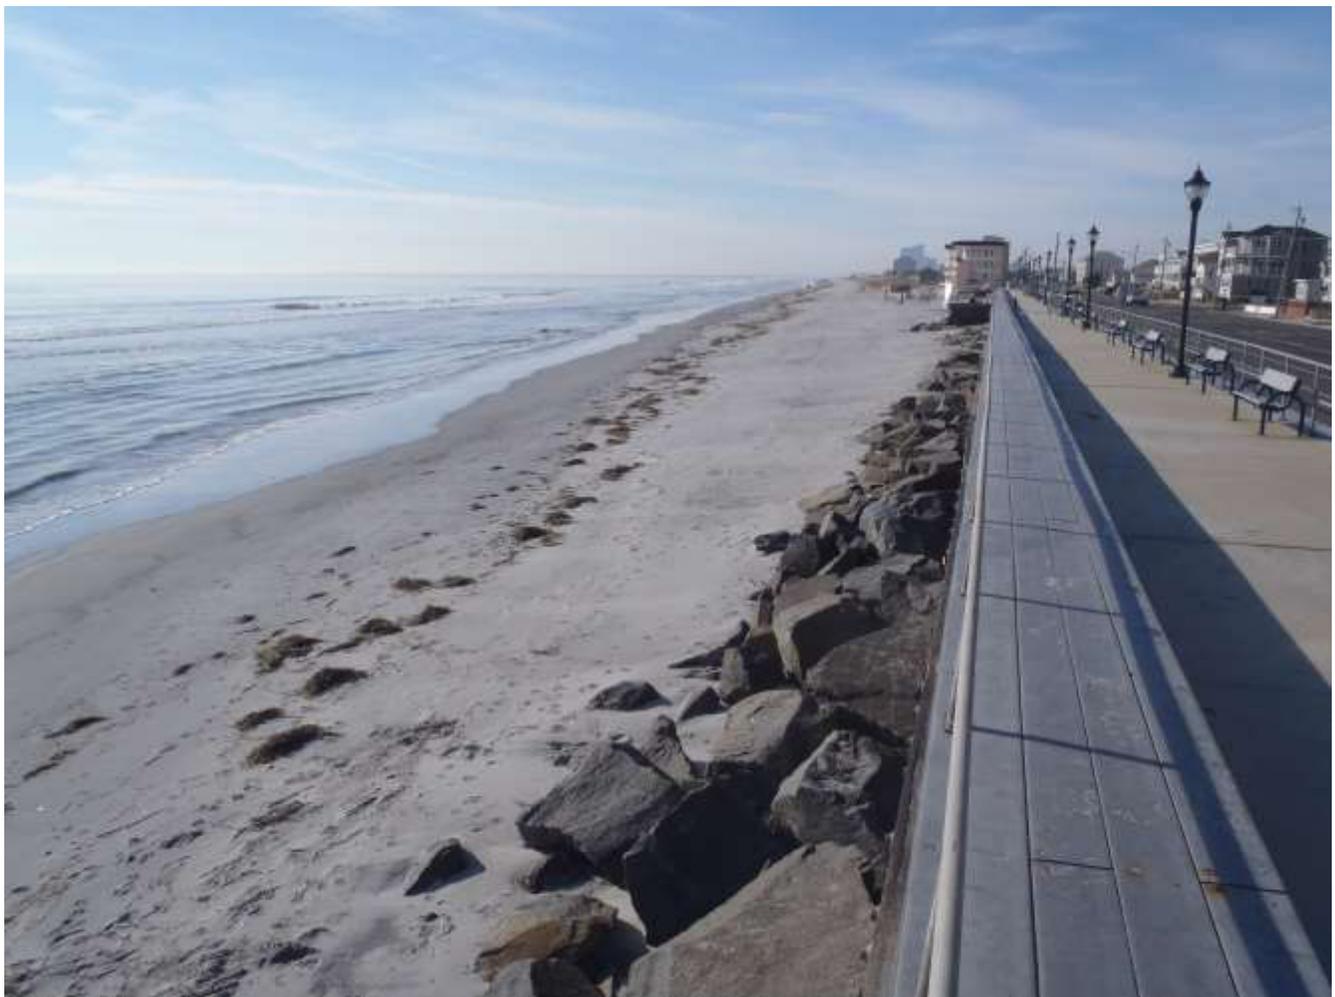
Figure 3c taken on January 27, 2016 this photo was taken from the same location following winter storm Jonas, a severe nor'easter. Photo shows a rapid deterioration of the beach conditions since October 2015 and exposure of the rock revetment. The orientation of the natural shoreline converges with the street end revetment and promenade in this location. Once the shoreline has retreated to the rocks, erosion rates accelerate from wave refraction off the hard structure resulting in a chronic erosional hotspot.

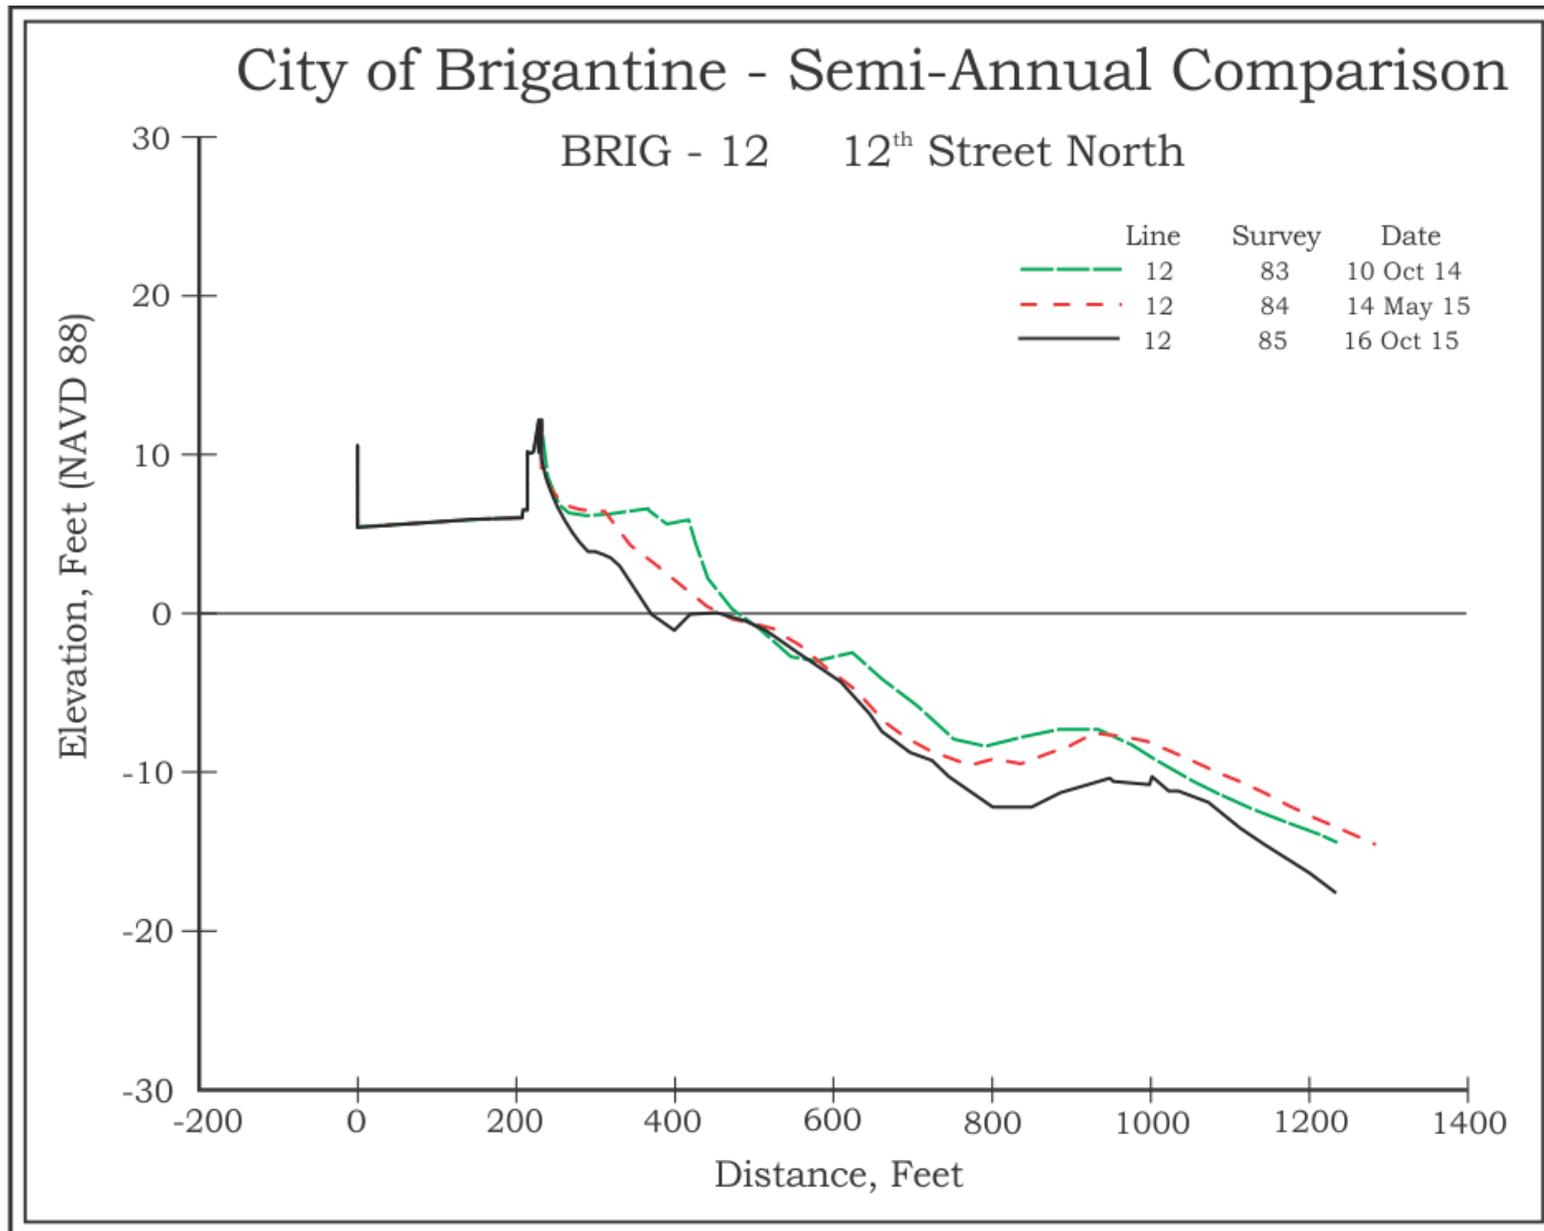
Figure 14 - The cross sections above shows a significant steady rate of sand loss across the entire profile during 2015. This known erosional “Hotspot” continued to erode and as sand on the “feeder” beach to the north diminished stability at Brig-12 deteriorated. During 2015 the shoreline position retreated 24 feet with a major net loss of 92.42yds³/ft. of sand from this chronic erosional location.

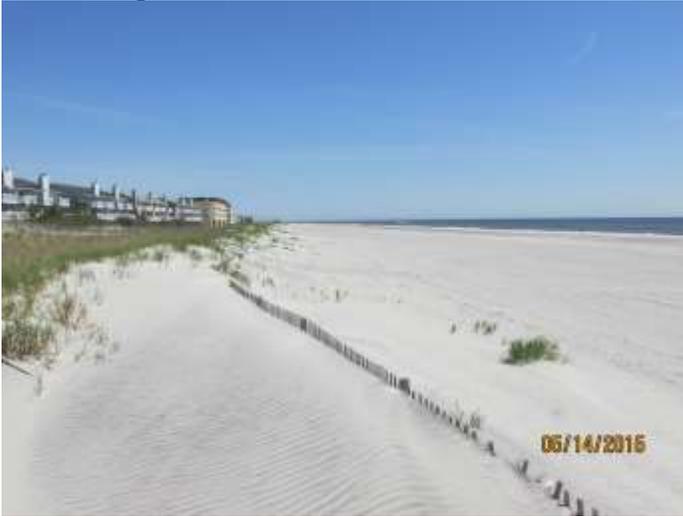
Figure 4a photo was taken looking north on May 14, 2015. This beach was fully restored to the design template two years prior. A new foredune has developed burying the installed fence, early colonizing plants have begun to propagate.

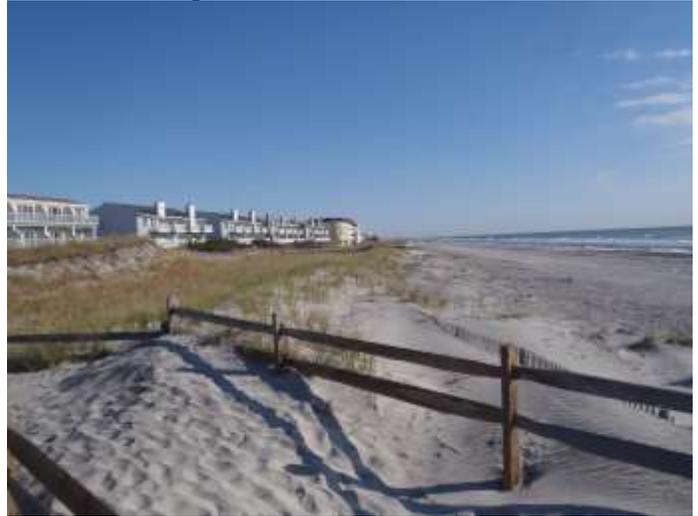
Figure 4b photo was taken looking north on October 15, 2015 following the early October storm. The beach width and elevation were reduced by the storm waves but the developing foredune remained intact.

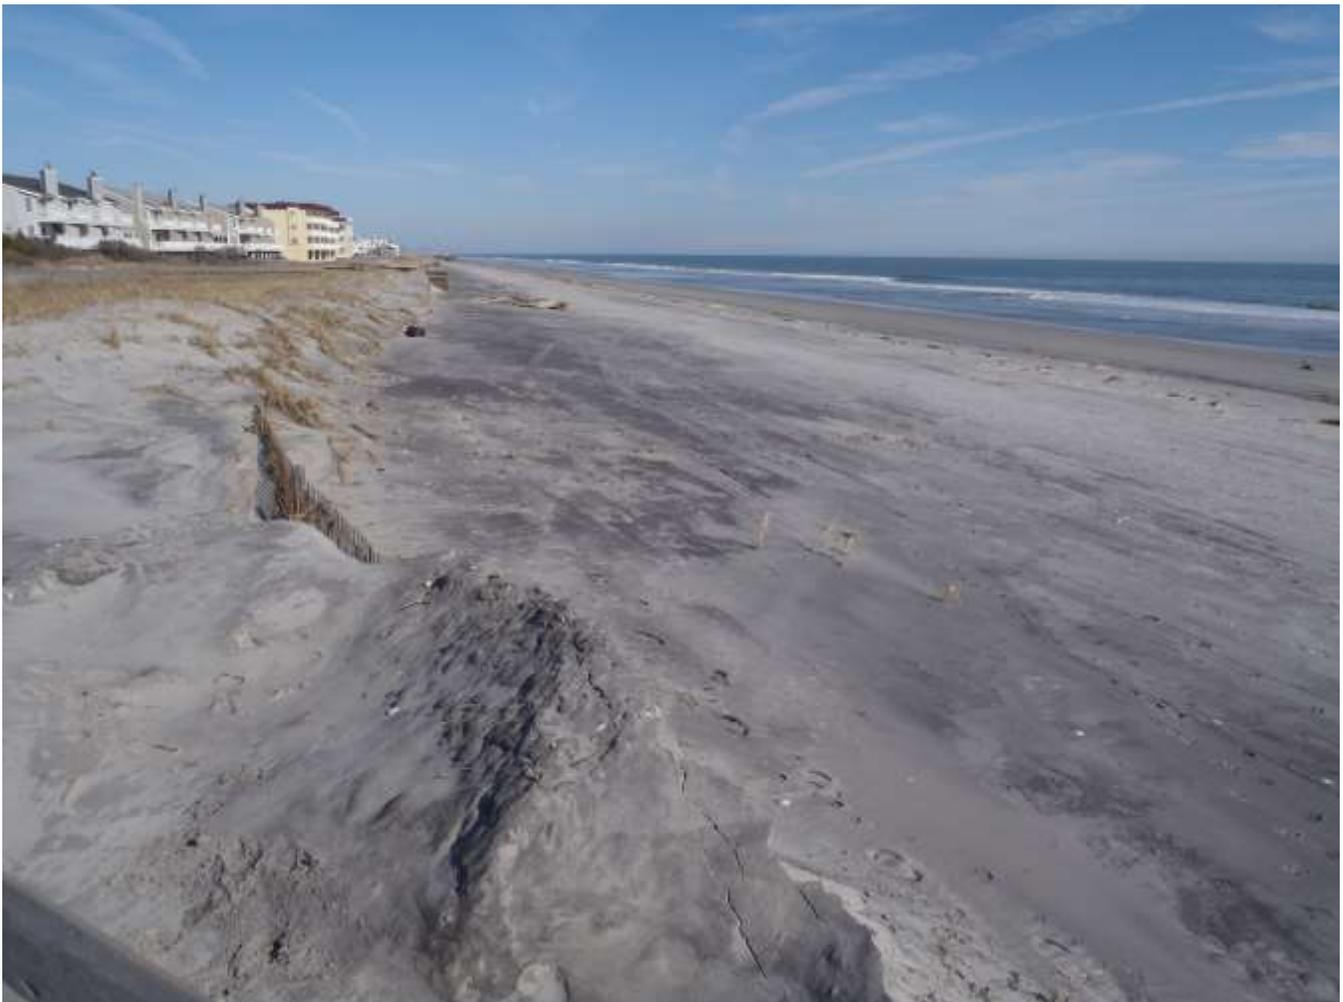
Figure 4c taken from a similar perspective looking north on January 27, 2016 following winter storm Jonas. The developing foredune has been truncated and the beach width and elevation further reduced by the storm waves. Although considerable dune width remained to protect the properties landward the reduced beach width and elevation leaves the dune vulnerable to further storm erosion.

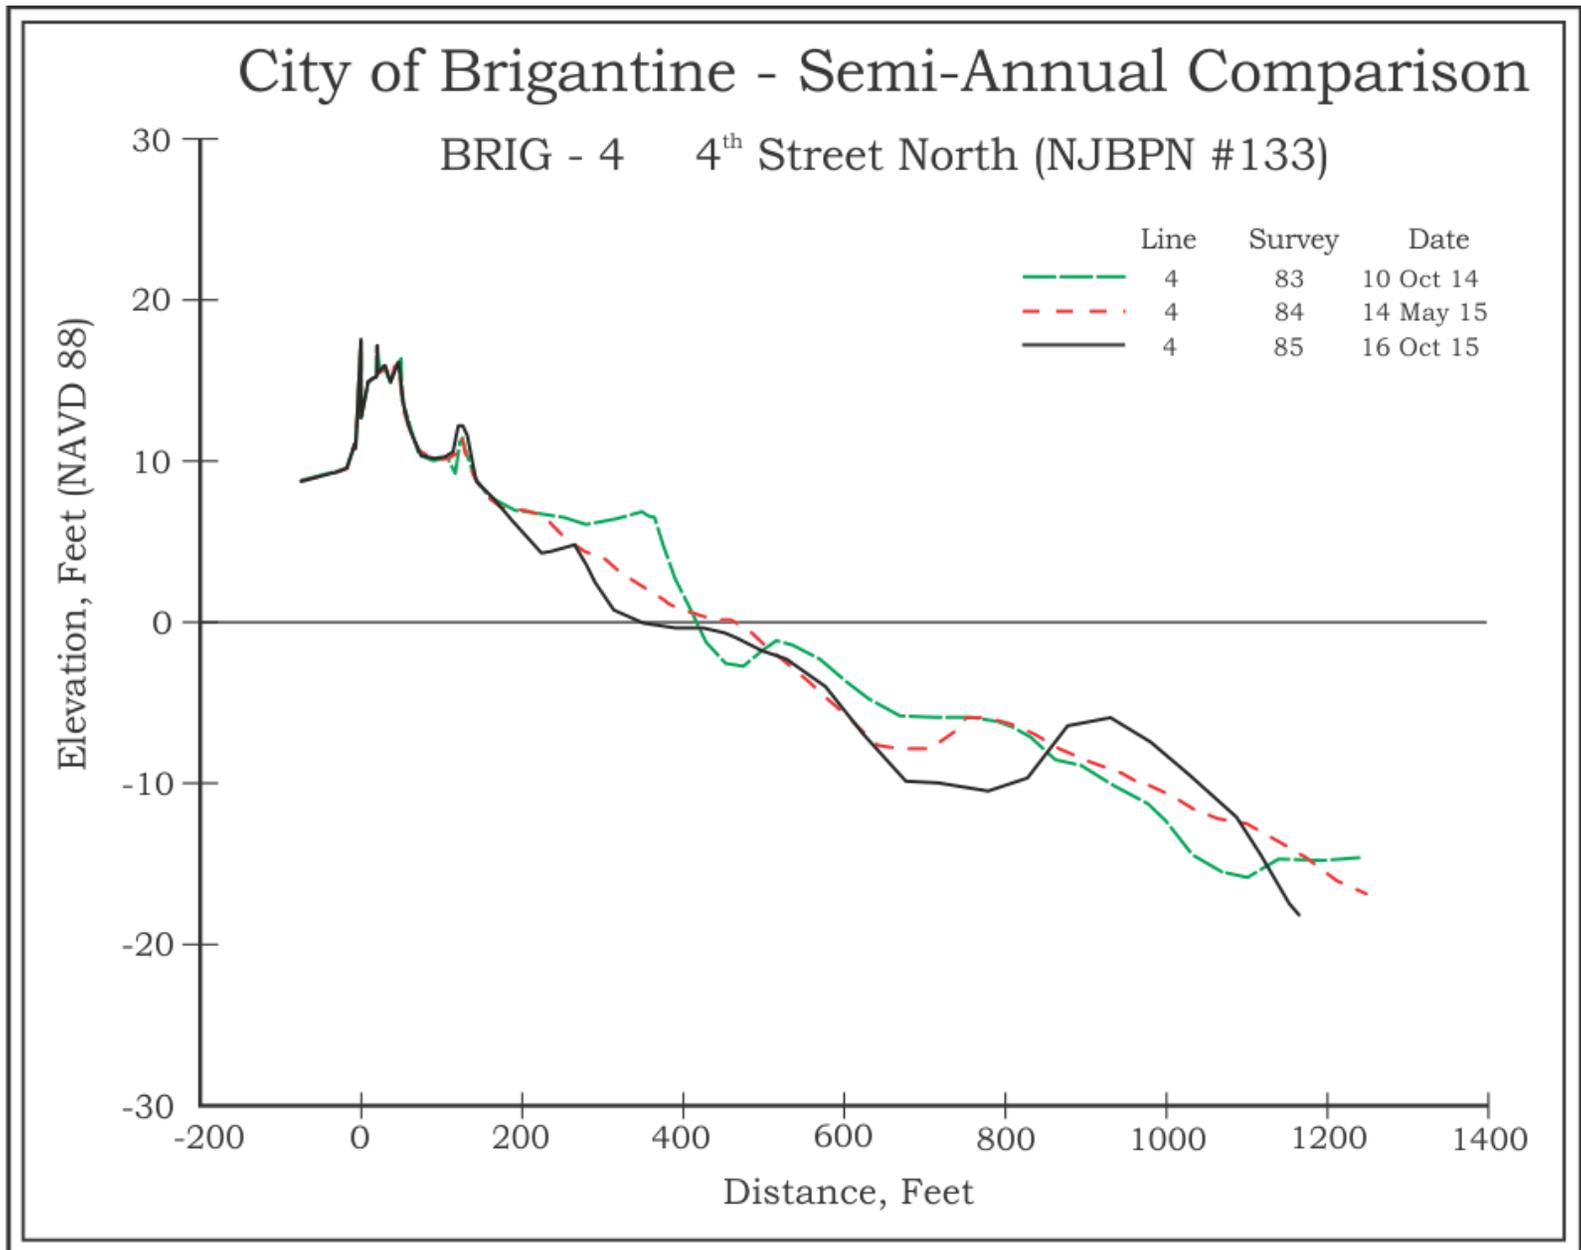
Figure 16 - The 3 cross sections above show the onshore and offshore changes at 4th Street North since October 2014. This site has not received sand since the summer of 2013. Sand has eroded onshore from the beachface to the seaward dune toe through 2015. Nearshore scouring formed a deep trough while further offshore a larger bar developed by fall 2015. The annual volume comparison shows a loss of -29.88 yds³/ft. of sand and shoreline position retreat of -69 feet.

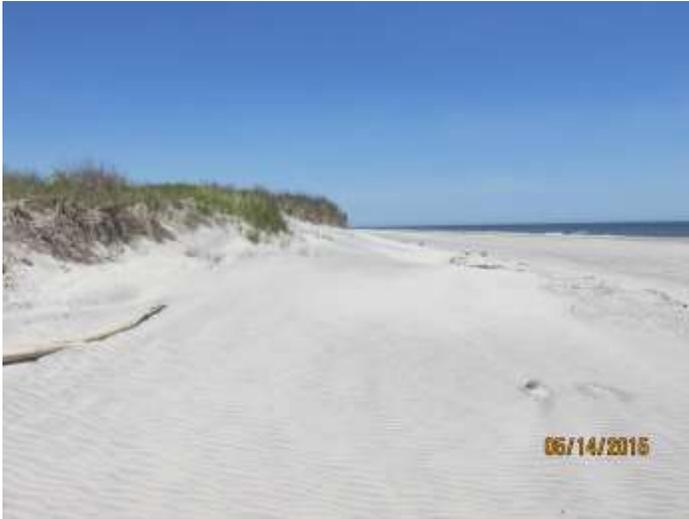
Figure 5a photo was taken looking north on May 14, 2015. Remnants of the dune scarp carved during Sandy remain partially visible in the seaward dune slope. All recovery here was natural; the 2013 USACE project ended 2 blocks north.

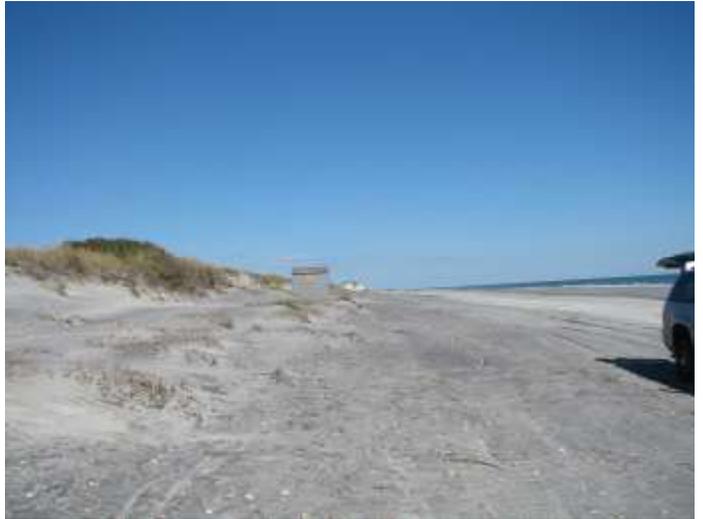
Figure 5b photo was taken looking north on October 15, 2014. Sand moved slightly landward into the dune toe with evidence of early colonizing plants propagation during the summer season. The early October northeaster again flattened and reduced the width of the beach berm.

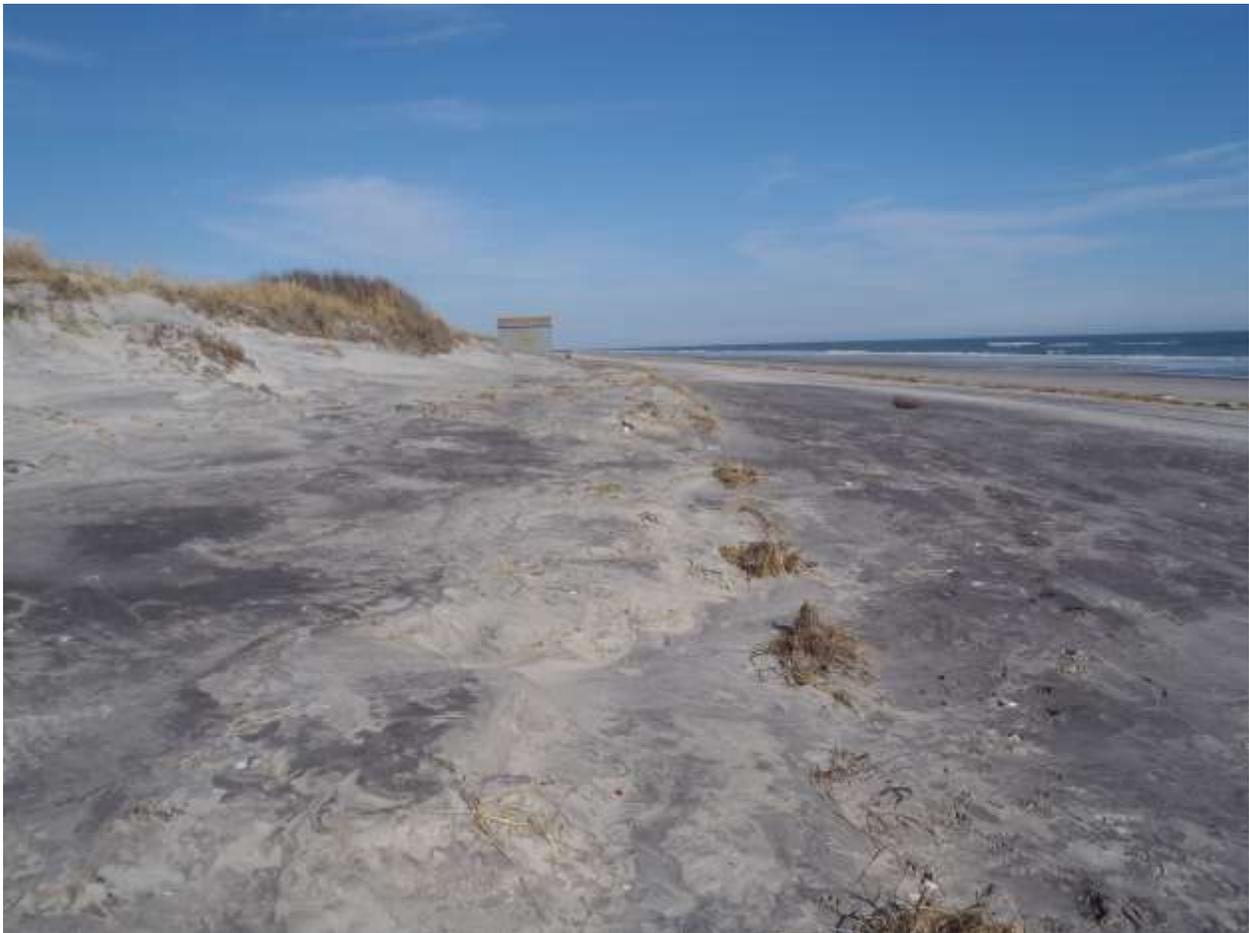
Figure 5c photo was taken looking north on January 28, 2016 immediately following winter storm Jonas. You can clearly see the storm debris wrack line deposited at the seaward dune toe. Storm wave runup cut a small scarp along the seaward dune toe. The storm further reduced the beach berm width and elevation leaving the dune toe at least temporarily vulnerable to future storm waves until natural recover restores the beach conditions.

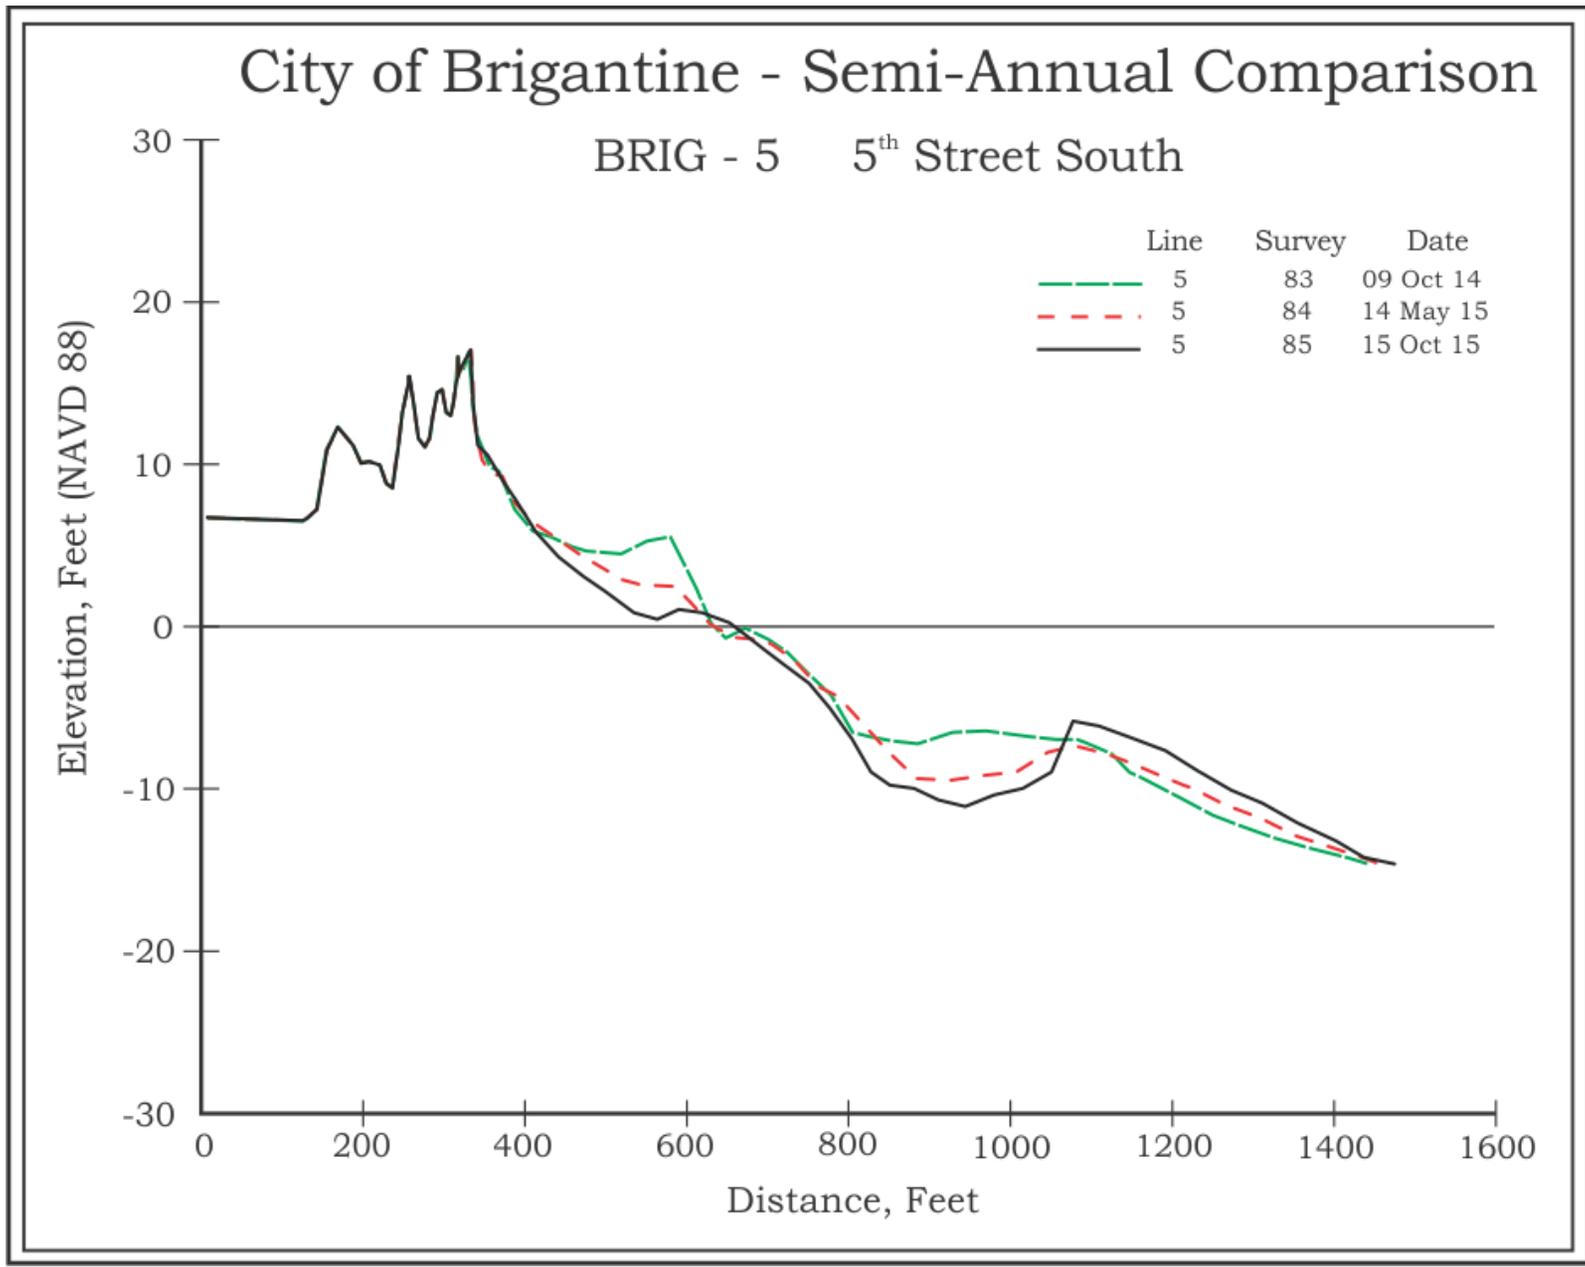
Figure 18 - The 5th Street South site since October 2014 showed a loss of sand from the beach and nearshore. Onshore the beach berm elevation was reduced over the winter of 2015 then further flattened by fall 2015. The nearshore was scoured forming a deep trough while sand was deposited further offshore forming a shore parallel bar. The annual changes for 2015 were a shoreline position advance of 26 feet while there was a net profile volume loss of -28.19 yds³/ft. of sand.
