**FINAL REPORT FOR 2015
ON THE CONDITION OF THE MUNICIPAL BEACHES
IN
THE CITY OF BRIGANTINE BEACH, ATLANTIC COUNTY, NEW JERSEY**

**PREPARED BY: THE STOCKTON UNIVERSITY COASTAL RESEARCH CENTER
30 WILSON AVENUE
PORT REPUBLIC, NEW JERSEY 08241**

May, 2016

Annual Report for 2015 to the City of Brigantine Beach on the Condition of Municipal Ocean Beaches

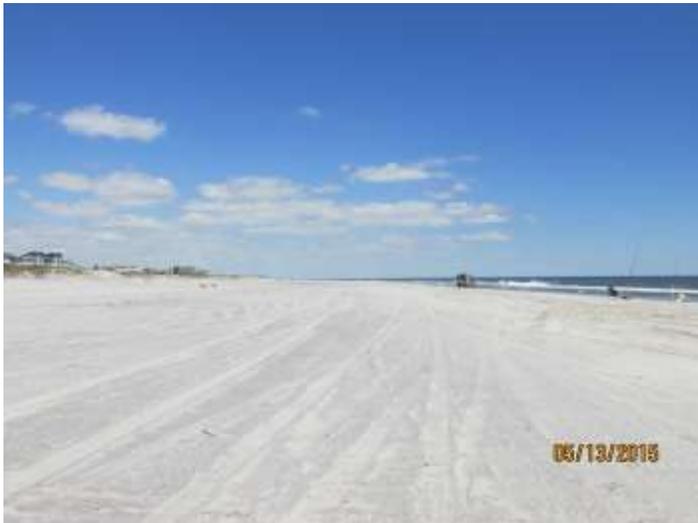
Figure 6a photo was taken looking north on May 13, 2015 heading into summer season. The beach berm is well-defined at this location as natural spring summer beach building processes are well underway.

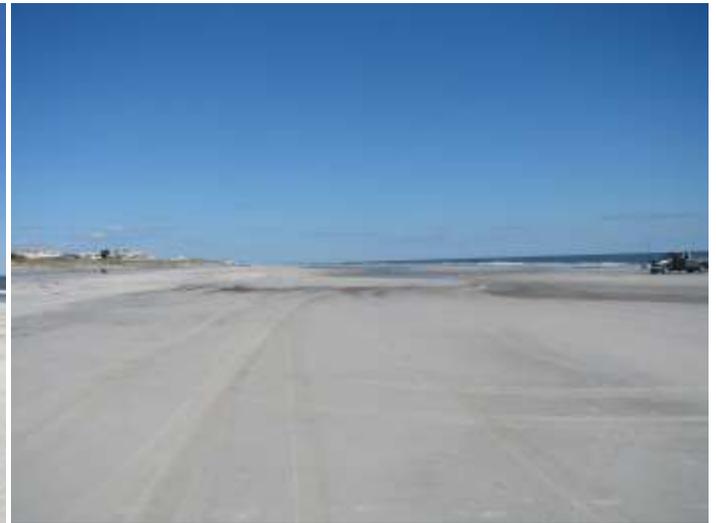
Figure 6b taken on October 15, 2015 after the October northeaster. The berm has been lowered and pushed seaward with a shallow runnel and ridge pictured here at low tide.

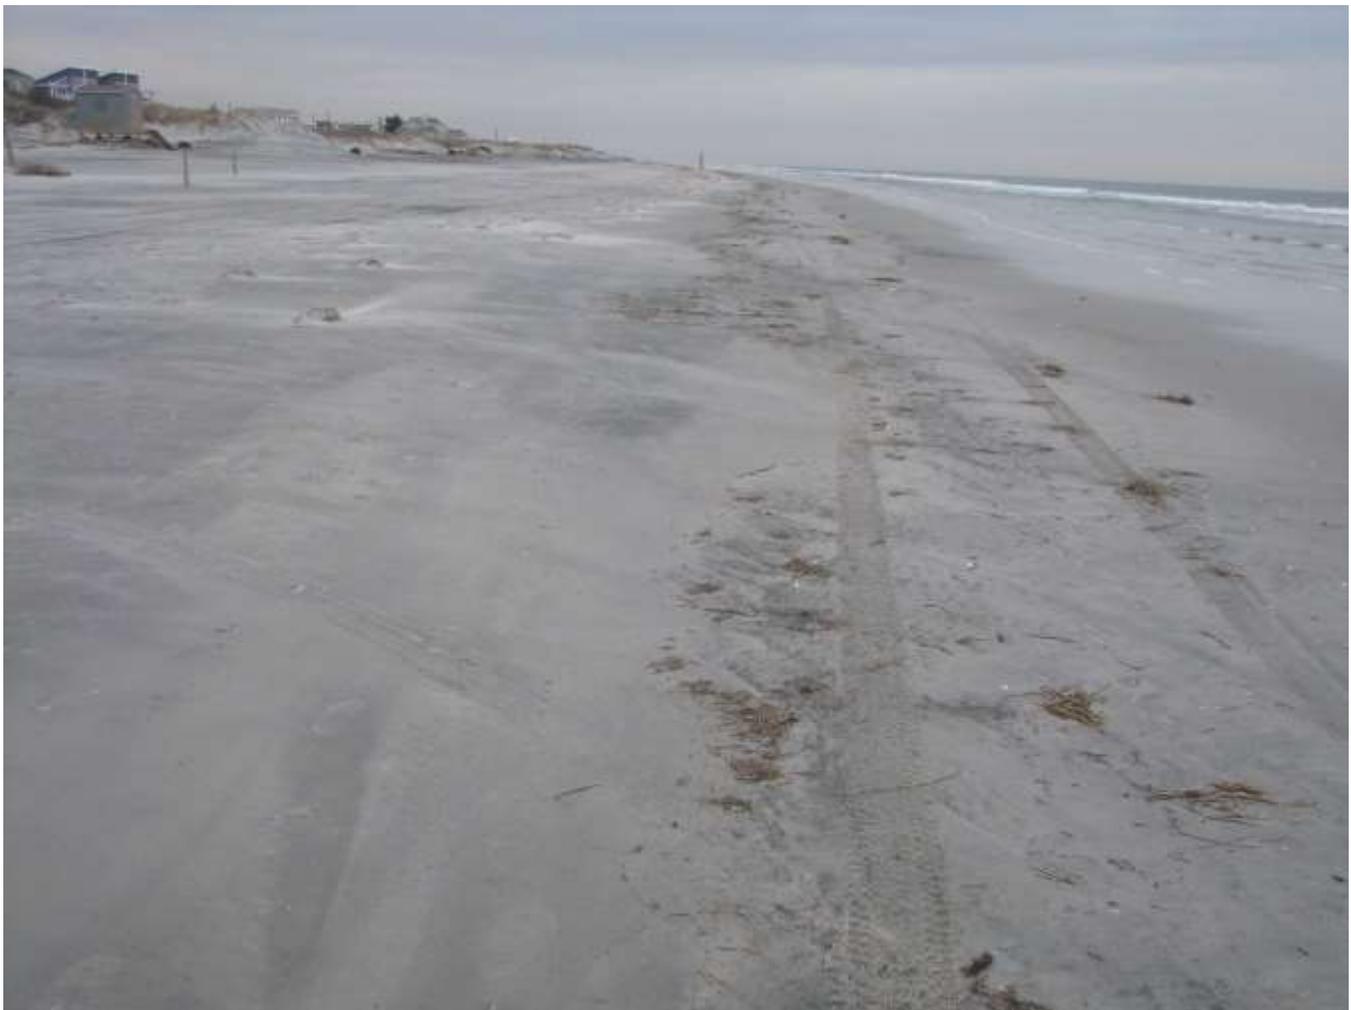
Figure 6c photo was taken looking north on January 29, 2016 following Jonas. Beach width and elevation have been further reduced but a sufficient wide beach berm remains to provide shore protection for the dune in the vent of future storm events.

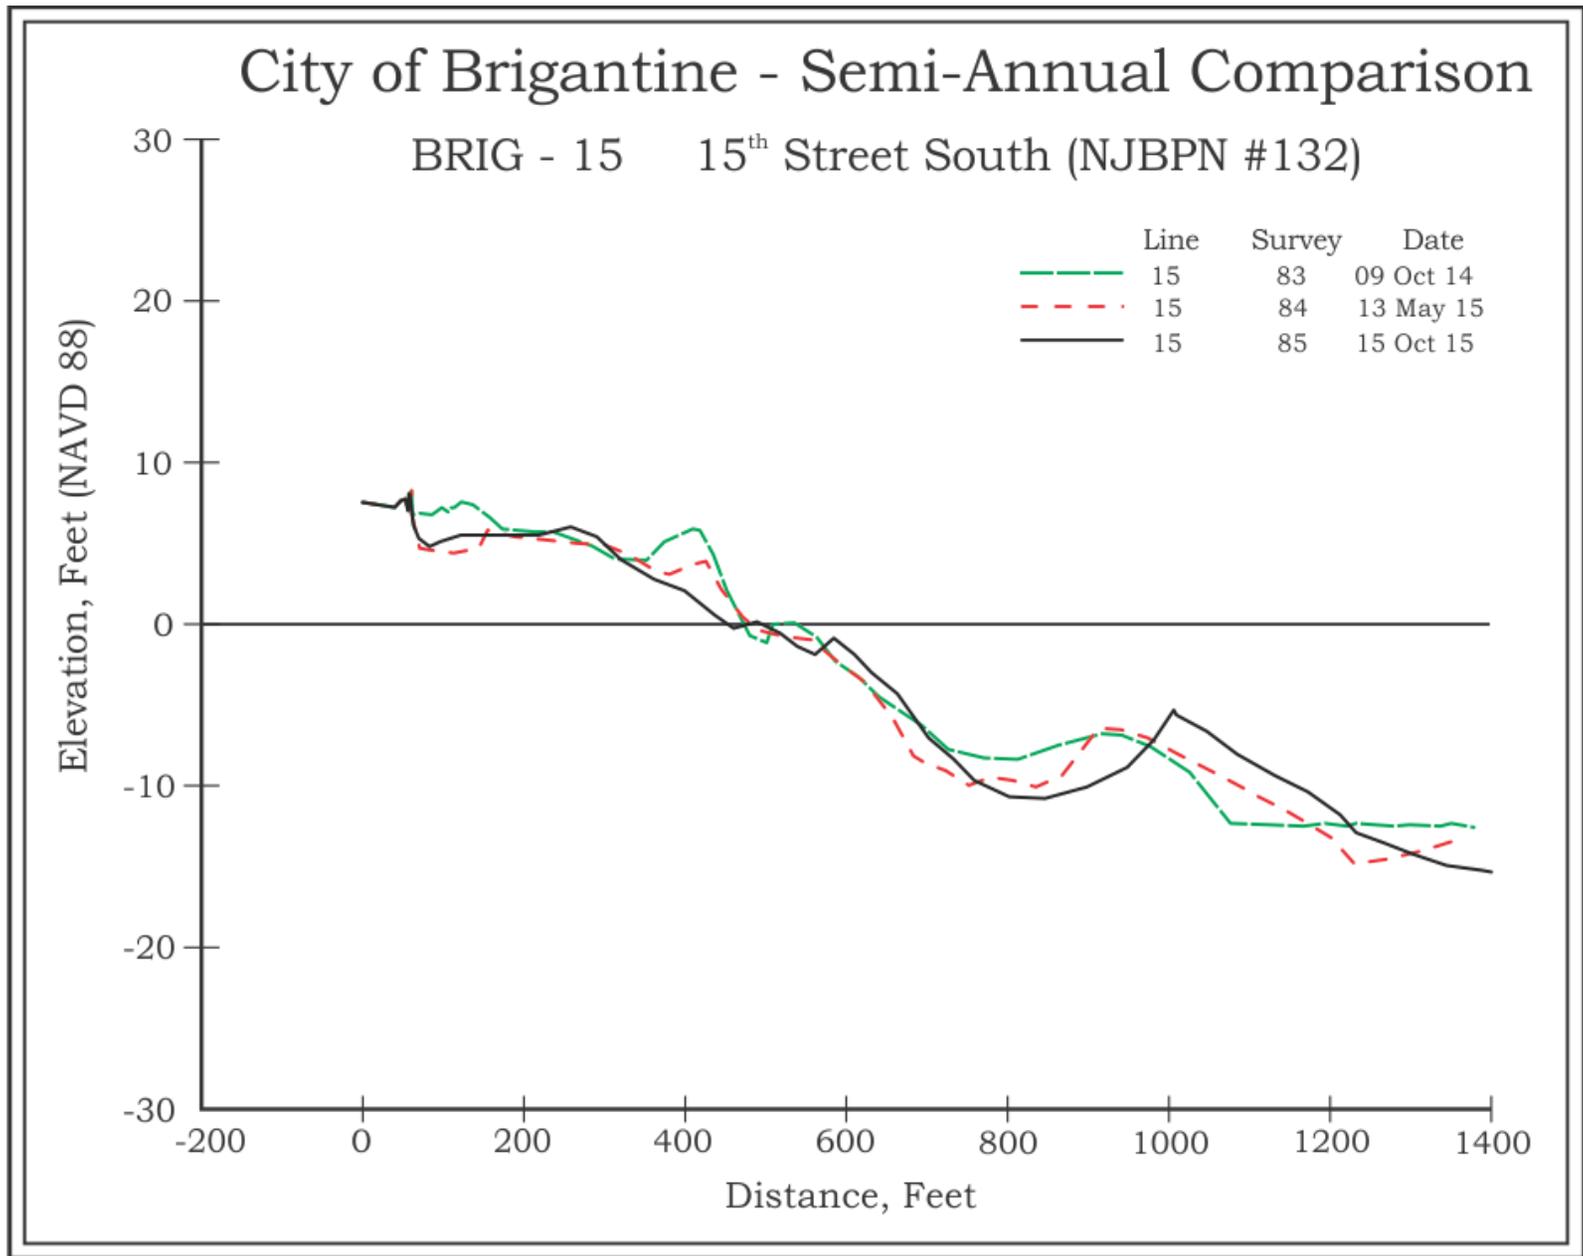
Figure 20 - At 15th Street South the 2015 erosional trend continued to dominate. Over the winter of 2015 the beach eroded losing sand from the revetment to the beach berm crest. There was some modest recovery on the upper beach over the summer of 2015 but by fall 2015 the beachface slope was flattened a trough was scoured nearshore, offshore sand was deposited forming a larger bar approximately 100 feet seaward of its previous location. The annual change for 2015 was 44 feet of retreat in the shoreline position with a net volume loss of -20.98 yds³/ft. of sand.

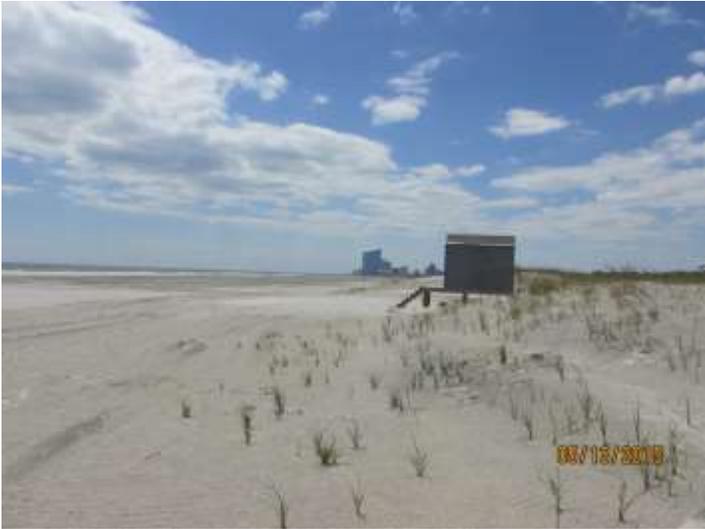
Figure 7a photo was taken looking south on May 13, 2015. Two years following Sandy natural aeolian accumulation of sand along the seaward dune slope fully restored and enhanced the seaward slope and toe. Grasses have colonized to the seaward toe.

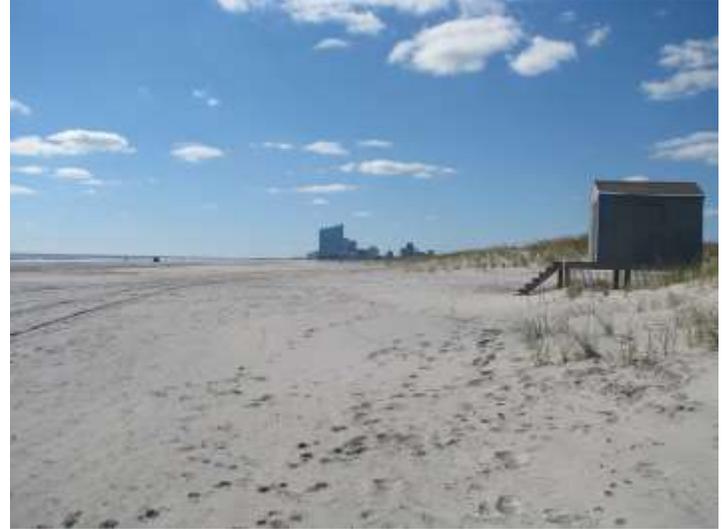
Figure 7b photo was taken looking south on October 15, 2015. The wide beach berm absorbed the full impact of the early October 2015 northeast storm event, first of a series in this El Nino season. There's no wrack line or indication wave run up reached anywhere near the seaward dune toe during the storm.

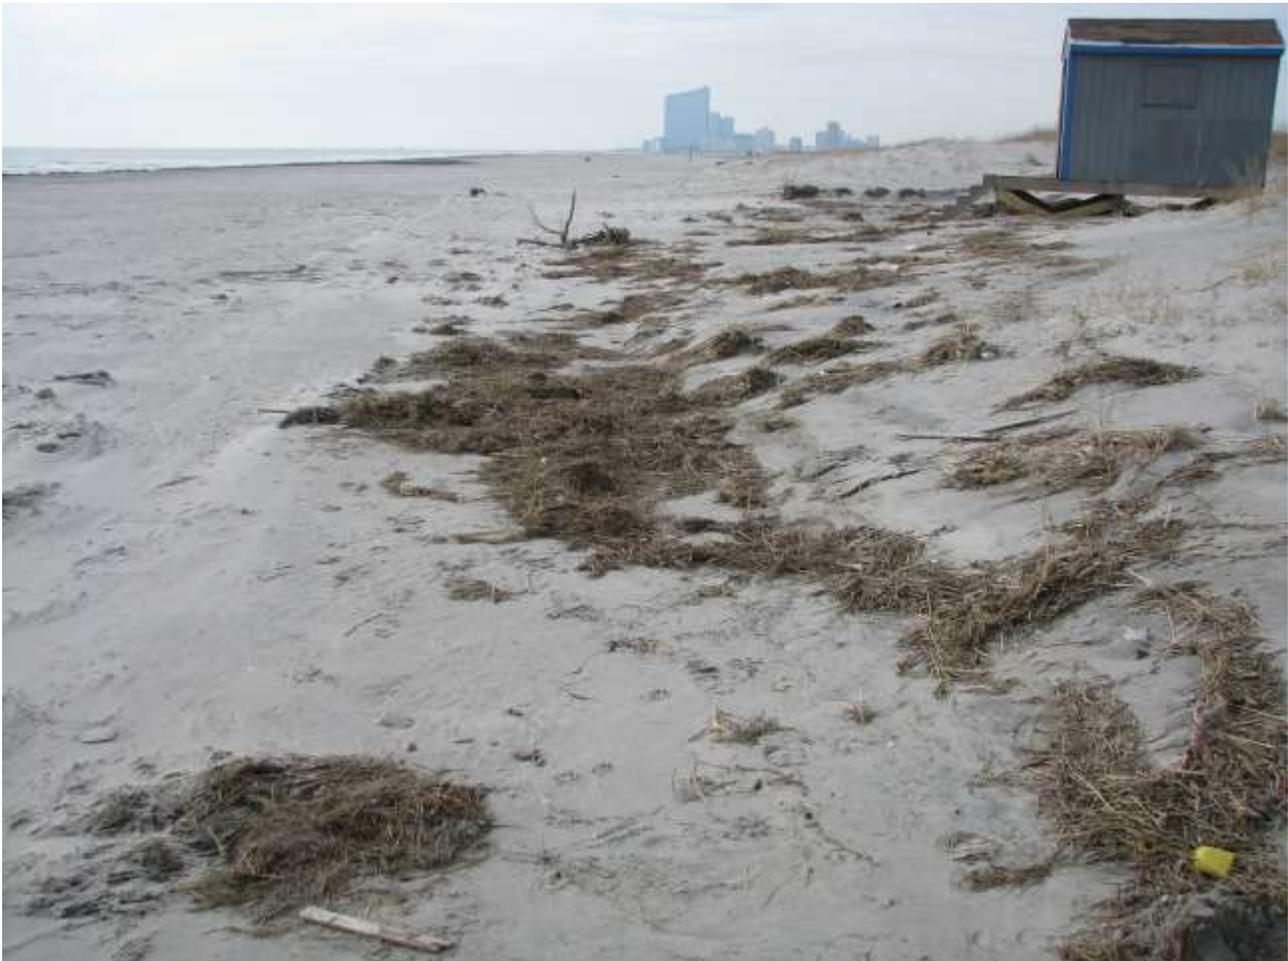
Figure 7c taken January 29, 2016, again looking south from the same location following winter storm Jonas. The thick debris wrack line is evidence that wave storm run up reached the seaward dune toe during Jonas. However, the wider beach berm did absorb most of the wave energy preventing any significant erosion along the dune toe in this region. The beach berm is slightly narrower following the storm but still wide enough to provide significant storm protection during future events.

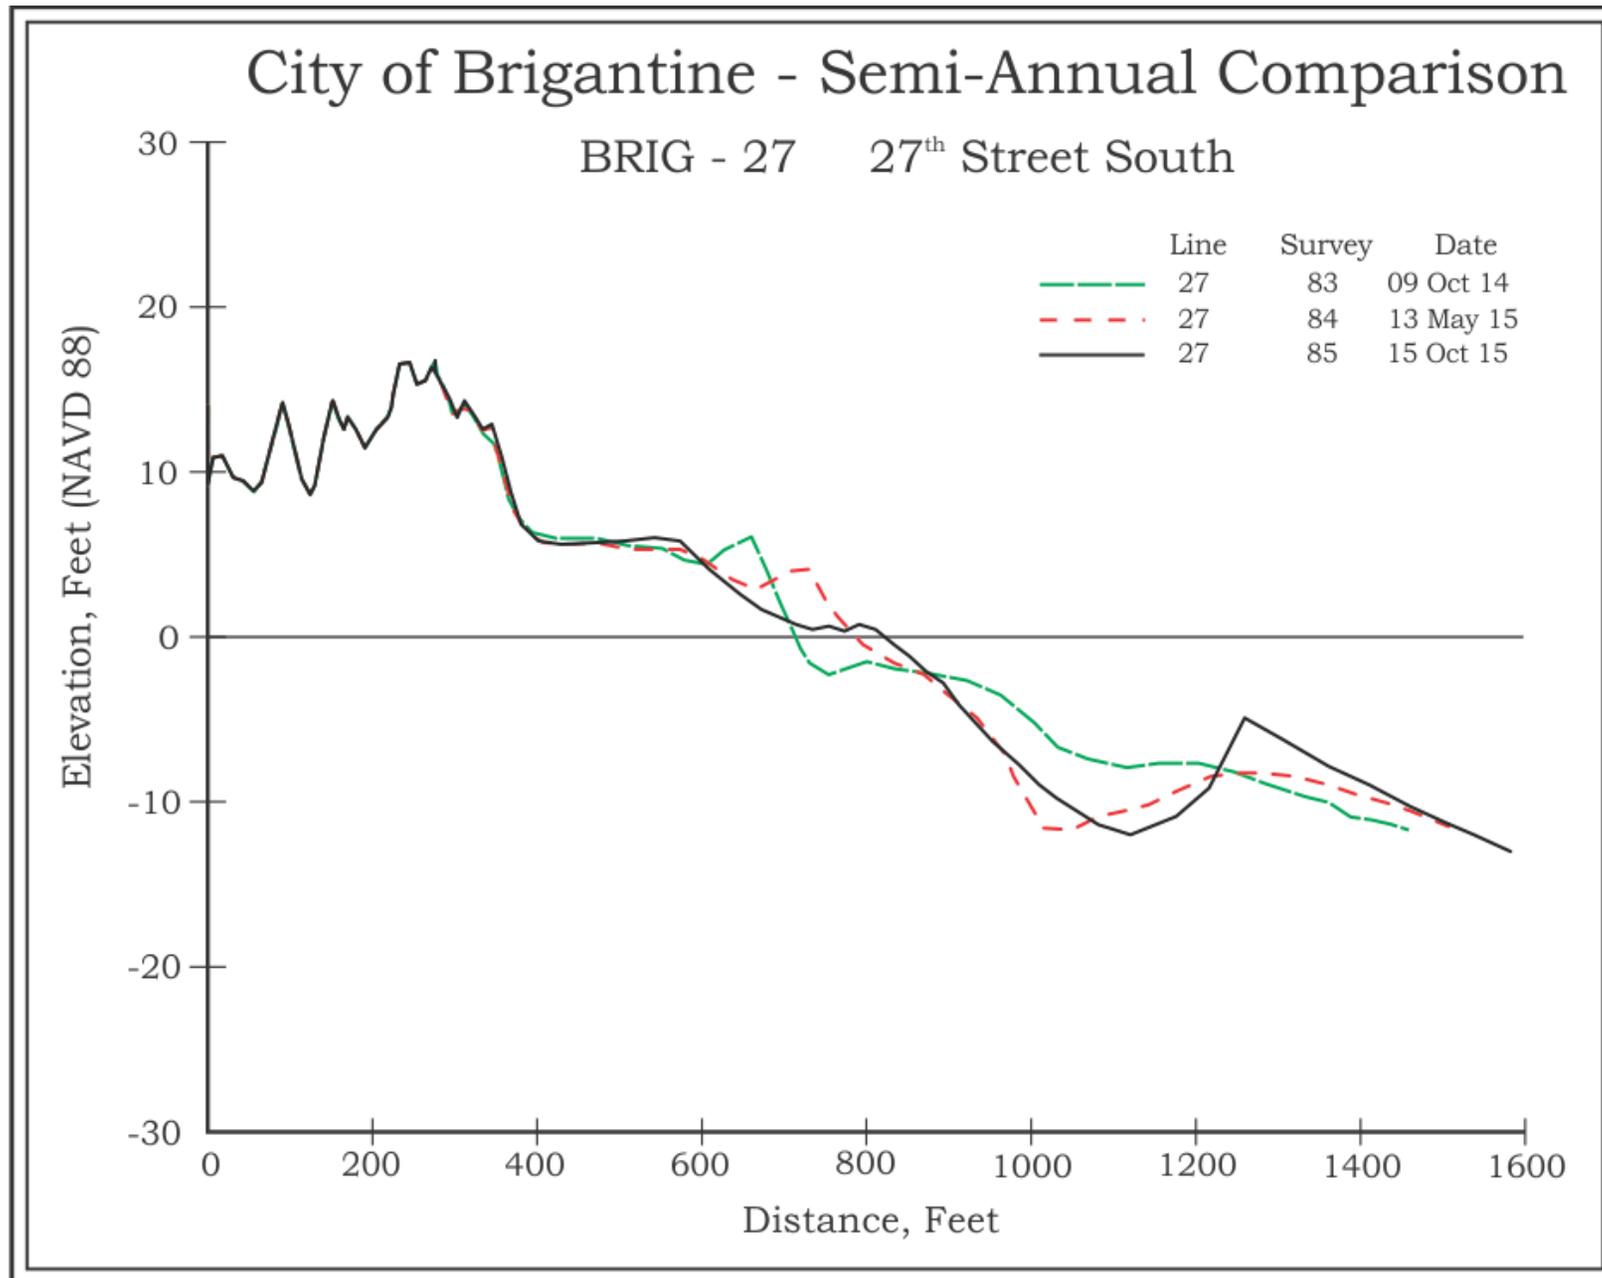
Figure 22 - The three cross sections above show the changes at 27th Street South from October 2014 to October 2015. As seen at the northern sites the beachface and beach berm crest again eroded through 2015. Nearshore a deep scour trough was cut and offshore a larger bar developed, partially offsetting onshore losses. The annual change for 2015 was a net volume loss of -11.50 yds³/ft. of sand but sand pulled from the upper beachface to the lower beachface advanced the shoreline position 108 feet despite a retreat in the recreational beach berm width.

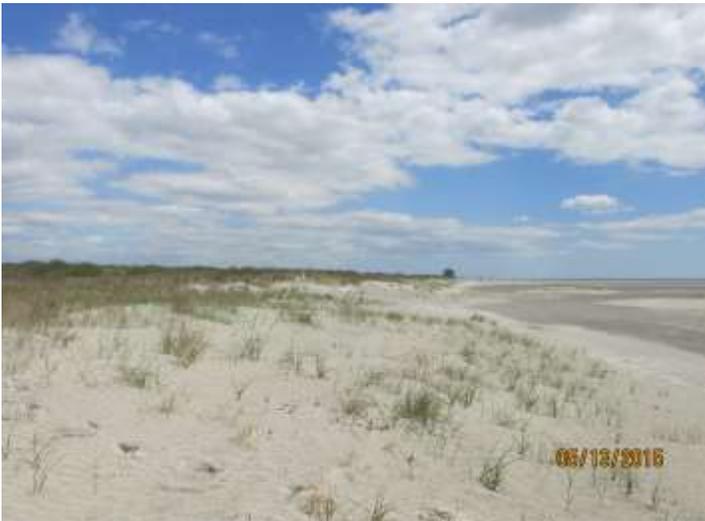
Figure 8a photo was taken looking north on May 13, 2015. The berm is extremely wide at this location and supports continued aeolian expansion of the dune onto the upper beach.

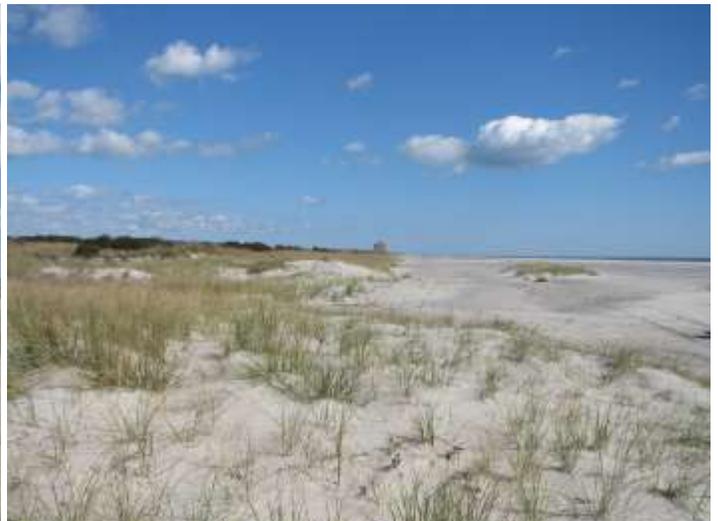
Figure 8b photo was taken looking north on October 15, 2016. The new foredune ridge was colonized by grasses and there is evidence of development of a new foredune seaward of the current toe position but no storm damage.

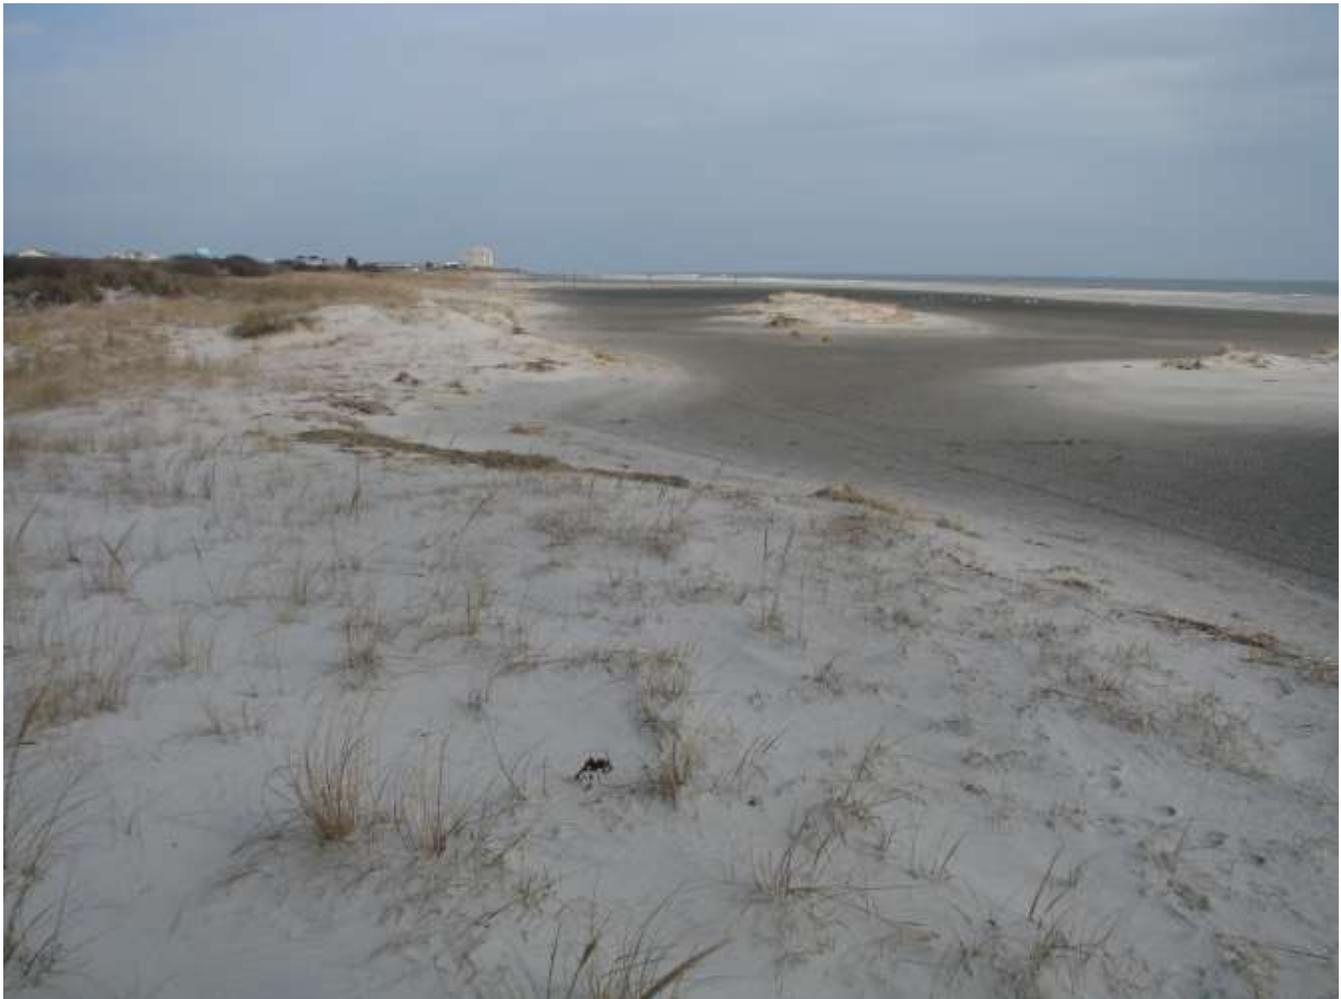
Figures 8c this picture was taken on January 29, 2016 following winter storm Jonas. There is wrack debris and the darker sand is evidence storm wave runup reached the seaward dune toe and caused berm top ponding around the dune hummocks that developed in 2015. There is no visual evidence that Jonas caused any significant beach erosion to the nearly 600-foot wide recreational beach berm.

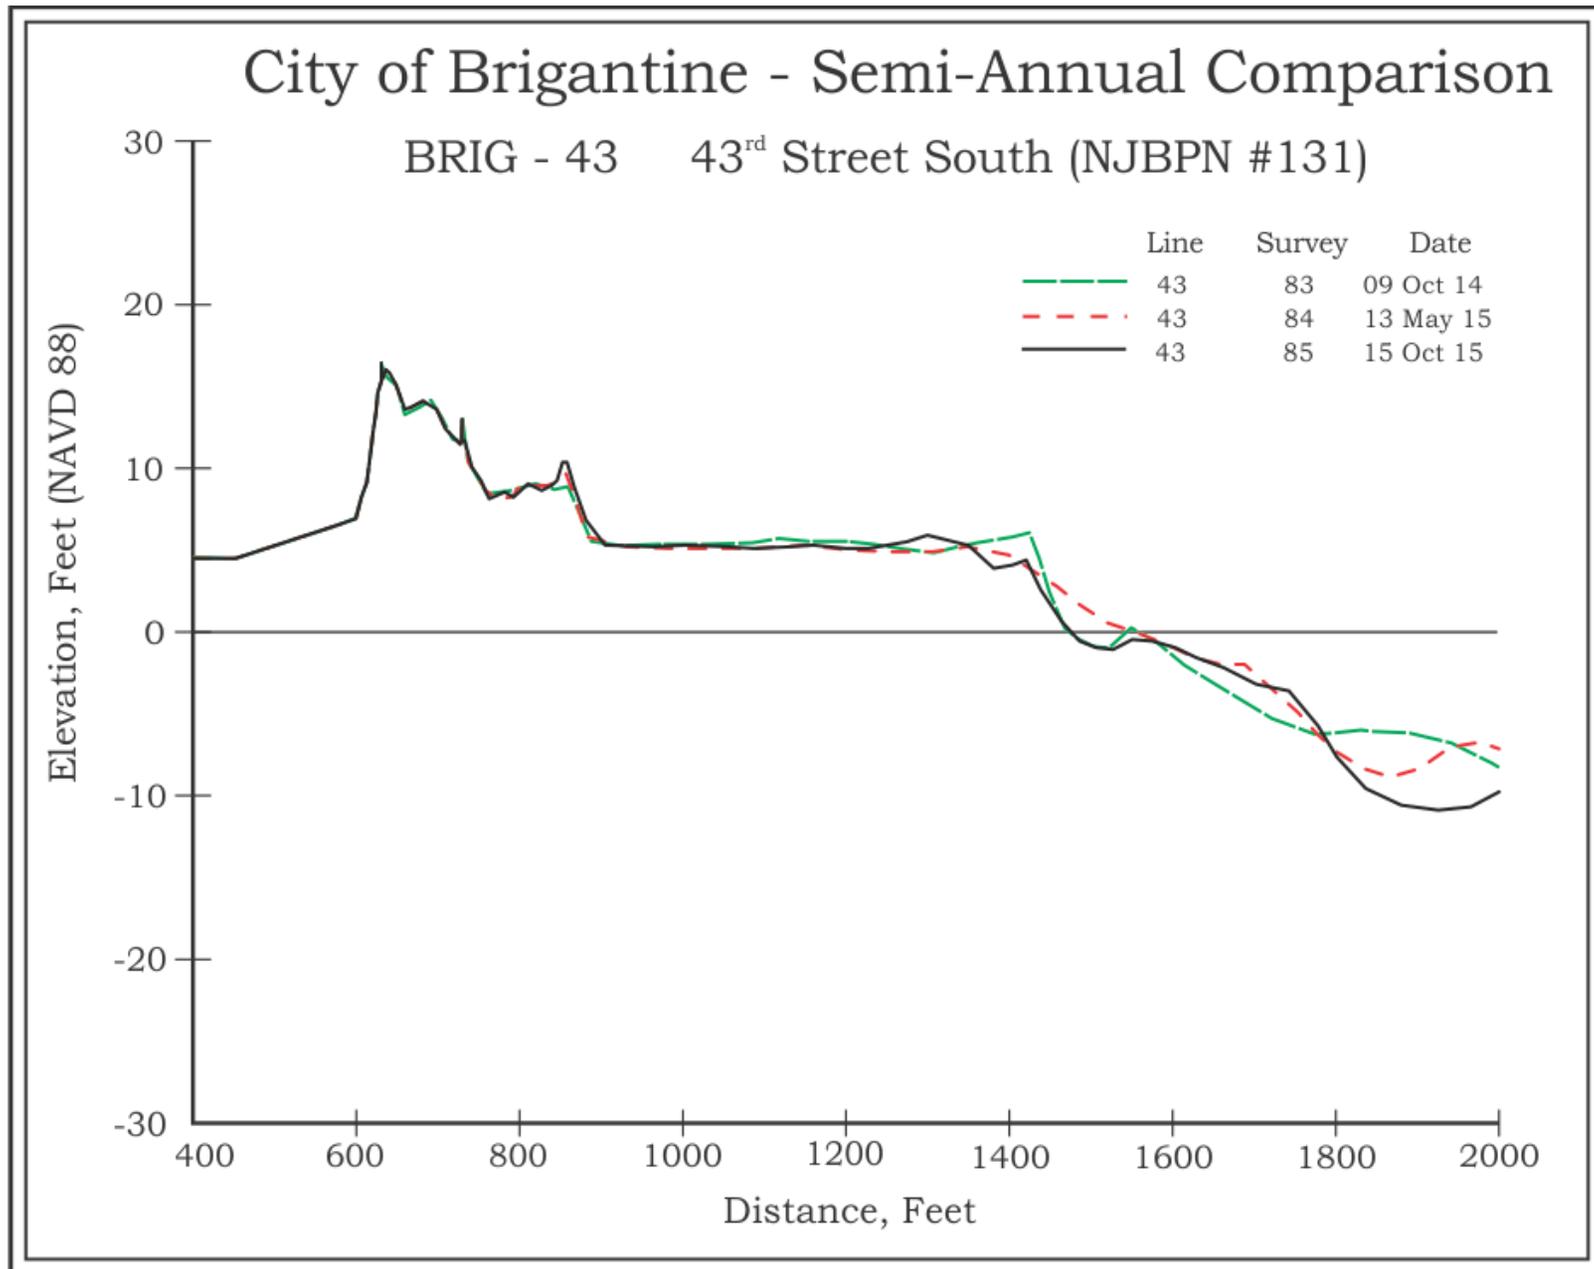
Figure 24 – This site has demonstrated significant and sustainable sand accumulation resulting in massive growth of the dune and beach width since monitoring began here 3 decades ago. The three cross sections above show a steady but modest accumulation of sand on the seaward dune slope and new developing foredune crest. In contrast to the northern locations the 43rd Street recreational beach berm width remained relatively stable. Wave scour at the shoreline position cut a shallow trough that resulted in a shoreline position retreat of 82 feet over 2015. The net volume gain was 6.35 yds³/ft. of additional sand.

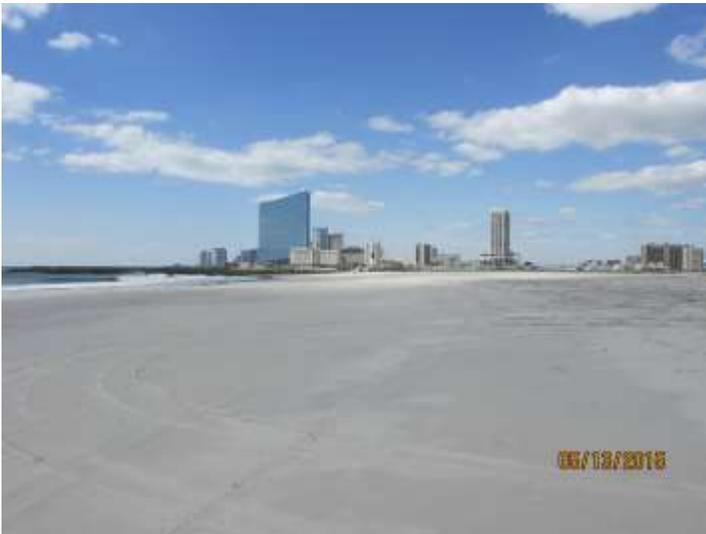
Figure 9a photo was taken looking south on May 13, 2015. The beach width had expanded sand recovered naturally at this site through late 2014 into 2015. Note the position of the Absecon Lighthouse in the distance.

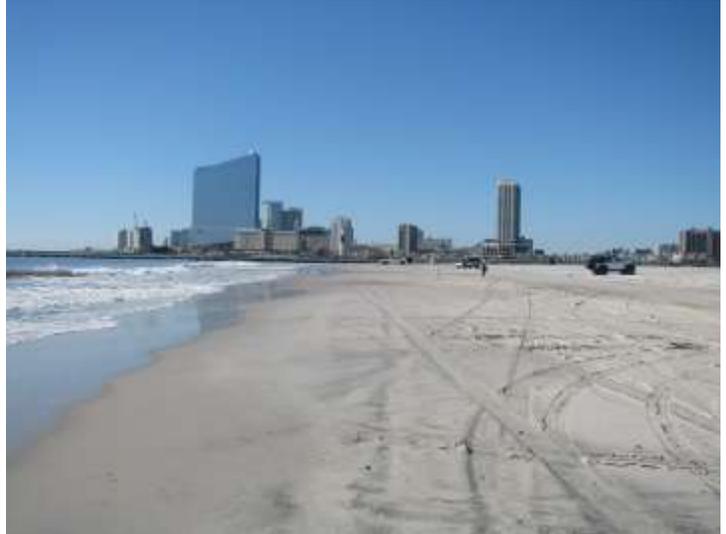
Figure 9b photo from October 15, 2015 after the first in a series of El Nino year northeast storm events. The wide beach protected the dune system from erosion with little net impact to the beach configuration

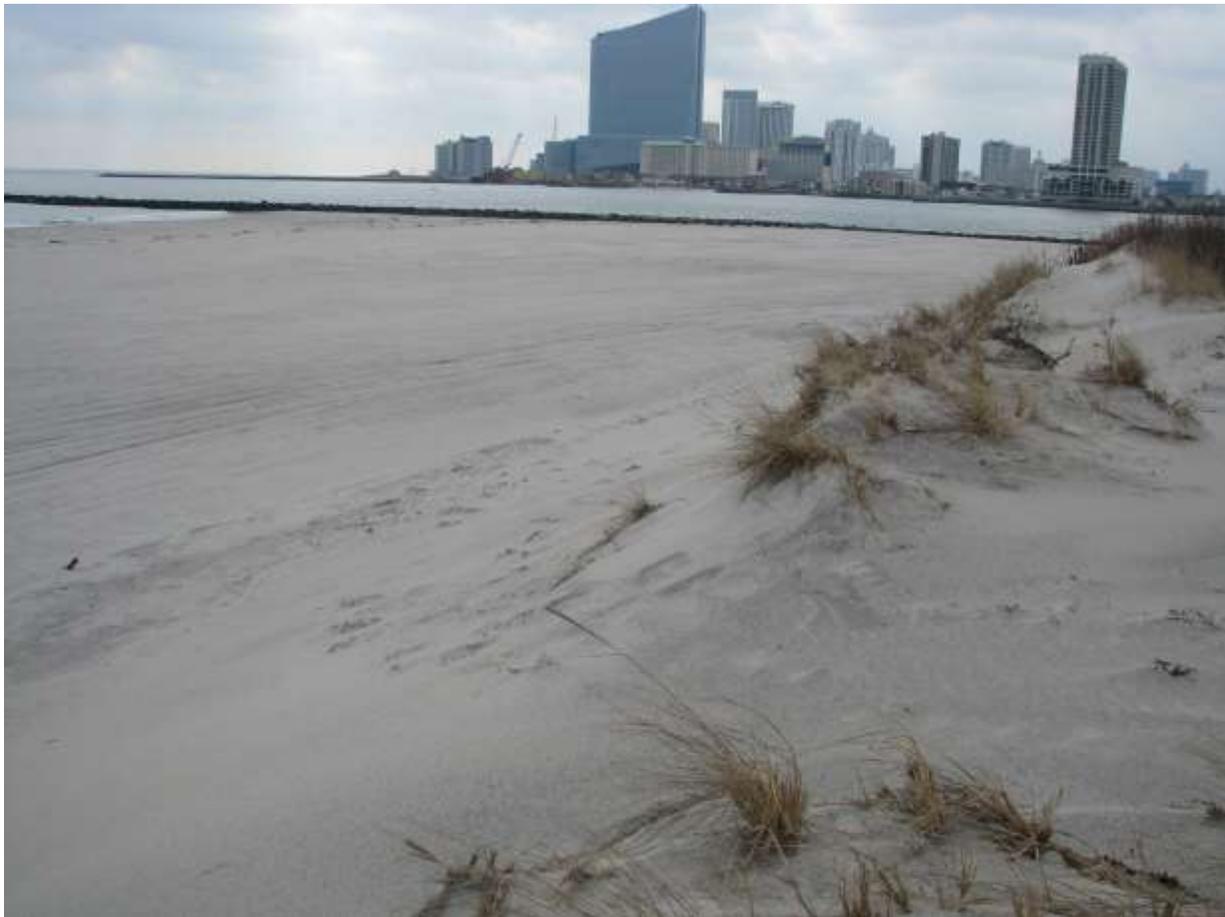
Figure 9c was taken January 29, 2016 after Jonas looking south towards Atlantic City in background. The beach remains in nearly the same configuration following Jonas with no evidence of the storm waves impacting the seaward dune toe in this location.

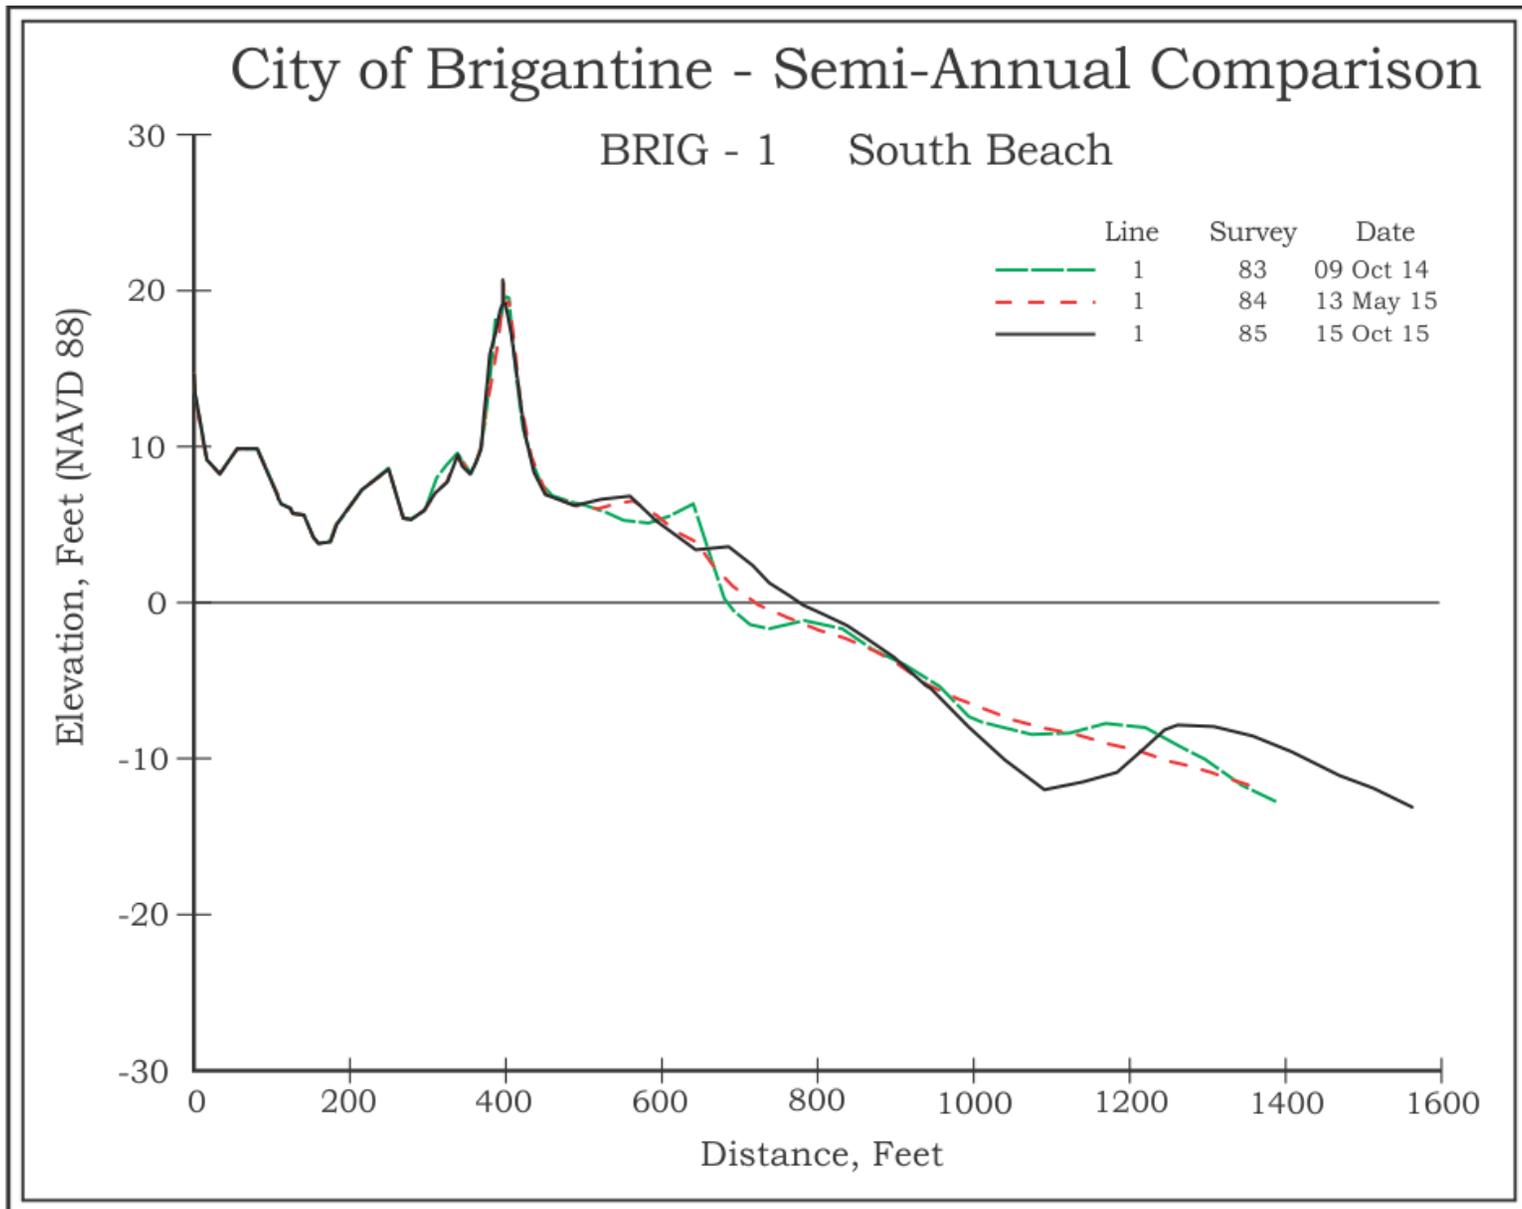
Figure 26 - The three cross sections above show the activity at the South Beach site in 2015. The dune system remained relatively stable although the primary frontal dune ridge remains extremely narrow. This location gained sand steadily over the course of 2014 into 2015. On the upper beach berm sand accumulated and additional sand continued to push onshore advancing the shoreline position seaward. By fall 2015 a large bar and trough system had developed. The net annual volume change (October 2014-October 2015) shows that the shoreline advanced 93 feet seaward while 2.29 yds³/ft. of sand was added across the site from the dune toe to the offshore bar. More sand was deposited near and beyond the profile limits not included in this analysis total.

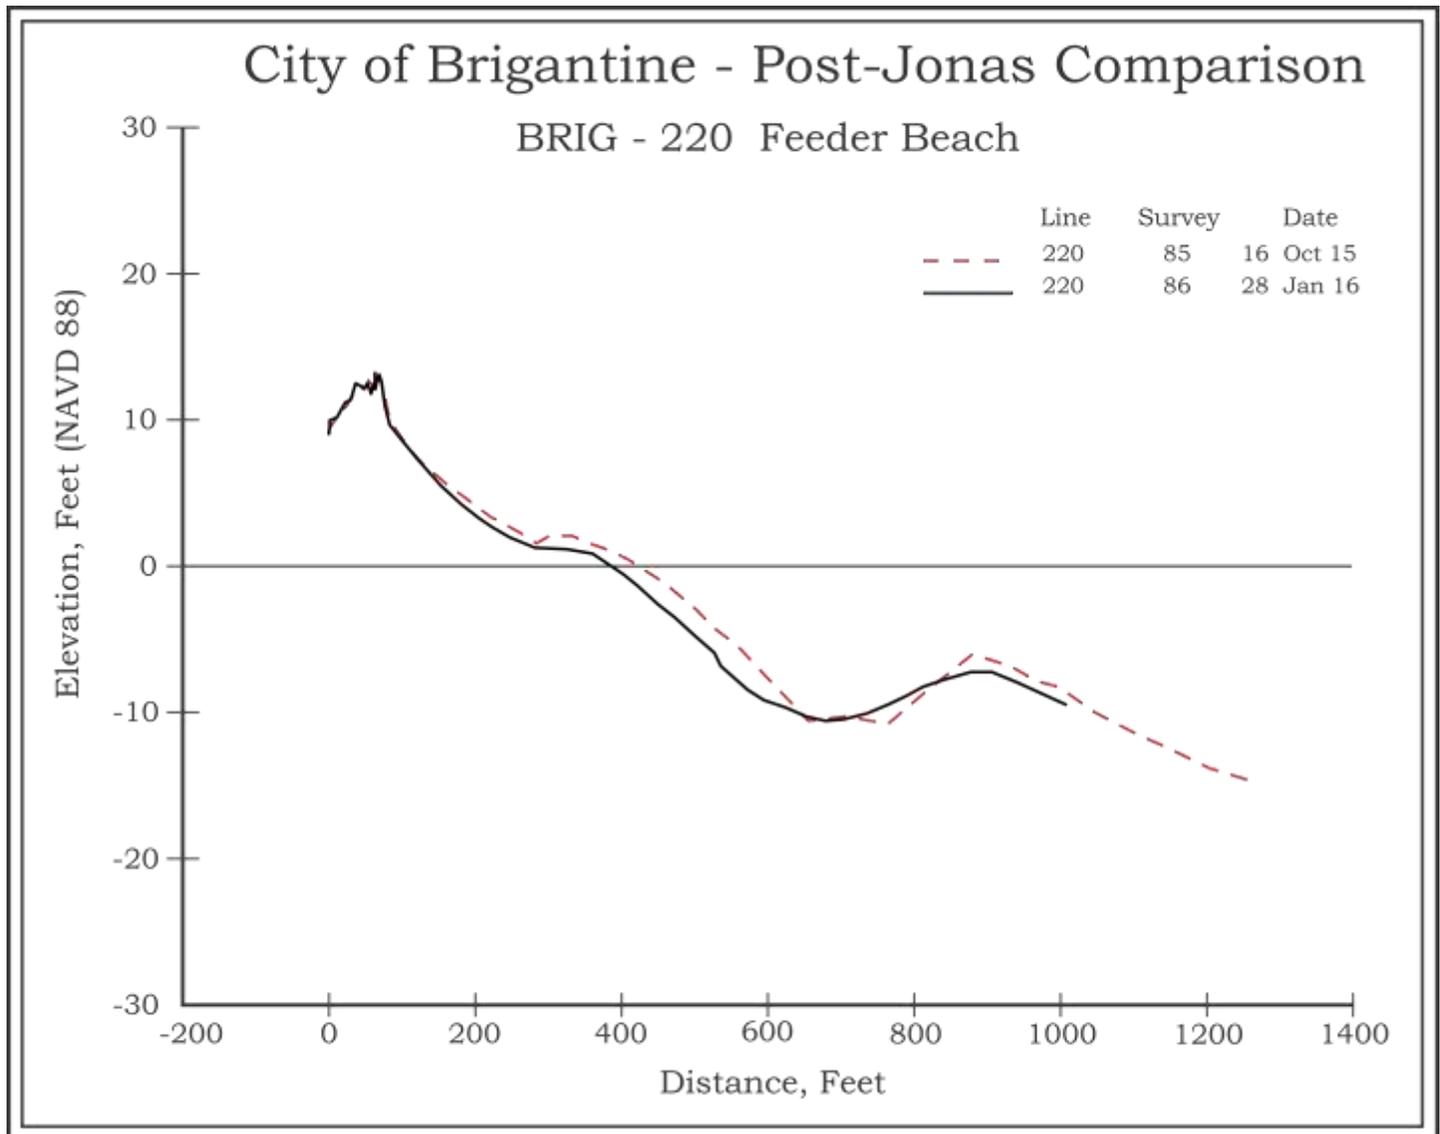
- **Profile Brig-220: Feeder Beach - Line 00+1200**

Figure 27 – By the end of 2015 the “feeder beach” configuration had been flattened by the early October 2015 northeast event. The wide recreational beach berm following the 2013 nourishment was completely eroded through 2015 and the sand volume that fed the downdrift beaches was depleted. Winter storm Jonas further eroded the beachface and nearshore, no cross-shore transfer of sand was evident resulting in a net loss to the site. Shoreline position at this location retreated landward 37 feet with a loss of -24.17 yds³/ft. of sand. The dune system remained intact as the remaining beach absorbed most of the storm surge and wave energy. Jonas has further reduced this regions capability to supply sufficient sand to stabilize downdrift beaches in the chronic erosion area. A major influx of sand and or nourishment will be needed for this region to continue to act as a “feeder beach”.

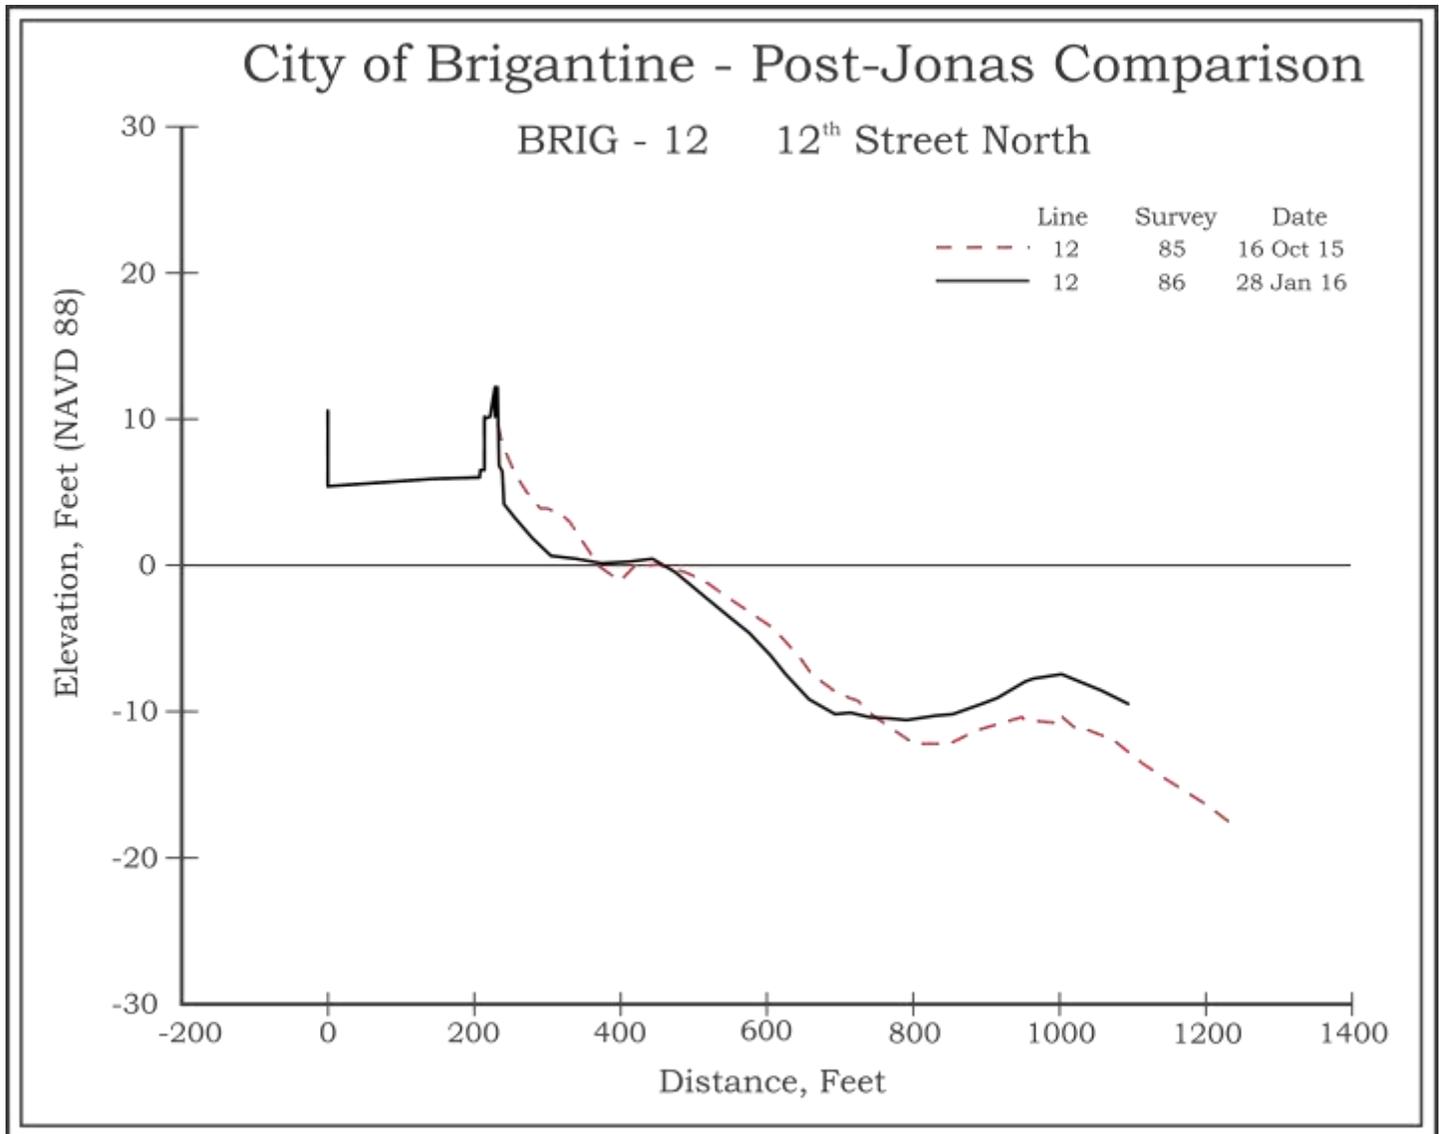
- Profile Brig-12: 12th Street North

Figure 28 – Throughout 2015 this chronic erosional beach had rapidly lost sand and by the end of 2015 the sand volume had decreased by a massive 92.42 yds³/ft. of sand. This onshore and offshore sand loss diminished the beach width and elevation increasing the regions storm vulnerability. Jonas storm surge and waves removed the remaining beach berm cutting the beach landward to the revetment. Refracted wave energy during the storm scoured the remaining beach exposing the rocks along the promenade. Onshore the site lost another 12.22 yds³/ft. of sand. A storm wave also scoured the nearshore slope removing an additional 14.08 yds³/ft. of sand but unlike the beach to the north sand was transferred offshore at this location forming a shore parallel bar with. The offshore deposition of 28 yds³/ft. of sand offset the onshore and nearshore losses resulting in a minor net gain of 3.95 yds³/ft. of sand at this site despite these onshore and nearshore erosion. The minor net gain indicates a modest influx of sand was still moving south from the “feeder beach” to this region during Jonas. However, with both the “feeder beach” and chronic erosion regions now depleted of sand it is extremely likely that accelerated erosion along the promenade revetment will increase the erosion rate towards the south along the remaining engineered beach. Efforts to nourish this region should be made to reduce the impact to the downdrift beaches.
