**FINAL REPORT FOR 2015
ON THE CONDITION OF THE MUNICIPAL BEACHES
IN
THE CITY OF BRIGANTINE BEACH, ATLANTIC COUNTY, NEW JERSEY**

**PREPARED BY: THE STOCKTON UNIVERSITY COASTAL RESEARCH CENTER
30 WILSON AVENUE
PORT REPUBLIC, NEW JERSEY 08241**

May, 2016

Annual Report for 2015 to the City of Brigantine Beach on the Condition of Municipal Ocean Beaches

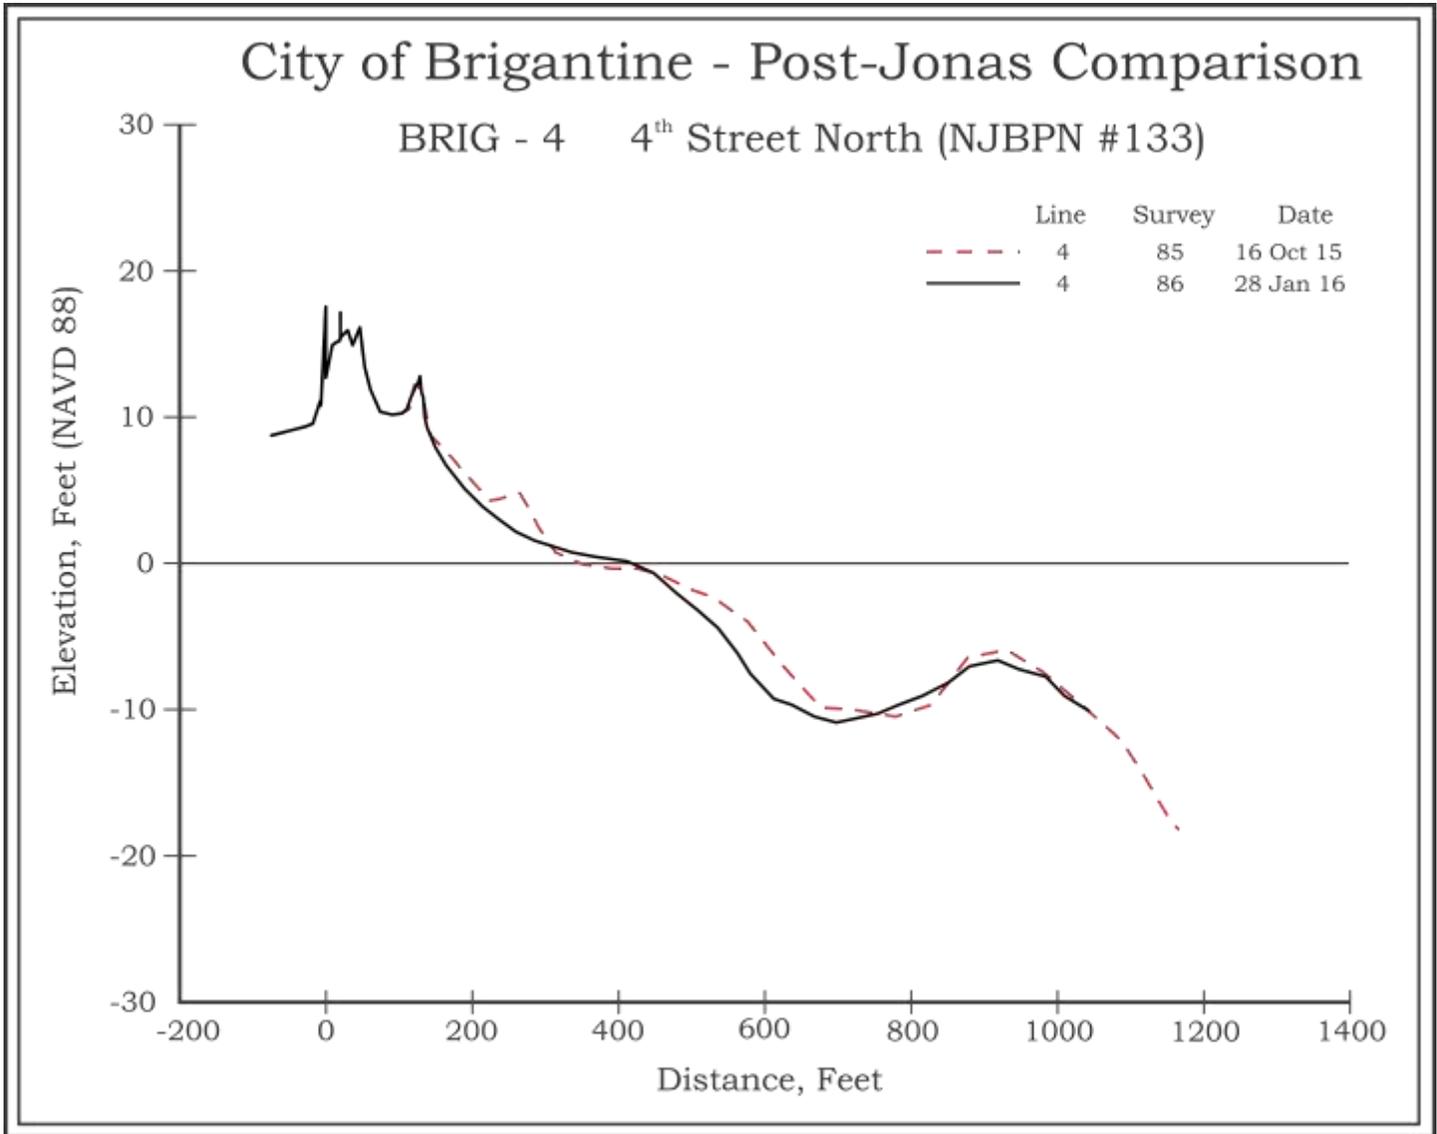
- Profile Brig-4: 4th Street North

Figure 29 – Although loss rates at 4th Street North were not as extreme as at 12th Street North this site did experience significant erosion throughout 2015 with a net loss of -29.88 yds³/ft. The beach berm width and elevation had been reduced following the October 2015 event leaving a modest beach berm to protect the dune system from winter storm events. Jonas’s storm surge and waves flattened the remaining berm and wave run up reached the toe of the developing foredune. Wave energy scoured the nearshore slope but there was little to no cross-shore transfer of sand evident at this location. As a result the net loss from Jonas was -24.05 yds³/ft. of sand. Although the dune system escaped erosion during Jonas the beach configuration leaves the foredune feature vulnerable to future events. With the feeder beaches to the north in a depleted condition the influx of sand to naturally restore this section of shoreline this spring will likely be derived from further erosion of the beaches seaward of the promenade as erosion progresses south along the rock revetment. In the absence of nourishment this sites dune system will likely remain susceptible in 2016 to future storm impacts.

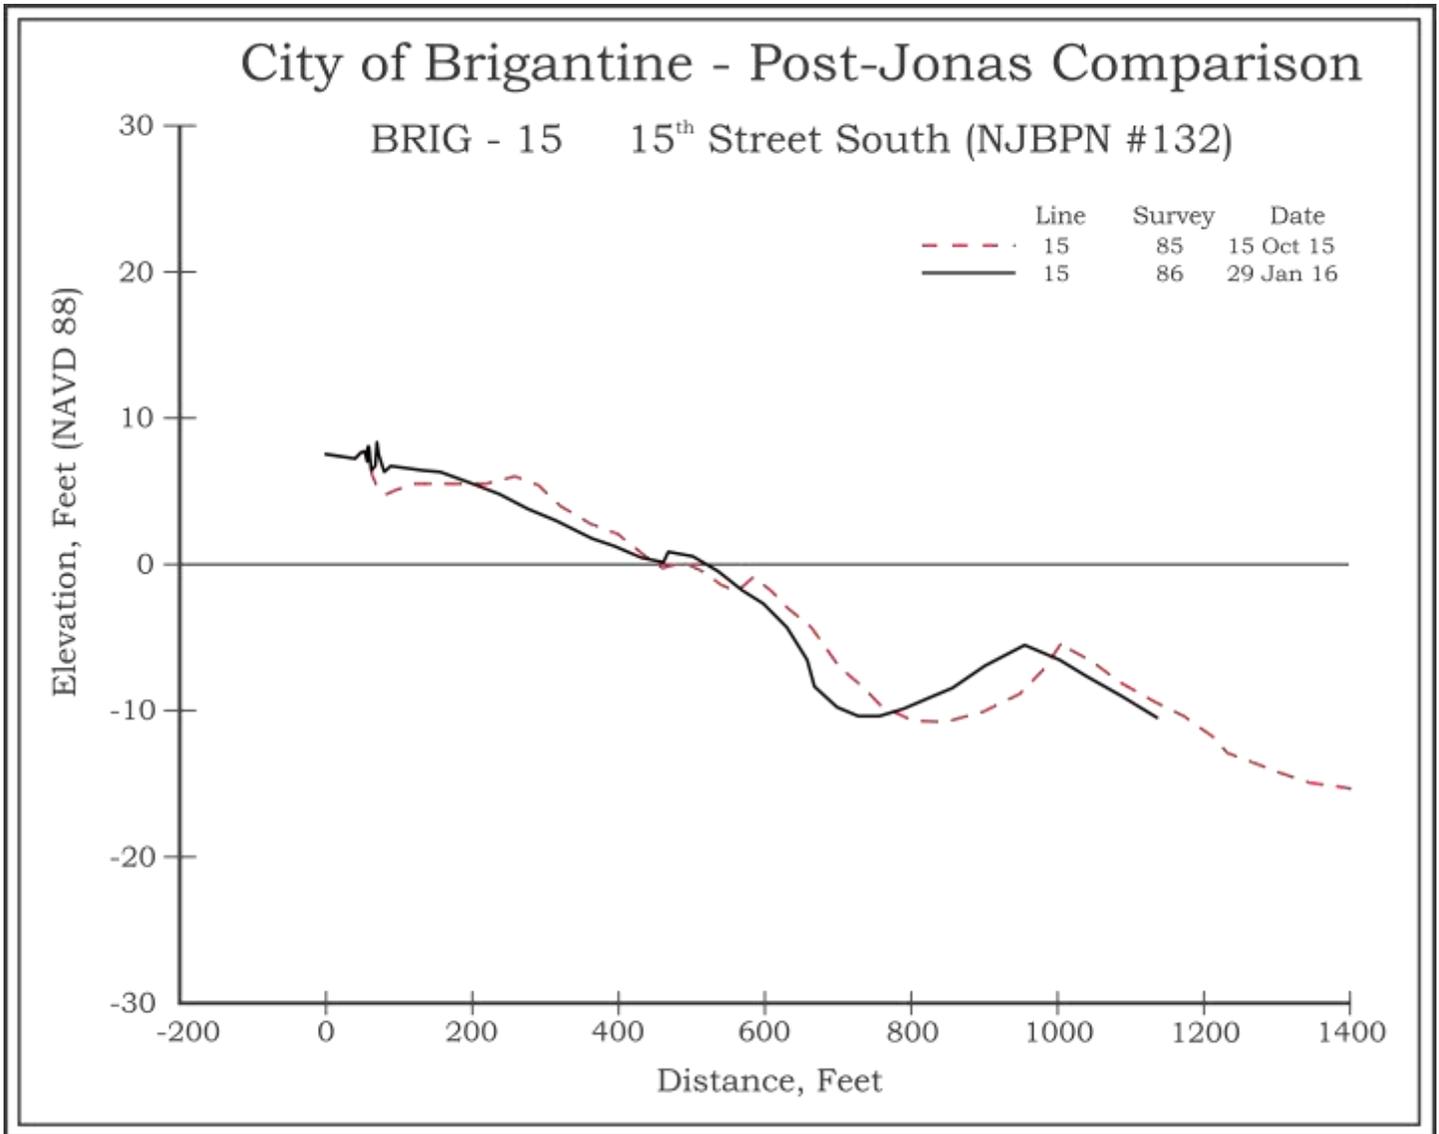
- Profile Brig-15: 15th Street South

Figure 31- Following the early October 2015 northeast event the beach was flattened as the beachface slope was pushed landward. During 2015, the site at 15th Street South had lost -20.98 yds³/ft. of sand with 44 feet of landward retreat in the shoreline position. Jonas’s storm surge and wave energy further flattened the berm and pushed the beachface slope further landward. Sand was pushed higher onto the beach accumulating along the street end revetment. The nearshore slope was scoured but some sand accumulated offshore moving the shore parallel bar position landward approximately 100 feet. Sand accumulation offshore and along the street end bulkhead reduced the net volume loss to -4.37 yds³/ft. The net onshore change in volume was -2.81 yds³/ft. of sand as material moved landward and seaward, offshore changes were minor -1.56 yds³/ft. of sand with material carried cross-shore in a seaward direction.

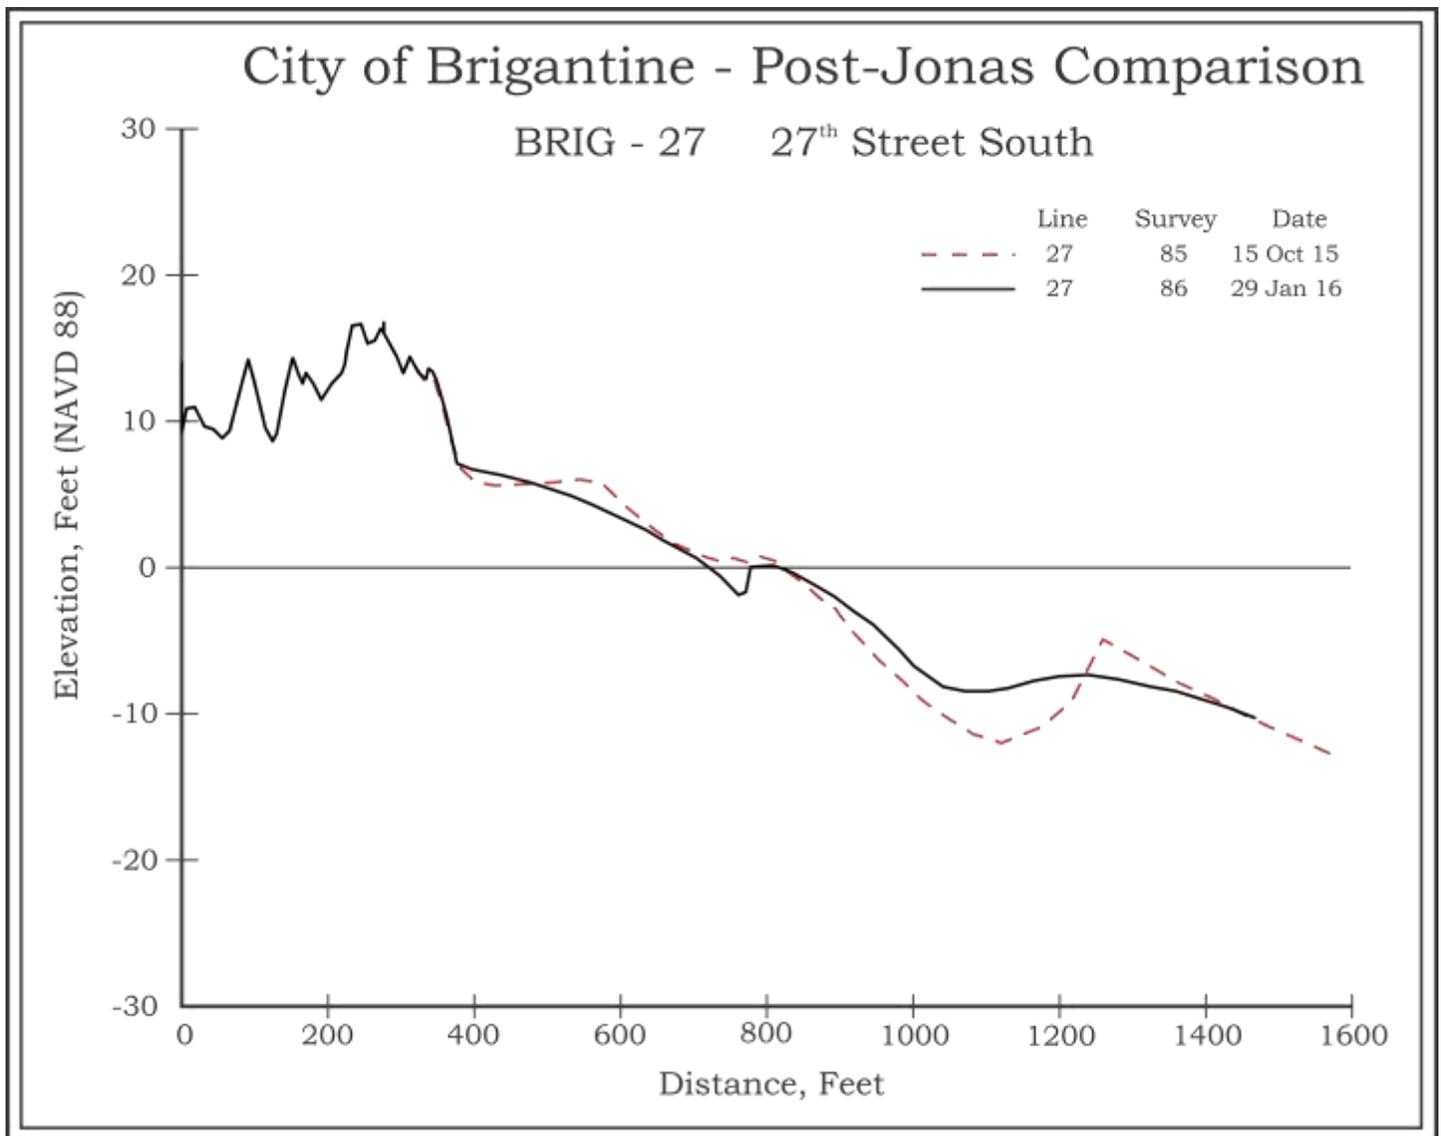
- Profile Brig-27: 27th Street South

Figure 32 - The 27th Street South site demonstrated a more resilient nature through 2015 with more modest changes to the beach and nearshore. Net sand volume losses here for 2015 was -11.50 yds³/ft. of sand while the shoreline position advanced seaward 108 feet. This site typically falls within the accretive transition zone between erosion towards the north and accumulation along the southern shoreline driven by predominant longshore currents. Following Jonas this site showed a net gain of 14.88 yds³/ft. of sand. The beachface slope was flattened, the berm elevation reduced with modest scouring at the shoreline position. Wave runup moved sand landward to the seaward dune toe but the seaward dune slope remained stable. A significant wedge of sand accumulated along the nearshore slope seaward through the trough. This sand appears to largely have been transferred to this site through longshore currents resulting in the net gain following Jonas. Natural recovery and expansion of this beach will likely continue as sand feeds into this region from north to south.

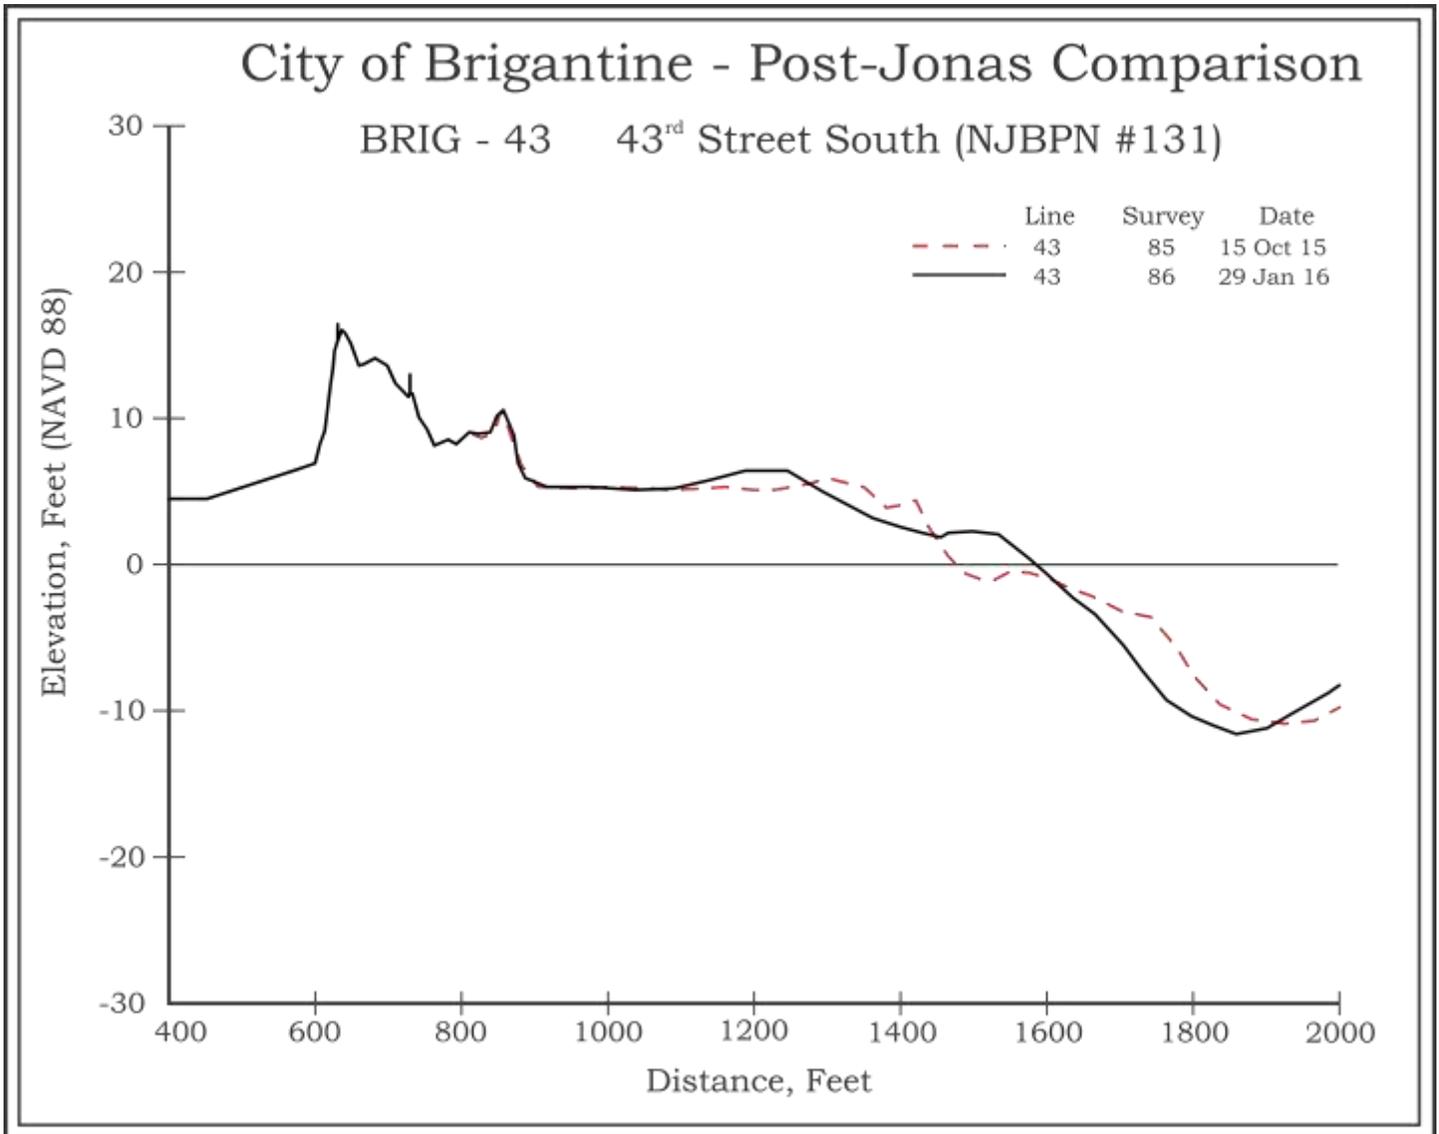
- Profile Brig-43: 43rd Street South

Figure 33 - Thirty years of monitoring at 43rd Street has shown this region to be remarkably resilient able to sustain near continuous growth in beach and dune width. There is currently over 1500 feet of beach and dune width between the shoreline and development. This site has sustained growth while the northend has suffered chronic erosion. The impact of storm events is marginalized by the nearly 700 feet of beach width that absorbs storm surge and wave energy even during Sandy there was only modest erosion of the seaward dune slope. In contrast to the northern beaches 43rd Street continued to gain sand adding 6.35 yds³/ft. of sand to the beach during 2015, reversing the erosional trend seen from 27th Street north. Jonas storm surge and wave energy was absorbed on the beachface and beach berm. Sand was pushed landward elevating the beach berm and cross-shore to the lower beachface slope. The sand added to the lower beachface slope extended the shoreline position seaward 110 feet. Nearshore scouring removed sand from the nearshore slope with evidence of some limited seaward cross-shore movement. Following Jonas this site showed a net loss of -13.76 yds³/ft. of sand indicating a predominant longshore component to sand movement during the storm event. With this sites remarkable history of sand accumulation it is very likely that this site will quickly recover from these recent storm losses through natural processes.

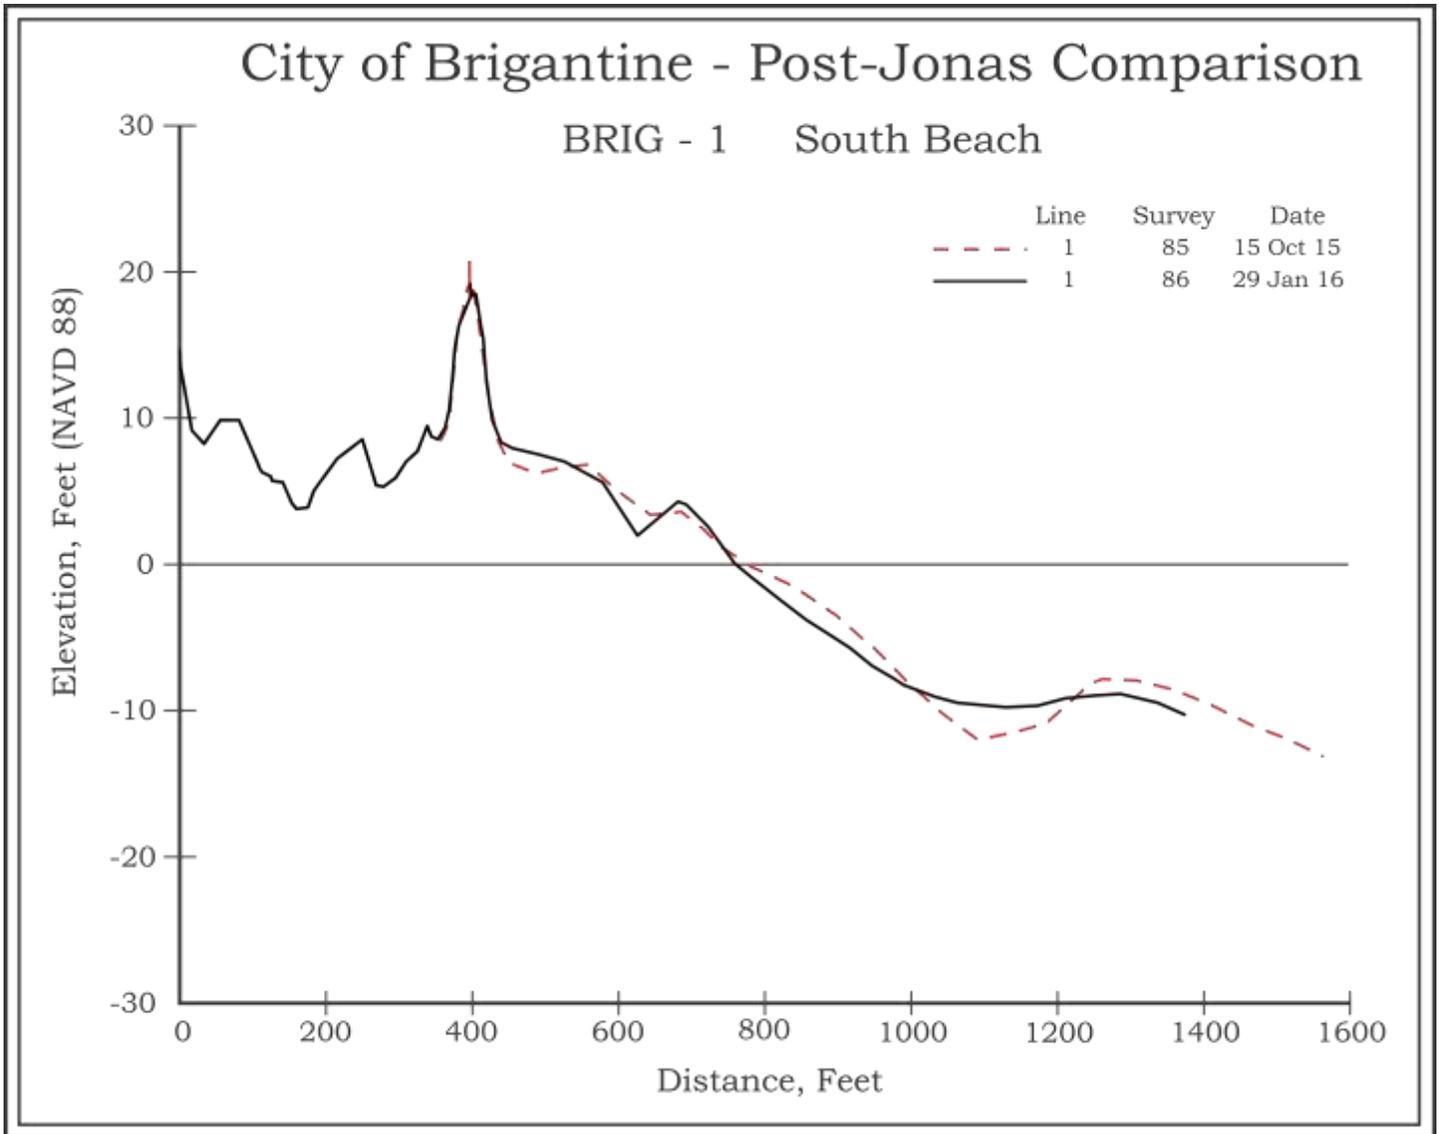
- Profile Brig-1: South Beach

Figure 34- The south beach site at the Absecon Jetty was relatively stable through 2015 showing a minor volume gain of 2.29 yds³/ft. of sand while the shoreline position moved seaward 93 feet. There was a 100 foot-wide elevated recreational beach berm seaward of the dune toe following the October 2015 northeast event that provided storm protection for the dune system. Winter storm Jonas scoured a second lower tier berm into the beachface slope and pushed sand landward to the seaward toe of the dune. No wave scarping occurred at the dune toe indicating most of the storm wave energy was absorbed by the beachface and berm. Nearshore scouring occurred on the slope with sand transferred seaward and re-deposited in the deep trough, the offshore bar elevation was reduced. The resulting net change following Jonas was a minor volume loss of -4.65 yds³/ft. of sand while the shoreline position retreated 17 feet landward. These storm losses are modest and will likely be naturally recovered as sand continues to move into this region from further north and seas return to conditions favorable for natural beach building processes to continue. Storm events like Jonas do help bypass sand from this oceanfront beach to the inlet shoreline. This processes has led to natural recovery of the Brigantine side of the Absecon Inlet shoreline following excavation of nearly 600,000 cubic yards of sand from the inlet borrow zone by the USACE in 2002-2003.

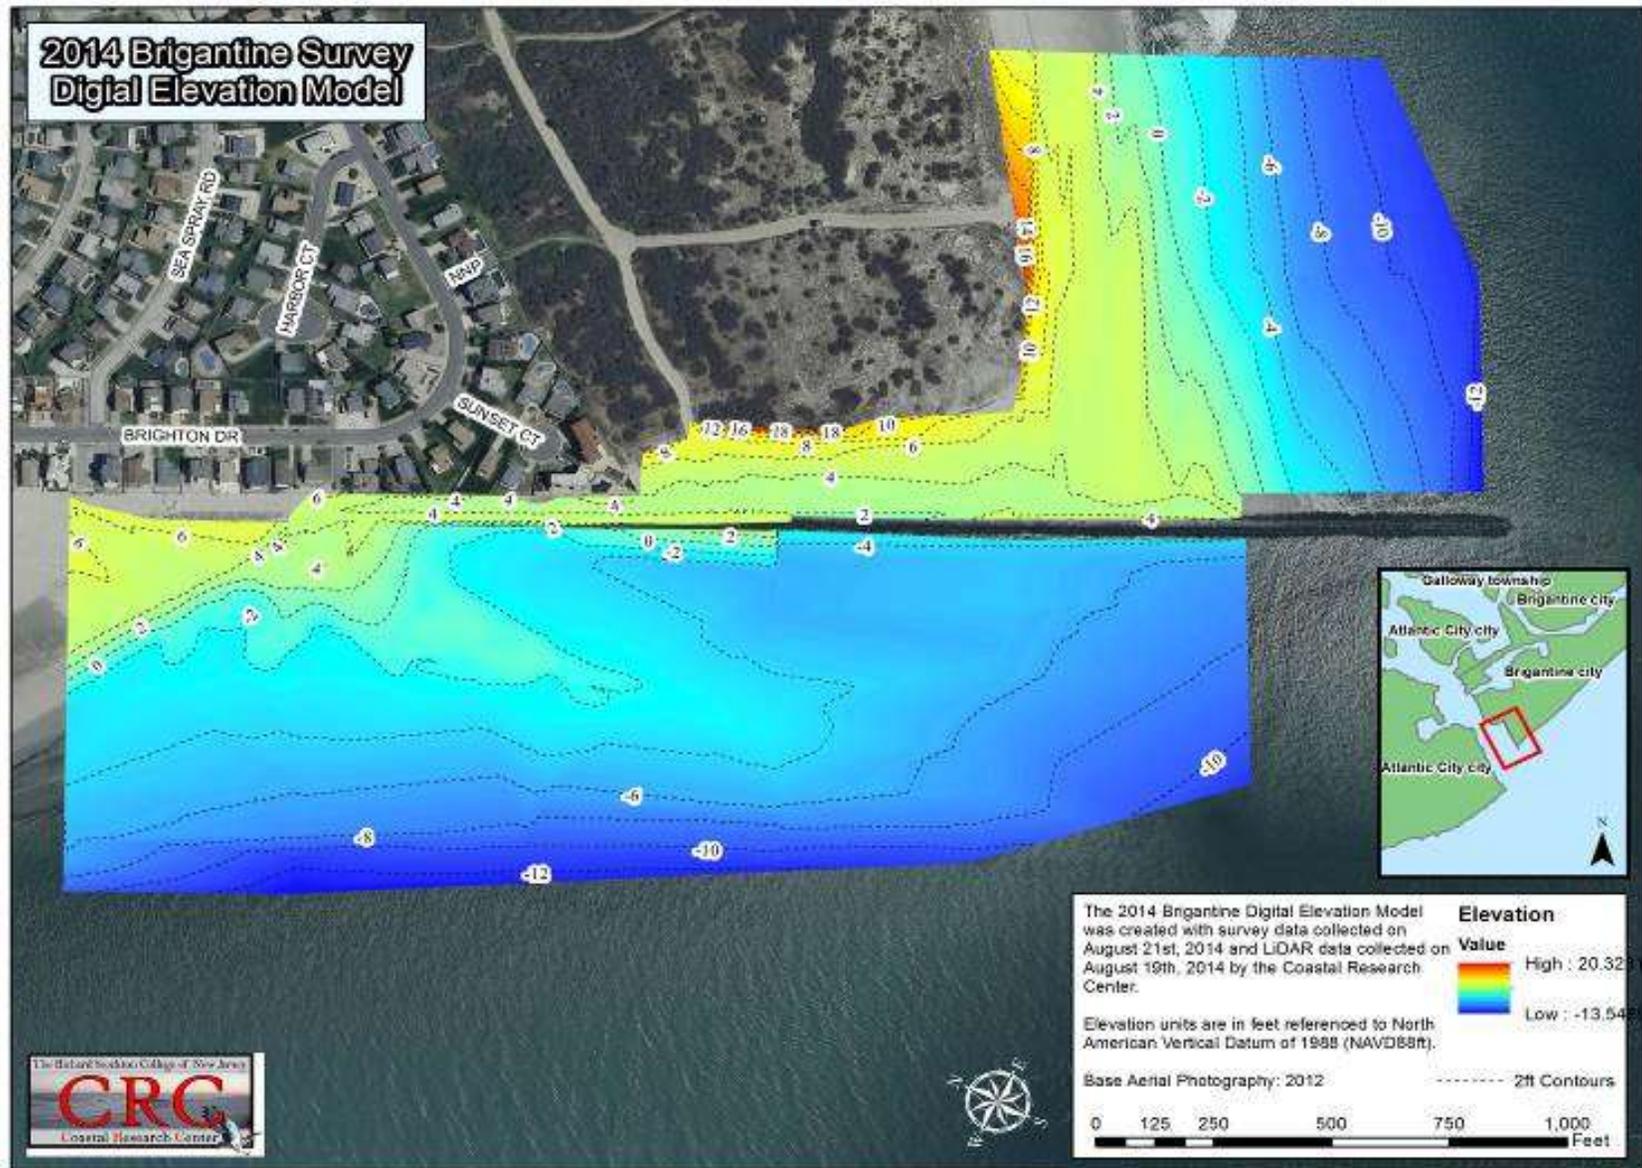
Figure 35 - Cooler blue colors represent lower elevations, and warmer yellow and red colors represent higher elevations. Contour intervals are at 2-foot intervals. Elevation units are in NAVD88. Much of the inlet beach surveyed is low lying and not much higher than 4 feet NAVD88. The ocean facing beach has a moderately sized beachface, backed by a large primary dune, giving way to a gradual downward slope.

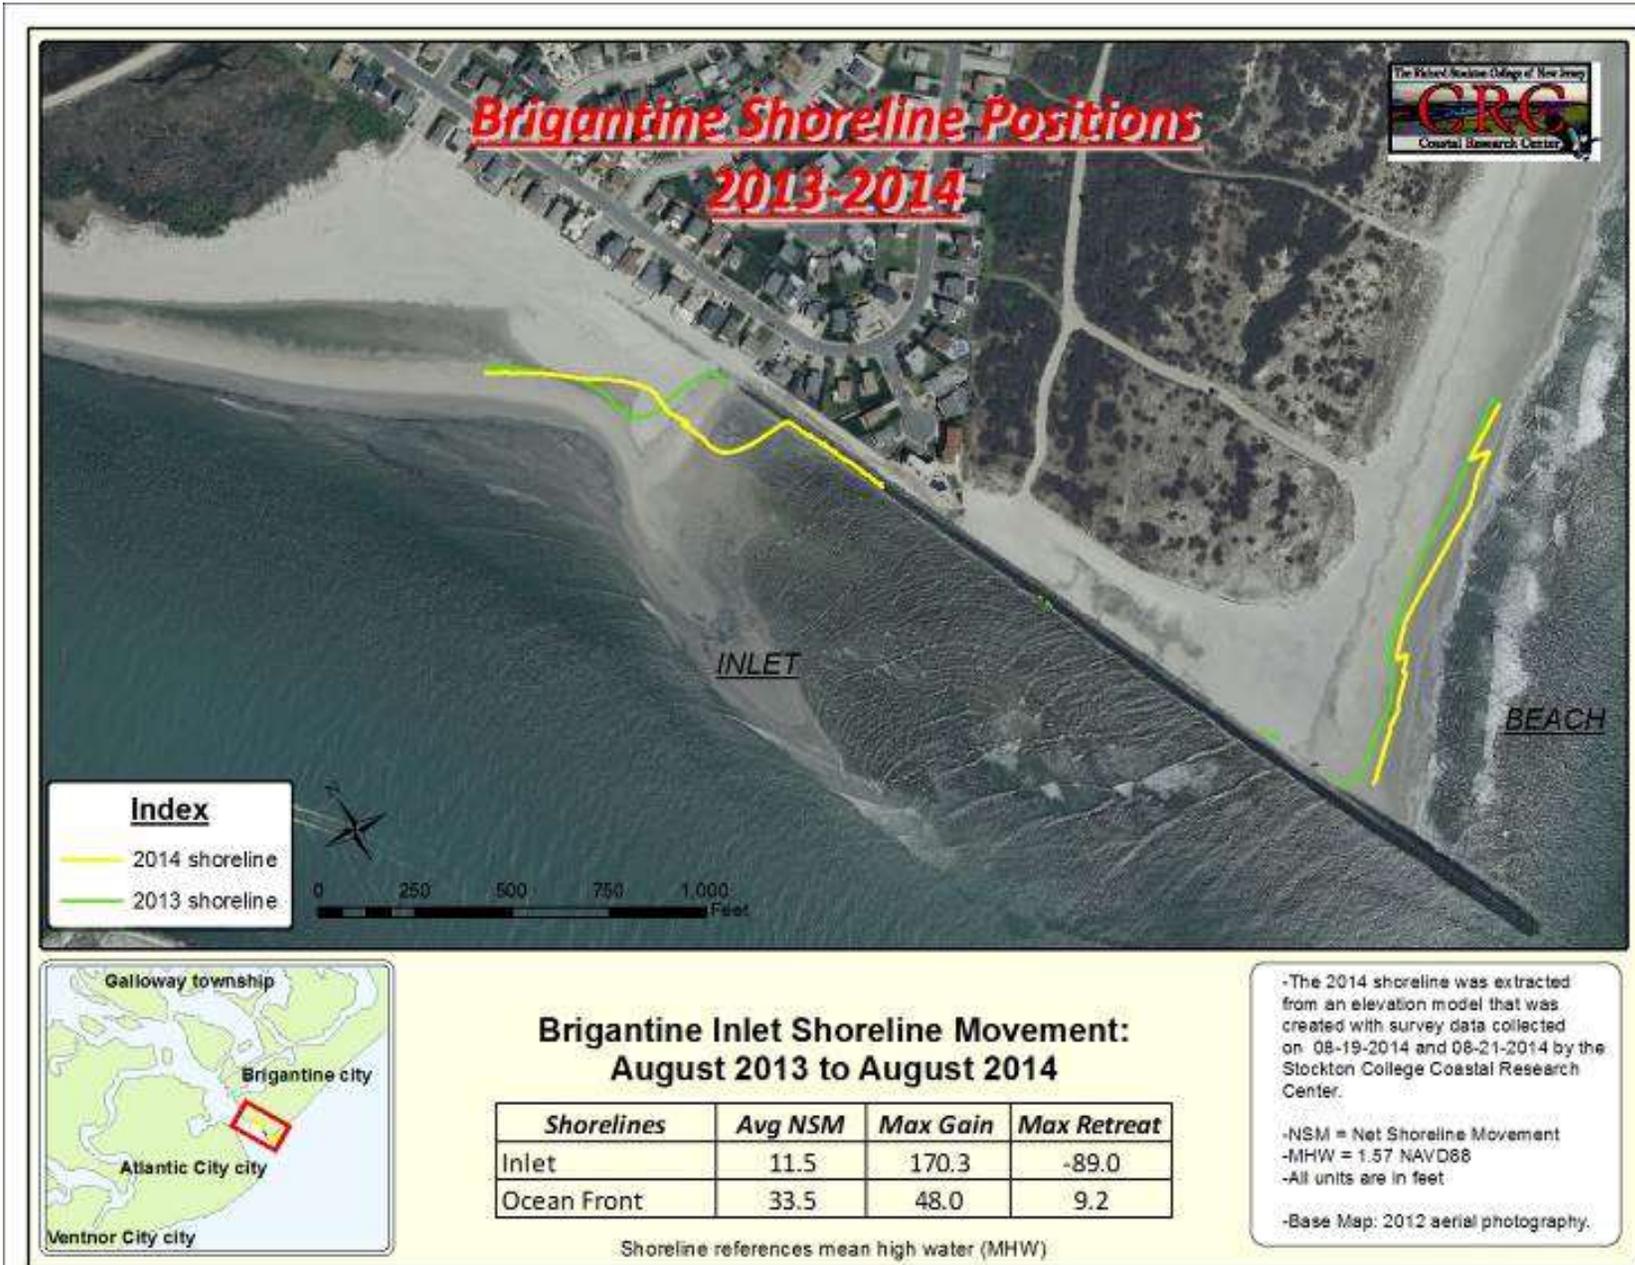
Figure 36 - Shoreline migration of Brigantine's beaches in the vicinity of Absecon Inlet where analyzed between 2013 and 2014. Shoreline positions are overlain on 2012 aerial photography. The average shoreline position advanced at both the inlet and ocean facing beaches over this study period.

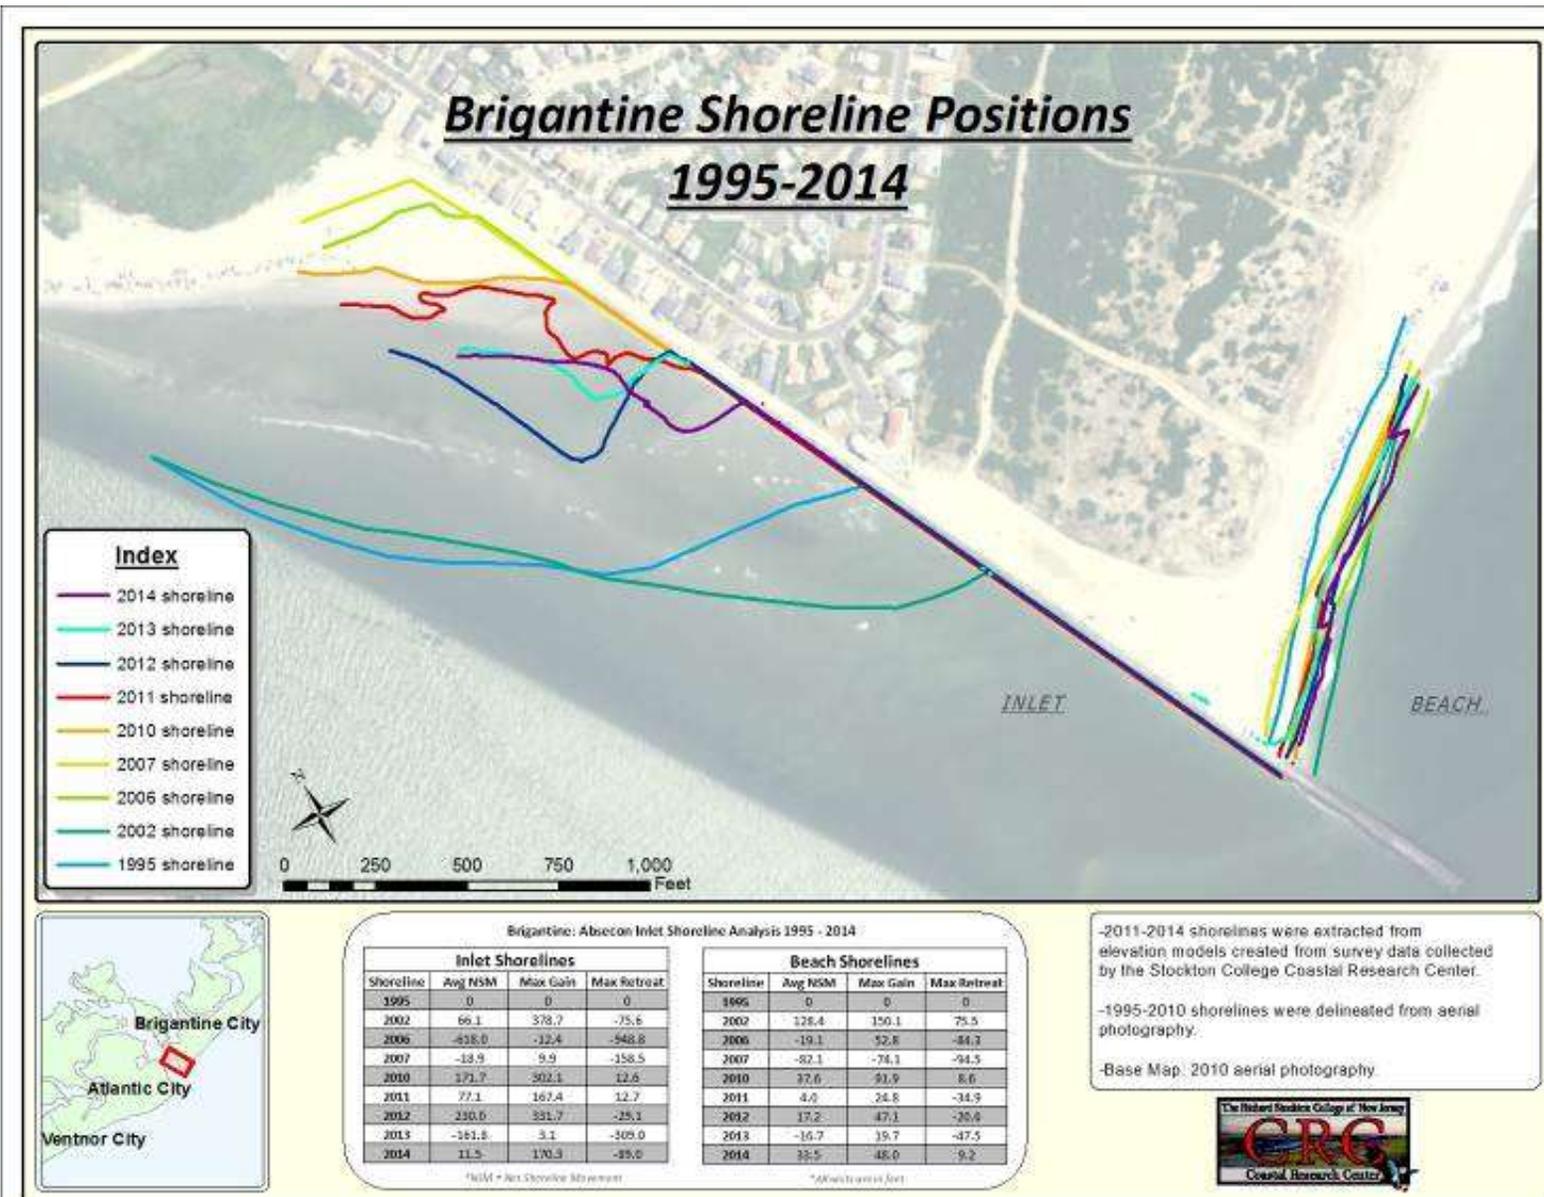
Figure 37 - Shoreline migration of Brigantine's beaches in the vicinity of Absecon Inlet where analyzed between 1995 and 2014. The pre-ACOE dredging shoreline of 1995 to 2002 reflects a maximum extent of sand on the inlet side of the jetty. By 2006 concerns for erosion flanking the western end of the jetty brought focus onto the problem. Since no further sand was extracted from the inlet borrow zone, the problem has moderated somewhat as oceanfront sand has moved around the jetty.
