**ANNUAL REVIEW FOR 2016
OF THE CAPE MAY POINT, NJ MUNICIPAL BEACHES**

PREPARED FOR: THE BOROUGH OF CAPE MAY POINT
215 LIGHTHOUSE AVENUE
CAPE MAY POINT, NJ 08212

PREPARED BY: STOCKTON UNIVERSITY COASTAL RESEARCH CENTER
30 WILSON AVENUE
PORT REPUBLIC, NJ 08241

June 19, 2016

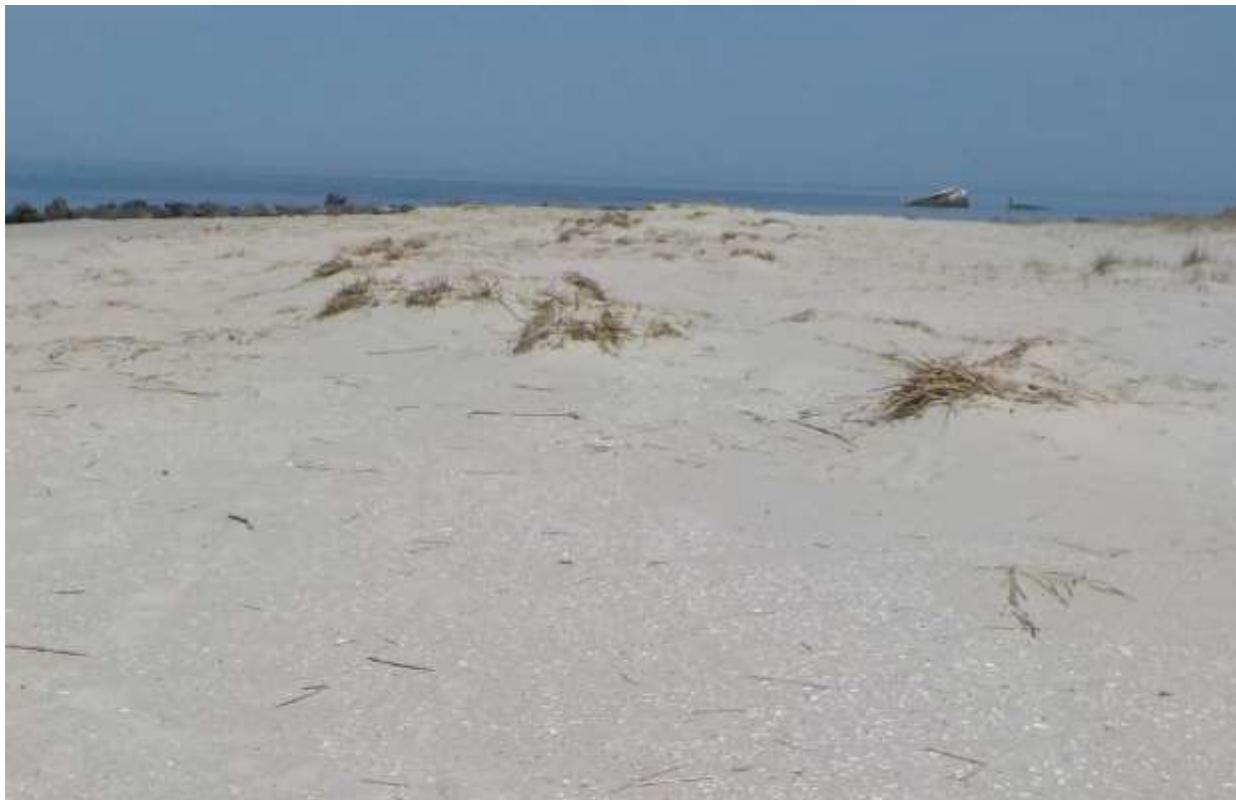
The Photo above taken on April 19, 2016 shows the existing offset conditions at the western end of the municipality between the beaches at Alexander Avenue in the foreground and Sunset Beach on the updrift side of the terminal rock groin. In the background the concrete shipwreck is visible that rests nearshore off Sunset Beach. Although the beach at Alexander Ave has benefited tremendously from sand influx shed from the updrift USACE project beaches, none of the material appears to continue west past the terminal groin at Alexander Avenue.

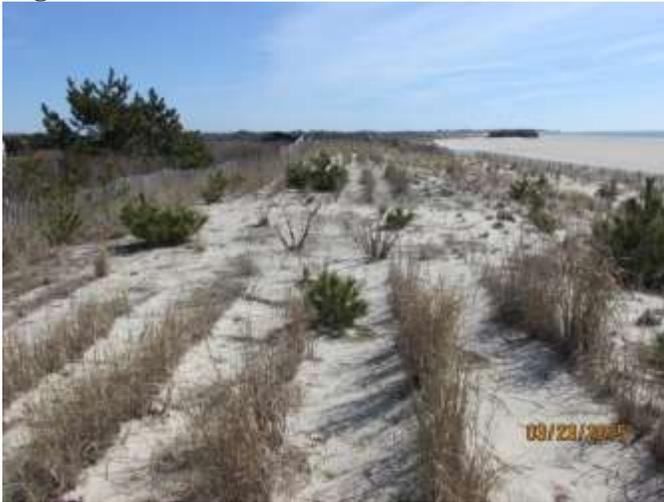
Lighthouse Avenue

The photo taken in March 2015 shows the dune and beach CMP-0. There are no visible indications of scarping or erosion to the beach or dune system. Dune grass and pine have colonized the dune.

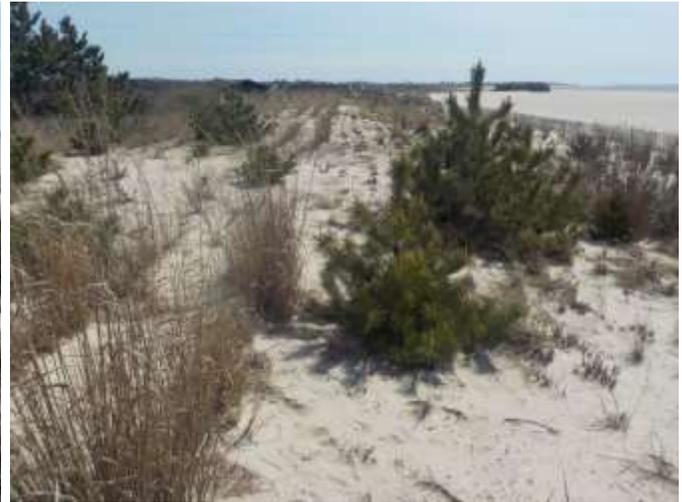
The photo taken in April 2016 shows the dune and beach remained remarkably stable this year. There were no visible changes to the beach or dune system other than continued plant growth.

CMP-0 (Cell 0) is the northeastern-most cell that borders the State Park and is bounded to the west by a rock groin. This location has benefited tremendously from the USACE Lower Cape May Meadows – Cape May Point restoration project, initial construction was completed June 2007. The project added over 250 feet of recreational beach berm and established a stable dune system 100 feet wide at the toe with a crest elevation of 18 feet NAVD88. Prior to the initial project the beach was narrow; a small dune armored with tensor mats on the seaward slope protected the exposed dune system from severe erosion.

The USACE authorized a second maintenance project with construction from November 2012 to January 2013. The project restored the design beach width and elevation. The beach width increased by 58 feet with 63.13yds³/ft. of sand added to each foot of shoreline seaward from the dune toe. Following the project the beach elevation ranged from 10-12 feet NAVD 88 and extended 275 feet seaward of the seaward dune toe.

The beach and dune system remained remarkably stable to accretive through April 2016. A massive wedge of sand moved onto the beachface and nearshore slope that continued seaward to the profile limit. This sand was likely shed from Cape May Meadows and Cape May City beaches following recent nourishment efforts in those locations. The sand added to the beachface at this location advanced the shoreline position seaward 80 feet. Onshore 23.12 yds³/ft of sand accumulated on the beachface slope between the beach berm crest and zero datum shoreline position. An additional 42.96 yds³/ft. of sand accumulated on the nearshore and offshore slope for a net sand volume gain of 66.08 yds³/ft of sand. This beach berm width now extends over 300 feet seaward of the dune toe and provides ample storm protection to prevent significant storm damage to the dune system and oceanfront properties. Aeolian sand from the beach continues to feed sand to the seaward dune toe and accumulates along the foredune around installed dune fences. The beachface slope remains relatively steep at a rate of approximately 10 to 1 so that within 200 feet the seafloor goes from 0 to -20 feet NAVD 88. Proximity to the nearshore tidal channel cause stronger longshore currents along this shoreline moving sand in the down drift direction.

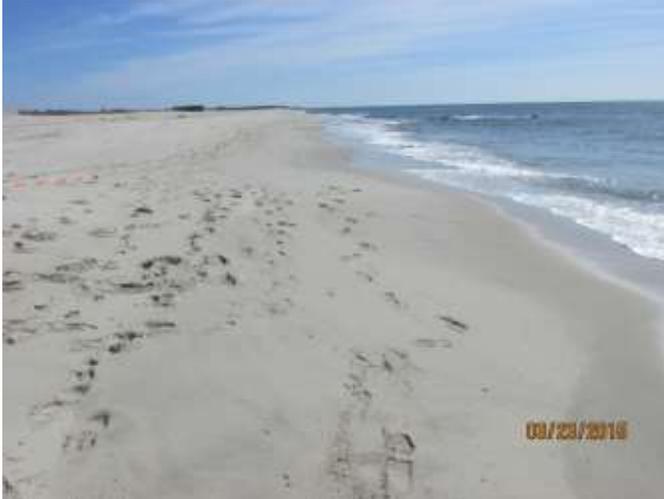
Lehigh Avenue

Taken on March 23, 2015, this photo shows a wide beach seaward of the dune toe. Note the position of the old bunker(background) on the beach and rock groin partially submerged.

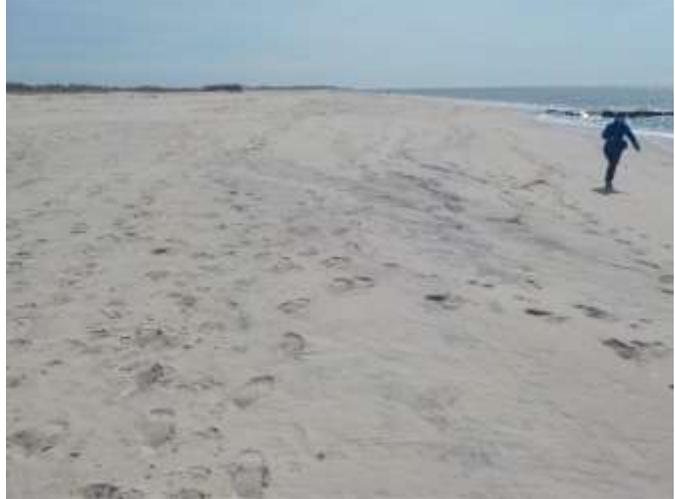
Taken on April 21, 2016, photo shows stable to slightly accretive beach. The berm is noticeably wider and higher a year later, sand has accumulated along the beach berm and beachface slope advancing the shoreline position.

CMP-1 (Cell 1) stretches from the Lighthouse Avenue groin to Lehigh Avenue. Prior to the initial USACE project no dry beach was present between the rock groins. Shore protection was provided by a rock seawall that armored the seaward dune slope. Beyond the groins the seafloor steeply dropped into the adjacent tidal channel. The initial USACE project re-established a dry recreational berm and covered the seawall with sand to restore the dune.

Although the dune system has remained remarkably stable to accretional since construction the beach has been exposed to several recent severe storm events. This site also received sand during the USACE authorized second maintenance project conducted between November 2012 to January 2013. The project restored the design beach width and elevation. The beach width increased by 60 feet with 56.39yds³/ft. of sand added to each foot of shoreline seaward from the dune toe. Following the project the beach elevation was 10 feet NAVD 88 and extended about 170 feet seaward of the seaward dune toe.

Aeolian process carried sand to the dune slope toe from April 2014 to April 2016 developing a new foredune ridge. Sand accumulated on the beach berm, beachface and nearshore slope while further offshore along the channel margin the slope retreated landward. The beachface slope remains relatively steep within the initial 125 feet the nearshore slope then steepens dramatically to a near angle of repose slope into the adjacent tidal channel. The proximity of this beach to the nearshore tidal channel with strong longshore currents near the end of the groins creates the potential for rapid retreat of the beachface slope as the channel cuts landward into the nearshore slope. This year the shoreline position advanced seaward 21 feet with the addition of 4.69 yds³/ft. of sand onshore while offshore the loss of -2.90 yds³/ft. of sand near the channel margin reduced the net volume gain to a minor 1.79 yds³/ft. of sand.

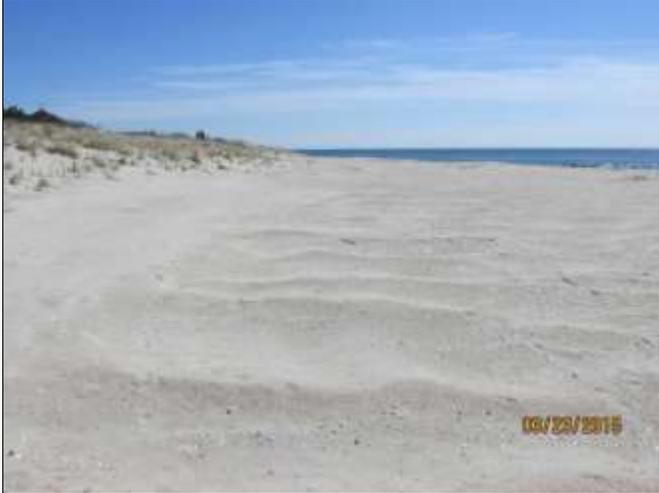
Lehigh to Whilldin Avenues

The photo taken on March 23, 2015 shows aeolian accumulation and colonization of plants seaward onto the open beach. Wide beach has supported continued growth along the seaward dune slope.

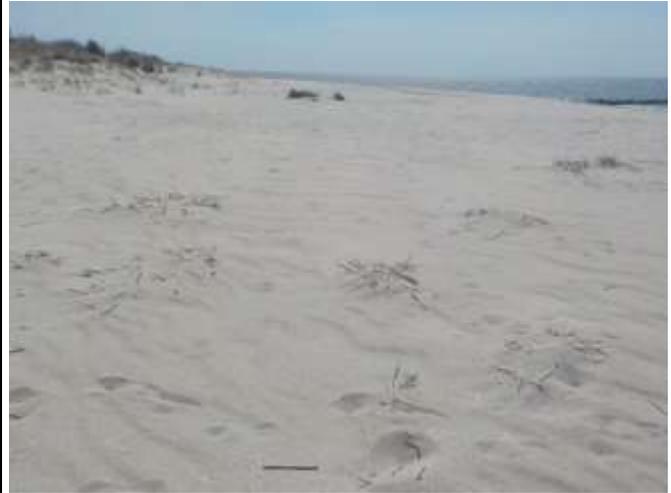
The photo above was taken on April 21, 2016. Seaward dune slope has accumulated sand but the berm lowered and retreated landward, not position of the rock groin in both photos.

The CMP-2 (Cell 2) beach is the northeastern-most of the groin cells with an early installation of the “Beachsaver” units from 1993, which still are functioning and show on the profile cross-section at the 520-foot distance from the reference point and remain relatively stable. Sand added to the system during the initial USACE project has resulted in the near burial of a rock seawall that served as property protection prior to the project. No additional sand was placed here during the 2013 2nd maintenance cycle.

Sand shed from the recent project beaches accumulated rapidly in this cell during 2013. From April 2014 to April 2016 time frame, sand accumulated on the seaward dune slope and upper beach offset by losses on the beachface and nearshore slope. Sand was also lost from beyond the reef unit to the profile limits for a net sand volume loss of -9.24 yds³/ft. of sand. Scouring around the reef unit has created a deeper trough (-11 feet NAVD88) landward and seaward of the “Beachsaver” units over the last 2 consecutive years.

The “Beachsaver” unit crest now protrudes about six feet above the nearshore slope. Landward of the units a deep trough was scoured that exposed the vertical landward face of the unit. This site has continued to erode both on the beachface, nearshore and offshore slopes. The shoreline position retreated landward 21 feet over the last two years. As of April 2016, the reef crest was 130 feet seaward of the zero elevation shoreline position (about mid-tide position) with the concrete units residing in -11 to -12 feet of water below the NAVD88 zero elevation. The reef crest protrudes up to elevation -6 feet NAVD88. In this position the units are unlikely to be encountered by swimmers this season within the middle of the groin cell. As always caution and restrictions should be in placed closer to the groins where the shoreline sand extends outward toward the concrete reef along each groin.

2. Cell 2 at Whilldin Avenues, the shoreline position (zero datum) is approximately 150 feet distance from the breakwater structure. Depth of the scour trough landward of the units has increased to nearly -12 feet NAVD88. The swimming area remains limited, especially closer to the groins but may again be manageable in the mid- beach cell this year. The CRC again recommends installing a line of floats indicating the maximum distance for swimming that should be about 30 feet from the breakwater reef.

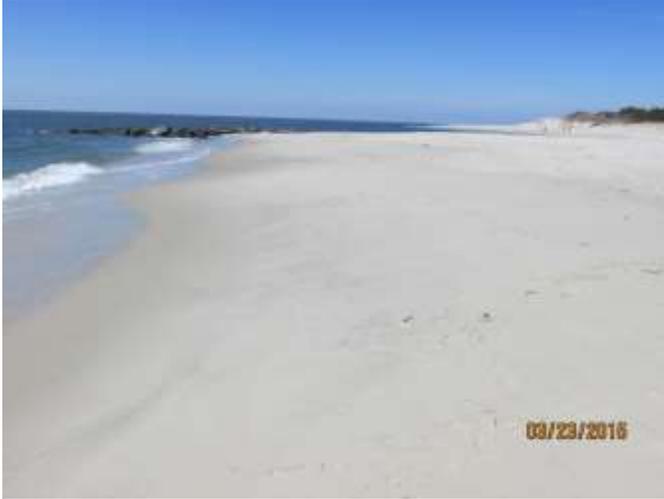
Whilldin to Coral Avenues;

The 2015 photo taken on March 23 shows the offset in beach width and berm elevation between Coral and Lake Avenue beaches along the Coral Avenue rock groin.

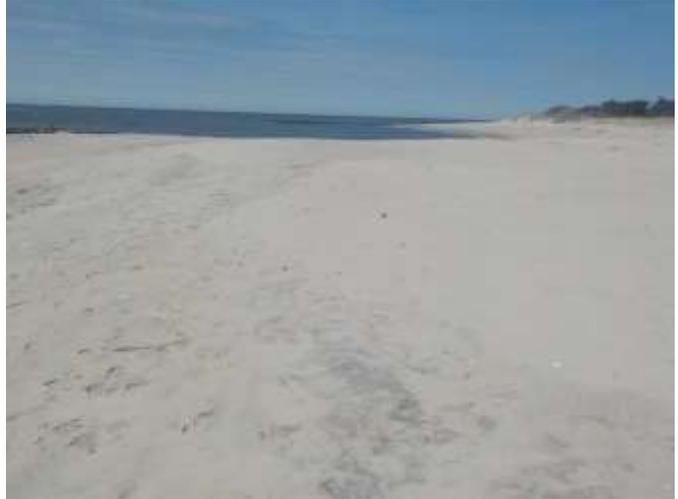
The April 21, 2016 photo shows the beach offset along the Coral Avenue groin continues to widen. By far this offset is the most pronounced in Cape May Point.

CMP-3 is bounded by rock groins at Whilldin Avenue and Coral Avenue. This beach cell was the second original 1993 “Beachsaver” unit installation in Cape May Point. Sand added to the system during the initial USACE project had resulted in the near burial of the entire beach unit structure. No additional sand was placed here during the 2nd maintenance cycle (2012-2013). Subsequent erosion offshore and inshore of the “Beachsaver” reef resulted in three to six feet of scouring of the seafloor from April, 2014 through April, 2016.

Erosion continued on the nearshore and beachface slope resulting in 14 feet of shoreline retreat from March 2015 to April 2016. Onshore sand accumulated on the beach berm and seaward dune toe further developing the new foredune ridge. The primary dune ridge remained remarkably stable since initial construction.

The modest loss of beach width keeps the “Beachsaver” units within relative close proximity to the shoreline, approximately 100 feet. The concrete crest protrudes to elevation -5.0 feet (NAVD88 zero datum) while the base is at -11 to -13 feet NAVD88. This location remains the most problematic in terms of swimmers encountering the structure while using the beach. There is a deep trough at the landward side of the reef structure but the swimming space has only increased marginally. Again this year the recommendation is to allow swimmers to wade nearshore in shallow water less than 3-4 feet deep regardless of the tide level. Water access could be allowed here in mid-beach but water access near the groins where the units are closer to shore should be prohibited.

3. Cell 3 at Coral Avenue, the shoreline position again retreated slightly, the breakwater units in April 2016 were approximately 110 feet from the shoreline position (zero datum). The beachface slope remains fairly steep with further development of a scour trough landward of the units -11 feet NAVD88. In the current beach configuration this location would only allow approximately half the distance between the reef and the mid-tide beach's water edge as safe for water activity. It is the CRC recommendation that entry into the water be limited to no more than 3- to 4-foot depths until such time that excavation removes sufficient sand from this region to draw the shoreline landward and increase the distance between the shoreline and the concrete units.

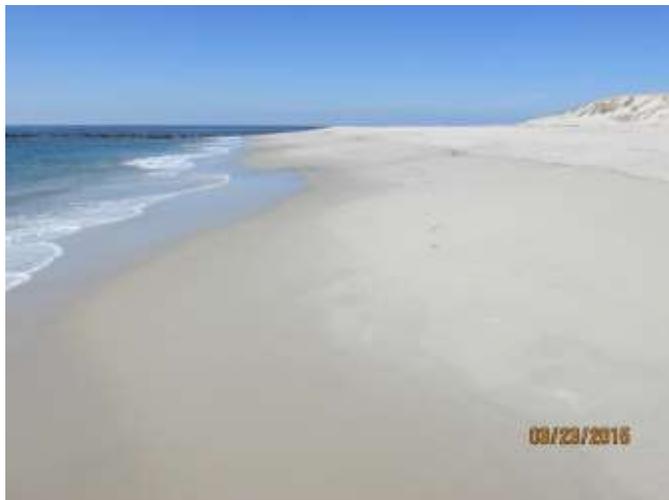
Coral Avenue to Lake Drive

Photo above was taken from the swash on March 23, 2015. The beachface is relatively steep with approximately 75-feet of dry recreational beach.

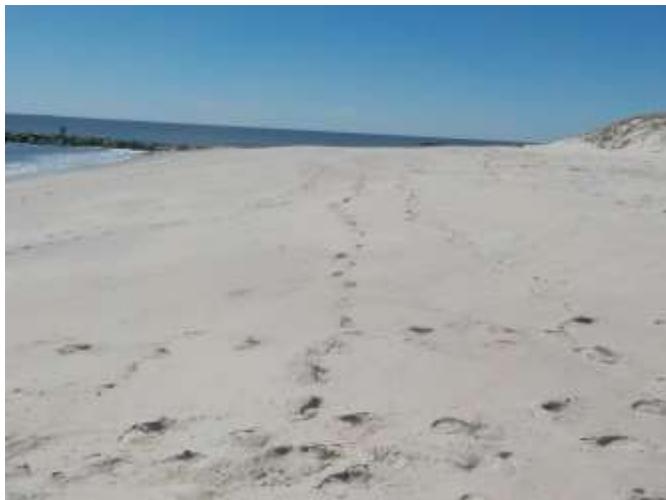
Photo above was taken on April 20, 2016 looking west at Lake Drive. There was a modest shift in sand from the beachface slope to the upper beach.

The Lake Drive (CMP-4, Cell 4) beach cell is bounded by the rock groins at Coral Avenue and south of Lake Drive (closer to Surf Avenue). This cell does not contain any nearshore “Beachsaver” structures but it has received sand both during the initial project and in the recent 2nd maintenance cycle nourishment project. Over the 2012/2013 winter the USACE reported sand placement of 37,000 cubic yards in the Lake Drive beach cell (Dwight Pakan, USACE). The beach berm width advanced to approximately 125 feet seaward of the dune toe at elevation 10 feet NAVD 88 with 43.63 yds³/ft. of sand added, the shoreline position advanced seaward 60 feet. This sand rapidly eroded and by April 2014 approximately half the beach width added during the recent project was removed.

The dune has remained relatively stable to slightly accretive through the recent monitoring time interval of April 2014 to April 2016. Aeolian processes accumulated sand along the foredune crest and slope. Natural processes also pushed sand higher onto the recreational beach berm. Over the last two years the beachface and nearshore slope has steadily eroded resulting in 25 feet of shoreline retreat from April 2014 to April 2016. Further offshore the platform lost sand as a thin layer of sand from the beachface slope to the profile limits. The net result was a loss -28.41 yds³/ft. of sand over the last two years.

From March 2015 to April 2016 the shoreline retreated 12 feet with a loss of -11.08 yds³/ft. of sand. This loss rate mimicked the erosion rate from April 2014 to March 2015. The dry beach width has been reduced from just over 80 feet to extending 50 feet seaward of the seaward dune toe. Despite the loss of dry recreational beach width this location remains one of the more desirable bathing beaches in the Borough. Approximately 50 feet of dry recreational beach extends seaward to a gradual descent into deeper water and a relatively large, shallow offshore platform area for recreational swimming within this groin compartment.

8. Cell 4 at Lake Drive continues to suffer chronic erosion reducing the recreational beach's stability to sustain higher levels of recreational activity and provide enhanced shore protection for the dune system. The last two years CMP 4 has lost 19,000 cubic yards of sand while the beach at CMP 8 has gained nearly 38,000 cubic yards in the same time frame. A program that hauled excess sand accumulating at CMP 8 back to CMP 4 may provide a sustainable management option for the USACE and municipality to explore as an alternative between nourishment cycles to stabilize the Lake Drive beach. Excavation of sand from the beachface at Alexander Avenue may also reduce the risk to swimmers in this cell from exposure to strong tidal currents in this location. An alternative remains to reinstitute a program of sand excavation from the beachface at CMP 3 and

or CMP 2 as a sand source to maintain the beach berm at CMP 4. This would have benefits for all locations increasing the sand supply for the Lake Drive beach while increasing the distance between the shoreline positions and “Beachsaver” reefs, reducing the risk of swimmers encountering the submerged structures.

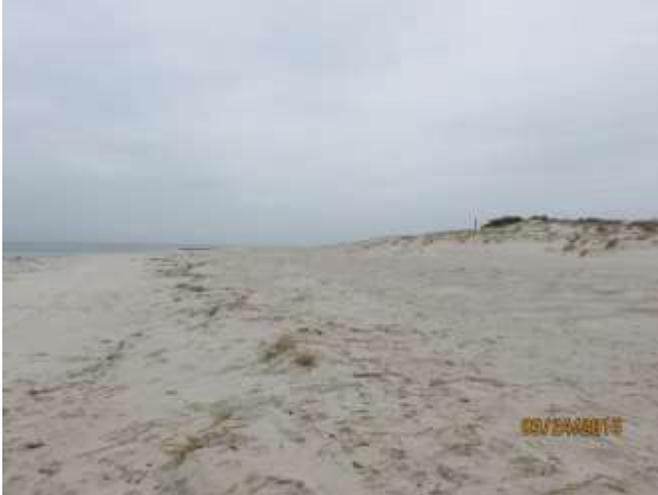
Surf to Cape Avenues

The photo taken on March 24, 2015 shows a wider recreational beach berm than Lake Avenue with a well-developed wide dune system.

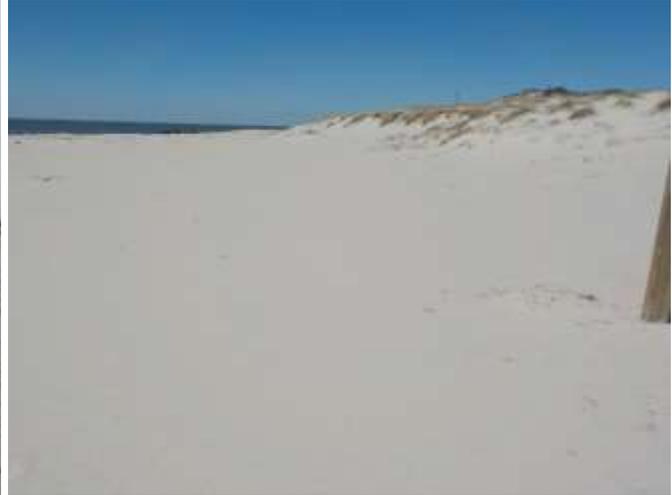
The Photo above was taken on April 20, 2016 shows sand accumulation on the seaward dune slope and upper beach berm that partially buried early colonizing plants but enhanced storm resiliency.

CMP-5 (Cell 5) contains the nearshore breakwater unit installed in 2002 during the USACE CMP-227 experimental project. The breakwater units are still present, located nearly 200-feet seaward of the zero elevation shoreline position. These units are furthest from the shoreline and lowest in elevation in the cell's mid-section where swimming is allowed. That prevents individuals from encountering the units. In this cell the units pose little threat to recreational swimming but swimming along the rock groins should be restricted where the units are closer to shore due to sand accumulation at the rocks.

No sand was placed west of Lake Drive during the 2012-2013 USACE renourishment project, but natural processes has moved sand from east to west along the Borough's shoreline over time. The wider beaches have provided a source of sand for Aeolian to move sand onto the seaward slope and crest of the dune. This process continued from April 2014 through April 2016. A thin layer of sand accumulated across the recreational beach berm onto the beachface slope. The seafloor was relatively stable during this timeframe with modest variations occurring landward of the "Beachsaver" units. Offshore beyond the reef units the seafloor elevation was more variable initially losing sand with nearly full recovery this year to the profile limits. Onshore the beach width remained relatively stable with 13.44 yds³/ft. of sand added to the profile distributed fairly evenly between above and below the datum. The shoreline position was relatively stable advancing 3 feet seaward from spring 2015 to spring 2016. Shore protection continues to be enhanced at this site through natural processes adding height and width to the dune and beach. Current configuration has a nearly 200-foot wide dune from toe to toe with a maximum crest elevation of 20 feet NAVD 88. The dry recreational beach berm extends seaward of the dune toe approximately 100 feet at elevation 10 feet NAVD 88.

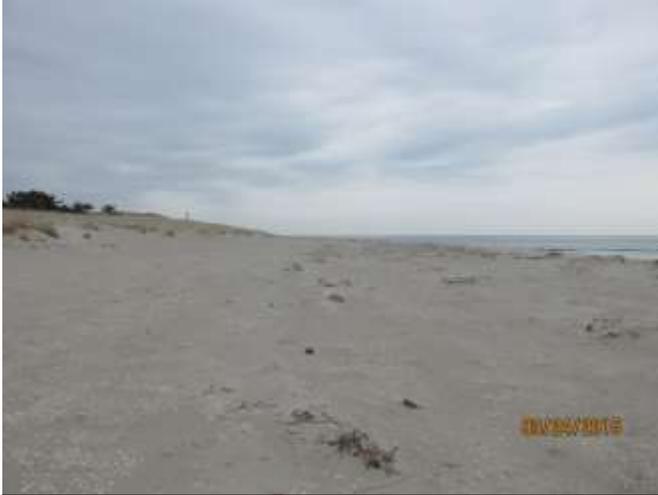
Cape to Pearl Avenues

This photo taken on March 24, 2015 looking east shows the seaward dune crest and slope with plants colonizing the seaward slope. Dry recreational beach berm width is approximately 150-feet and supports dune growth.

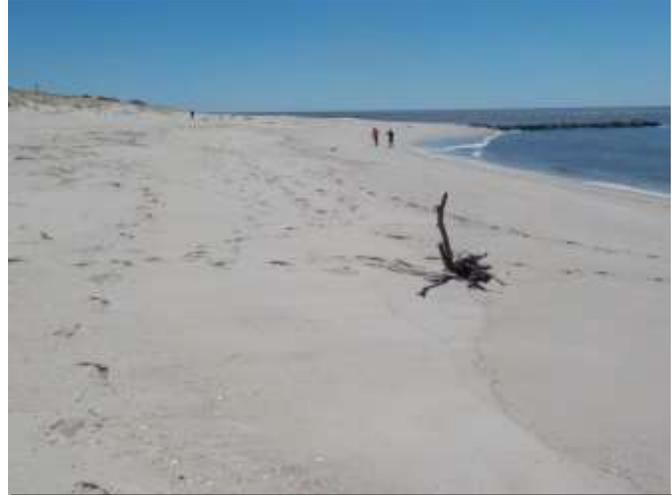
This photo taken on April 20, 2016 shows accumulation of sand along the seaward dune slope and upper beach. Beach cusp formation in the beachface on the downdrift side of the groin resulted in modest shoreline retreat.

CMP-6 (Cell 6) is bounded by the rock groins at Cape Avenue and Pearl Avenue. The nearshore bay floor contains the “Double Tee” structures that were installed as part of the USACE CMP-227 experimental project. These units were quickly buried and have remained buried by sand in the past seven annual surveys. Consequently, they have limited ability to influence additional sand retention.

Sand shed from the initial up drift federal project beaches moves into this site seasonally by predominant longshore drift. As a result it is unlikely erosion will expose these units in the near future provided the USACE continues to remain committed to regular project maintenance by adding sand to the system. These units are located on the seafloor 11 feet below the 0.0 ft. NAVD88 datum and buried by 4 feet of sand nearly 100 feet offshore. The units however might be accessible adjacent to the rock groins, and any recreational activity in the water close to the rock groins should already be prohibited.

No sand was placed this far west during the USACE nourishment project, so beach building has been a result of natural processes. By April 2016 sand had accumulated on the dry recreational beach berm and seaward dune slope and crest through aeolian processes and wave runup. On the beachface the waves cut into the slope resulting in 30 feet of shoreline retreat. Offshore there was a loss of sand near the profile limits. The net change in sand volume was a loss of -16.77 yds³/ft. of sand. Despite the overall modest loss of sand from the profile the dunes continued to accumulate sand on the seaward slope and crest into 2016.

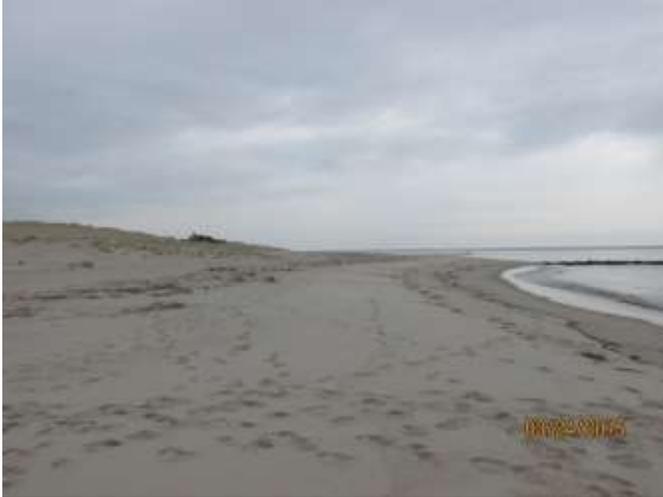
Pearl to Stites Avenues

This photo taken on March 24, 2015 shows the accretion dune that occurs from natural aeolian conditions. The beach berm width provides an ample source of sand.

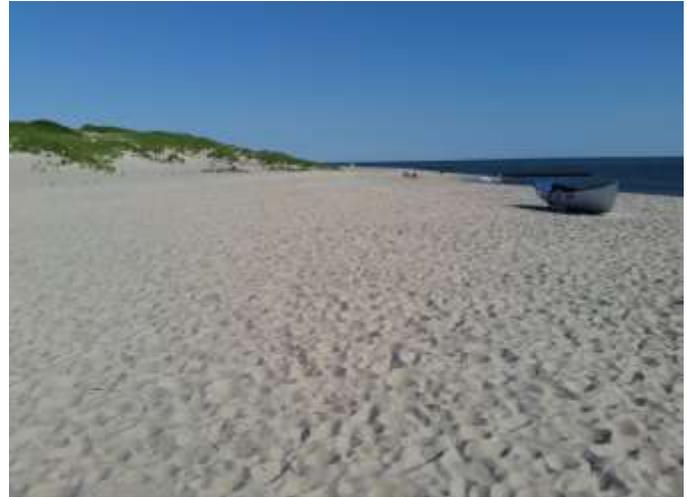
The photo above was taken on June 1, 2016 from a similar perspective. Dune grass has colonized the seaward slope to the toe. The wider beach berm provides sufficient storm protection for continued dune growth.

Profile CMP-7, located southeast of Brainard Avenue, (Cell 7) is bounded by the rock groins near Pearl Avenue and Stites Avenue. The cell has not received any sand directly from the past USACE beach restoration or maintenance projects. Natural processes dominated by longshore drift continue to transfer sand from east to west along the Borough's shoreline. This process has benefited the western beaches as sand has accumulated across the entire profile length from the dune crest to the offshore seafloor limits this process continued through April 2016. With no structures present at this location the wide dry beach should provide beach patrons with abundant recreational area and good nearshore swimming conditions for the summer season.

In 2016 the annual net volume gain was 10.54 yds³/ft. of sand but with 5 feet of landward shoreline position retreat as the beachface slope was cut back by wave energy. The elevation of the recreational beach berm increased by nearly 2 feet as sand accumulated onshore. Aeolian transport moved sand to the seaward dune slope and up to the crest. Sand accumulation was nearly continuous across the entire profile length except the beachface slope and offshore profile limits. The wind transport effect has been evident on the Stites Avenue beach access pathway where sand deposition has repeatedly buried the pathway and seating area at the dune crest.

Following a site visit this June 18th it was observed that once again public works was forced to dig out the beach entrance pathway at Stites Avenue due to wind deposition of sand. This pathway also has a picnic table and platform at the dune crest making raising the walkway difficult, but that is impacted with wind-deposited sand as well. Two solutions are suggested; 1) place 40-50 feet of snow fencing more or less parallel with the cut at the crest, but 30 feet toward the west from the cut; or 2) abundantly plant the 30 feet of dune crest toward the west with beach roses or dune grass between the existing dense vegetation and partly down the upper seaward dune slope. Either solution will reduce the deposition of sand in the Stites Avenue dune walk over. Each winter add another row of fencing at the toe of material trapped by the initial fence row or add more plants at the sand toe.

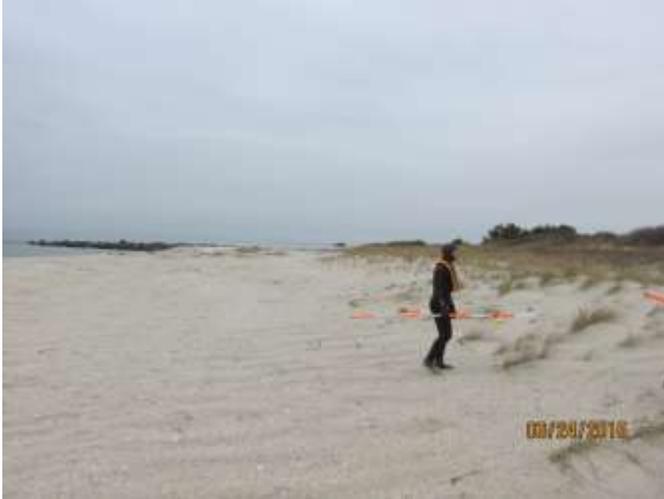
Stites to Alexander Avenues

This photo taken on March 24, 2015 shows the dune and berm conditions similar to the 2014 survey. This site experienced negligible changes between 2014 and 2015.

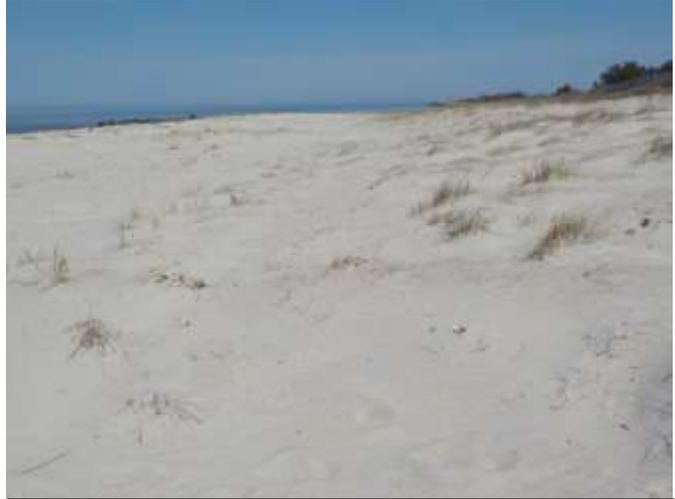
This photo taken on April 19, 2016 shows continued dune growth and seaward expansion of the beach berm and shoreline position.

The Alexander Avenue location, CMP-8 is the western most beach cell in the Borough. Sand placement was never included for this location during the USACE projects. Natural processes have moved sand from the project beaches to this location. The beach extends seaward nearly to the tip of the western groin. Sediment loss from this cell is to the western Delaware Bay shoreline and shoals locally known as the “Cape May Rips”. The offset in the beach west of the Alexander Avenue groin means that most of the sand is transported to the nearby bay floor and does not appear on the Sunset Beach shoreline.

Following completion of the initial USACE project sand began to accumulate in increasing amounts, 2015 was the first year in which this accretive trend stopped. In 2016 the accretive trend continued with a large wedge of sand accumulating from the seaward dune crest seaward to the profile limits. The dune advanced seaward 20 feet as a result of sand accumulation on the seaward slope. Recreational beach berm height increased 2 feet while the width advanced seaward 30 feet. Sand accumulated along the beachface slope advancing the shoreline position seaward 64 feet. The net annual volume change was a significant gain of 55.77 yds³/ft. of sand with onshore gains accounting for nearly one third of the sand volume added to the length of the profile.

The dry beach provides ample area to support summer recreational activity onshore while the nearshore slope is steeper in this cell with water depths of -10 feet NAVD88 within 100 feet of the shoreline. The steeper slope and drop off near the end of the groins along with strong tidal currents in this region should probably limit swimming activity by most to the shallow nearshore region.

7. Cell 8 at Alexander Avenue, a massive accumulation of sand this year has elevated and pushed the recreational berm seaward. Available recreational area has been substantially improved at this beach since 2005. Unfortunately, the beach has now expanded to the seaward end of the terminal groin putting the shoreline position in close proximity to strong tidal currents flowing past the terminal groin. These conditions have guided the Borough's decision to close the Alexander Avenue beach to swimming. This condition has not changed and may require extensive sand excavation to alleviate this concern in order for swimmers to utilize this location.
