**FINAL REPORT FOR 2021
ON THE CONDITION OF THE MUNICIPAL OCEANFRONT BEACHES
BATHYMETRY OF TOWNSENDS INLET
THE BOROUGH OF AVALON, CAPE MAY COUNTY, NEW JERSEY**

**PREPARED BY: THE STOCKTON UNIVERSITY COASTAL RESEARCH CENTER
30 WILSON AVENUE
PORT REPUBLIC, NEW JERSEY 08241**

**ANNUAL REPORT FOR 2021 - TO THE BOROUGH OF AVALON
ON THE
CONDITION OF THE MUNICIPAL BEACHES & BATHYMETRY OF TOWNSENDS INLET**

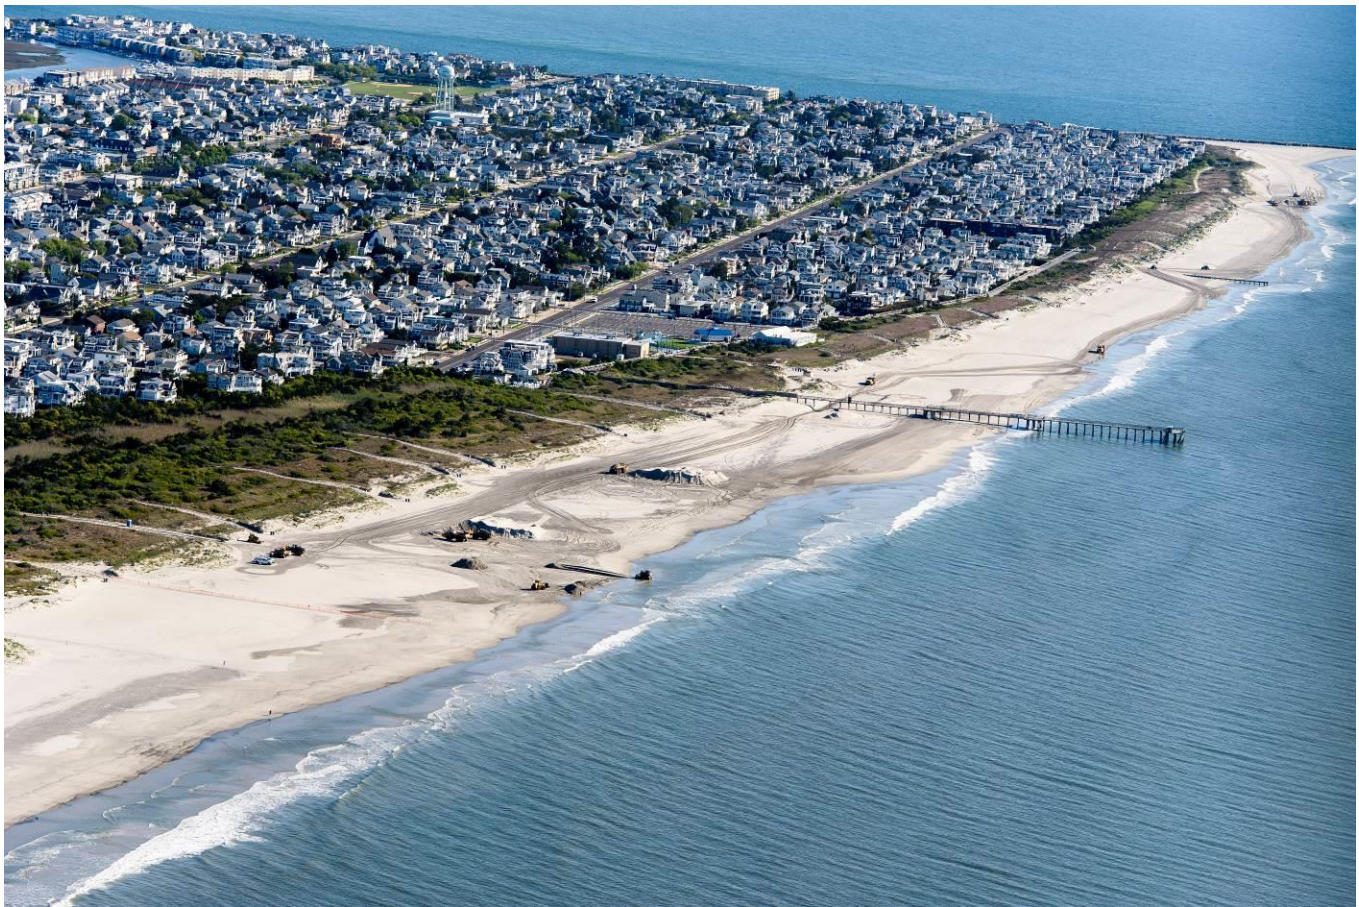
View of the Avalon oceanfront May 13, 2021 showing the extent of the 2021 sand back-passing operation underway to add additional sand from the 32nd to 38th Street region. The sand was extracted from the intertidal zone, stockpiled on the berm then loaded into trucks that drove to the placement area between 12th and 17th Streets. 56,000 cubic yards of sand were moved. PHOTO by Ted Kingston.

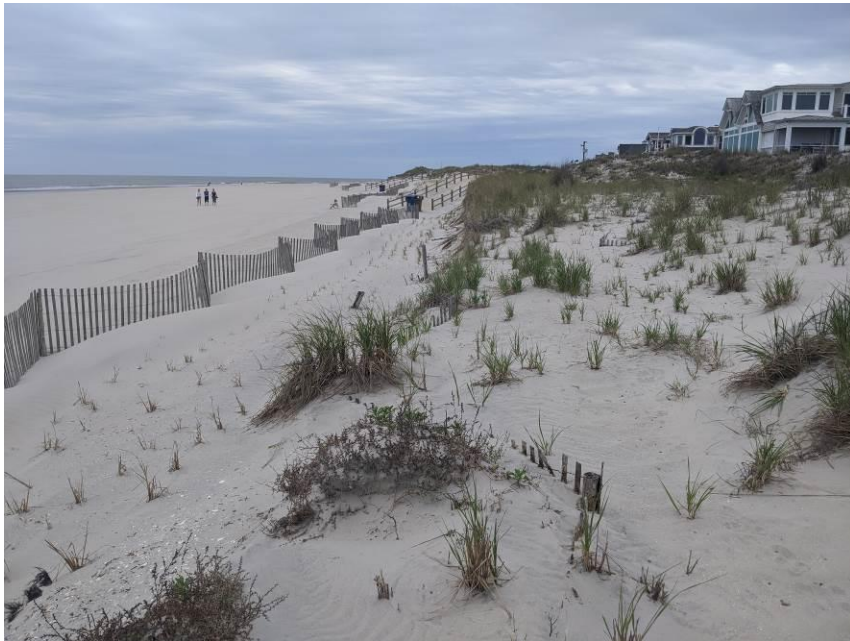
1a. June 3, 2020

View 1a. was taken in June following addition of new fencing. Some beach retreat had occurred, but the site remains in good condition.

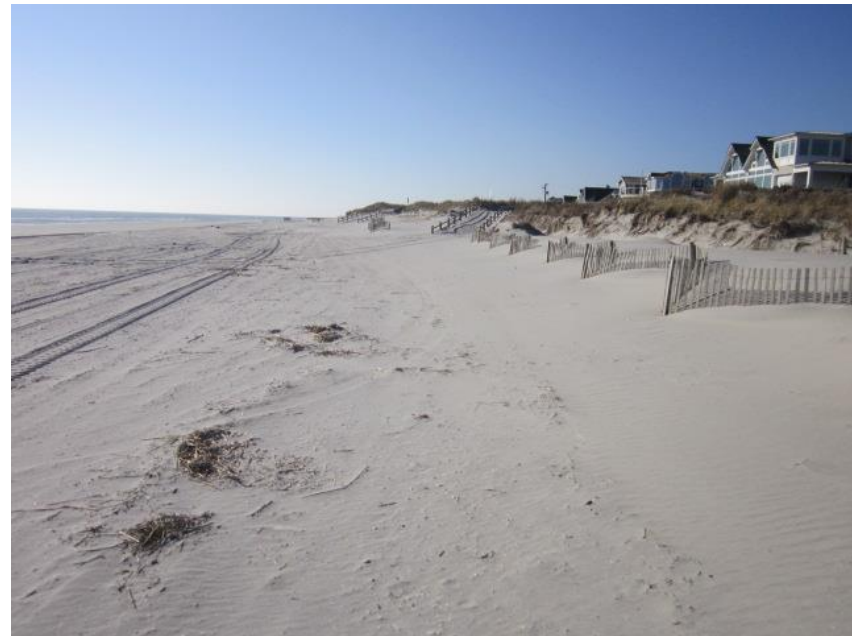
1b. December 11, 2020

View 1b. This view from December 2020 and shows the remaining expanse added to the beach width by the USACE maintenance effort. Wind transport was actively burying the new fence line.

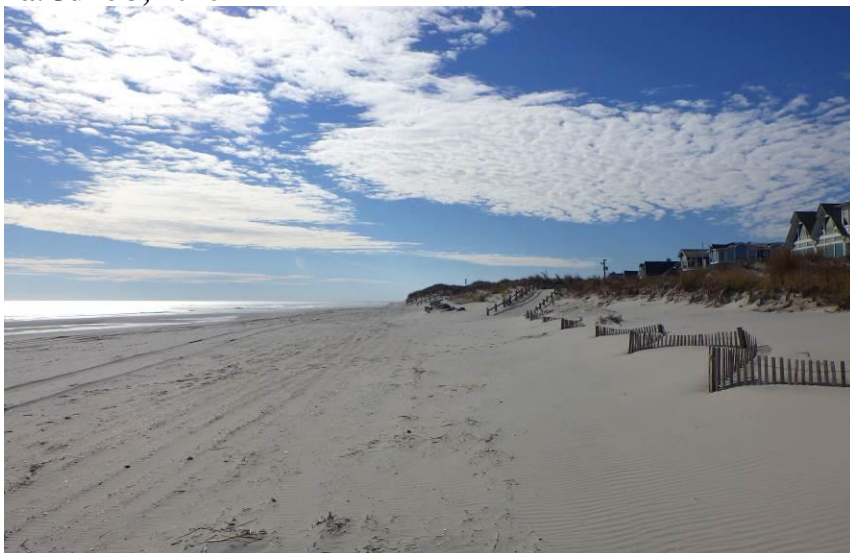
1c. December 3, 2021

View 1c. The beach width remains acceptable and wind transport continues to bury the newest fencing placed after the 2019 maintenance.

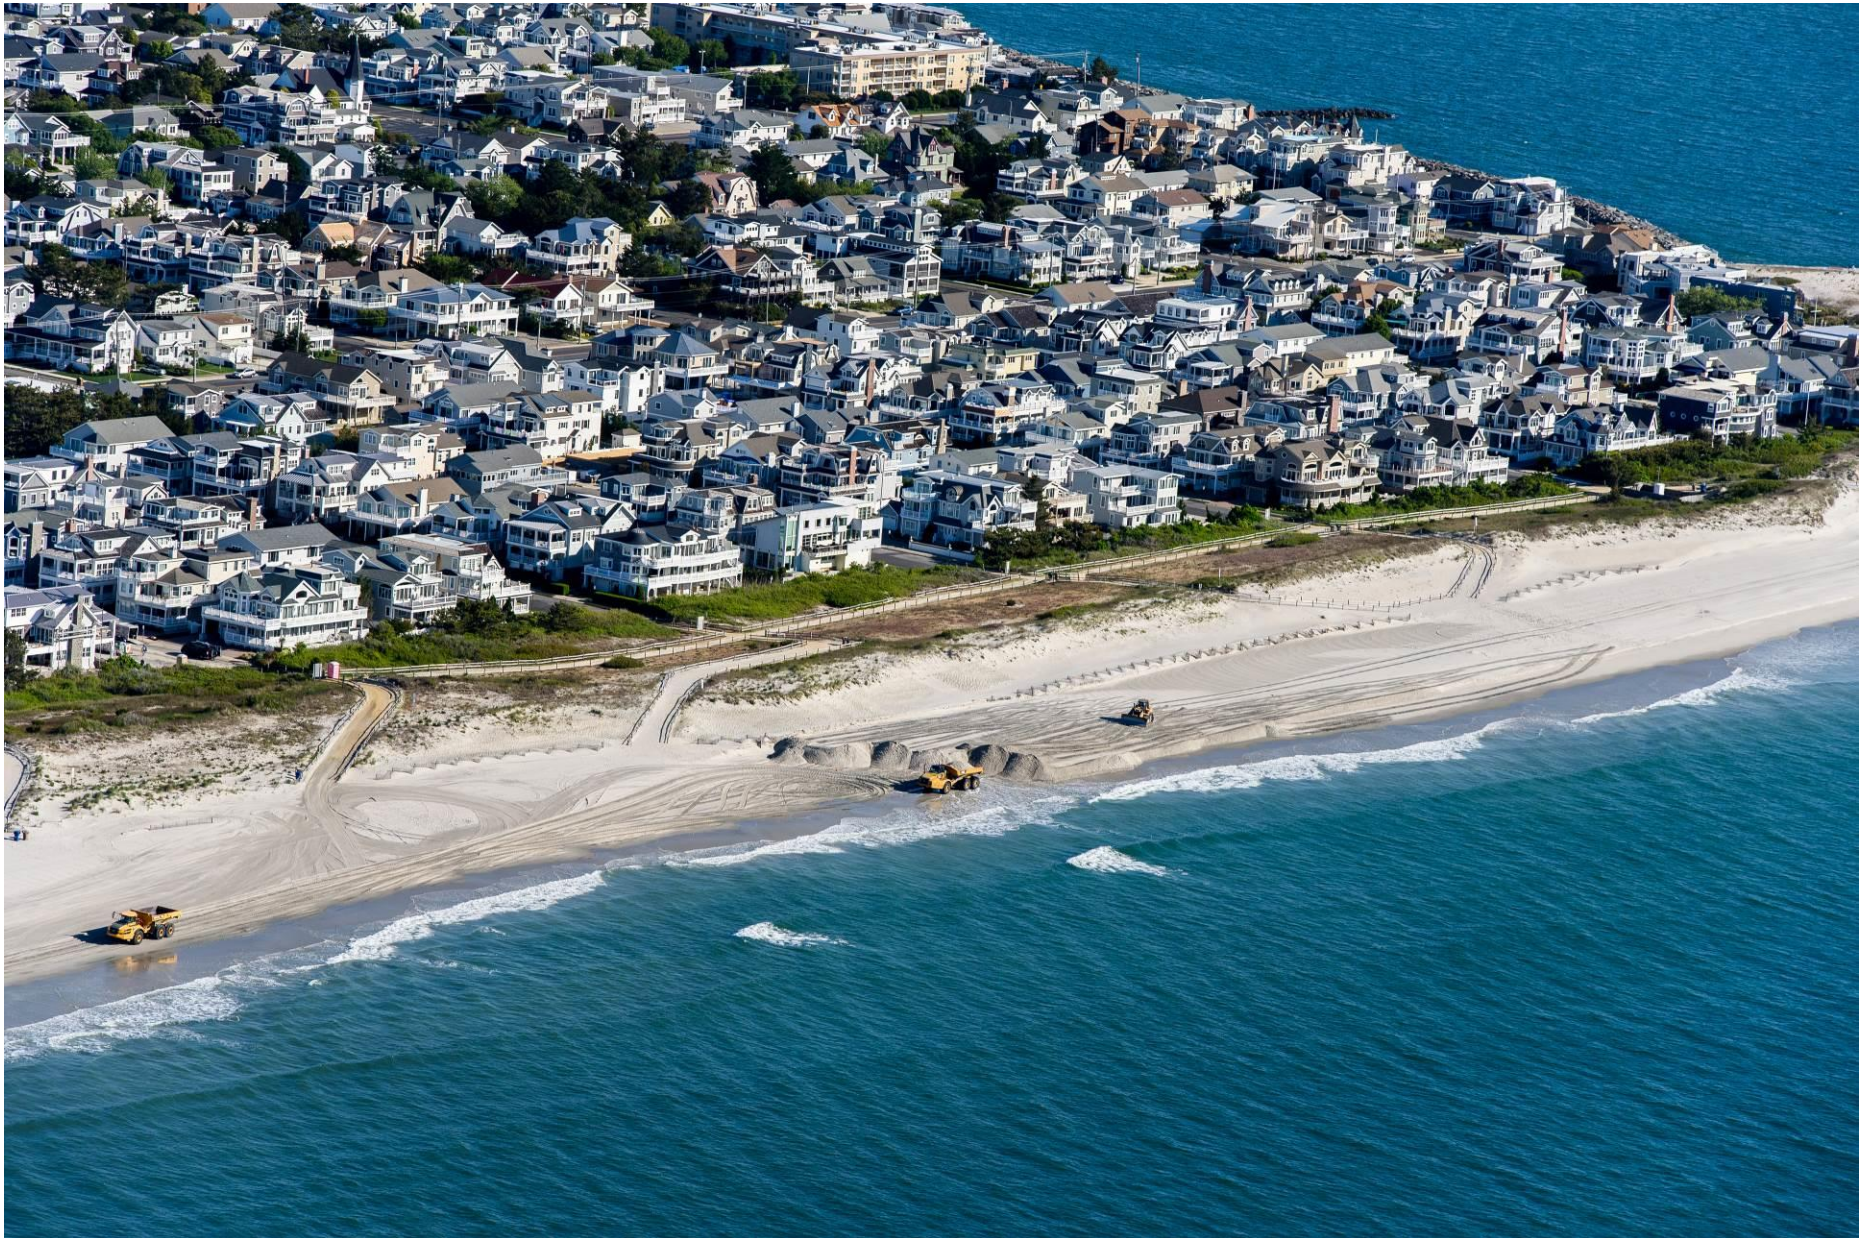
Figure 3a. May 13, 2021 aerial view of the Avalon back-passing depositional zone between 12th and 15th Streets where the truck loads are dropped off and then graded into the desired beach template. Erosion continues its work between 11th and 17th Streets so beach utility depends on regular episodes of sand addition to keep the resource functional as both storm protection and a recreational space.

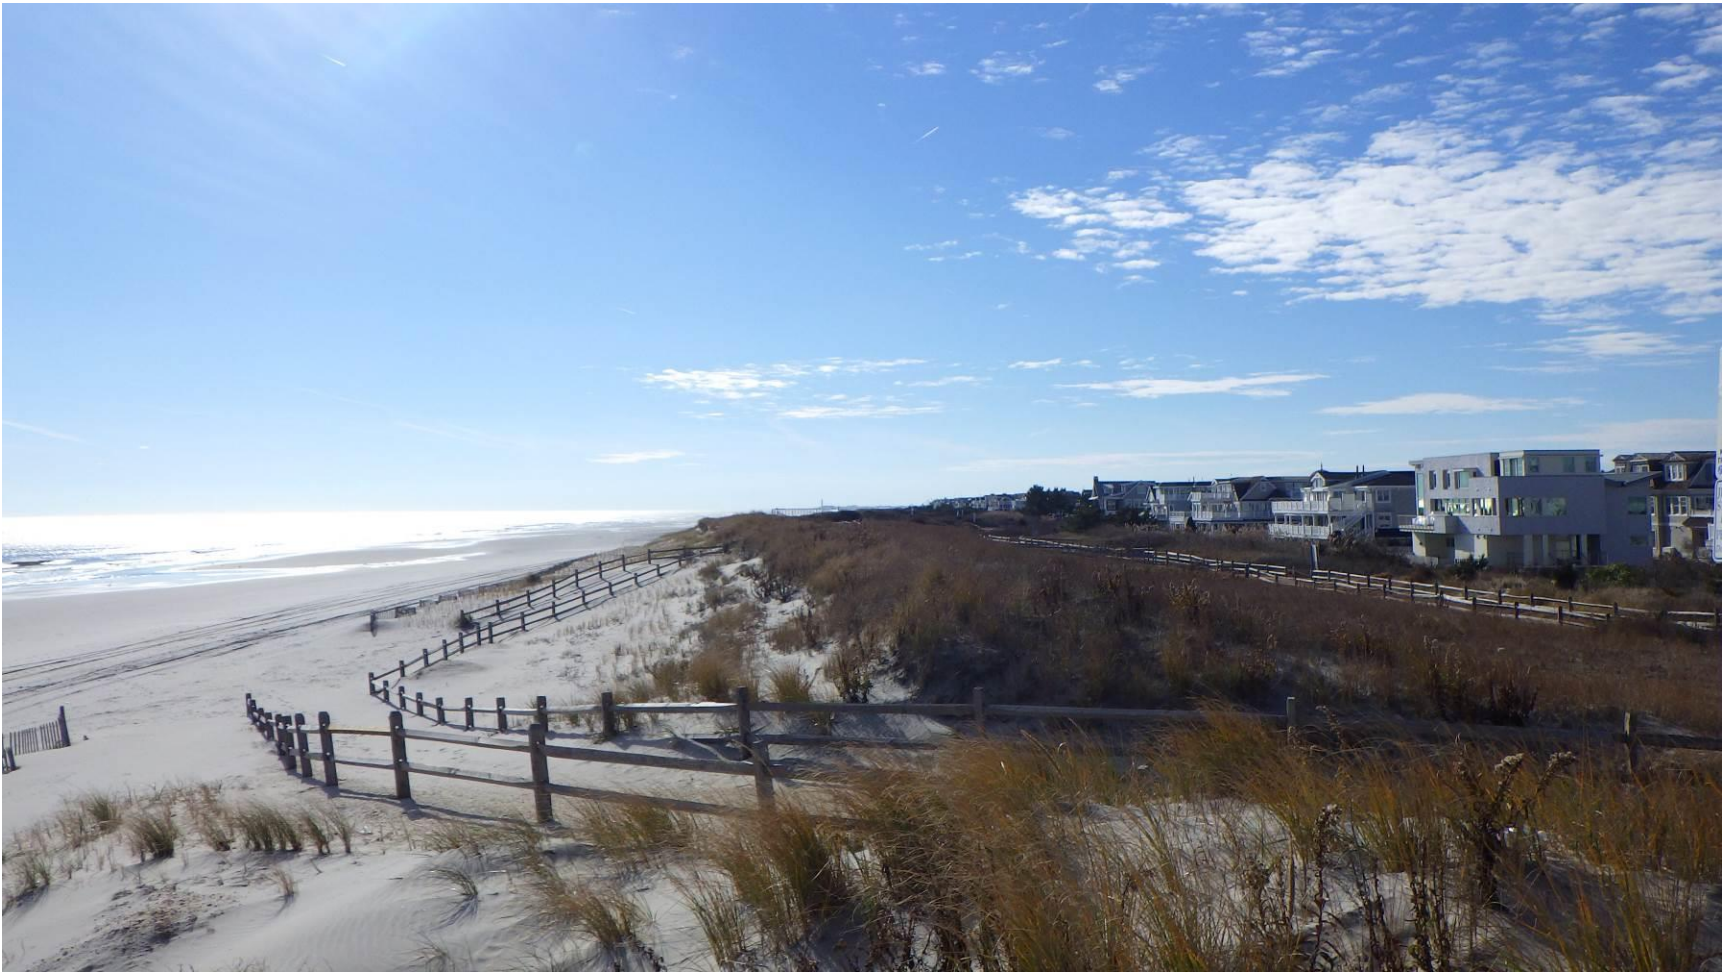
Figure 3b. December 3, 2021 view to the south from the dune crest at 12th Street. The extent of this beach including the intertidal zone is due to the back-pass project completed last May. The rocks remain buried in the dune's seaward slope with the dense vegetation defining the landward crest of the revetment rock wall and bulkhead.

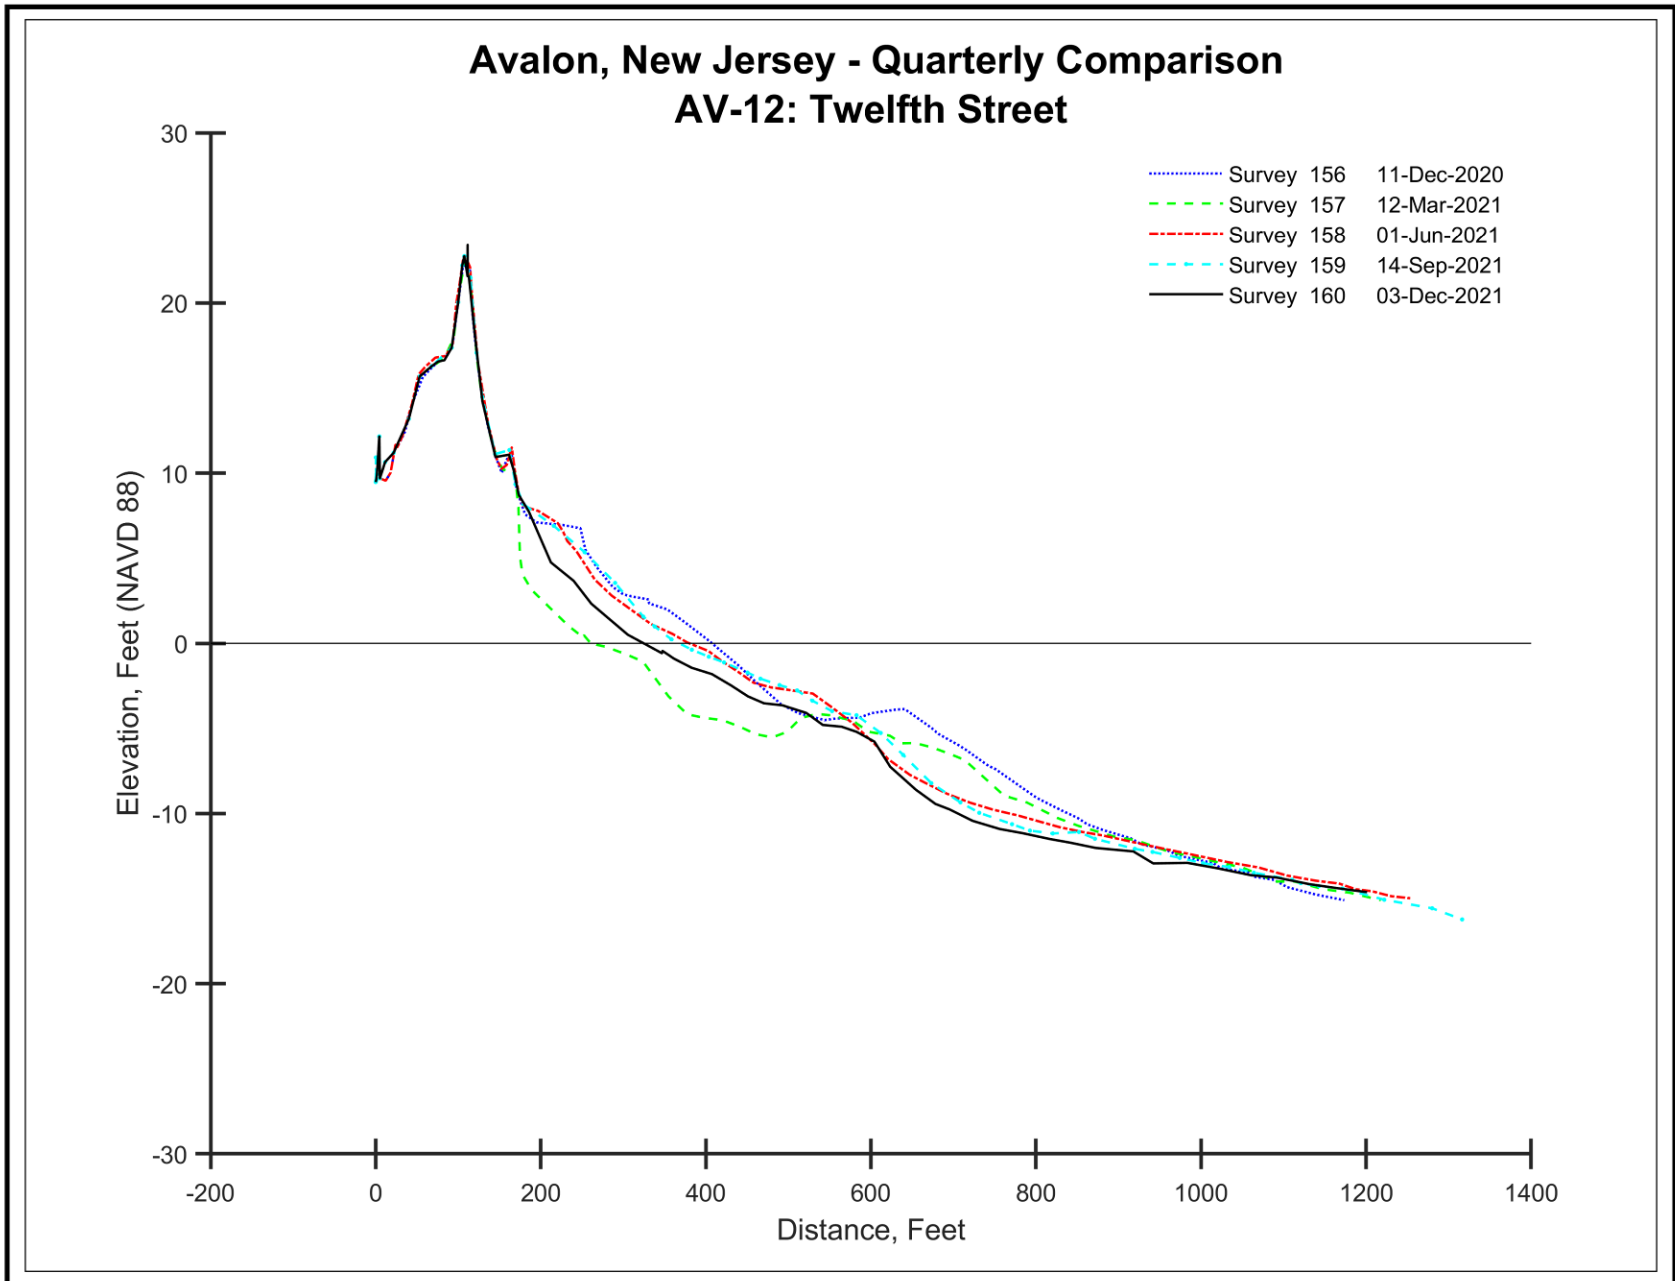
Figure 4. Storm-generated retreat occurred between Dec. 2020 (two late Dec. storms) and March 2021 (Feb 1 & 2, 2021). Sand placement during the spring of 2021 shows in the June, September and with a somewhat lower elevation as of December 2021, but above elevations seen in March 2021. Sand offshore as of Dec. 2020 may have contributed to material on the beach presently.

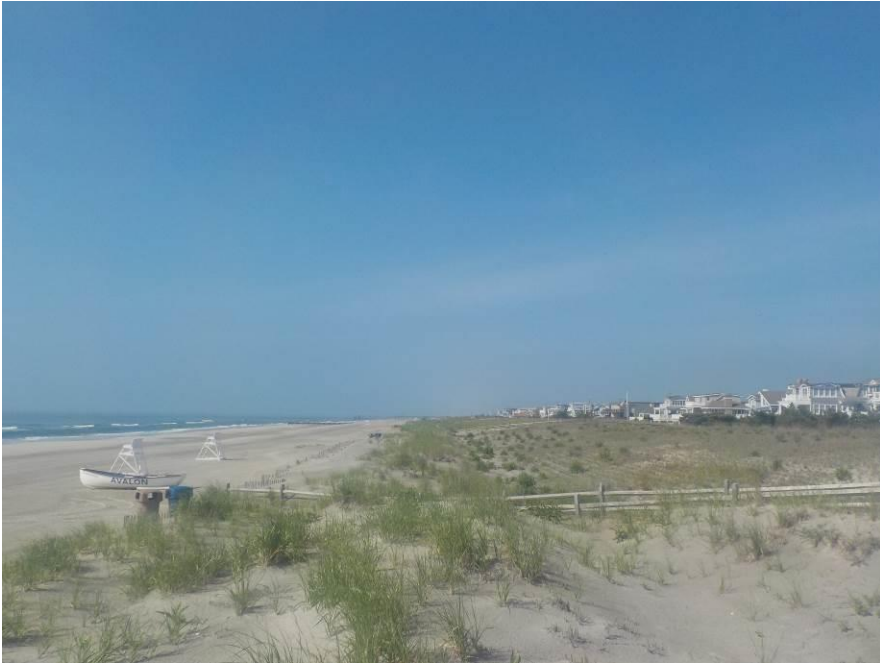
5a. May 30, 2020

View 5a. By May 30th the grass had advanced into the ridge between the fences. The beach remained in decent condition as the new dune ridge continued to grow.

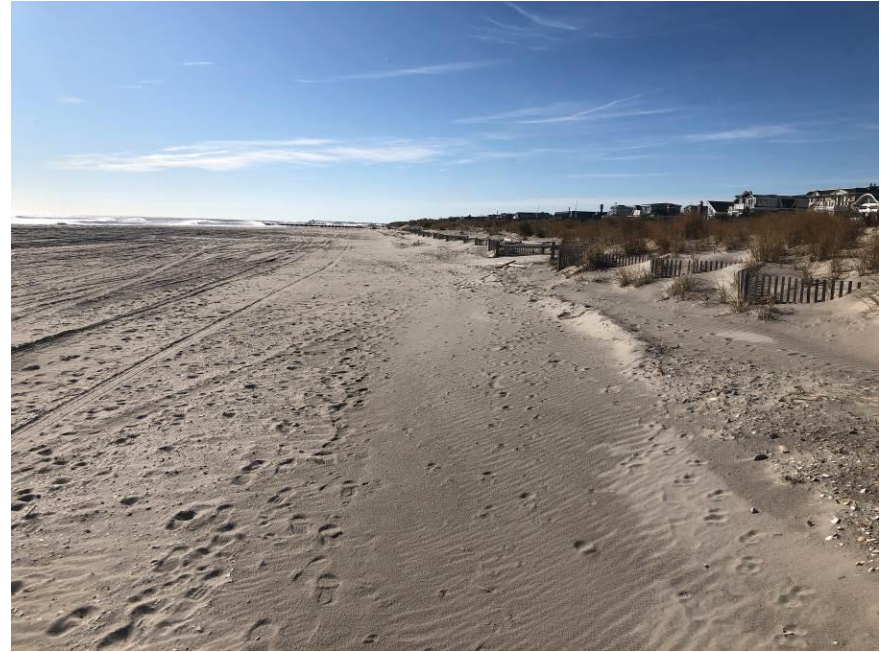
5b. December 11, 2020

View 5b. This view shows the beach width reduced somewhat, but still an effective barrier to dune erosion as of the end of 2020.

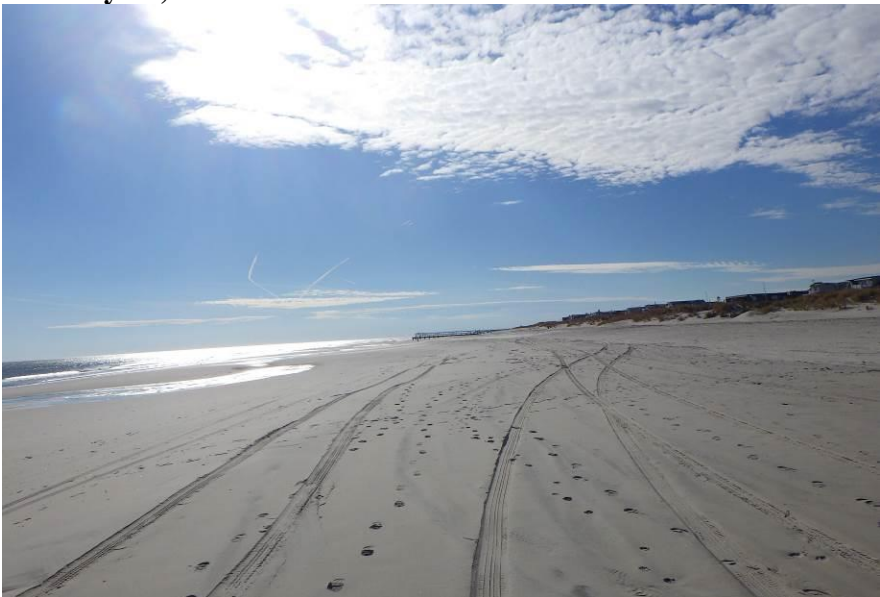
5c. December 3, 2021

View 5c. As of December 3, 2021, the beach slope was flatter with a small, lower elevation berm built in the absence of storm activity to that date.

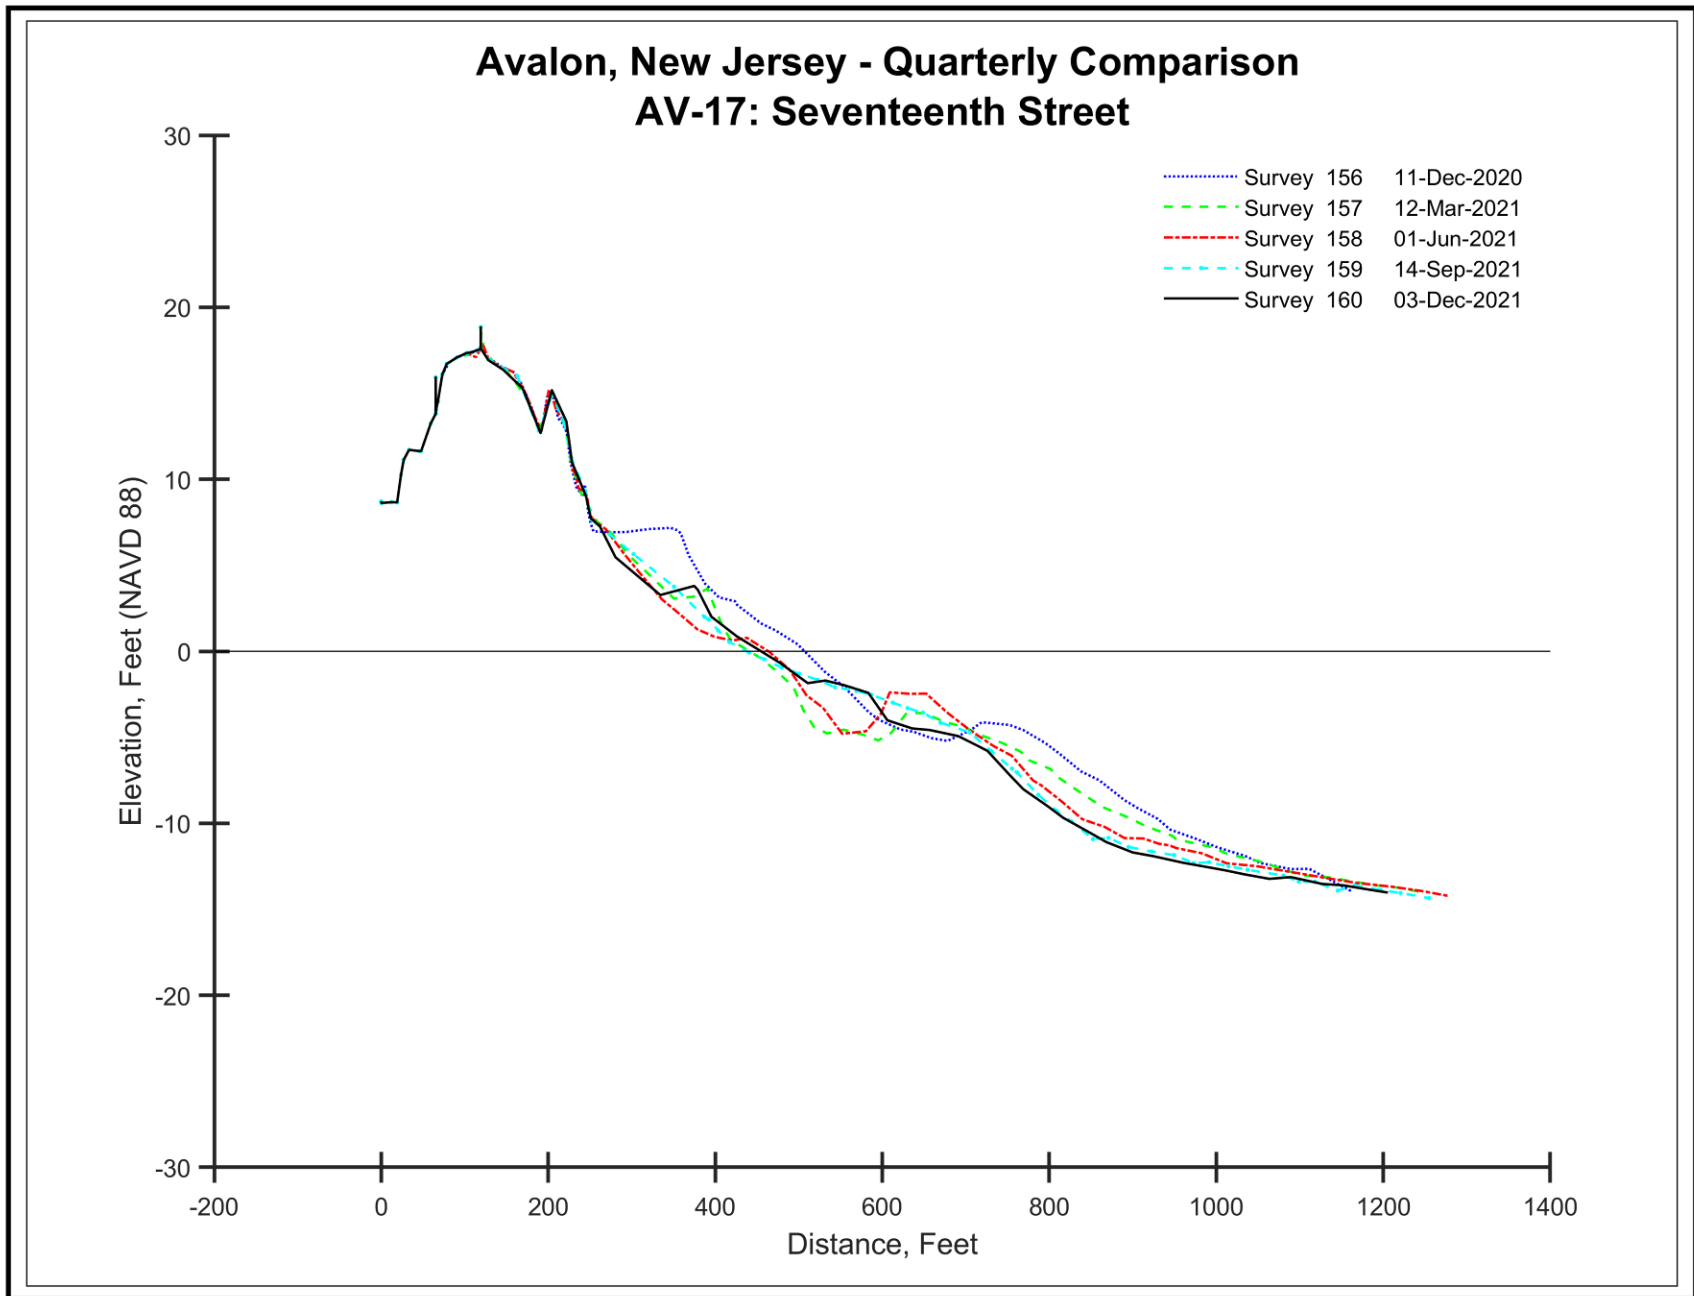
Figure 6. The Dec. 2020 berm eroded due to the spring 2021 storms (see Figure 4). Sand did accumulate by Sept. 2021 in modest volumes. The December 2021 cross section shows a small berm at a lower beach elevation and some material in the nearby offshore region.

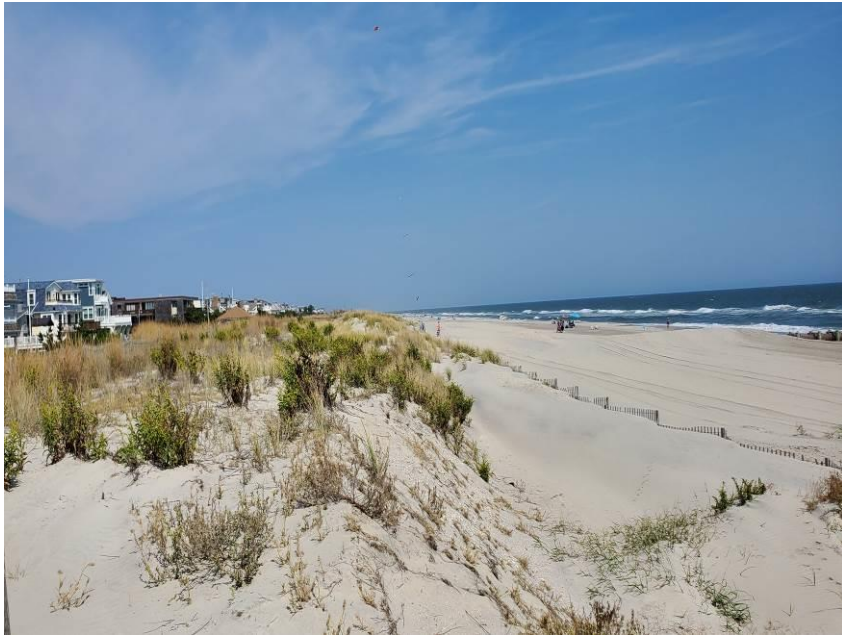
7a. September 18, 2020

View 7a. By September 2020 the beach was somewhat wider as sand was transferred to the site from further north. Little additional fence burial occurred.

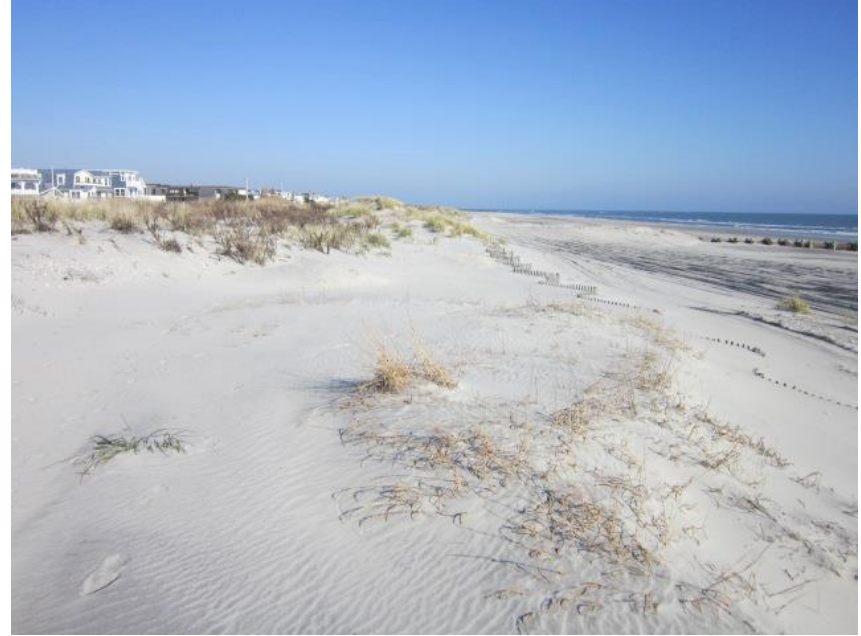
7b. December 11, 2020

View 7b. By December 2020 the beach showed added wind deposition on the dune slope with added material at the stormwater pipeline in the distance.

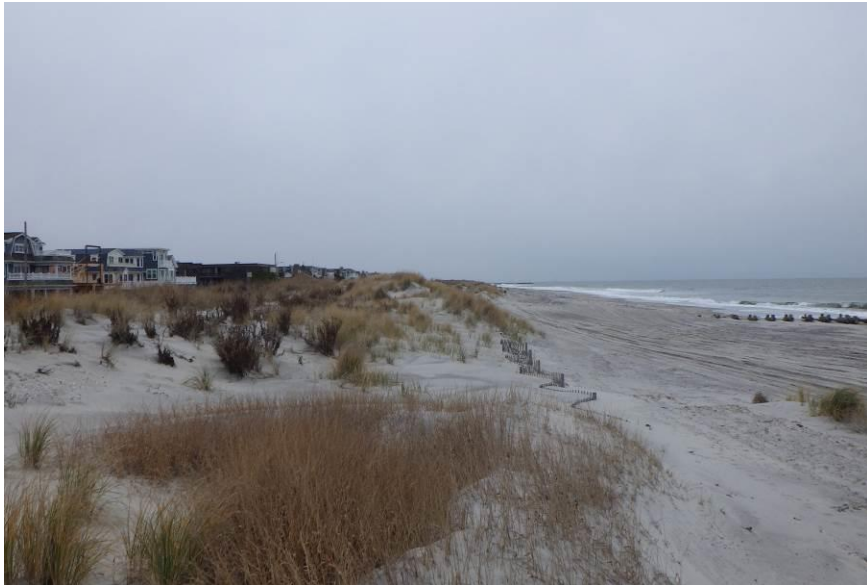
7c. December 3, 2021

View 7c. The December 2021 view shows a beach width at similar values with a small added sand volume on the dune slope due to wind deposition.

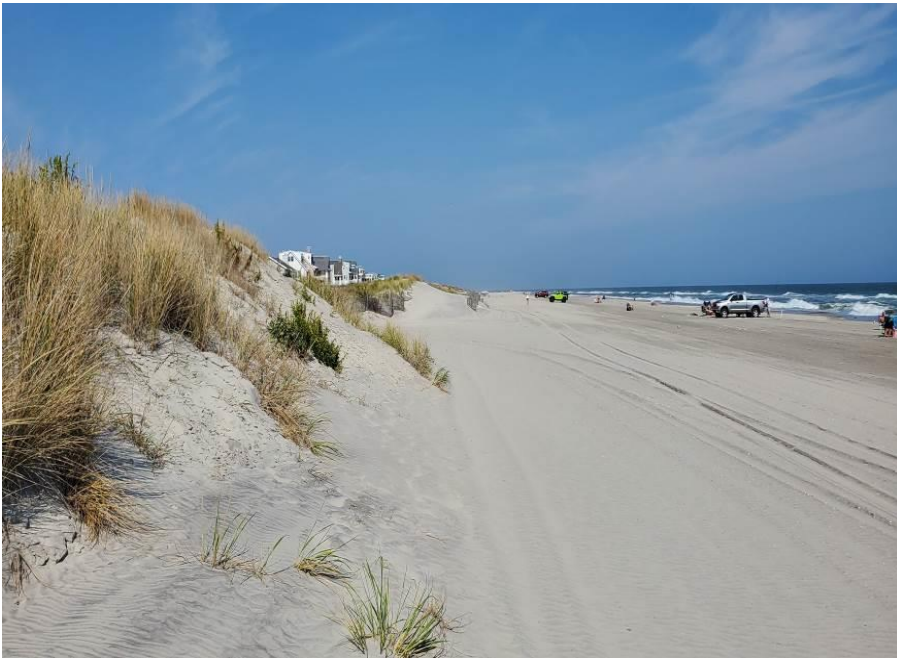
9a. September 18, 2020

View 9a shows the 28th Street beach following the summer 2020 season as the beach width improved in width due to sand deposition derived from northern beach sites.

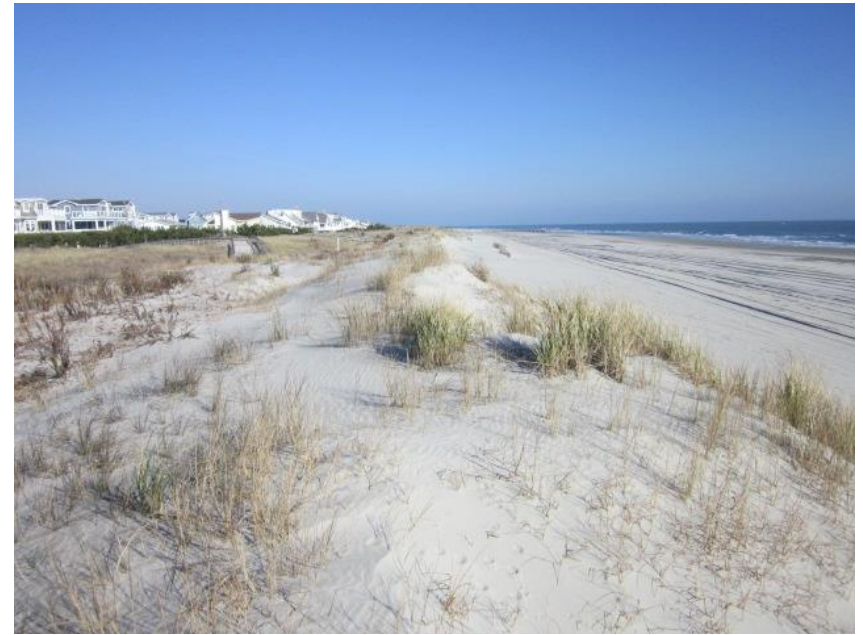
9b. December 11, 2020

View 9b shows the beach with wind deposition along the seaward dune slope and a generally higher beach elevation.

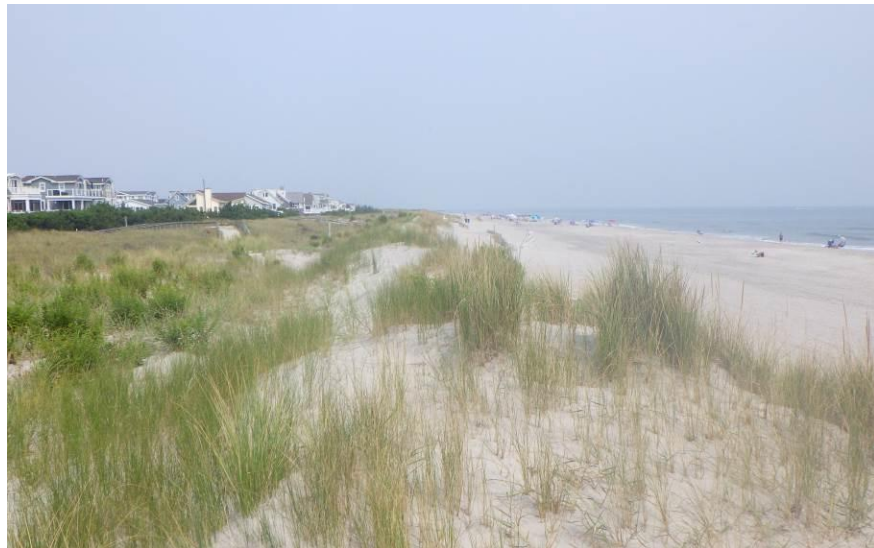
9c. September 14, 2021

View 9c was taken a year later than 9a and demonstrates continued vegetation improvement and a stable beachfront.

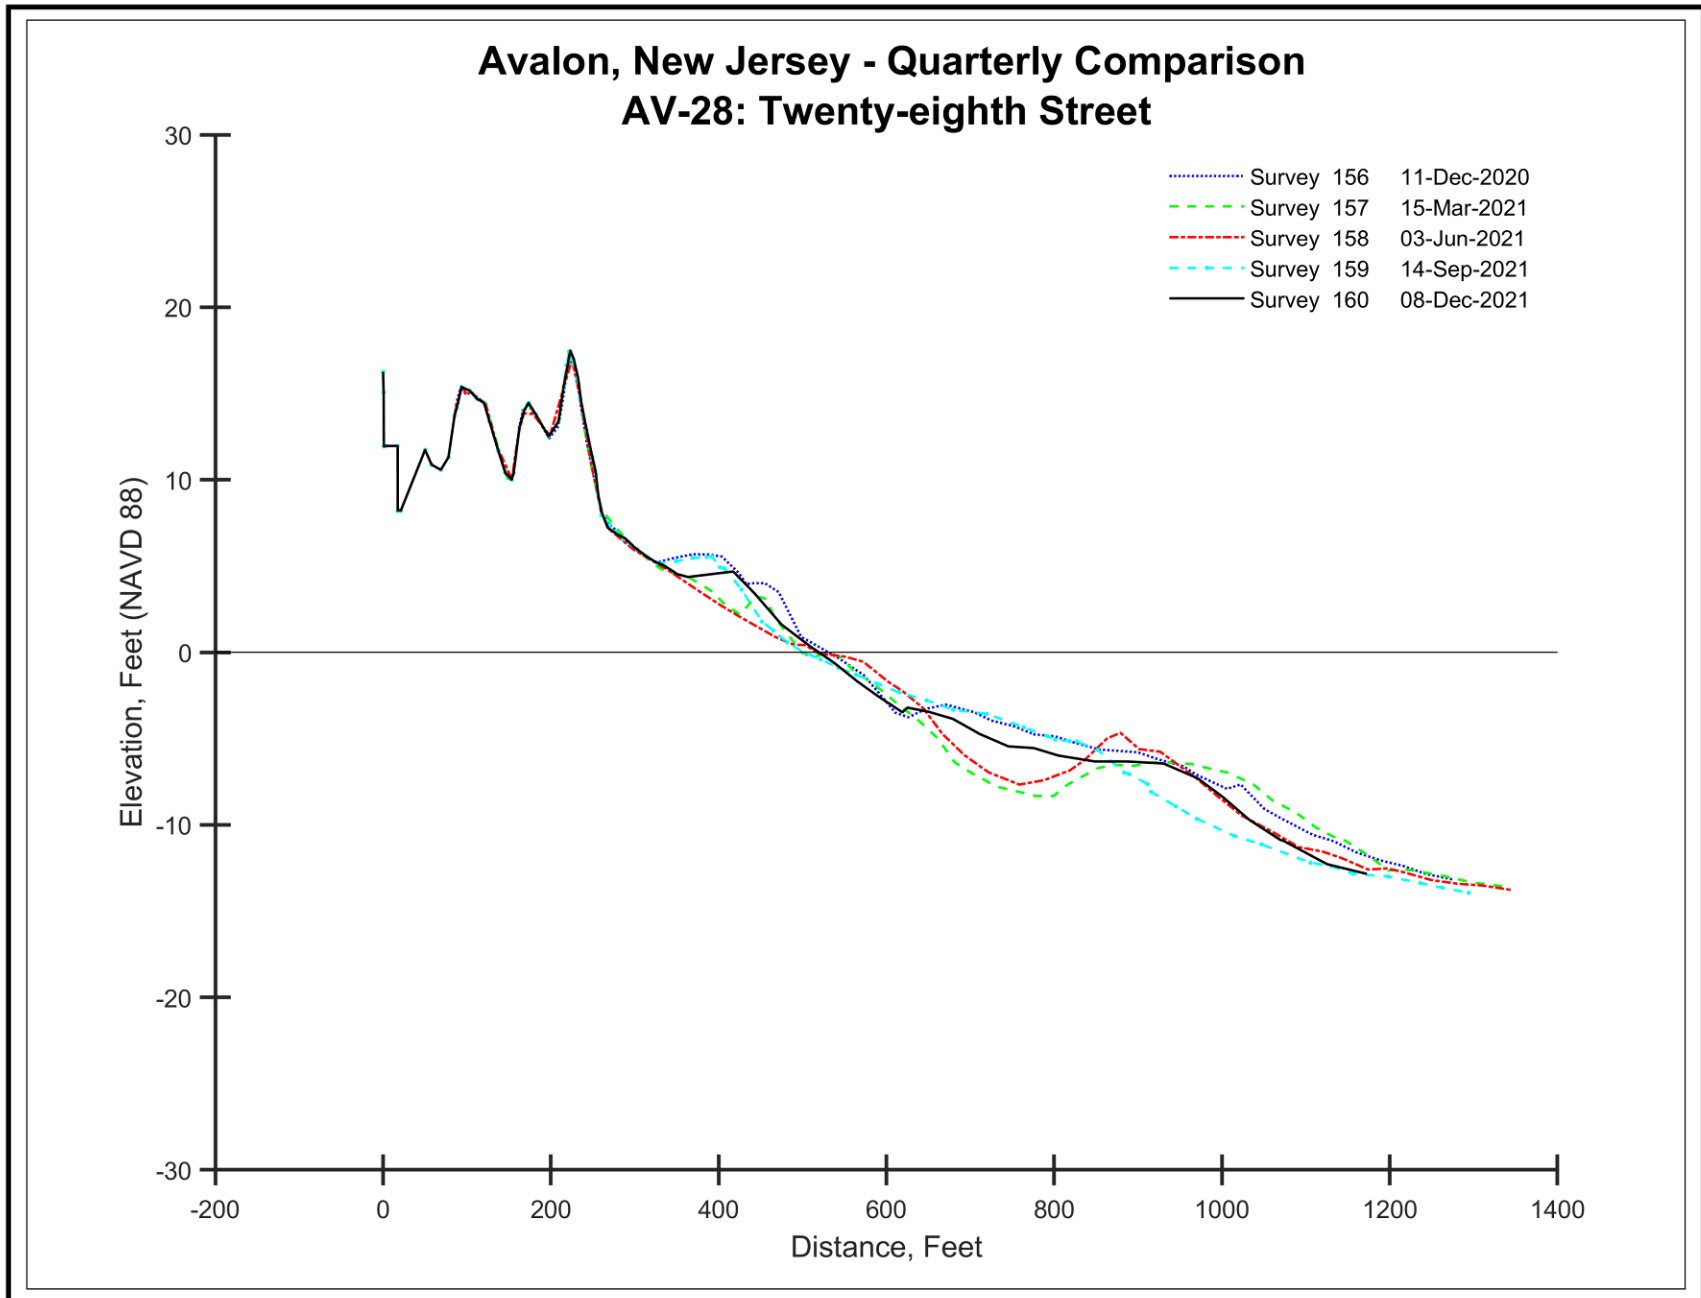
Figure 10. No sand has been placed at 28th Street directly in many years. The site benefits from littoral transport south from upstream beaches. Berm development was present in three of five surveys with sand deposited offshore in the bar trough as of December 2021.

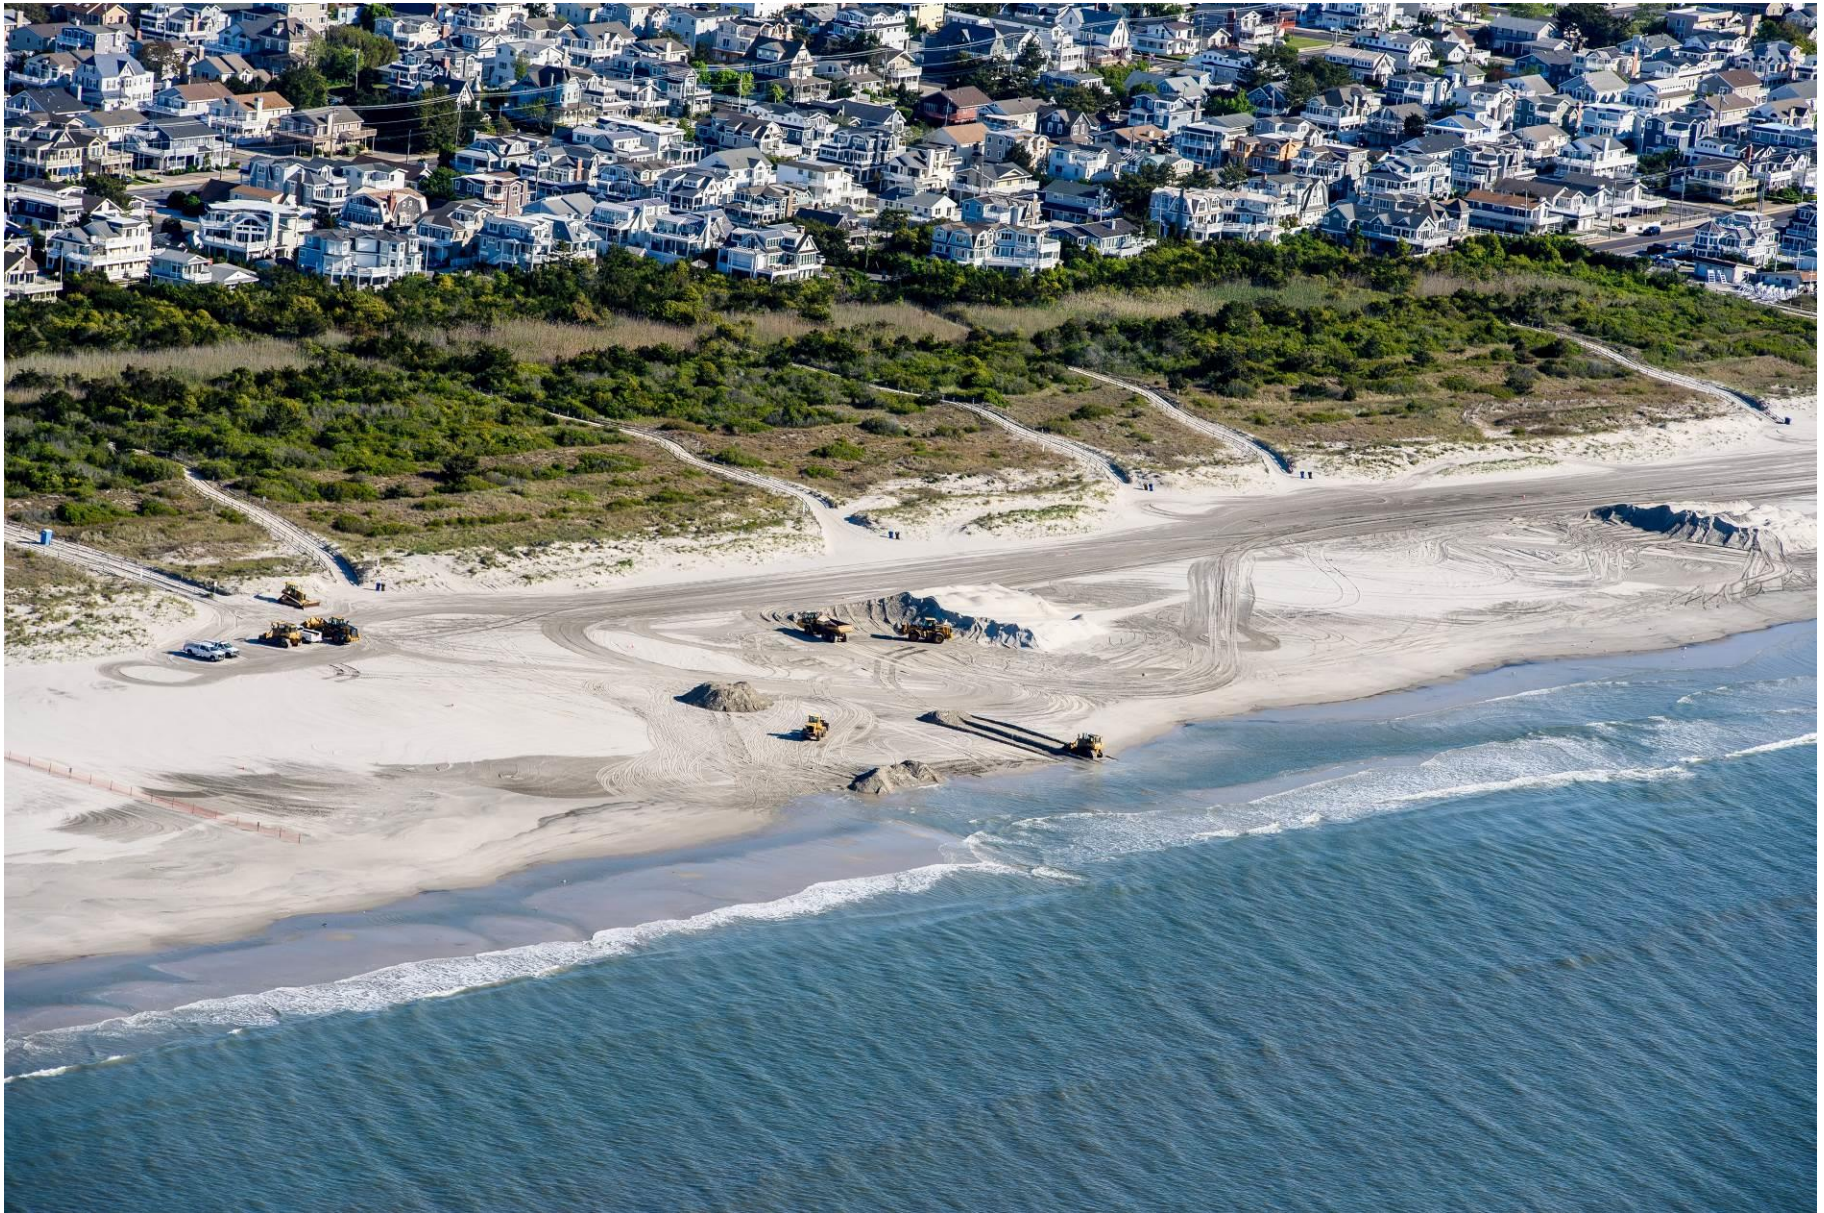
Figure 11. May 13, 2021 aerial view of sand harvesting between 35th and 38th Streets on the Avalon oceanfront. The bulldozer is pushing sand up from the intertidal zone derived from the small ridges of material migrating onto the dry beach. The stockpiled material is loaded into trucks and hauled on the beach to the depositional zone between 12th and 17th Streets. This view also illustrates the extensive dune system present at this site along with a wide dry beach that has accumulated sand over the past 35 years of study at this location specifically. To the left side of the photo is an orange fence defining the USF&WS exclusion zone for sand harvesting.

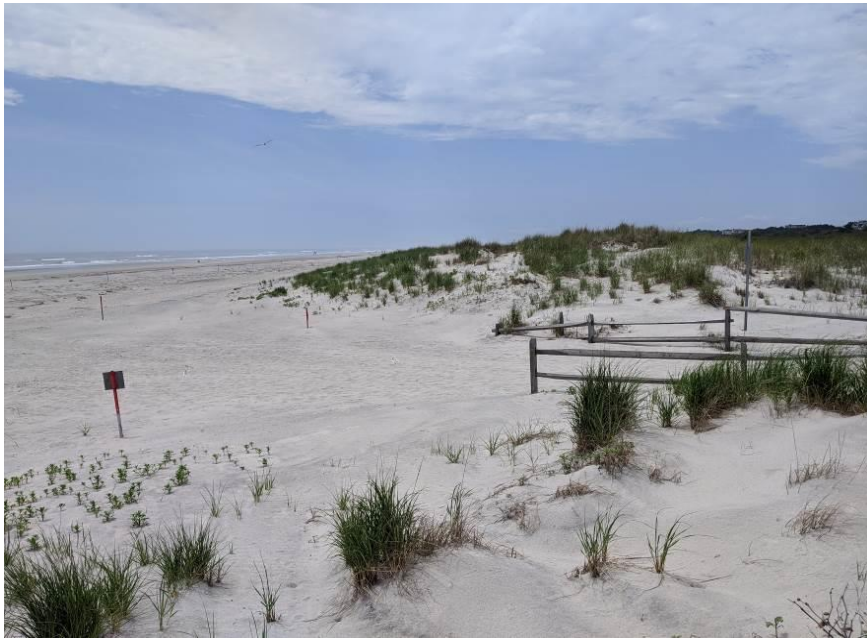
13a. June 4, 2020

View 13a is the same view in June showing grass growth and wind deposition in the dunes.

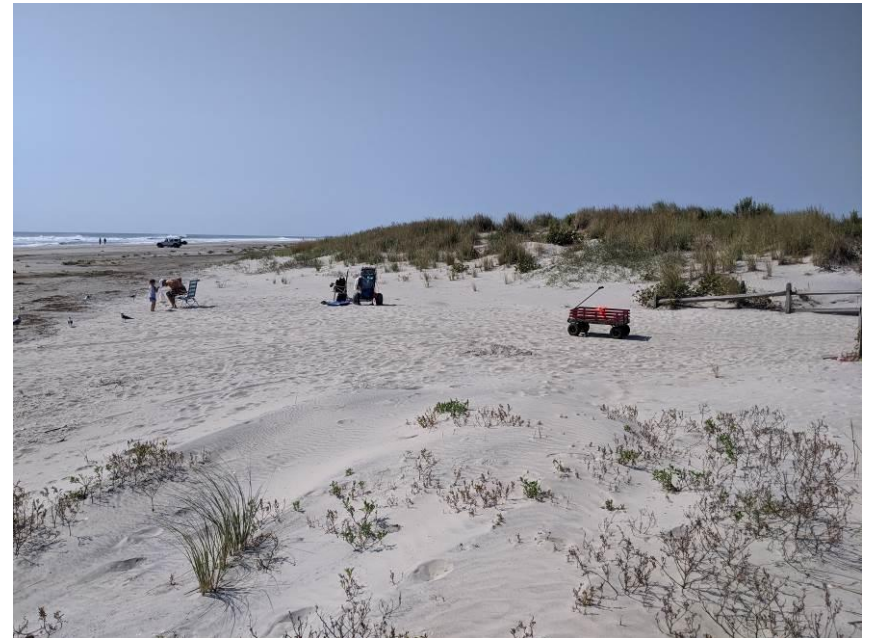
13b. September 23, 2020

View 13b is the September 2020 view to the south showing the dunes and beach where debris has been deposited near the dune toe recently.
