**FINAL REPORT FOR 2021
ON THE CONDITION OF THE MUNICIPAL OCEANFRONT BEACHES
BATHYMETRY OF TOWNSENDS INLET
THE BOROUGH OF AVALON, CAPE MAY COUNTY, NEW JERSEY**

**PREPARED BY: THE STOCKTON UNIVERSITY COASTAL RESEARCH CENTER
30 WILSON AVENUE
PORT REPUBLIC, NEW JERSEY 08241**

**ANNUAL REPORT FOR 2021 - TO THE BOROUGH OF AVALON
ON THE
CONDITION OF THE MUNICIPAL BEACHES & BATHYMETRY OF TOWNSENDS INLET**

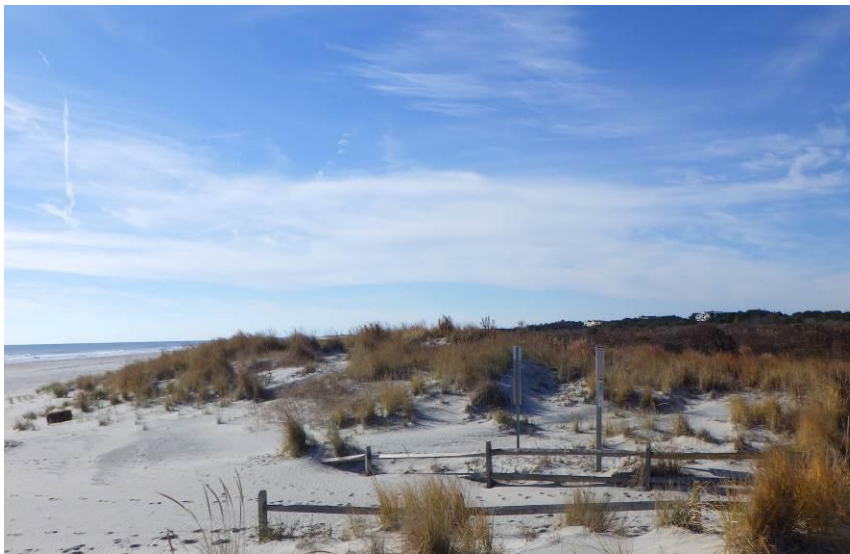
13c. December 7, 2021

View 13c represents the December 2021 view to the south along the foredune crest location including the upper beach. Comparing the June 2020 view with this picture demonstrates the added wind deposition at the post and rail fence.

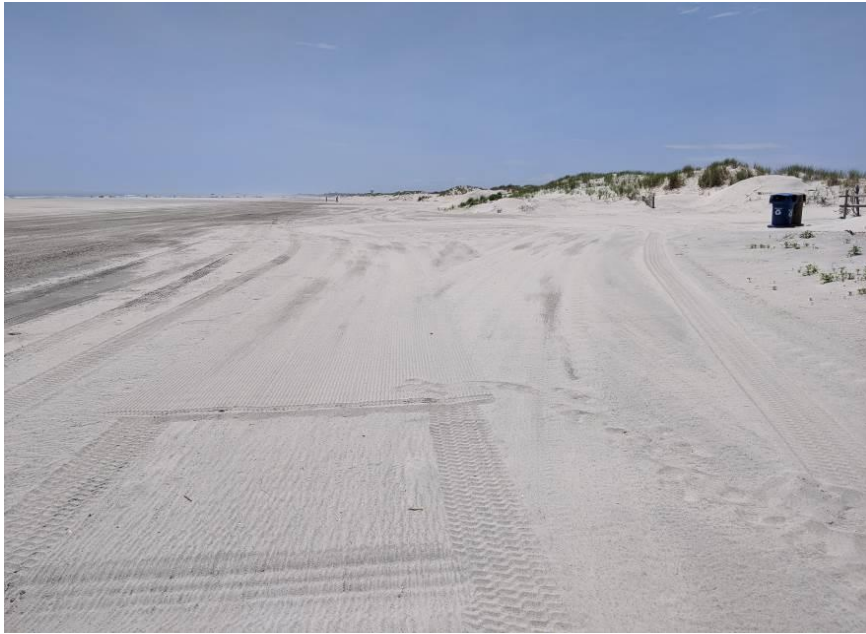
15a. June 4, 2020

View 15a. This June view shows the impact of beach raking at the dune toe with the debris removed from the beach.

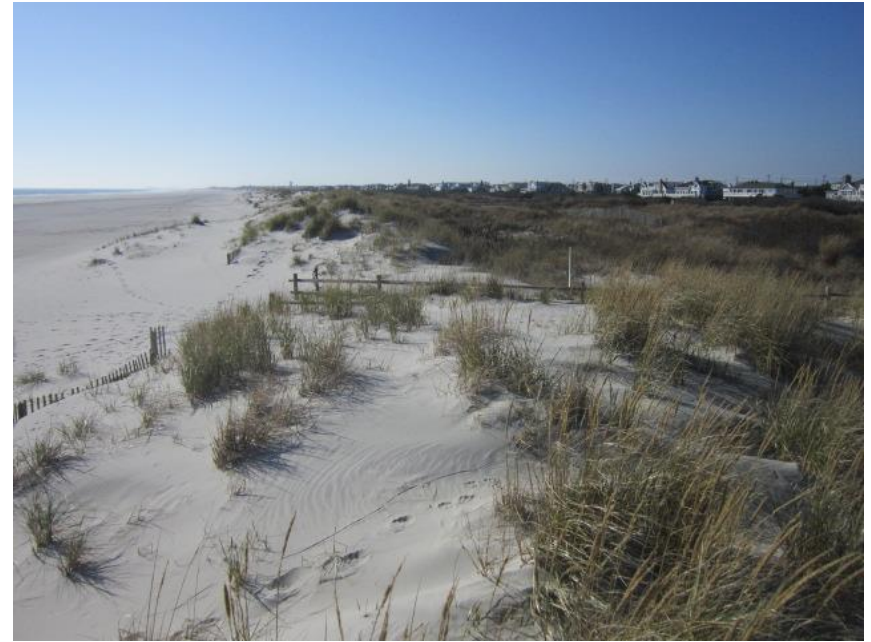
15b. December 11, 2020

View 15b. The December 2020 view shows sand accumulation in the dunes at the site.

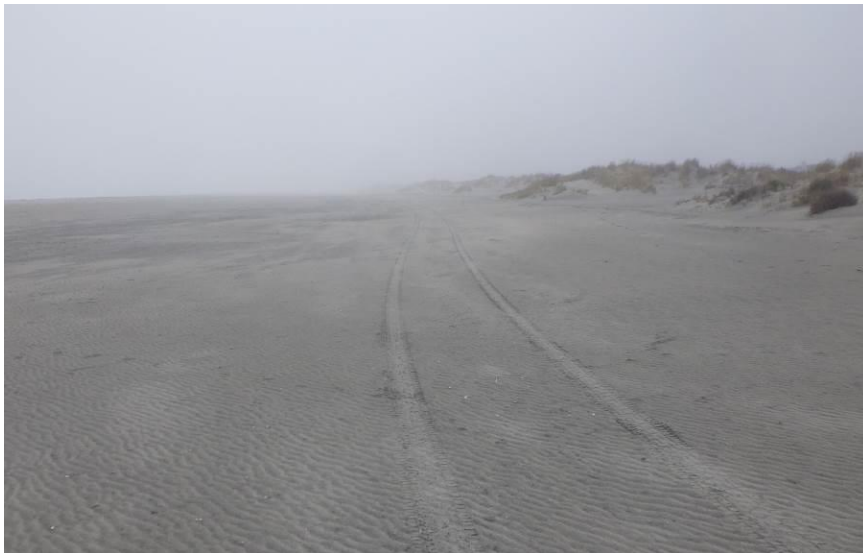
15c. December 6, 2021

View 15c. By December 6, 2021 fog obscures the view, but sand has materialized across the upper dry beach and into the dunes.

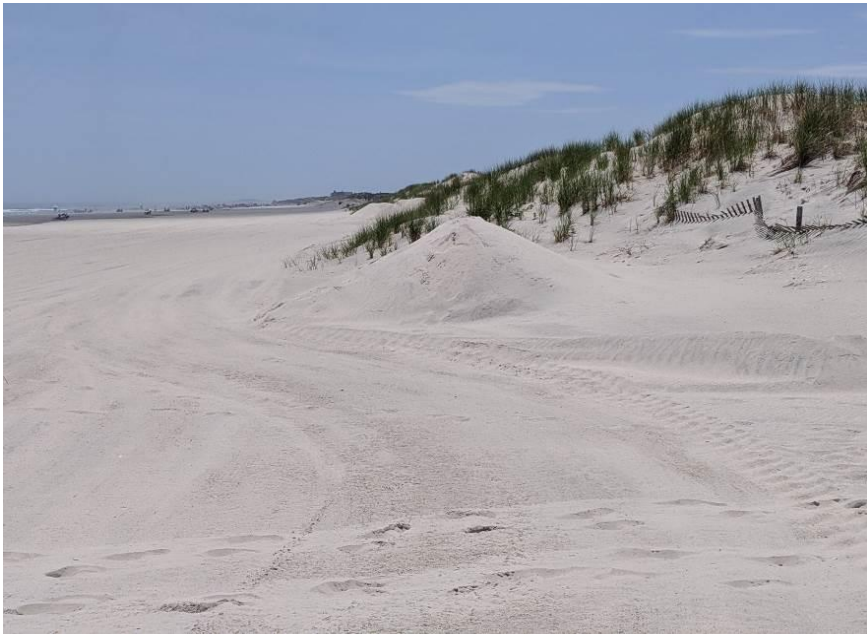
17a. September 23, 2020

View 17a is a view along the dune toe showing the expanse of dry beach and the foredune seaward slope.

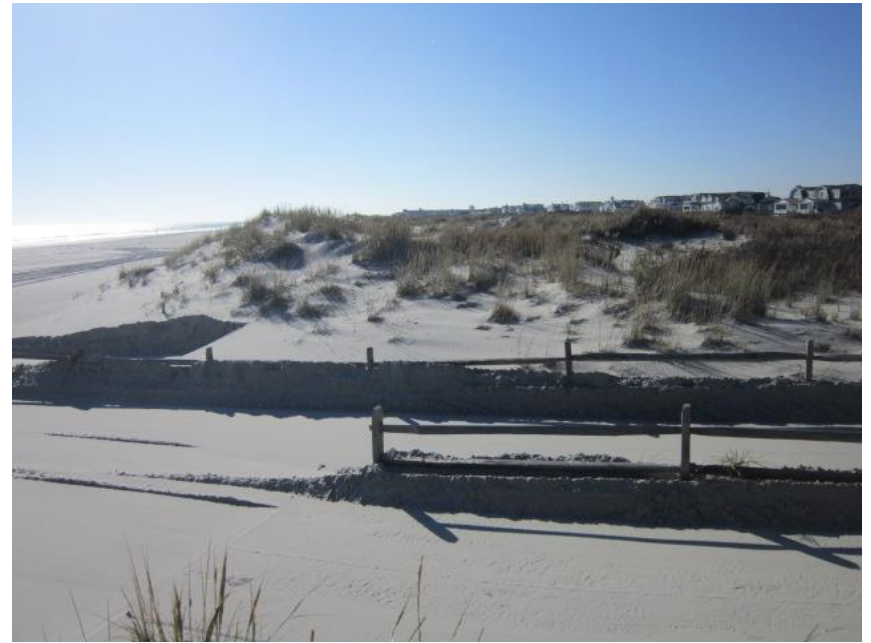
17b. December 11, 2020

View 17b. This view from north of the access pathway shows the dunes and dry beach with some sand pushed up along the pathway.

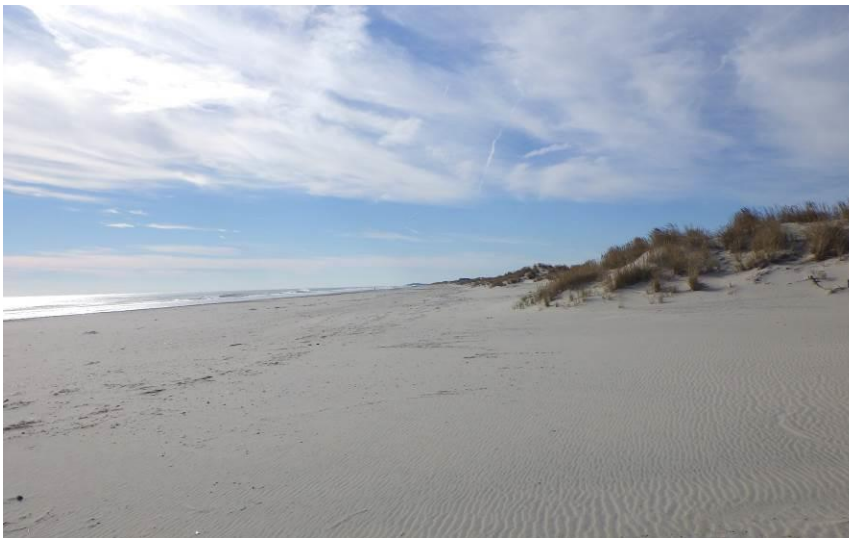
17c. December 7, 2021

View 17c. The December 2021 view is to the south along the seaward dune toe and across the dry beach width.

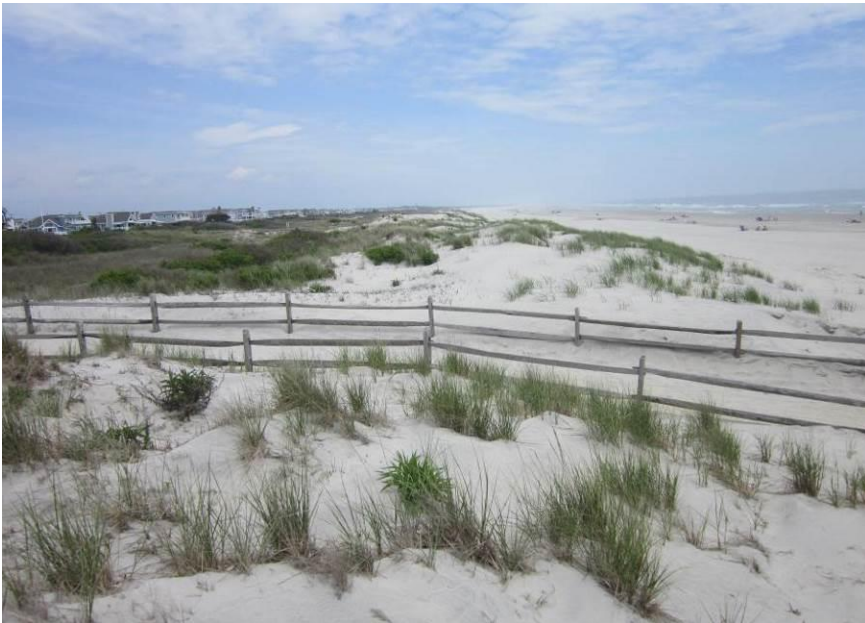
19a. June 5, 2020

View 19a. The spring view shows grass growth in full swing as the season gets going.

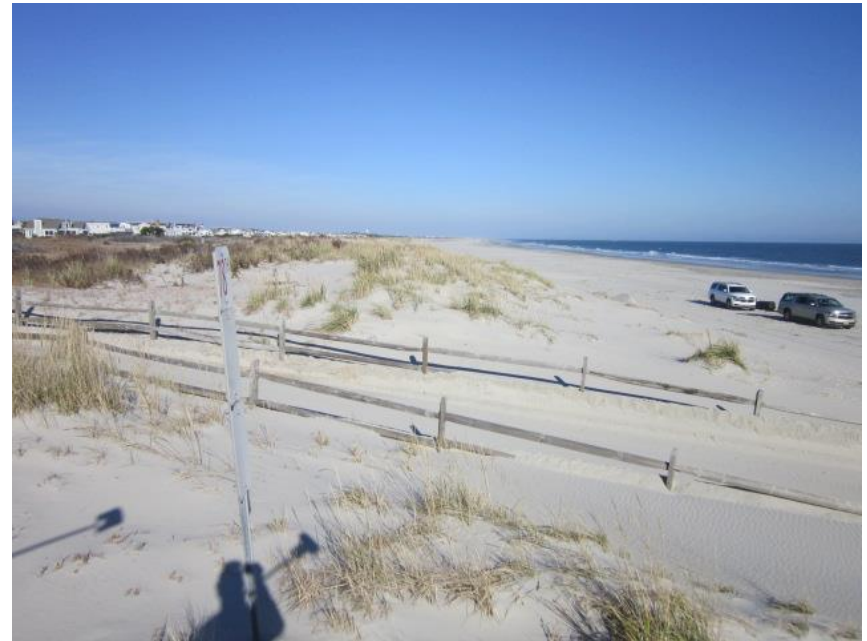
19b. December 11, 2020

View 19b. This view along the foredune area shows continued stability at the site with added sand across the seaward dune slope.

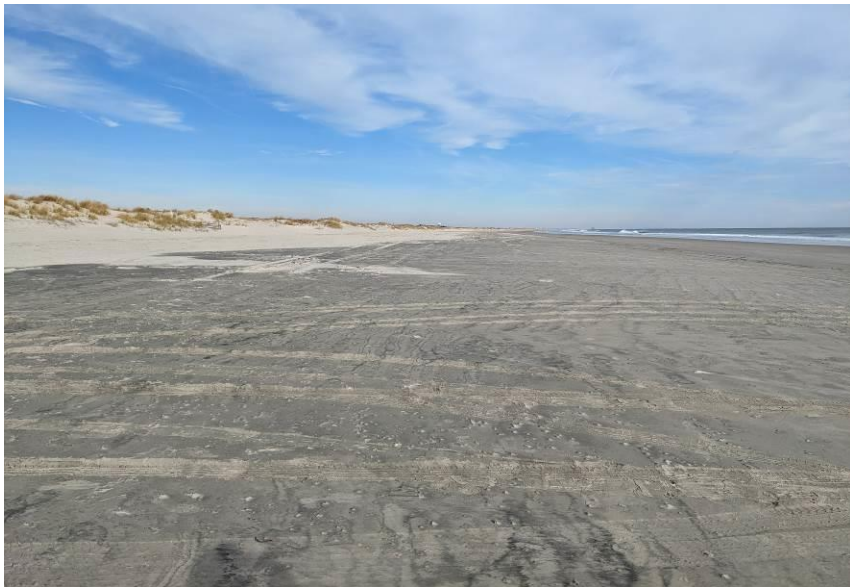
19c. December 7, 2021

View 19c. Out on the dry beach, wave run-up reached over half way to the dunes on this day when high tide was at 5.8 feet on a new moon.
