**FINAL REPORT FOR 2017  
ON CHANGES TO THE MUNICIPAL BEACHES  
FOR  
THE BOROUGH OF MANTOLOKING, OCEAN COUNTY, NEW JERSEY**

**PREPARED FOR: THE BOROUGH OF MANTOLOKING  
202 DOWNER AVENUE  
MANTOLOKING, NJ 08738**

**PREPARED BY: STOCKTON UNIVERSITY COASTAL RESEARCH CENTER  
30 WILSON AVENUE  
PORT REPUBLIC, NEW JERSEY 08241  
MARCH 30, 2018**

**Annual Report for 2017**  
**On the**  
**Mantoloking**  
**Oceanfront Municipal Shoreline**

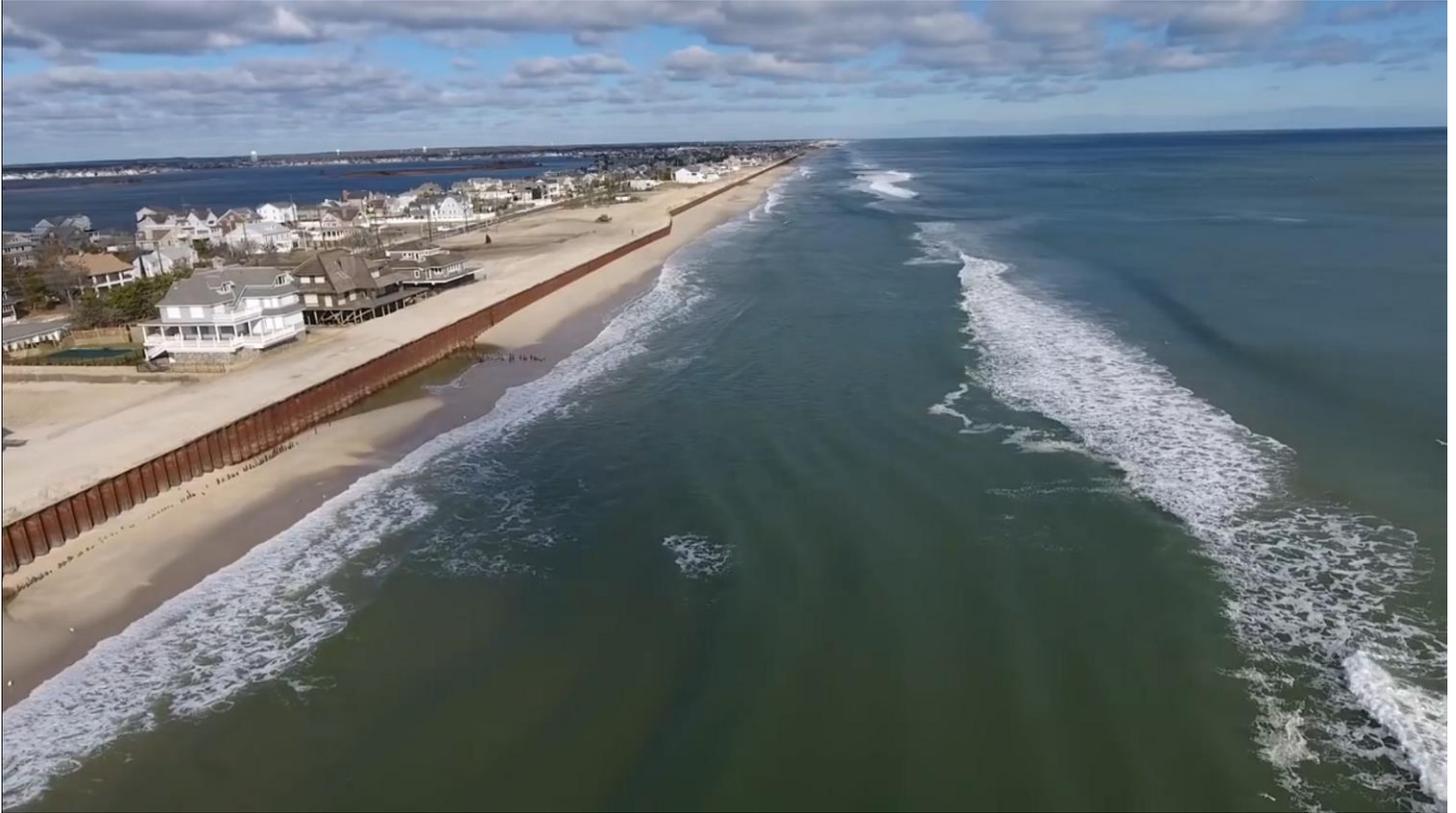
*Aerial view looking north along the region of Mantoloking devastated by Hurricane Sandy following yet another moderate nor'easter coastal storm in January 2017. This storm caused extensive beach erosion exposing the steel wall installed following Sandy. Storm waves and tidal surge reflexing off the exposed steel wall caused significant scouring and erosion removing a dry beach in this region. Although beach erosion was severe, the wall did prevent waves from impacting the remaining dune and from potential breaches occurring, averting over wash, property damage and serious community flooding. The storm deposited offshore parallel sand bar is clearly visible by the wave break and provided a source of sand for natural beach recovery in spring when the wave climate favored beach building. (Aerial photo courtesy of Ms. Jenny Buck)*

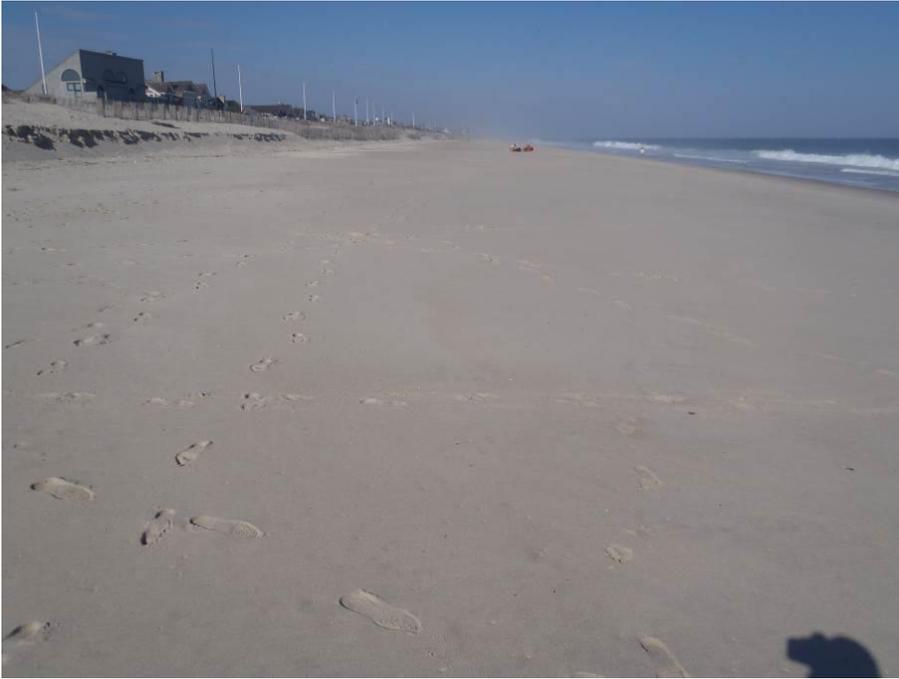
**1a. October 17, 2016**

***Photograph 1a shows the view from the beach berm during the final survey for 2016 with a relatively intact berm and beach but there is a dune scarp at the seaward dune toe indicating storm waves had recently over washed the beach and reached the dune.***

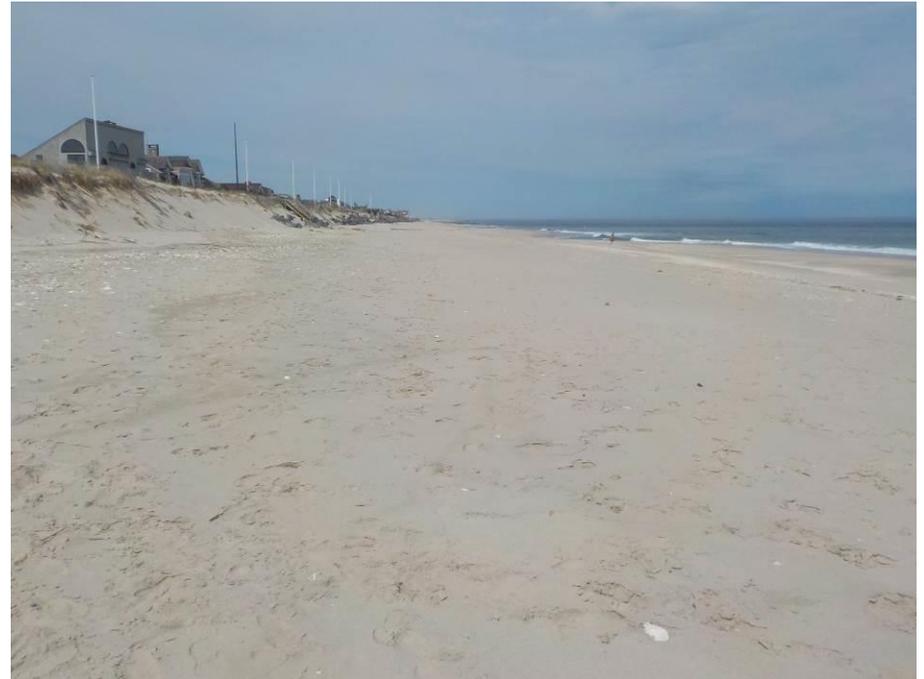
**1b. April 12, 2017**

***Photograph 1b shows a steeper seaward dune face, indicating winter storms had cut away at the seaward dune slope. By April, the beach had partially recovered through natural processes, reforming a berm ridge on the lower beach. To the north, the rock revetment is partially exposed.***

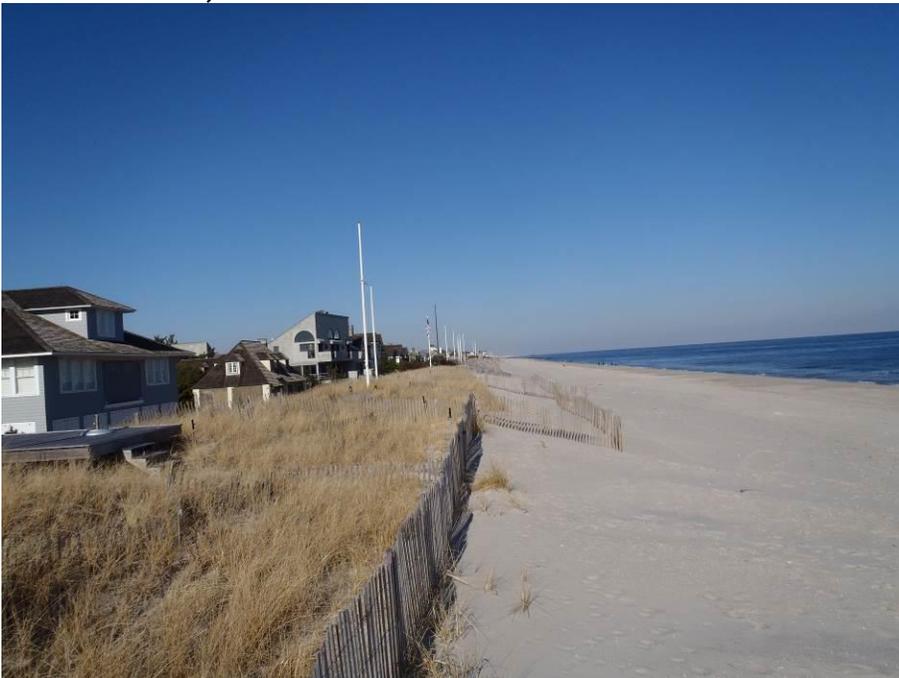
**1c. December 21, 2017**

***Photograph 1c shows the beach following the summer and fall seasons. By the December survey, the seaward dune slope and width of the toe, partially restored through maintenance efforts covered the rock revetment. The beach width and elevation mimicked its fall 2016 appearance.***

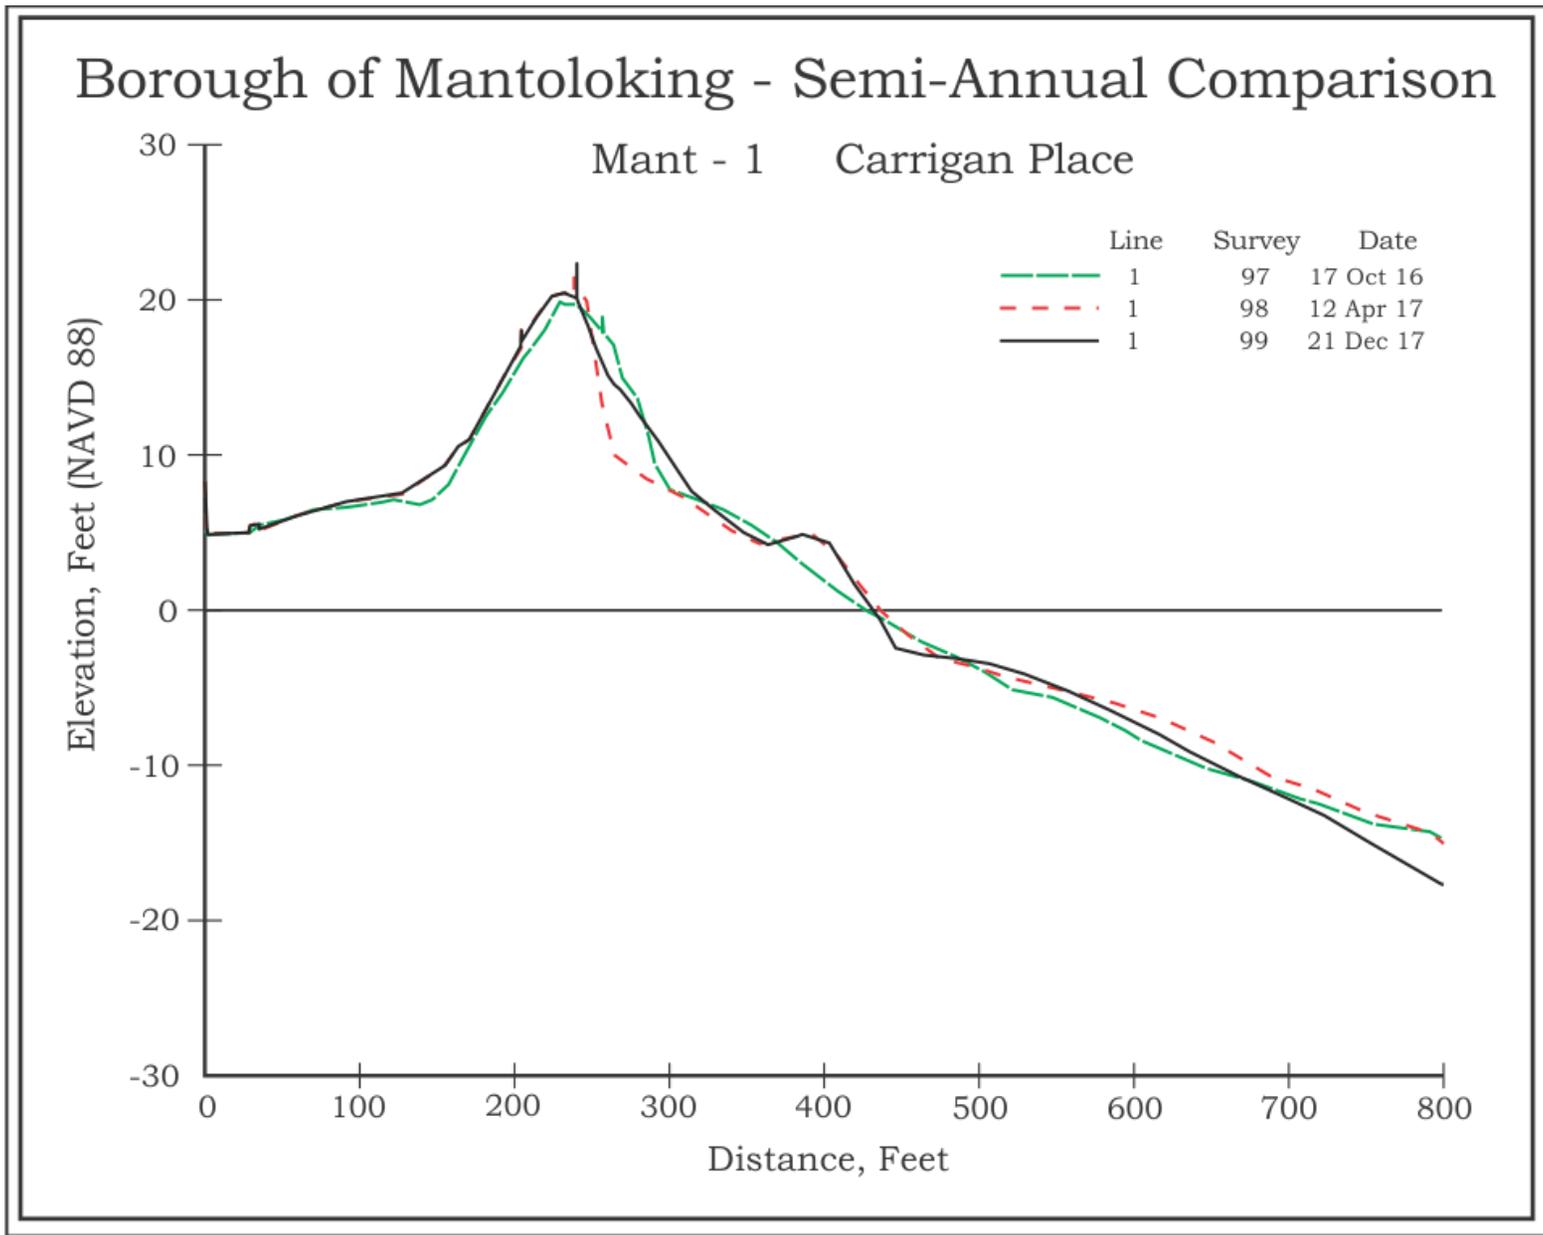
**Figure 1d: The cross section comparison above shows a significant loss of sand and width from the seaward dune slope over the winter season. The April survey showed some sand accumulated on the landward dune crest and slope and there was sand accumulation nearshore while the beach elevation was relatively stable with development of a new berm ridge on the beach face slope. By late fall 2017, the upper beach and seaward dune slope accumulated sand, fully restoring the October 2016 beach configuration and partially restoring the seaward dune slope.**

The winter wave climate eroded the upper beach and seaward dune slope, creating a steeper slope and removing 25 feet of dune width. By April 2017, natural processes moved sand onshore, reforming a berm ridge on the lower beach. Sufficient sand returned to the beach (6.98 yds<sup>3</sup>/ft.) over the remainder of 2017 to allow maintenance efforts to move landward and restore a gentler seaward dune slope although offshore losses offset onshore gains for a net loss of -7.36 yds<sup>3</sup>/ft. of sand. The December 2017 survey, showed the dune toe width had actually expanded over the year to 180 feet while the crest elevation accumulated sand, at 20 feet NAVD88. Some sand shifted from the seaward crest to the landward slope but the net volume remained approximately the same from October 2016 to December 2017. The net changes for the year included a gain of 3.89 yds<sup>3</sup>/ft. of sand and a 4-foot advance in the shoreline position.

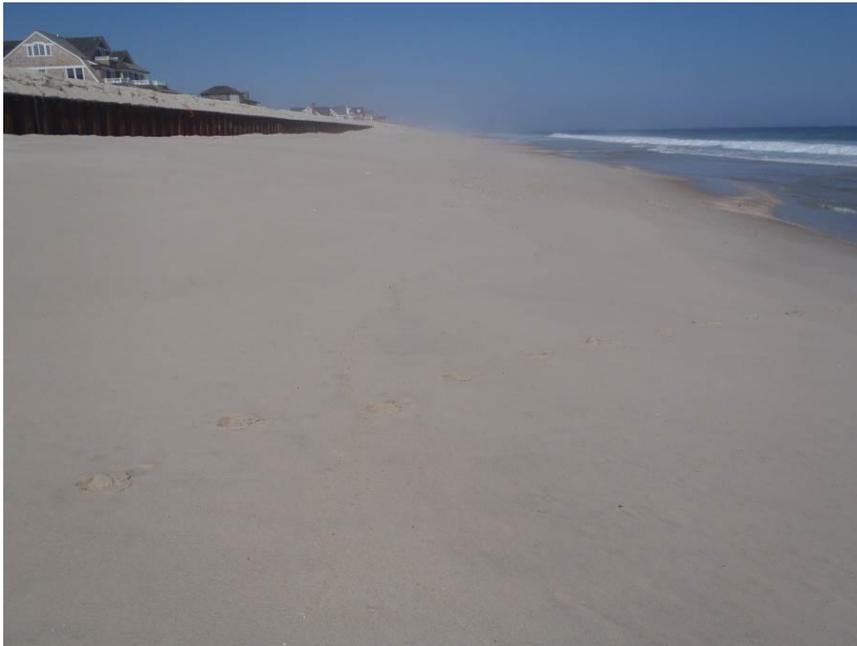
**2a. October 17, 2016**

***Photograph 2a. shows a steep, narrow beach resulting from Hurricane Hermine and a late September storm event that exposed 5.5 feet of the steel sheet wall along a 400-foot section.***

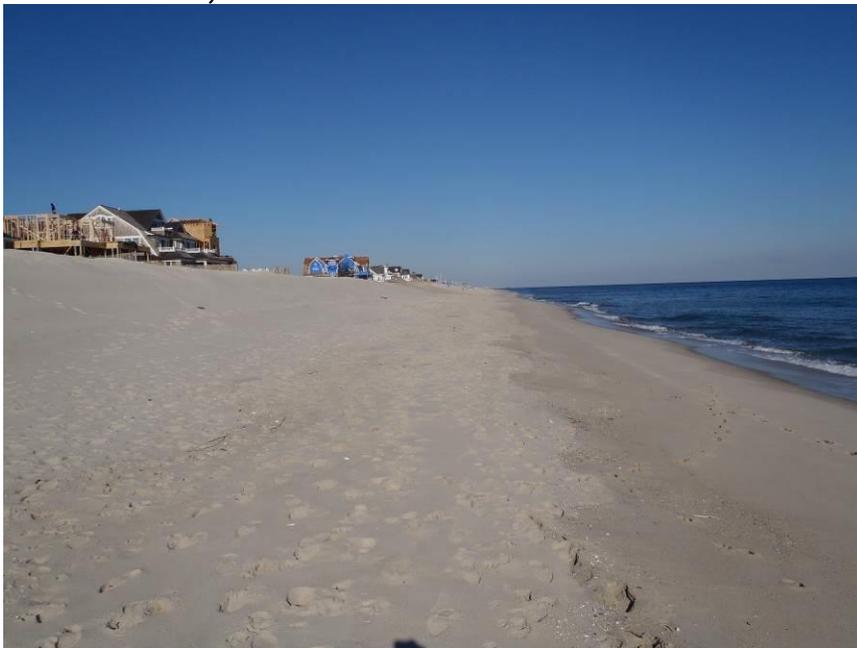
**2c. December 21, 2017**

***Photograph 2c. Natural sand recovery occurred over the summer and fall as sand moved landward cross-shore from the offshore slope. Maintenance efforts moved sand onto the seaward dune slope covering the steel wall, restoring the seaward slope and a modest recreational beach.***

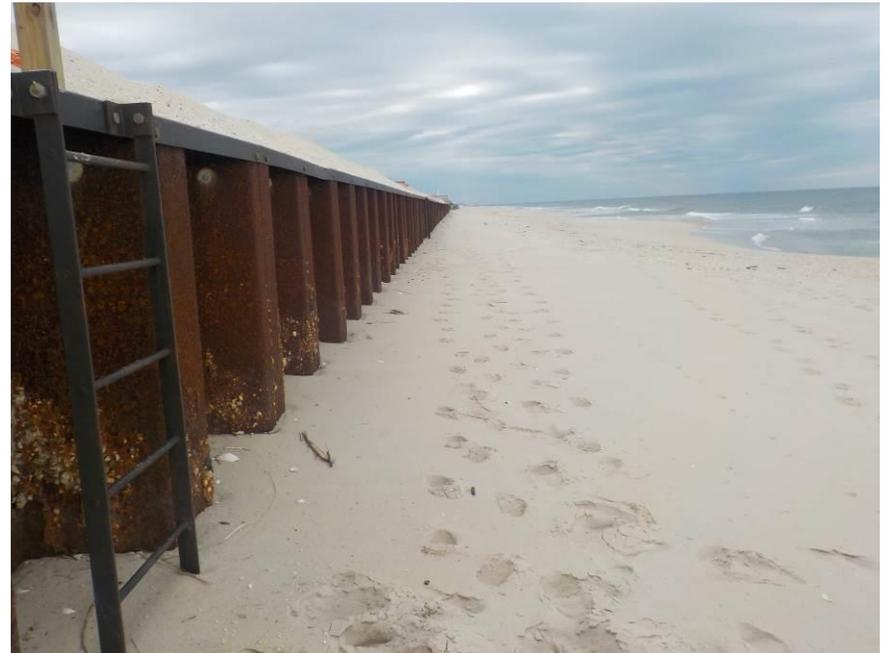
**2b. April 12, 2017**

***Photograph 2b. shows the winter storms prevented any significant sand recovery along the steel wall but lower on the beach natural processes pushed sand onshore expanding the beach width. The thin strip of sand seaward of the wall provided minimal beach access in this section.***

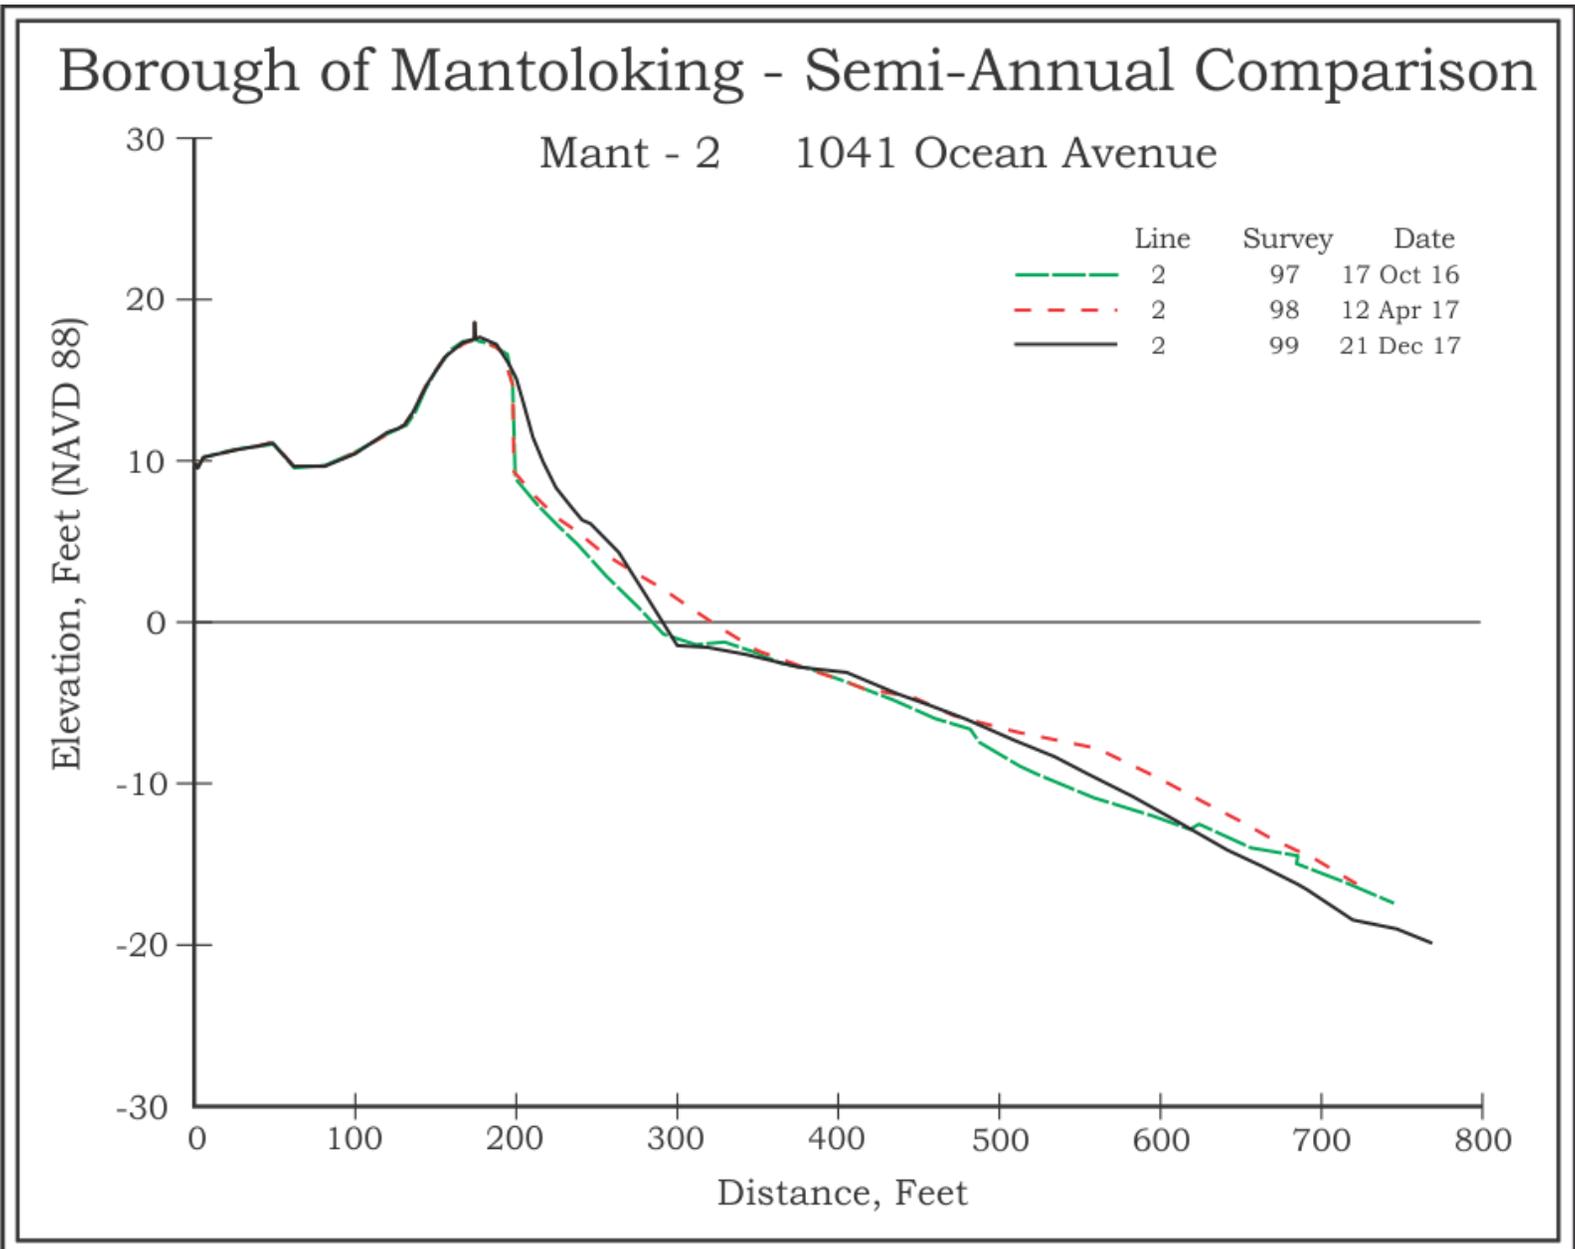
**Figure 2d: The cross sections at 1041 Ocean Avenue show the shoreline position advanced from October 2016 to April 2017 with sand accumulation on the beach face slope and further offshore. By December 2017, sand moved onshore, but waves and maintenance efforts moved the sand higher onto the beach and to the seaward dune slope. The steeper beachface slope resulted in shoreline retreat while the loss of sand offshore resulted in a net sand volume loss from April and December. The annual change was a modest volume gain.**

In 2017, the wall exposed at the end of 2016 and during the winter months through several storm events. Sand accumulated nearshore and on the lower beachface slope by April 2017. The early spring volume gain of 24.07 yds<sup>3</sup>/ft., most of which accumulated below the datum (19.54 yds<sup>3</sup>/ft.) pushed the shoreline position seaward (37 ft.). Over the summer and early fall sand moved onshore through natural processes from the nearshore then pushed higher onto beach to restore the seaward dune slope through maintenance activity. The movement of sand from the beachface slope to the dune resulted in 30 feet of shoreline position retreat by December 2017. Although sand may have accumulated on the beach in greater volumes over the summer, by December the fall wave climate likely eroded any beach berm that developed. The net onshore accumulation of 3.49 yds<sup>3</sup>/ft. of sand didn't offset the significant loss (-16.64 yds<sup>3</sup>/ft.) of sand offshore resulting in a net profile volume loss of -13.15 yds<sup>3</sup>/ft. of sand. Despite this loss in the second half of 2017, the net annual changes still resulted in a net gain here of 9.34 yds<sup>3</sup>/ft. of sand, mostly to the dune and beach (8.02 yds<sup>3</sup>/ft.), that advanced the shoreline seaward 6 feet.

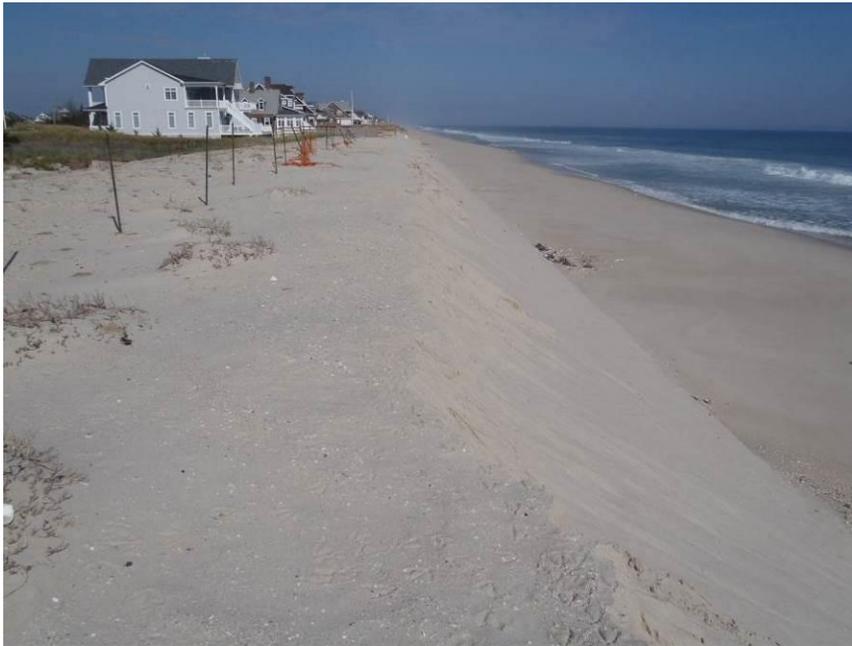
**3a. October 16, 2016**

***Photograph 3a The October beach profile shows the impact of a late September 2016 NE storm that lasted several days with a mild wind set, but a long duration. This resulted in the scarp seen in the dune toe and narrow beach. Erosion did not expose the wall exposed in this location.***

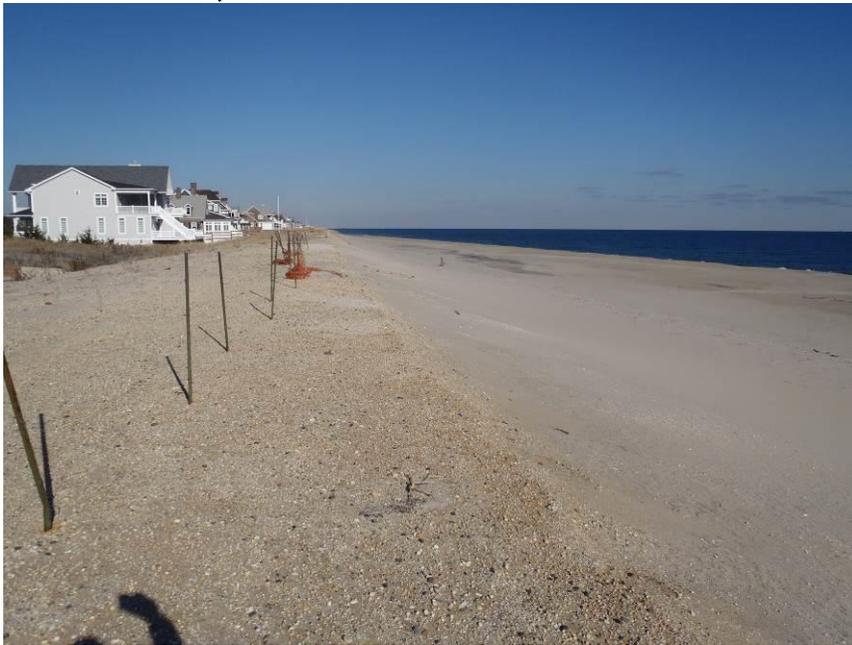
**3c. December 21, 2017**

***Photograph 3c. By December, a combination of natural sand recovery over the summer and an infusion of sand from the startup of the federal shore protection project in fall restored the seaward dune slope and added significant beach width.***

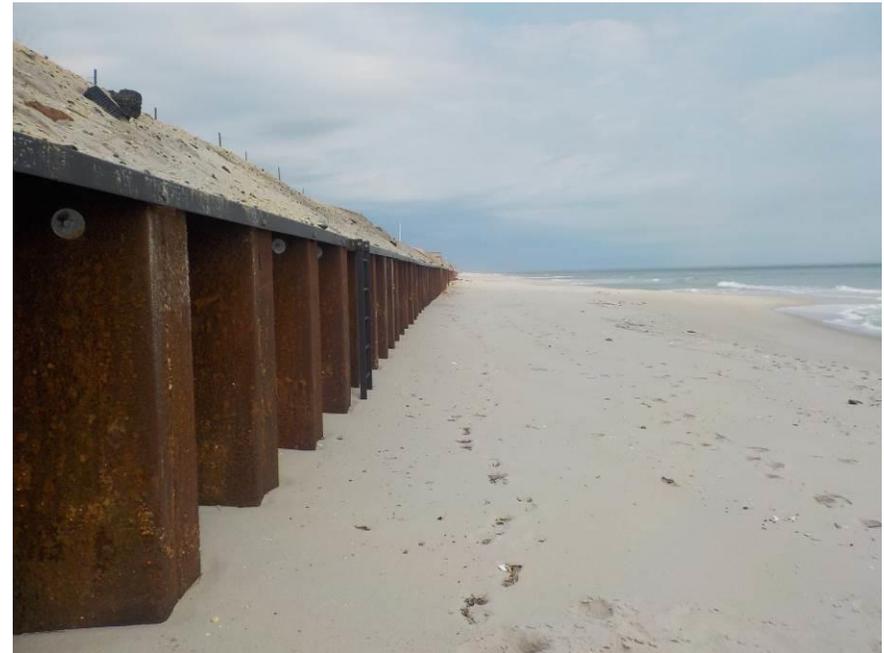
**3b. April 12, 2017**

***Photograph 3b shows the winter wave climate further eroded the beach, exposed the steel wall and steepened the dune scarp on the seaward slope. By April, the beach showed multiple beach cusp along the shoreline. Scouring along the wall resulted in about 6 feet of vertical relief to the beach.***

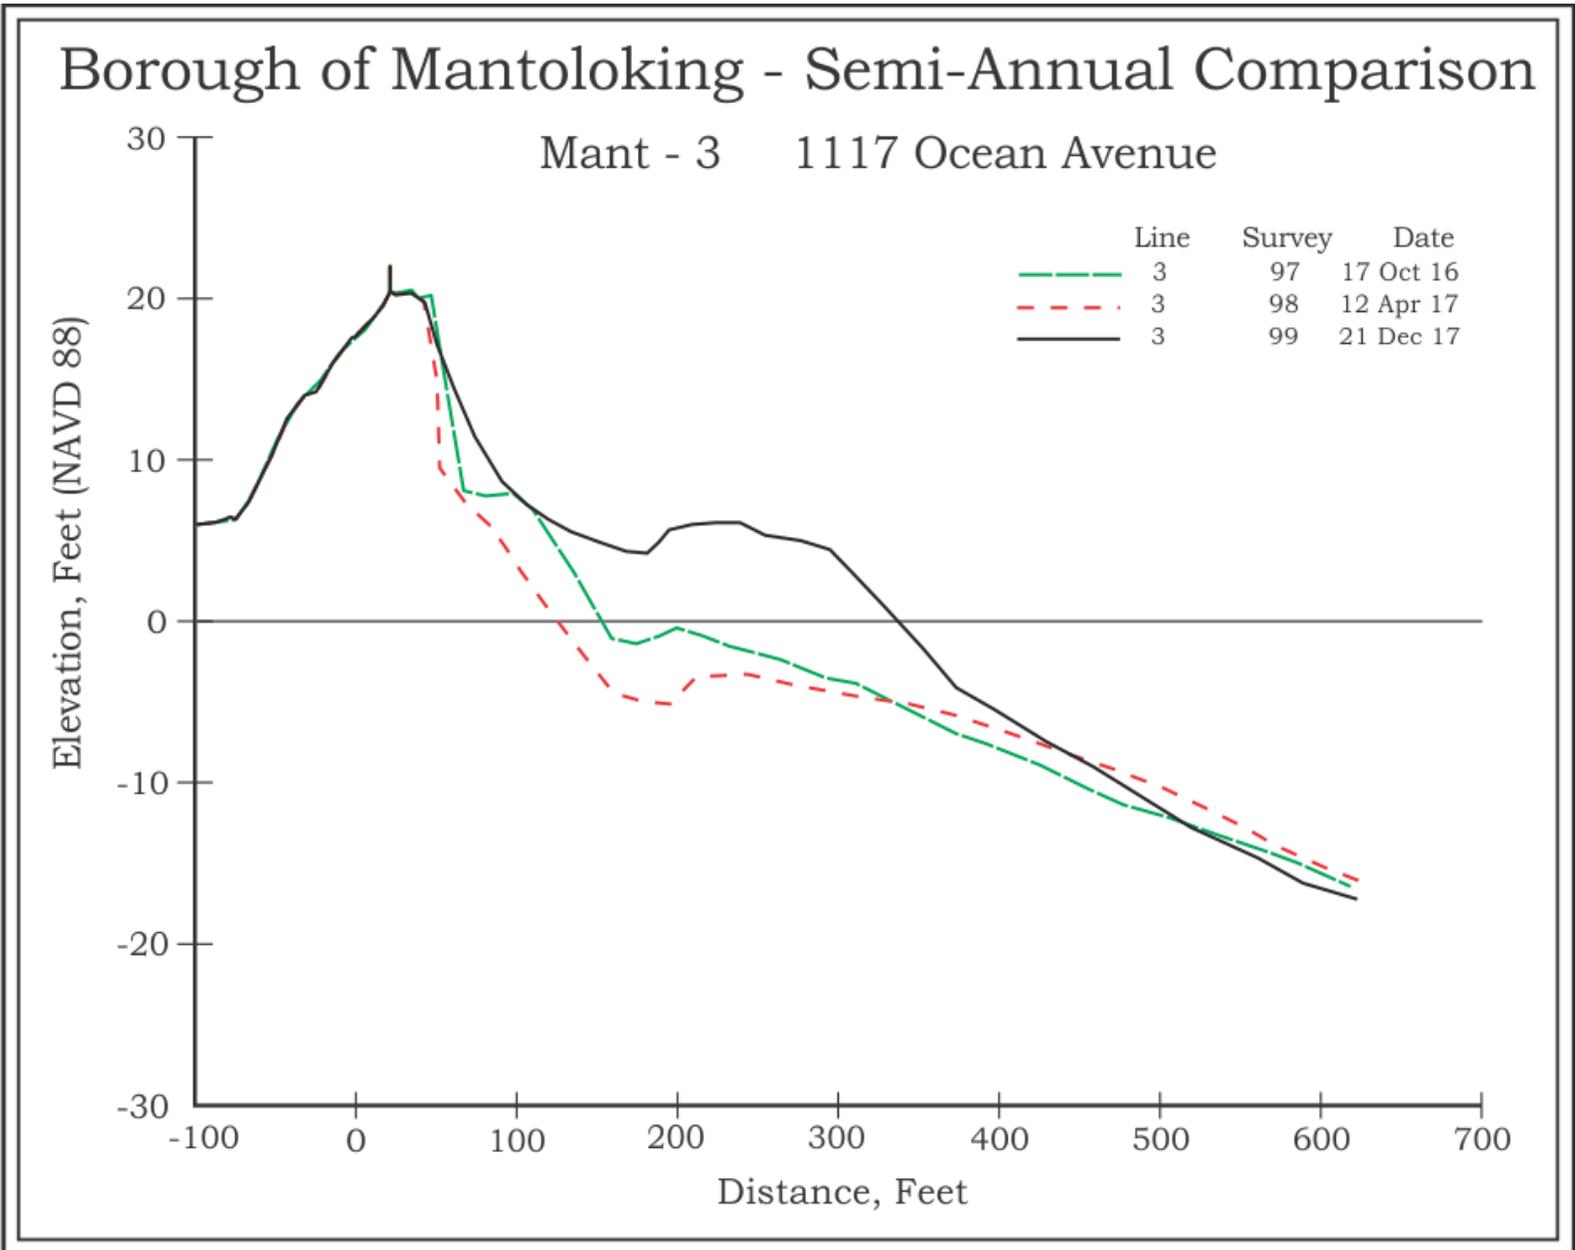
**Figure 3d: The cross sections show significant shoreline changes at 1117 Ocean Avenue. The dune and beach initially retreats landward following several storms with modest sand accumulation offshore by April. Over the summer, some sand did move back onshore naturally and sand pushed up to restore the seaward dune slope and cover the wall. By December 2017, sand from the federal project had accumulated nearshore as a wedge at the shoreline, raising the elevation over 6 feet and moving the shoreline seaward over 200 feet.**

Erosion continued to plague this site over the winter of 2017, following several moderate northeast storms the beach berm eroded and the seaward dune slope eroded to the steel wall, exposing the feature with a 5-6 foot vertical drop to the beach. Nearshore wave scouring transferred sand from the shoreline to further offshore, partially offsetting the onshore and nearshore loss. Net loss from October 2016 to April 2017 included 28 feet of shoreline position retreat and -16.28 yds<sup>3</sup>/ft. of sand loss.

Over the remainder of the spring through early fall conditions favored natural beach building and sand recovery. Maintenance activity restored the seaward dune slope and buried the steel wall to restore beach access. The greatly anticipated USACE federal shore protection project for northern Ocean County began placing sand on the Mantoloking shoreline in late fall 2017 and by December 21, 2017 sand had accumulated at this location. The project added a wedge of sand to the beachface and nearshore extending the shoreline position seaward 212 feet. A wider beach width supports continued development of the dune and enhanced shore protection for this once vulnerable section of shoreline. Although the project was ongoing at the time of this survey the site had already received 80.08 yds<sup>3</sup>/ft. of sand. The anticipated final sand placement volume should exceed the volume of material eroded during Sandy. Based upon past monitoring this should remain a relatively stable shoreline as cross-shore transport dominates sand movement in this region, exchanging sand between the dune and beach and nearshore based on the seasonal wave climate. Now that the beach width is sufficient to support dune growth the need and frequency of maintenance diminishes in moving sand from the beach to restore the dune slope and keep the steel wall buried.

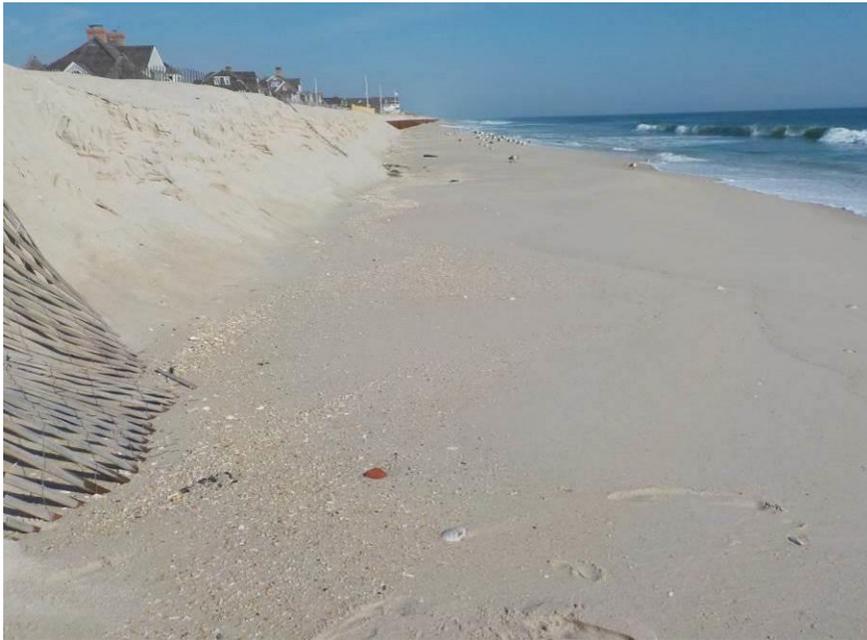
**4a. October 16, 2016**

***Photograph 4a This view shows the impact of September 2016 storm erosion that exposed the steel wall visible in the distance to the north but remained buried here. Large waves are breaking on the shallow platform created by the transfer of eroded sand from the beach cross-shore where it accumulated nearshore.***

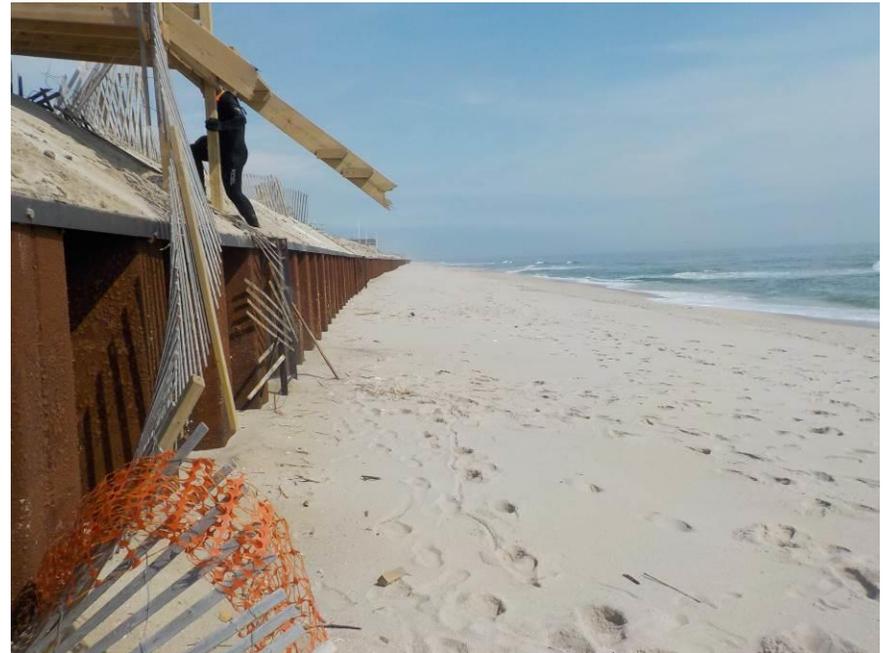
**4b. April 12, 2017**

***Photograph 4b Winter storms caused significant beach and dune erosion, exposing the steel wall and leaving 4-6 feet of vertical relief from the remaining seaward dune slope to the beach below the wall.***

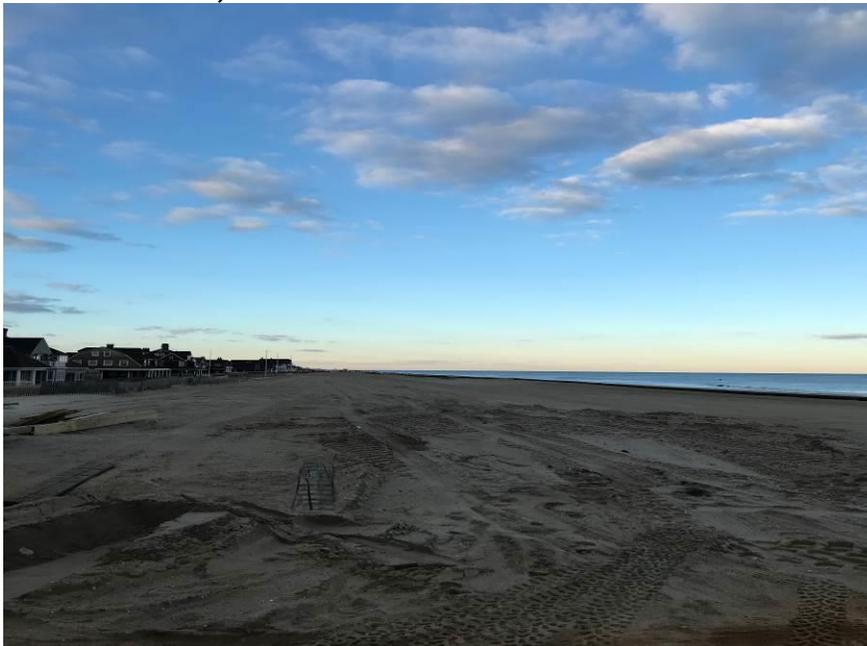
**4c. January 19, 2018**

***Photograph 4c The Federal shore protection project, completed here by January 19, 2018, added a massive quantity of sand to this site that extended seaward to the profile limits. The dune more than doubled in size and beach width expanded seaward several hundred feet.***

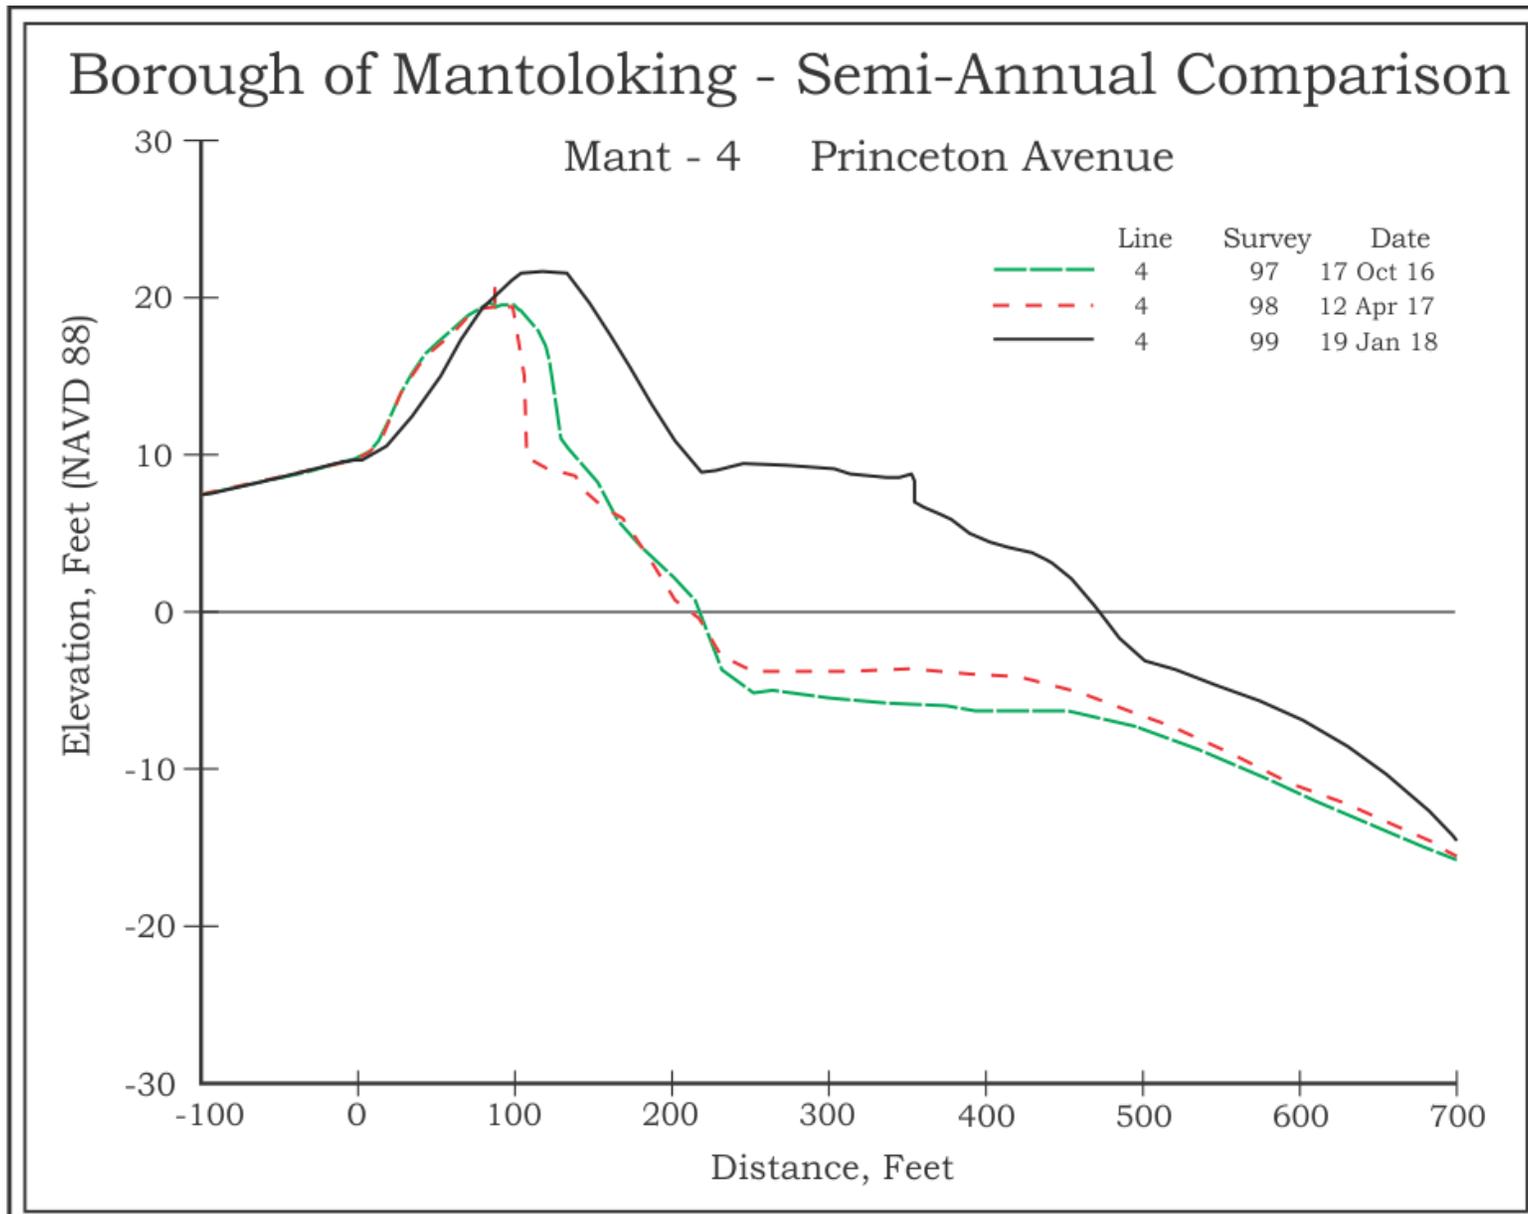
**Figure 4d: Initially the seaward dune slope eroded to a vertical scarp in response to the winter wave climate, by April the steel wall was fully exposed. The beach width was relatively stable over the winter and sand accumulated nearshore. Natural recovery occurred over the summer months but by the end of the year the USACE project had started here. By January, a massive wedge of sand added transformed the typical minimal beach profile seen here for the last three decades into a formable shore protection feature. Note that the new federal beach profile comes to closure 700 feet from the reference position indicating possible future adjustment seaward.**

Erosion of the seaward dune slope occurred over the winter of 2017. Waves removed 20 feet of width at the toe and cut away the sand covering the steel wall. Erosion left a steep 10-foot near vertical drop from the dune crest to the beach, with 5-6 feet of vertical relief along the wall exposed from top to base. During the same period sand accumulated nearshore to the offshore profile limits offsetting the onshore losses. By April 2017, the site accumulated a net 14.96 yds<sup>3</sup>/ft. of sand, despite the dune and beach erosion. This offshore sand deposit provided a source of sand for natural sand recovery and beach building as the weather pattern and wave climate shifted to favorable conditions for beach building in late spring and summer.

The USACE project started in this region during late fall, a massive quantity of sand placed by January 19, 2018 masked any natural changes that occurred since April. The dune volume nearly doubled while the crest elevation reached 22 feet and 30 feet wide with a dune toe width of 200 feet. The project dune expansion provided significant shore protection and should keep the steel wall buried for some time to come. The beach berm width went from approximately 40 feet to over 150 feet seaward of the dune toe but since the dune also expanded the net gain in width was over 250 feet. Sand accumulation continued across the nearshore to the profile limits with 173.65 yds<sup>3</sup>/ft. of sand added during the project. Comparing October 2016, to the post project survey, revealed an amazing annual transformation with the shoreline position advancing seaward 255 feet, 188.74 yds<sup>3</sup>/ft. of sand added. The project improvements will enhance shoreline stabilization while protecting property and infrastructure from storm events in this section of Mantoloking.

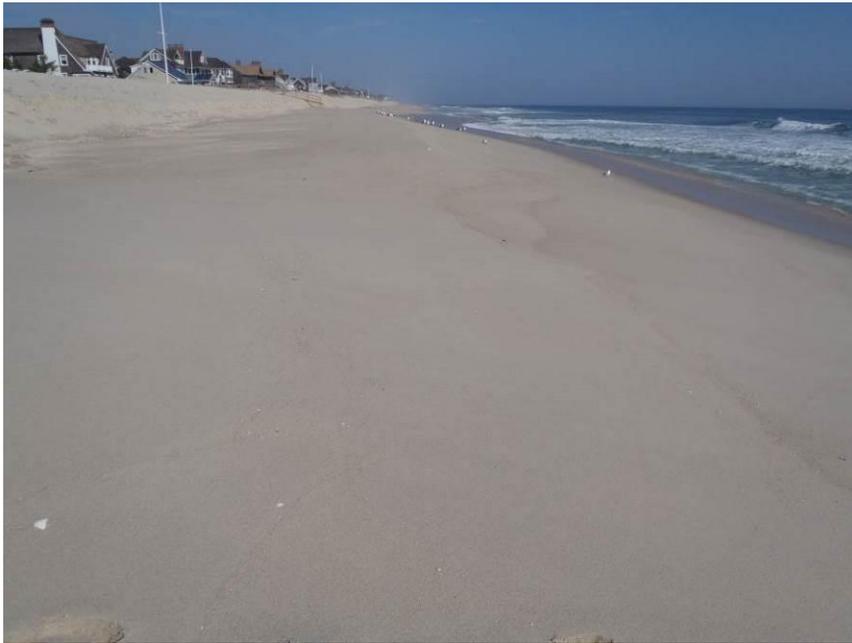
**5a. October 16, 2016**

***Photograph 5a The post-September NE storm beach was flatter and narrower with a scarp cut into the seaward dune toe, but no exposed steel wall here. Sand deposited offshore balanced the beach loss yielding a small net gain in sand volume.***

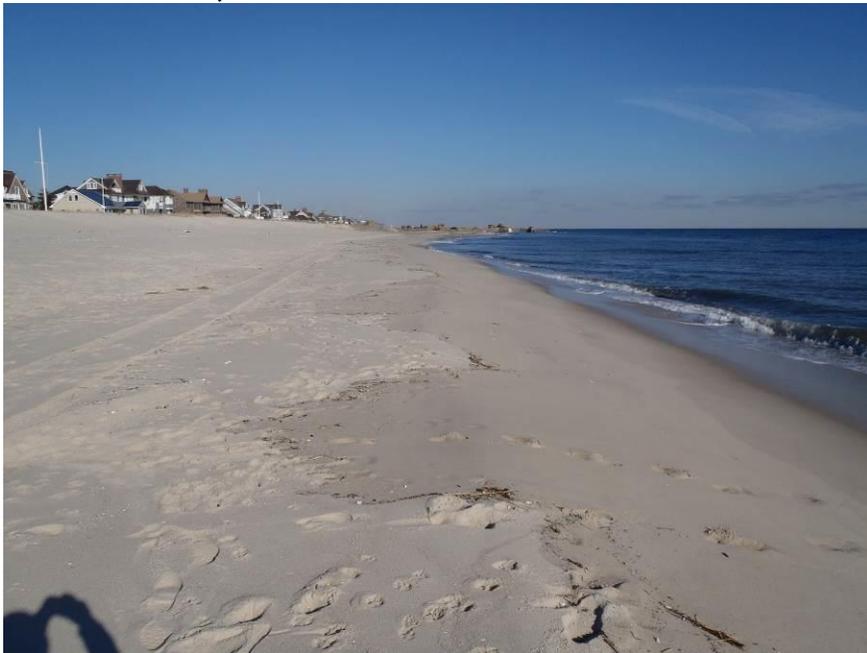
**5c. December 21, 2017**

***View 5c Natural recovery onshore over the summer and fall months restored the beach width by December 2017, with the seaward dune slope regraded through maintenance activity. The ongoing USACE project activity and resulting seaward beach offset is visible in the far distance.***

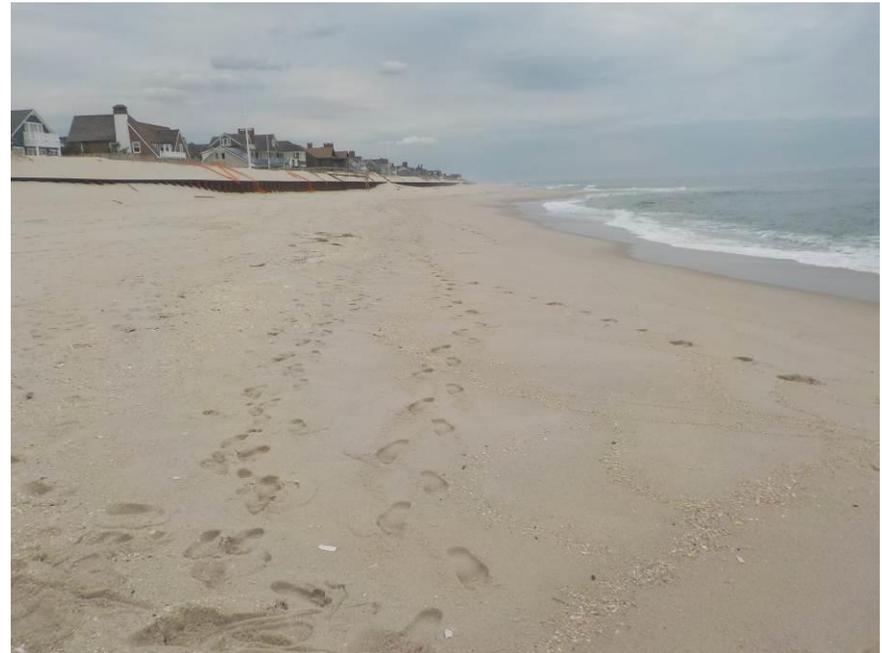
**5b. April 12, 2017**

***View 5b Shows the beach following the winter season. Storm waves eroded the beach and seaward dune slope, exposing the steel wall to varying degrees in nearby sections, ranging from several feet of seaward face exposed to just the top of the steel wall uncovered.***
