**FINAL REPORT FOR 2017  
ON CHANGES TO THE MUNICIPAL BEACHES  
FOR  
THE BOROUGH OF MANTOLOKING, OCEAN COUNTY, NEW JERSEY**

**PREPARED FOR: THE BOROUGH OF MANTOLOKING  
202 DOWNER AVENUE  
MANTOLOKING, NJ 08738**

**PREPARED BY: STOCKTON UNIVERSITY COASTAL RESEARCH CENTER  
30 WILSON AVENUE  
PORT REPUBLIC, NEW JERSEY 08241  
MARCH 30, 2018**

**Annual Report for 2017**  
**On the**  
**Mantoloking**  
**Oceanfront Municipal Shoreline**

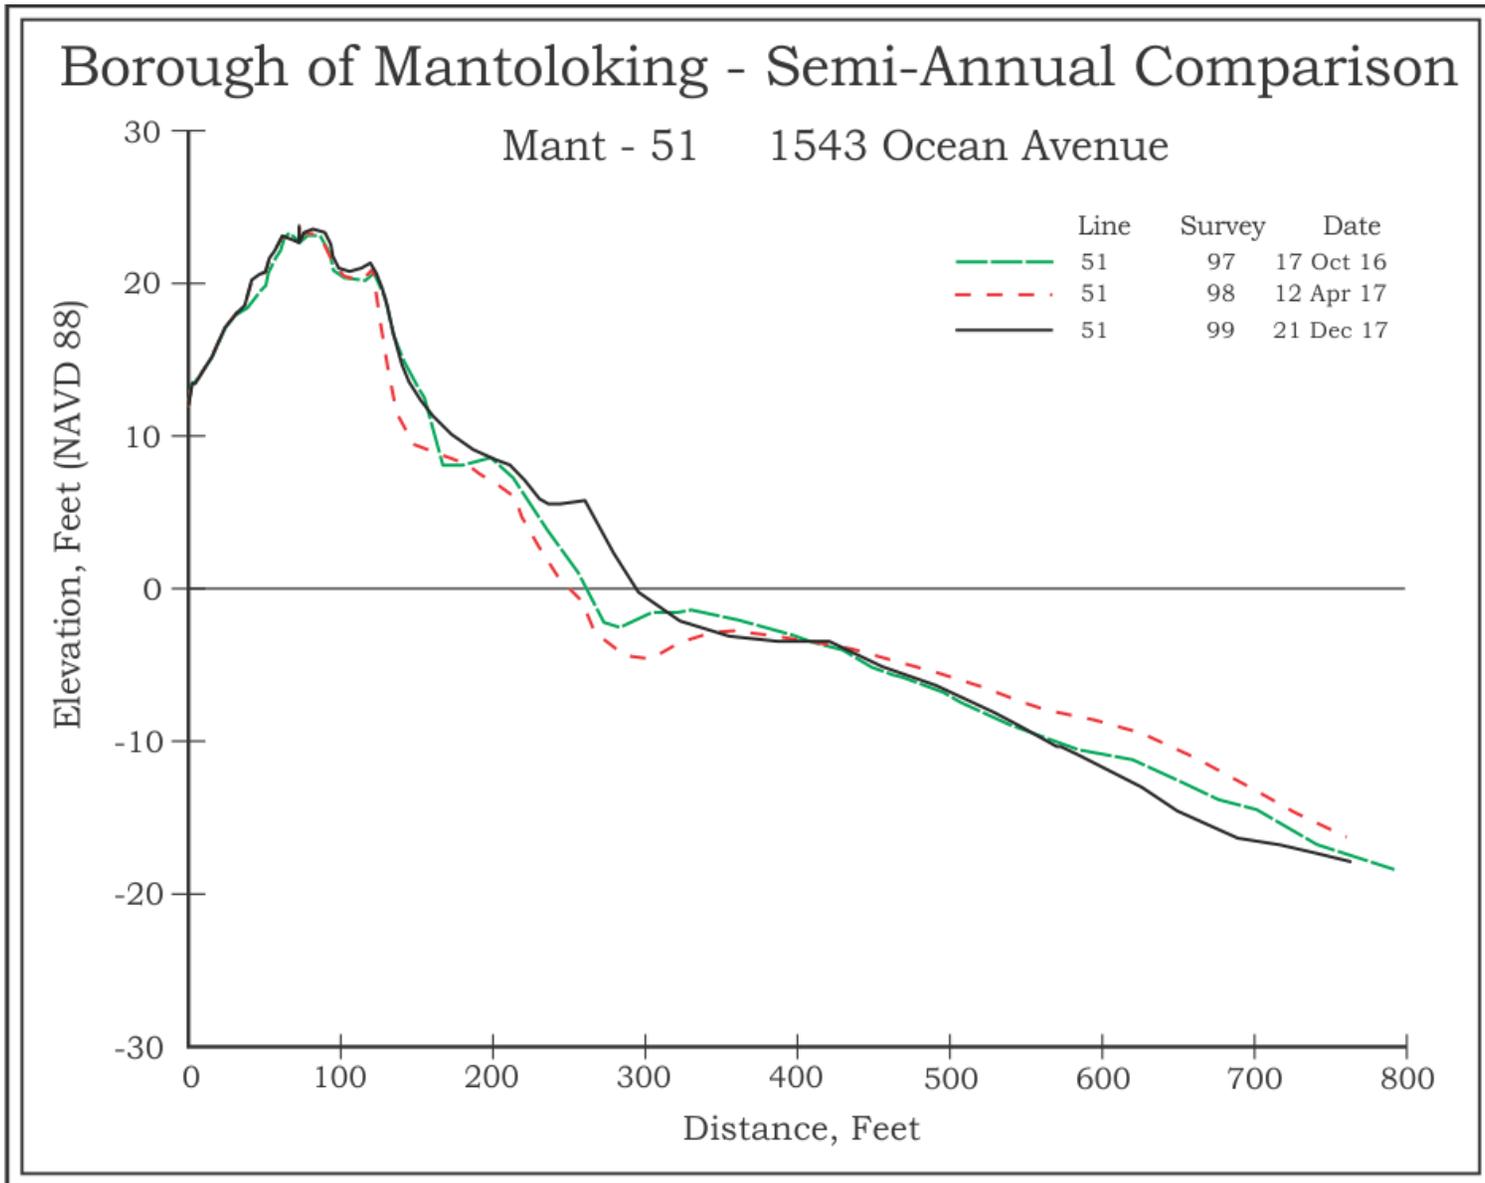
**Figure 5d: The southern site suffered beach and dune erosion over the winter months. By April, the seaward slope eroded, cut vertically and retreated, exposing the top of the steel wall. The beachface slope and shoreline position retreated landward but sand accumulated below the zero datum, indicating cross-shore transport dominated here. By December 2017, the beach had recovered and sand pushed onto the seaward slope to restore the pre-winter configuration, burying the steel wall. Sand also accumulated on the dune crest and a large summer beach berm was still present at the end of the year.**

For 2017, winter storms initially eroded the beach and seaward dune slope exposing the steel wall. The seaward dune toe retreated landward 20 feet with similar shoreline retreat that occurred as the waves scoured the nearshore. Sand accumulated offshore transferred cross-shore from the dune, beach and nearshore. Offshore accumulation offset the beach loss for a modest net volume gain of 3.48 yds<sup>3</sup>/ft. of sand from October 2016 to April 2017.

Wave climate during spring and summer favored natural beach building and sand recovery. By December 2017, sand had accumulated across the dune crest, the seaward slope restored through maintenance and natural accumulation and a typical summer beach berm developed as cross-shore sand transfer shifted offshore sand to the beach. The net volume change of 0.18 yds<sup>3</sup>/ft. reinforces the pattern of cross-shore sand motion with a loss of -18.95 yds<sup>3</sup>/ft. of sand offshore offset by a gain of 19.12 yds<sup>3</sup>/ft. of sand onshore.
