**2015 ANNUAL REPORT - TO THE CITY OF NORTH WILDWOOD  
ON THE  
CONDITION OF THE CITY BEACHES**

**PREPARED FOR: THE CITY OF NORTH WILDWOOD  
901 ATLANTIC AVENUE  
NORTH WILDWOOD, NJ 08260**

**PREPARED BY: THE STOCKTON UNIVERSITY COASTAL RESEARCH CENTER  
30 WILSON AVENUE  
PORT REPUBLIC, NJ 08241  
March 5, 2016**

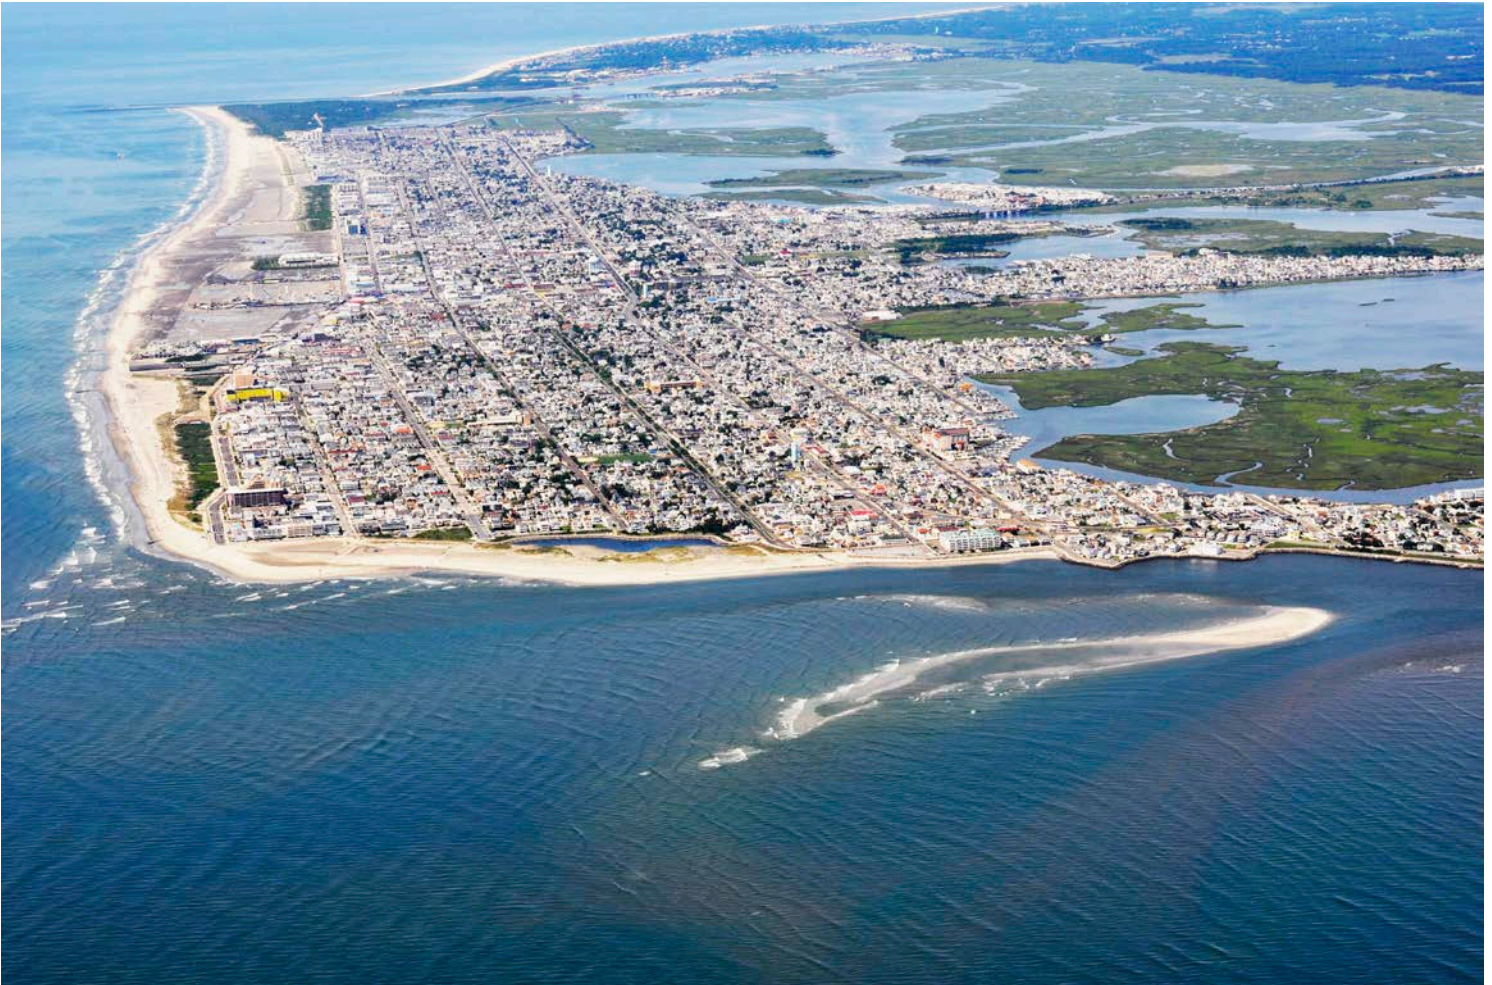
*Aerial view of North Wildwood looking south from the Hereford Inlet perspective on June 24, 2015. The main channel is shown as the darker, smoother water running parallel to the North Wildwood Inlet beaches and along the rock revetment wall. A smaller secondary channel can be seen in this photo on the northern side of Champagne Island. Waves can be seen breaking on the shoal system at the northern portion of the oceanfront beaches. (Aerial photo taken by Ted Kingston)*

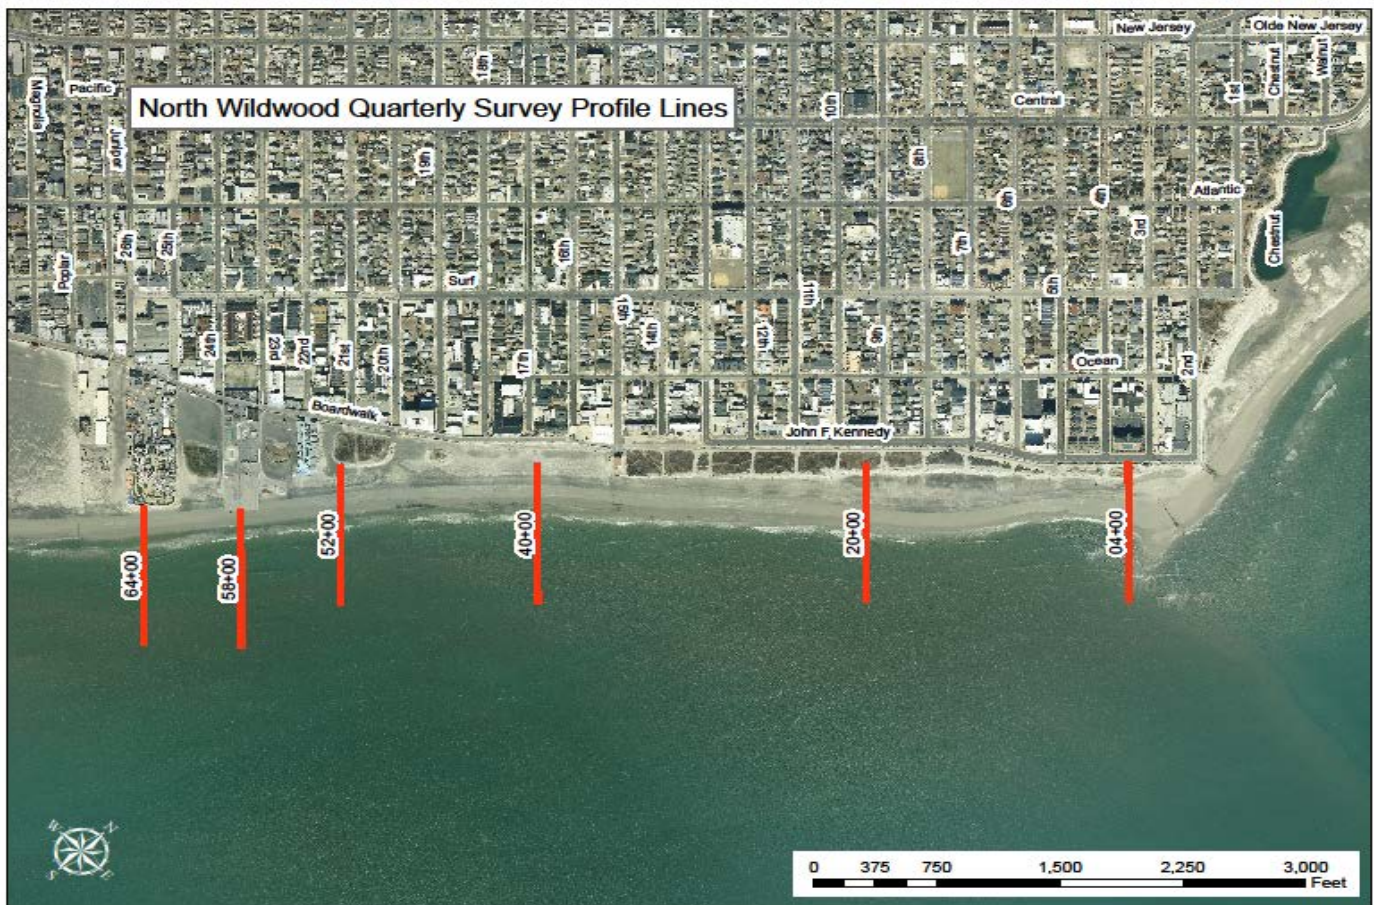
**Figure 1.** Shown above are locations of six representative profile sites of the 54 profile stations where shoreline changes were measured on the City’s oceanfront from April 2014 to November 2015. For each of the six profile stations descriptions and cross sections are provided to show typical changes over the year.

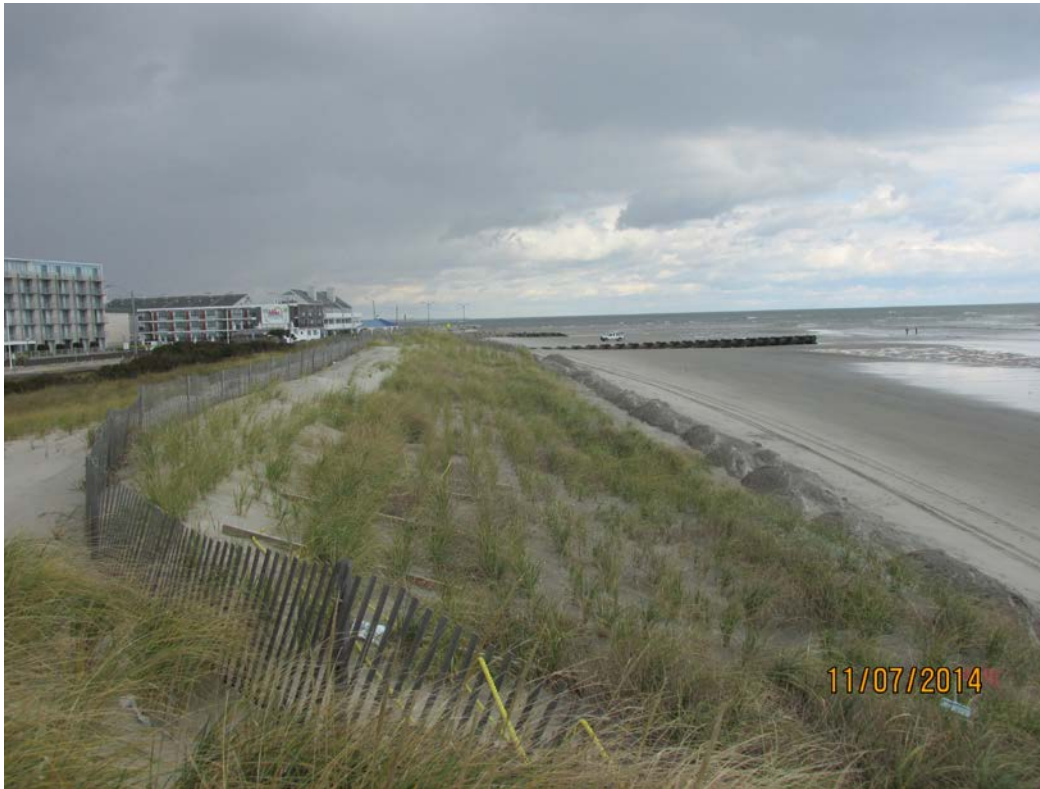
**Figure 5. View from 5th Avenue looking north taken on November 7, 2014 displaying trucked-in piles of sand at the seaward dune toe. Nearshore bar gains had taken place since April 2014 while the dune and beachface remained stable. From November 2013 to November 2014 the shoreline remained virtually unchanged while below datum gains of 8.81 yds<sup>3</sup>/ft. were recorded.**

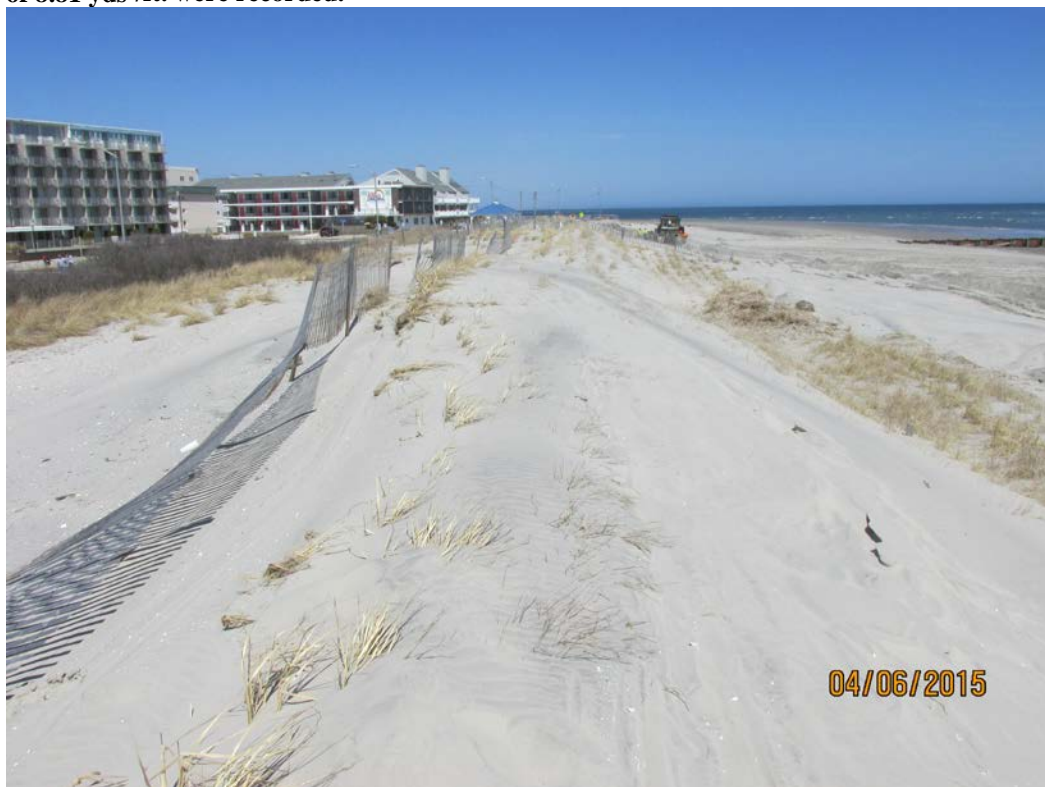
**Figure 6. View from 5<sup>th</sup> Avenue looking north taken on April 6, 2015. The primary dune configuration mirrors the November 2014 configuration while the beachface increased in elevation from the sand backpassing project from Wildwood beaches. Aeolian processes deposited sand along the seaward duneslope.**

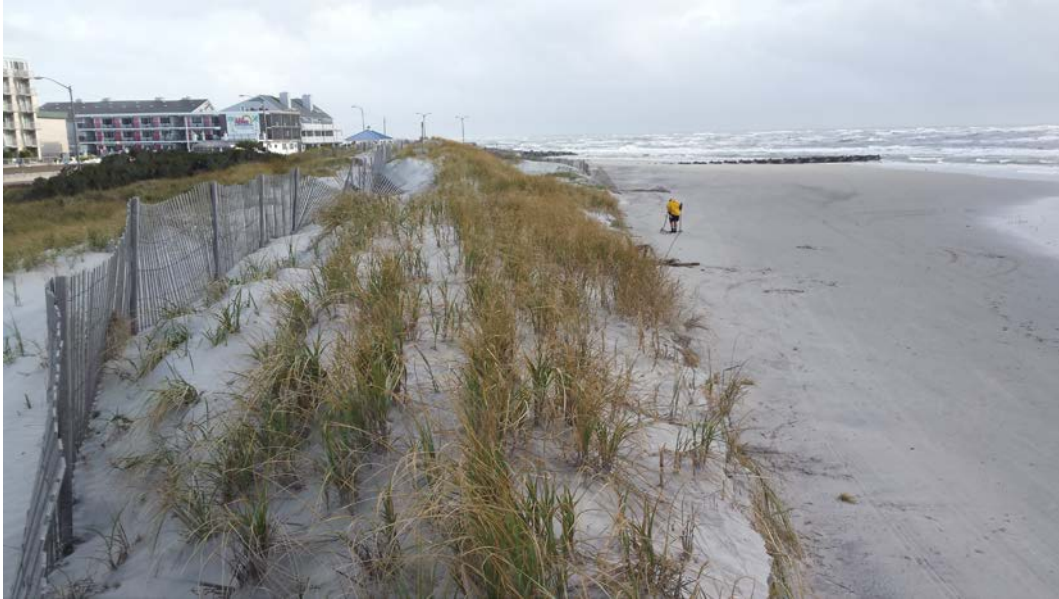
**Figure 7. View from 5<sup>th</sup> Avenue looking north taken on October 3, 2015 following the northeast storm events and Hurricane Joaquin. A significant scarp in the seaward duneface is shown along with recreational beach elevation and shoreline losses observed.**

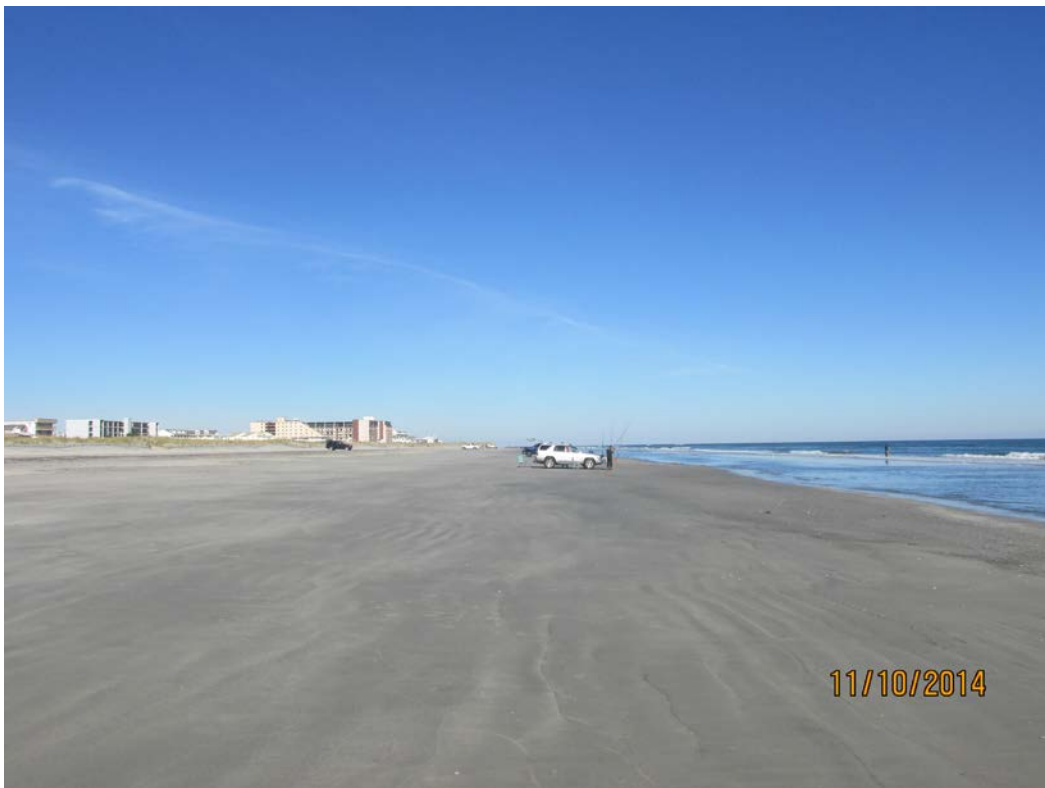
**Figure 9. View to the north taken from the berm at 13<sup>th</sup> Avenue on November 10, 2014. The beachface began to erode from the berm seaward but maintained an elevation around 6ft NAVD 88 in the recreational beach region.**

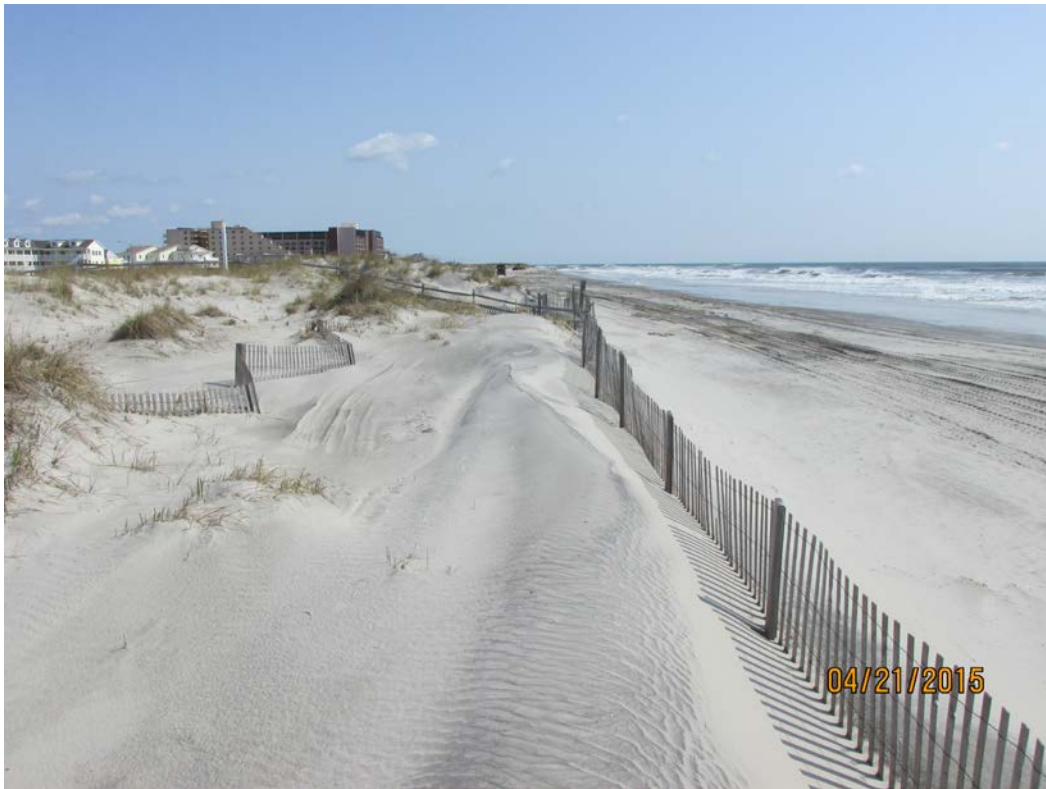
**Figure 10. View to the north taken from the foredune at 12<sup>th</sup> Avenue on April 21, 2015. The foredune toe, recreational beach, and beachface eroded significantly with sand shifting outside the profile limits.**

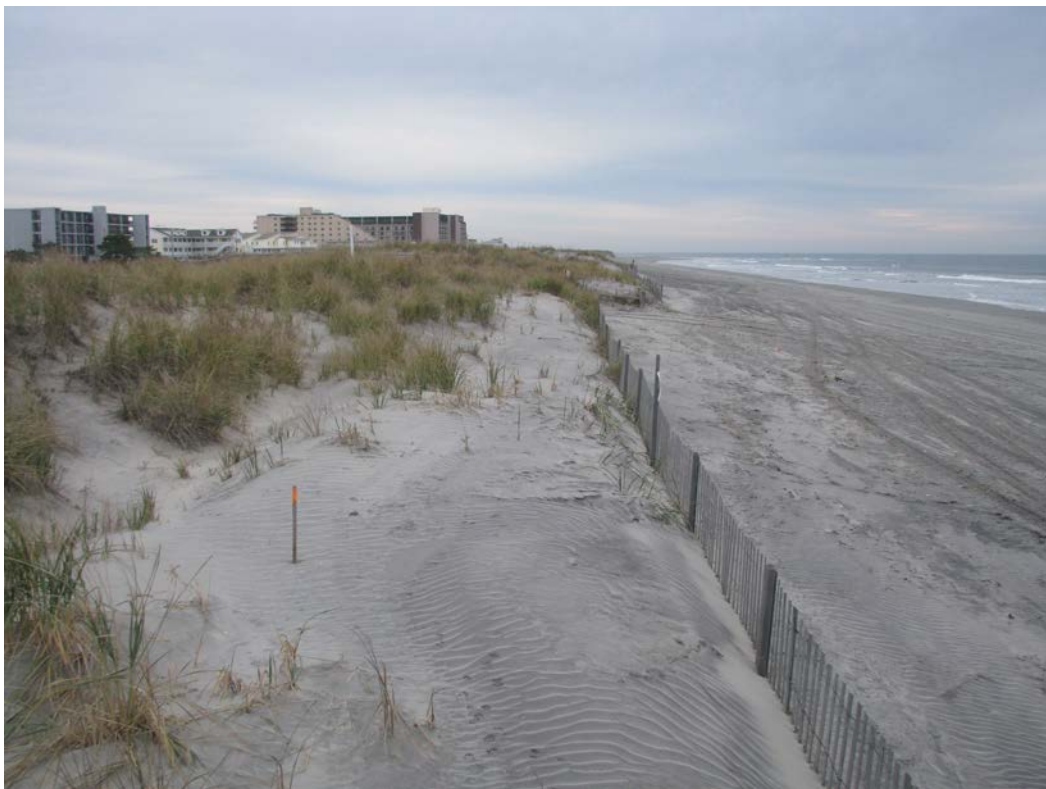
**Figure 11. View to the north taken from the foredune at 13<sup>th</sup> Avenue on November 2, 2015. The beachface eroded slightly from the April survey. For the November 2014 to October 2015 comparison the shoreline position retreated 52 feet with material shifting offshore.**

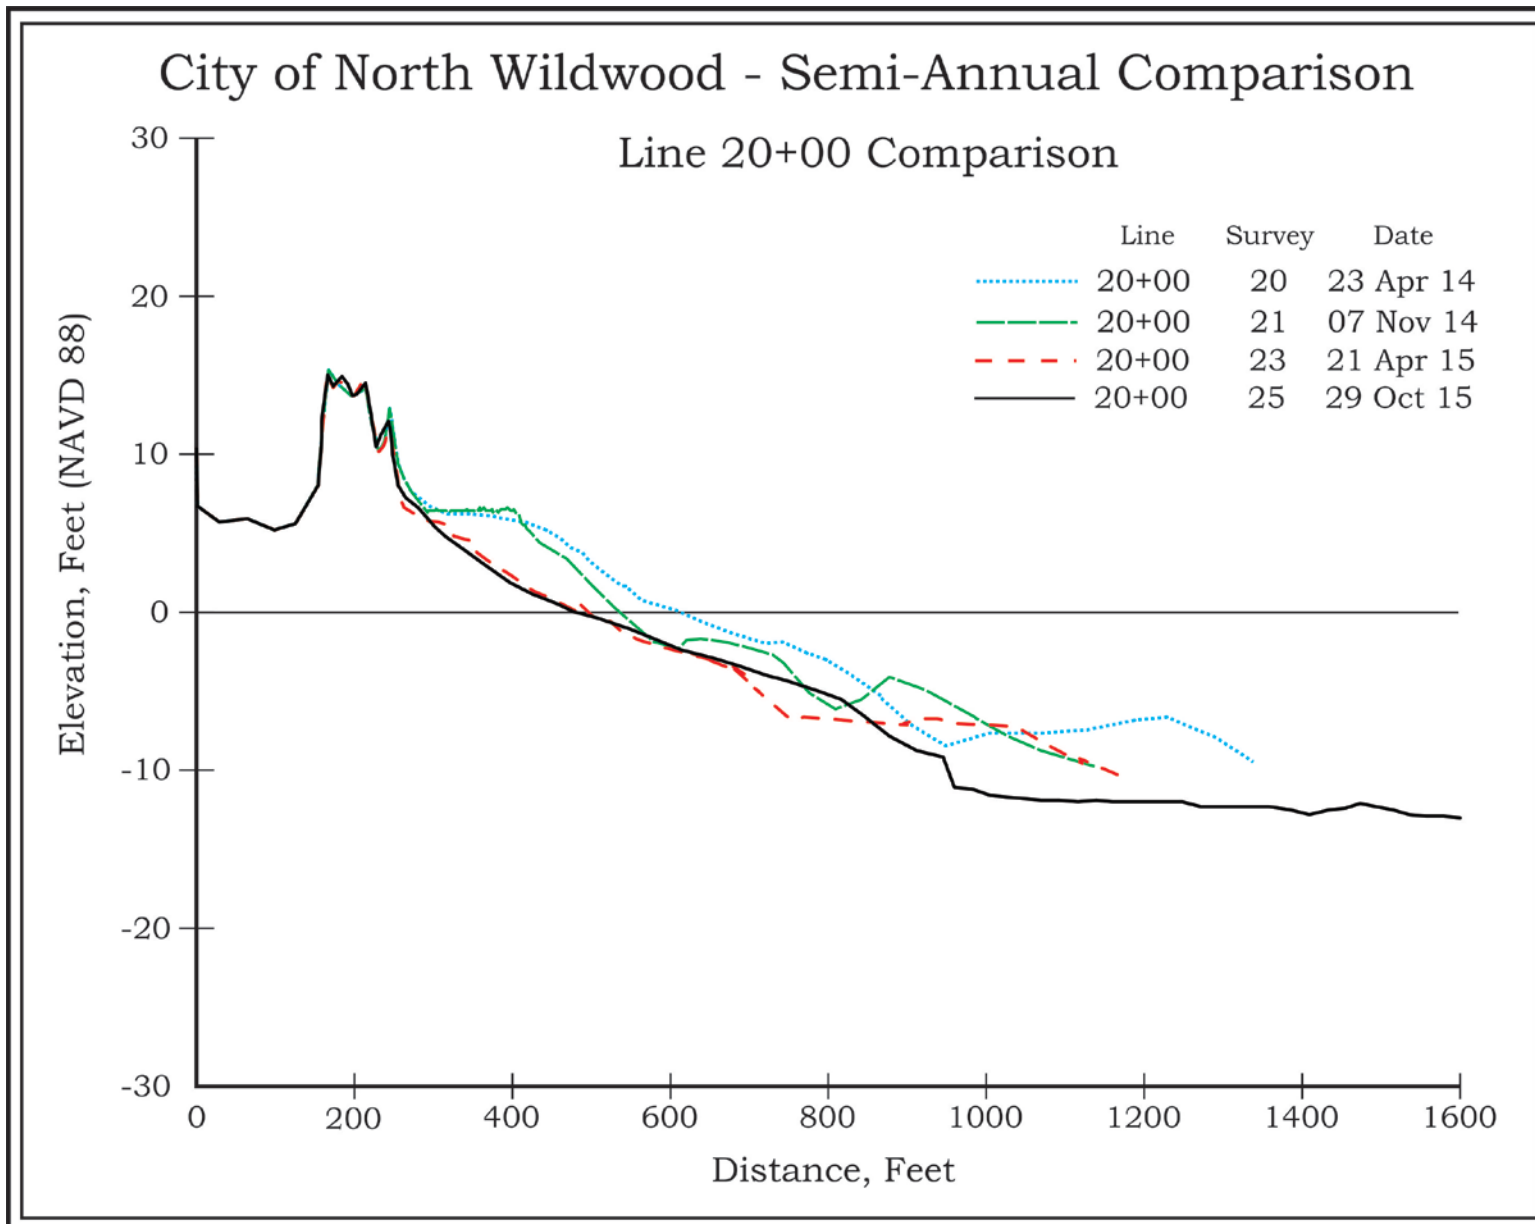
This erosional trend continued through the spring and fall surveys conducted by the CRC in 2015. The recreational beach and berm were significantly reduced with the material shifting outside our profile limits. The annual comparison from the fall 2014 to the fall 2015 yielded a shoreline retreat of 52 feet and cumulative losses of 70.07 yds<sup>3</sup>/ft.

**Figure 12.** The beachface and nearshore regions were dominated by erosion throughout 2015. Material continued to shift offshore beyond the survey limits of this profile. The foredune toe also displayed erosional effects by Survey 23. Overall from Survey 21 to Survey 25 the shoreline retreated 52 feet and recorded volume losses of 70.07 yds<sup>3</sup>/ft.

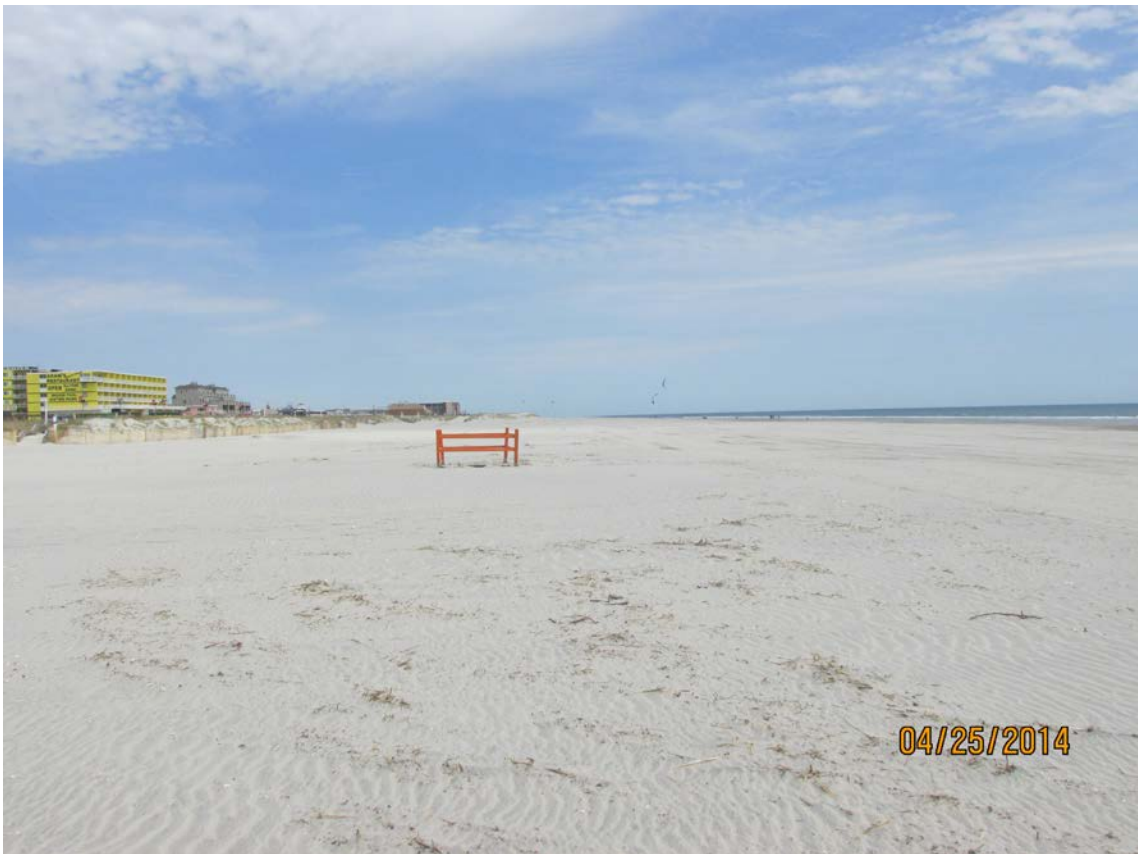
**Figure 13.** View to the north from the beach located near 18<sup>th</sup> Avenue on April 25, 2014. The recreational beach berm width is massive extending seaward approximately 300 feet from the dune toe at between elevations 6-7 feet NAVD88.

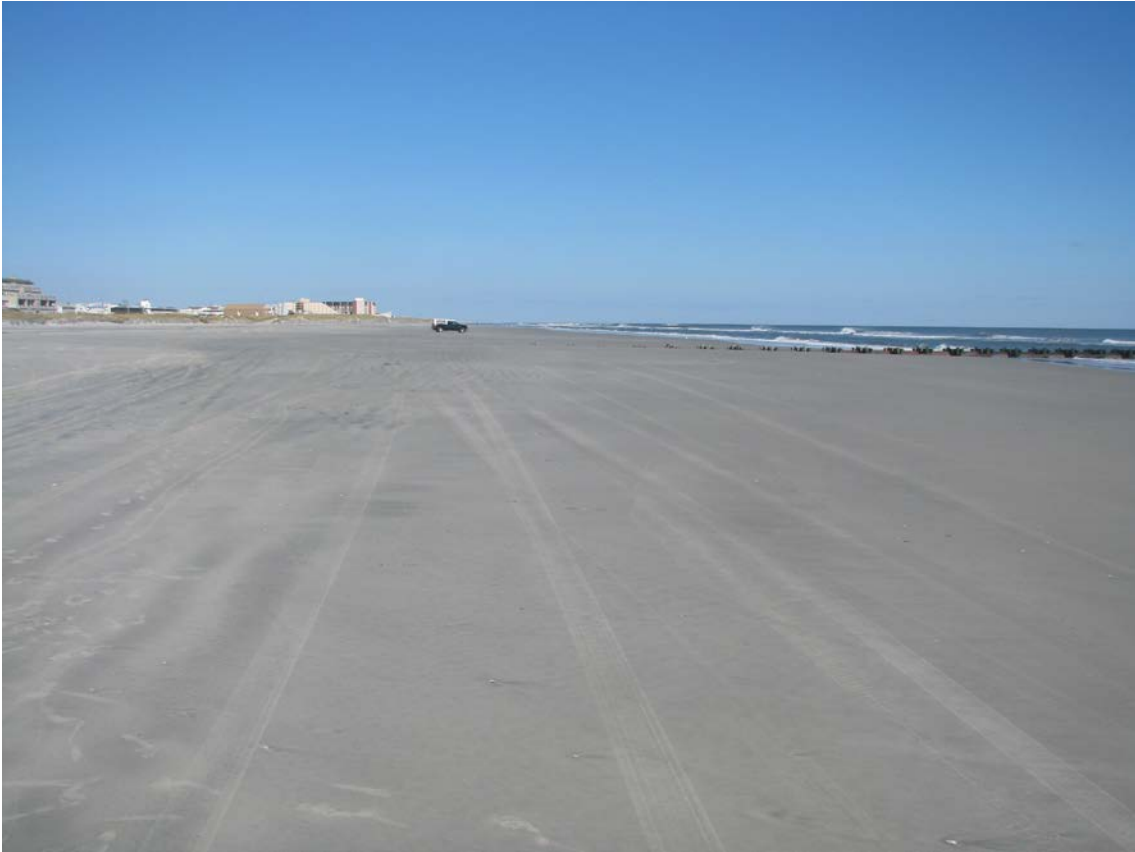
**Figure 14. View to the north from the beach located near 19<sup>th</sup> Avenue on October 30, 2015. The berm and recreational beach had eroded over 100 feet since the fall 2014 survey with sand shifting beyond the profile limits.**

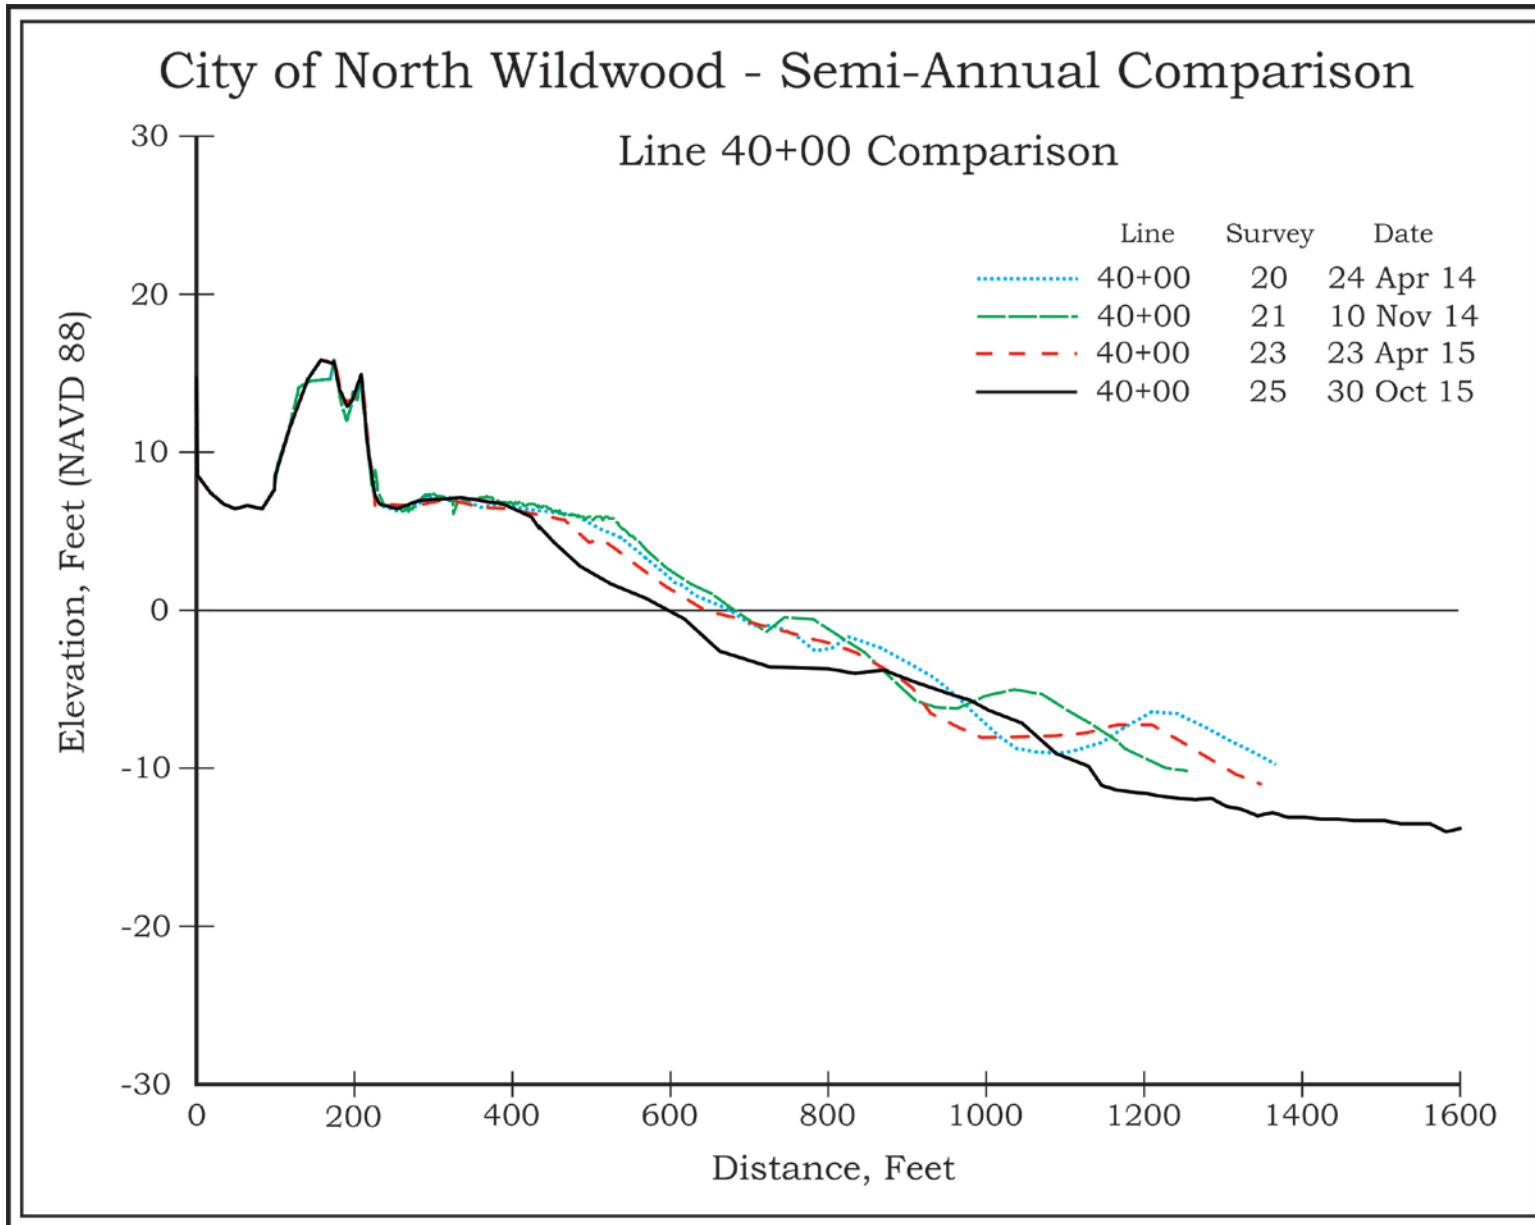
Both the primary dune and foredune remained stable through both the spring 2015 and fall 2015 surveys. Although the beachface and nearshore regions eroded throughout 2015, the upper recreational beach (approximately 250 feet from the seaward dunetoe) remained relatively stable. The annual comparison from the fall 2014 to the fall 2015 yielded a shoreline retreat of over 85 feet and cumulative losses of 64.17 yds<sup>3</sup>/ft.

**Figure 15.** For the annual comparison (Survey 21 to Survey 25) the recreational beach and berm position remained relatively stable. Cumulative volume losses of 64.17 yds<sup>3</sup>/ft. were recorded with a modest shoreline retreat of 85 feet. The offshore bar had migrated outside the profile limits by the October 2015 survey.

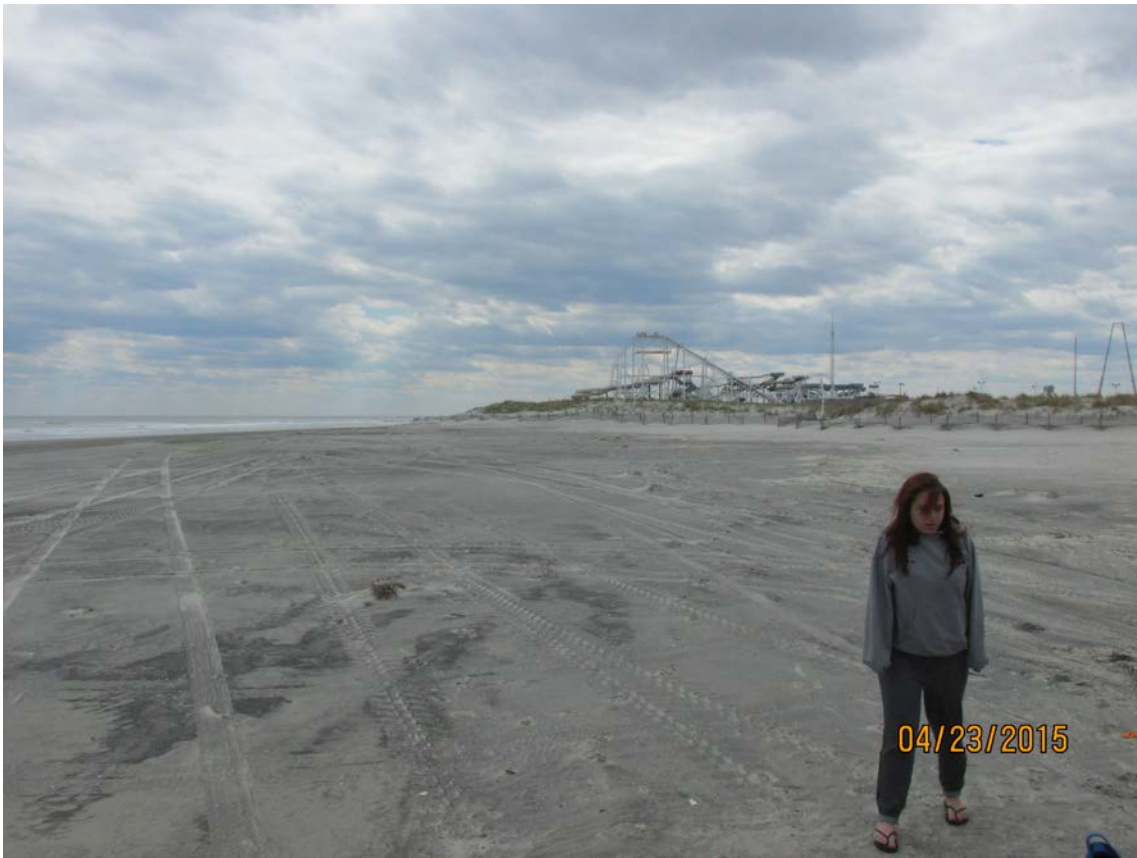
**Figure 17.** View to the south taken from the beachface at 21<sup>st</sup> Avenue on April 23, 2015. The recreational beach and beachface began to erode at this time and continued throughout the remainder of 2015.

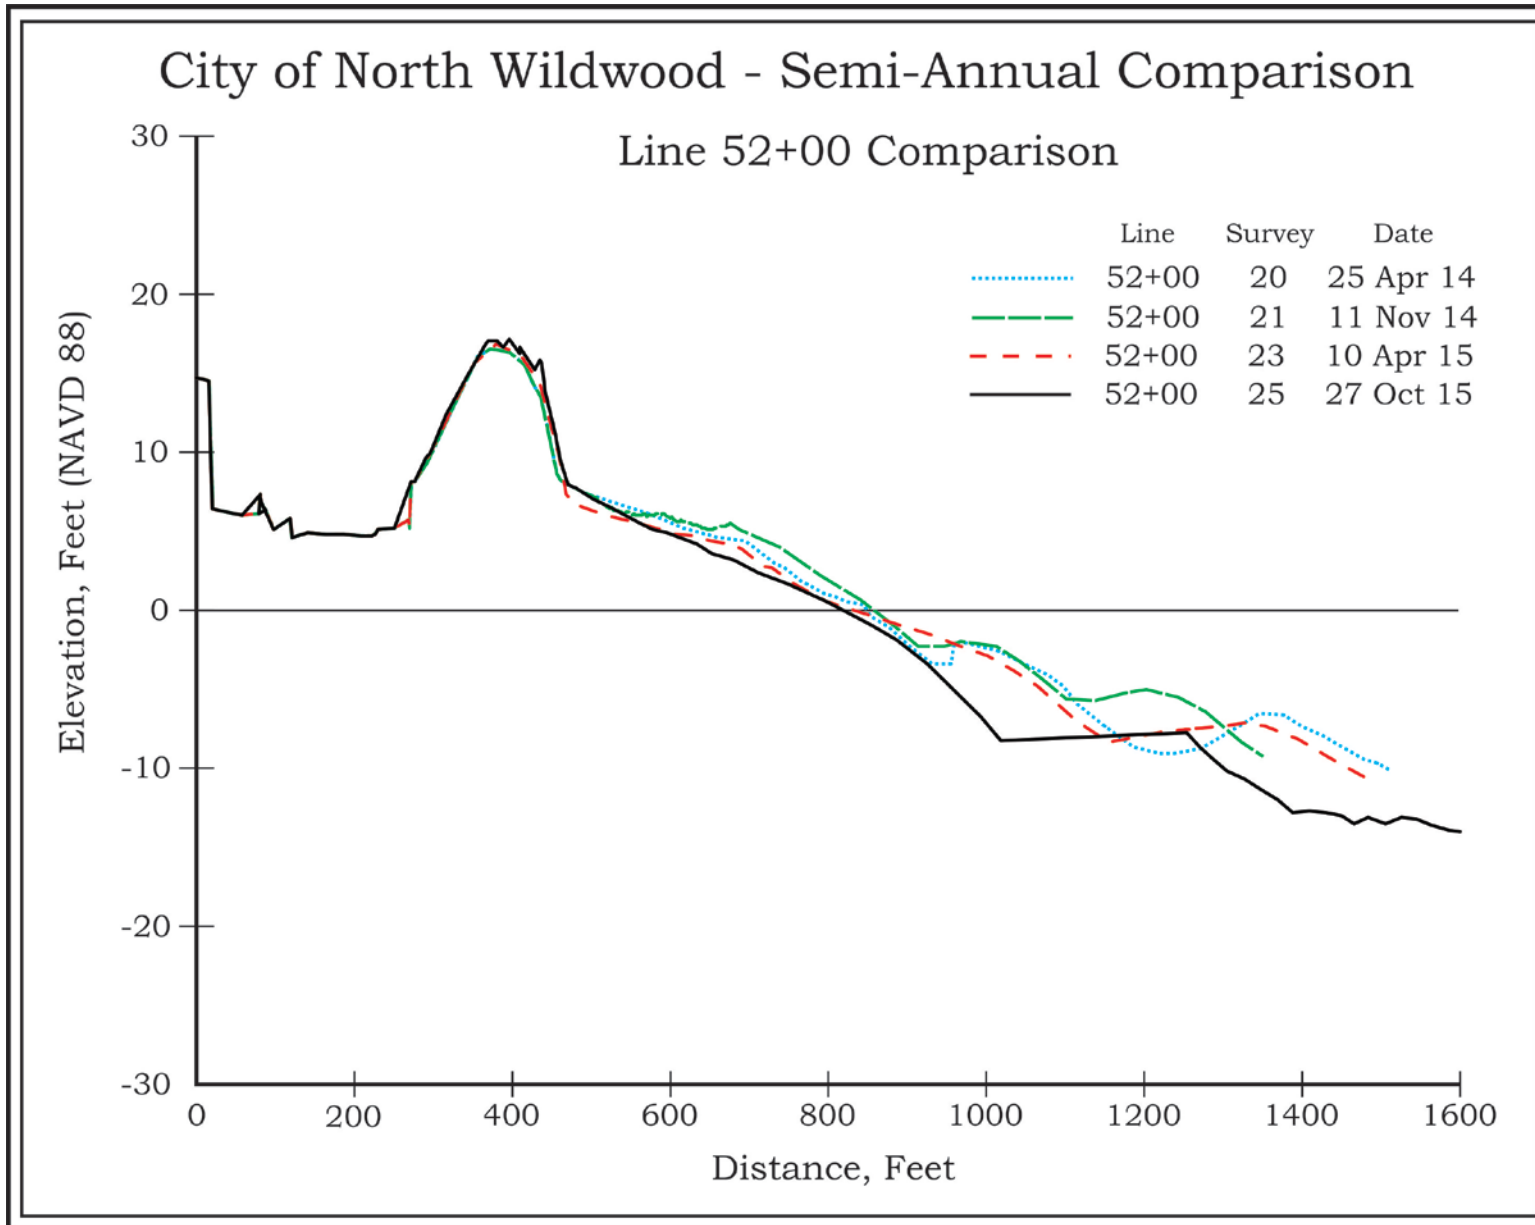
The primary dune accreted sand through both the spring 2015 and fall 2015 surveys while the recreational beach and beachface eroded material during this time. By Survey 25 the nearshore and offshore regions experienced significant losses of sand beyond the end of the surveyed profile. The annual comparison from the fall 2014 to the fall 2015 yielded a shoreline retreat of over 40 feet and cumulative losses of 60.86 yds<sup>3</sup>/ft. (52.71 yds<sup>3</sup>/ft. below the datum).

**Figure 18. The recreational beach and beachface experienced an erosional trend overall during 2015. Aeolian accretion at the dune crest and seaward dune face can be seen by Survey 23. For the November 2014 to October 2015 comparison the net volume change was a loss of 60.86 yds<sup>3</sup>/ft. of sand with a moderate shoreline position retreat of 40 feet.**

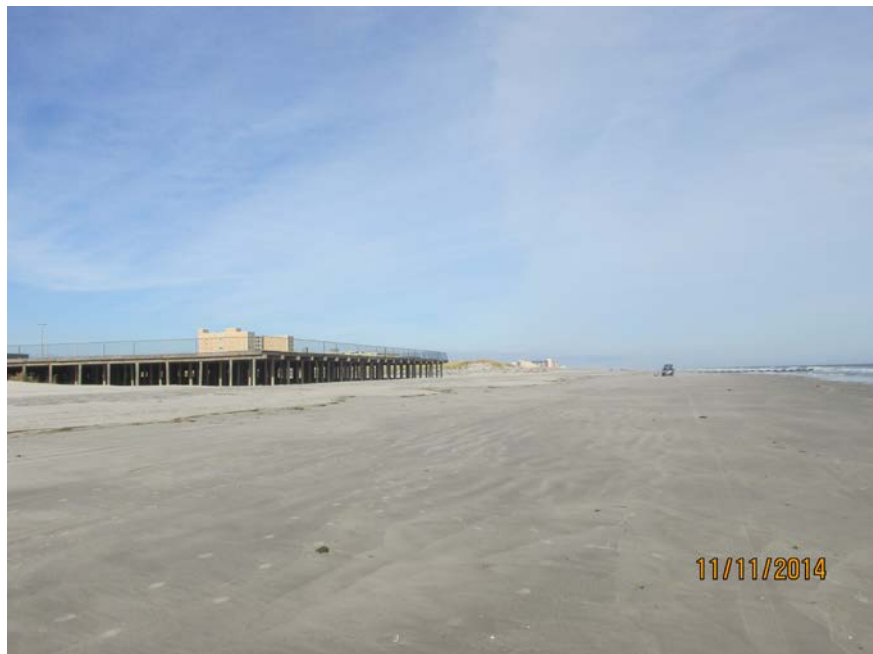
**Figure 19. View to the north taken on November 11, 2014 near 25<sup>th</sup> Avenue showing the configuration of the beachface. The two surveys conducted in the spring and fall 2015 revealed approximately a 2-foot lower elevation in this region than that pictured above.**

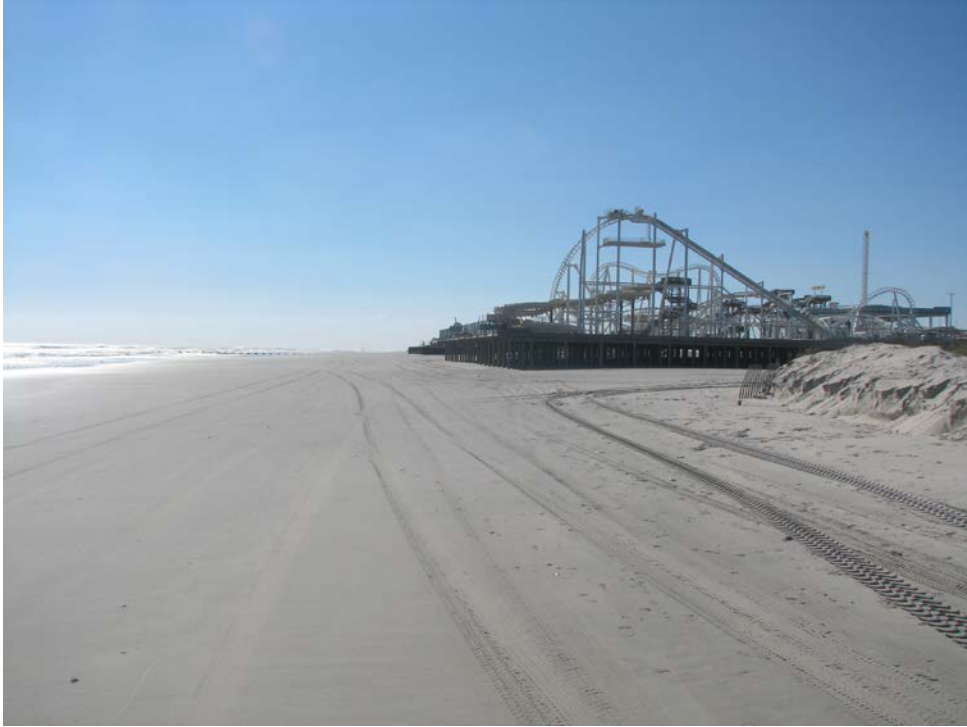
**Figure 20.** A close up view of the dune looking to the south from the berm located near 23<sup>rd</sup> Avenue on October 30, 2015. The low elevation of the beach is clearly displayed resulting in a small scarp to the seaward dune toe.

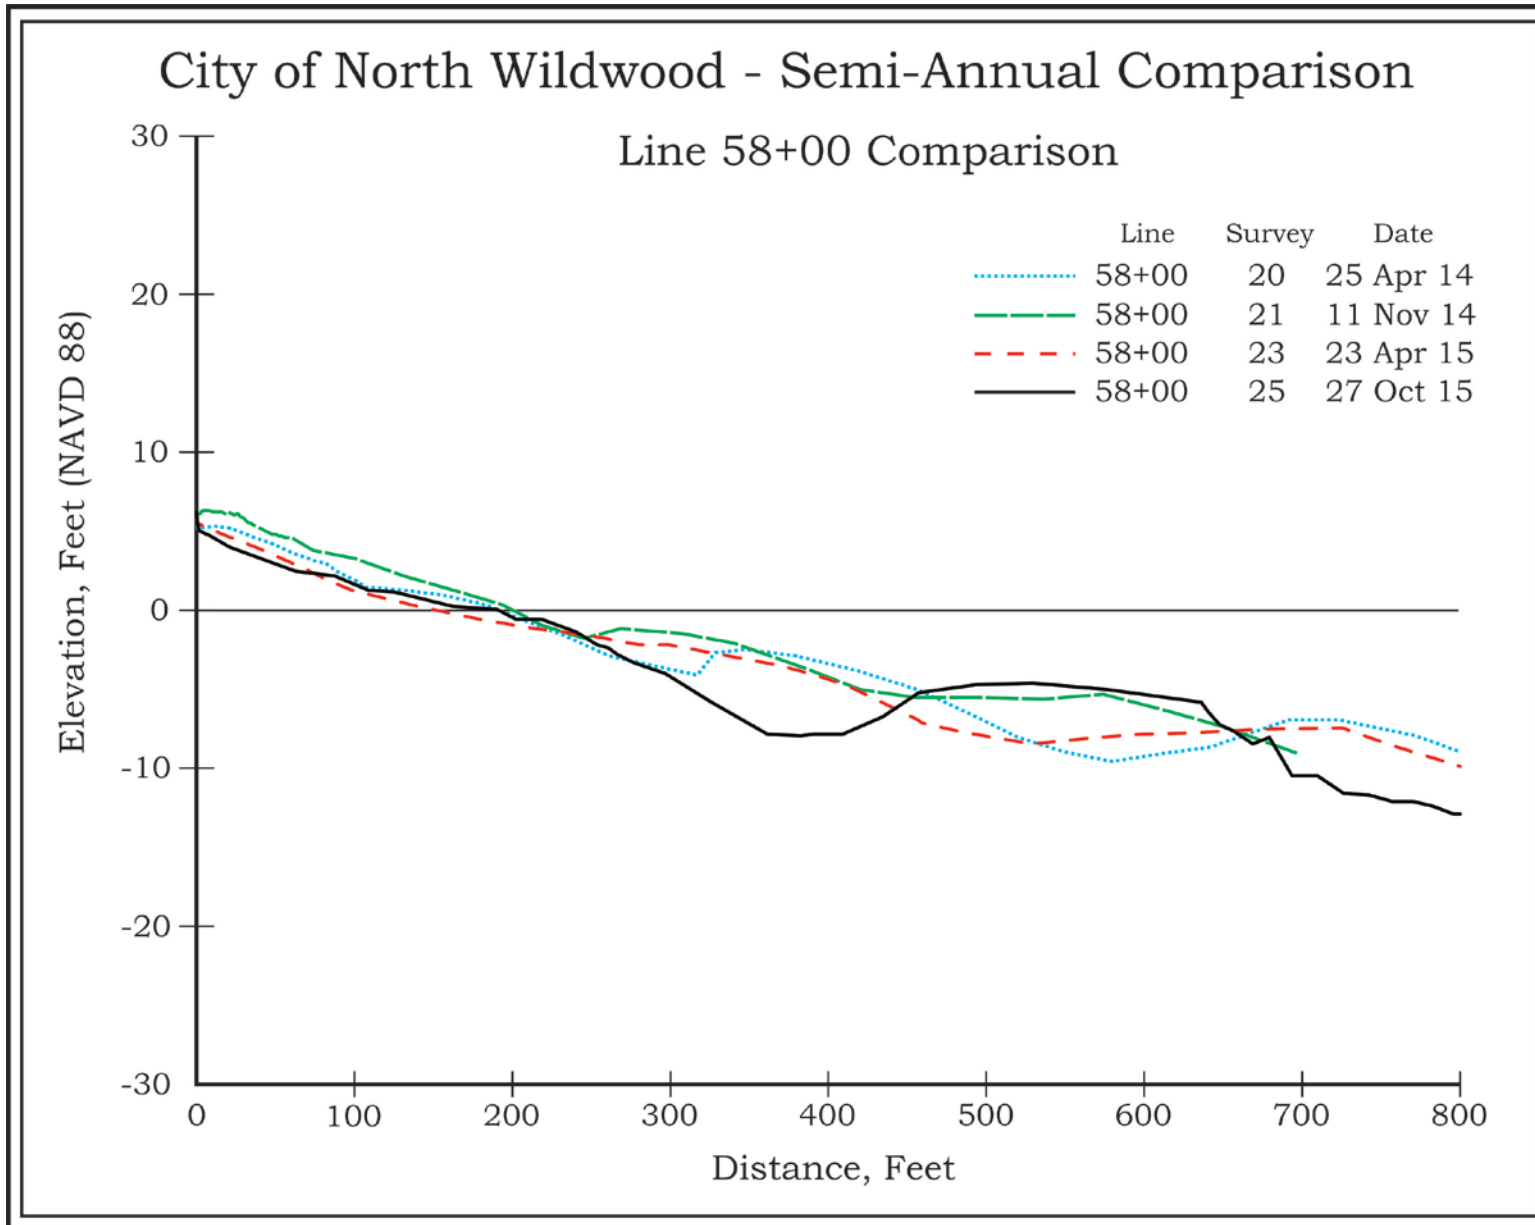
Over the 2014 and into the 2015 winter months the recreational beach in front of the 24<sup>th</sup> Avenue pier had begun to erode and lose elevation. By the April 2015 survey the beach and beachface recorded an elevation loss of around 2 feet. The milder weather patterns over the summer months allowed for a minor shoreline advance by the October survey (Survey 25). The annual comparison from the fall 2014 to the fall 2015 yielded a minimal shoreline retreat of 10 feet and cumulative losses of 28.45 yds<sup>3</sup>/ft.

**Figure 21. Natural erosion of the constructed dune system forced the landward repositioning of this feature in early 2014. By the April 2014 survey there is no visible remnants of the original dune. The nearshore and offshore bars shifted landward by Survey 21 adding to the beach elevation. This added elevation was eroded throughout 2015 which resulted in total annual volume losses of 28.45 yds<sup>3</sup>/ft. and a minor shoreline retreat of 10 feet.**

By the spring 2014 survey (April 25<sup>th</sup>) the dune had been eroded to a point where the City was forced to reposition this feature landward of the easternmost point of the piers. This allotted for a wider beach area configuration seaward of the dune system to capture Aeolian sand transported to the duneface and aligned with planned federal project specifications.

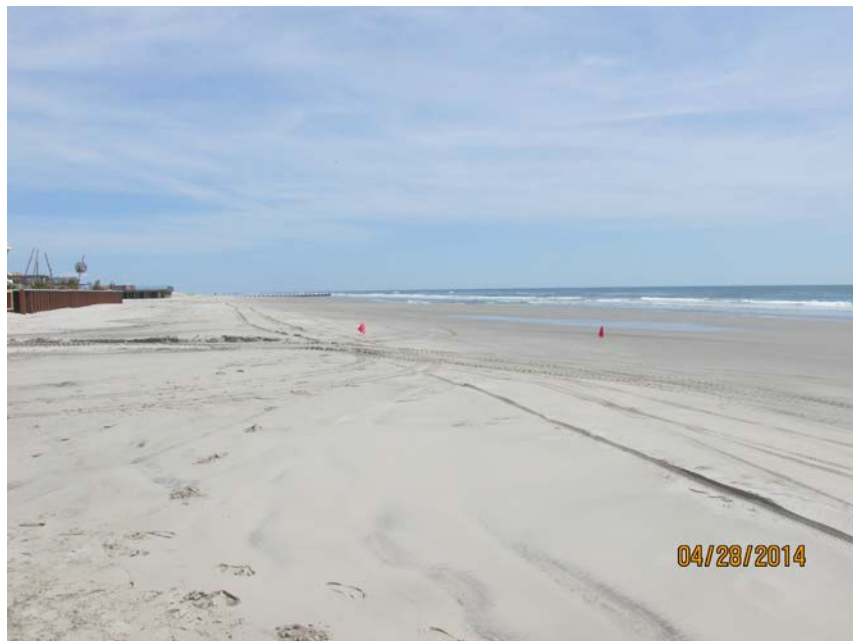
**Figure 22. View to the north taken on April 28, 2014 from near 26<sup>th</sup> Avenue showing the extent of dune erosion and repositioning of the initial dune system landward of the eastern-most portion of the southern piers. As a direct result of the initial position of this protection feature being constructed seaward of the piers, by February 2014 the majority of the dune system had eroded.**
