**2015 ANNUAL REPORT - TO THE CITY OF NORTH WILDWOOD  
ON THE  
CONDITION OF THE CITY BEACHES**

**PREPARED FOR: THE CITY OF NORTH WILDWOOD  
901 ATLANTIC AVENUE  
NORTH WILDWOOD, NJ 08260**

**PREPARED BY: THE STOCKTON UNIVERSITY COASTAL RESEARCH CENTER  
30 WILSON AVENUE  
PORT REPUBLIC, NJ 08241  
March 5, 2016**

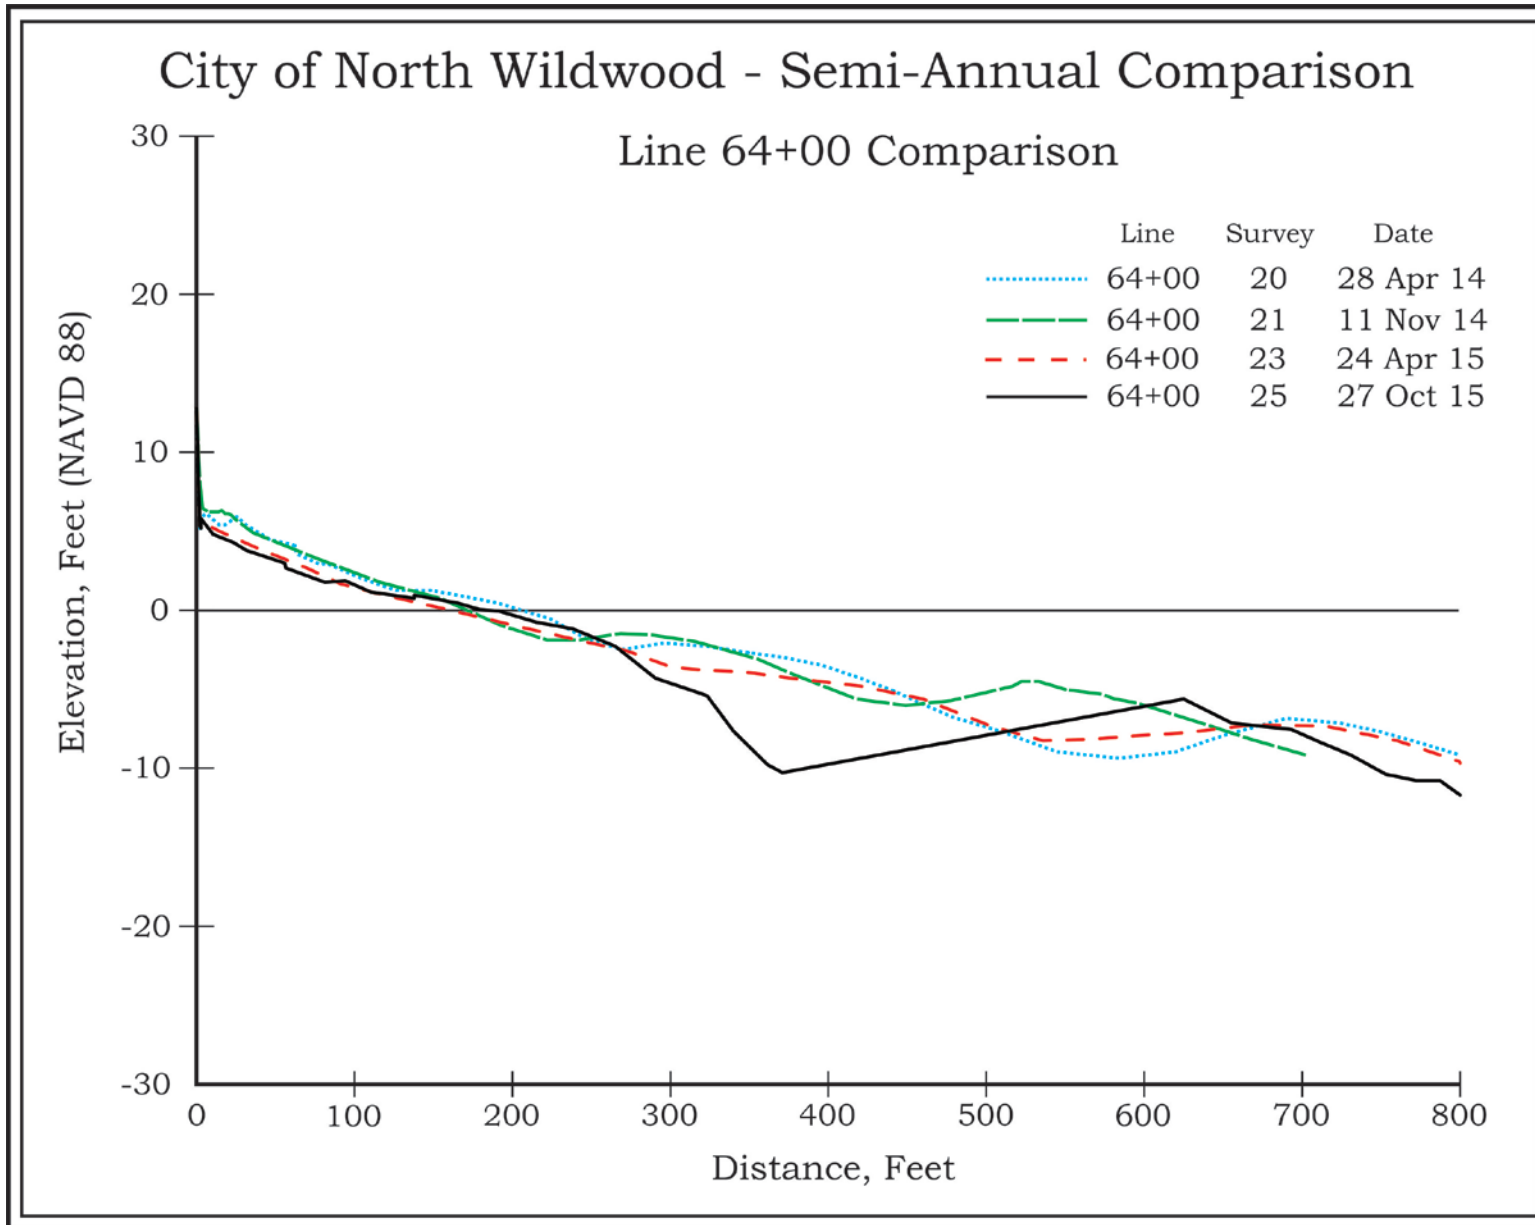
Similar to profile 58+00 located to the north, the early 2015 winter months eroded the recreational beach at this location. By the April 2015 survey the beach recorded an elevation loss of between 1 and 2 feet. The milder weather patterns over the summer months allowed for a minor shoreline advance by the October survey (Survey 25). The annual comparison from the fall 2014 to the fall 2015 yielded a minimal shoreline retreat of 14 feet and cumulative losses of 39.68 yds<sup>3</sup>/ft.

**Figure 23. Natural erosion of the constructed dune system forced the landward repositioning of this feature in early 2014. The 2015 survey seasons were marked by erosional process both on the beach and into the offshore regions of this profile. Although the shoreline did advance 14 feet for the annual comparison, 39.68 yds<sup>3</sup>/ft. were lost.**

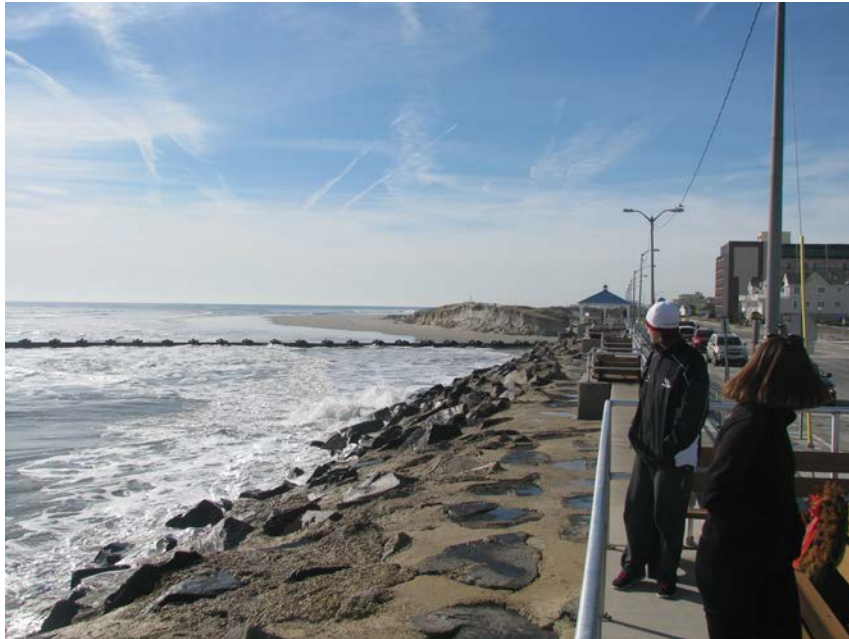
**Figure 24. A close up view of the exposed seawall looking to the south at 2<sup>nd</sup> Avenue on January 25, 2016. Winter Storm Jonas eroded sand in this area completely exposing the wall at virtually all stages of the tide cycle.**

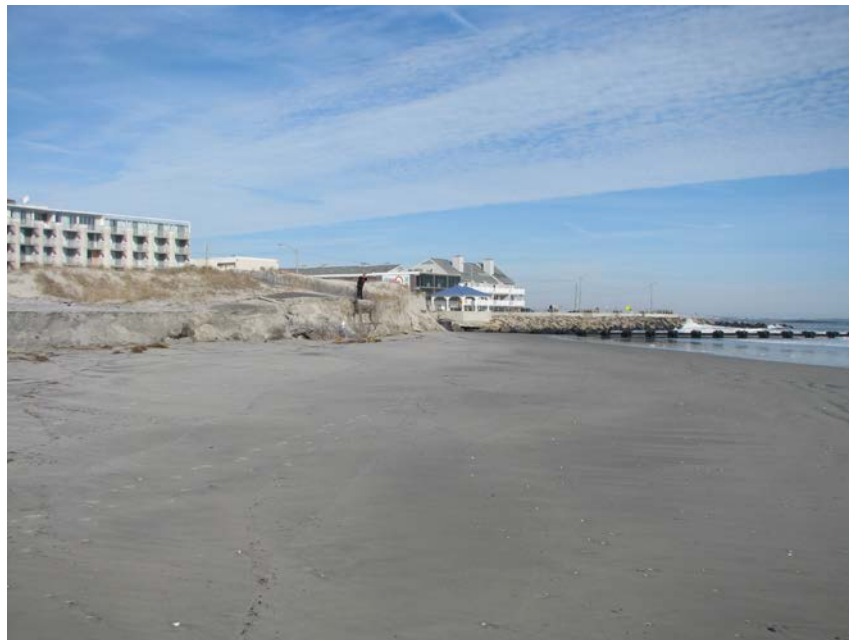
**Figure 25. View to the north following Jonas taken at 5<sup>th</sup> Avenue on January 25, 2016. The storm caused severe erosion to the beach and dune system creating the large scarp seen in the dune and the remainder of the sand from the Beach Creek dredge material pile.**

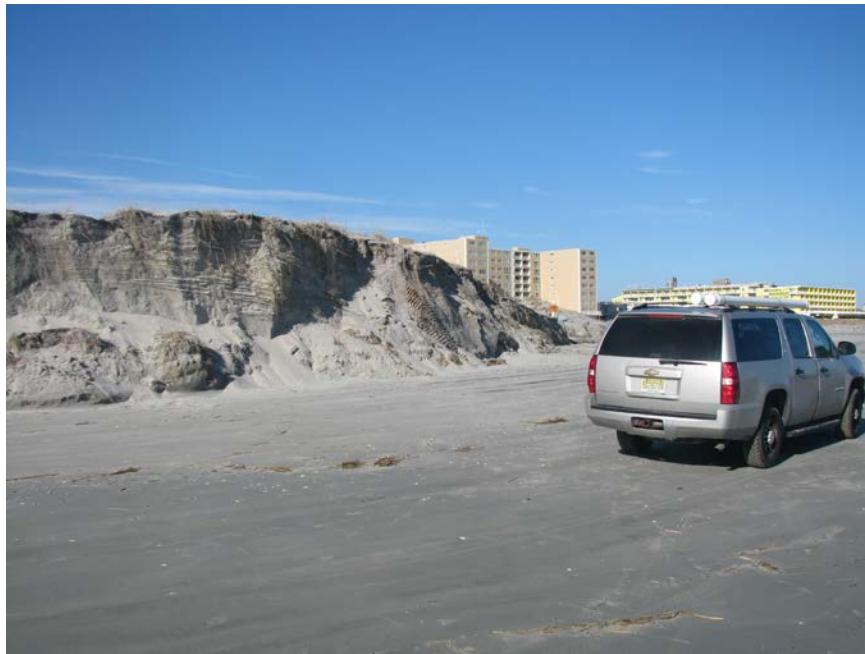
**Figure 26. A close up view of the dune looking to the north from the beach located near 22<sup>nd</sup> Avenue on January 27, 2016. Jonas caused severe erosion to the dune where a large scarp can be seen.**
