**2016 ANNUAL REPORT - TO THE CITY OF NORTH WILDWOOD
ON THE
CONDITION OF THE CITY BEACHES**

**PREPARED FOR: THE CITY OF NORTH WILDWOOD
901 ATLANTIC AVENUE
NORTH WILDWOOD, NJ 08260**

**PREPARED BY: THE STOCKTON UNIVERSITY COASTAL RESEARCH CENTER
30 WILSON AVENUE
PORT REPUBLIC, NJ 08241
February 25, 2017**

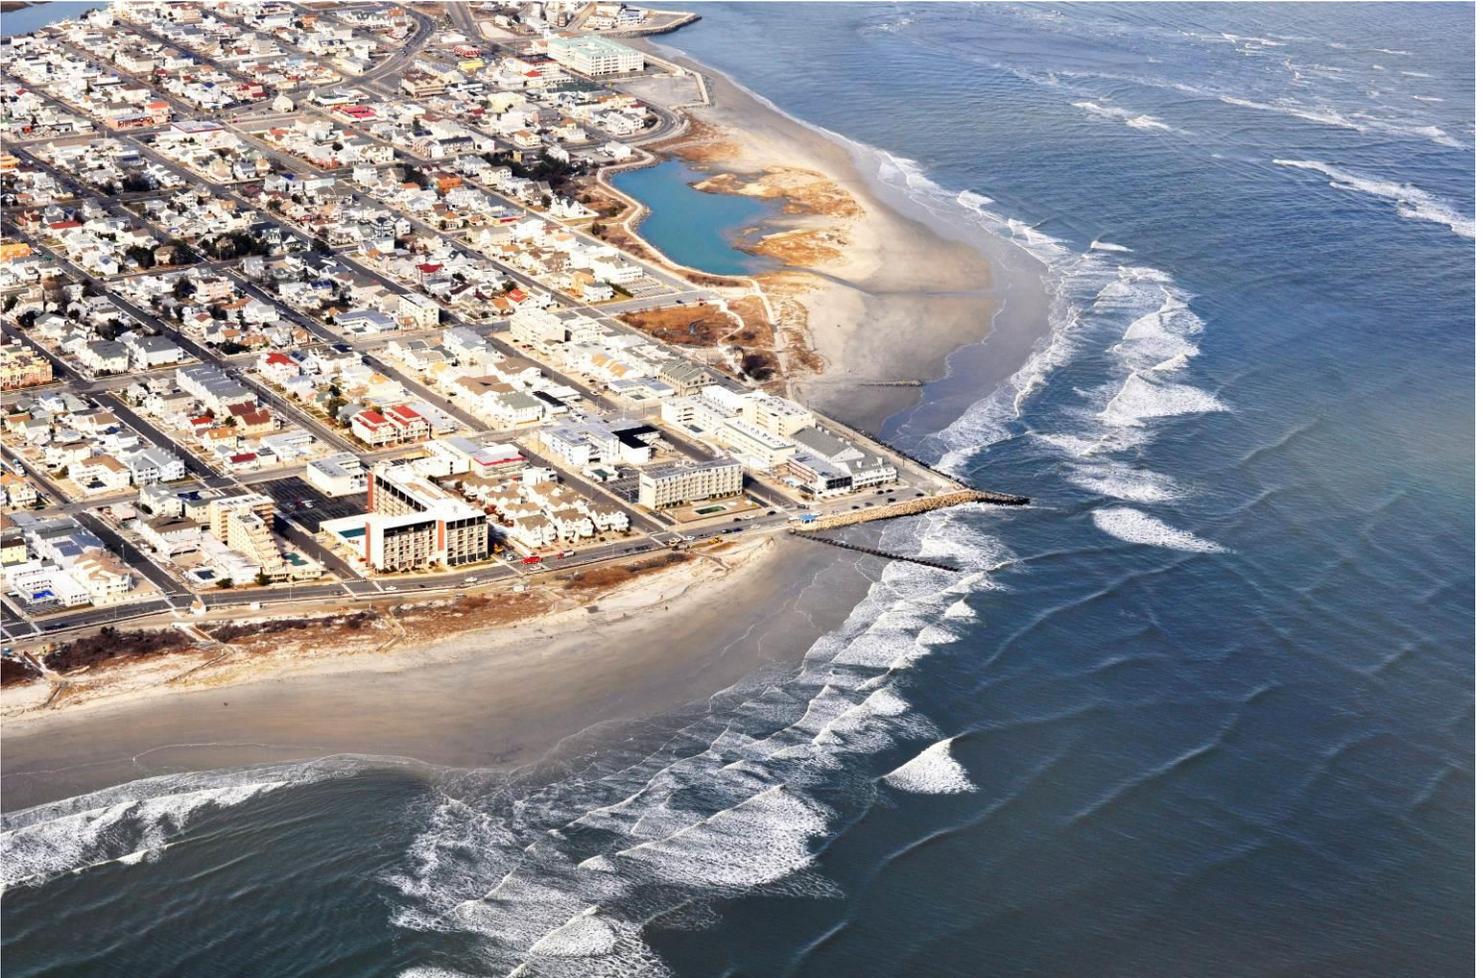
Aerial view of North Wildwood looking northwest into Hereford Inlet on June 25, 2016 following Winter Storm Jonas. This northeast event caused significant erosion to the beachface and dune system along the inlet and northend oceanfront beaches, in the process exposing more of the rock revetment wall. The main channel is shown as the darker, smoother water running parallel to the North Wildwood Inlet beaches. (Aerial photo taken by Ted Kingston)

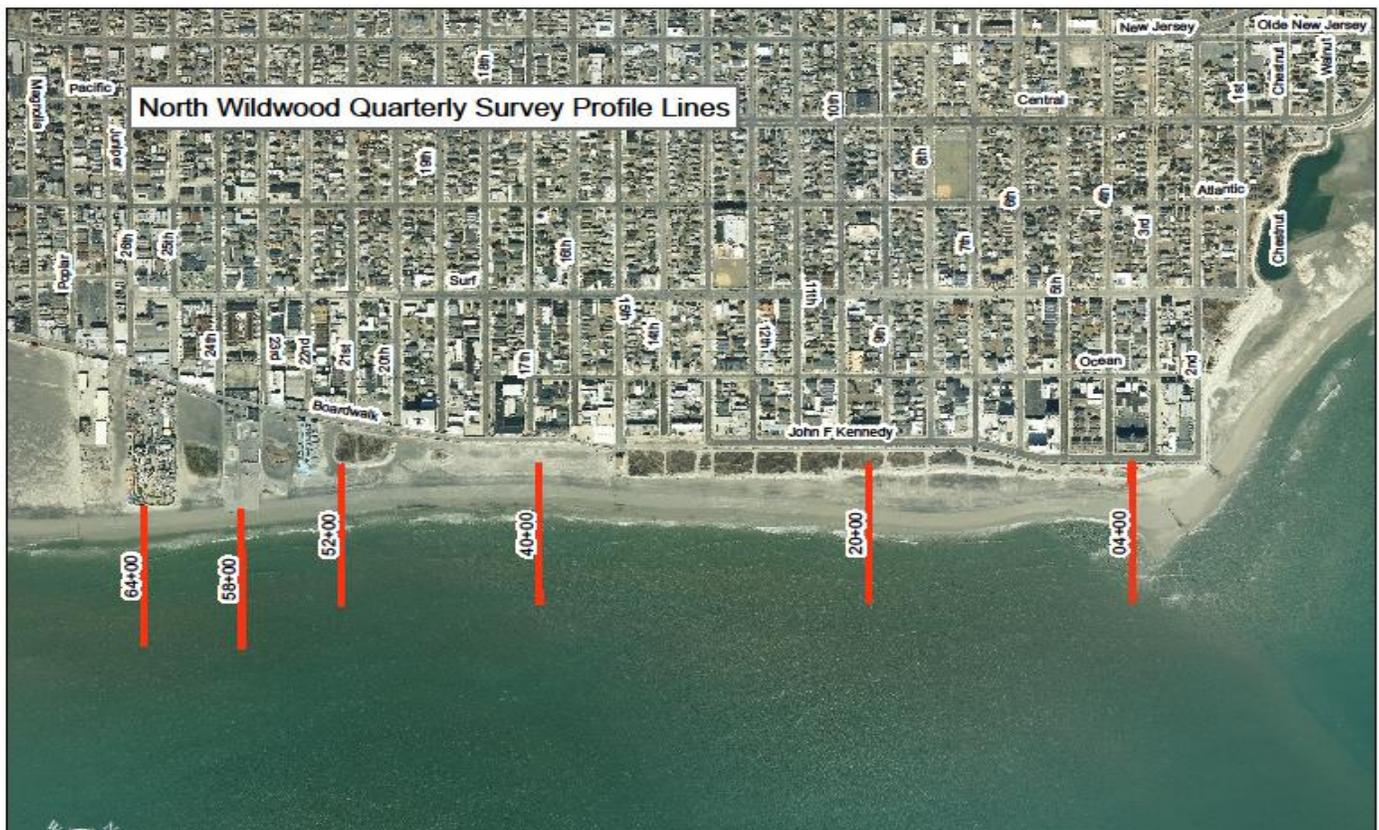
Figure 1. Shown above are locations of six representative profile sites of the 54 profile stations where shoreline changes were measured on the City’s oceanfront from October 2015 to November 2016. For each of the six profile stations descriptions and cross sections are provided to show typical changes over the year.

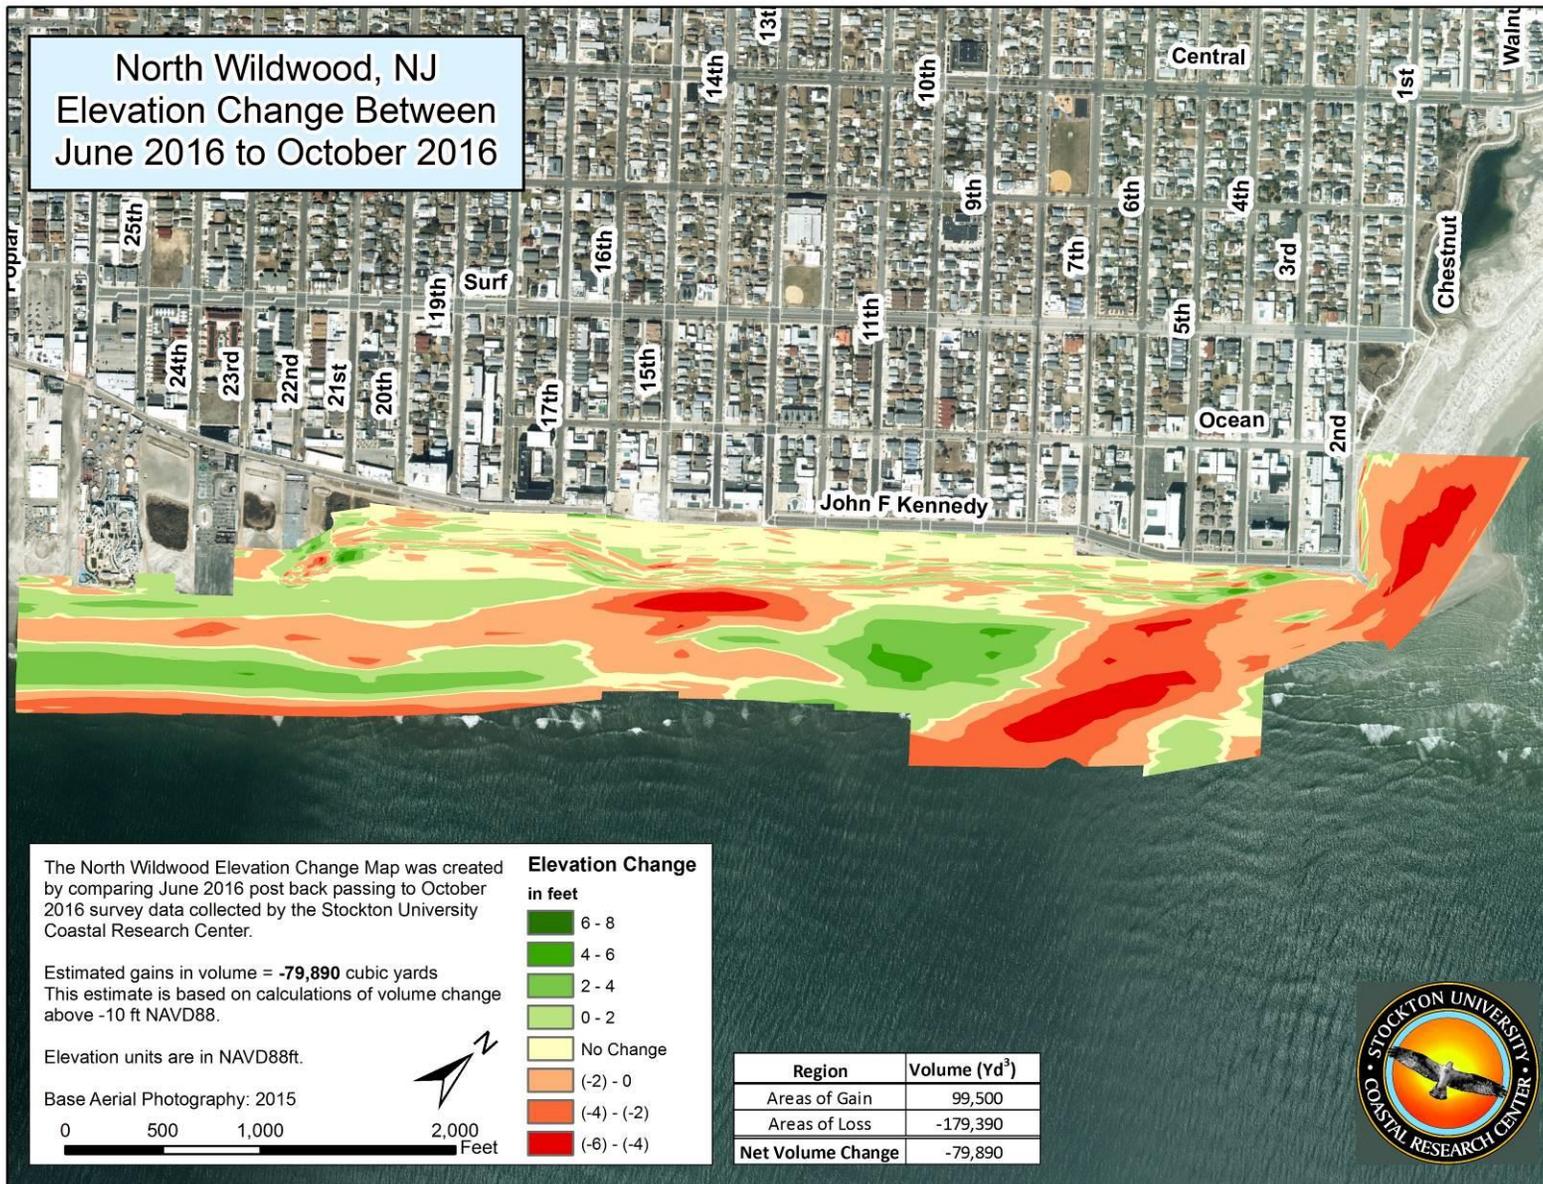
Figure 2. A digital elevation change map for the North Wildwood City shoreline. This elevation difference map of the North Wildwood City engineered beaches shows the change in elevations between June 2016 and October 2016 surveys. There is a dark green area of accretion concentrated between 3rd and 4th Avenues directly related to the sand backpassing project. The reddish band that wraps around the northern offshore regions through to the surveyed inlet area located to the north of the 2nd Avenue jetty displays the significant losses experienced through the second half of 2016. A breakdown by region of sand volume gains vs losses is include in the volume change table on the map. Cumulative volume losses for this time period amounted to 79,890 cubic yards concentrated around the 2nd Avenue jetty south to 8th Avenue.

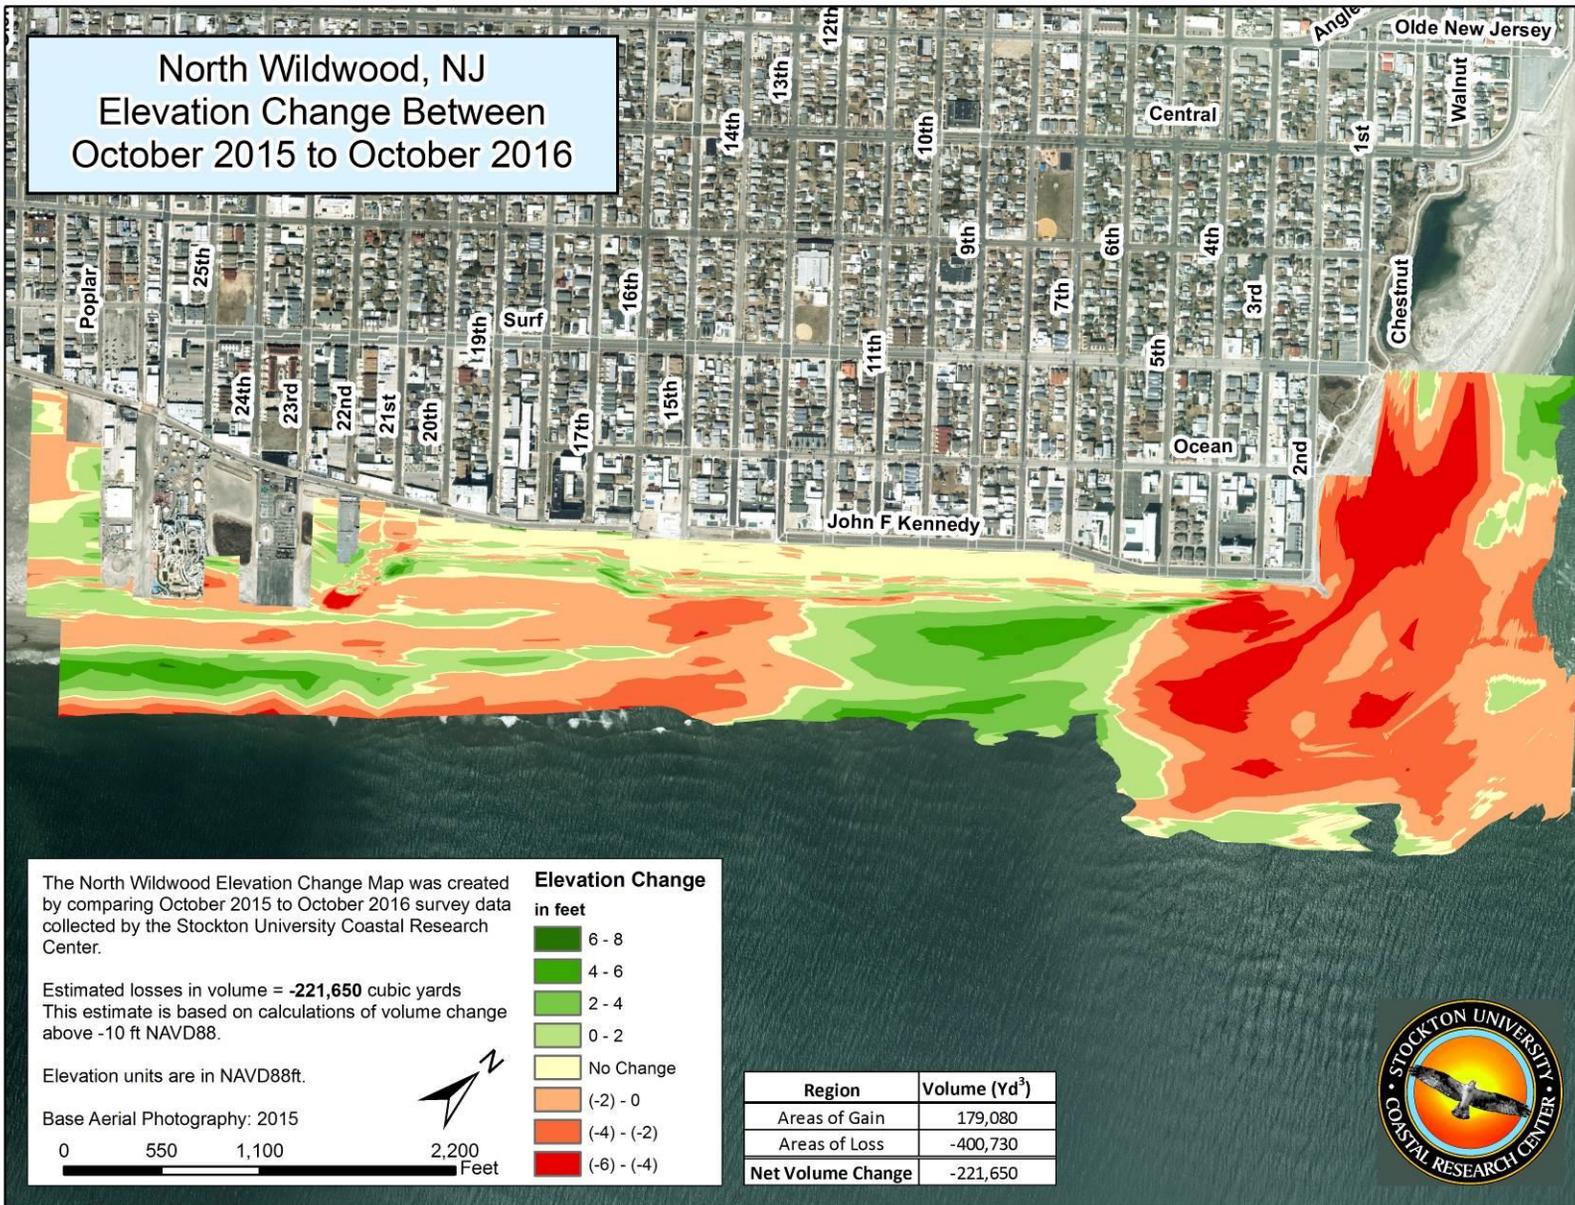
Figure 3. A digital elevation change map for the North Wildwood City shoreline showing the conditions of the engineered beach between the fall 2015 survey through the fall 2016 survey. The shades of color intensify with the magnitude of the change both positive and negative, with the yellow color showing regions with no change over the time interval. Losses were concentrated in the northern portion of the island, around the 2nd Avenue groin apex, continuing into the inlet beaches. Overall 221,650 cubic yards of sand loss was recorded for this annual comparison.

At the north end, inlet dynamics, orientation to the northeast and tidal flow exposes this region to near continuous erosional processes associated with its proximity to Hereford Inlet. Offshore, the shoal system on the south side of Hereford Inlet lost significant material continuously throughout 2016 (figures 2 and 3). Areas of sand gain were limited to the central portions of the area, between 5th Ave. and 12th Ave. as well as offshore between 21st Ave. and Poplar Ave. Unfortunately, these sand volume gains (179,080 cubic yards) were offset by the considerable losses (400,730 cubic yards) yielding a cumulative volume loss of 221,650 cubic yards from October 2015 to October 2016 (figure 3).

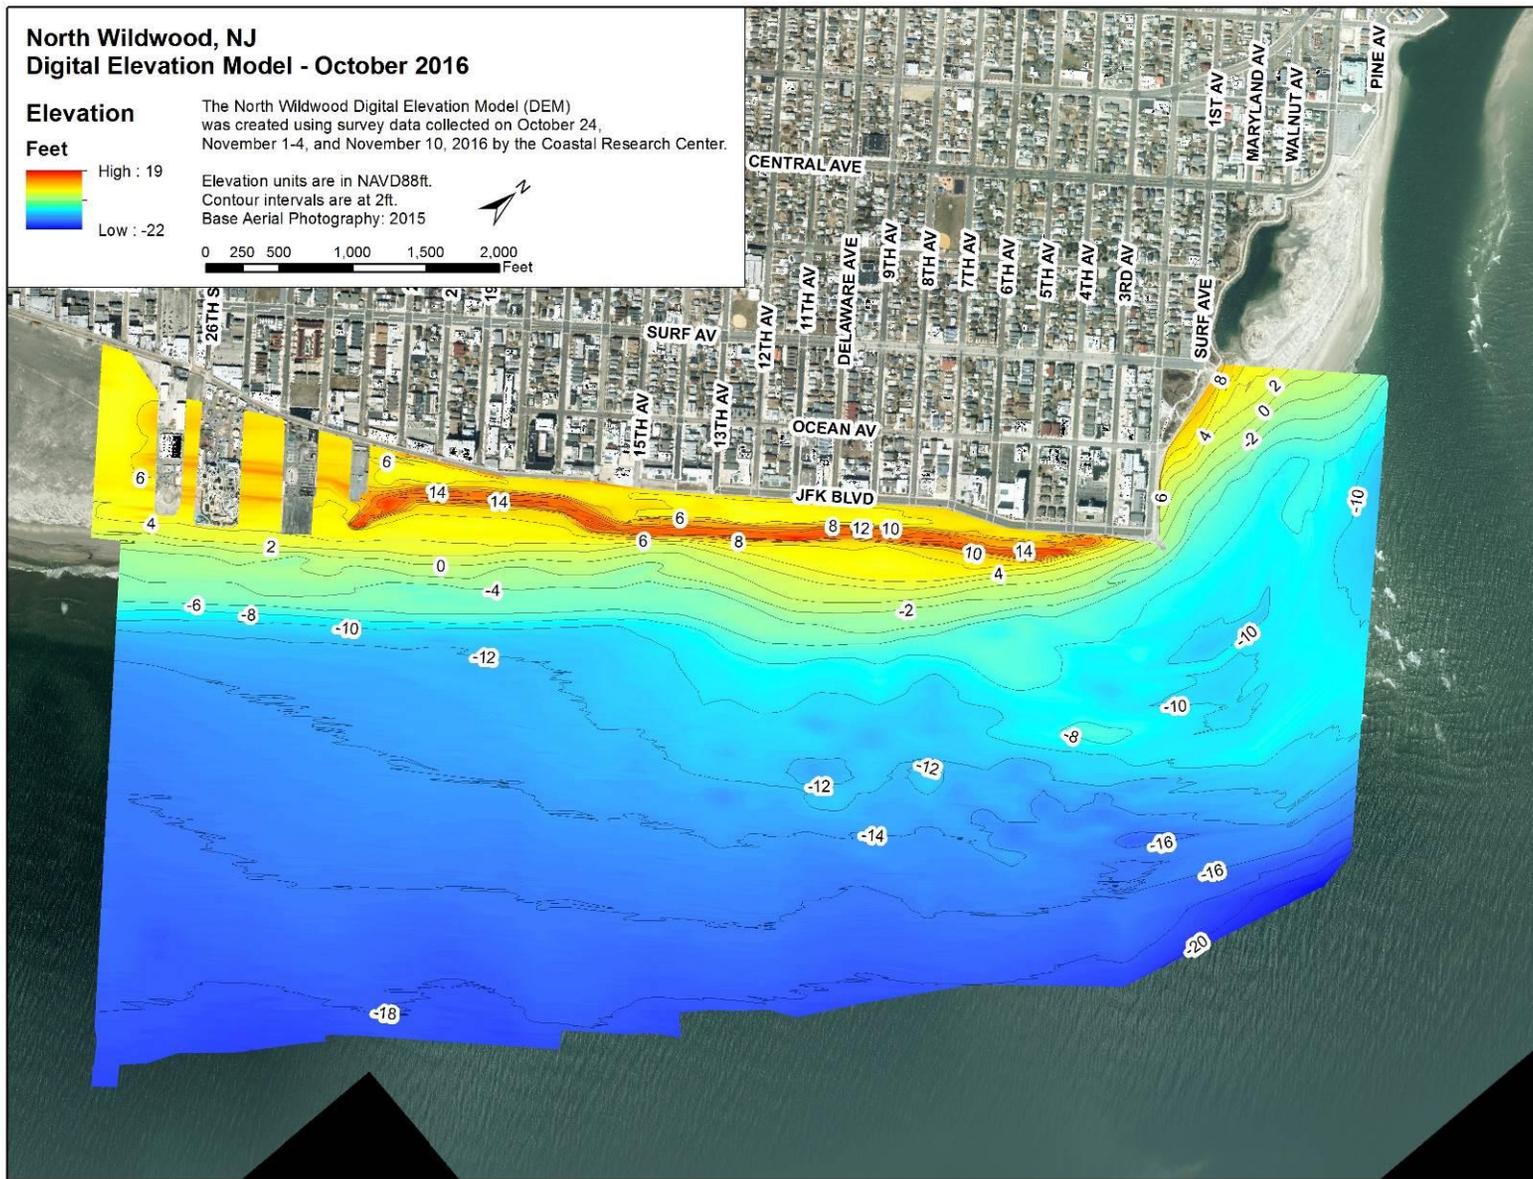
Figure 4. A digital elevation model for the North Wildwood City Shoreline. The higher elevations are colored red/orange and outline the dune and recreational beach regions. The green/blue colors represent the lower elevations nearshore and offshore. The lighter blue colors in the right portion of the map outline the inlet shoal position, and southern boundary of the main tidal channel, as of October 2016.

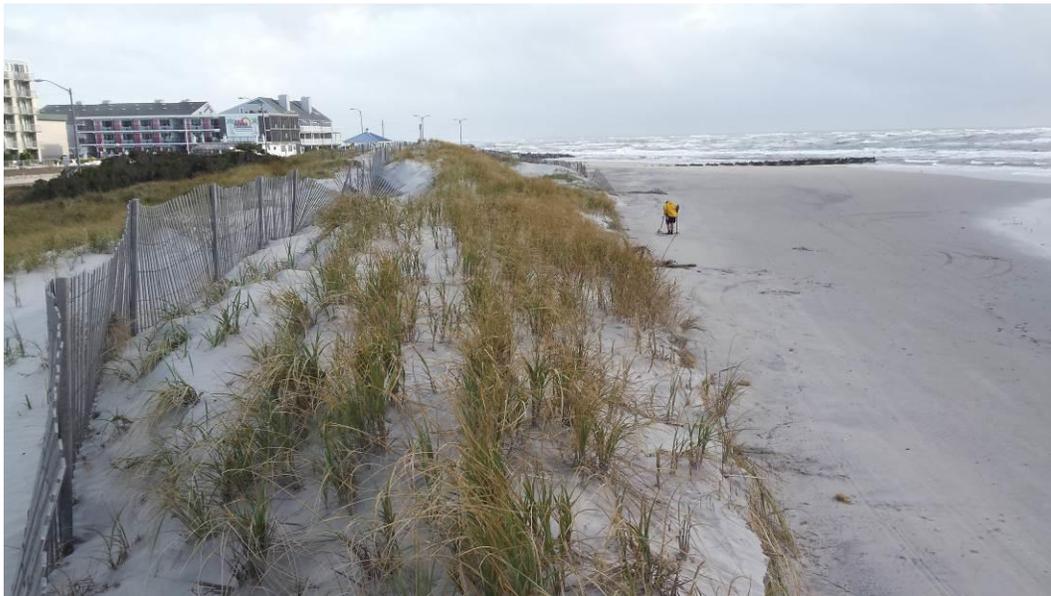
Figure 5. View from 5th Avenue looking north taken on October 3, 2015 following the northeast storm events and Hurricane Joaquin. A significant scarp in the seaward duneface is shown along with recreational beach elevation and shoreline losses observed.

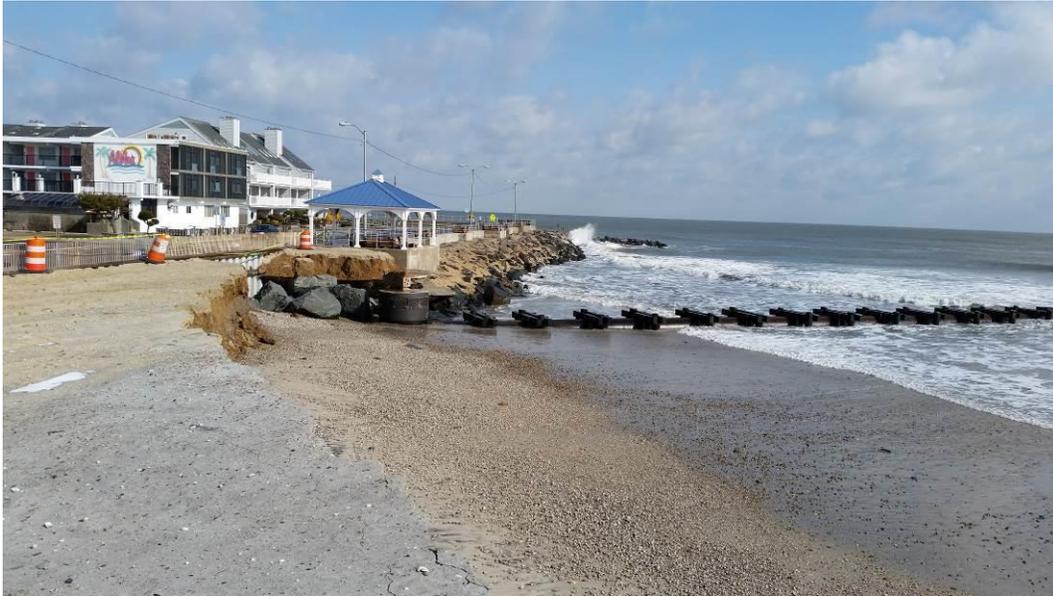
2016 began with two serious winter storms, Jonas (January) and Nacio (February). The northern beaches and dune system, and offshore regions sustained severe damage, exposing the wooden bulkhead and gazebo to storm related damages. The completion of the sand backpassing project in May, from material harvested in Wildwood, modestly repaired the damages suffered earlier in the year. A final sand relocation to the dunecrest using existing material can be seen by the November 2016.

Figure 6. View from 4th Avenue looking north taken on February 10, 2016. The primary dune and beachface has suffered severe erosion in the form of a large scarp. The gazebo and manhole access cover to the storm outflow pipe is completely exposed and extremely vulnerable to wave approach.

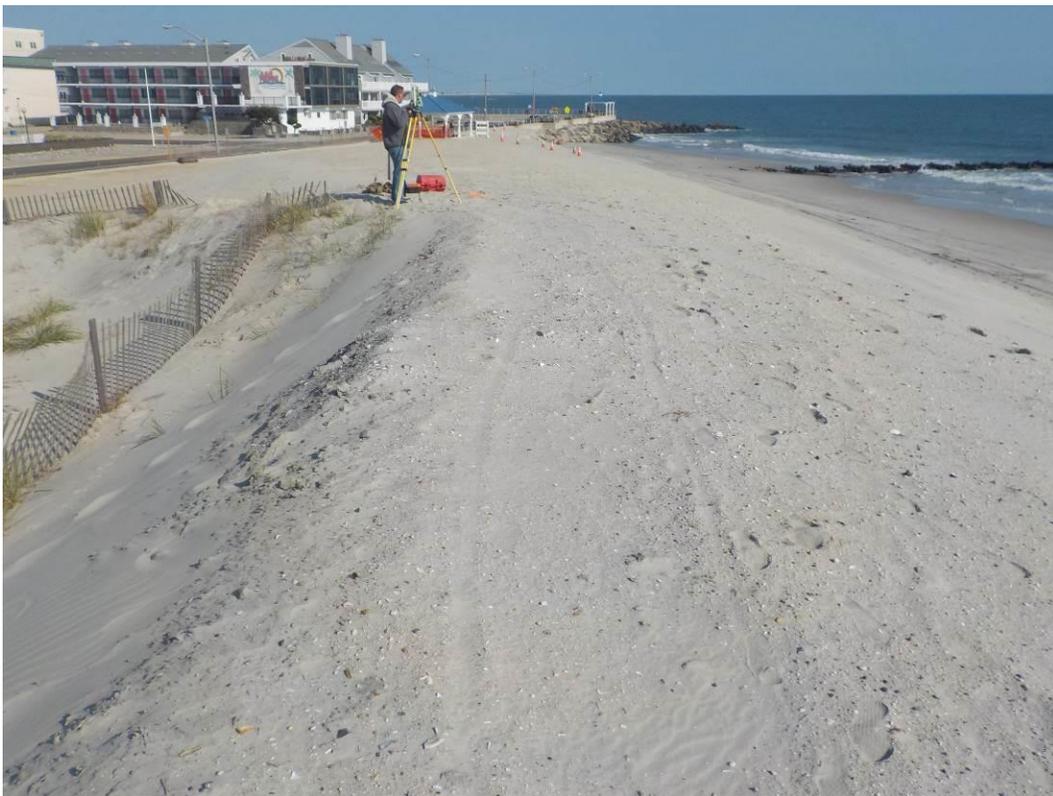
Figure 7. View from 6th Avenue looking north taken on November 2, 2016. The successful sand backpassing project from in front of Wildwoods outfall pipes in conjunction with sand relocation from the beach resulted in a fortified primary dune.

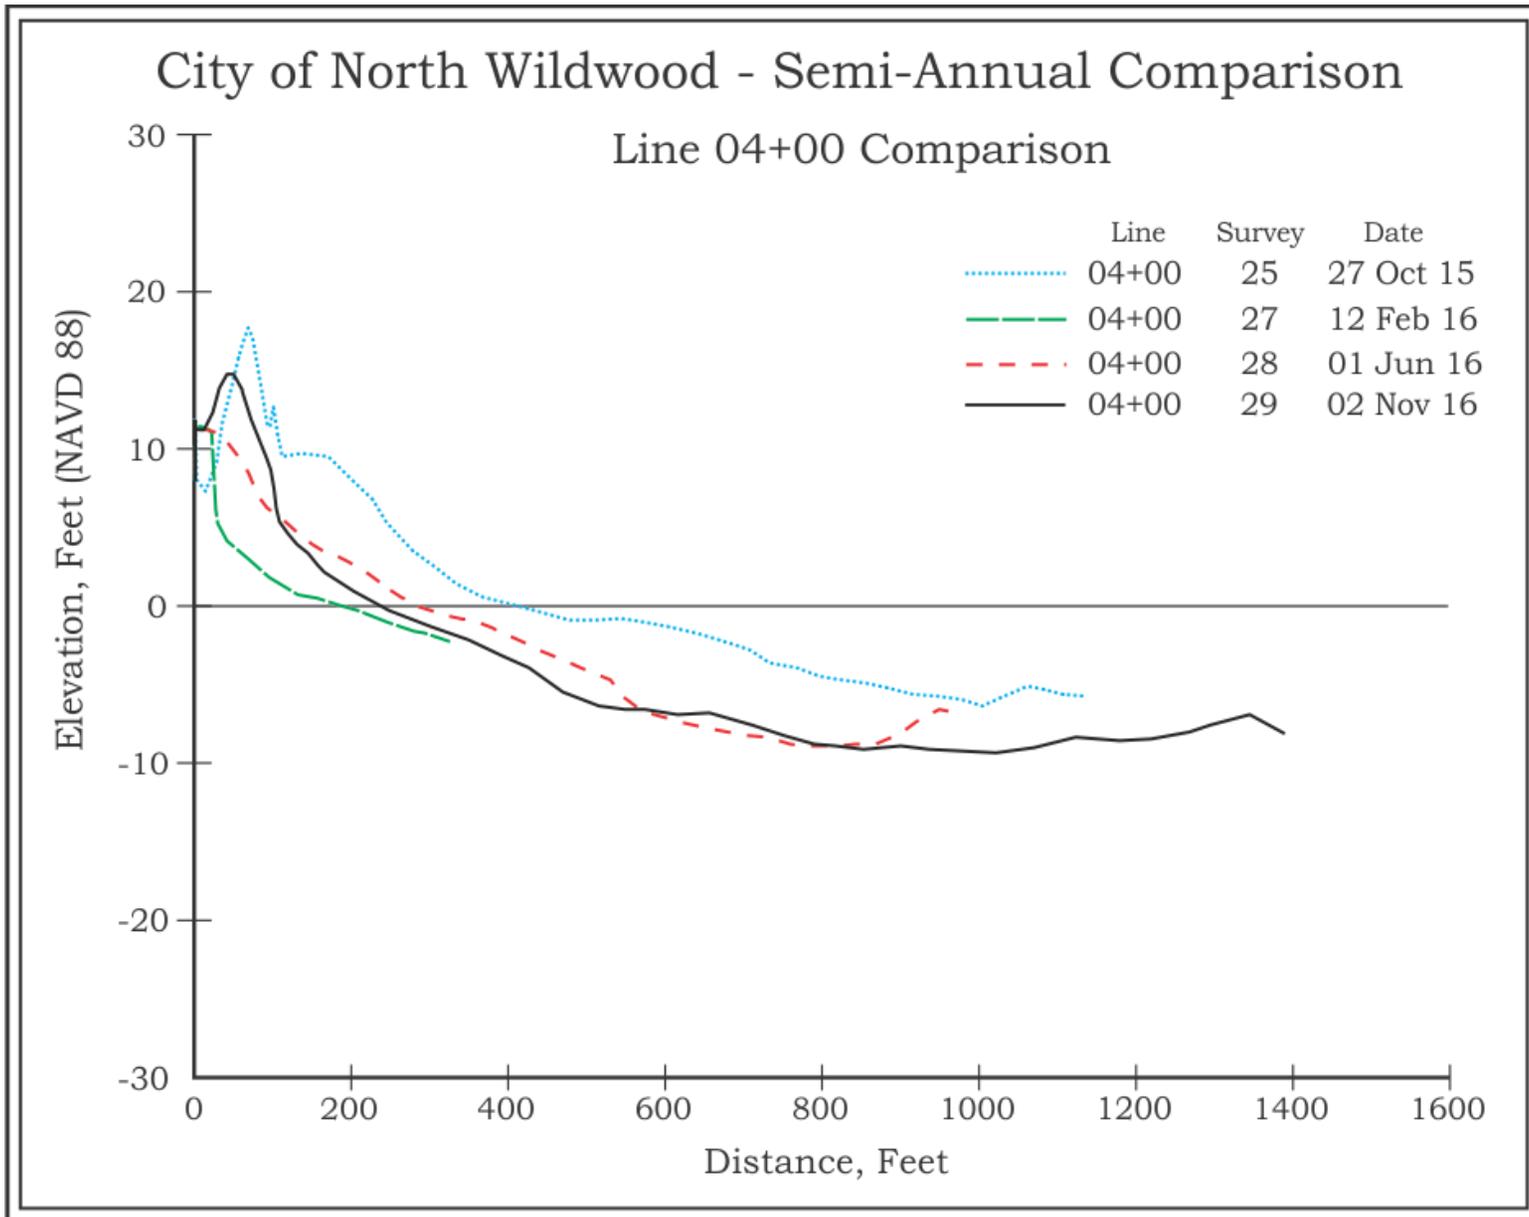
Figure 8. The material mined from Beach Creek that was placed on the northern portion of the island was completely wiped out from Winter Storms Jonas and Nacio. The dune and beachface was repaired in April using sand transported from the Wildwood storm water outfall pipes as shown in Survey 28. The annual comparison from the fall 2015 to the fall 2016 revealed a cumulative volume loss of 181.29 yds³/ft. and a shoreline retreat of 172 feet directly related to the early storms of 2016.

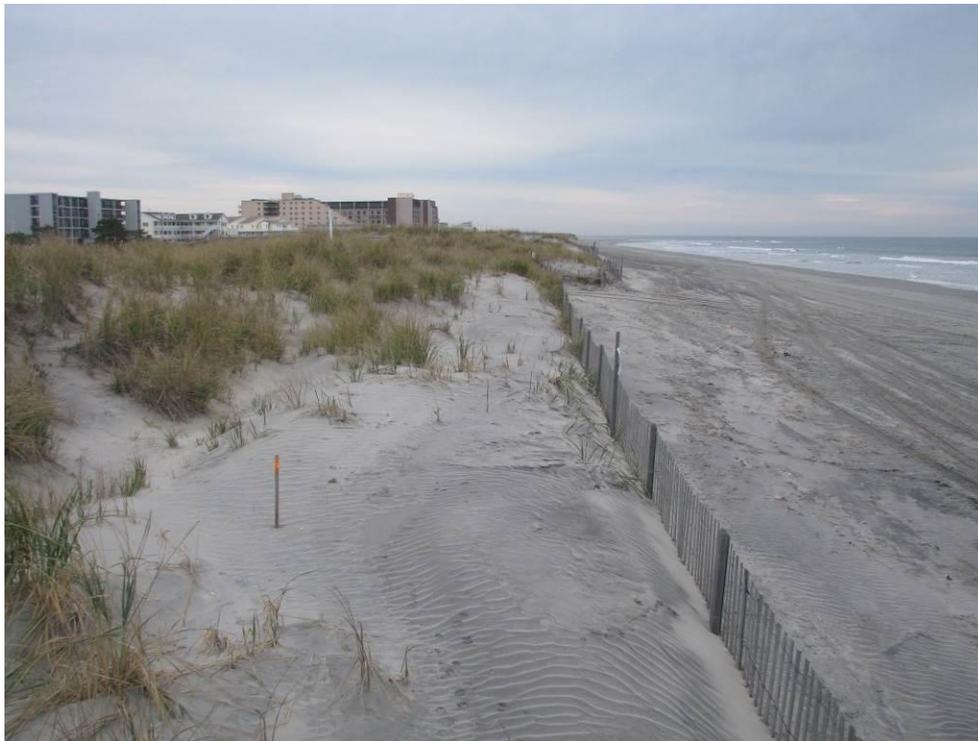
Figure 9. View to the north taken from the foredune at 13th Avenue on November 2, 2015. The beachface eroded slightly from the April survey. For the November 2014 to October 2015 comparison the shoreline position retreated 52 feet with material shifting offshore.

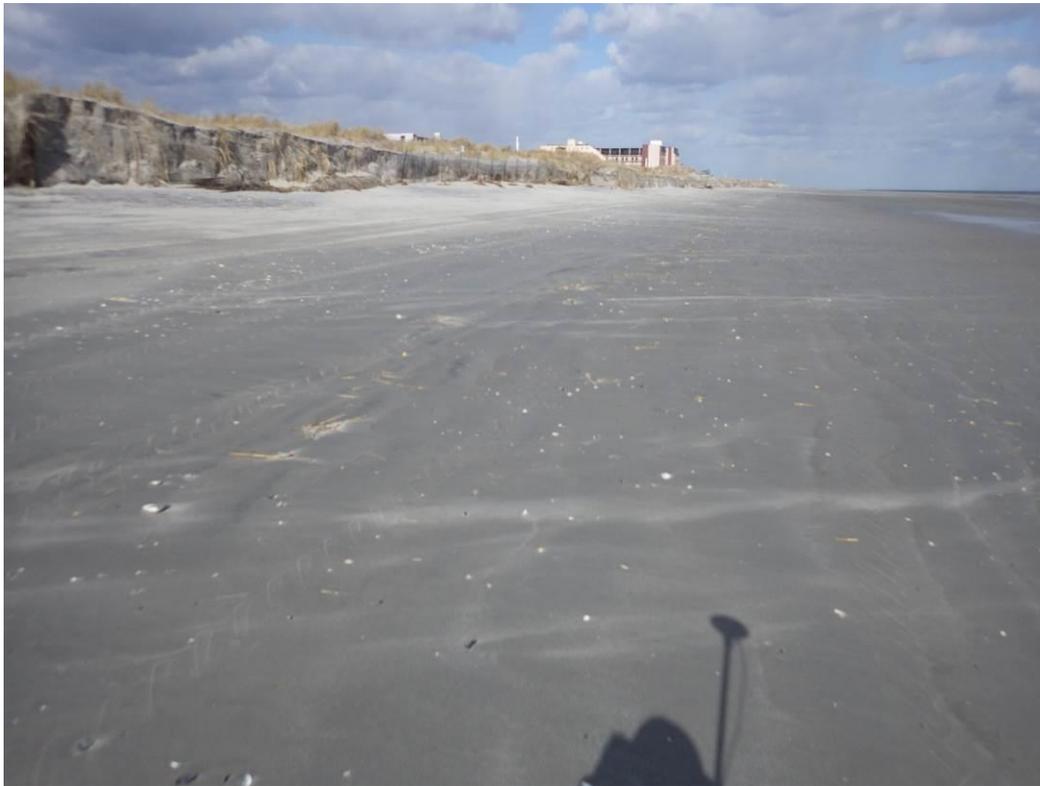
The effects of the two serious winter storms, Jonas (January) and Nacio (February) is documented at this profile site in the form of a dunescarp and eroded beachface. The completion of the sand backpassing project in April, from material harvested in Wildwood, modestly repaired the damages suffered earlier in the year. As littoral drift carried sand from the north, the berm and nearshore regions continued to gain position seaward by the final survey of 2016. Overall, from Survey 25 to Survey 29 the shoreline accreted 198 feet and recorded volume gains of 129.14 yds³/ft.

Figure 10. View to the north taken from the foredune at 12th Avenue on February 11, 2016. A large scarp developed on the seaward dune face as the beachface eroded following the early 2016 storm season.

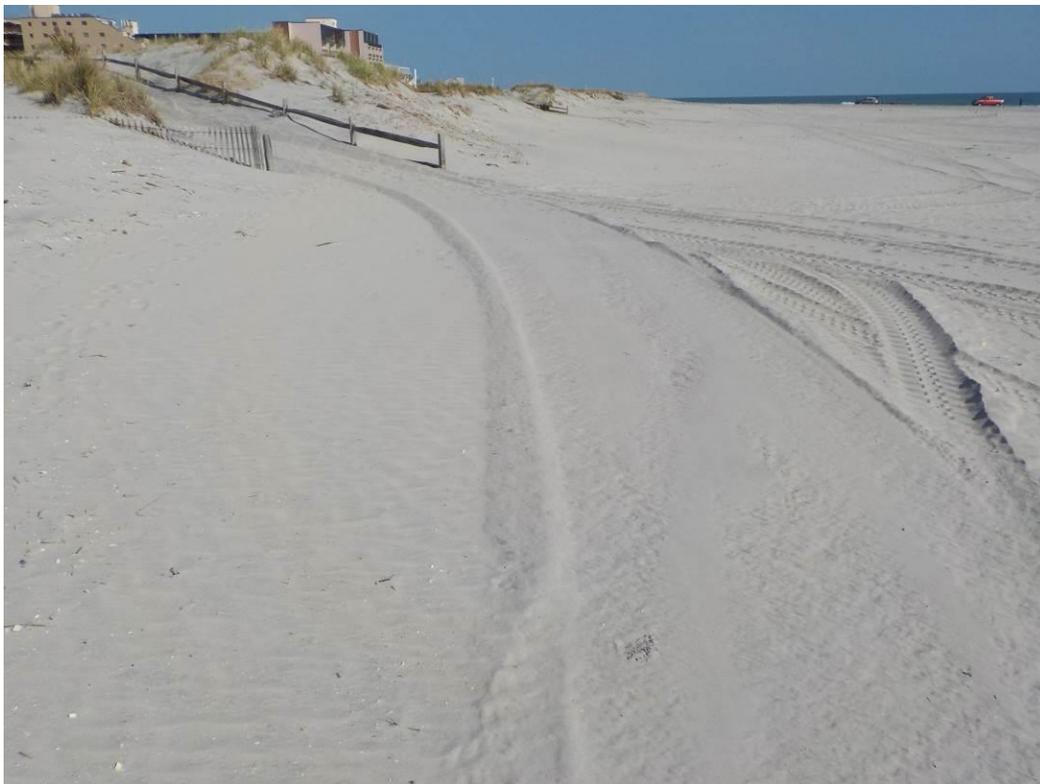
Figure 11. View to the north taken from the foredune at 11th Avenue on November 2, 2016. The beachface and dune system has received material from the Wildwood backpassing project, restoring their respective positions and elevations.

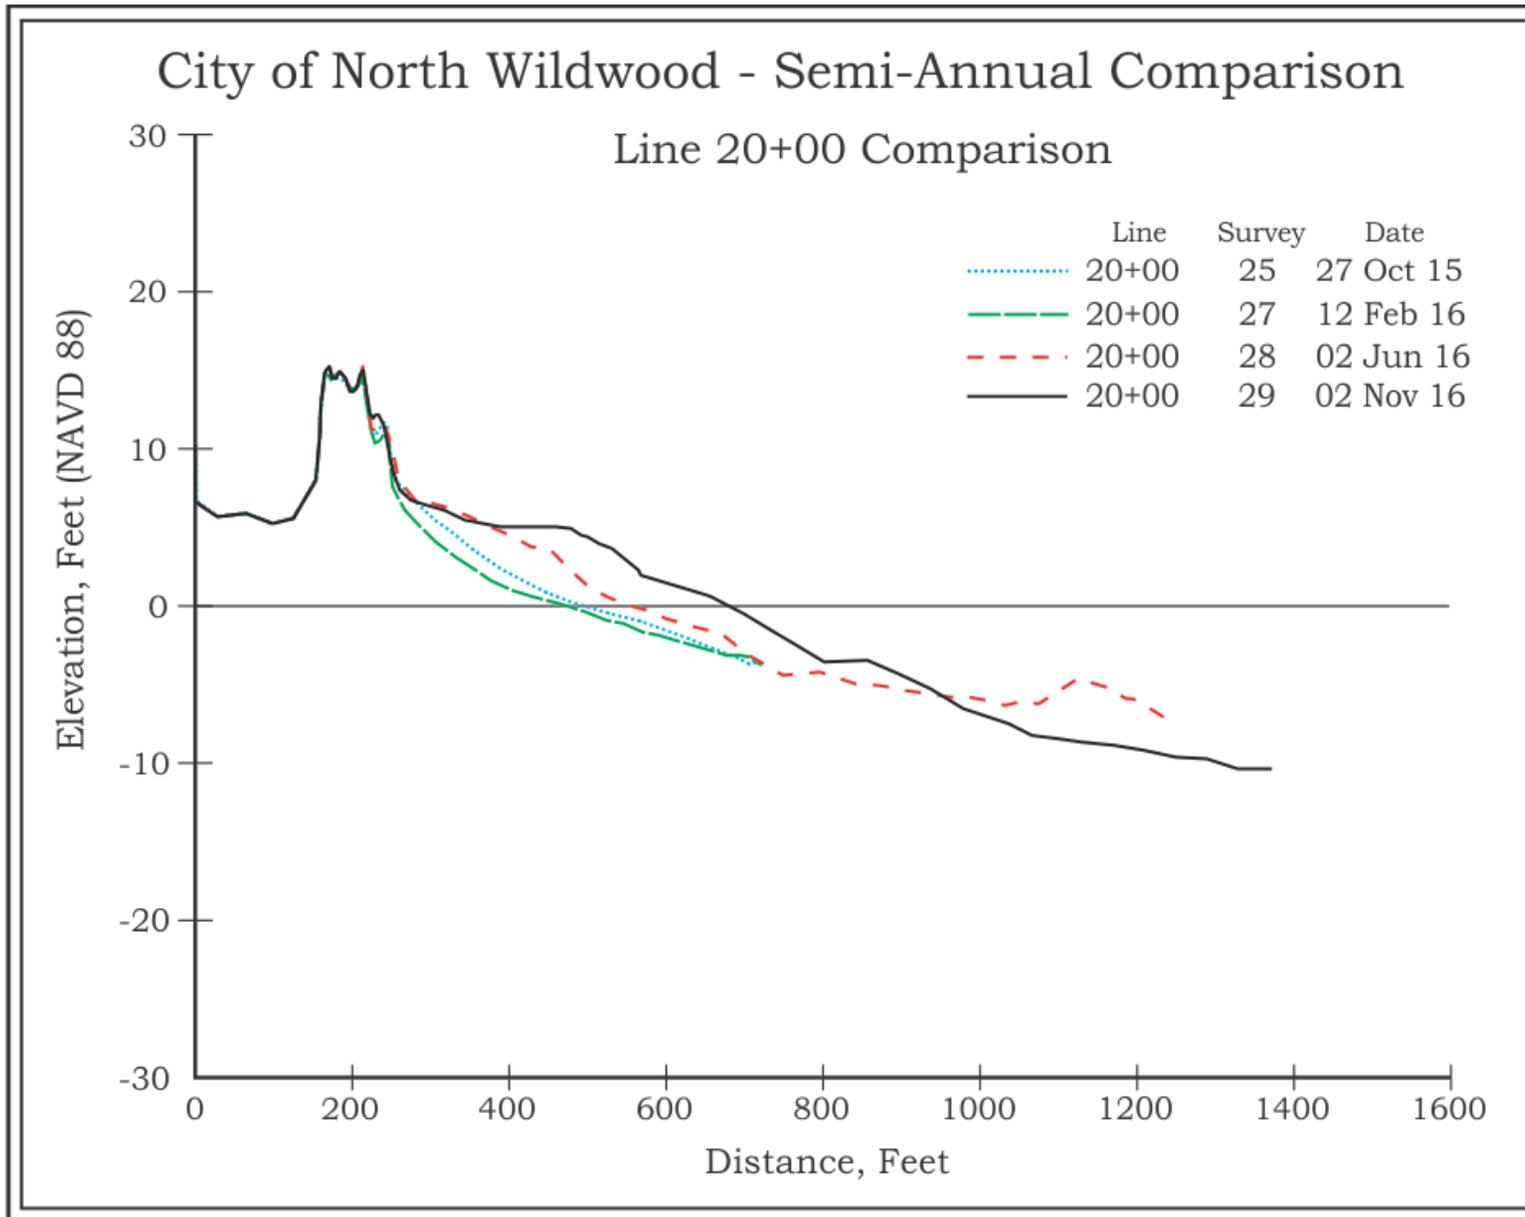
Figure 12. The dunetoe, beachface, and nearshore regions were dominated by erosion through Survey 27. Material from the sand backpassing effort repaired the dune and beachface by the June 2016 survey. As littoral drift carried sand from the north, the berm and nearshore regions continued to gain position seaward. Overall, from Survey 25 to Survey 29 the shoreline accreted 198 feet and recorded volume gains of 129.14 yds³/ft.

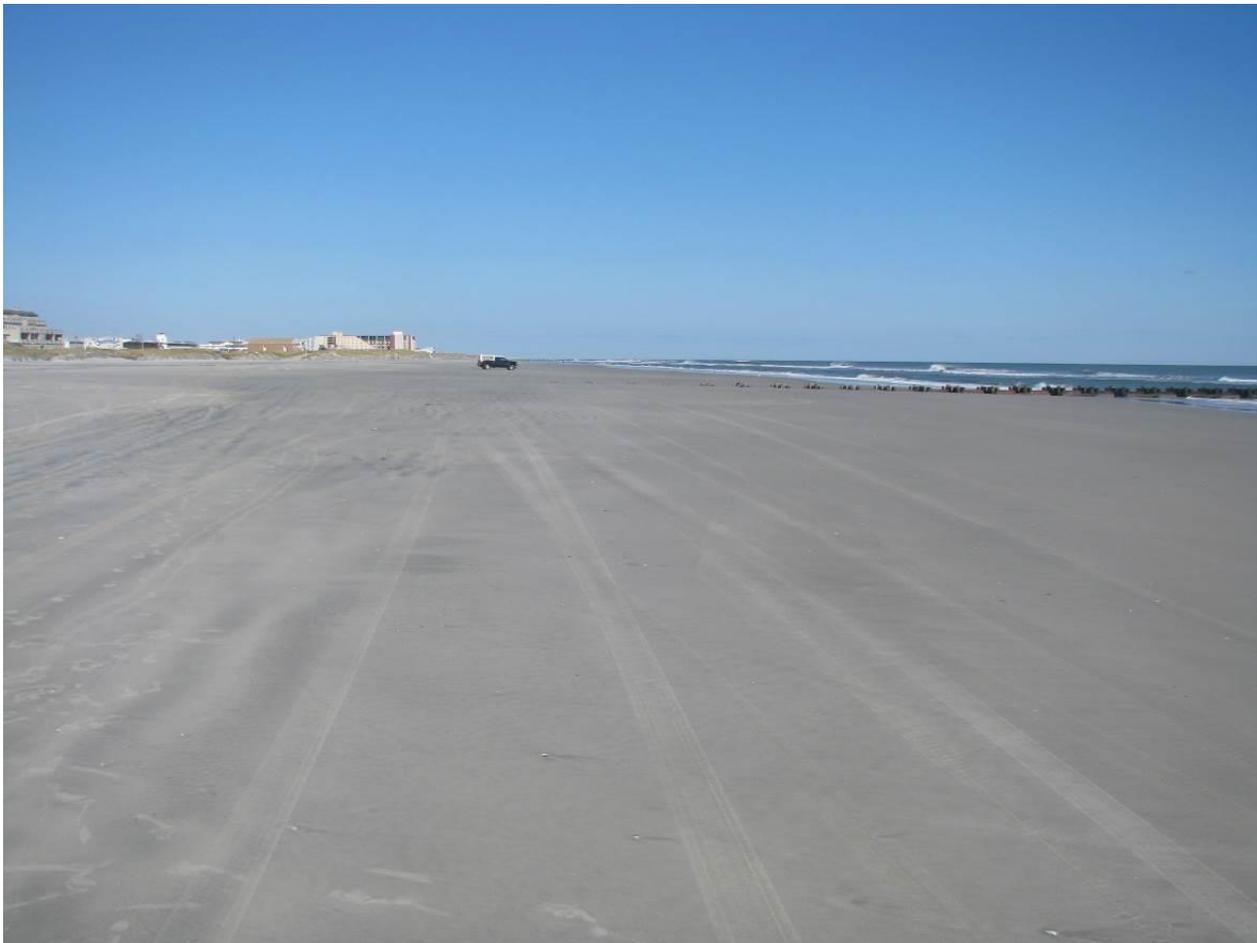
Figure 13. View to the north from the beach located near 19th Avenue on October 30, 2015. The berm and recreational beach had eroded over 100 feet since the fall 2014 survey with sand shifting beyond the profile limits.

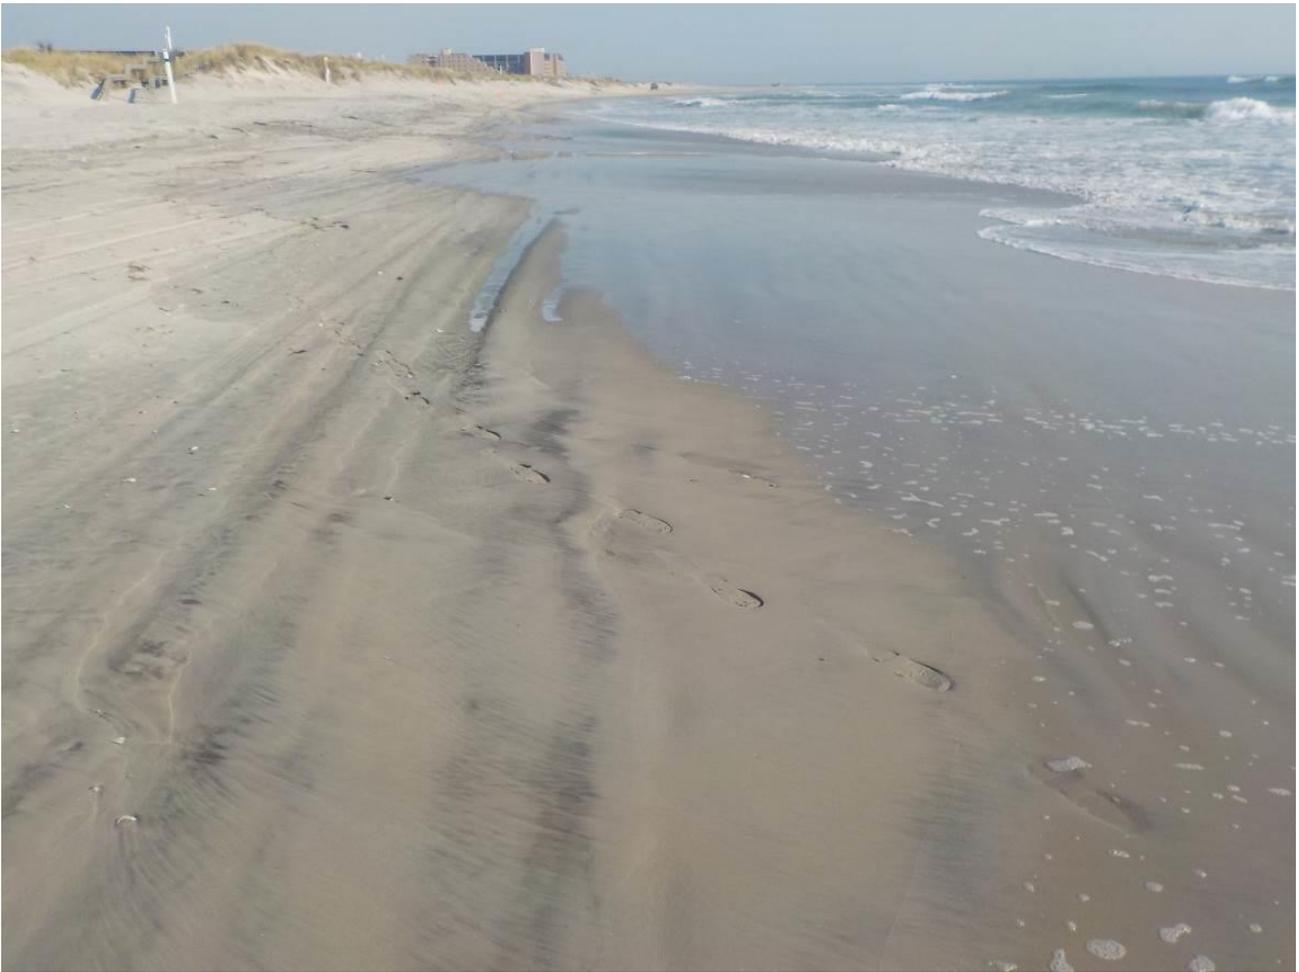
Figure 14. View to the north from the beach located near 18th Avenue on November 2, 2016. The berm and recreational beach has not fully recovered following the NE storm events at the beginning of the year.

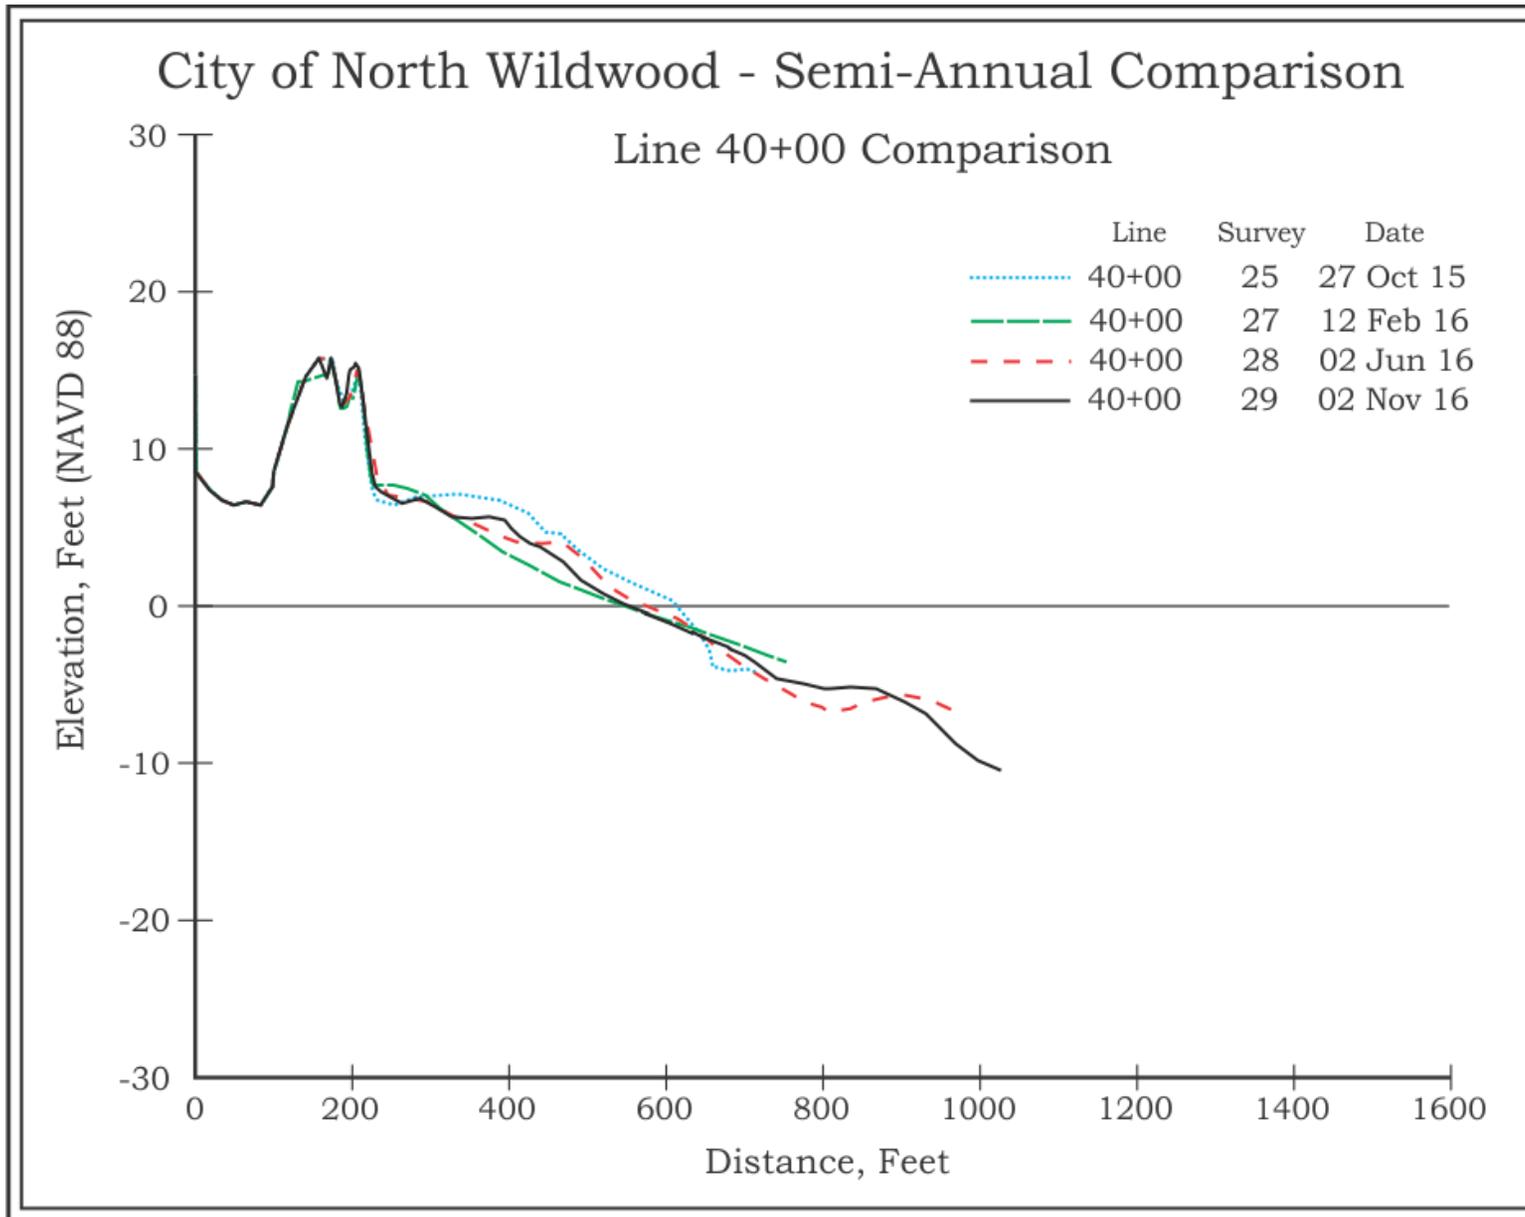
Both the recreational beach and beachface suffered erosional processes as a result of NE Storms Jonas and Nacio, decreasing elevation and shoreline position. The primary dune however, did not receive damage from these events, and actually gained material at the seaward dunetoe by Survey 27. For the annual comparison between Surveys 25 and 29 the shoreline position retreat was 43 feet and the cumulative volume losses were recorded at 34.14 yds³/ft. along the profile.

Figure 15. For the annual comparison (Survey 25 to Survey 29) the recreational beach and berm lost elevation and position as a result of the NE storm activity at the beginning of the year. However, throughout the 2016 survey seasons, the primary dune remained intact and unaffected by the storm events.
