**2016 ANNUAL REPORT - TO THE CITY OF NORTH WILDWOOD
ON THE
CONDITION OF THE CITY BEACHES**

**PREPARED FOR: THE CITY OF NORTH WILDWOOD
901 ATLANTIC AVENUE
NORTH WILDWOOD, NJ 08260**

**PREPARED BY: THE STOCKTON UNIVERSITY COASTAL RESEARCH CENTER
30 WILSON AVENUE
PORT REPUBLIC, NJ 08241
February 25, 2017**

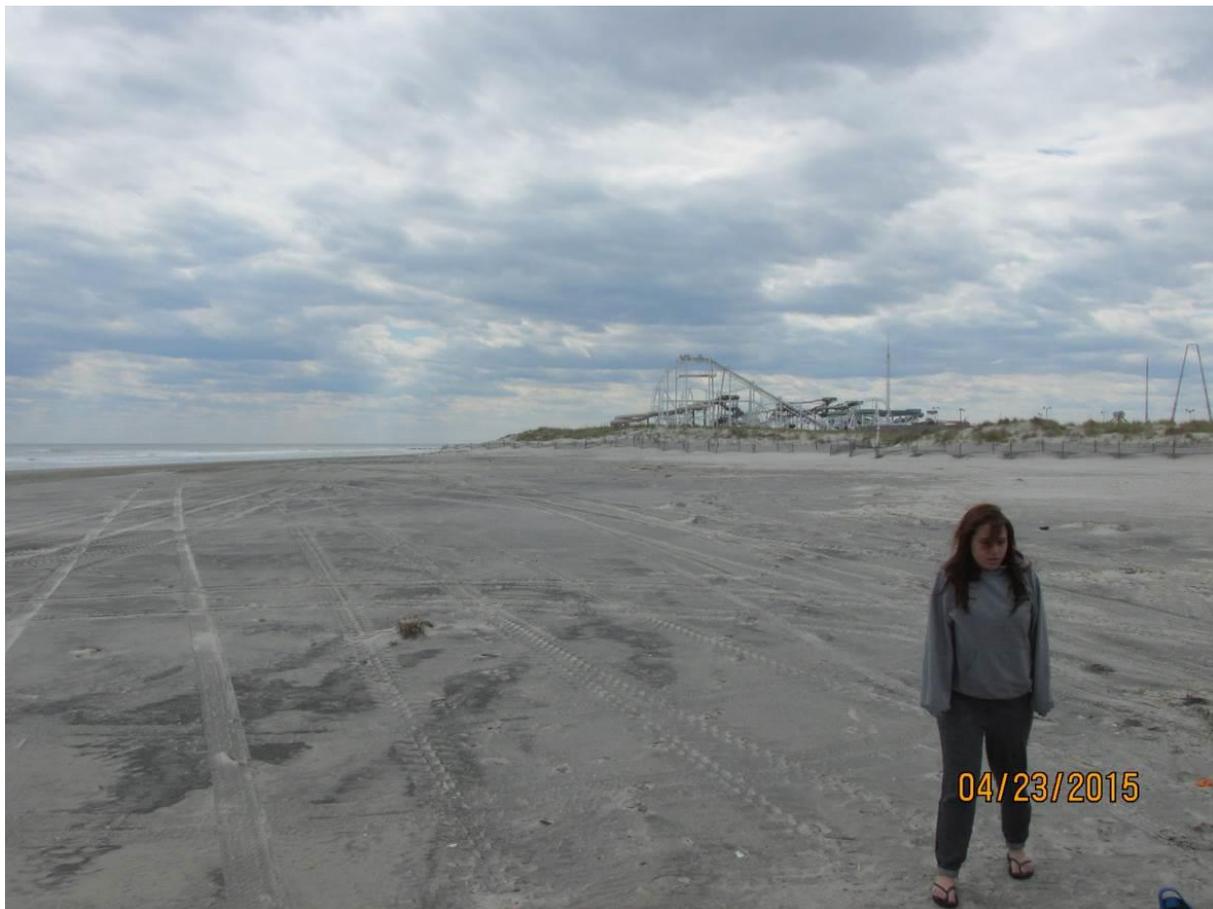
Figure 16. View to the south taken from the beachface at 21st Avenue on April 23, 2015. The recreational beach and beachface began to erode at this time and continued throughout the remainder of 2015.

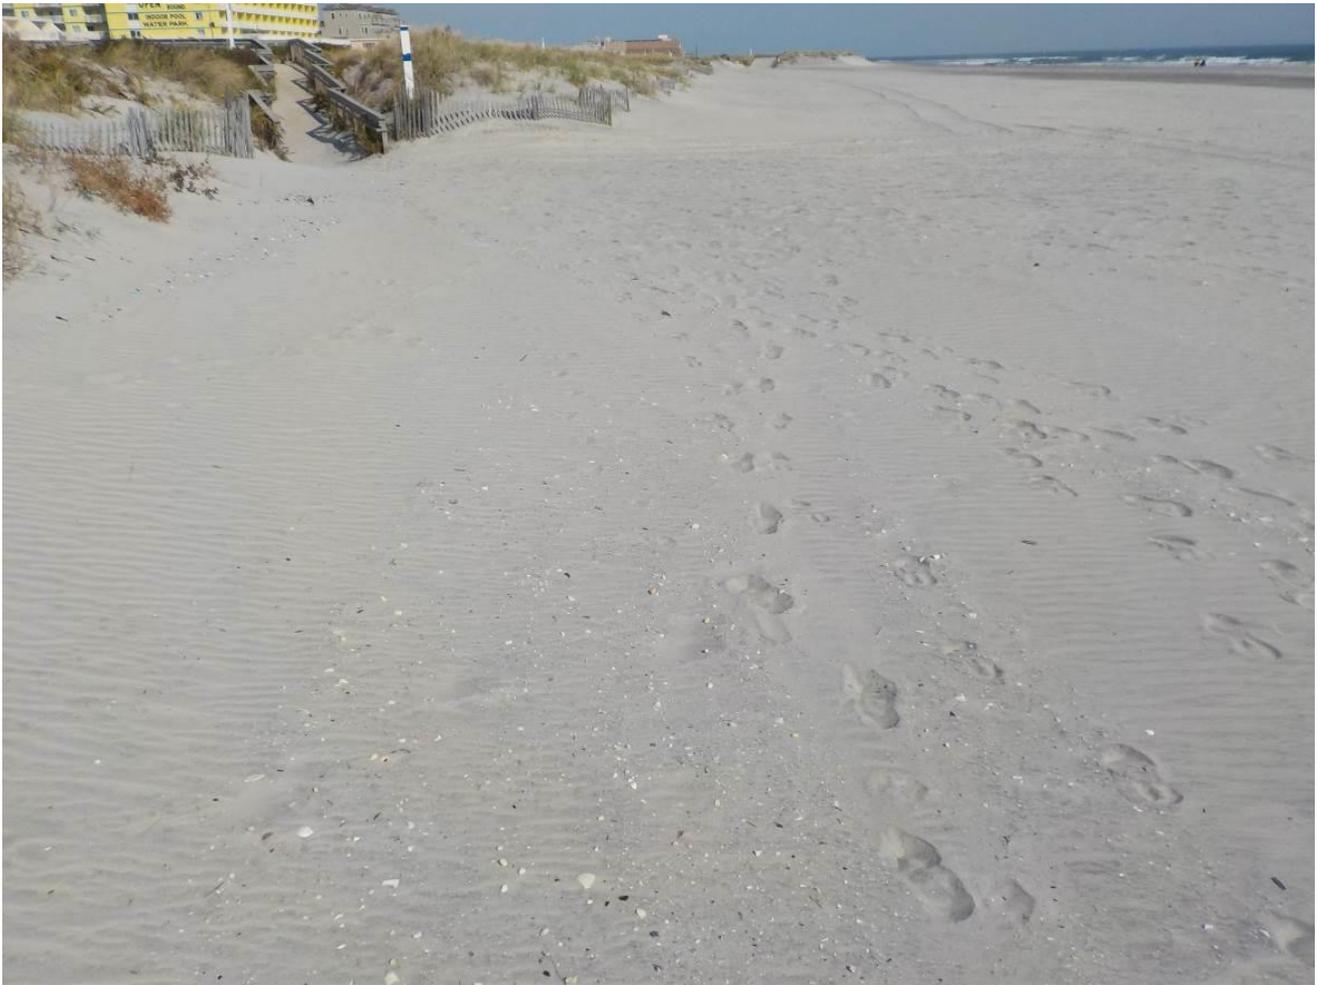
Figure 17. View to the north taken from the beachface at 21st Avenue on November 3, 2016. The photograph displays the primary dune system intact and unaffected by the storms of early 2016. The recreational beach elevation did suffer minor elevation losses by the June 2016 survey, which remained by the final November 2016 survey.

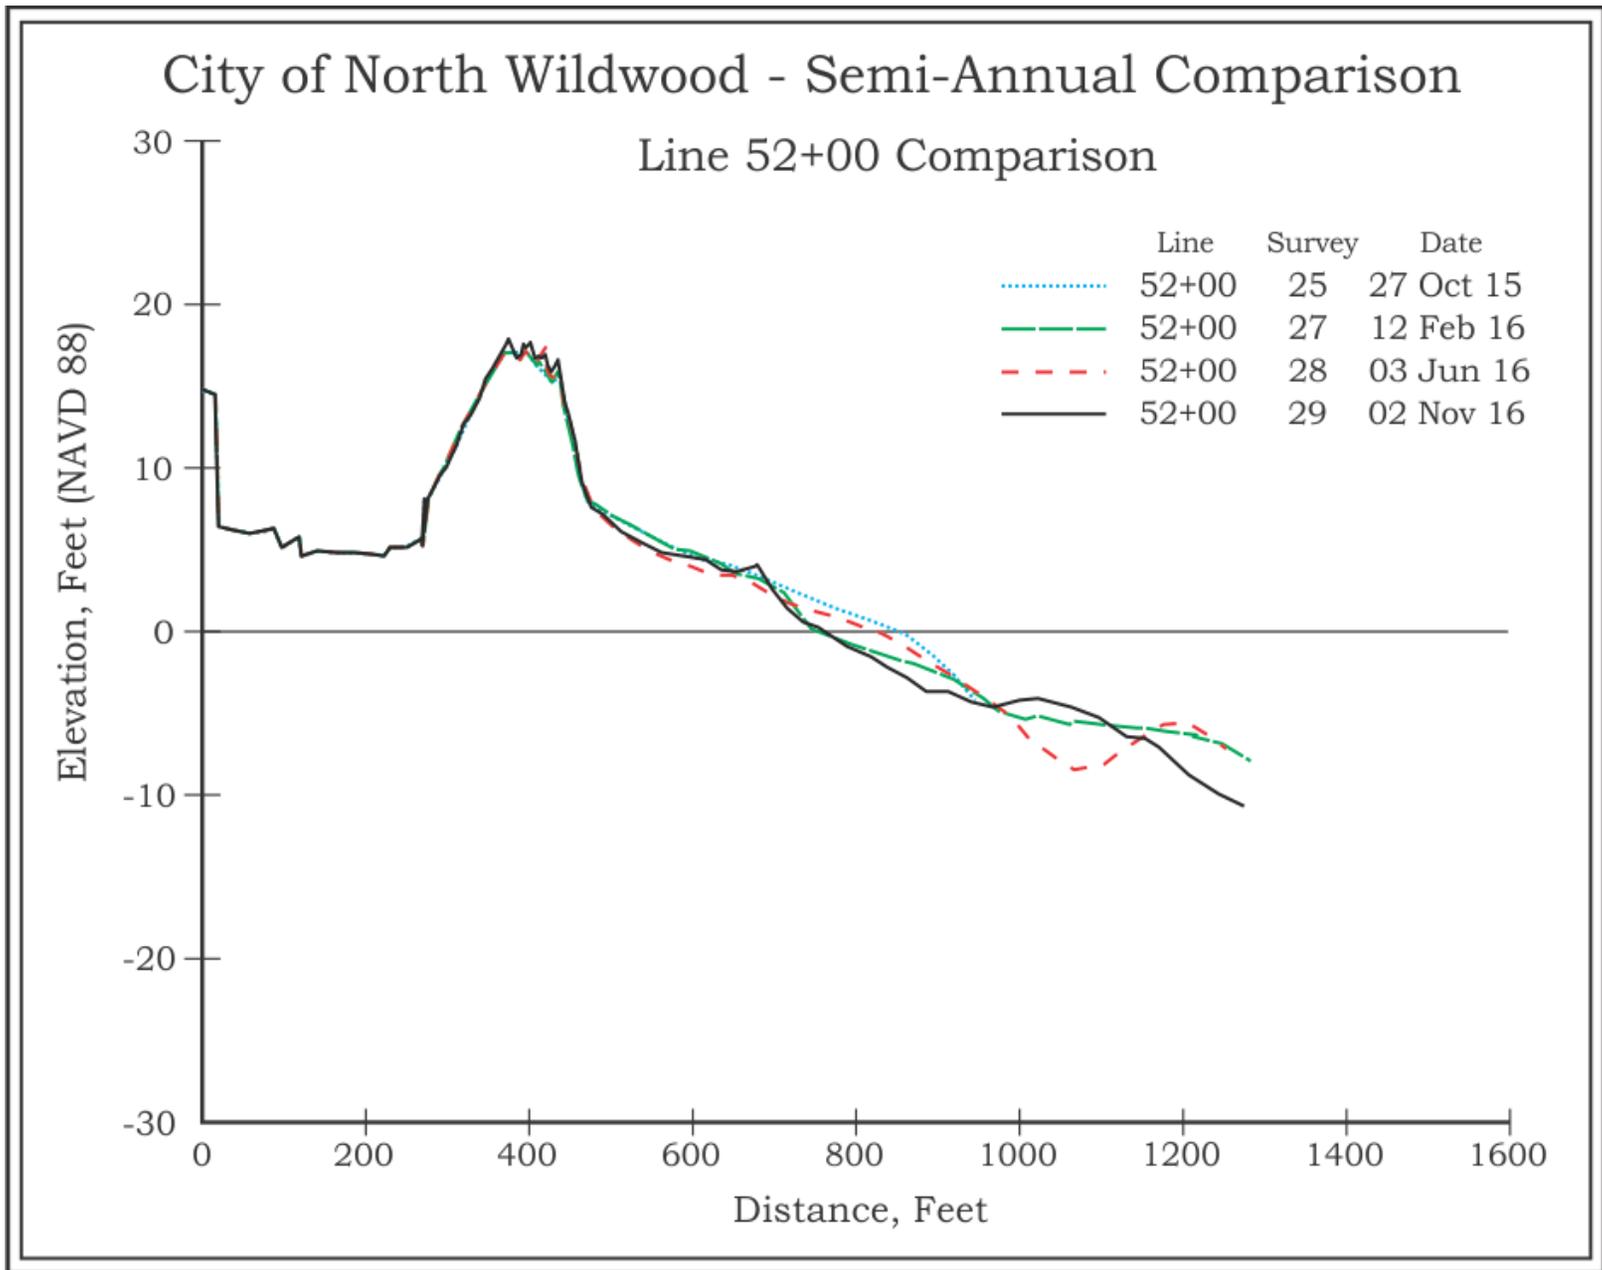
For this southerly location, the impacts of Winter Storms Jonas and Nacio were seen along the erosional beachface. This trend reversed itself and the shoreline accreted by the June 2016 survey, only to once again reduce shoreline position as material shifted offshore by Survey 29. The berm elevation increased by the final survey conducted in 2016. For the October 2015 to November 2016 comparison the net volume change was a gain of 2.41 yds³/ft. of sand with a shoreline position retreat of 57 feet.

Figure 18. The recreational beach and beachface experienced an erosional trend following the February 2016 survey. NE Storms Jonas/Nacio had a negative impact on the beachface at this location. Calmer weather patterns allowed for the shoreline position accretion by June 2016, only to have this trend reversed by the final survey.

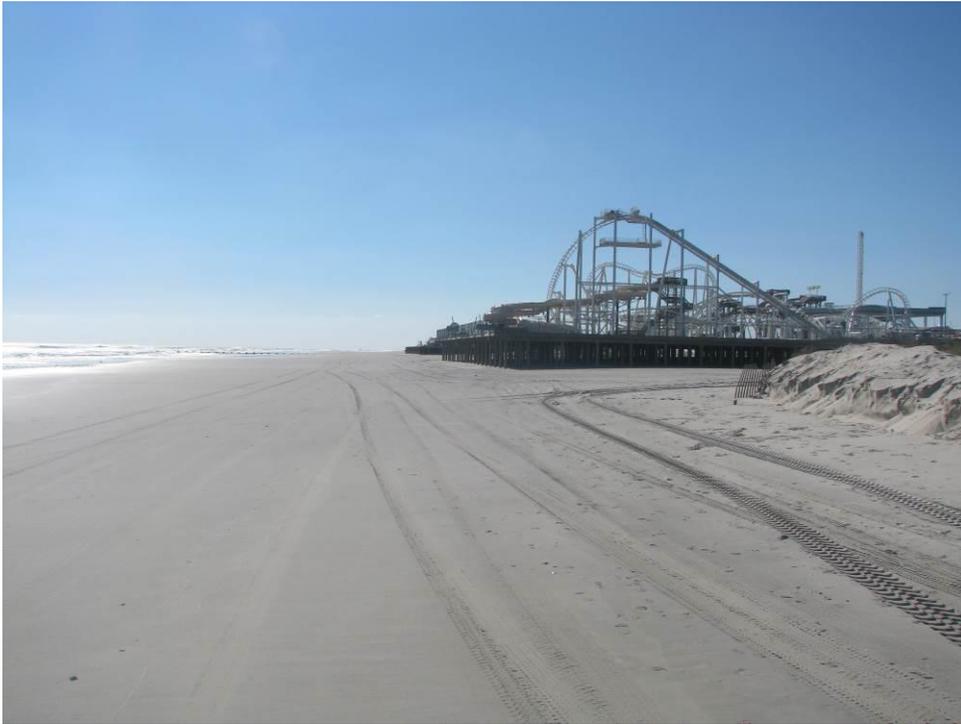
Figure 19. A close up view of the truncated primary dune looking to the south from the berm located near 23rd Avenue on October 30, 2015. The low elevation of the beach is clearly displayed, resulting in a small scarp to the seaward dune toe.

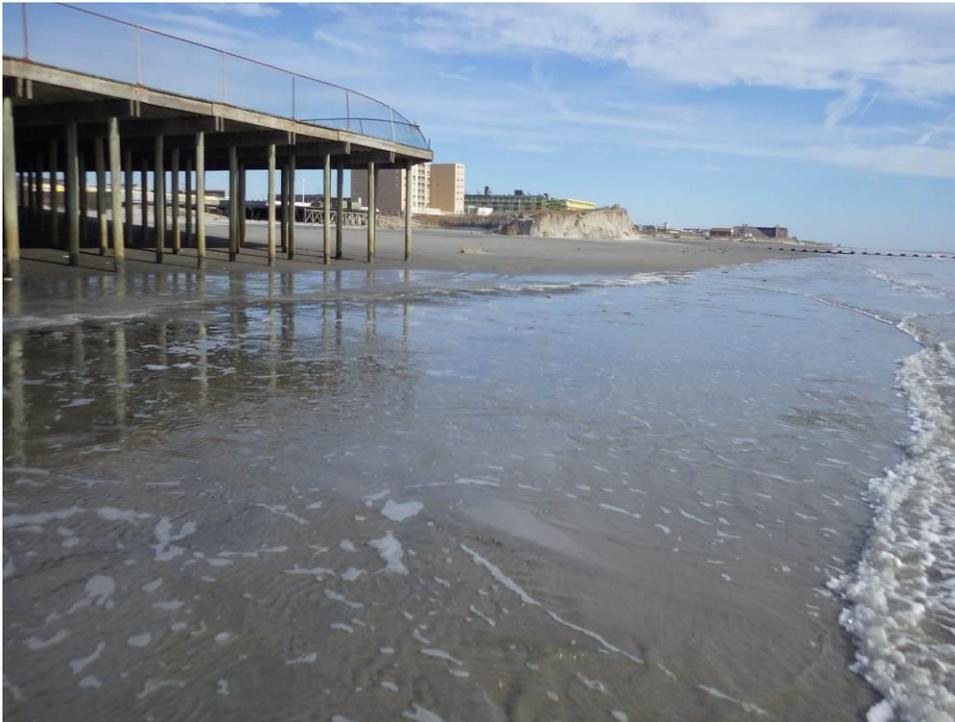
Figure 20. A view of the dune looking to the north from the shoreline located near 23rd Avenue on November 3, 2016. The low lying recreational beach and absence of a protective berm has rendered the dune vulnerable to wave approach. Notice the large scarp in the dune located to the north of the pier. This dune was initially designed to extend to points seaward of the timber pier and extend south past all the pier structures. This design was mandated by the Land Use Regulatory agency of the NJDEP. It failed to survive storm events and was re-positioned at a point parallel with the shoreline at the existing scarp.

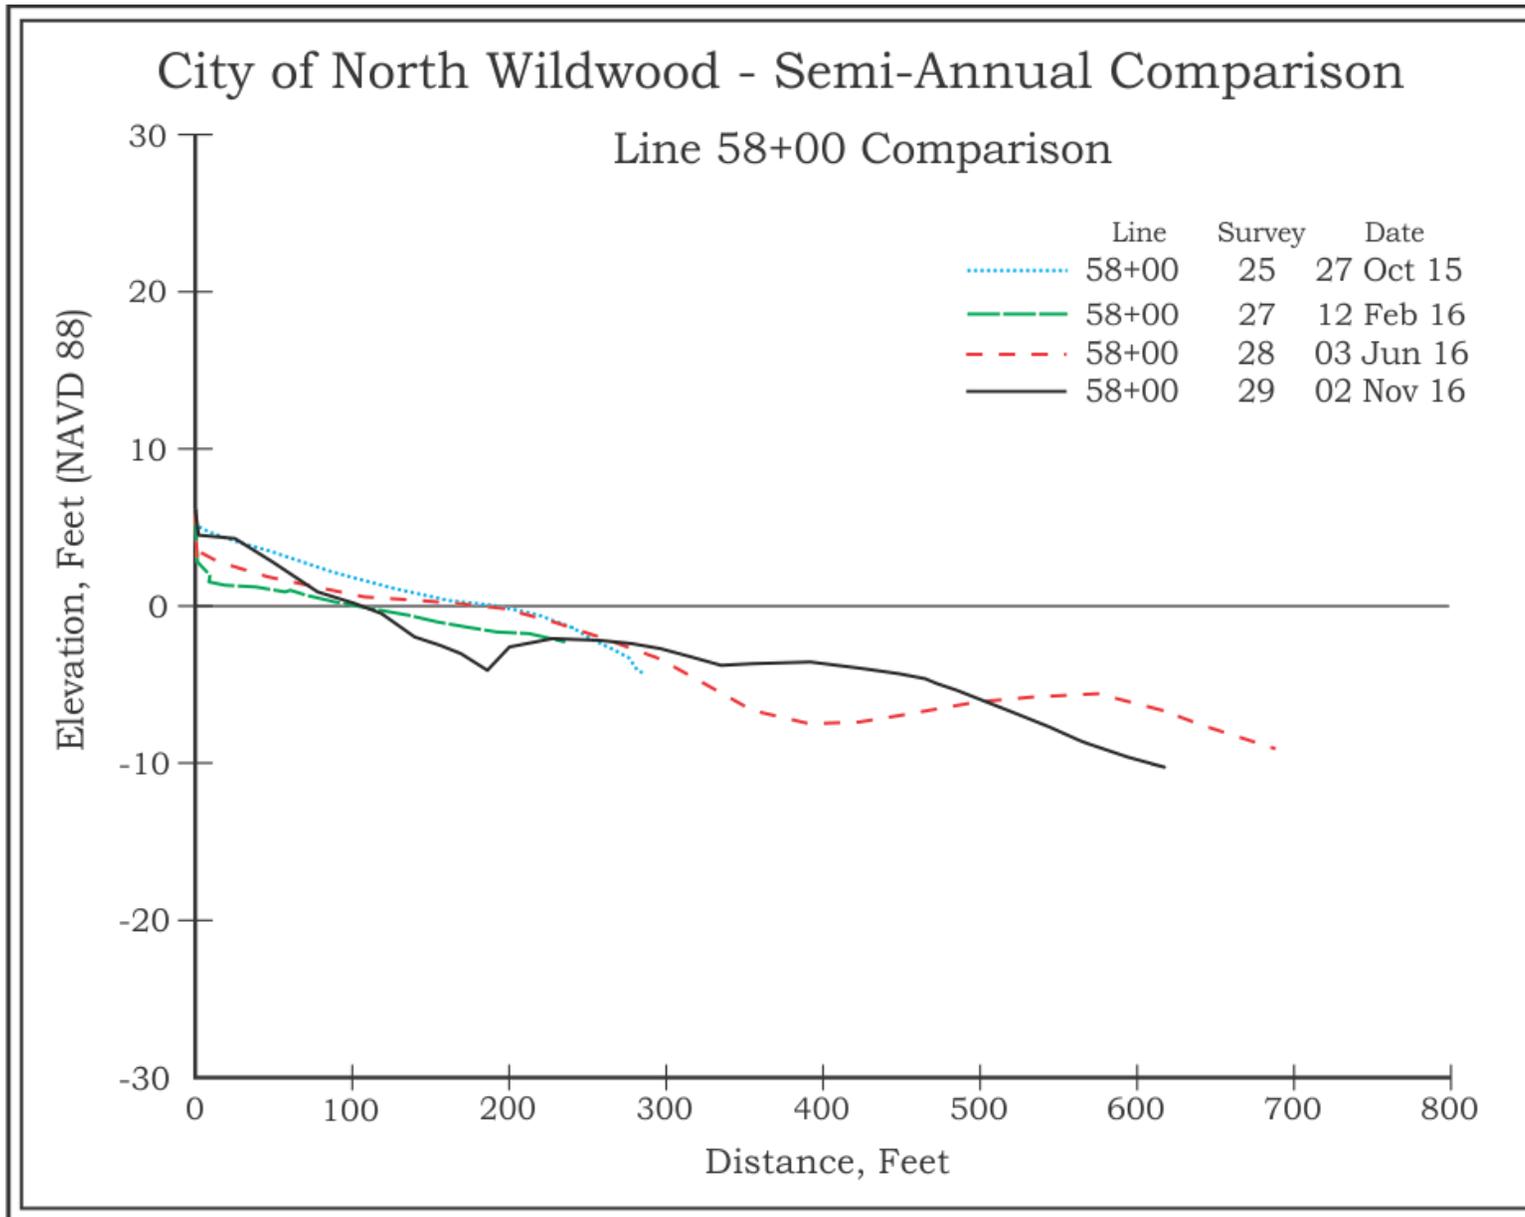
2016 began with significant erosion along virtually the entire profile at line 58+00 directly related to the January and February NE storm events. Shoreline retreat of 86 feet was recorded at this time as well as a cumulative volume loss of 14.48 yds³/ft. The upper portions of the beach continued to show modest recovery for the remainder of the survey year as material offshore began to migrate landward. For the annual comparison from fall 2015 to fall 2016, the shoreline retreated 85 feet and lost 14 yds³/ft. on the beachface and nearshore regions.

Figure 21. Considerable losses to the recreational beach, beachface, and nearshore had taken place between Surveys 25 and 27 due to the early storm of 2016. The upper beach portions of the profile continued to increase in elevation throughout the remainder of survey year. However, a large scour trough had formed in the nearshore area by the concluding survey.

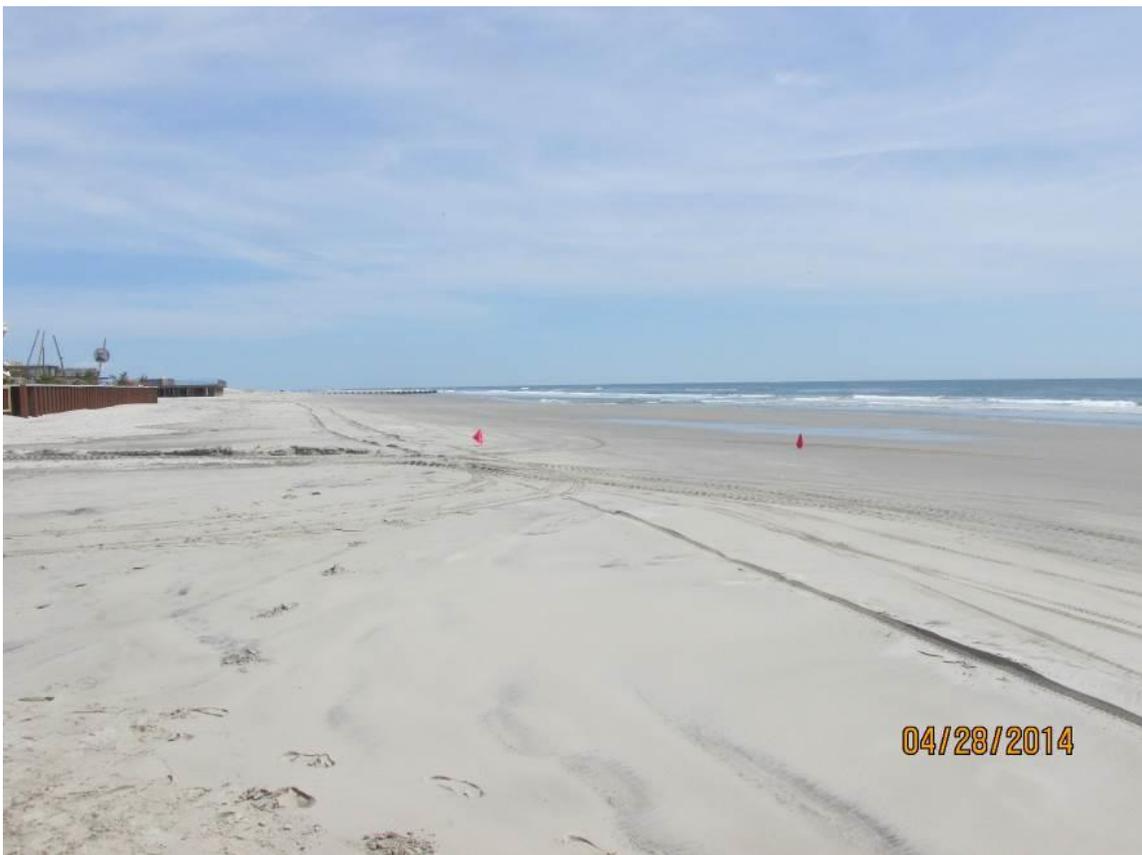
Figure 22. View to the north taken on April 28, 2014 near 26th Avenue showing the elevated dry beach seaward of the southerly piers. The dry beach was low, but of substantial width at this point in time.

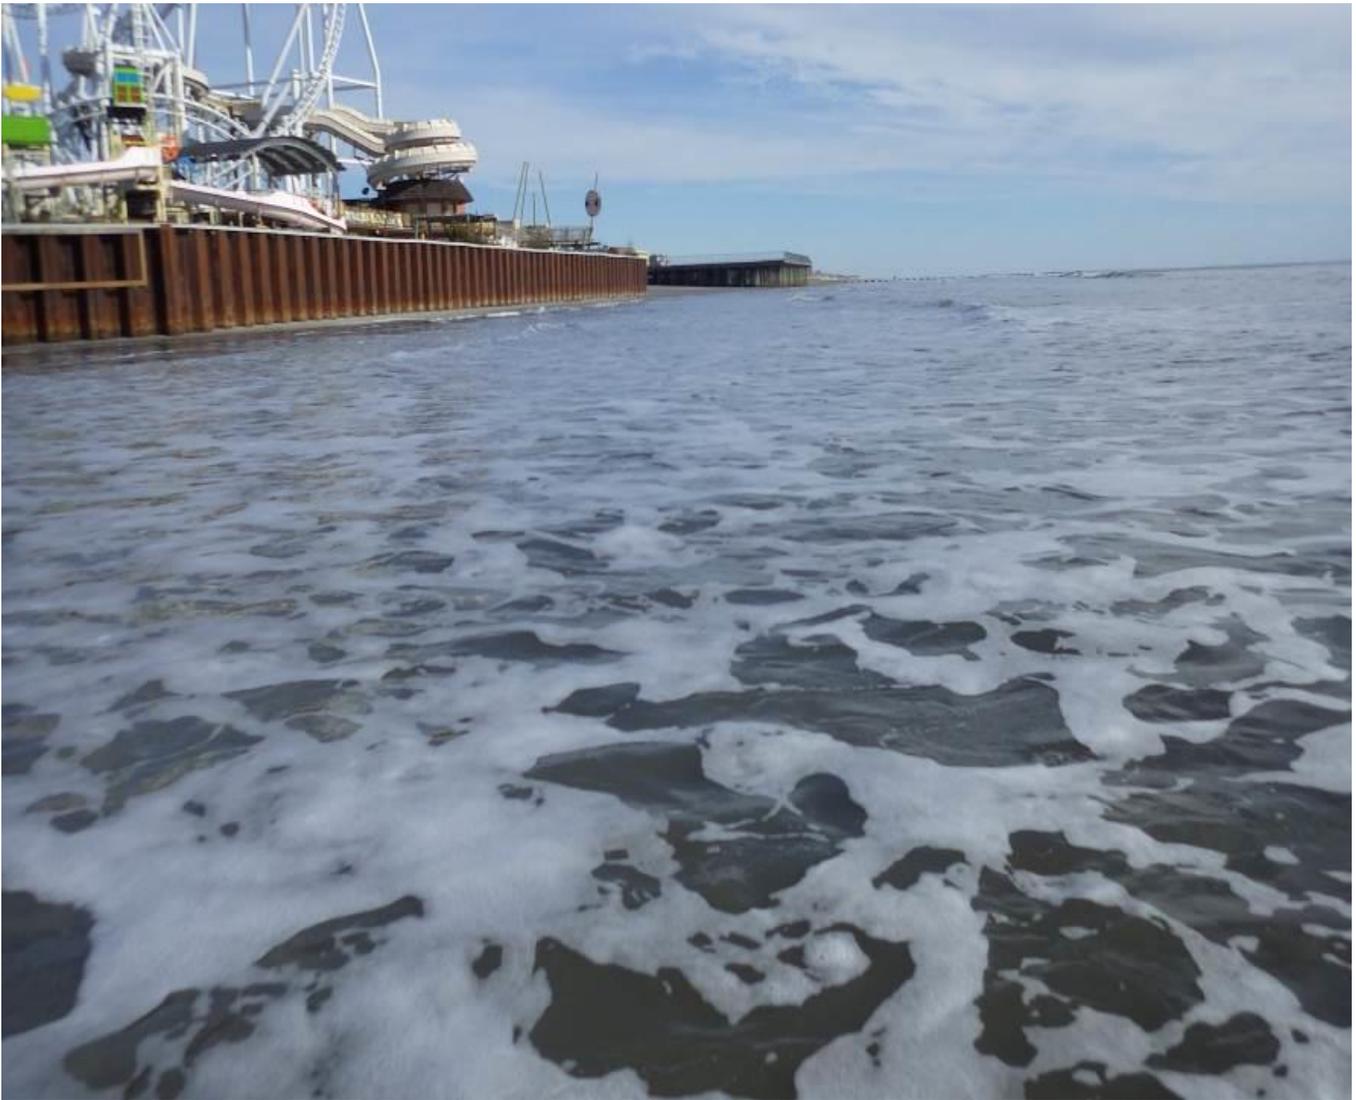
Figure 23. View to the north taken on February 12, 2016 near 26th Avenue following winter storms Jonas and Nacio. The dry beach that was present less than two years ago has been eroded, leaving the ocean waves lapping at the base of the pier's steel bulkhead walls.

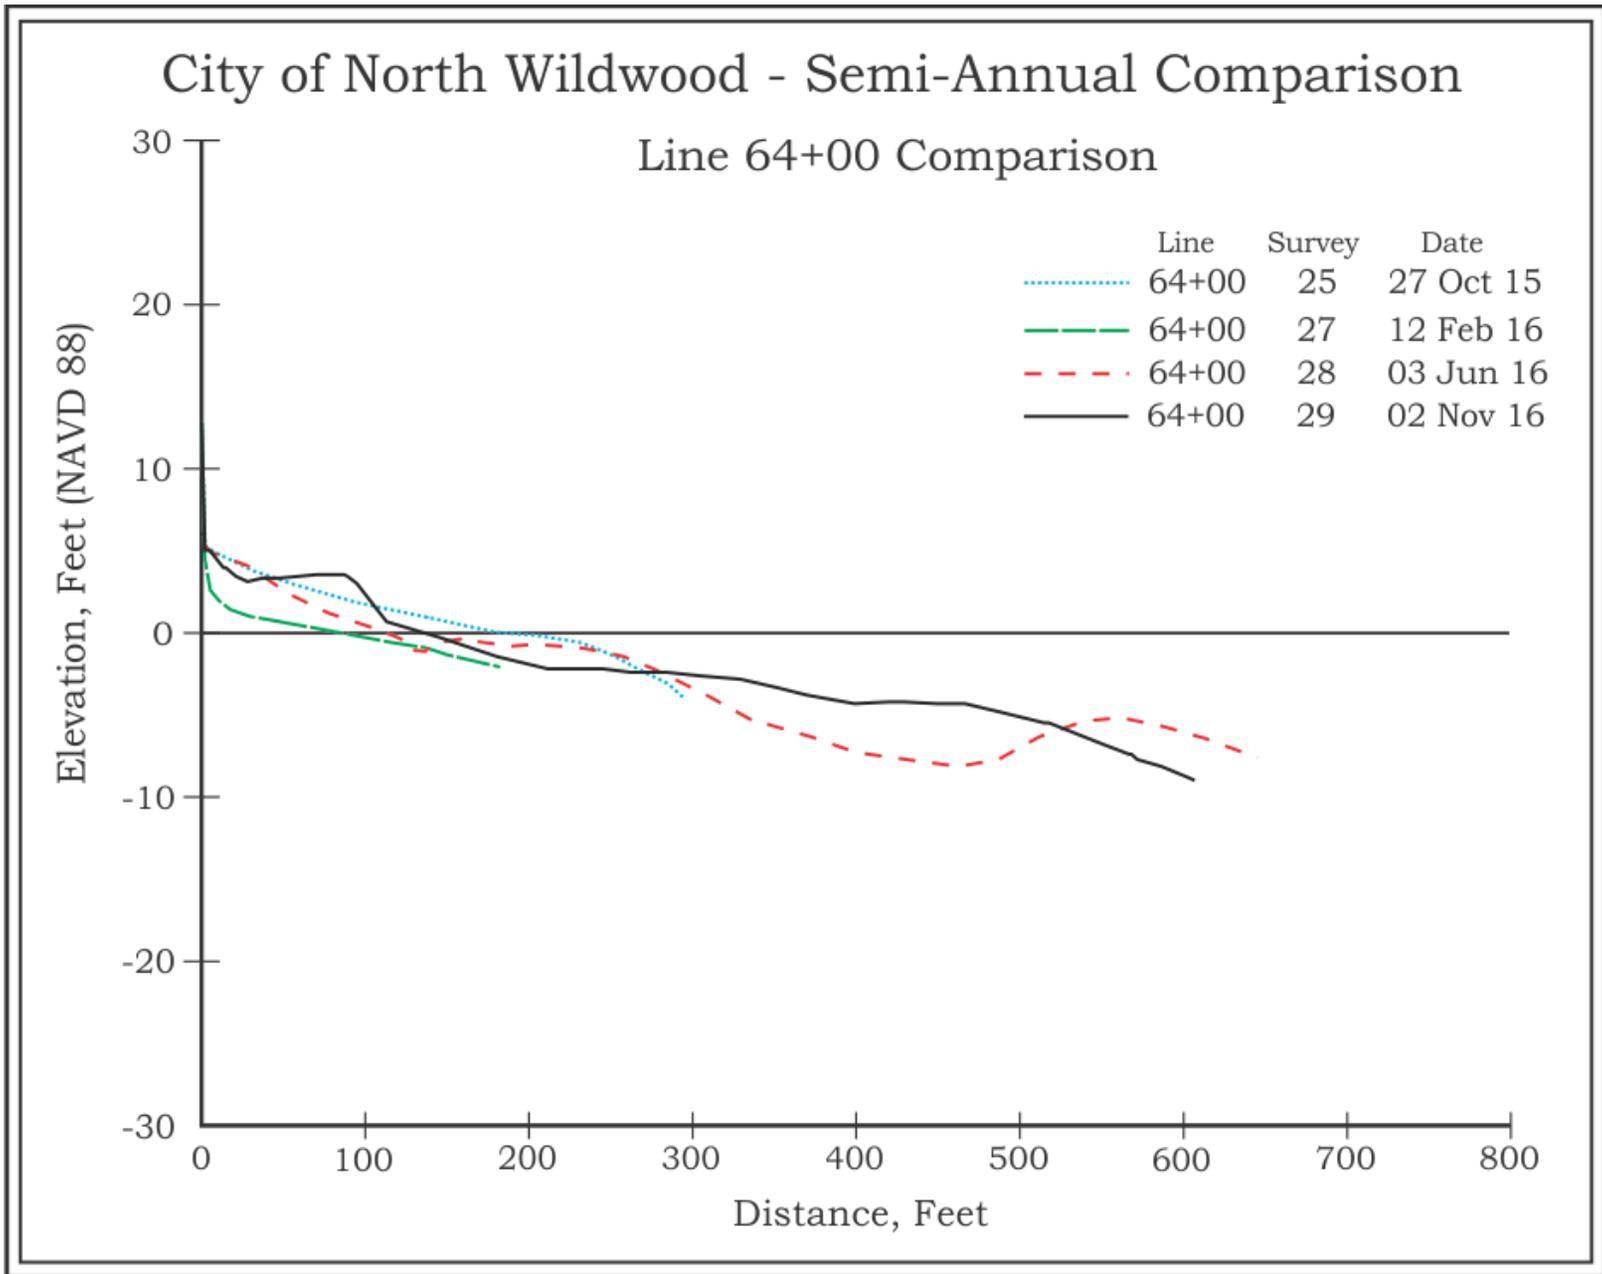
Once again, 2016 began with significant erosion along the entire profile at line 64+00 directly related to the January and February NE storm events. The shoreline retreat was recorded at 99 feet during this time interval as well as a cumulative volume loss of 14.35 yds³/ft. The upper portions of the beach continued to show modest recovery for the remainder of the survey year as material offshore began to migrate landward. For the annual comparison from fall 2015 to fall 2016, the shoreline retreated 48 feet and 30.30 yds³/ft. volume gains were recorded on the beachface and nearshore regions.

Figure 24. The erosional effects from Winter Storms Jonas and Nacio are recorded by Survey 27 in the form of a lowered profile from the beach through the nearshore. By June 2016 some of the recreational beach had returned raising the level of the upper beach. As sand continued to shift landward, a more pronounced berm had developed by the final survey conducted in 2016.

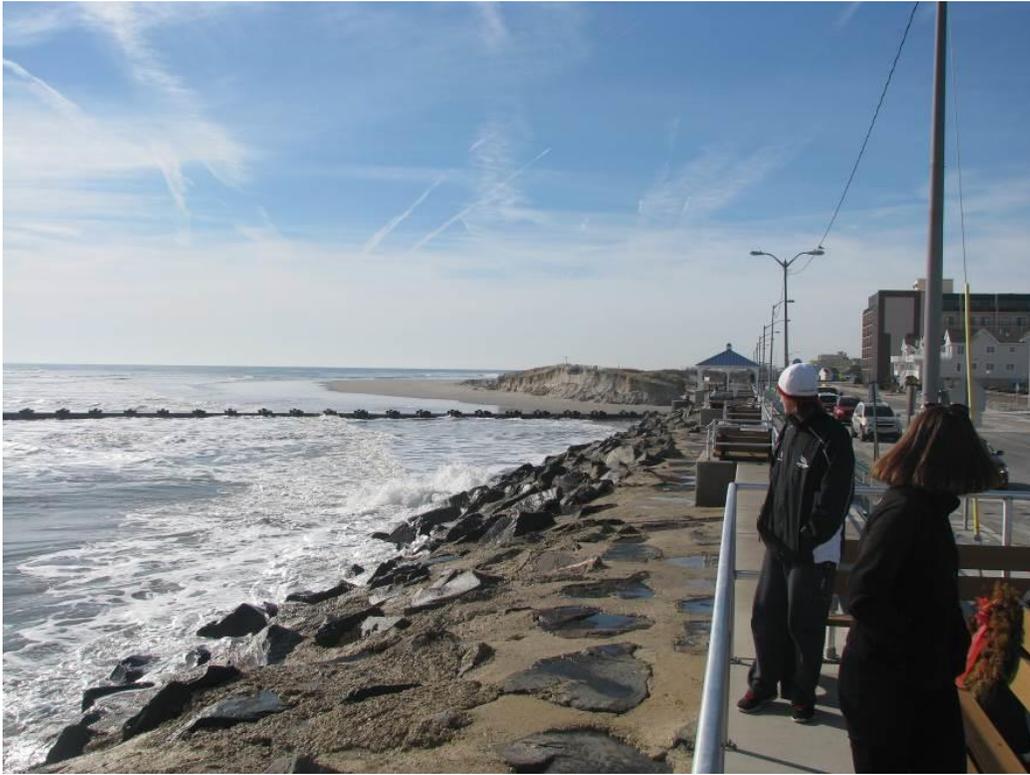
Figure 25. A close up view of the exposed seawall looking to the south at 2nd Avenue on January 25, 2016. Winter Storm Jonas eroded sand in this area completely exposing the wall at virtually all stages of the tide cycle.

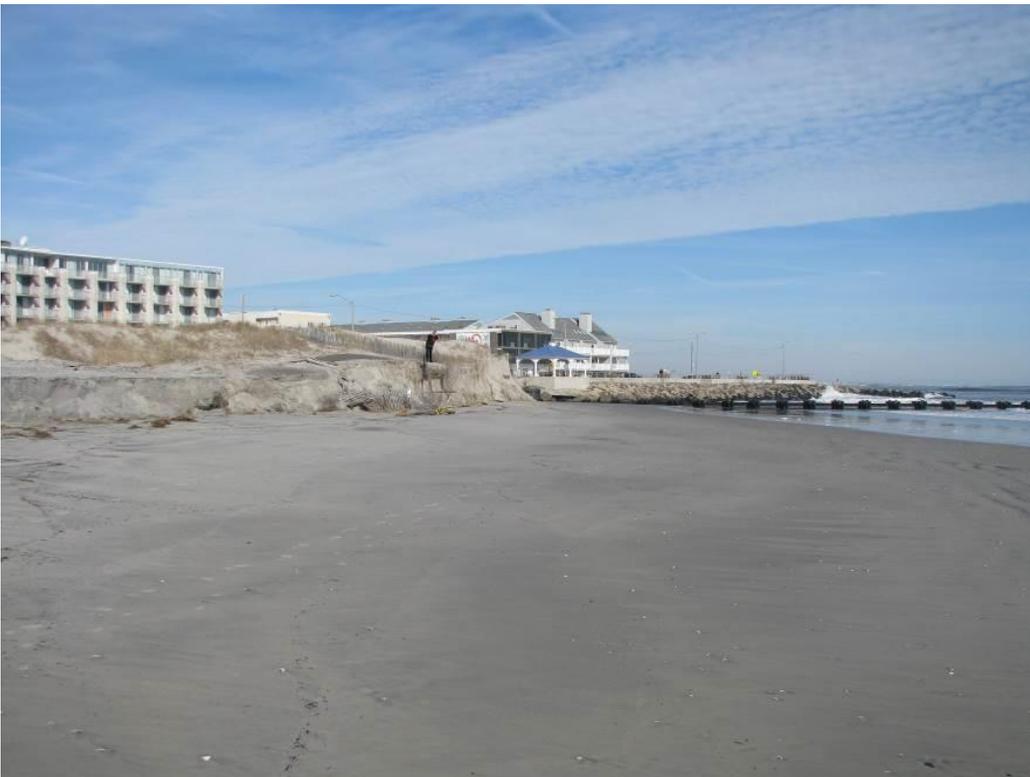
Figure 26. View to the north following Jonas taken at 5th Avenue on January 25, 2016. The storm caused severe erosion to the beach and dune system creating the large scarp seen in the dune and the remainder of the sand from the Beach Creek dredge material pile.

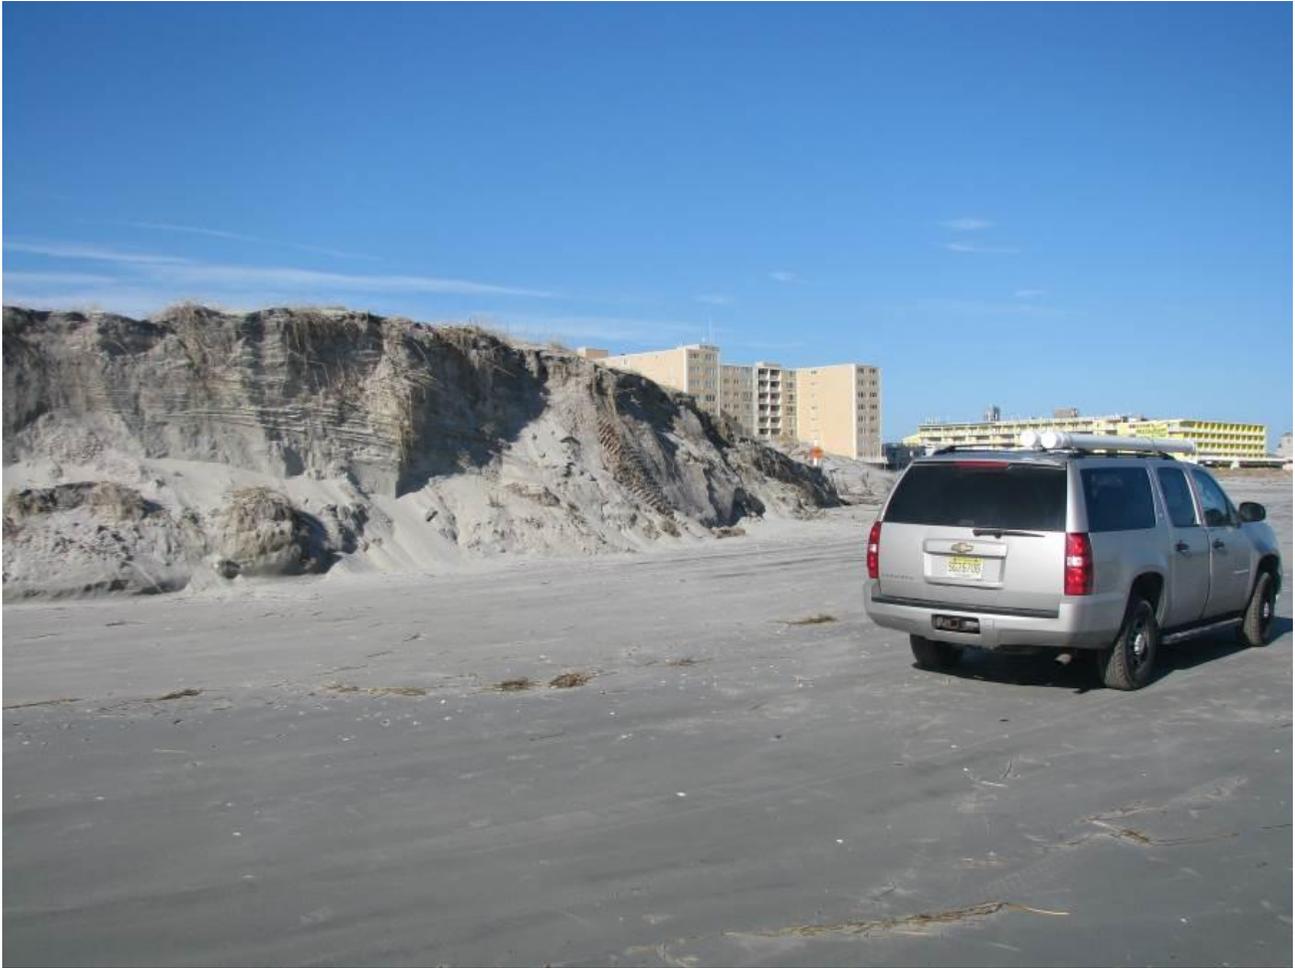
Figure 27. A close up view of the dune looking to the north from the beach located near 22nd Avenue on January 27, 2016. Jonas caused severe erosion to the dune where a large scarp can be seen.
