**2017 ANNUAL REPORT - TO THE CITY OF NORTH WILDWOOD
ON THE
CONDITION OF THE CITY BEACHES**

**PREPARED FOR: THE CITY OF NORTH WILDWOOD
901 ATLANTIC AVENUE
NORTH WILDWOOD, NJ 08260**

**PREPARED BY: THE STOCKTON UNIVERSITY COASTAL RESEARCH CENTER
30 WILSON AVENUE
PORT REPUBLIC, NJ 08241
March 5, 2018**

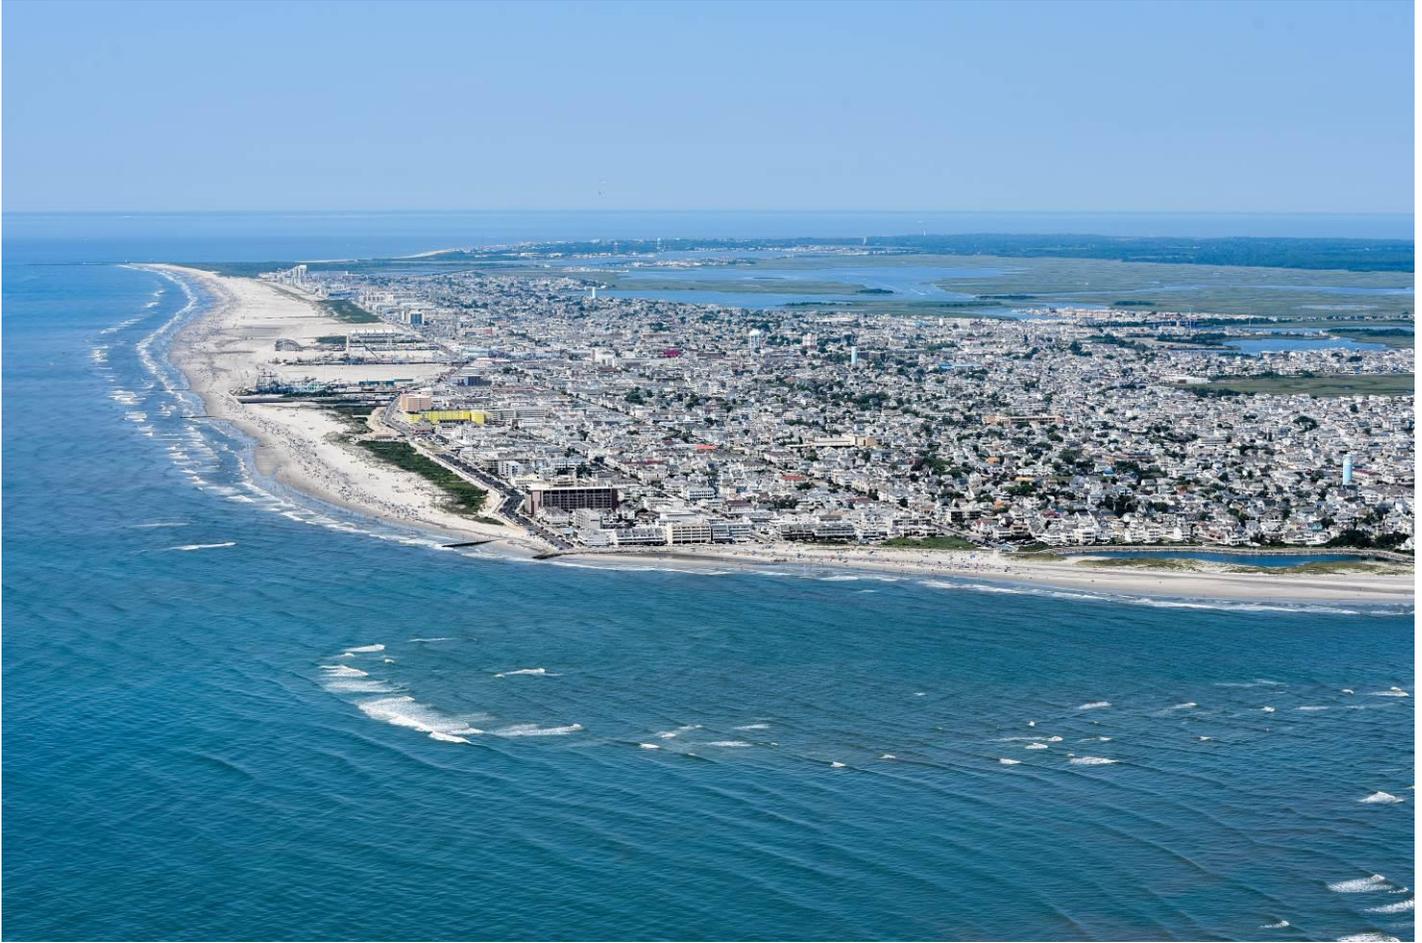
Aerial view of North Wildwood looking southeast from Hereford Inlet on July 2, 2017 showing nearly the entire City plus the remainder of the barrier island to Cape May Inlet. The fall loss of beach in the zone five city blocks south from the jetty at 2nd Avenue had yet to occur, but the sand shoal distribution near the jetty does appear relatively sparse as of the summer of 2017. This perspective also explains why the Wildwood and Wildwood Crest beaches are so wide due to development in North Wildwood into Wildwood extending one to two city blocks further seaward from its extent further south. (Aerial photo taken by Ted Kingston)

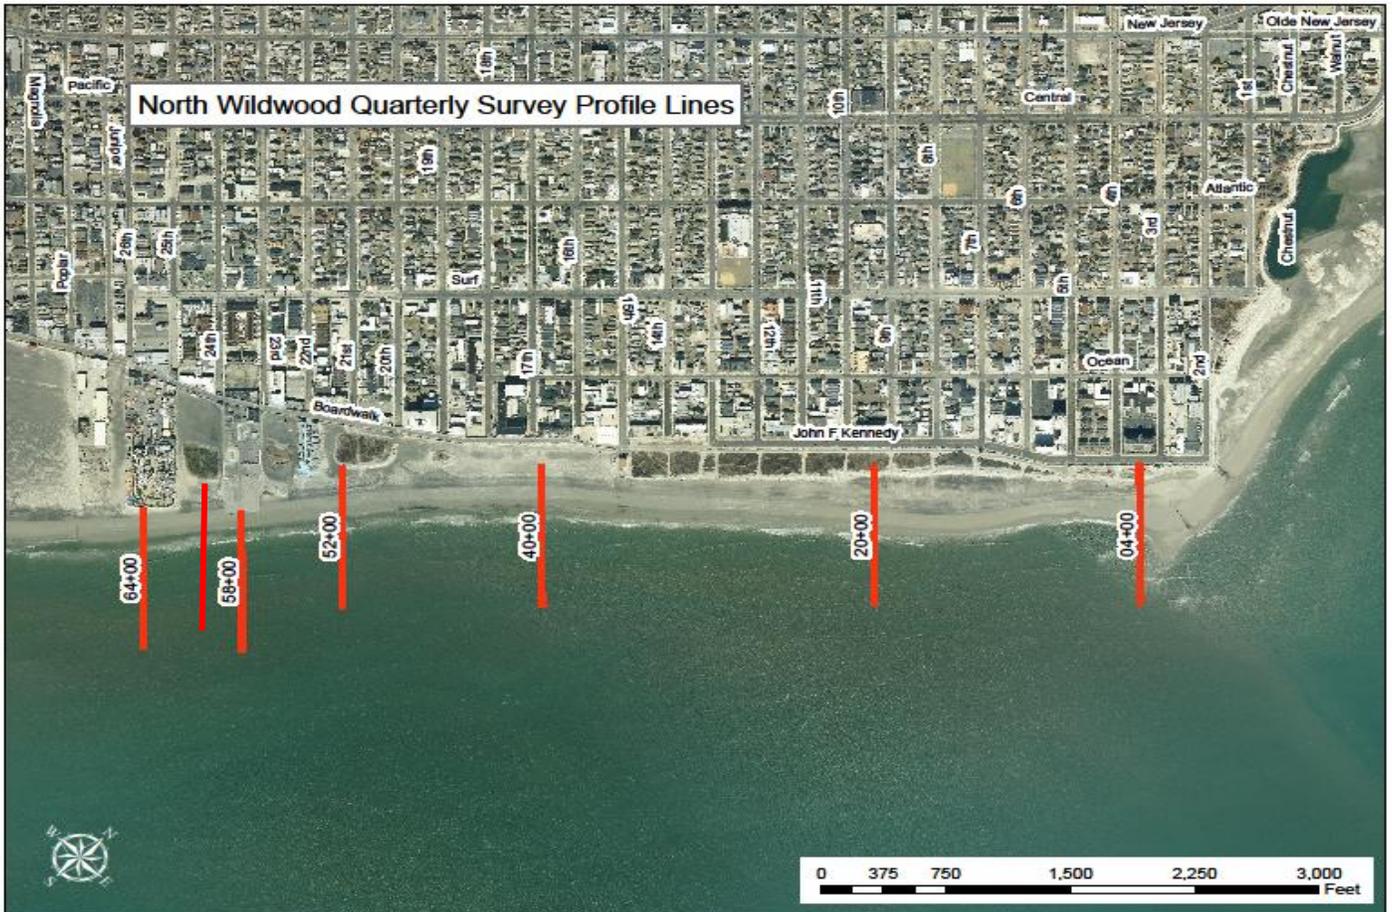
Figure 1. Shown above are locations of six representative profile sites of the 54 profile stations where shoreline changes were measured on the City’s oceanfront from October 2015 to November 2016. For each of the six profile stations descriptions and cross sections are provided to show typical changes over the year. In addition, 6 survey lines are completed along the inlet beach in Hereford Inlet. They are spread non-uniformly from the 2nd Avenue jetty to Central Avenue northwest of the jetty. Four go at 200-foot spacing from the jetty to 600 feet northwest, another at 1,200 feet and the final survey line at 2,400 feet northwest at the end of Central Avenue.

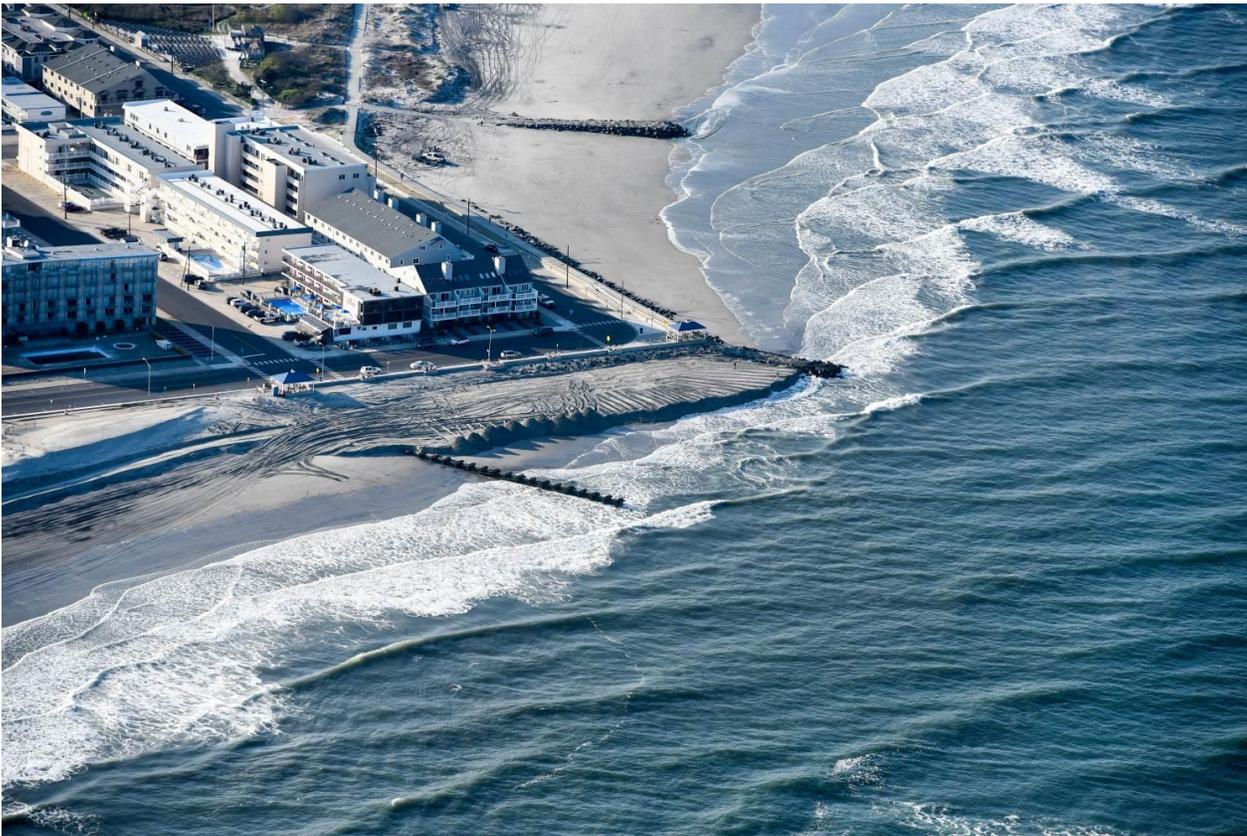
Figure 2. Aerial view of 2nd and Kennedy Blvd. April 26, 2017 as the sand back-passing from the City of Wildwood was underway. The zone of placement was particularly problematic because the beach between 2nd and 3rd Avenues is simply too erosional to sustain any deposit of sediment for any time period due to direct, constant wave attack. There already was a vertical scarp cut into the deposit with the sand either going south along the beach or into Hereford Inlet. By October, the material was gone and some was documented between 10th and 21st Avenues on the oceanfront. In prior years the sand was placed south of 3rd Avenue with some allowed to migrate north into the pocket between the stormwater discharge pipeline and the jetty. The jetty needs to be extended at least twice its current length if it is to retain sand at the inlet oceanfront beach.

As the two pictures below (Figures 2 and 3) show, the 2017 back-pass sand placement did not last until the fall season was shifting into winter. Major sand shoal movement close to North Wildwood's inlet beach prevents the ebb tide from moving as much material in proximity of the 2nd Avenue jetty. Therefore, the beach receives little inlet sand and relies on material moved north toward the inlet. This supply has been depleted, leaving the natural forces free access to the dunes south of 3rd Avenue. Most of the loss appears to have occurred during the fall of 2017 reaching the point of deep concern at present. Construction of an enhanced seawall south of the gazebo should reach basic installation prior to a northeaster arriving March 2, 2018. The digital maps below (Figures 4 - 6) detail the areas of loss and a few zones of sand accumulation.

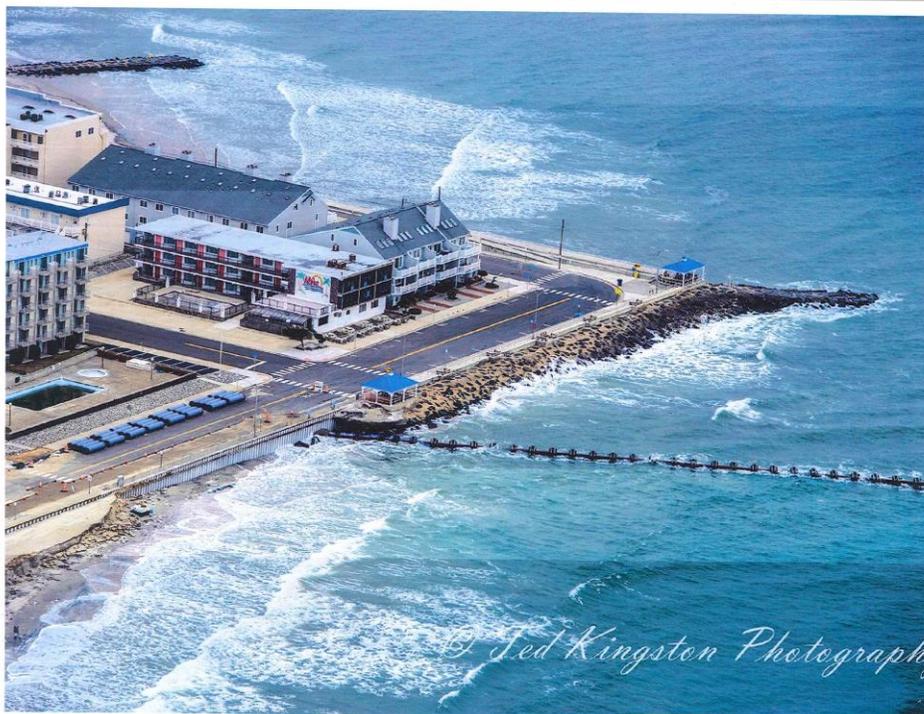
Figure 3. View taken by Ted Kingston January 2018, showing the severe depletion of the sand supply surrounding the northeast corner of the City of North Wildwood. While it is high tide in the view, the loss of beach width is serious and will require both natural and manmade assistance to correct.

At the north end, inlet dynamics, orientation to the northeast and tidal flow exposes this region to near continuous erosional processes associated with its proximity to Hereford Inlet. Offshore, the shoal system on the south side of Hereford Inlet lost significant material continuously throughout 2017 (figures 2 and 3). Areas of sand gain were limited to the central portions of the area, between 11th Ave. and 20th Aves. as well as offshore between 21st Ave. and Poplar Ave. Unfortunately, these sand volume gains (179,080 cubic yards) were offset by the considerable losses (400,730 cubic yards) yielding a cumulative volume loss of 221,650 cubic yards from October 2016 to October 2017 based on the data from the 200-foot cross sections surveyed (photo in Figure 3).

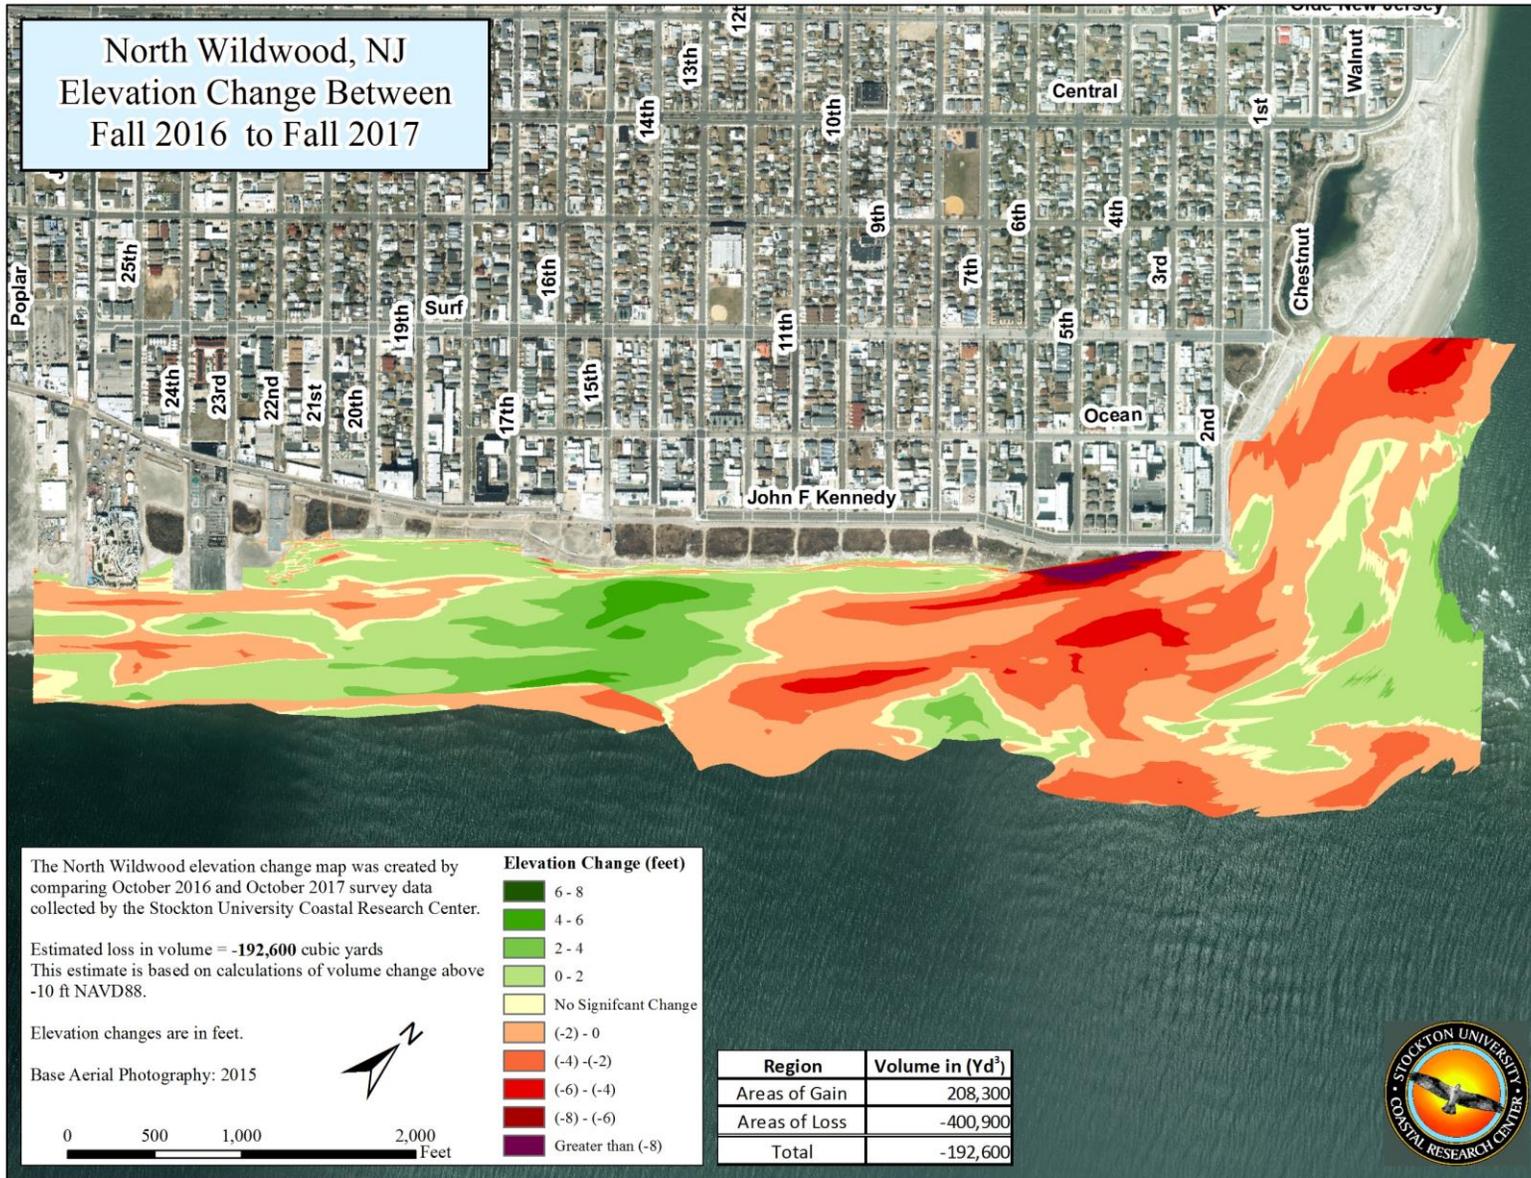
Figure 4. A digital elevation change map for the North Wildwood City shoreline. This elevation difference map of the North Wildwood City engineered beaches shows the change in elevations between October 2016 and the October 2017 surveys. There is a dark green area of accretion concentrated between 11th and 20th Avenues where sand eroded from the northeast corner of the island was redeposited to the south. This region contributed the majority of the 208,300 cubic yard sand volume gain. However, this was far exceeded by the zone of severe loss at the inlet, south to 11th Avenue. The loss volume was 400,900 cubic yards, concentrated between 2nd and 7th Avenue. Vertical changes amounted to greater than -8.0 feet 3rd to 5th Avenues as the dune was stripped away. Some gains did appear to the northeast of the 2nd Avenue jetty, but separated from the beach by 500 feet of turbulent shallow water.

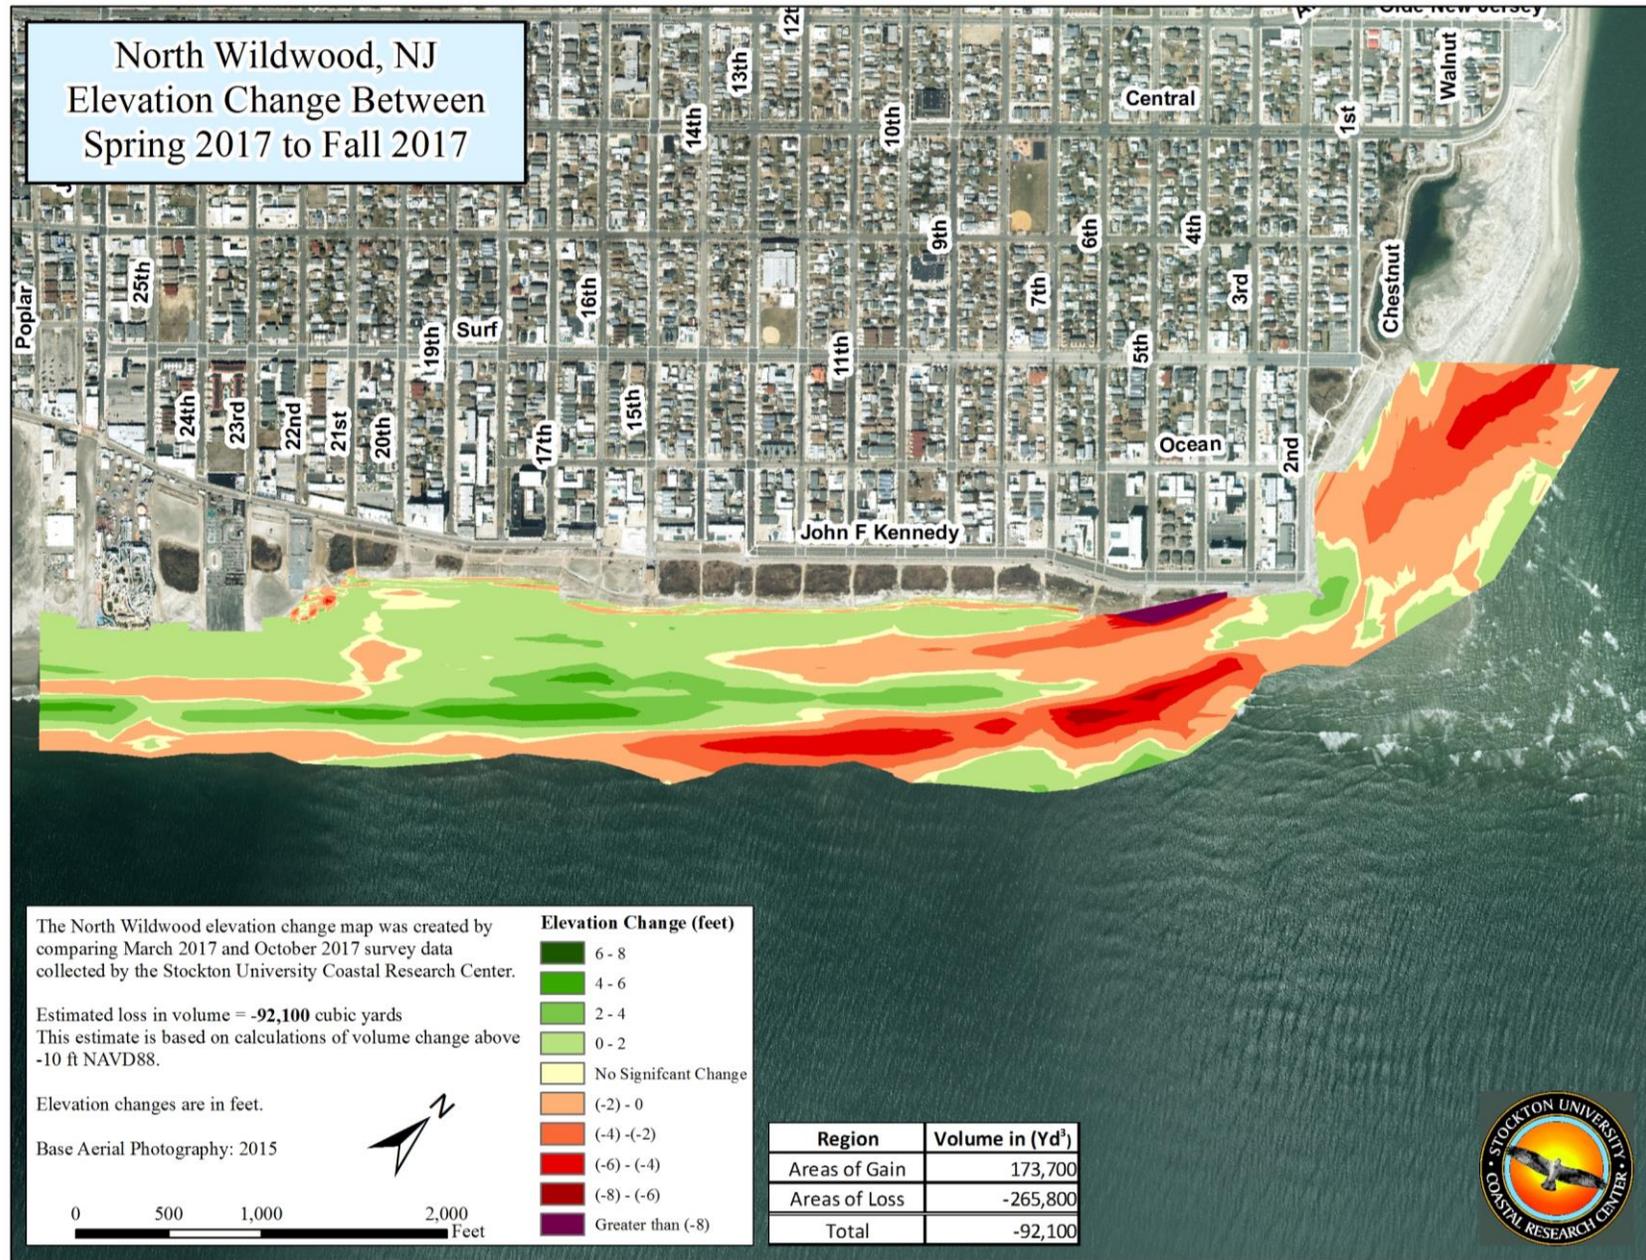
Figure 5. A digital elevation change map for the North Wildwood City shoreline showing the changes limited to between the spring of 2017 versus the fall of 2017. The severe loss at the dunes between March and October was generated during the fall time period. During the summer, sand offshore moved onto the beach leaving a fairly minor regional loss (including the inlet shoreline) of -92,100 cubic yards. The breaking waves to the northeast of the jetty at 2nd Ave. indicate shallow water with an offshore sand supply, but it must move landward to be of any help.

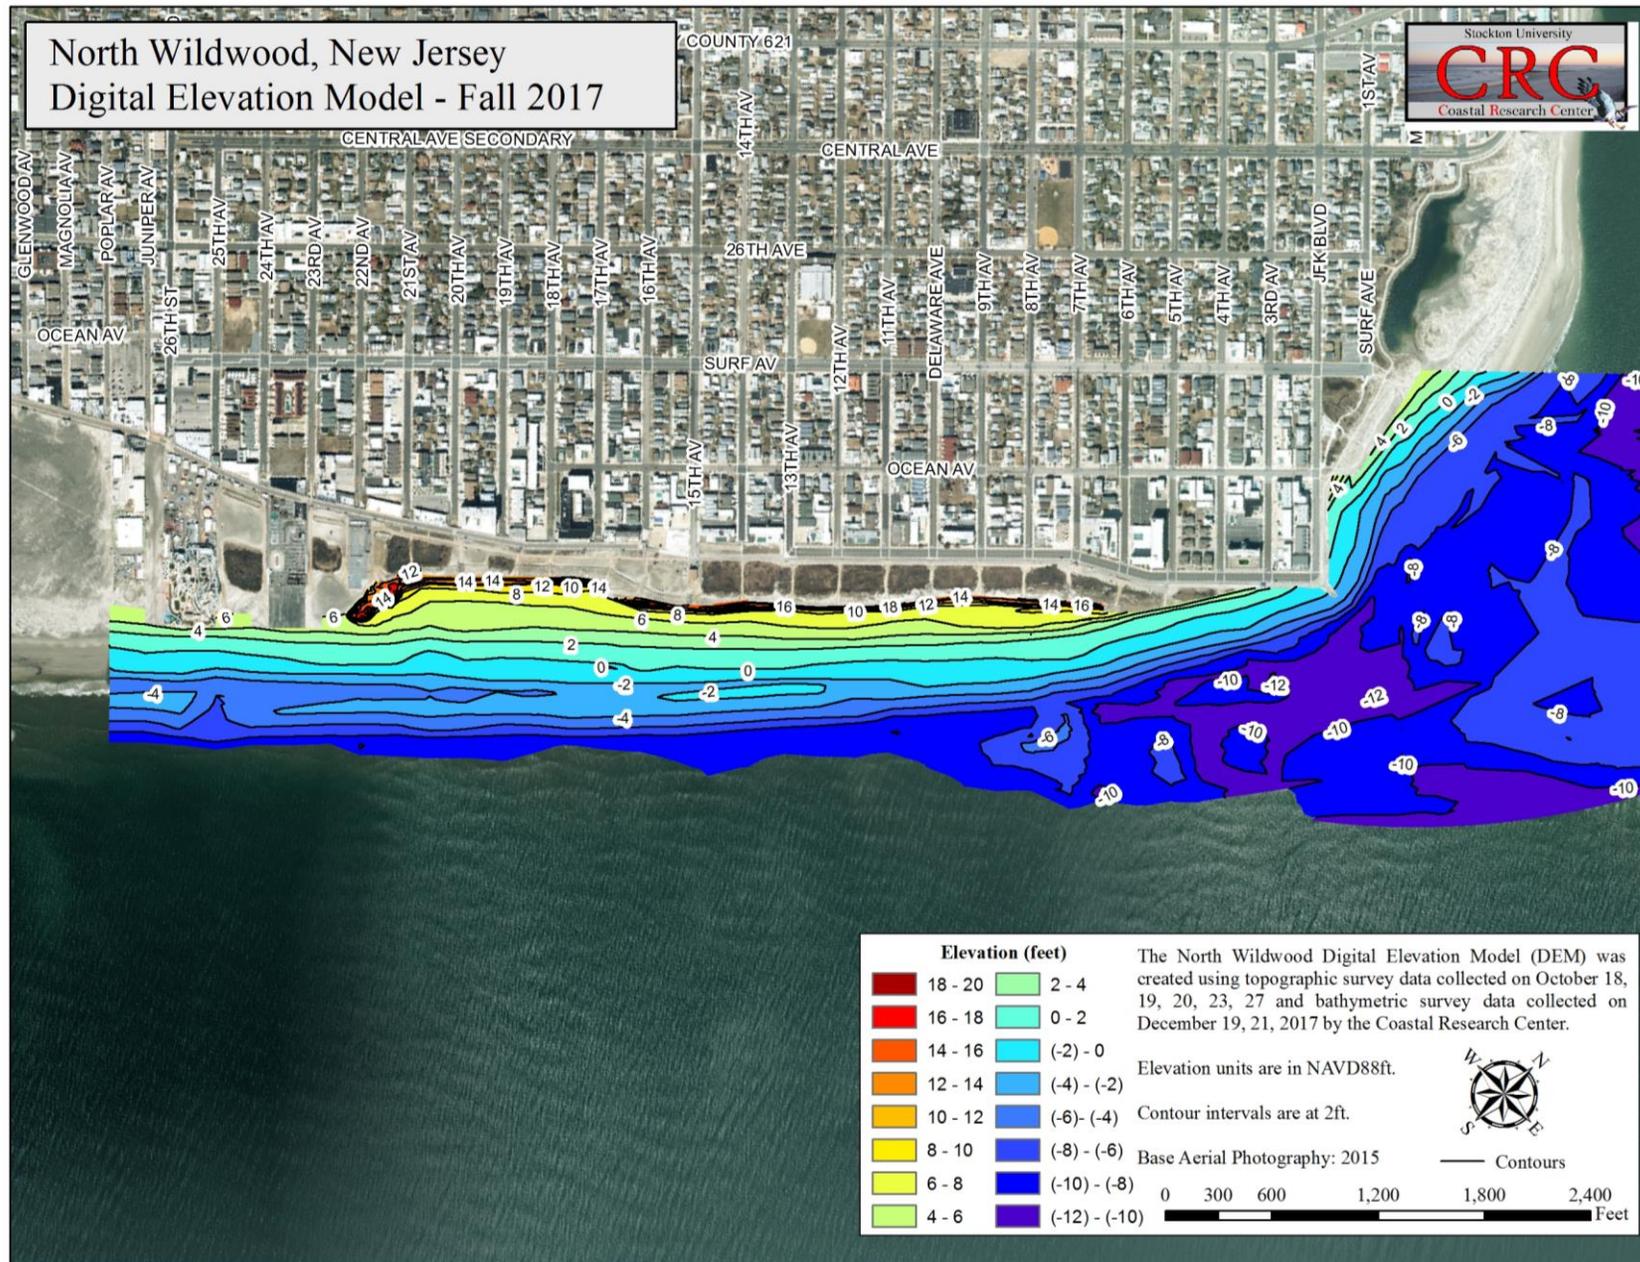
Figure 6. The digital elevation map completed in October 2017 shows the elevation contours for the region. The sand reservoir offshore lies in 8 to 10 feet elevations below NAVD 1988. The zero elevation contour reaches the seawall at the end of 3rd Ave. and continues a short distance along the inlet seawall parallel to 2nd Ave. The dune ends at 6th Avenue.

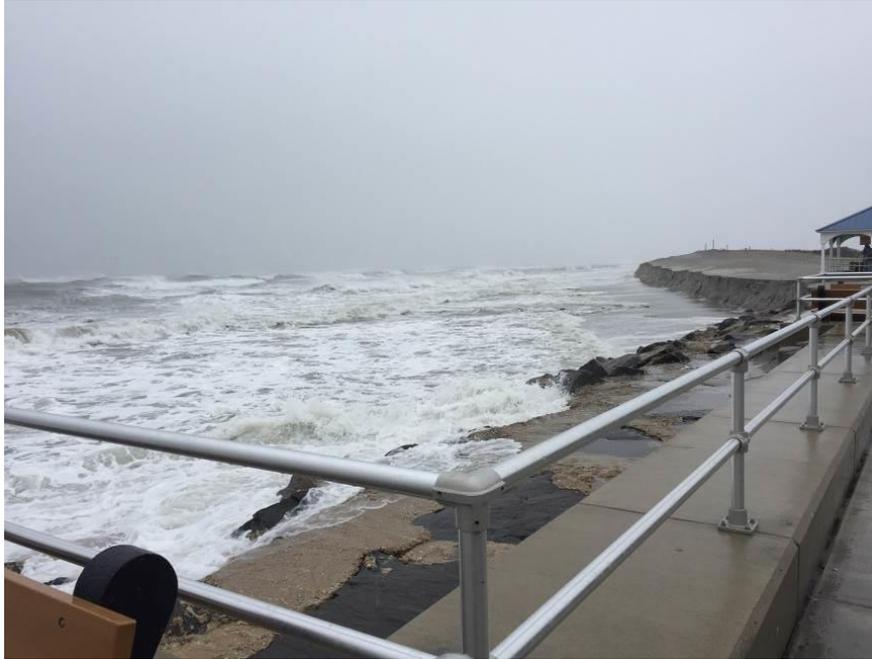
Figure 7. View from the 3rd Avenue gazebo looking south taken during the March 14, 2017 northeast storm. A significant scarp in the seaward dune is shown along with observed recreational beach elevation and shoreline losses and waves breaking on the revetment.

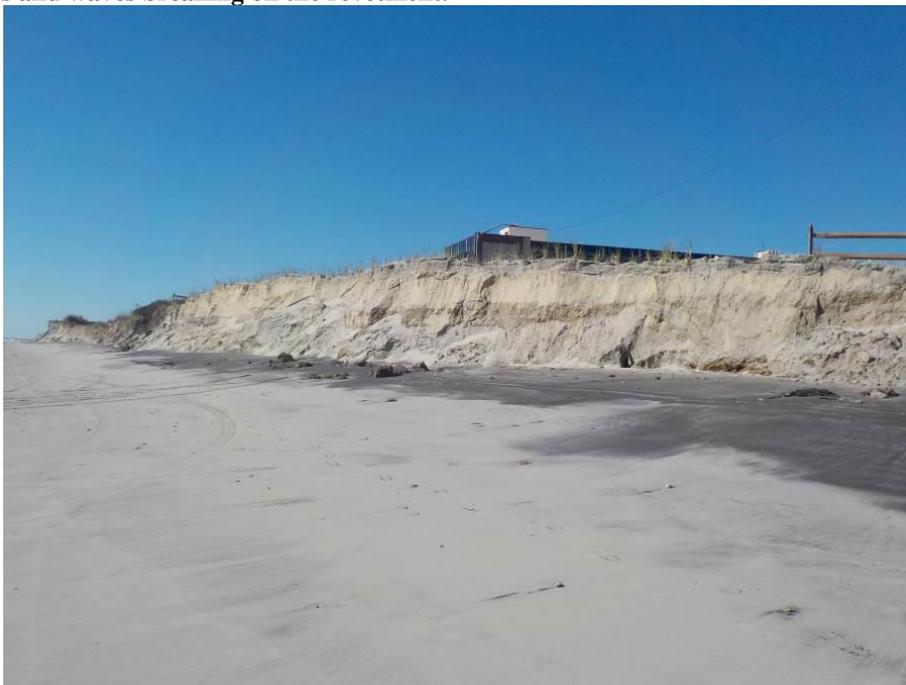
Figure 8. View from 4th Avenue looking south on October 19, 2017. The primary dune is cut back to its crest and the scarp extends south of 6th Avenue. No dry beach remains, so waves reach the dune each high tide.

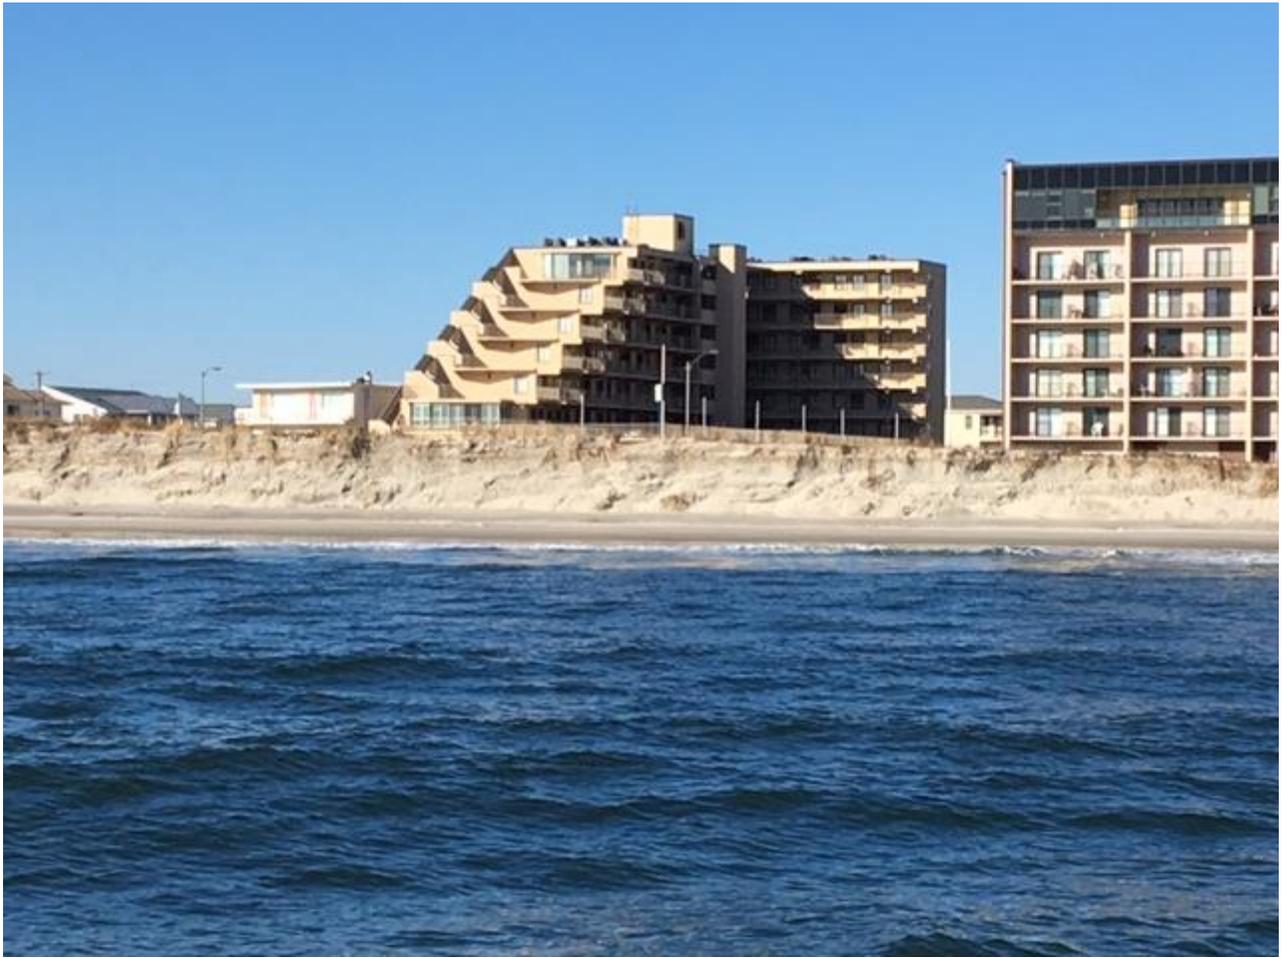
Figure 9. View from offshore December 21, 2017 as the offshore surveys were completed for the year. Emergency work was proceeding between the gazebo and 4th Avenue at the bulkhead. This scarp is positioned between 6th and 7th Avenues, (7th to the left of the stair-stepped condominium in the center). Presently the entire dune has been eroded so that the wet beach goes to the bulkhead to this location and dune erosion extends south to 8th Avenue.

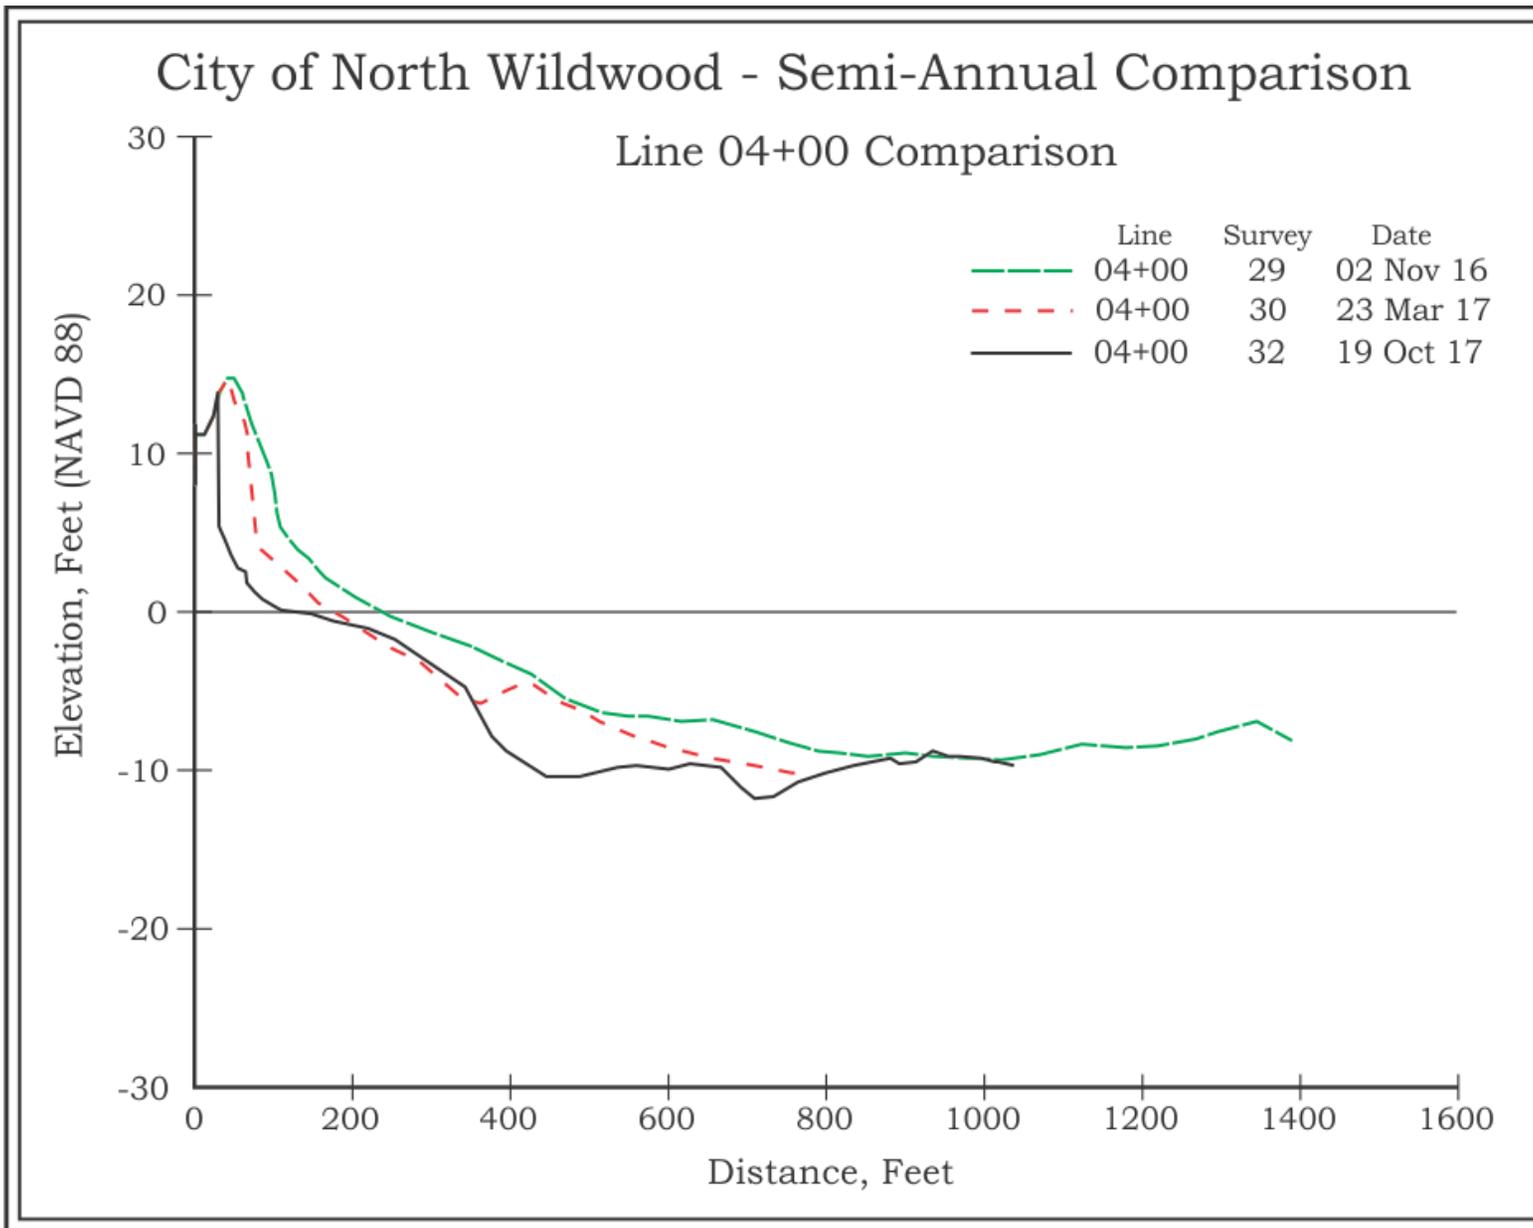
Site 04+00 (between 3th and 4th Avenues)

The site is located in the northern portion of the island adjacent to Hereford Inlet 400 feet south of the 2nd Avenue jetty. This area has typically been an erosional shoreline due to the proximity to the inlet and the direct impact from northeast storms.

Figure 10. Losses in the dunes increase with each successive survey. The beach elevation declines to the point where the dune toe lies at zero elevation NAVD 1988 by October.

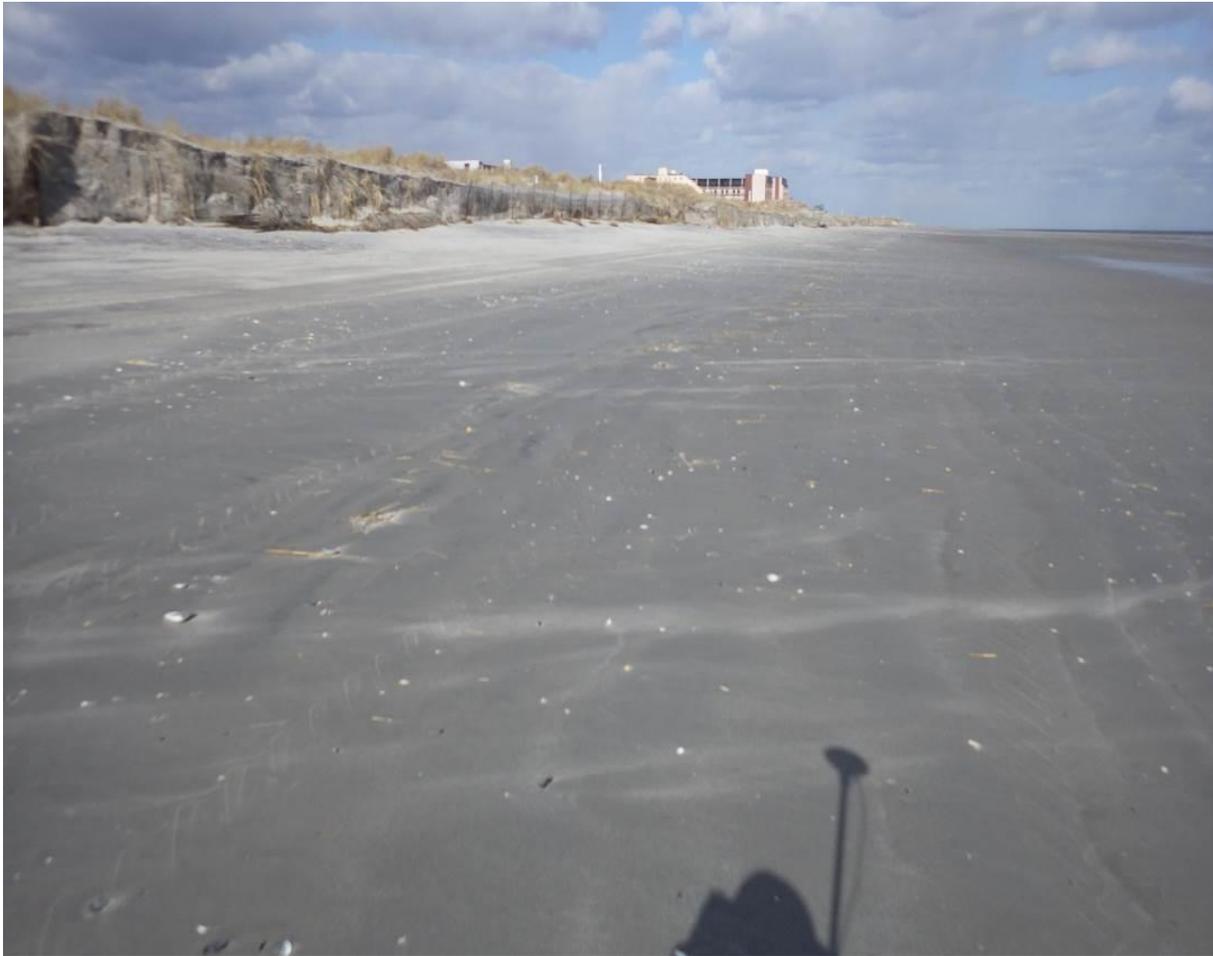
Figure 11. View to the north taken from the beach at 10th Ave. on March 24, 2017. The flat beach following the March 14th northeast storm leads up to a moderate scarp cut into the dunes. This represents the pre-summer survey dataset used to show summer gains.

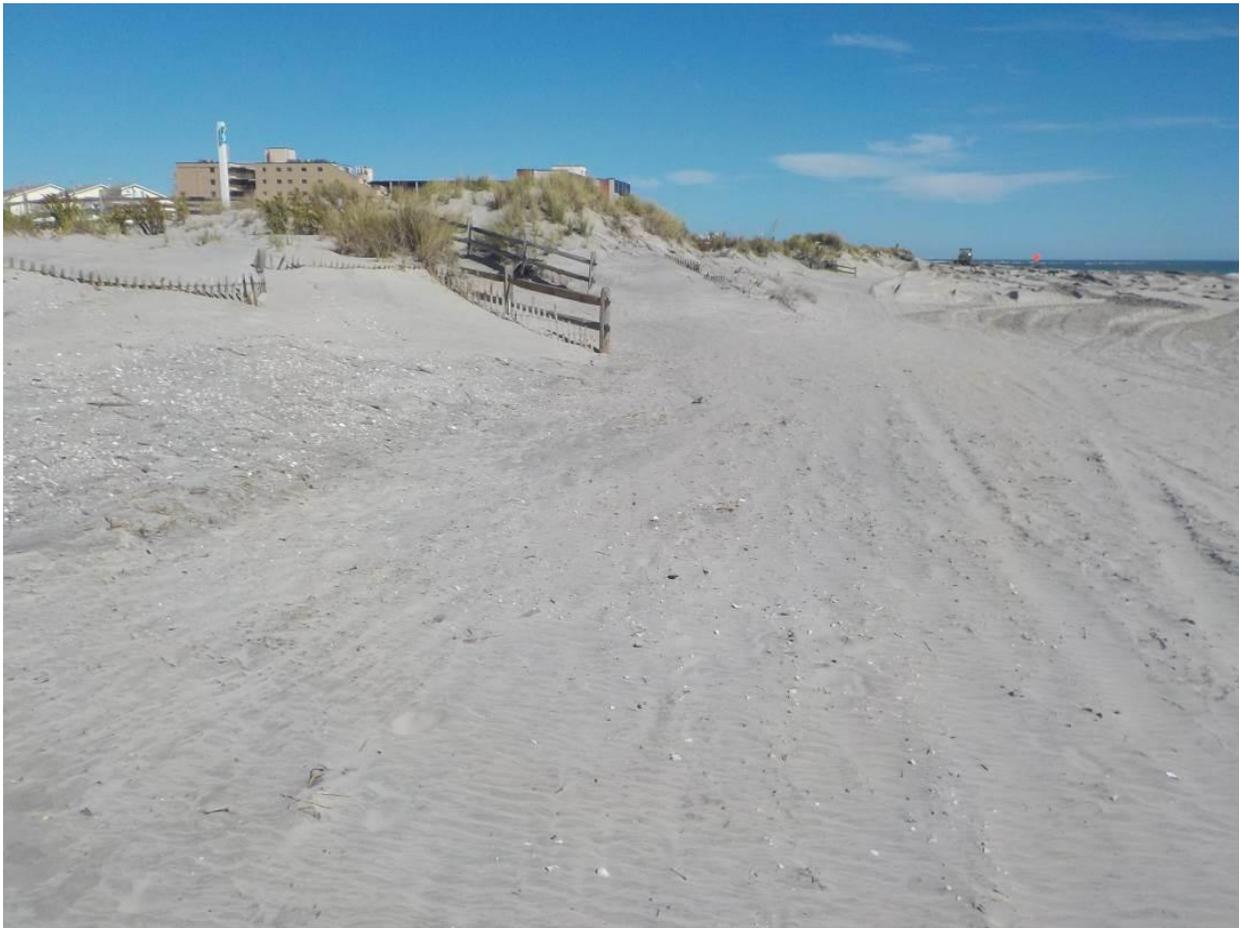
Figure 12. View to the north taken from the toe of the dunes at 11th Ave. October 19, 2017 following spring sand placement and some accretion at the repaired scarp.

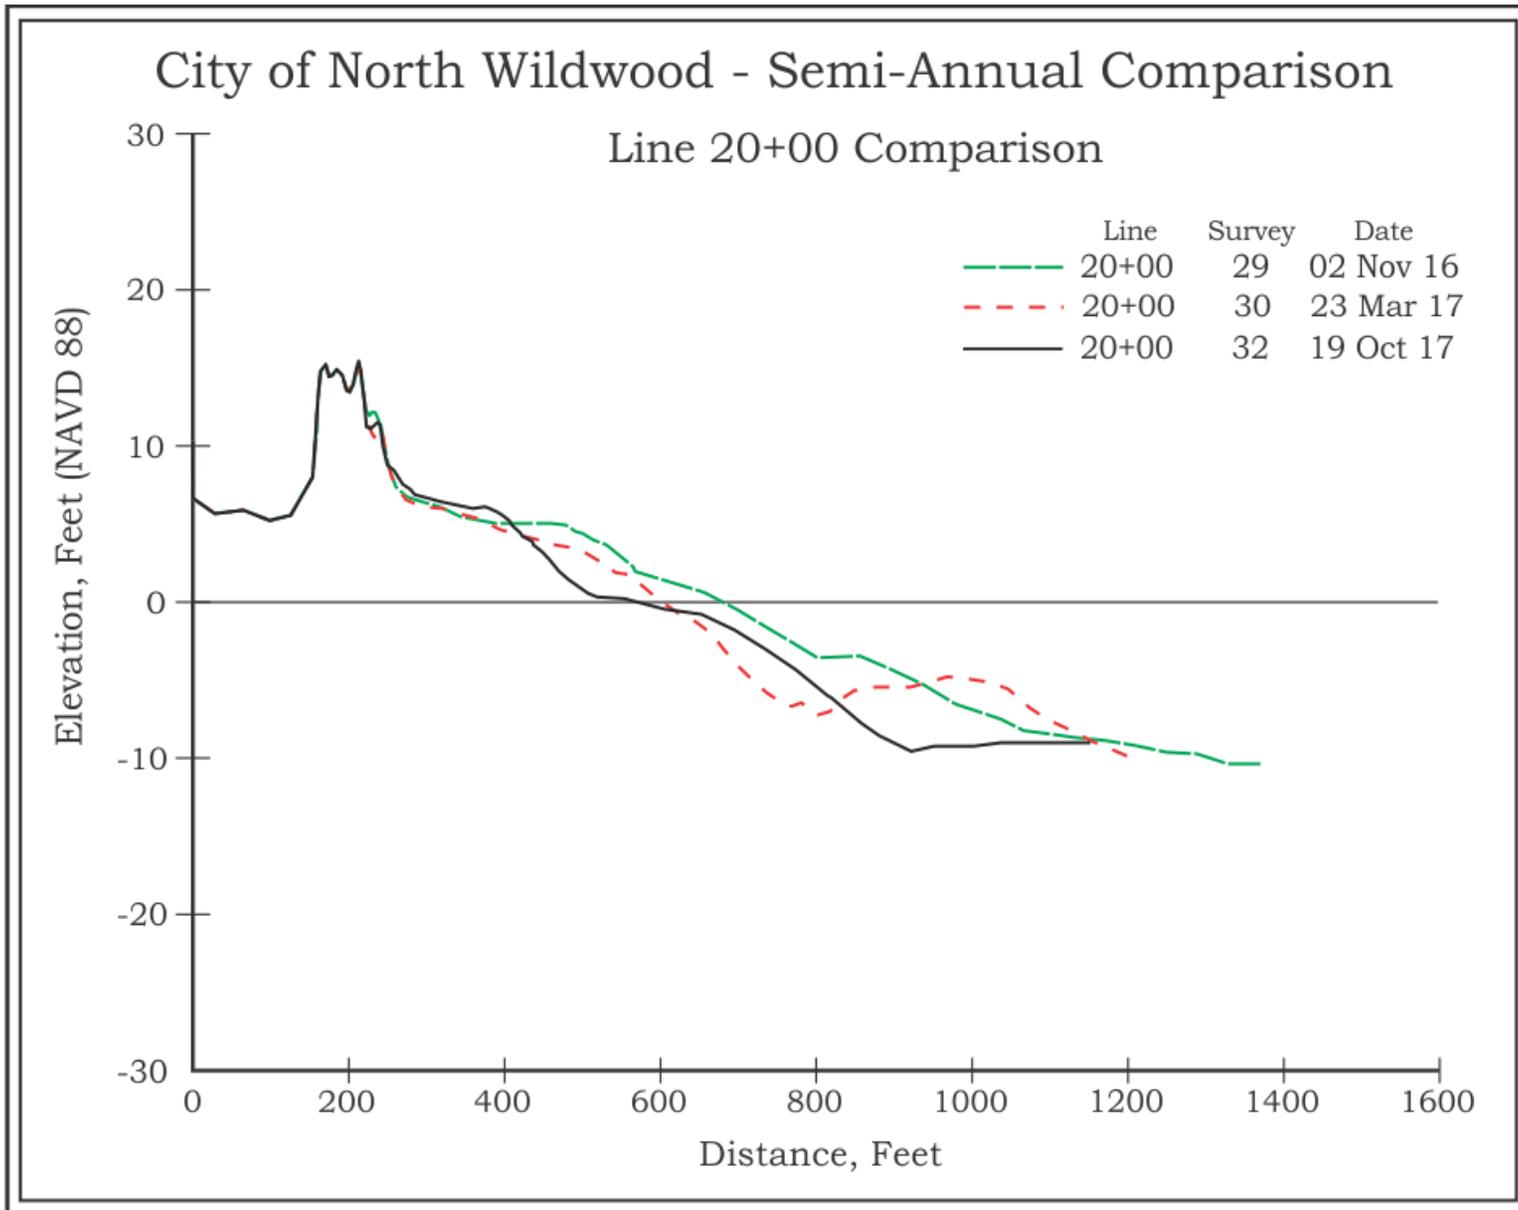
Site 20+00 (between 9th and 10th Avenues)

This site is located approximately 2,000 feet south of the inlet and has represented a transition zone (from erosion to deposition) in previous years. no sand was placed in this region during the 2013 maintenance project. The March 14, 2017 northeaster did significant damage to the beach by reducing the berm elevation and allowing waves to remove the seaward dune toe creating a scarp. The back-passing operation did place sand north of this site as part of the dune restoration effort and to build a higher elevation beach at the dune toe. This site suffered net annual loss approximately a third that seen at site 04+00 above. The loss factor vanished 2,000 feet further south as erosion became equivalent deposition (-56.90 yds³/ft. in losses here versus 57.10 yds³/ft. in sand volume gains at site 40+00, 21st Avenue). The transition from erosion to deposition likely occurred by the 15th Avenue location.

Figure 13. Positioned between 9th and 10th Avenues, this site did not as yet suffer severe dune erosion, but the beach berm pulled back by almost 100 feet and the sand volume declined by 56.90 yds³/ft.

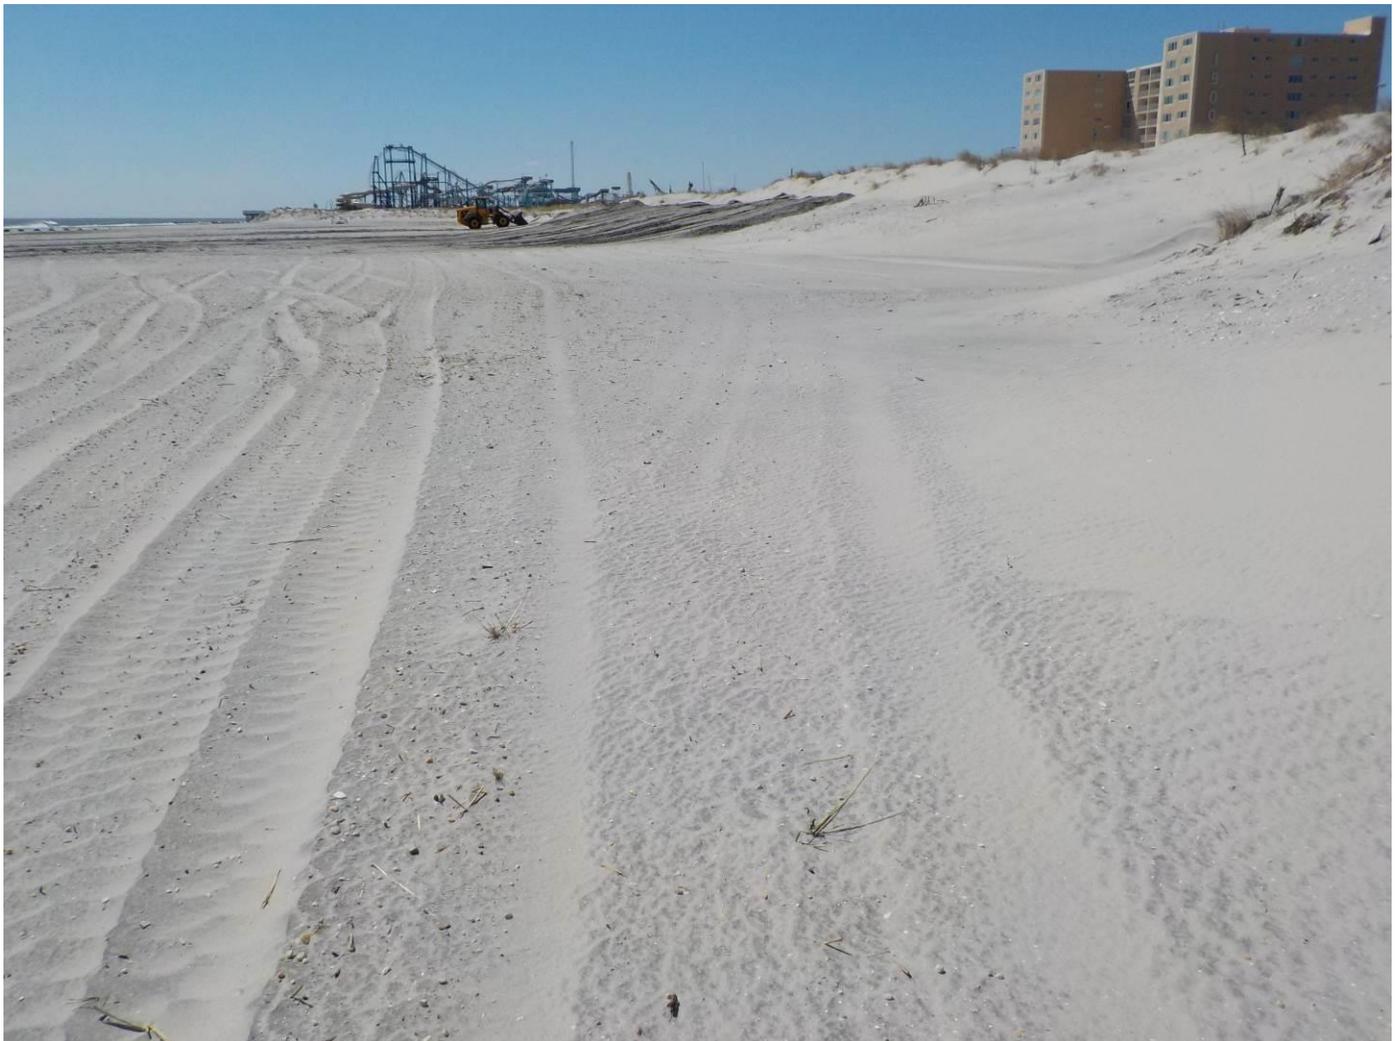
Figure 14. View to the south along the seaward dune toe March 23, 2017 as work was in progress pushing sand onto the seaward dune slope. Sand accumulated here during the year adding to the stability.
