**2017 ANNUAL REPORT - TO THE CITY OF NORTH WILDWOOD
ON THE
CONDITION OF THE CITY BEACHES**

**PREPARED FOR: THE CITY OF NORTH WILDWOOD
901 ATLANTIC AVENUE
NORTH WILDWOOD, NJ 08260**

**PREPARED BY: THE STOCKTON UNIVERSITY COASTAL RESEARCH CENTER
30 WILSON AVENUE
PORT REPUBLIC, NJ 08241
March 5, 2018**

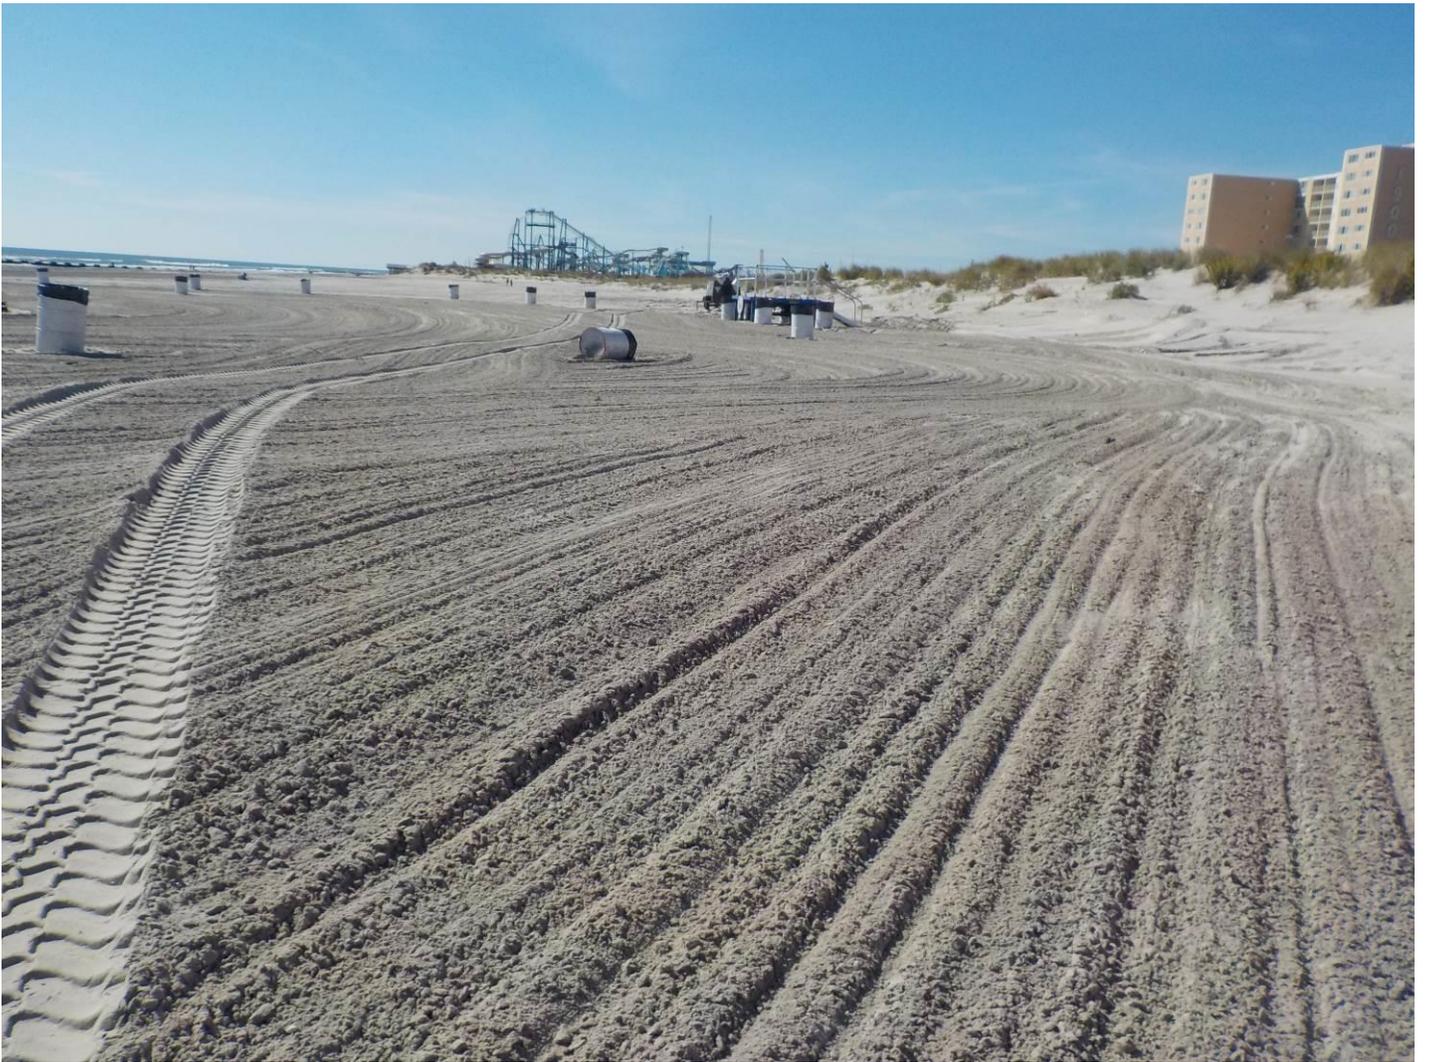
Figure 15. View to the south on the beach near the dunes October 19, 2017 showing the beach raking and a large number of trash containers still present late in the bathing season. Sand volume gains continued from this point south to the Wildwood City boundary.

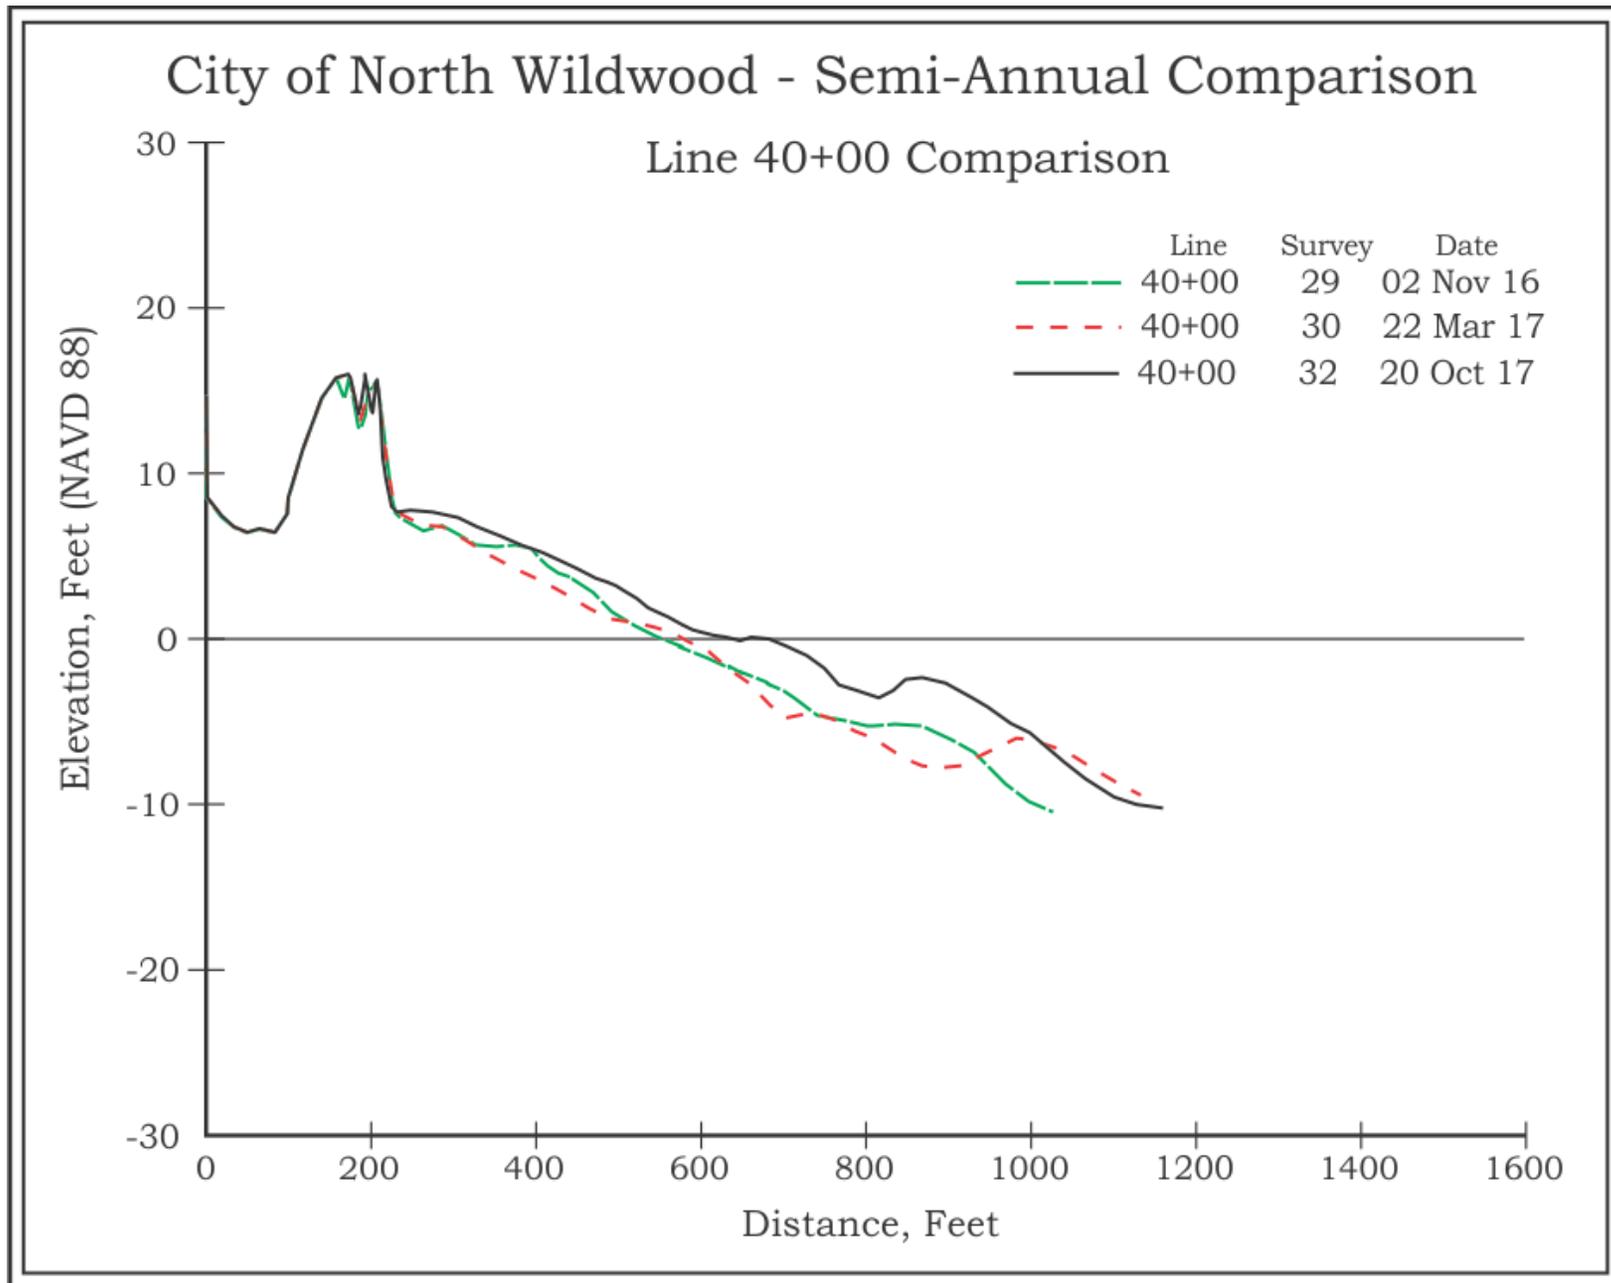
Site 40+00 (17th Avenue)

Beach erosion occurred during the winter of 2016 into 2017 generating a flat beach by March 23, 2017. Summer accretion generated recovery as sand eroded from northern sites accumulated on this beach producing a 57.91 yds³/ft. sand volume gain and a 123-foot shoreline advance over the year.

Figure 16. The annual comparison is between survey 29 and survey 32 showing that the entire profile gained material across the area between the toe of the dune and 1,200 feet offshore from the reference position behind the dunes. The gain above the zero elevation was 12.70 yds³/ft. while the gain below zero elevation was 45.20 yds³/ft. The shoreline advanced 123 feet.

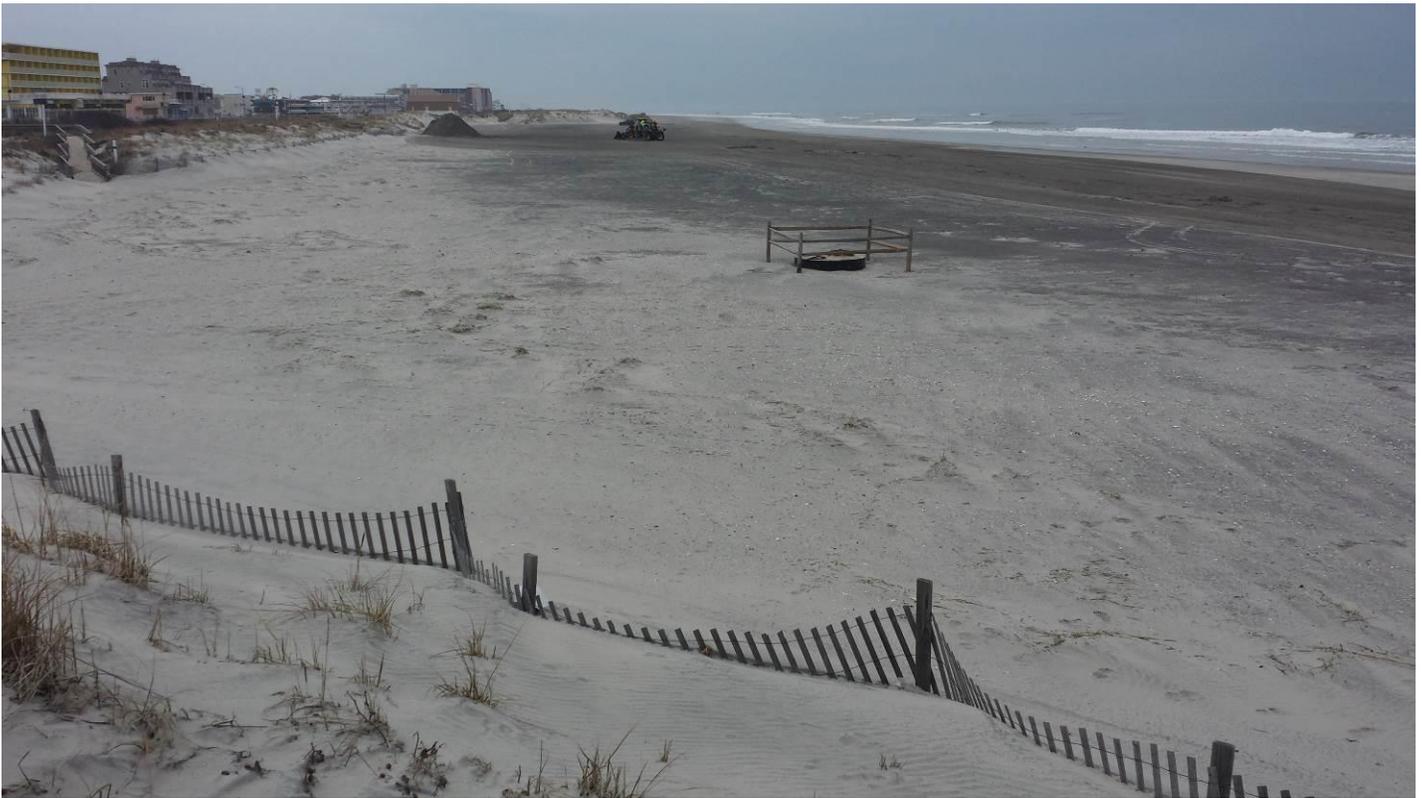
Figure 17. View to the north taken from the dune crest at 21st Avenue on March 23, 2017. Sand continued to accumulate at the dune fencing installed after Hurricane Sandy and work in the distance was underway to recover sand from the beach berm to use on pedestrian beach access paths and at the dune toe where needed.

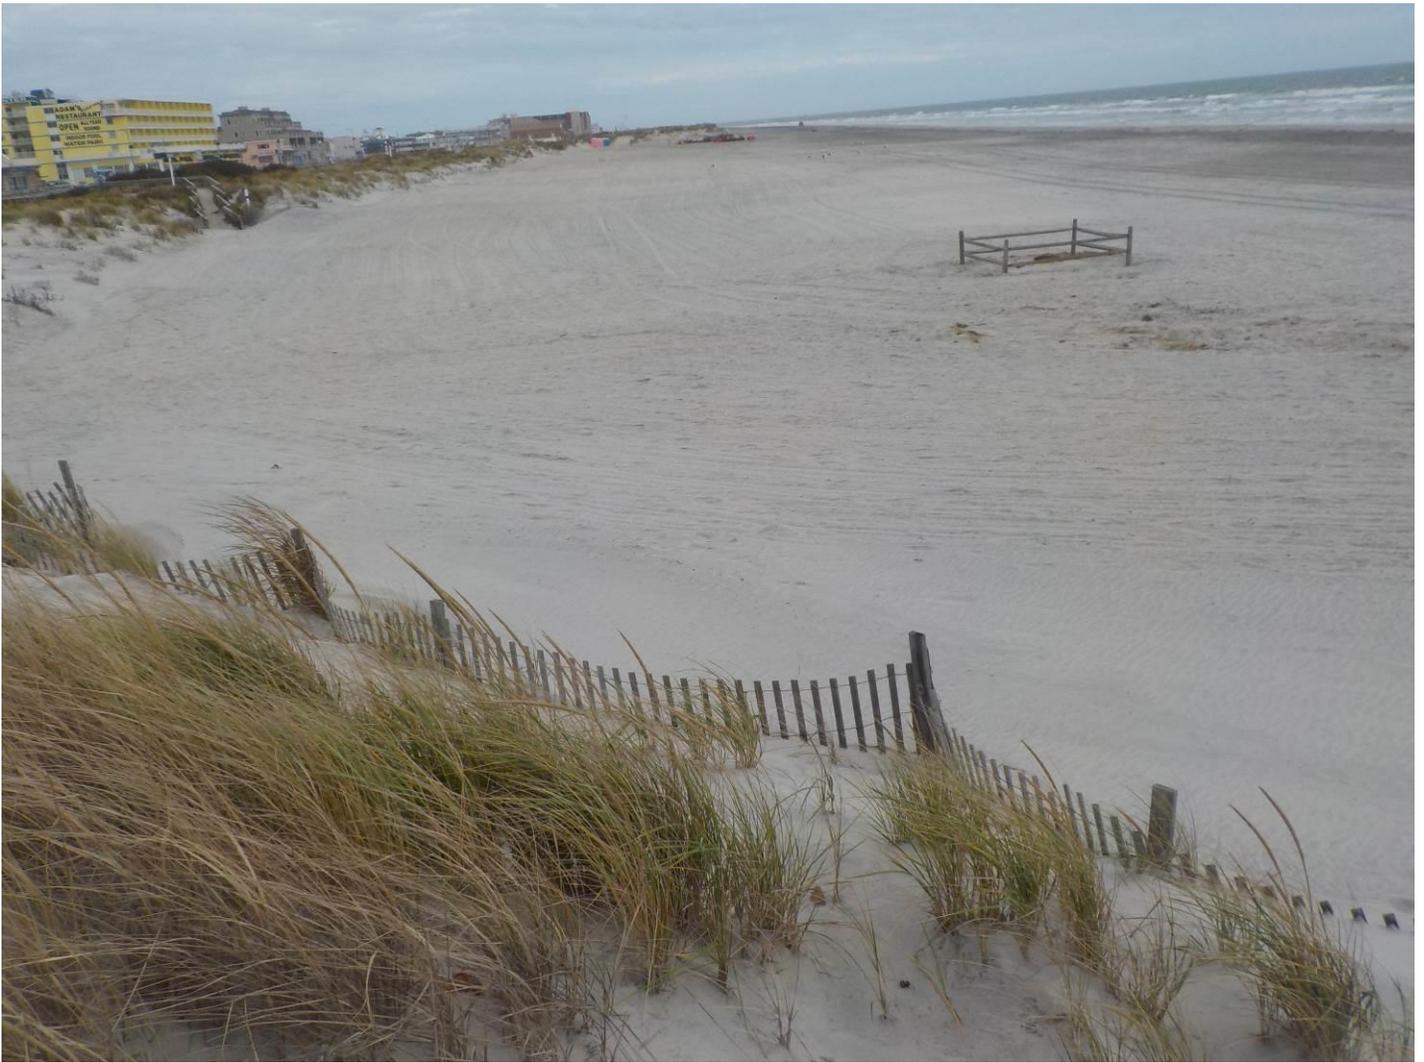
Figure 18. View to the north taken from the dune crest at 21st Avenue on October 20, 2017. Conditions remain stable at this site with wind-transported sand having nearly buried the dune fencing along this section of the oceanfront beach.

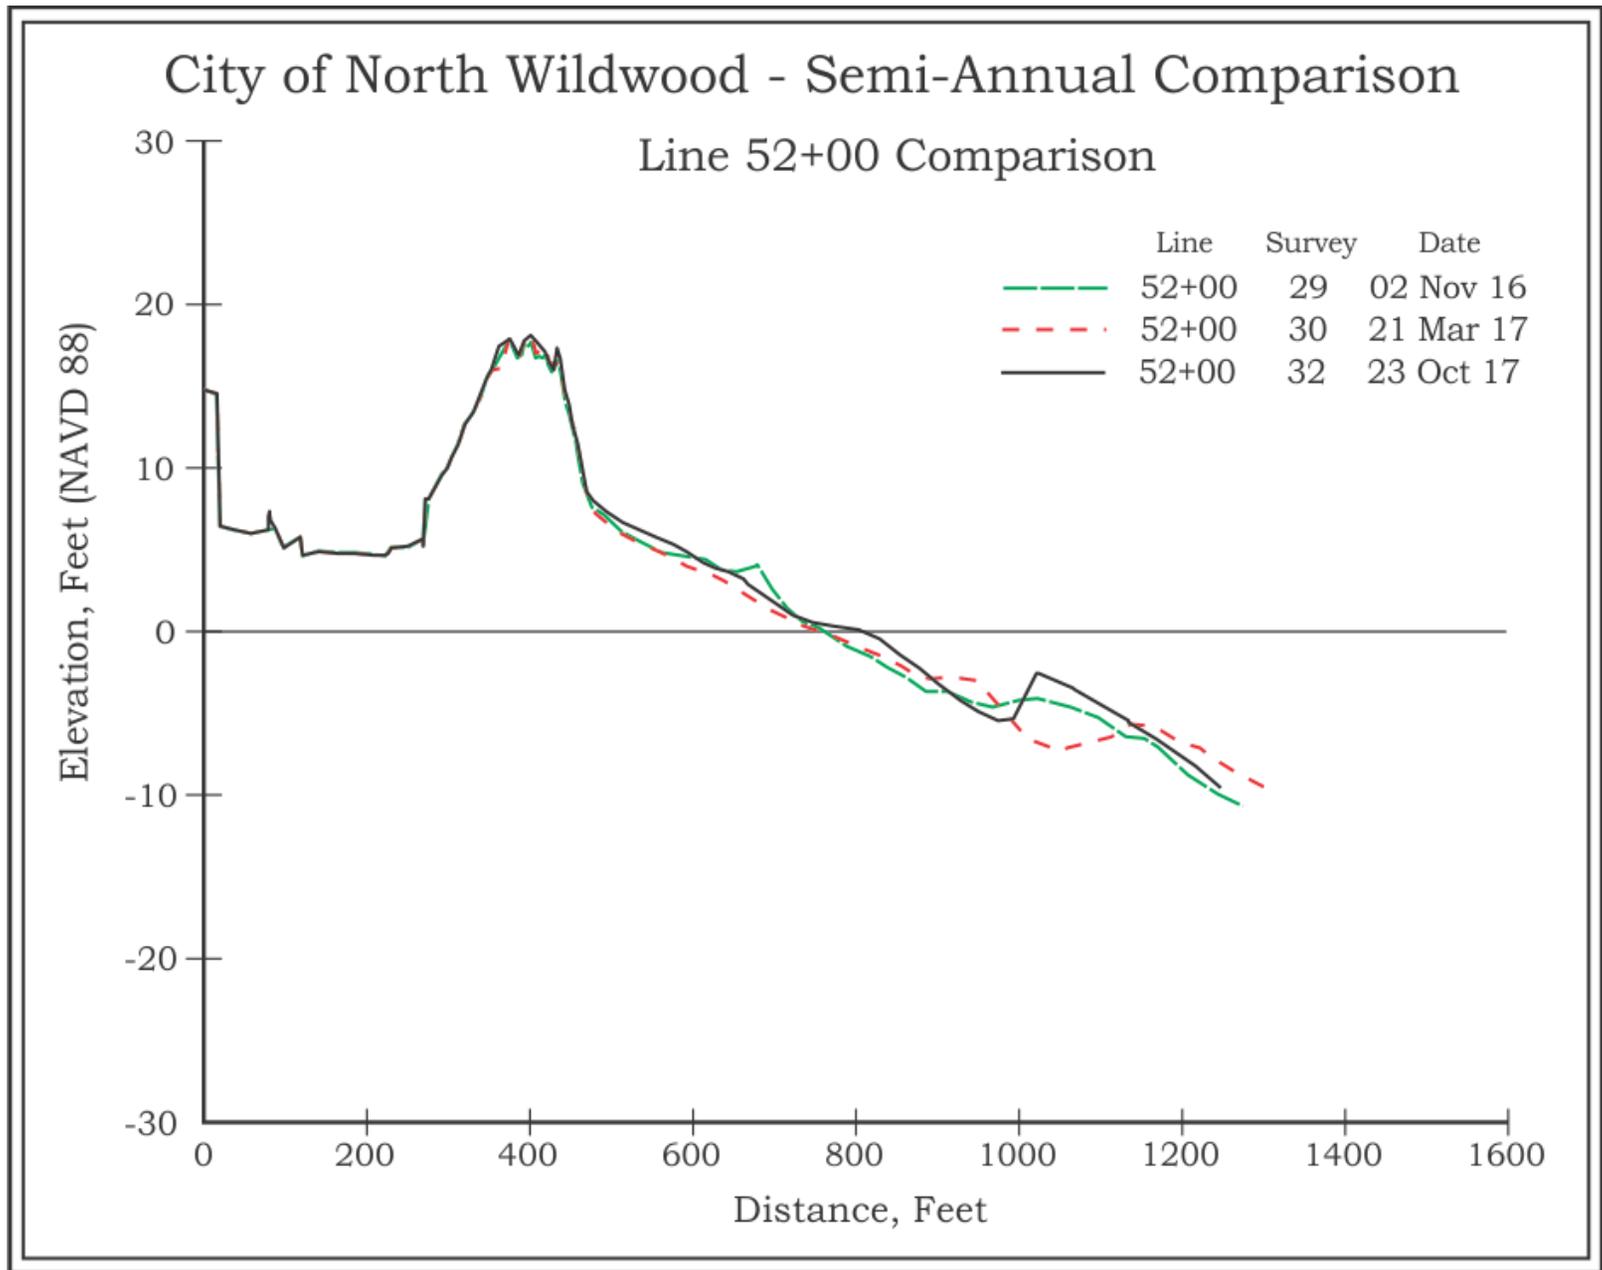
Site 52+00 (21st Avenue)

Figure 19. The recreational beach and beachface at 21st Avenue remained stable gaining 14.40 yds³/ft. as the shoreline advanced 49 feet seaward over the year between November 2016 and October 2017.

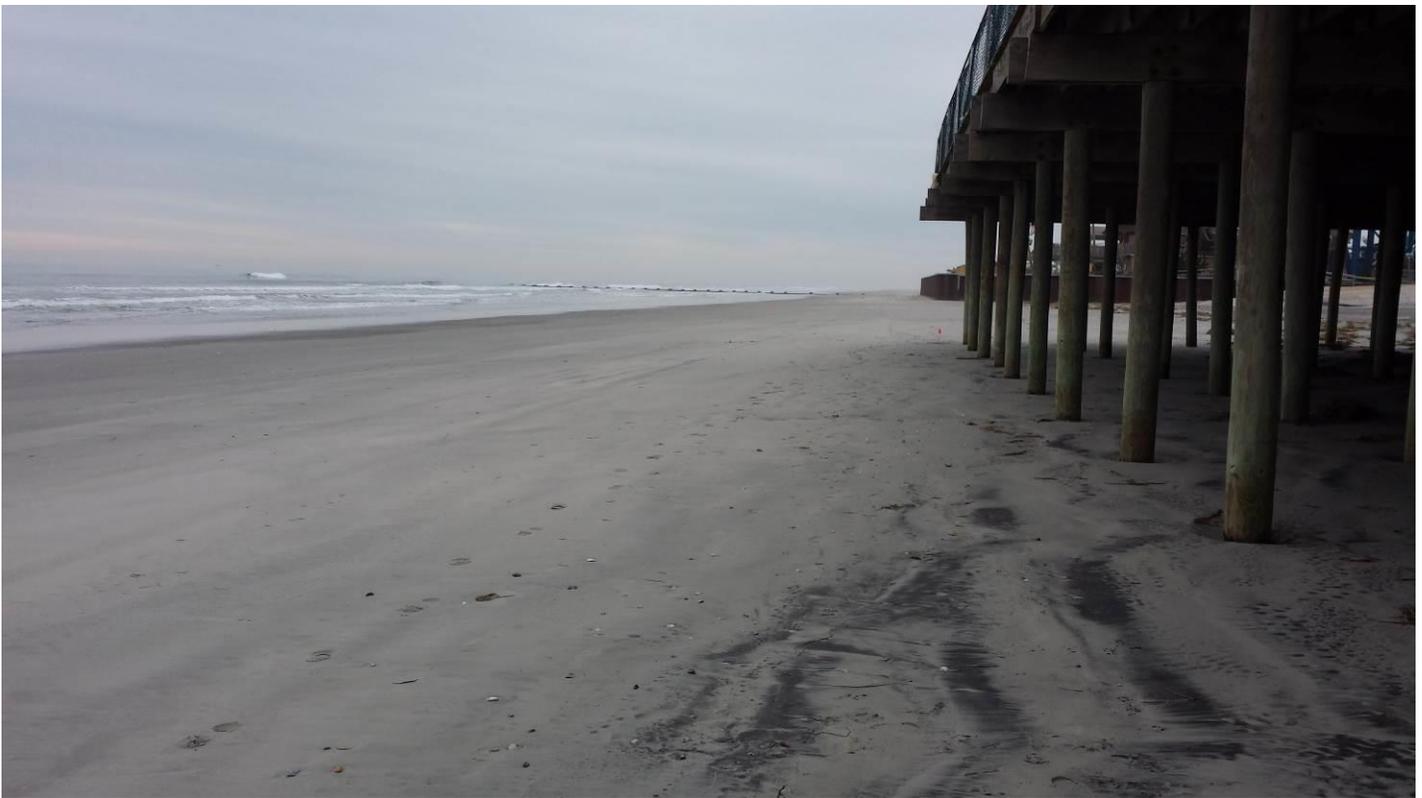
Figure 20. A close up view of the beach at the very seaward end of the timber pier indicating that no dry beach or dune feature remains at the pier's end (March 2017). Visible between the pier pilings is the re-positioned dune between this pier and Morey's Surfside Pier.

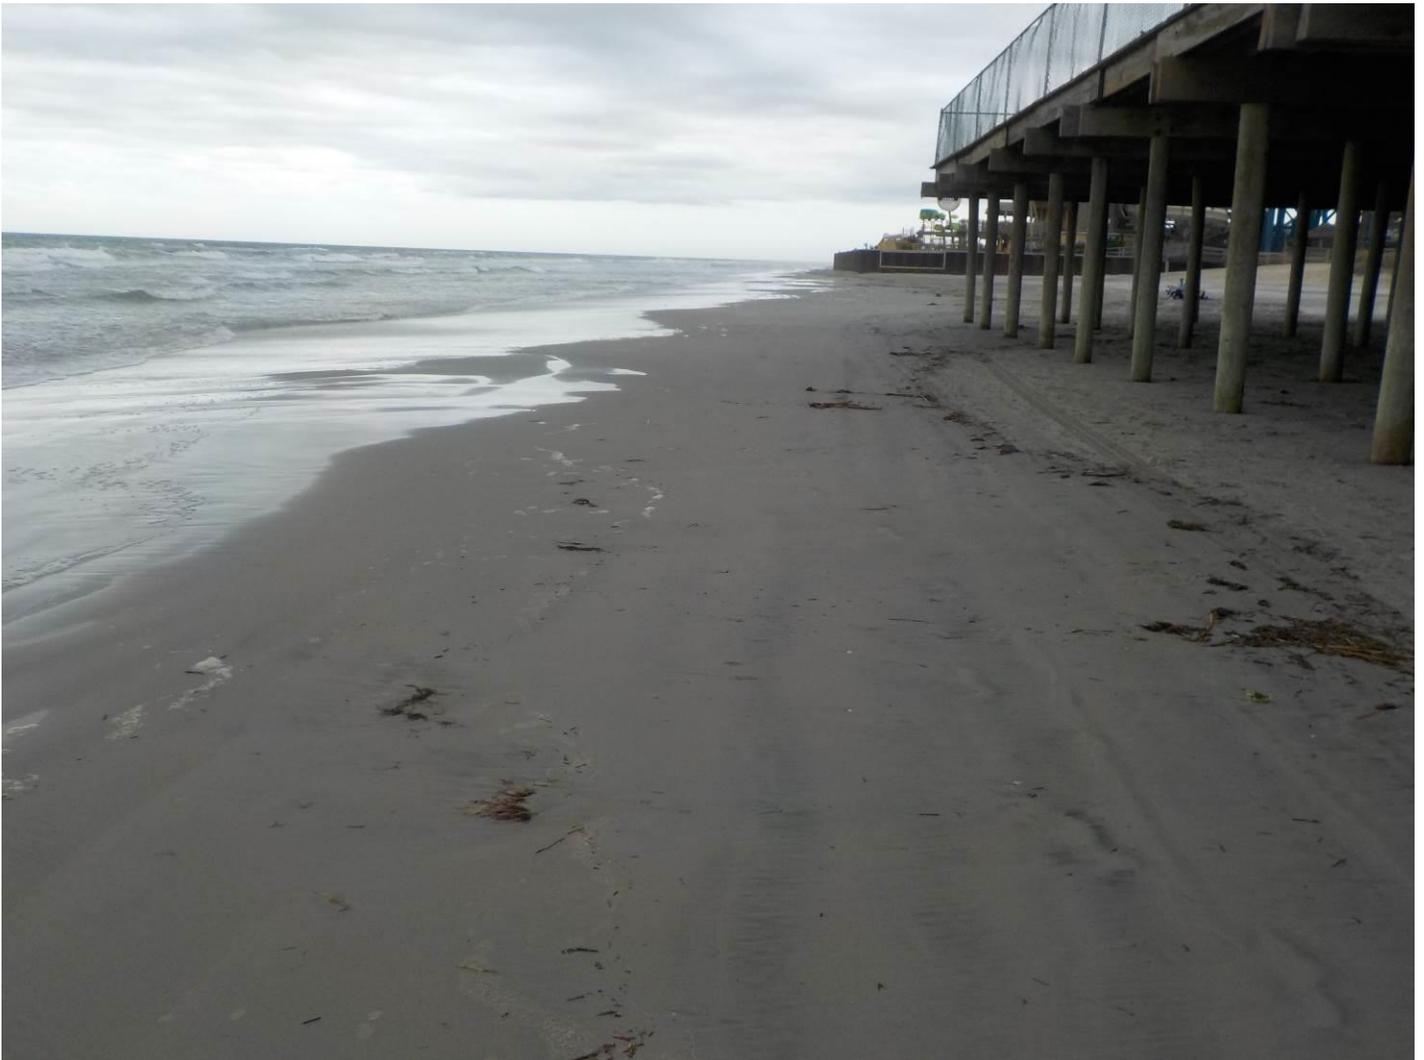
Figure 21. This view to the south October 27, 2017 shows nearly identical conditions at the seaward end of the timber pier between 23rd and 24th Avenues. Waves readily reach under the pier on a very flat beach. The revised dune system shows in the distance beside Morey's Surfside Pier so beach width is critical to this site's ability to moderate wave action.

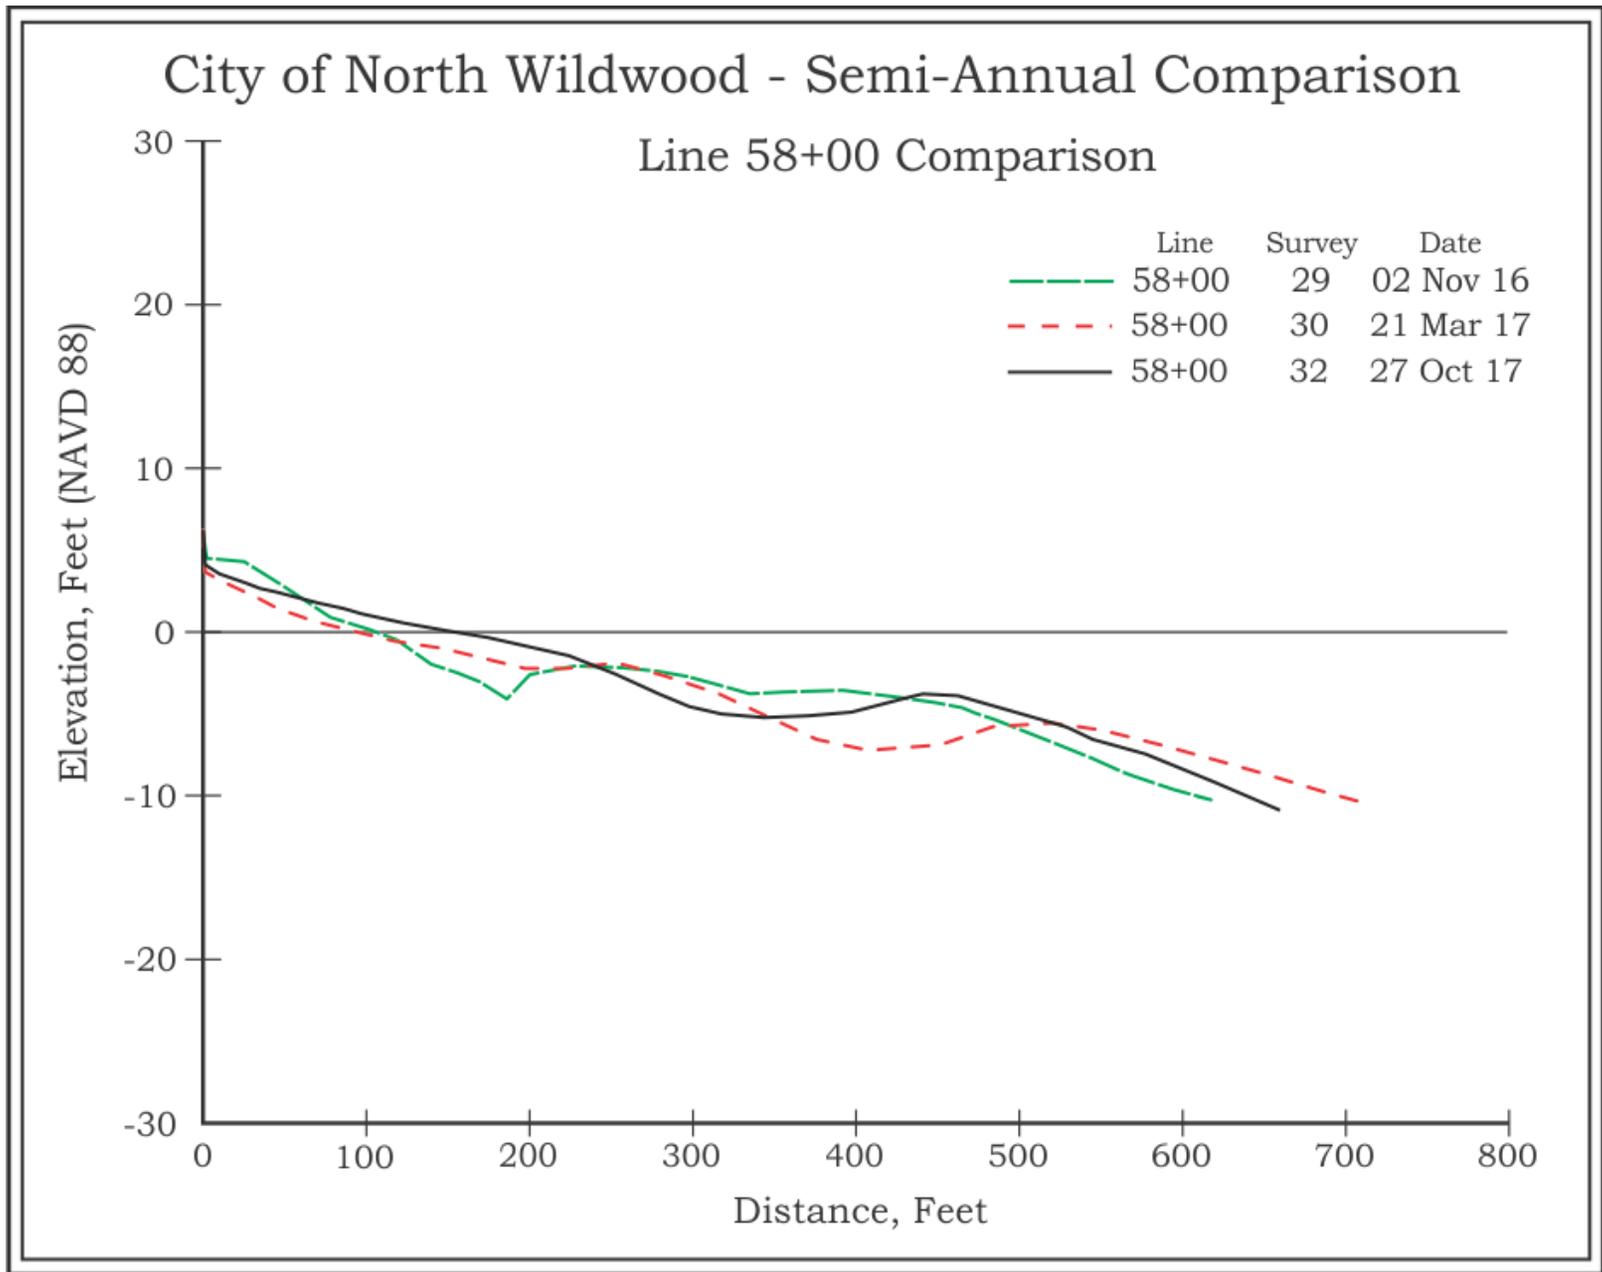
Site 58+00 (Between 23rd & 24th Avenues)

Figure 21. The absence of a dune on the cross section means that there is little or no attenuation of strong waves until the dune line is reached landward of the timber structure’s seaward end. Sand did add to the beach over the summer of 2017, but not sufficiently to reduce storm impacts at the pier ends.

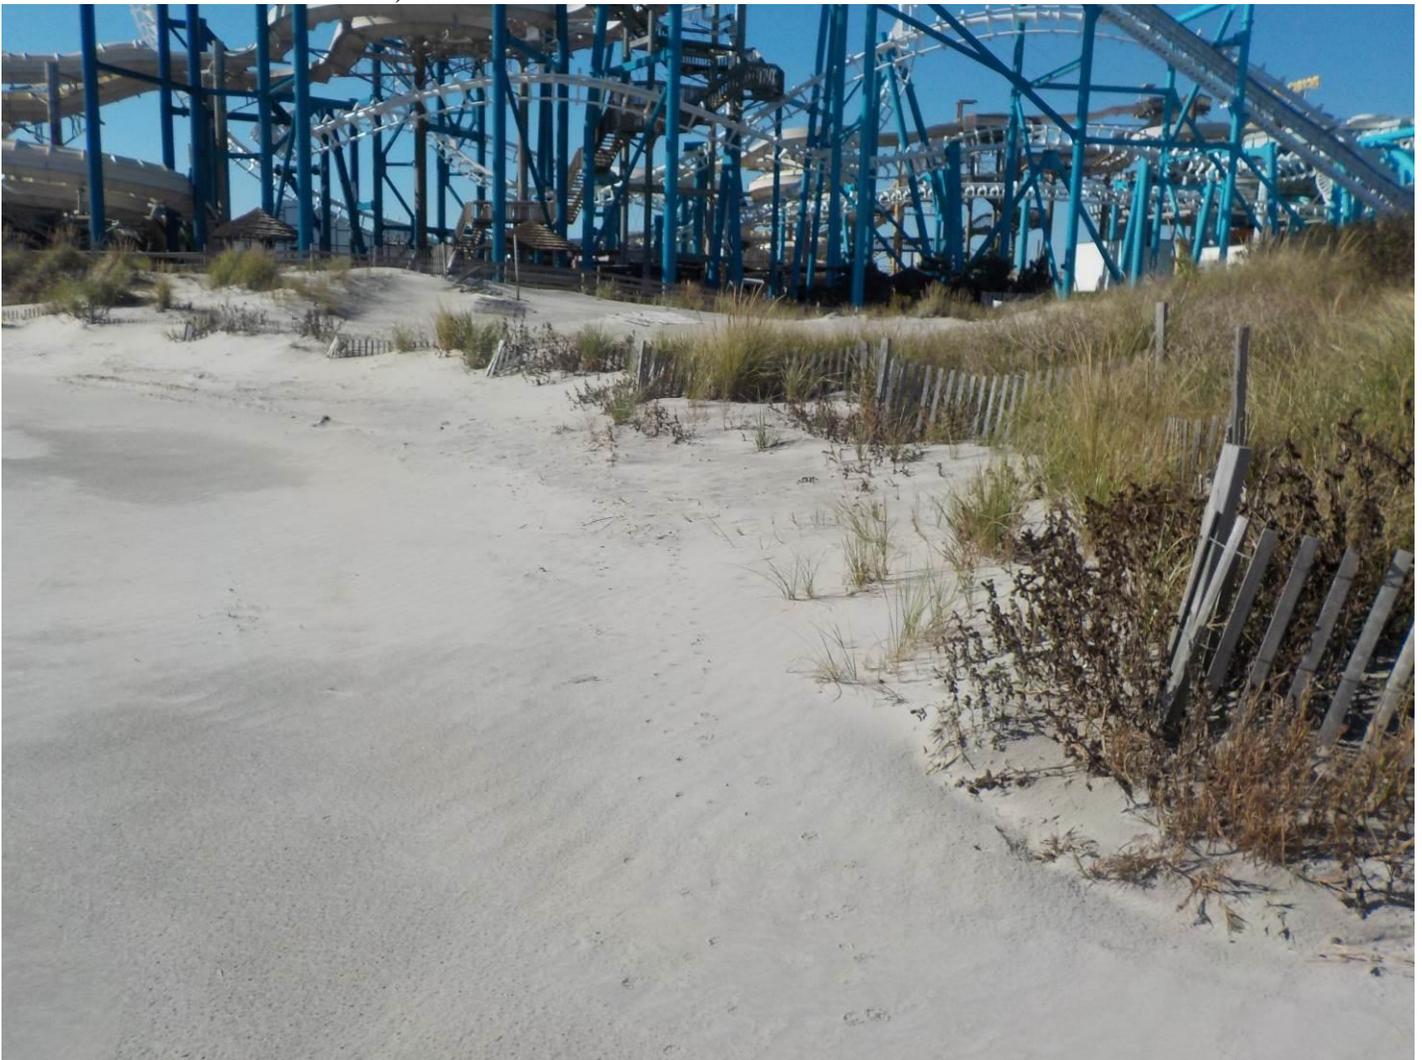
Figure 22. Site 60+00 was included this year in the surveys with calculations for sand volume and shoreline changes. The view was taken October 20, 2017. This site lies in proximity to 24th Avenue, between the Surfside Pier in the photograph and the timber pier to the north. This dune toe is part of the older island dune present here for years. The re-positioning process that took place in 2014 created the lower, sparsely vegetated section between the old dune and the pier's northeast side steel bulkhead at its landward end.

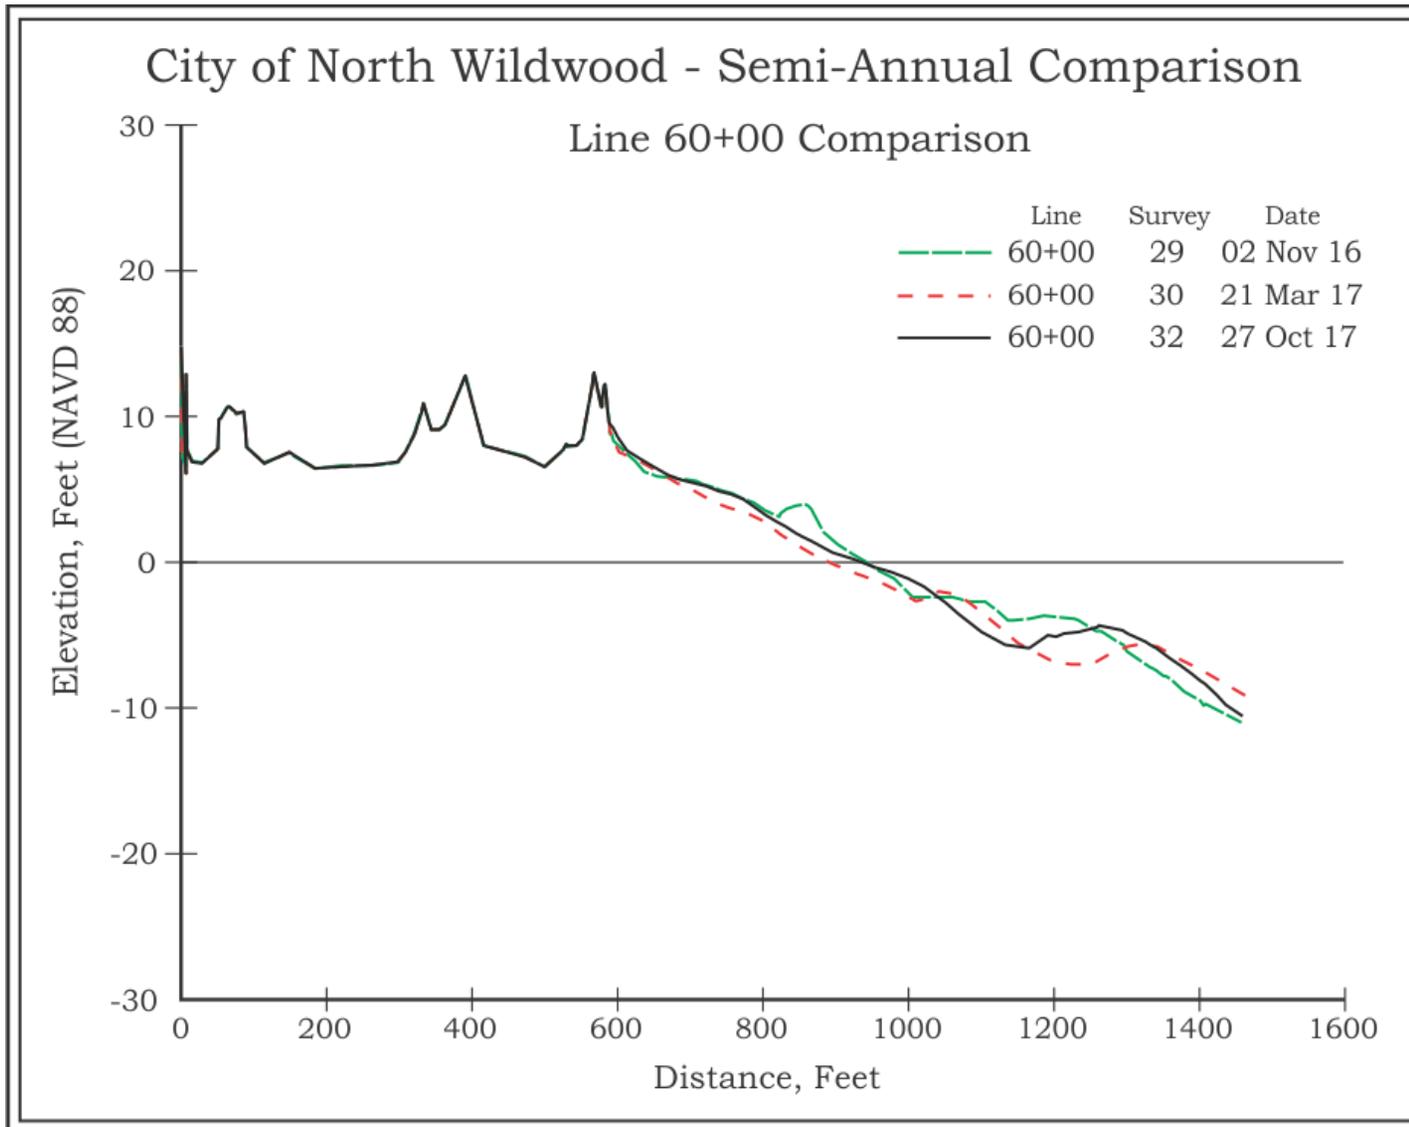
Site 60+00 (24th Avenue)

Figure 23. Cross section at 24th Avenue between the Surfside Pier and the timber pier to the north. The island dune developed on beach raking debris initially and has become a robust defense against storms. The feature was extended north and south to connect as well as possible to the pier structures. The Surfside contact is directly to the steel wall bulkhead put in place to defend the pier not built on pilings. The sand is pushed under the timber pier, but not raised up across the entire width of the structure. A bulkhead defends the boardwalk at the landward end of the pier. This beach lost 4.03 yds³/ft. while the shoreline retreated 4 feet. The beachface gained material as the offshore bar system moved seaward.

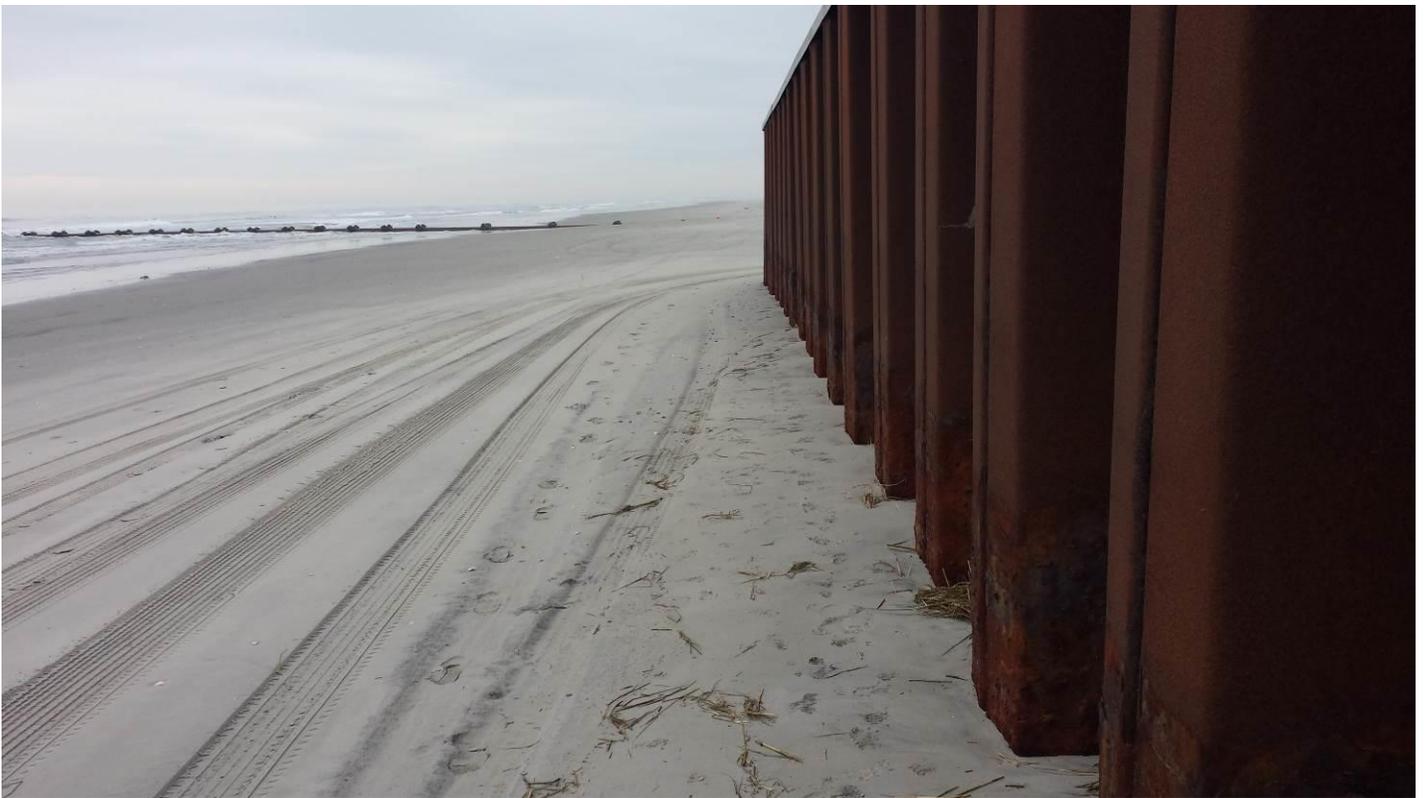
Figure 24. View to the south taken on March 20, 2017 near 26th Avenue showing the beach at the Surfside Pier's seaward end steel bulkhead. Waves easily reach the bulkhead making a dry berm unlikely until the shoreline advances about 100 feet further seaward.

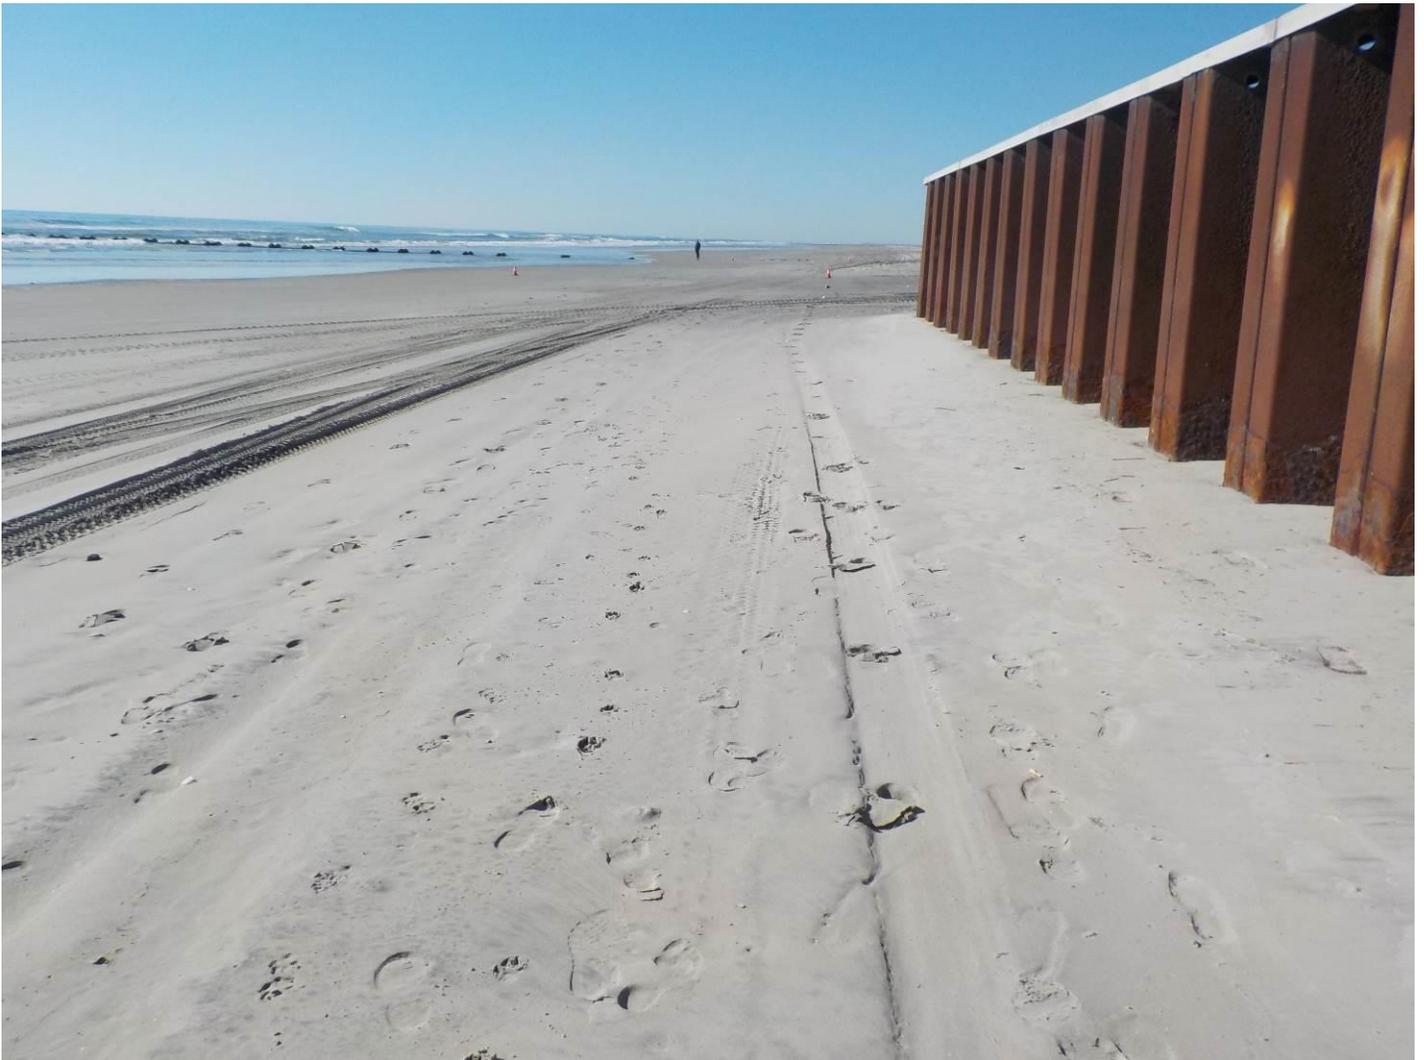
Figure 25. View to the south taken on October 20, 2017 near 26th Avenue following the summer season demonstrates that sand does not accumulate above normal high tide because wave reflection off the wall moves it back into the swash and eventually south into Wildwood. There is a significant bar offshore, but that material has yet to migrate onto the beach.

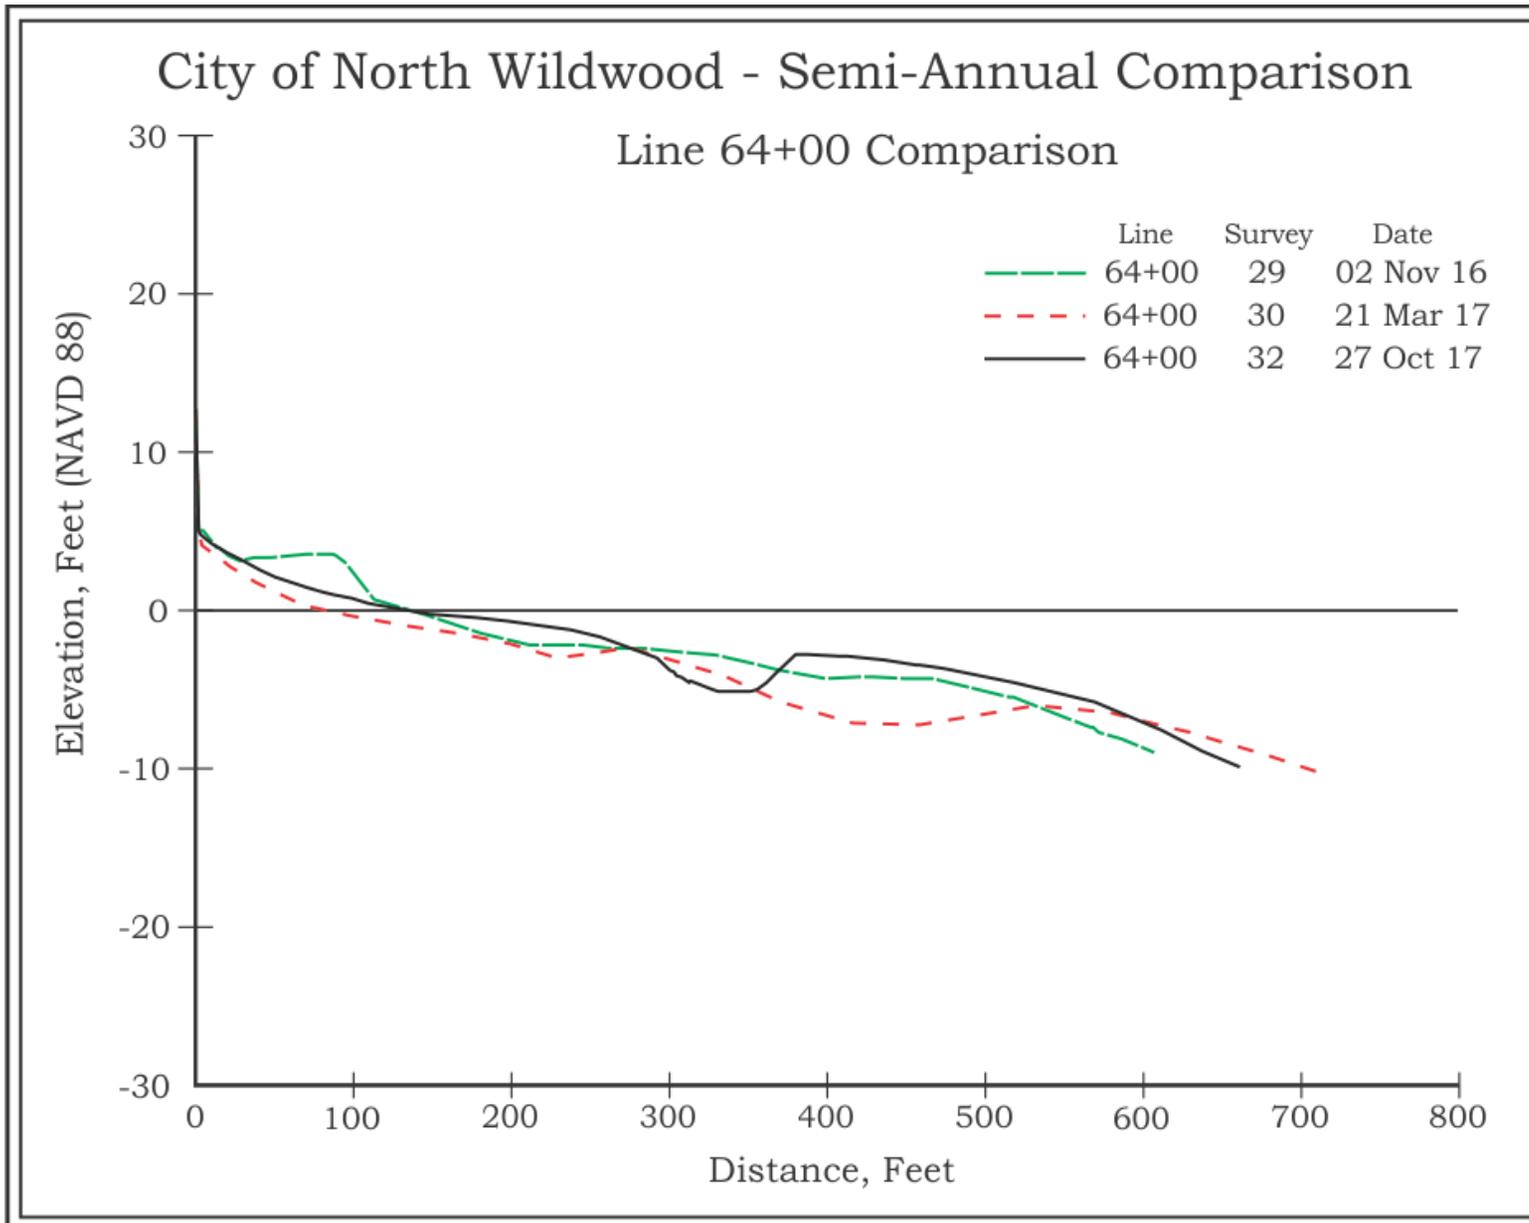
Site 64+00 (between 25th and 26th Avenues)

Figure 27. Between March and October, sand did accumulate at the base of the steel bulkhead. The sand volume added amounted to 4.63 yds³/ft. and the shoreline retreated 2 feet since last November. Sediment passes through this location because unless the shoreline advances seaward to the point where a dry beach is possible seaward of the steel bulkhead, no vertical accumulation of material is possible. Waves reflect off the wall and return the sand to the swash. It moves on past not up onto the beach.
