**2019 ANNUAL REPORT ON
THE CONDITION OF THE MUNICIPAL BEACHES FOR
THE BOROUGH OF STONE HARBOR, CAPE MAY COUNTY, NEW JERSEY**

**PREPARED FOR: THE BOROUGH OF STONE HARBOR
9508 SECOND AVENUE
STONE HARBOR, NJ 08247**

**PREPARED BY: THE STOCKTON UNIVERSITY COASTAL RESEARCH CENTER
30 WILSON AVENUE
PORT REPUBLIC, NEW JERSEY 08241**

March 10, 2020

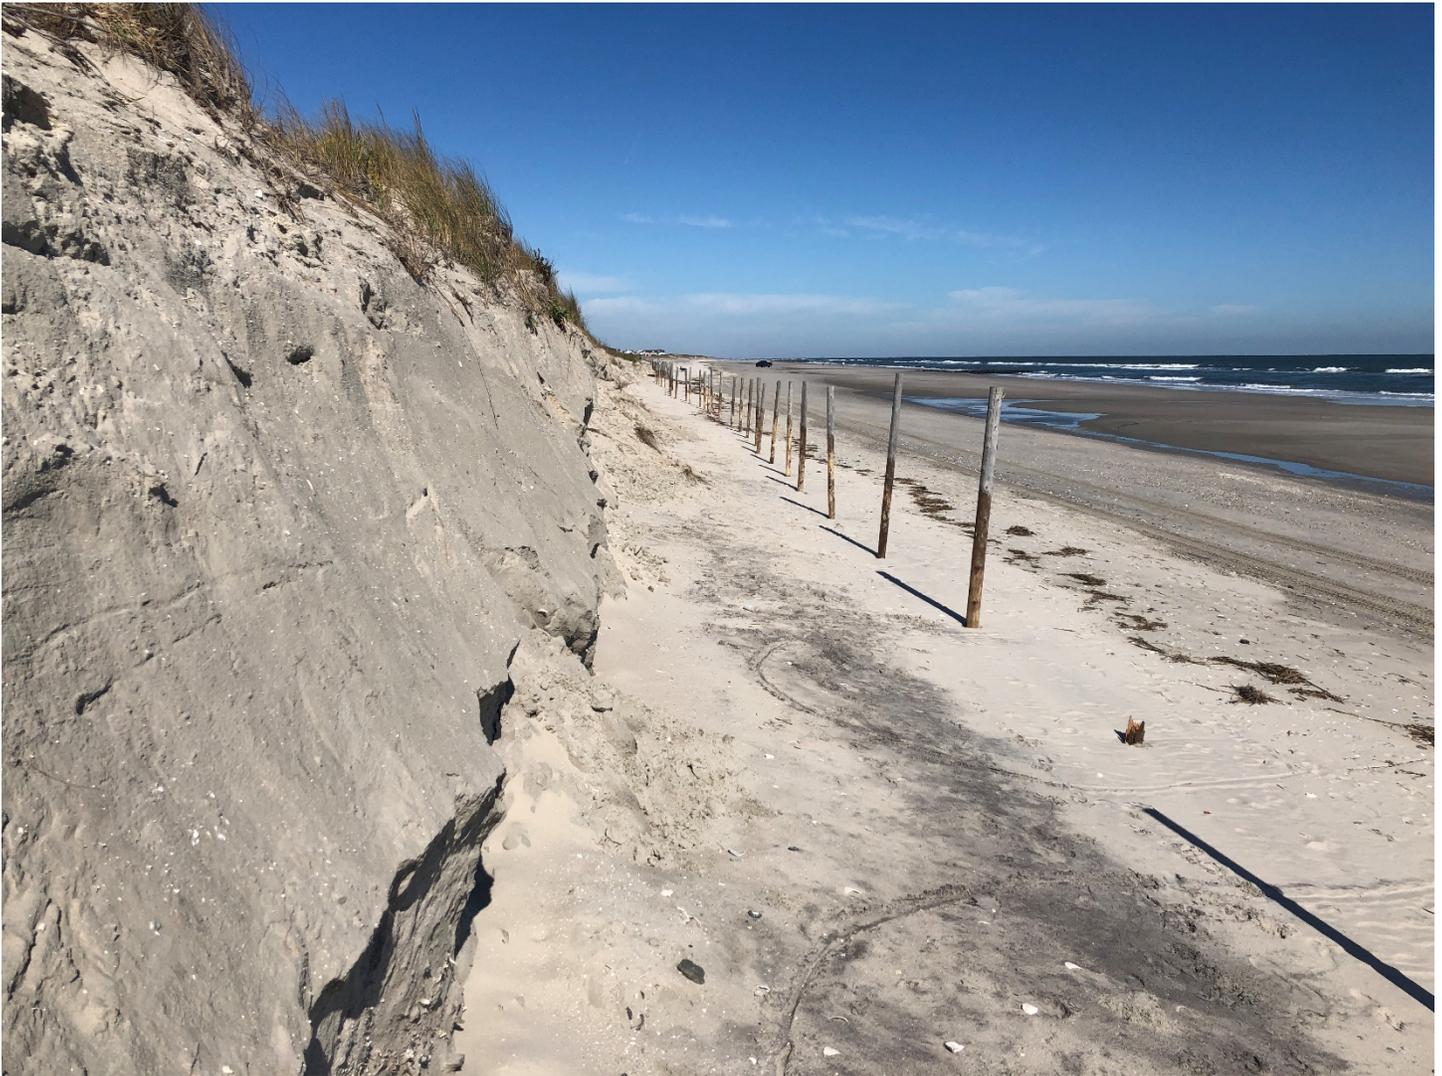
This view to the north along the 123rd Street survey line presents the most vulnerable segment of the Stone Harbor oceanfront. There were few events of any significance following the summer of 2019 where sand built up on the beach to the toe of the dunes. The same situation appeared last year as minor storms cut back to the dune and generated this scarp. The pilings are installed to mour catamarans each summer. The sand fence installed last spring was destroyed between Labor Day and Oct. 15th. Note the bar offshore and the deposition of sand at the low tide line creating a minor ridge. The last high tide was almost to the catamaran poles.

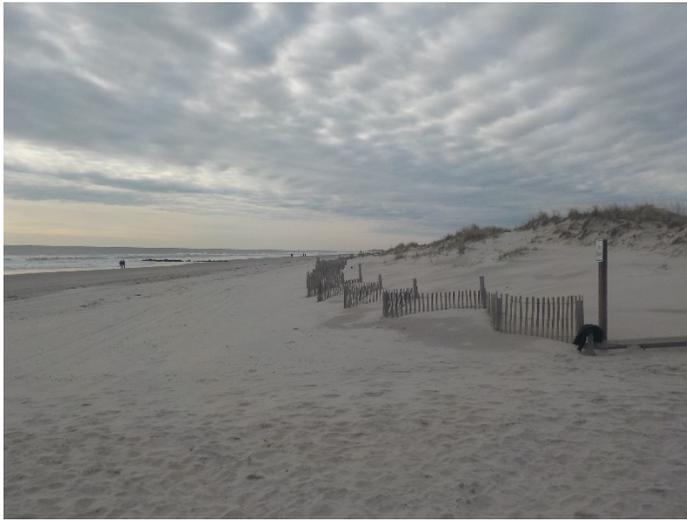
Photo 1a – Photo taken November 8, 2018, this was a year plus the summer after the federal/state project was completed.

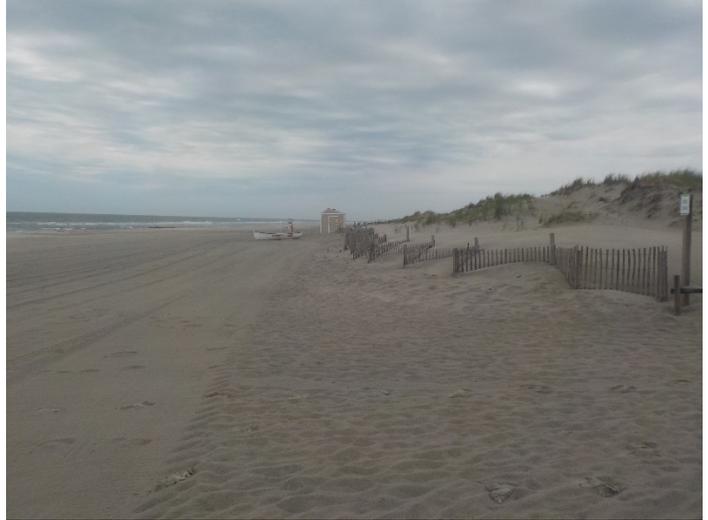
Photo 1b - Photo taken May 28, 2019 following a series of mild northeast storms ending May 13th. No damage was seen at the dunes where the fencing installed is two thirds buried.

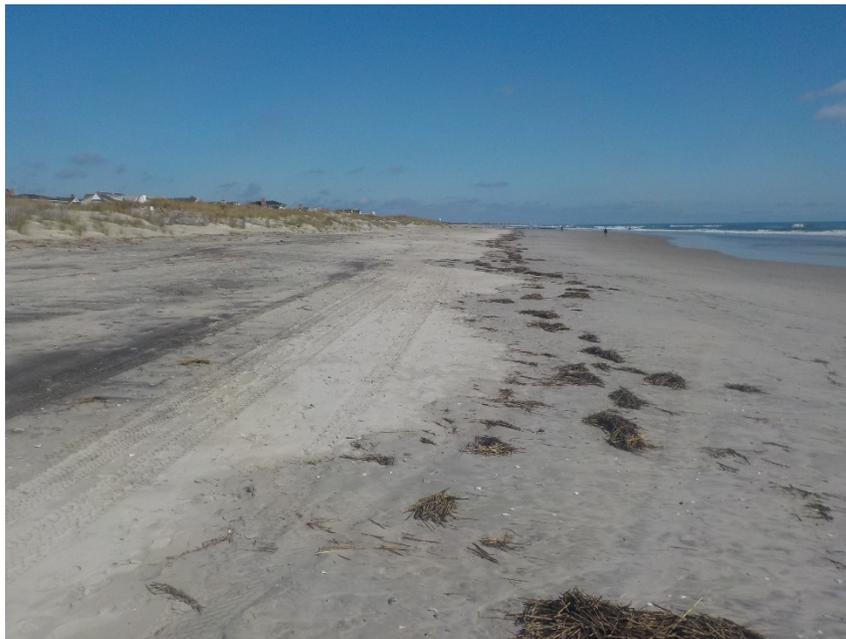
Photo 1c – Photo taken on October 14, 2019, looking north along the high tide line after the summer berm was eroded flat by northeast waves.

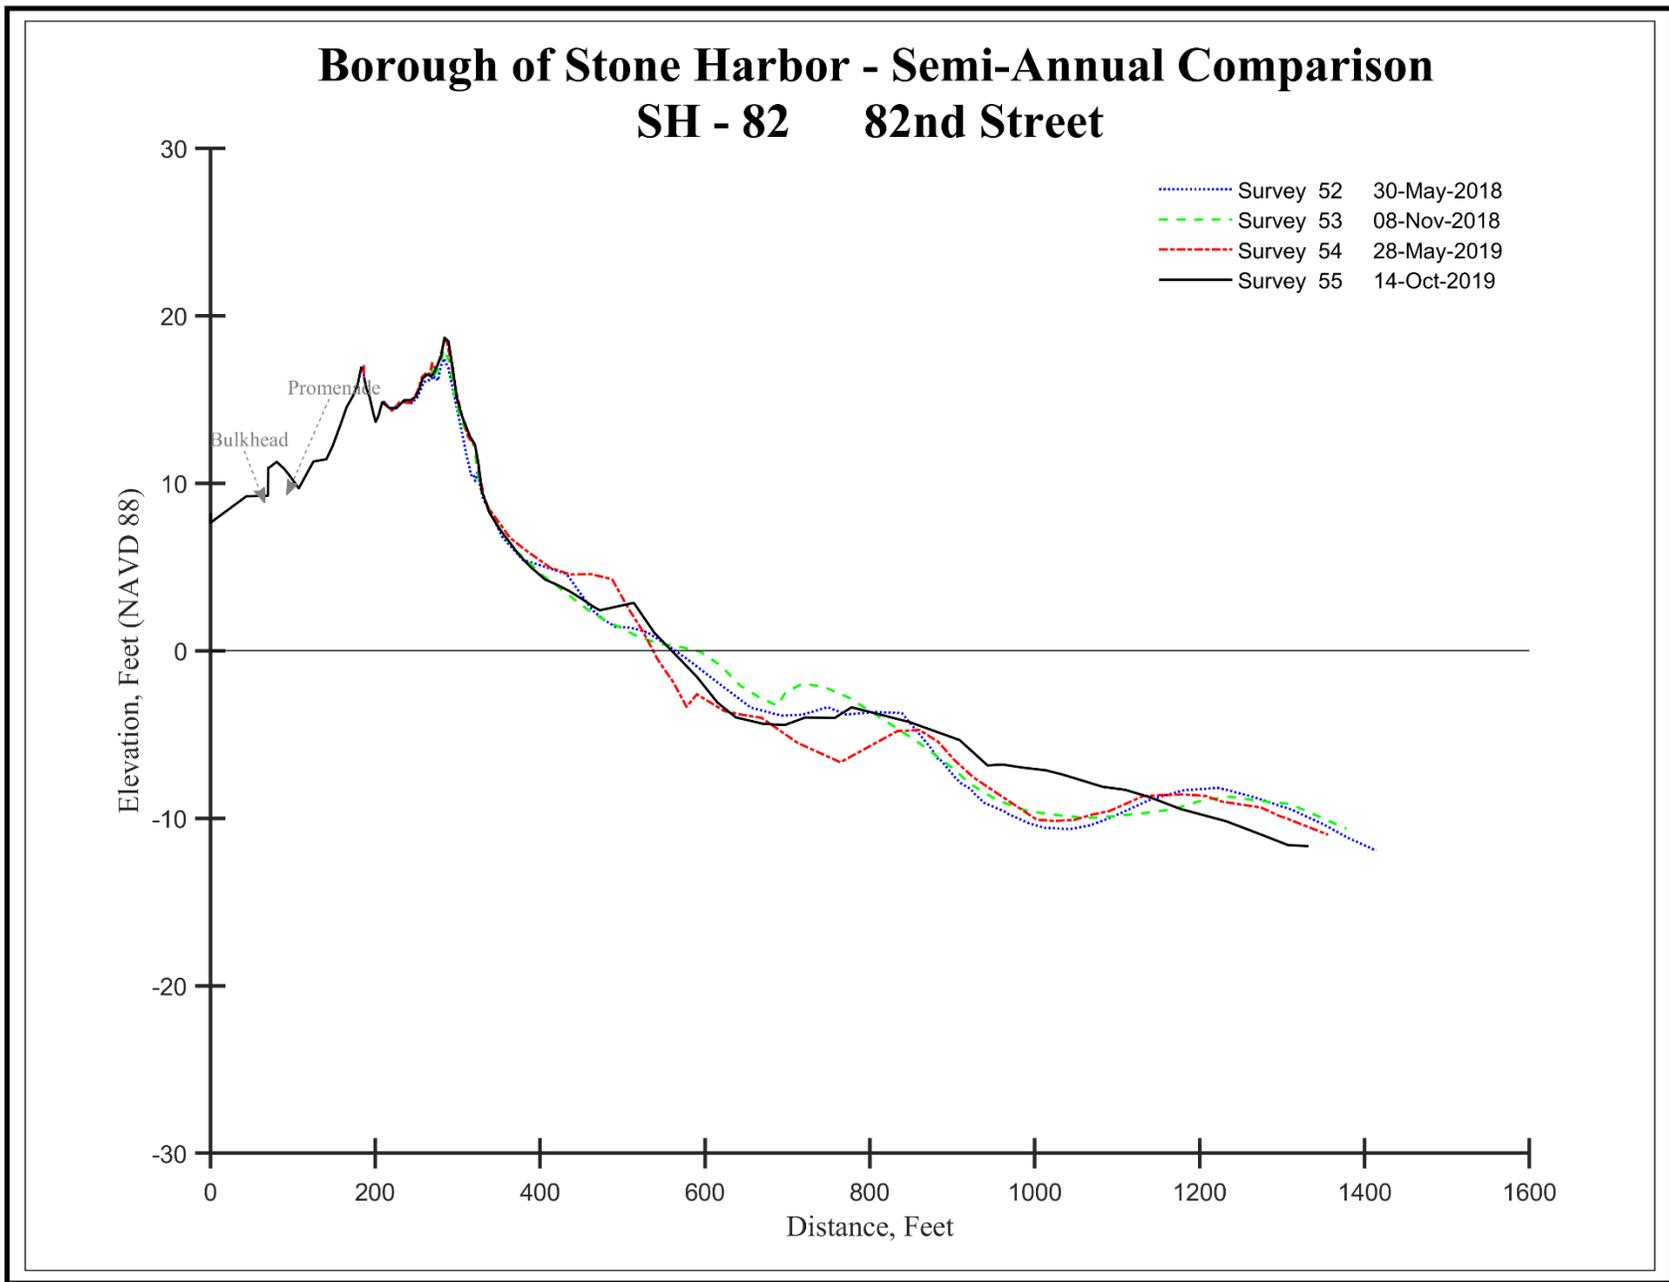
Figure 1d. The profile cross sections show the changes starting a year since the latest beach restoration took place. The berm developed by May 2019, then eroded back to generate a uniformly seaward sloping beach by October 2019, along with the growth of a significant bar offshore. The beach retreated 4 feet landward as a small berm was redeveloping, but the sand volume increased by 11.08 yds³/ft. The May to October 2019 sand volume gain was 17.65 yds³/ft., making the last 5 months the most accretional interval.

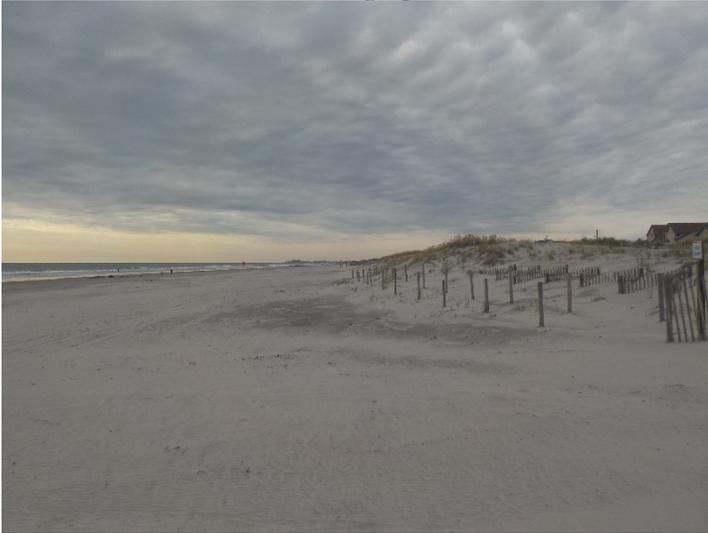
Photo 2a – Photo taken November 8, 2018 shows some loss of recent fence, but no dune damage.

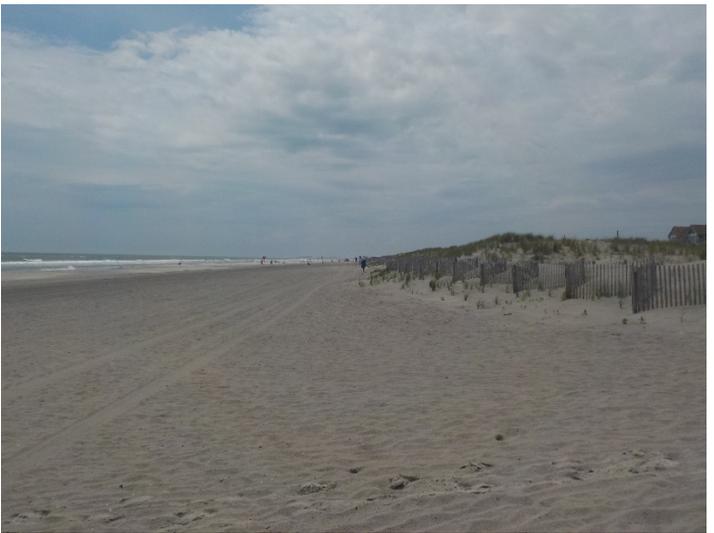
Photo 2b - Photo taken May 28, 2019 as summer began. Grass is beginning to migrate seaward onto the beach.

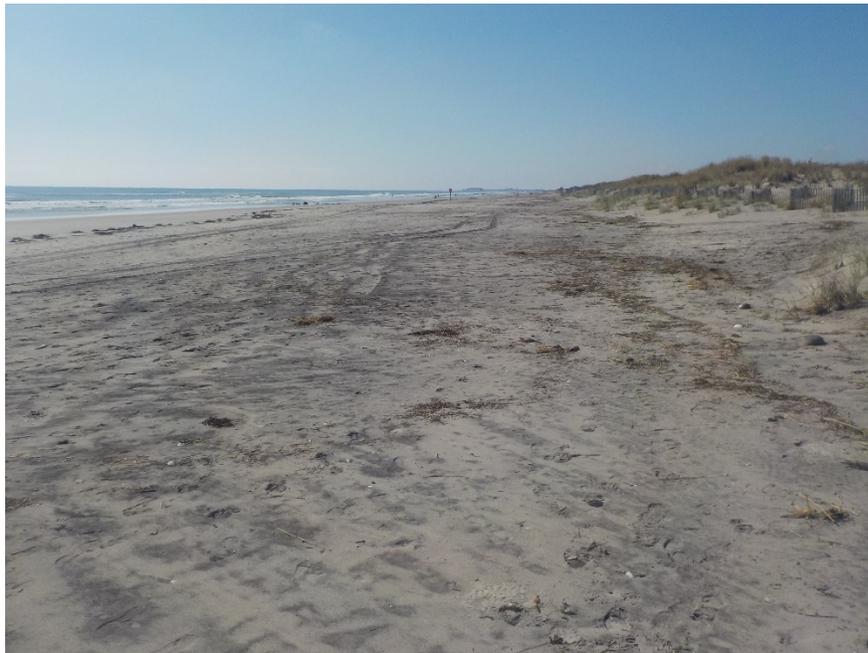
Photo 2c - Photo taken October 14, 2019 shows substantial dune growth in spite of early winter storm waves reaching the toe of the dune.

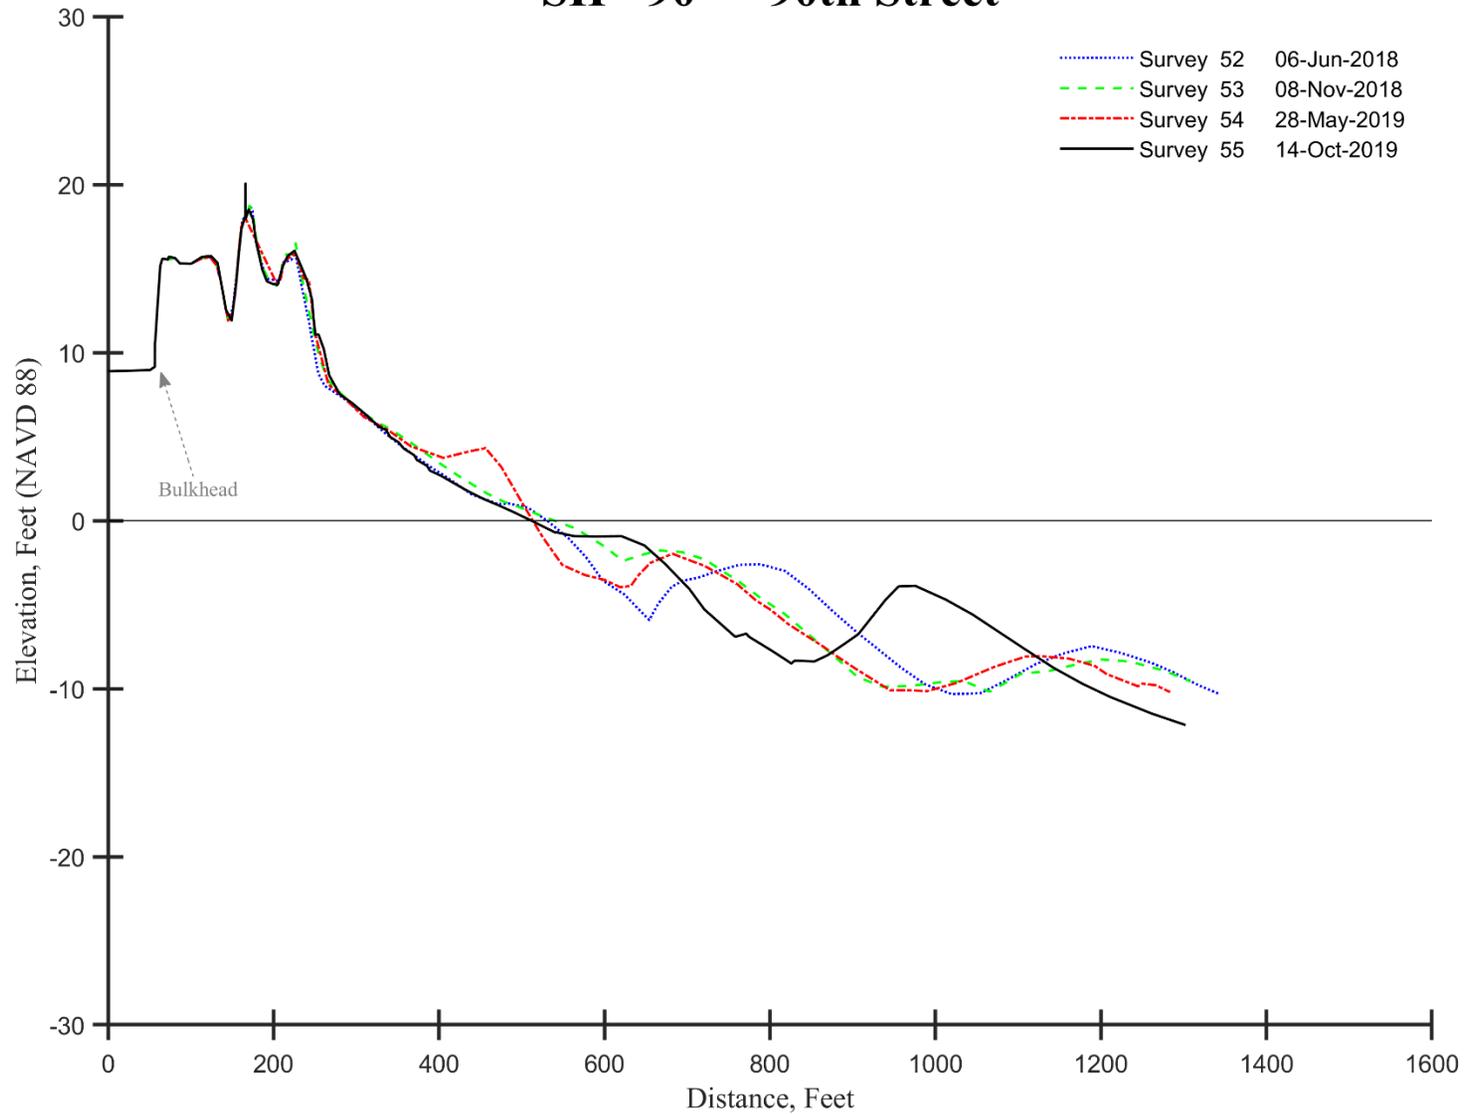
Borough of Stone Harbor - Semi-Annual Comparison SH - 90 90th Street

Figure 2d. The cross sections show minor additions to the dune and the May 2019 berm development. The beach slope returned to previous slopes by October 2019, while a very large offshore bar appeared at the 1,000-foot distance. The 18-month sand volume gain was 2.09 yds³/ft. (11.32 yds³/ft. May to October 2018) and the shoreline retreated 19 feet.

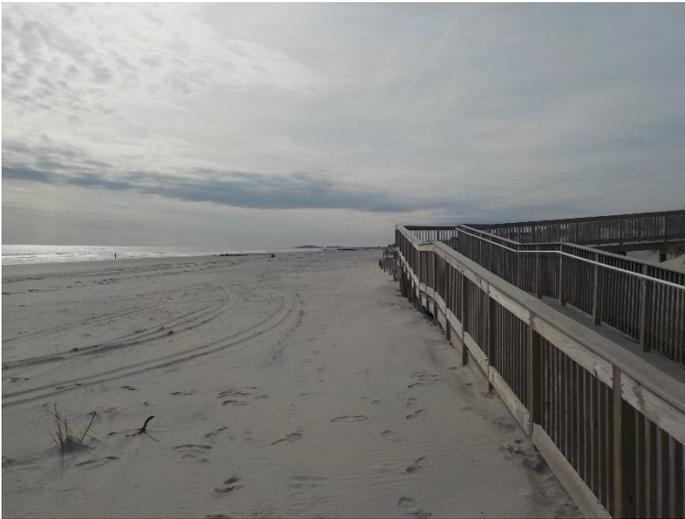
Photo 3a - Photo taken November 8, 2018 shows the dune crosswalk onto the beach looking south.

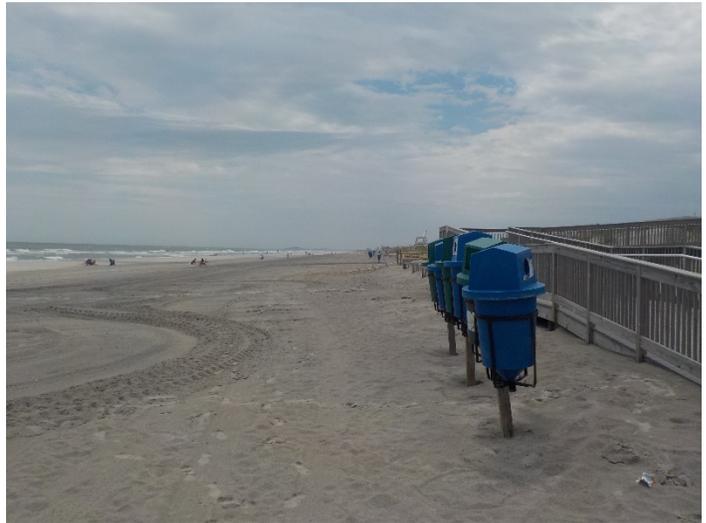
Photo 3b – The May 28, 2019 photo shows the same perspective with the seasonal trash cans installed. A sizable berm had been established at summer's start.

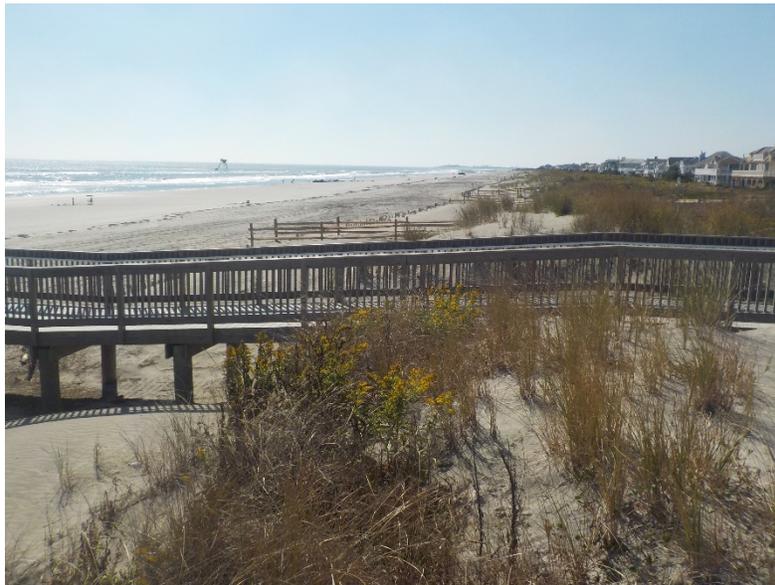
Photo 3c – The photo taken October 14, 2019 shows a height over the access walkway that includes the dune and the beach to the south.

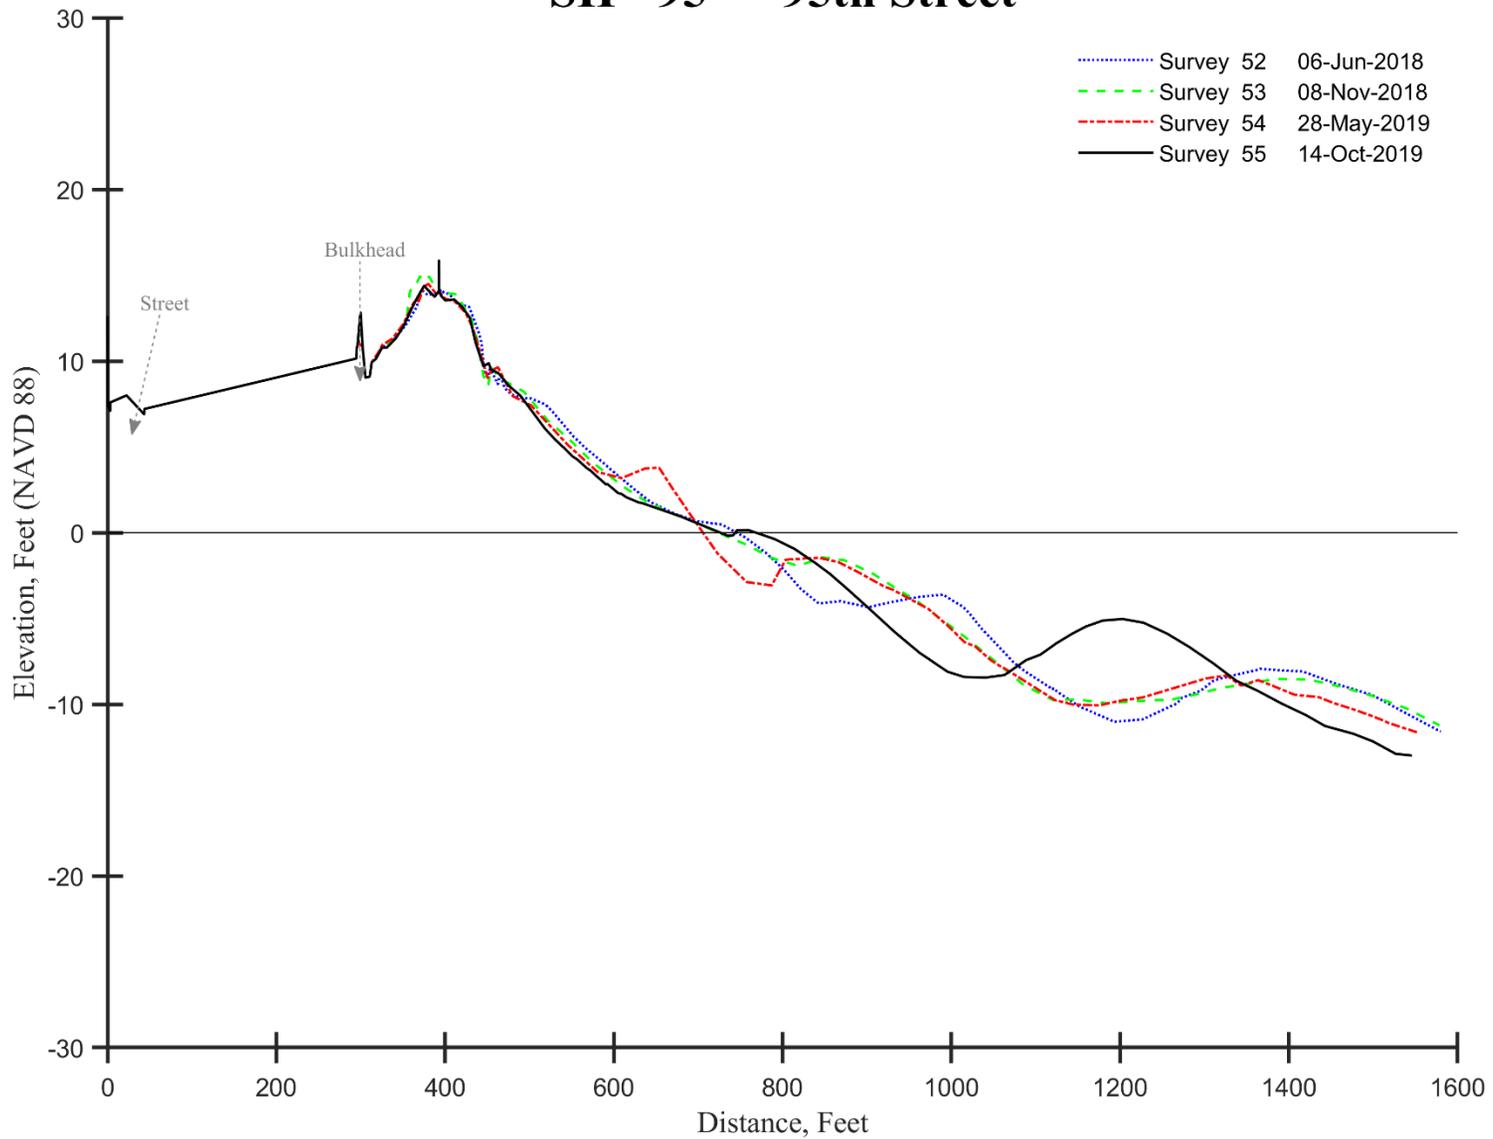
Borough of Stone Harbor - Semi-Annual Comparison SH - 95 95th Street

Figure 3d. The dunes and upper beach area saw little change in the past 18 months, but the same berm growth by May 2019 followed by its removal by October 2019 and the appearance of a very large offshore bar at the 1,200-foot distance required attention as to its cause. The site lost 0.44 yds³/ft. since May 2018 accompanied by a 23-foot shoreline advance.

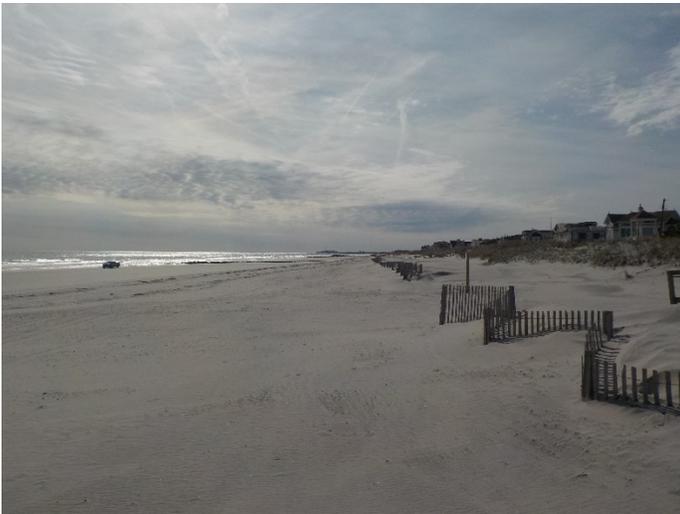
Photoplate 4a - Photo taken November 8, 2018 showing sand fencing partially buried and a fairly wide beach.

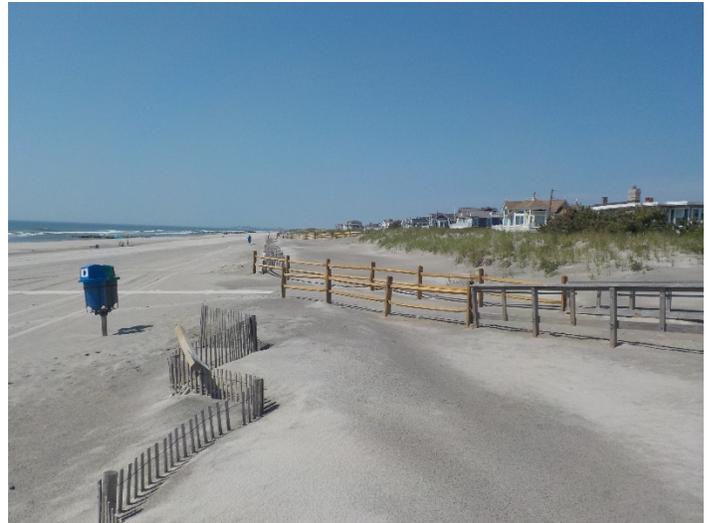
Photoplate 4b - Photo taken May 29, 2019 shows the added pedestrian walkway fence and the dune toe looking south.

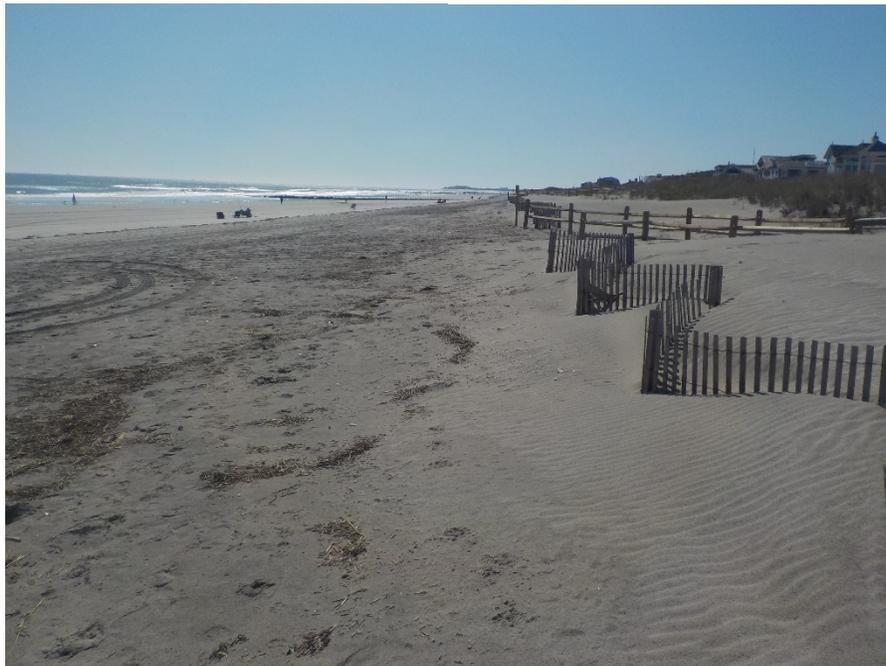
Photoplate 4c – Photo taken October 14, 2019 showing sand continuing to fill the 4-foot high snow fencing creating a new foredune. The beach width was sufficient to provide the supply.

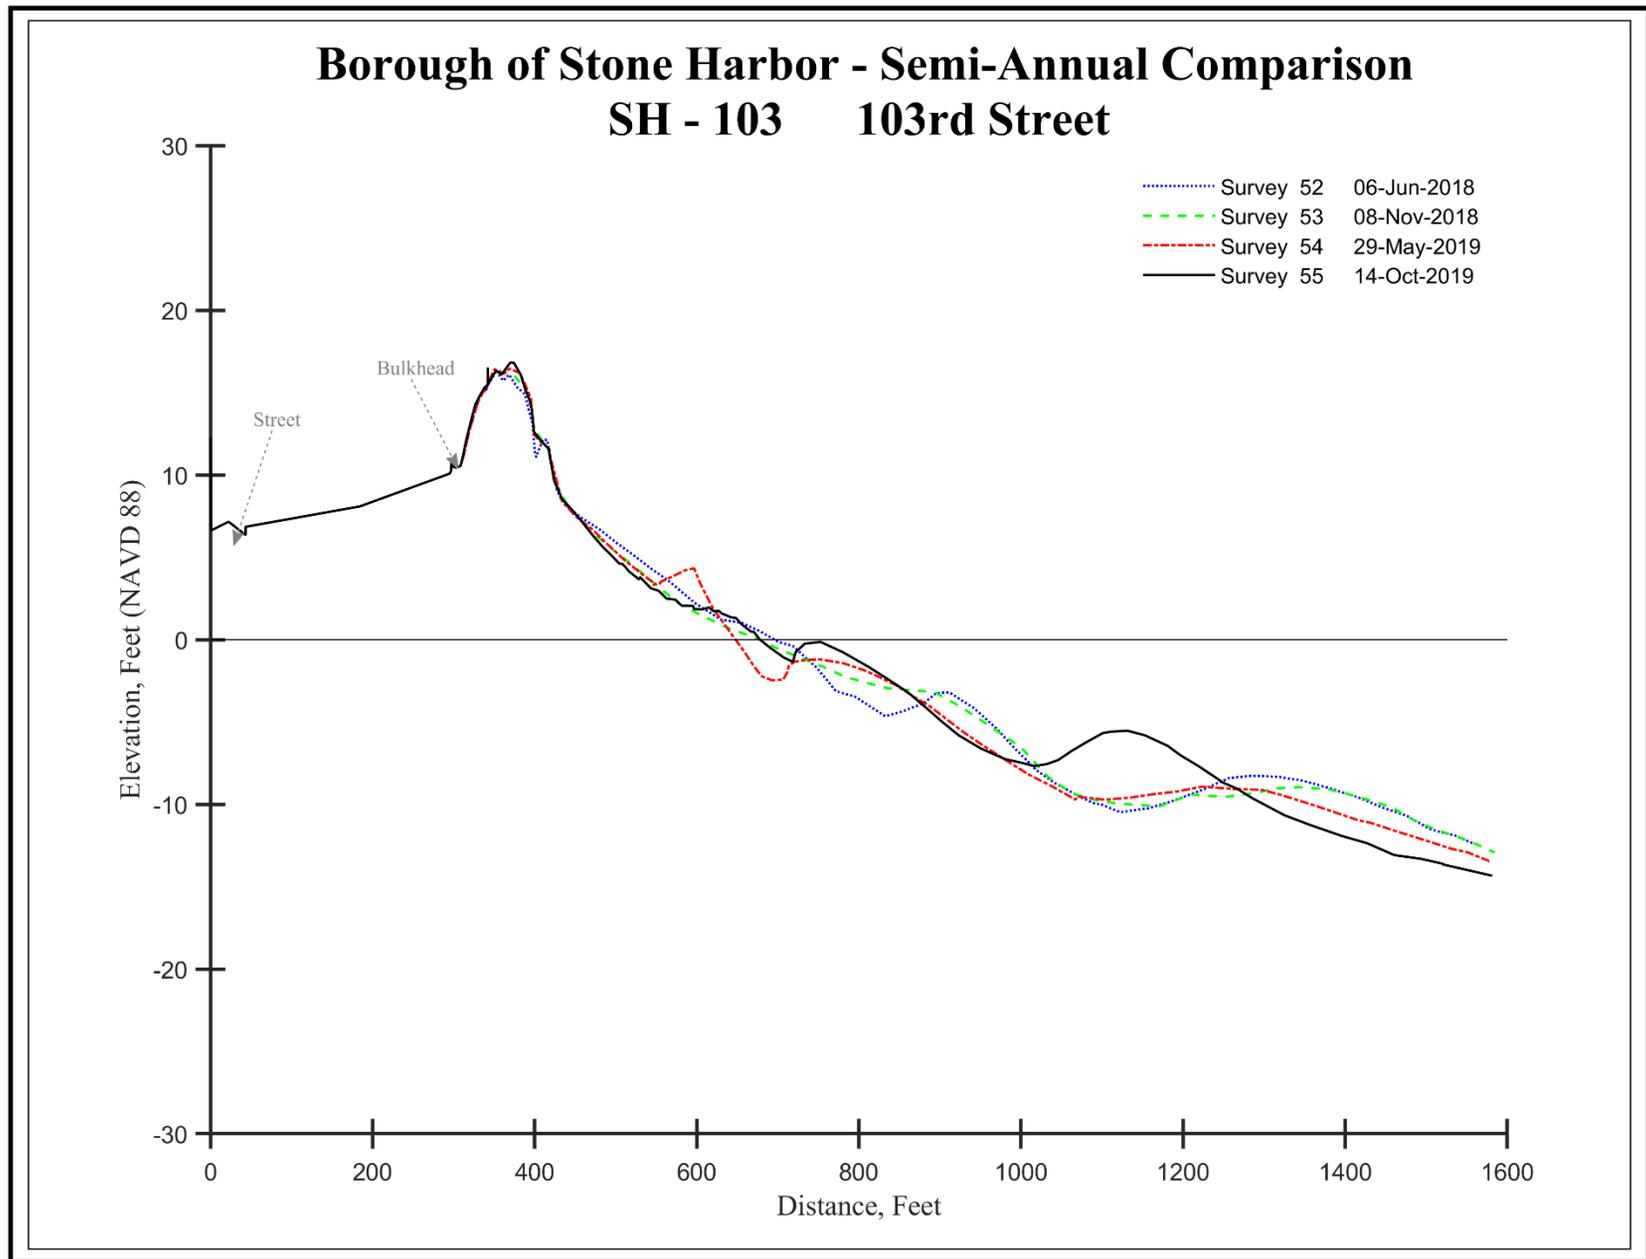
Figure 4d. The cross sections at 103rd Street show the same pattern of berm development by May 2019 followed by its erosion by October 2019. There was a nearshore bar about to attach to the beachface in October as well. The same pattern of a large offshore bar appearing added sand to that part of the system. The net change was a loss of 1.02 yds³/ft. over the past 18 months accompanied by an 18-foot shoreline retreat. The site did gain 11.89 yds³/ft. and a 30-foot shoreline advance May to October 2019.

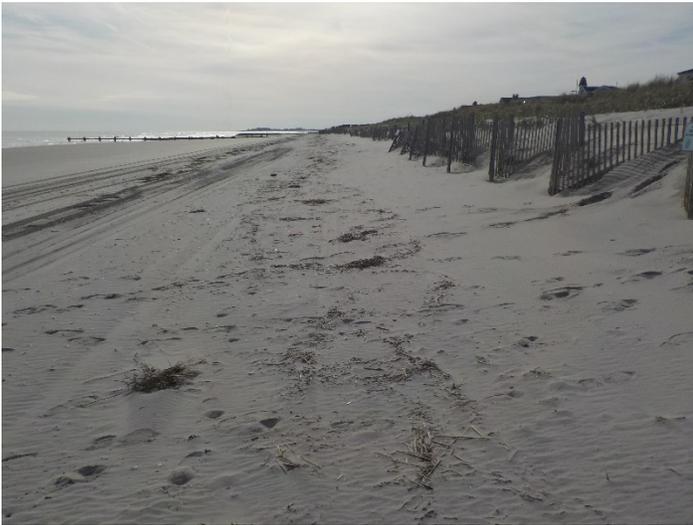
Photoplate 5a – The November 8, 2018 photo shows the proximity of the high tide to the dunes on a narrow beach.

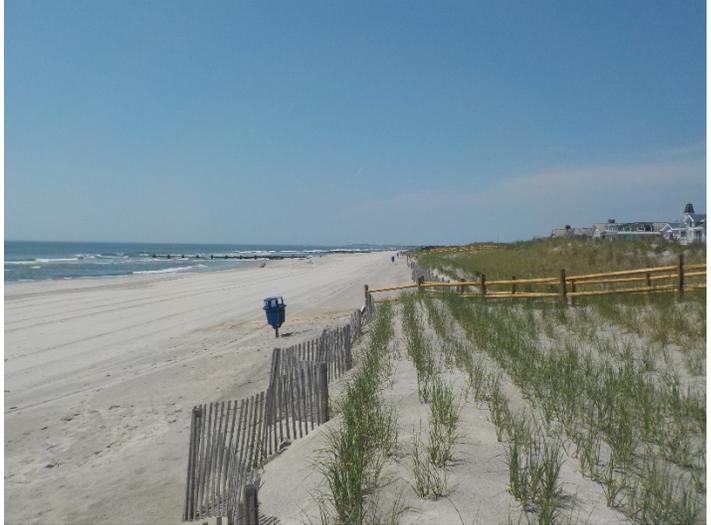
Photoplate 5b – The photo taken May 29, 2019 shows new dune plants within the accumulation of sand at the newest fence line. The summer berm has created a wider beach.

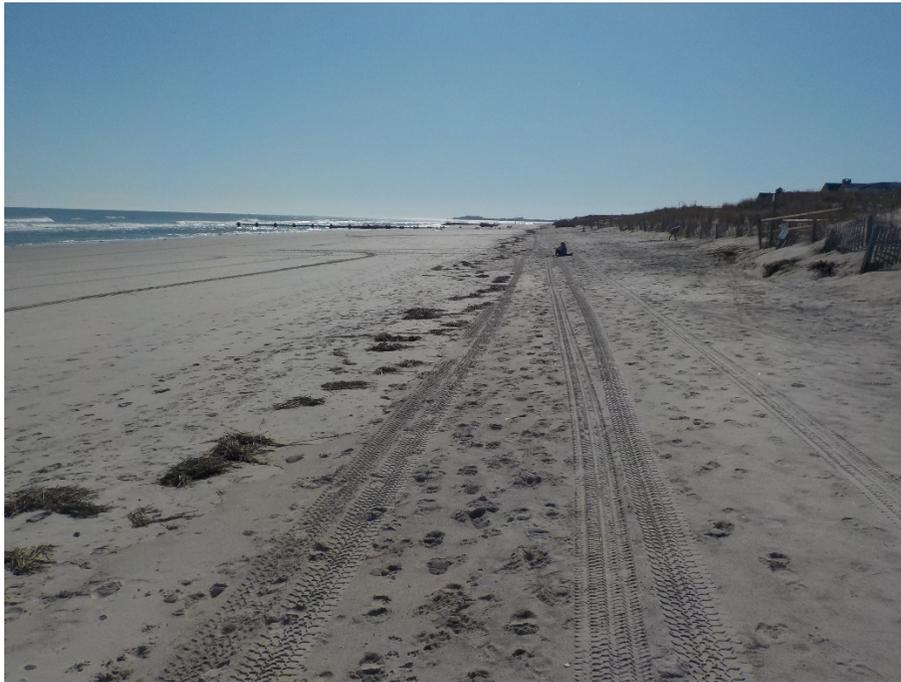
Photoplate 5c – Photo taken October 14, 2019 shows the wet-dry line on the beach about 30 feet from the dune toe following the erosion of the summer berm. Waves can be seen breaking on the bar just offshore.

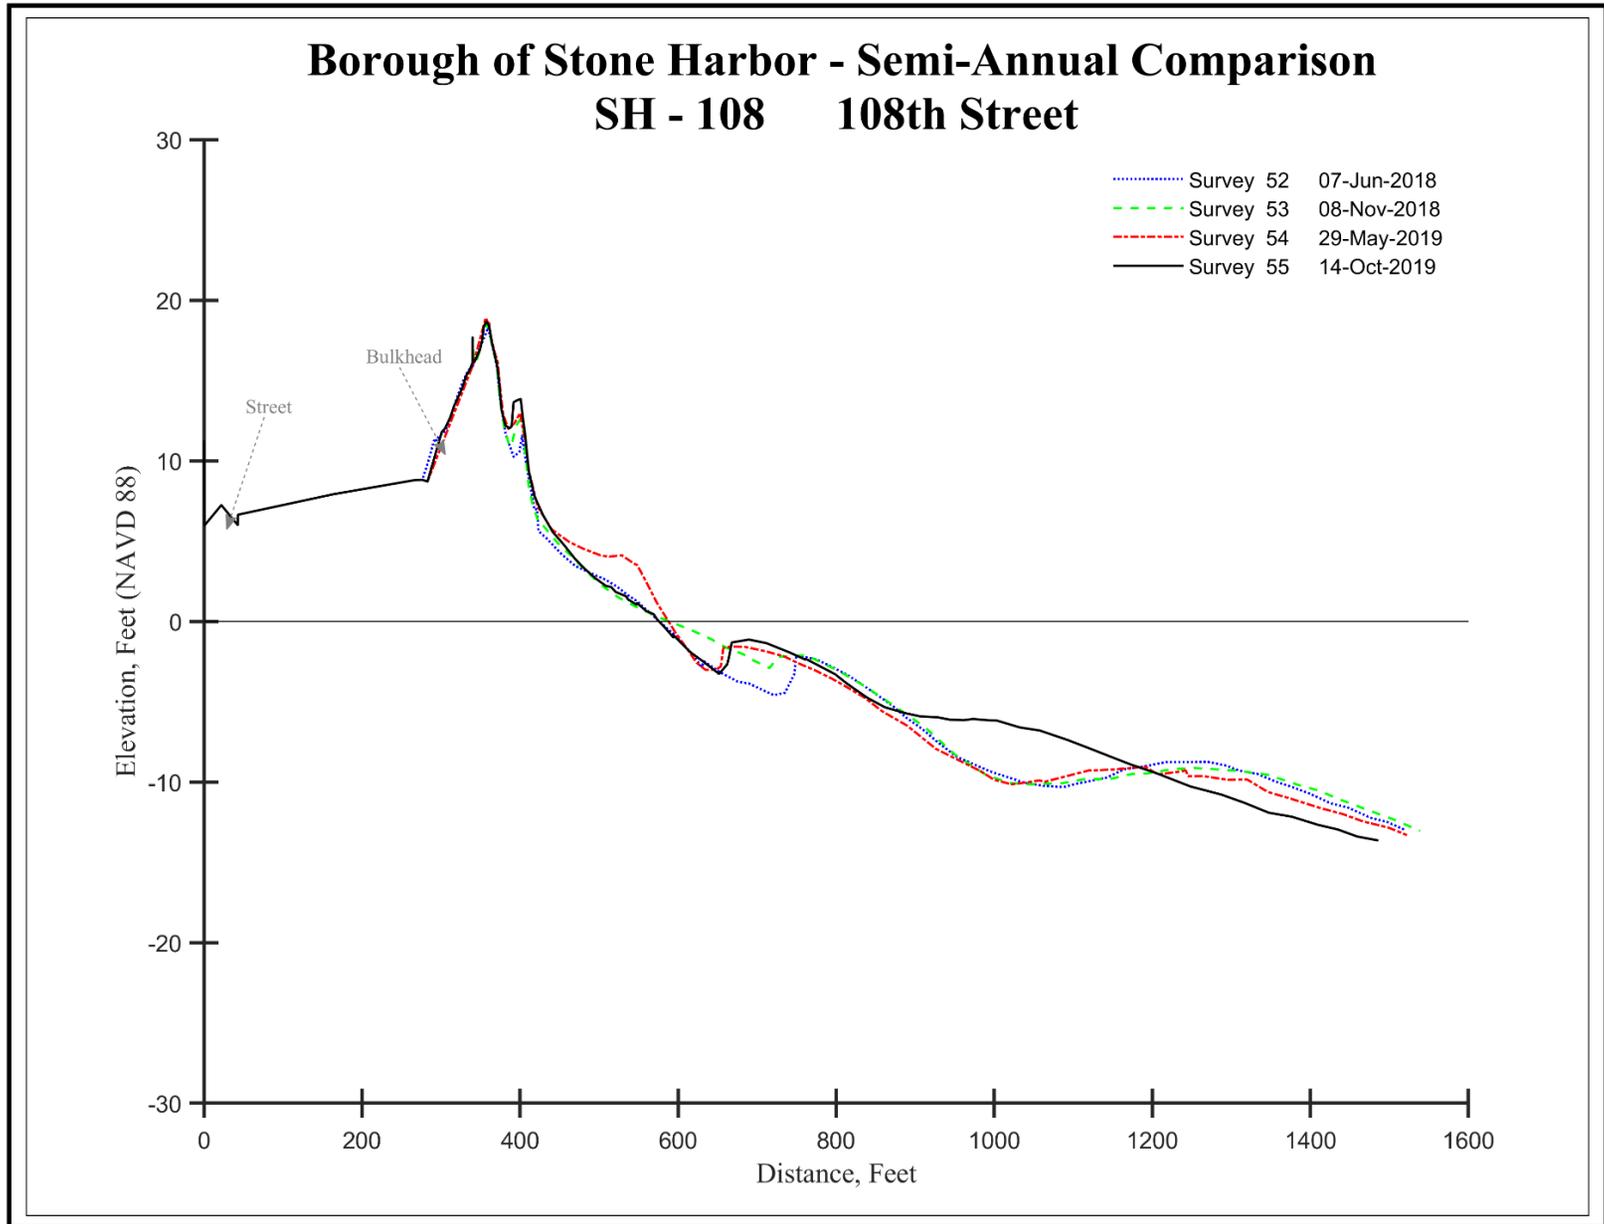
Figure 5d. The cross sections show dune development at the seaward fencing creating a new foredune. The May 2019 berm was quite pronounced along with multiple occasions where nearshore bars attached to the beach. Sand filled a trough offshore without generating a pronounced bar system here. The site gained 15.96 yds³/ft. with no change in the shoreline position over 18 months.

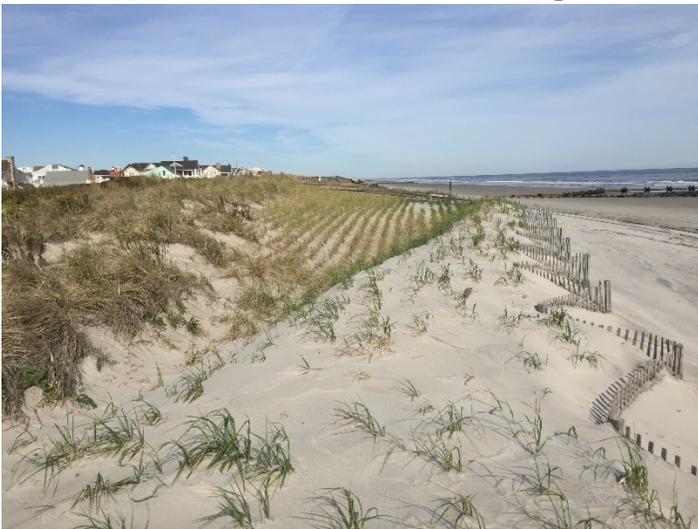
Photoplate 6a – The November 8, 2018 photo shows the accreting foredune with new natural plants springing up seaward of the rows of plants added in 2017.

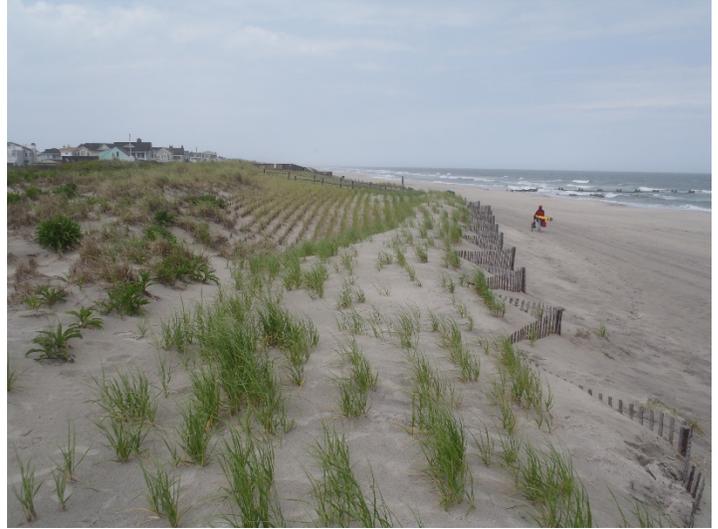
Photoplate 6b - Photo taken May 28, 2019 a year after the rows of new plants were added and after the fence captured abundant wind transported sand as a foredune.

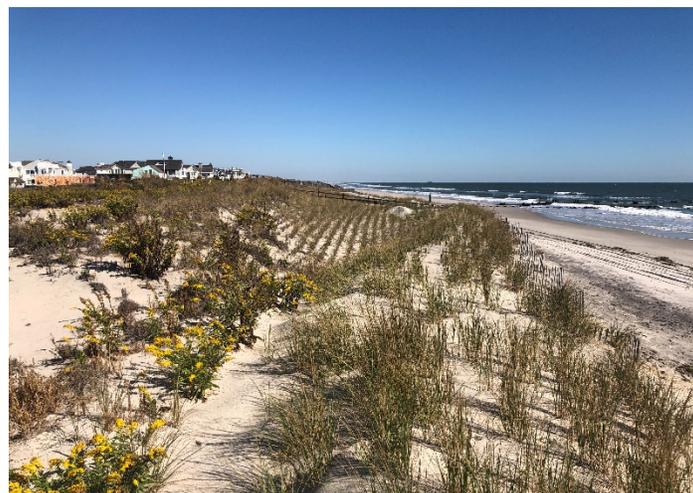
Photoplate 6c – Photo taken October 15, 2019 overlooking the accreting foredune encroaching onto the planted project dune slope with its neat rows of grass established. The fencing is buried with new sand from the beach that is colonized quite densely. The beach is quite narrow after early storms.

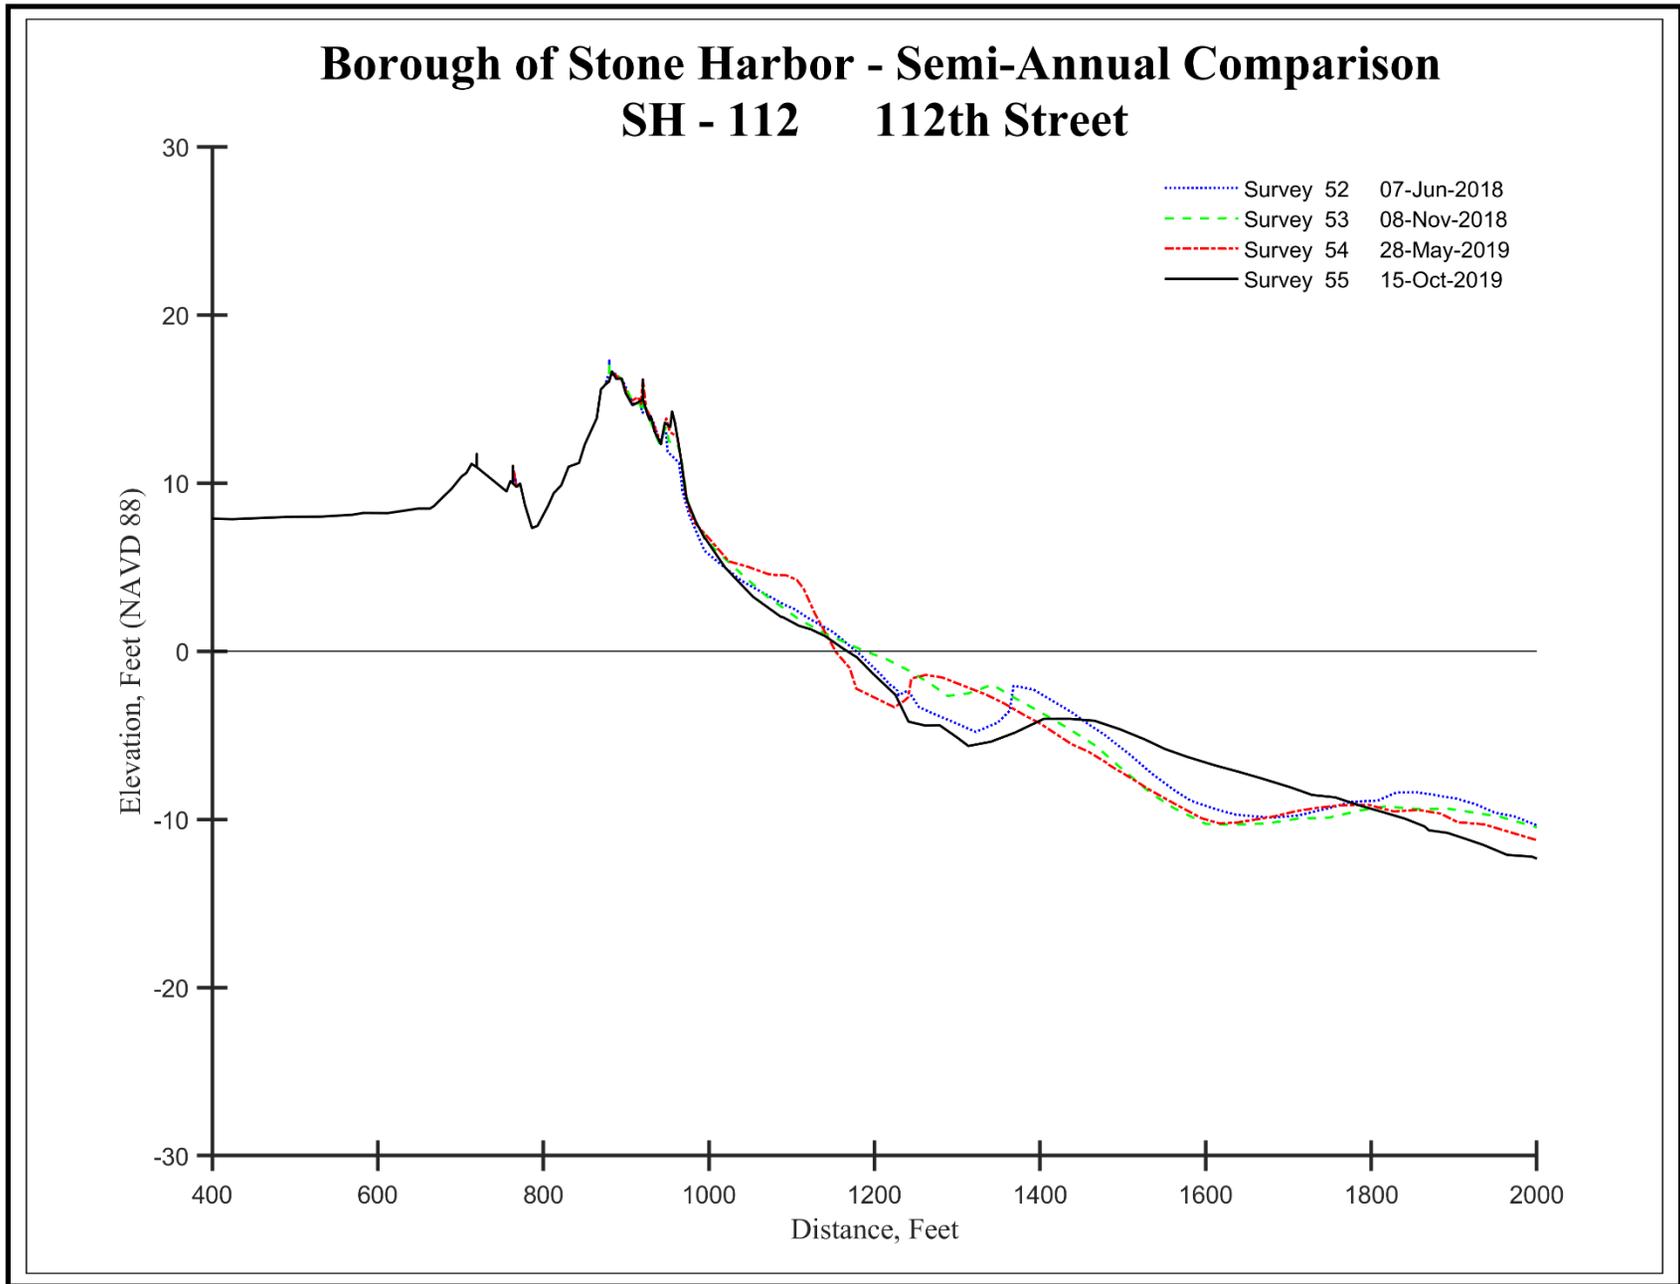
Figure 6d. The profiles at 112th Street lost the most sand over the past 18 months (-15.25 yds³/ft. and the shoreline retreated 11 feet). The May to October 2019 time interval produced a small decline in sand volume (-2.61 yds³/ft. with a 14-foot shoreline advance).

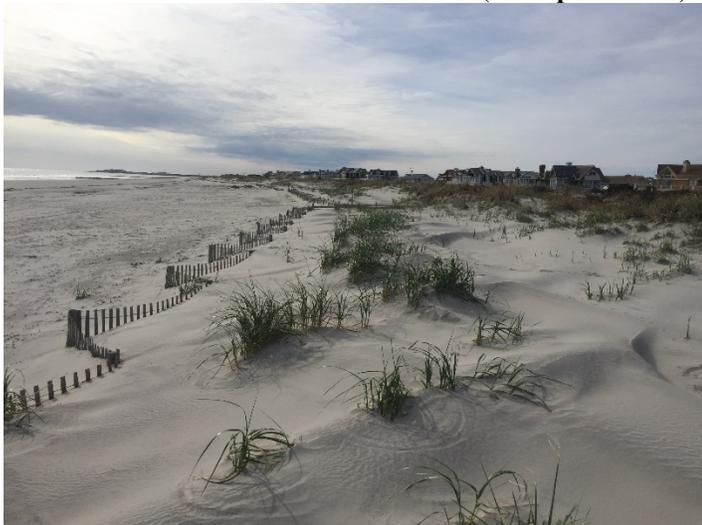
Photoplate 7a - Photo taken November 8, 2018 shows a well-established dune with material adding to the fencing.

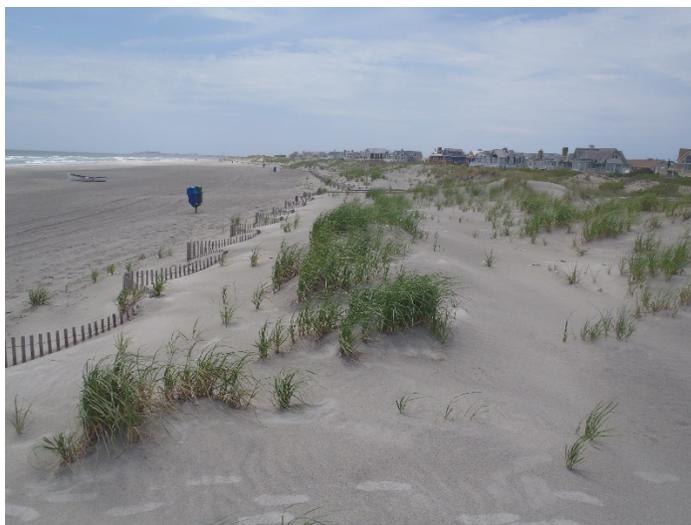
Photoplate 7b – Photo taken May 28, 2019 showing continued sand deposition around the fencing and a wide beach seaward .
