**2019 ANNUAL REPORT ON
THE CONDITION OF THE MUNICIPAL BEACHES FOR
THE BOROUGH OF STONE HARBOR, CAPE MAY COUNTY, NEW JERSEY**

**PREPARED FOR: THE BOROUGH OF STONE HARBOR
9508 SECOND AVENUE
STONE HARBOR, NJ 08247**

**PREPARED BY: THE STOCKTON UNIVERSITY COASTAL RESEARCH CENTER
30 WILSON AVENUE
PORT REPUBLIC, NEW JERSEY 08241**

March 10, 2020

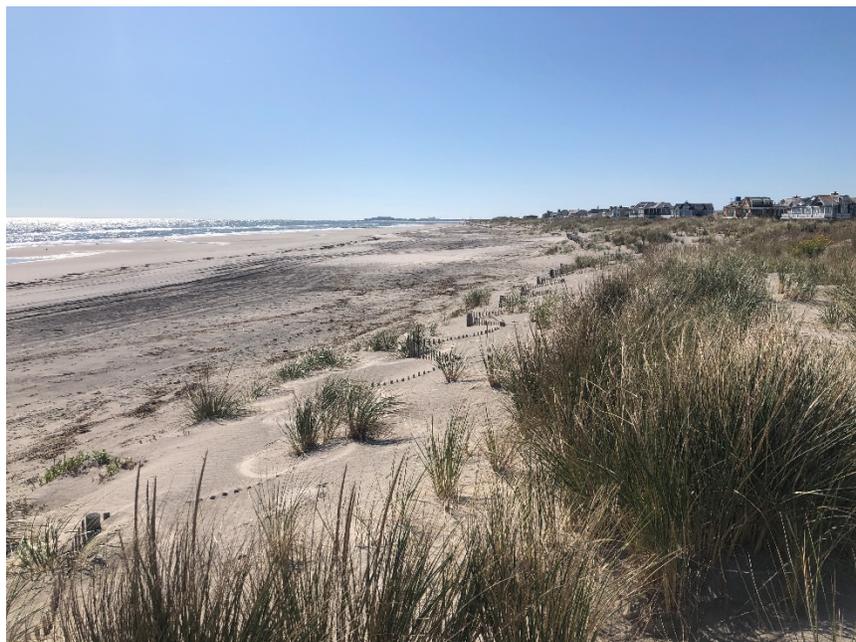
Photoplate 7c – Photo taken October 15, 2019 finds the fencing placed in 2017 completely buried and luxuriant dune grass growing across the feature created since the fence was built.

- The zigzag pattern of the installed fence captured wind-blown sand allowing the dune toe to move seaward. Fence installation should follow recommendations given in past CRC reports and from the NJ Dept. of Environmental Protection, Div. of Coastal Engineering and Div. of Land Use Regulation.
- The Borough needs to maintain pressure on the US Army to act forcefully and in concert with the City of North Wildwood and the Borough of Avalon to seek the complete restoration of Federal agencies' ability to access the Hereford Inlet borrow zone for major shore protection projects. Secretary Bernhardt provided a letter of interpretation accepting the use of CBRA material for adjacent municipal beach restoration utilizing best beach nourishment practices. He may not hold office beyond the next election and a new Interior Secretary may view CBRA sand extraction differently.

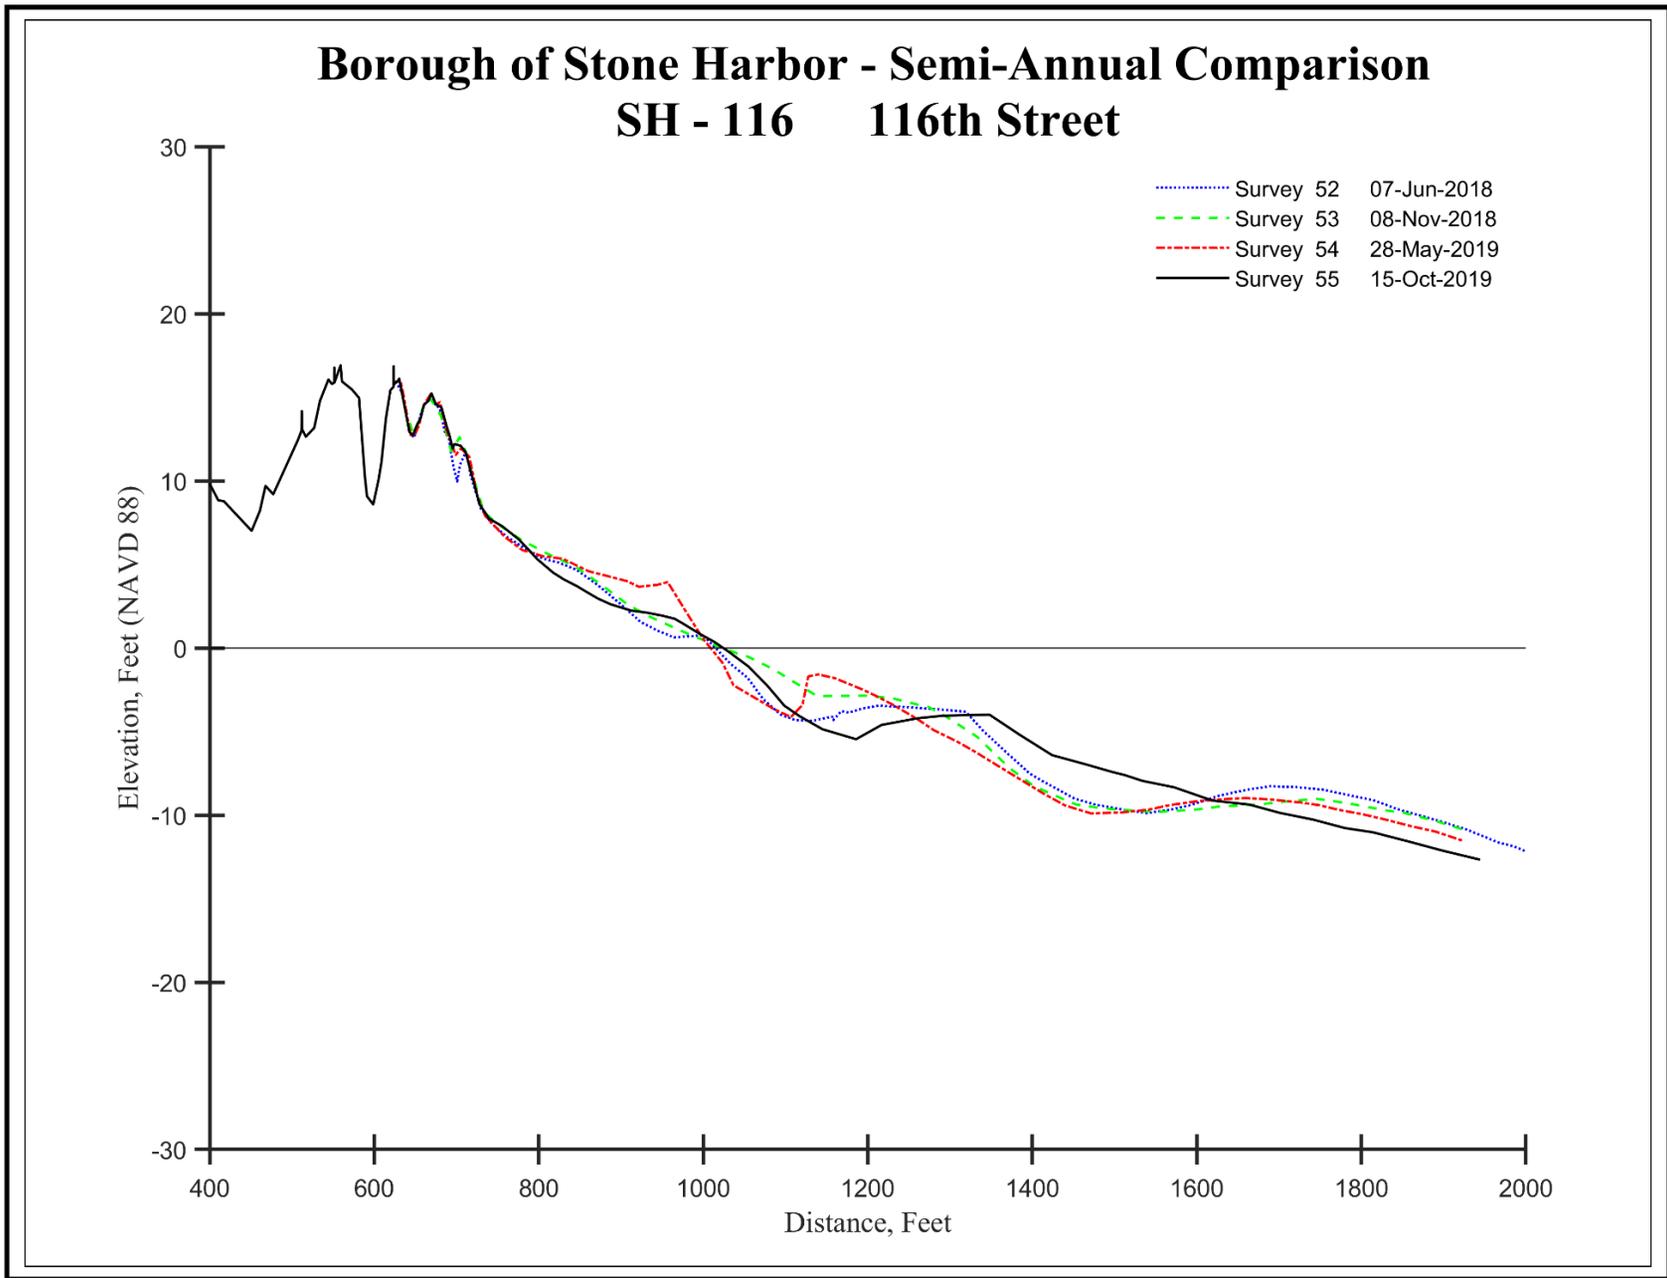
Figure 7d. The 116th Street location includes a double dune system which appears to have developed a new foredune peak adding to the dune volume. The beach produced a berm by May 2019 which was derived from the attachment of nearshore bars during the summer. This site lost 3.17 yds³/ft. over the past 18 months as the shoreline advanced 10 feet seaward.

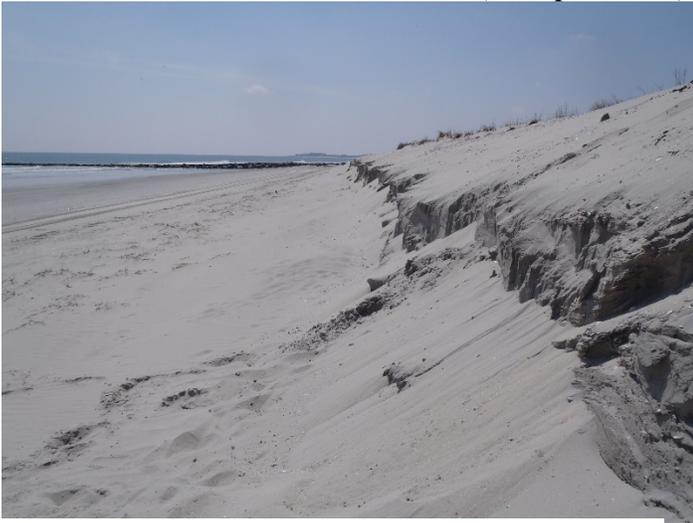
Photoplate 8a - Photo November 8, 2018 with the storm damage to the dune still evident. Storm high tide waves can easily reach the dune toe along this reach.

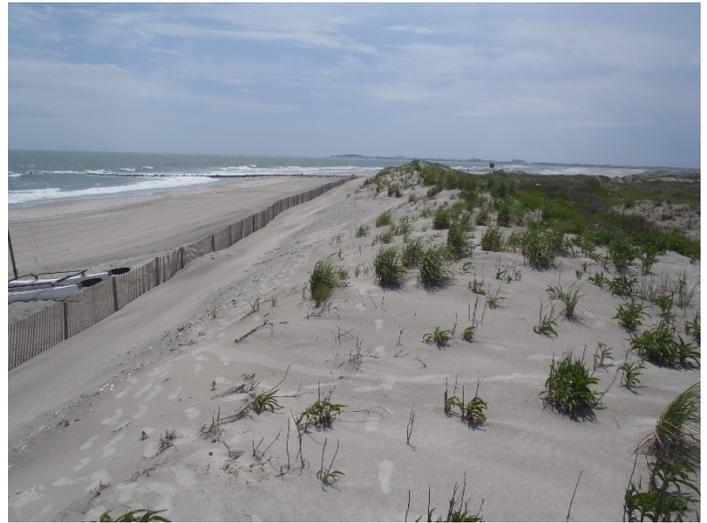
Photoplate 8b – Photo taken May 29, 2019 after sand reformed a berm at the dune toe and fencing was reinstalled.

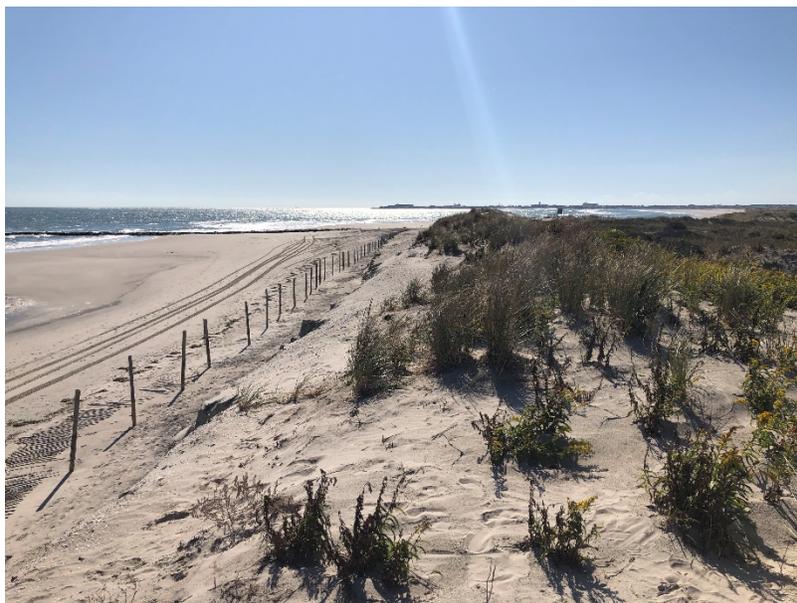
Photoplate 8c – The photo taken October 15, 2019 following another episode of dune toe erosion generating a 4-foot scarp in the toe. The sand supply is not sufficient to maintain even a minor storm proof dune.

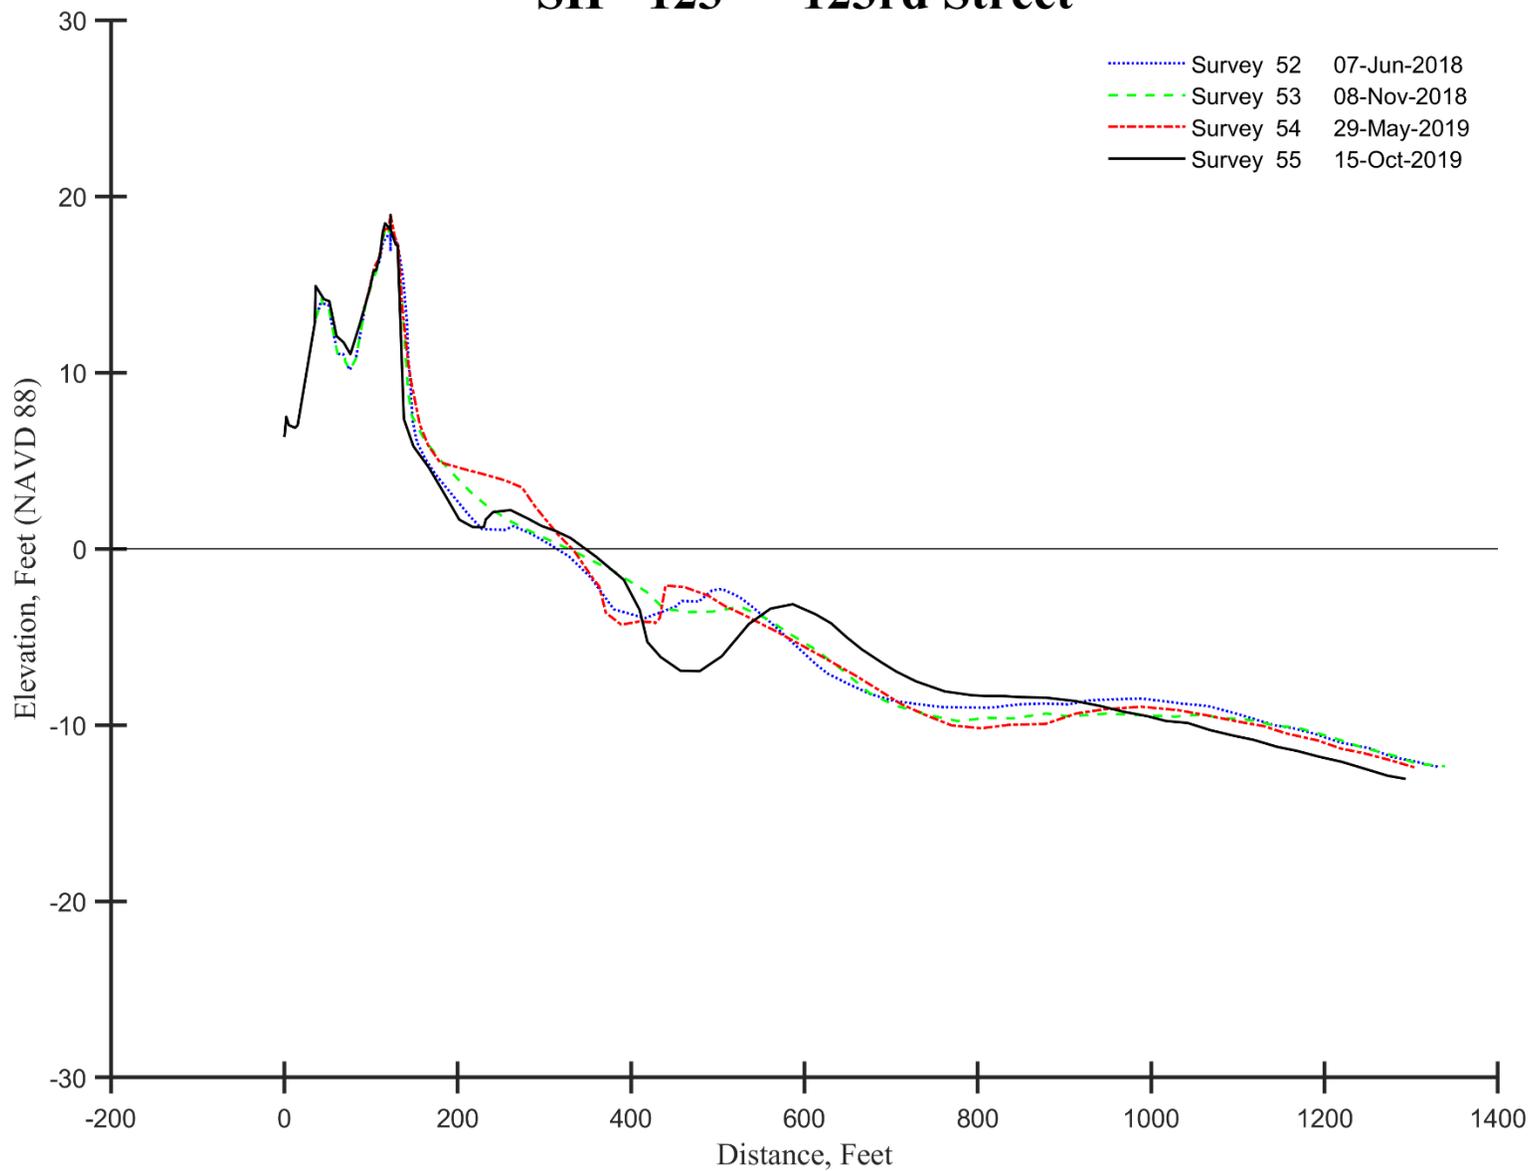
Borough of Stone Harbor - Semi-Annual Comparison SH - 123 123rd Street

Figure 8d. 123rd Street saw nearshore bar accretion producing a decent beach berm by May 2019. Early storm events removed it and cut into the dune toe. The site lost 5.60 yds³/ft. over the past 18 months, but the shoreline advanced 15 feet seaward because of the October bar attachment. Offshore, a larger bar system appeared as well.

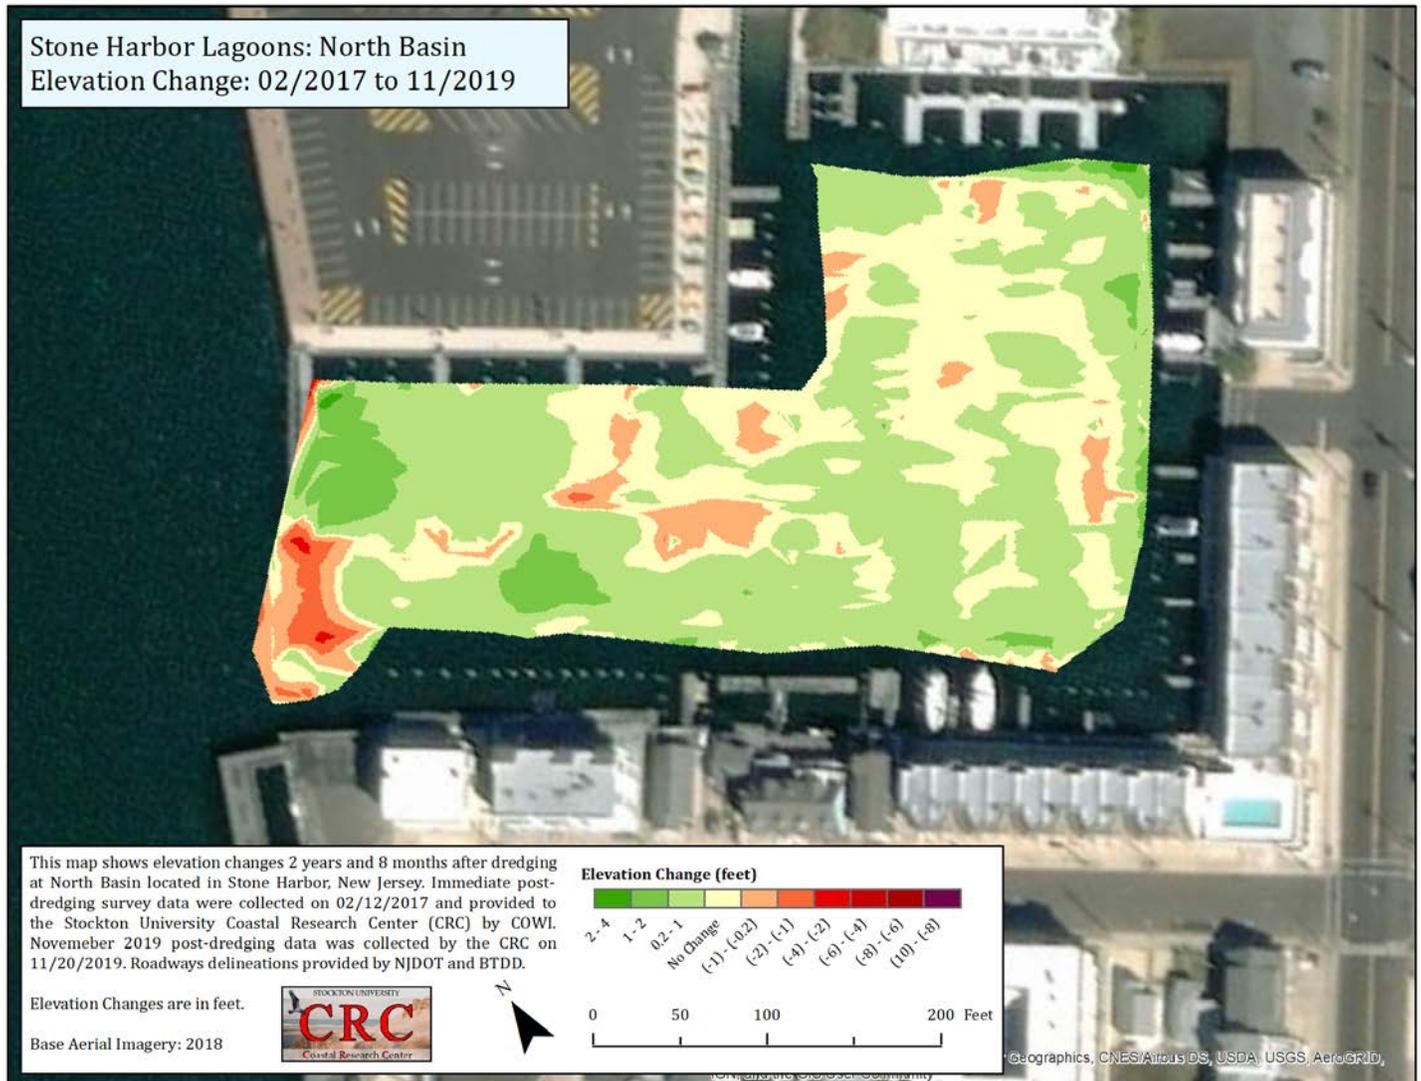
Figure 9a. This basin remains at or slightly shallower than it was immediately after dredging was complete. The entrance area is between 0.2 and 2.0 feet deeper in a narrow zone right at the point where tidal water enters the lagoon. The inner basin remains with about half the area as dredged and half about 0.2 to 1.0 feet shallower. There were a number of spots where the depths were 0.2 to 1.0 feet deeper than immediately after dredging.

1. Sediment has eroded at the immediate points of entrance to most of the lagoons as a series of, or a single band of greater depths. The greatest depth increase was found to be under 4.0 feet at the southern side of the entry to Stone Harbor Lagoon where Great Thorofare channel migration is approaching the developed bayside shoreline.

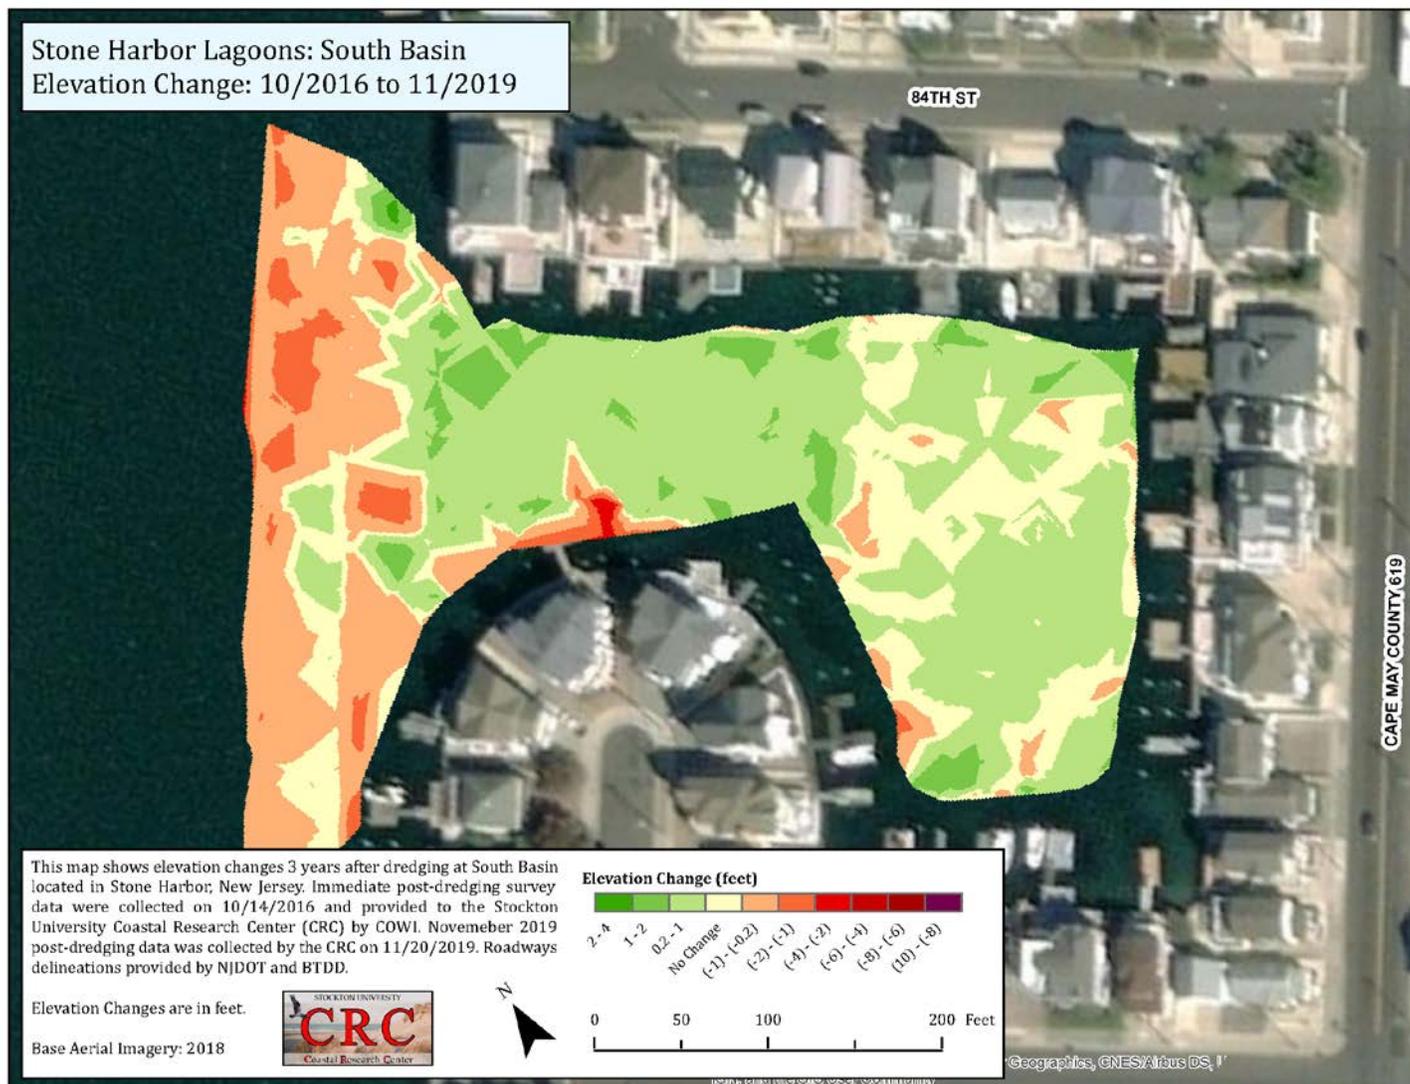
South Basin lagoon has behaved in similar fashion with deposition concentrated in the main entry channel adding as much as 2.0 feet of sediment in spots while the inner basin accumulated 0.2 to 1.0 feet of sediment across much of the area. South Basin did see greater entry point depths as a result of main Thorofare migration toward the bayshore in Stone Harbor. This is a relatively new pattern because prior to dredging, the entry points were the most impacted by accumulated sediments.

Figure 9b. South Basin has performed in similar fashion to the post-dredging changes seen in the North Basin. Between 0.2 and 1.0 feet of sedimentation since dredging has appeared over three years across the main channel and to a lesser degree, within the inner basin, while entry point erosion has created deeper water where the Great Thorofare main channel joins the navigation channel into South Basin.

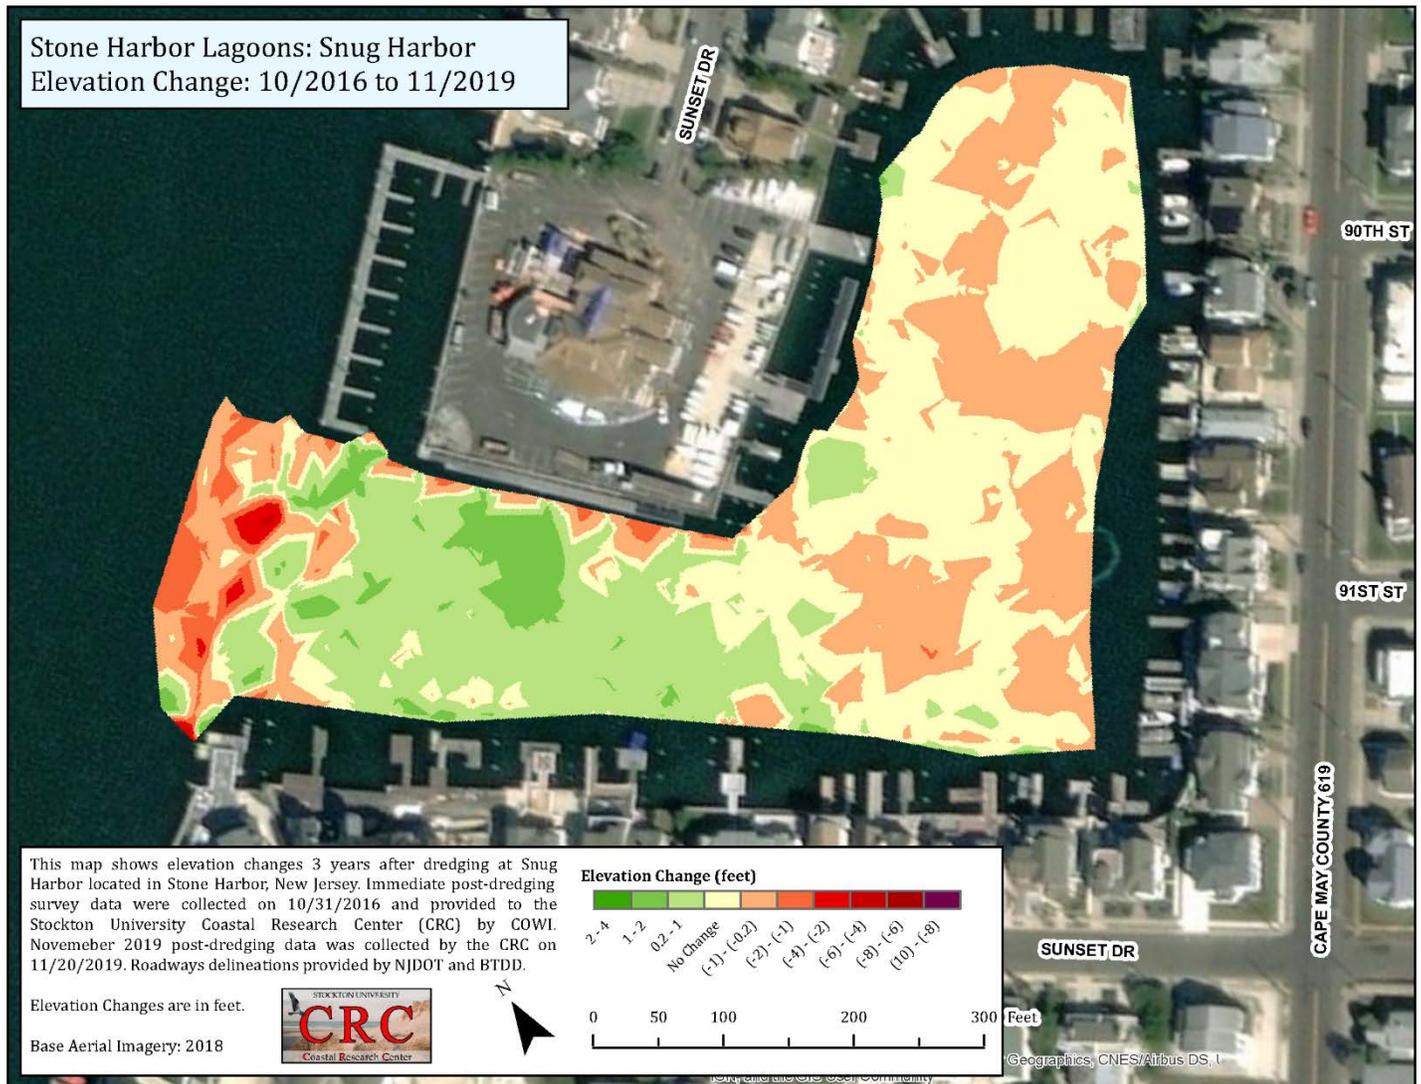
Snug Harbor shows a contrast between the inner basin where some minor deepening has occurred. The yellow color represents + or - 0.2 feet of change while the lightest green color represents between 0.2 and 1.0 feet of sediment accumulation. The entrance channel area has become between 0.2 to 1.0 feet shallower since October 2016 with a zone between 1 to 2 feet of deposition adjacent to the yacht club. At the entrance point from Great Thorofare there are multiple bands of deeper areas ranging up to 3.0 feet deeper in small patches. The eastern channel margin of Great Thorofare has been migrating closer to Stone Harbor bayside development for a couple of years, evidenced by the erosion seen right at the entry point into the lagoon basins.

Figure 10. Snug Harbor shows between zero and 1.0 feet of deepening in the inner basin, while showing 0.2 to 2.0 feet of shallower areas within the entrance channel. A complex set of bands across the entrance show areas of deeper depths with patches of shallower areas. These range from -3.0 to zero to 1.0 foot shallower. The survey covered a zone into the main channel at the yacht club.

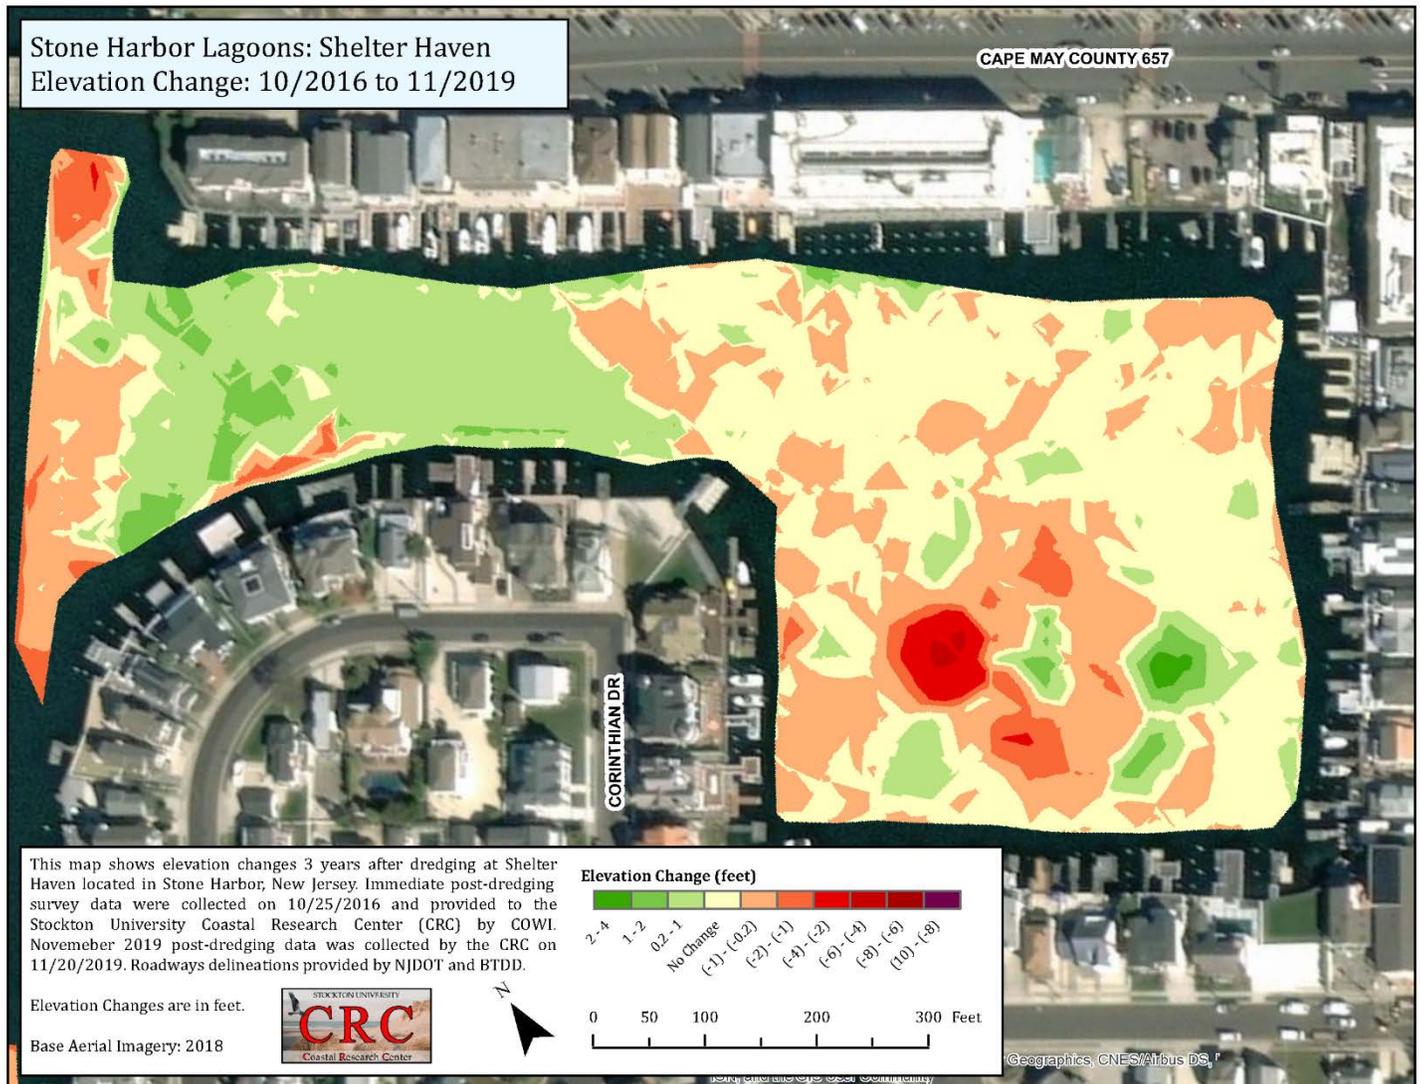
Shelter Haven compares in pattern to the two northern sites where the inner basin shows no change to a minor amount of sediment accumulation between 0.2 and 1.0 feet. The inner basin has a circular depression reaching 22 feet of depth in the southwest corner where depths have increased by between 2 and 4 feet. There were a few areas of deeper water as well. This excavation likely dates to the initial regional development when the lagoon basin was originally created. The entrance channel showed regional deposition by 0.2 to 1.0 feet with a few areas of no change, and erosion along the south channel margin. The entry point from Great Thorofare shows between 0.2 and 1.0 feet of sediment removal.

Figure 11. Shelter Haven is located just south of 96th Street and is similar in the pattern to the north where the inner basin is unchanged or marginally deeper, the entrance channel is up to a foot shallower and the entry point from Great Thorofare has seen sediment erosion at the point where the eastern Great Thorofare channel margin is met.

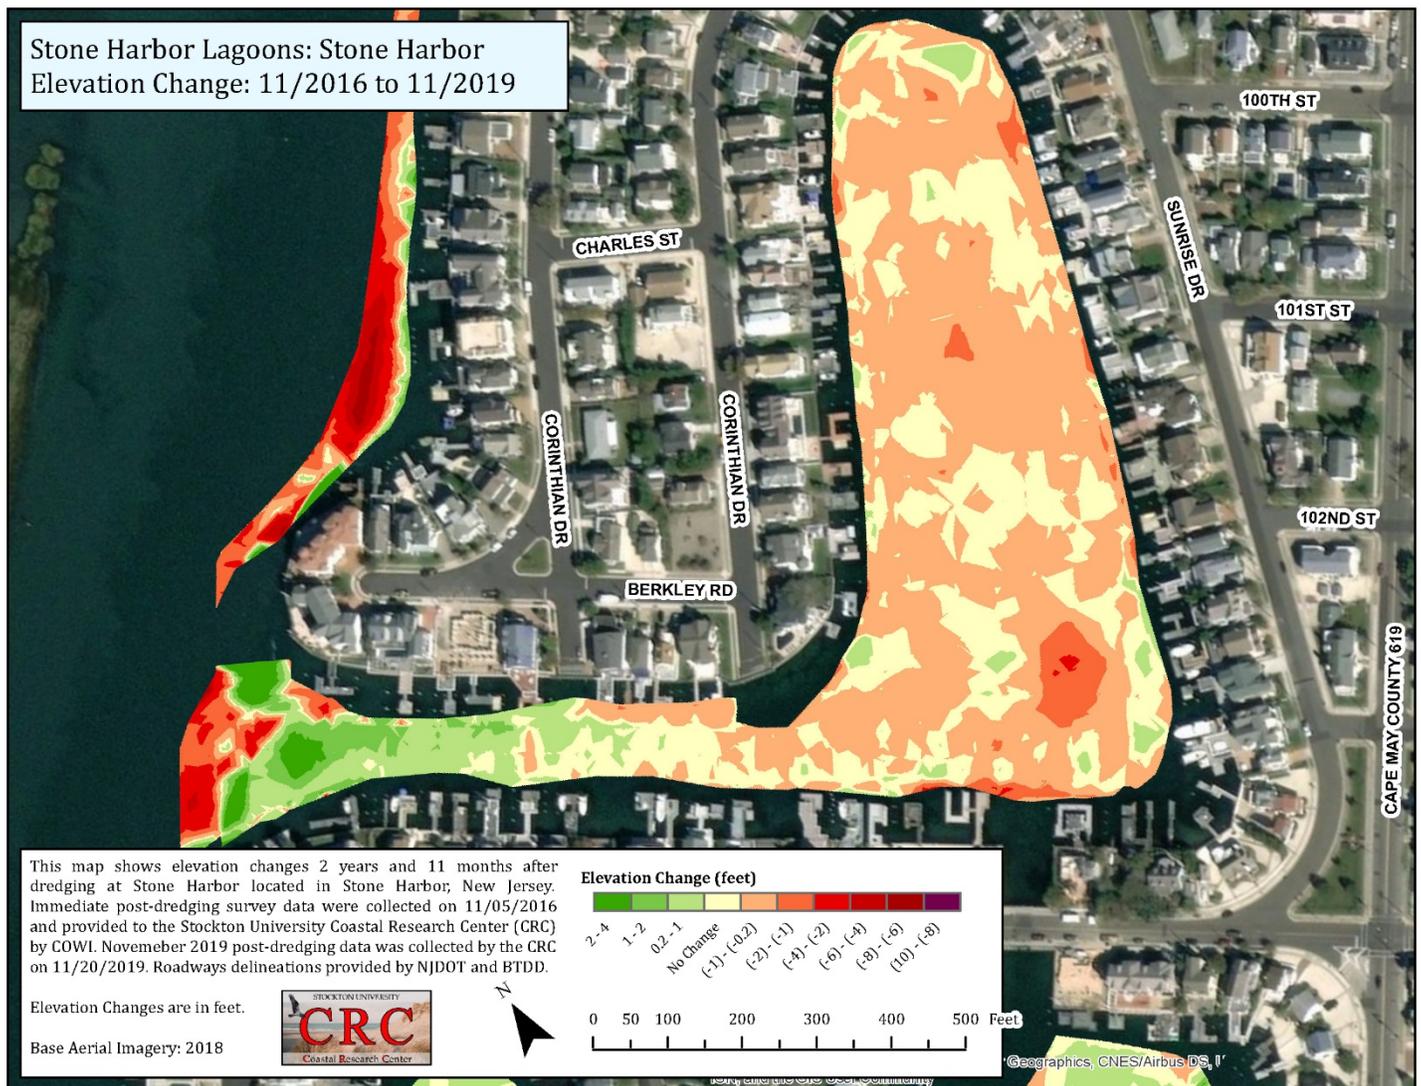
In addition, the survey conducted along the Great Thorofare east channel margin north of the entry to Stone Harbor Lagoon emphasizes the migration of the main channel toward the developed shoreline. Greater depths approaching -10 feet appear opposite the cove by Berkley Rd. and Corinthian Drive.

Figure 12. Stone Harbor Lagoon displays a consistent pattern associated with the northern basins where the inner basin has remained as dredged or become marginally deeper (-0.2 to -1.0 feet) while the entrance channel has become shallower since November 2016. Sediment erosion has impacted the entry point with up to 4 feet of lost material at the southern margin bulkhead. This erosion extends north of the entrance as well, reaching 10-foot greater water depths.

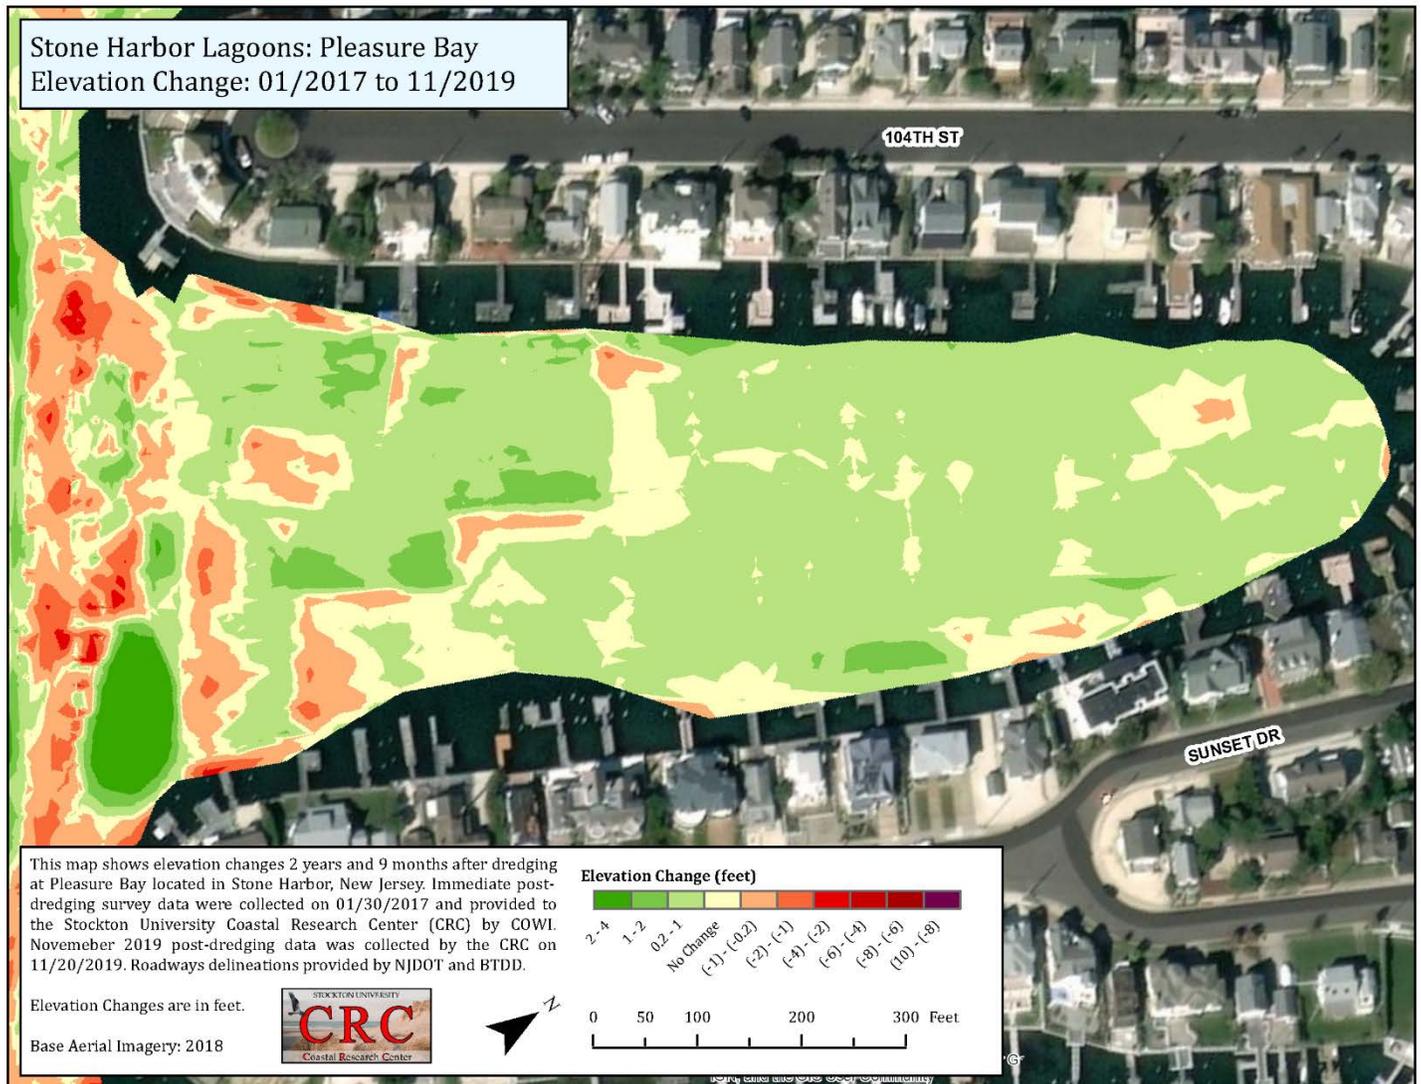
Figure 13a. Pleasure Bay is the westernmost lagoon of this pair, located south of 104th Street. This basin has become between zero and 1.0 feet shallower since March 2017. There is a scour located at the entry to Pleasure Bay that continues east to the entrance of Carnival Bay. The entry areas show spotty sediment accumulation at the entry point.

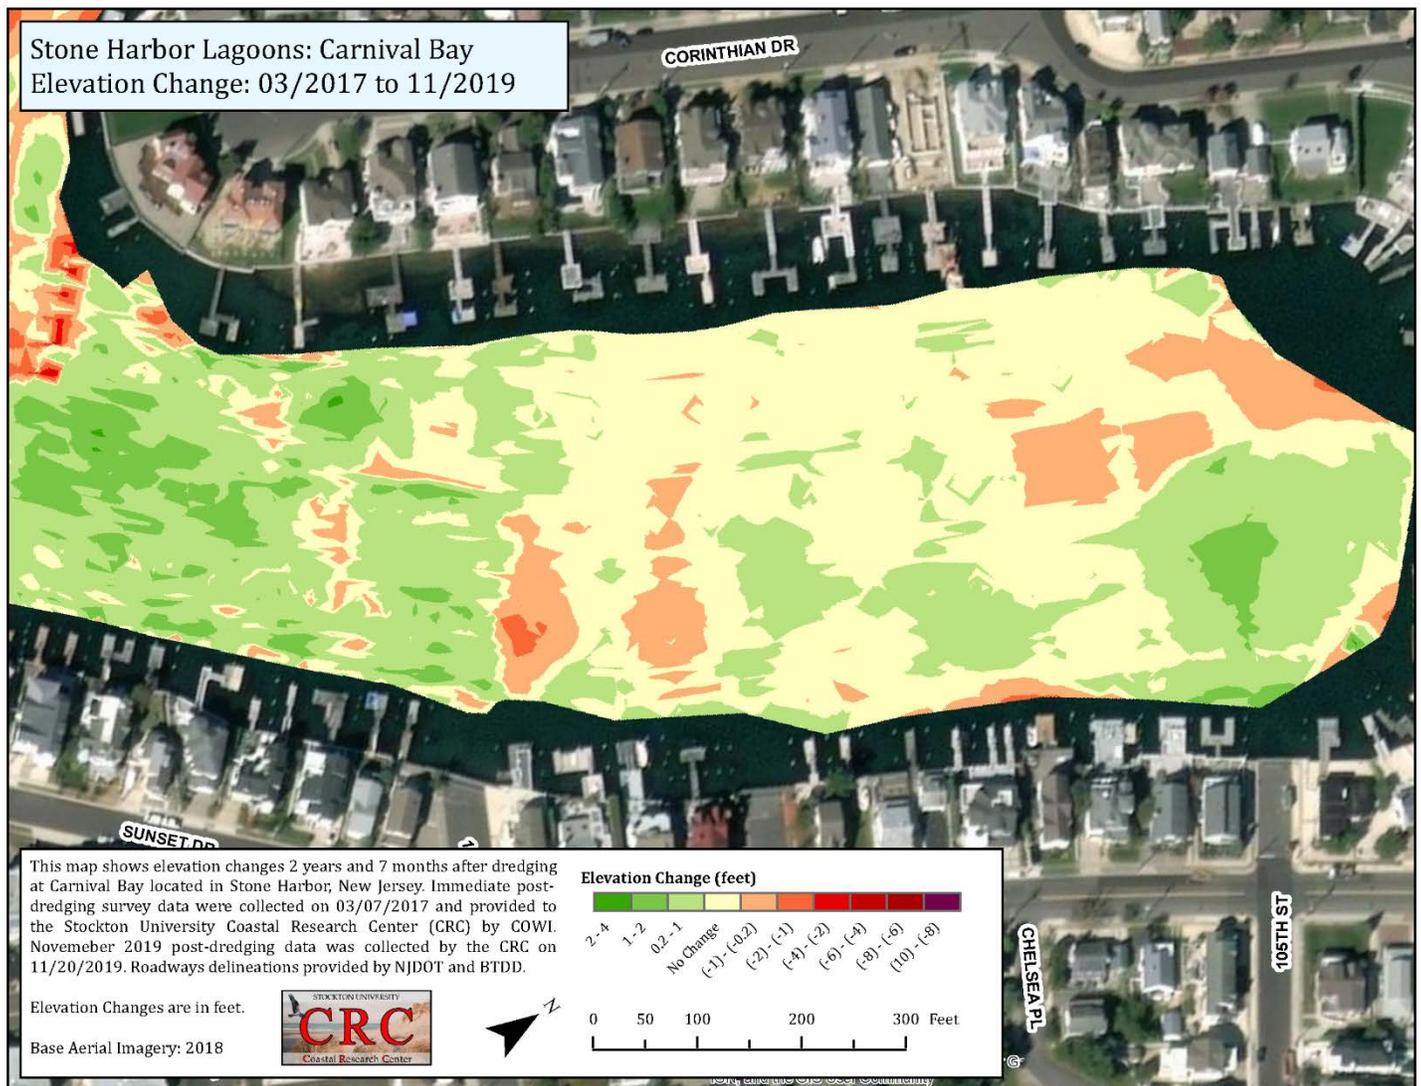
Figure 13b. Carnival Bay is east of Pleasure Bay and conforms to the same general configuration, but east of Corinthian Drive. The southern third is shallower while the remainder of the basin shows either no change or a pattern of zones of accretion and deepening. This area is at a maximum distance from the sediment source carried by incoming tidal flow, so receives smaller quantities of suspended sediment.

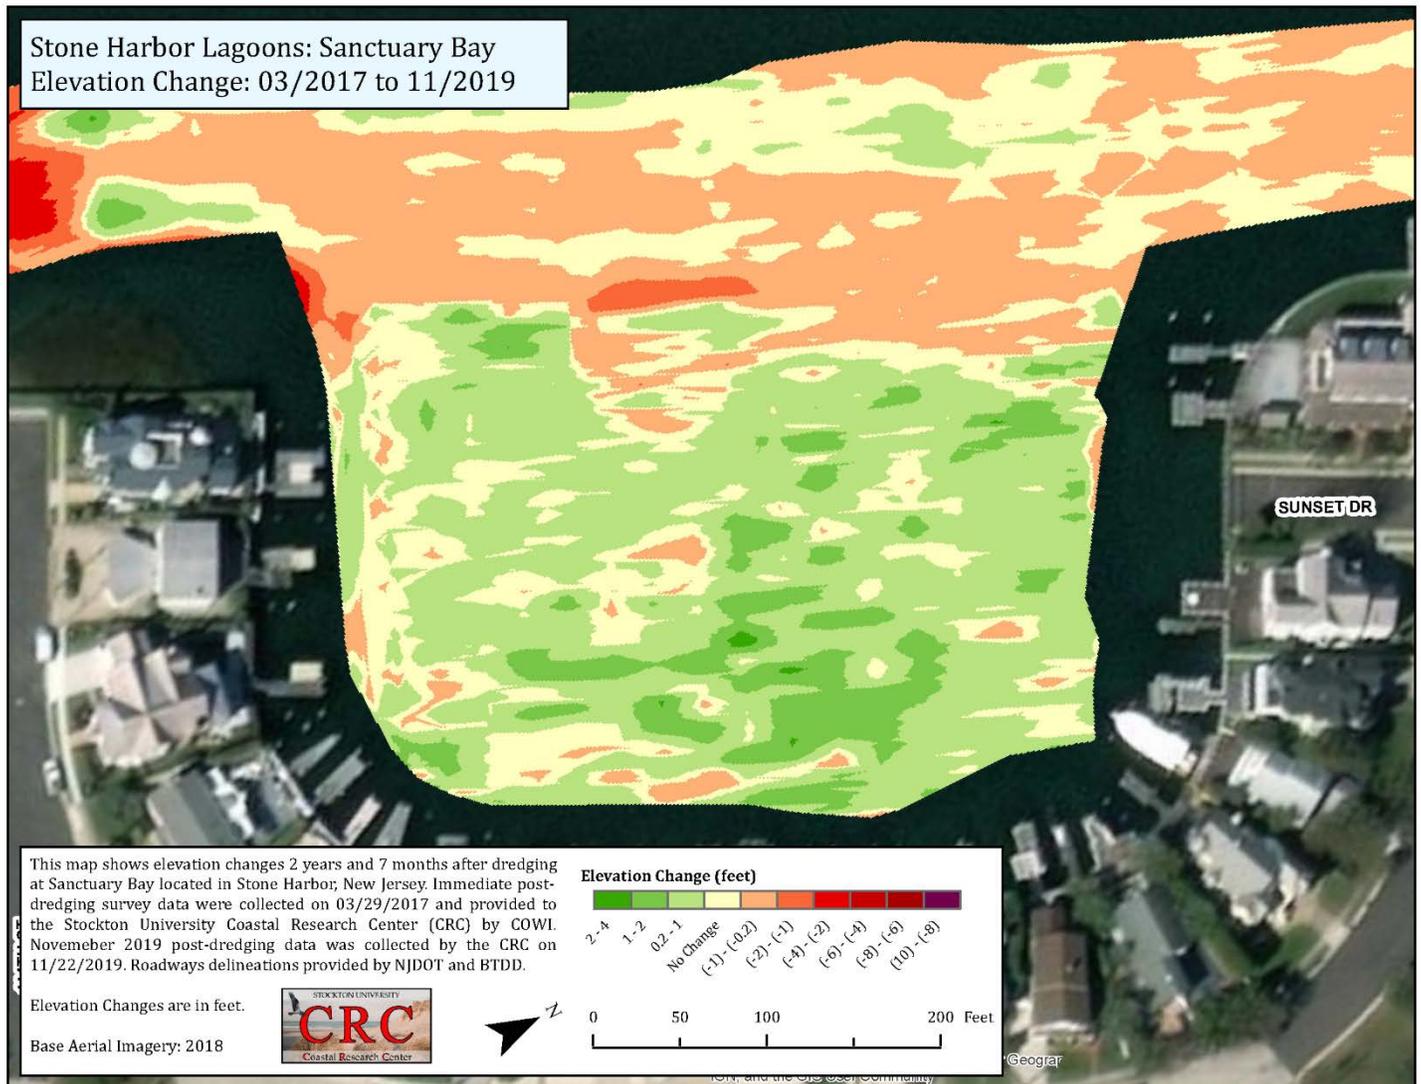
Sanctuary Bay is a cove along the bayshore where depth changes appear generally shallower by 0.2 to 2.0 feet in the excavated cove, but deeper along the axis of the tidal channel leading from Carnival Bay to the exit point back to Great Thorofare at the bridge to North Wildwood.

Figure 14. Sanctuary Bay lies east of the channel running south from the entrance to Carnival Bay and that exits at the bridge to North Wildwood. The excavated basin appears shallower by 0.2 to 2.0 feet in some spots, while the channel area is deeper by the same measure (0.2 to 2.0 feet). Substantial areas of no change still exist.

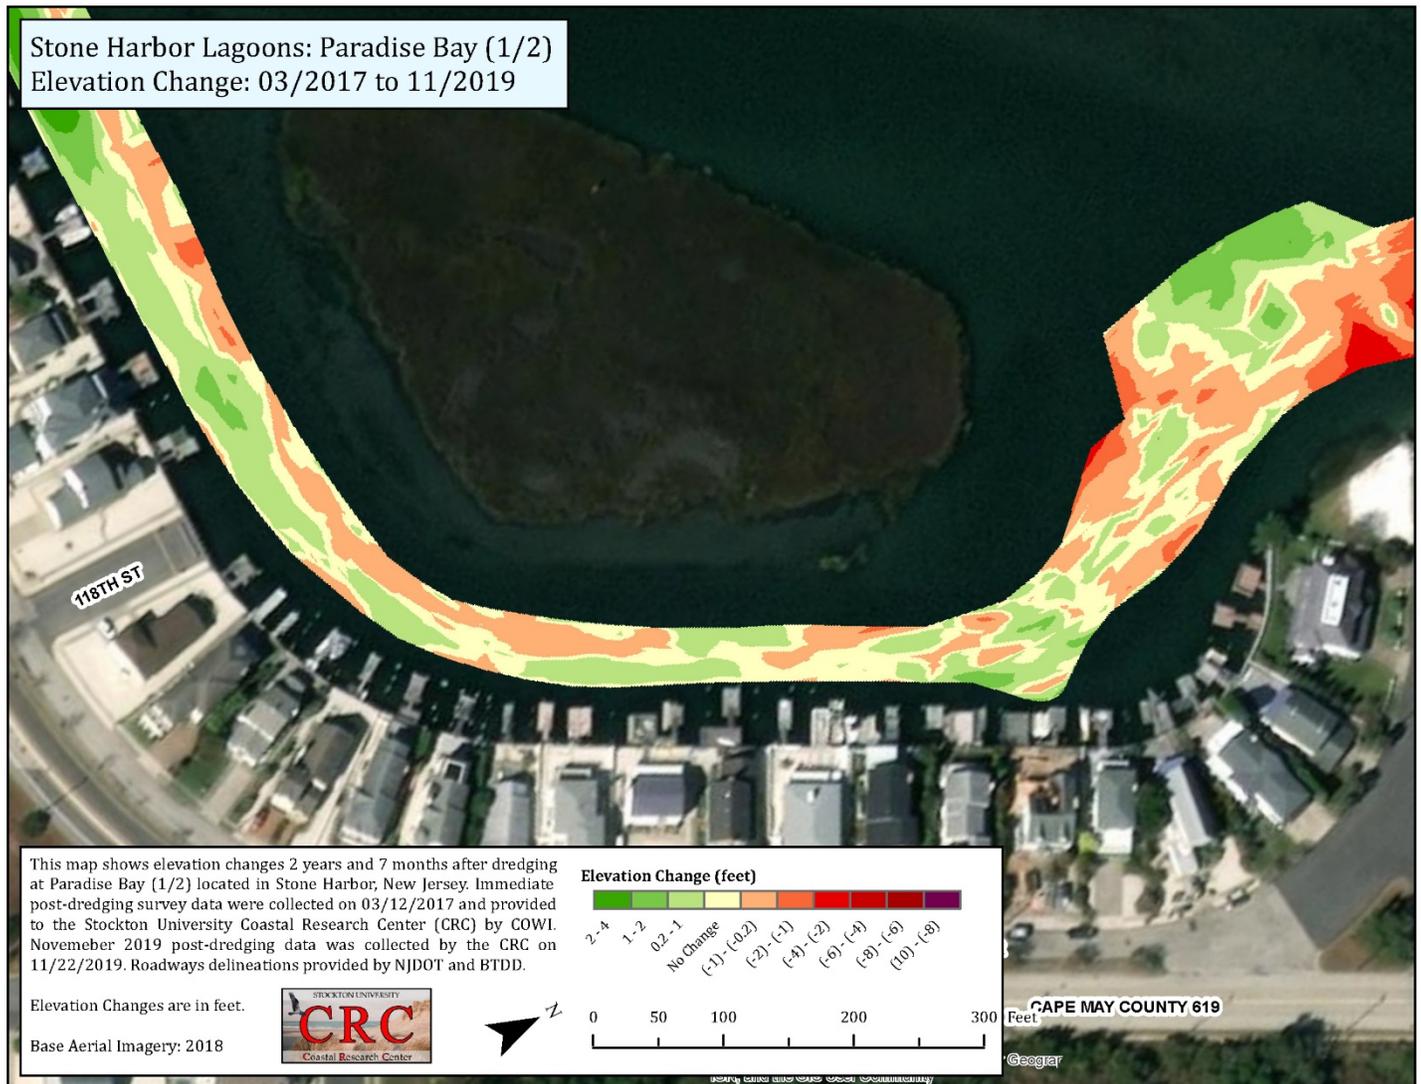
Figure 15a. The northern end of Paradise Bay is a dug channel between development and a marsh bay island to the west. There is spotty pattern of accumulation, no change and erosion since March 2017 when dredging was completed. The pathway south between marsh islands west of this channel is shallower to the point of avoidance by larger vessels particularly at low tide.
