**2019 ANNUAL REPORT ON
THE CONDITION OF THE MUNICIPAL BEACHES FOR
THE BOROUGH OF STONE HARBOR, CAPE MAY COUNTY, NEW JERSEY**

**PREPARED FOR: THE BOROUGH OF STONE HARBOR
9508 SECOND AVENUE
STONE HARBOR, NJ 08247**

**PREPARED BY: THE STOCKTON UNIVERSITY COASTAL RESEARCH CENTER
30 WILSON AVENUE
PORT REPUBLIC, NEW JERSEY 08241**

March 10, 2020

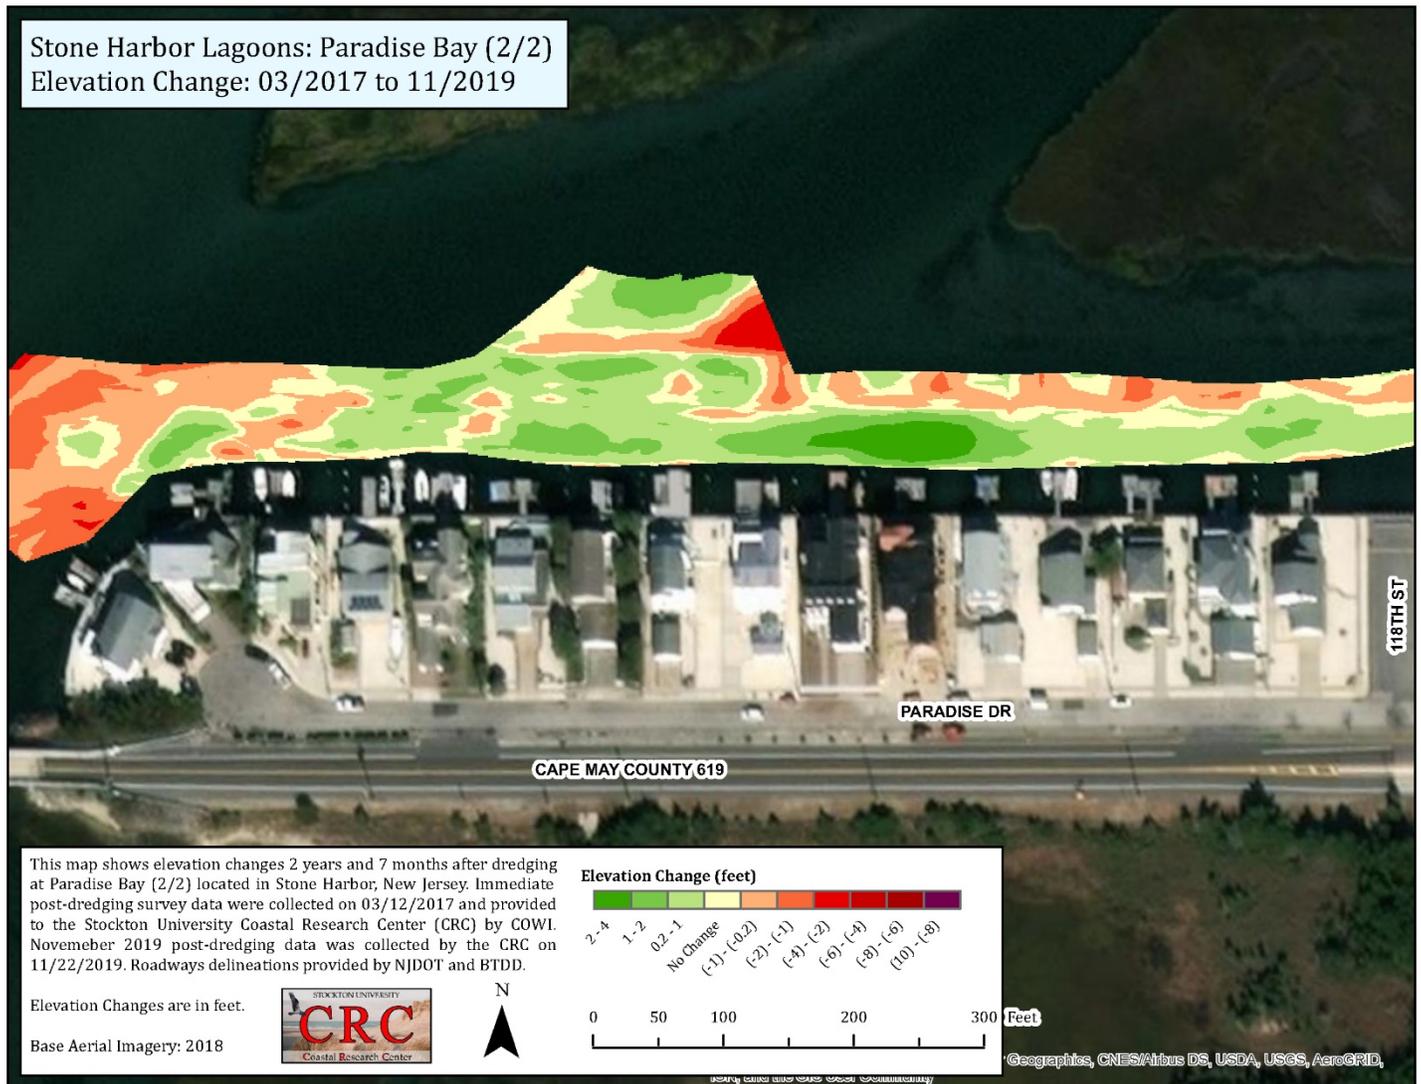
Figure 15b. The southern end of the Paradise Bay channel has accumulated sediment since dredging except for the entry back into Great Thorofare. The branch leading north between the marsh islands was surveyed but was barely navigable except within a few feet from the bay island to the right side going north in the cut. The western shoreline was exposed as a mud flat when the 2019 review was conducted.

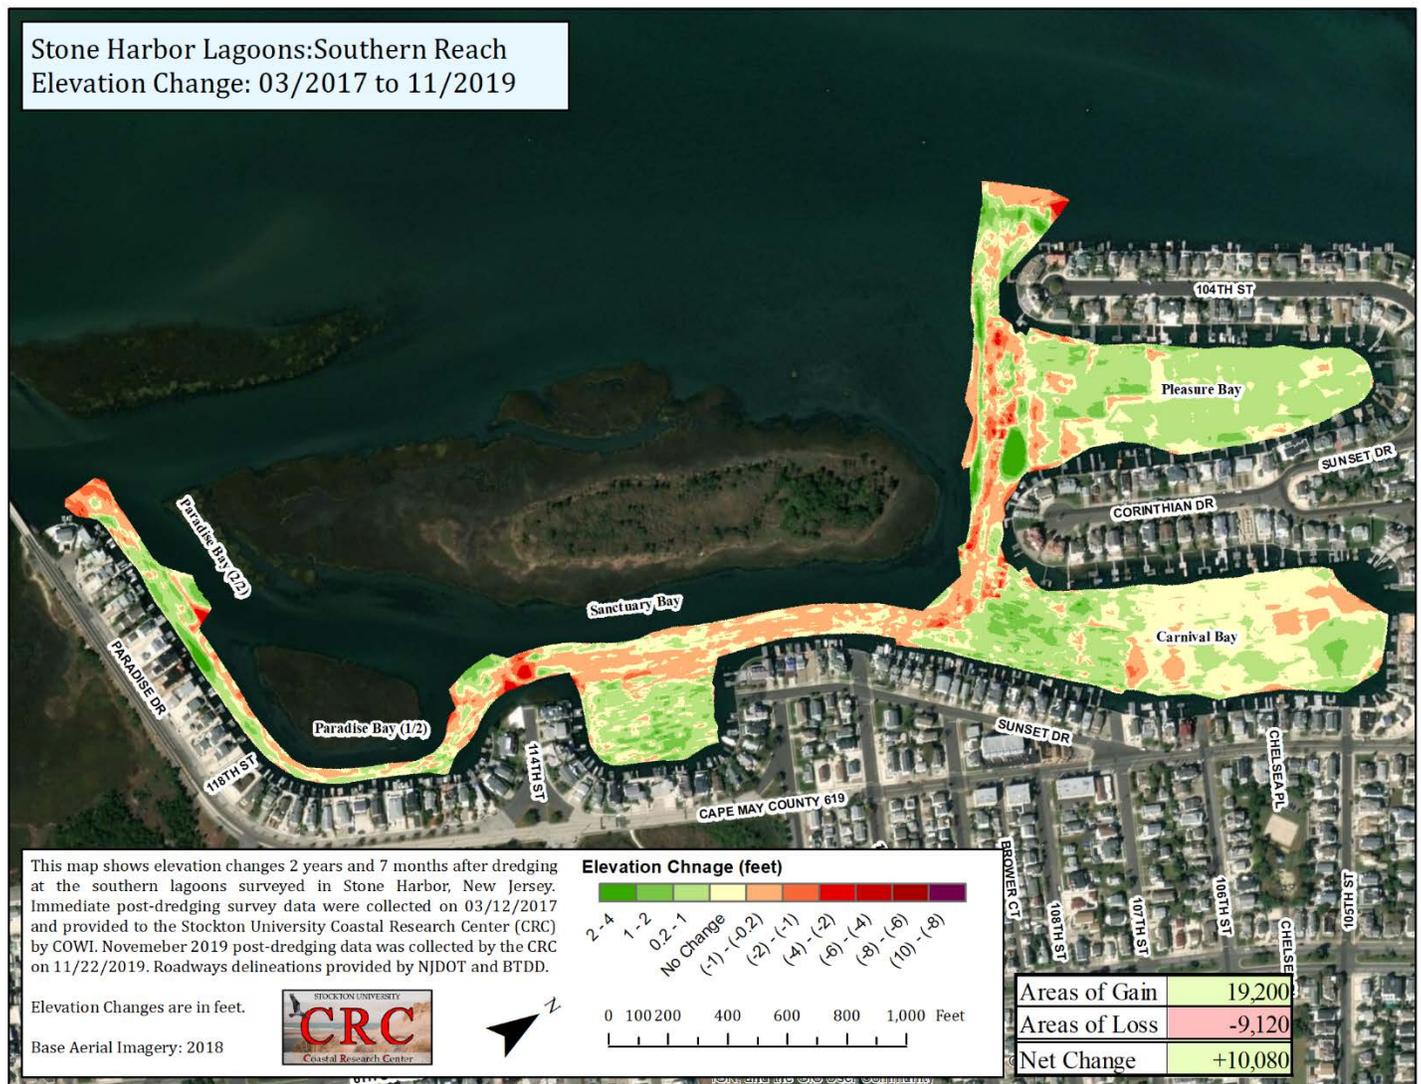
In order to show the complex of channels and basins associated with Sanctuary Bay which includes both Pleasure and Carinival Bays, plus Paridise Bay channels, the regional map is produced as Figure 16. The entire area gained about 10,000 cubic yards of new sediment since dredging was completed, over 8,700 cubic yards of which was deposited in Pleasure and Carinival Bays. The Paridise Bay channels are the most difficult to navigate for larger vessels due to compact width limits and perioding shoals already appearing. The direct route north toward Carnival Bay is marginally navigable at present at low tide. The western margin along the marsh island was exposed as a wide mud flat in Decemeber 2019, so was not surveyed. The navigation channel exists within a few feet of the sod bank on the eastern marsh island.

Figure 16. This map ties together five separate locations above into a composite for Sanctuary Bay and its associated lagoon basins. The entire region gained just over 10,000 cubic yards of sediment since dredging was completed. This was dominated by sediment deposition in Pleasure and Carnival Bays. The access route among the four developed lagoons appears to be getting deeper since dredging with minor exceptions along Paradise Bay channel.
