**FINAL REPORT FOR 2015
ON THE CONDITION OF THE MUNICIPAL BEACHES
IN
THE TOWNSHIP OF UPPER, CAPE MAY COUNTY, NEW JERSEY**

**PREPARED BY: THE STOCKTON UNIVERSITY COASTAL RESEARCH CENTER
30 WILSON AVENUE
PORT REPUBLIC, NJ 08241
May 25, 2016**

Annual Report for 2015
To
The Township of Upper On the
Condition of the Municipal Beaches

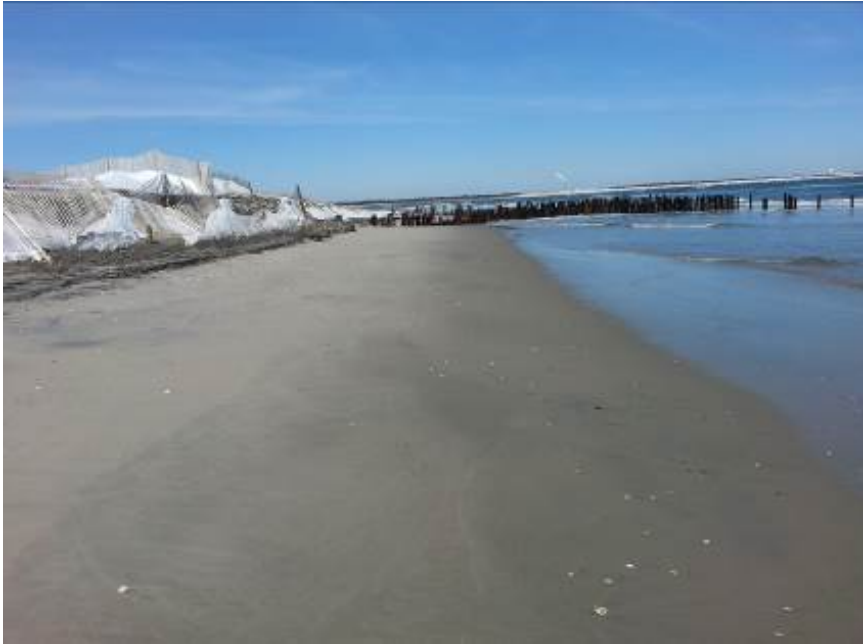
2a. March 5, 2014

Figures 2a to 2c. Close proximity to survey line 36+00 near Seaview Avenue. View to the north.

Photograph 2a shows that the extent of the winter erosion suffered in this area. The old timber pilings are exposed as well as the dune scarp and low elevation of the beach.

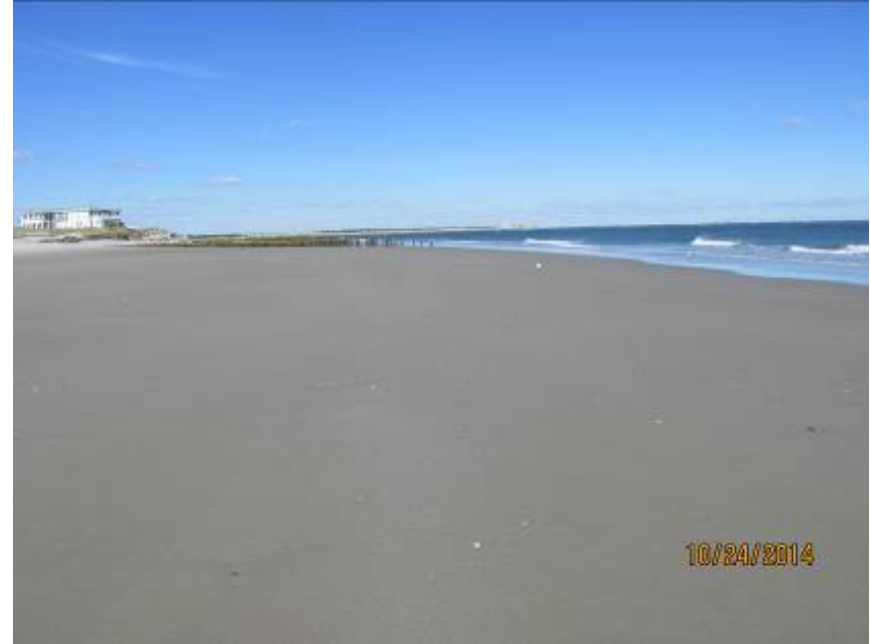
2b. October 24, 2014

Photograph 2b was taken on October 24, 2014 a couple hundred feet south of photographs 7a and 7b. The dune scarp is visible in the distance as well as the exposed timber pilings. Note the low elevation of the beachface.

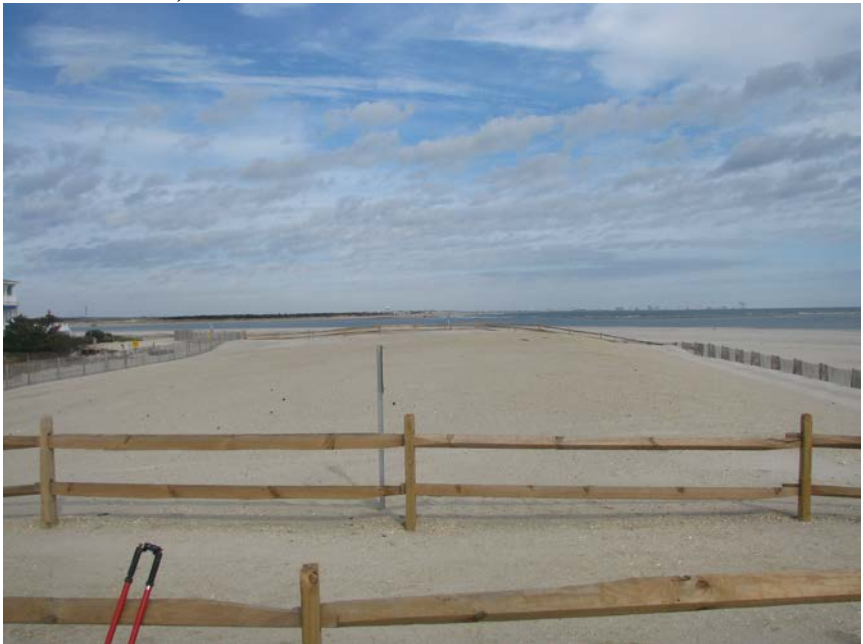
2c. November 5, 2015

Photograph 2c was taken on November 5, 2015 shows the newly constructed USACE dune system. The old timber pilings are now buried.

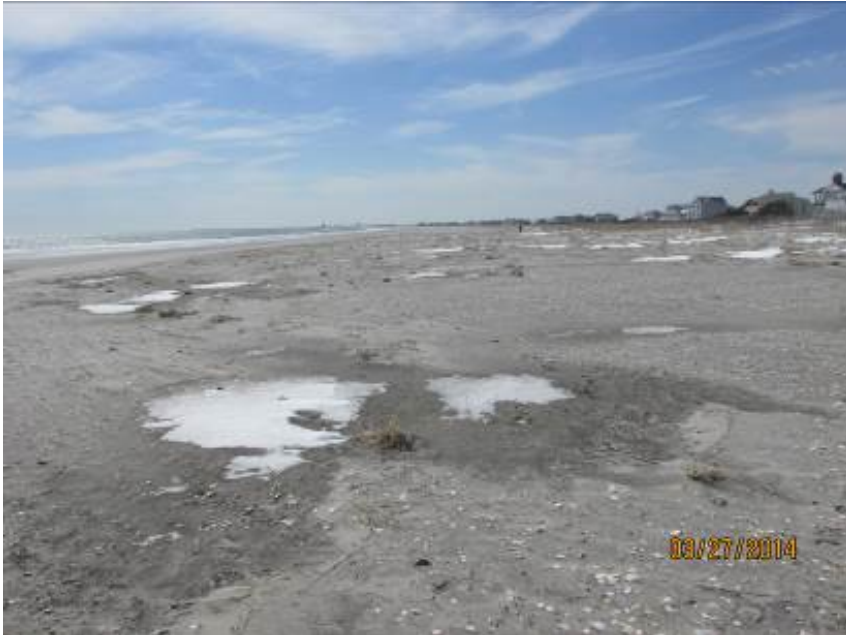
4a. March 27, 2014

Figures 4a to 4c. Survey line 22+00 located between Whittier and Sumner Avenues. 9a & 9c view to the south, 9b view to the north.

Figure 4a taken just north of Tecumseh Avenue, begins to display an erosional beachface. Shoreline retreat amounted to 79 feet from the November 2013 survey.

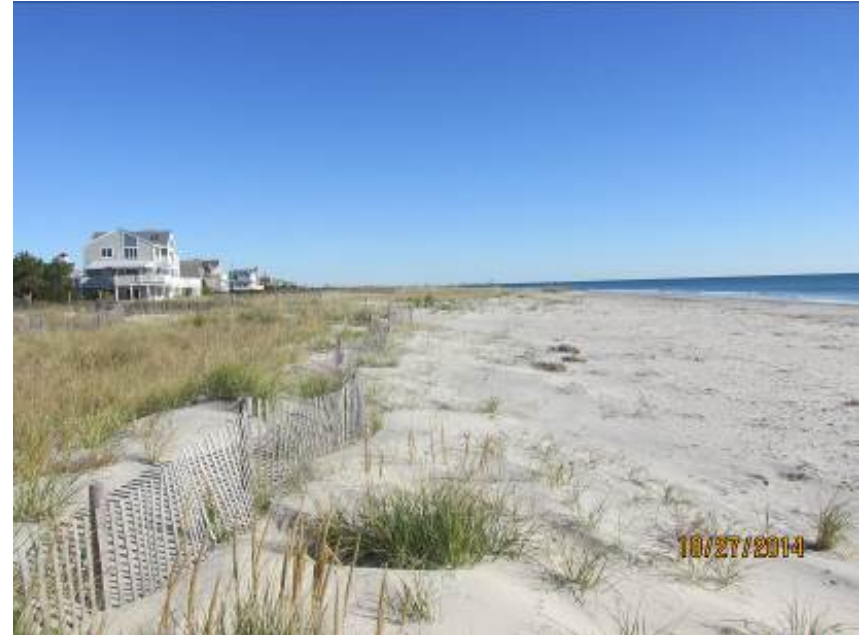
4b. October 27, 2014

Figure 4b taken around Sumner Avenue shows the stable dune system but an erosion of the beachface amounting to an additional shoreline retreat of 52 feet.

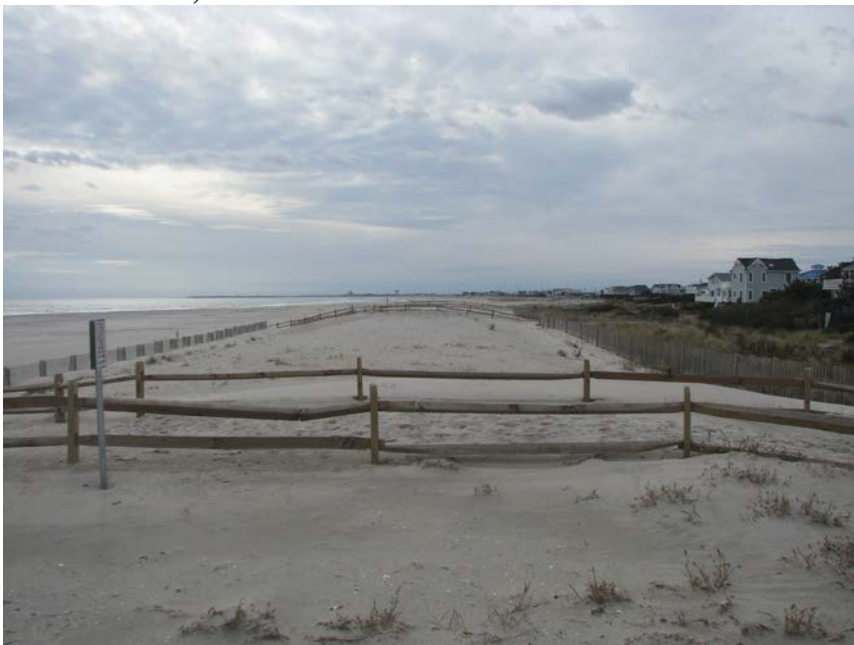
4c. November 6, 2015

Figure 4c taken around Tecumseh Avenue shows the reconstructed USACE dune and beach width.

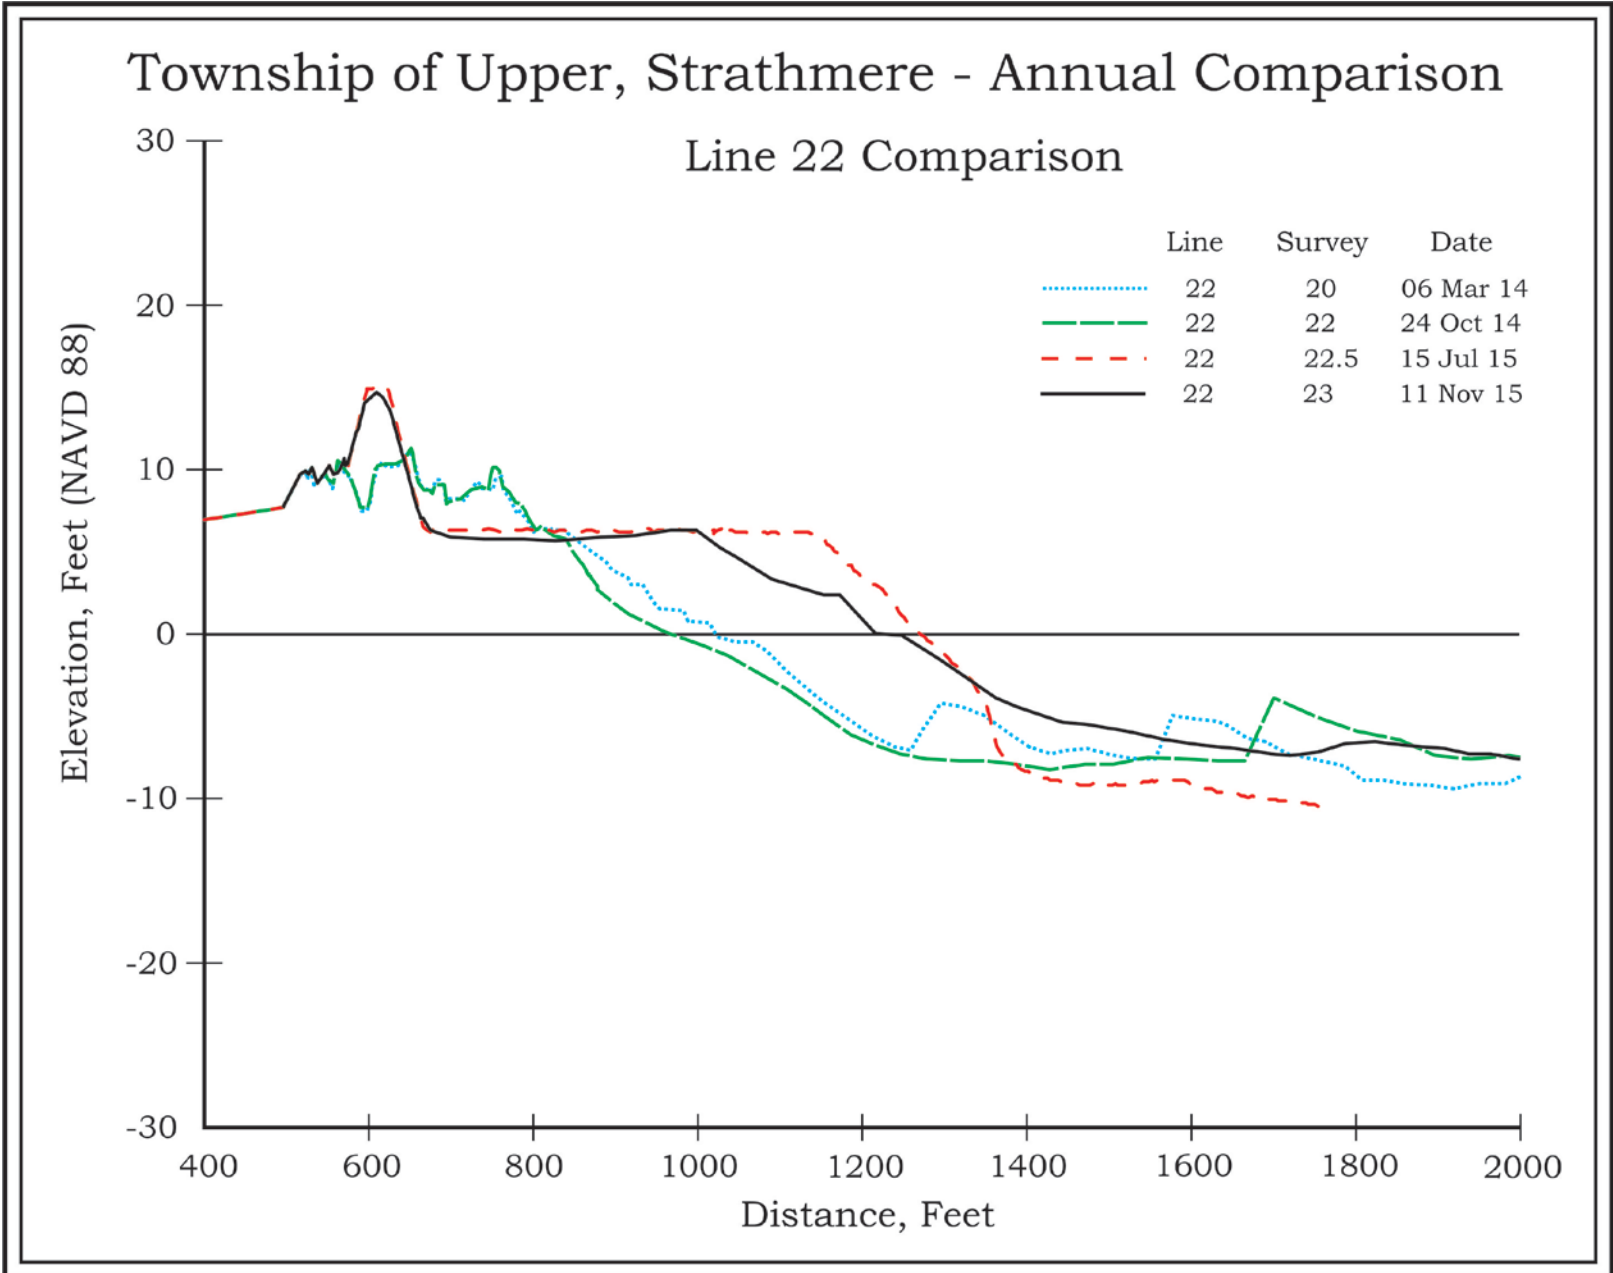
From November 2013 through October 2014 the survey line at 22+00 and its surrounding areas lost significant sand volume in the seaward beachface and nearshore regions. The shoreline eroded over 131 feet and volume losses for the profile amounted to 30.89 yds³/ft. The seaward foredune and offshore bar grew by survey 20 (March 2014) but the continued losses incurred at the recreational beach and nearshore regions are documented through the final survey conducted October 2014.

By July 2015, the USACE sponsored beachfill was completed which elevated the primary dune and extended the beachface seaward nearly 350 feet. By the final survey in November, erosion to the beachface of the engineered beach had already taken place. The annual comparison from October 2014 to November 2015 revealed a shoreline advance of 260 feet with a gain of 120.99 yds³/ft. of sand.

Figure 5. By Survey 22.5, the extent of the nourishment project is displayed in this area by the extended beachface and dune height. Erosion of the beachface by an October northeast weather event had taken place and is shown by Survey 23. For the year, from October 2014 to November 2015, the shoreline position advanced nearly 260 feet with a gain of 120.99 yds³/ft. of sand.

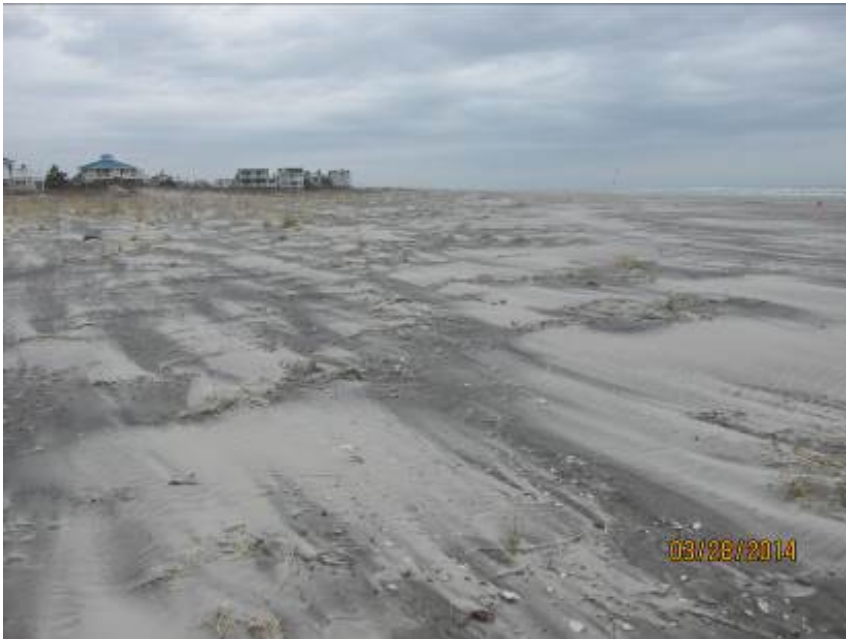
Figure 6a. March 28, 2014

Figures 6a and 6b taken looking north.

Figure 6a South of Putnam Ave. shows the extent of the wide beach. The wide beach provides an excellent source of aeolian sand to continue development of the new foredune here.

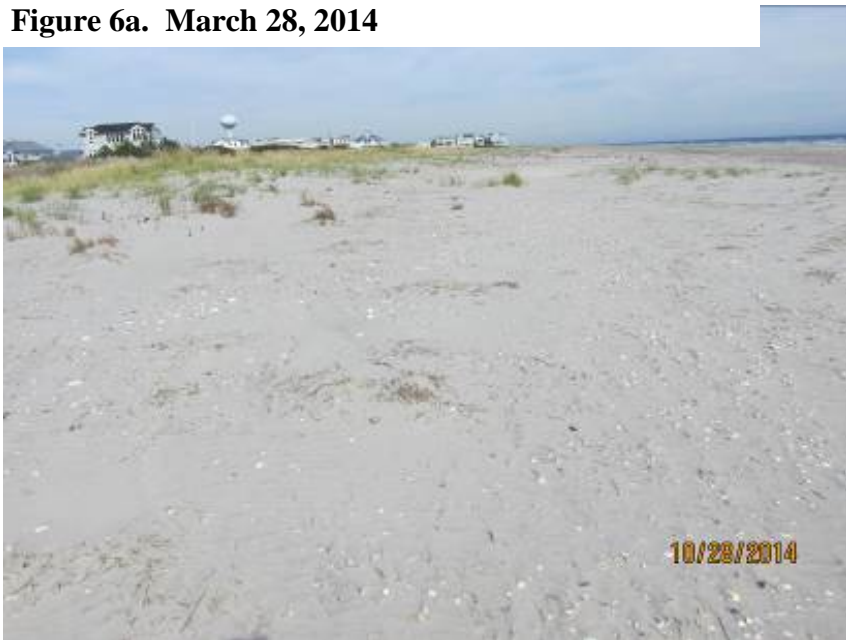
Figure 6b. October 28, 2014

Figure 6b South of Prescott Terrace shows aeolian sand has accumulated along the seaward dune toe and plants have colonized the region a new foredune feature has developed.

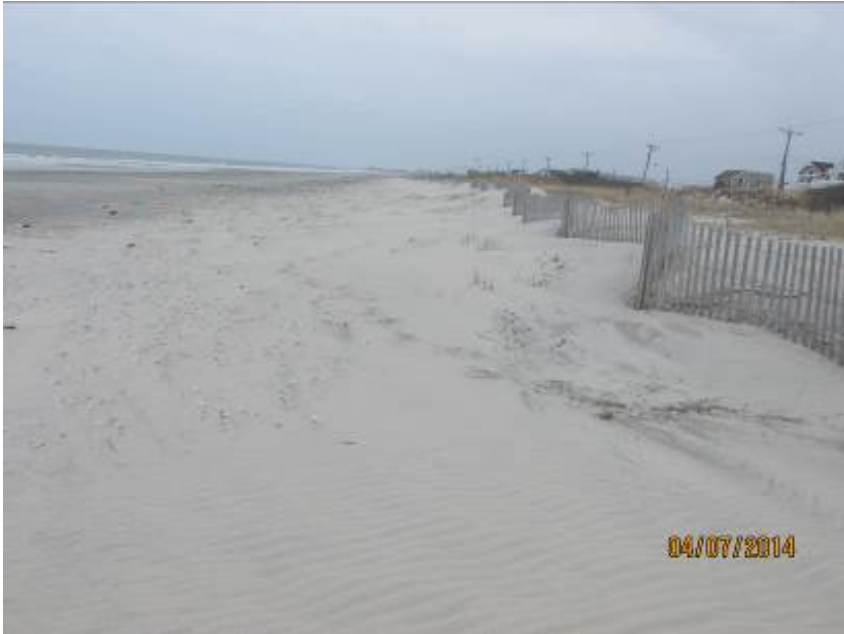
8a. April 7, 2014

Figures 8a to 8b at Line -20+00 at the Southern Strathmere Beach. View to the south.

Photograph 8a by late spring losses to the recreational beach are observed with a shoreline retreat of 42 feet recorded between November 2013 and April 2014.

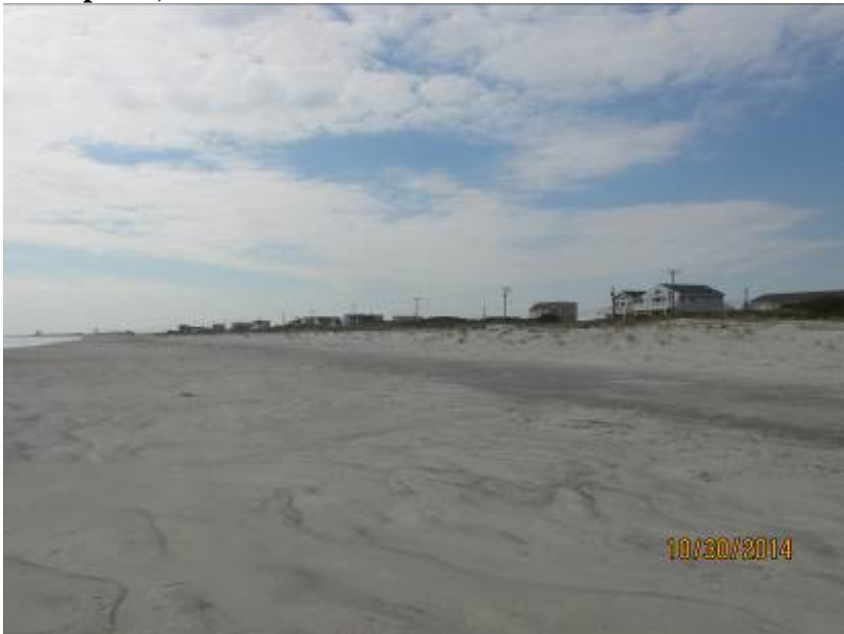
8b. October 30, 2014

Photograph 8b taken in October 2014 the beach having accumulated sand over the summer appears to have significant growth in the foredune area.

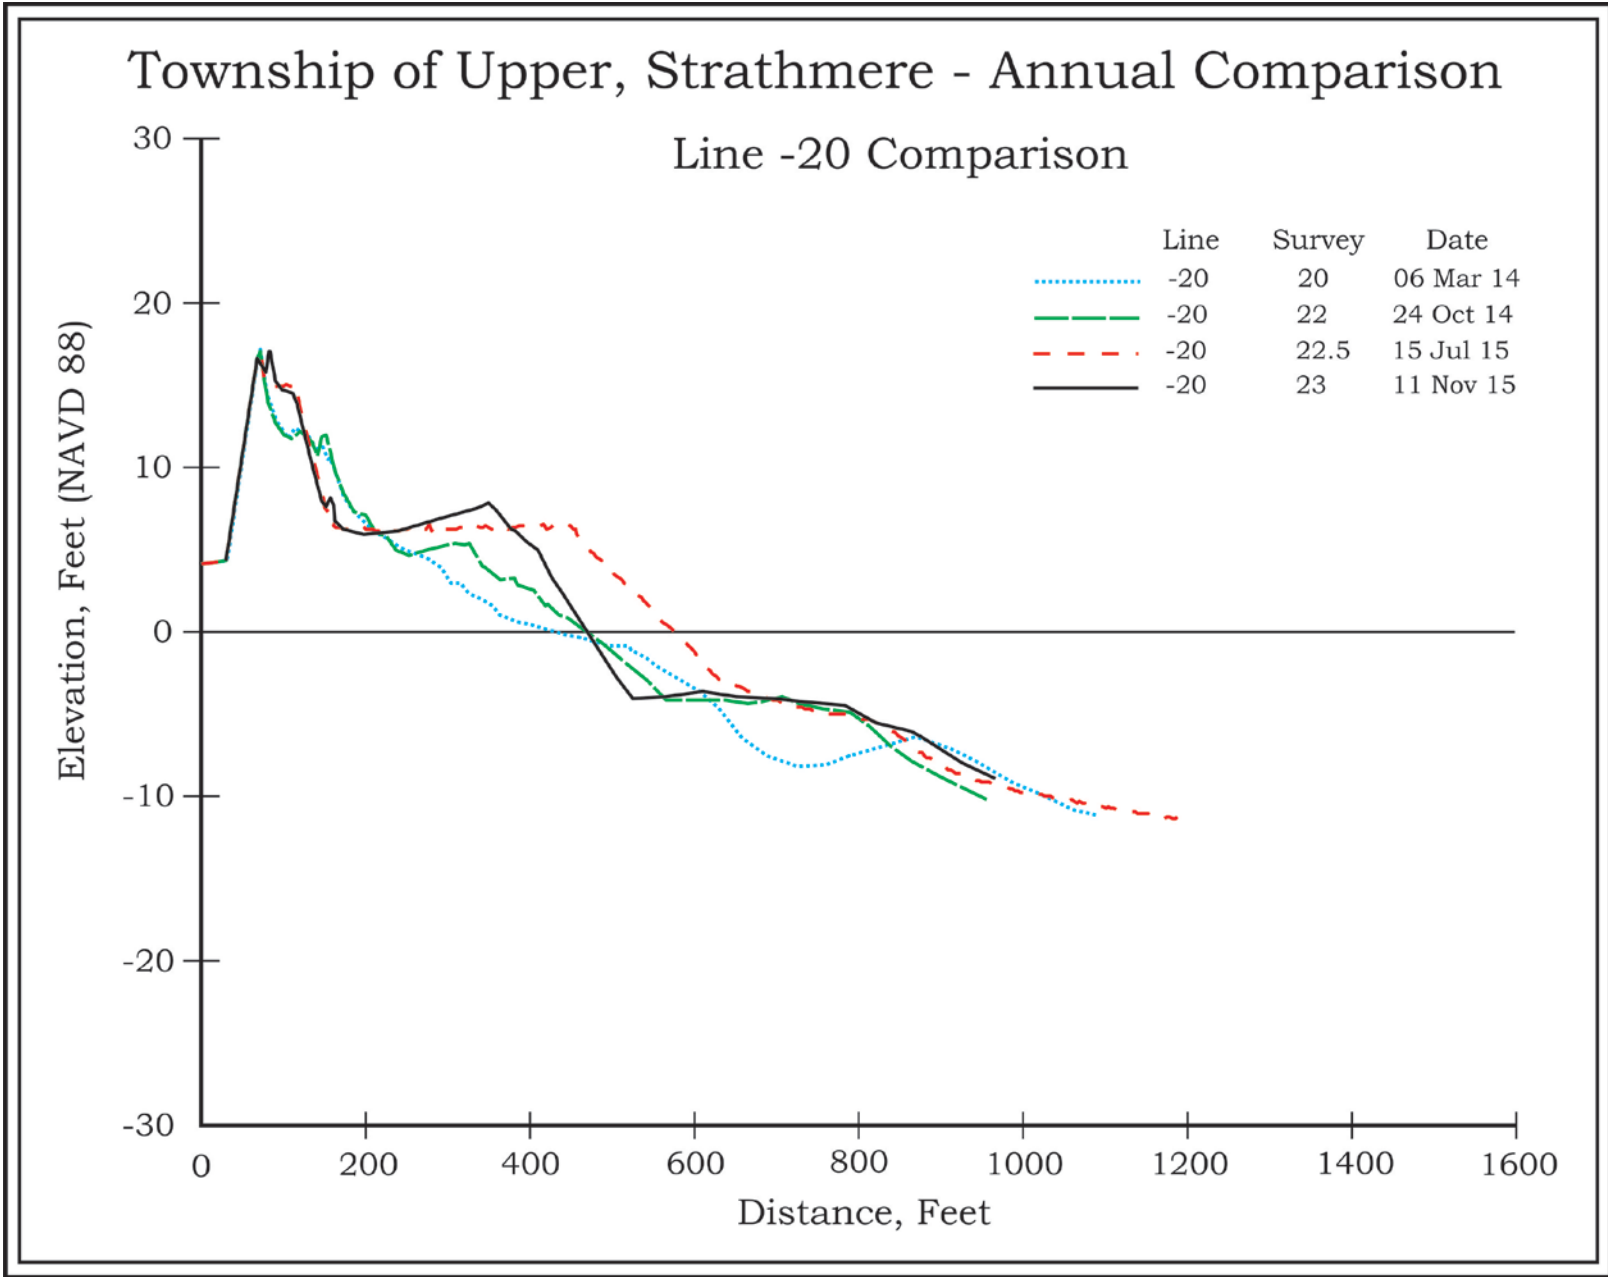
By July 2015, the USACE sponsored beachfill was completed which elevated and extended the berm position seaward nearly 250 feet. By the final survey in November, erosion to the beachface of the engineered beach had already taken place. The annual comparison from October 2014 to November 2015 revealed a minimal shoreline advance of 3 feet with a gain of 24.133 yds³/ft. of sand.

Figure 9. The 2015 USACE renourishment project widened the beachface seaward 109 feet (survey 22.5). Almost immediately, erosion of the beachface and nearshore had taken place. The net effect of the nourishment and erosional processes amounted to a net effect of a 3 foot shoreline advance for the annual comparison.

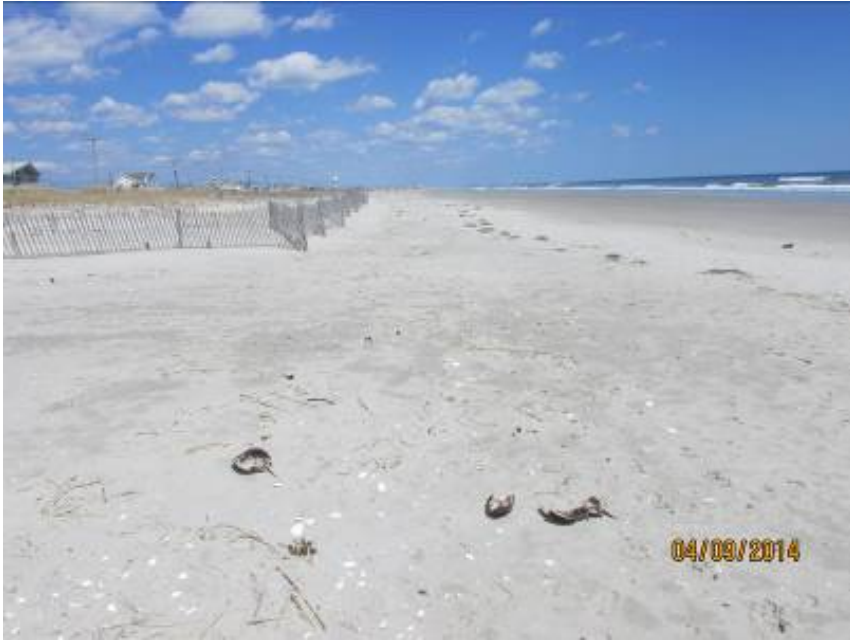
10a. April 4, 2014

Photograph 10a. The April photograph reveals minimal changes to the recreational beach area from the previous survey.

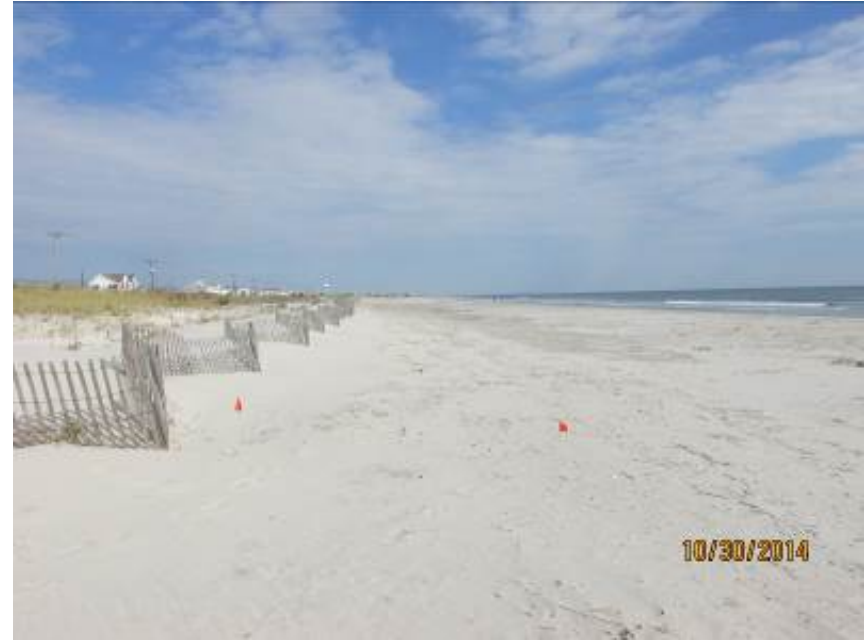
Figure 10b. October 30, 2014

Photograph 10b. Again, following the typical summer beach building pattern, sand has pushed up onto the upper beach forming a wider more elevated dry beach seaward of the dune system.

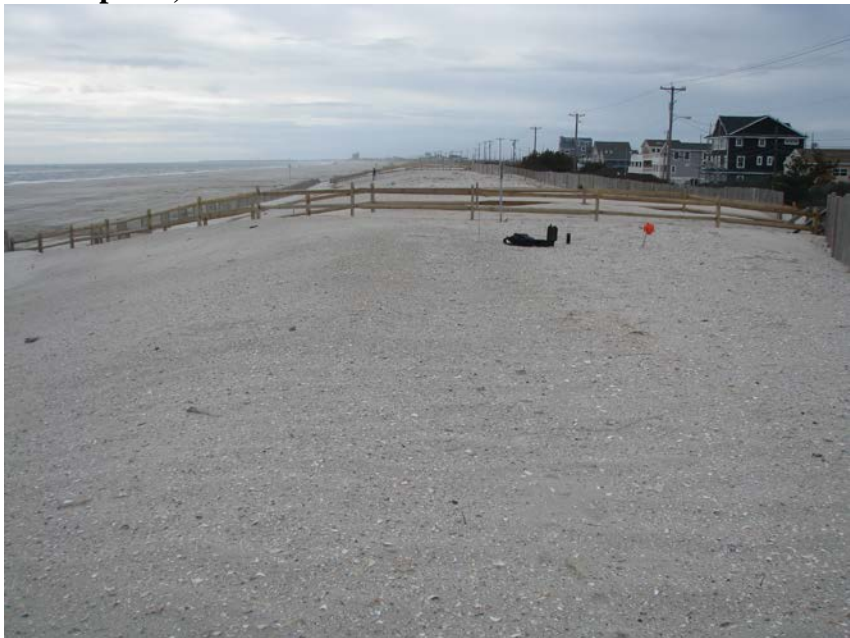
10c. November 9, 2015

Photograph 10c. Following the USACE beachfill, the wider and higher dune system and beachface are shown in this photograph.

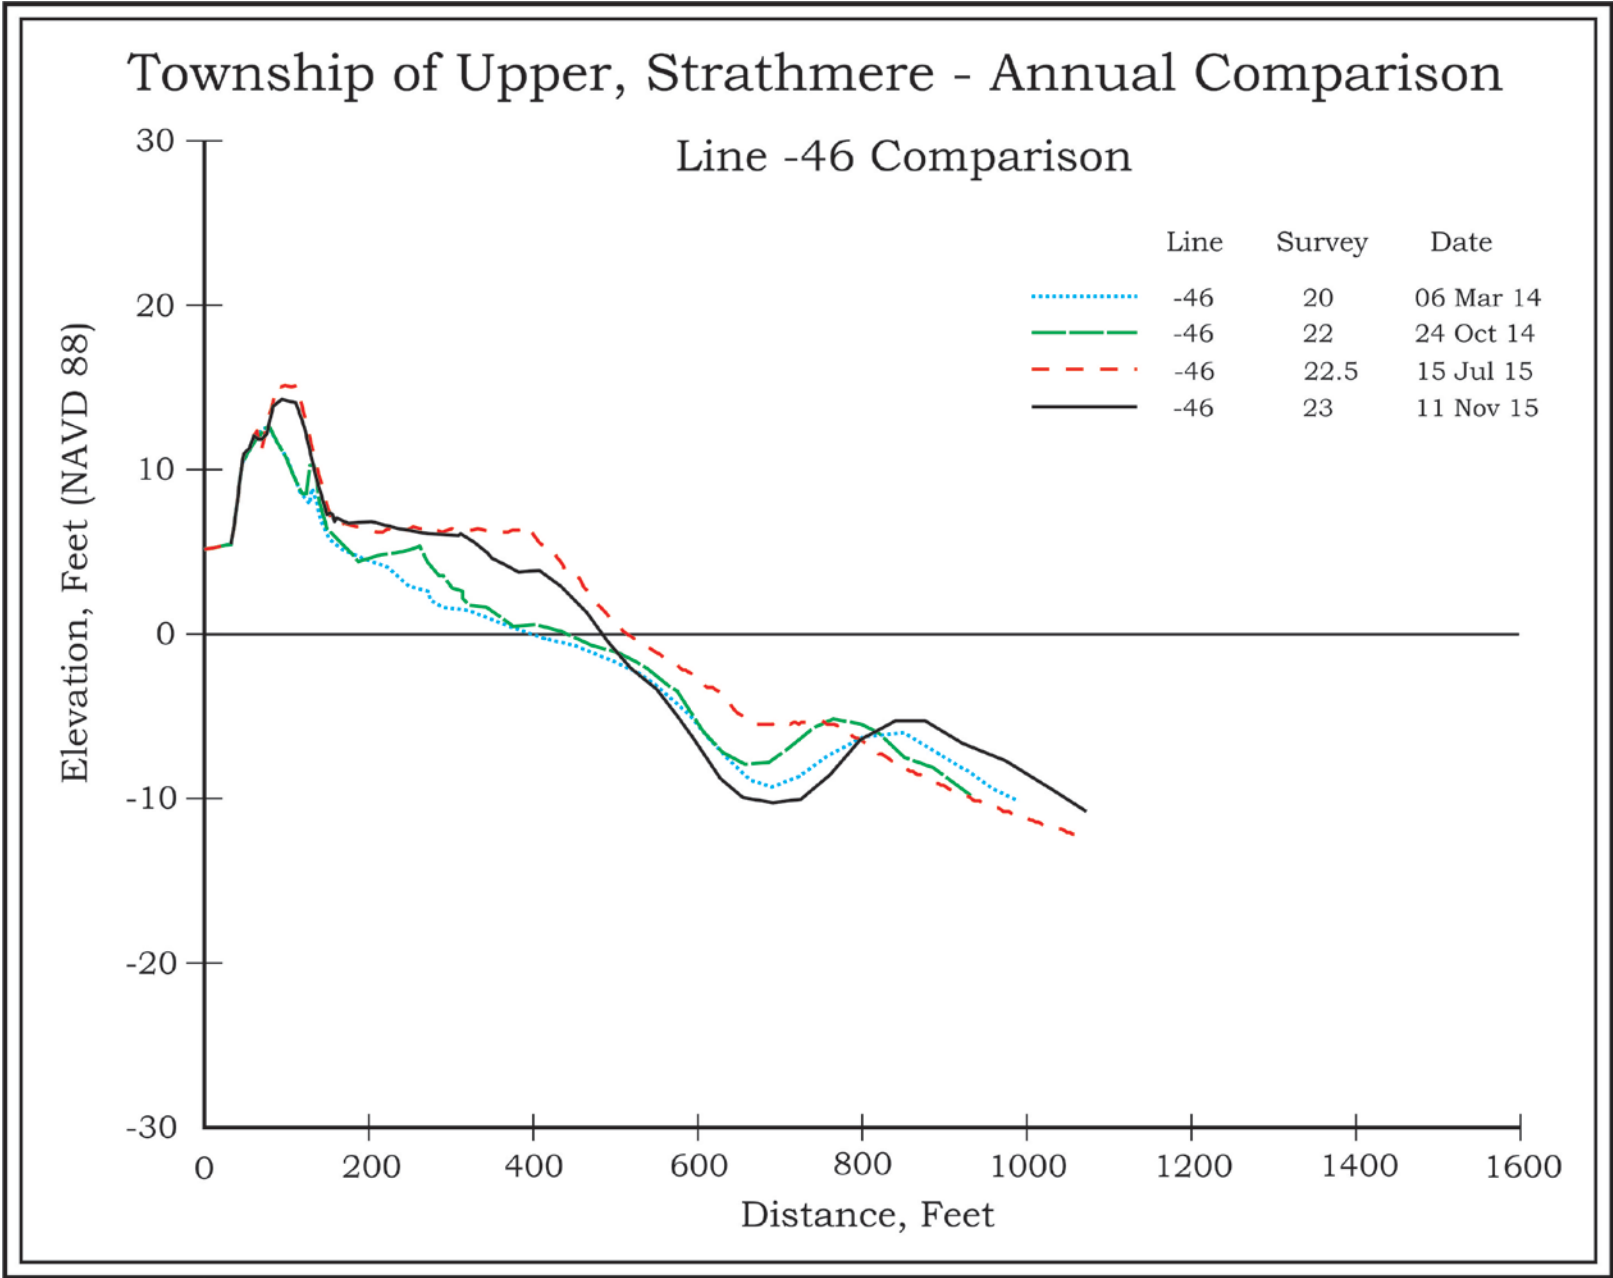
From November 2013 through October 2014 the survey line at -46+00 and its surrounding areas remained relatively stable absent of any significant storm activity. An elevated beach and foredune growth can be seen by the fall 2014 survey but the narrow beach width still renders this area of the island vulnerable to wave activity. For the annual comparison, the shoreline position advanced 27 feet and cumulative volume gains amounted to 19.77 yds³/ft. (6.89 yds³/ft. above the datum).

The USACE sponsored beachfill was completed by July 2015 which significantly extended and elevated the dune and beachface seaward. The berm and upper beachface began to show signs of erosion by November 2015. By the November survey a pronounced nearshore trough had formed as material shifted to the offshore bar. The shoreline advanced 42 feet from October 2014 to November 2015, coupled with a gain of 24.74 yds³/ft. of sand.

Figure 11. The dune and recreational beach height/width were enhanced during the 2015 beachfill project. By November 2015, the berm and beachface had eroded while the nearshore scour trough deepened as material moved seaward to the offshore bar. From October 2014 to November 2015 the shoreline advanced 42 feet and volume gains of 24.74 yds³/ft. were recorded.
