**FINAL REPORT FOR 2016  
ON THE CONDITION OF THE MUNICIPAL BEACHES  
IN  
THE TOWNSHIP OF UPPER, CAPE MAY COUNTY, NEW JERSEY**

**Annual Report for 2016**  
**To**  
**The Township of Upper On the**  
**Condition of the Municipal Beaches**

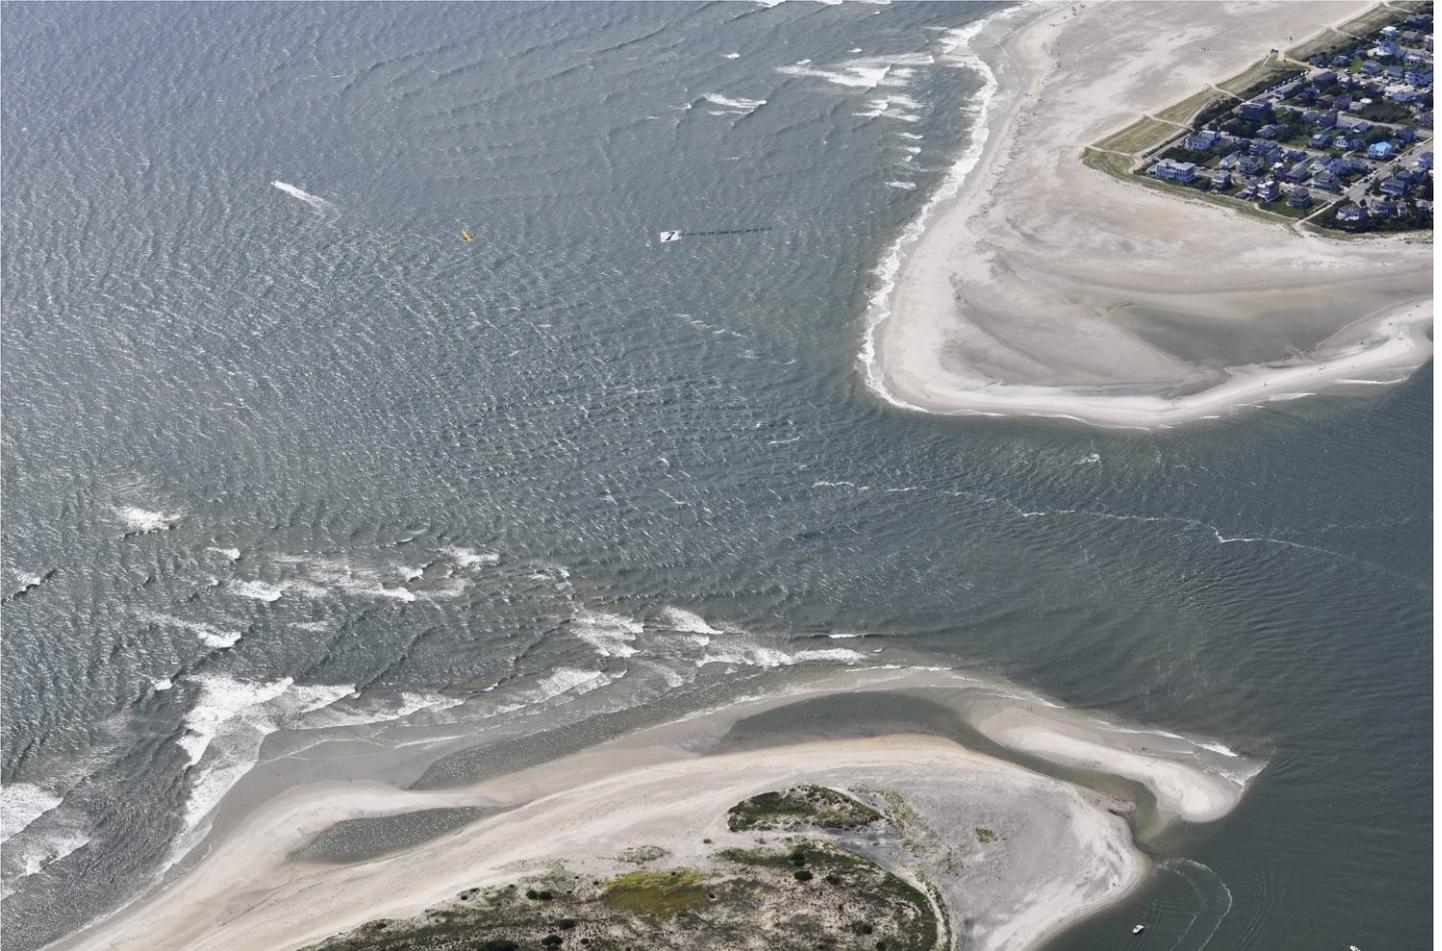
*Aerial photograph at Corson's Inlet on September 2, 2016 showing the beach details at the inlet along with the growing sand shoals on the Ocean City side. The restored beach in Strathmere has its narrowest width at the northeastern most corner of Strathmere and the NJ State Park at the seaward end of Seaview Avenue.*

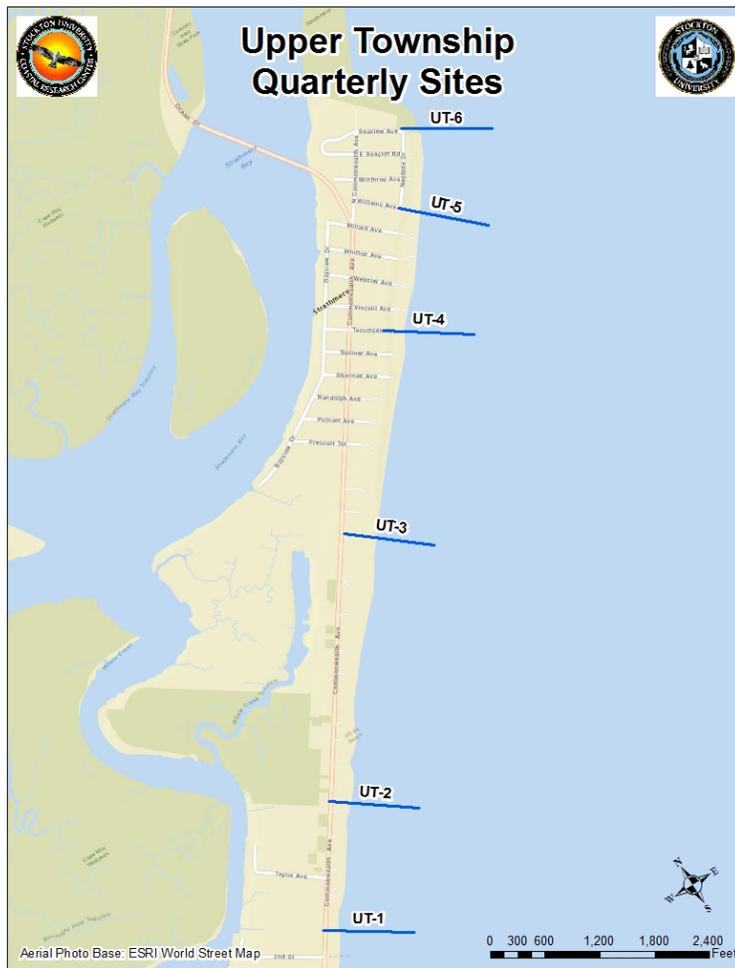
**Figure 1. Locations of the 6 beach profile stations for the engineered beach in Upper Township.**

Figure 1 located below shows the locations of the 6 cross section locations used for this analysis.

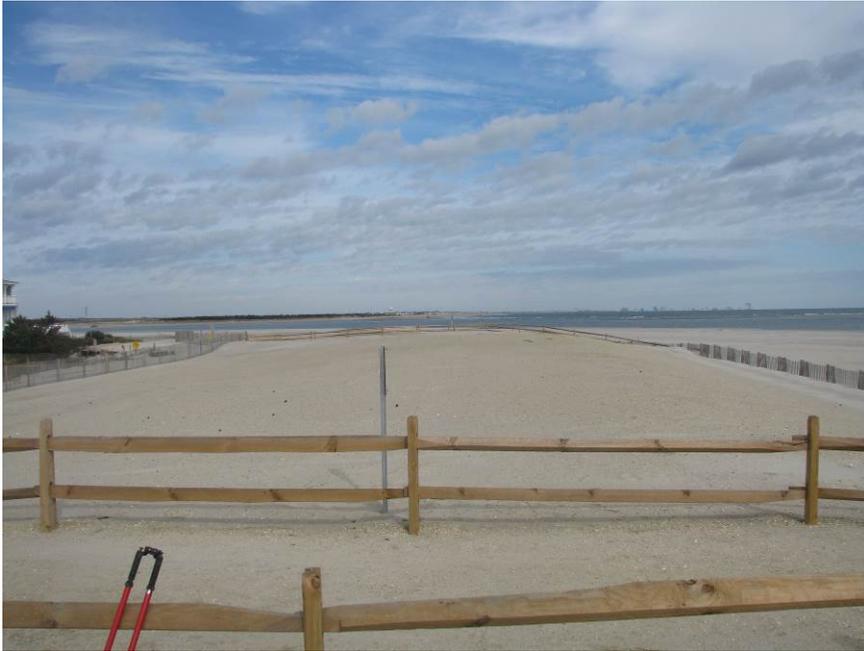
**2a. November 5, 2015**

**Figures 2a to 2c. Seaview Avenue survey site. View to the north.**

**Photograph 2a shows the extent of the new sand added by the ACOE. New fencing and access paths are in place.**

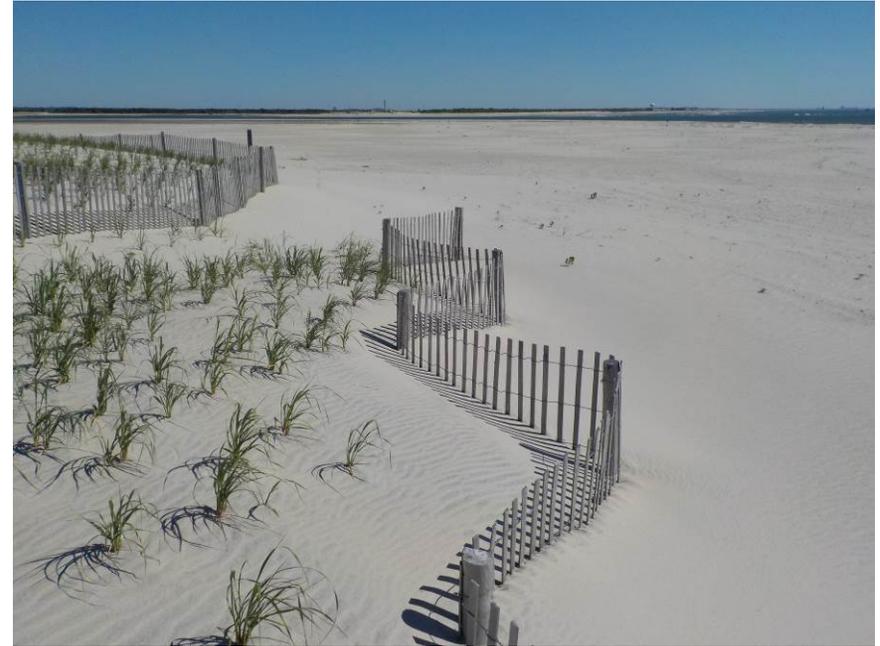
**2b. June 10, 2016**

**Photograph 2b shows the same perspective in June following grass planting.**

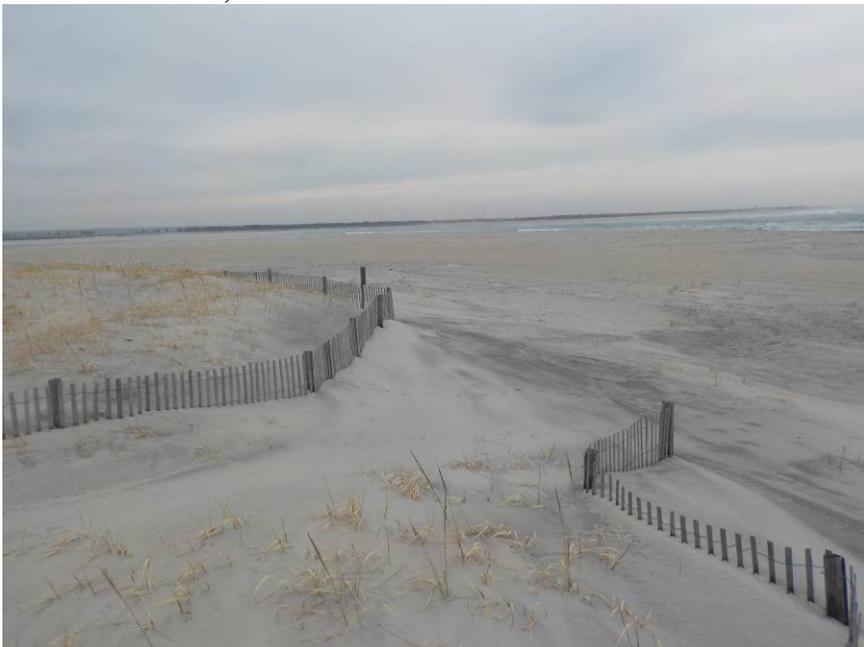
**2c. December 16, 2016**

**Photograph 2c was taken on December 16, 2016 as the grass had turned brown, but survived and sand accumulated at the fence line derived from the wide, dry beach.**

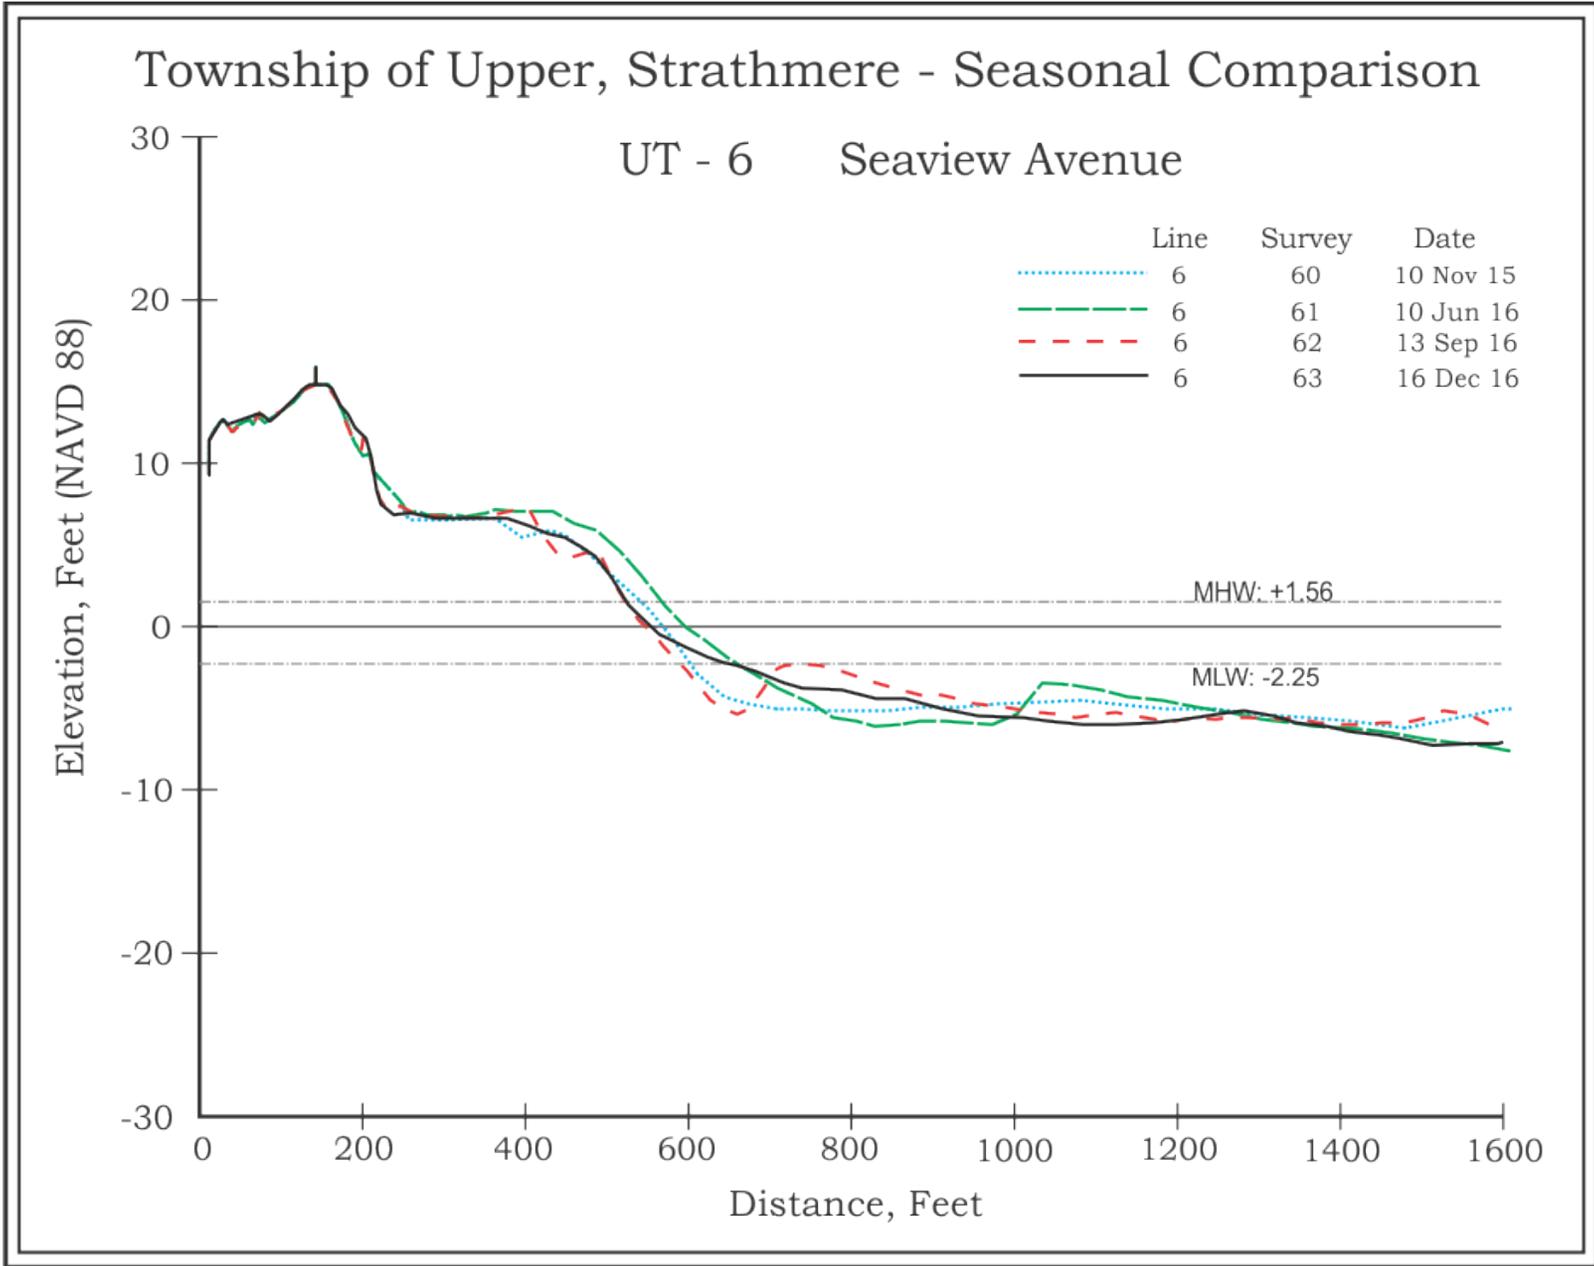
**Figure 3.** The November 2015 cross section saw sand volume added prior to June surveys followed by minor retreat in the beach face and zero elevation position. Bar migration offshore continued as recorded frequently at this location. The annual change was a -8.90 yds<sup>3</sup>/ft. loss in sand volume combined with a 15-foot shoreline retreat.

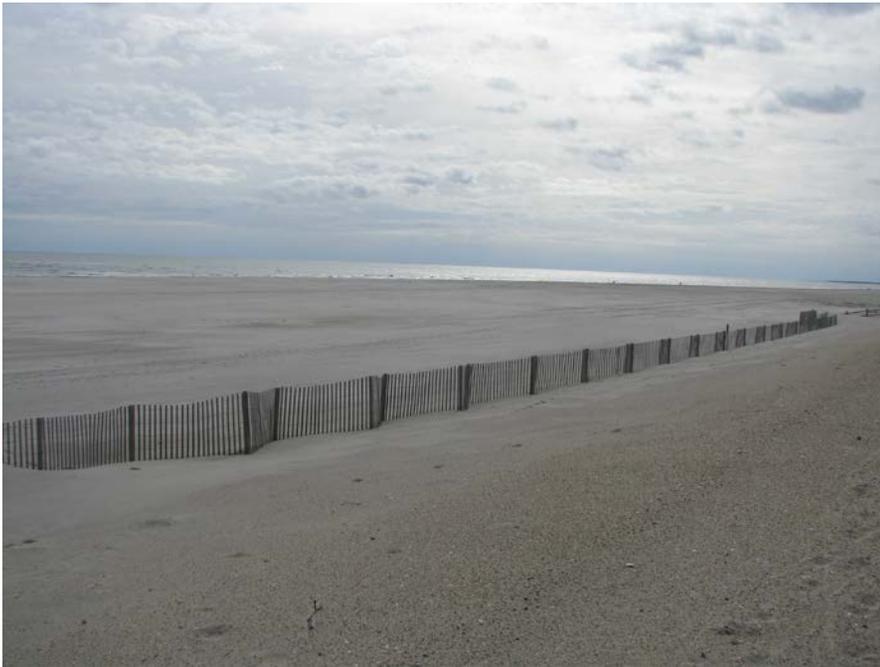
**4a. November 6, 2015**

**Figures 4a to 4c. UT-5 survey site on Williams Avenue.**

**Figure 4a shows the winter beach with the new USACE width.**

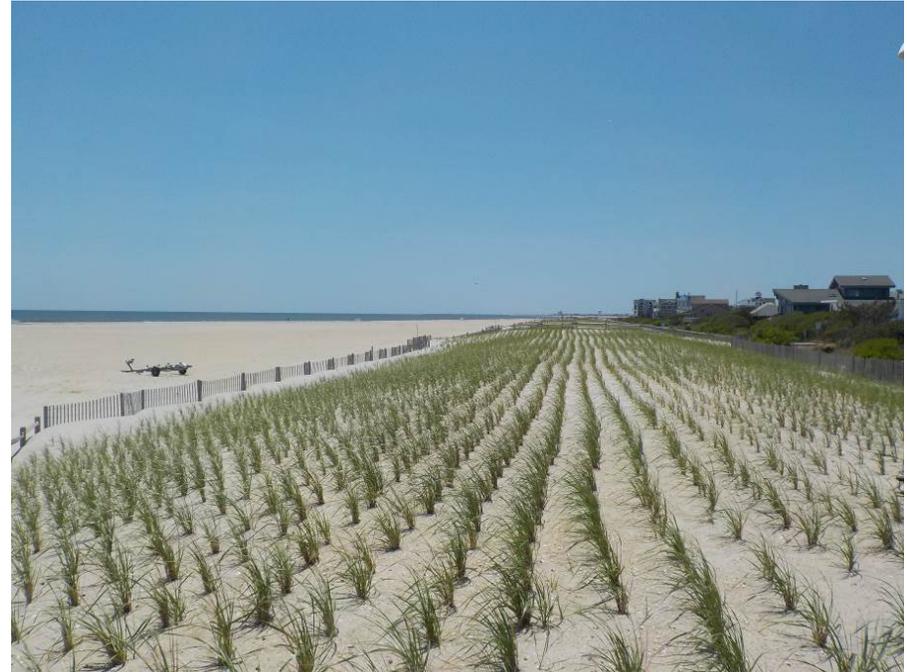
**4b. June 3, 2016**

**Figure 4b was taken following storm damage repairs and the planting of the dune grass.**

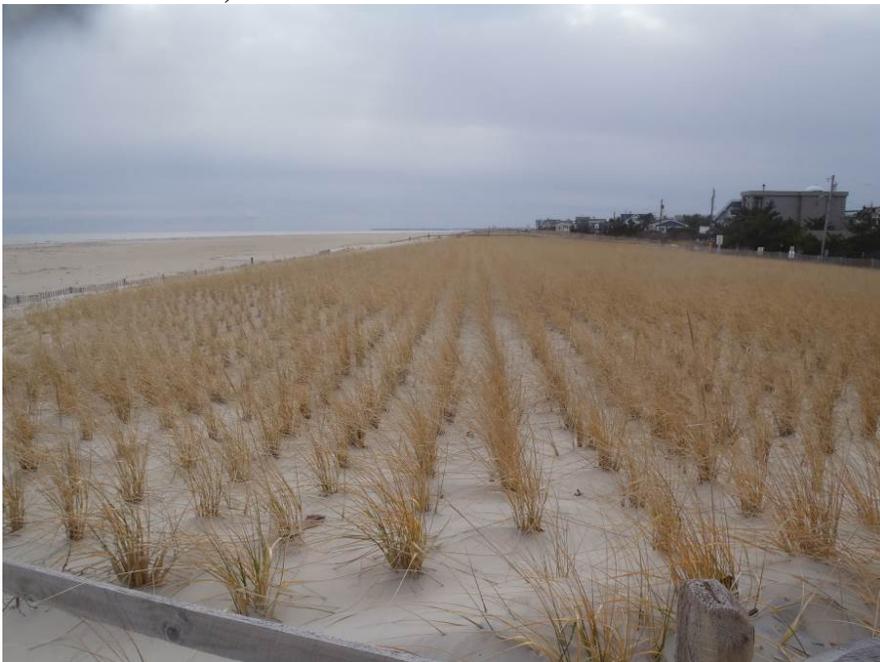
**4c. December 16, 2016**

**Figure 4c shows the winter beach at the dune grass position looking south.**

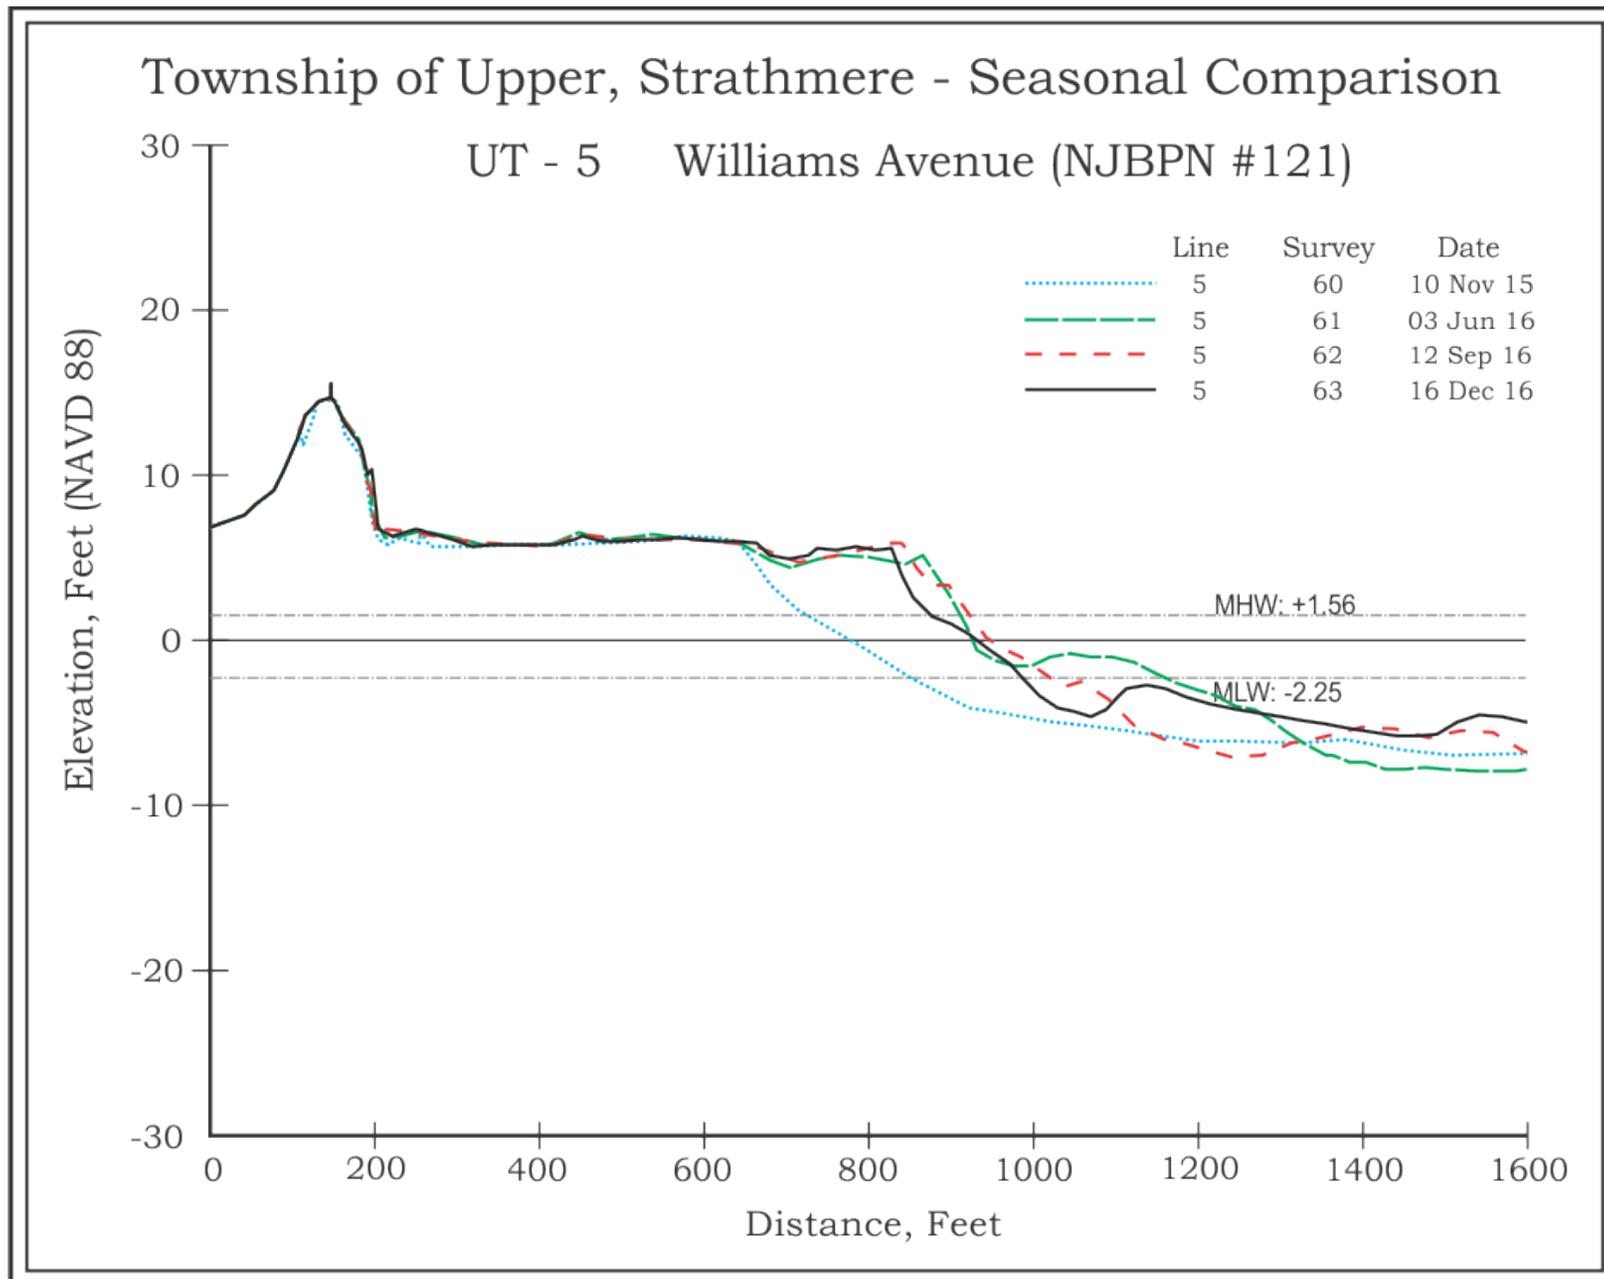
**Figure 5.** This site lies just south of the influence of the ebb-tidal delta for Corson's Inlet, but not beyond the accretion generated by sand moving landward. The November 2015 to June 2016 comparison shows the effect of the USACE repair to the storm damage in January. This site gained 98.40 yds<sup>3</sup>/ft. while the shoreline advanced 153 feet.

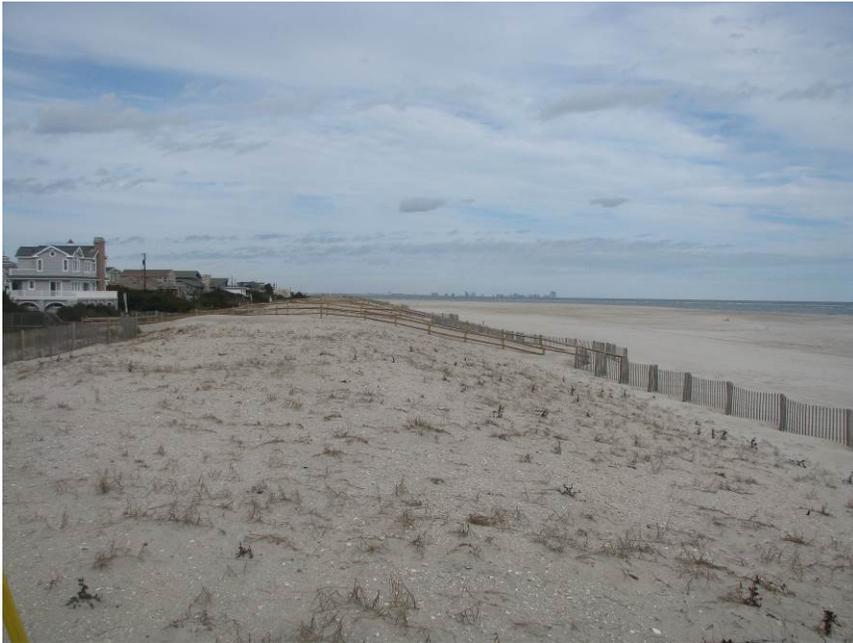
**Figure 6a. November 10, 2015**

**Figure 6a is a view to the north along the seaward dune toe before Jonas hit the shoreline in late January 2016.**

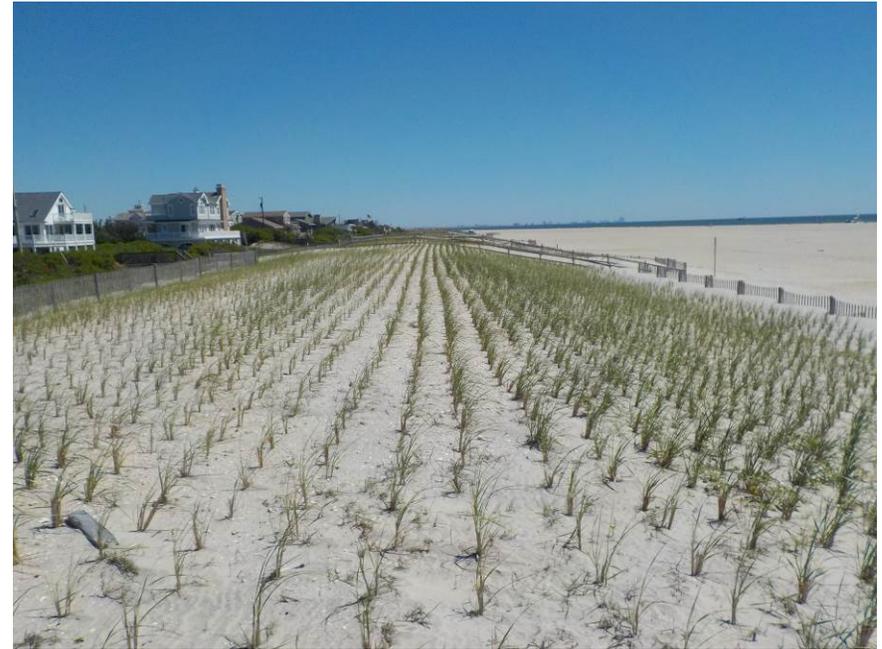
**Figure 6b. June 10, 2016**

**Figure 6b shows the newly planted grass following USACE restoration of the Jonas damage to the Ludlam Island beach project.**

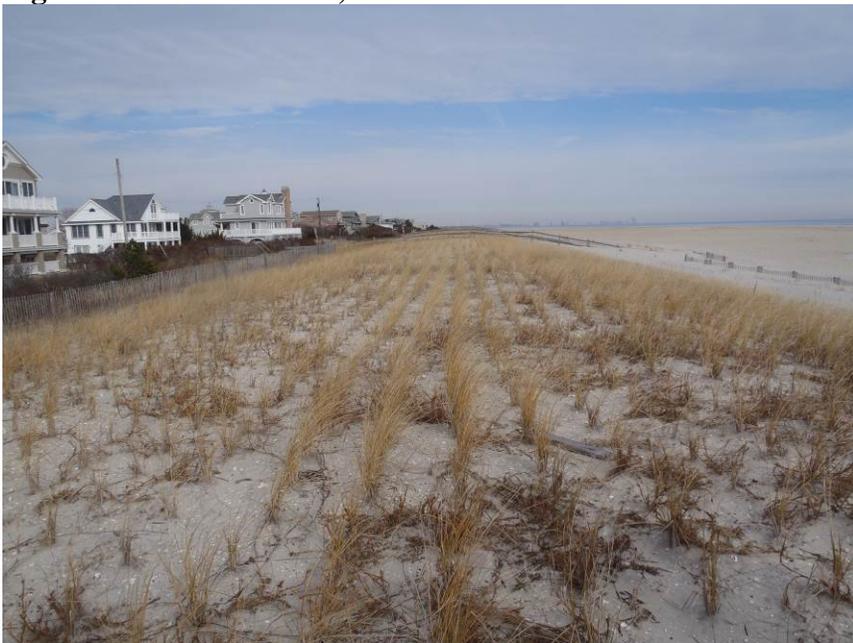
**Figure 6c. December 16, 2016**

**Figure 6c shows the same perspective by December 2016 with the beach fencing nearly buried as the wind has transported dry beach sand to the dunes.**

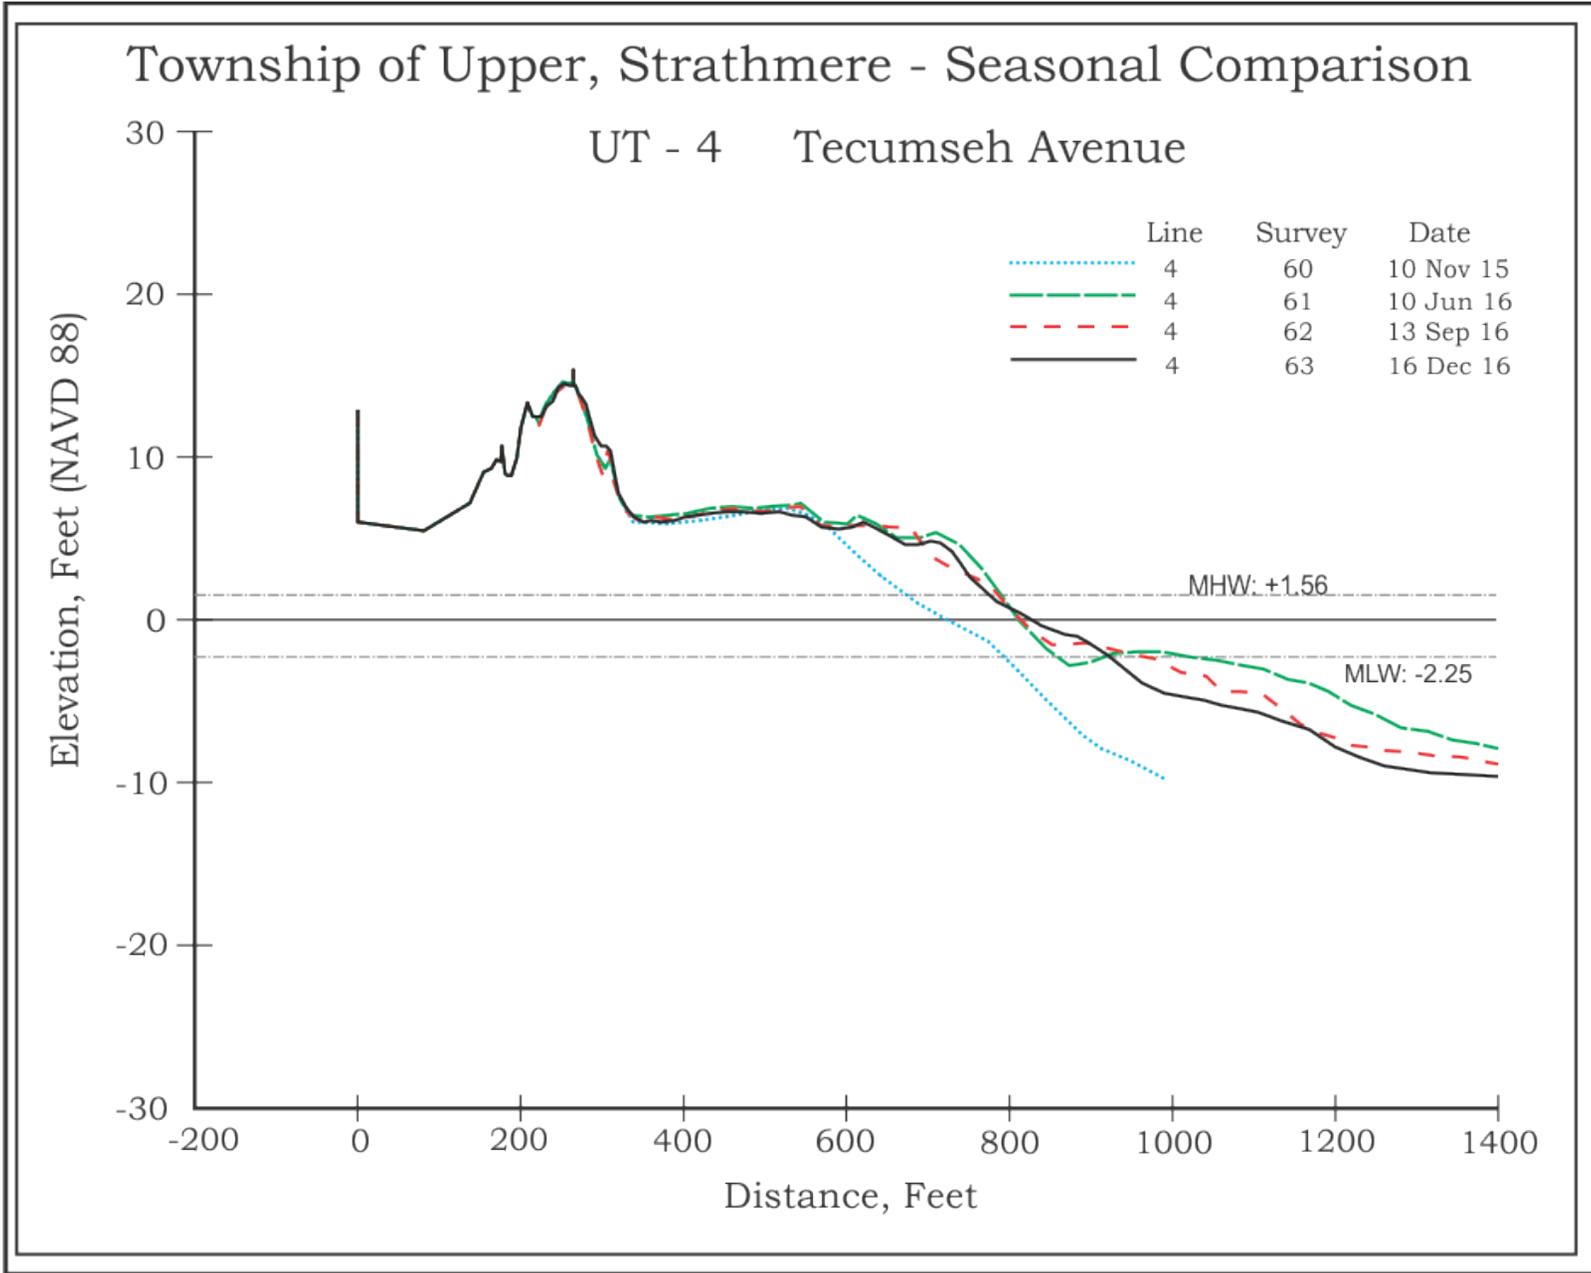
**Figure 7.** This site shows the results of adding sand following NE Storm Jonas to restore the project to design template. The addition amounted to 61.39 yds<sup>3</sup>/ft. by December 2016. Change since June was fairly minimal reflecting offshore bar migrations.

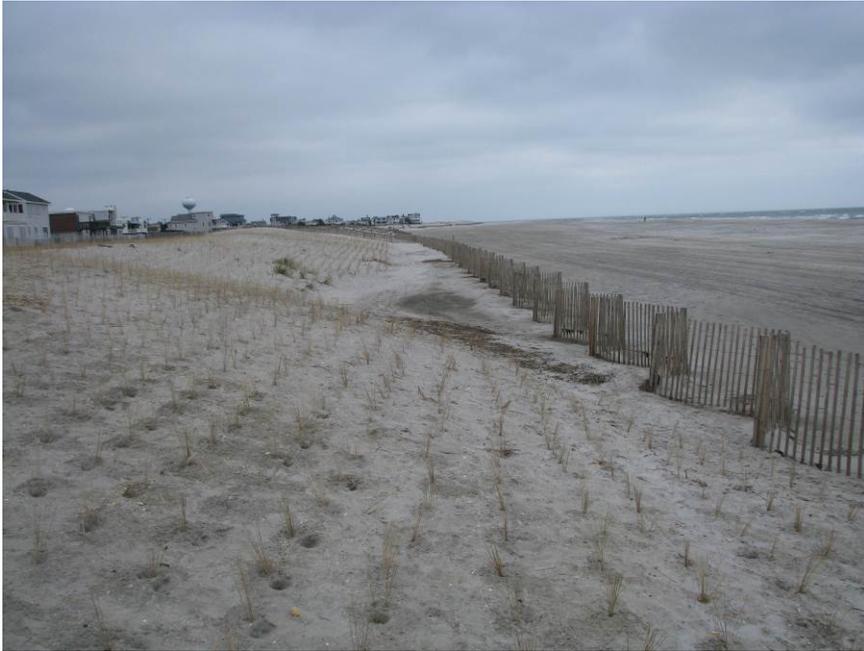
**8a. November 15, 2016**

**Photo 8a shows the new USACE dune with new plants and fencing.**

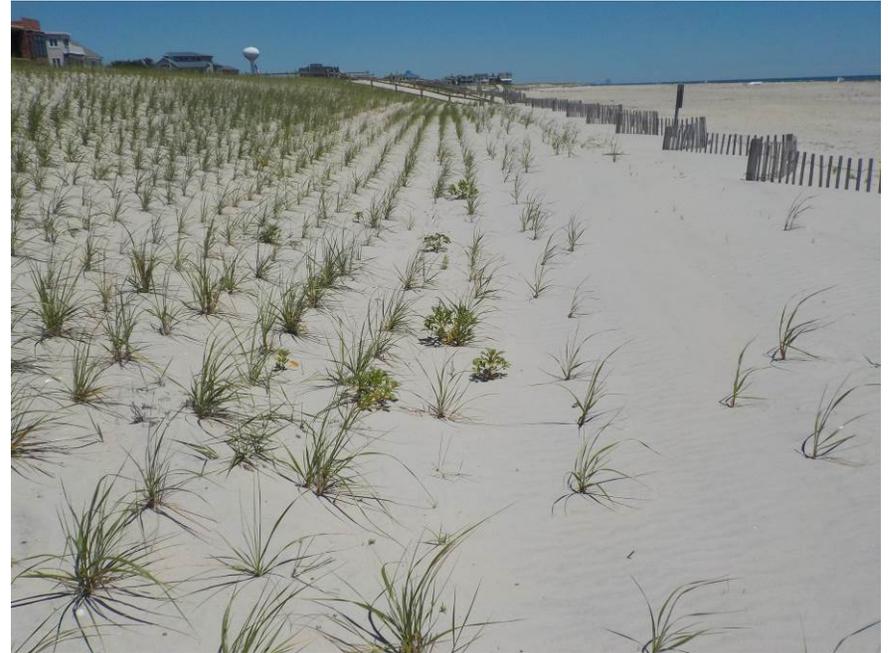
**8b. June 10, 2016**

**Photograph 8b was taken following the USACE restoration following NE Storm Jonas, with sand building at the fence and plant growth underway.**

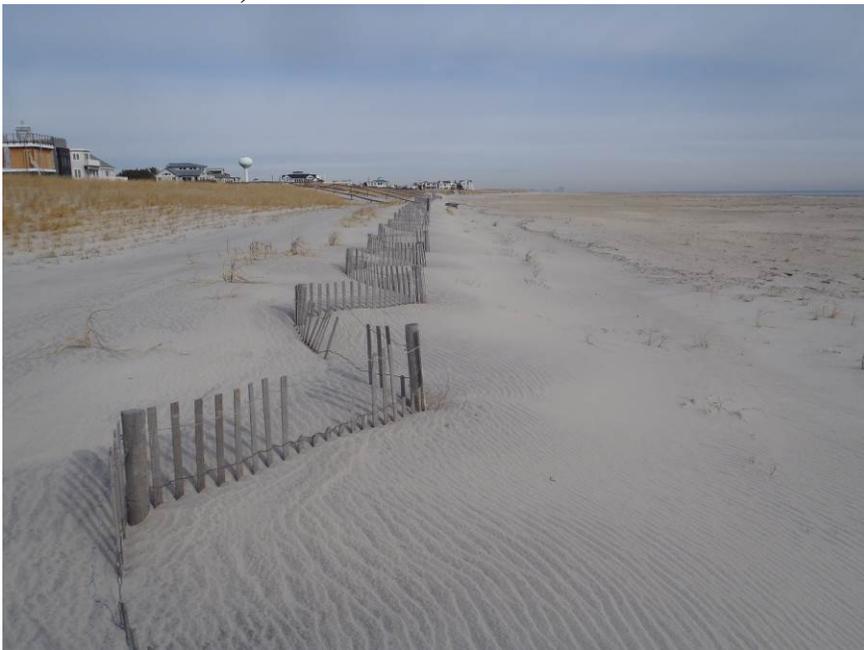
**8c. December 16, 2016**

**Photograph 8c shows the deposit at the fence in one year. The dune's seaward slope has built up to the point where it shows below on the cross section.**

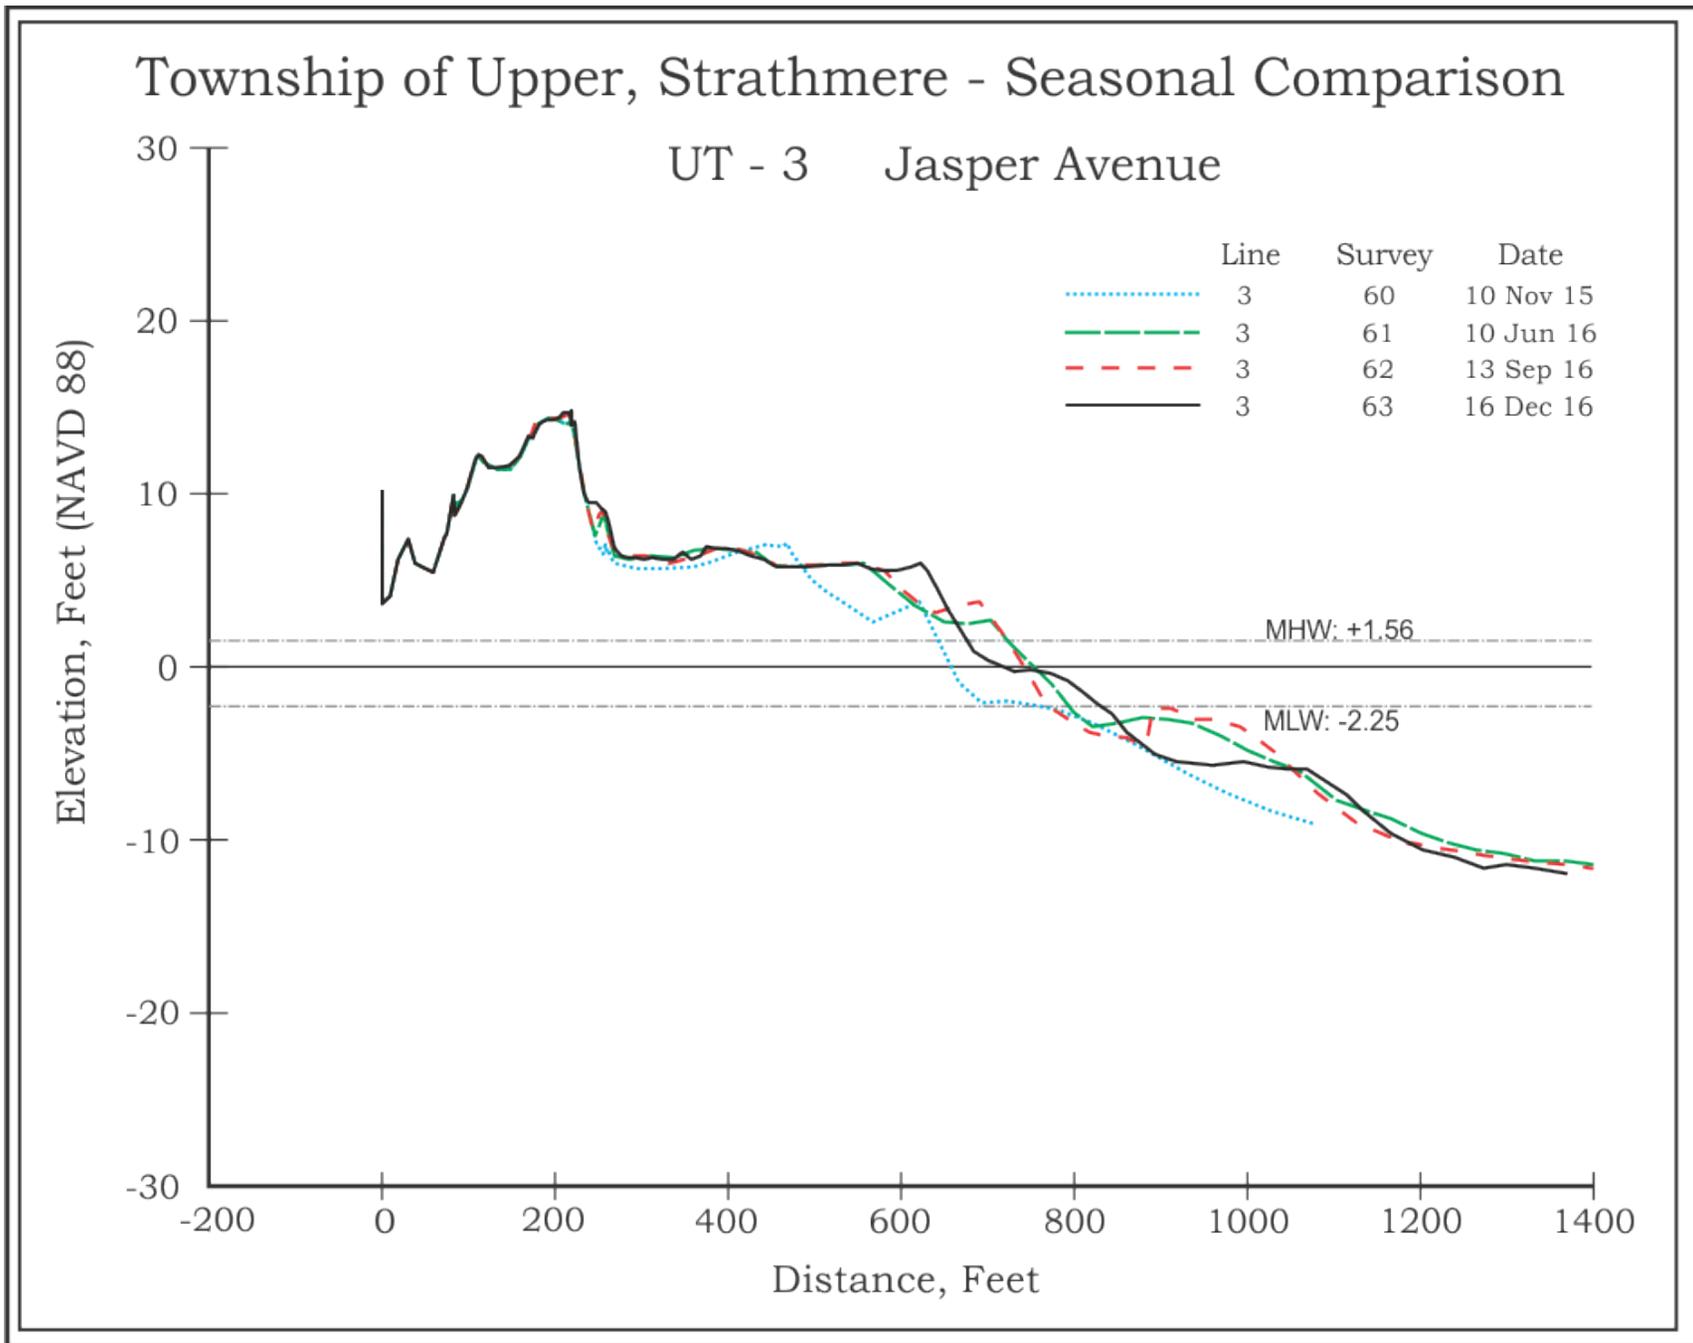
**Figure 9. This site had 43.98 yds<sup>3</sup>/ft. added to the cross section as of the December survey. The most dramatic feature is the pronounced berm crest present in the December survey.**

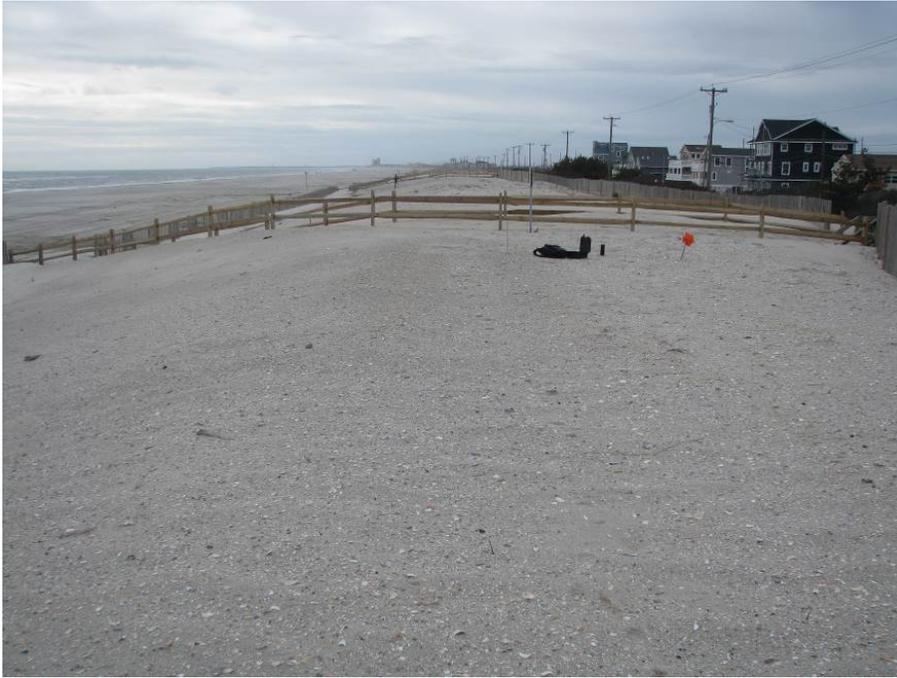
**10a. November 10, 2015**

**Figure 10a is a view to the south along the dune crest after the federal project was complete.**

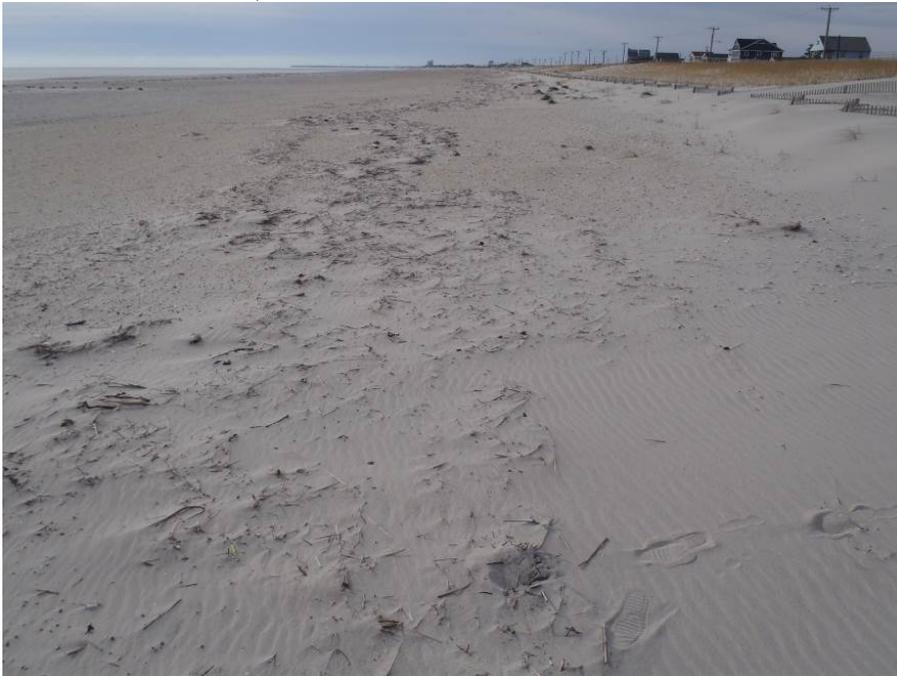
**10c. December 16, 2016**

**Photograph 10c is a view to the south along the wrack line seaward of the dune toe that shows near burial of the 4-foot high fencing.**

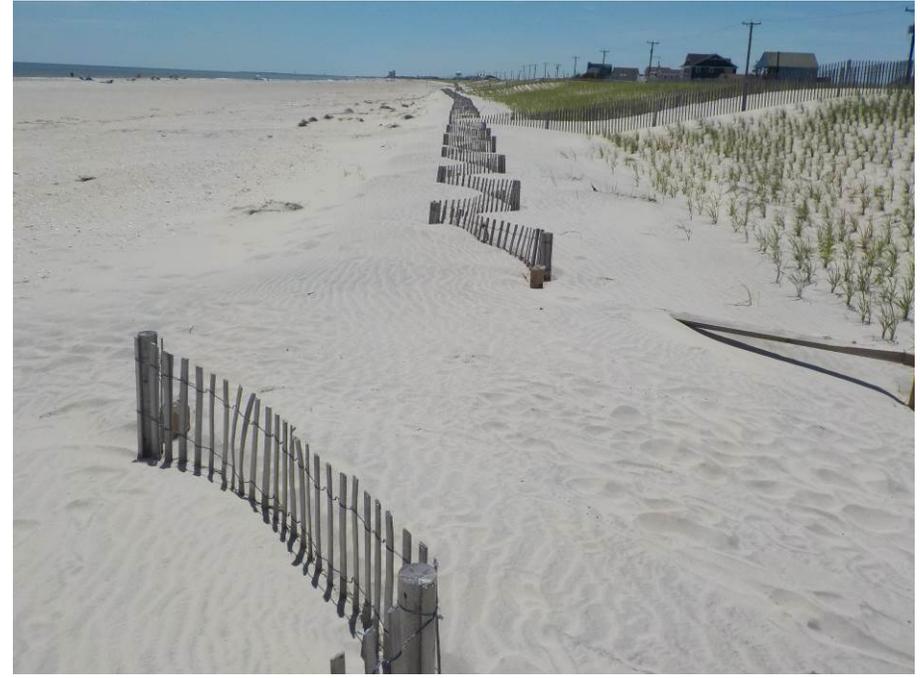
**Figure 10b. June 10, 2016**

**Photograph 10b shows the dune toe in June with a substantial deposit of wind transported sand added at the fence. The plants are in place as well.**

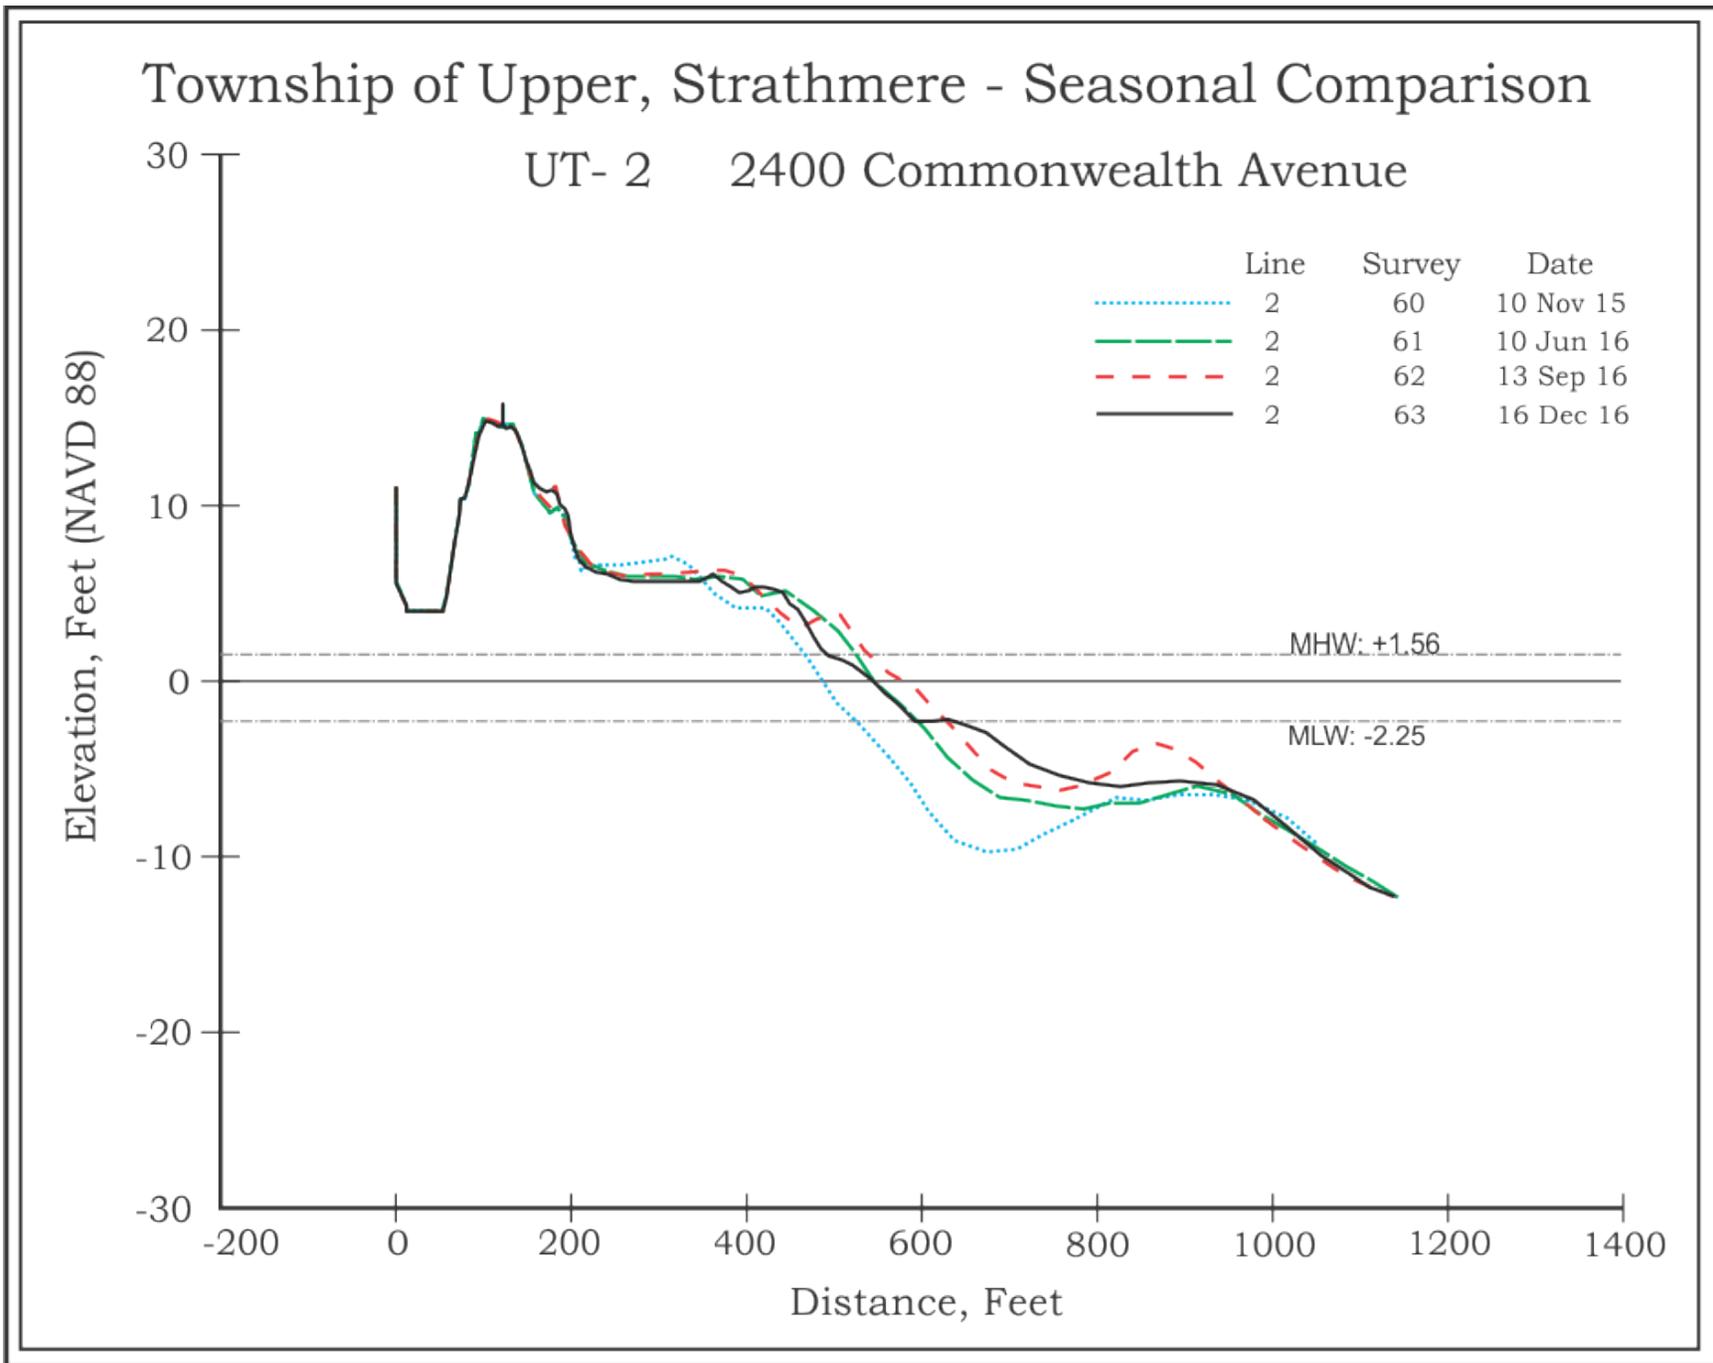
Figure 11. These cross sections demonstrate the sand volume added by June 2016 following NE Storm Jonas with details on the offshore bar system and additions to the dune toe shown above in the photographs.

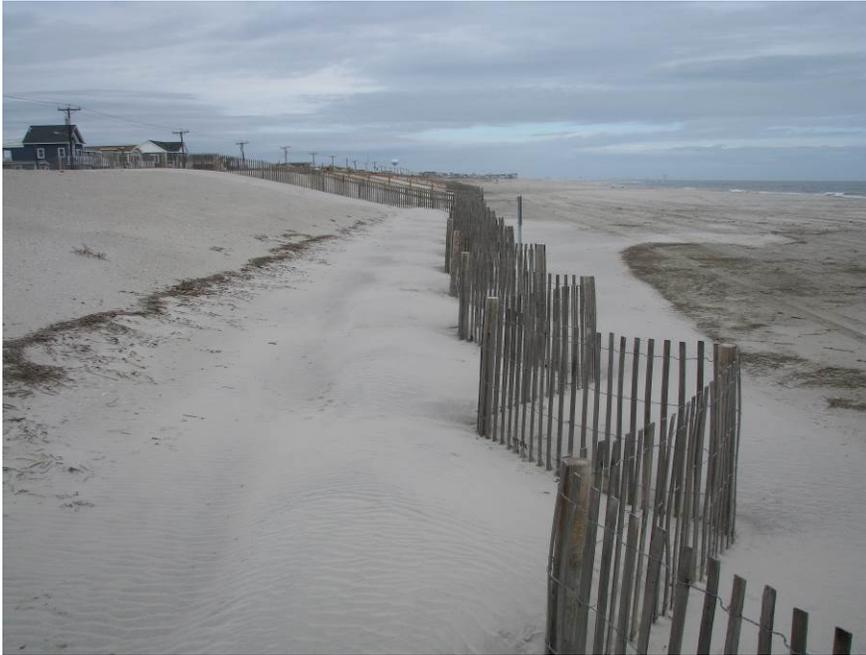
**12a. November 10, 2015**

**Photograph 12a shows the new dune fencing at the base of the USACE dune with two wrack lines indicating storm flood levels quite recently.**
