**FINAL REPORT FOR 2016  
ON THE CONDITION OF THE MUNICIPAL BEACHES  
IN  
THE TOWNSHIP OF UPPER, CAPE MAY COUNTY, NEW JERSEY**

**Annual Report for 2016**  
**To**  
**The Township of Upper On the**  
**Condition of the Municipal Beaches**

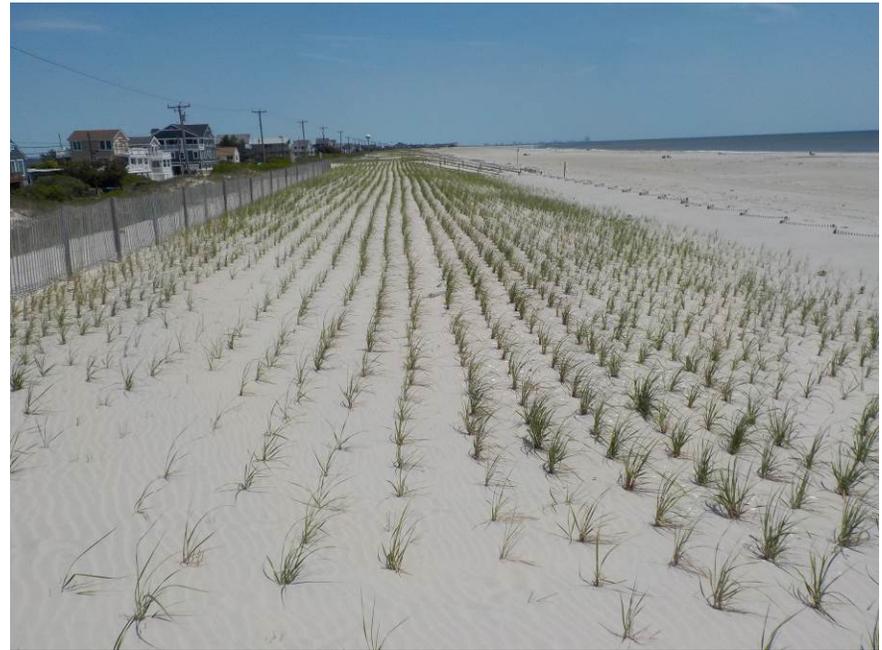
**12b. June 10, 2016**

**Photograph 12b shows the restored dune with new grass plants and the deposition of wind transported sand nearly to the top of the 4-foot fence.**

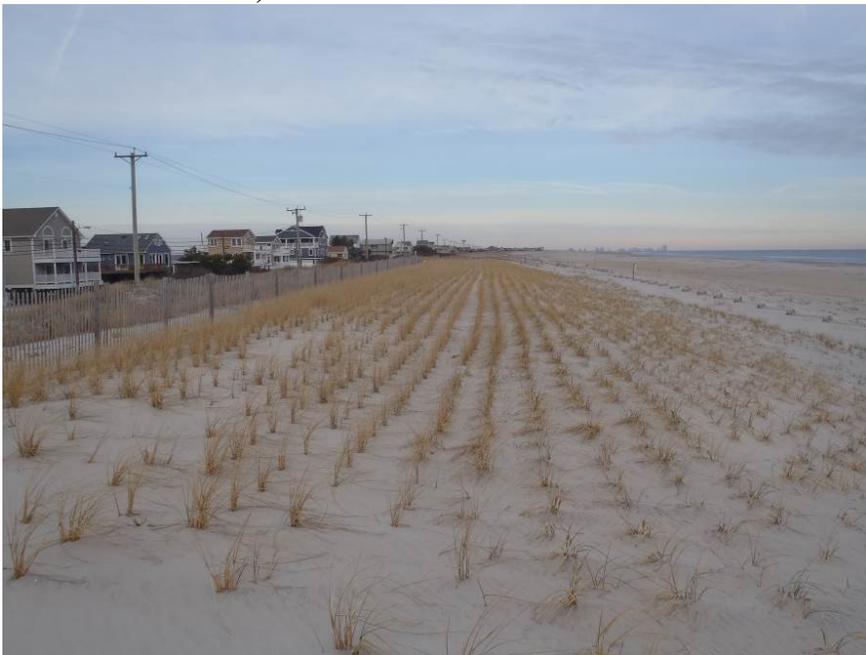
**12c. December 16, 2016**

**Photograph 12c provides the winter view to the north across the dune and onto the beach. The fence continues to be increasingly buried in new sand added to the dune toe.**

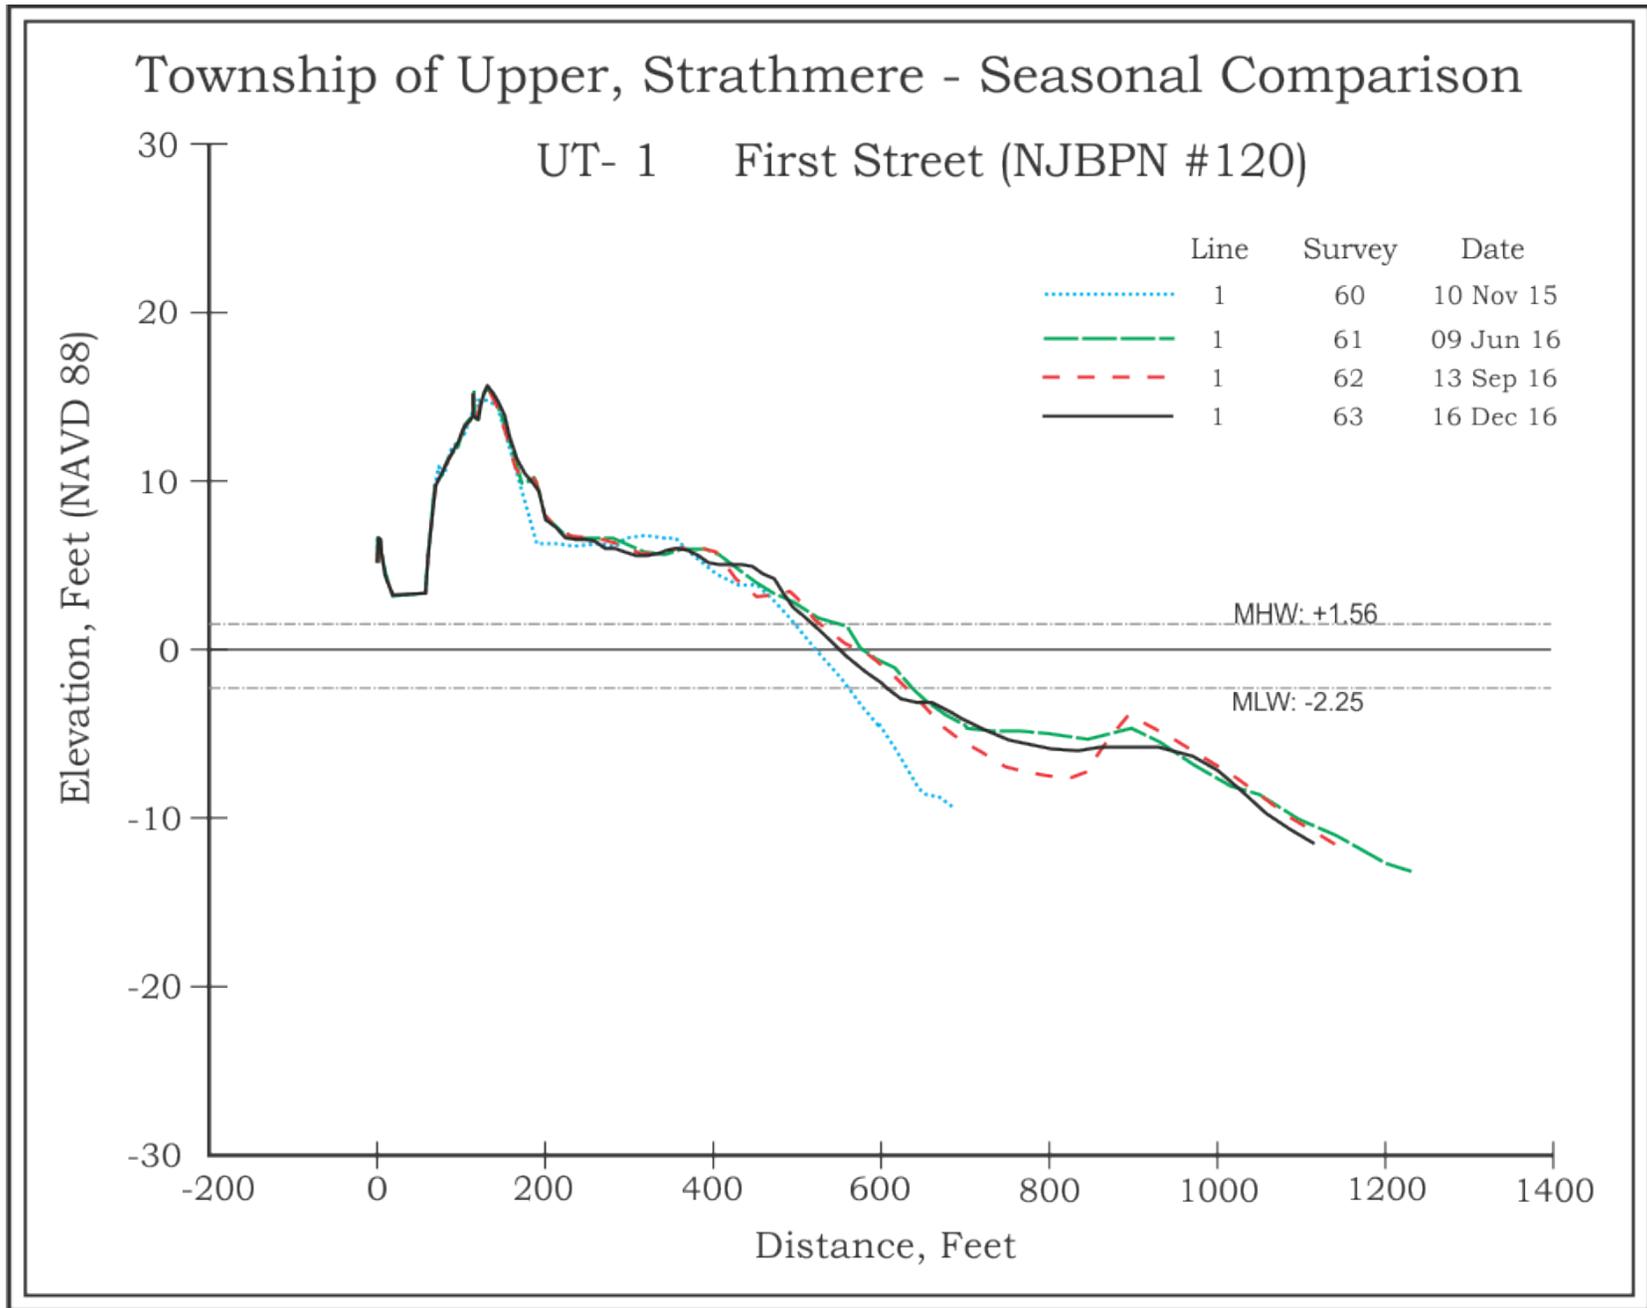
**Figure 13.** In spite of fewer cubic yards of repair sand (26.86 yds<sup>3</sup>/ft. & a 28-foot shoreline advance as of December 2016, this site really achieved a wider cross section at shallower depths offshore that just do not show in volume calculations because the shorter distance seaward reached in November 2015.

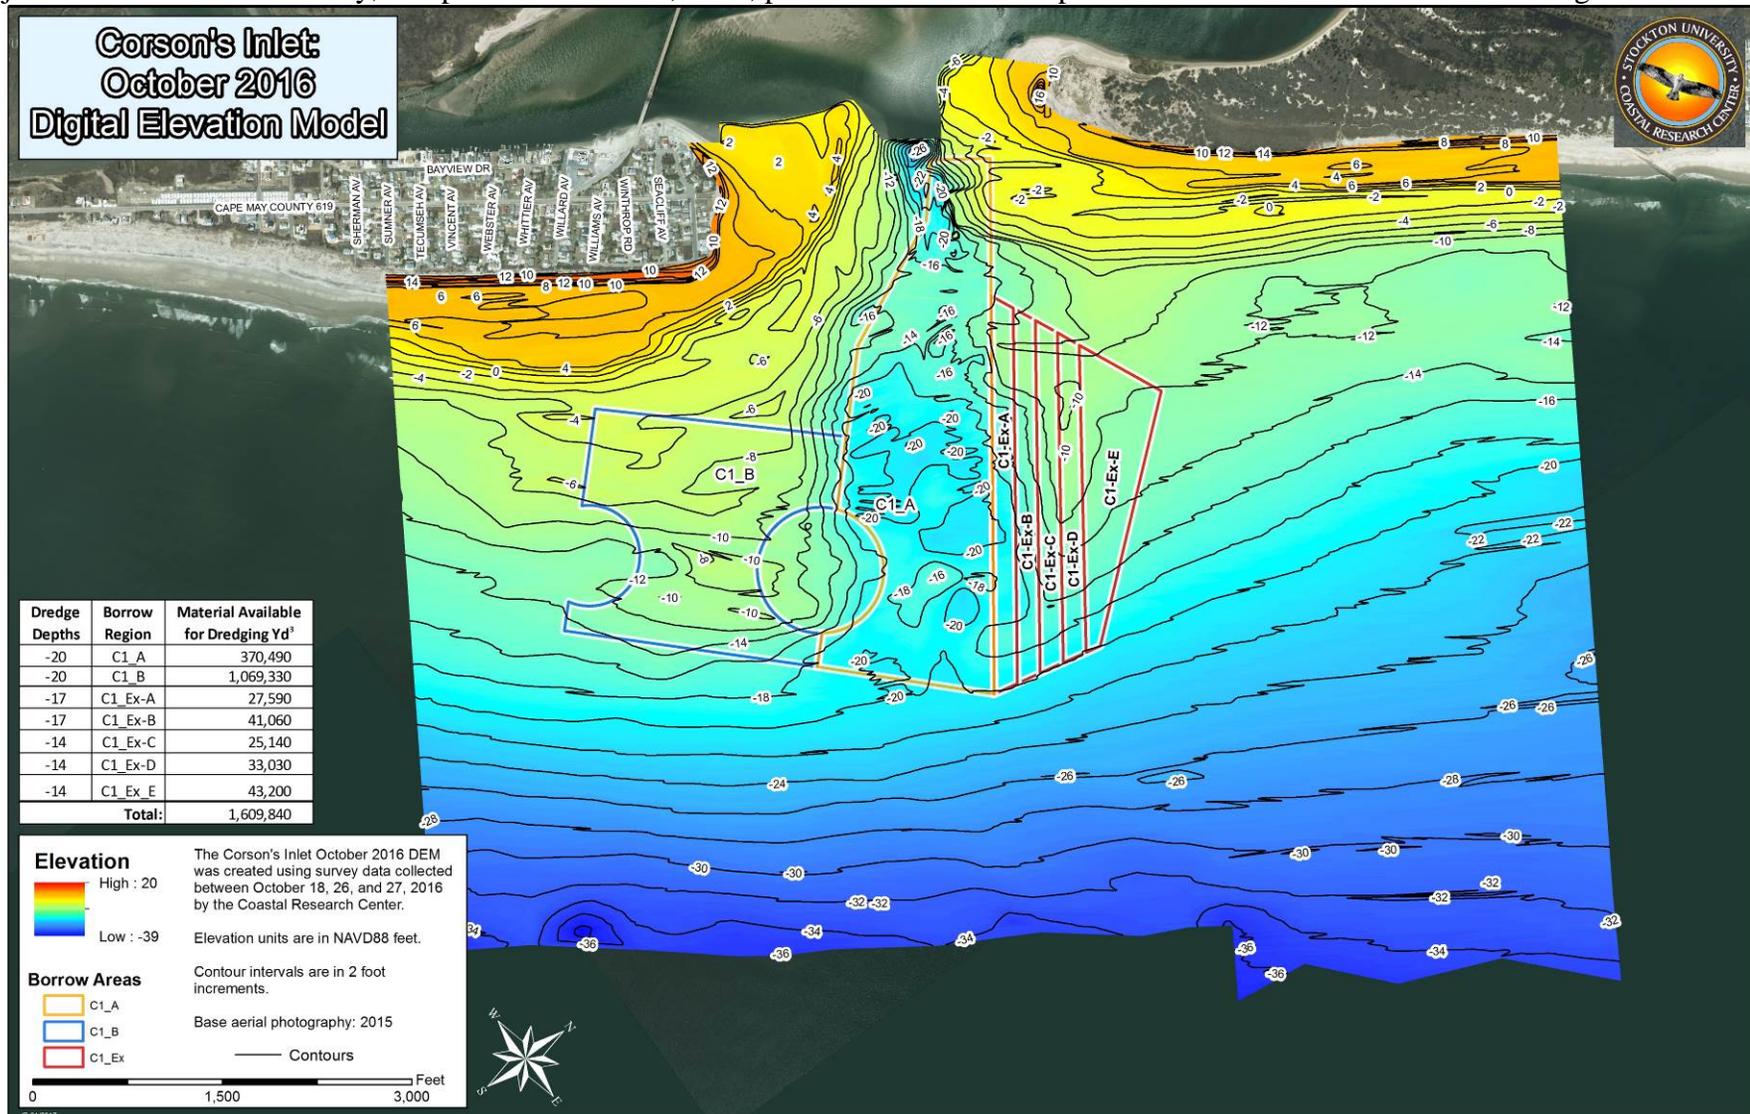
The Division of Coastal Engineering has funded the CRC survey of Corson's Inlet ebb-tidal and nearby beaches twice annually since the 2009 beach project. The most recent survey, completed October 27, 2016, presents below as a map of the seafloor and beaches surrounding the inlet.

**Figure 14. Bathymetry of Corson's Inlet from October 18, 26 & 27, 2016 showing the main channel exiting straight seaward with accumulating shoals along the northeast margin. A complex of shoals also extends seaward on the Strathmere side as well indicating an abundance of sand to maintain the inlet shoreline in Strathmere and the State Park. The line work within the inlet defines the approved sand borrow zones used for beach maintenance. The initial 2015 work brought in sand from offshore borrow sites meaning that the sand is new to the barrier system and increases the sediment budget by 3.4 million cubic yards.**

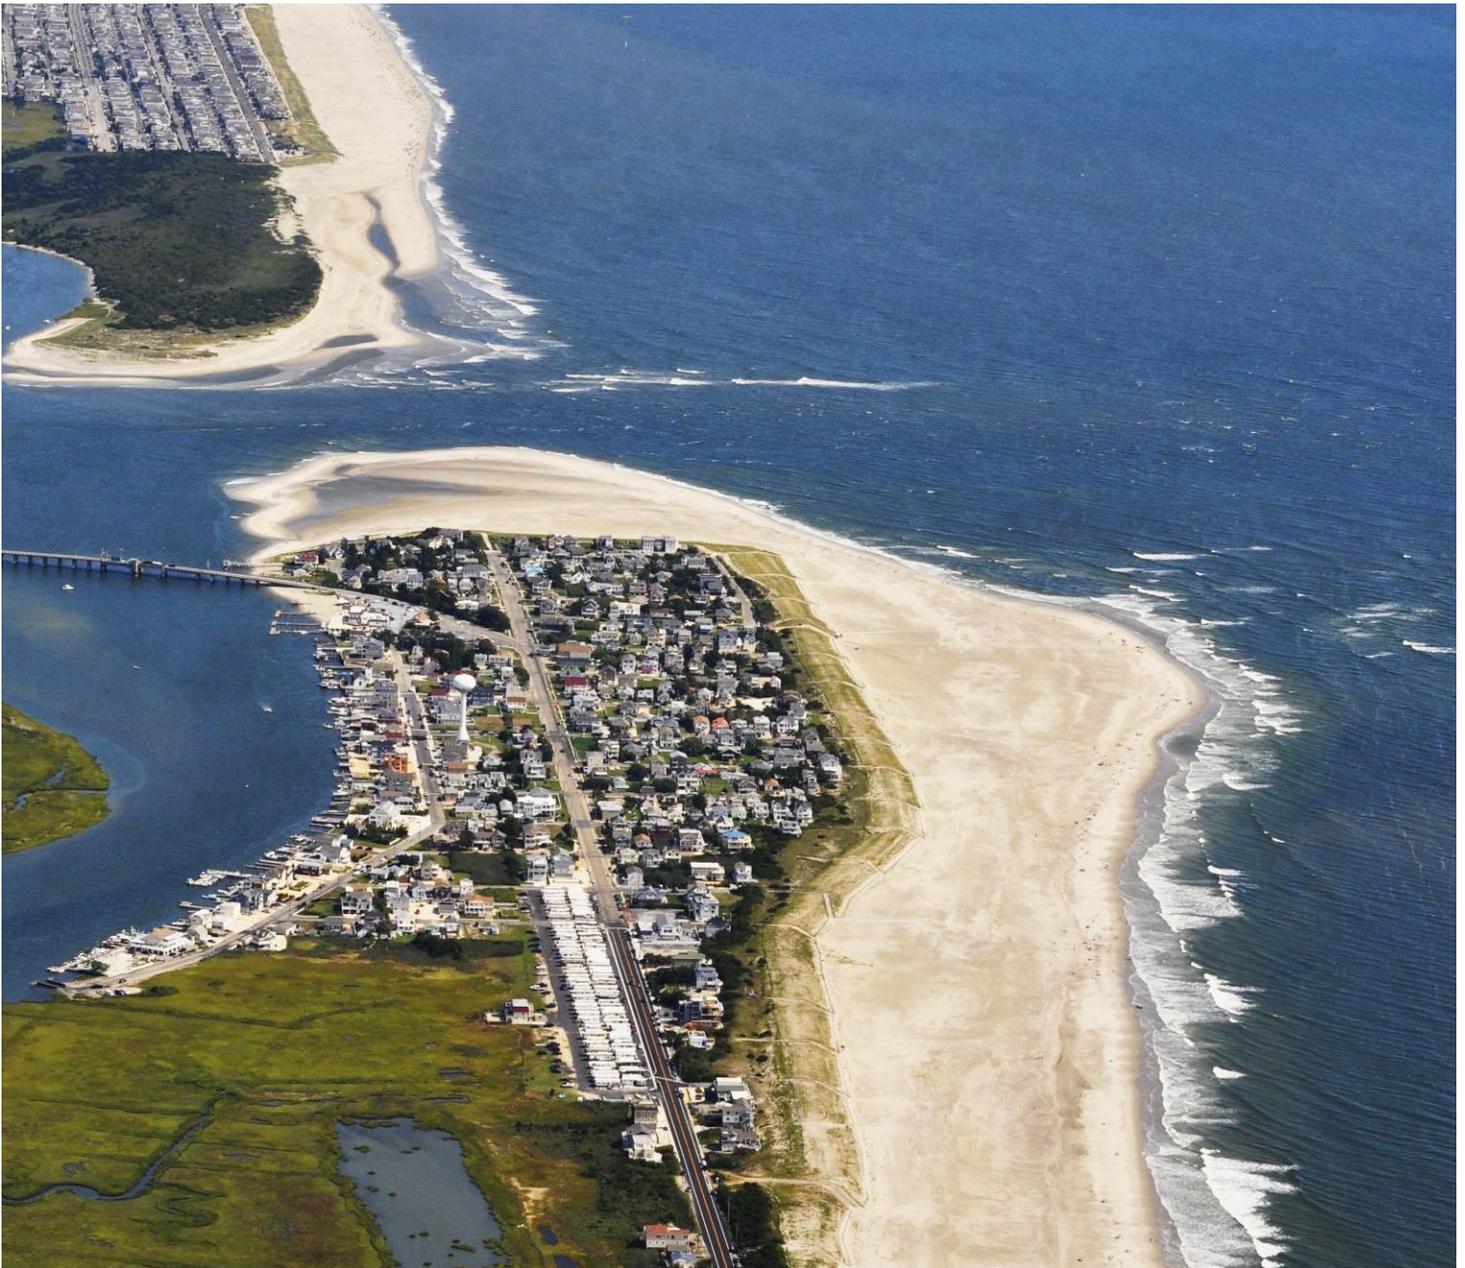
**Figure 15. Aerial photograph taken September 2, 2016 by Ted Kingston looking north, northeast across the wide central beaches of Strathmere showing where sand is accumulating in the zone between Williams and Tecumseh Avenues as a pronounced lobe extending several hundred feet seaward of the average shoreline trend. The sand coming south from Ocean City is clearly present as the long spit reaching the inlet as a barely submerged shoal. The northeast Strathmere shoreline has assumed a northeast perpendicular straight line shape signifying both wave and tidal current effects. Flood tidal currents do bring sand along this straight segment so long as the lobe remains in place with shoals to the seaward of it. The tidal currents in the inlet also show clearly as a straight-out exit for the moment.**
