# STOCKTON UNIVERSITY COASTAL RESEARCH CENTER

## New Jersey Beach Profile Network 2020 Annual Report on Shoreline Changes in New Jersey's Four Coastal Counties Raritan Bay to Delaware Bay Spring of 2019 Through Fall of 2020

August 31, 2021

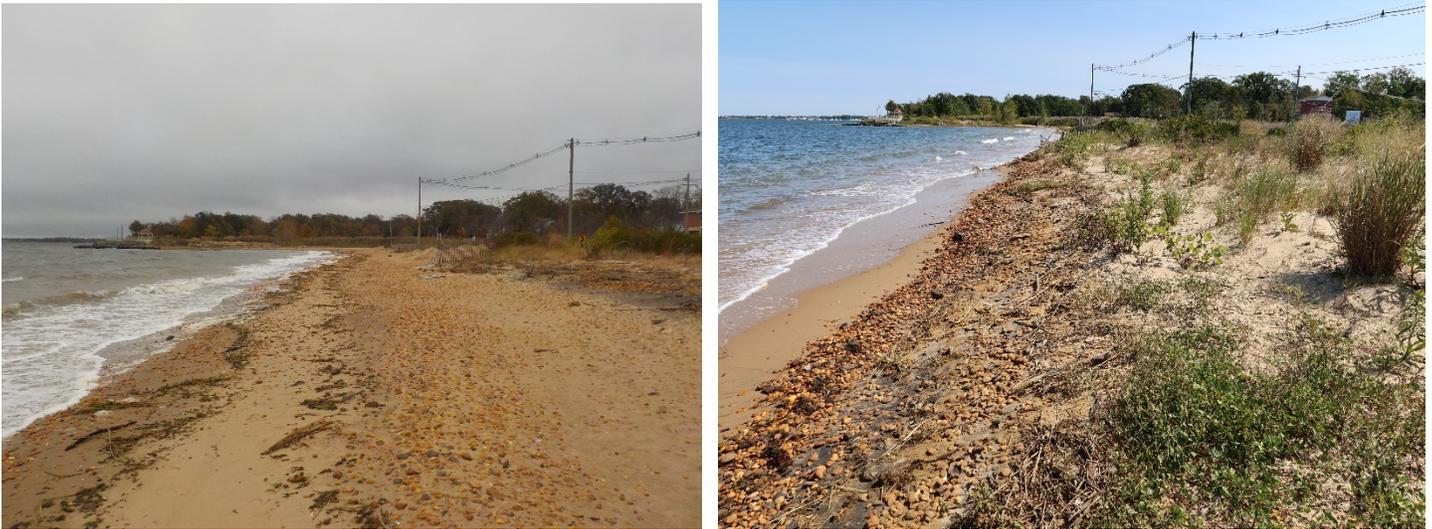
**NJBPN 187 – Beach Park, Cliffwood Beach**

This is the westernmost NJBPN site located on Raritan Bay. The photograph on the left shows the shoreline on October 11, 2019 at a particularly low tide revealing the fine sand composing the Raritan Bay floor. The right picture was taken September 22, 2020 and shows a higher tide stage, but a very similar beach and dune profile.

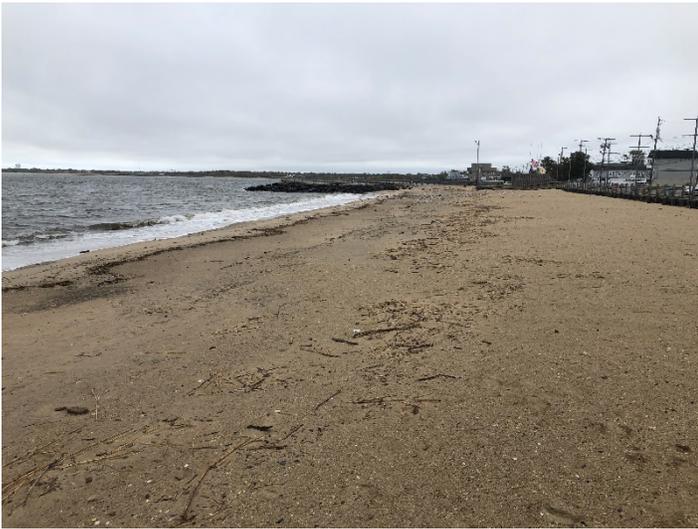
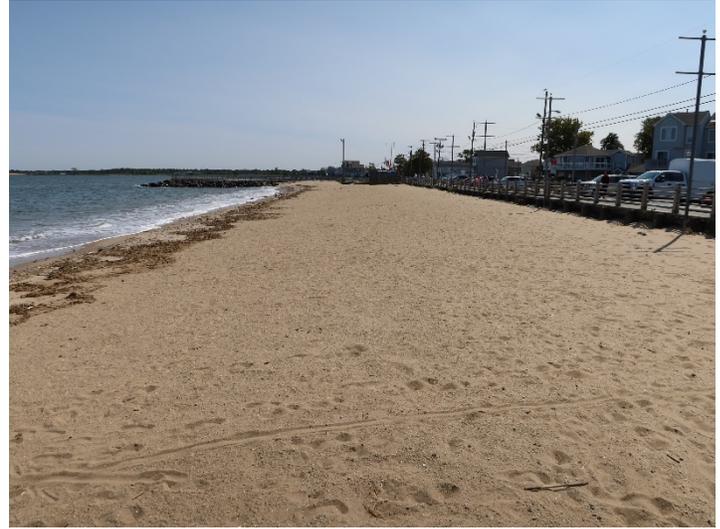
**NJBPN 286 – Beach Street, Union Beach**

This site was moved to the public bathing beach in 2009. The photograph on the left shows the shoreline on October 24, 2019. The photo on the right shows the beach width and berm on October 24, 2019 with a beach slope created by the bay wave action. The photo on the right shows the shore line on September 22, 2020. The shoreline has seen very minimal change during these two photos.

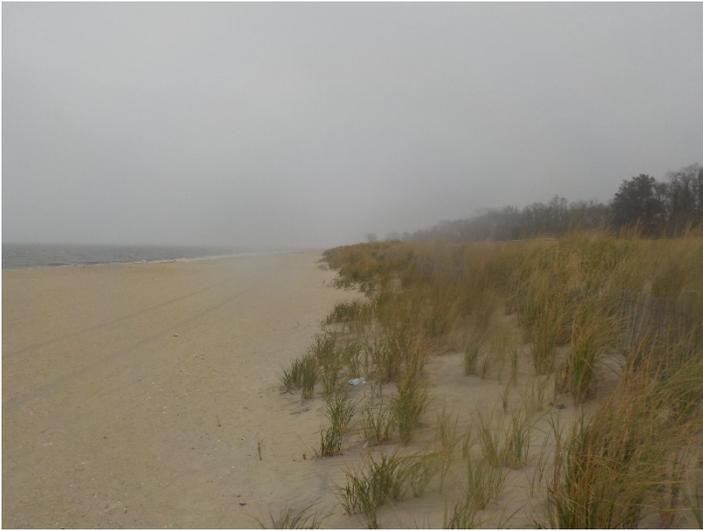
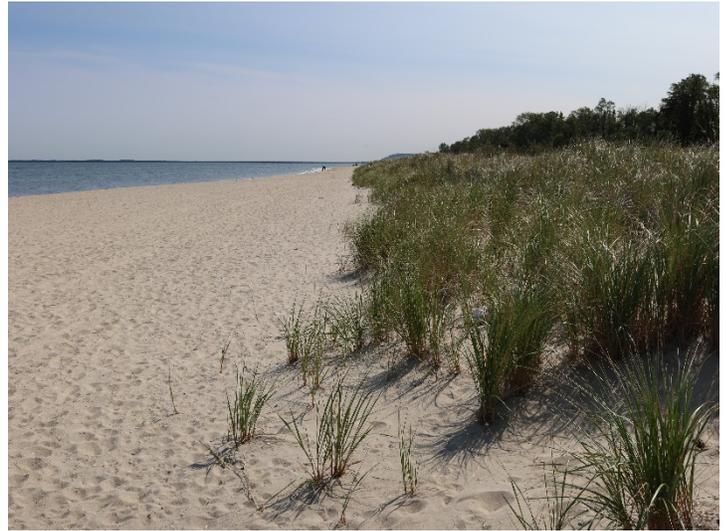
**NJBPN 185 – Bay Shore Waterfront Park, Port Monmouth**

This site was greatly enhanced during 2014 by the NY USACE. The left picture was taken October 22, 2019 showing dune grass progressing out onto the upper dry beach beyond the fence. The right photo was taken September 22, 2020 showing the continued growth of dune grass outward onto the dry beach.

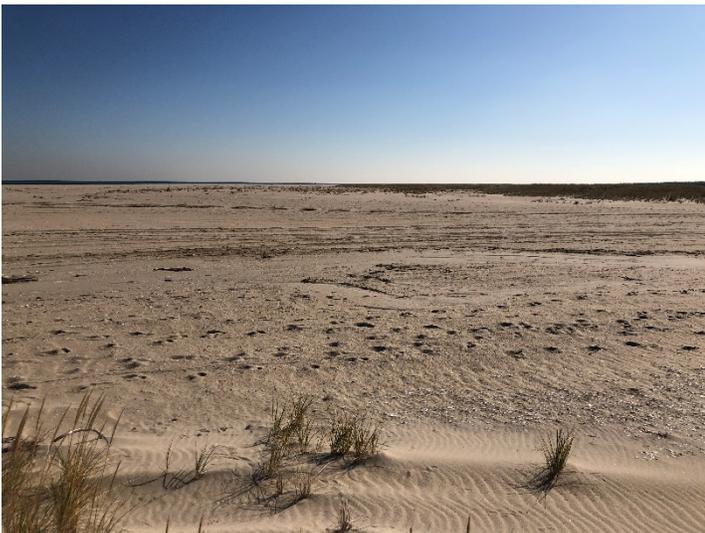
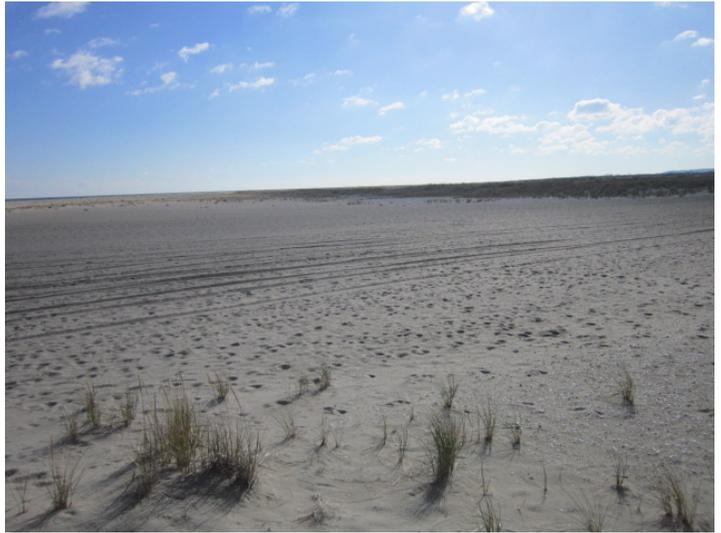
**NJBPN 385 - North Beach, Sandy Hook National Seashore**

This Sandy Hook location was established in December 2016. The view on the left, taken November 22, 2019, shows the extensive expanse of dry sand making up the northern end of the Sandy Hook spit. The photo on the right, taken December 10, 2020, shows the continued growth of dune grass as well as the sheer mass of the northern end of Sandy Hook.

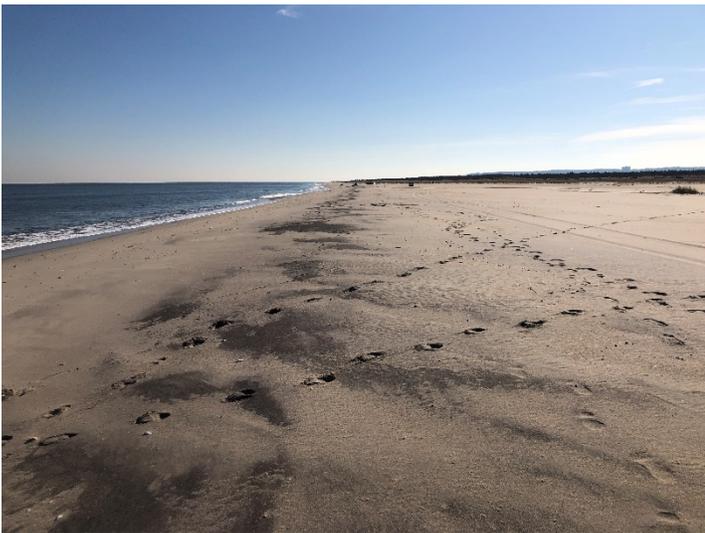
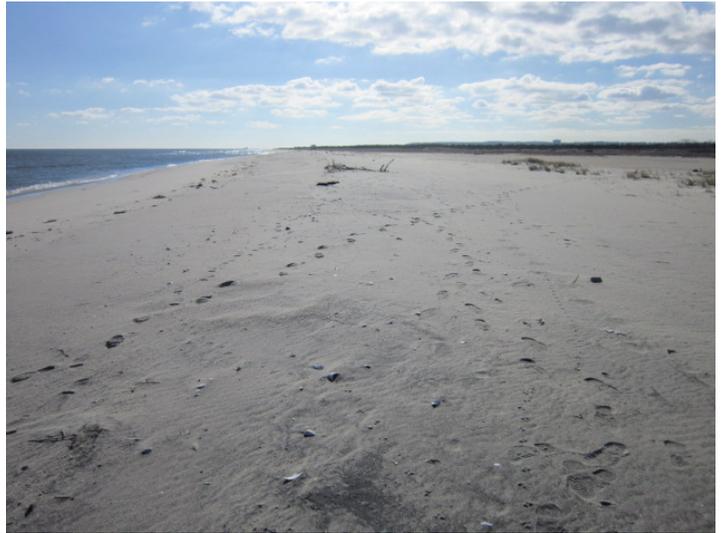
NJBPN 285 – Gunnison Beach, Sandy Hook National Seashore

The photograph on the left shows On November 22, 2019 the berm presented a common ridge with alternating patches of dark minerals separated by the swash. The expanse of beach to the right is enormous. The photo on the right, taken December 10, 2020, shows the gradual transition between the dry beach and the beachface slope.

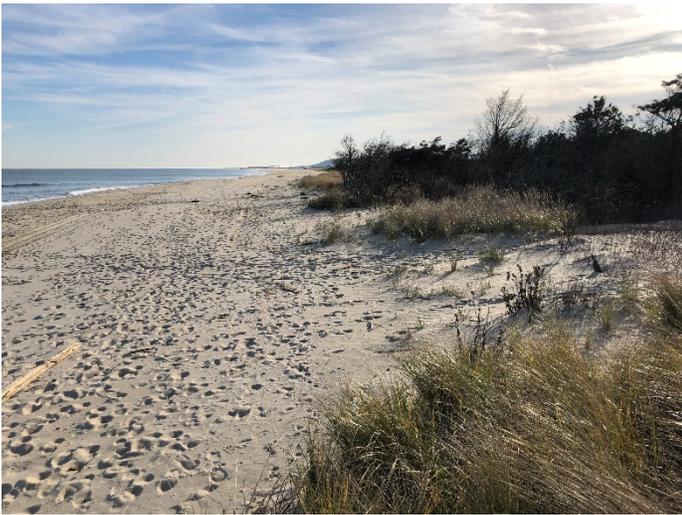
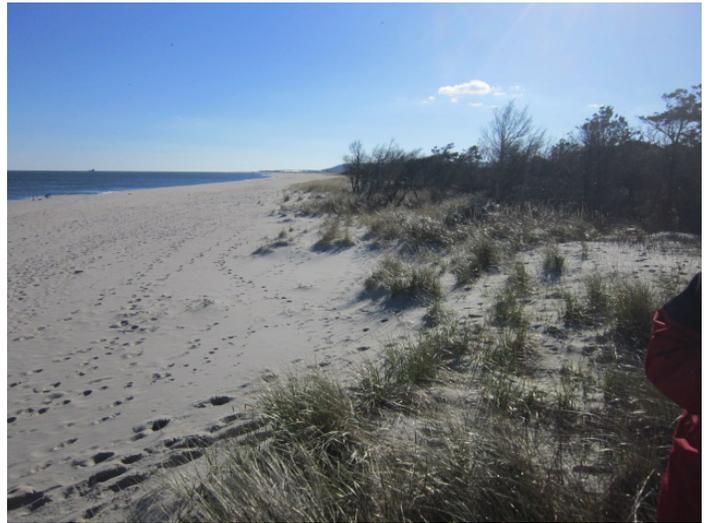
NJBPN 28401 - Area F Road, Sandy Hook National Sea Shore

The left view from November 22, 2019 is to the south along the dune crest shows vegetation on the dunes near the beach. The right-side photograph was taken December 10, 2020 with the beach wider by 55 feet with 33.5 yds<sup>3</sup>/ft. more sand in place.

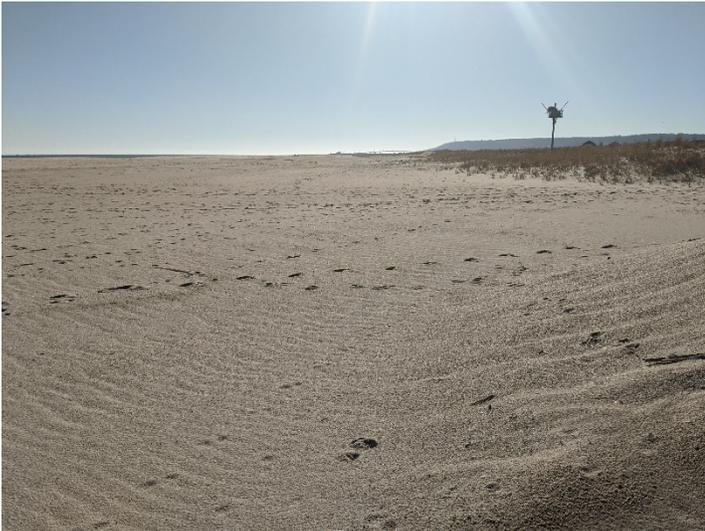
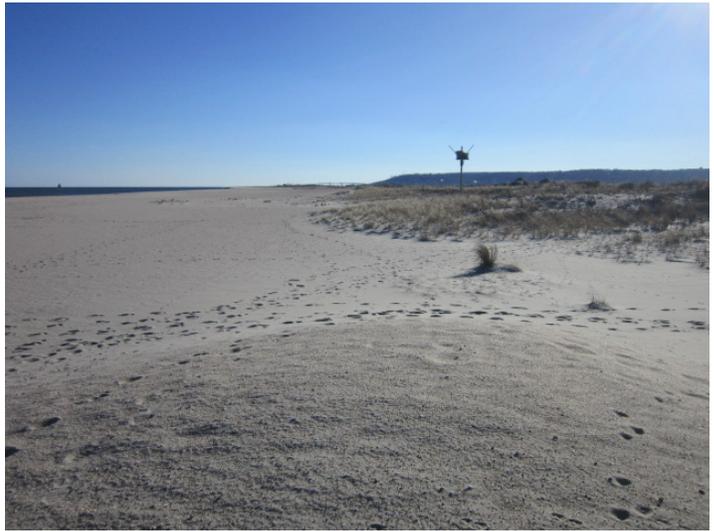
On the left is a beach picture from November 26, 2019 looking south along the dune toe. A similar perspective on December 10, 2020 shows the dune toe and a wide dry beach seaward of the dunes.

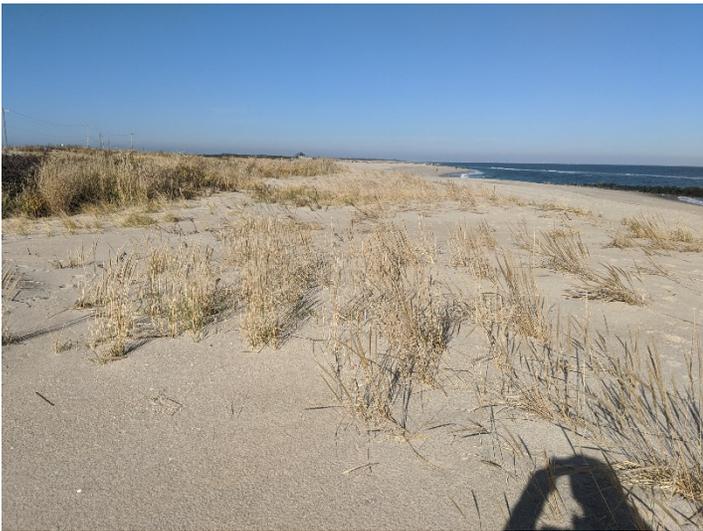
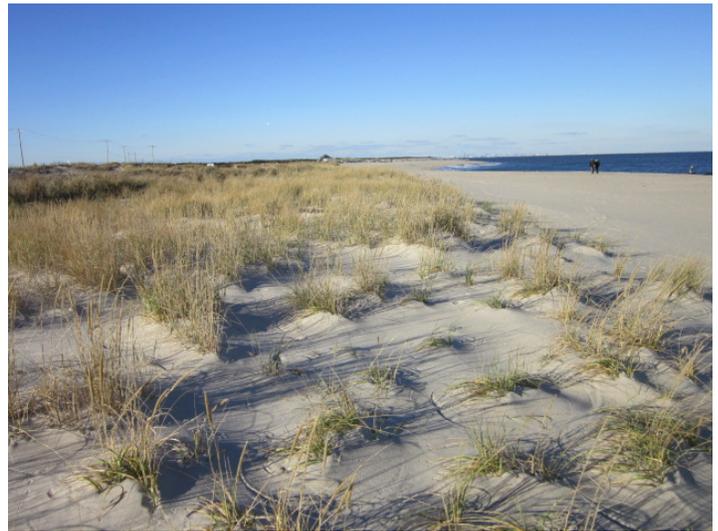
NJBPN 18401 - Parking Lot C, Sandy Hook National Sea Shore

This photo taken of a USACE site on November 26, 2019, shows a wide area of dune growth. A similar view from a photo taken on December 10, 2020, on the right shows that the beach has developed additional sand moved into the dunes as the berm advanced seaward.

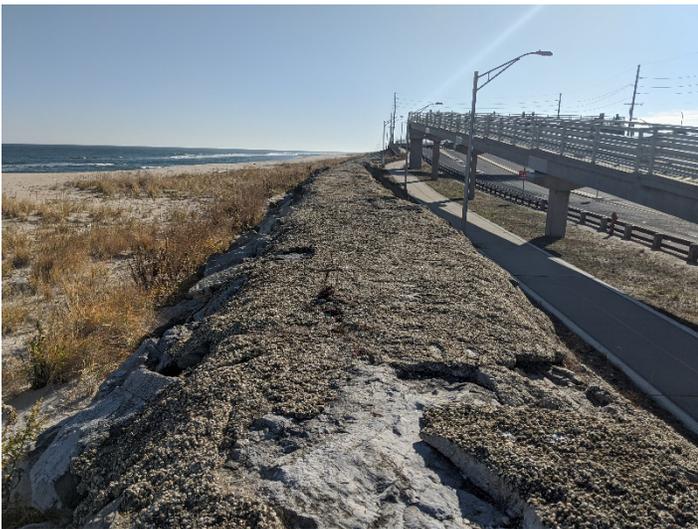
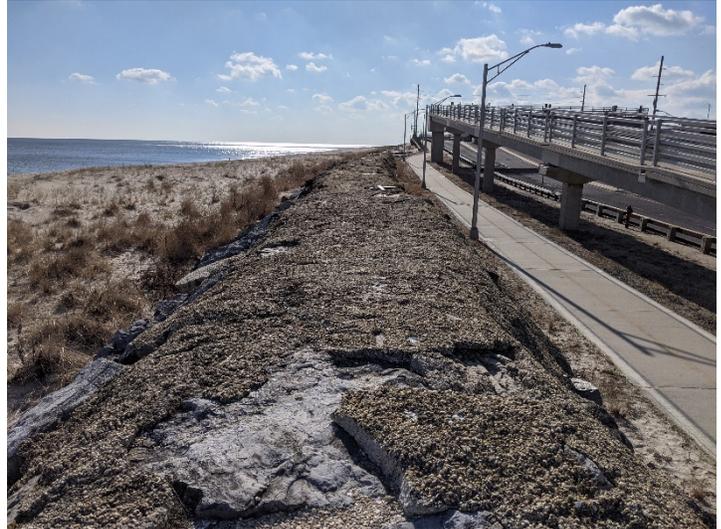
**NJBPN 184 – Highlands Beach, Sandy Hook National Seashore**

This southern Sandy Hook site is located near the entrance to the park. The left view, taken Nov. 26, 2019, faces south from the rock seawall showing the dune system and the beach and offshore bar system. The photo on the right, taken January 21, 2021, shows a very similar landscape, with slightly less dune grass.

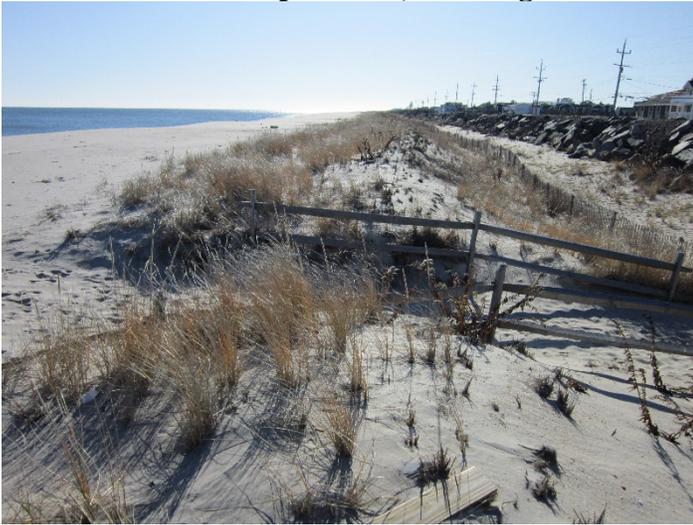
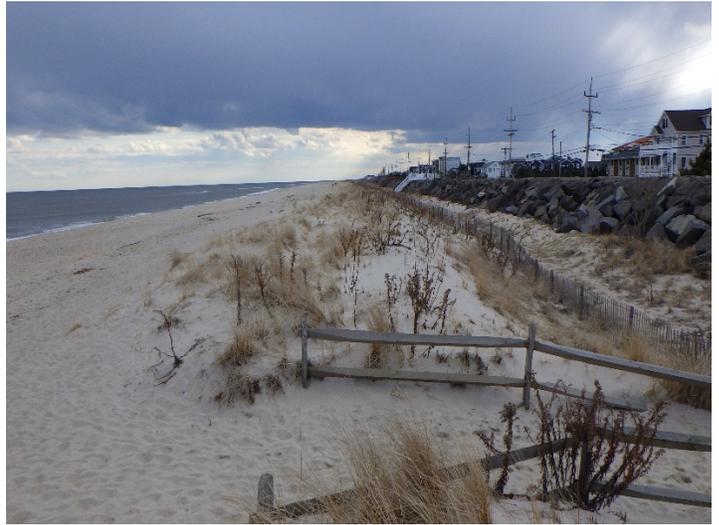
**NJBPN 183 – Via Ripa Street, Sea Bright**

This site is near the northern limit of the initial Federal shore protection project. The left photo shows the seawall and the line of dunes looking south on Dec. 20, 2019. The right photo (Jan. 18, 2021) shows an almost identical looking landscape.

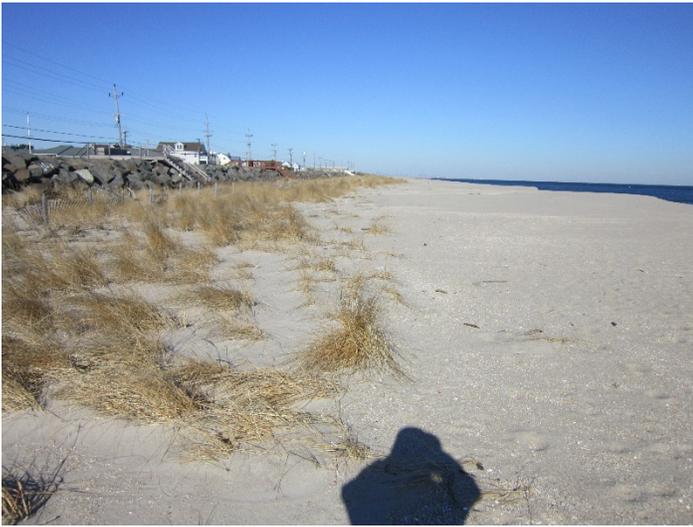
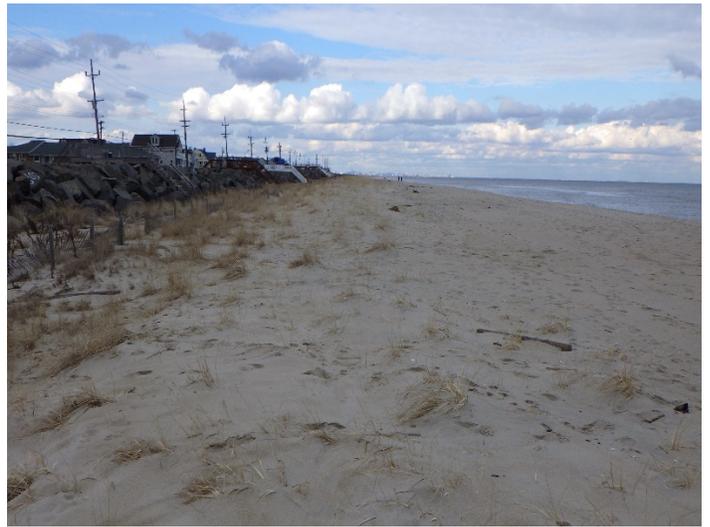
**NJBPN 28202 - 300 Ocean Avenue, Sea Bright**

This new site has beach grass established along the toe of the rock seawall, but no extensive dune exists yet (Dec. 20, 2019). The right-hand photograph was taken Jan. 18, 2021 at the seaward edge of the dune grass, where much of the dune grass seems to be covered by the sand deposited by wind since early spring 2020.

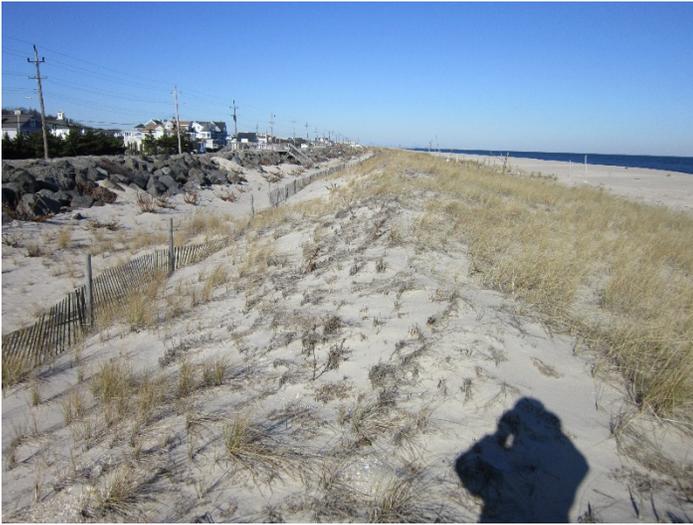
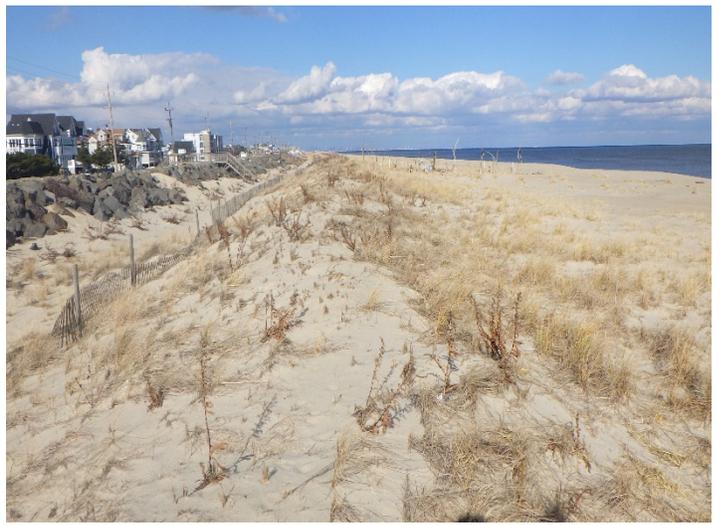
NJBPN 28201 - 436 Ocean Avenue, Sea Bright

A short distance south, this location has a substantial dune developed seaward of the seawall with a wider beach and dune grass extending onto the sand flats near the dune (Dec. 20, 2019). By January 18, 2021 (on right) the grass coverage remained constant with minimal change to the beach.

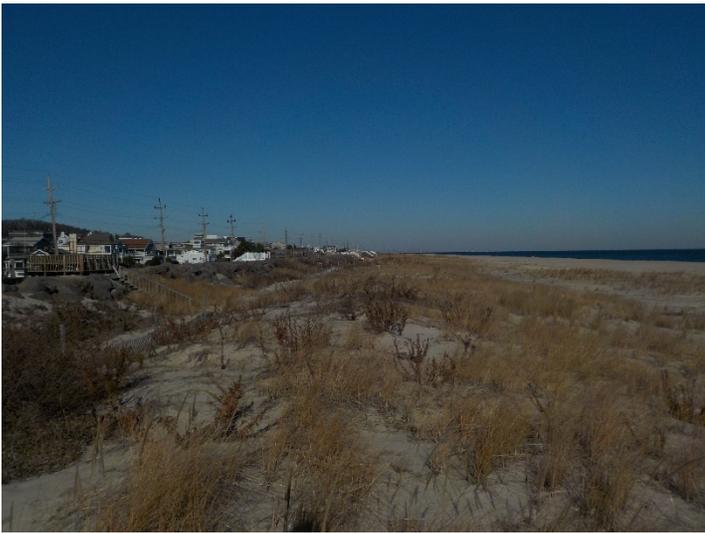
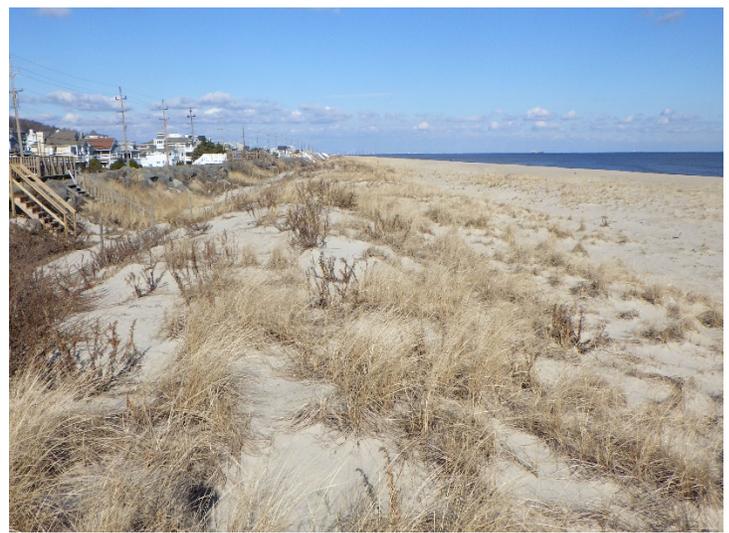
The left view shows the federal project from the crest of the dune on Dec 20, 2019 (view to north). The right photo, also from the dune crest looking north, shows the dune and beach seaward of the rock seawall on Jan. 18, 2021.

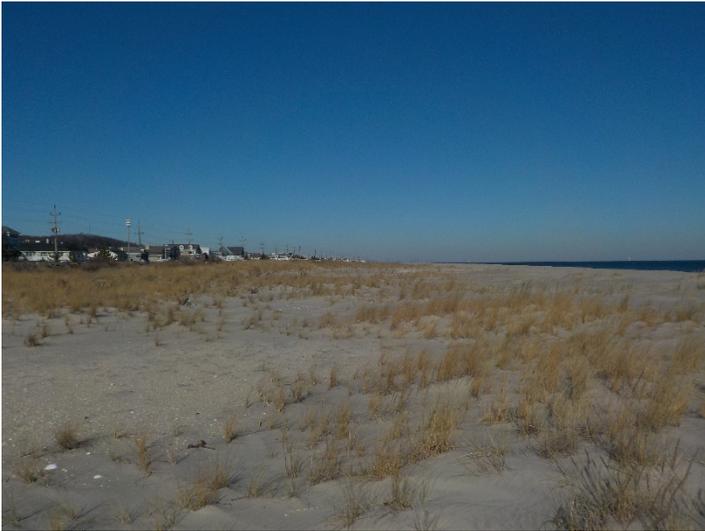
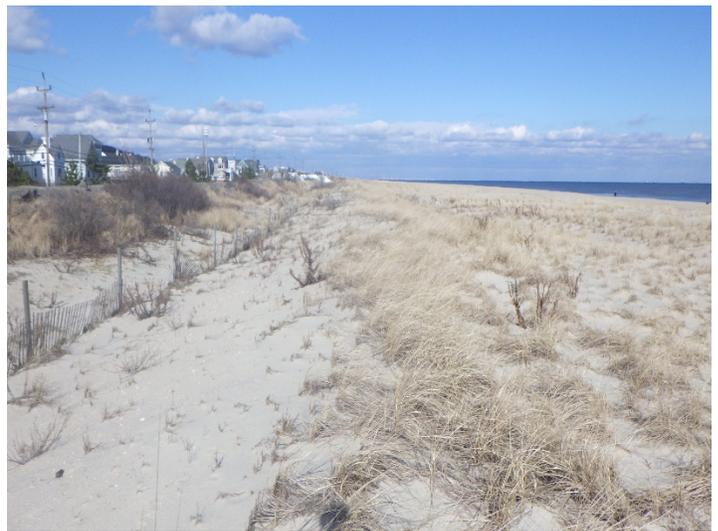
NJBPN 18202 - 678 Ocean Avenue, Sea Bright

The photo on the left, taken December 20, 2019, shows the extent of grass propagation seaward is evident as a foredune development. There was no attempt along Sea Bright to build a dune system except place a line of fence seaward of the seawall. The photo on the right, taken January 18, 2021, depicts a similar landscape, with some wind deposited sand covering the dune grass.

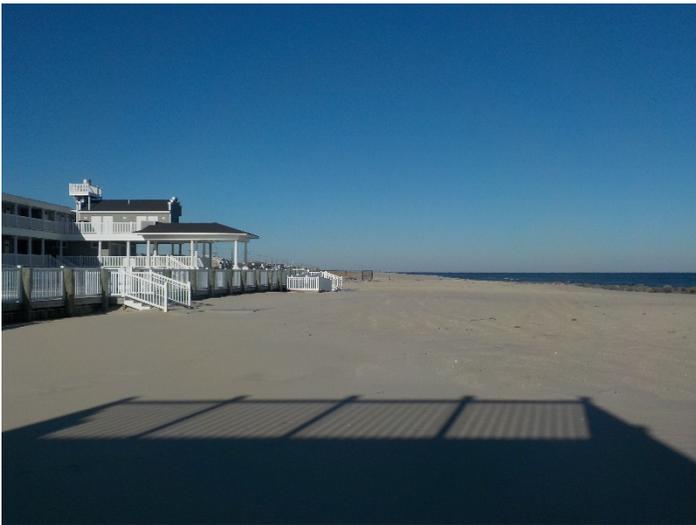
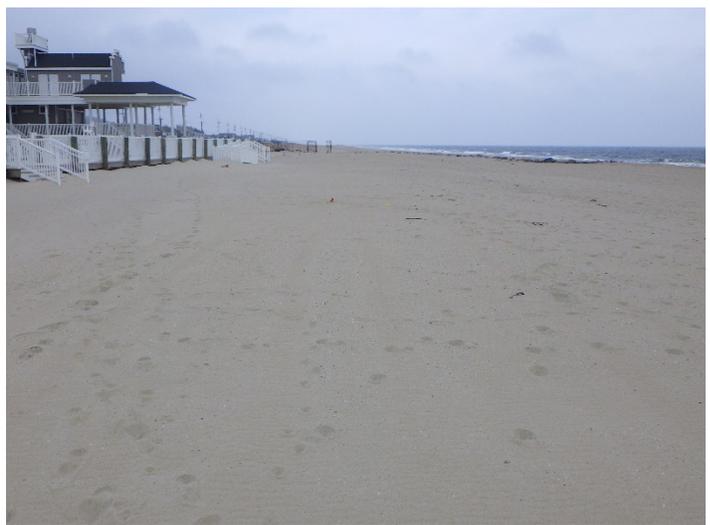
**NJBPN 18201 - 801 Ocean Avenue, Sea Bright**

Positioned between two beach clubs, this line starts at the parking lot, ramps up to the dry beach without any dune present. The beach extends 500 feet seaward of the parking lot where the beachface drops into the water (Dec 20, 2019). By January 15, 2021 minor beach retreat was reversed by gain on the berm as sand move onto the beach from offshore.

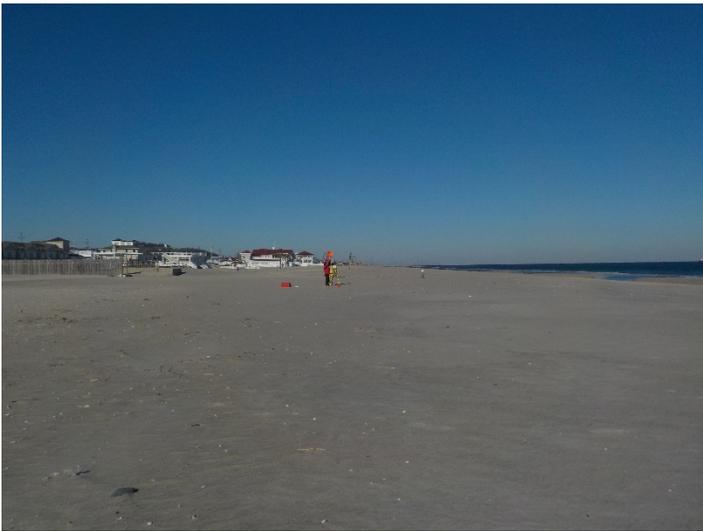
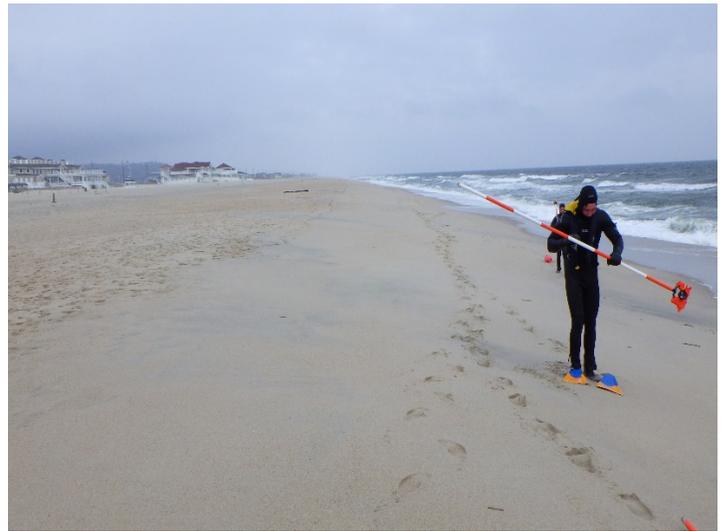
NJBPN 182 – Public Beach, Sea Bright

The photo on the left, taken December 20, 2019, shows the expanse of dry beach seaward of the beach club. The photo on the right, taken January 15, 2021, shows the same beach at a higher tide, along with a steeper berm slope due to accumulation of sand.

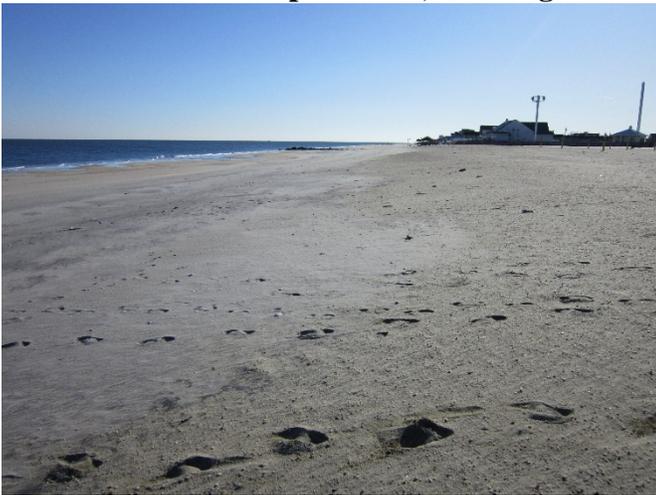
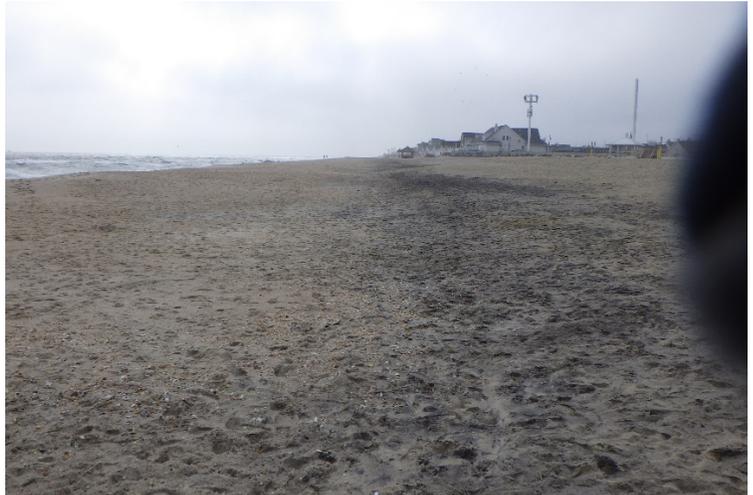
**NJBPN 181 – Municipal Beach, Sea Bright**

The December 22, 2019 view on the left seems to indicate that retreat slowed considerably based on the exposure of the distant rock groin. The view on the right, taken January 15, 2021, seems to be following the same trend as the groin is even less visible.

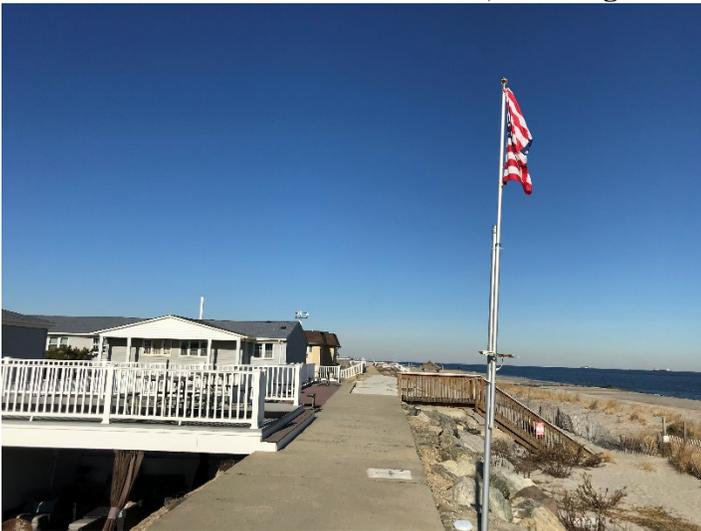
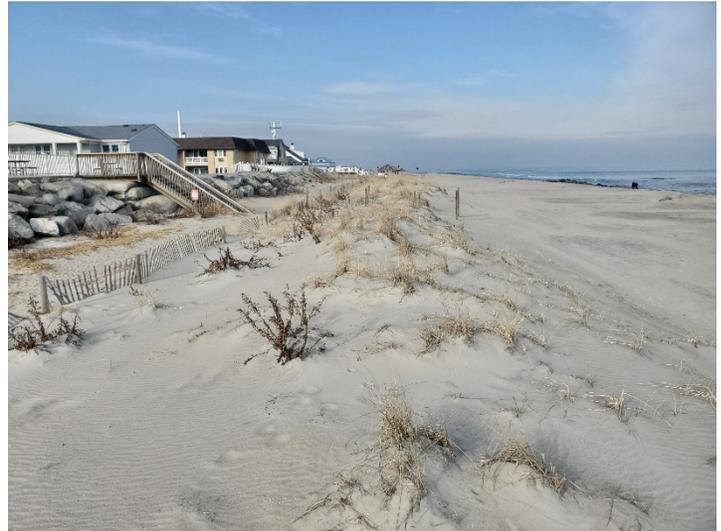
**NJBPN 18003 - 1201 Ocean Avenue, Sea Bright**

This site starts at the concrete and rock seawall with a small dune present on the landward beach's first 70 feet of width (Jan. 30, 2020 on left). The photo on the right, although from another view, shows minor change in the dune but a wider dry beach (Jan. 14, 2021).

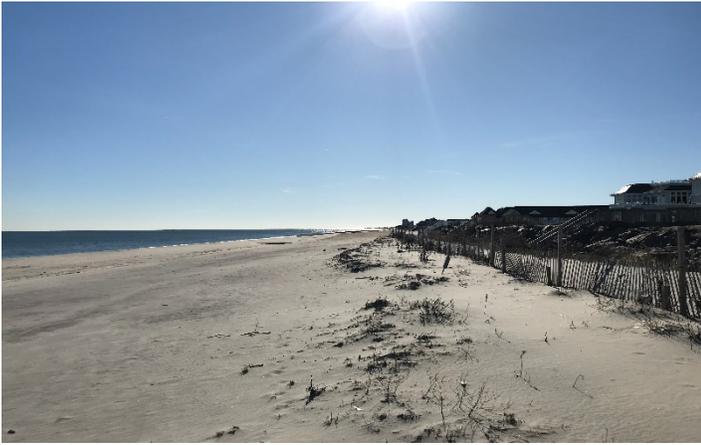
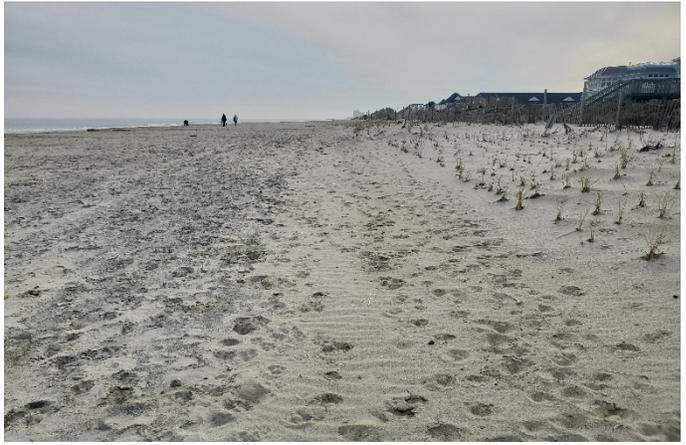
**NJBPN 18002 - 15 Tradewinds Ln., Sea Bright**

The dune at this location has developed along the single row of fencing. By Jan 2020 some dune vegetation loss is evident, but sand has blown over the dune toward the rock wall. The right photo, taken Jan 14, 2021, shows dune vegetation growth has occurred.

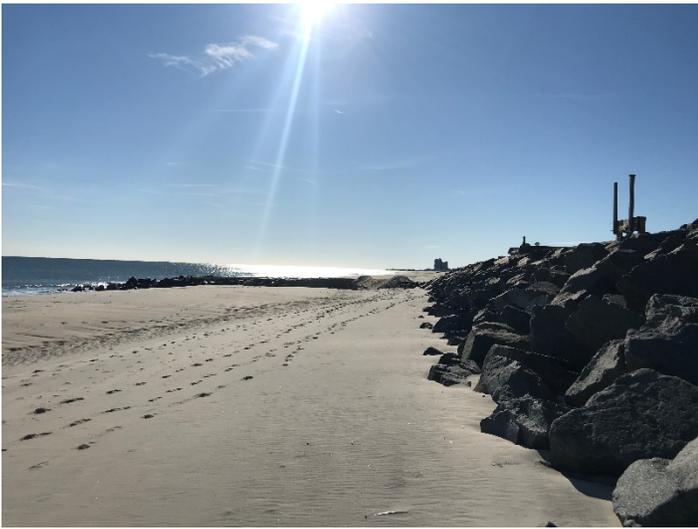
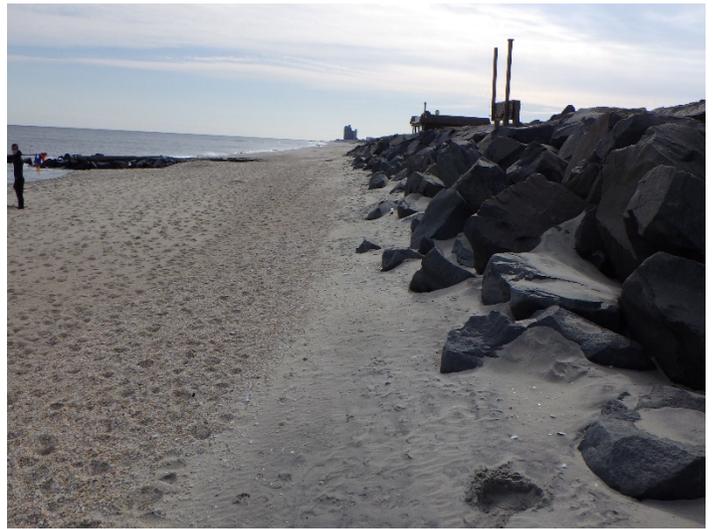
NJBPN 18001 - 1485 Ocean Avenue, Sea Bright

This site starts at a bulkhead and rocks considerably seaward of Ocean Avenue because the structures have been built seaward of the highway. There are no dunes, and a narrow beach that is losing sand (left view Jan. 30, 2020). As of Jan. 14, 2021, the beach shows that waves regularly reach the rocks while a new ridge of sand has just built onto the shoreline at the low tide line.

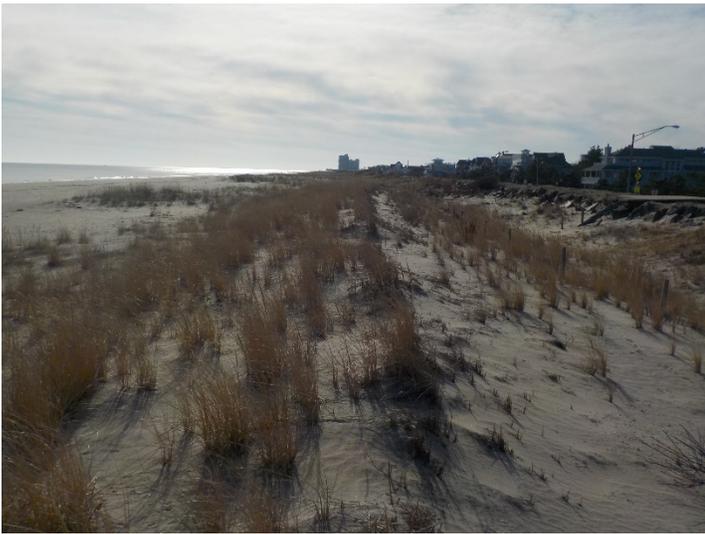
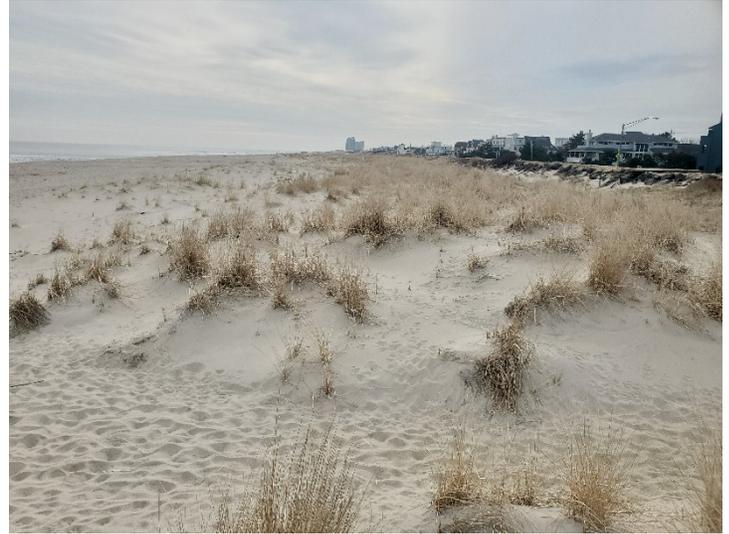
NJBPN 180 – Sunset Court, Sea Bright

The view on the left taken Dec. 22, 2019 shows the sand build-up on the dune at the seaward slope (on left). By January 14, 2021, the fence area filled in with new grass and growth was extensive on the dune.

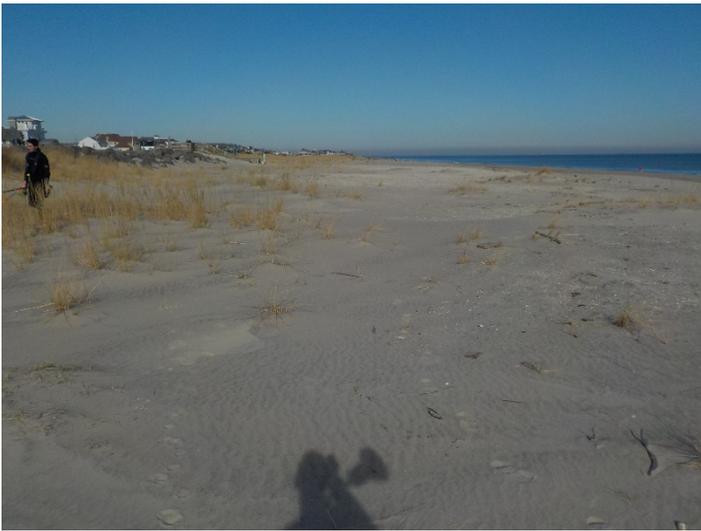
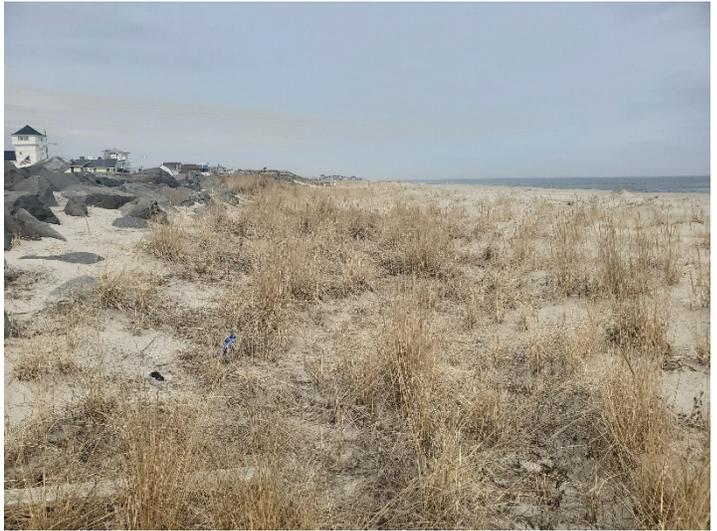
NJBPN 17901 - 122 Ocean Avenue, Monmouth Beach

The left view from December 23, 2019 shows sand blown up into the seaward face of the seawall filling in among the rocks, but no dune is present. The right-side view was taken Jan. 14, 2021 and shows extensive grass growth with dune mounds appearing on the beach.

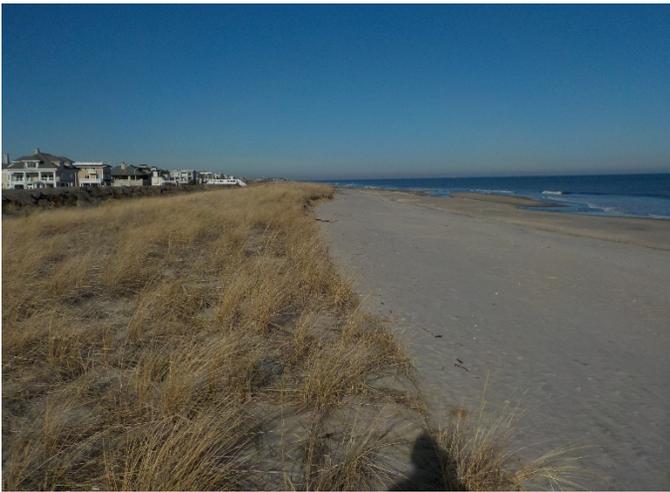
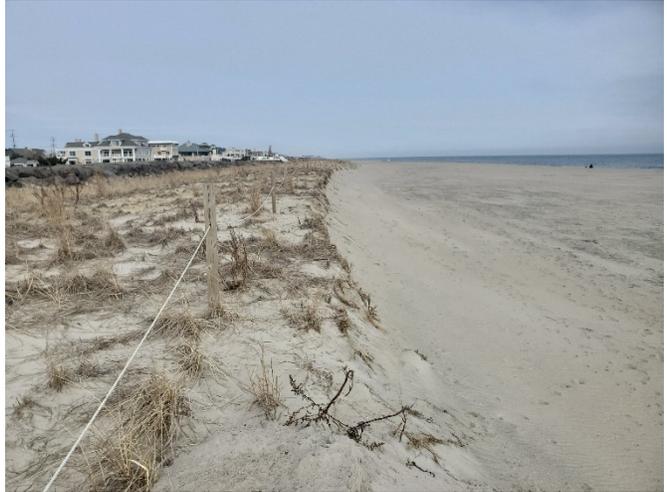
**NJBPN 179 – Cottage Road, Monmouth Beach**

This site has been where the worst erosion occurs in Monmouth County. The left photograph December 23, 2019 shows the existing beach has narrowed the point where the dune becomes in jeopardy. The right-side view illustrates the same scarp cut into the dunes but with the newly maintained beach extending seaward as of January 14, 2021. Wind effects have added a layer of sand into the grass.

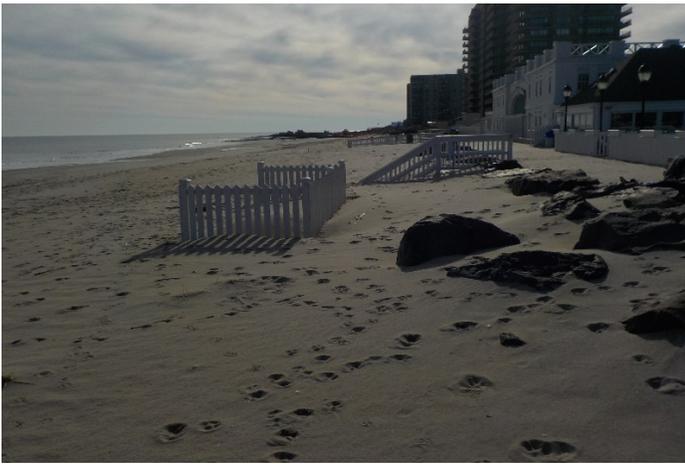
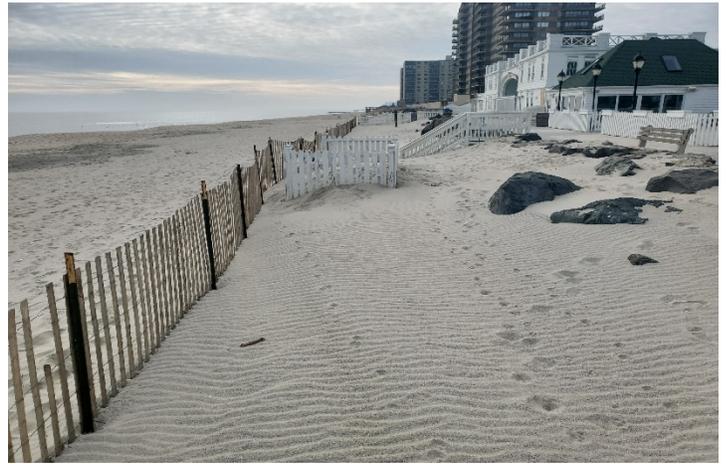
NJBPN 17801 - 65 Ocean Avenue, Monmouth Beach

This site is south of the groin at Cottage Road and the beach has a lower gradient beachface (left December 23, 2019). The right view (January 14, 2021) shows where the beach fencing has been reestablished and wind deposition has partially buried the rocks.

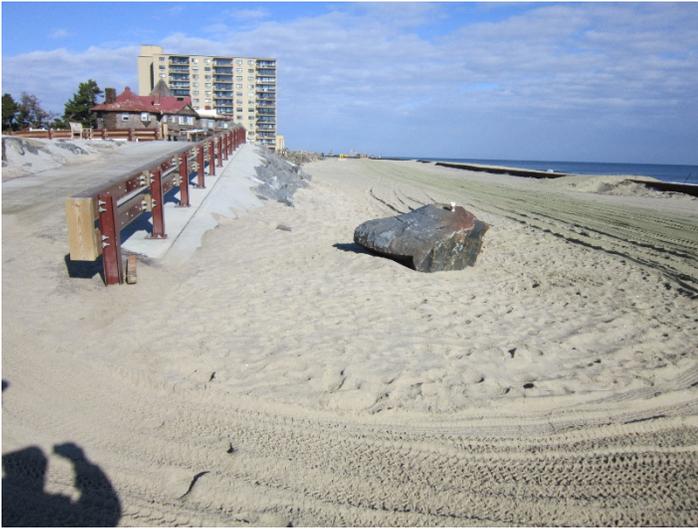
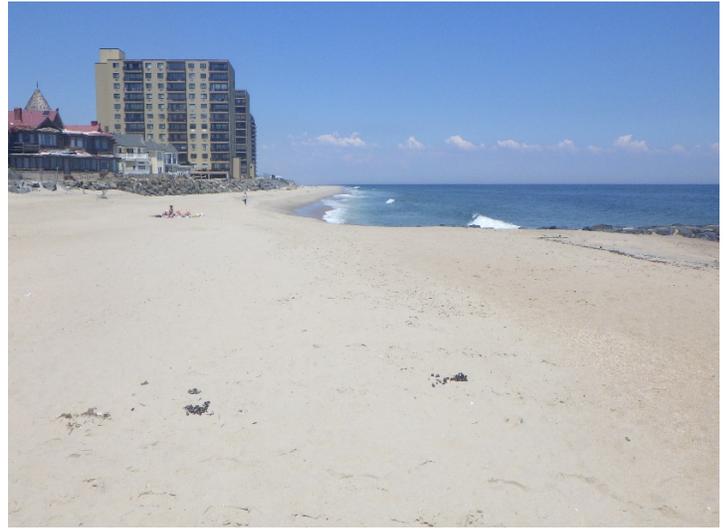
As of January 6, 2020, the rock wall was complete, and the sand pipeline was in place on the beach. The right photo, taken January 13, 2021, shows the beach with the offset in the shoreline produced by the groin at the property line.

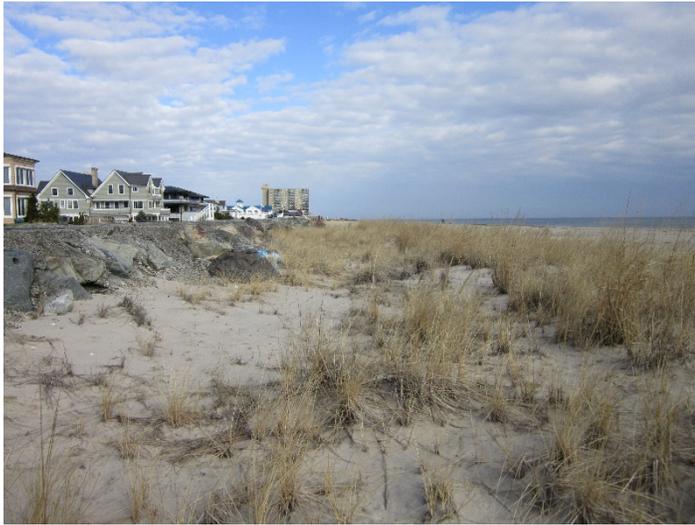
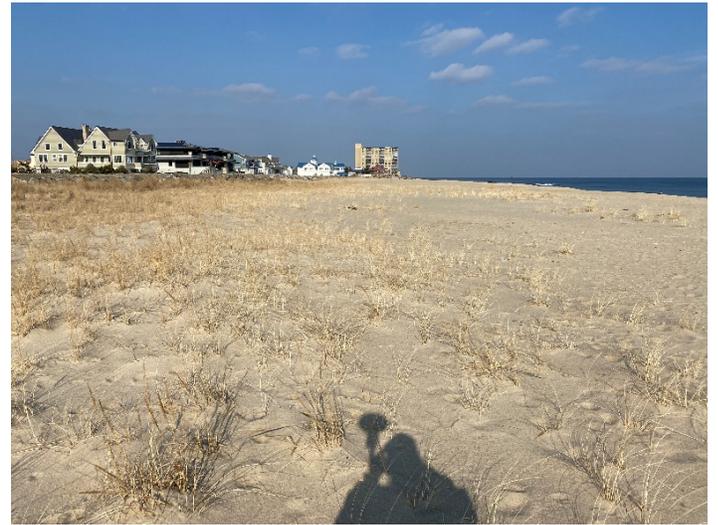
NJBPN 17701 - 9 Ocean Avenue, Monmouth Beach

This location has the seawall as the ultimate backstop for this beach. As of January 6, 2020, some added vegetation is evident with the construction to the north completed. The right-side photo, taken January 13, 2021, shows the extent of how far seaward the dune grass growth extends.

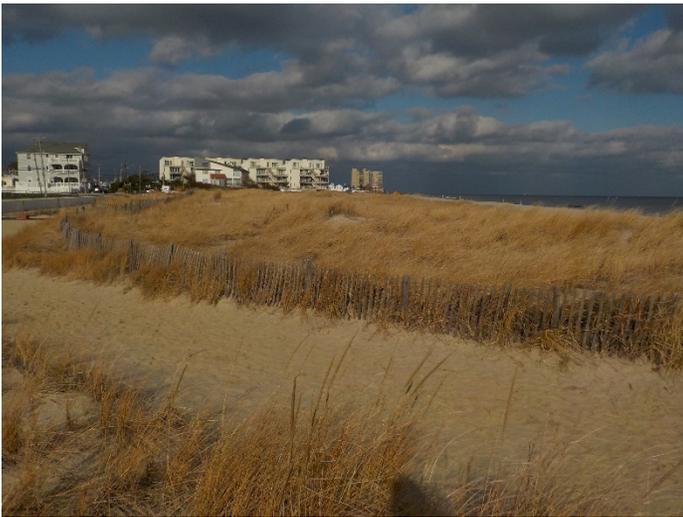
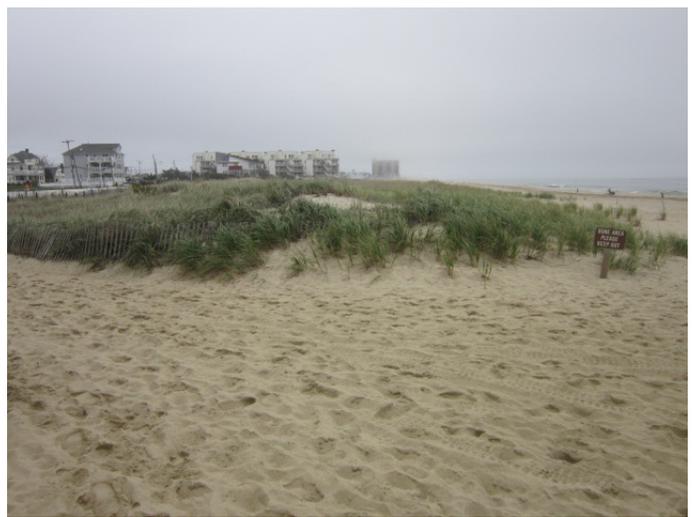
The left photo was taken December 18, 2019 looking north along the dune toe. The right view along the foredune crest shows lush grass growth in the dunes, but much of the beach is obscured (Oct. 22, 2020).
