# STOCKTON UNIVERSITY COASTAL RESEARCH CENTER

## New Jersey Beach Profile Network 2020 Annual Report on Shoreline Changes in New Jersey's Four Coastal Counties Raritan Bay to Delaware Bay Spring of 2019 Through Fall of 2020

August 31, 2021

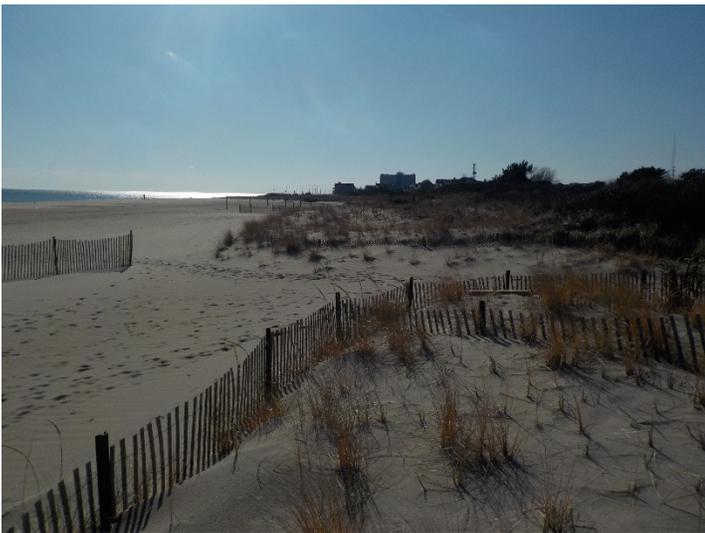
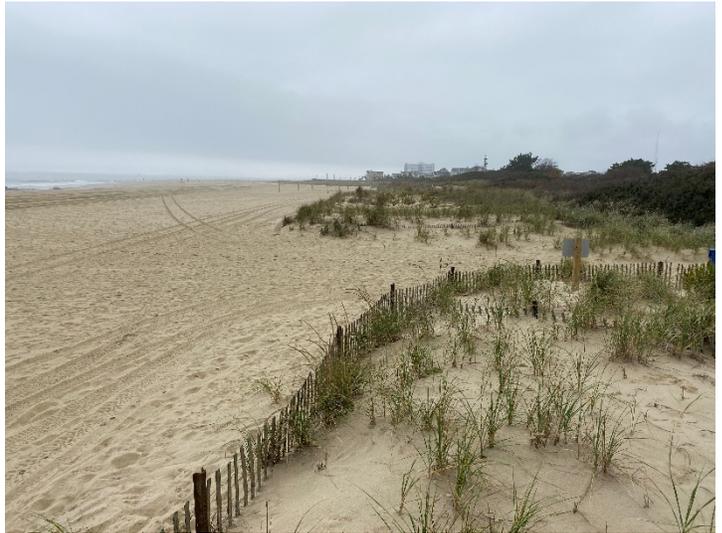
**NJBPN 17601 – 300 Ocean Avenue North, Long Branch**

The left view was taken Dec. 18, 2019 and shows the access pathway and the dunes with a wide beach. As of October 20, 2021, the grass had improved further, and fencing had been rearranged once again.

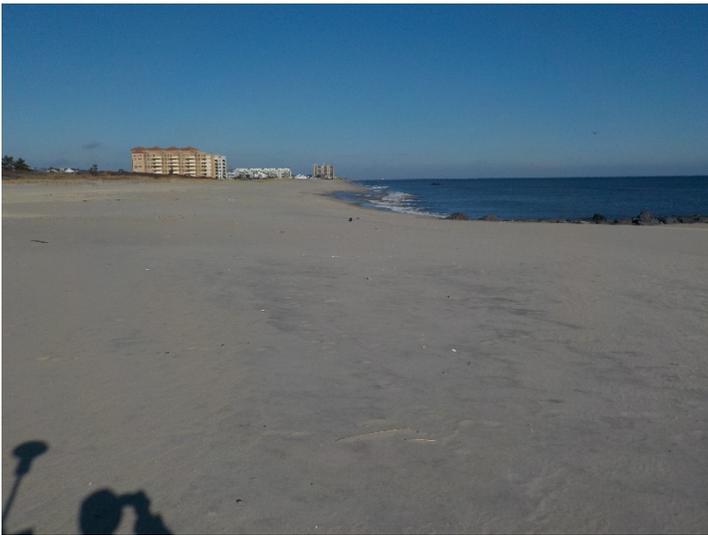
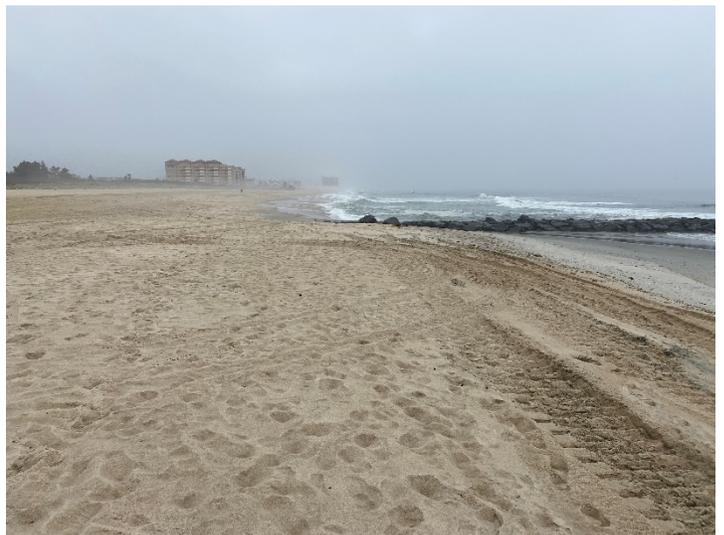
This December 18, 2019 (left) photo shows the groin rocks were exposed with a south to north offset in the beach width. The same perspective on October 22, 2020 has the same offset with more rock showing near low tide.

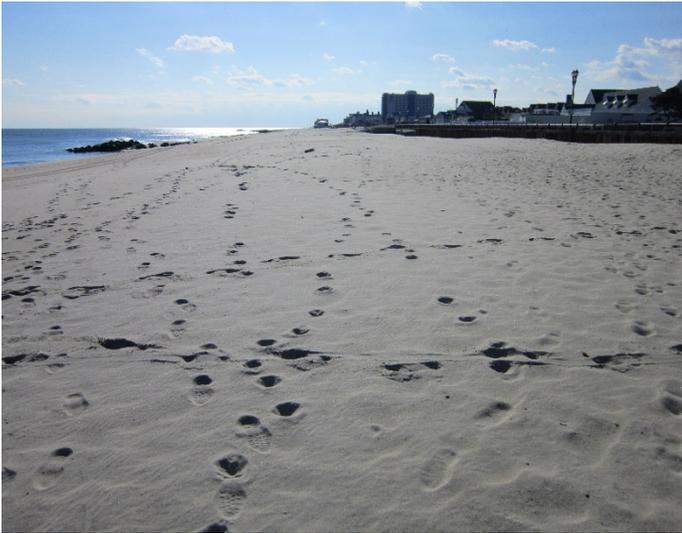
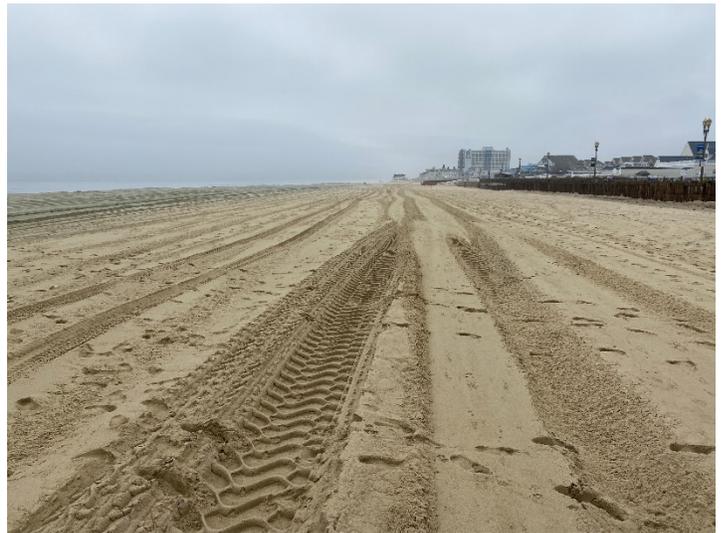
This location is at the very northern end of the old steel sheet pile wall at the Long Branch uplands bluff edge. There is no dune established here, but sand is ramped up against the wall (left view December 18, 2019). On the right is an October 22, 2020 view in essentially the same location on the profile showing the greatly increased width of the dry beach.

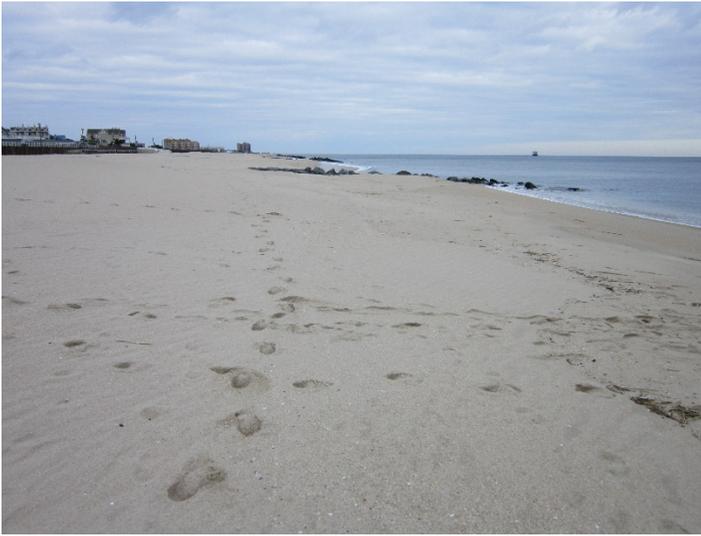
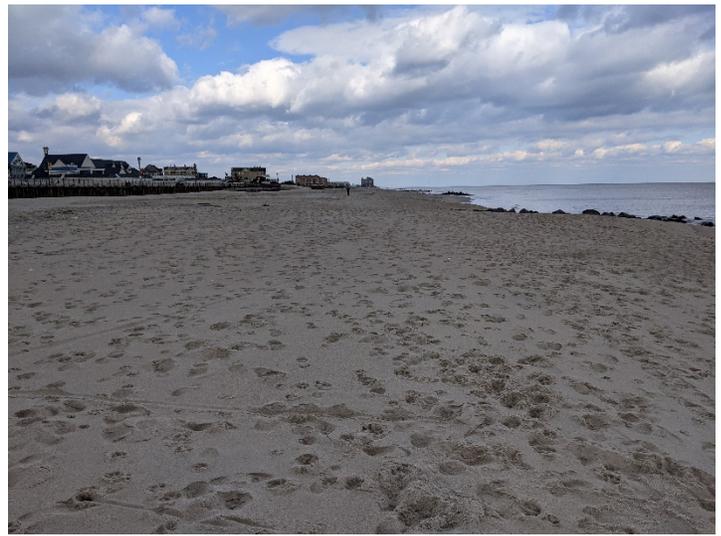
NJBPN 175 – Broadway Avenue, Long Branch

The left photograph taken January 6, 2020 shows the berm in a robust condition. As of January 20, 2021, the beach was essentially the same with limited groin rocks exposed.

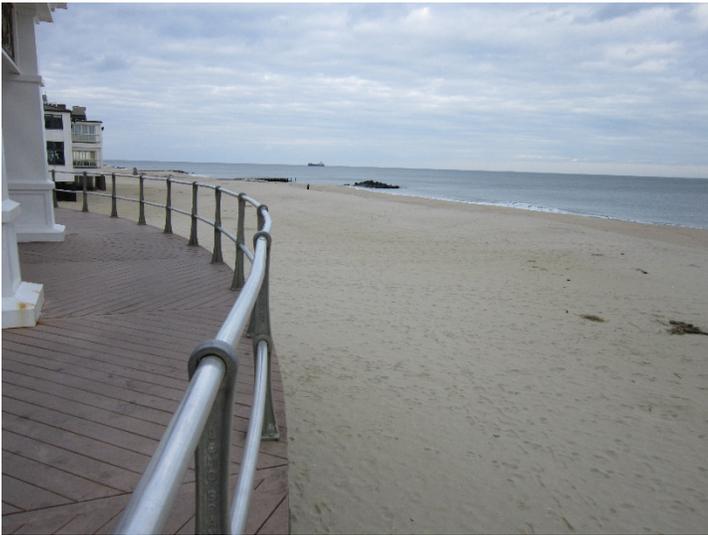
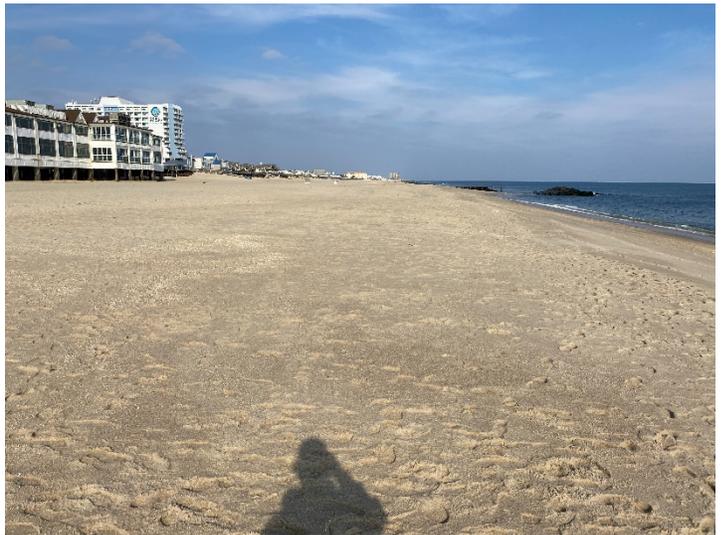
NJBPN 17402 – 45 Ocean Avenue, Long Branch

The beach narrows to 150 feet without any bar system present by January 6, 2020 on left). The beach remained relatively the same as of Jan. 13, 2021 if the distant groin rock exposure is compared (on right).

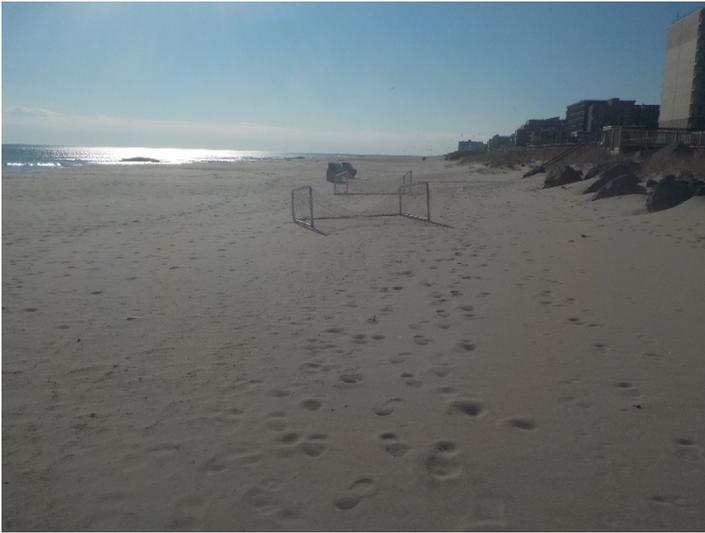
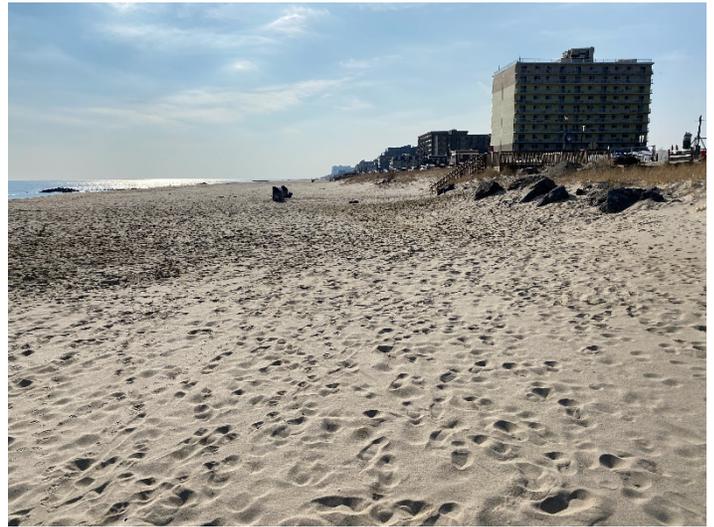
NJBPN 17401 – North Morris Avenue, Long Branch

The left view is from Jan. 6, 2020 and shows the sand ramped up against the rock revetment protecting the beach bluff. The right view from Jan. 13, 2021 shows that grass did develop between rocks in that wind deposited sand.

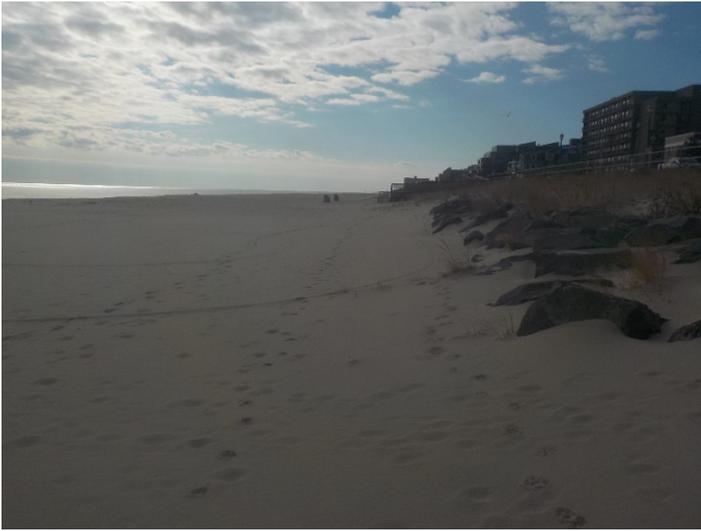
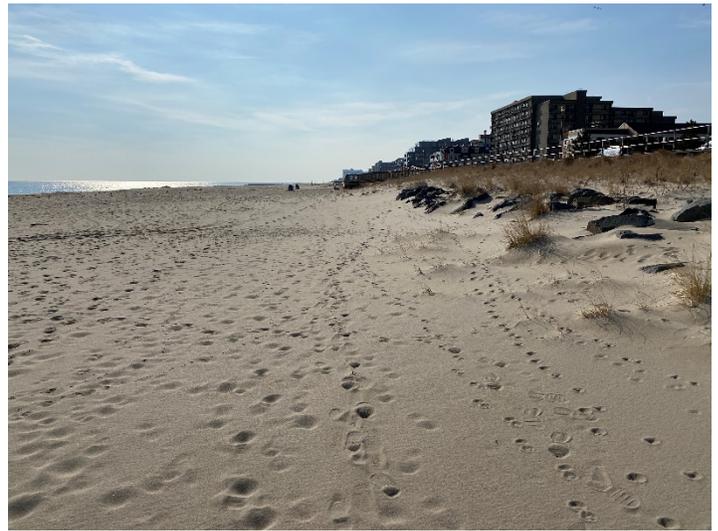
NJBPN 174 – Morris Avenue, Long Branch

The left-side view, taken January 6, 2020 shows some grass growth above the rock toe on the beach as wind deposition placed sand up the bluff face. As of Jan. 13, 2021, the grass progressed, but does not appear to be extending onto the dry beach surface (right).

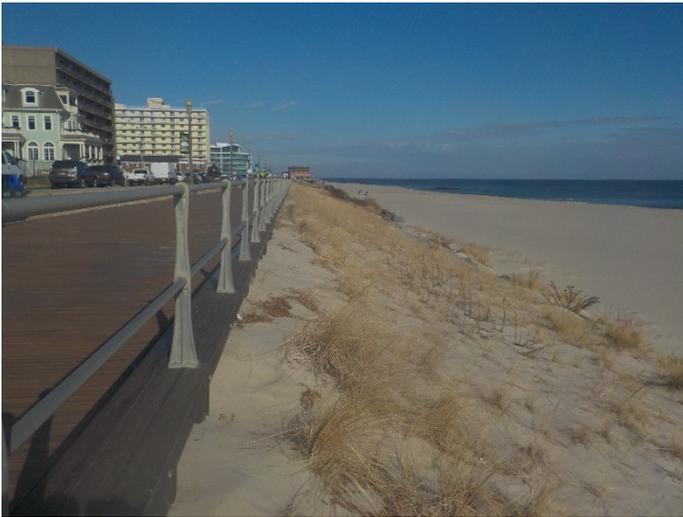
NJBPN 17303 – 276 Ocean Avenue, Long Branch

South of Morris Avenue the rock revetment continues with a 240-foot wide beach and no dune system (Jan. 6, 2020). On the right on Jan. 13, 2021, a similar view shows much of the dune grass coated by wind-transported sand.

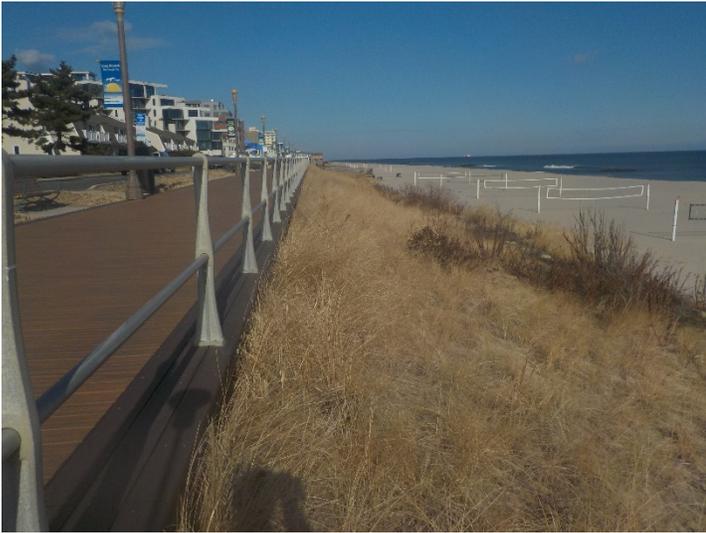
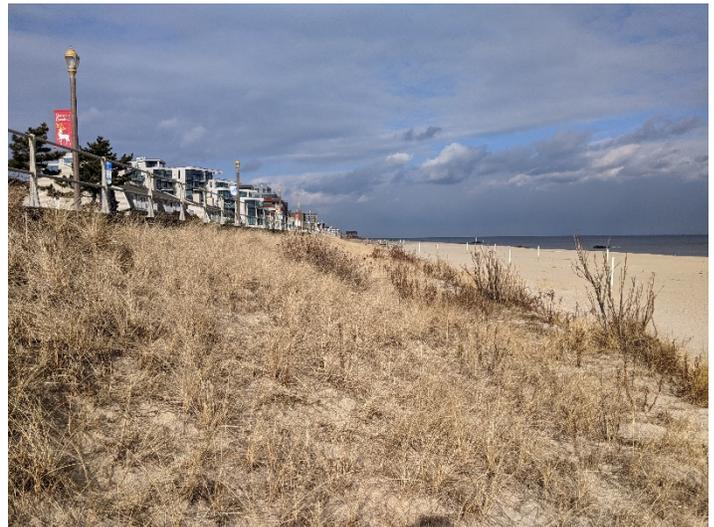
NJBPN 17302 – 378 Ocean Avenue, Long Branch

The bluff revetment is the first element in the survey with a 230-foot wide beach to the berm (Jan. 6, 2020 on left). No dune exists at the foot of the revetment, but the beach width remained relatively constant (January 20, 2021 on right).

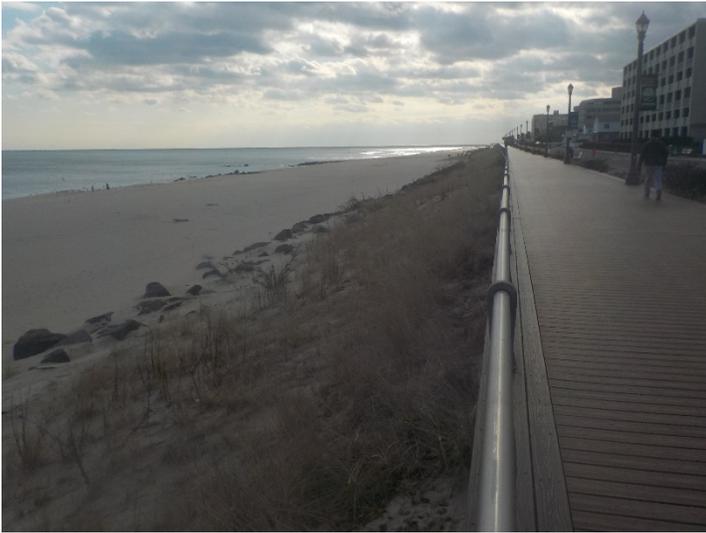
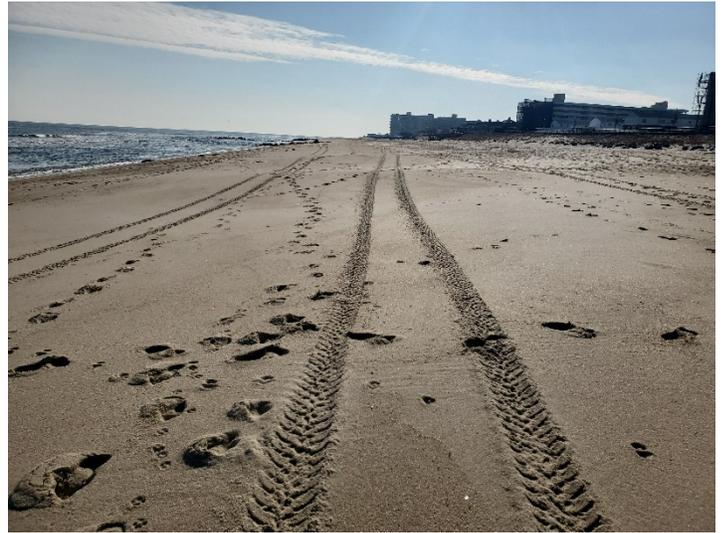
NJBPN 17301 – Wooley Court, Long Branch

The rock revetment on the left was photographed Jan. 6, 2020. On the right by Jan. 12, 2021, more grass is present among the rocks, exposed at the toe, but covered up-slope. The beach width remained constant.

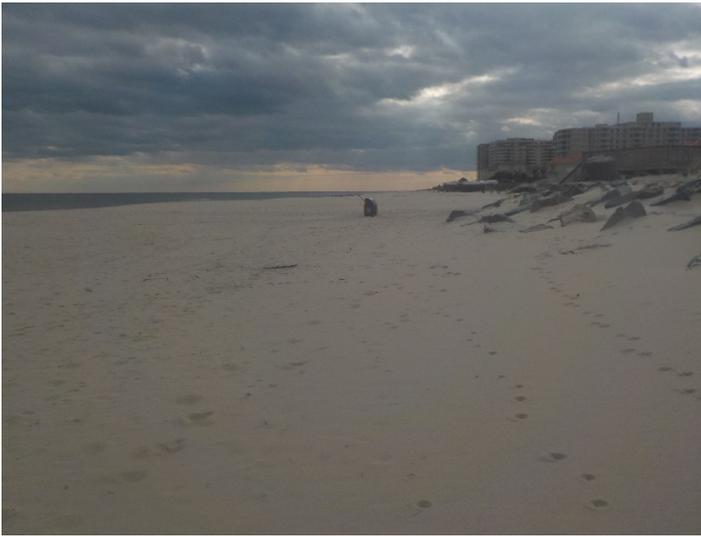
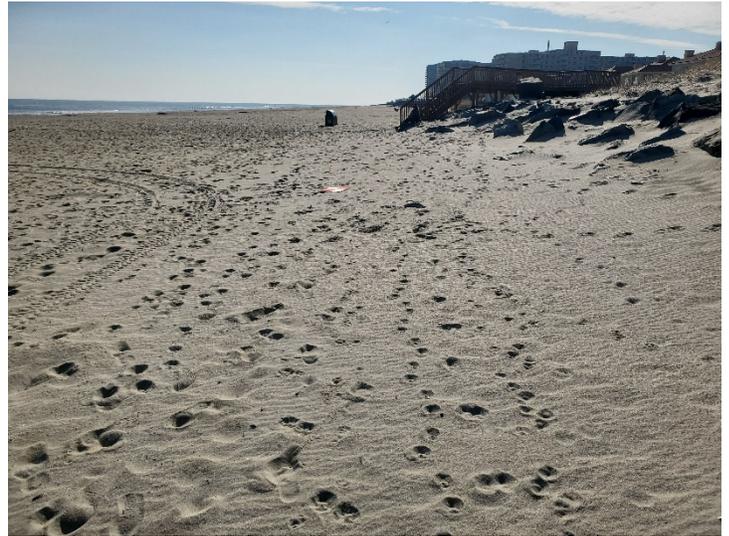
NJBPN 173 – West End Avenue, Long Branch

This site was the southern location within Phase I of the federal project. On the left, the rock wall was partially buried in wind-transported sand (Jan 16, 2020). The right-hand view on Jan. 12, 2021 shows the rock toe of the revetment further buried in wind-deposited sand.

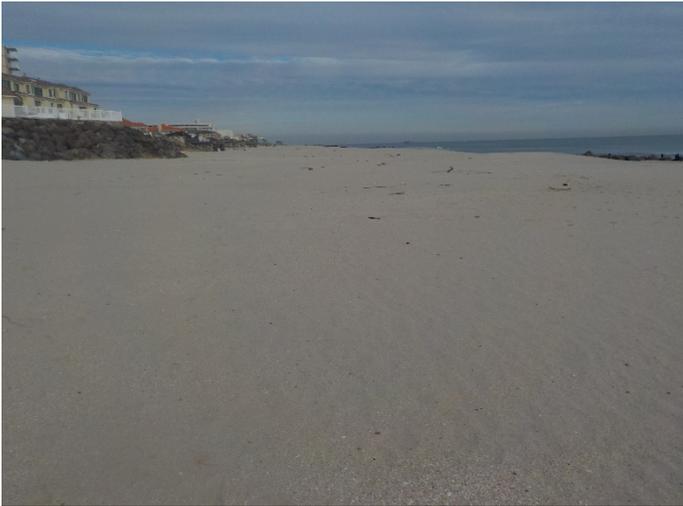
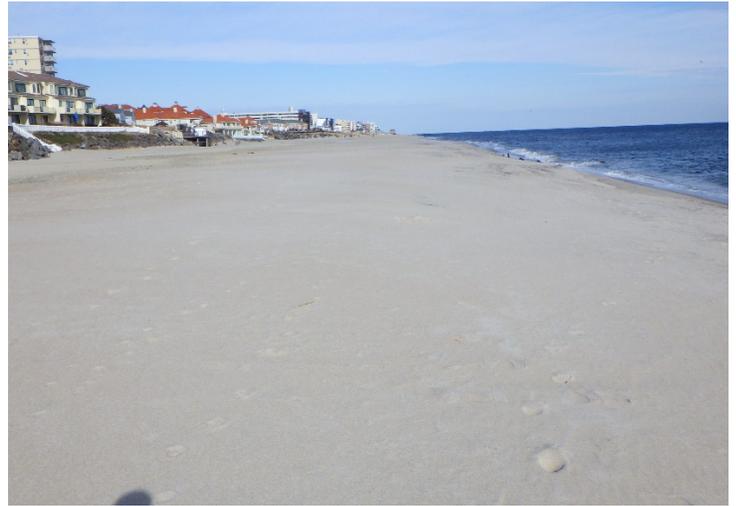
NJBPN 27201 – 717 Ocean Avenue, Long Branch

Located in the northern limit for the Phase III USACE beach restoration project, this location was photographed on Jan. 7, 2020 showing the rocks protecting the structures with the dry beach seaward of the rocks. The January 21, 2021 view on the right, shows a very similar view approximately a year later with a wider dry beach.

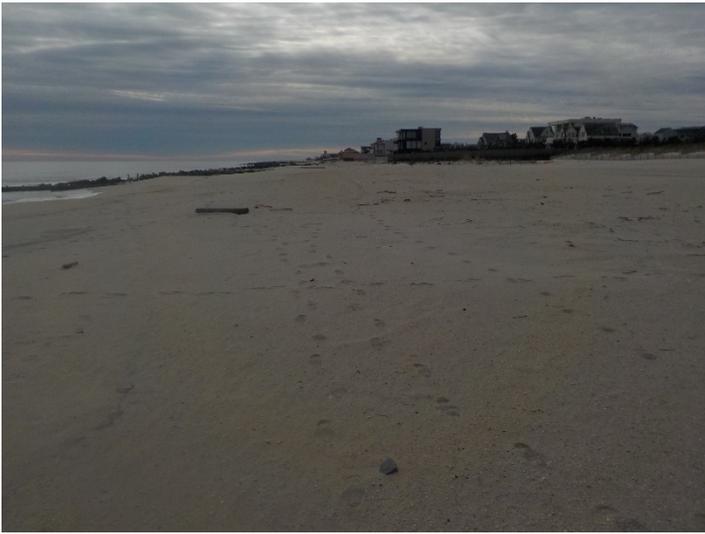
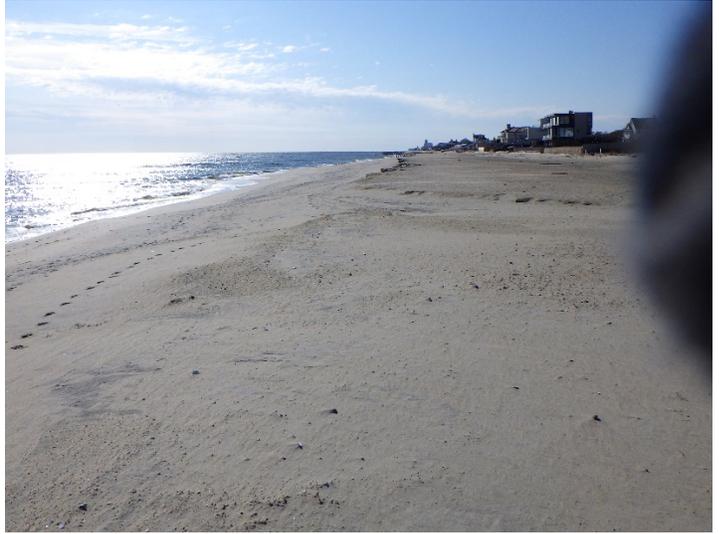
NJBPN 272 – 805 Ocean Ave, Long Branch

This site, established in 2010, is located on the northeastern edge of Lake Takanassee. The view to the left, taken January 7, 2020, shows retreat at the berm with rocks showing on the south groin. As of January 21, 2021, the rocks cannot be seen in the photo on the right because of sand additions most likely by direct placement.

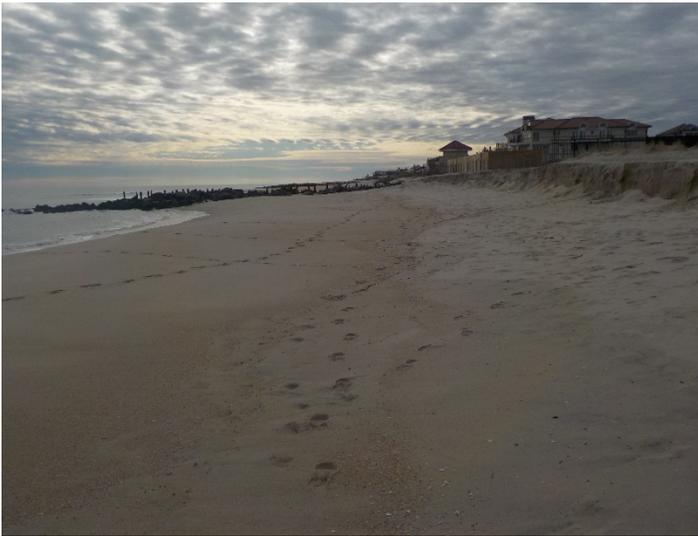
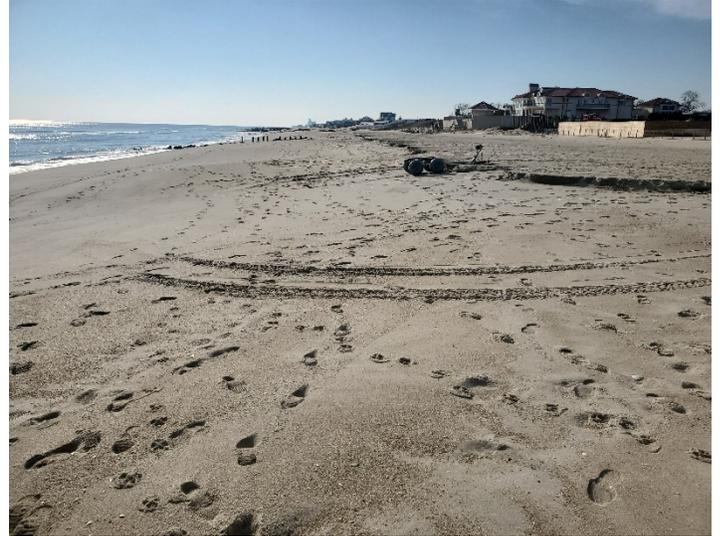
NJBPN 17101 – Plaza Court, Long Branch

This site is located south of Lake Takanassee positioned south of the lake's freshwater exit flume structure. The left picture from Jan. 7, 2020, erosion has taken a serious toll on the beach width with a scarp present and much more of the groin visible. The right photo displays the beach following a recent nourishment (January 12, 2021) but the scarp is still visible.

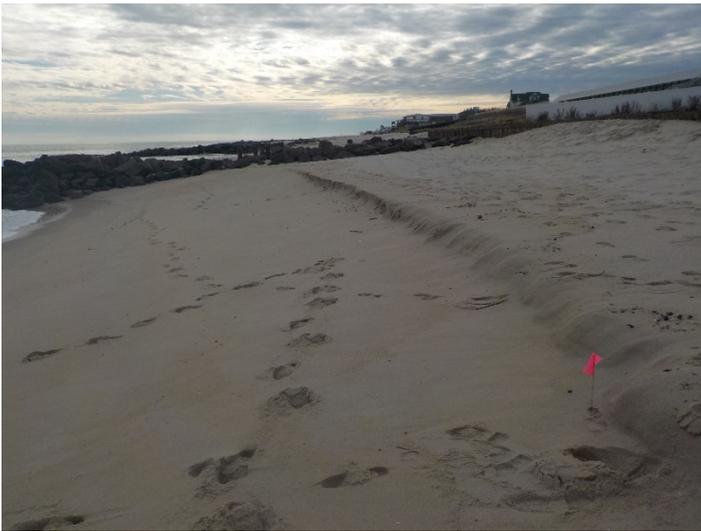
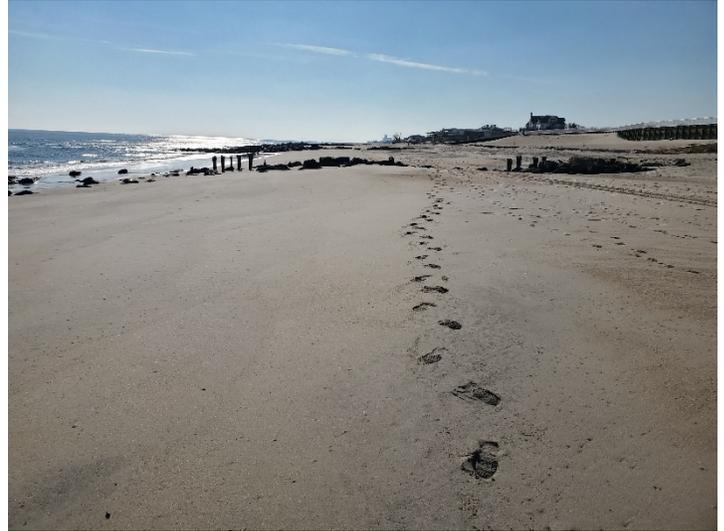
NJBPN 171 – Pullman Avenue, Elberon

This site is located on the highest point along the bluff shoreline. By January 7, 2020 erosion had fully exposed the rock groin and pushed the beach berm nearly to the main shore-parallel bulkhead. The right view taken January 12, 2021 shows a much less exposed groin following maintenance nourishment.

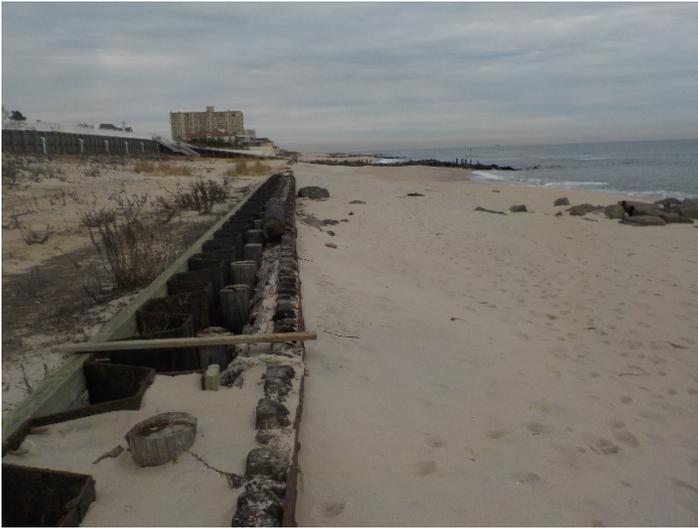
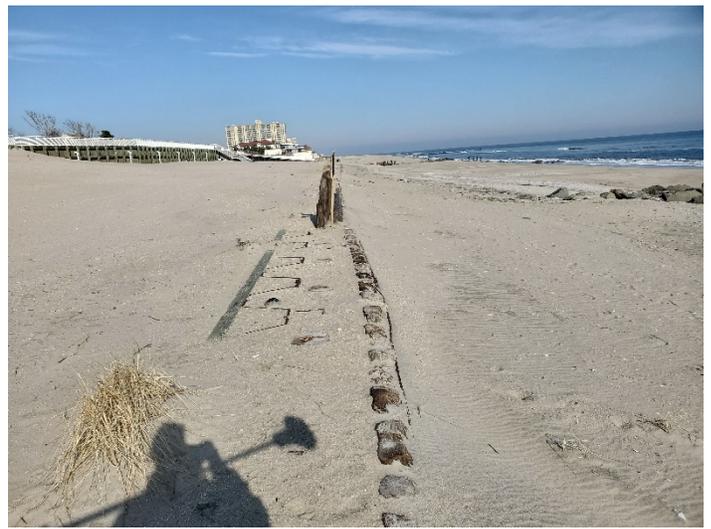
NJBPN 17005 – 981 Ocean Avenue, Long Branch

Located in the Elberon groin field, this location was completed during 2016 and suffered retreat, producing exposed rocks by Jan. 7, 2020. The beach was lower in elevation with the old timber bulkhead clearly visible on upper beach. The right photo, taken January 12, 2021 exhibits the beach where the groin is much less exposed, as well as sand recovering the bulkhead.

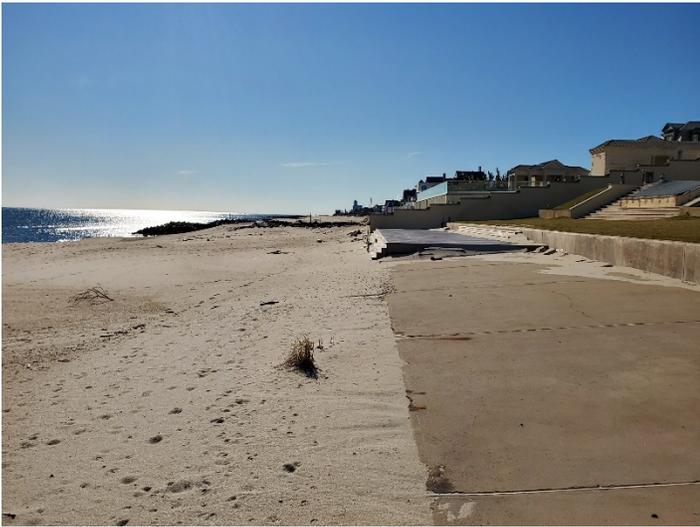
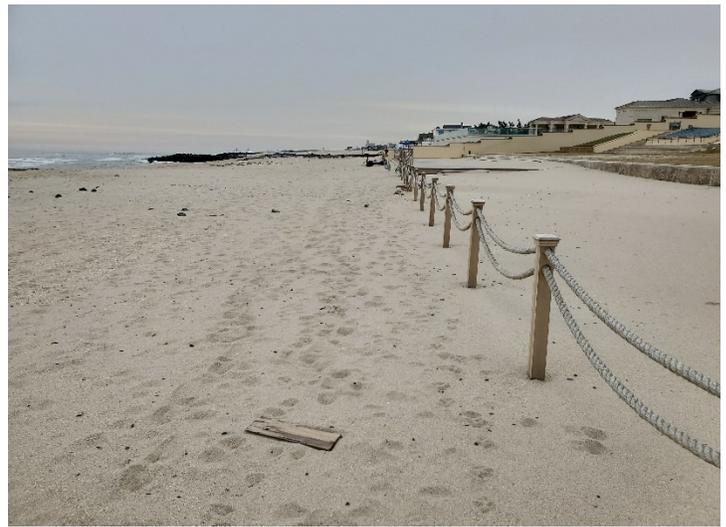
NJBPN 17004 – 1115 Ocean Avenue, Long Branch

This location is also within the Elberon groin field. The left view was on Jan. 9, 2020 and shows some rock exposure in the distance to the south. As of Jan. 11, 2021 the same perspective on the right shows a new 'fence' has been established, and sand has blown onto the concrete patio.

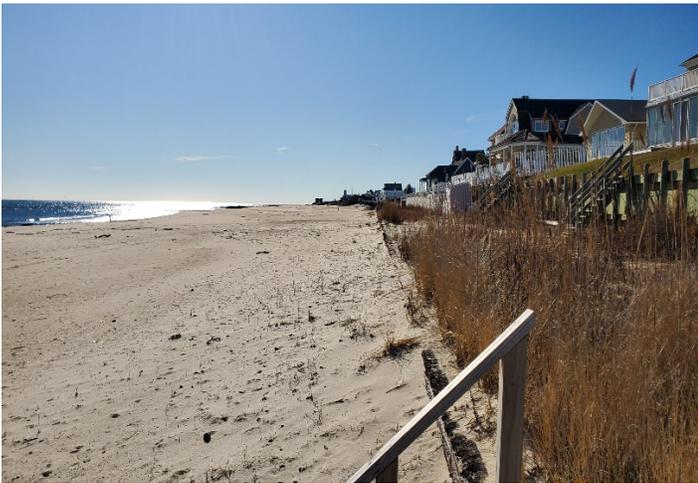
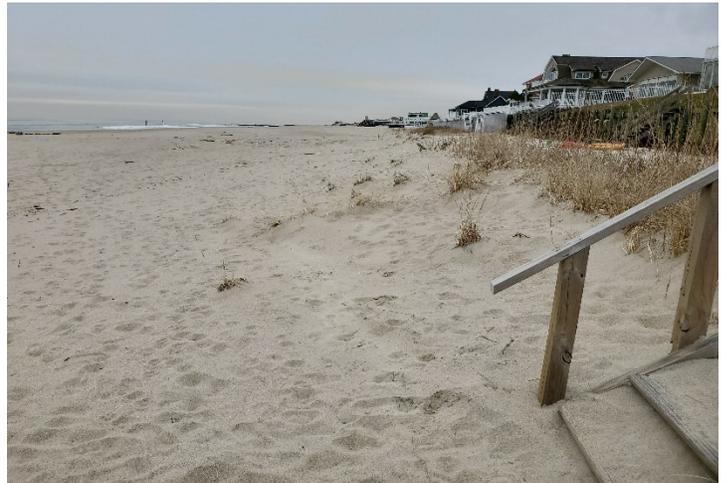
NJBPN 17003 – Ocean Court, Long Branch

The left view was taken Jan. 9, 2020 and shows a wide beach with little dune development. The right view shows a similar beach configuration as of Jan. 11, 2021 with few changes, aside from the dune grass being covered with wind transported sand.

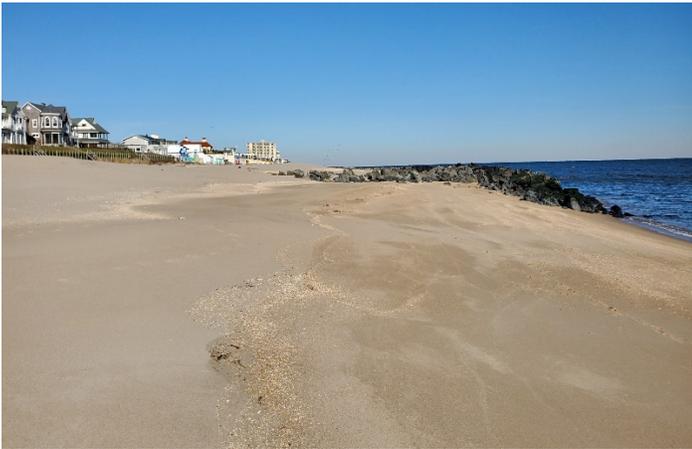
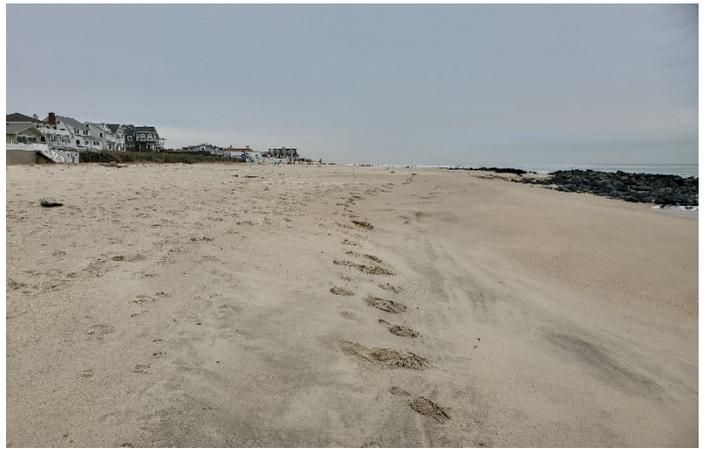
NJBPN 17002 – Garfield Road, Long Branch

The left view on Jan. 9, 2020 shows a beach with some rock groin exposure, while the right view on Jan. 11, 2021 shows the retreat in the berm crest at the rock groin with the seaward beachface slope starting sooner at the groin.

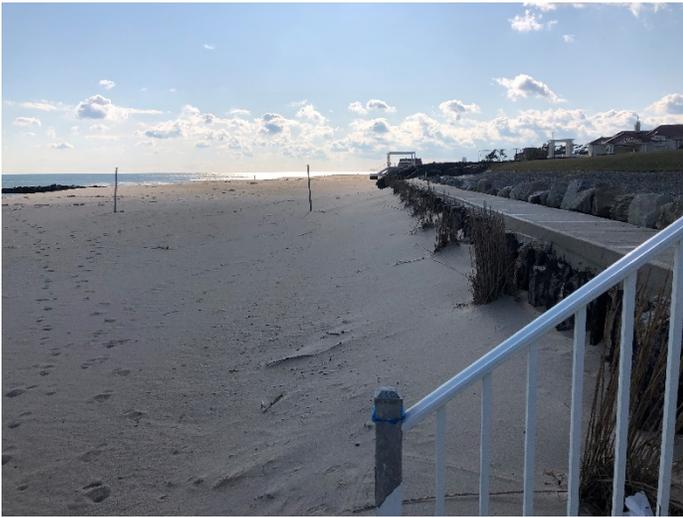
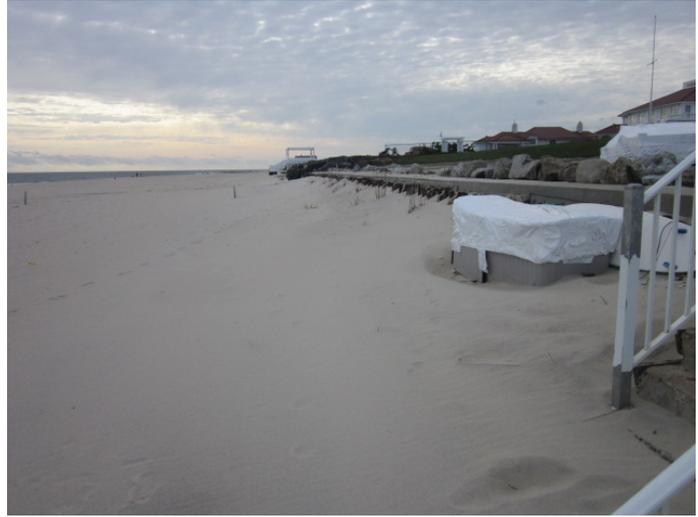
The left view on Dec. 12, 2018 shows the beach to the rock wall. The right-hand view on Jan 8, 2020 shows no sand deposited as incipient dunes but with a fairly stable beach width.

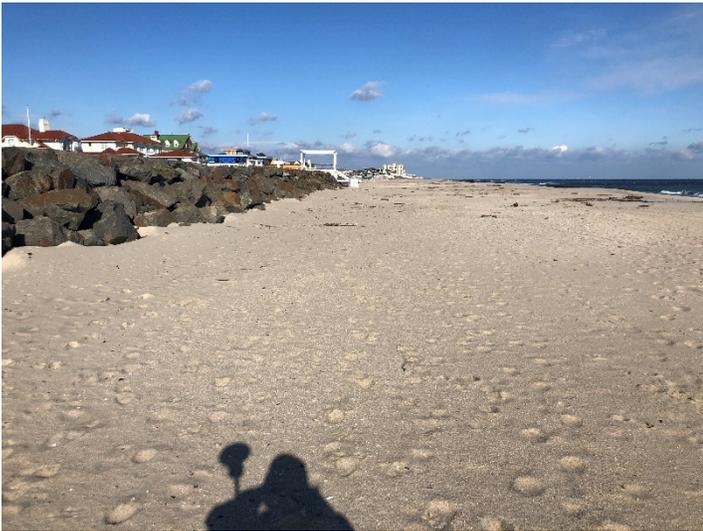
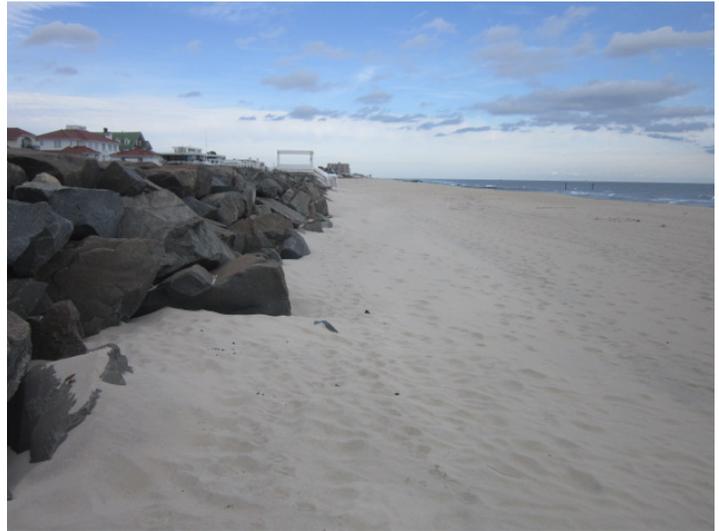
**NJBPN 170 – Roosevelt Avenue, Deal**

By December 11, 2017 the project was complete. As of Jan. 8, 2020 (left), the situation had changed very little at the rock revetment but with modest retreat of the beachface position. The view on the right, taken November 25, 2020, shows a similar view with slightly more sand deposited against the revetment due to wind.

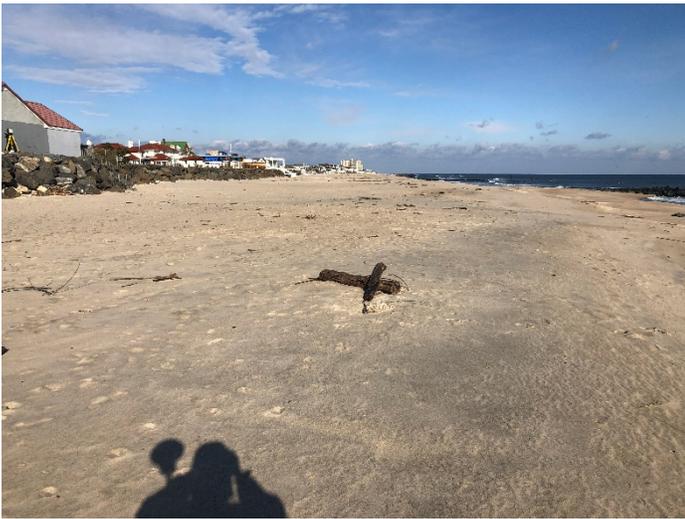
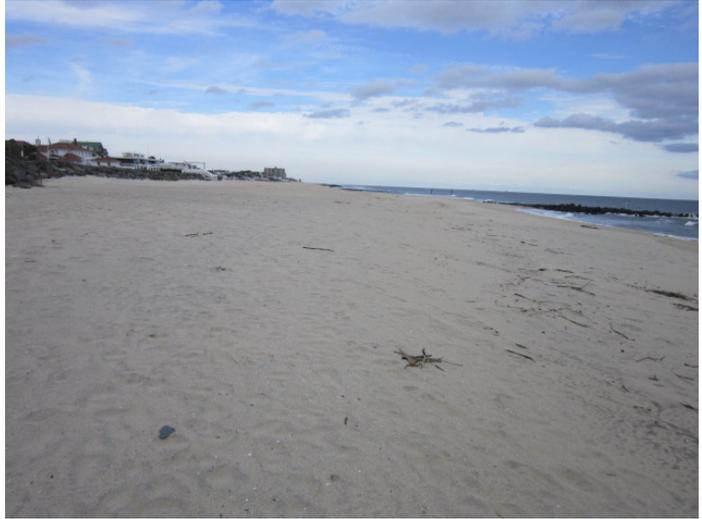
This new site is just south of Roosevelt Avenue in Deal. As of Jan. 8, 2020, the beach width was practically the same with some sand deposited at the toe of the rock by the wind. The November 25, 2020 photo to the right, shows an almost identical view of this site.

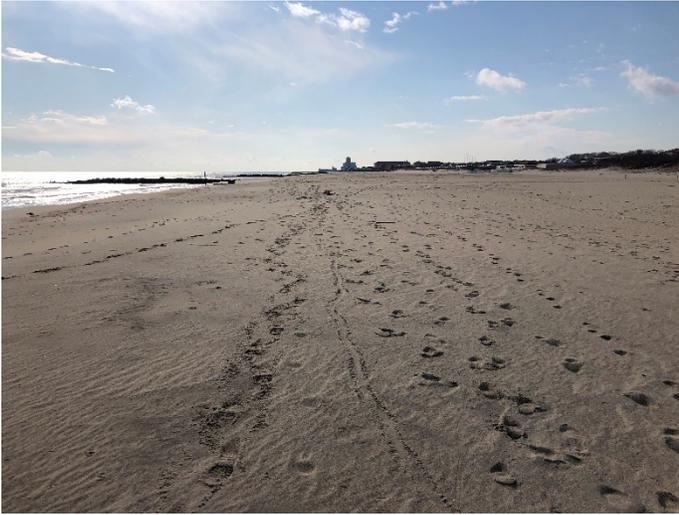
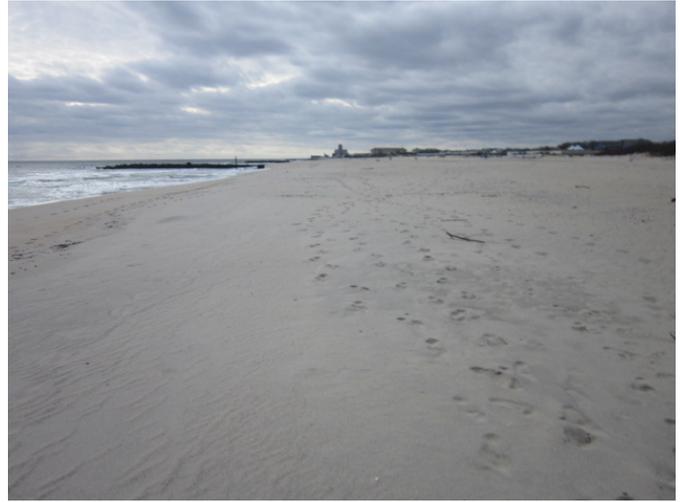
NJBPN 16904 – 71 Ocean Avenue, Deal

Located south of Poplar Brook, as of Jan. 8, 2020 some beachface retreat has occurred (left view) with a beach still far wider than pre-project. The right side photo (November 25, 2020), shows a fairly similar view with a similar berm.

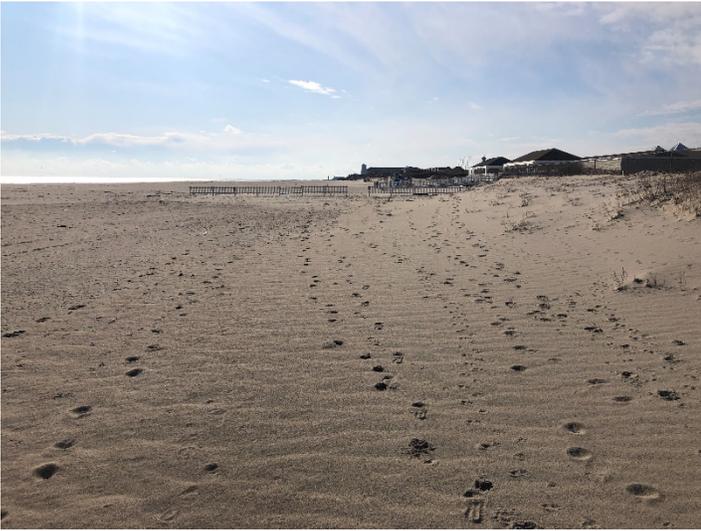
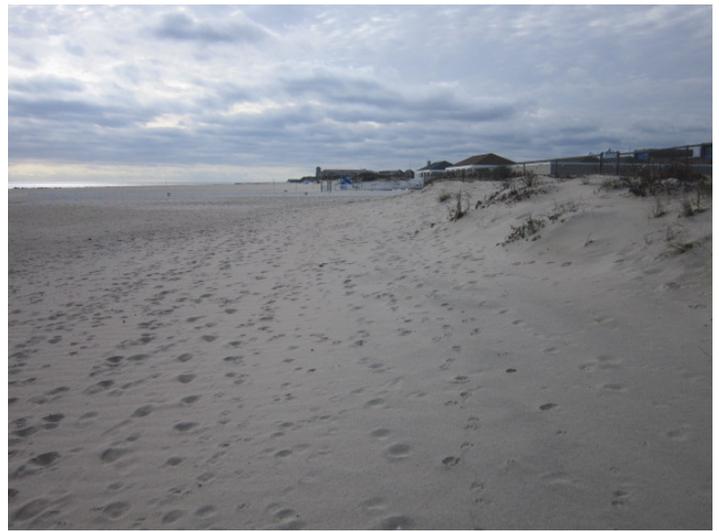
This site is in proximity to Phillips Avenue bathing pavillion, severely damaged by Hurricane Sandy. The left side shows the beach as of Jan. 8, 2020 with wind deposited sand adding to the dune toe. The right photo, taken November 25, 2020 shows a very similar dune and beach configuration.

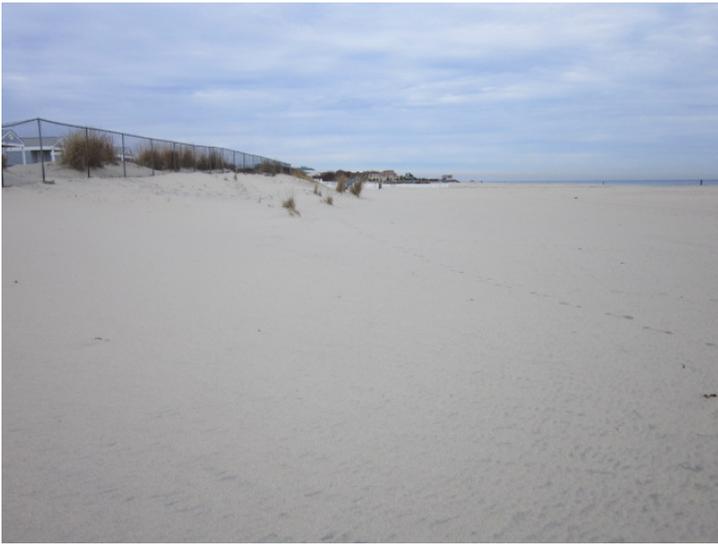
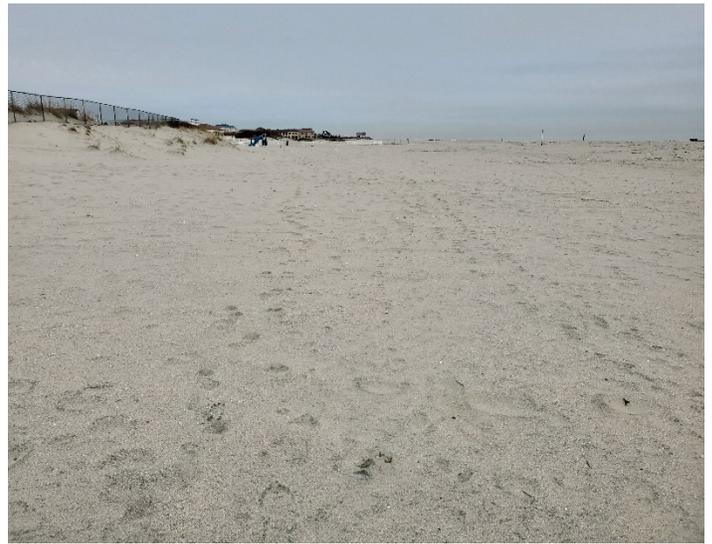
**NJBPN 16902 – Brighton Avenue, Deal**

The Deal Casino bathing complex is the site of this cross section. The left view photo, taken January 7, 2020, shows the new sand ridge was not present as sand deposited on the small dune growing at the fence line on the beach. The right hand photo, taken January 11, 2021, shows some growth of the dune along the fence line, as well as dune grass growth.

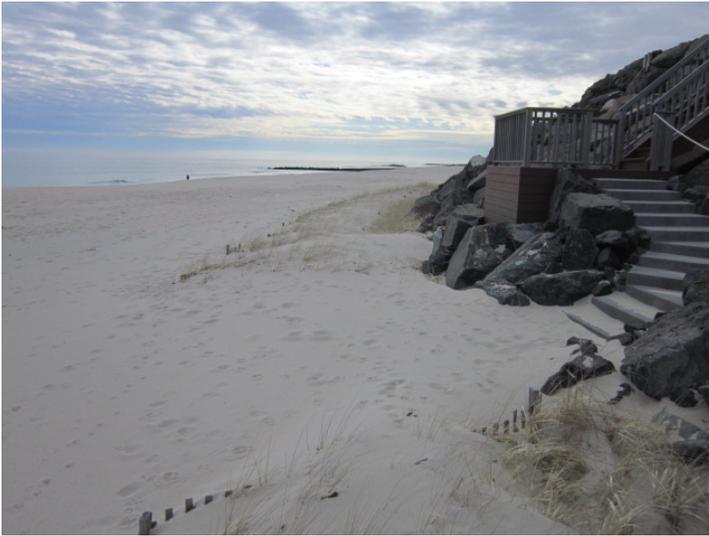
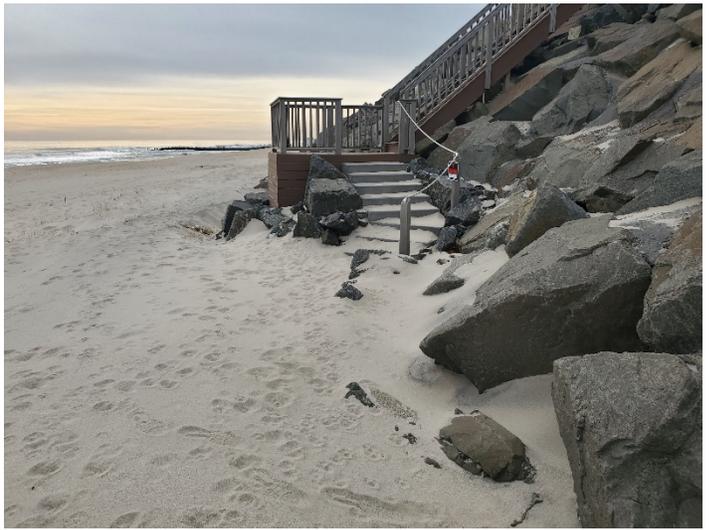
NJBPN 16901 – Wallace Road, Deal

This site is located on the boundary between the bathing complex and private homes which extend south of the location. The Jan. 7, 2020 view was shot at the toe of the rock revetment built post-Sandy at the site with some wind deposition generating an incipient dune (left view). The 4-foot high fence has been buried. The right hand side photo shows additional sand deposition at the rocks with fewer steps exposed.

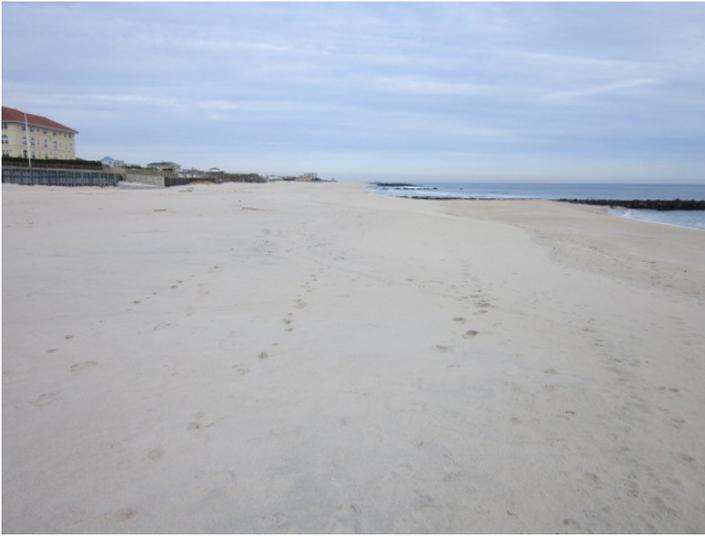
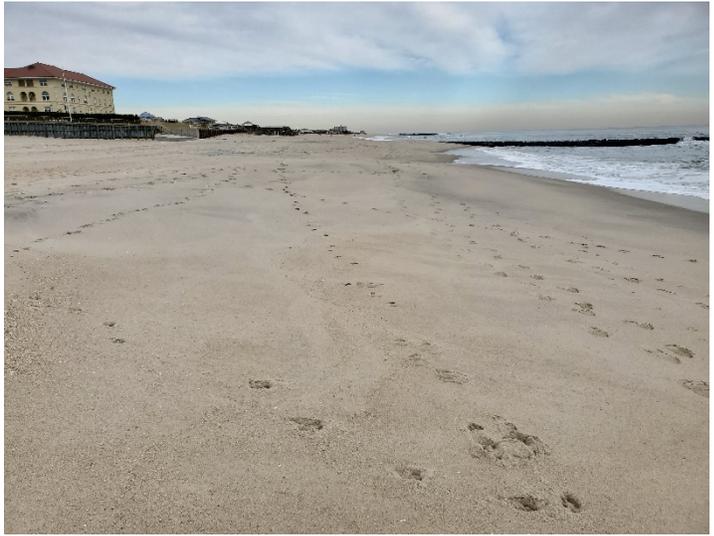
NJBPN 169 – Darlington Avenue, Deal

The Darlington site has maintained the as-built width quite well. Completed early during Phase III, there is a wide beach with a berm extending 340 feet beyond the bluff. The January 7, 2020 view shows the beach width quite well (left side) and the Jan. 8, 2021 view on the right shows the berm and beachface at the outer part of the dry sand beach.

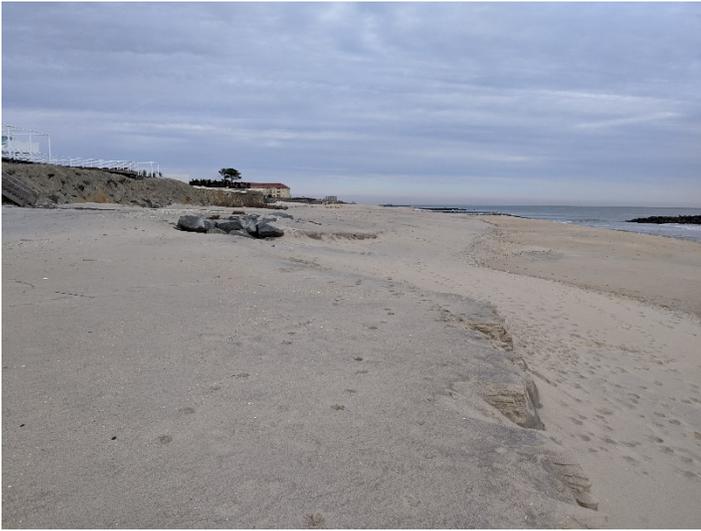
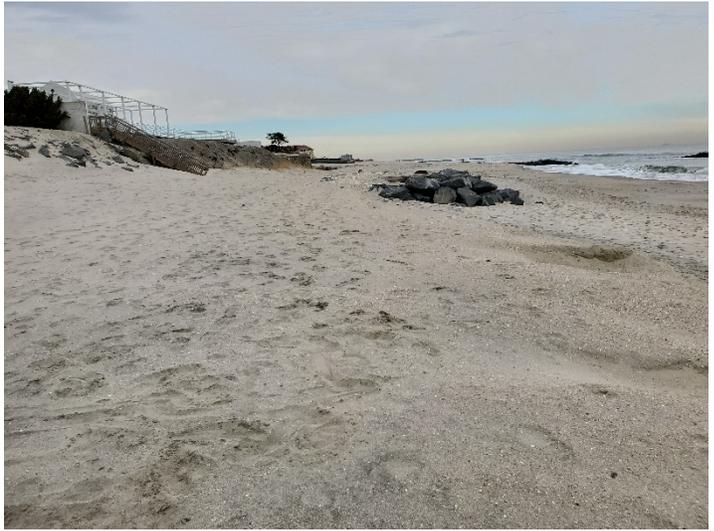
NJBPN 16802 – Monmouth Drive, Deal

This site fronts a private home at the bluff. As of Jan. 7, 2020, the beach developed a scarp near the rock revetment with sand deposited as a repair berm seaward of the scarp on the left side view. The January 8, 2021 view presents a very similar perspective with the rock revetment having increased exposure.
