# STOCKTON UNIVERSITY COASTAL RESEARCH CENTER

## New Jersey Beach Profile Network 2020 Annual Report on Shoreline Changes in New Jersey's Four Coastal Counties Raritan Bay to Delaware Bay Spring of 2019 Through Fall of 2020

August 31, 2021

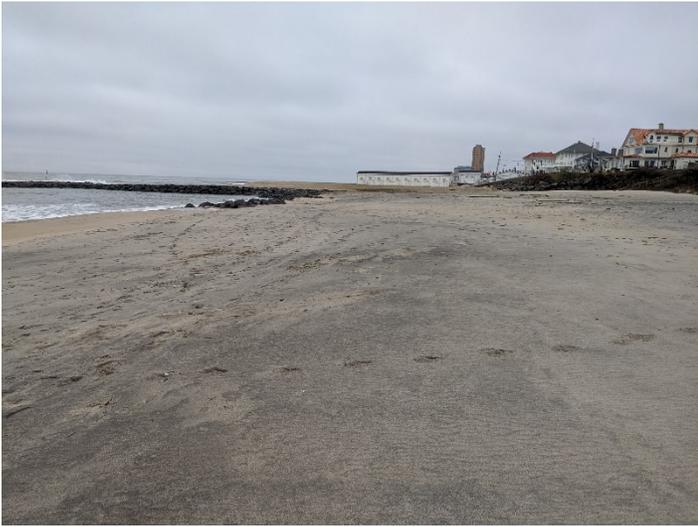
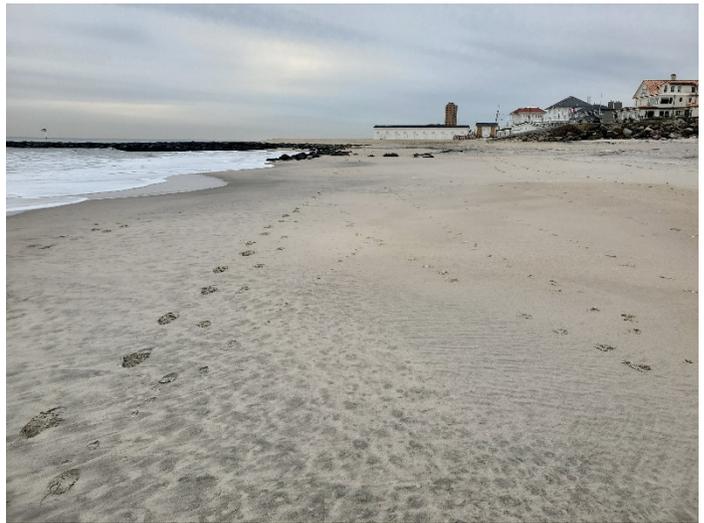
NJBPN 16801 – Neptune Avenue, Deal

This is the southernmost site in Deal with the bluff protected by armor stone. This beach sits just north of a massive rock structure designed to hold sand in Allenhurst built decades ago. The left view was taken Jan. 3, 2020 and the right taken Jan. 8, 2021.

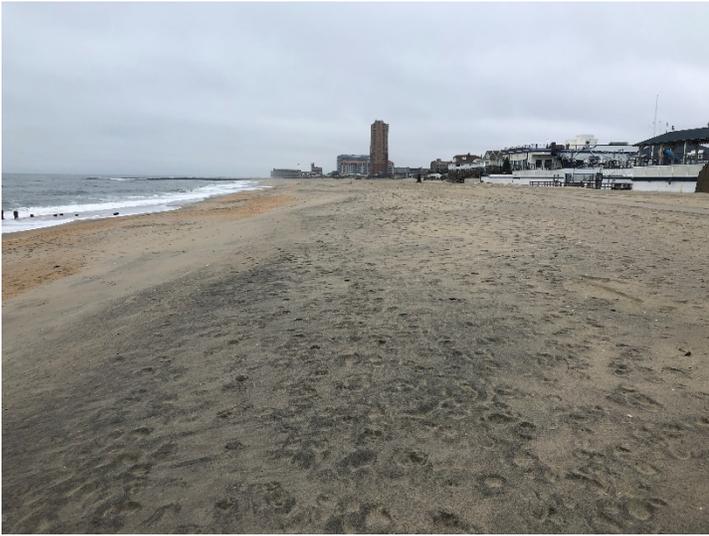
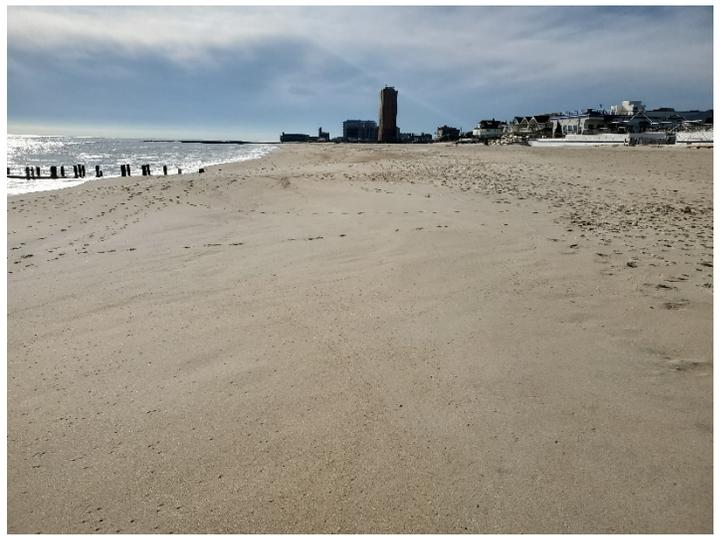
This site in Allenhurst was the starting point for Phase III USACE work in 2015. The left side view (Jan. 30, 2020) to the south includes Loch Arbor and, in the distance, Asbury Park. The right-side photo presents a similar view and tide, revealing more of the pilings at the swash that were previously nearly buried (January 8, 2021).

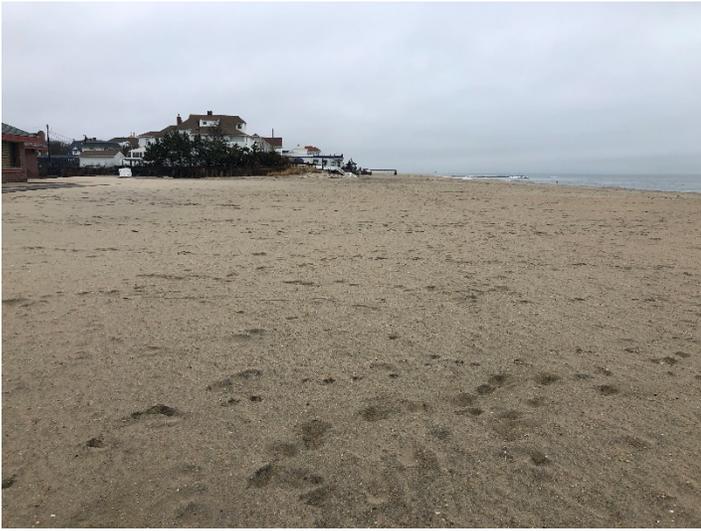
NJBPN 26703 – Euclid Avenue, Loch Arbor

This site is located on the public half of the Loch Arbor shoreline. The Jan. 30, 2020 view on the left shows the beach width in comparison with the Jan. 7, 2021 view on the right taken approximately in the same location on the transect.

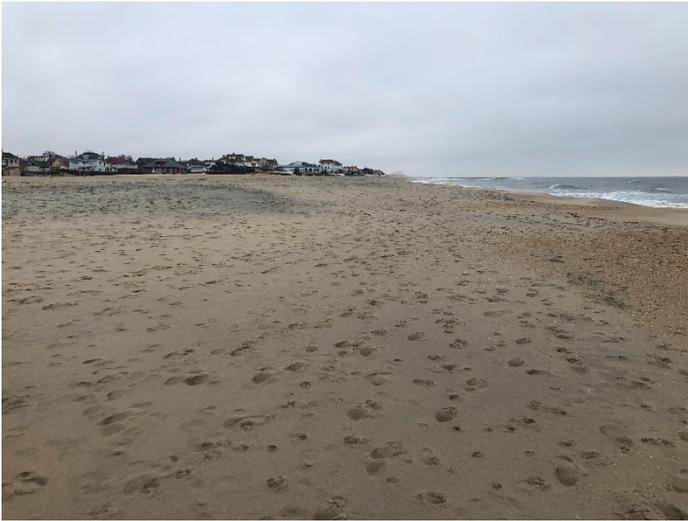
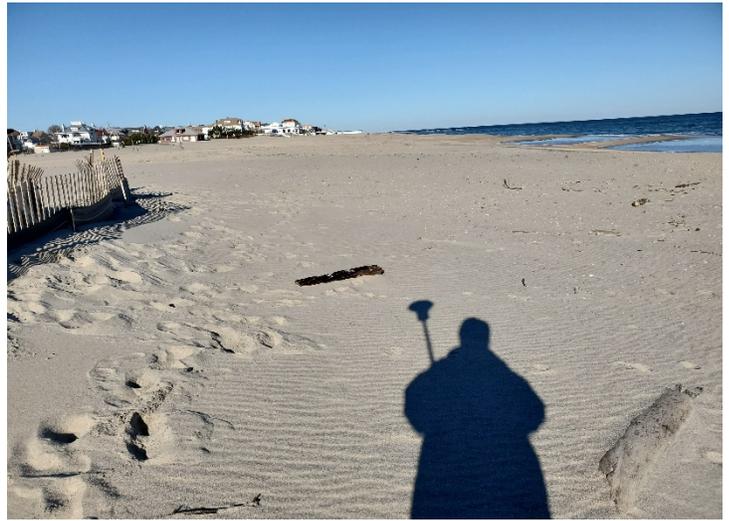
NJBPN 26702 – Edgemont Avenue, Loch Arbor

This site is located on the private half of the Loch Arbor shoreline, adjacent to the Deal Lake exit flume. The Jan. 30, 2020 view on the left shows the natural beach slope. The right-side photo presents a similar view of the beach at a lower tide, along with some of the fence configuration (January 7, 2021). The 18-month comparison gives a skewed view of sand loss due to the presence of the scour hole offshore in 2021 (sand loss of 62.7 yds<sup>3</sup>/ft., but a shoreline advance of 58.8 feet).

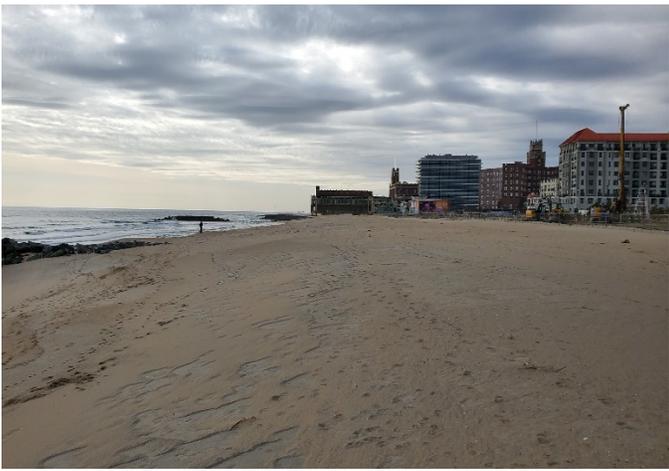
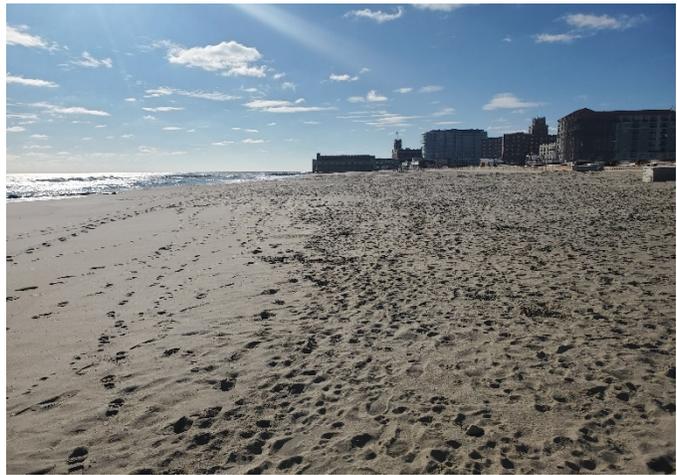
NJBPN 26701 – 1740 Ocean Avenue, Asbury Park

Positioned at the northern limit of the Asbury Park shoreline, this site sits at the boardwalk with a tiny dune seaward of the walk. The Jan. 30, 2020 view (left), shows the rocks were clearly exposed as the beach retreated. The photo on the right, taken January 6, 2021, shows the dry expanse of the beach a bit further up onto the dry beach.

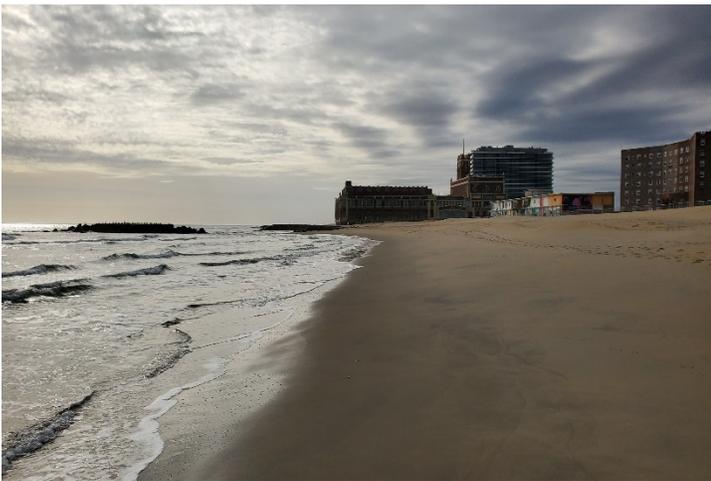
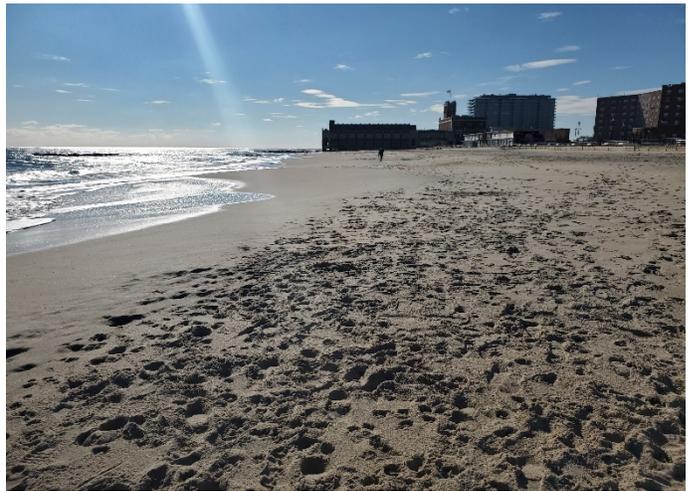
NJBPN 267 – 7th Avenue, Asbury Park

This site is the northernmost location in the Phase II part of the Monmouth County project. The beach face view on Jan. 11, 2020 shows the rock groins with greater exposure indicating shoreline retreat. The January 6, 2021 photo on the right exhibits a less exposed rock groin because the tide was higher with a view across the dry expanse of the beach.

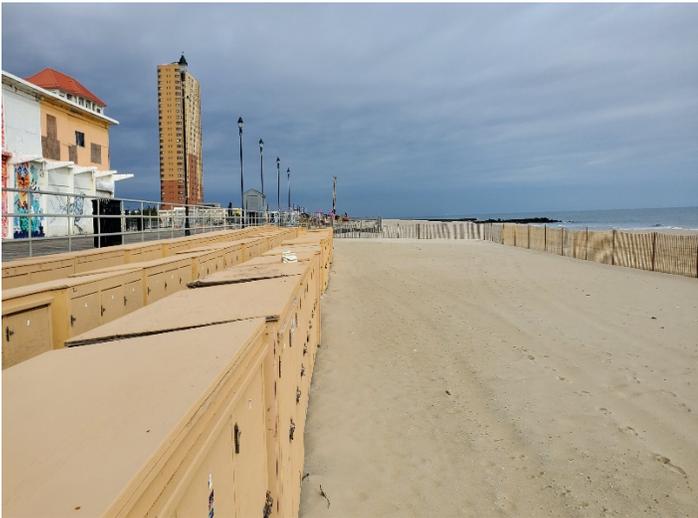
NJBPN 16701 – Sunset Avenue, Asbury Park

The Jan. 10, 2020 view on the left shows the beach just past the storage boxes and right before the fencing. The Jan. 6, 2021 view on the right shows the storage boxes completed next to the boardwalk with the beach essentially the same.

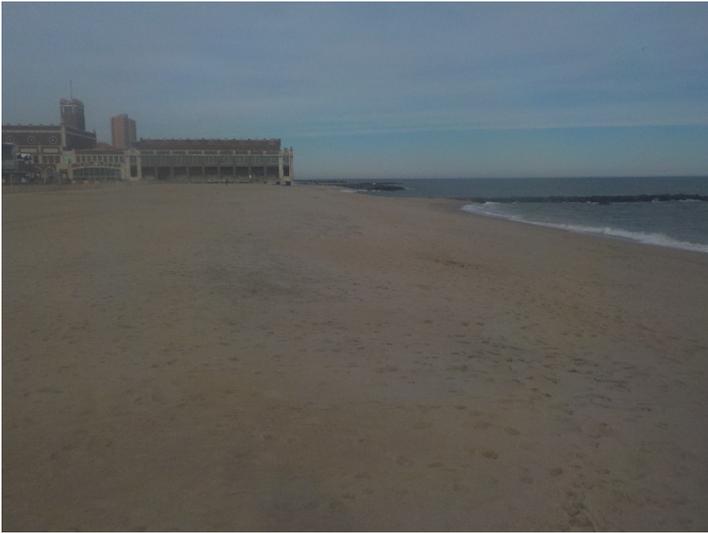
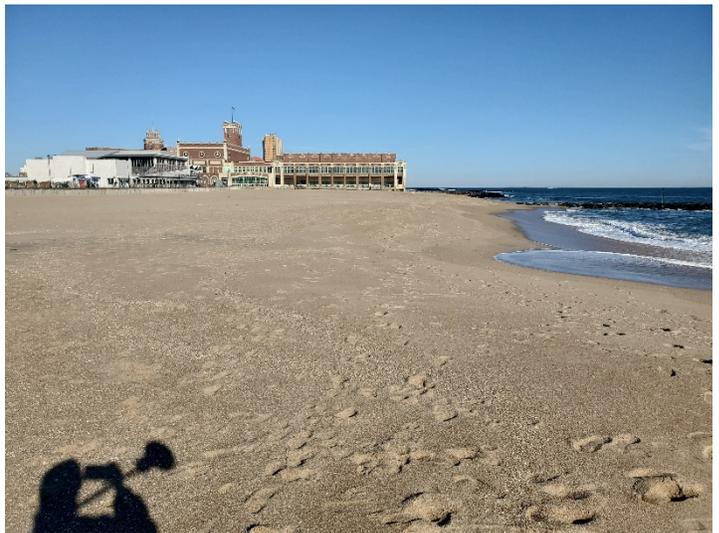
NJBPN 167 – 3rd Avenue, Asbury Park

The left view was taken Jan. 11, 2020, showing the berm crest and the exposed groins along with a comparison of the beachface slope position with the Asbury Park convention center building. The right photo presents a very similar view of the beach, revealing slightly more of the Asbury Park boardwalk.

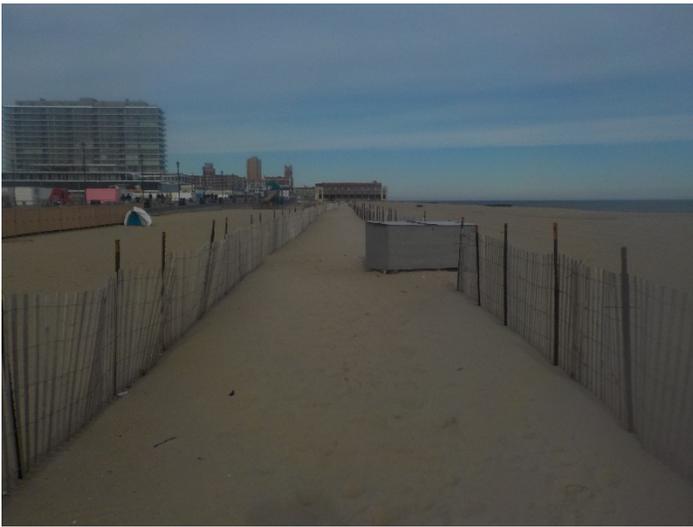
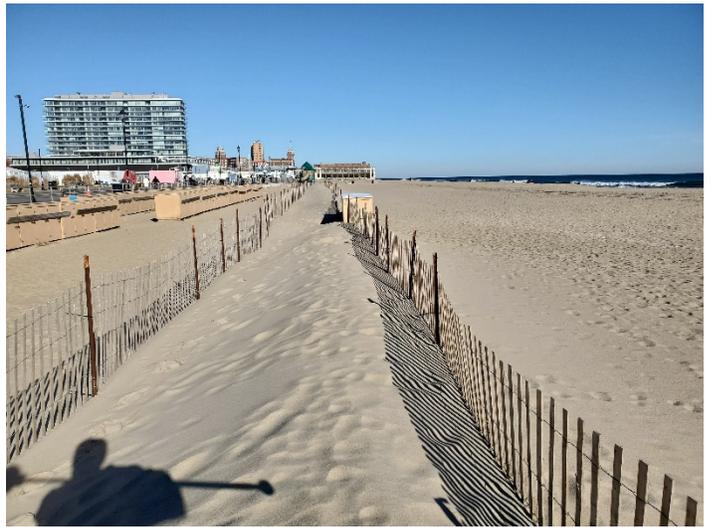
NJBPN 16602 – Asbury Avenue, Asbury Park

The left view was taken between a double row of sand fence on Jan 2, 2020. The right photo shows where sand has begun to collect between the two rows of fencing (Jan. 7, 2021).

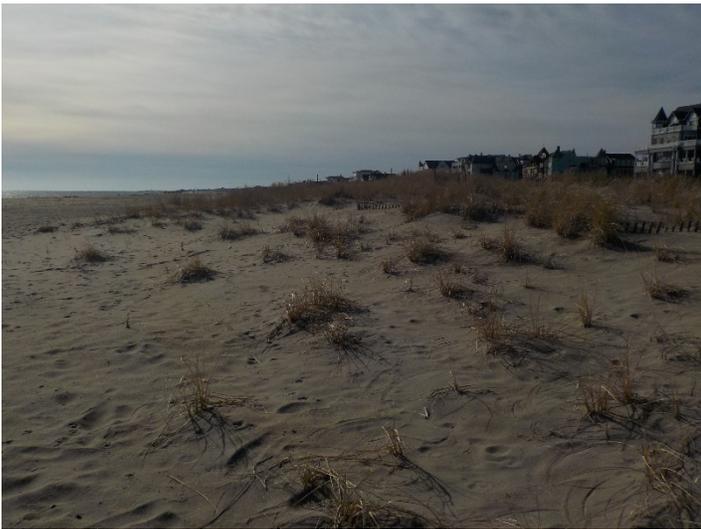
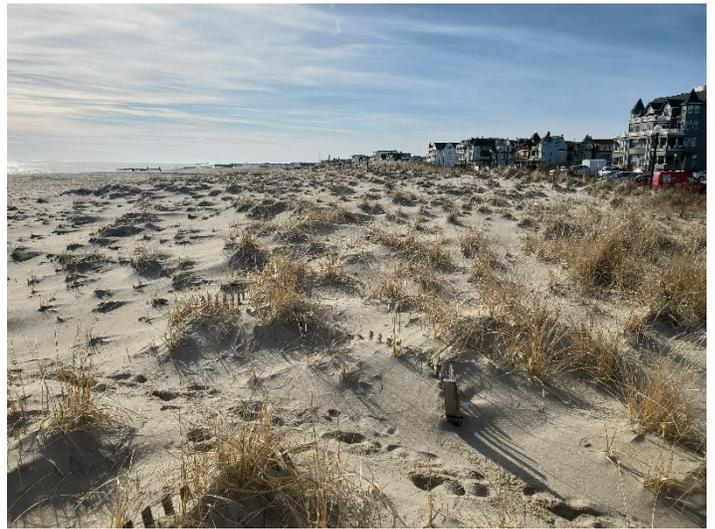
NJBPN 16601 – Spray Avenue, Ocean Grove

The Jan 2, 2020 view on the left shows the dune toe with grass plants extending onto the foredune slope as conditions continue to improve in the Ocean Grove dunes. The December 23, 2021 view on the right presents the same perspective, showing more dune grass, as well as some buried sand fencing.

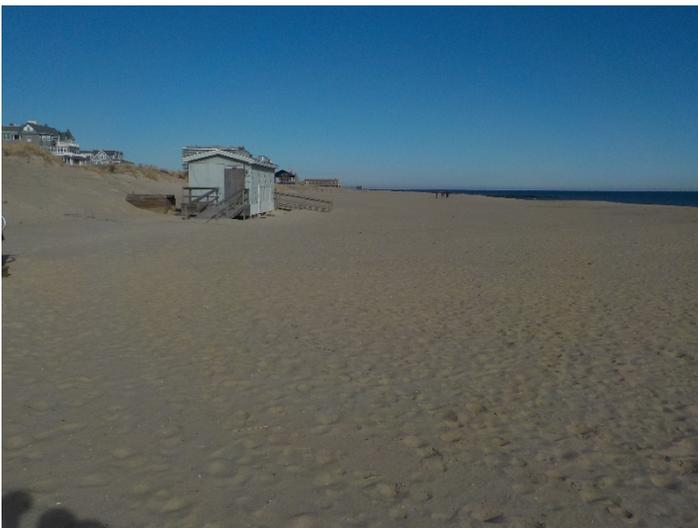
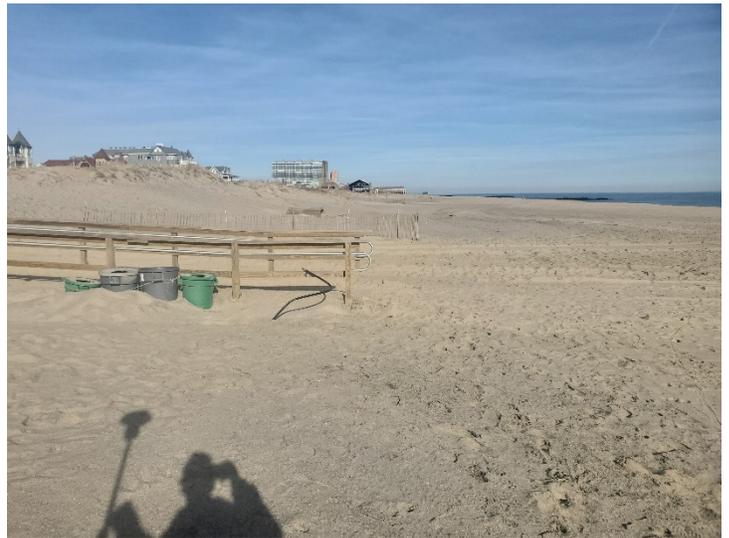
NJBPN 166 – Ocean Pathway, Ocean Grove

The Jan. 2, 2020 view on the left shows the new service building put on the seaward dune toe and the dry beach width present at the time. The December 23, 2020 view on the right provides a closer view of the access path, just in front of the building pictured on the left.

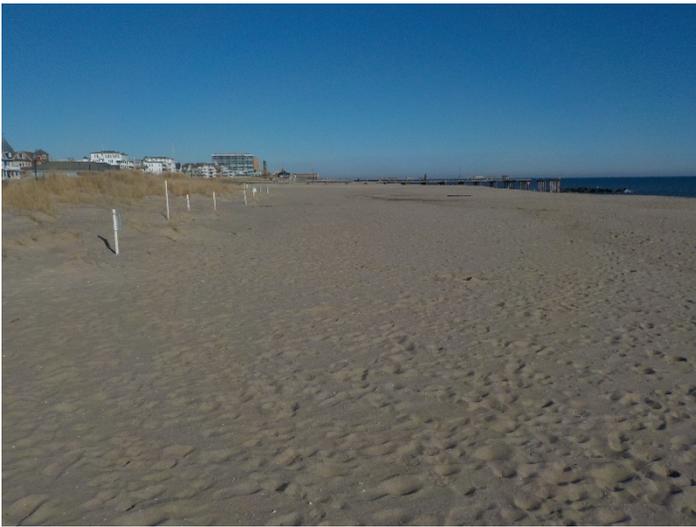
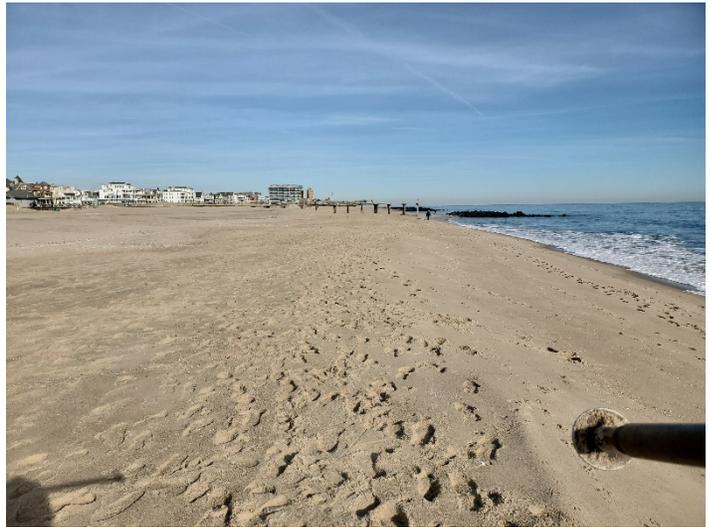
NJBPN 16502 – Broadway, Ocean Grove

The left view from Jan. 2, 2020 shows the beach width and seaward dune slope without pushed up material. The photo on the right, taken December 23, 2020, provides a look at the berm during a lower tide.

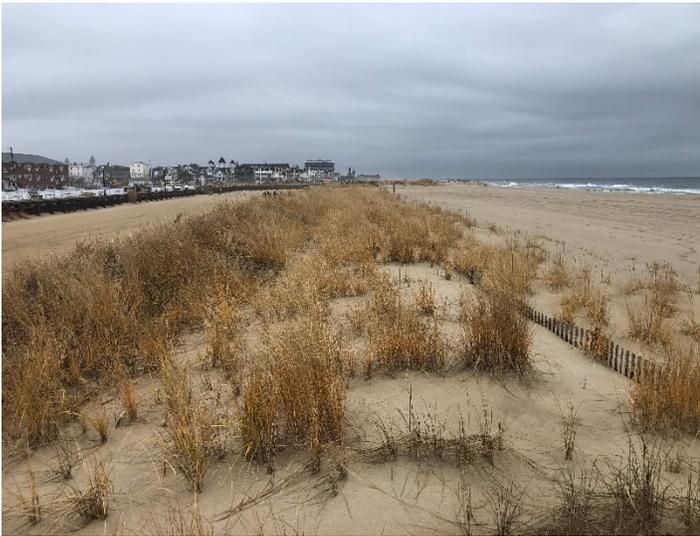
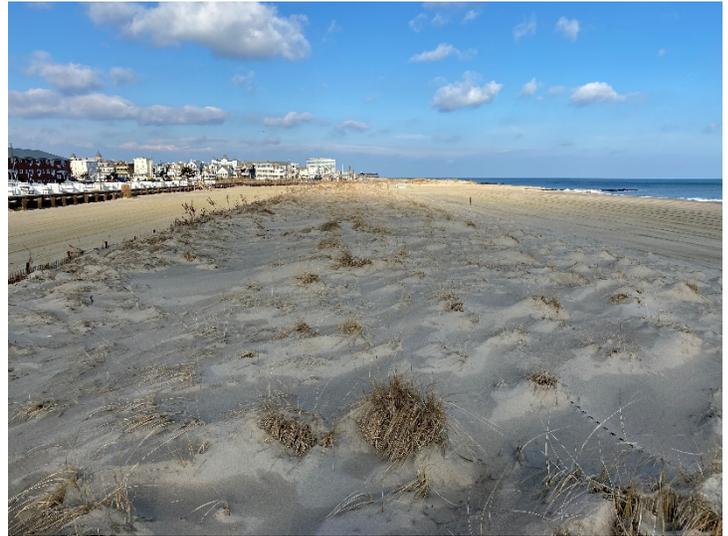
NJBPN 16501 – Cliff Avenue, Bradley Beach

The Dec. 12, 2019 view on the right was taken at the dune crest looking north showing the open space landward of the dunes and the beach width seaward. The December 22, 2020 photo on the right was taken at the same position, showing the dune grass layered by wind-deposited sand.

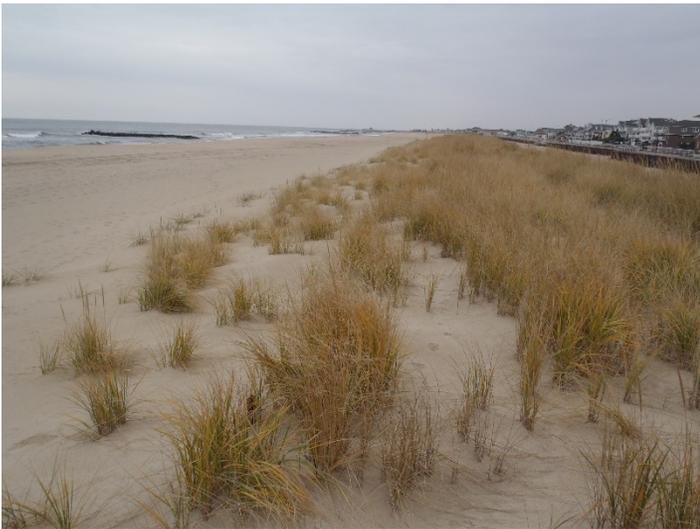
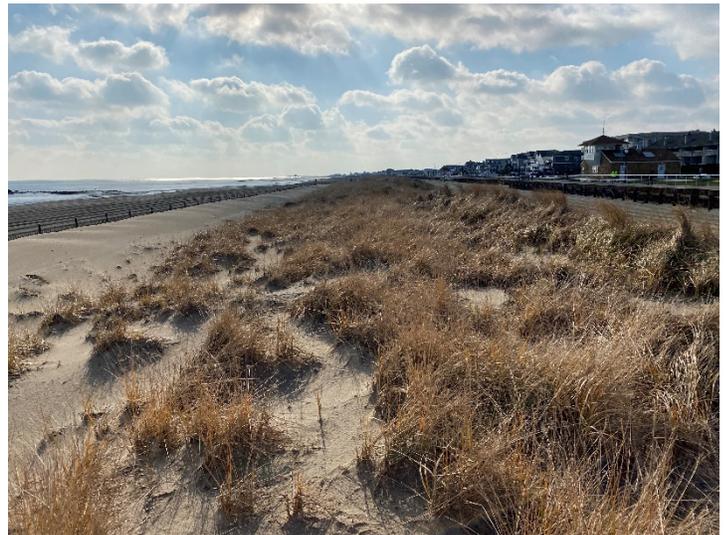
NJBPN 165 – McCabe Avenue, Bradley Beach

The Nov. 22, 2019 view (left), shows the dunes and the dry beach with conditions appearing to be stable. The right view (December 22, 2020) atop the crest, shows the continued growth of dune grass, as well as the addition of fencing.

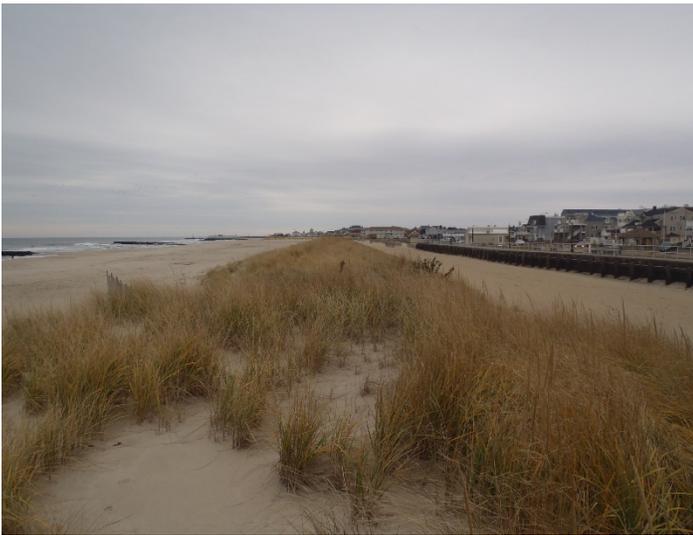
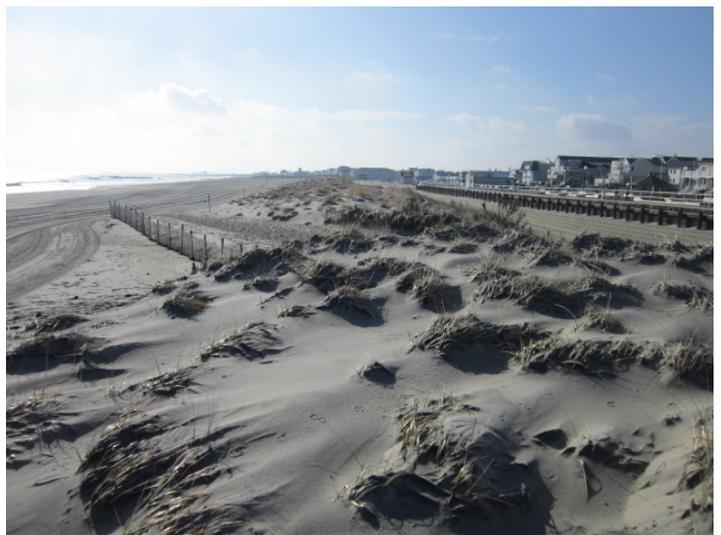
NJBPN 16402 – 4<sup>th</sup> Avenue, Bradley Beach

A dune lies seaward of the promenade with a wide space between it and the boardwalk. The Nov. 22, 2019 view on the left was taken from the dune crest showing both the beach and the promenade. The right-hand photo shows the crest in a similar orientation, however, a significant amount of wind deposited sand was added on top of the dune grass.

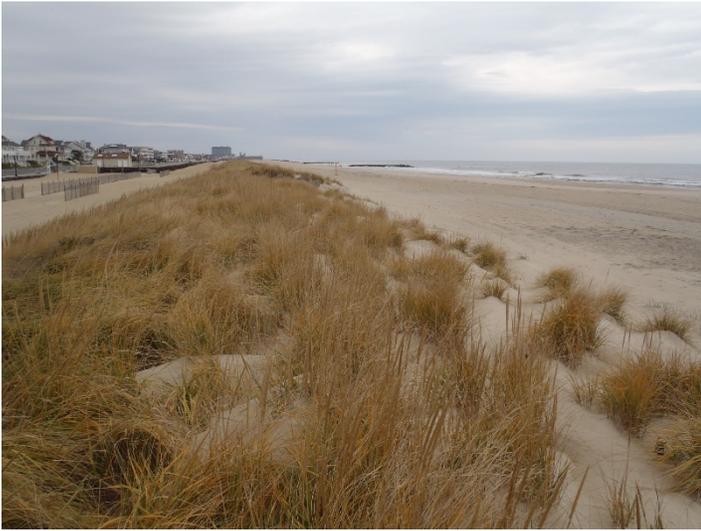
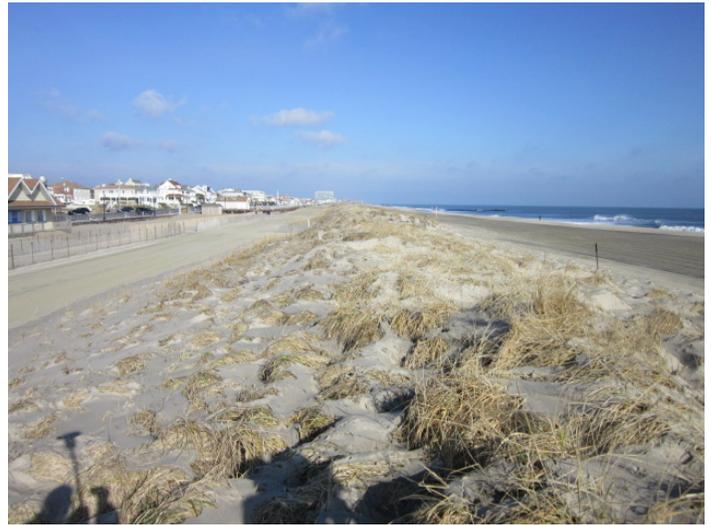
NJBPN 16401 – 2<sup>nd</sup> Avenue, Bradley Beach

The Nov. 22, 2019 view on the left shows extensive grass growth from the prior year and sand added to the seaward slope as well. The December 22, 2020 view on the right shows the dune grass blanketed by wind deposited sand, causing the ridge to grow.

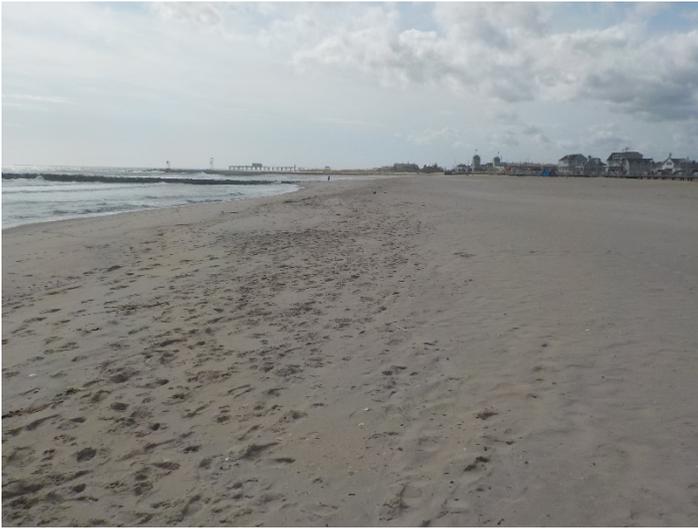
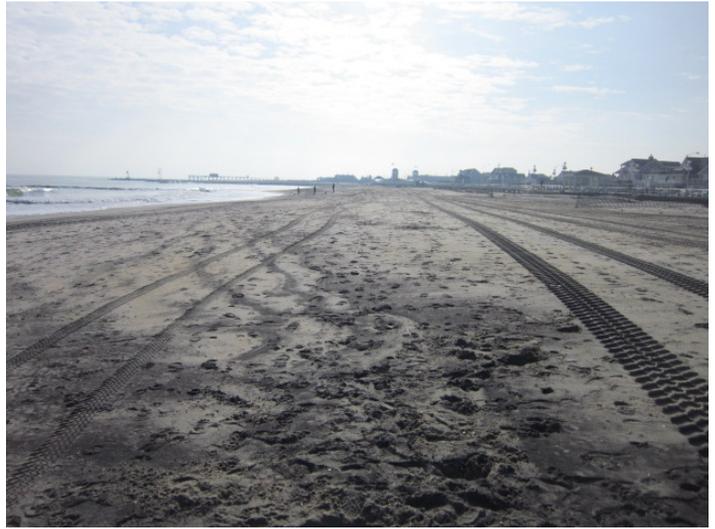
NJBPN 164 – Sylvania Avenue, Avon-by-the Sea

This site is located north of the Shark River Inlet. The left view on October 11, 2019 taken on the berm crest, shows the beach width and configuration around the groins on the beach north of the inlet jetties. The December 21, 2021 photo (right), shows a similar beach profile, with some darker minerals in the sand separated by the swash.

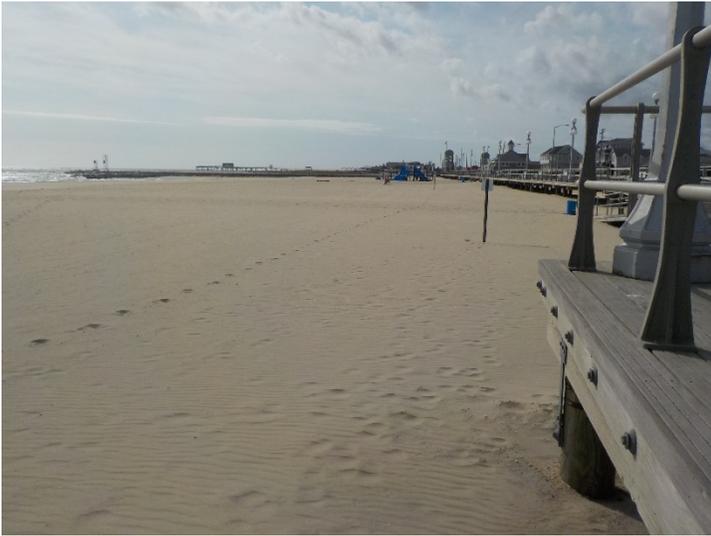
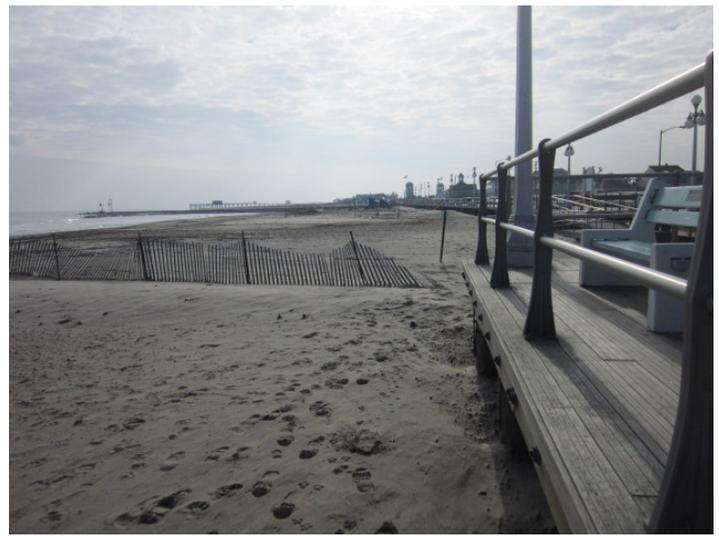
NJBPN 16303 – Garfield Avenue, Avon-by-the Sea

Sand has accumulated at the boardwalk in the absence of any dune system. The beach as of Oct. 10, 2019 is free of the fencing and the dry beach width is substantial (left). The photo on the right, taken December 21, 2020 shows another fence system present, as well as some wind deposition collecting against the boardwalk.

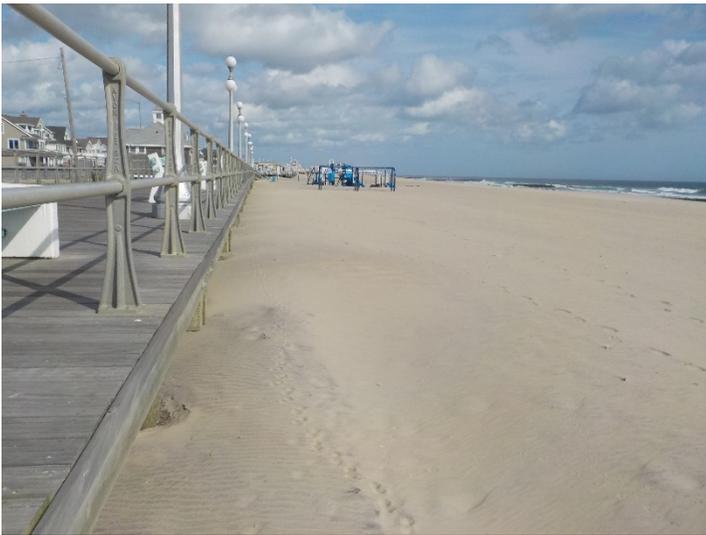
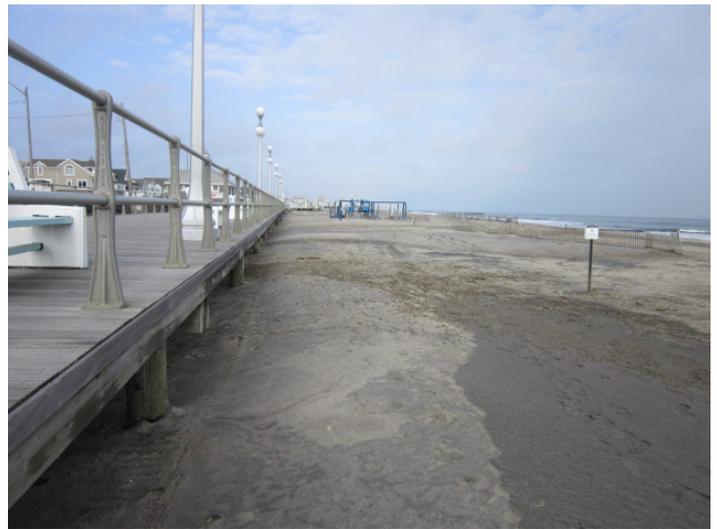
NJBPN 16302 – Washington Avenue, Avon-by-the Sea

This new site is located approximately 300 ft. north of the Shark River Inlet north jetty. The October 7, 2019 view on the left was taken at the boardwalk looking north along the dry beach with the fencing removed. The right-side photo, taken December 21, 2020 shows the same view of the beach, along with an area where water seems to have collected.

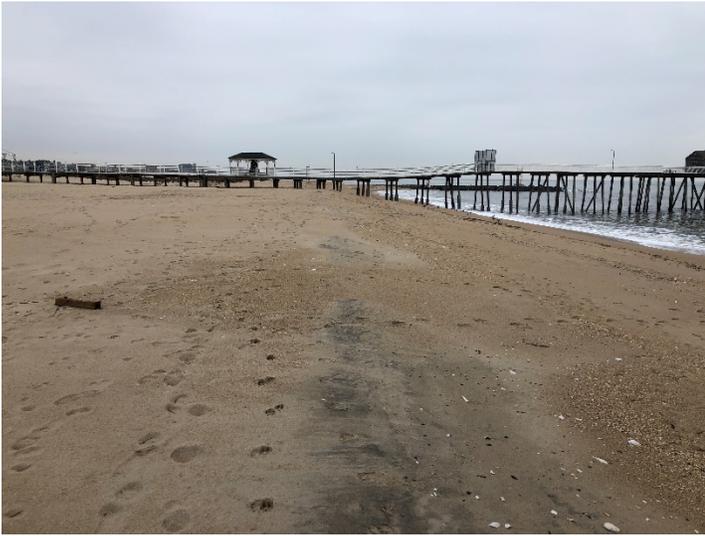
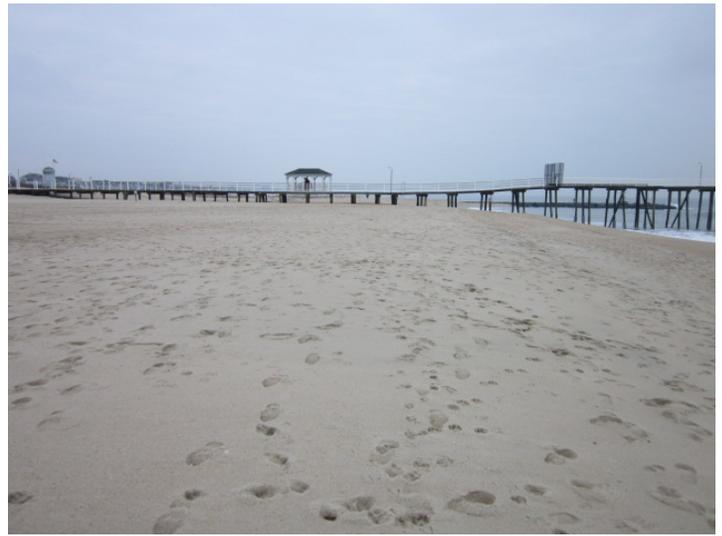
NJBPN 16301 – 2<sup>nd</sup> Avenue, Belmar

The northernmost site in Belmar includes a 450-ft wide beach with no dune. The Shark River Inlet jetty can be seen behind the pier supports north of this site. The beach width as measured by the pier pilings as of Oct. 7, 2019 is slightly seaward of the same view on the right taken Dec. 21, 2020.

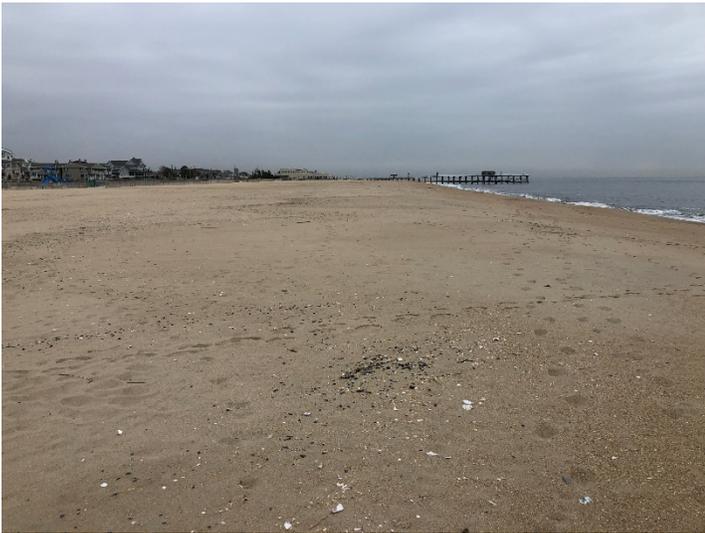
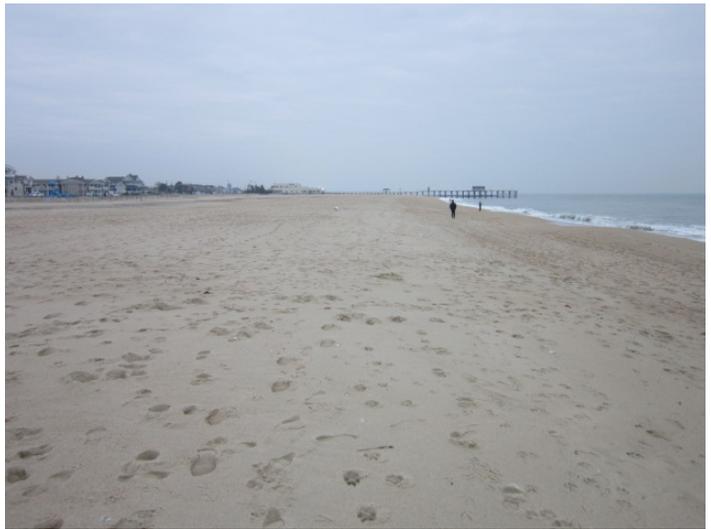
NJBPN 163 – 5<sup>th</sup> Avenue, Belmar

This site never has had a dune but had a wide, dry beach. By October 7, 2019 (left photo) the shoreline was in a similar position as it was the year prior due to sand trapping by the Shark River Inlet jetty. The right photograph, taken December 18, 2020 show the generous if flat expanse of dry beach.

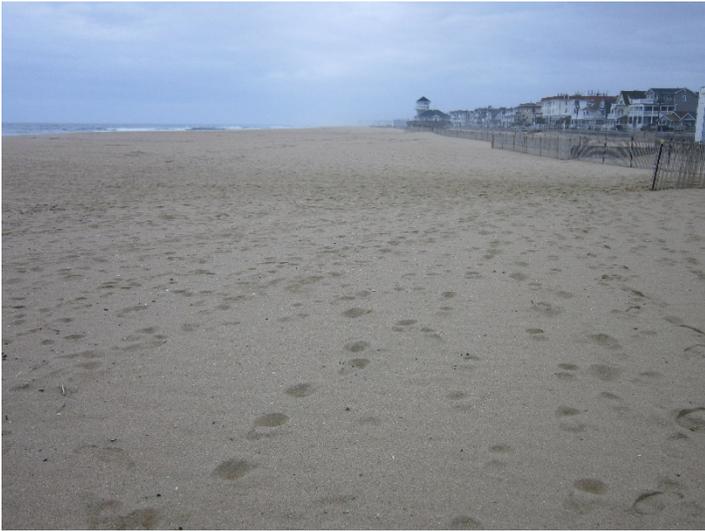
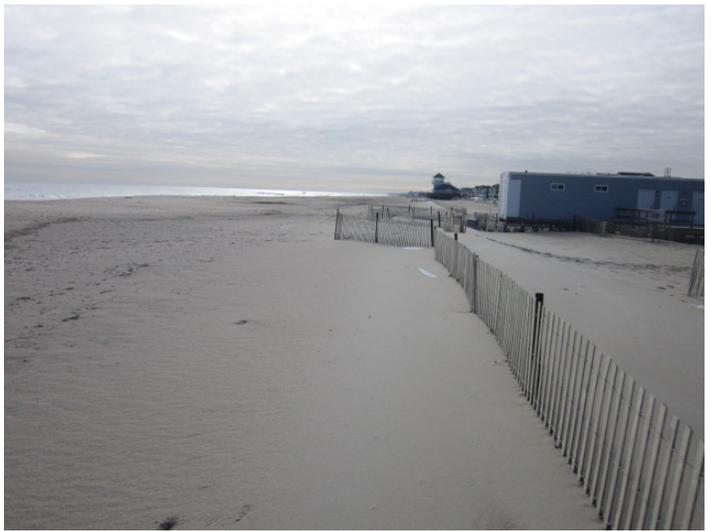
NJBPN 16202 – 8<sup>th</sup> Avenue, Belmar

The boardwalk is the backstop for the beach, since there is no dune system. The Dec. 13, 2019 view on the left shows the fencing at the boardwalk put in to lessen wind transport into Ocean Avenue during the winter. The right-side photo shows that same area a year later in a similar condition (December 18, 2020).

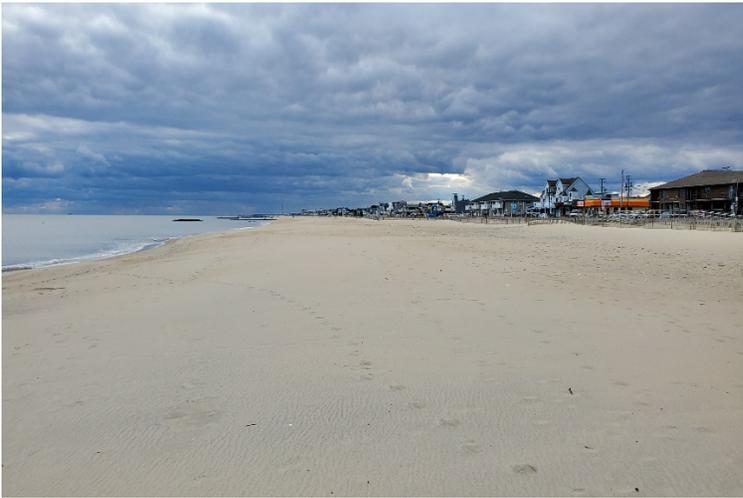
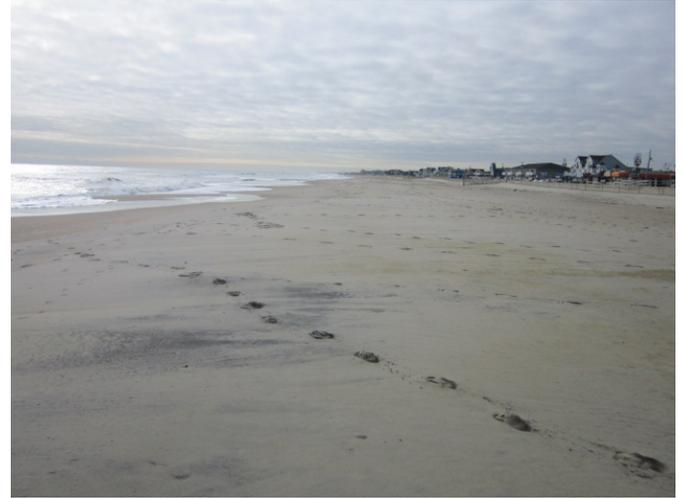
NJBPN 16201 – 14<sup>th</sup> Avenue, Belmar

The 14<sup>th</sup> Avenue site does have a tiny dune feature immediately seaward of the boardwalk. As of Dec. 5, 2019, this ridge was present, removed as of May 2020, and returned once more in a larger size as of Dec. 2020. The beachface slope advanced and then retreated over the four surveys and the loss continued offshore between May and Dec. 2020. The net 18-month change was a gain of 6 yds<sup>3</sup>/ft. and a small 1.75-foot shoreline decrease.

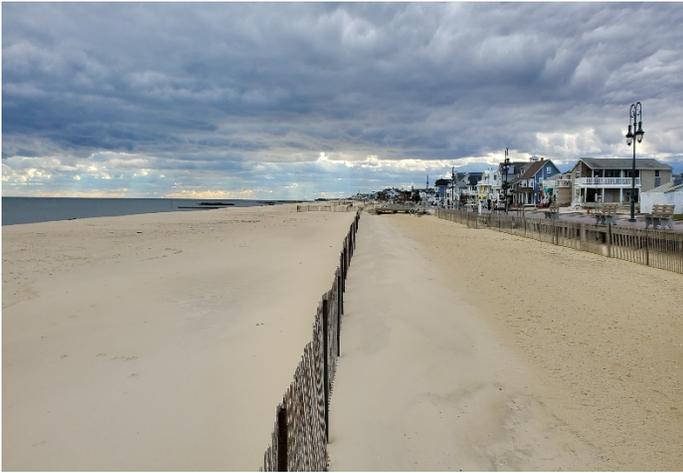
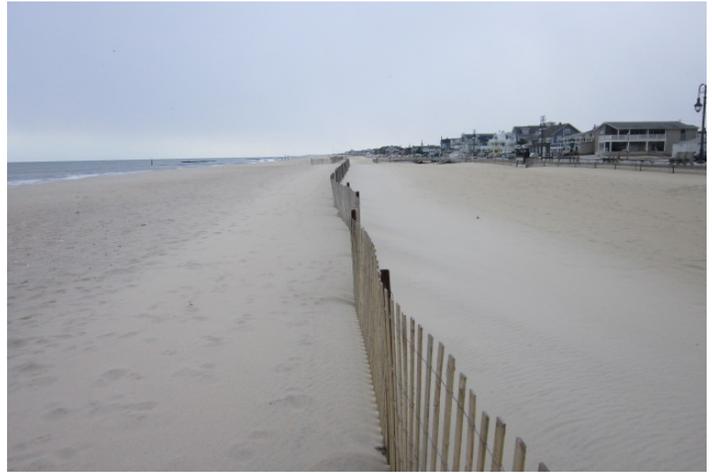
**NJBPN 162 – 18th Avenue, Belmar**

The December 5, 2019 view (left) taken at a sand fence put in place to collect material from blowing into Ocean Avenue shows an uncluttered dry beach seaward. The photo included on the right-hand view taken December 9, 2020 presents an extremely similar photo of the 18<sup>th</sup> Avenue beach.

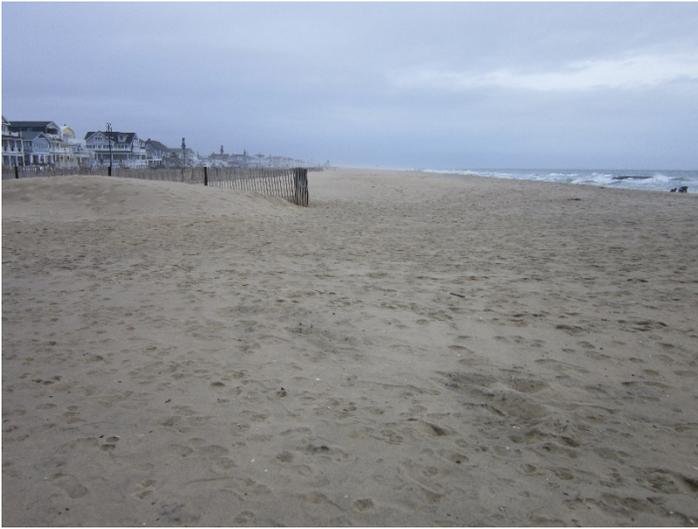
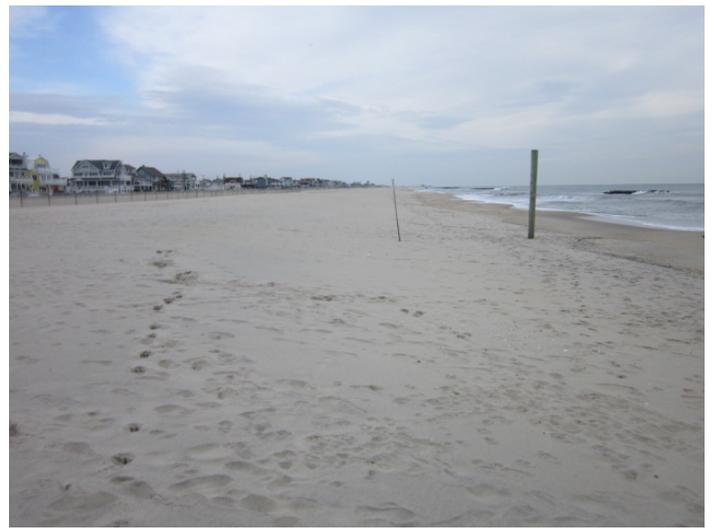
NJBPN 16104 – North Boulevard, Belmar

This site is located on the north side of Lake Como, the estuary lake between Belmar and Spring Lake. The Dec. 13, 2019 view on the left shows sand fencing instead of a storm ridge along this beachfront in southernmost Belmar. On December 9, 2020 a similar view to the north shows the wide beach and beachface slope.

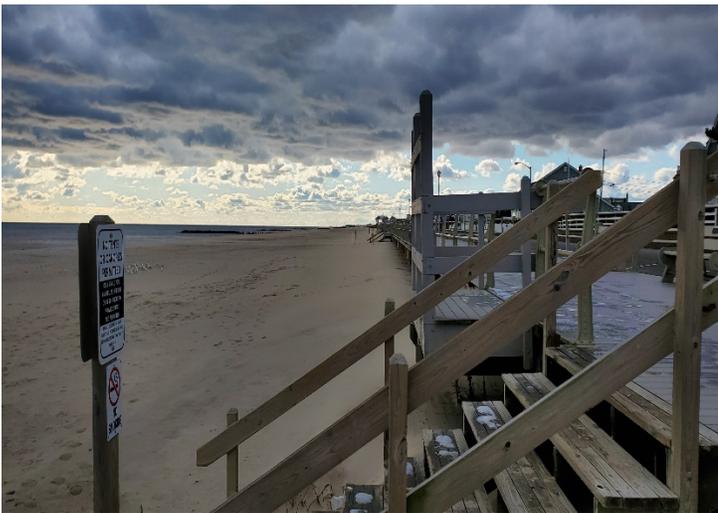
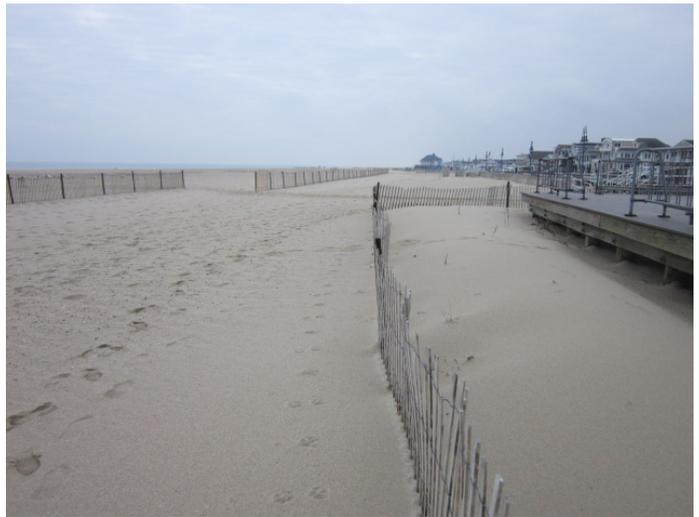
NJBPN 16103 – Remsen Avenue, Spring Lake

A grass strip separates Ocean Avenue and the boardwalk. On December 3, 2019 (left), sand had ramped up under the boardwalk as wind transport moved it landward. In Spring Lake sand dunes exist landward of the boardwalk between it and Ocean Avenue. The December 9, 2020 view of Remsen Avenue on the right shows a fence configuration to stop sand from blowing landward toward the boardwalk.

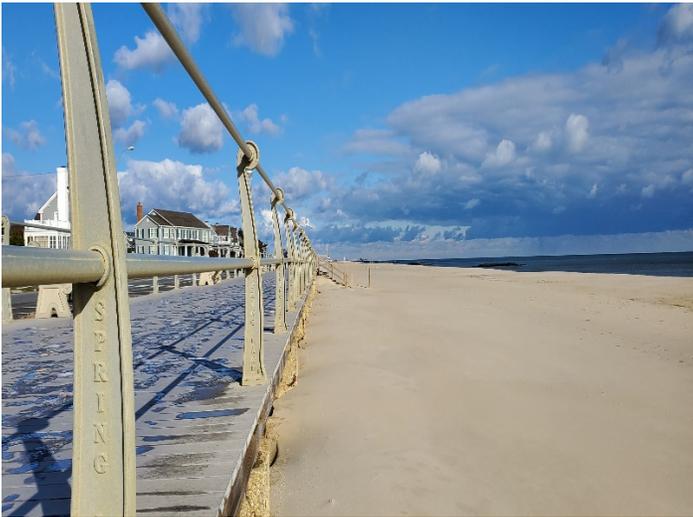
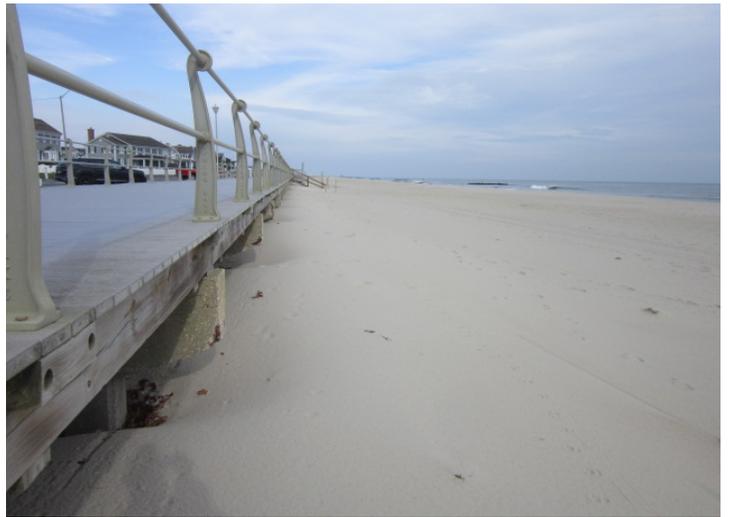
NJBPN 16102 – Lorraine Avenue, Spring Lake

This site follows the same pattern as the site to the north with a boardwalk fronted by a 250-foot wide beach. The grass strip between the boardwalk and Ocean Avenue has no dune. Both the Oct. 2018 and the December 9, 2020 view show the seaward base of the boardwalk, with the wind deposited sand collected against it.

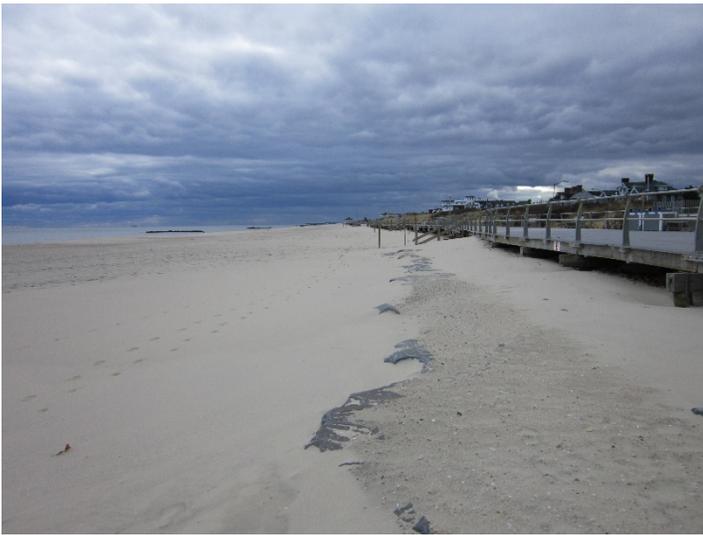
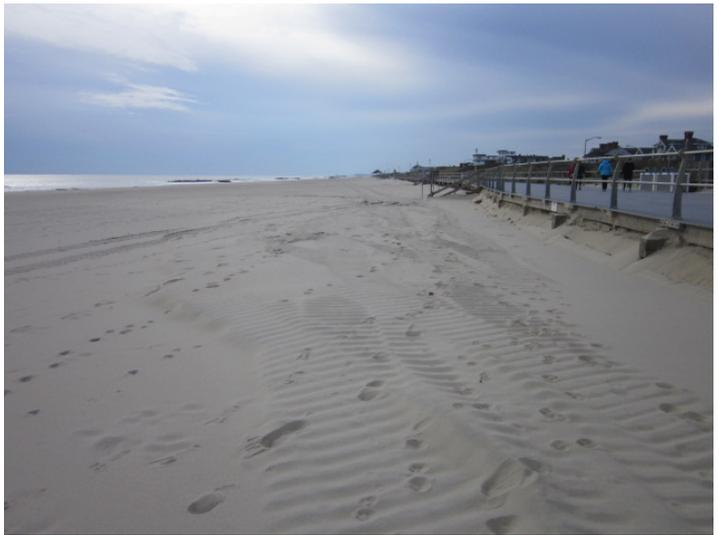
NJBPN 16101 – Tuttle Avenue, Spring Lake

The Dec. 5, 2019 view shows sand accumulating under the boardwalk as the wind deposits the material there with some carried into the vegetated dunes present landward of the boardwalk. The December 9, 2020 view on the right shows a continued trend of wind deposited sand, to the point where it has filled the gap underneath the boardwalk.
