# STOCKTON UNIVERSITY COASTAL RESEARCH CENTER

## New Jersey Beach Profile Network 2020 Annual Report on Shoreline Changes in New Jersey's Four Coastal Counties Raritan Bay to Delaware Bay Spring of 2019 Through Fall of 2020

August 31, 2021

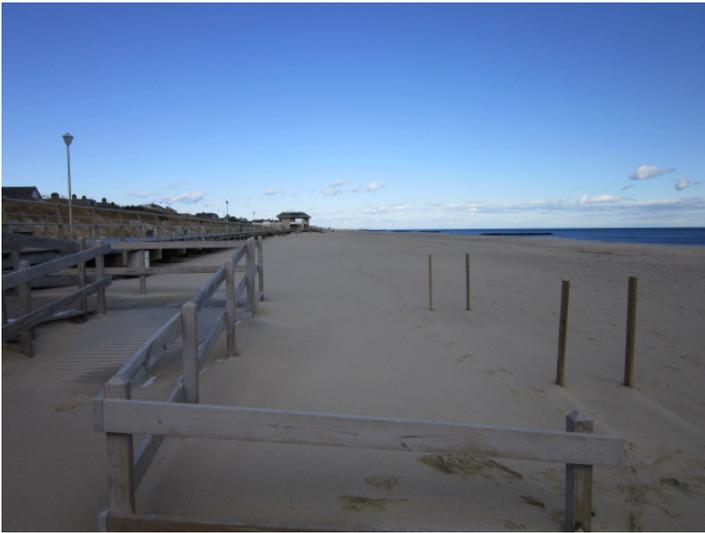
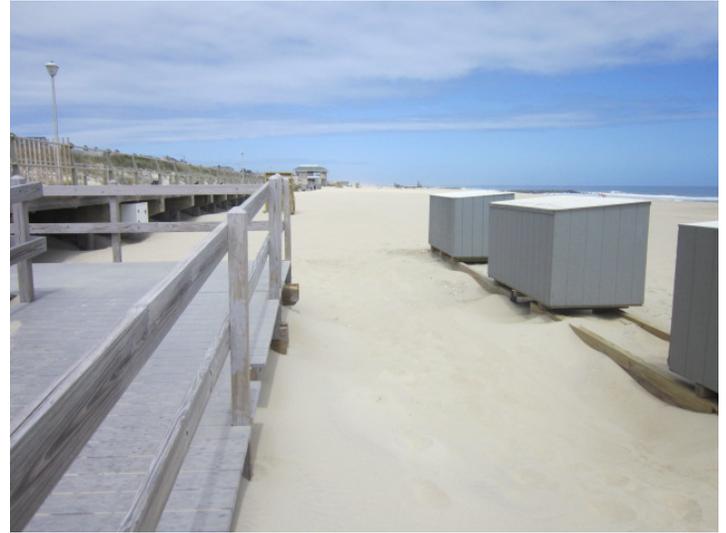
**NJBPN 161 – Brighton Avenue, Spring Lake**

The left photo was taken Dec. 5, 2019 from the base of the boardwalk showing wind deposition at the structure because the dune is landward in Spring Lake. The December 8, 2020 view on the right shows a similar beach, with the storage sheds added.

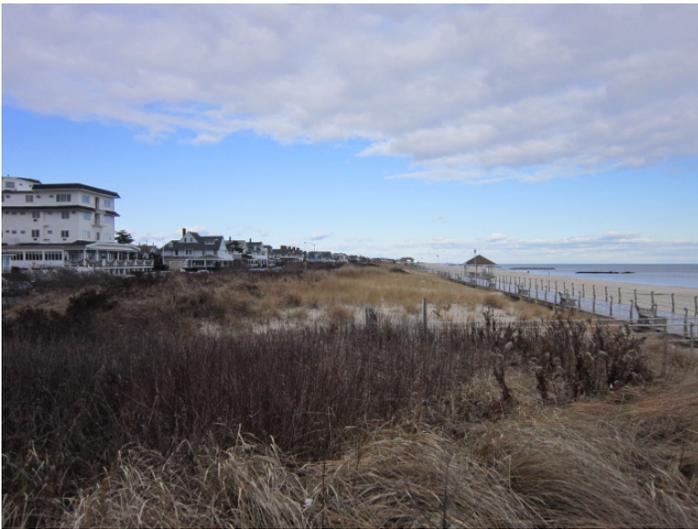
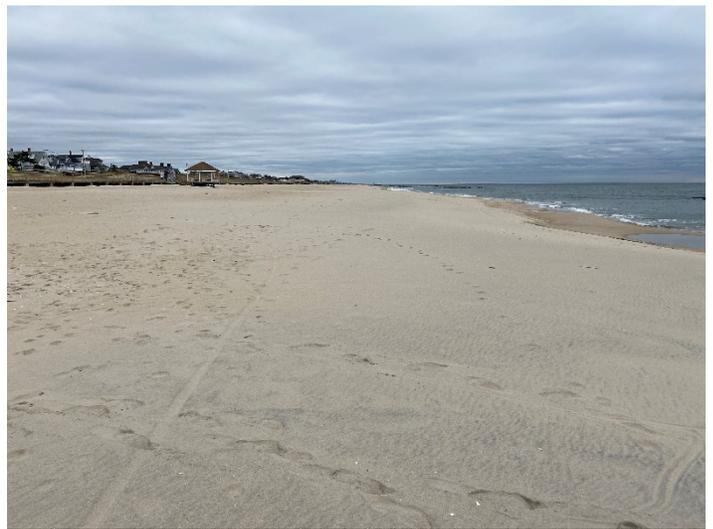
NJBPN 16004 – Madison Avenue, Spring Lake

The dune is robust between Ocean Avenue and the boardwalk. The dune present at this site shows in the right photograph including the boardwalk and just a glimpse of the beach seaward. This dune view on Dec. 5, 2019 is to illustrate the Spring Lake dune system relative to the shoreline development. The right photograph illustrates the berm and beachface Dec. 2020.

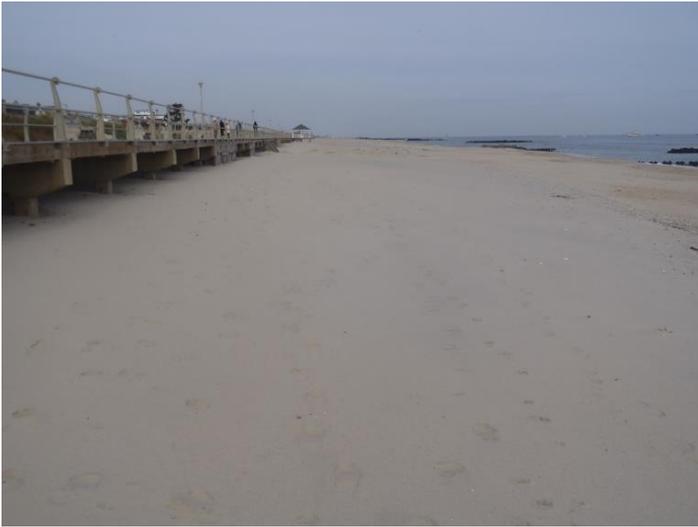
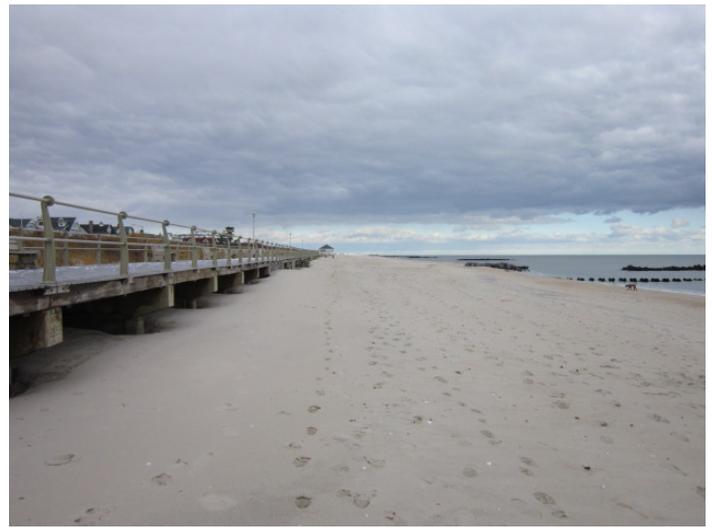
NJBPN 16003 – Morris Avenue, Spring Lake

The left-hand photograph, taken on Dec. 5, 2019, shows the sand accumulating under the boardwalk, but some retreat in the beach width has occurred. The right-hand photo taken on December 8, 2020 shows a similar perspective.

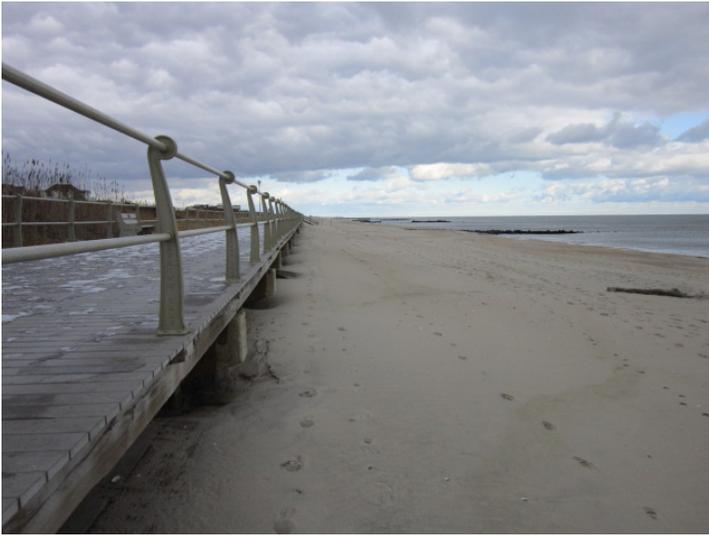
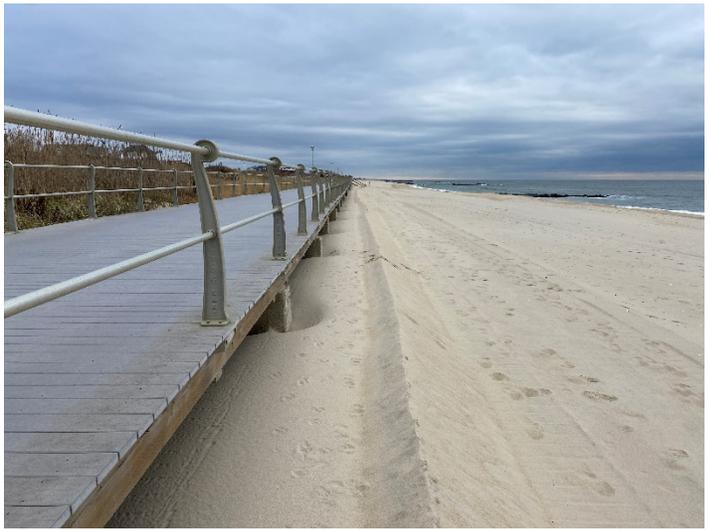
NJBPN 16002 – Mercer Avenue, Spring Lake

The dune is slightly lower and narrower at Mercer Avenue with a distinct separation from the boardwalk. The Dec. 5, 2019 view depicts the beach at the base of the boardwalk, and it appears to indicate a narrower beach than it had the year prior. The December 8, 2020 view on the right side shows the same perspective, facing north at the seaward base of the boardwalk, where a small sand ridge seems to have been constructed.

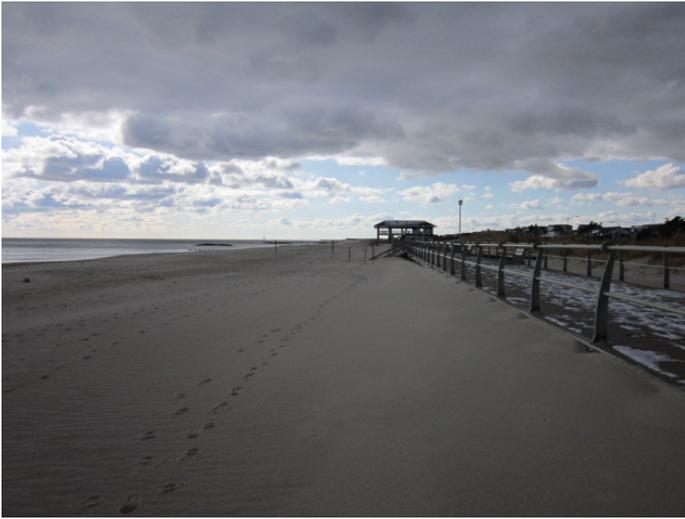
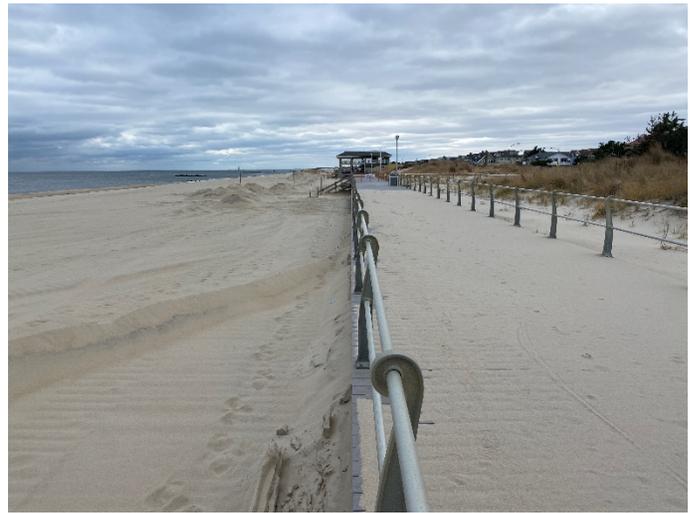
NJBPN 16001 – Essex Avenue, Spring Lake

The dune/boardwalk combination are quite large as a storm barrier. The Dec. 5, 2019 view on the left demonstrates the sand deposition at the boardwalk ramping to the surface at this site. The right-hand side photo, taken atop the boardwalk on December 8, 2020, showcases sand blown onto the deck with no drop off at the landward edge..

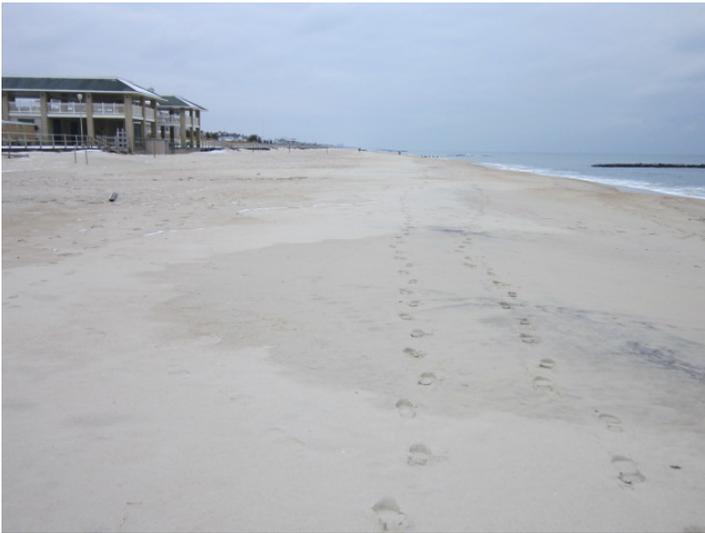
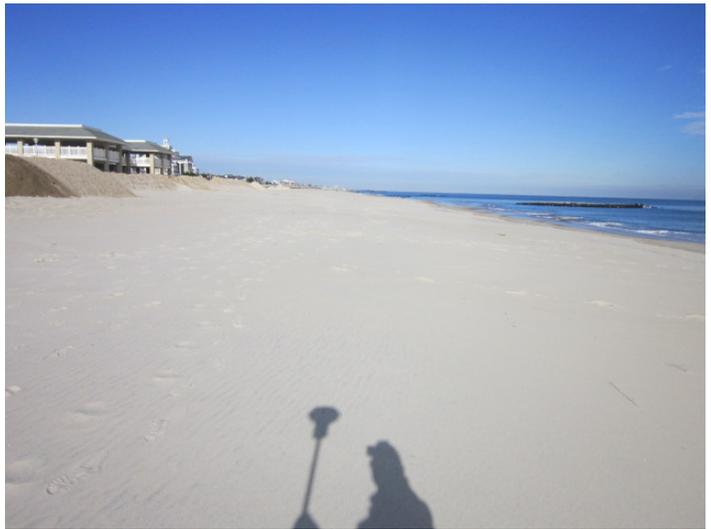
NJBPN 160 – Salem Avenue, Spring Lake

The Salem Avenue beach site lies just south of one of the municipal beach facilities. The left, the Dec. 3, 2019 shows the expanse of the beach during the winter, with a snow-covered boardwalk. The December 7, 2020 view on the right shows the same perspective of the beach, including the beginning of a construction project.

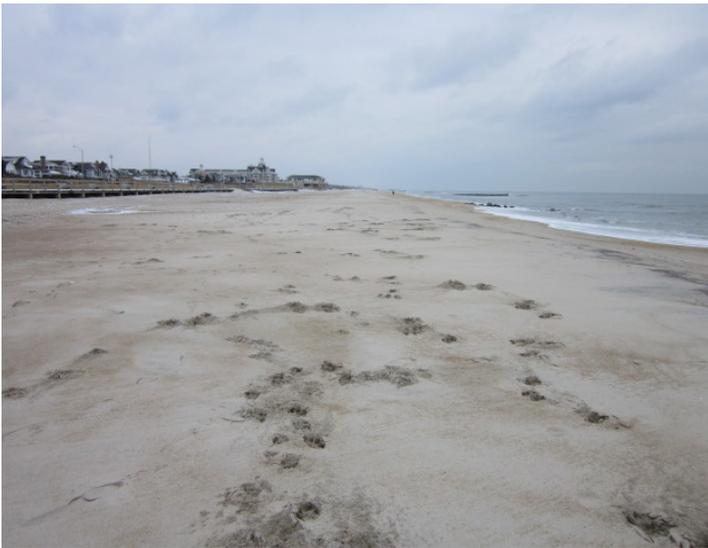
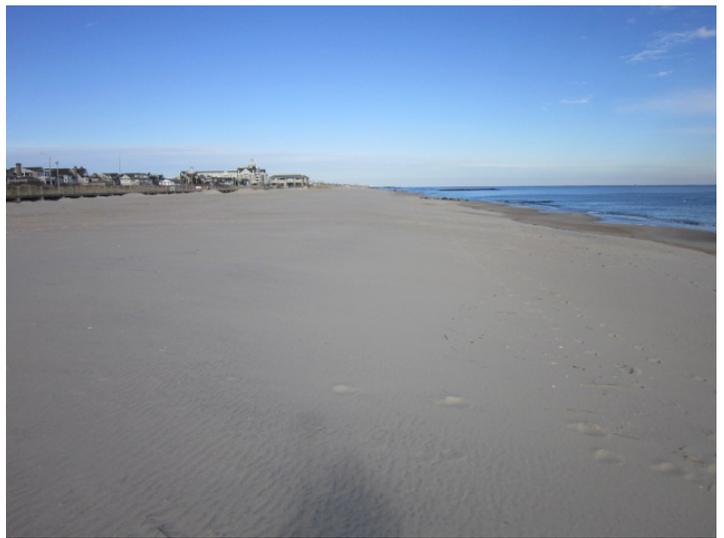
This site has a narrow dune with the boardwalk seaward of it. The Dec. 4, 2019 view on the left was taken at the berm crest following a minor snowfall. The December 7, 2020 view on the right presents a much less textured beach, smoothed out by wind action.

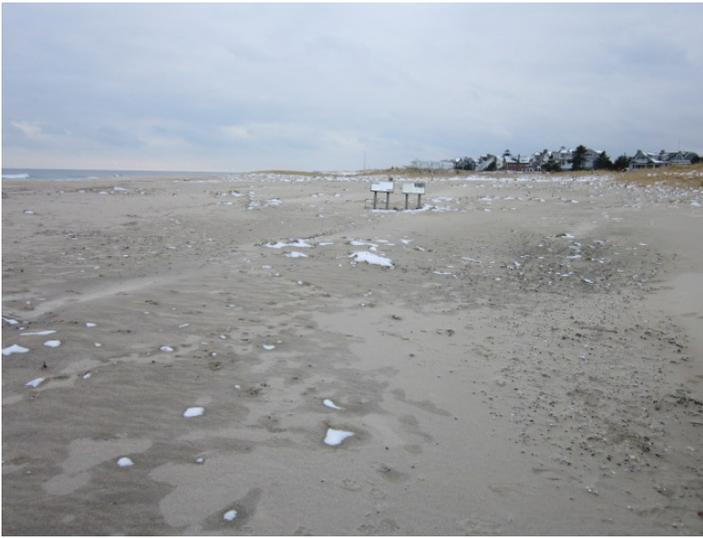
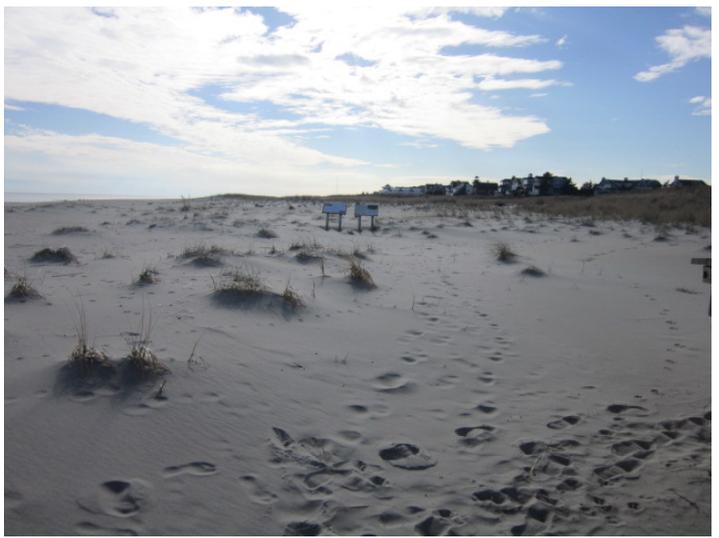
NJBPN 15901 – Brown Avenue, Spring Lake

At the south end of Spring Lake, the dune is not significantly higher than the surface of the boardwalk. The Dec. 4, 2019 view on the left shows the boardwalk and dune system, along with a wide beach to the center of the view. The Dec. 7, 2020 view on the right shows a similar landscape with the introduction of some newly grown dune grass.

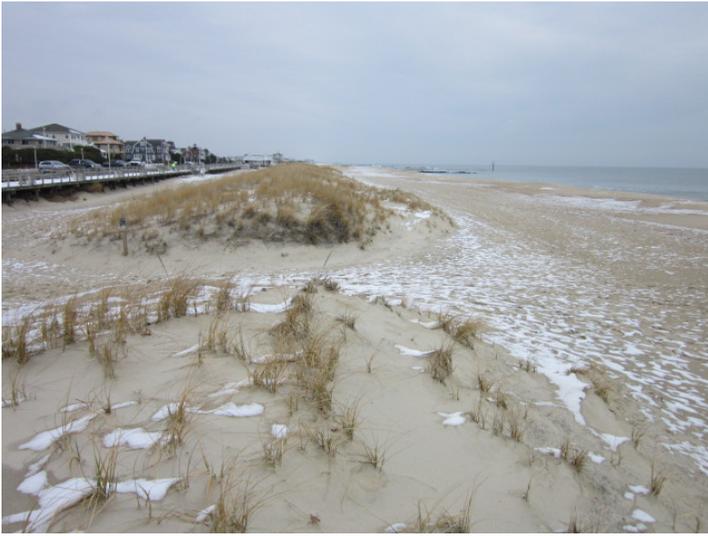
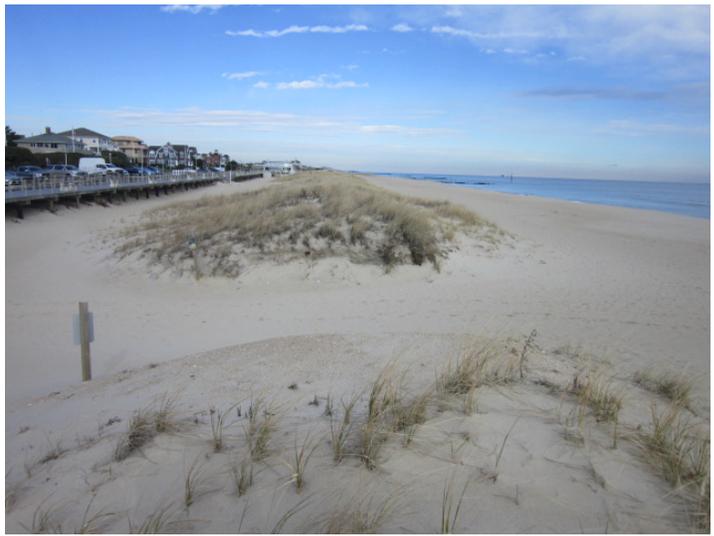
NJBPN 159 – New York Avenue, Sea Girt

The Dec. 4, 2019 view on the left followed a snow storm that dusted the beach. The dunes were built after Sandy to have pedestrian paths through them that the Borough fills with sand prior to a storm. The right side photo is nearly identical, with the dune remaining the same.

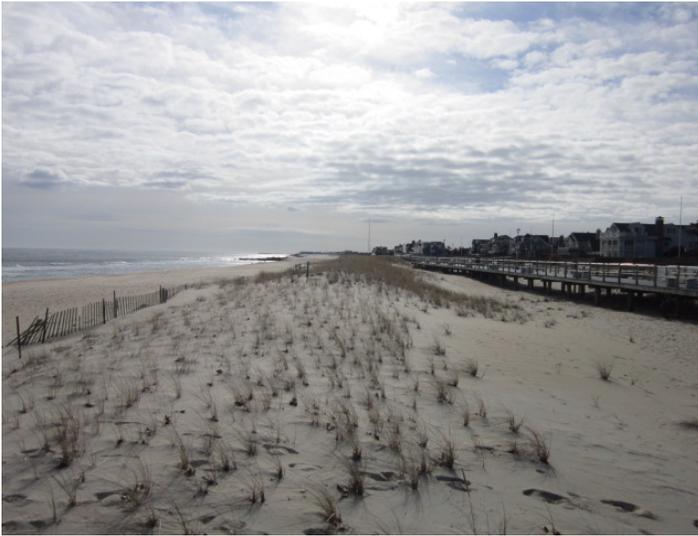
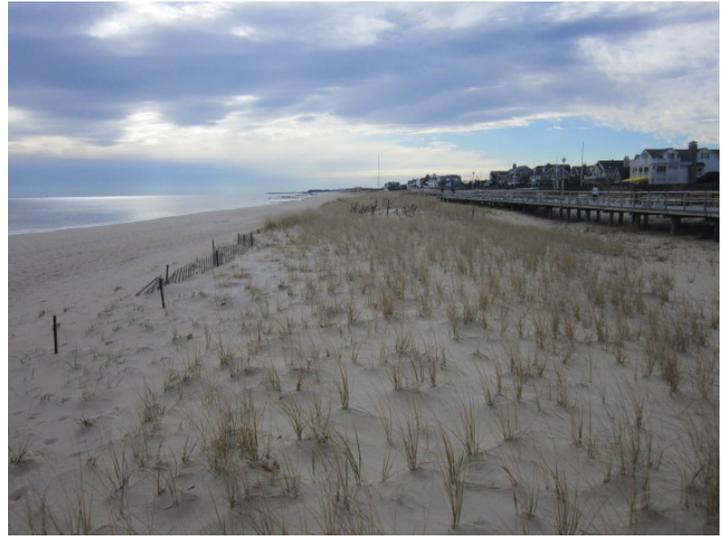
NJBPN 15801 – Crescent Park, Sea Girt

The photo on the left (Jan 10, 2020) shows the grass was partially buried by added wind deposition and the damaged fence was still unrepaired. The December 7, 2020 view on the right shows the fence once again, unrepaired but still capturing a minor amount of sand.

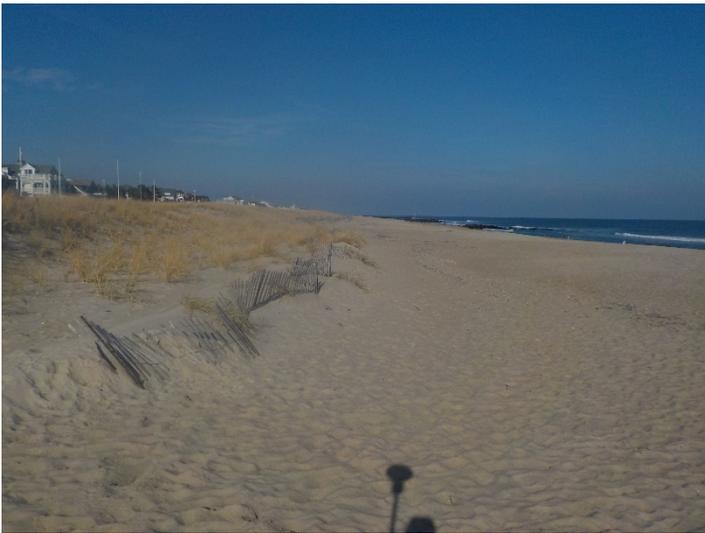
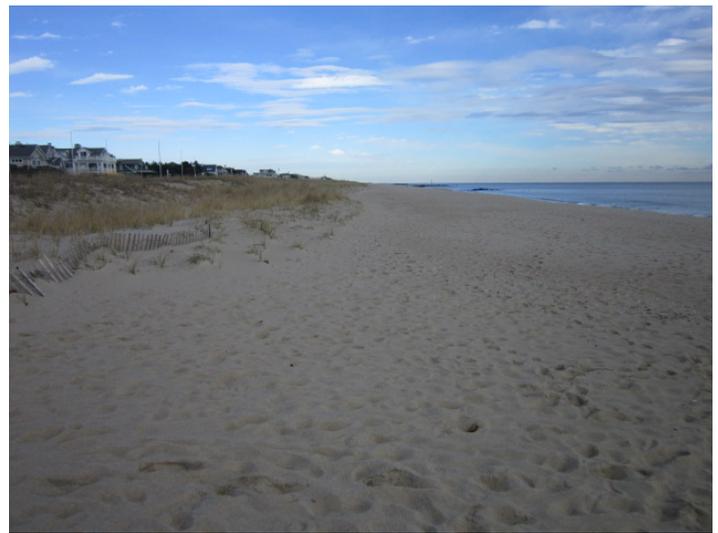
NJBPN 158 – Trenton Avenue, Sea Girt

The Nov. 25, 2019 view (left photo) is at the toe of the dunes showing minor scarping and fence damage, like that seen to the north at site 15801. The right-hand side photo shows the damaged fence further buried, with dune grass growth proceeding seaward beyond the fencing.

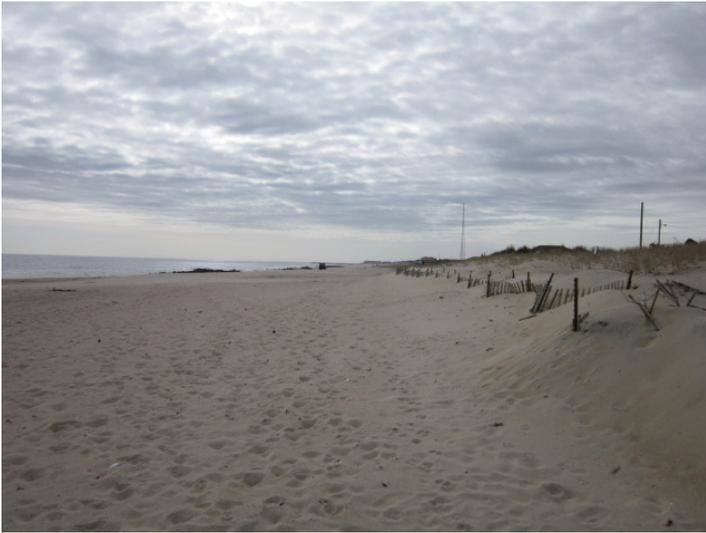
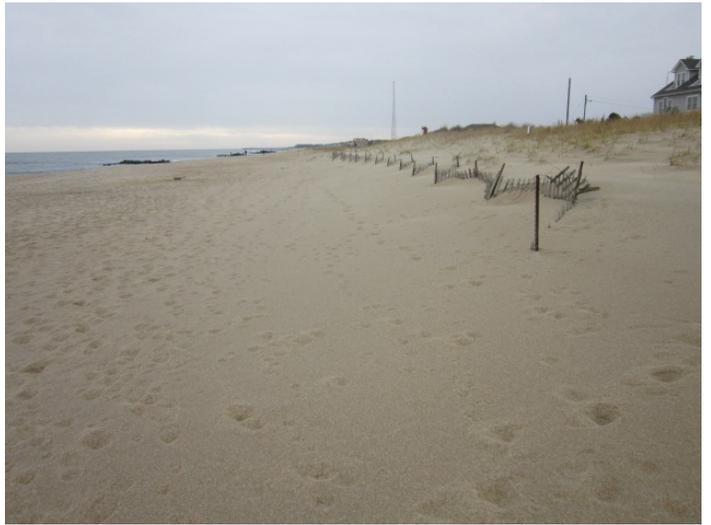
In the left-hand photo, wind transport appears to have replaced some dune toe sand as of Jan. 10, 2020. The photograph on the right seems to show the same trend of wind driven sand collecting at the toe of the dune (Dec. 7, 2020).

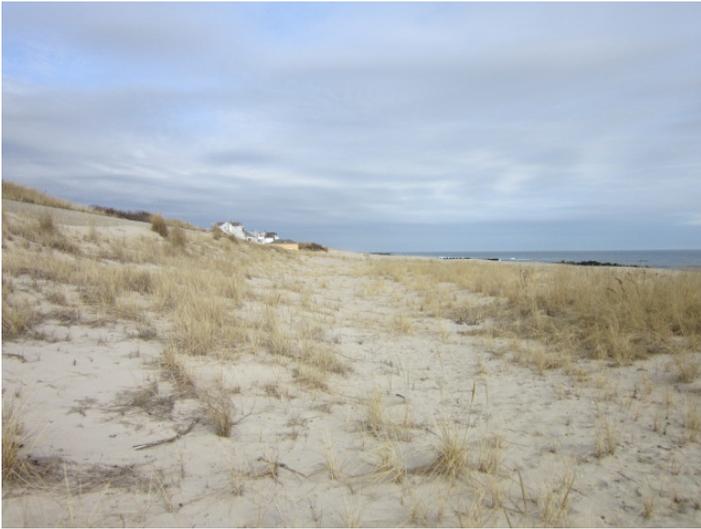
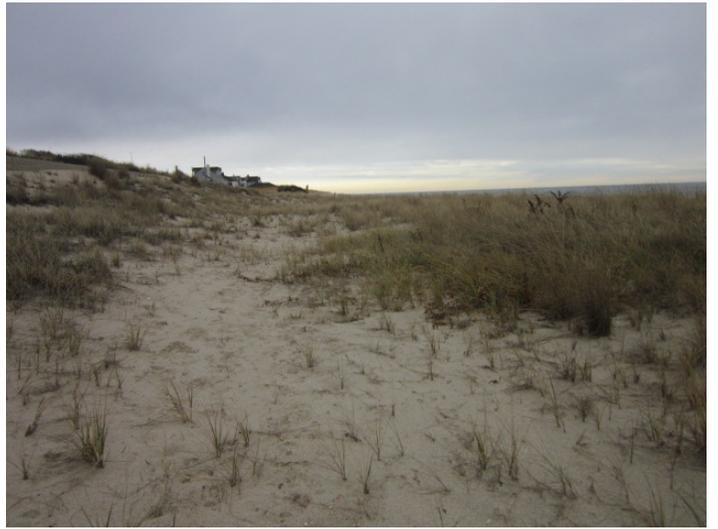
NJBPN 15702 – NGTC - North, Sea Girt

The extraordinary dune elevation is because the National Guard shooting range ends at its landward side, so the extra height was added to stop bullets years ago. The Jan. 10, 2020 view on the left shows the site continued to accumulate sand in the foredune zone as the main dune remained unchanged. The lush dune grass can be seen on the right with continued growth (December 4, 2020).

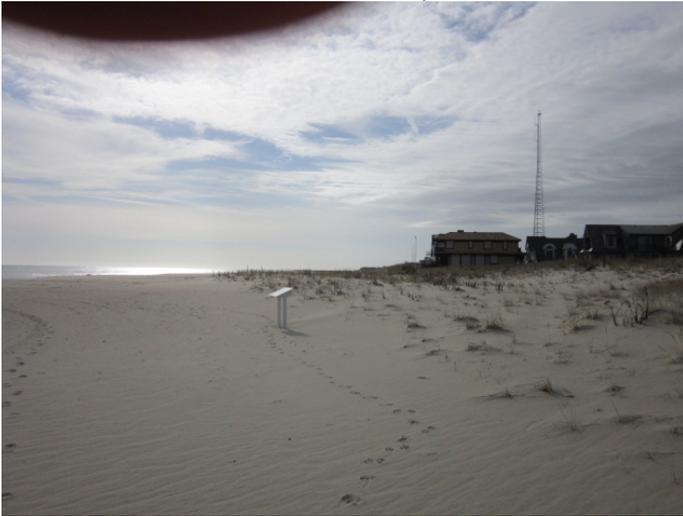
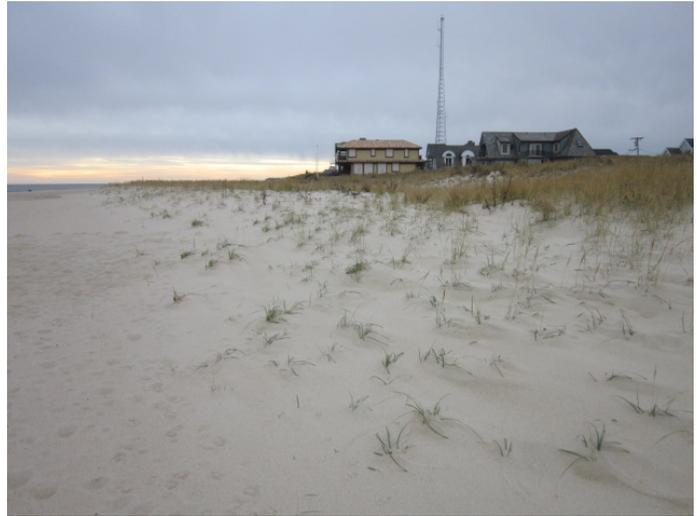
**NJBPN 15701 – NGTC - South, Sea Girt**

This site is located at the south end of the National Guard training facility beachfront. The dune is lower because it is outside the rifle range aiming area. The left photo was taken Jan. 10, 2020 showing little change in the upper beach and dune. The Dec 4, 2020 view on the right provides a view slightly closer to the toe of the dune.

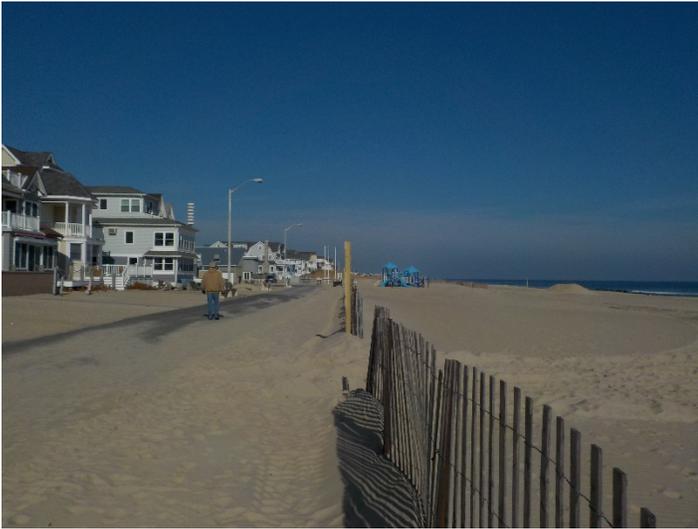
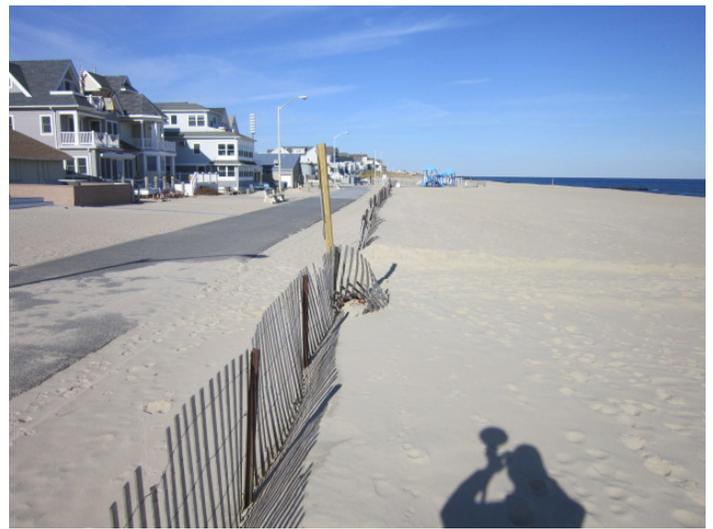
**NJBPN 157 – Riddle Way, Manasquan**

On the left is a view taken Nov. 25, 2019 showing the relative inadequacy of the single row of sand fence in stopping wind transport into both the promenade and development at Riddle Way. The right view taken November 24, 2020 shows sand still blowing onto the promenade but also collecting at the line of fencing.

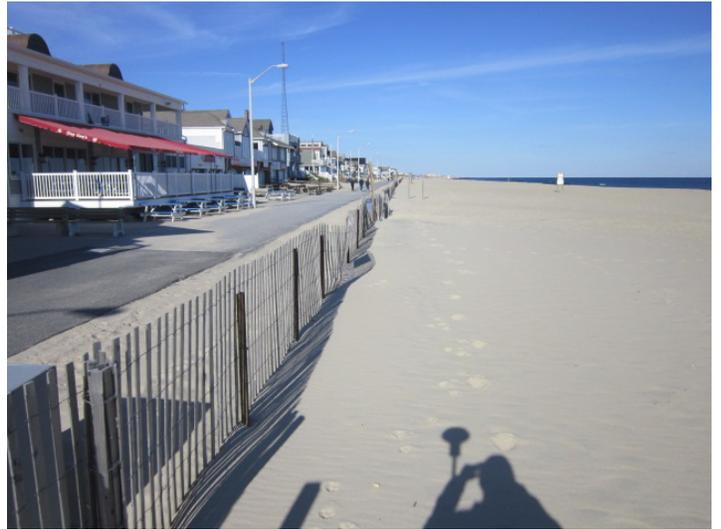
NJBPN 25602 – Main Street, Manasquan

On the left, (November. 25, 2019) sand has collected at the sand fencing largely by having been pushed back off the promenade repeatedly. Sand hummocks appear on the open beach, but the storm ridge is absent. The photo on the right, taken November 24, 2020 shows the expanse of dry beach to the east.

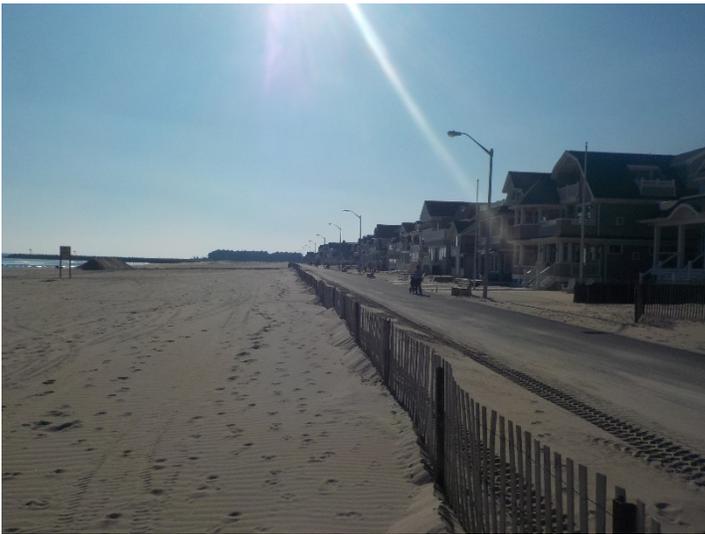
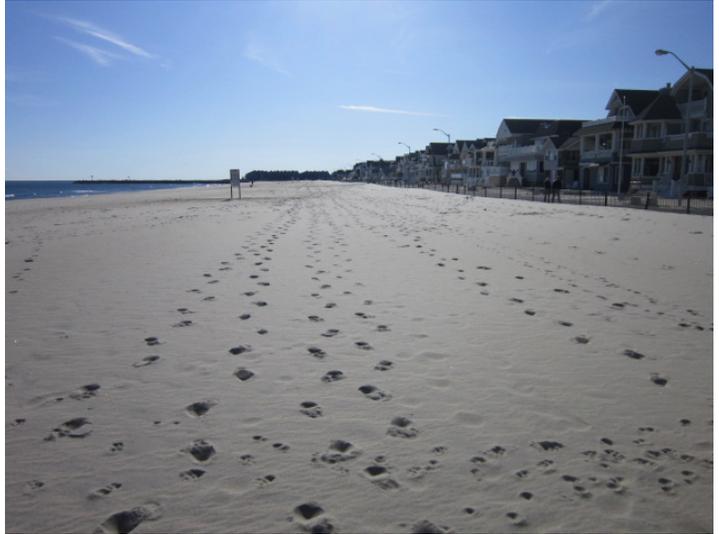
NJBPN 25601 – Brielle Road, Manasquan

The Nov. 25, 2019 view on the left shows sand accumulating at the sand fencing by the promenade, but no dune present and no storm ridge as of the date of this survey. The photo on the right shows the beach east of the first photo, showing the dry beach with no sand mound (November 24, 2020).

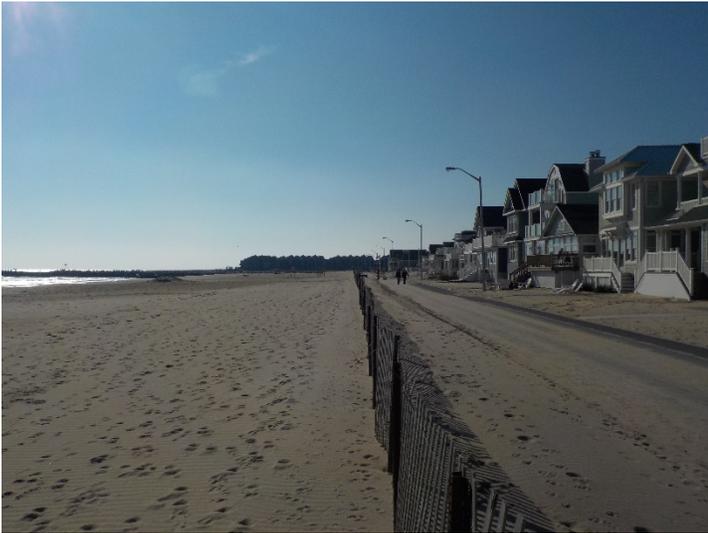
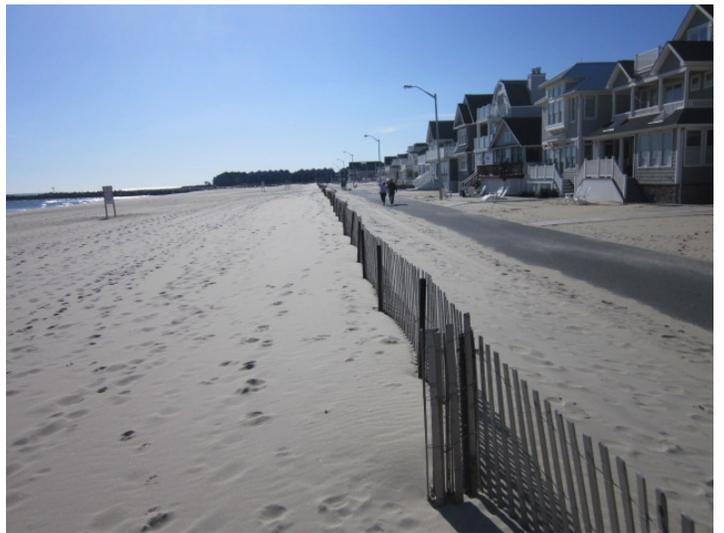
NJBPN 256 – Pompano Avenue, Manasquan

As of Nov. 25, 2019, conditions remained essentially the same where winds transport beach sand through the single line of fence adding material to the oceanfront “yards” of the homes facing the promenade. The right photo shows the same beach, with a promenade nearly free of sand (November 24, 2020).

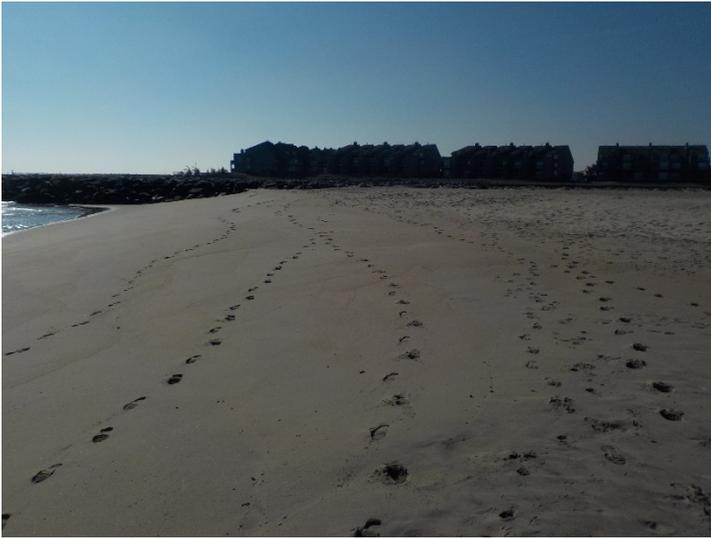
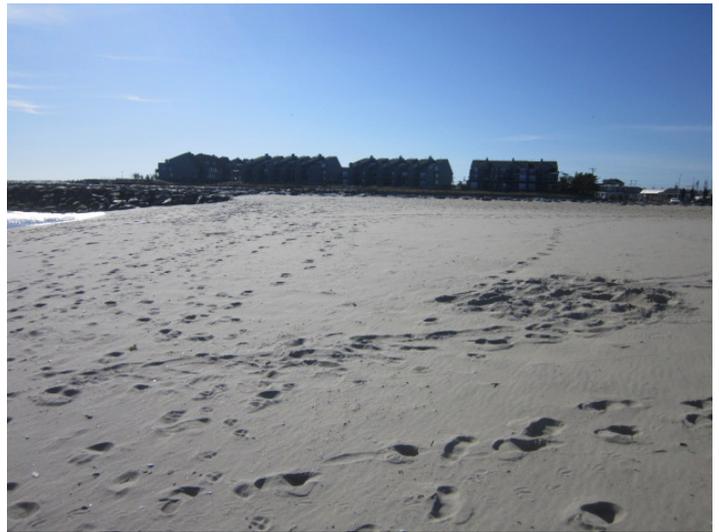
NJBPN 15601 – Riverside Drive, Manasquan

The southernmost survey site in Monmouth County lies a few hundred feet from the north Manasquan Inlet jetty. The left photograph was taken Nov. 25, 2019 at the berm crest showing the very short distance between the transect line and the north jetty to Manasquan Inlet. The November 24, 2020 photo on the right shows the jetty of the Manasquan Inlet with the beachface slope just about the same position as the year previous.

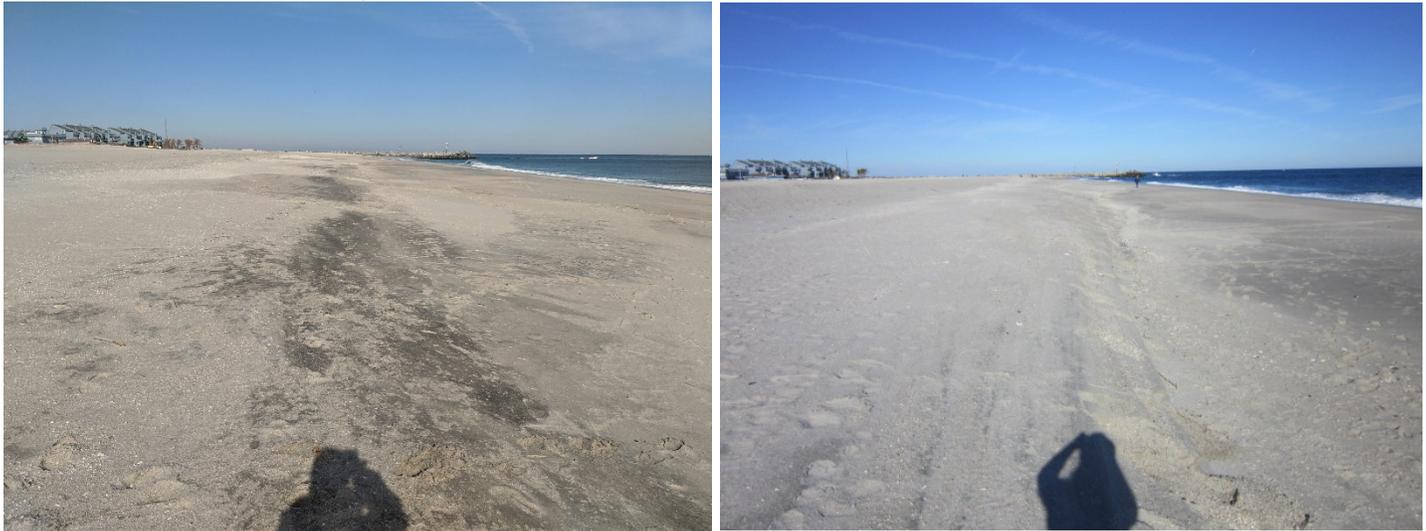
**NJBPN 156 – Water Street, Point Pleasant Beach**

The Water Street site is located near the south end of the Point Pleasant Beach boardwalk and 1,400 ft south from the Manasquan Inlet jetty. The 2019 and 2020 fall surveys show scarps between the berm and the swash zone (left photo taken November 15, 2019 and right photo taken November 20, 2020).

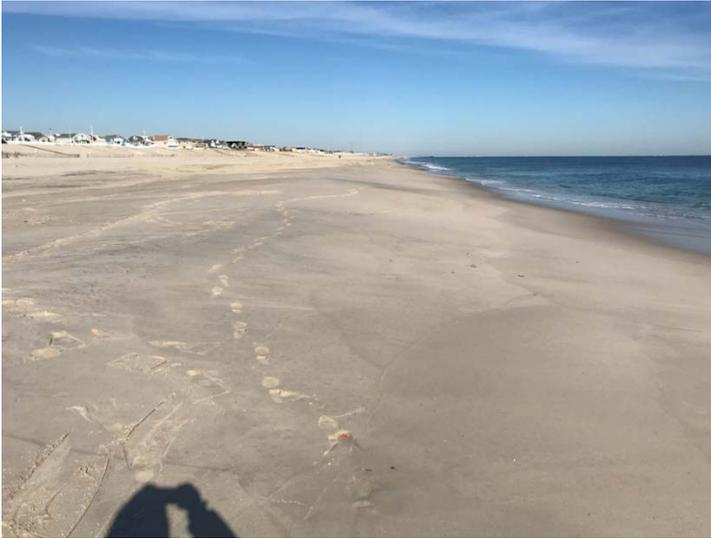
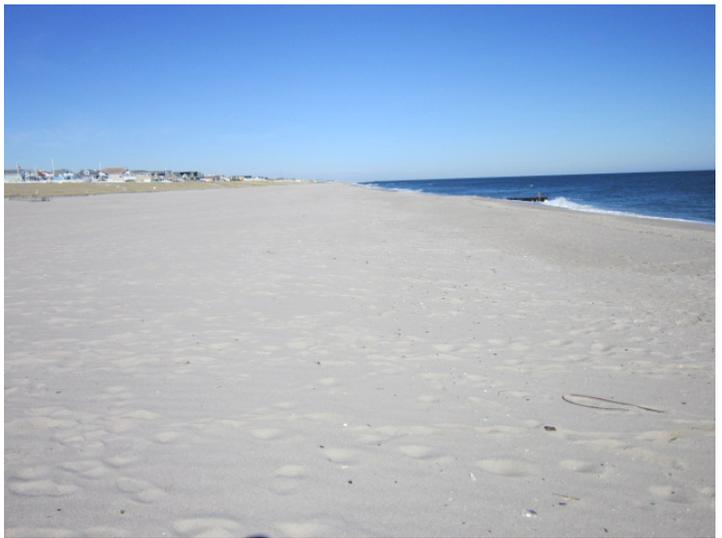
**NJBPN 155 – Maryland Avenue, Point Pleasant**

This Maryland Avenue profile site was included in the federal beachfill that was completed in July 2019. Since nourishment, the berm width decreased but the engineered dune remained as construction (left photo taken November 15, 2019 and right photo taken November 20, 2020).

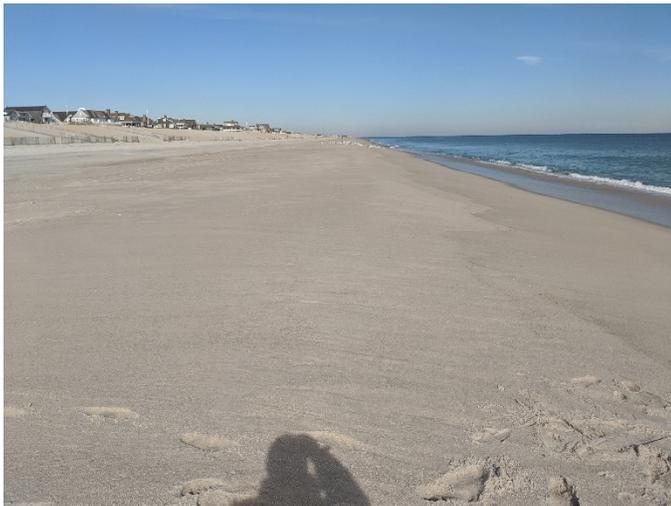
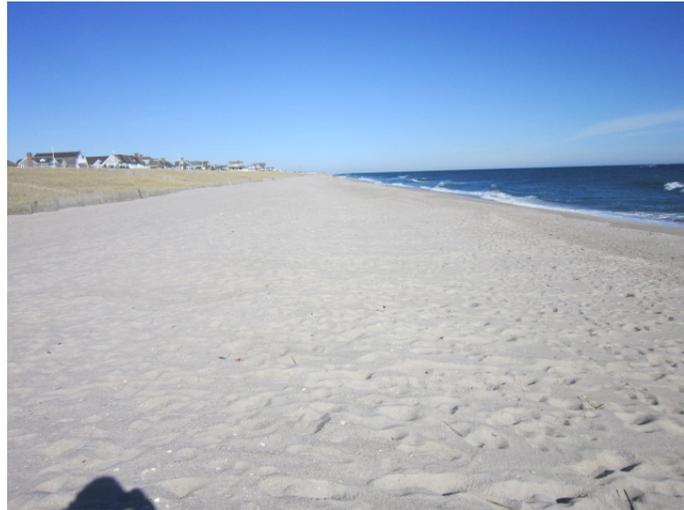
**NJBPN 154 – Johnson Avenue, Bay Head**

Sand placement was completed at the Johnson Avenue profile in June 2019. The photos show the extent of the berm during the 2019 and 2020 fall surveys (left photo taken November 15, 2019 and right photo taken November 20, 2020). The dry berm sand shown in the 2020 photo indicates higher elevation (not impacted by daily tides/waves) from the 2019 photo.

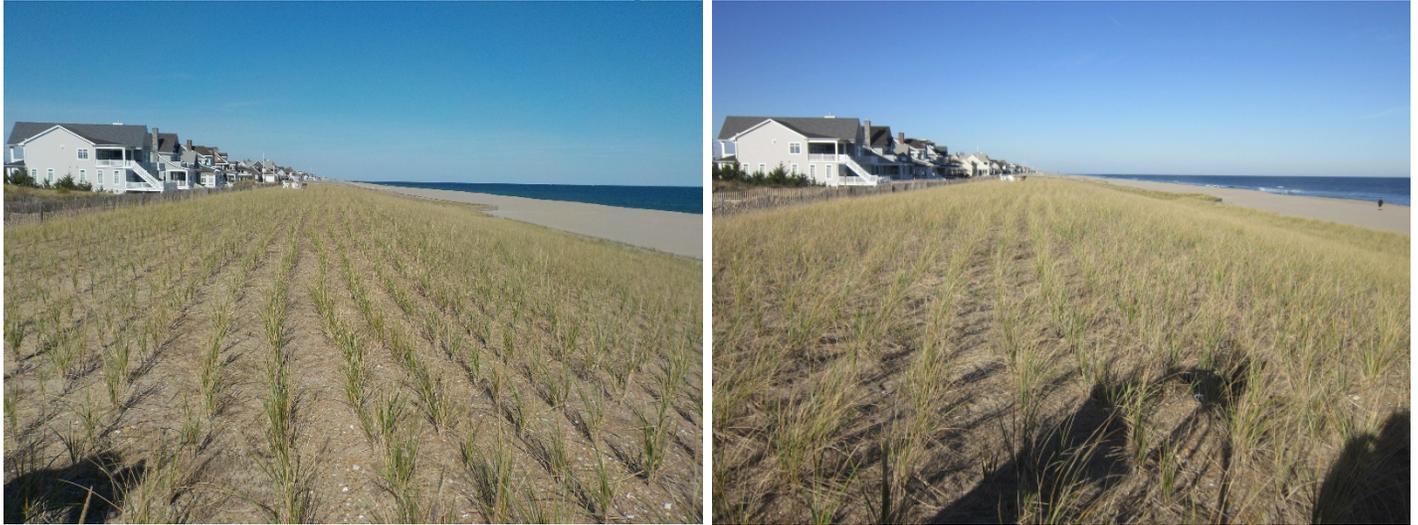
**NJBPN 153 – 1117 Ocean Avenue, Mantoloking**

The photos of the 1117 Ocean Avenue profile show the condition of the engineered dune that covers a steel bulkhead that was constructed in 2015 (left photo taken November 4, 2019 and right photo taken November 20, 2020). The dune remained stable over the 2019-2020 time period, but berm width decreased. The 0.0 ft NAVD shoreline moved landward (-46.25 ft) from its fall 2019 position.

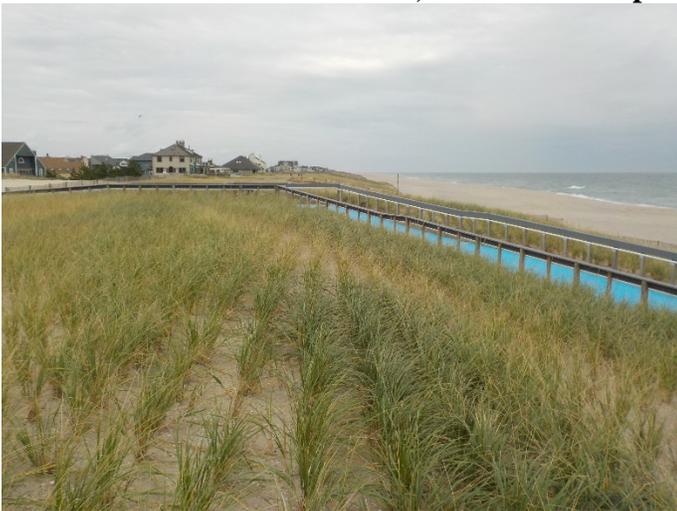
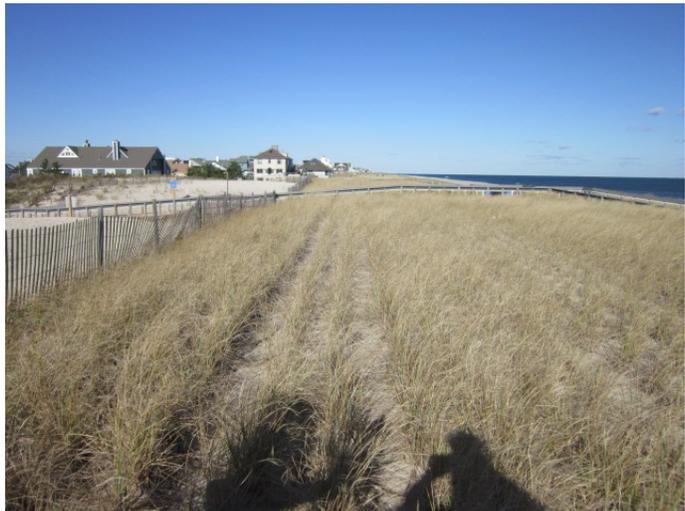
**NJBPN 152 – Public Beach #3, Brick Township**

The beachfill was completed at the Brick Township Public Beach #3 profile site in summer 2018 with the engineered dune covering the steel bulkhead. The photos show the condition of the dune (left taken November 5, 2019 and right taken November 18, 2020). The dune remained in position and elevation throughout 2020.

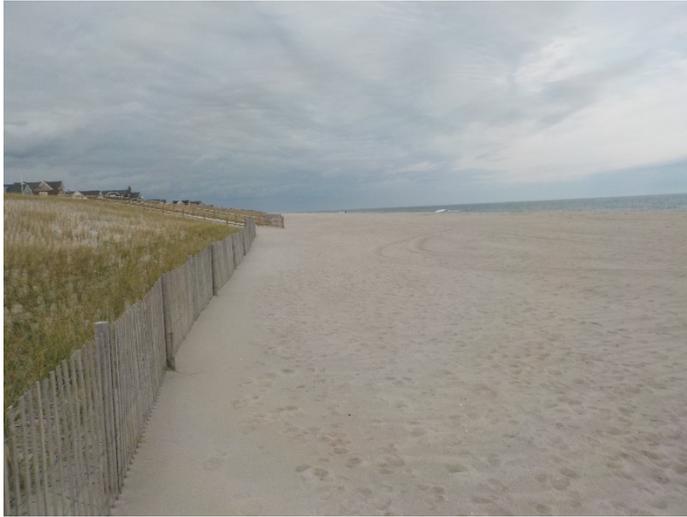
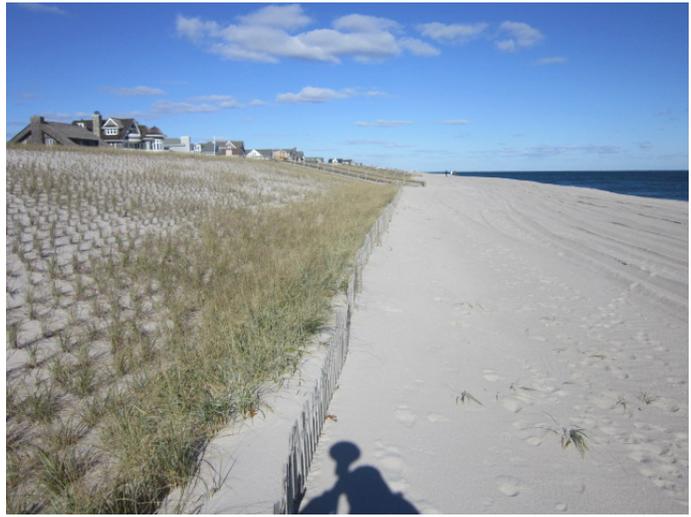
**NJBPN 151 – 1<sup>st</sup> Avenue, Normandy Beach**

The photos of the Normandy Beach profile show the conditions of the seaward dune toe of the engineered dune that was completed in December 2018 (left photo taken November 5, 2019 and right photo taken November 18, 2020). The fall 2020 photo and profile show sand accumulated at the fence.

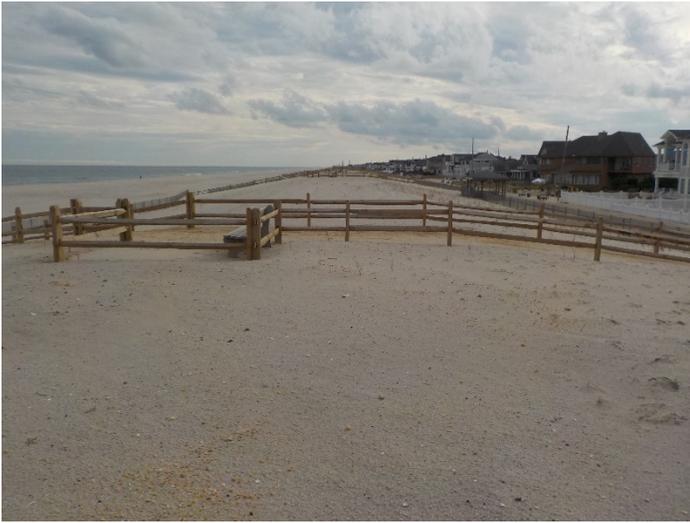
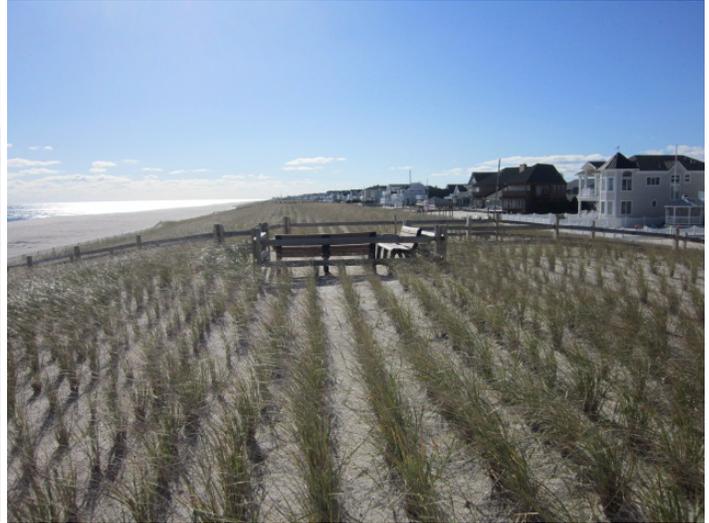
NJBPN 150 – White Avenue, Lavallette

The left photo (taken November 5, 2019) shows the engineered dune which was created from the integration of sand recovered from Hurricane Sandy and the beachfill that was completed at this location in April 2019. The right photo (taken November 18, 2020) shows planted vegetation on the engineered dune.

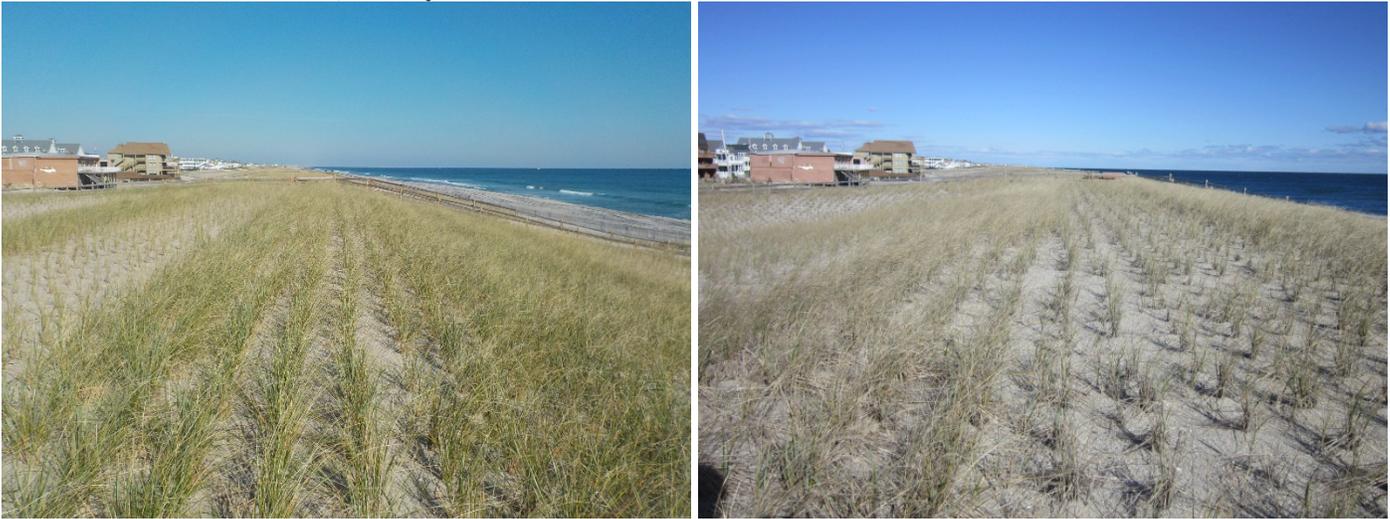
NJBPN 149 – 8<sup>th</sup> Avenue, Ortley Beach

The Ortley Beach photos show conditions on the engineered dune that was completed in November 2018 (left photo taken November 6, 2019 and right photo taken November 18, 2020). Over 2019-2020, the 22 ft high dune remained in position and elevation.
