# STOCKTON UNIVERSITY COASTAL RESEARCH CENTER

## New Jersey Beach Profile Network 2020 Annual Report on Shoreline Changes in New Jersey's Four Coastal Counties Raritan Bay to Delaware Bay Spring of 2019 Through Fall of 2020

August 31, 2021

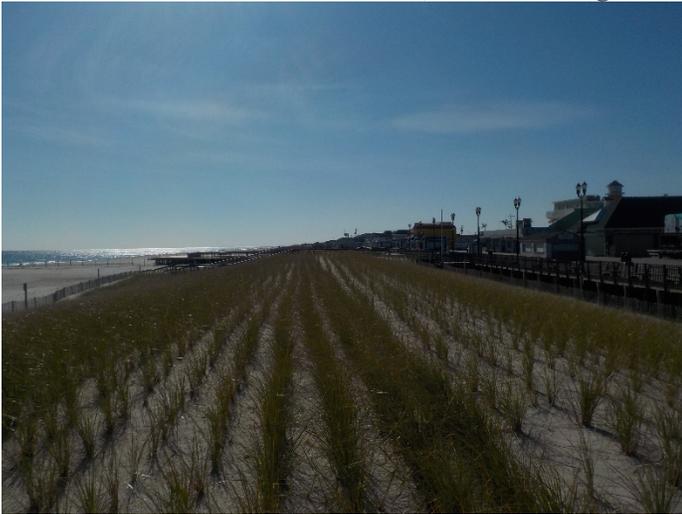
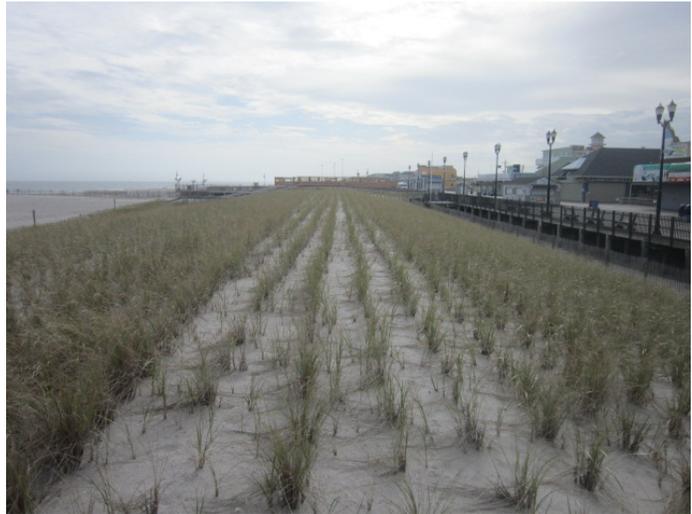
**NJBPN 248 – Franklin Avenue, Seaside Heights**

At the Franklin Avenue profile, an engineered dune was constructed within the federal beachfill in January 2019. No dune existed prior to the beachfill. The dune remained stable through 2020 (left photo taken November 6, 2019 and right photo taken November 11, 2020).

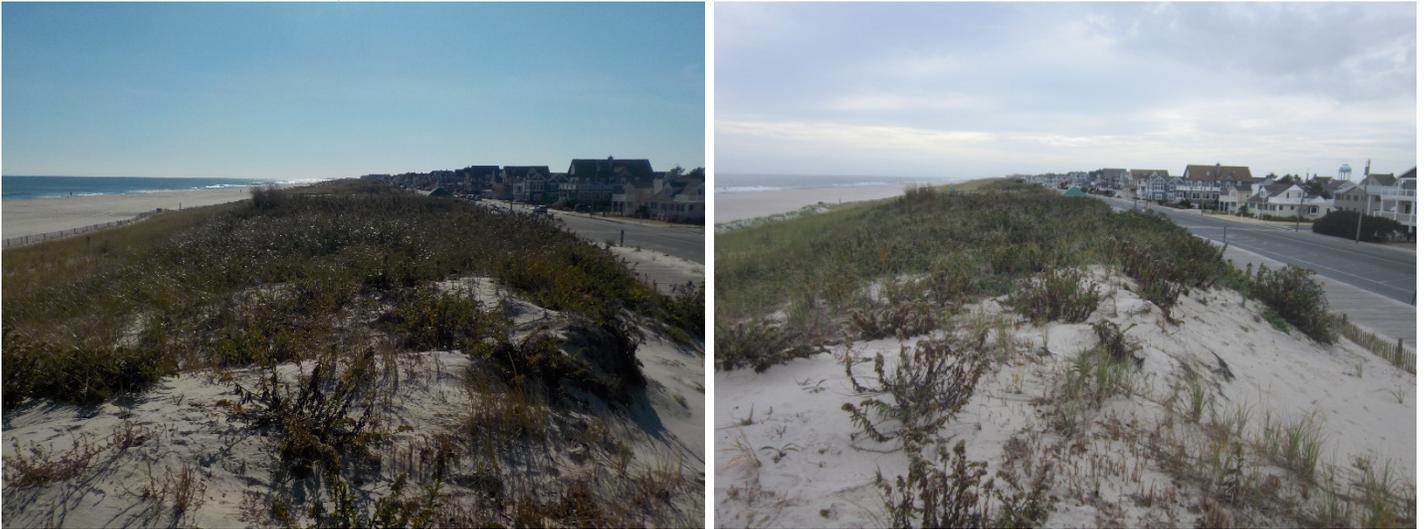
**NJBPN 148 – 4<sup>th</sup> Avenue, Seaside Park**

There was little change in the dune at 4<sup>th</sup> Avenue between fall 2019 and fall 2020 (left photo November 6, 2019 and right photo taken November 11, 2020). The beachfill at this Seaside Park location was completed in January 2019 and did not include additional sand on the dune. Backshore elevations also remained consistent over 2019-2020.

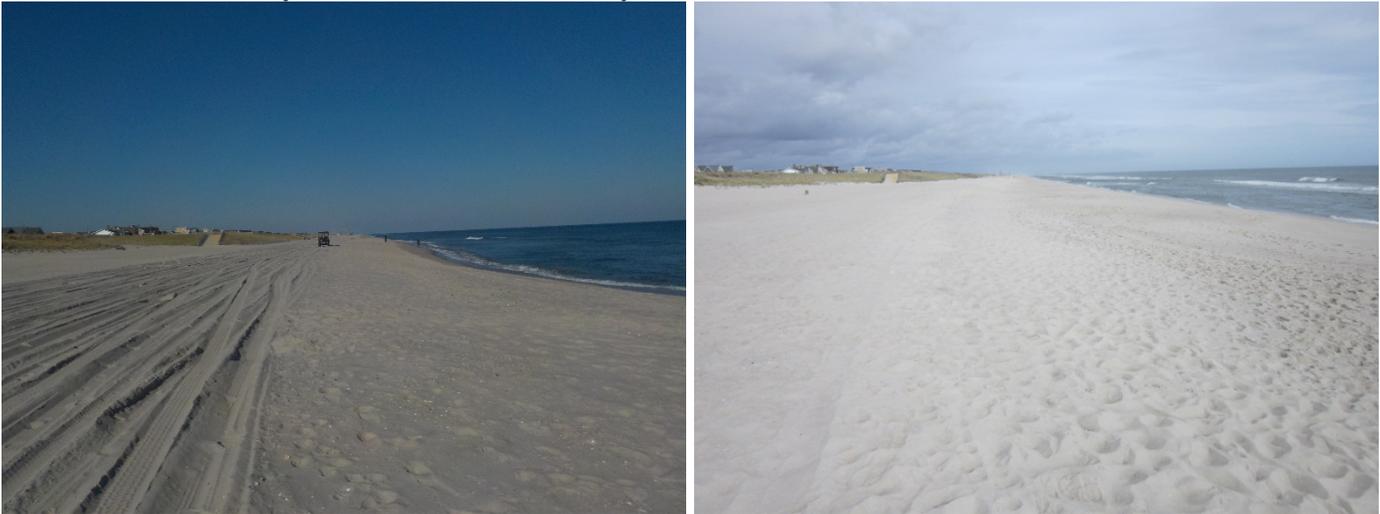
NJBPN 347 (formerly 147) – 6<sup>th</sup> Lane, Midway Beach (S. Seaside Park)

The photos of the 6<sup>th</sup> Lane location (left November 5, 2019 and right taken November 11, 2020) show the conditions of the berm since completion of the beachfill that occurred in February 2019. The seaward portion of the berm gained in elevation between spring 2019 and fall 2020.

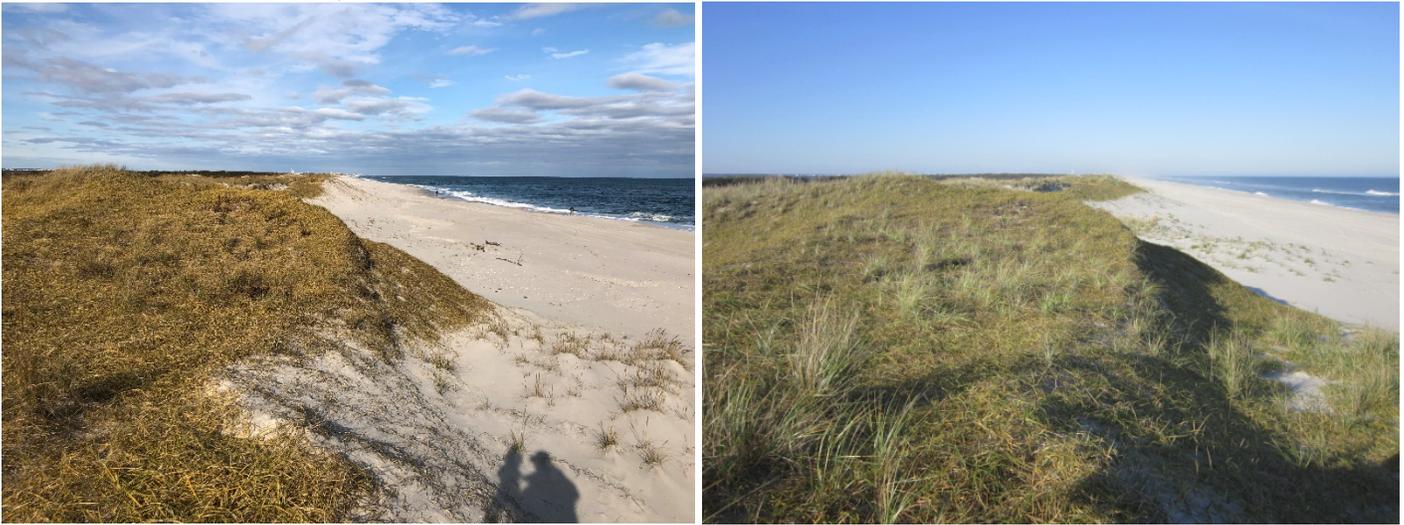
**NJBPN 247 – North End, Island Beach State Park**

The dune at the Gillikin Access location has remained stable in shape and elevation since the seaward dune face was scarped during Hurricane Sandy in 2012 (left photo taken November 20, 2019 and right photo taken November 6, 2020). The Island Beach State Park profile sites were not included in the federal beachfill project but are downdrift. Accretion occurred at this state park location in 2018-2019.

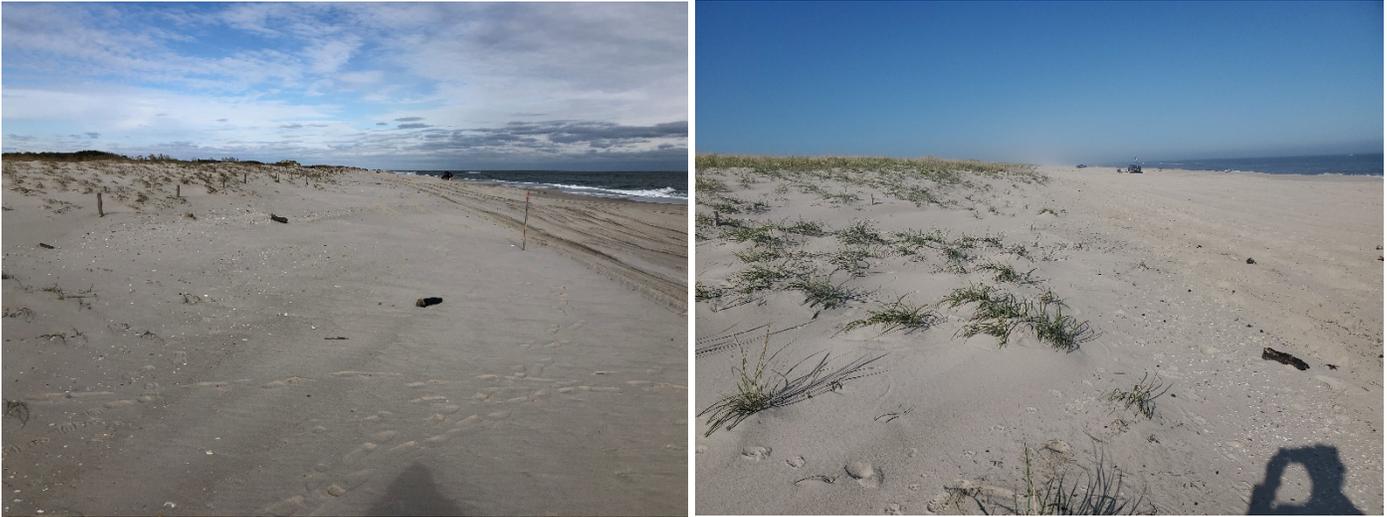
**NJBPN 246 – Parking Lot A7, Island Beach State Park**

The IBSP Parking Lot A7 profile photos show a change at the dune toe. Sand accumulated and nearly covered the sand fencing poles by November 6, 2020 (right photo) and there was sparse dune vegetation coverage. The left photo (taken November 20, 2019) shows a similar berm width as in November 2020.

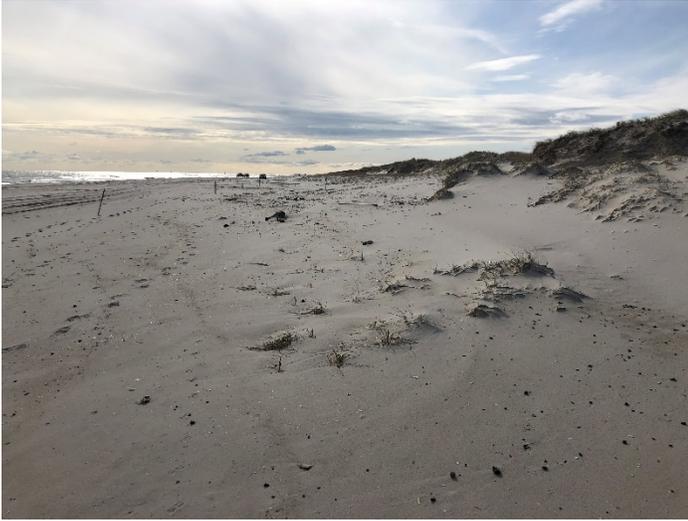
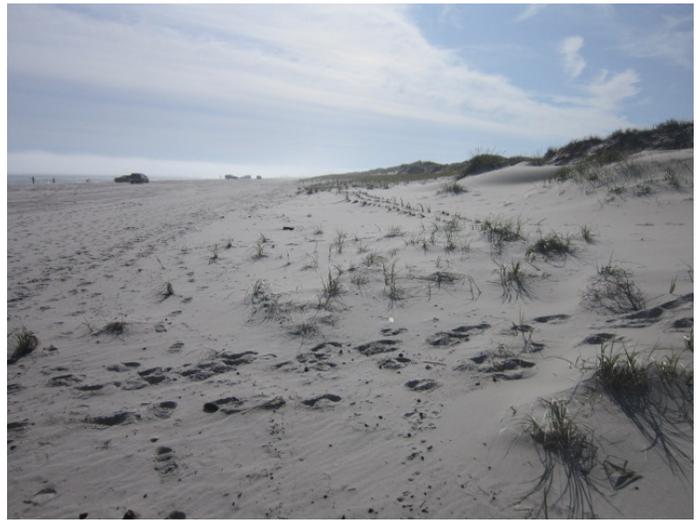
**NJBPN 146 – South End, Island Beach State Park**

The 2019 and 2020 photos from the South End (IBSP) profile location show similar dune toe shape, elevation, and vegetation coverage. Berm elevations and extent were around 8.0 ft NAVD88. The berm was wider and lower in spring 2019 but berm width and elevation were similar from fall 2019 through fall 2020 (left photo taken November 20, 2019 and right photo taken November 6, 2020).

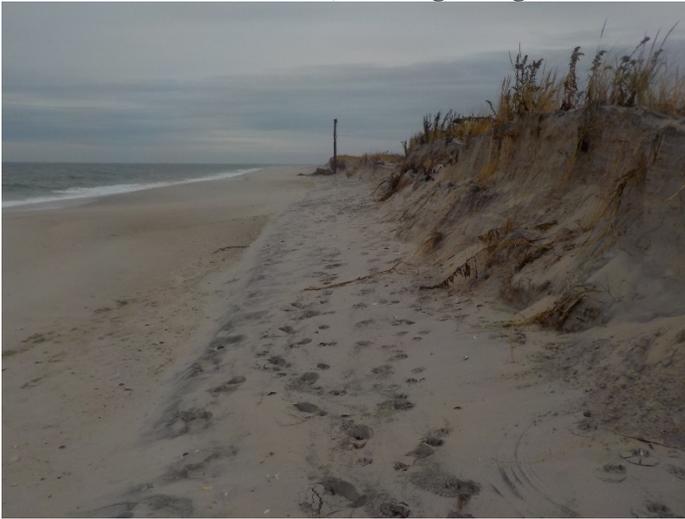
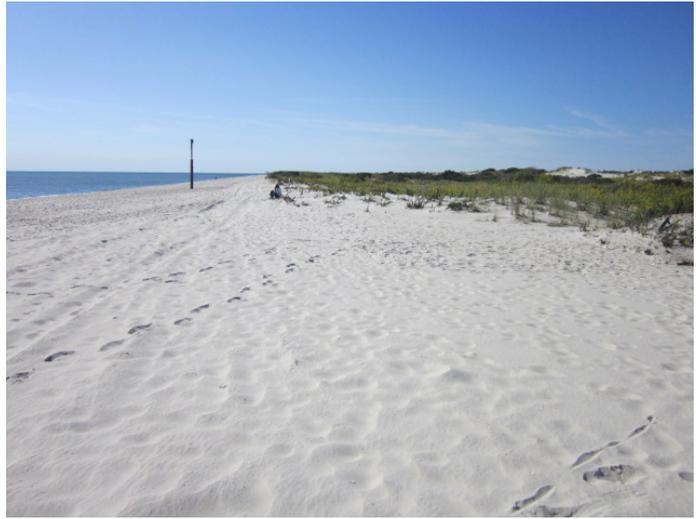
**NJBPN 245 – 10<sup>th</sup> Street, Barnegat Light**

The 10<sup>th</sup> Street profile is characterized by a wide dune field and narrow berm but the foredune has been eroding and moving landward since the fall 2015 survey (left photo taken November 27, 2019 and right photo taken October 9, 2020). The mast of the shipwrecked Sea King (buried by sand and once well landward of the seaward dune toe) now stands on the backshore. Over the timeframe displayed by the photos the 0.0 ft NAVD88 shoreline proxy moved landward (-8.5 ft).

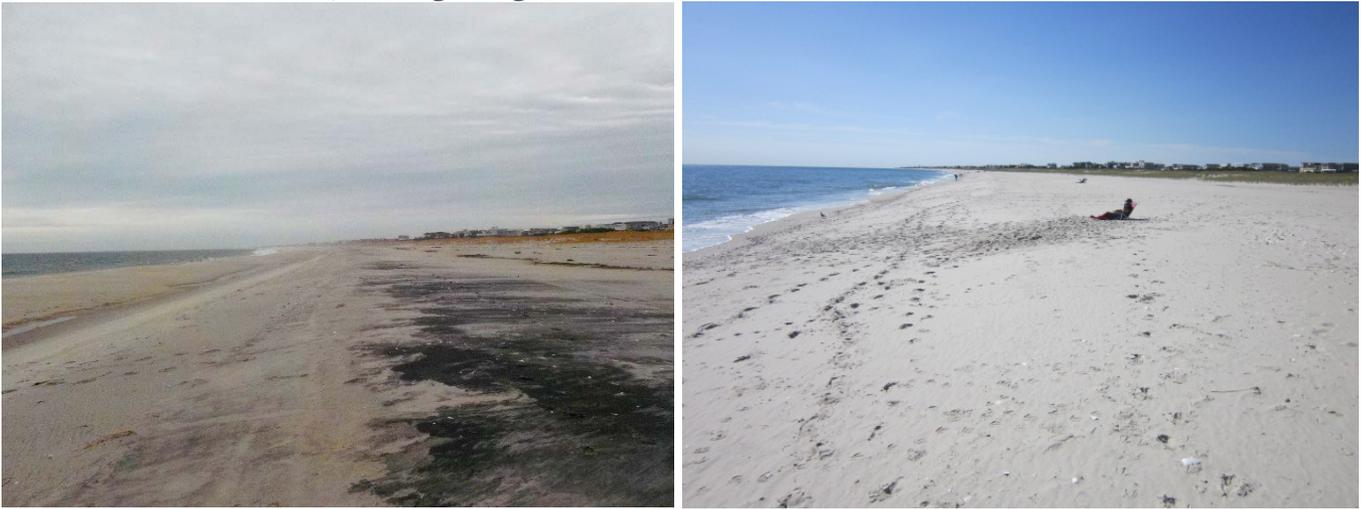
**NJBPN 145 – 26<sup>th</sup> Street, Barnegat Light**

The berm at the 26<sup>th</sup> Street profile was similar in width in the fall 2019 (left photo taken November 27, 2019) and fall 2020 (right photo taken October 9, 2020). The natural dune at this location has remained at the same elevation and width for over a decade.

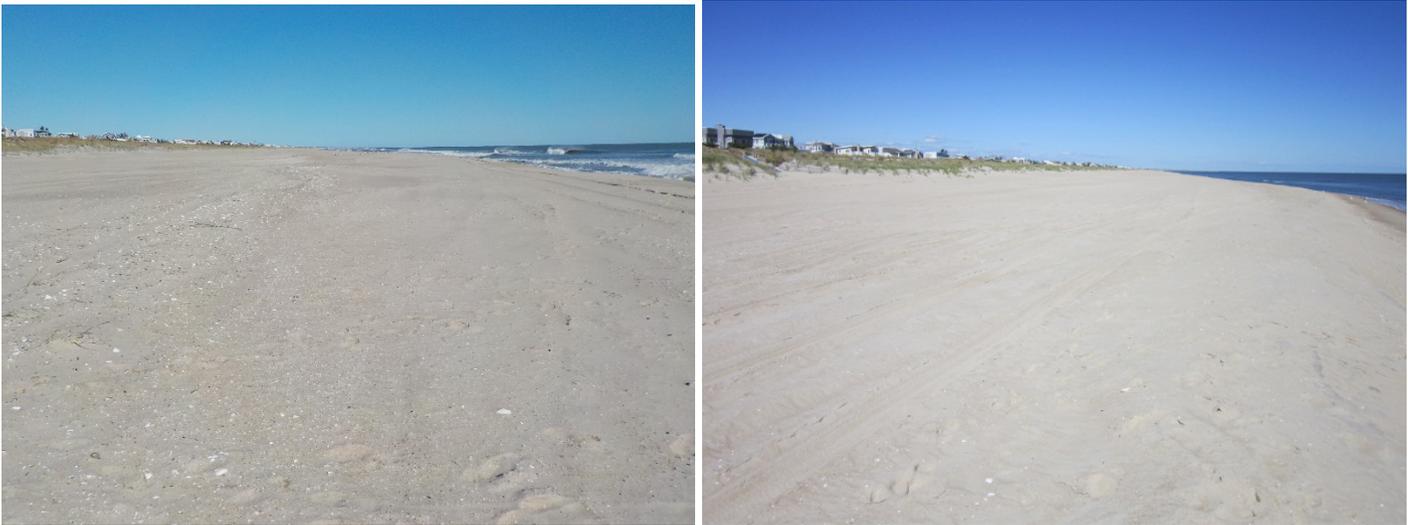
NJBPN 143 – 73<sup>rd</sup> Street, Harvey Cedars

The berm at the 73<sup>rd</sup> Street profile reduced in width between fall 2019 and fall 2020 (left photo taken November 1, 2019 and right photo taken October 8, 2020). However, there was a modest amount of sand accumulation on the seaward face of the dune during that time period, but not nearly the amounts documented in the past few years.

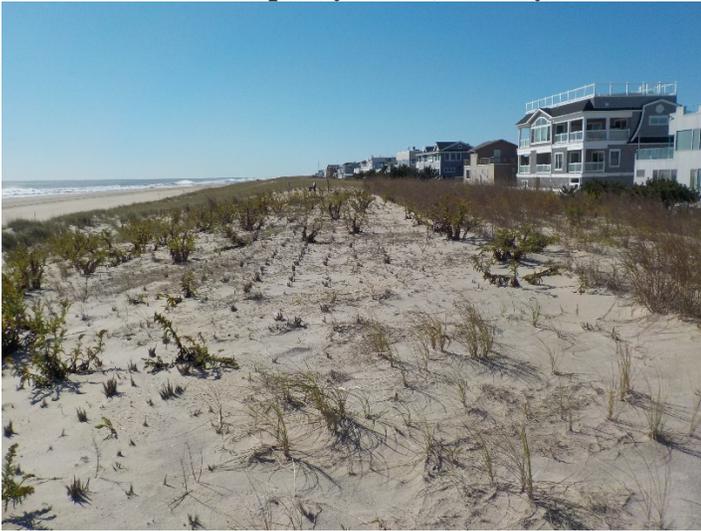
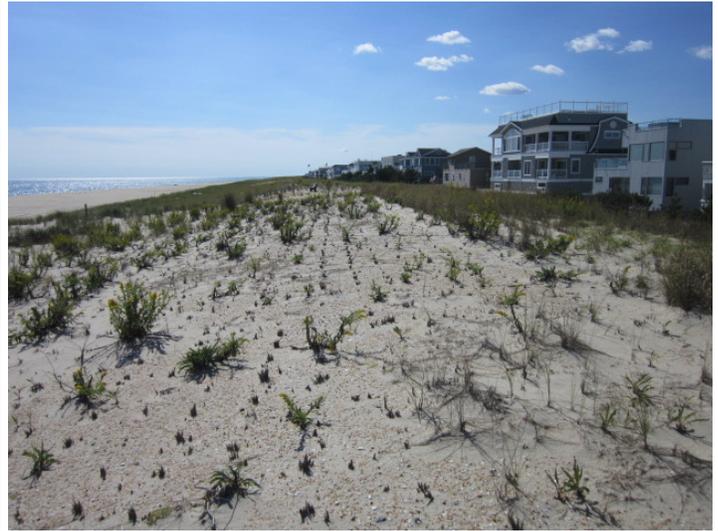
NJBPN 142 – Tranquility Drive, Harvey Cedars

Vegetation on the engineered dune at the Tranquility Drive profile has not reached the density observed at the engineered dune at nearby NJBPN profiles (left taken September 19, 2019 and right taken October 9, 2020). Wind-blown sand contributed to gains at the dune toe from fall 2019.

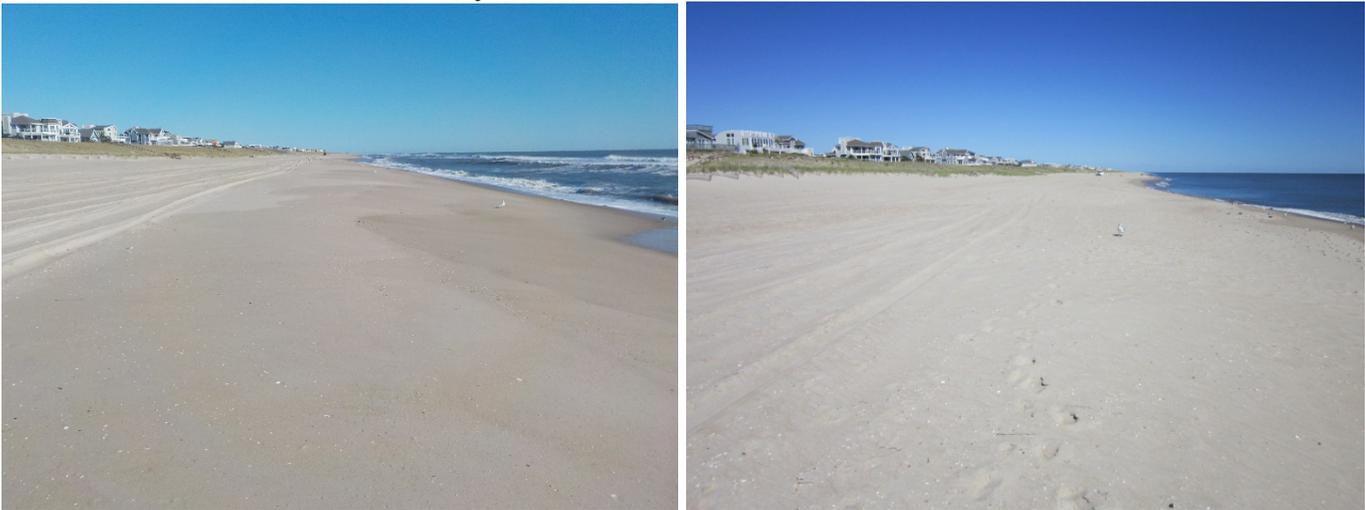
**NJBPN 241 – 20<sup>th</sup> Street – Surf City**

A supplemental beachfill was completed at the 20<sup>th</sup> Street profile in July 2018. By fall 2019 (left photo taken November 1, 2019) berm width was within 25 feet from the fall 2018 position. In fall 2020, berm width was similar to fall 2019 (right photo taken October 8, 2020).

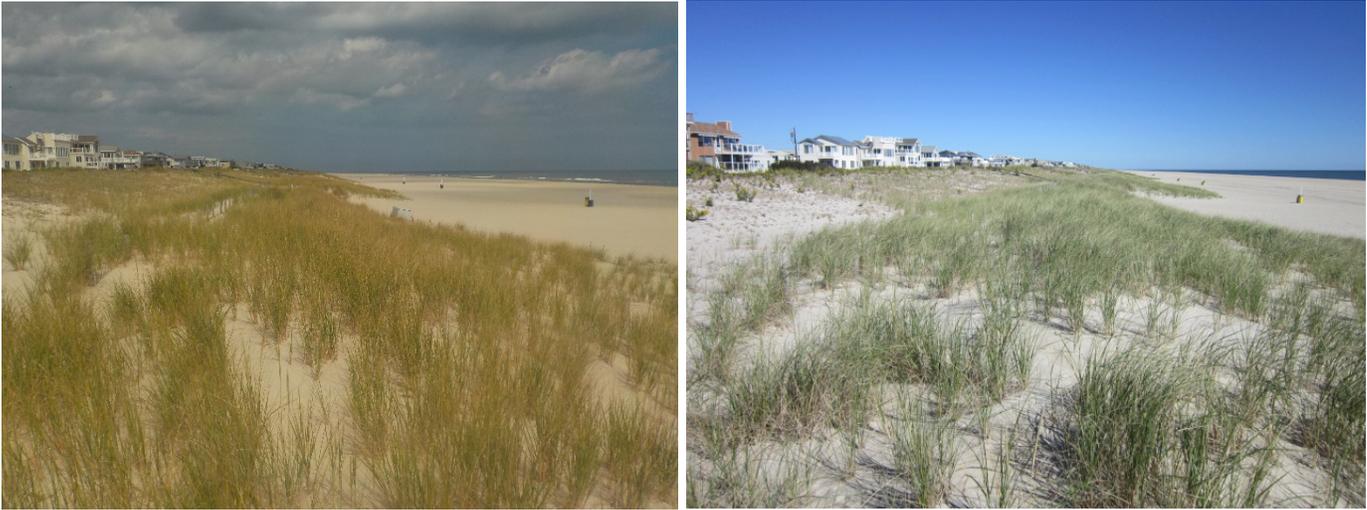
## NJBPN 141 – 8<sup>th</sup> Street, Ship Bottom

The Ship Bottom 8<sup>th</sup> Street photos show the views from the top of the foredune and to the north (left photo taken September 12, 2019 and right photo taken October 8, 2020). The dune and berm portions of the profile have maintained similar elevation and shape over the 2019-2020 time period.

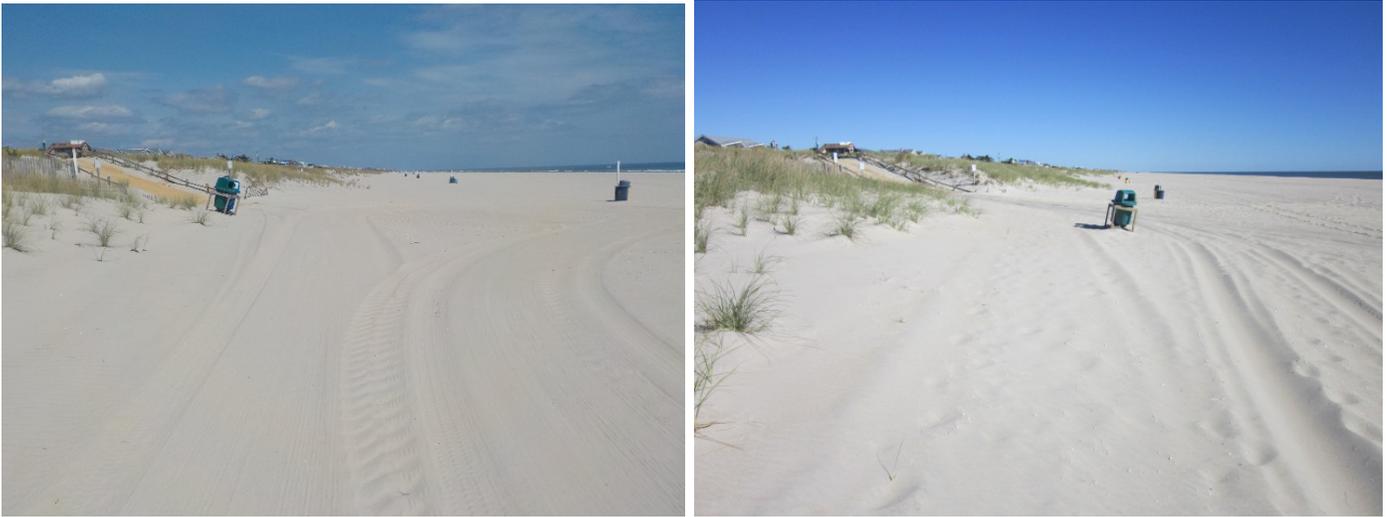
**NJBPN 140 – 32<sup>nd</sup> Street, Long Beach Township**

The photos show the view to the north of the dune toe and backshore at 32<sup>nd</sup> Street in Brant Beach (left taken September 12, 2019 and right photo taken October 8, 2020). The dune and berm elevations remained consistent throughout 2019-2020.

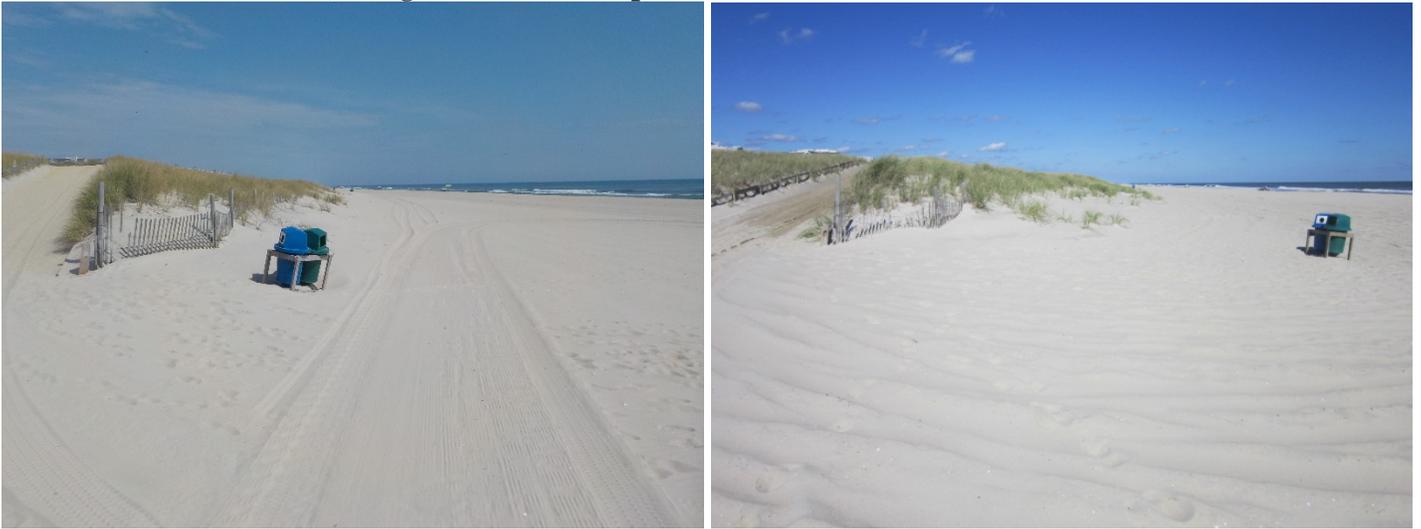
**NJBPN 139 – 81<sup>st</sup> Street, Long Beach Township**

At the Township’s 81<sup>st</sup> Street profile there was a modest accumulation of sand at the seaward dune toe between 2019 and 2020 (left photo taken September 12, 2019 and right taken September 30, 2020). The engineered dune has remained at the same elevation since it was constructed in 2015.

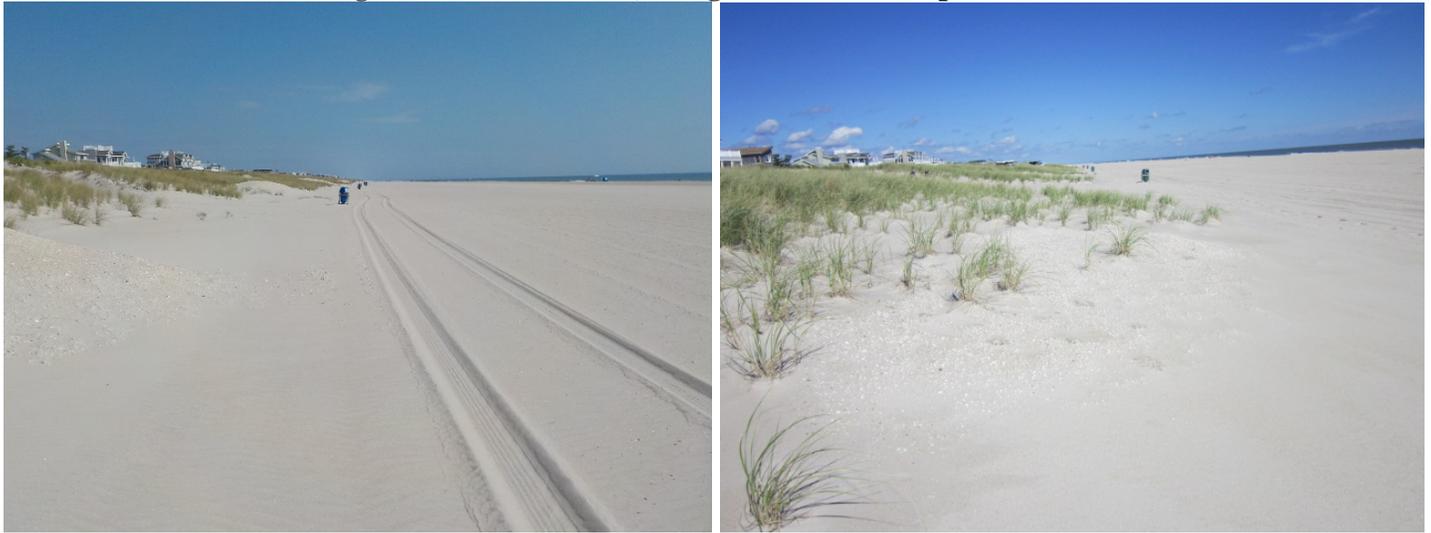
**NJBPN 138 – Old Whaling Road (124<sup>th</sup> Street), Long Beach Township**

The photos show the view to the north along the dune toe at the Old Whaling Road profile (left taken September 12, 2019 and right photo taken September 30, 2020). This profile has shown consistent growth of the seaward portion of the dune from accumulations of windblown sand. The profile has retained a wide berm since the 2016 beachfill repairs.

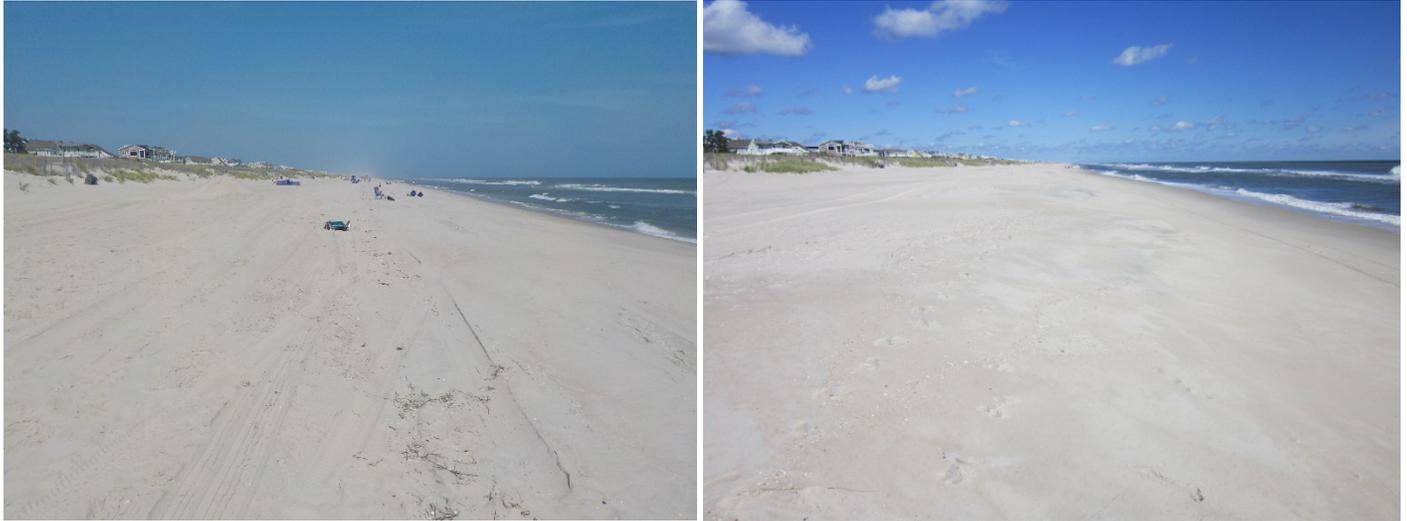
**NJBPN 137 – Taylor Avenue, Beach Haven**

At the Taylor Avenue profile, there was a small gain in elevation of the berm over 2019-2020 (left taken September 11, 2019 and right taken September 30, 2020). This profile typically has narrower berm widths than those LB Twp. NJBPN profiles to the north.

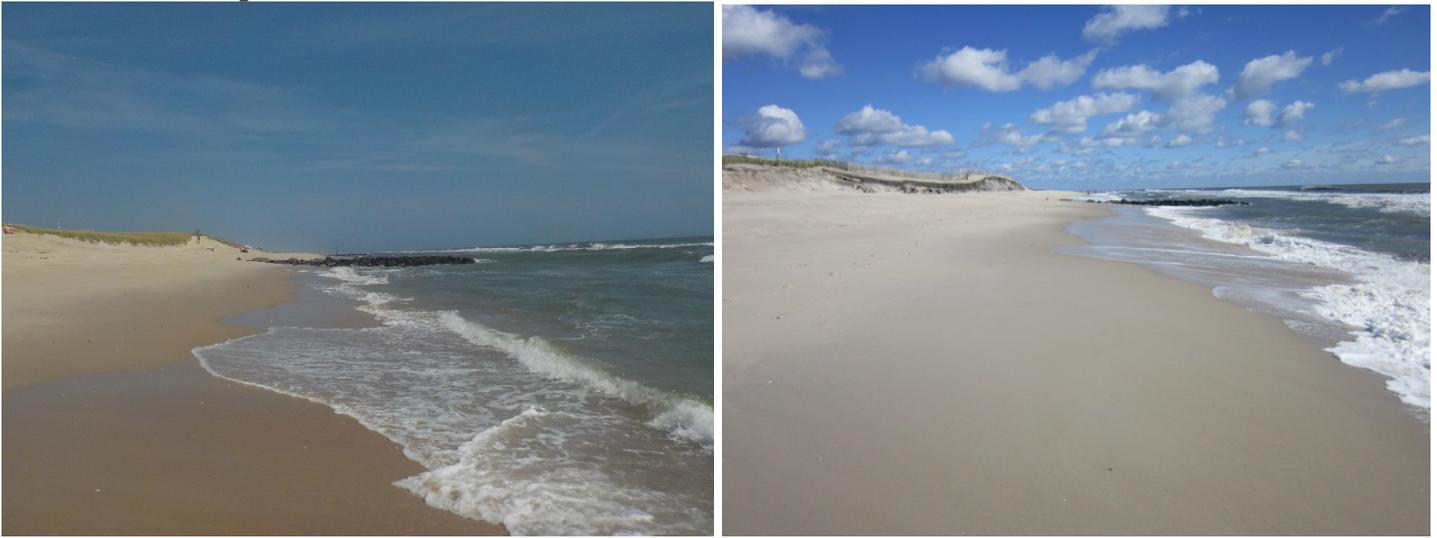
**NJBPN 136 – Dolphin Avenue, Beach Haven**

The Dolphin Avenue dune crest was shifted landward to accommodate changes to the USACE dune template and sand was added in early 2018 from the dredging of Little Egg Inlet. From 2019-2020 the elevation of the dune remained the same but scarping of the dune occurred in the September 2020 survey (probably the result from high surf generated a week earlier from the passing of Hurricane Teddy. (left photo taken September 11, 2019 and right photo taken September 30, 2020).

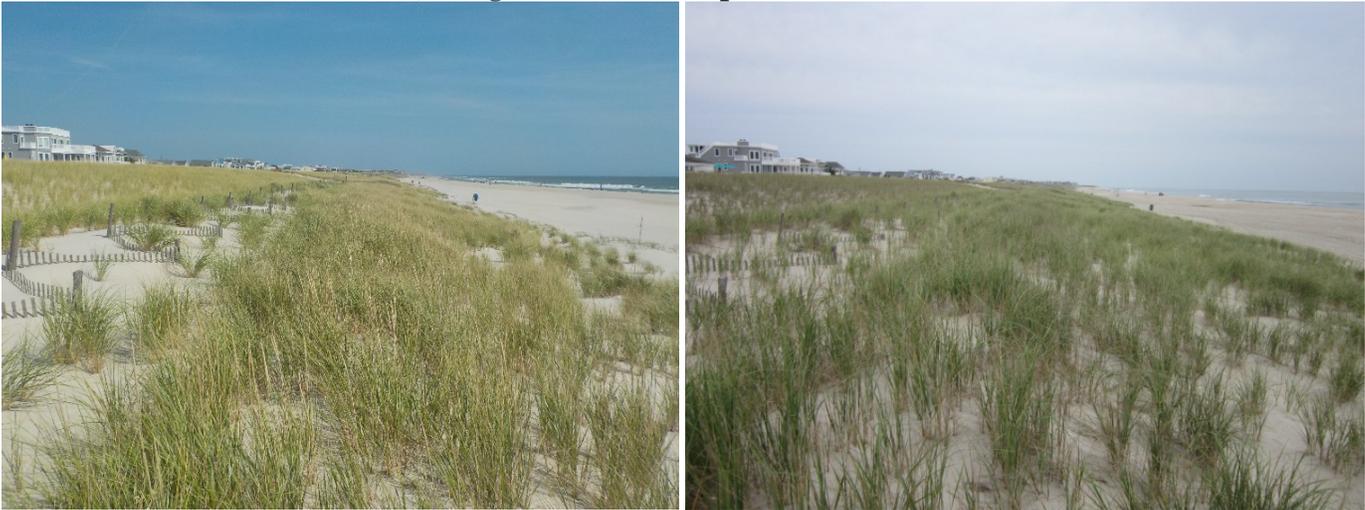
**NJBPN 135 – Webster Avenue, Long Beach Township**

The Webster Avenue photos show the seaward portion of the dune which remained stable over 2019-2020 (left taken September 9, 2019 and right taken September 24, 2020). There was only a minor accumulation of sand at the dune toe over that timeframe.

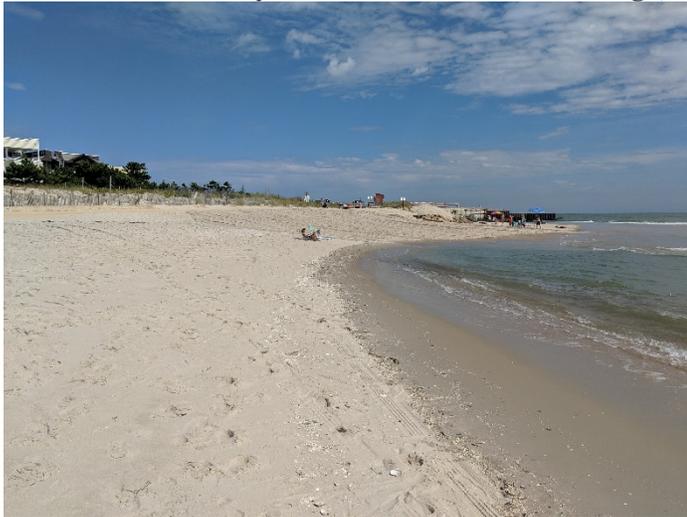
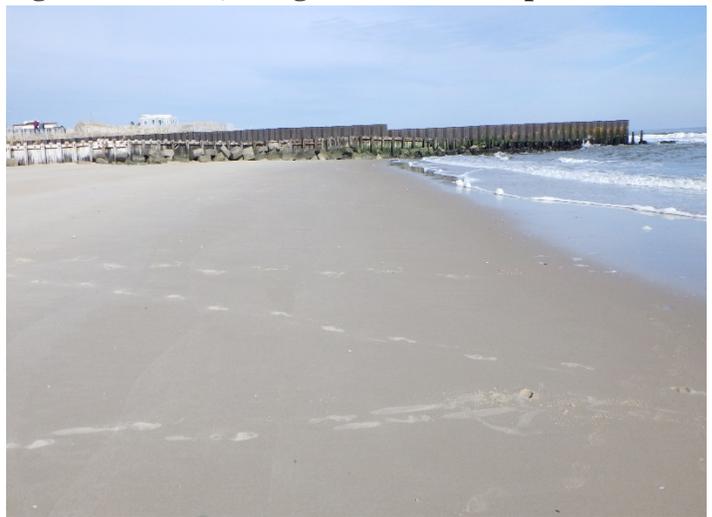
**NJBPN 234 – Forsythe National Wildlife Refuge, Holgate Entrance, Long Beach Township**

The Holgate profile lies 200 feet downdrift of the Holgate terminal groin and the photos show the changes near the swash zone (left photo taken September 9, 2019 and right taken September 25, 2020). Berm widths and sand accumulations have been highly variable through the 26 years of profile monitoring largely due to large differences in sediment supplies passing the terminal groin onto this beach.

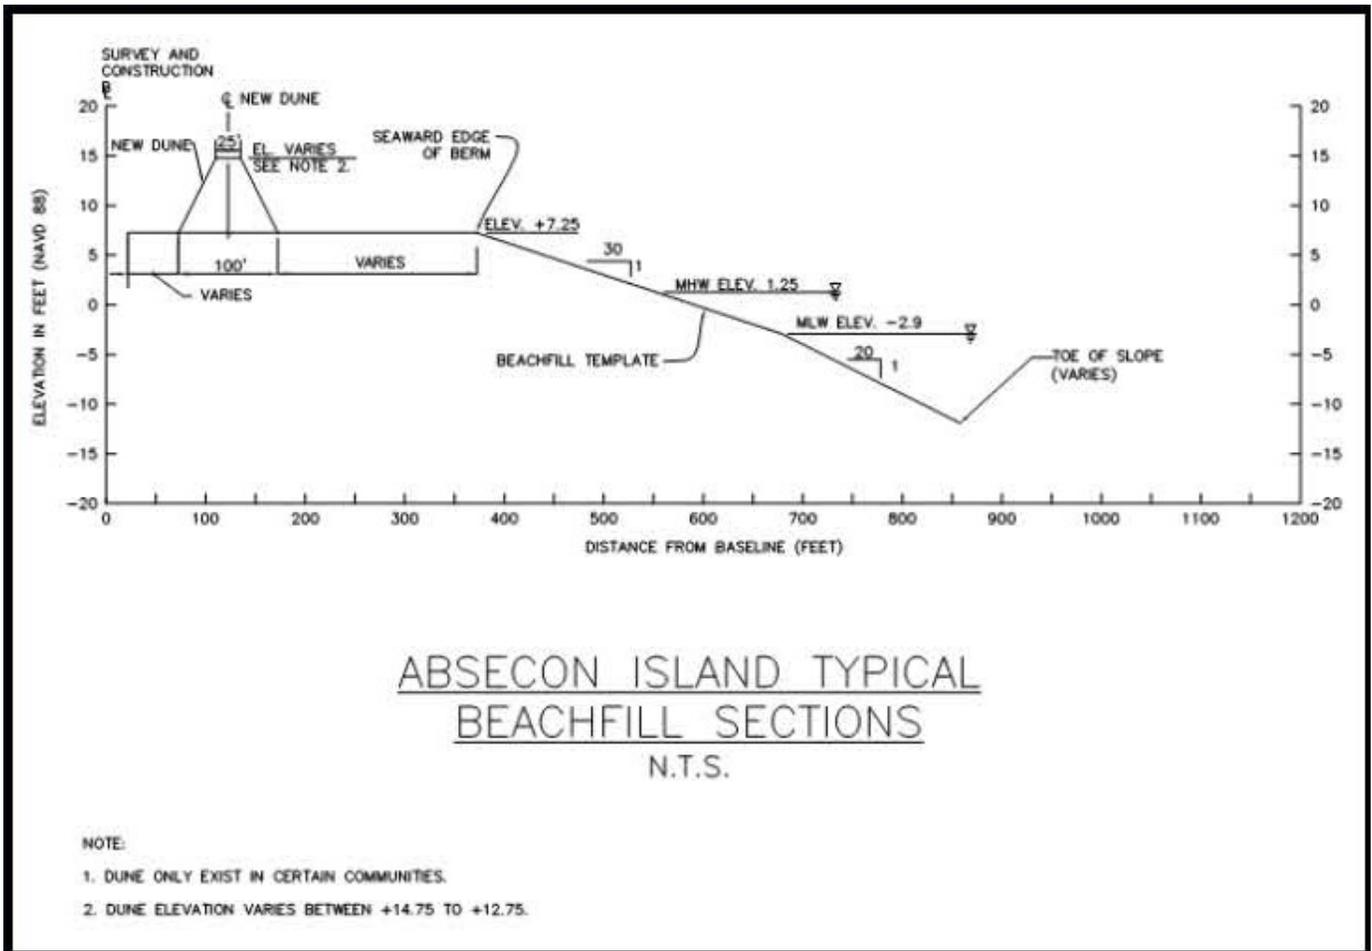
Figure 136 - Typical USACE beach design template for the Absecon Island project

To date, the Absecon Island storm damage reduction project has placed over 13.3 million cubic yards of sand on the Longport, Margate, Ventnor and Atlantic City project beaches from 2004 to February 2021. Figure 136 below is from the USACE Philadelphia District Fact Sheet on the Absecon Island Project and shows the typical beach profile design template.

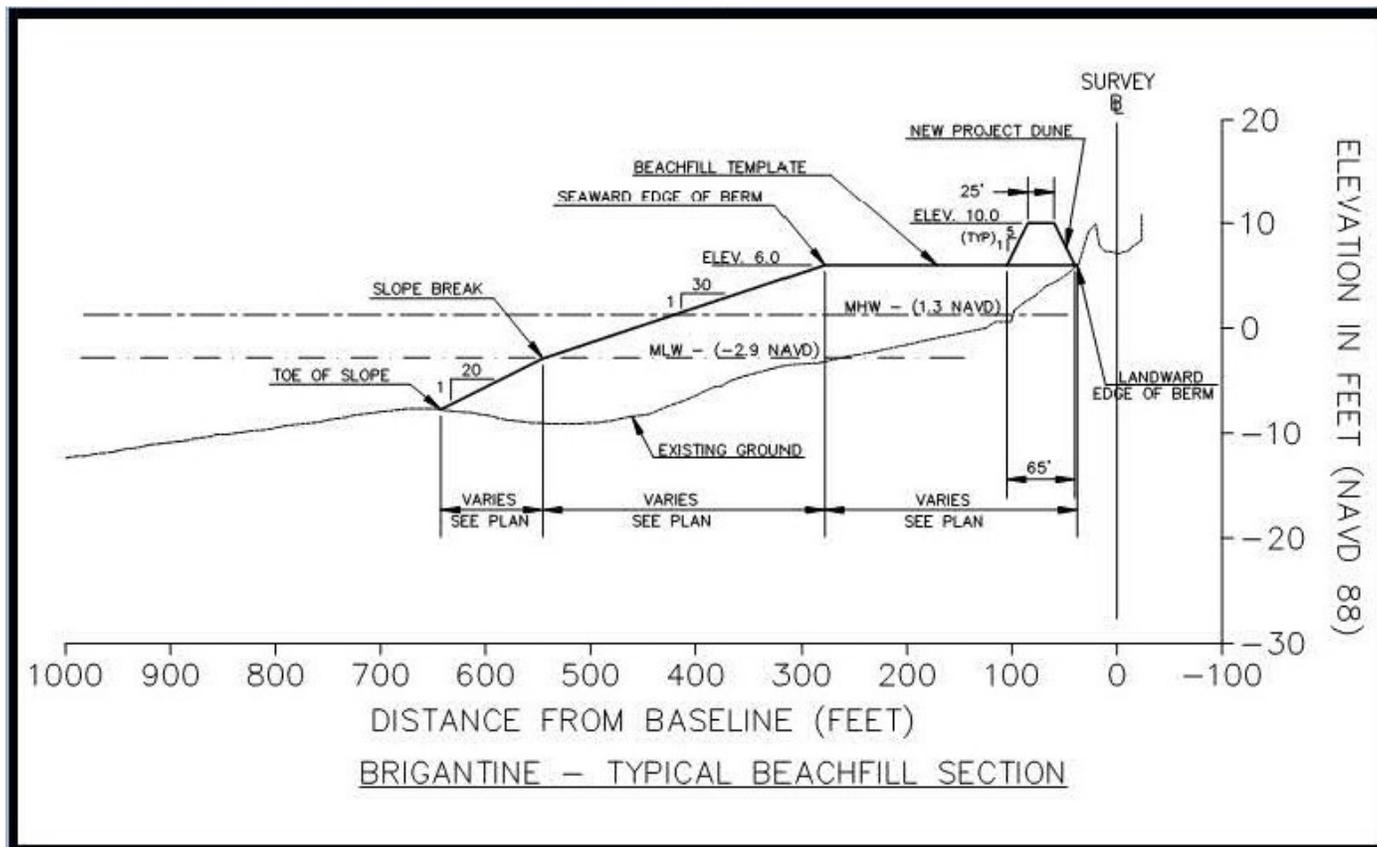
Figure 137 - Typical USACE beach design template for the Brigantine Island project

yards, Erik Rourke, USACE). No further beach nourishment activity occurred in Brigantine during 2019. The 4<sup>th</sup> periodic nourishment cycle is scheduled for FY 2023, funding dependent. Figure 137 below shows the typical USACE beach profile template for the Brigantine Island project and includes a minimum 100-foot-wide beach berm at elevation 6 feet NAVD 88 and 65-foot-wide dune with a crest elevation of 10 feet NAVD 88 for storm damage reduction.

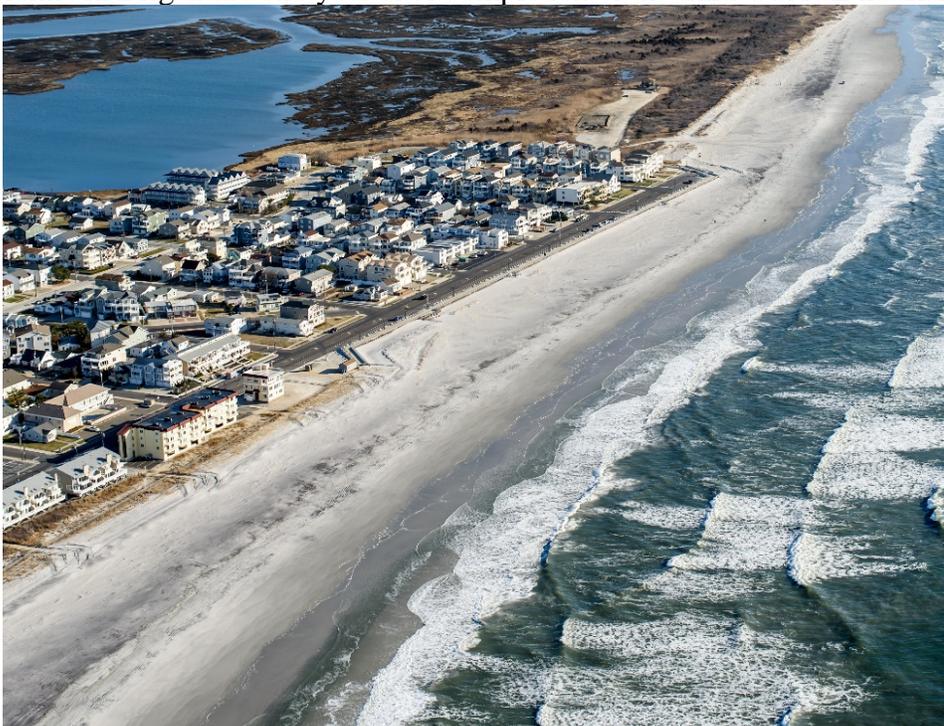
**Figure 138. Photo taken March 28, 2019, note orientation offset between the natural beach (north) and Brigantine Ave.** At the erosional north end local engineered beach nourishment projects commenced in 1997 and 2001 with State sponsorship to mitigate deteriorating conditions. By 2006, the initial USACE project commenced along approximately 1.8 miles of coastline fronting the northern third of the city beaches, followed by maintenance projects in 2011, 2013. Brigantine beaches last received sand in 2018 during the 3<sup>rd</sup> USACE maintenance project (754,090 cubic yards, Erik Rourke, USACE).

South of the State Natural Area the municipal shoreline rapidly transitions from a natural beach to a fully developed shoreline. The approximately 2000 feet of transition zone has been incorporated into the federal project as a “feeder beach” for a highly erosional section of shoreline from 9<sup>th</sup> Street north to 15<sup>th</sup> Street north seaward of the Brigantine Avenue promenade and revetment. This section of beach suffers accelerated erosion due to the orientation difference between the revetment and fixed physical infrastructure along the north end of Brigantine Avenue and the long-term regressive changes in the natural shoreline to the north. Within this erosional hotspot, the beach is narrow with no oceanfront development on the east side of Brigantine Avenue a rock revetment provides the primary storm protection for public infrastructure and properties west of the road. This region's rapid erosion rate prevents development of a significant dune system despite several attempts during early-engineered beach projects to establish one. Consequently, this region has been subject to several episodes of storm overwash, the most recent occurred as Sandy moved onshore. No NJBPN profile exists in this immediate region although the municipality established a monitoring program with the CRC in 1992 to follow changes in this section of shoreline. The photo below shows the erosional hotspot along the northern developed shoreline in Brigantine one-year after completion of the third USACE nourishment cycle.

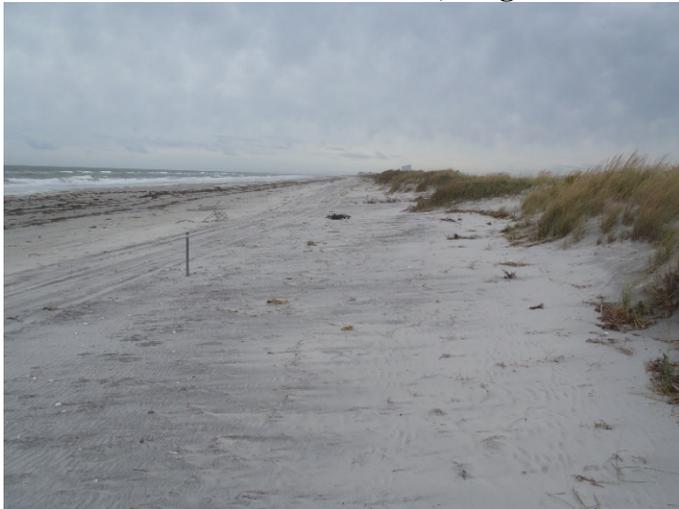
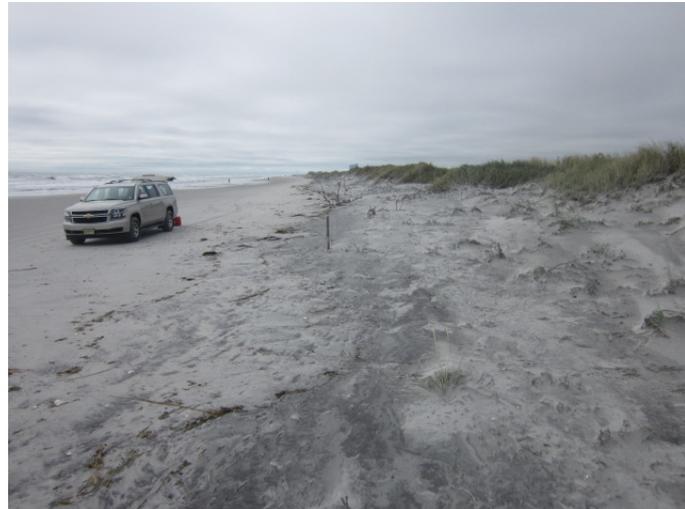
**NJBPN 134 – Green Acres Area, Brigantine**

This site is in the natural area on the northern segment of Brigantine Island preserved as public open space. On the left (October 16, 2019) the view is south along the seaward dune crest. The seaward slope rapidly transitions into a narrow beach with a nearshore sand ridge visible in the distance just beyond the shoreline. Photo on the right taken October 13, 2020 is a similar view from the seaward dune crest showing modest sand accumulation on the seaward dune slope and the upper beach but no summer berm is evident. This low-profile beach remains vulnerable to storm wave overwash.

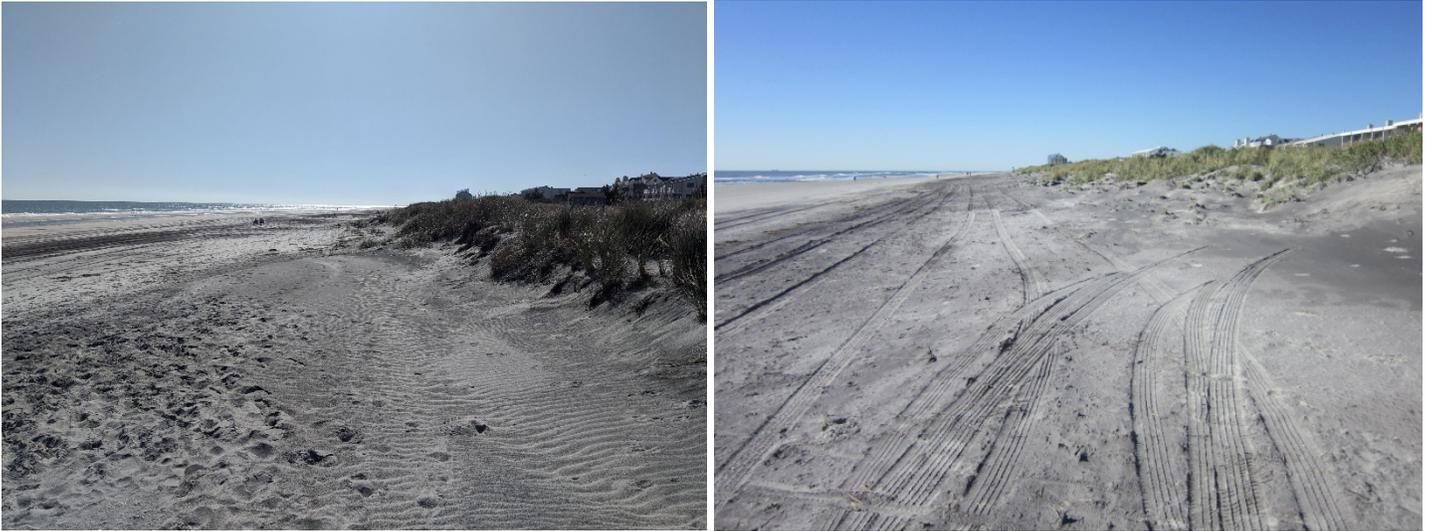
**NJBPN 133 – 4<sup>th</sup> Street North, Brigantine**

This site is located near the northern limit of development and within the 1997, 2001, 2006, 2013 and 2018 beach fill projects. Photo on the left (October 15, 2019) is a view south along the foredune ridge built naturally from aeolian processes over time and now fully colonized by American Beach grass. The wider project beach berm is evident in the background. Photo on the right (October 14, 2020) shows modest sand accumulation at the seaward dune toe while the beach berm eroded.

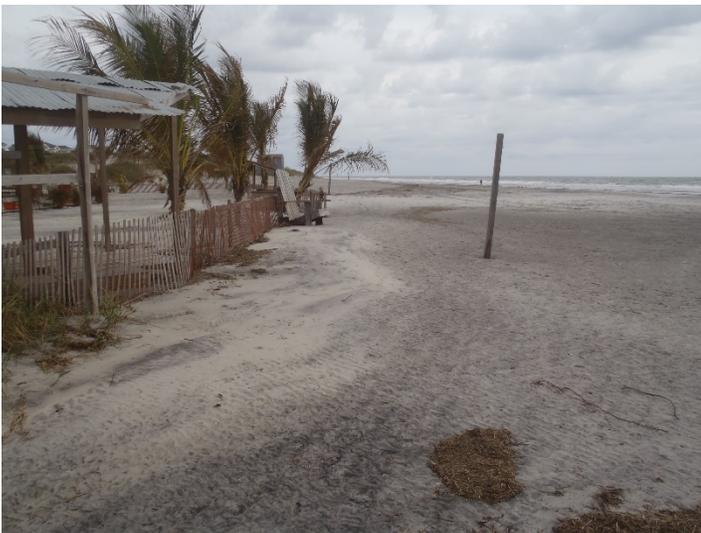
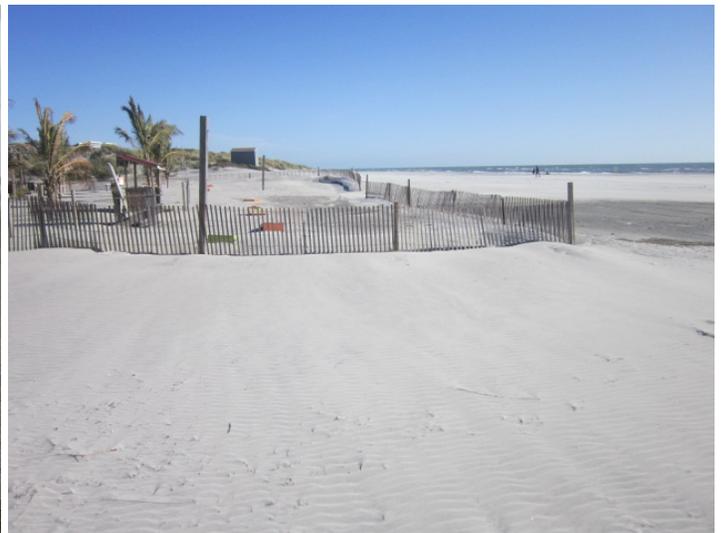
**NJBPN 132 – 15<sup>th</sup> Street South, Brigantine**

The left photo taken October 16, 2019, shows the view north and seaward of the beach club, the dune is absent here, but the beach is wide providing some storm protection. There is visible evidence (wrack debris) of recent tides reaching the beach club fence. Photo on the right shows a similar view on October 15, 2020, immediately seaward of the beach club the beach is wide and dry while to the north the dune is well developed and visible in the distance providing enhanced storm protection.
