# STOCKTON UNIVERSITY COASTAL RESEARCH CENTER

## New Jersey Beach Profile Network 2020 Annual Report on Shoreline Changes in New Jersey's Four Coastal Counties Raritan Bay to Delaware Bay Spring of 2019 Through Fall of 2020

August 31, 2021

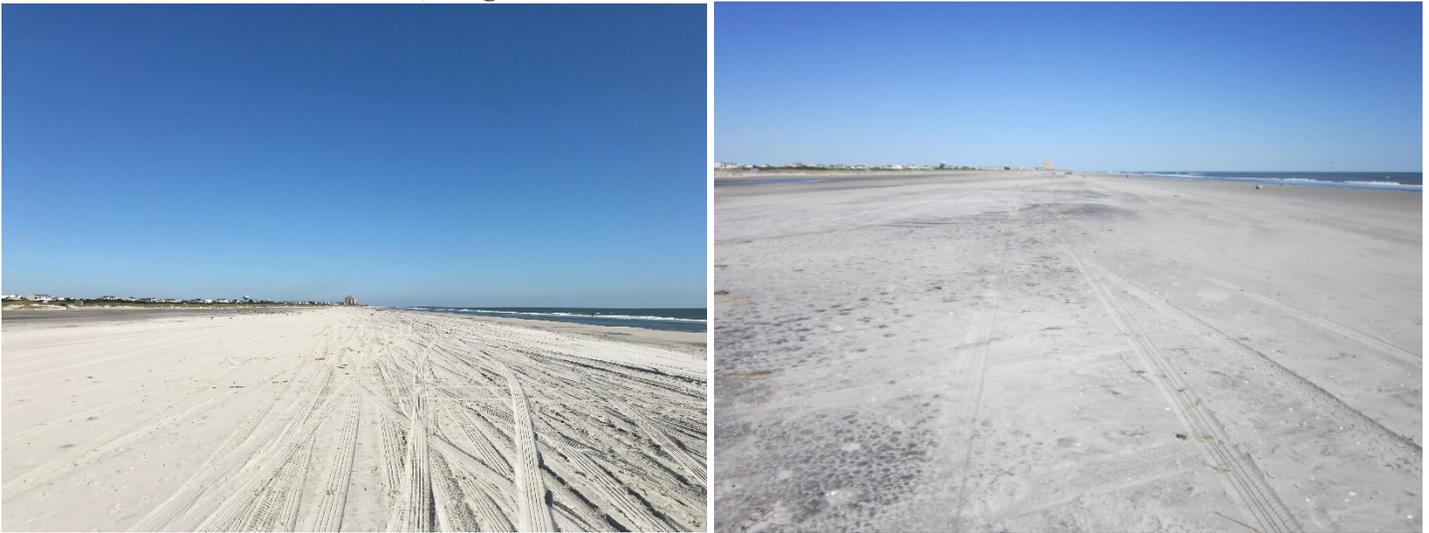
**NJBPN 131 – 43<sup>rd</sup> Street South, Brigantine**

The photo on the left is a view to the north taken on October 15, 2019, shows the massive 600-foot wide recreational beach located between the dune and high-water line. Photo on the right taken October 14, 2020 shows the section of beach continued to accumulate sand along the seaward beach berm ridge. The line of waves breaking just offshore indicates the position of a nearshore sand bar building landward. The dune system not visible in this photo provides an additional 950 feet of protection.

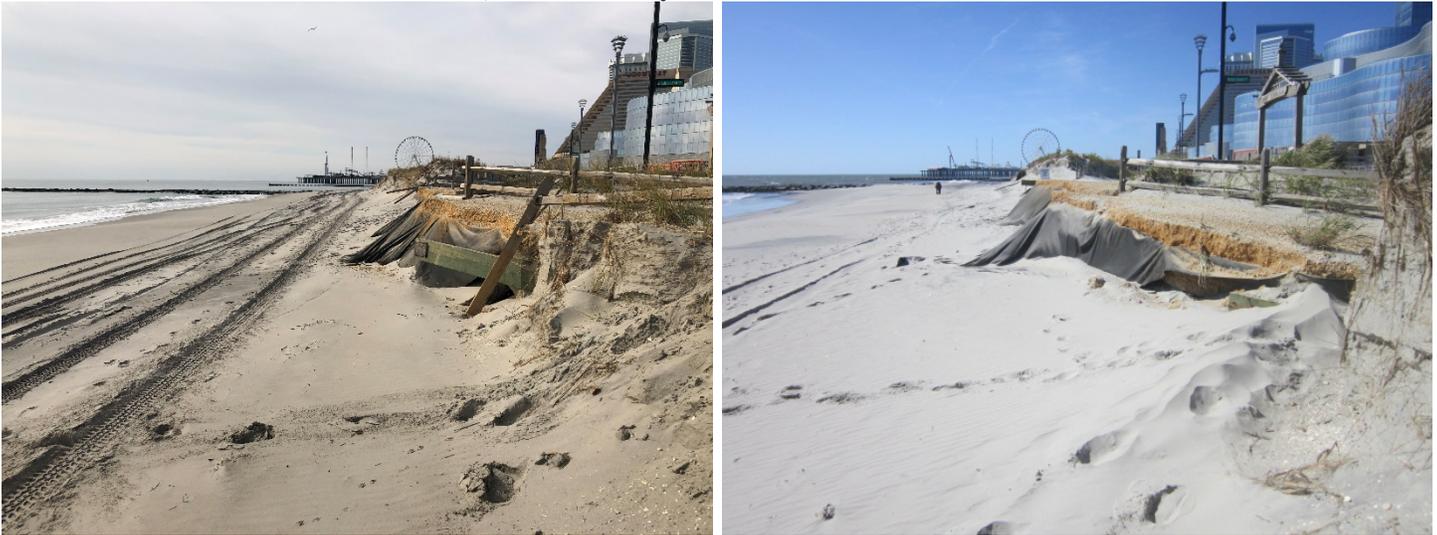
NJBPN 230 – Rhode Island Avenue, Atlantic City

This profile site is located near the Absecon Inlet south jetty. The left photo (taken October 16, 2019) shows the remaining fill material placed in 2017 following erosion, the beach was narrow with waves starting to cut into the seaward dune slope. By October 15, 2020 (right photo) erosion had cut the away the dune to the landward crest and reduced the overall beach width. This site remains an erosional hotspot for Atlantic City despite rehabilitation and modifications to the adjacent rock groins. The 4<sup>th</sup> nourishment cycle was scheduled to start in December 2020.

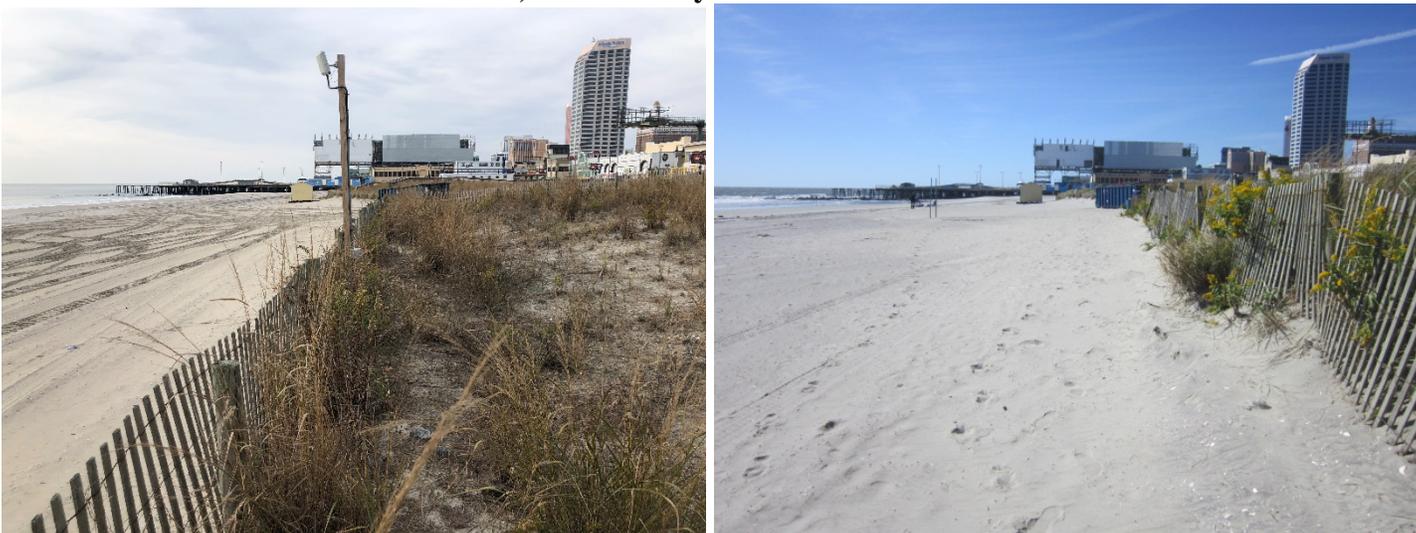
**NJBPN 130 – North Carolina Avenue, Atlantic City**

This Atlantic City site is located south of Steel Pier with Central Pier visible to the south. The left photo, taken November 14, 2019, shows the beach after grading with the well-established dune system. Photo on the right, taken October 15, 2020, shows loss of the beach berm and modest reduction in overall beach width but the upper beach and dune remained intact.

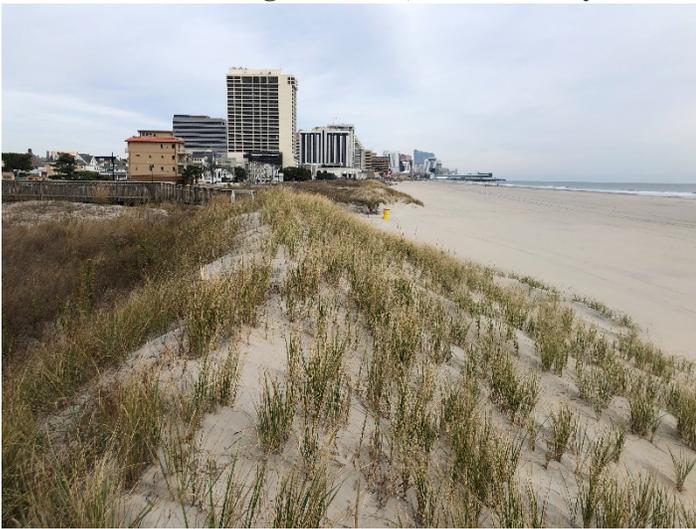
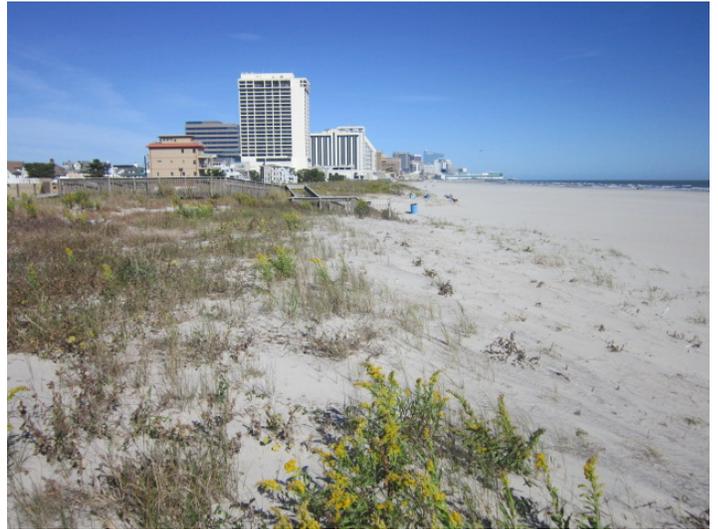
NJBPN 129 – Raleigh Avenue, Atlantic City

This site lies near the south end of Atlantic City and middle of Absecon Island where erosional loss is minimal. Photo on the left taken November 14, 2019 shows the wider beaches and an expanding foredune nearly burying the dune fence. Photo on the right taken October 15, 2020 shows the foredune growth was flattened but the beach remained stable to accretive. Beach and remaining dune stability make wave runup, storm erosion or wind deflation unlikely forces for this foredune flattening.

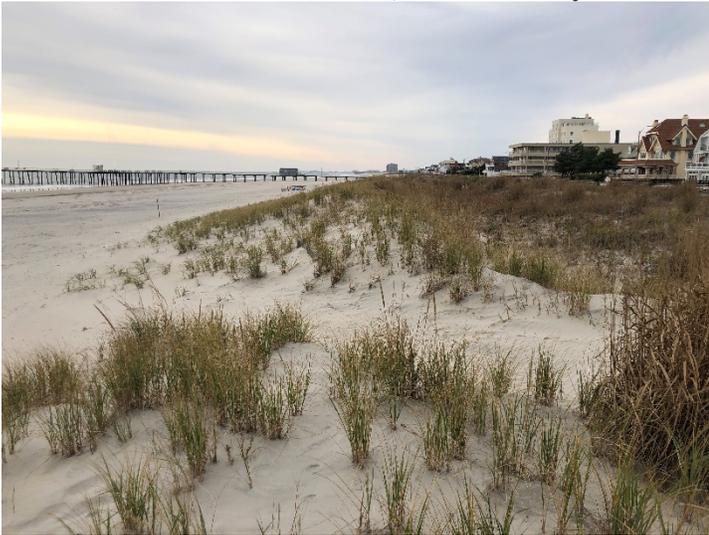
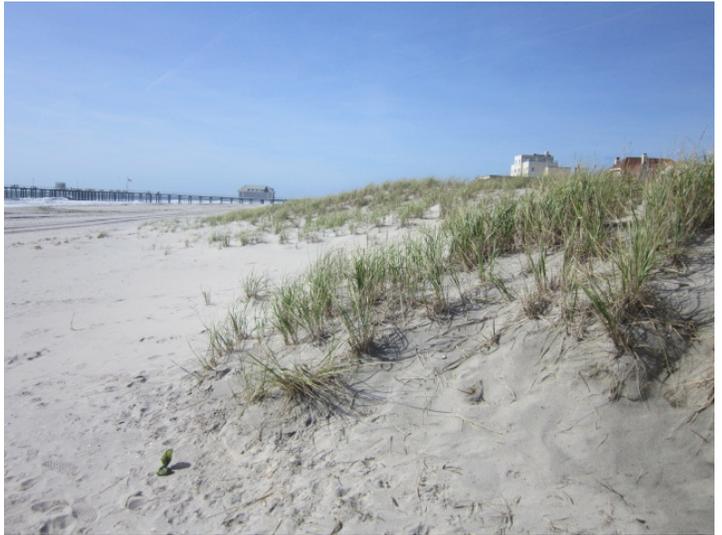
**NJBPN 128 – Dorset Avenue, Ventnor City**

The Dorset Avenue site positioned centrally on Absecon Island is stable in terms of net losses, seasonal changes and any long-term erosion trends. Left photo taken November 14, 2019 shows a view to the south of the dune and beach with the Ventnor pier in the background. A similar view taken on October 19, 2020 shows minor variations in the beach and dune conditions.

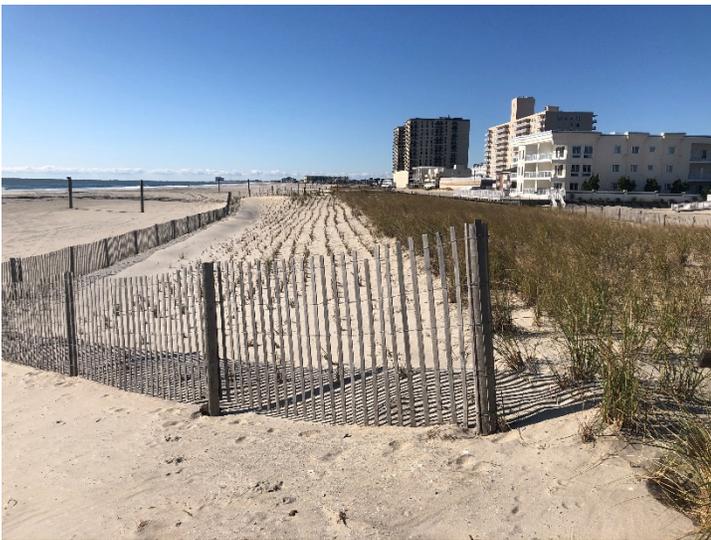
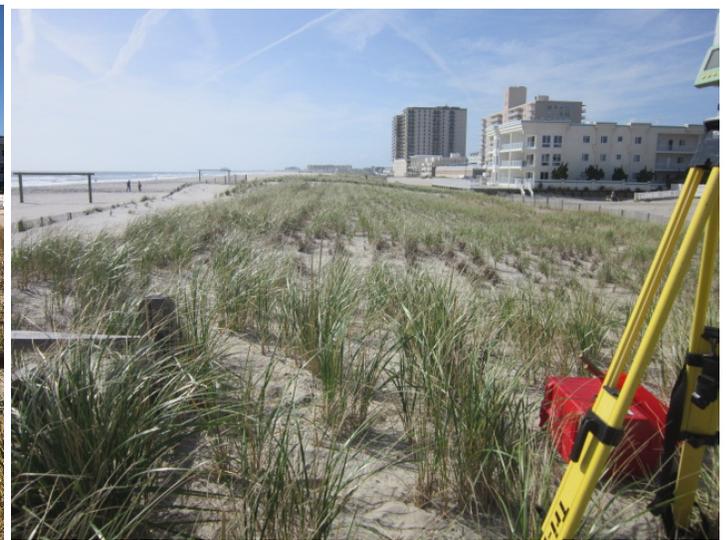
**NJBPN 127 – Benson Avenue, Margate City**

The Benson Avenue site is located approximately one mile south of the end of the original USACE project in Ventnor. The left photo taken November 13, 2019 shows the post project dune and beach configuration with a wide dry beach berm and newly planted dune and installed dune fence. By October 19, 2020, the dune fence is accumulating sand and the vegetation flourishing on the crest. Following construction, the beach has remained relatively stable throughout the study interval.

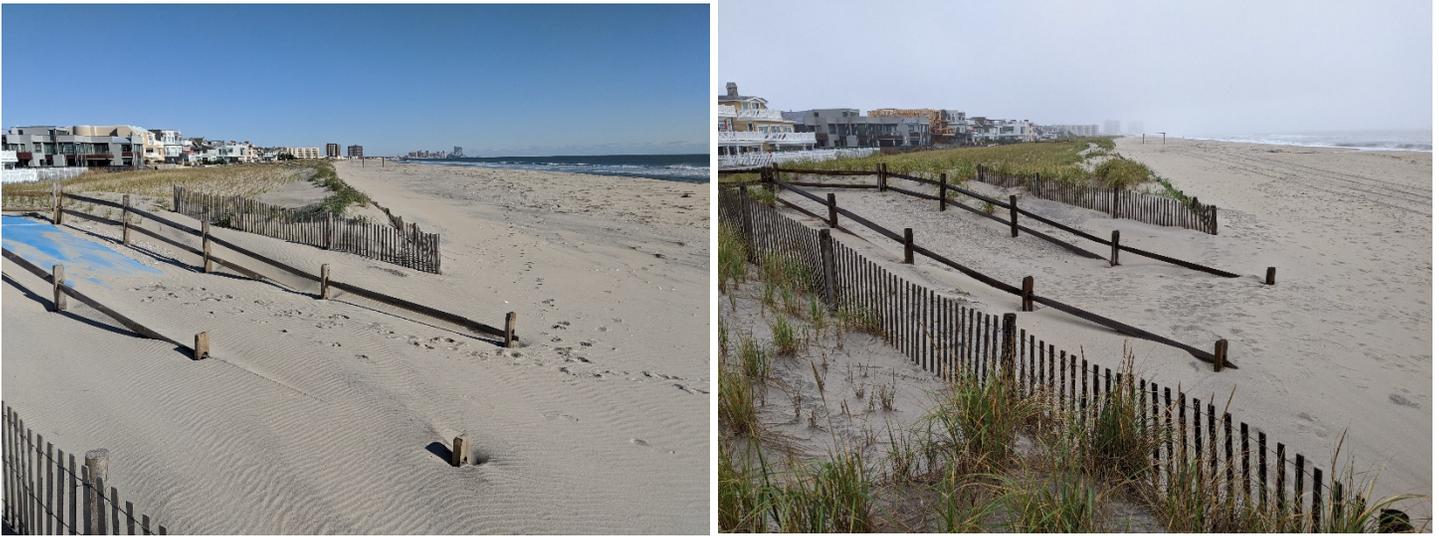
## NJBPN 126 – 17<sup>th</sup> Street, Longport

The 17<sup>th</sup> Street profile is located about 6 blocks north of the Great Egg Harbor Inlet. The left photo, taken November 13, 2019, shows the post USACE project established dune and wider beach conditions. Aeolian sand accumulated along the seaward dune slope has nearly buried the seaward beach access and dune fence. A similar view taken October 20, 2020 (right photo) shows sand continued to accumulate at the seaward end of the access path and along the dune fence. Dune plant colonization and propagation improved vegetation density coverage as the plants flourished over the past year. The recreational beach width remained relatively stable providing an ample source of aeolian sand to continue dune growth.

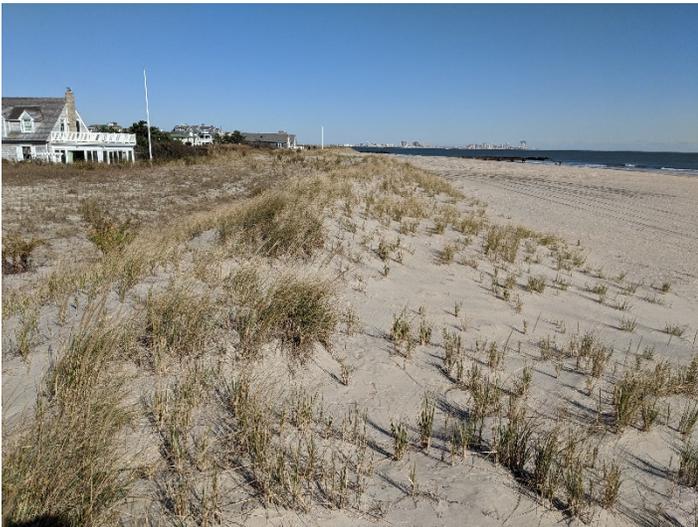
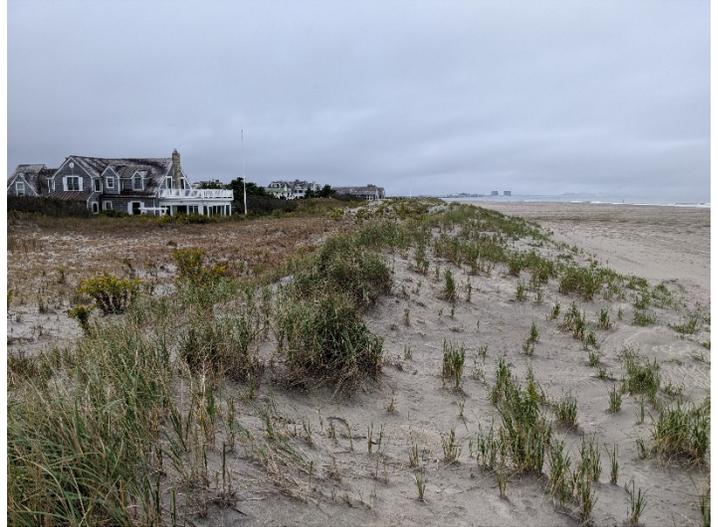
**NJBPN 225 - Gardens Road, Ocean City**

The Gardens Road site is the northernmost profile in Ocean City and located near Great Egg Harbor Inlet. (Left photo is from April 23, 2020. Right photo is from October 20, 2020). In August of 2020, sand was added to the beach once again showing significant improvement to the elevation of the beach profile and increasing the width of the beach.

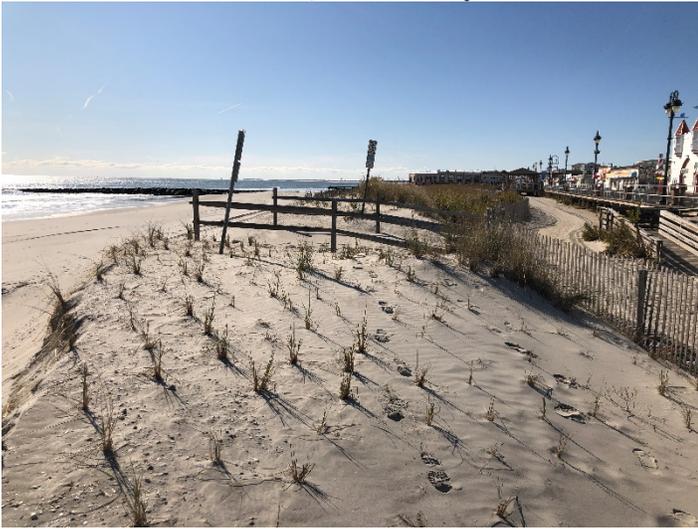
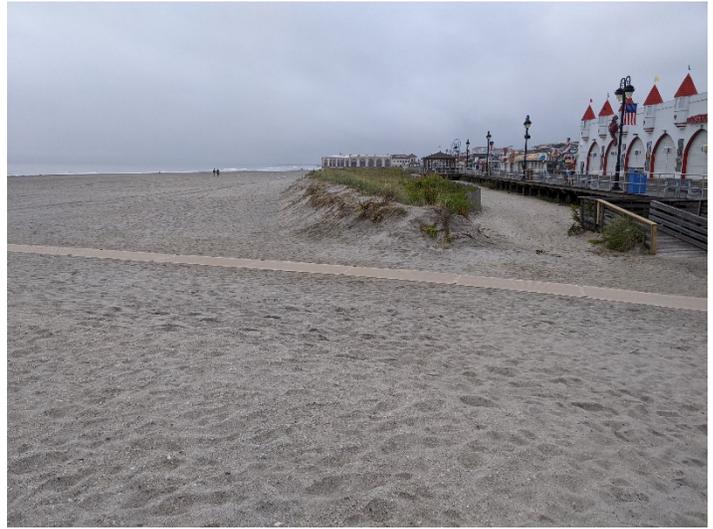
NJBPN 125 - 6<sup>th</sup> Street, Ocean City

The left photo (taken November 11, 2019) displays the magnitude of erosion at this location. A significant scarp has formed deep into the primary dune while the beach face has experienced continuous erosion. The right photo (taken October 20, 2020) shows the dune and beach entrance to have completely eroded but does display a wider beach and higher elevation due to the beachfill that was completed in 2020.

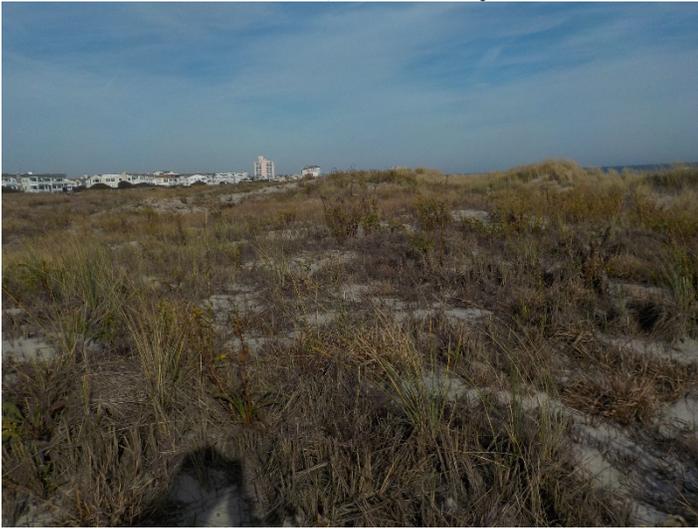
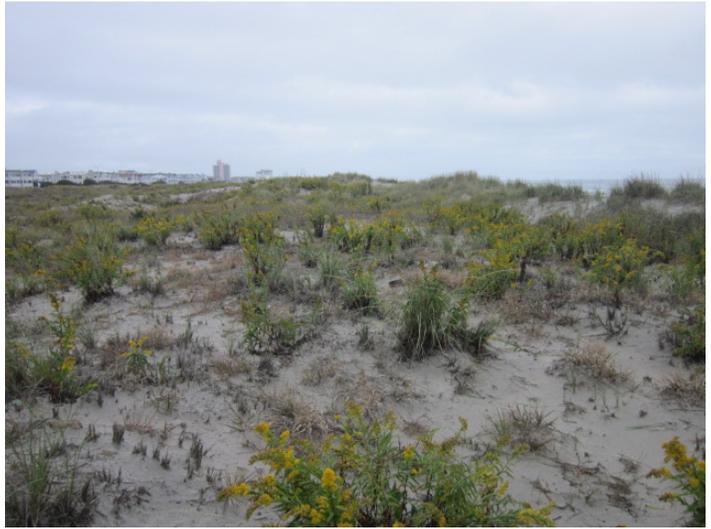
NJBPN 124 - 20<sup>th</sup> Street, Ocean City

The 20<sup>th</sup> Street profile is located near the center of the island and hosts an extensive dune and wide beach. The area has been stable since the initial beach restoration in 1992. Photo on left was taken November 11, 2019. Right photo was taken October 20, 2020. The view from the instrument station location provides a panoramic feeling for the expanse of this beach. In 1991, the low tide line was under the boardwalk to the extreme left of the pictures.

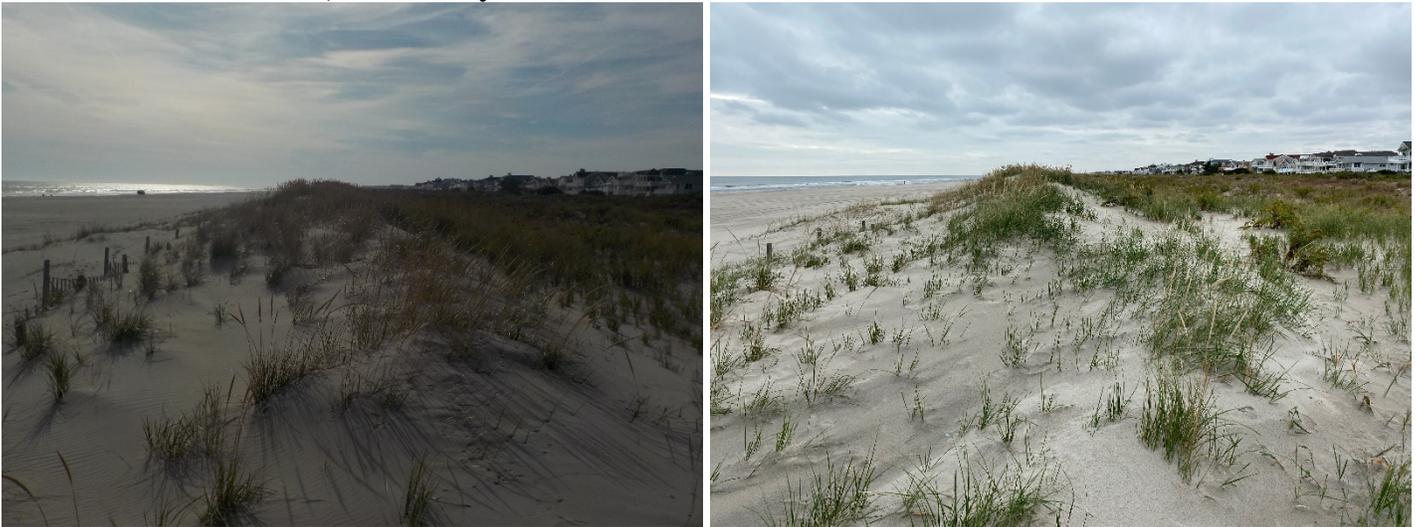
NJBPN 223 - 34<sup>th</sup> Street, Ocean City

The comparison photos, with the view to the south, (left taken April 22, 2020 and right photo taken October 27, 2020) show changes in dune composition over the past 7 months. The old fence from 2014 has been buried with accreted sand, and a newer fence is nearing complete burial by October 2020.

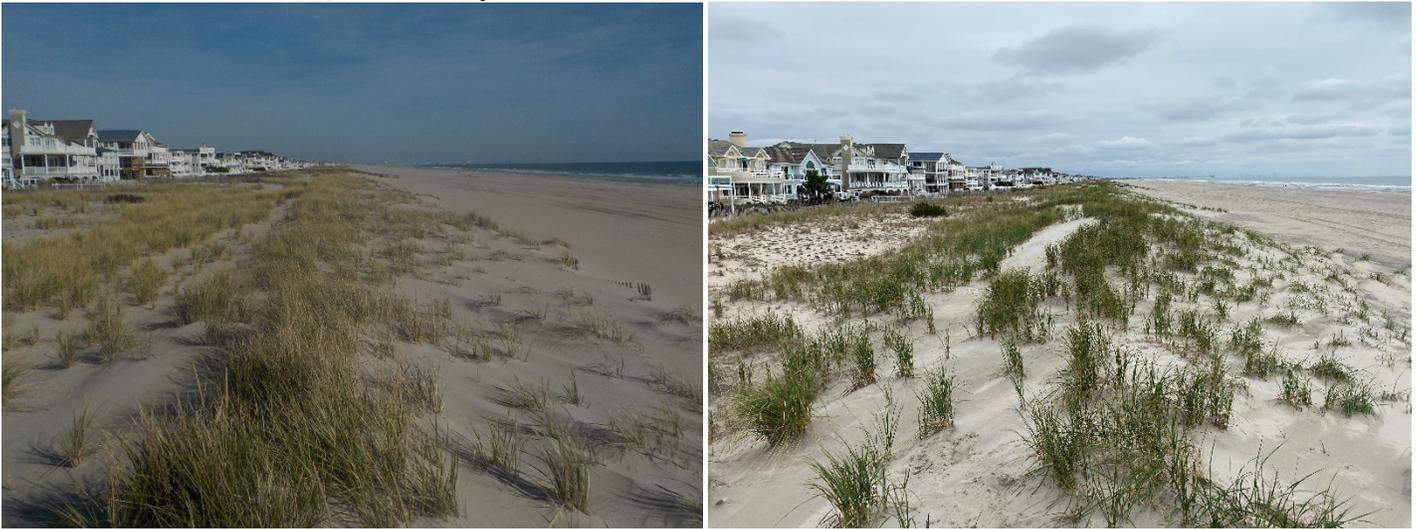
NJBPN 122 - 56<sup>th</sup> Street, Ocean City

In 2015, the 56<sup>th</sup> Street site received its first sand replenishment since the 1995 state beach fill. The new dune was planted and a fence that was placed then is now covered by sand as shown on the left photograph (November 11, 2019). The right view was taken October 27, 2020 and shows that the newest line of sand fencing is now completely buried by accreting sand with the foredune vegetation growth remaining strong. The images also show the growth in height of the foredune crest.

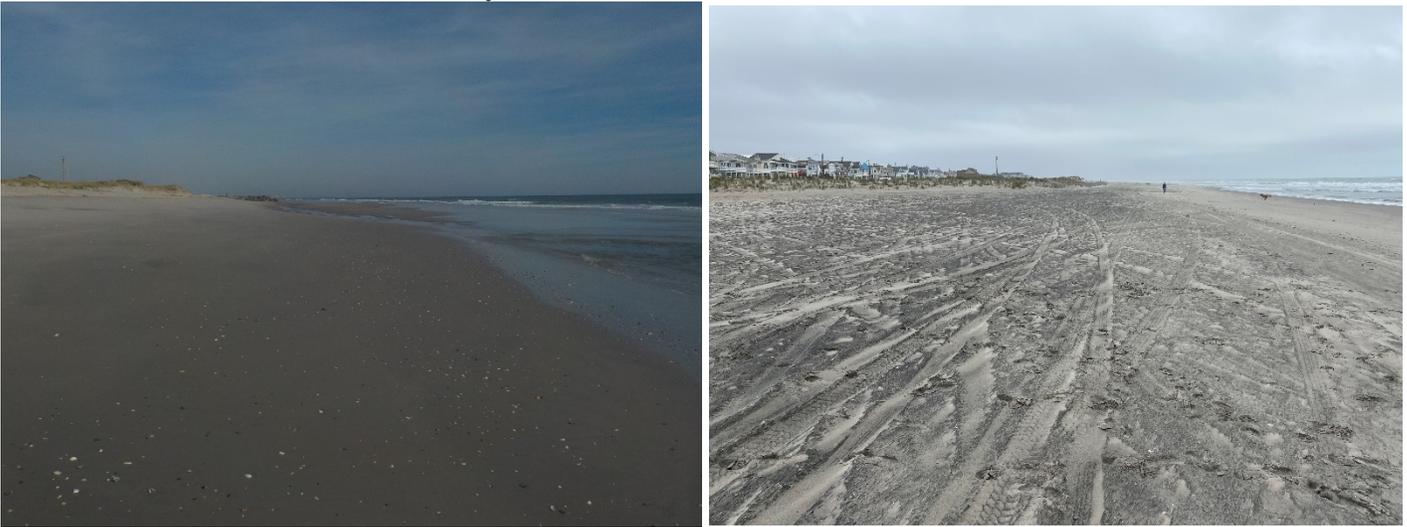
NJBPN 222 - 59<sup>th</sup> Street, Ocean City

The 59<sup>th</sup> Street site is located at the southern end of the developed section of Ocean City within the Corson's Inlet State Park. This site is also within the 2015 federal beach fill project area. (Left photo taken November 11, 2019. Right photo taken October 26, 2020). The beach and berm are in an erosional state on November 2019. By October 2020, remaining project sand from the recent nourishment cycle had advanced the shoreline and raised the beach elevation.

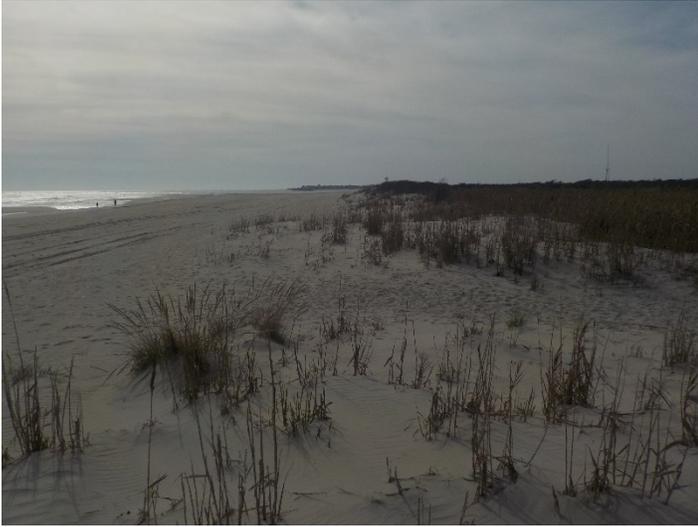
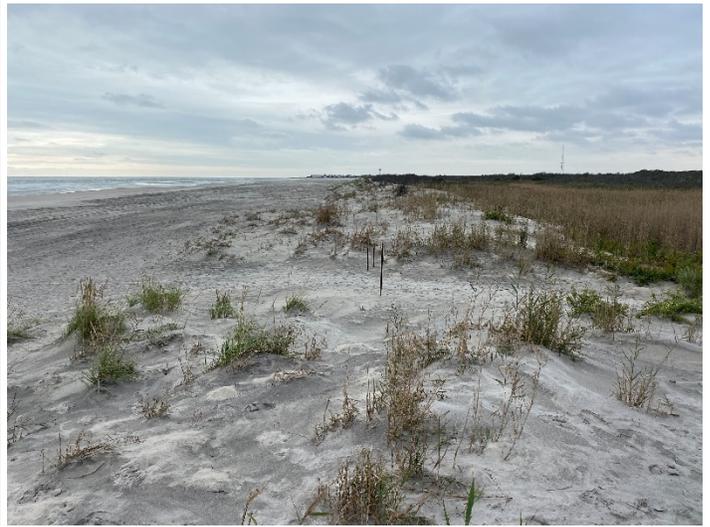
**NJBPN 221 - Corson's Inlet State Park, Ocean City**

Natural dune recovery has continued following Hurricane Sandy which destroyed the foredune. The left photograph, taken September 23, 2019 shows the beach view to the south from the toe of the foredune with a dry beach berm extending seaward. By October 26, 2020 (right photo), the dune continued to accumulate sand around the vegetation, but the beach had eroded leaving a narrower dry recreational beach.

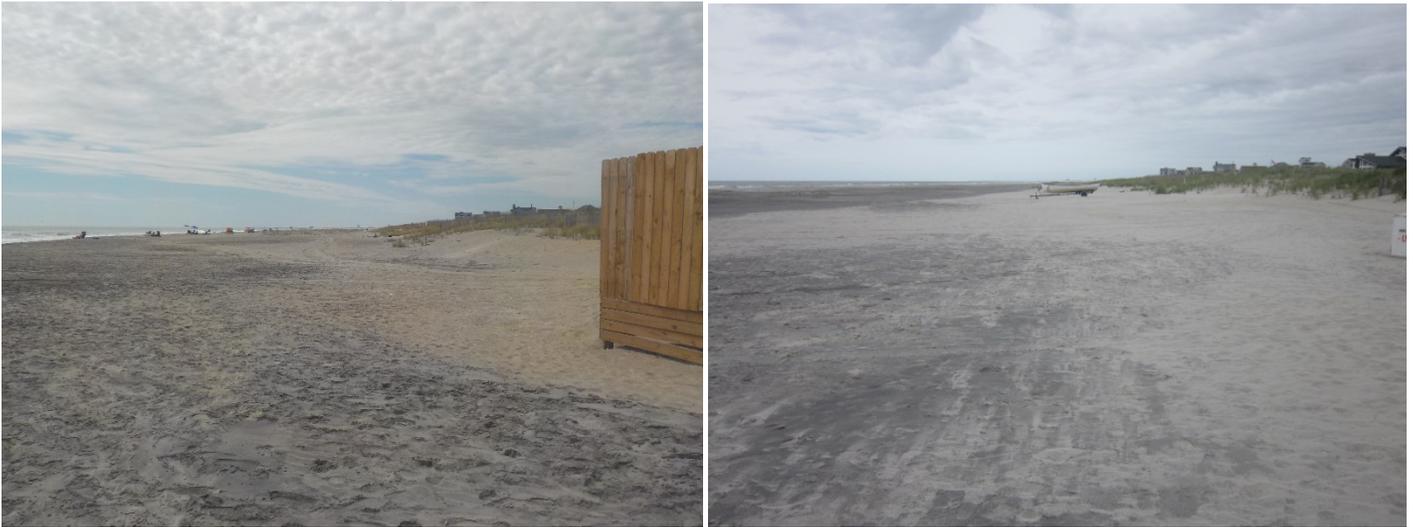
**NJBPN 121 - Williams Road, Strathmere**

The Williams Road site is dominated by the ebb-tidal delta at Corson’s Inlet. The extensive width of the dry beach serves to protect the dunes from wave damage. The post summer beach had eroded back to the proximity of the seaward dune toe as of September 17, 2019 (left photo). The photo on the right (taken September 17, 2020) shows evidence of a wider beach profile following the 2020 USACE nourishment cycle.

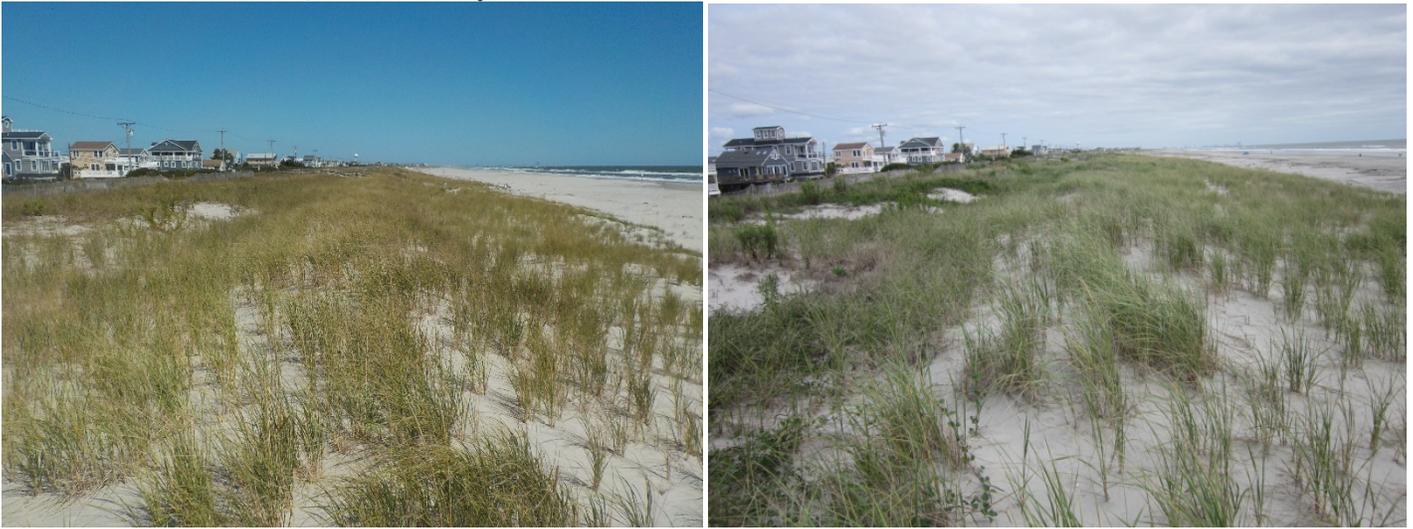
**NJBPN 120 - 1<sup>st</sup> Street, Sea Isle City**

The dune here at the 1<sup>st</sup> Street location consists of a geotextile core covered by sand. The core has been in place for 26 years without failure. However, more extensive beach maintenance has occurred since 2001 leading to the federal project in summer 2015. The left photograph was taken September 19, 2019 and shows dense dune grass with extensive foredune development that has buried fencing that had been installed in 2015. The right view was taken September 16, 2020 and shows that the dune grasses have flourished.

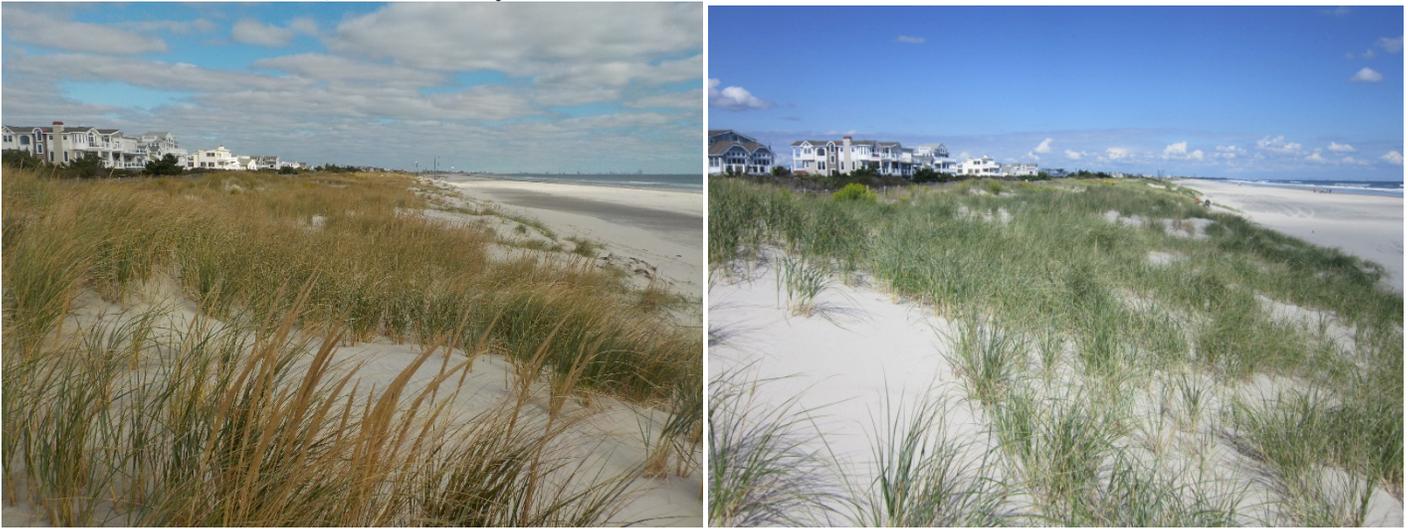
NJBPN 119 - 25<sup>th</sup> Street, Sea Isle City

The 25<sup>th</sup> Street site is reasonably stable and was enhanced in 2009 under the NJ State project and then again in 2015 during a federal project. The 2015 project greatly widened the beach and added to the dune. The left photograph from October 18, 2019 shows the foredune development with the growing vegetation and accreted sand having buried the 4-foot fencing. The right photo taken on October 5, 2020 shows dune grasses have remained and matured on the seaward dune face.

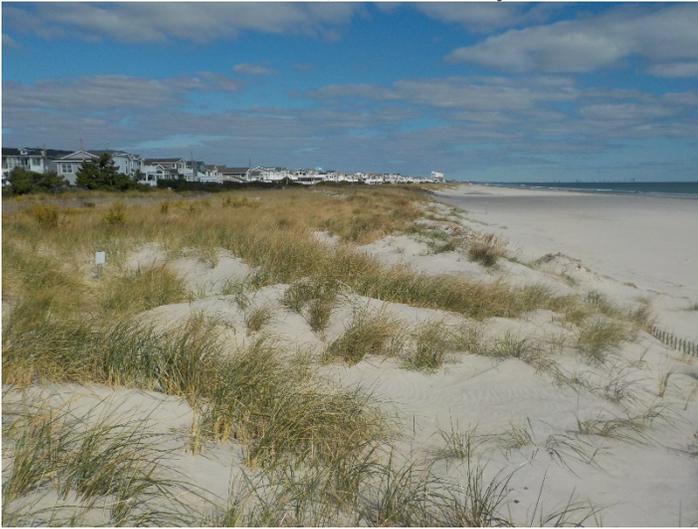
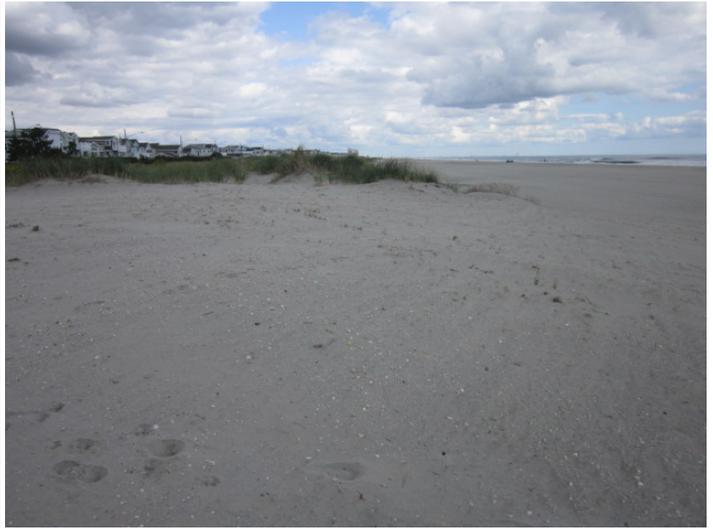
**NJBPN 118 - 57<sup>th</sup> Street, Sea Isle City**

The left photo (taken October 18, 2019) shows established dune grass on a healthy foredune; a nearly buried dune fence is visible along the foredune toe. The right photo (taken on October 5, 2020) shows a complete loss of the established foredune, its grasses, and the fence that existed at its toe. Aside from the complete loss of the foredune, the beach face remains wide and stable. Not clear if this dune change was mechanical or natural.

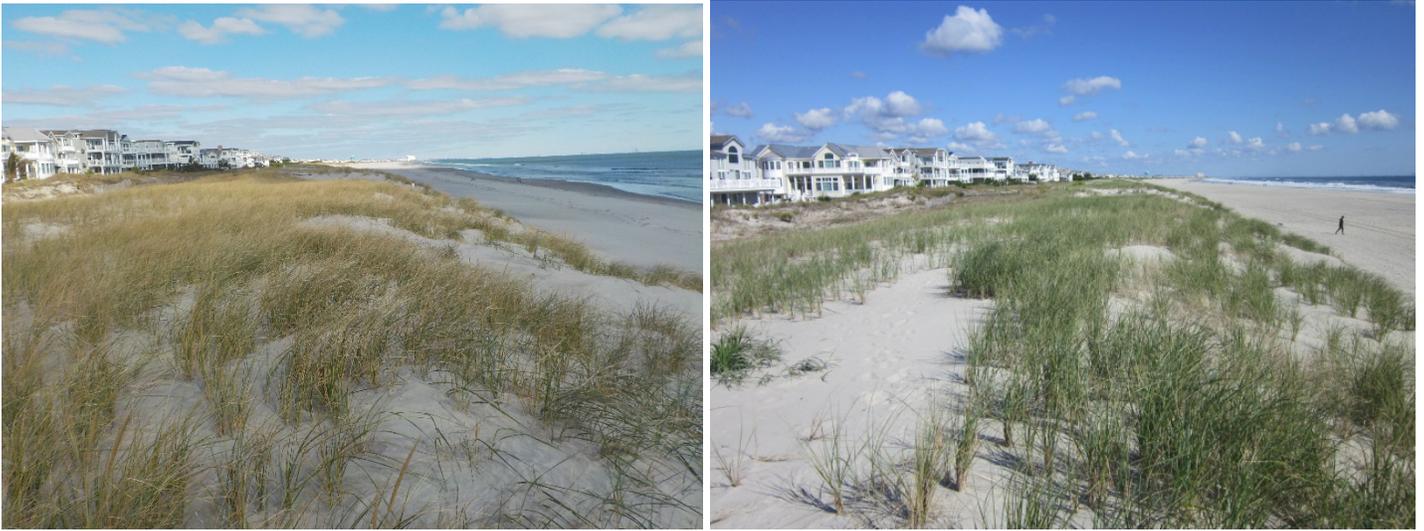
NJBPN 117 - 80<sup>th</sup> Street, Sea Isle City

The left photo was taken October 28, 2019 and shows the southern end of Sea Isle City facing North. The fore dune crest is well established and nearly fully vegetated. The right photo (taken on October 5, 2020) shows the dune has remained stable and fully vegetated a year later. The fore dune in October 2020 seems to have accreted sand from wind deposition on the landward edge of the fore dune crest, partially burying the vegetation in spots.

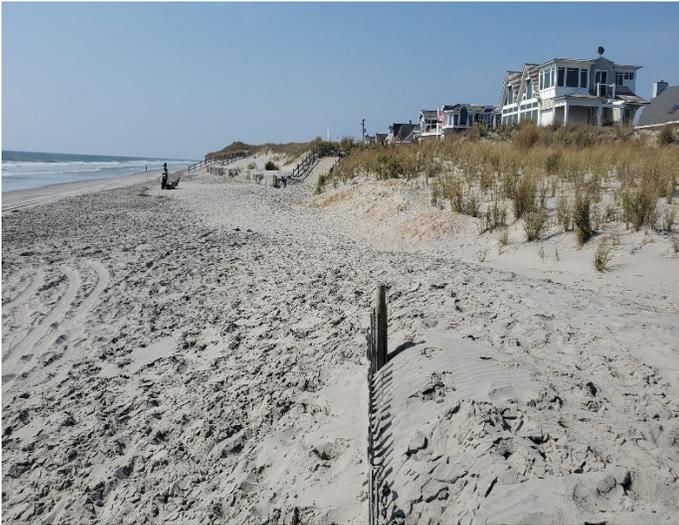
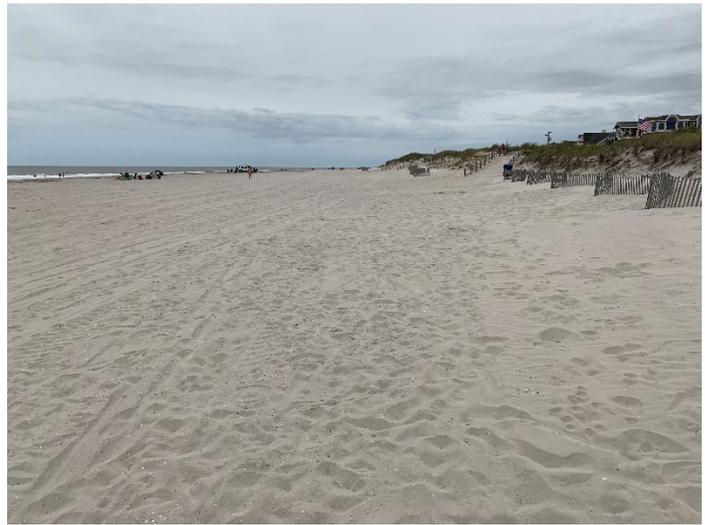
**NJBPN 216 - 9<sup>th</sup> Street, Avalon**

The 9<sup>th</sup> Street site is located near the Townsend's Inlet south jetty. The fall of 2019 survey (left photo taken October 15, 2019), shows the beach remained virtually unusable for recreational use, as the beachface had eroded back to just in front of the primary dune. The dune here remained unaffected. The right photo (taken September 17, 2020) shows the effects of the 2020 winter beachfill with the expanded recreational beach. The previous fence has been completely covered by sand and a new fence was placed along the seaward dune at the toe.

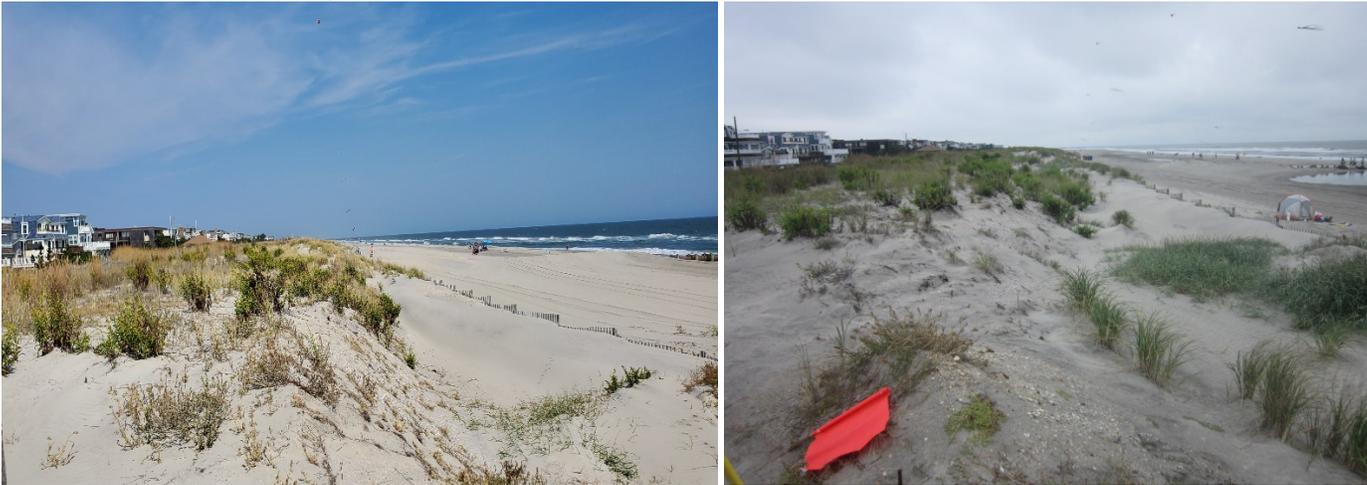
NJBPN 116 - 23<sup>rd</sup> Street, Avalon

The left photo (September 23, 2019) shows the foredune fencing virtually covered by accreting sand, while the berm elevation has eroded landward. The right photo taken on September 18, 2020 displays the decreased elevation of the recreational beach while the primary dune remains unchanged.

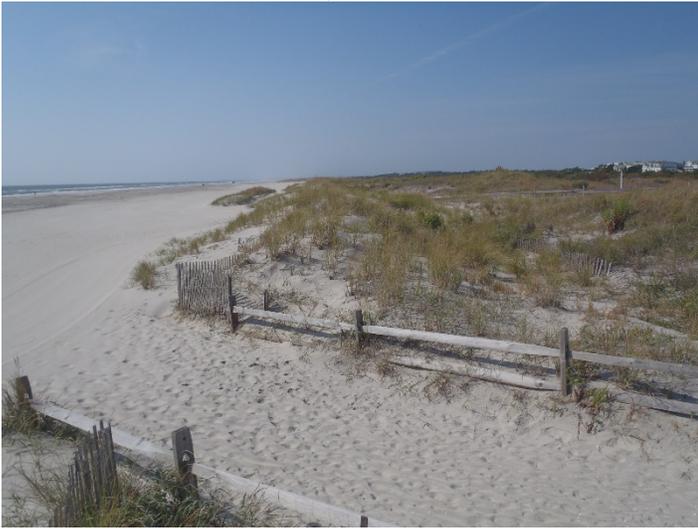
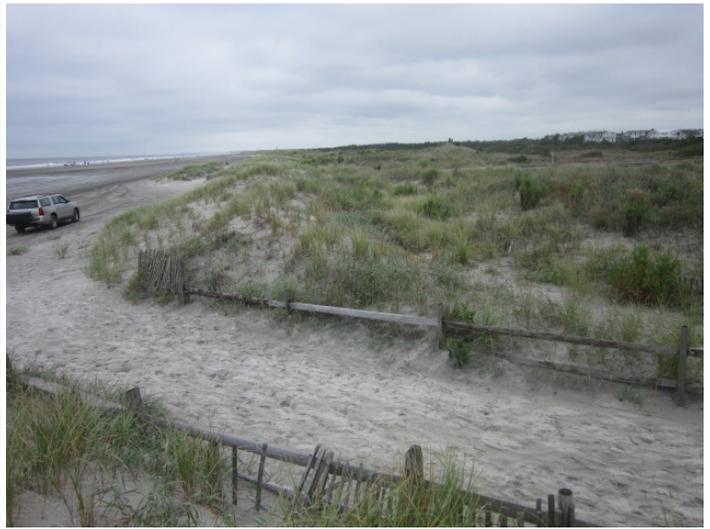
**NJBPN 115 - 35<sup>th</sup> Street, Avalon**

This site lies south of the Avalon beach nourishment project zone and is generally within an accretion zone that is owned by the Borough. The left photo, (view to the south) taken September 23, 2019 looking to the south, displays very healthy dune system and recreational beach area. The right photo, taken on September 23, 2020 looking to the south, displays denser dune vegetation and a stable recreational beach.

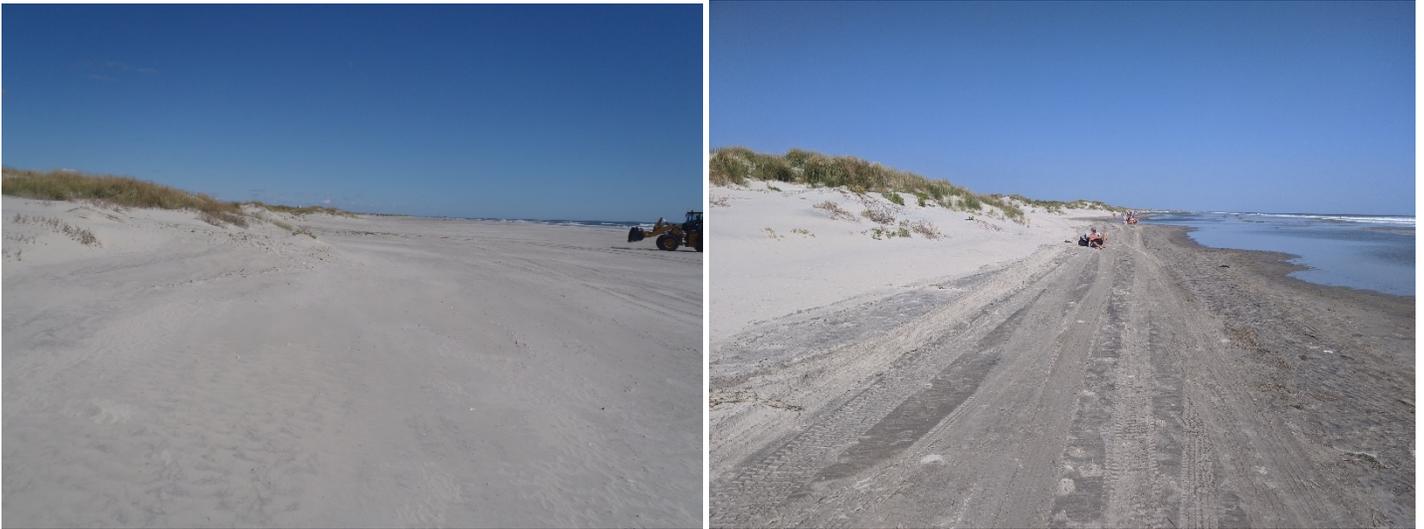
**NJBPN 114 - 70<sup>th</sup> Street, Avalon**

The 70<sup>th</sup> Street location has been a stable area for decades and lies at the very north limit of the Stone Harbor segment of the USACE Seven-Mile Island shore protection project, which breaks between 31<sup>st</sup> Street and 70<sup>th</sup> Street due to that shoreline not requiring maintenance. The left photo was taken September 23, 2019 looking north, shows the buried dune fencing and low lying recreational beach. The right photo, taken September 23, 2020, displays the slightly over-washed beach at a higher tide stage.

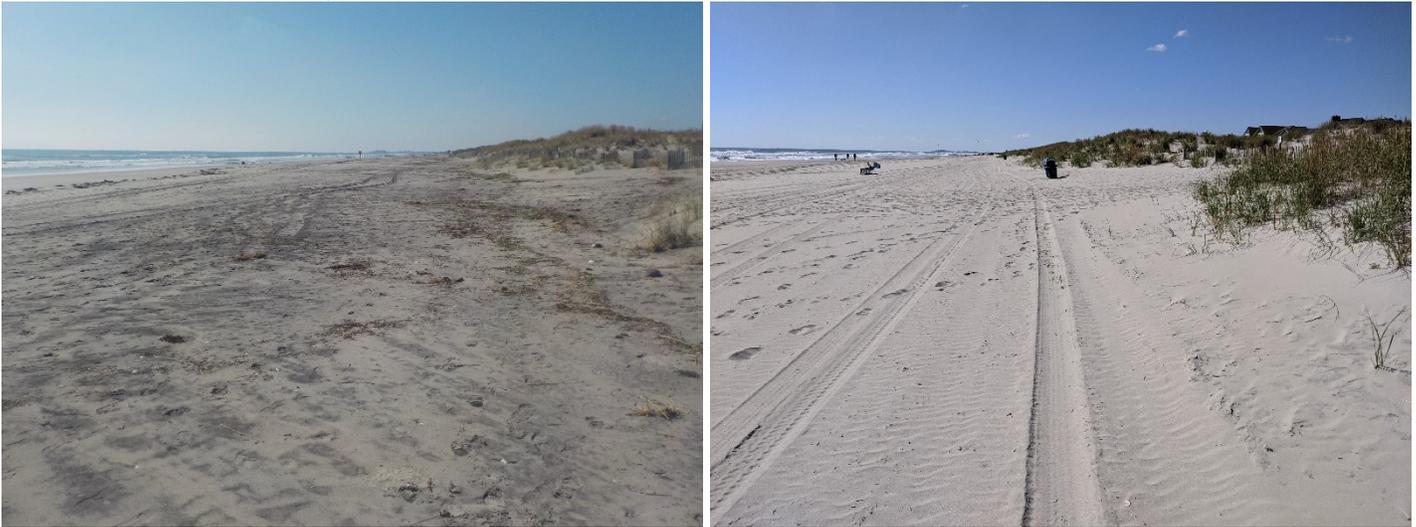
**NJBPN 113 - 90<sup>th</sup> Street, Stone Harbor**

The 90<sup>th</sup> Street location has been quite stable not needing maintenance as frequently as sites further south. The left photo, taken October 14, 2019, includes the berm and seaward dune toe. The right photo, taken on October 6, 2020, shows a slightly wider beach with a more pronounced berm.

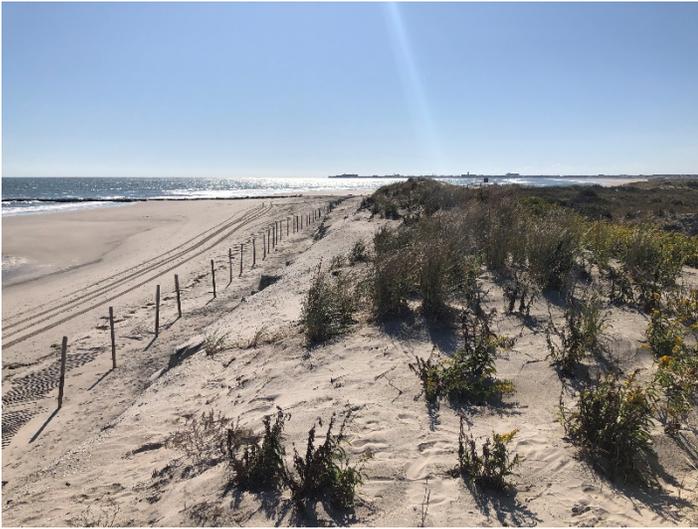
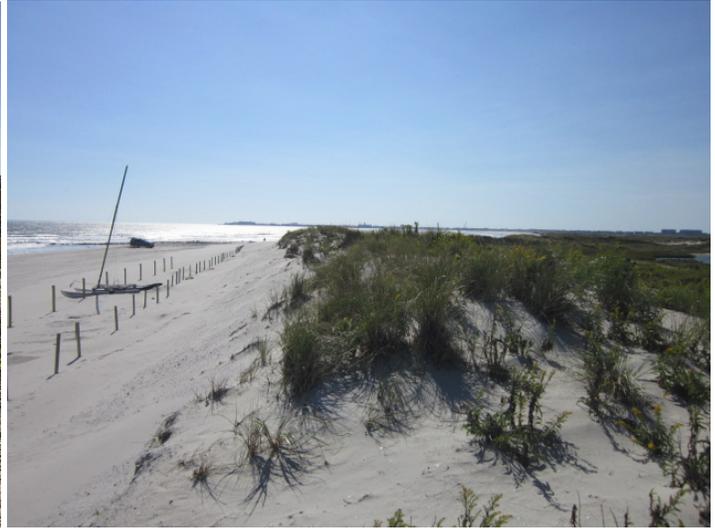
**NJBPN 212 - 121<sup>st</sup> Street, Stone Harbor**

The south end Stone Harbor site has shown a long-term erosional trend that may be influenced by changes surrounding Hereford Inlet. The site has been the recipient of numerous beach nourishment projects including municipal and Federal efforts. November 8, 2019 (left photo) shows a new fence line on the beach, a profusion of seaside goldenrod plants at the dune crest and a slightly wider beach. The photo also shows a seaward dunescarp had formed along with a noticeable pocket of sand added to the shoreline. The right photo, taken on October 7, 2020, shows the seaward dunescarp shown in survey 59 has filled in as sand accumulated on the back beach area.
