# STOCKTON UNIVERSITY COASTAL RESEARCH CENTER

## New Jersey Beach Profile Network 2020 Annual Report on Shoreline Changes in New Jersey's Four Coastal Counties Raritan Bay to Delaware Bay Spring of 2019 Through Fall of 2020

August 31, 2021

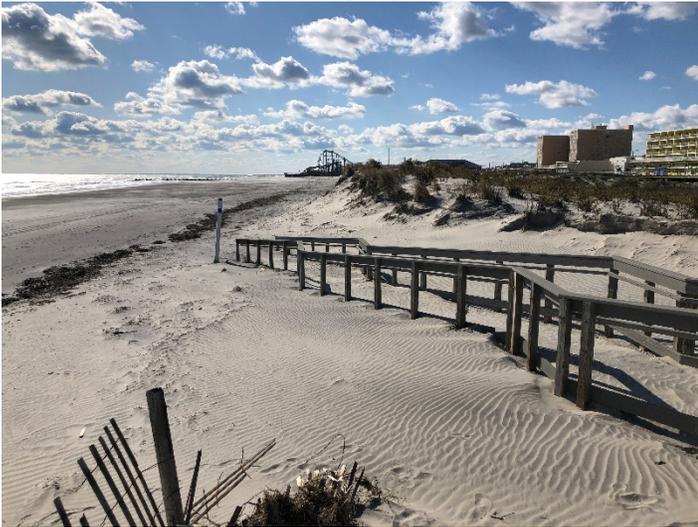
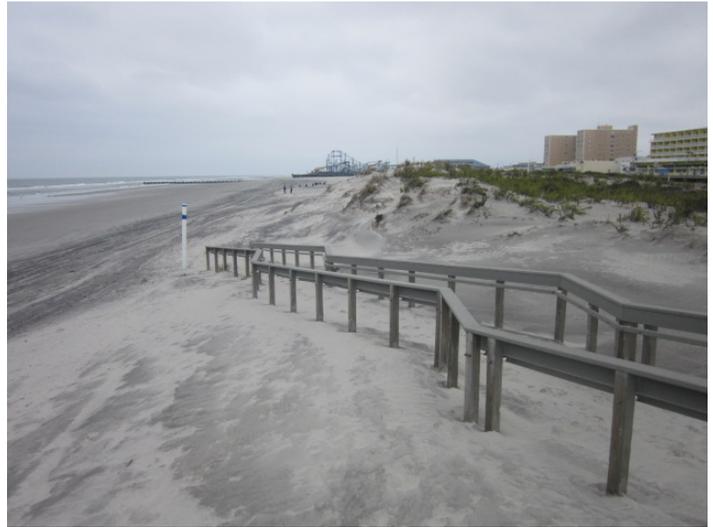
## NJBPN 111 - 15<sup>th</sup> Avenue, North Wildwood

The 15<sup>th</sup> Avenue site began to incur some of the erosion problems seen to the north. The November 8, 2019 view to the left, shows some dune retreat had occurred. Notice the high tide line positioned at the toe of the dune. By October 28, 2020, the dune system and recreational beach both remained at their March 2020 positions.

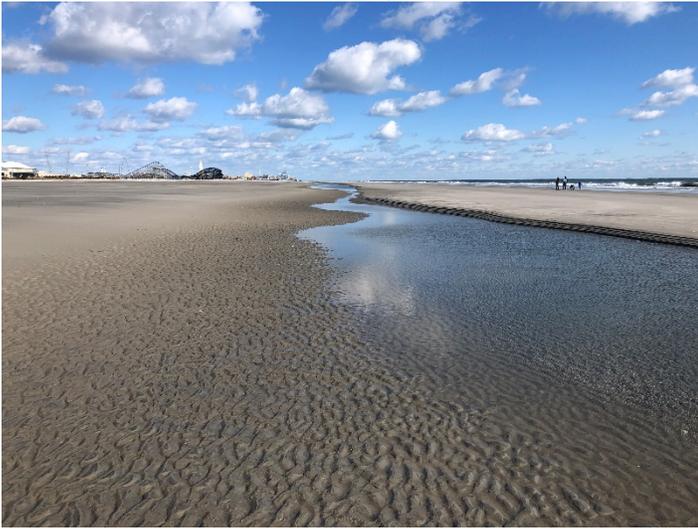
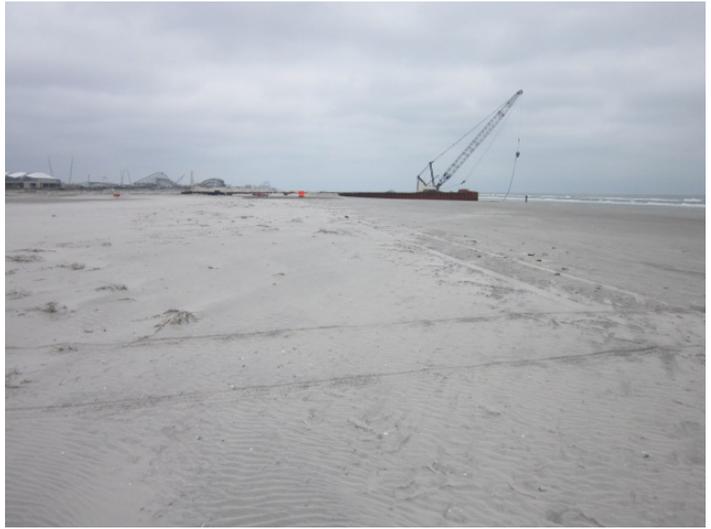
**NJBPN 110 - Cresse Avenue, Wildwood**

The Cresse Avenue site has been accumulating sand volume since 1992. Sand lost from North Wildwood migrates south adding to the beach width each year. The left photo, taken November 8, 2019, shows the beach width accompanied by the migration of the offshore bar onto the beachface. The right photo, taken on October 28, 2020, shows the extensive low-lying beach along with a construction crane in the distance.

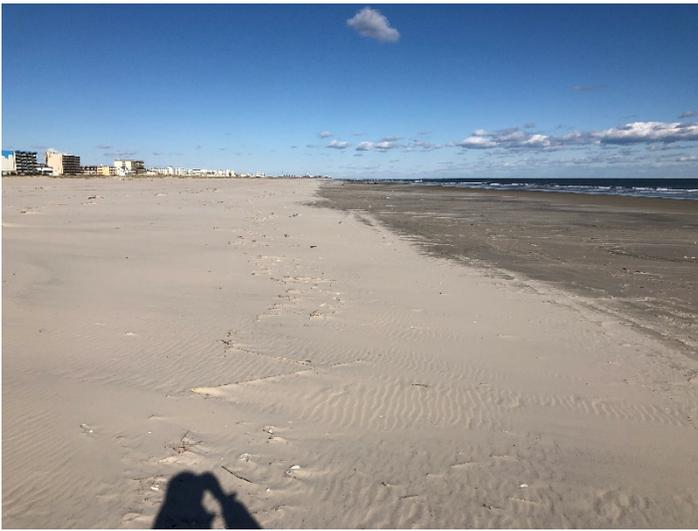
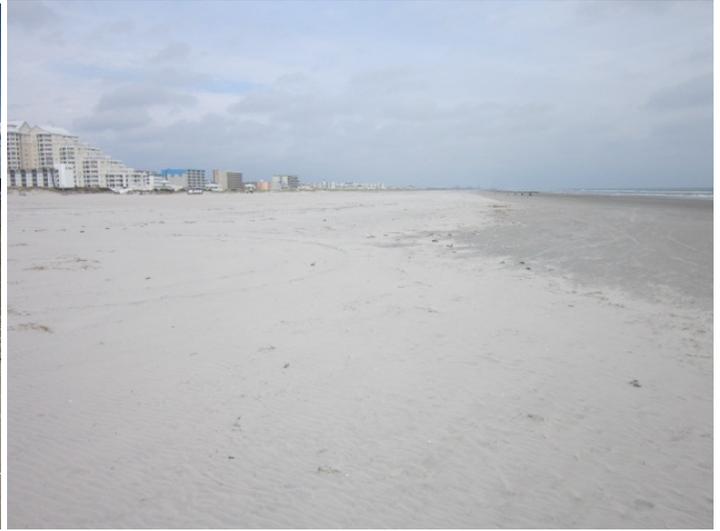
**NJBPN 109 - Raleigh Avenue, Lower Township**

The left photo (taken on November 8, 2019) shows the wide beach present in Lower Township. The right photo, taken on October 28, 2020, shows the bottom zone of the beach and gives a good view of the width which continued to increase through the fall 2020

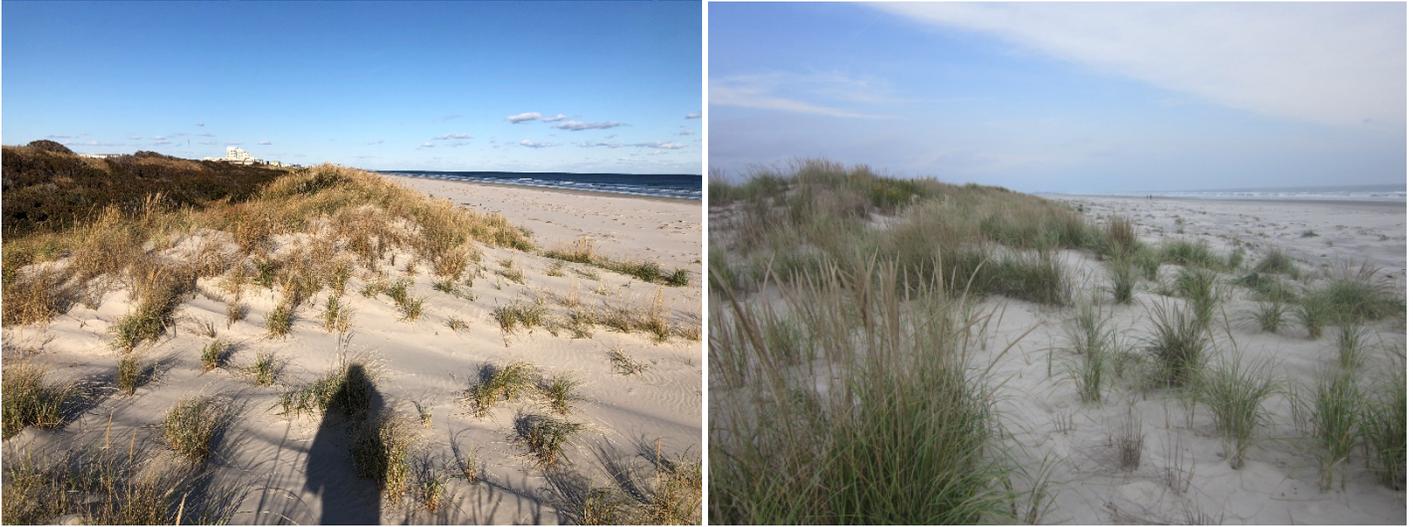
**NJBPN 208 – Cape May National Wildlife Refuge, Lower Township**

The left photo was taken October 4, 2019 and is a view along the foredune crest to the north displaying the gentle shoreward gradient occurring on the wide beach. The right photo was taken on October 28, 2020, and shows improvement in the grass coverage in the foredune area.

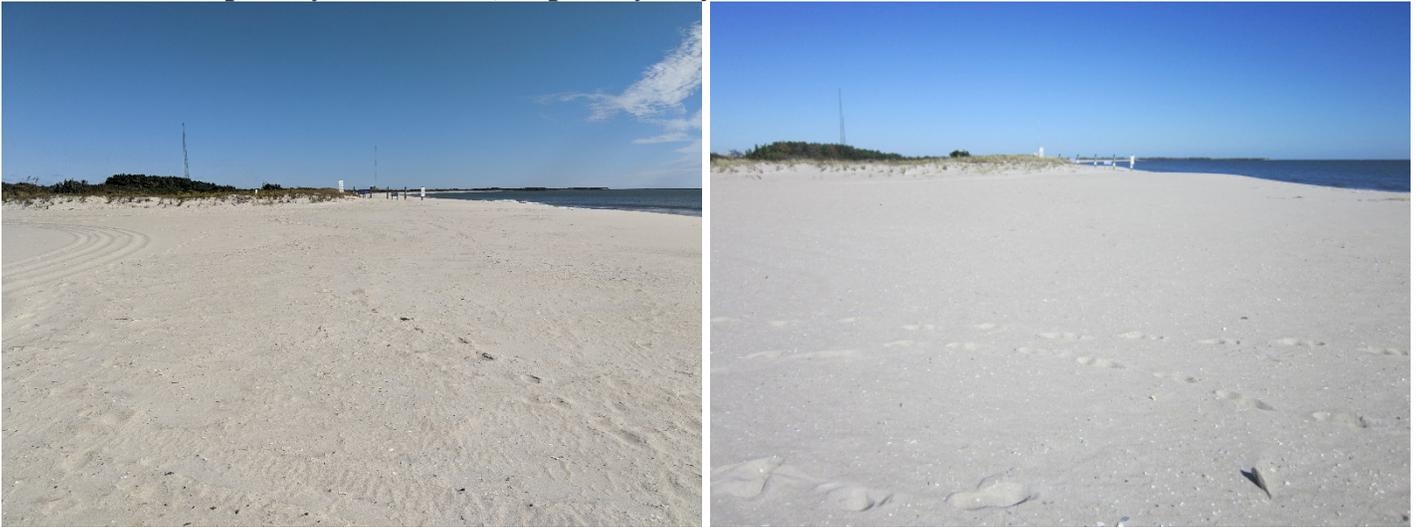
**NJBPN 108 - Cape May Beach Club, Cape May City**

The left photo was taken October 4, 2019. The right photo was taken on November 4, 2020, and in comparison, shows consistency in configuration and beach elevation. The berm did retreat minimally over the 20-month interval.

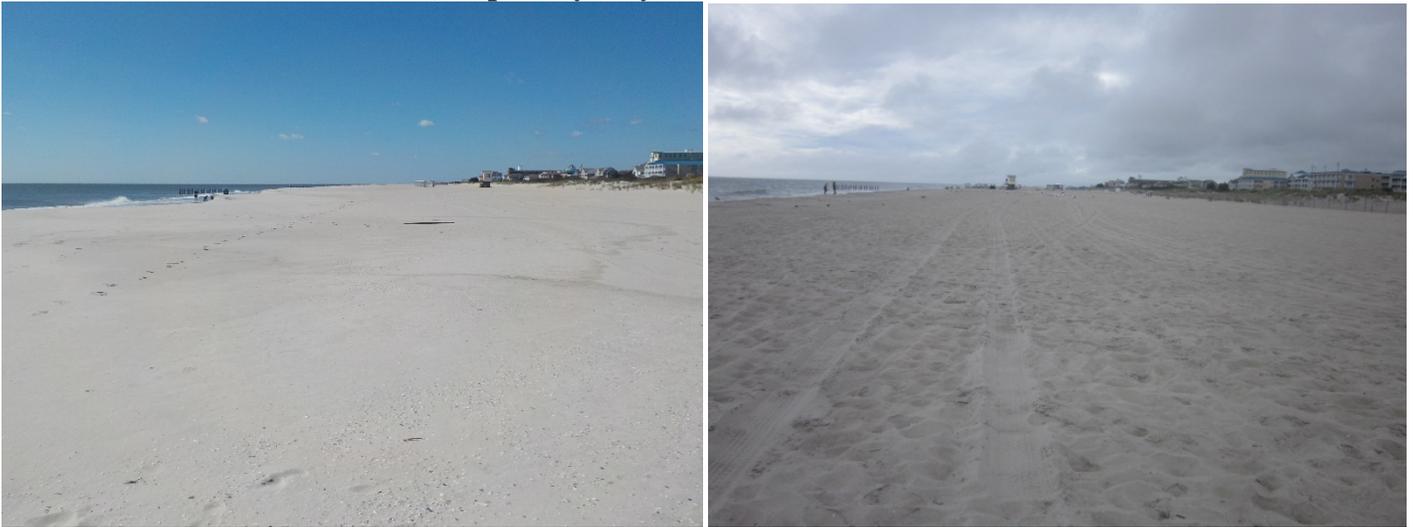
**NJBPN 107 - Baltimore Avenue, Cape May City**

The post-beach restoration is remarkable given that in 1989, the waves broke on the rock seawall at low tide at Baltimore Avenue. The left photo was taken on October 4, 2019. The right photo was taken on September 9, 2020. The September 2020 photo displays a similar beach and berm over the last 18 months.

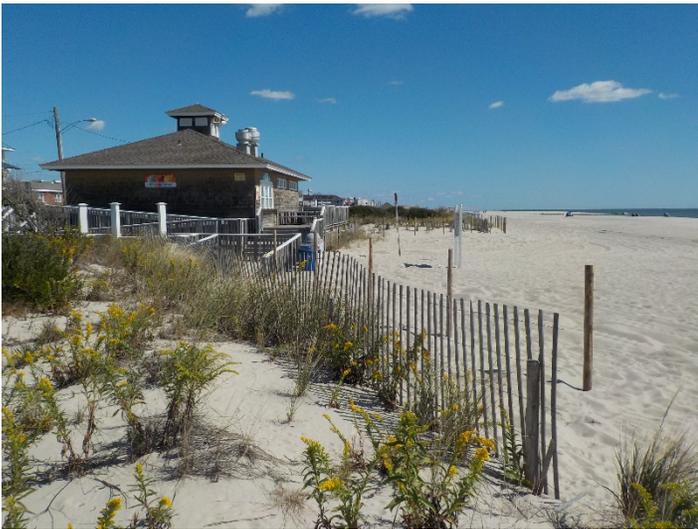
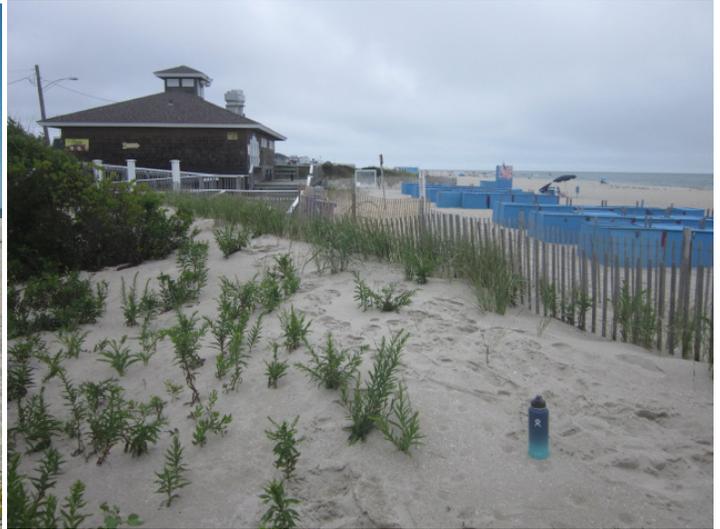
**NJBPN 206 - Broadway Avenue, Cape May City**

The left photo was taken on September 4, 2019. The right photo (206) was taken on September 9, 2020 and shows similar conditions within the dune system. The cross sections below display changes in the berm elevation and position by the fall 2020.

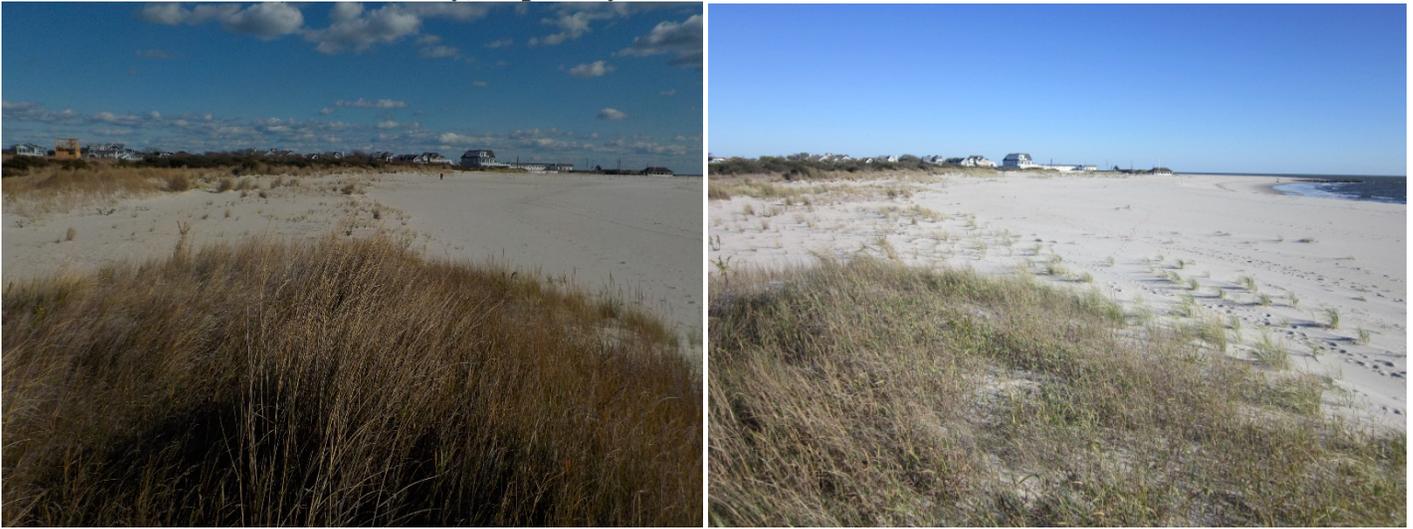
**NJBPN 105 - Nature Conservancy, Cape May**

The left photo was taken November 8, 2019. The right photo taken on November 4, 2020, and shows a slightly wider beach 12 months later. The dune system remained substantial and very stable.

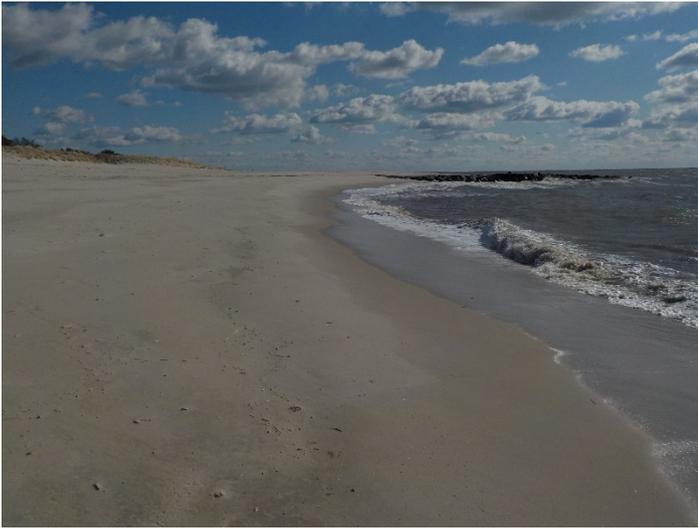
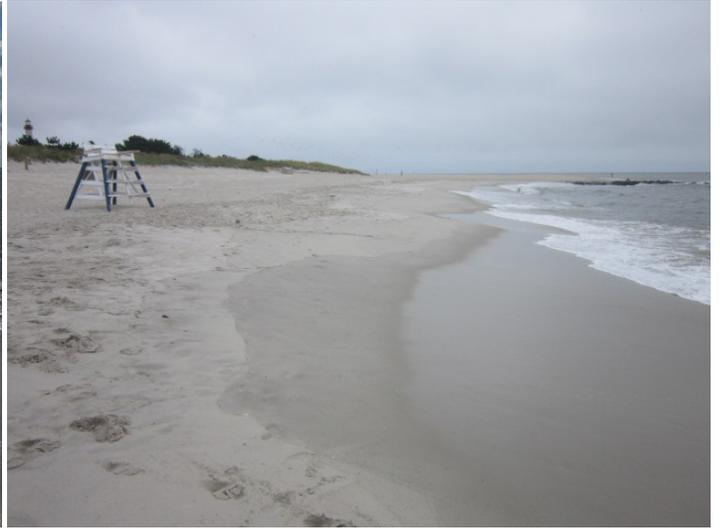
**NJBPN 104 - Lake Drive, Cape May Point**

The left photo was taken on November 8, 2019. The right photo was taken on September 9, 2020. The berm in the right photo is positioned slightly seaward than the photo on the left but at a lower elevation.

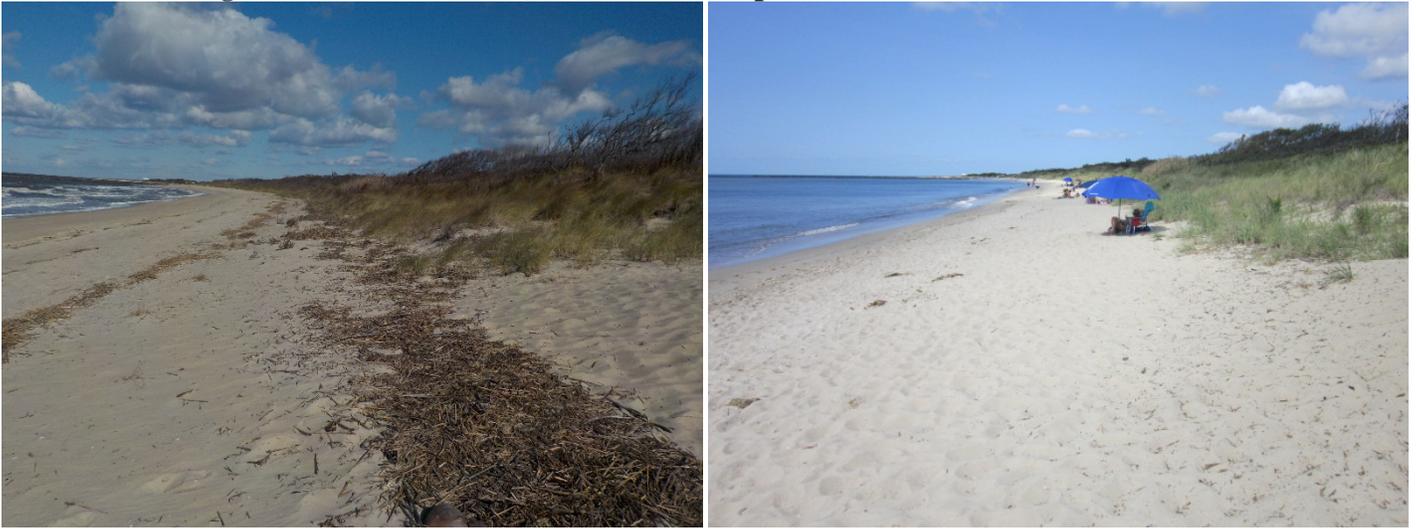
**NJBPN 103 - Higbee Beach State Park, Lower Township**

The left photo was taken November 8, 2019. The right photo taken September 8, 2020, shows minimal changes. Both photographs are looking in the northern direction. Notice the storm and high tide wrack lines in the earlier photo.

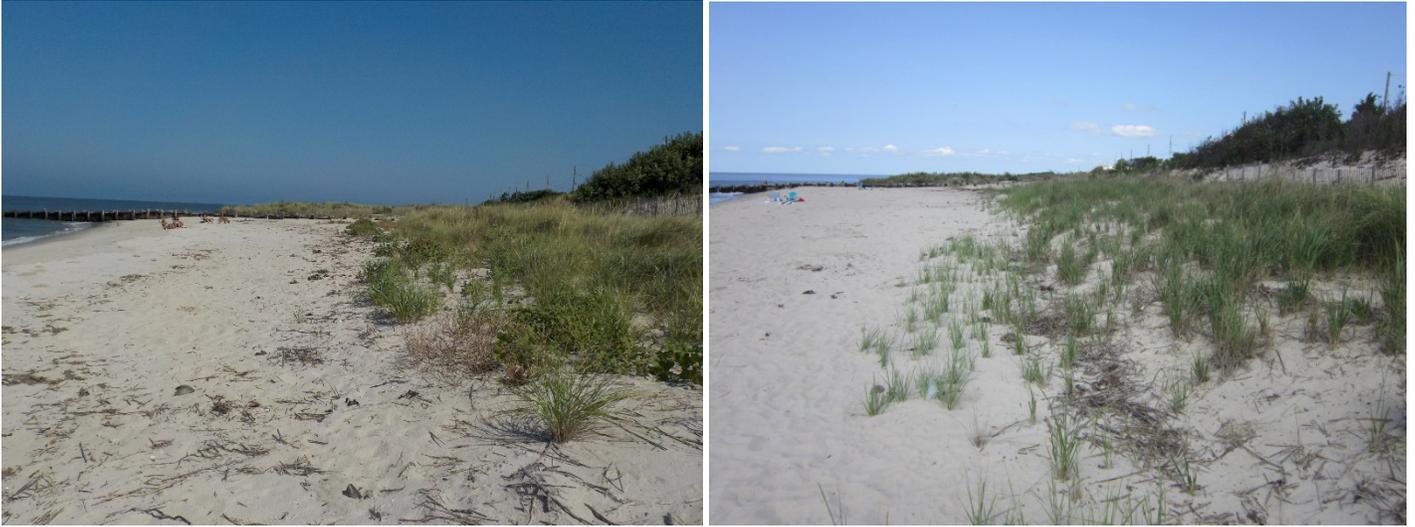
NJBPN 102 - Whittier Avenue, North Cape May

The left photo was taken on September 4, 2019. The right photo, taken on September 8, 2020, shows a continued growth in seaward dune slope. Denser vegetation and a wider recreational beach is present by survey 61.

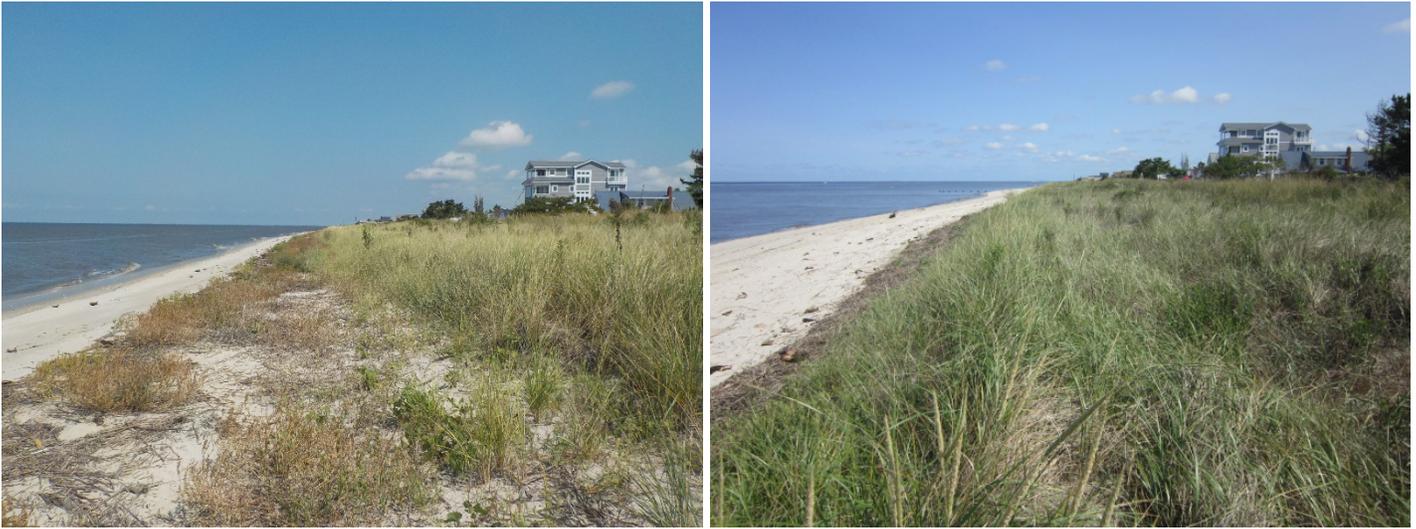
**NJBPN 201 - Pacific Avenue, Villas**

The left view was taken November 13, 2019. Right photo (201) was taken on September 8, 2020. Minimal changes occurred in this photo comparison at Pacific Avenue with only some recession of dune grass growth landward.

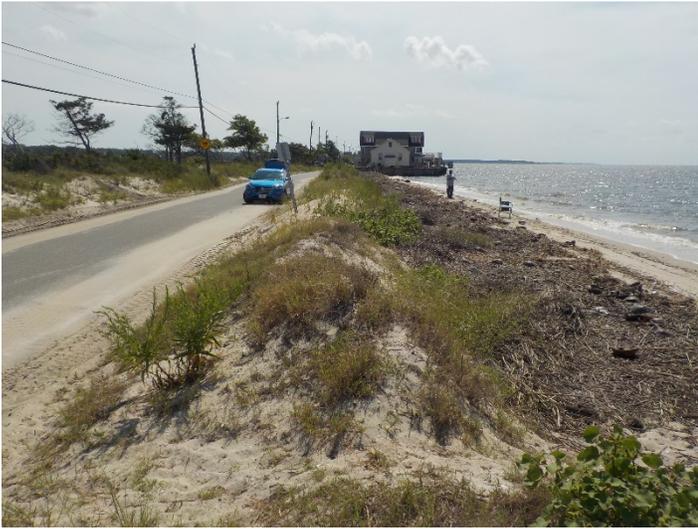
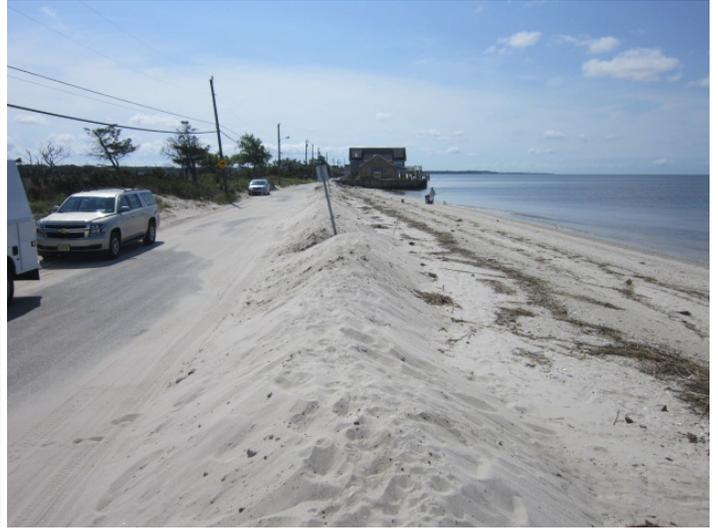
**NJBPN 100 - Reeds Beach, Middle Township**

The left photograph was taken on September 4, 2019 which shows dune grass growth and a noticeable wrack line. The right photo was taken on September 8, 2020. There is a lack of dune grass in the September 2020 photograph and the storm wrack has since been carried away.

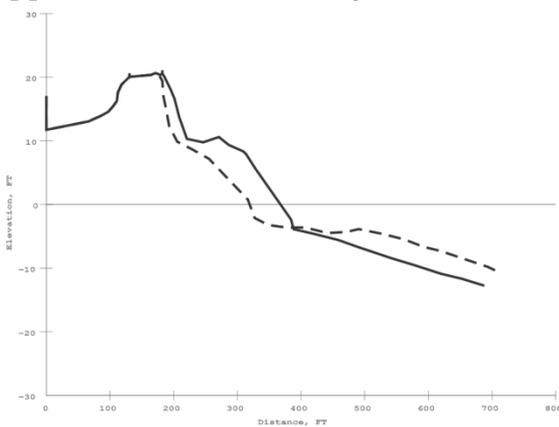
The pair of profiles to the left show typical seasonal beach profile changes. The dashed line profile develops during a winter season, where wave conditions move material offshore. The solid line profile is generated during a summer season, where wave conditions move sand onshore, building a well developed berm and wider beach and adding to the dune. The winter wave conditions shift this beach material to the offshore region of the profile.
