New Jersey Beach Profile Network

Cape May County

**Great Egg Harbor Inlet
to Stow Creek**

**NJBPN Profile #'s
225 - 100**

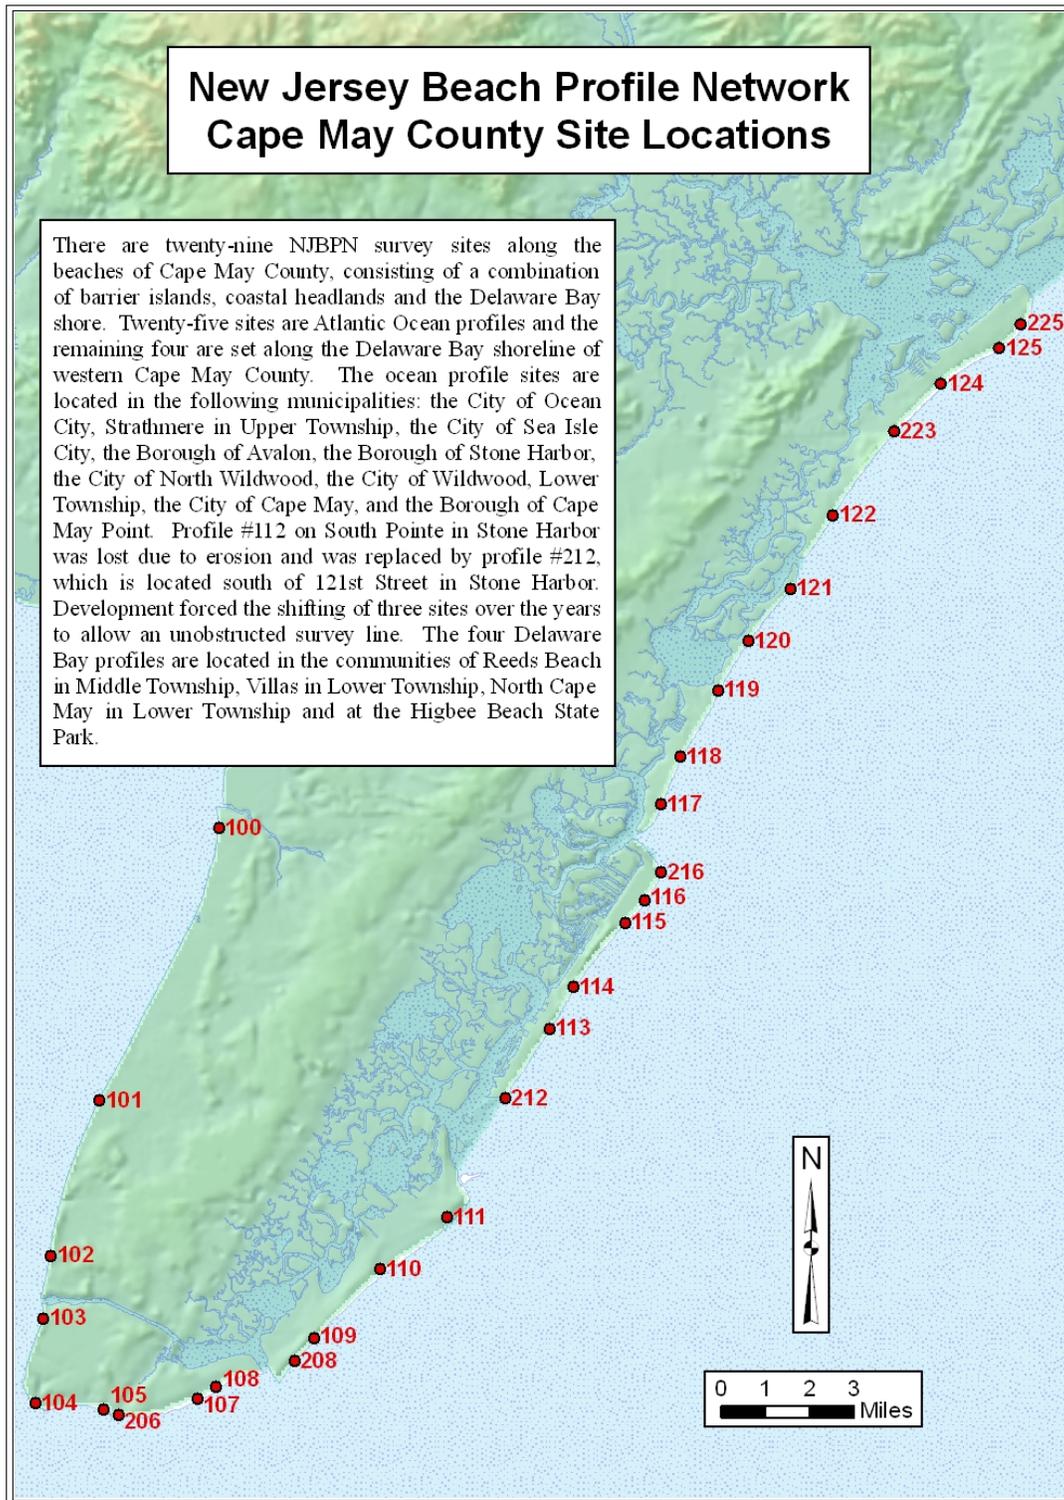
Figure 87. Locations for the 29 NJBPN profile sites in Cape May County, NJ

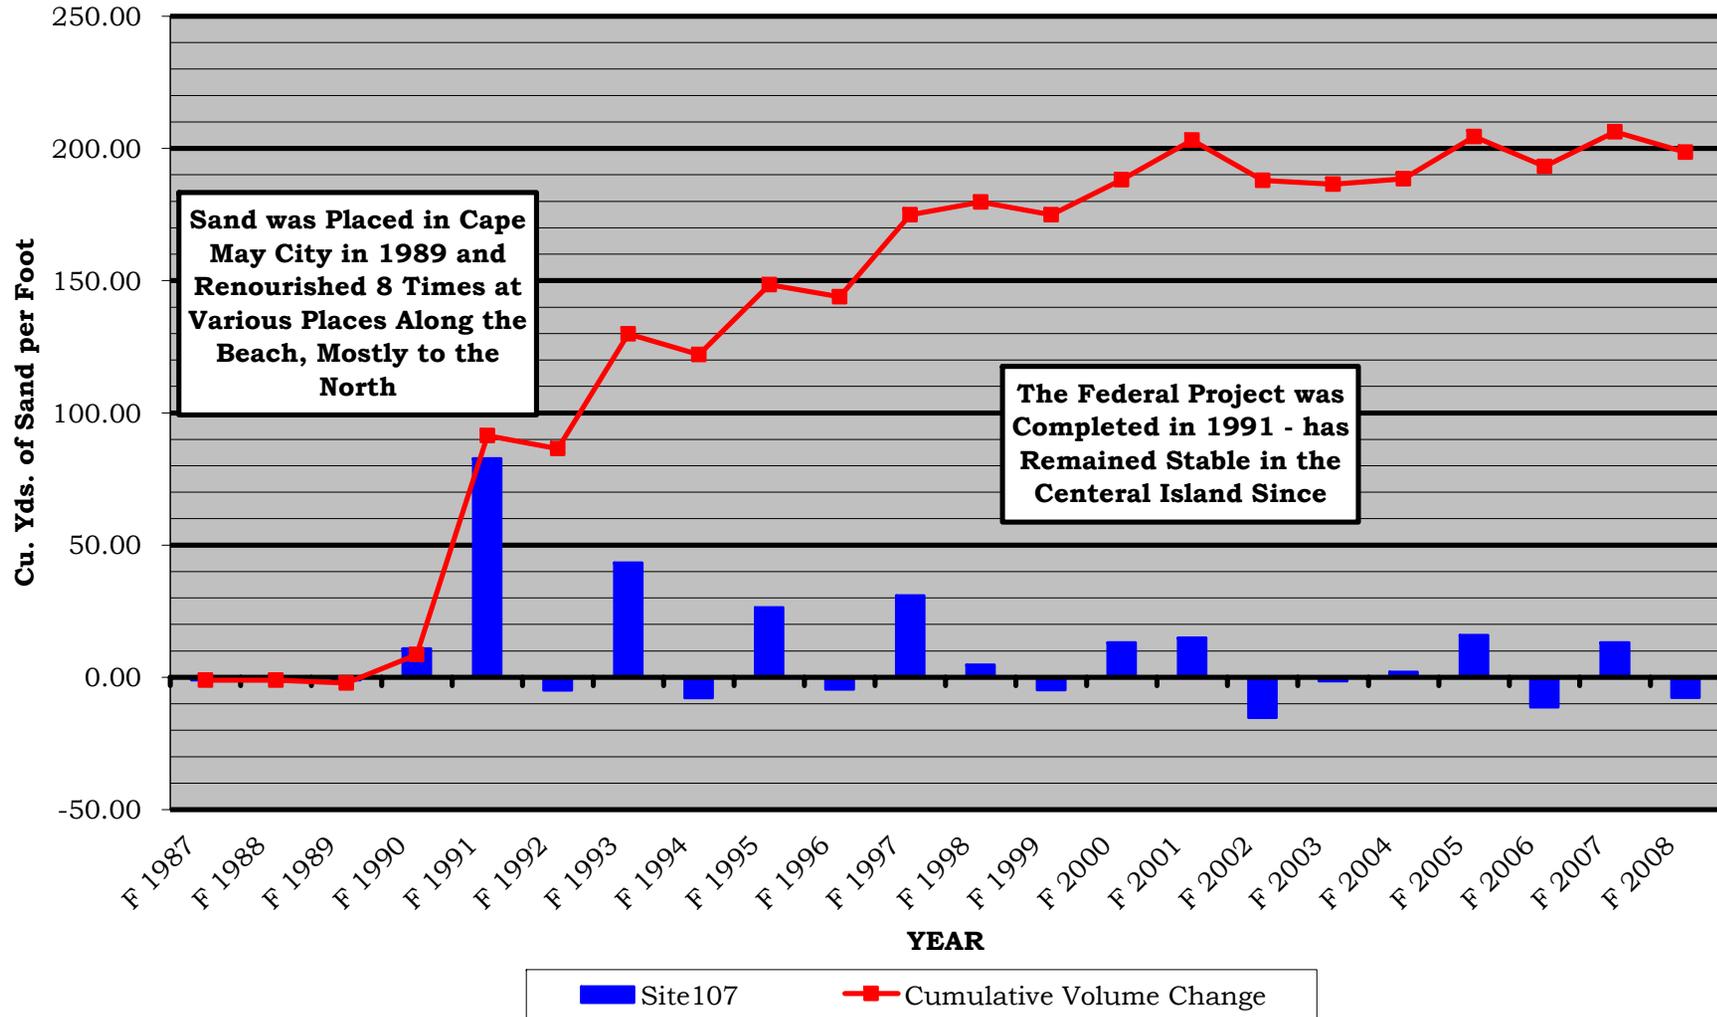
22- Year Sand Volume Changes at Site 107, Baltimore Ave. Cape May City

Figure 89. Beach nourishment was started in Cape May City in 1989 as the initial Federal project in New Jersey. Initially this beach was wet to the rock revetment defending Ocean Avenue along Cape May City. The lack of change was understandable until sand pumping provided sand in 1990 and 1991. There have been 8 maintenance efforts since 1989, each one augmenting the total volume present here. With about 200 yds³/ft. in additional sand volume, the Baltimore Avenue beach is a model for this project.

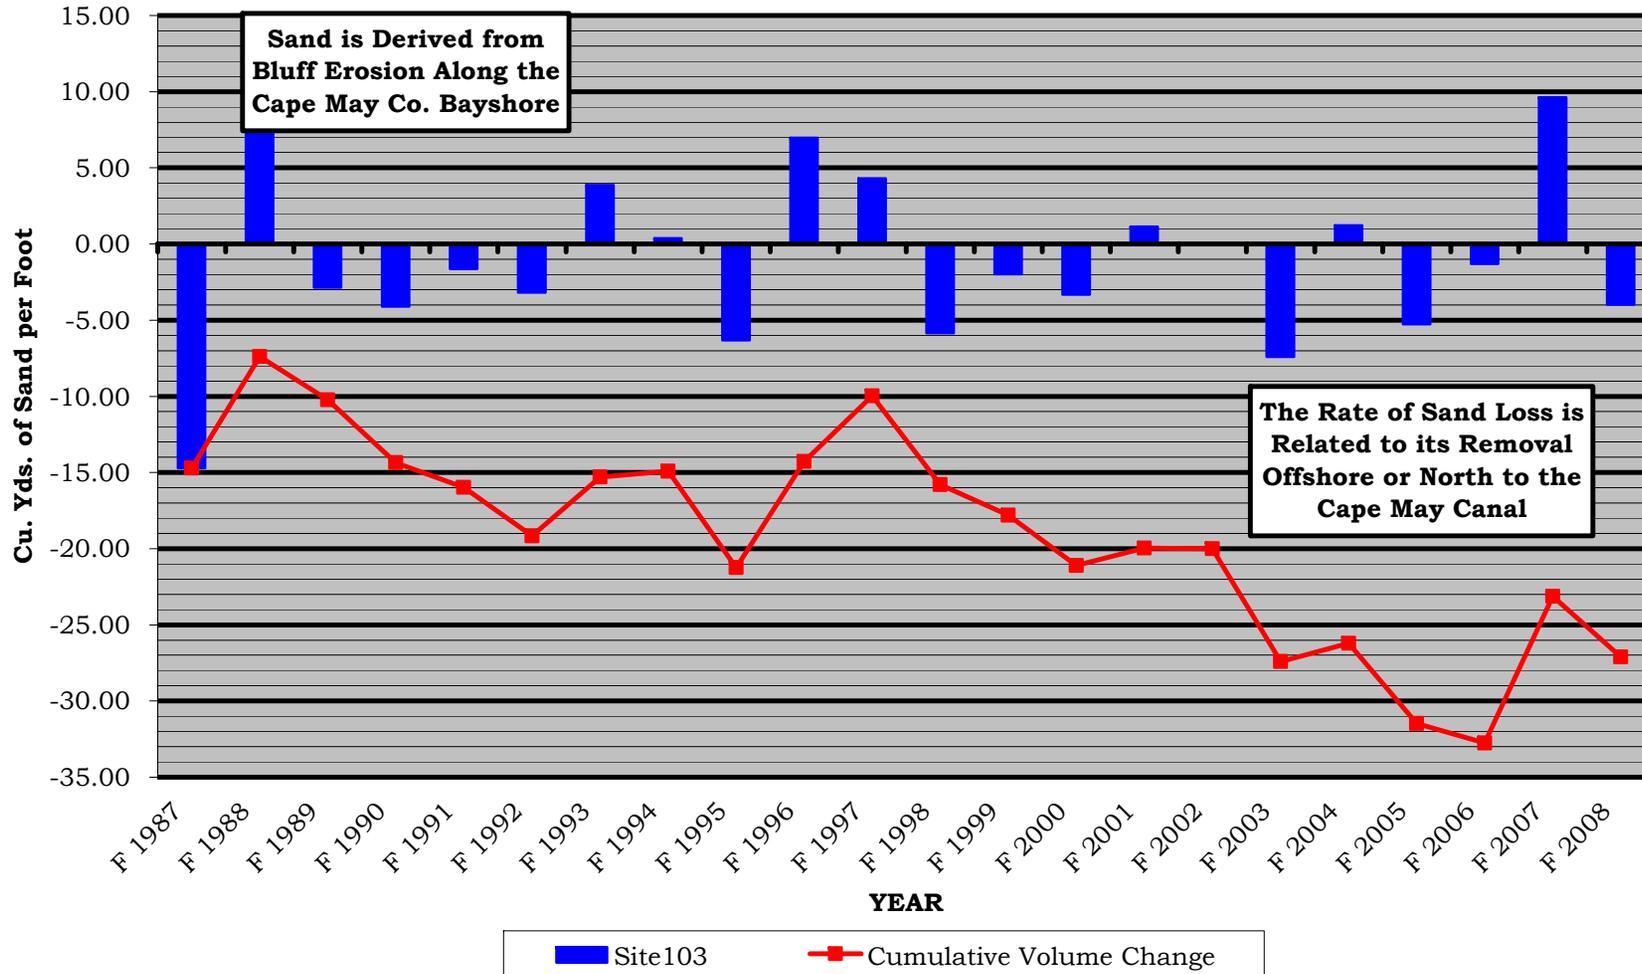
22- Year Sand Volume Changes at Site 103, Higbee Beach, Lower Township

Figure 90. The four sites on Delaware Bay in Cape May County display far smaller changes each year due to the far smaller wave energy available to change things. Higbee Beach is a natural area in the southern part of this western bay shoreline and consists of a sandy vegetated bluff which erodes when storms raise the tide or strong northwest winds at high tide raise big waves on Delaware Bay. The derived sand becomes part of the beach and travels north to the jetties confining the Cape May Canal or moves offshore onto the Delaware Bay floor as a thin layer spread over a several hundred-foot range seaward of the low tide line. It took 21 years to double the initial year's sand loss volume recorded.

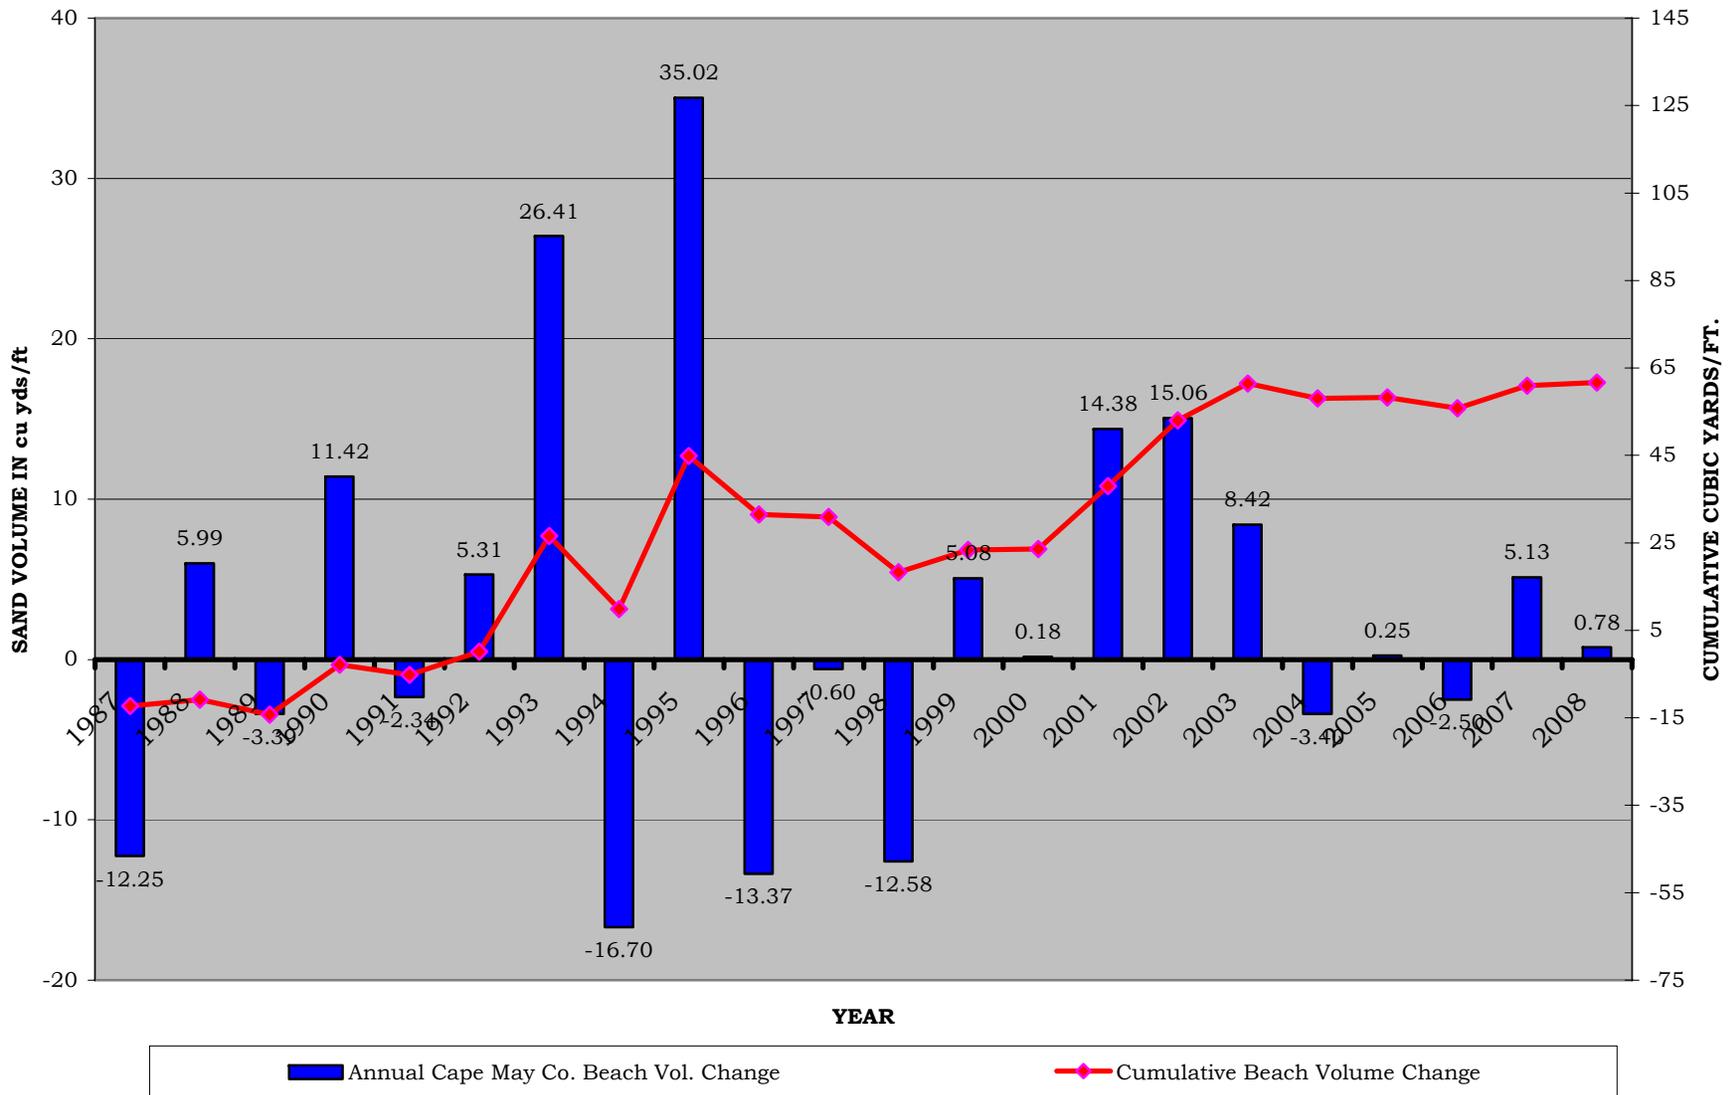
AVERAGE BEACH SAND VOLUME CHANGE for 29 PROFILES in CAPE MAY COUNTY 1987 - 2008

Figure 91. The average sand volume present on Cape May County beaches is clearly associated with the many major projects conducted within the County. Starting in 1889 the communities of Ocean City and Cape May City along with Avalon provided large volumes of sand to the municipal beach. The ACOE is involved in Ocean City, Avalon, Stone Harbor, Cape May City and Cape May Point with the State placing sand in Strathmere in 2001. These projects have produced the rising trend line for the County shoreline.

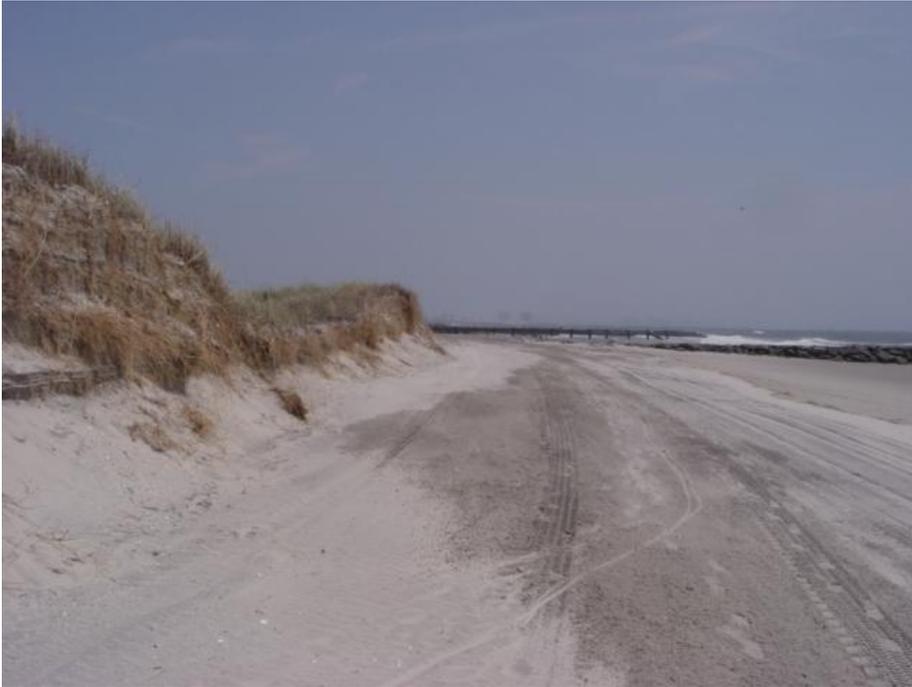
GARDENS ROAD, OCEAN CITY - SITE 225

The Gardens Road site has suffered erosion beginning in 2005 as the sand supply from the northern end of the oceanfront beach receiving beach nourishment periodically declines with time. The last effort was the 4th renourishment done by the ACOE by February 2004 (1.6 million cubic yards). Funding has been absent to continue until the NJ State completed a project in late 2008. This May 16, 2007 photograph shows a vertical scarp with moderate sand slumping as drying occurred between erosional episodes. There is a narrow beach and little tendency to develop a berm.

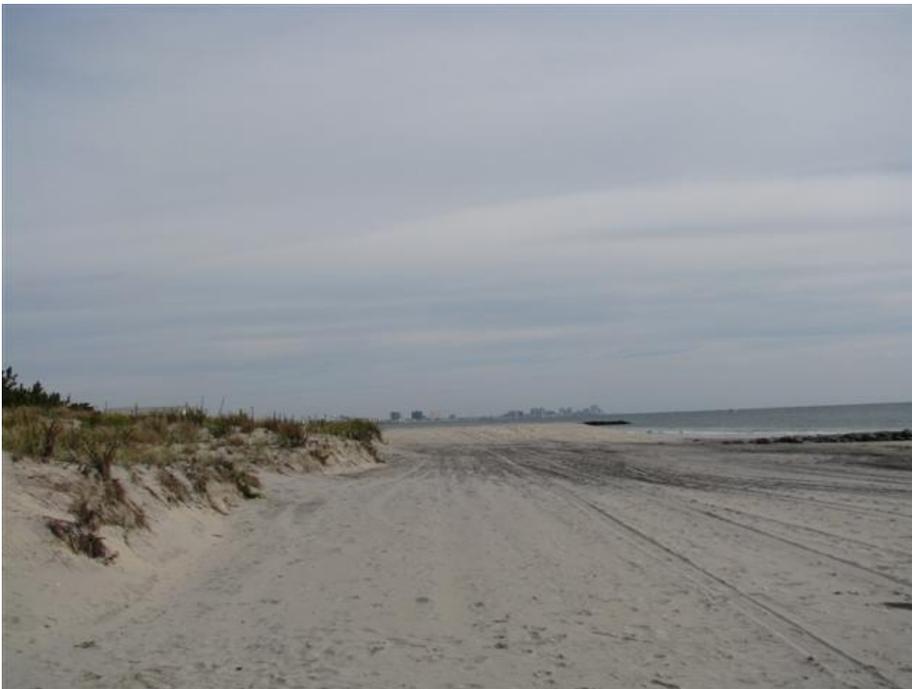
By October 8, 2008 the beach was a little wider, but the scarp was still present in spite of renewed sand placement along the oceanfront in the fall of 2008. The dunes and shoreline are sufficient to protect the development until the shoreline wraps more deeply into the inlet opening. There the homes are built closer to the shoreline and are more vulnerable to inlet coastal erosion. The reaction to the beach nourishment was a 48.32 yds³/ft. sand volume gain by March 6, 2008 as the shoreline advanced 117 feet. The summer produced a 33.33 yds³/ft. sand volume loss as the shoreline retreated 143 feet. This occurred by October 8th.

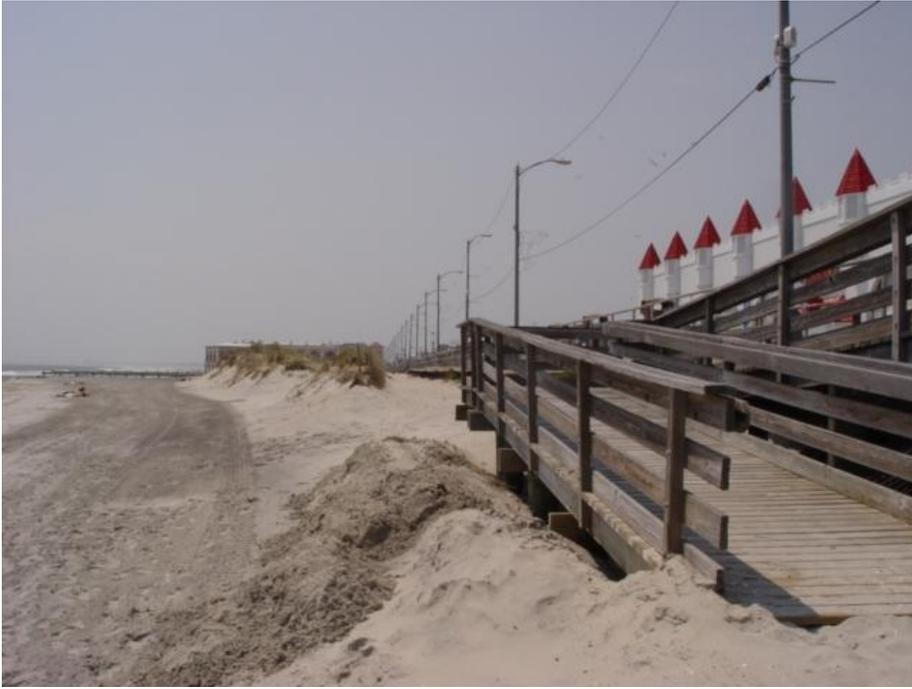
At 6th Street the beach was shrinking in width causing dune erosion by May 16, 2007. The remainder of the dune shows to the south as a remnant left between the beach and the Ocean City boardwalk. The sand volume change was -10.18 yds³/ft. between May and October 2007, followed by the beach replenishment effort.

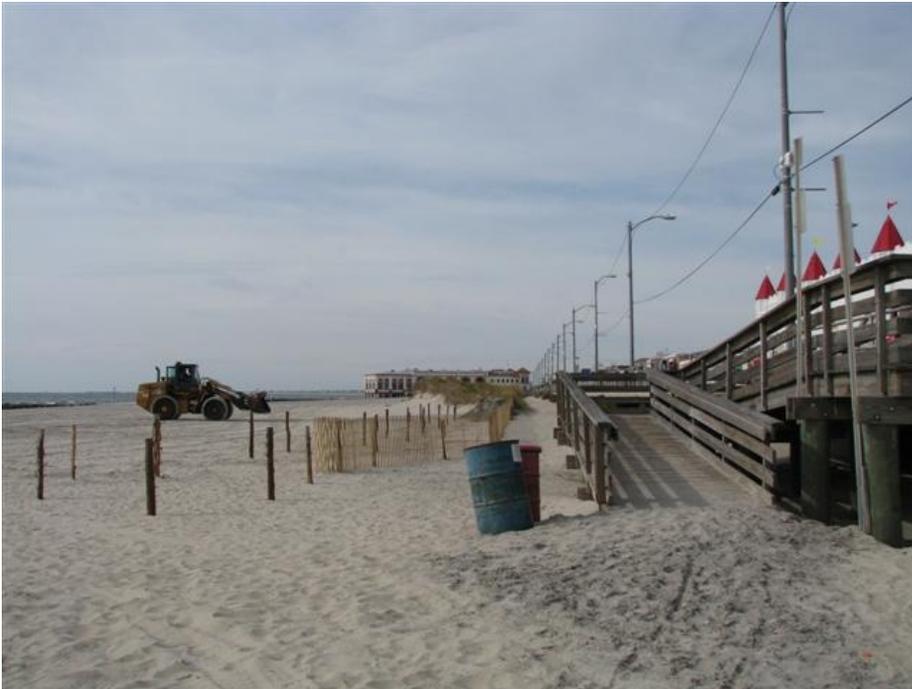
By October 8, 2008 the beach was wider due to a project financed by the State of NJ and the local municipality. This occurred as a result of a lack of Federal funding for the Corps District to continue its maintenance program in Ocean City. The photograph shows the new beach and snow fencing erected to begin the process of rebuilding the dunes in the gap where erosion took all the material. Sand placement produced 119.99 yds³/ft. and a 204-foot shoreline advance by the March 6, 2008 survey and the site lost 21.56 yds³/ft. during the following summer as the shoreline retreated 106 feet. Clearly this location continues as an erosional “hot spot” on Pecks Beach.

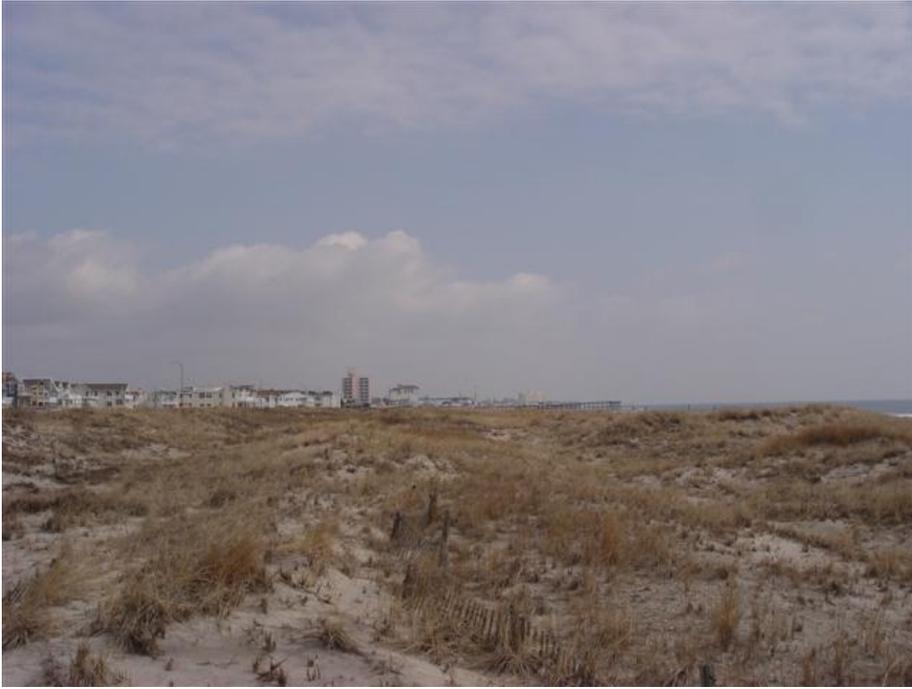
The 20th Street profile is a dramatic example of beach nourishment success. The photograph to the left was taken February 27, 2007 toward the foredune position on the beach. Prior to the 1992 initial construction of this project, the photographer would have been swimming far beyond the limit allowed by life guards. The high tide position was under the boardwalk some 400 feet westward.

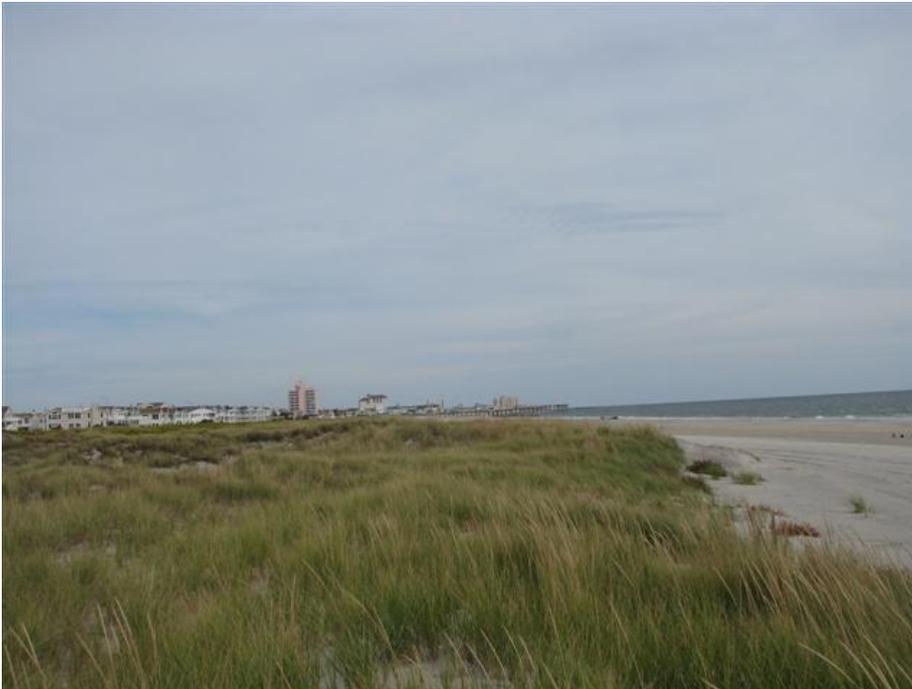
The October 8, 2008 shot was closer to the beach and shows the summer grass growth and the gradational transition to the dry beach. The homes barely show in the distance to the left of the photograph 16 years following the initial nourishment. The added sand has come from the losses seen north of 12th Street in Ocean City. The 18-month study found a 2.23 yds³/ft. sand volume loss with a 16-foot shoreline advance.

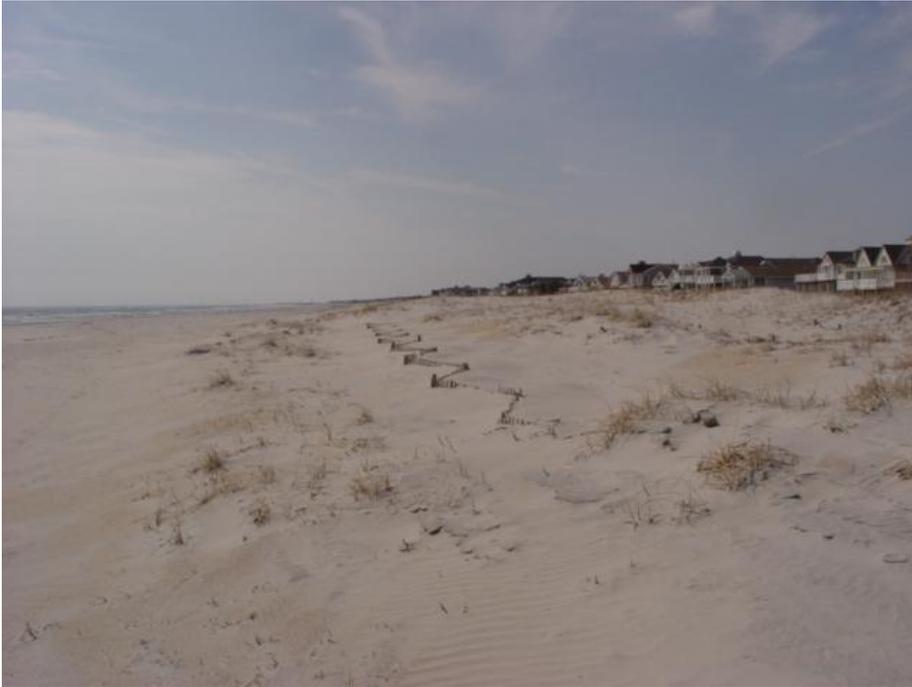
34th STREET, OCEAN CITY - SITE 223

The Federal portion of the Ocean City beach restoration ends at 34th Street. A State-local project completed the work south to 59th Street showed in this March 27, 2007 view. This site was shifted south to cover the growth in the dune since the dune is not present at the street end because it is an emergency vehicle entrance to the beach. Note the essentially buried snow fencing at the seaward edge of the dune.

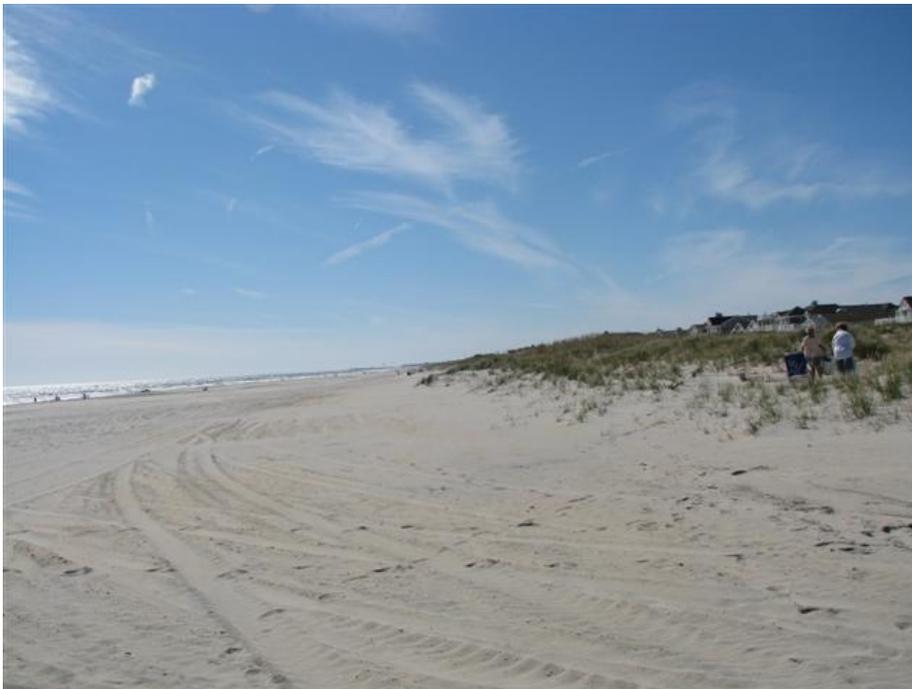
By October 10, 2008 the grass had migrated across the buried fence and colonized the dune to the toe at the dry beach berm. This site is much wider due to the nourishment activities than it was prior to 1995 when the State portion was completed. Modest change occurred as 6.73 yds³/ft. of sand were added to the beach, but only a foot of shoreline position change occurred seaward.

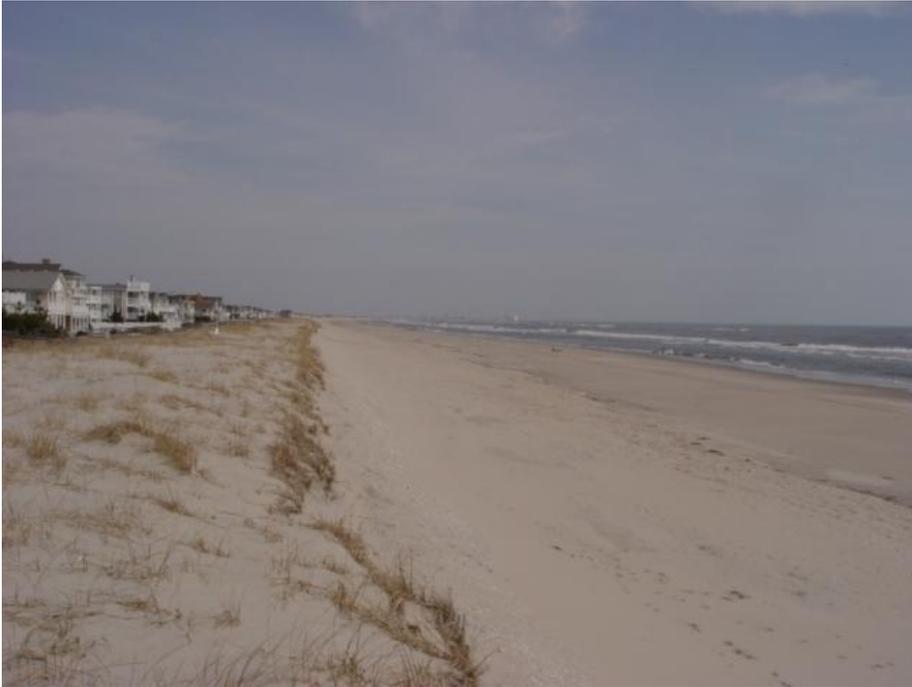
56th STREET, OCEAN CITY - SITE 122

The southern part of the developed part of Ocean City has a narrower beach, but a substantial dune shown here as of March 27, 2007. The slow erosion has reduced the initial 1995 beach width to the point where restoration is presently working through the permitting process. The State will maintain this section of the beach for the first time since 1995.

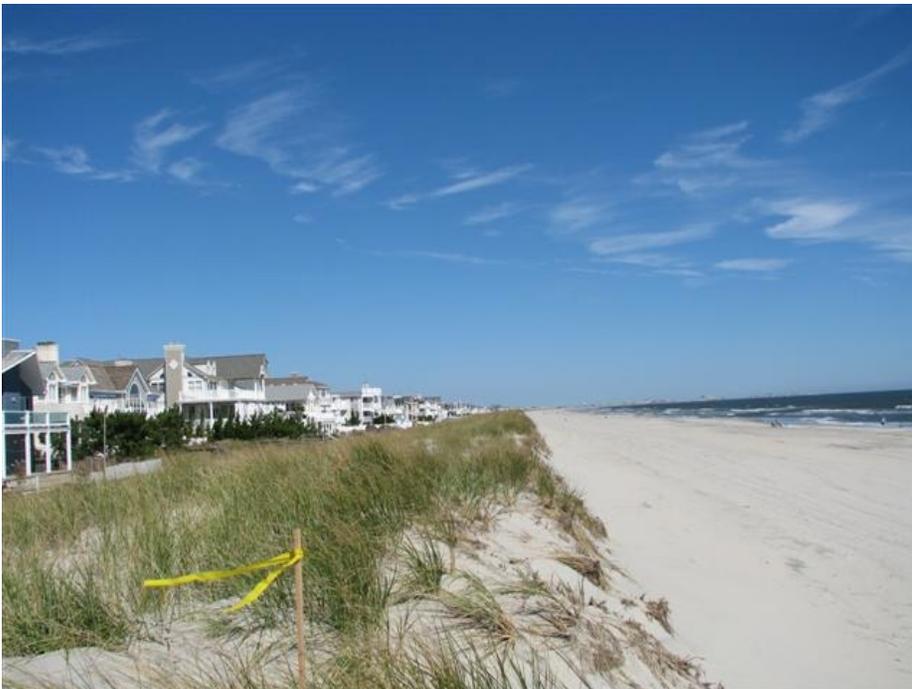
By October 10, 2008 grass growth has made the dune look more impressive, but the width and height is substantially the same. The beach is stable if narrow. The sand volume confirms this observation (-0.56 yds³/ft. with a 2-foot advance in the shoreline).

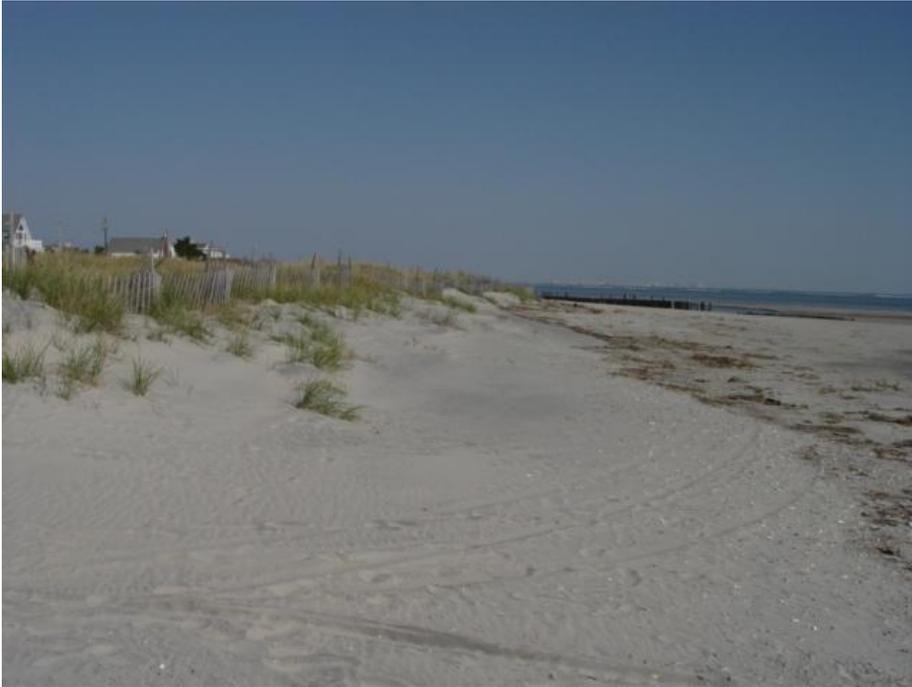
WILLIAMS ROAD, STRATHMERE - SITE 121

The beach at Williams Road was still wide enough to prevent dune erosion by high tides November 5, 2007. The issues that plagued the local municipality during 2008 were just beginning to appear. North of the groin that just barely shows down the beach erosion was carving away at the sand from that point to the inlet.

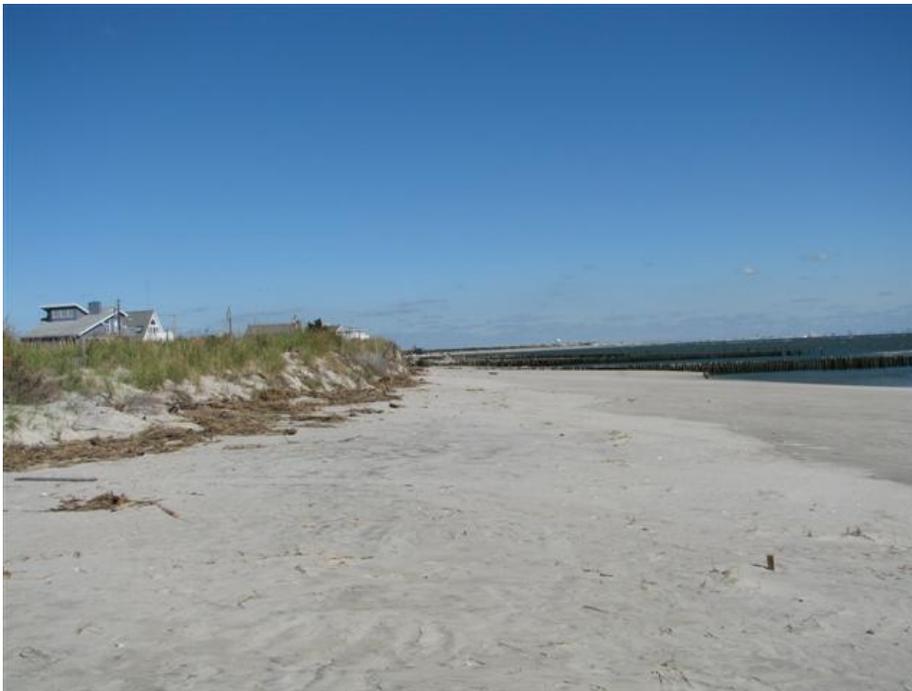
By October 22, 2008 the loss was beginning to affect this site as well. Note that the dune is scarped and the debris is pushed up against the dune toe where it lay out on the beach a year earlier. Normal high tide is still coming short of the dune toe, but any sort of tide elevation enhancement allows the waves to reach the dune. Note that far more of the old timber groin is exposed in the distance. Serious loss occurred during the winter 2007 to 2008, (-86.92 yds³/ft.) but recovery restored nearly all the loss by the fall 2008 survey (-13.69 yds³/ft. in decreased sand volume, but a 160-foot advance seaward in the shoreline).

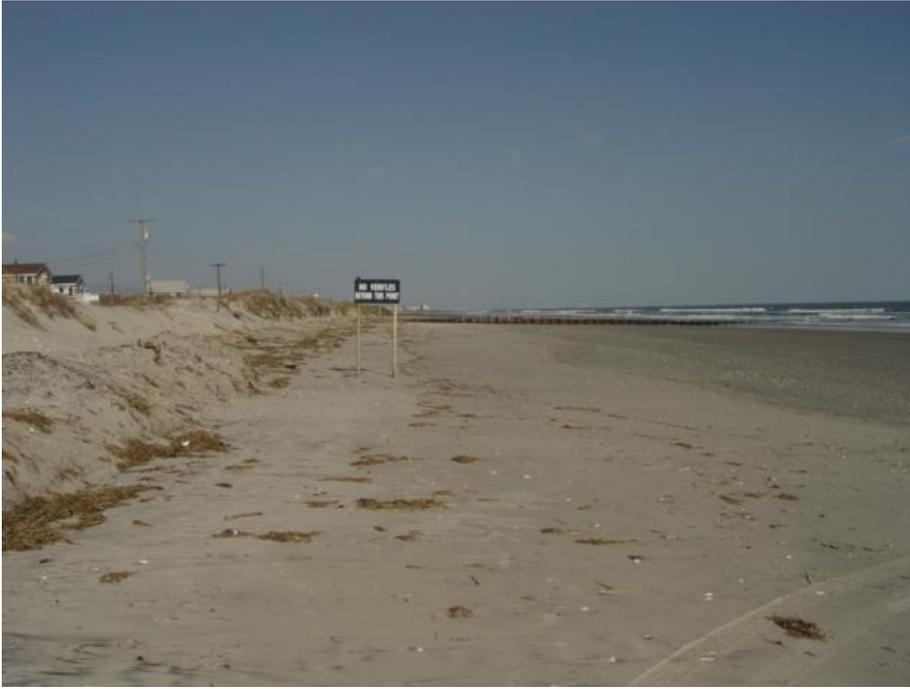
1st STREET, SEA ISLE CITY - SITE 120

This central island location has a sand starvation problem that shows in the narrow beach, low, narrow dune where the tide reaches the dune almost every day. The photograph was taken November 5, 2007 during relatively calm weather and the beach was entirely wet during the previous high tide. There is a 10-foot diameter geo-tube located in the dune that is exposed to the south, but not right at the profile cross section or to the north.

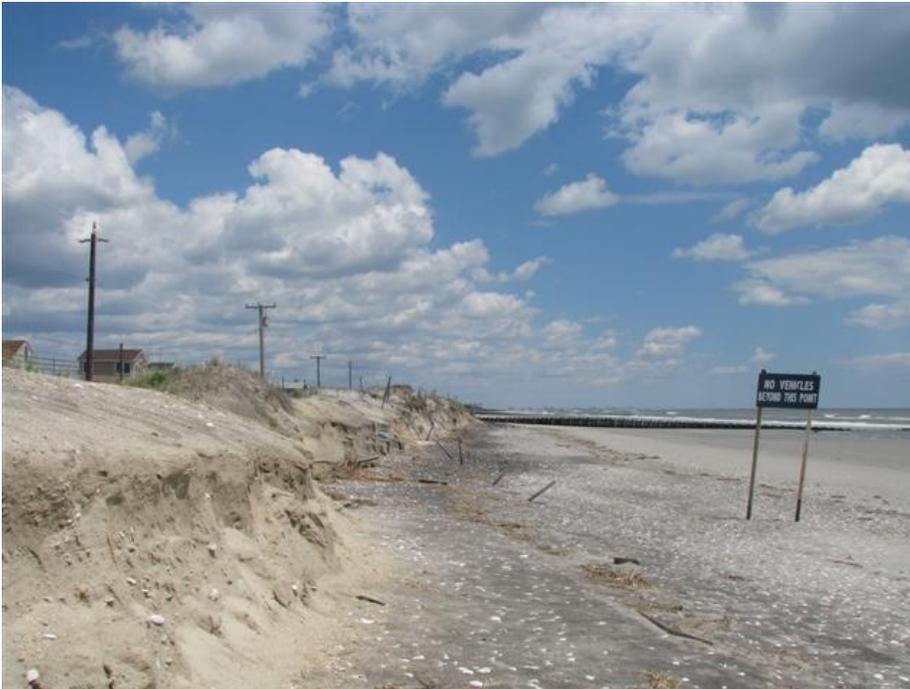
Conditions were slightly better by May 19, 2008, but only with a 20-foot wide buffer between the last high tide and the dune toe. The lack of serious storms have allowed this site to remain undamaged. The sand volume increased 10.53 yds³/ft., but the shoreline retreated 44 feet. over the 18-month interval.

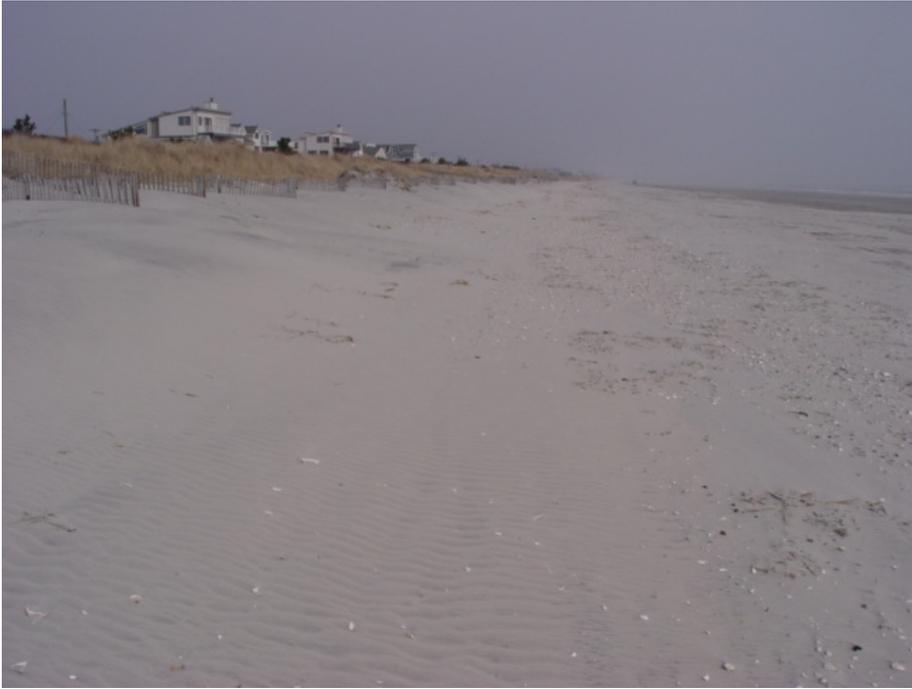
Conditions improved in terms of beach elevation, width and dune dimensions further south in Sea Isle City. This March 15, 2007 photograph shows the beach and dune with sufficient width to preclude wave impact on the dunes.

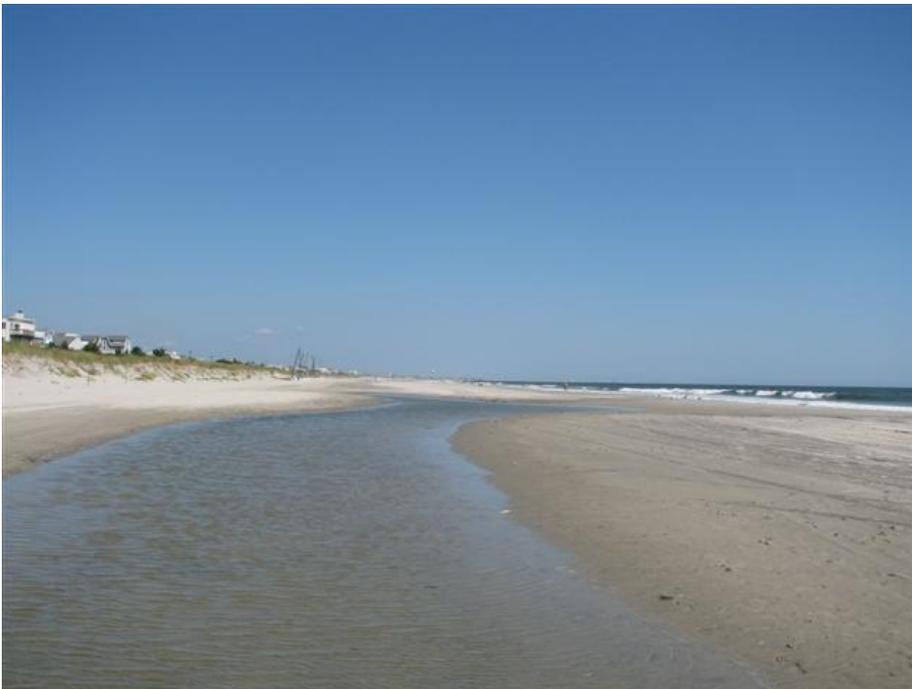
In September 18, 2008 the beach was recovering as the offshore sand bar was welding to the beach. The trough shown is termed a “runnel” and the sand seaward is the “ridge”. This is the climax of summer accretion as the sand in the bar migrates onto the beach. The sand volume decreased by 9.49 yds³/ft. and the shoreline retreated 14 feet.

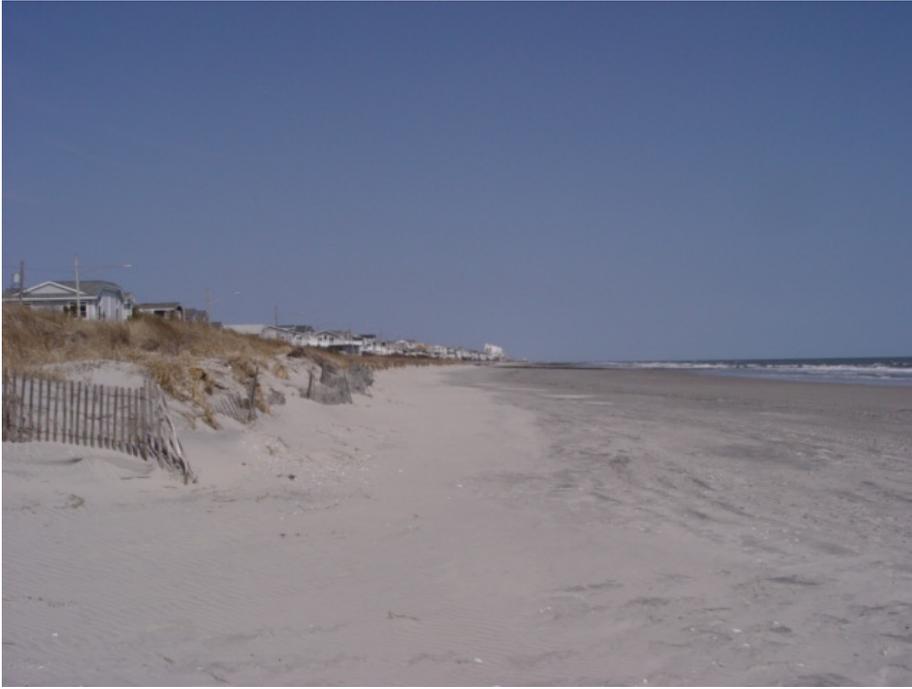
The heavy-use section of the Sea Isle City beach remains reasonably stable with a dune between the promenade and the beach. The March 21, 2007 photograph shows the beach at the dune toe following the winter storm events.

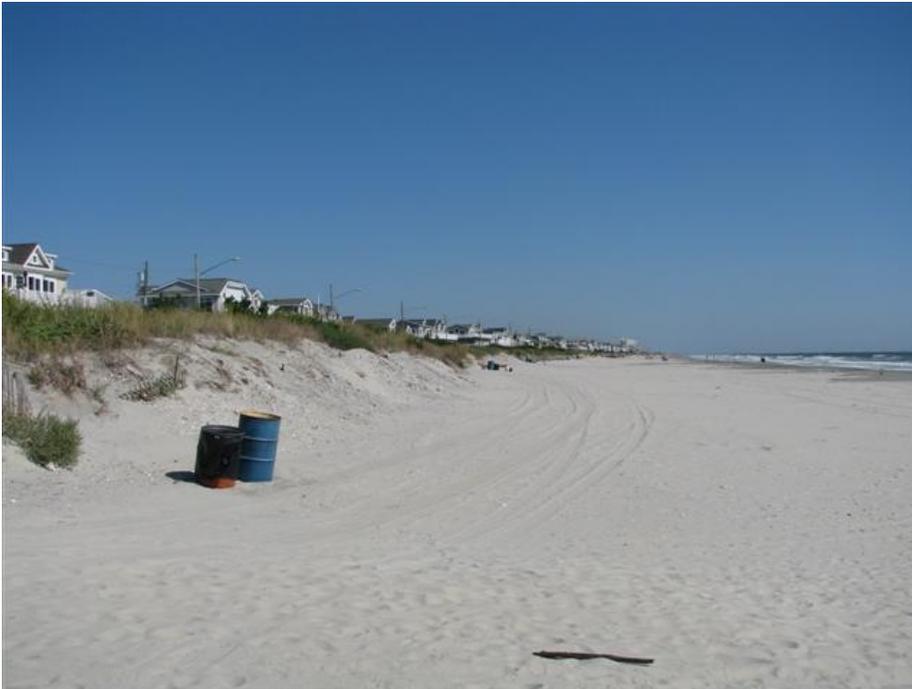
By September 18, 2008 a wider dry beach is present as sand moved onto the shoreline. The dune toe is still about the same with minor additions to the seaward slope. Substantial sand accumulation occurred on the beach as $41.89 \text{ yds}^3/\text{ft.}$ was added to the sand volume and the shoreline advanced 87 feet without any new sand added to the system from human activity.

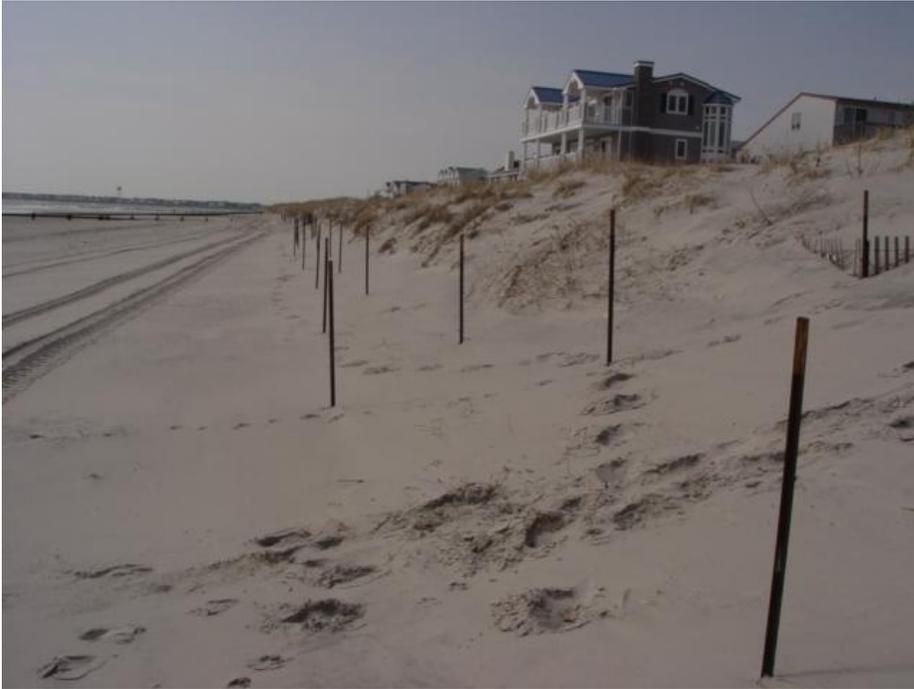
The southern segment of Sea Isle City was slightly impacted with dune scarping in March 27th 2007. The fencing was torn from the posts leaving the steel posts sticking up out of the sand.

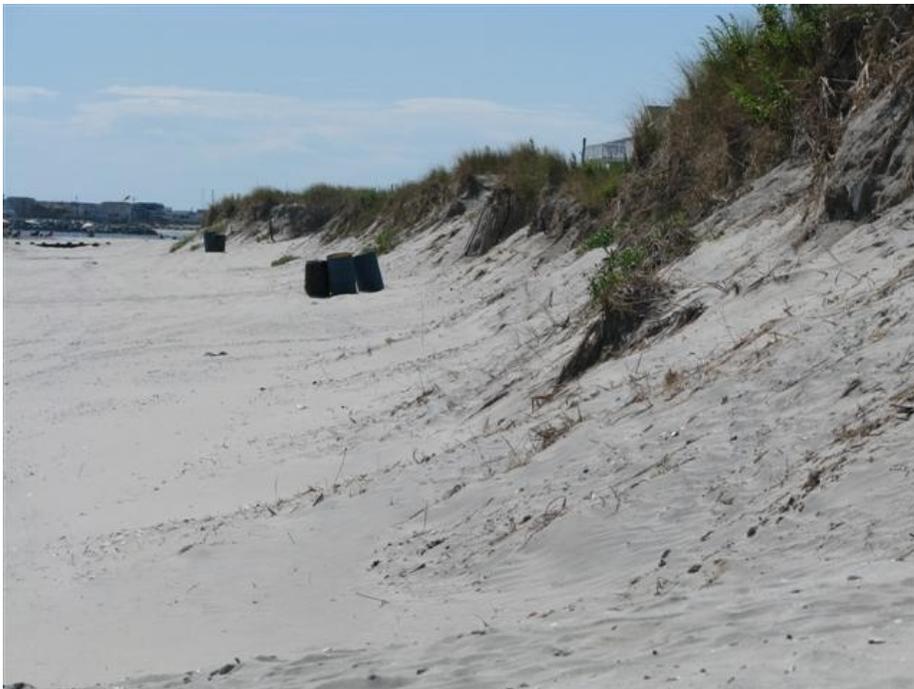
By September 15, 2008 the results from the May 12, 2008 northeast storm are evident in the sharp rise in the dune toe slope. The storm was relatively minor, but reached the dune toe in many places with narrow beaches. The shoreline advanced 11 feet, but the sand volume decreased by 6.64 yds³/ft.

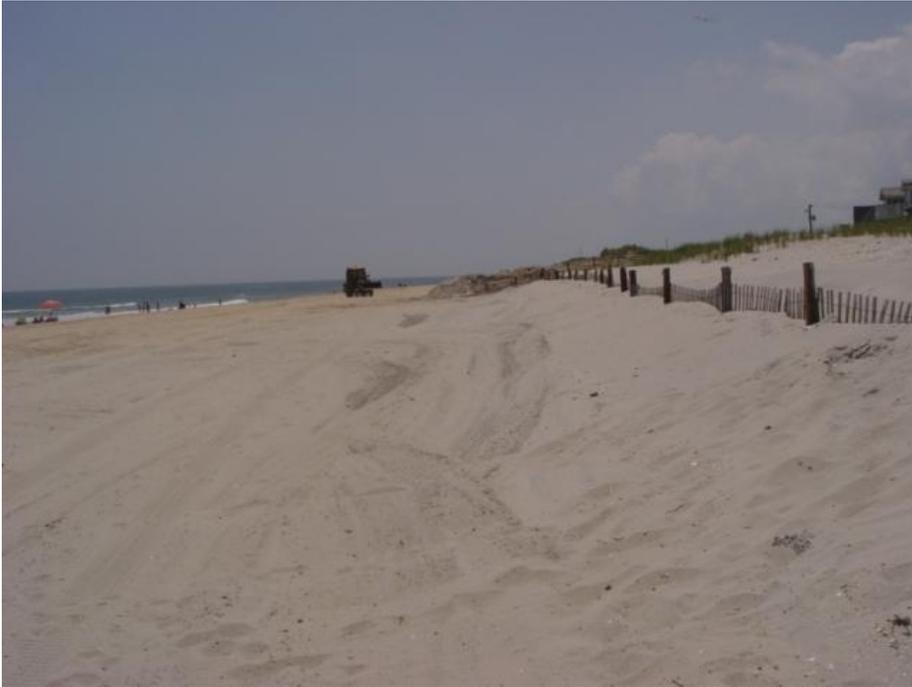
9th STREET, AVALON - SITE 216

The June 11, 2007 survey followed the completion of truck hauling about 80,000 cubic yards of quarry sand to the beach between 10th and 17th Streets. The slight yellow cast to the dry beach is the clue that this occurred.
