New Jersey Beach Profile Network

Cape May County

**Great Egg Harbor Inlet
to Stow Creek**

**NJBPN Profile #'s
225 - 100**

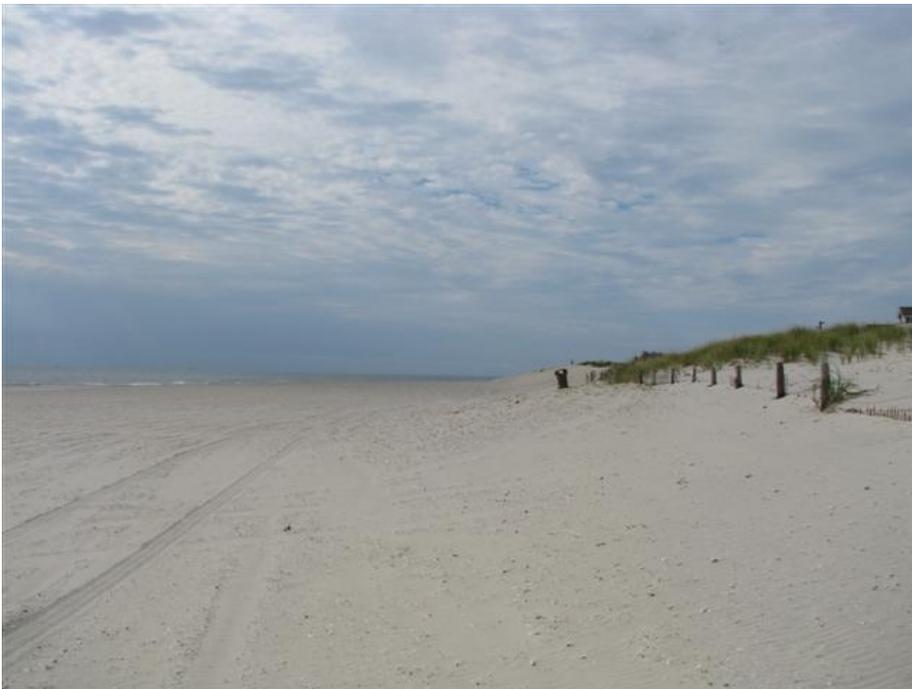
By September 16, 2008 the beach was significantly wider following the hydraulic pumping of 242,637 cubic yards of sand from Townsend's Inlet onto the shoreline between 10th and 18th Streets. This provided a successful summer recreational season for the Avalon citizens. 2007 saw losses during that summer and winter, but sand replacement added 53.68 yds³/ft. of sand by the December 17, 2008 survey date. The shoreline advanced 125 feet as well.

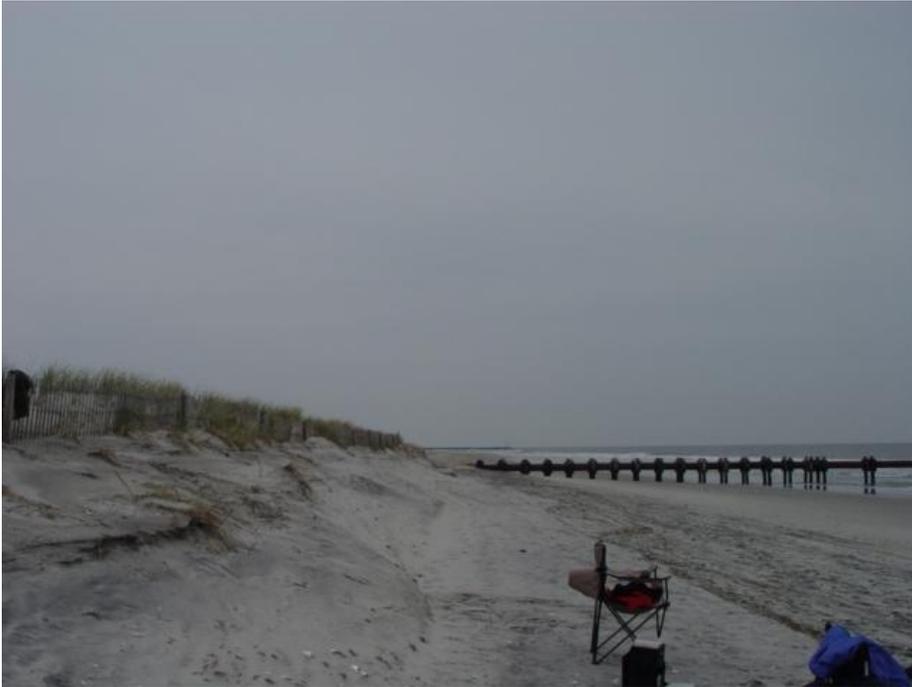
23rd STREET, AVALON - SITE 116

the beach on November 12, 2007 showed significant narrowing as the high tide line was approaching the toe of the dunes. The berm was reduced as the wet/dry line in the picture shows.

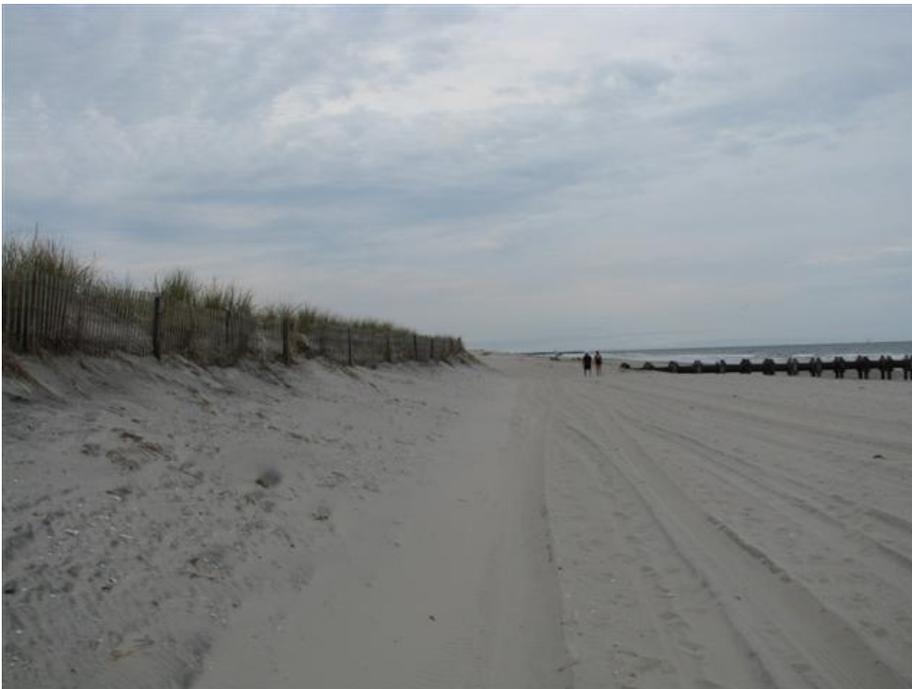
By September 16, 2008 some accretion had returned a dry beach berm as the height of the supports to the storm water outfall line show in the distance when compared to the earlier picture. The dune toe slope is uniform and has traces of wind transported sand spread across it. Following the various efforts at beach augmentation further north, the net result here was a 1.43 yds³/ft. increase in sand volume with a 14-foot shoreline retreat.

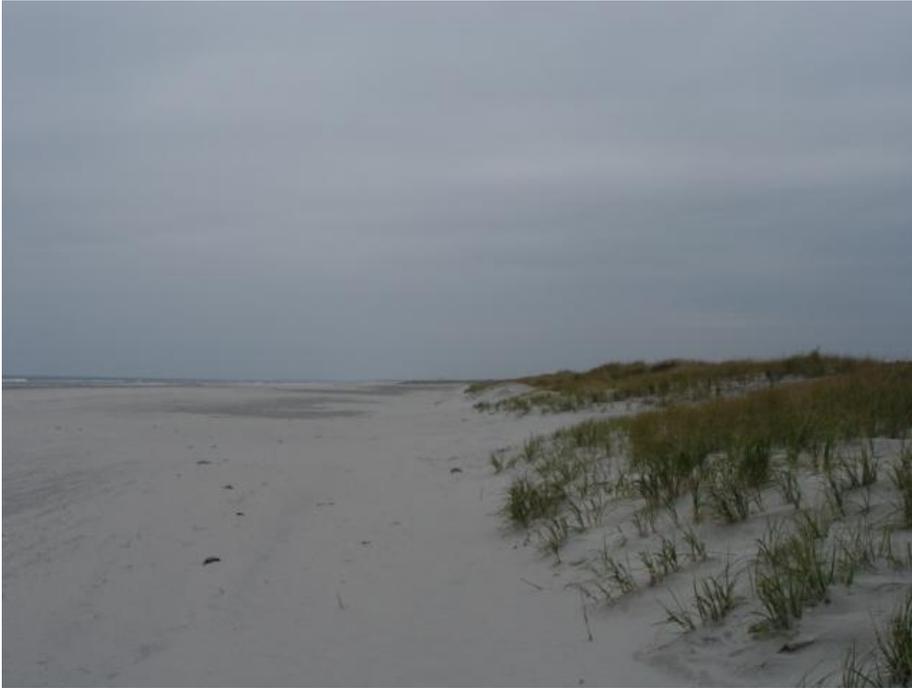
South of 28th Street the Avalon beach becomes wide and the dune system grows to be the largest anywhere along the NJ shoreline. With elevations reaching 55 feet and a width between the dune toe and the development exceeding 1,000 feet there is no better protection along the coast. The fortuitous accident leading to public ownership of the majority of the dune area between 32rd and 56th Streets is a major bonus to the Borough of Avalon. In November 12, 2007 the dune toe was 235 feet from the thigh tide line at 35th Street with a beach that reached the horizon.

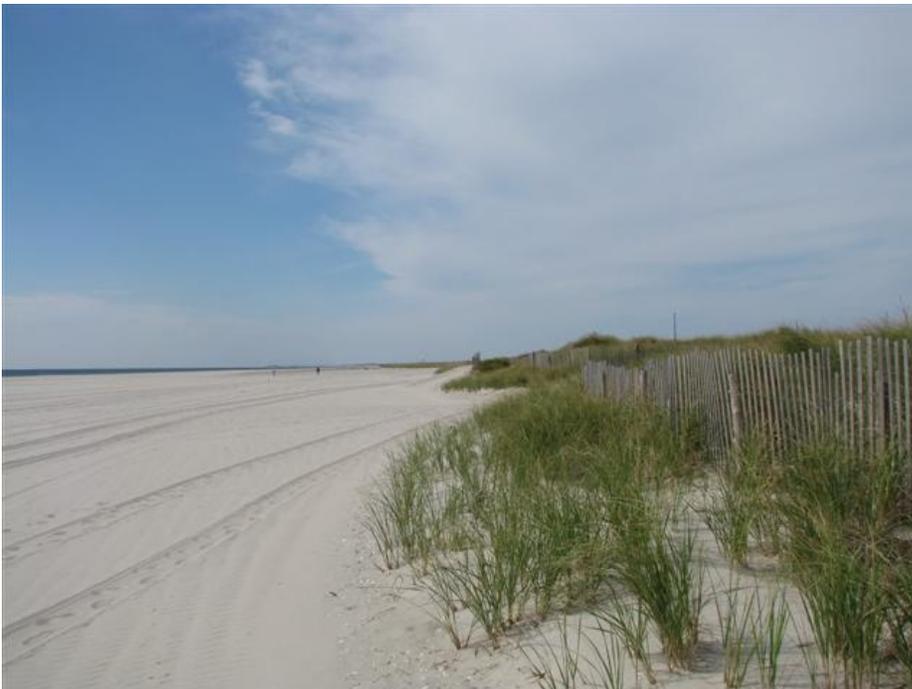
By September 17, 2008 the grass was a bit more lush and had moved slightly seaward onto the dry sand. The beach and dune system was essentially the same adding modest quantities of material. The sand volume increased 10.51 yds³/ft. as the shoreline advanced 39 feet.

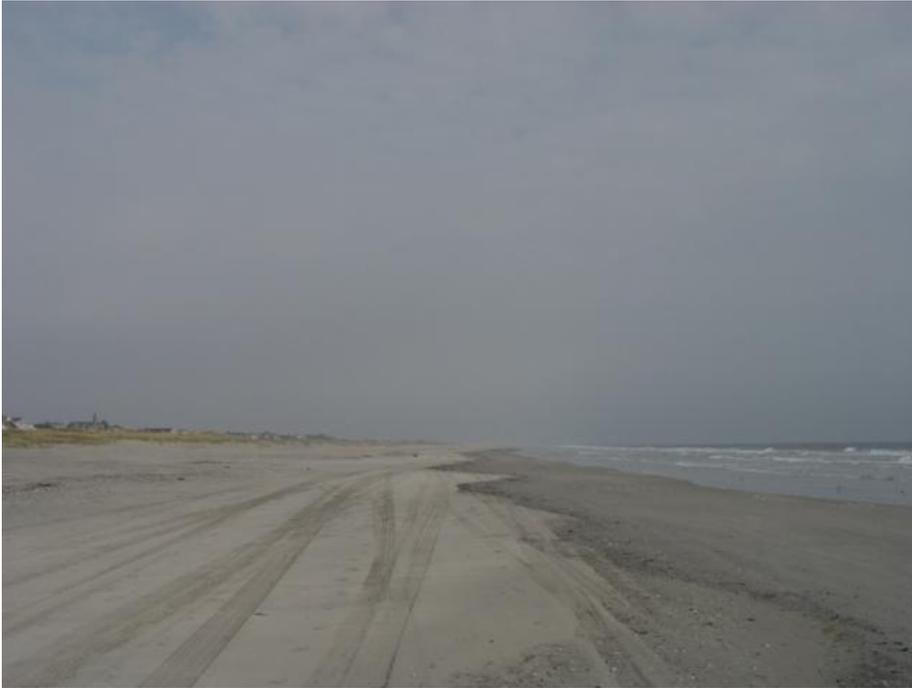
The beach in southern Avalon has a significant dune and a wide beach in spite of development east of Dune Drive. The November 14, 2007 photograph shows the sharp wet/dry line from the last high tide. The line is well seaward of the dune toe.

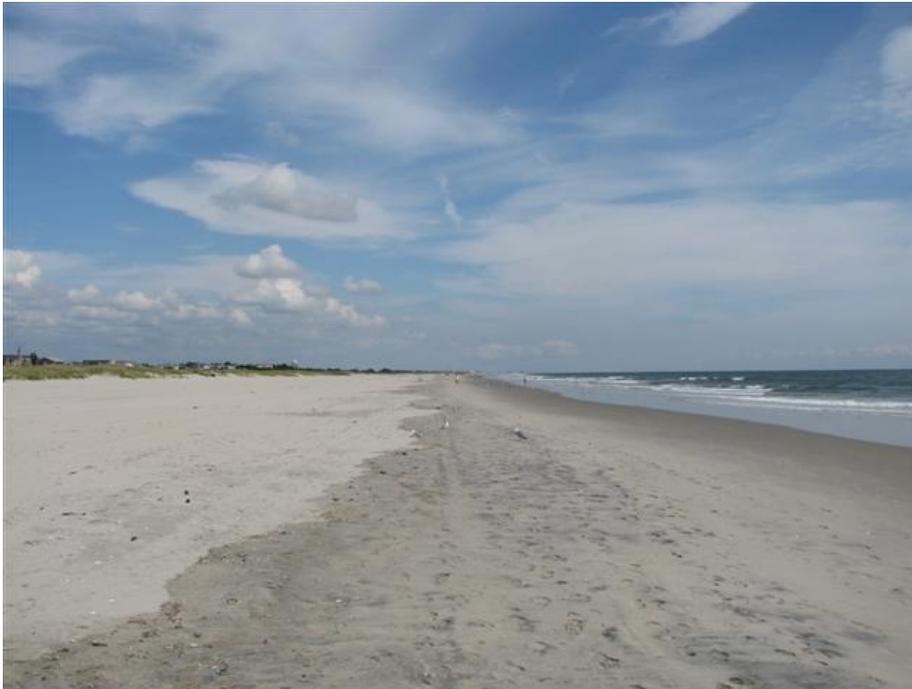
A similar situation prevailed on September 17, 2008 as the beach remained essentially constant. The sand volume increased by 26.98 yds³/ft. almost all of which appeared offshore in a pair of bars and the shoreline advanced 44 feet due to the proximity of the bar closest to the beach.

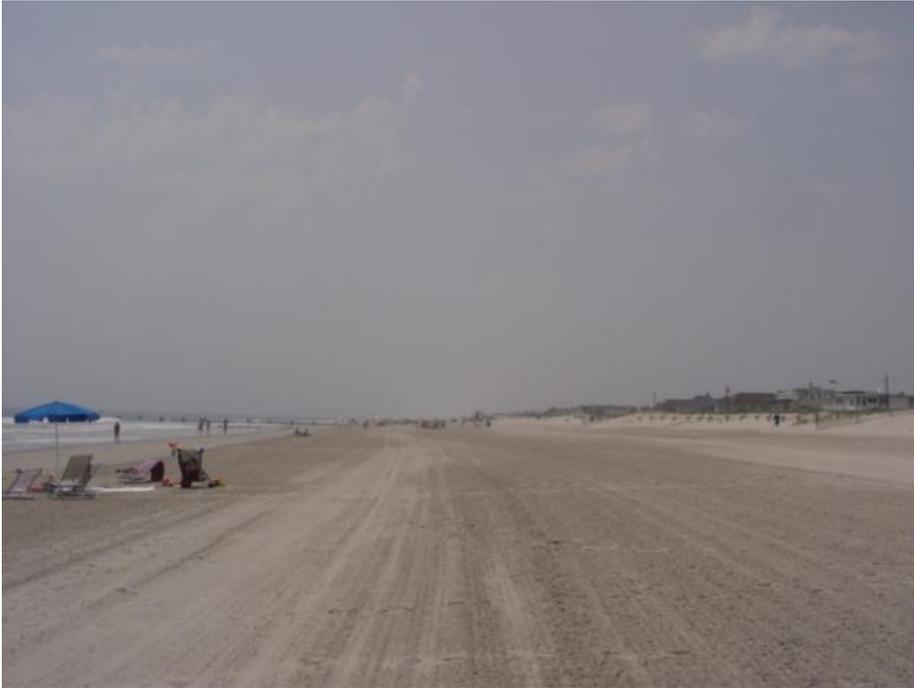
Stone Harbor conducted a beach restoration in 1998 and participated in a Federally-sponsored project in 2003. The beach width as of June 8, 2007 continued to show a significant amount of sand on the beach. Both projects resulted in dramatic increases in the sand volume present in the dunes.

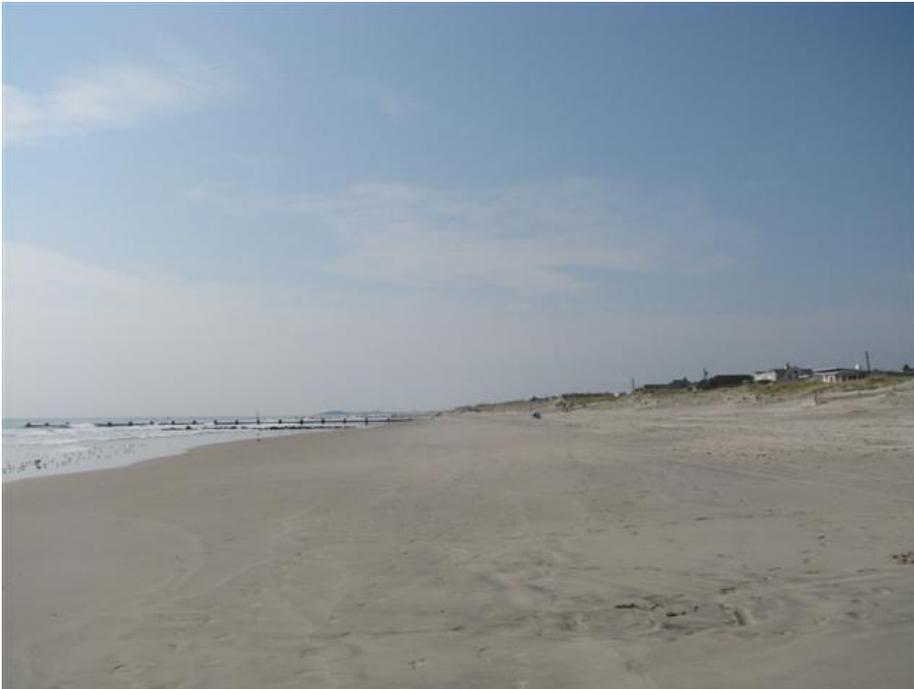
By September 30, 2008 the beach had narrowed somewhat, but low storm intensity and frequency has prevented any wave damage to the dunes. The situation is approaching the moment when re-nourishment will be needed to preclude dune erosion during storms. In the middle of the Borough the sand loss was just 1.55 yds³/ft. and the shoreline retreated 17 feet.

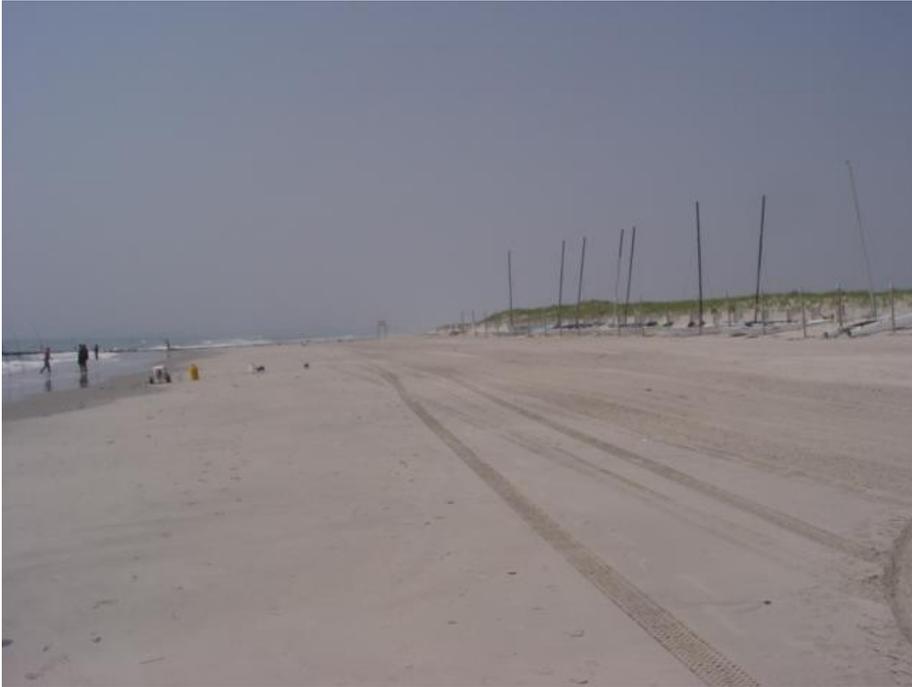
This beach is entirely composed of nourishment sand since the stone revetment was the principle barrier to wave damage prior to 1998. This June 8, 2007 picture shows that the rocks are buried and a dune grows over the revetment. The beach width has decreased slowly since 2003.

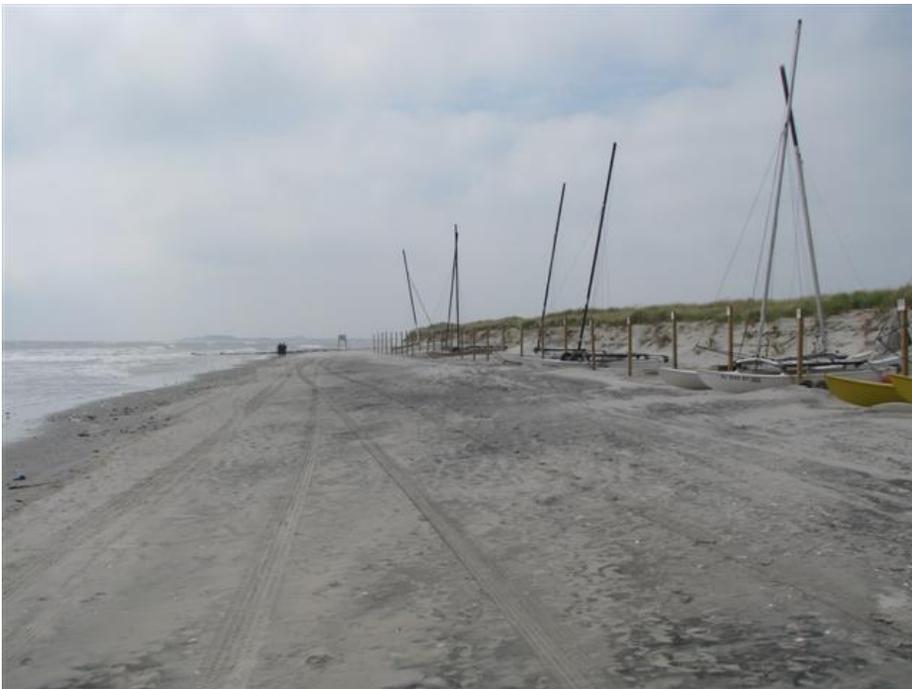
By September 22, 2008 the beach width continued to decline bringing the dune toe within easy reach of potential storm waves. The primary use of the beach is storage of the small sail craft used in the surf and just offshore during the summer. The sand volume loss was 31.18 yds³/ft. and the shoreline retreated 44 feet.

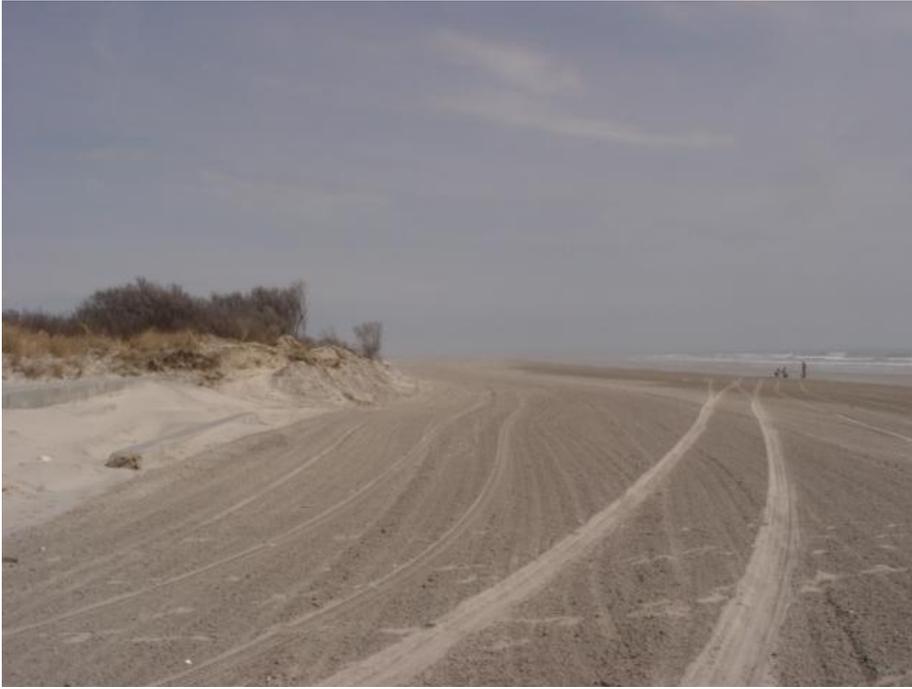
15th AVENUE, NORTH WILDWOOD - SITE 111

This beach has retreated over a thousand feet since 1998 due to dramatic change in the tidal flow pattern into and out of Hereford Inlet. This March 28, 2007 picture shows a dune system surviving with a low-gradient beach seaward of it. This location is far landward of the shoreline in 1998. The rate of retreat appears to have slowed at this point.

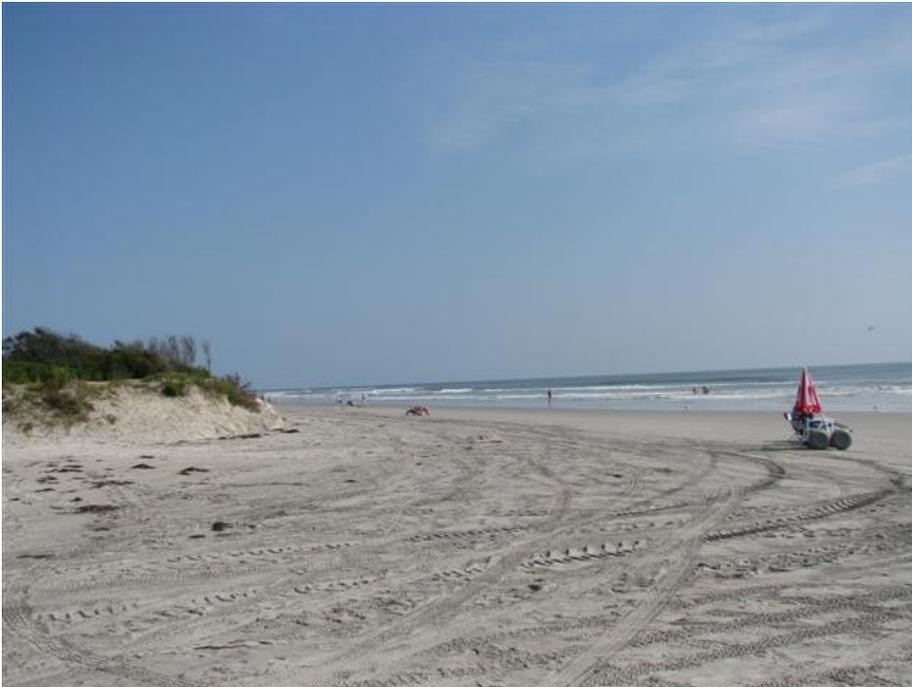
By September 30, 2008 the dune was trimmed a little, but the beach width had not declined since 2007. The NJ State is in cooperation with the local municipality to conduct a major beach restoration project in the City during 2009. Since 2006 this profile has remained stable following a dramatic 1,000-foot retreat in the shoreline position. The sand volume only declined by 2.37yds³/ft. and the shoreline advanced 3 feet.

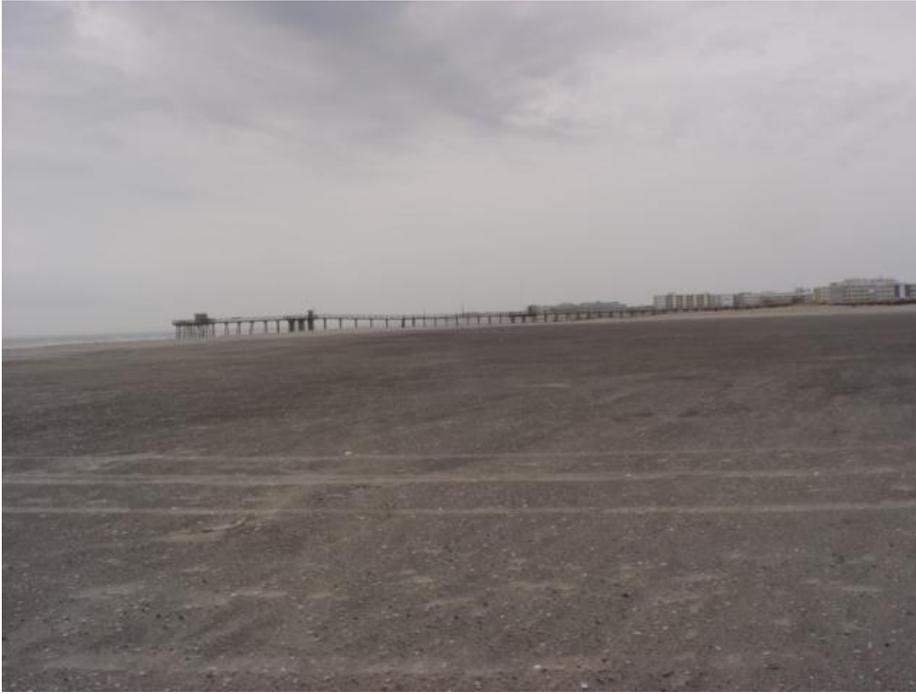
The Cresse Avenue site has grown 500 feet wider over the same period that the North Wildwood beach eroded. This March 28, 2007 view shows the wide, wind-swept dry beach between the boardwalk and the shoreline.

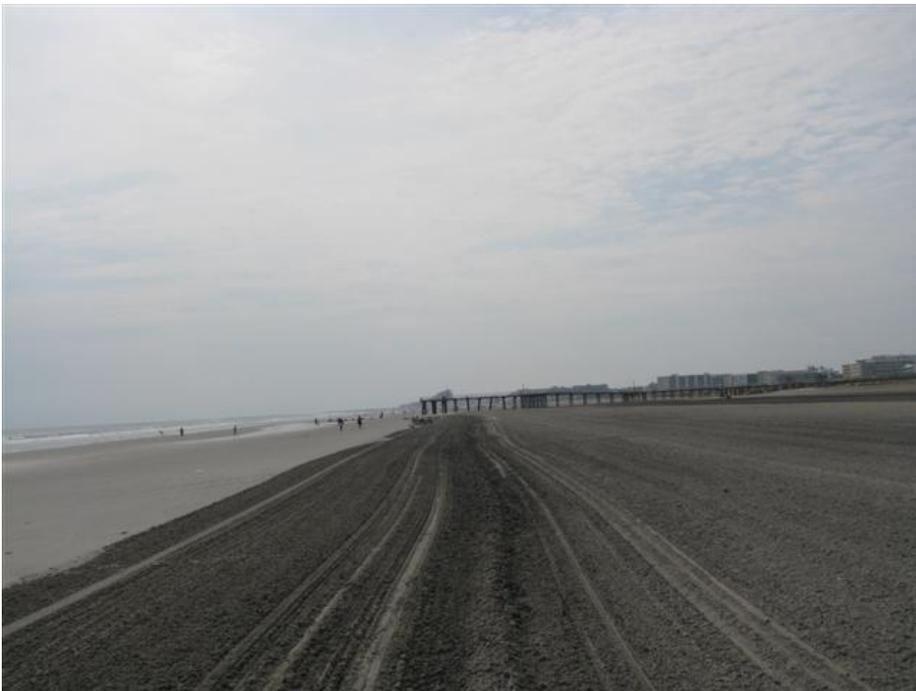
Conditions changed little between 2007 and September 30, 2008. The lines are left from the beach raking machine used to extract litter and natural debris. The sand volume change was positive at 21.11 yds³/ft. and the shoreline advanced 67 feet as sand was deposited at this location in a continuation of the past decade's sediment movement pattern on this barrier island.

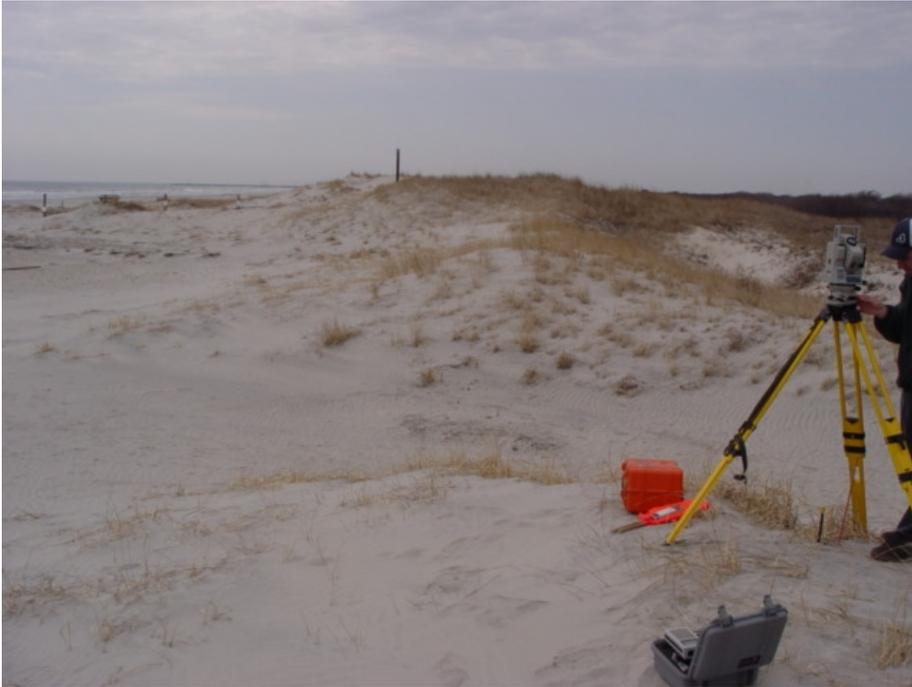
RALEIGH AVENUE, LOWER TOWNSHIP - SITE 109

Wide beaches and sizable dunes mark the southern part of this shoreline. The March 14, 2007 photograph shows a rolling set of dunes and the Cape May Wildlife Refuge in the distance. This beach is wide and dry and relatively storm resistant.

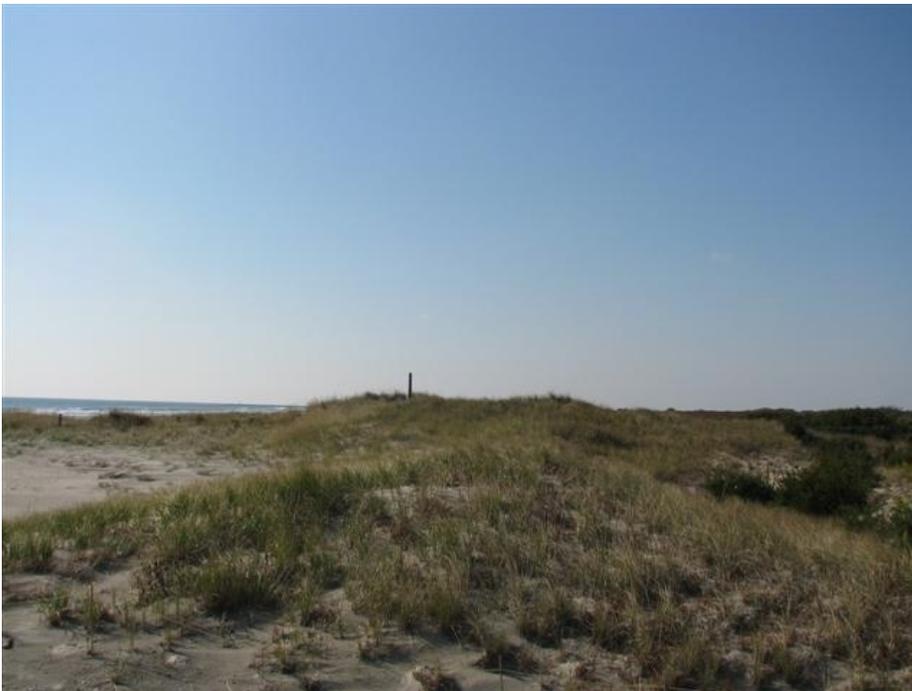
This view taken October 27, 2008 shows a green dune grass growth cycle following the summer with a significant development of dune field potential. The sand volume change was positive at 32.75 yds³/ft. and the shoreline advanced 20 feet as sand was deposited at this location.

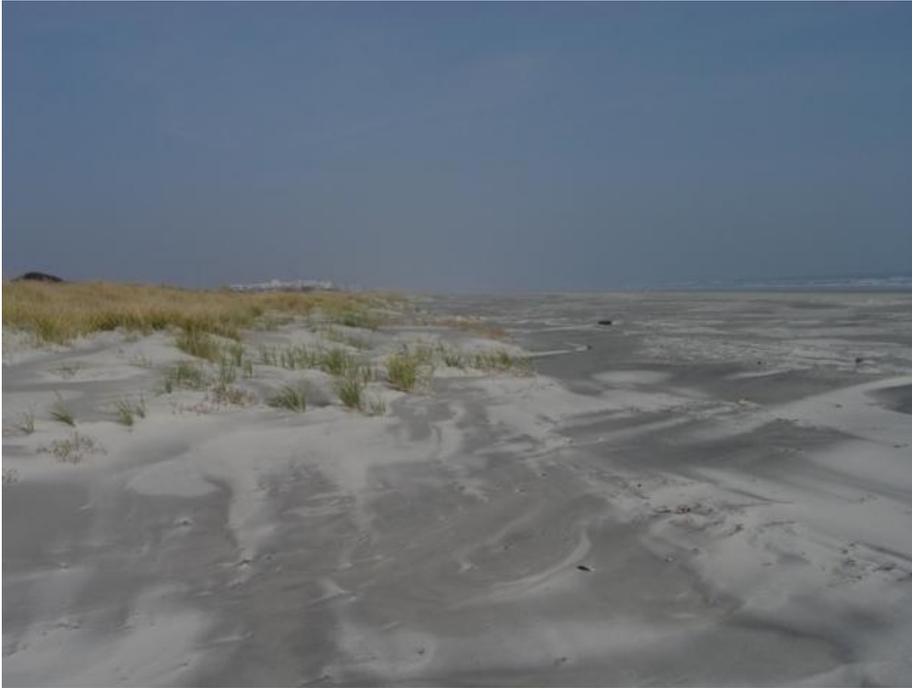
CAPE MAY NATIONAL WILDLIFE REFUGE - SITE 208

The refuge site was established in 1994 to have a better handle on the changes close to the inlet. The November 21, 2007 view shows the gradual transition between the primary dune and the dry beach. The sand volume gets trapped behind the Cold Springs Inlet jetty and creates a wide beach situation.

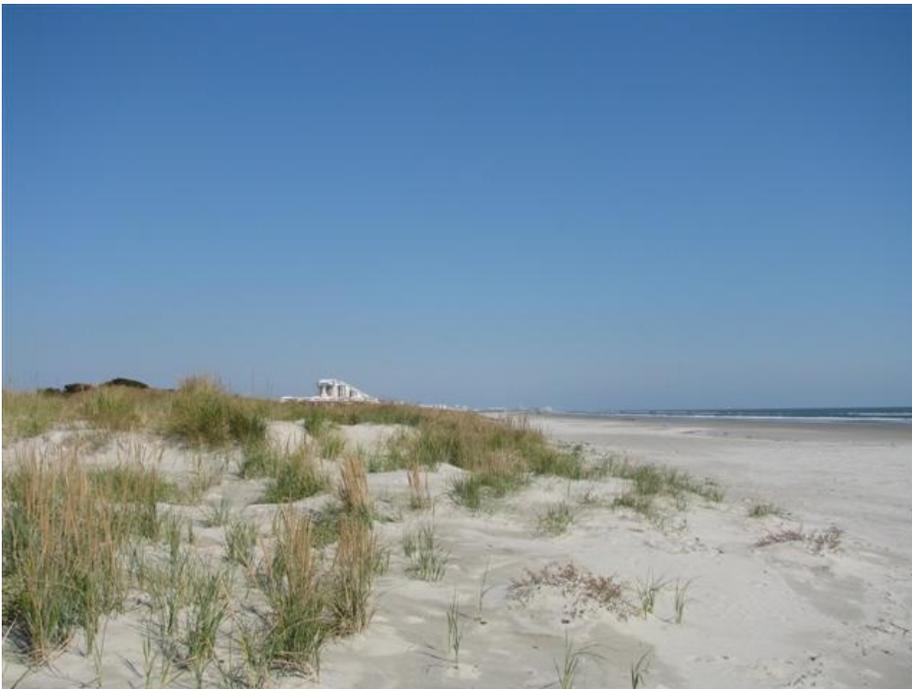
By October 27, 2008 this area simply gained more wind-transported sand and more abundant grass growth. There are few bathers and off-season, fewer visitors to observe this excellent beach ecosystem. This interval saw slow and relatively minor sand accumulation at this site with a 4.79 yds³/ft. and a 10-foot shoreline retreat.

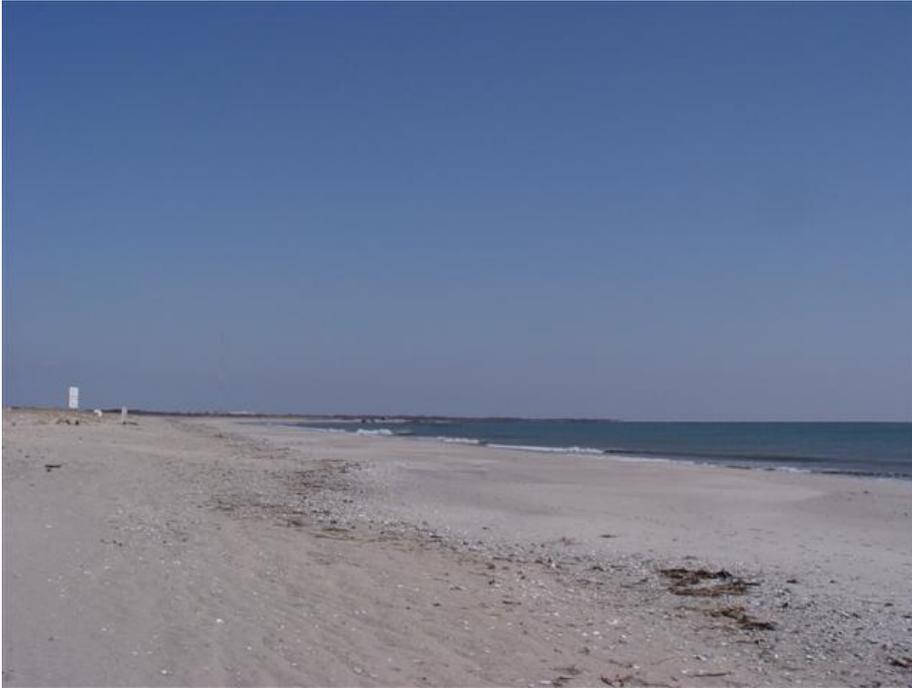
CAPE MAY BEACH CLUB - SITE 108

The Beach Club site was renourished in 1989 as the Cape May City project got underway. This February 28, 2007 photograph shows the sand built up on the berm following a period of quiet weather during the winter. The fill project placed sufficient sand to prevent easy wave attack on the local development.

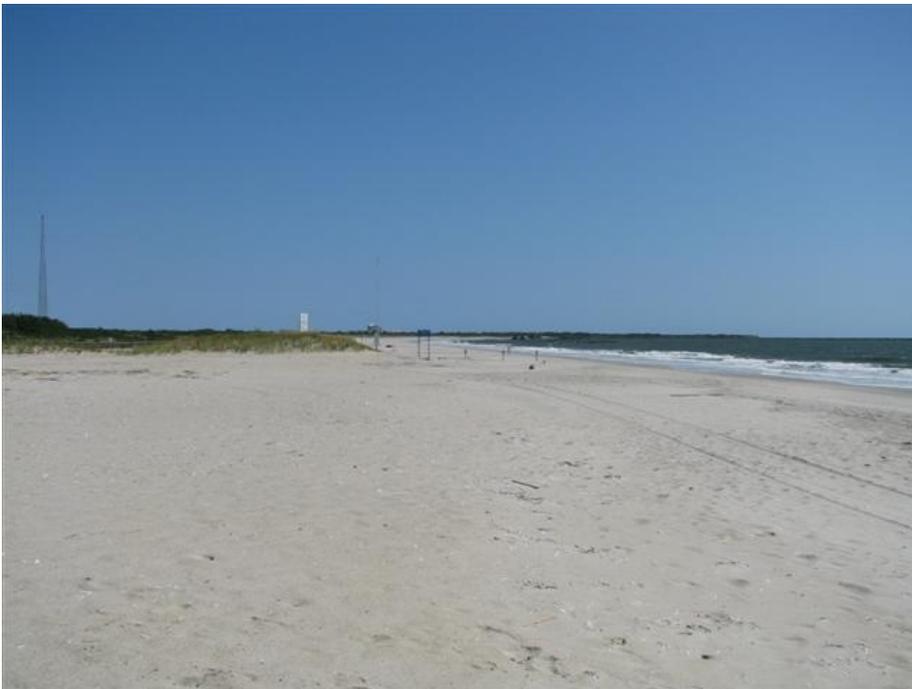
By September 11, 2008 the situation was essentially the same without additional sand volume added by artificial means. The dune development is proceeding slowly since little human effort has been undertaken to speed up the process. Sand volume changes and shoreline shifts were minor (2.48 yds³/ft. and -18 feet) as this beach was quite stable.

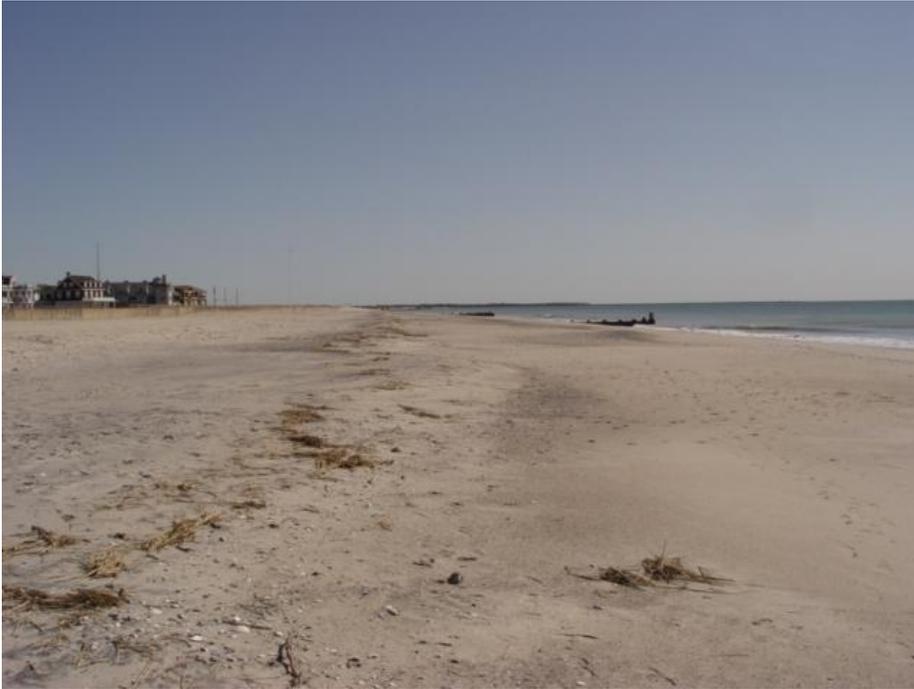
The photograph looks northeast along the berm and gives an idea of the distance back to the development. In 1989 the photographer would have been in water over 10 feet deep since at that time the waves broke on the revetment rocks located just east of Ocean Avenue. This March 29, 2007 picture shows the tips of the groins exposed, but the beach has remained stable for over 20 years.

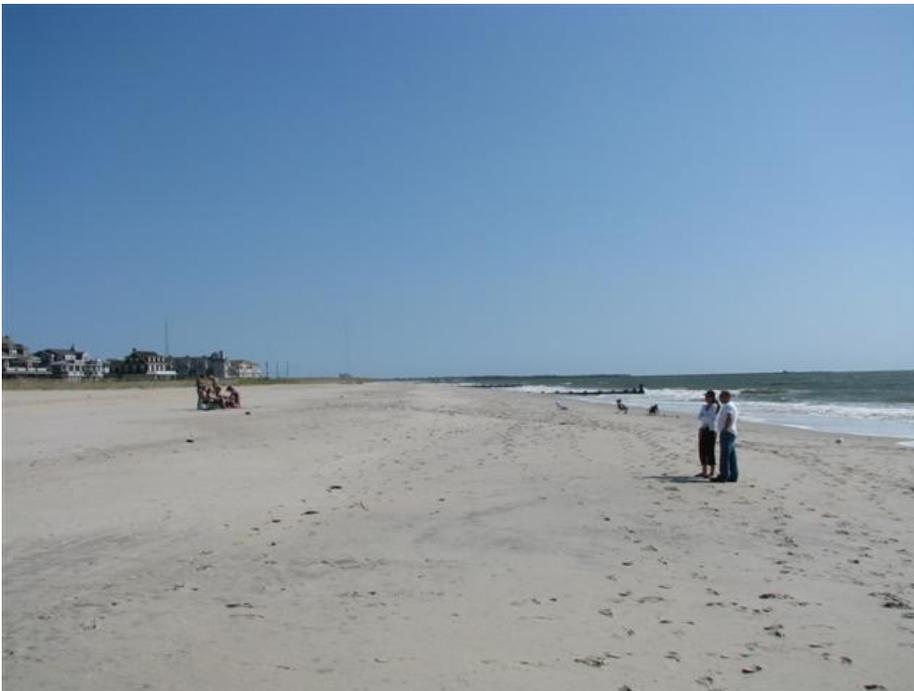
The September 11, 2008 photograph shows some beach flattening, but the total sand volume is quite stable. Sand volume changes and shoreline shifts were minor ($-5.65 \text{ yds}^3/\text{ft.}$ and -11 feet) as this beach was quite stable.

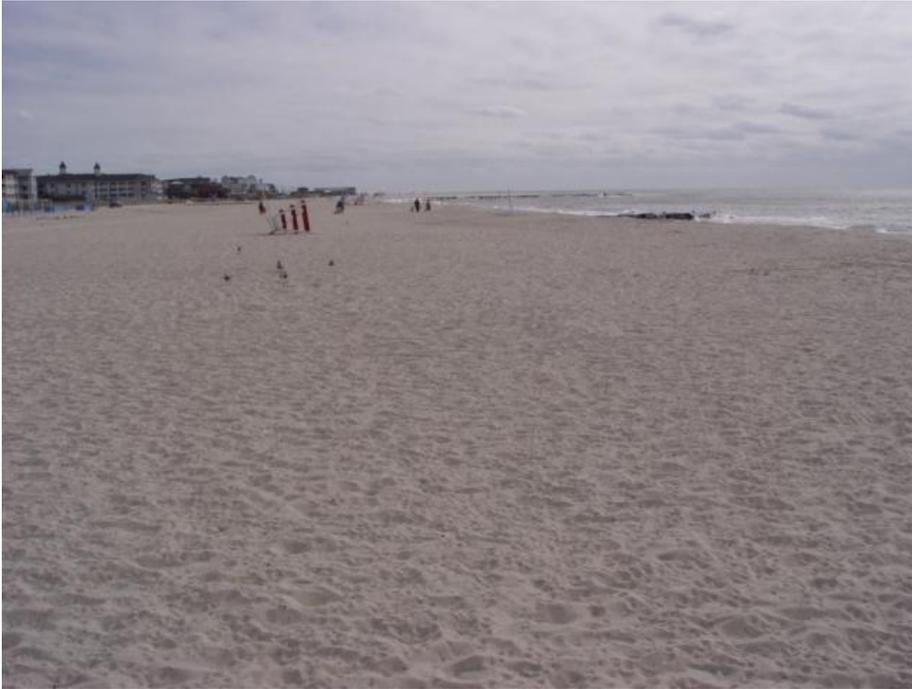
BROADWAY AVENUE, CAPE MAY CITY - SITE 206

This is the main recreational beach area in Cape May City and was restored in 1990. This September 18, 2007 photograph shows the recreational beach as an expanse of dry sand held in place by the terminal groin to the south of this northeast view.

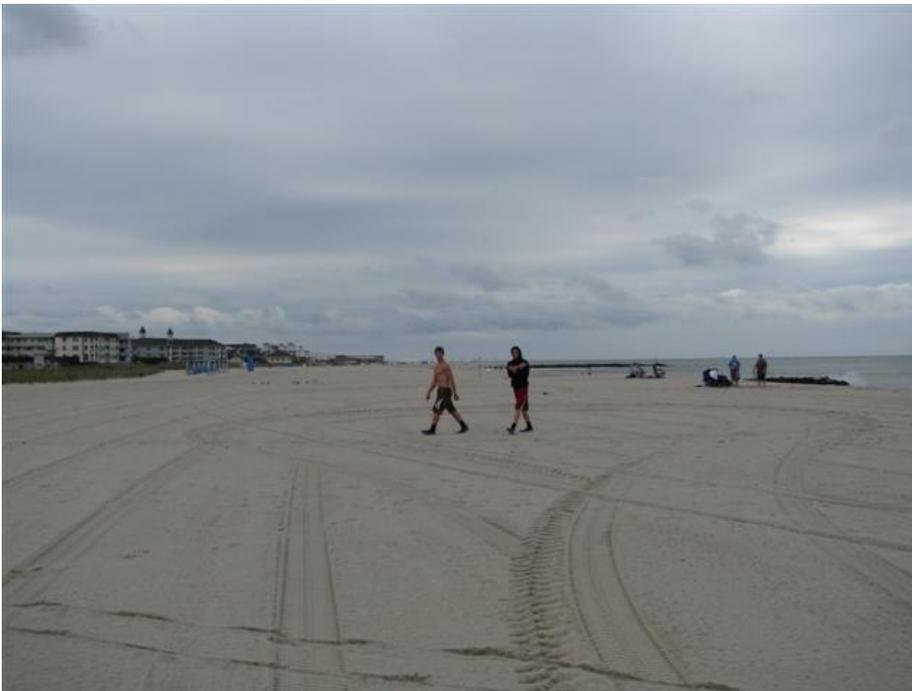
By September 10, 2008 the beach was in similar condition since there has been very few storms. The groin in the picture is a little more exposed, but not significantly so. The survey data indicates a minuscule sand volume change of $0.04 \text{ yds}^3/\text{ft}$. coupled with a 17-foot shoreline advance.

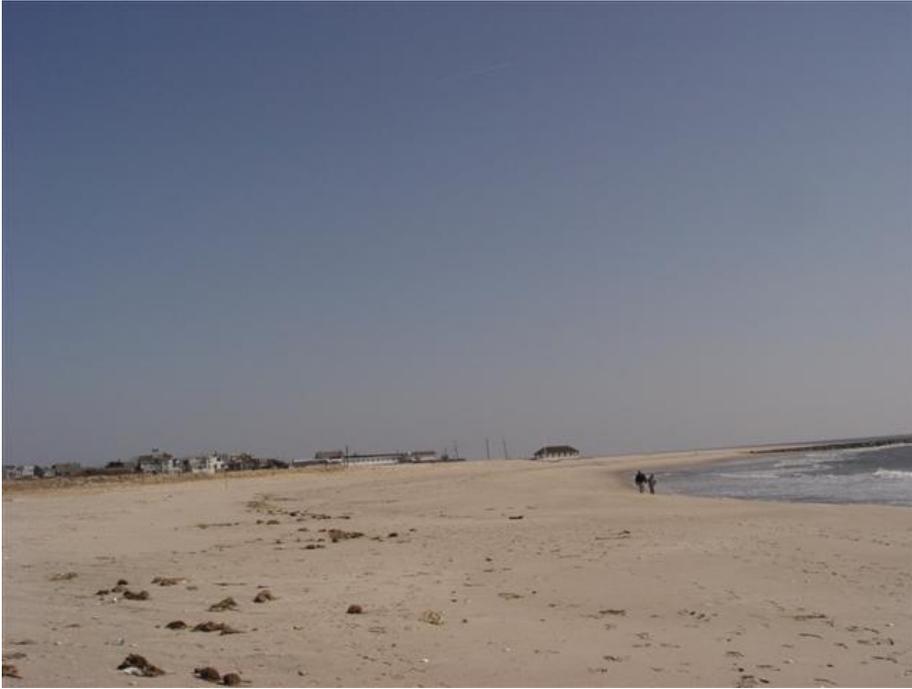
NATURE CONSERVANCY, CAPE MAY - SITE 105

Sand shed from Cape May City is deposited along this beach segment. The Cape May City terminal groin located at Third Avenue shows in the distance along the curve of the shoreline. The photograph is from February 28, 2007 and is in a long sequence of shoreline advances seaward since 1990.

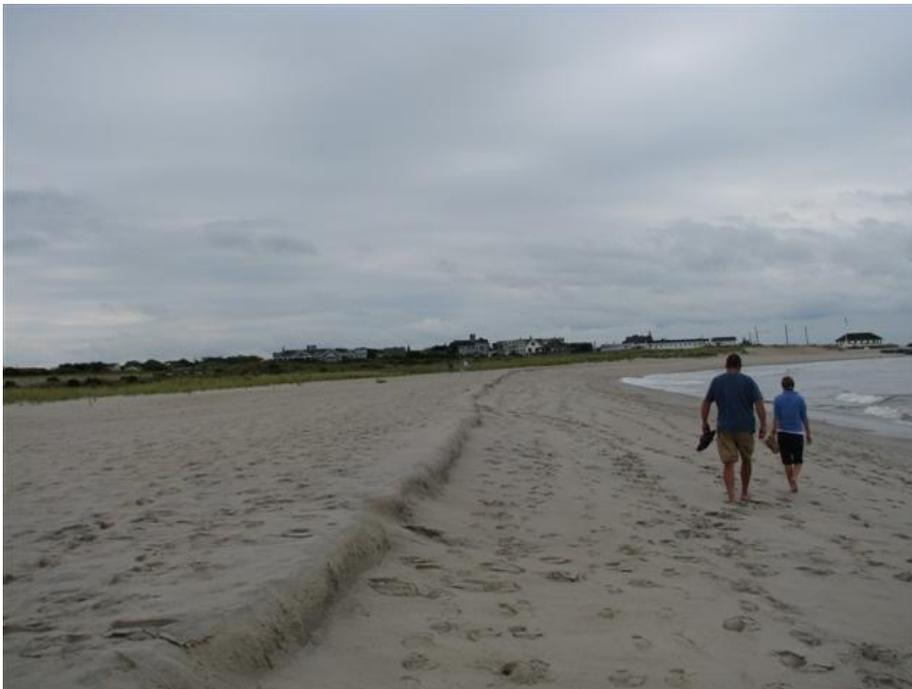
By September 10, 2008 the beach was the subject of a ACOE project to restore the southern section of this natural area with about a quarter million cubic yards of sand hauled in by truck from an upland quarry. The beach shows a small scarp in the berm as the survey was completed. The sand was distributed on the south end at the State Park land so the change recorded here was negative in the quantity of 17.44 yds³/ft. of sand, but the shoreline advanced 10 feet seaward.

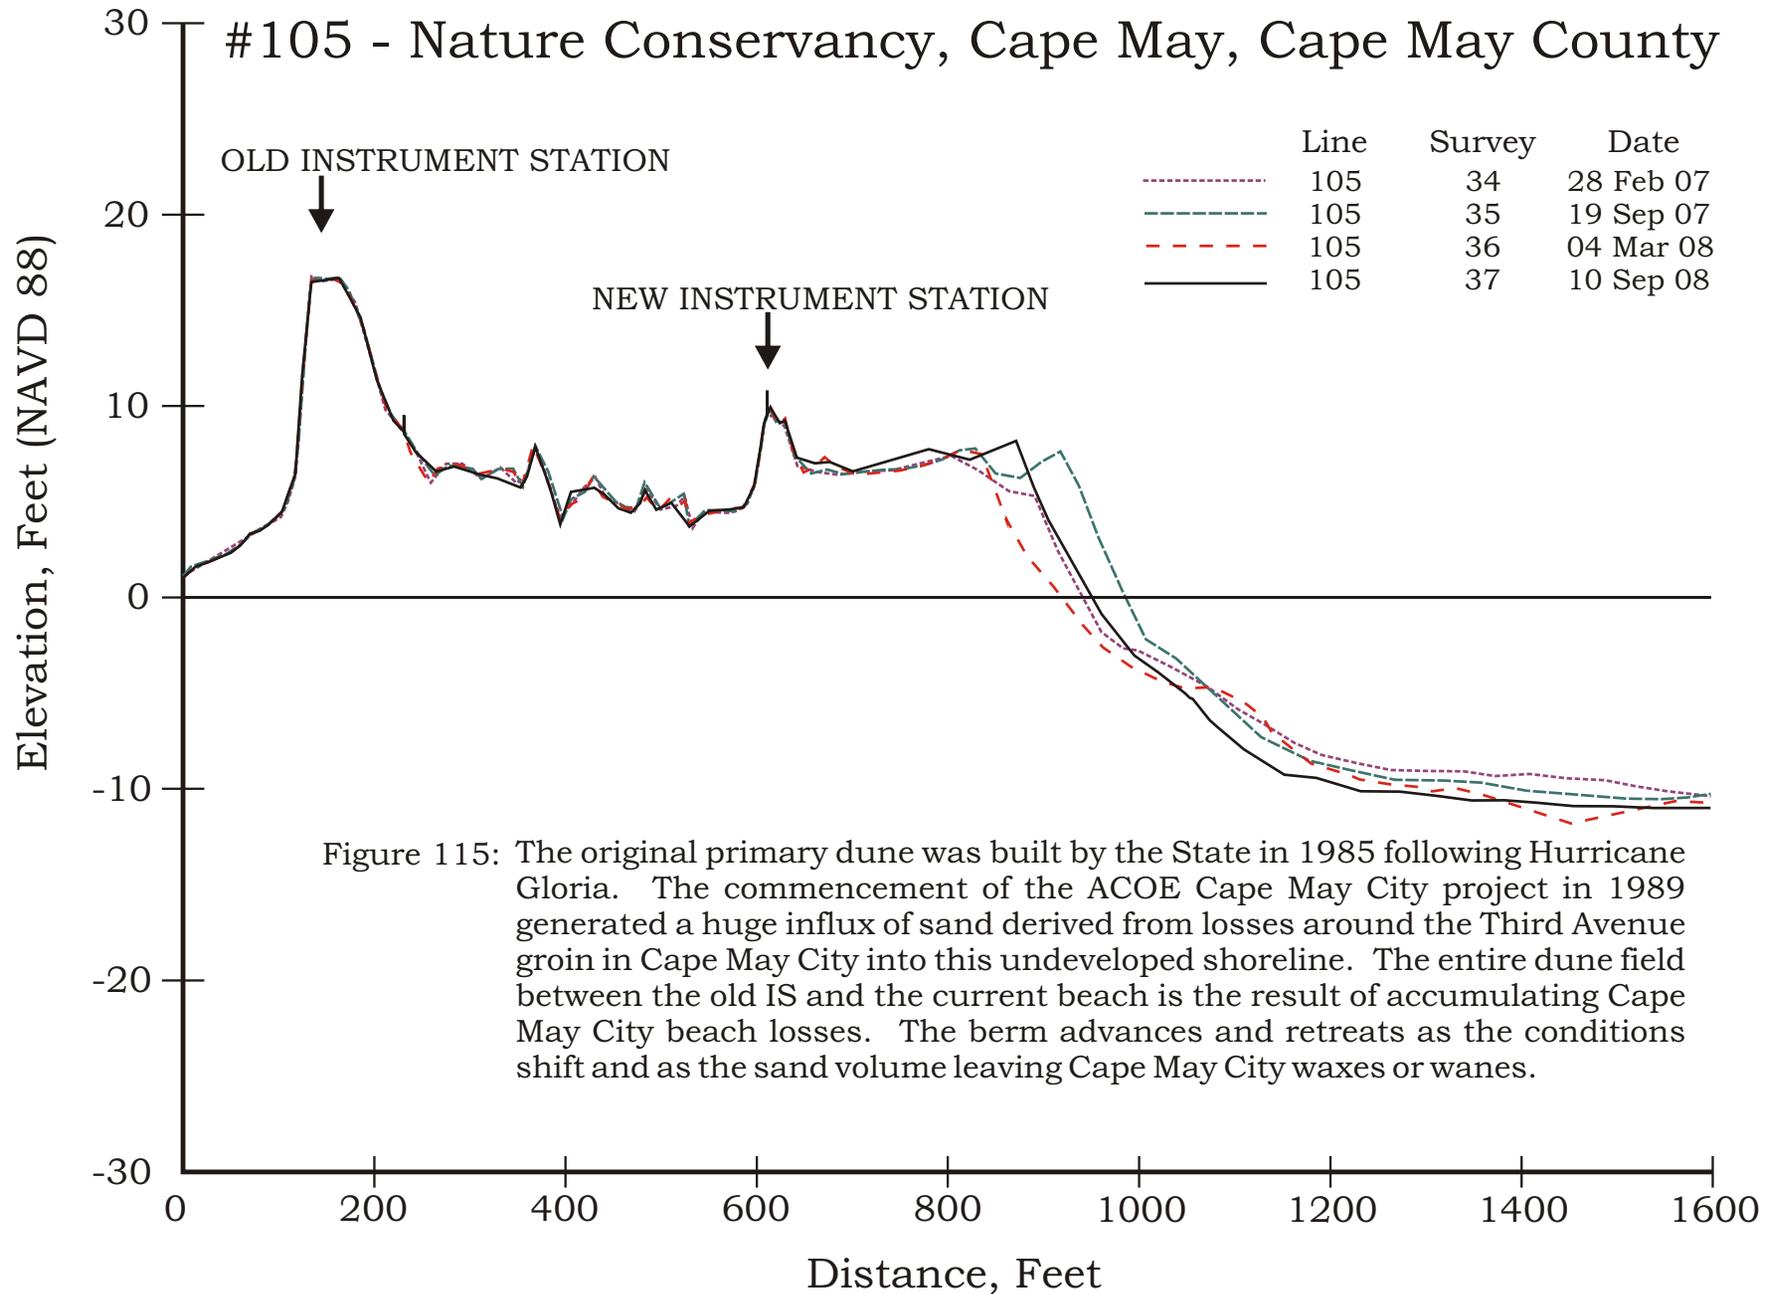
#105 - Nature Conservancy, Cape May, Cape May County

Figure 115: The original primary dune was built by the State in 1985 following Hurricane Gloria. The commencement of the ACOE Cape May City project in 1989 generated a huge influx of sand derived from losses around the Third Avenue groin in Cape May City into this undeveloped shoreline. The entire dune field between the old IS and the current beach is the result of accumulating Cape May City beach losses. The berm advances and retreats as the conditions shift and as the sand volume leaving Cape May City waxes or wanes.

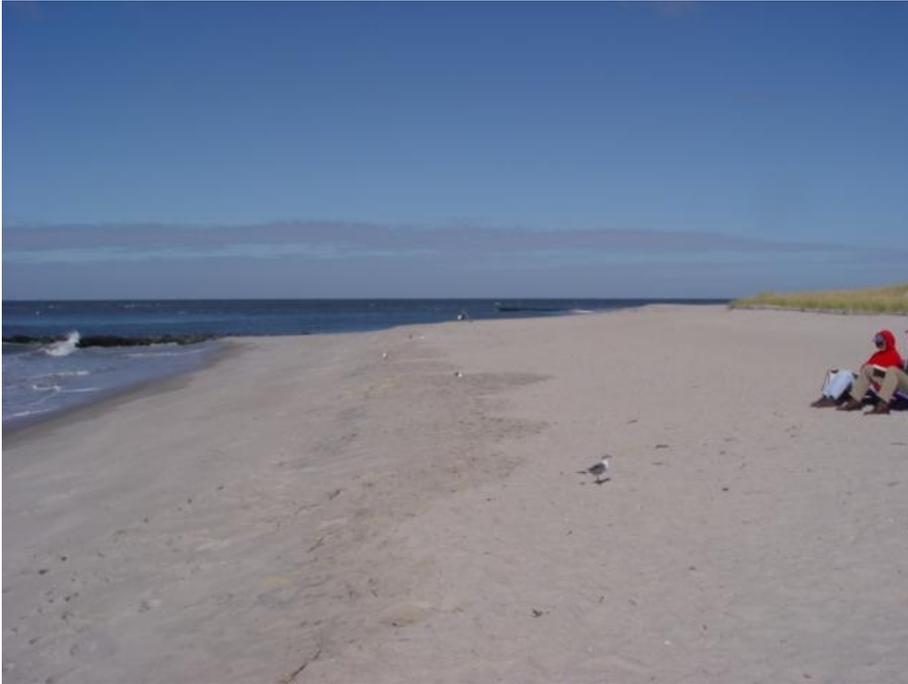
Located at the extreme southern tip of the Cape May County peninsula in the Borough of Cape May Point, this site was nourished in 2005 by the ACOE. By September 19, 2007 the shoreline had retreated by about half the initial deposit of sand, much of which was re-deposited on the beaches to the west beyond the groin in the photograph.
