New Jersey Beach Profile Network

Cape May County

**Great Egg Harbor Inlet
to Stow Creek**

**NJBPN Profile #'s
225 - 100**

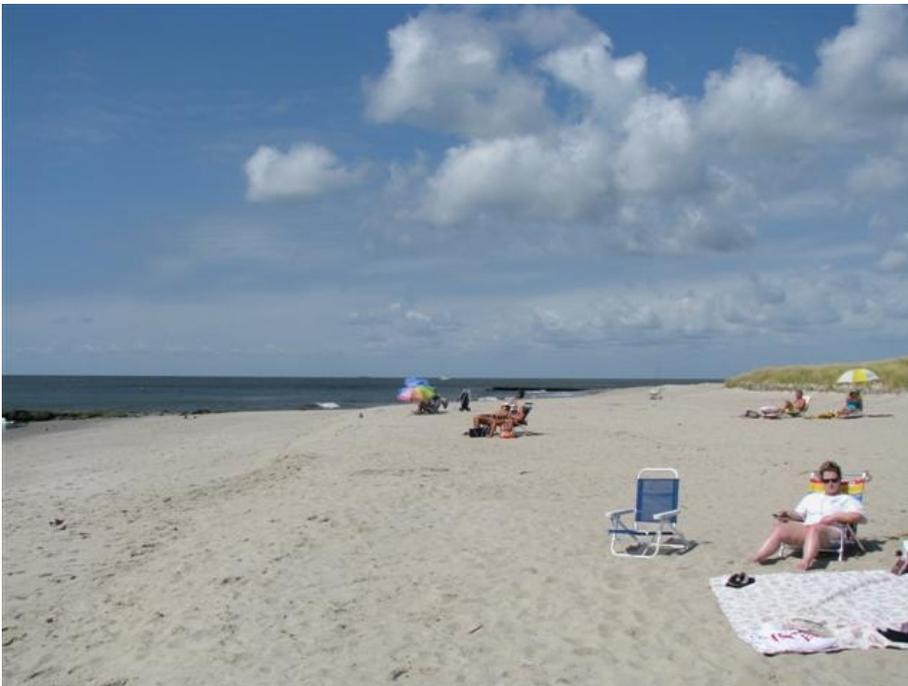
A year later on September 11, 2008, the ACOE truck in project brought additional sand to this site advancing the shoreline back to the 2005 position. This sand came from excavating the two cells to the east along the shoreline because excess deposition had pushed the shoreline so close to the offshore submerged breakwater reef structure that swimming had to be restricted during the summers of 2007 and 2008. The loss seen during the summer of 2007 was recovered with a 17.43 yds³/ft. sand volume gain over the winter of 2007 to 2008. The shoreline advanced 9 feet as well. The accumulation continued during the following summer.

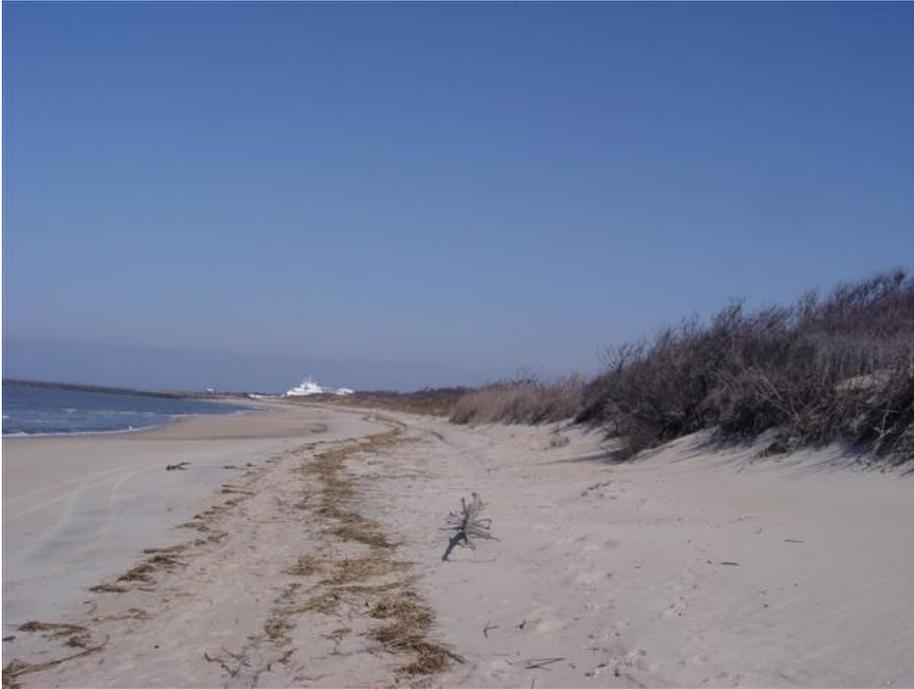
This is a natural area without any development. The changes to the shoreline are driven by southwest winds and the strong northwest winds that follow winter northeast events. The view is to the northwest along the berm toward the Cape May Ferry terminal at the Cape May Canal entrance into Delaware Bay on February 28, 2007. Sand is excavated from the bluff and much of it is carried offshore. Long shore transport redistributes the sand toward the canal entrance or south toward Cape May Point. Long periods of quiet weather produces a berm and small bars near the low tide line.

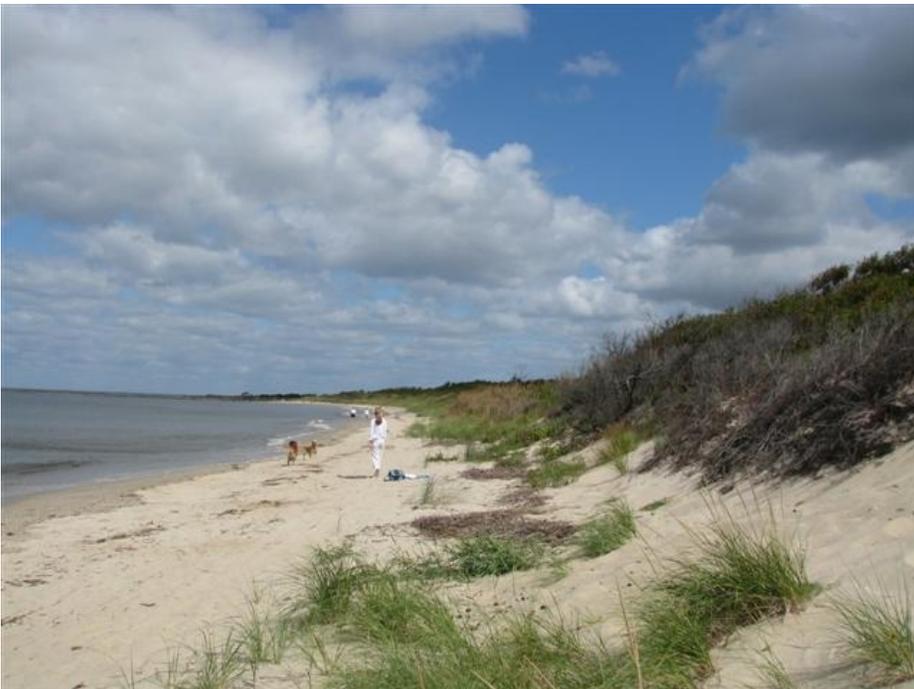
By September 19, 2008 the grass growth is in evidence and the absence of bluff erosion shows in the advance of the vegetation down the slope. The survey data confirms the photographic evidence with a $2.31 \text{ yds}^3/\text{ft}$. sand volume increase as the shoreline advanced 6 feet.

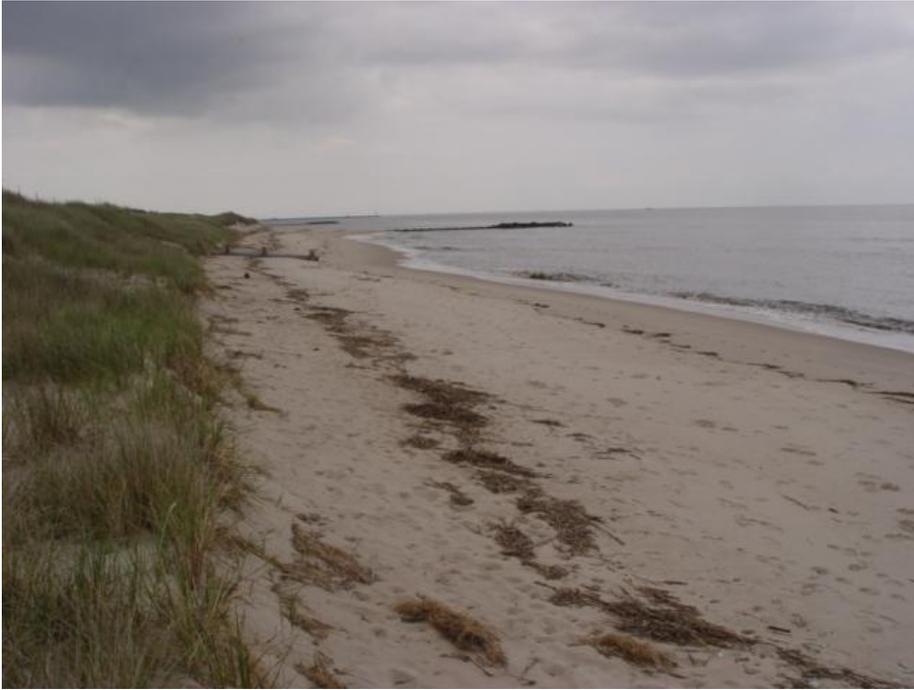
The final three sites are within Delaware Bay and are only influenced by westerly winds. This picture was taken May 17, 2007 and shows the dry beach with a line of debris from a higher-than-normal tide. Some debris is as far up the beach slope as the grass line.

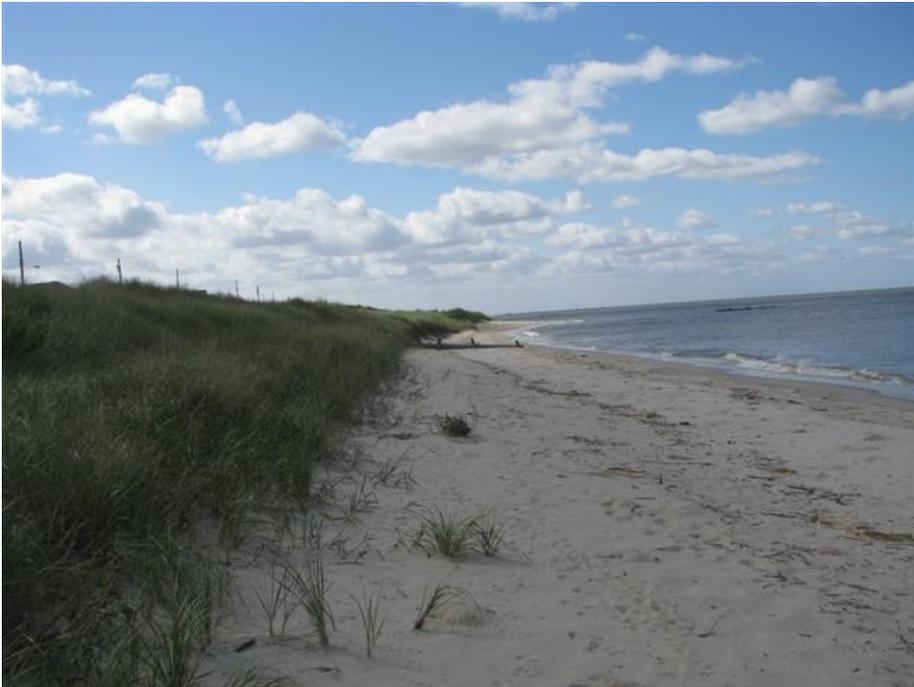
Extensive change is absent, but sand does move along the shoreline as this September 19, 2008 view shows. The berm is higher and grass has moved onto the upper slope. A $2.99 \text{ yds}^3/\text{ft}$. sand volume loss was combined with a 16-foot shoreline advance over the 18-month study interval.

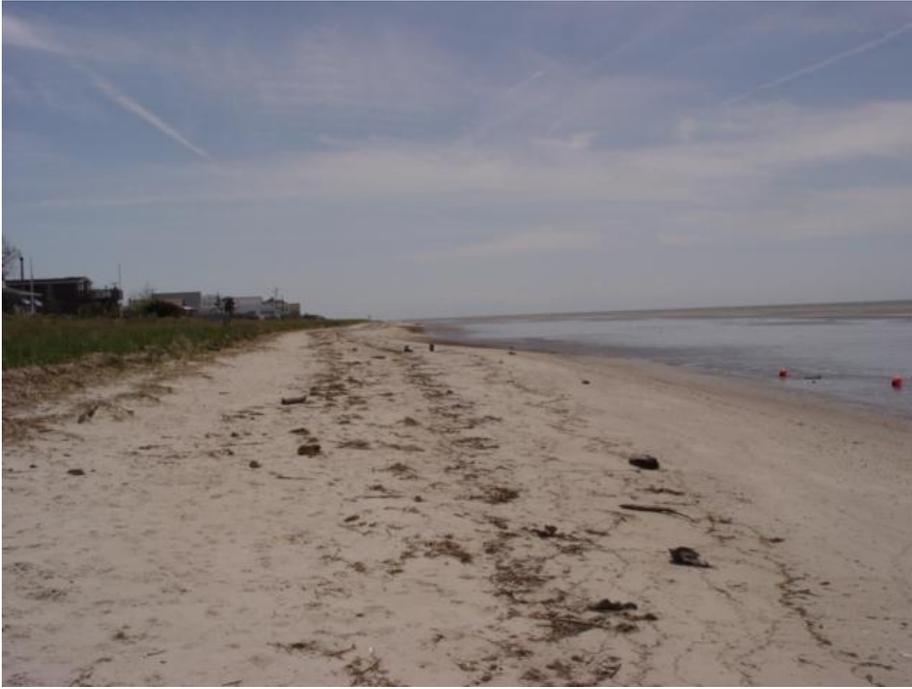
PACIFIC AVENUE, VILLAS - SITE 101

The Villas site has few major changes. This May 14, 2007 photograph shows a series of debris lines from different tidal elevations. Offshore there is a wide, shallow terrace veneered by sand, but composed of compact bay mud left as the shoreline retreats about 2 feet per year over time. The bay margin is a thin veneer of sand over the marsh which is tens of feet thick. Bay erosion of the shoreline only reaches the effective base of the wave action so the terrace is flat and graded to an elevation of about zero NAVD 88. The gradient actually slopes toward the bay over a 1,400-foot distance that mirrors sea level rise somewhat. The slow erosion rate combined with the homogeneous sediment type has generated this wide terrace all along this part of the western Cape May County shoreline.

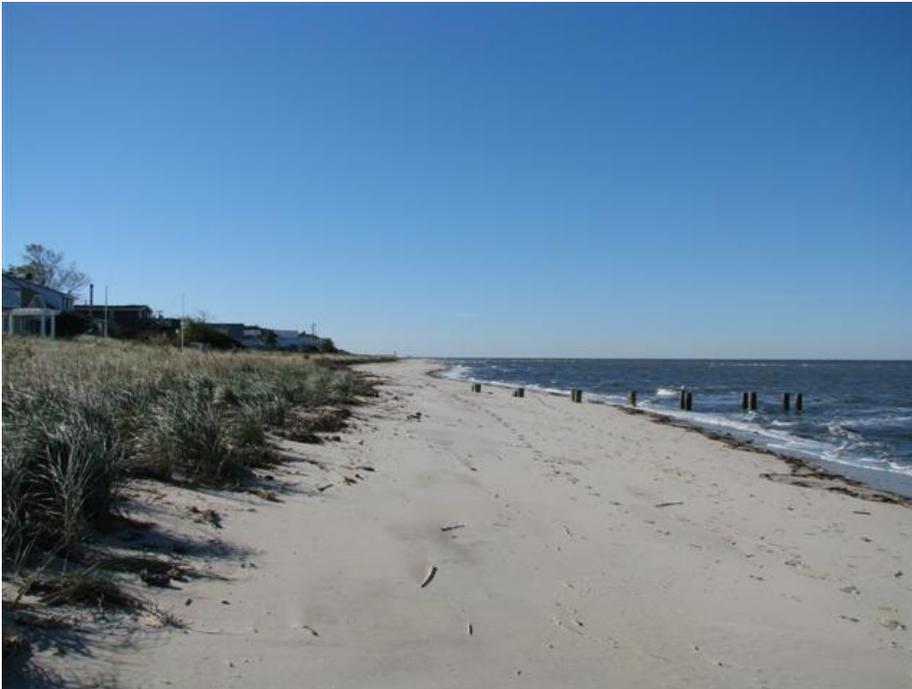
By October 20, 2008 some shoreline erosion is evident and the berm present above is now almost a scarp at the toe of the grass. The entire time period between the spring of 2007 and the fall of 2008 saw only 2.46 yds³/ft. in sand volume change with a 3-foot shoreline advance.

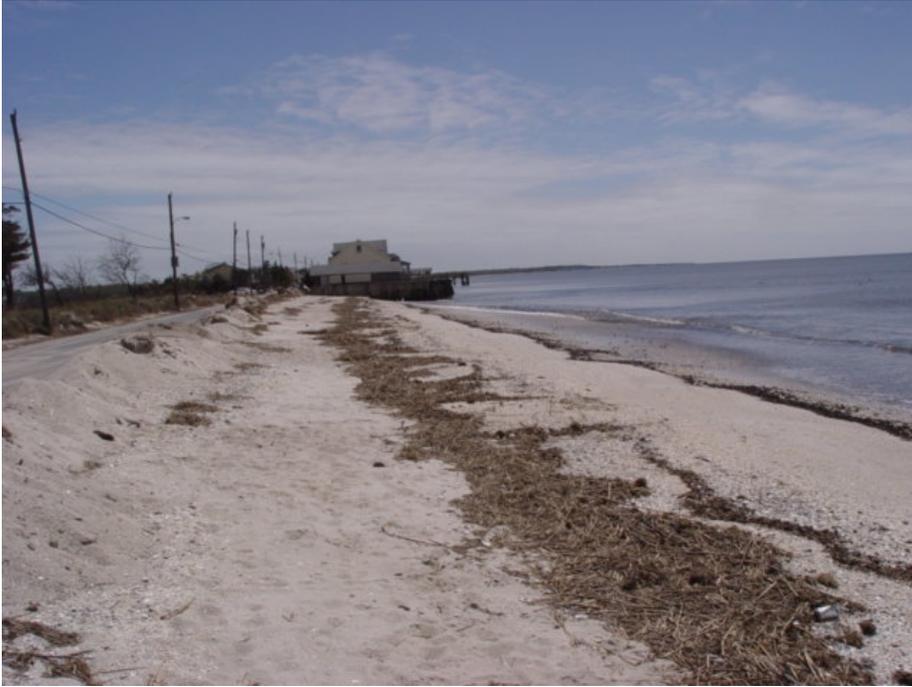
REEDS BEACH - SITE 100

The Reeds Beach location has been erosional over the past 20 years, but not to the point of property loss. This May 8, 2007 view to the south shows the segment of undeveloped shoreline chosen for the survey site location.

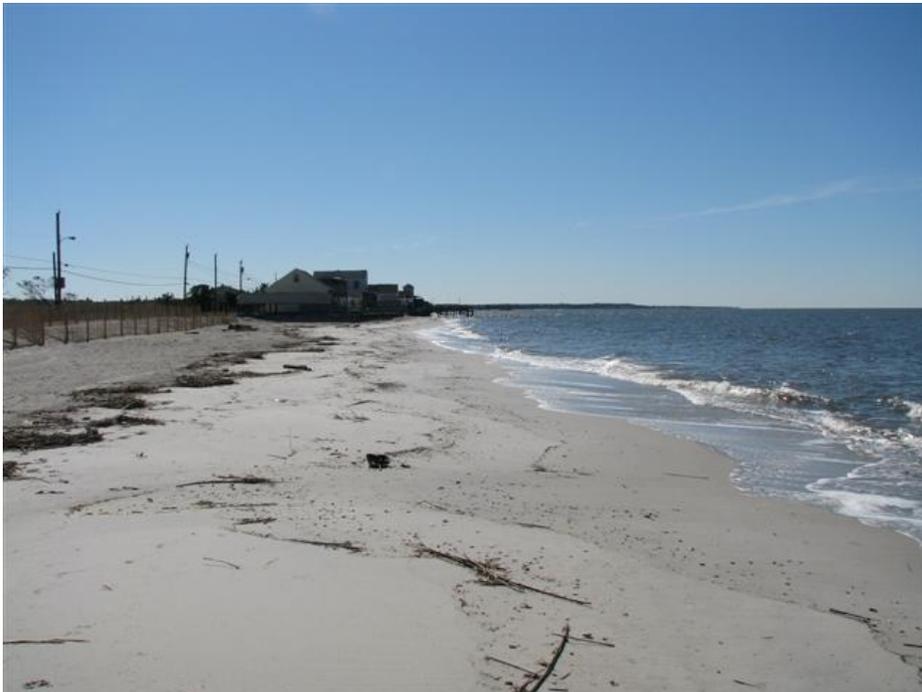
Dredging for navigation purposes at Bidwell Creek, located north of this site, used the sand derived from the creek to enhance the Reeds Beach shoreline as shown in this October 20, 2008 photograph. A new 4-foot high dune was built to keep sediment off the road, and the beach was extended 60 feet into the bay following completion of the dredging project. This has been the most significant change to this shoreline since monitoring began in 1986. The project deposited 23.57 yds³/foot of shoreline by the survey completed Oct 20, 2008. The shoreline advanced 52 feet into the bay reclaiming area lost due to erosion over the past decade.
