New Jersey Beach Profile Network

Cape May County

Great Egg Harbor Inlet
to Stow Creek

NJBPN Profile #'s
225 - 100

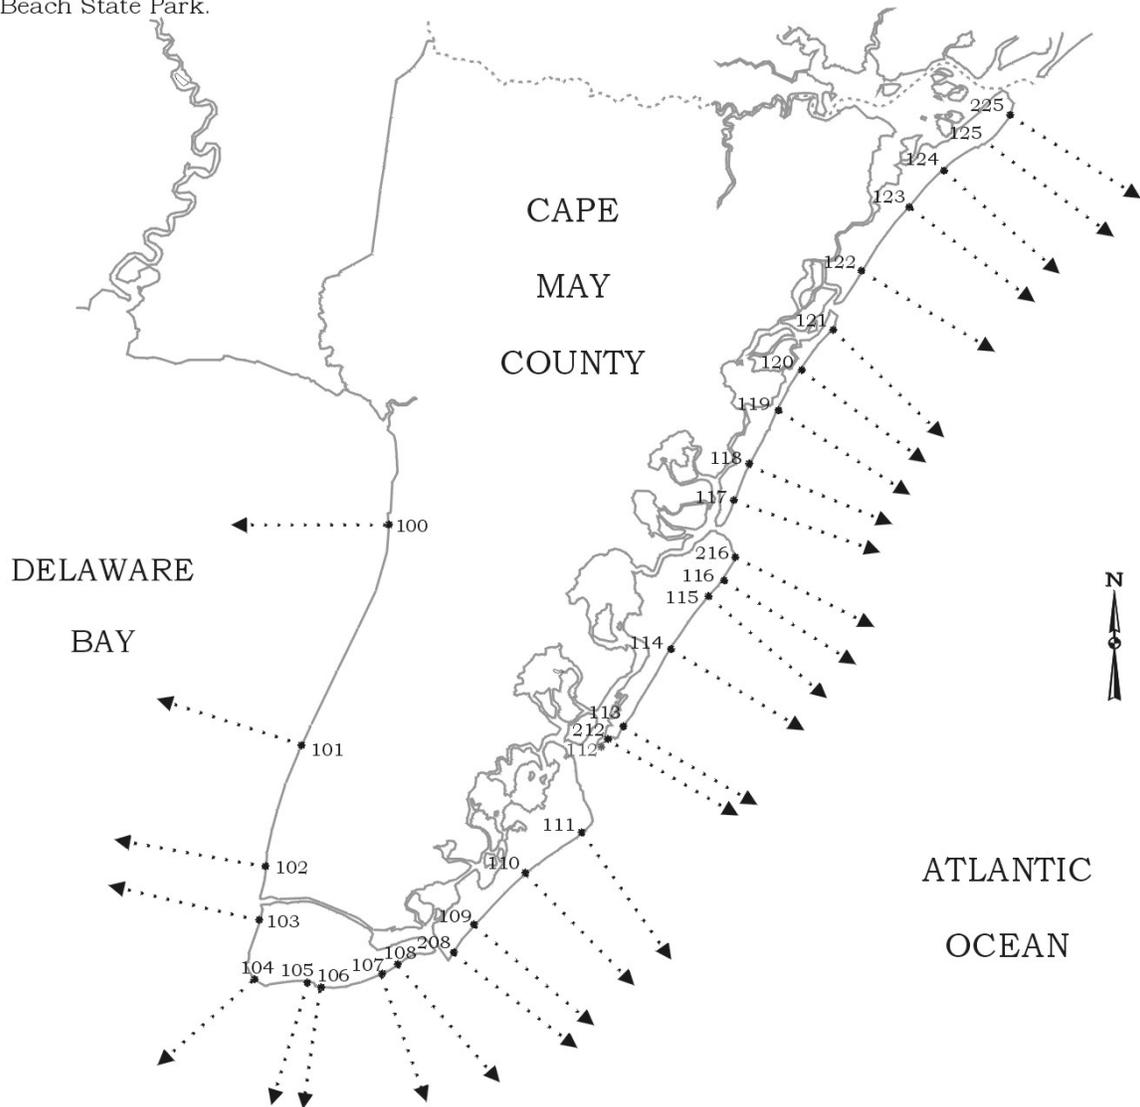
Figure 81

New Jersey Beach Profiles Network Cape May County Profile Site Locations

There are twenty-nine NJBPN survey sites along the beaches of Cape May County, which are a combination of barrier islands, coastal headlands and bayshore. Twenty-five sites are Atlantic Ocean profiles and the remaining four are set along the Delaware Bay shoreline of western Cape May County. The ocean profile sites are located in the following municipalities: the City of Ocean City, Strathmere in Upper Township, the City of Sea Isle City, the Borough of Avalon, the Borough of Stone Harbor, North Wildwood, the City of Wildwood, Lower Township, the City of Cape May, and the Borough of Cape May Point. Profile #112 on South Pointe in Stone Harbor was lost due to continuous erosion and was replaced by profile #212, which is located south of 121st Street in Stone Harbor. The four Delaware Bay profiles are located in the communities of Reeds Beach in Middle Township, Villas in Lower Township, North Cape May in Lower Township and at the Higbee Beach State Park.

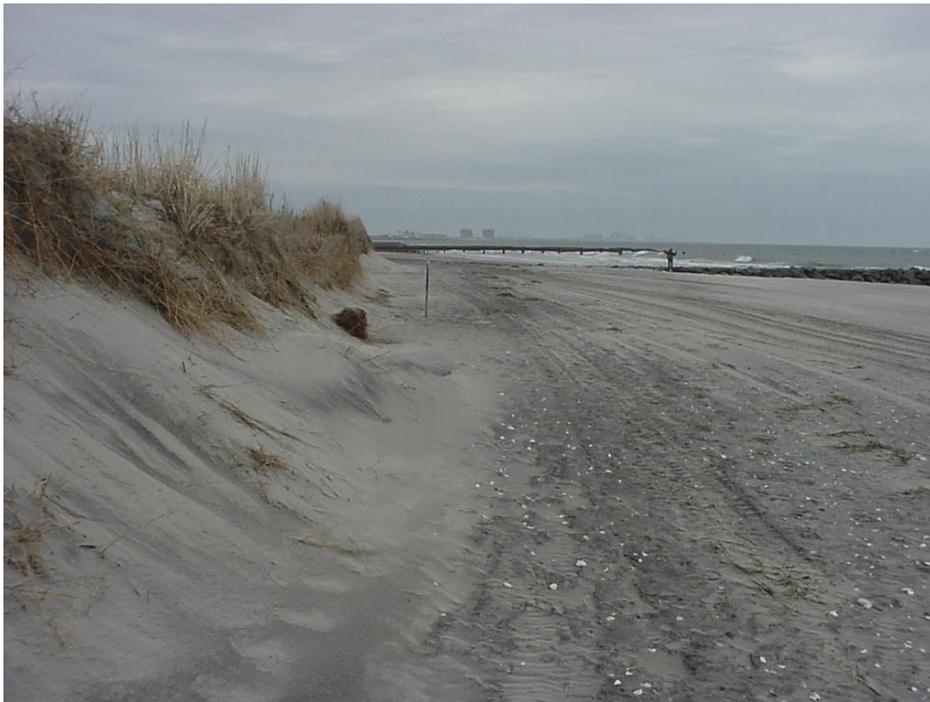
Figure 234. The site was established in 1994 as part of an expansion of the program to cover beaches adjacent to each of the State's inlets. Inlet shorelines tend to be very dynamic due to the combination of effects by both waves and tidal currents. This location has gained and lost sand in direct response to the pumping of sand onto the oceanfront beach in Ocean City over the past 15 years. The most recent history has been one of erosion. This past summer approximately 878,127 cubic yards of new sand was pumped from the inlet onto the beach south of Surf Road. It would be expected that subsequent surveys would see substantial advance in the shoreline position and beach volume increases in the near future. This past 18 months the site lost 20.90 yds³/ft with a 14-foot advance in the shoreline position. This photograph was taken April 6, 2006 and shows sand in front of a scarp in the dunes during a pause in the retreat in the shoreline since the 2004 nourishment.

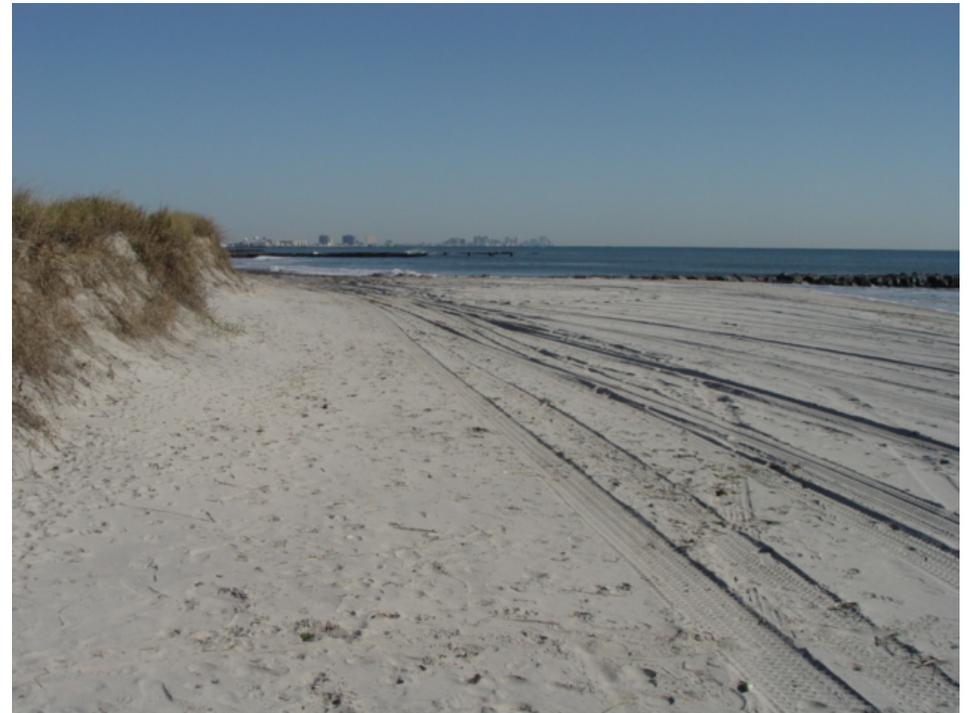
Figure 235. The photograph to the right was taken October 30, 2007 and shows the dune toe in an erosional condition. The loss was due to northeast storm activity with the dune giving up sand reserves as the influx of nourishment material declined from the oceanfront beaches.

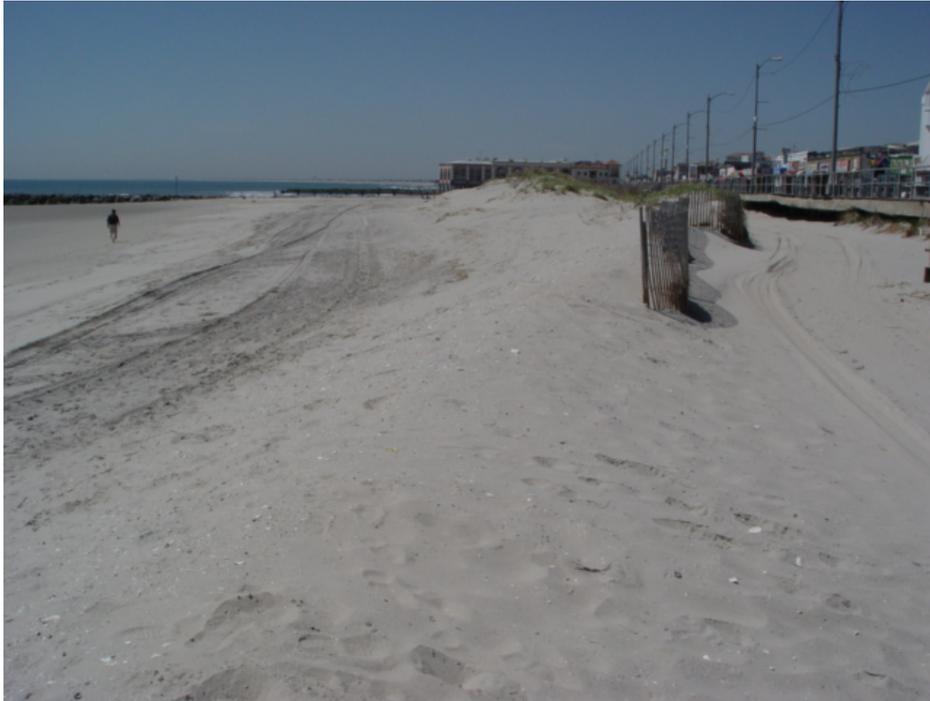
Figure 237. The beach at 6th Street in Ocean City has been a long-term site of serious erosion that originally took the low tide line under the boardwalk in 1989. That situation has not reoccurred due to repeated sediment additions under a US Army Corps project that commenced in 1991. The fourth renourishment was completed in 2004 with over a million cubic yards of sand. The State of NJ added 878,127 cubic yards in 2008 due to a lack of Federal appropriations for continued maintenance by the ACOE. This photograph was taken April 27, 2006

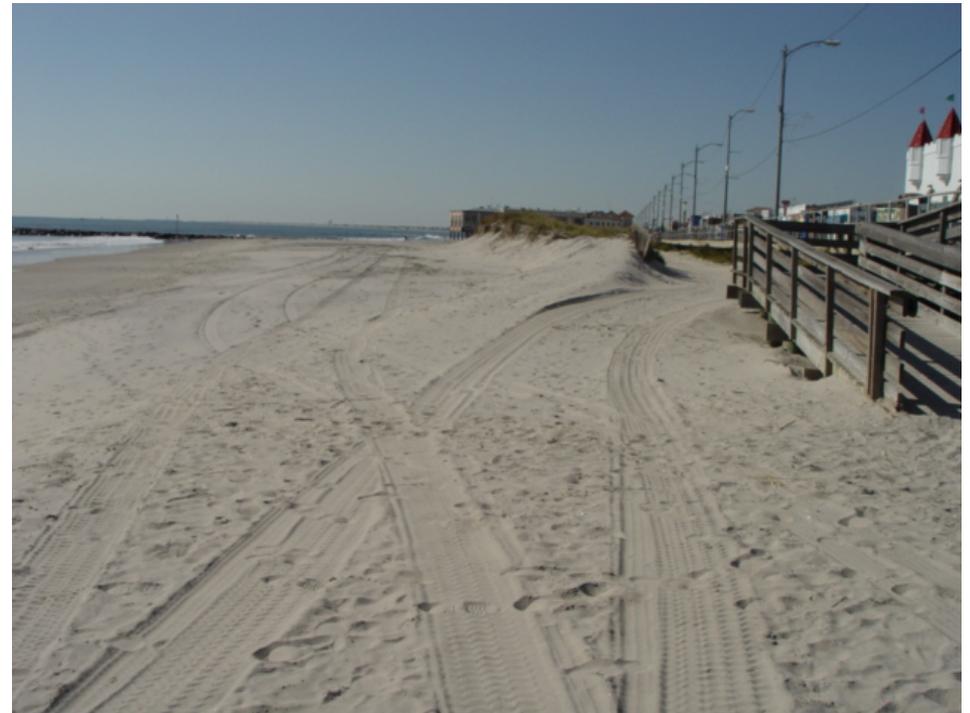
Figure 238. This view taken October 30, 2007, shows continued sand volume loss (-32.27 yds³/ft). The shoreline did not retreat significantly however, (+3.3 feet) as the material still present adjusted into a flatter gradient in spite of dune retreat of about 20 feet.

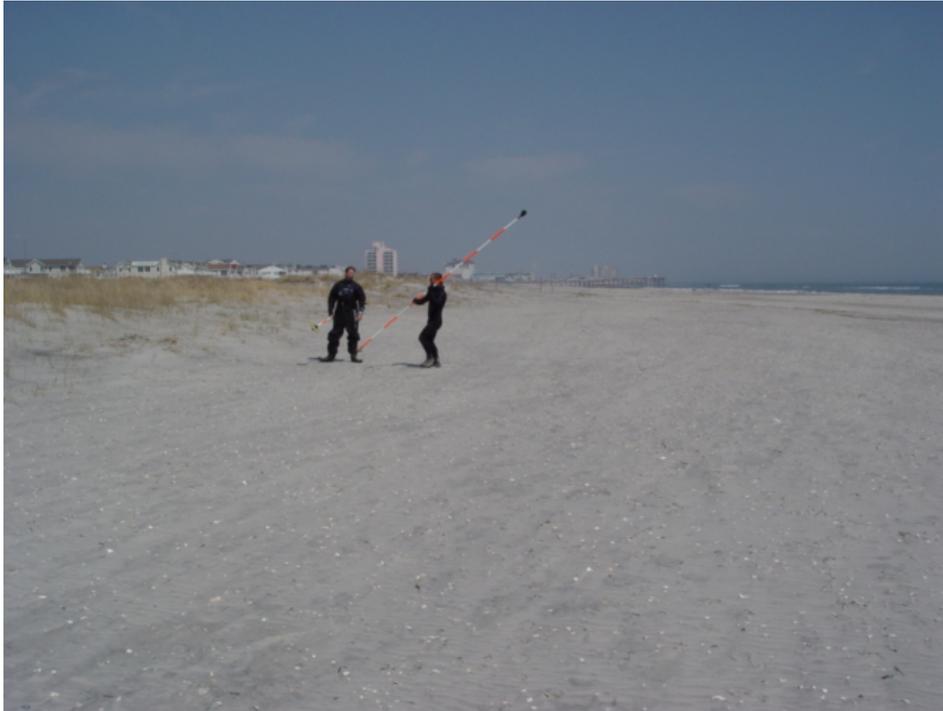
Figure 240. The 20th Street site lies in the middle of the Federal beach nourishment project, which extends to 34th Street. This position is ideal for stability since sand losses are always compensated by additions equally from either the north or the south. As a result, the dunes, beach and offshore has grown dramatically wider over the years since 1991. The success compared with the pre-initial construction situation is amazing since the high tide reached west of the boardwalk during the fall of 1991.

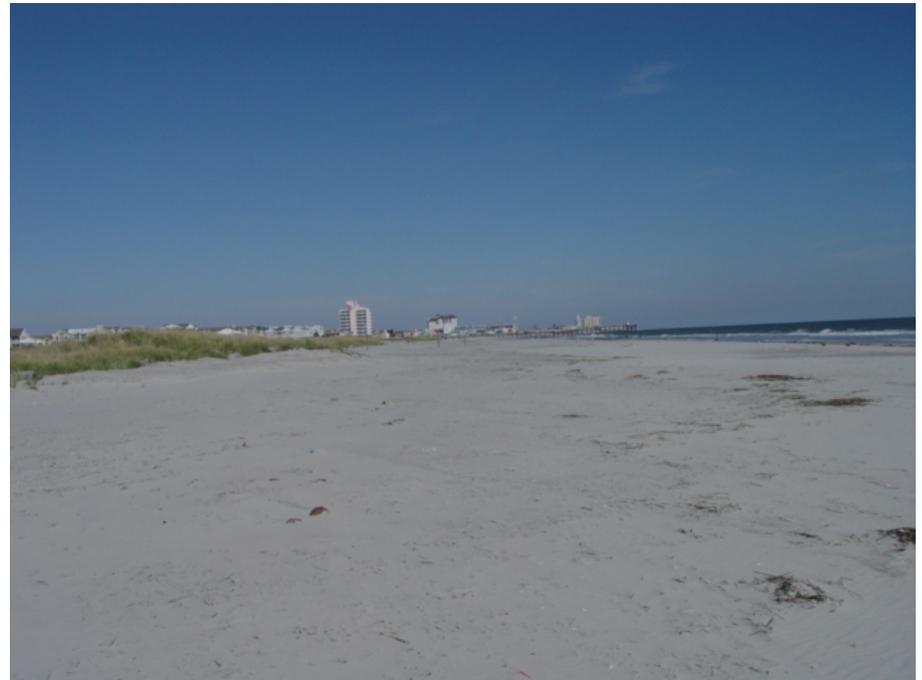
Figure 241. The October 2007 photograph shows little change over 18 months, but the shoreline actually retreated 42 feet accompanied by a 13.27 yds³/ft sand volume loss as a result of changes in the offshore bar.

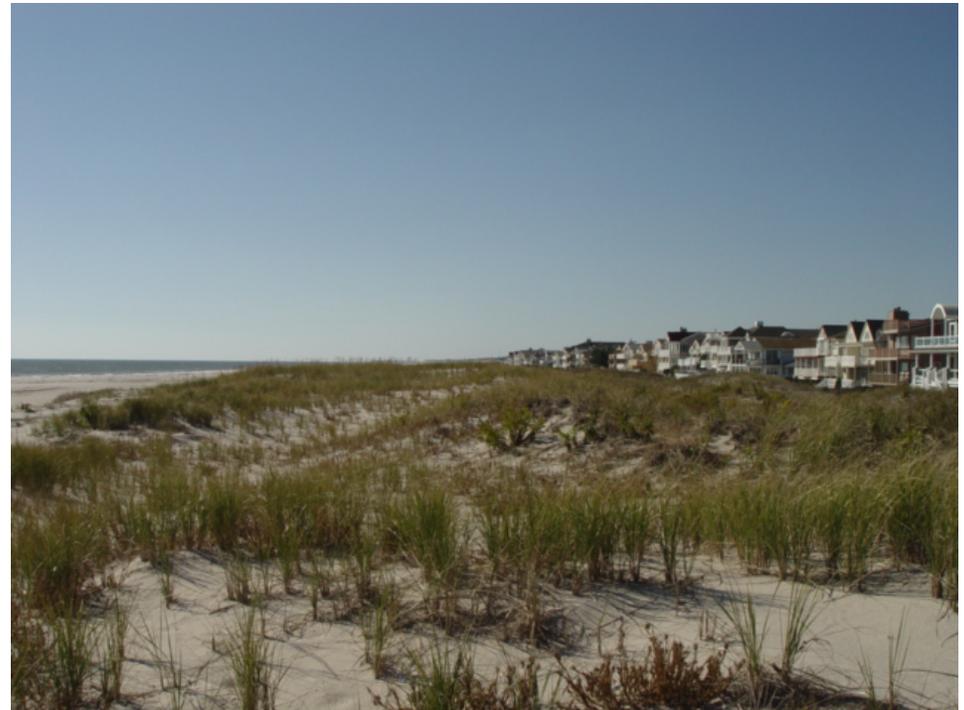
Figure 244. This view taken October 31, 2007, shows the dune between the development and the beach. This area is twice as wide as it was prior to beach restoration and provides a great measure of storm protection in spite of owner complaints that the distance is too great and the view of the ocean has been diminished. The shoreline has advanced 13 feet and the beach/dune system gained 23.75 yds³/ft.

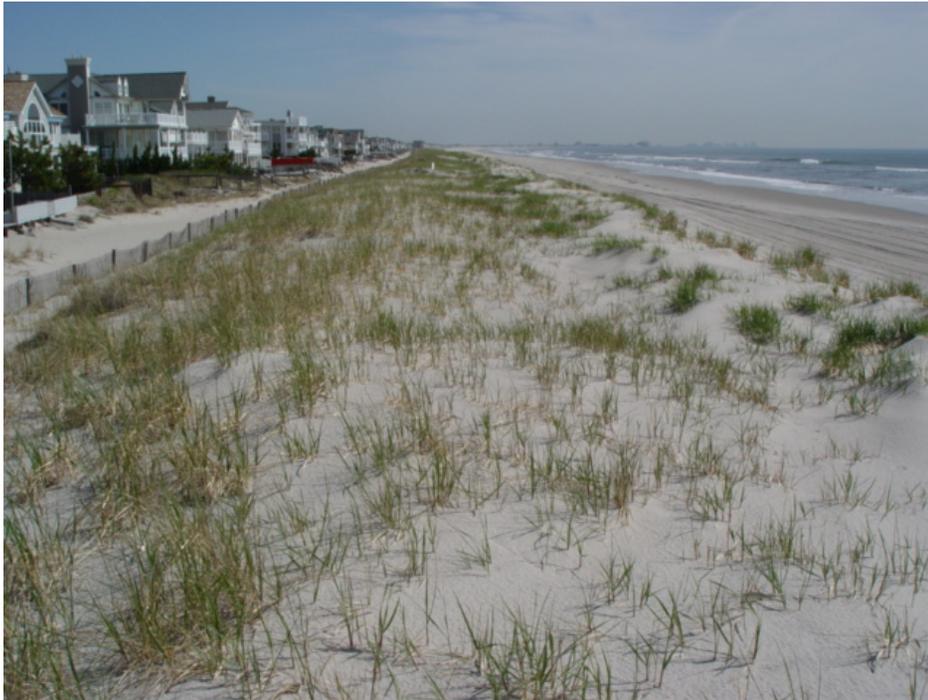
Figure 246. This photograph is a view to the north along the dune crest at 56th Street taken April 27, 2006. The beach replenishment from 34th Street south was initiated by the State of NJ in 1995. This dune has increased in size and presents a significant barrier to storms. Note the ridge at the seaward edge of the vegetation where recent sand blown from the beach has accumulated in a new foredune.

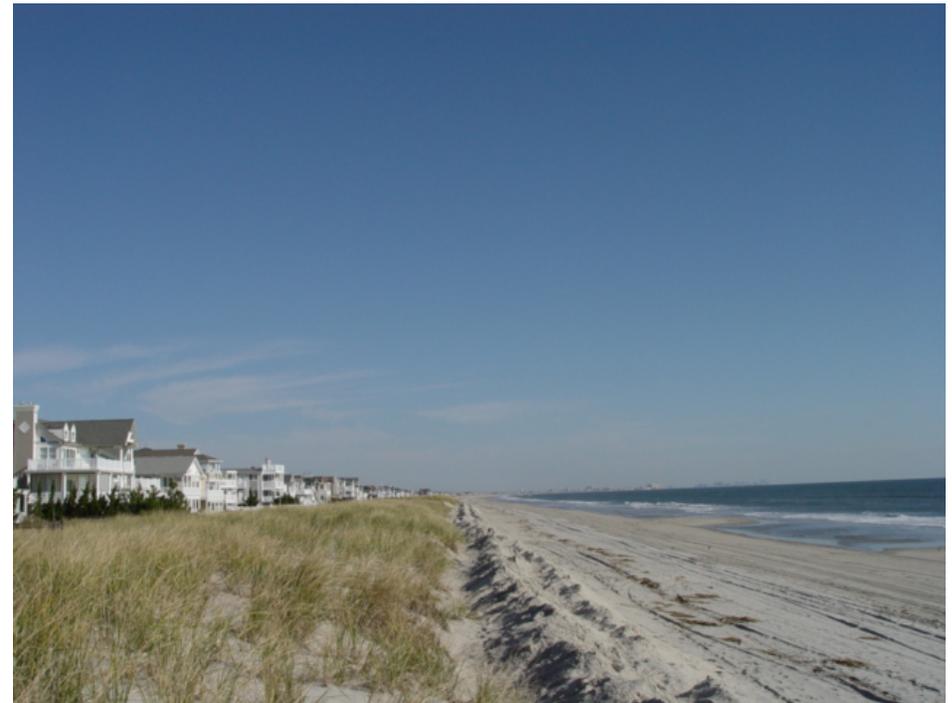
Figure 247. By October 31, 2007 the beach had suffered an erosional event sometime prior to the fall 2006 survey. The fall survey followed tropical storm Ernesto by just a few days. That survey showed the removal of the little foredune ridge and the presence of a scarp at the toe of the original dune. The new ridge in the photograph to the right was created with the bulldozer following the summer accumulation of sand near the toe of the scarp on the beach. The comparison between April 2006 and October 2007 was one where the sand volume had decreased by 1.10 yds³/ft, while the shoreline had advanced by 20 feet. This is a narrow beach, but the net change was essentially zero in spite of the minor erosional event in the fall of 2006.

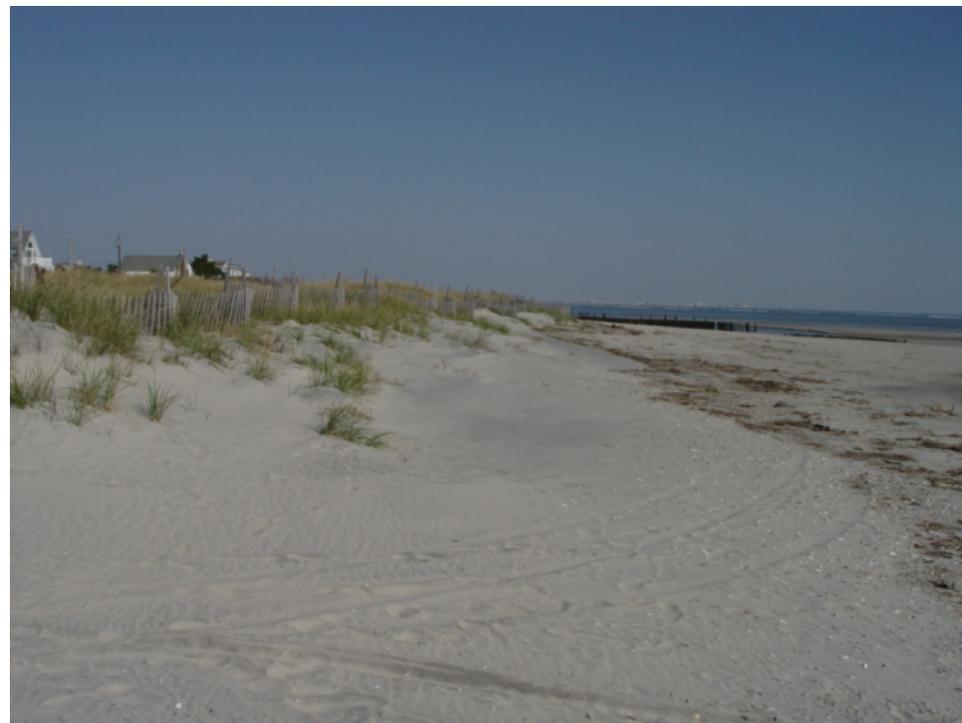
Figure 250. The view to the right was taken November 5, 2007 and shows swash effects to the toe of the seaward slope in the dune. However, the comparison of the beach between June 2006 and November 2007 found 141.35 yds³/ft of new sand deposited on the dune and in the shallow offshore as a pair of huge offshore bars migrated to the shoreline. The shoreline advanced 38 feet as a result of the addition of sand to the berm. This survey followed a minor northeast storm and became convincing evidence of serious erosion taking place about 500 feet north up to the inlet channel during the remainder of that winter.

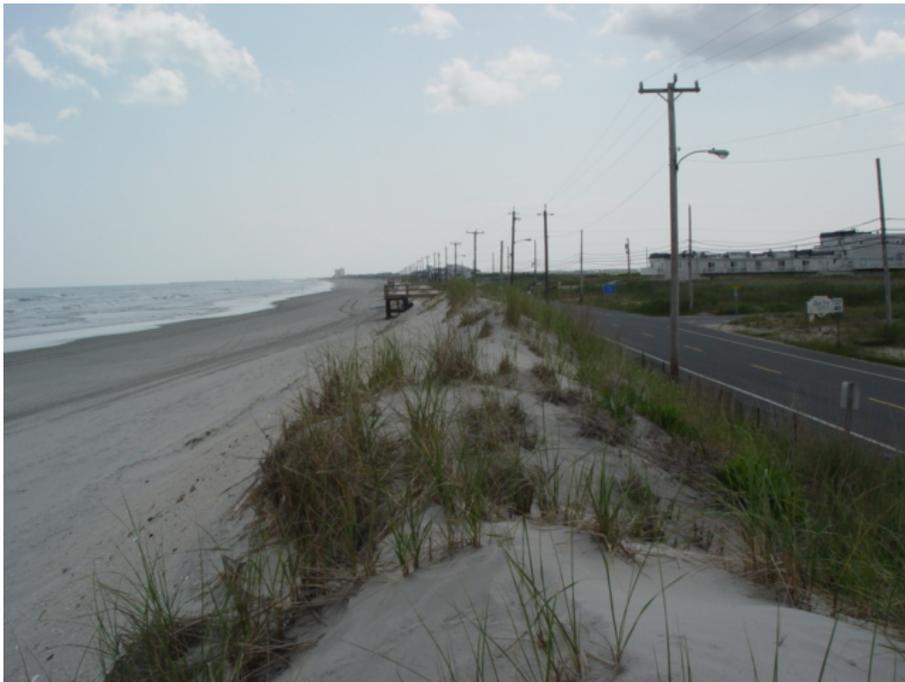
Figure 252. Located at the northernmost part of Sea Isle City, this site is known for its narrow dune, low elevation beach and limited sand supply (June 6, 2006). The dune to the south is cored with a 10-foot diameter geo-textile tube that replace other core materials in 1998 following storm destruction of most of the dune system south of this site. Since then the County has maintained the foredune slope by bulldozing sand from the beach back up to the exposed geo-textile structure each time a minor storm carves away the veneer of sand covering this feature. Thus far, it has withstood the minor events with out serious overtopping or a breach.

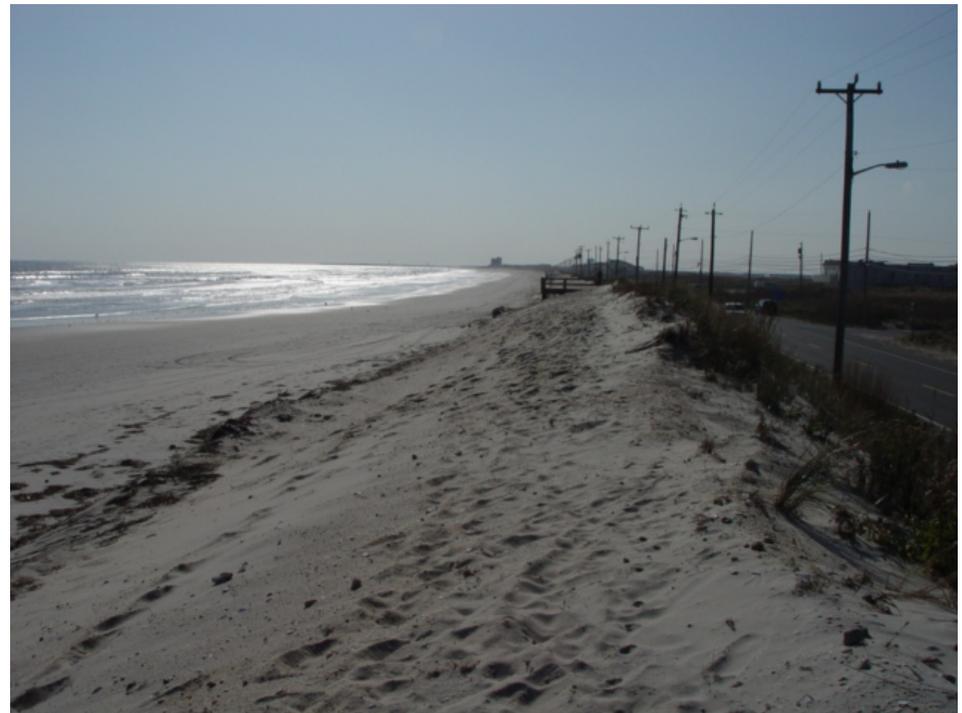
Figure 253. The photograph to the right was taken November 5, 2007 following a minor northeast event that reached the toe of the dune and exposed the textile fabric further south. Between the two dates the beach changed very little (1.81 yds³/ft, with a 10-foot shoreline advance). Storms have substantial impact on the dune and a major event will overtop the geo-textile core pushing sand onto the highway once again.

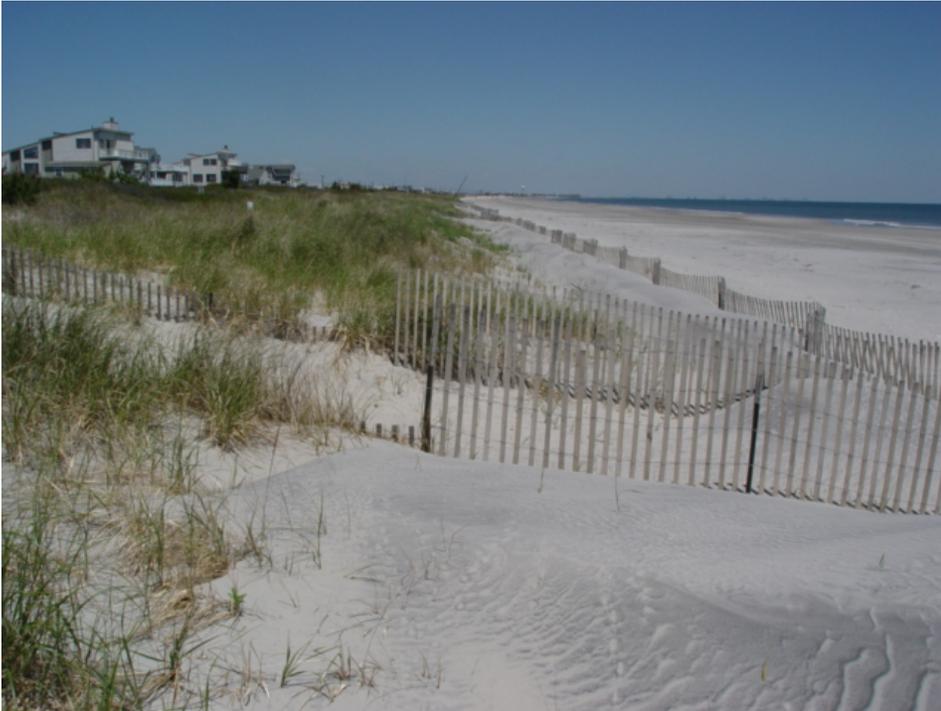
Figure 255. A view to the north from 25th Street showing a nice accumulation of new sand along the dune toe fencing by May 23, 2006. The dune system is wider and healthier this far south into Sea Isle and affords greater protection from storms.

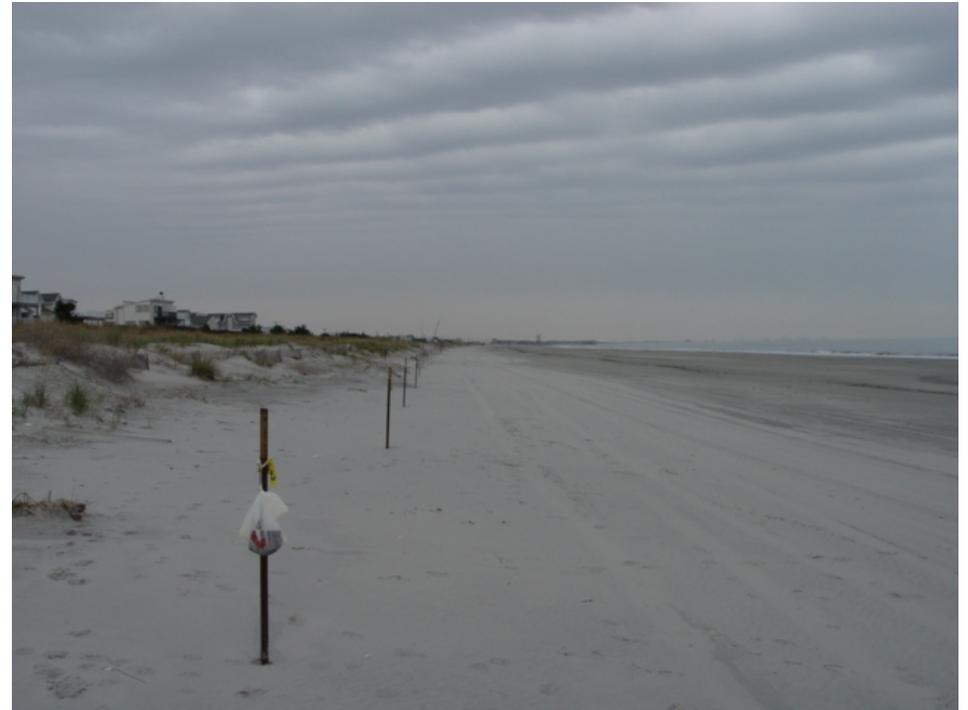
Figure 256. This view taken November 9, 2007, shows the impact of minor storms. The dune fencing placed at the toe of the slope was destroyed. This is why putting this relatively fragile, yet effective sand trapping fencing about half to two-thirds the distance up the seaward dune slope allows the fence to trap sand, but remain unaffected by small storms. The naked posts on the right are testimony to the costs associated with placing fencing too far seaward at a low elevation. Over 18 months the beach lost 10.87 yds³/ft., but the shoreline advanced 26 feet seaward.

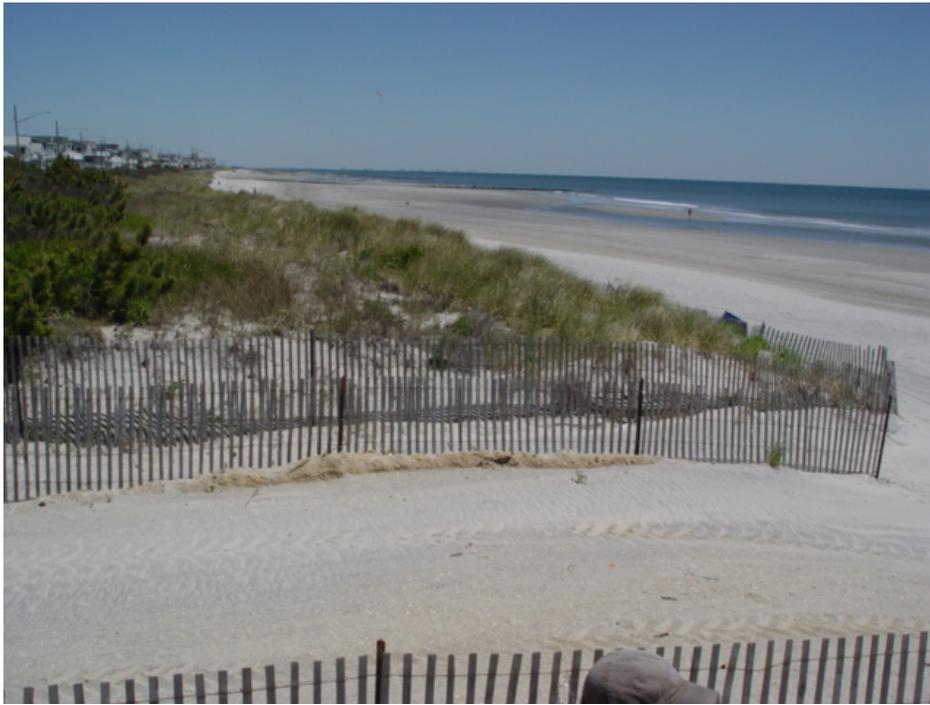
Figure 258. Located in the center of the tourist district of Sea Isle City, the promenade is positioned on the landward slope of the dunes. There is a reasonably wide beach so that this dune is unaffected by modest storms. There are repeated groins from north of this site south to Townsend's Inlet to slow the southerly transport of sand. It has been nearly three decades since sand was pumped onto this beach. The photograph was taken May 23, 2006.

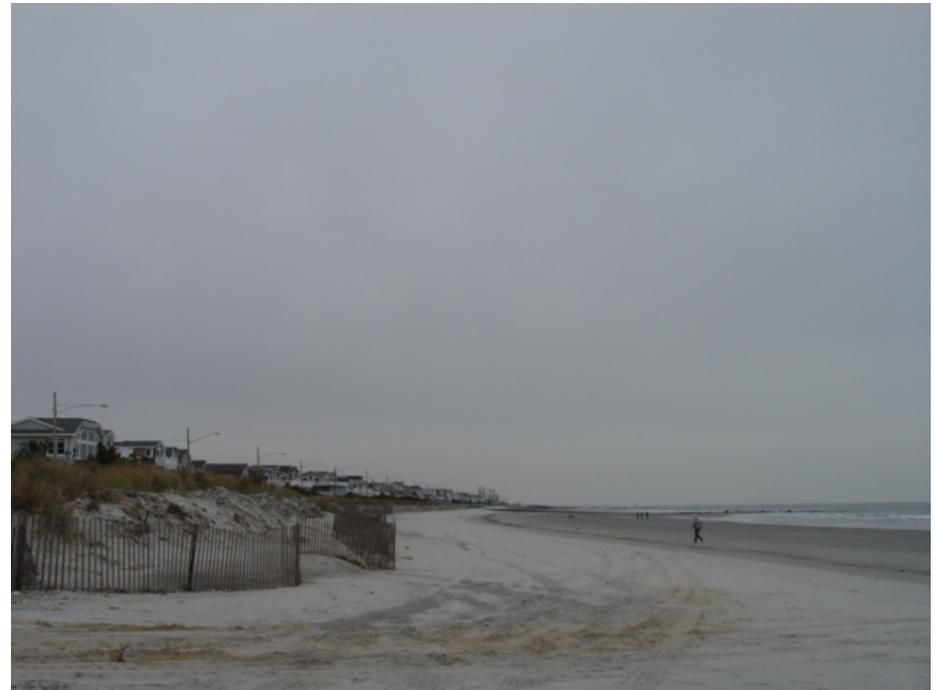
Figure 259. The photograph to the right was taken November 9, 2007 and shows the groins to the north and a curve landward on the beach. There were few significant changes over the past 18 months (8.55 yds³/ft. gain in beach volume with a 13-foot shoreline retreat).

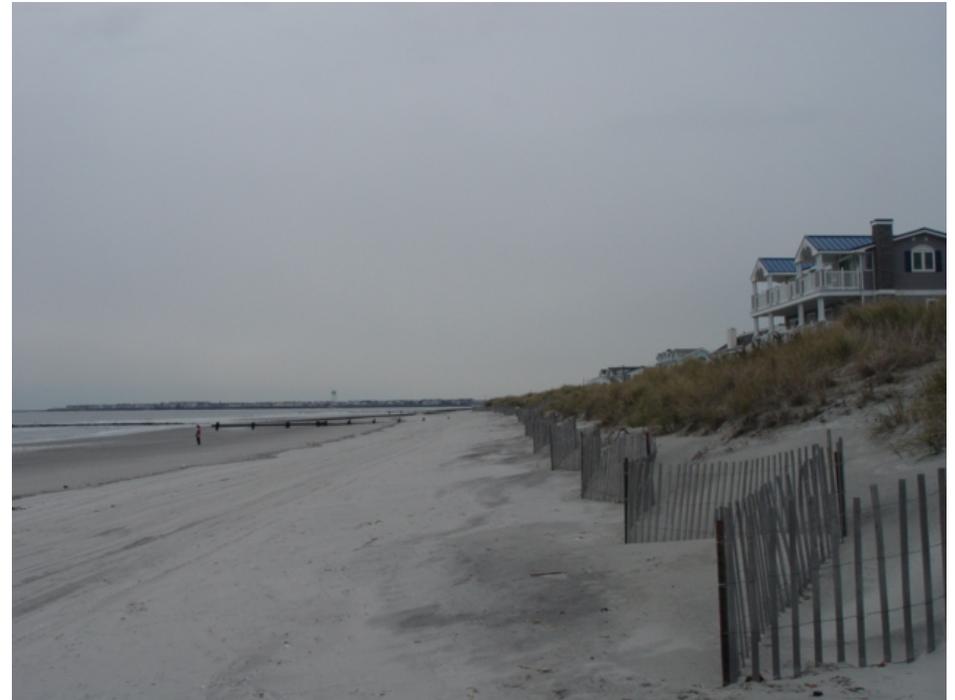
Figure 262. By November 9, 2007 the sand fencing had been replaced with a zigzag pattern in an up-slope position on the seaward dune profile. The structure in the foreground on the beach is a storm water outfall pipeline, not a groin. The Borough of Avalon is the distant skyline showing the barrier island offset at the inlet. The beach lost a minimal 2.44 yds³/ft. with a minuscule shoreline advance of 0.27 feet.

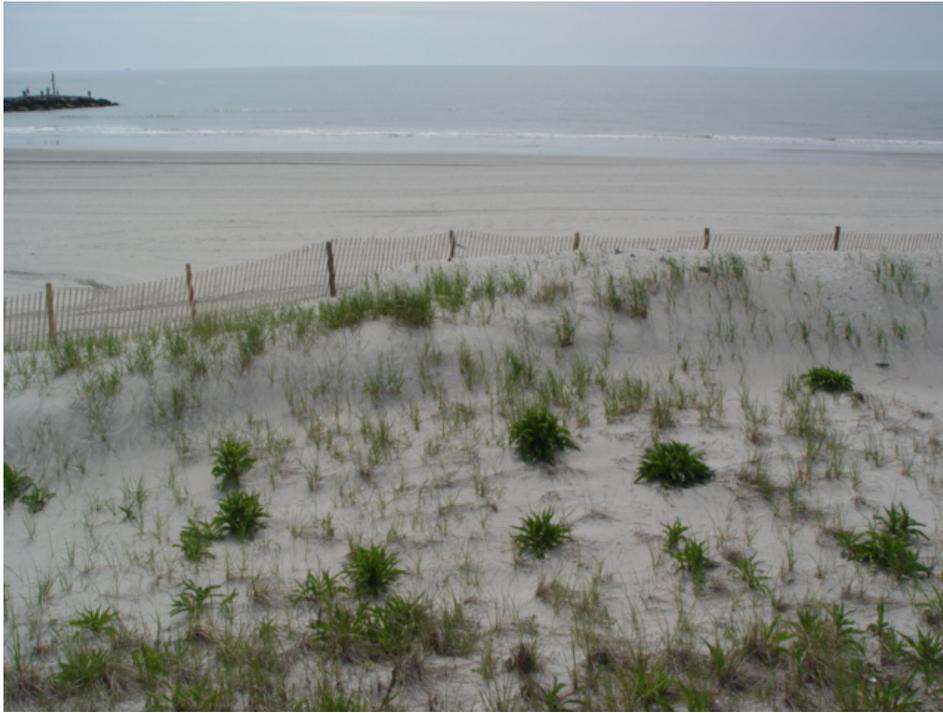
Figure 264. 9th Street in Avalon is position only 500 feet south of Townsend's Inlet. There is a rock jetty protecting the shoreline along the inlet, however, the structure provides northeast wave protection for this beach. Sediment loss ramps up to the south from this site, but the jetty does prevent serious erosion from here north. The photograph was taken May 25, 2006.

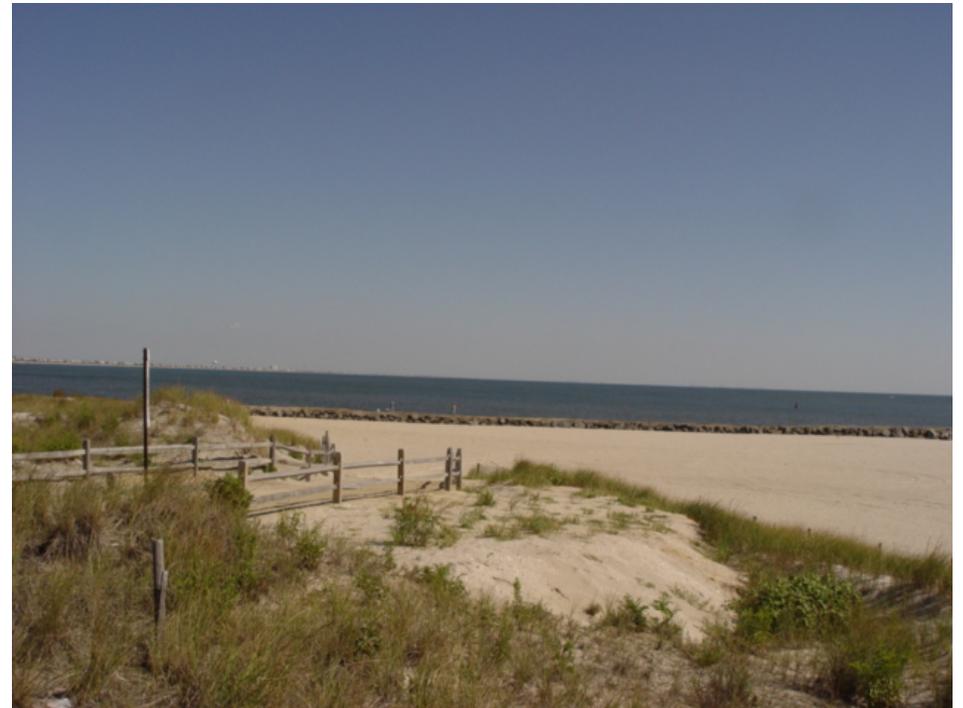
Figure 265. The photograph to the right was taken November 12, 2007 and shows the dunes and a view across the beach to the Townsend's Inlet jetty. This wide area is retained by the jetty and acts as a buffer for the northeast corner of the municipality. Over the study interval the sand volume increased by 6.79 yds³/ft. and a shoreline advance of just 2 feet. One minor sand deposit has been hydraulically pumped onto this shoreline since the 2004 Federal project was completed. Avalon did move sand back to northern beaches in 2006 using both a minor dredge project and truck-hauled back passing of about 53,000 cy. In 2007 a small 80,000 cubic yard addition was made using quarry sand hauled to the beach by truck.

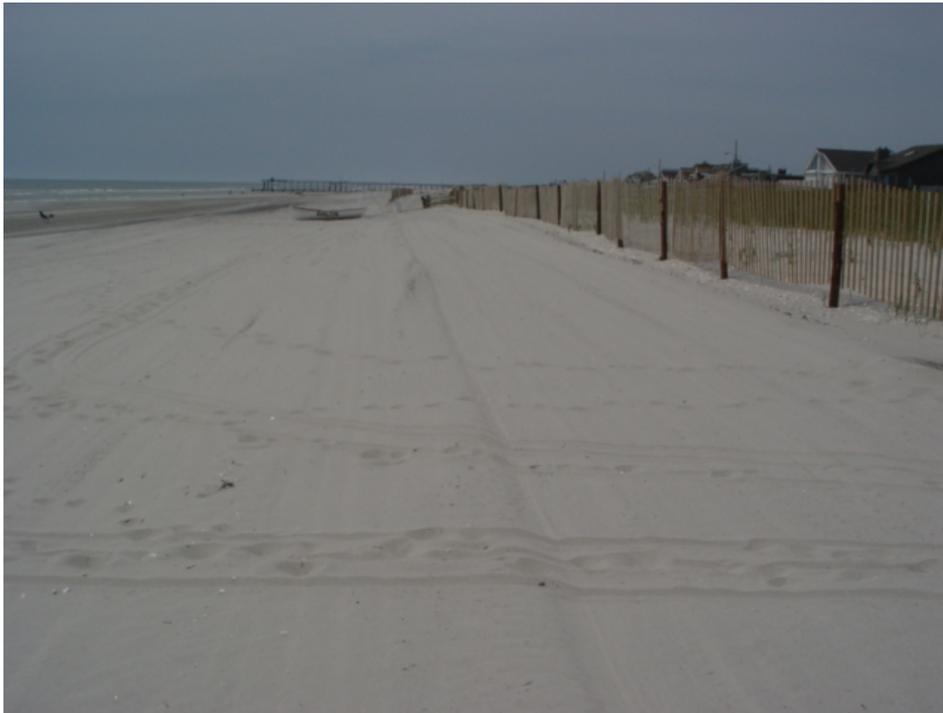
Figure 267. Looking south from the 23rd Street site the beach and fence are new from the recently completed back passing of 55,000 cubic yards of sand from the mid-island beach. Trucks hauled the sand back and placed in it a huge ridge that was graded into the profile shown as survey 32. The picture was taken May 25, 2006.

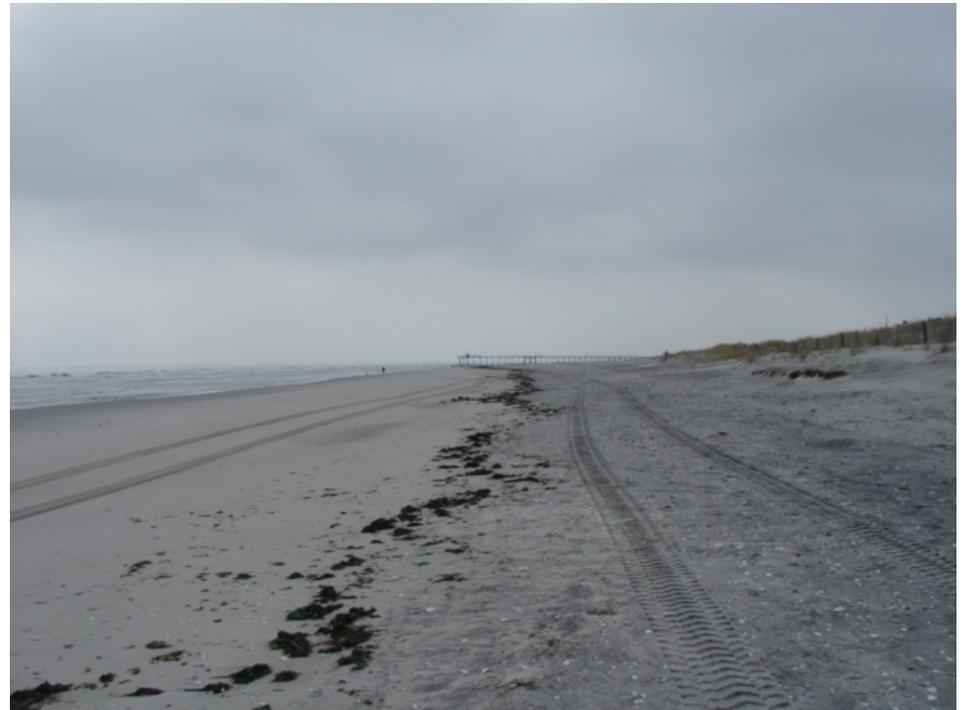
Figure 268. This view taken November 12, 2007, shows the same scene 18 months later as the beach lost material between September 2006 and November 2007. The net loss was 41.09 yds³/ft. with a 65-foot shoreline retreat. This loss rate was similar to that seen over the past 15 years.

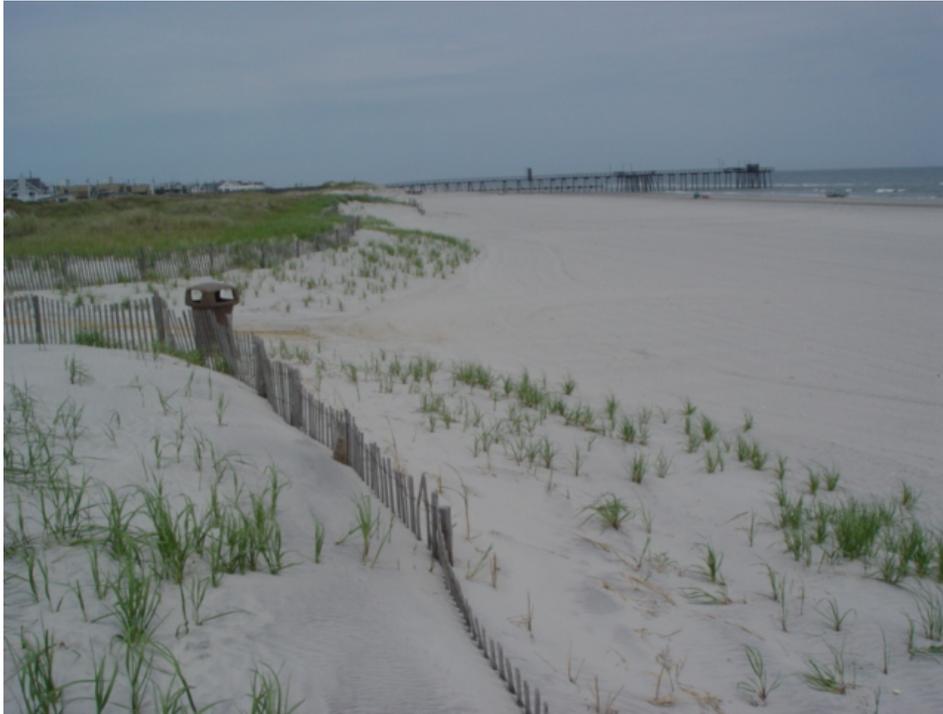
Figure 271. The photograph to the right was taken November 12, 2007 with a view to the north along the dune toe. Change over the past 18 months was in the form of oscillation in the position of the shoreline between the present and survey 34 the previous spring. The beach volume declined by 7.59 yds³/ft., but the shoreline advanced 20 feet.

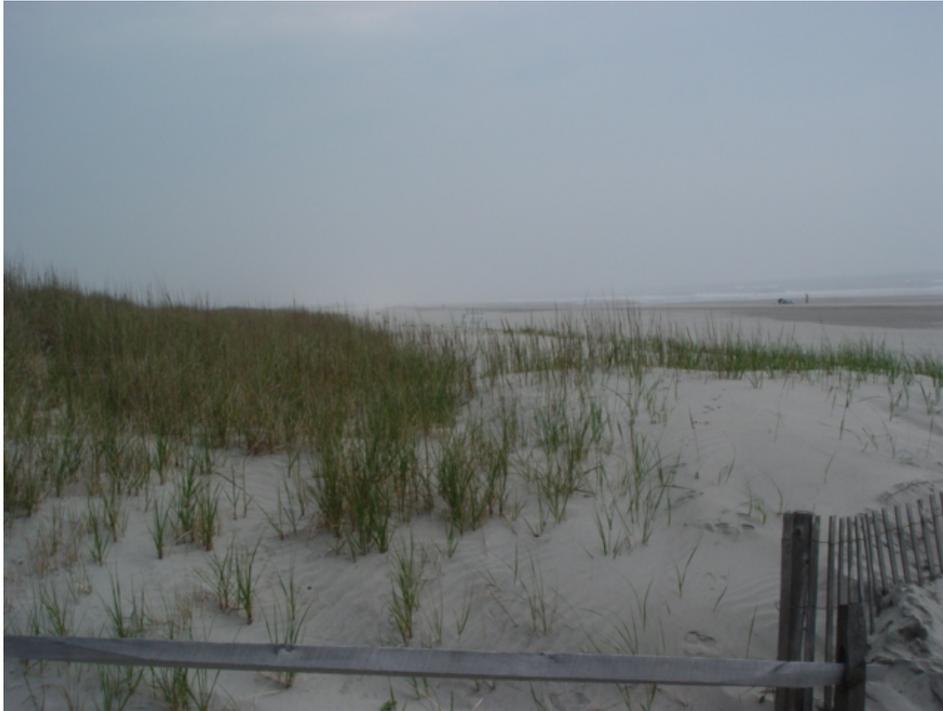
Figure 273. May 26, 2006 shows the beach seaward of a large dune system that has grown substantially over the past 20 years. The site continues to gain a marginal quantity of sand as material is cycled between the beach and the offshore bar system.

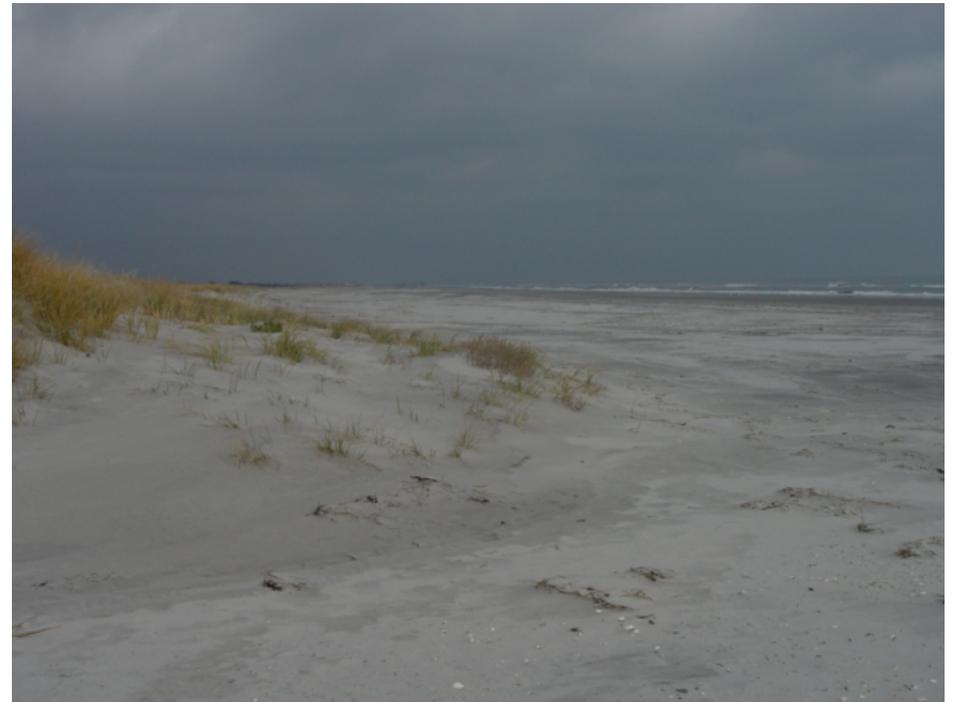
Figure 274. By November 14, 2007 the beach was only 1 foot wider to the zero elevation position with 6.32 yds³/ft. additional sand on the profile. Sand accumulated at the dune toe, but the beach remained constant.

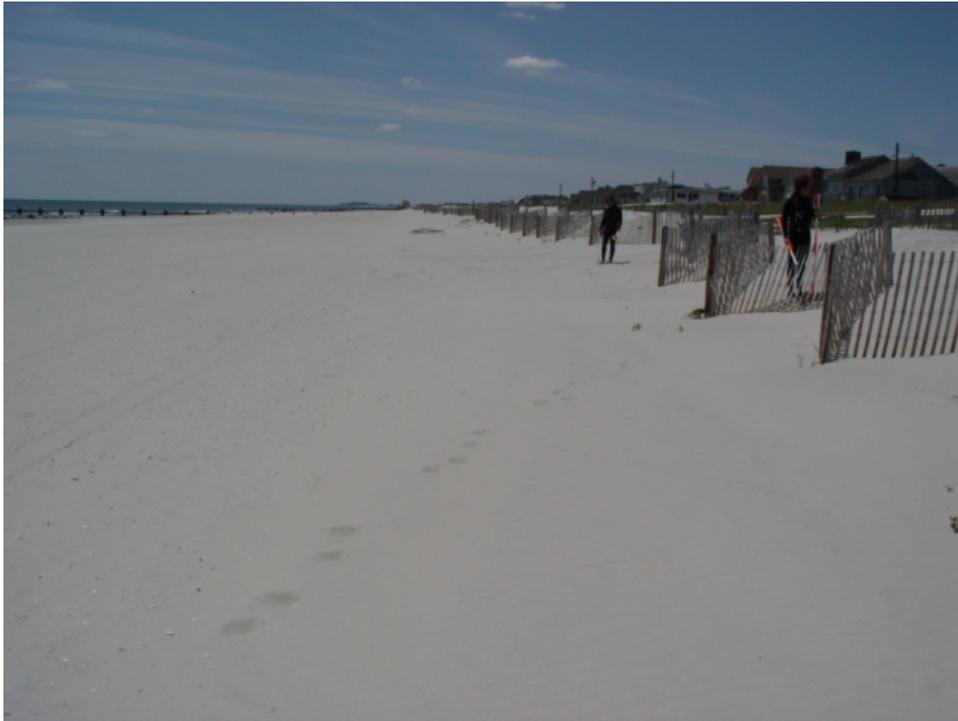
Figure 276. Stone Harbor completed a NJ State and local beach fill in 1997, followed in 2004 by a Federal, State and local project that covered all the beaches on the barrier island except the accretional zone in the middle of the island. This May 22, 2006 picture shows a reasonable width of beach extending up to a recently fenced dune toe.

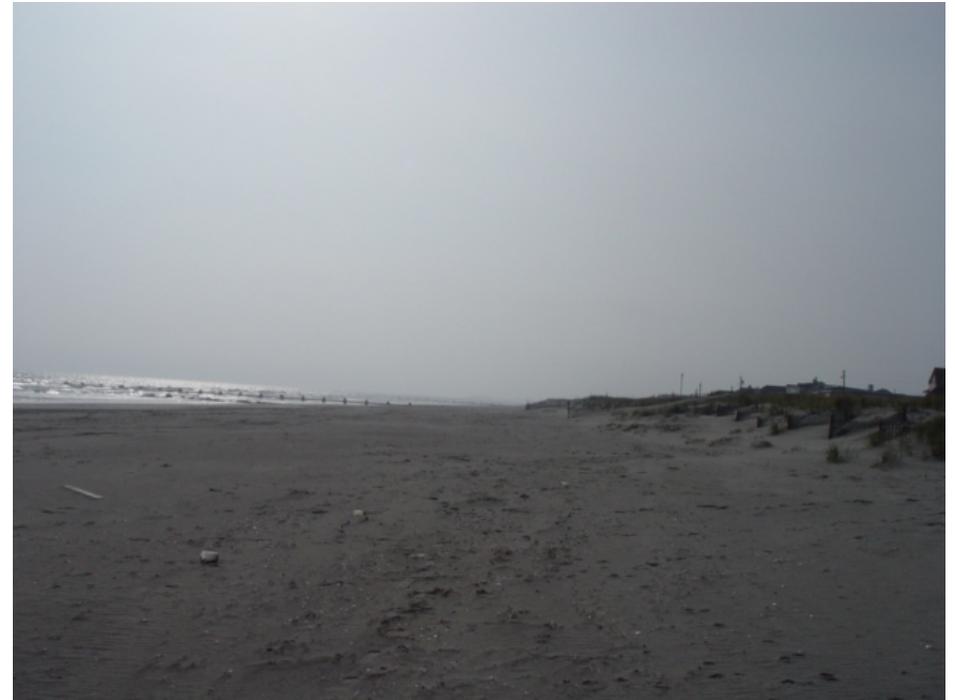
Figure 277. The change in this site between May 2006 and November 14, 2007 was growth in the dunes, retreat in the beachface, and continued migration back and forth of the offshore bar. The net change was a small loss of 4.13 yds³/ft., with a 5-foot retreat in the shoreline position.

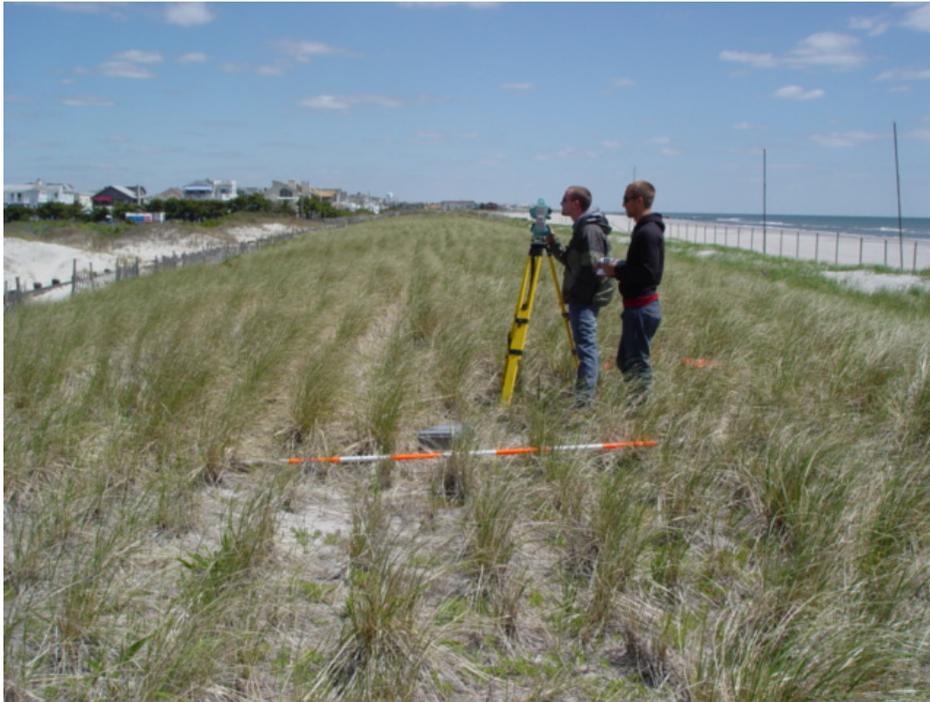
Figure 279. The dune at the south end of Stone Harbor was developed during the 2004 Federal beach restoration project. Positioned seaward of the revetment rocks that reside just in front of the bulkhead just visible at the extreme left of the left hand photograph taken May 22, 2006. The beach remains reasonably wide in spite of some retreat due to the retaining effect of the terminal rock groin along this shoreline.
